Building and Timber Pest Inspection Report

Inspection Date: Fri, 16 Jan 2026

Property Address: 17 Price St, Bowral NSW 2576, Australia

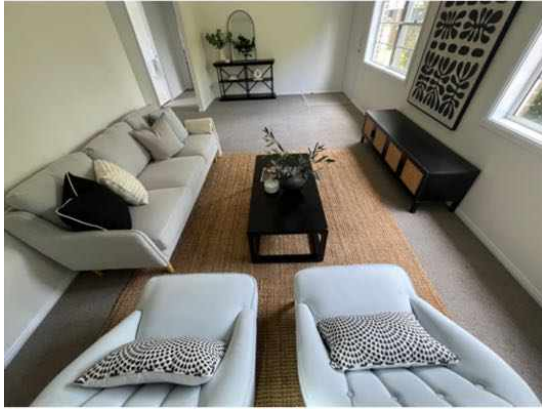
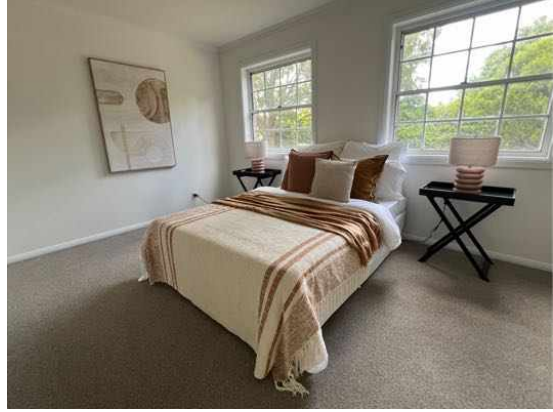
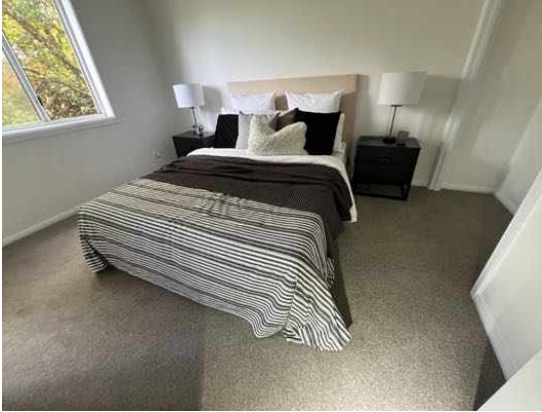
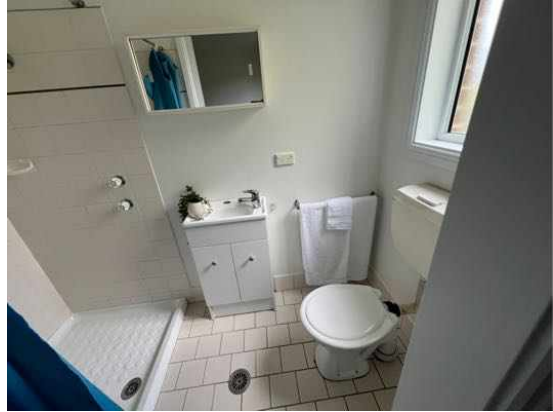
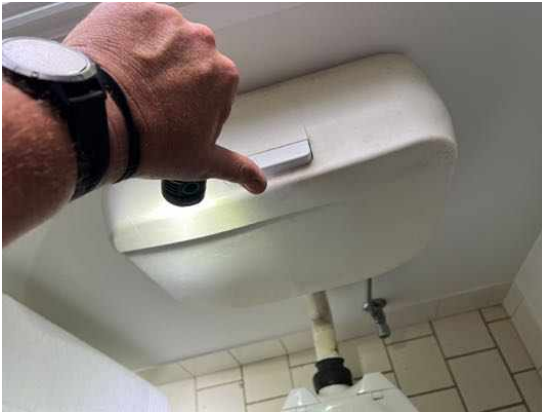
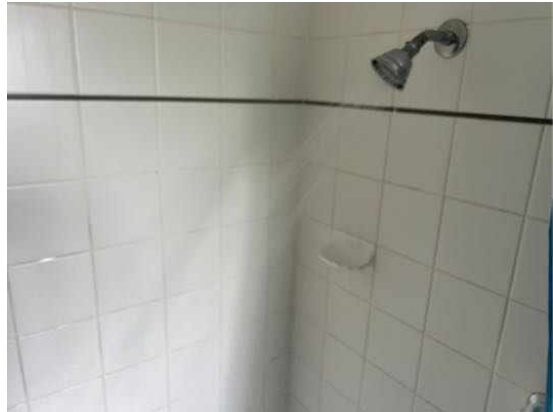
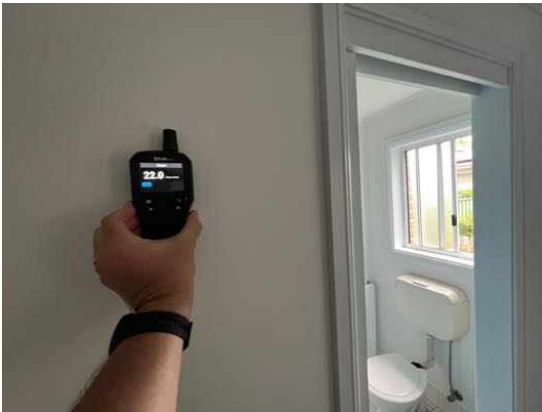
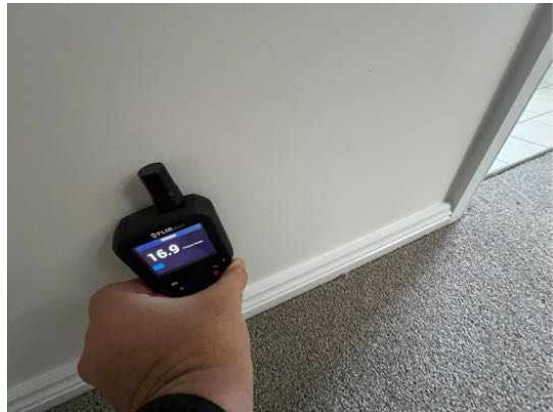
Finding: FYI - Additional Photos

Information: Additional photos are provided for your general reference and may include obstructions, testing of water & windows, moisture readings or minor maintenance items.

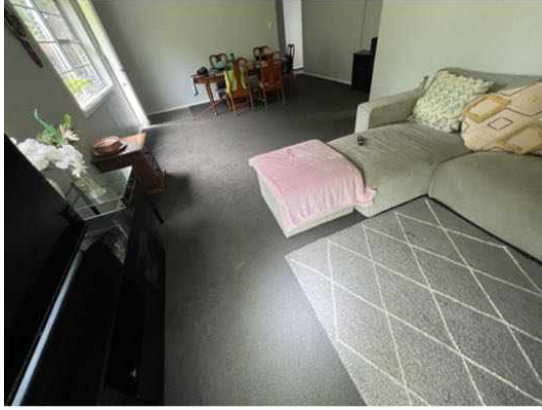
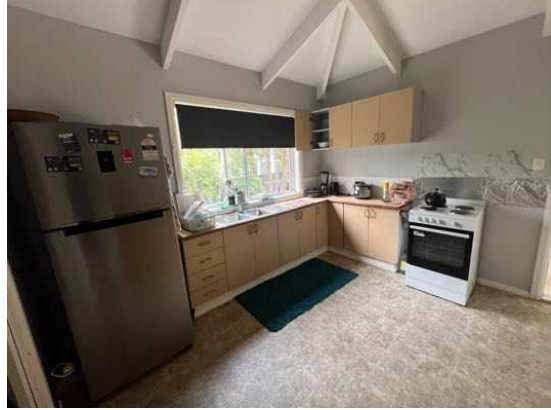
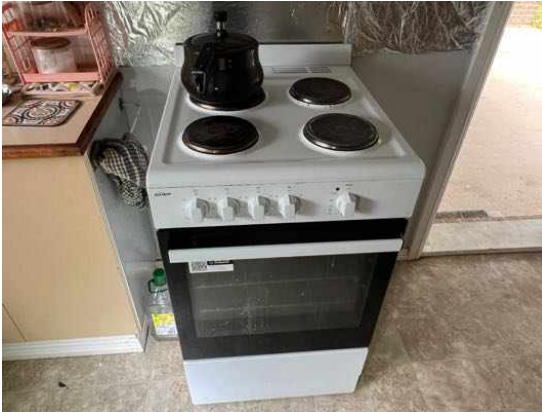
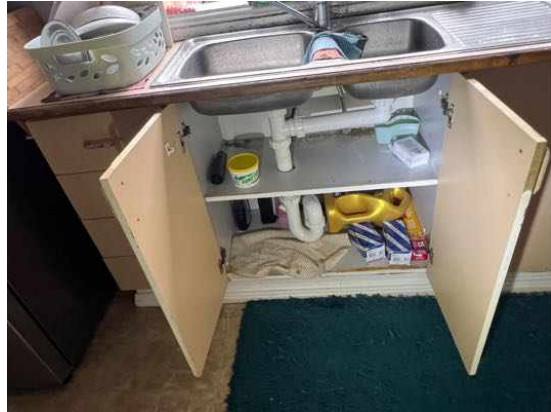
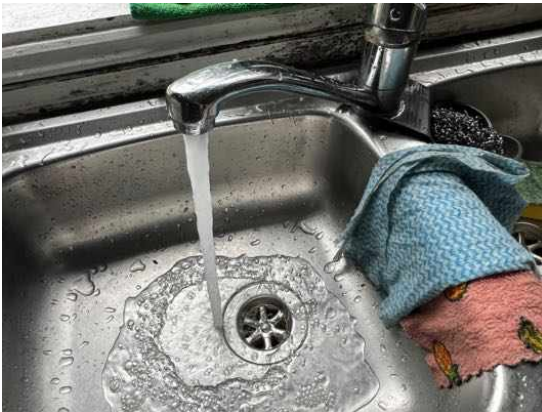
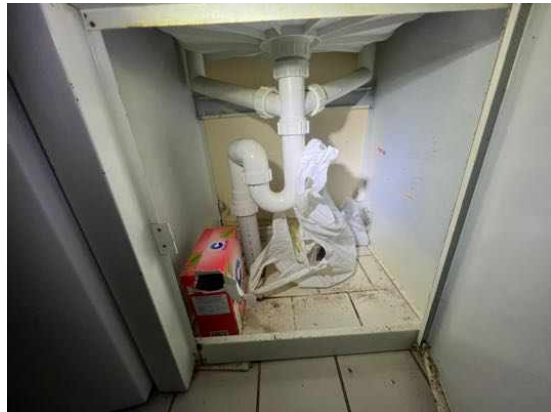
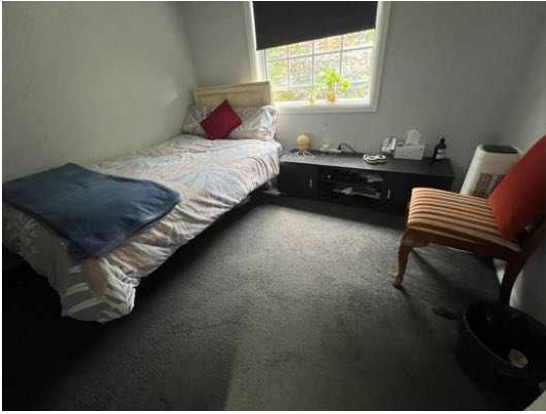
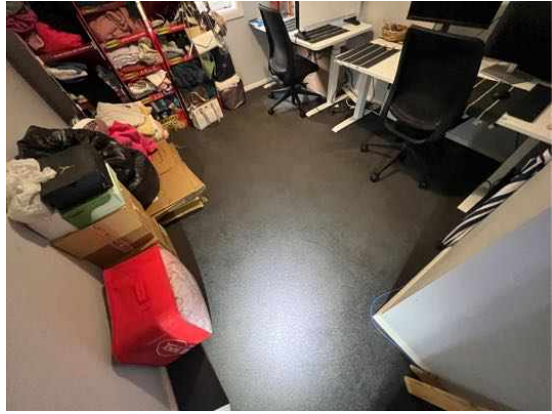
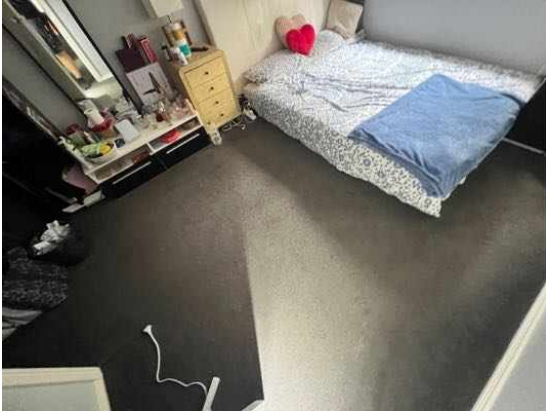
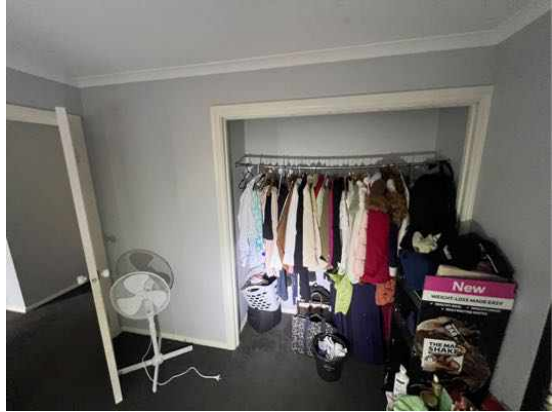
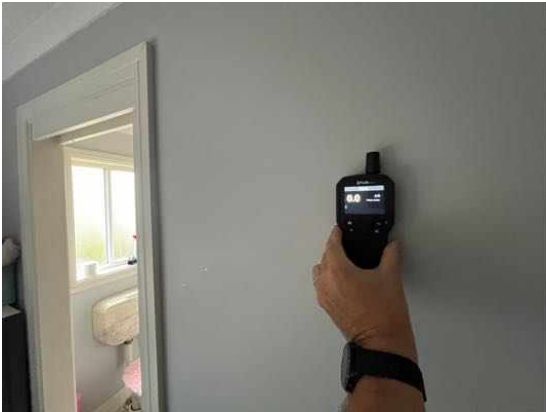
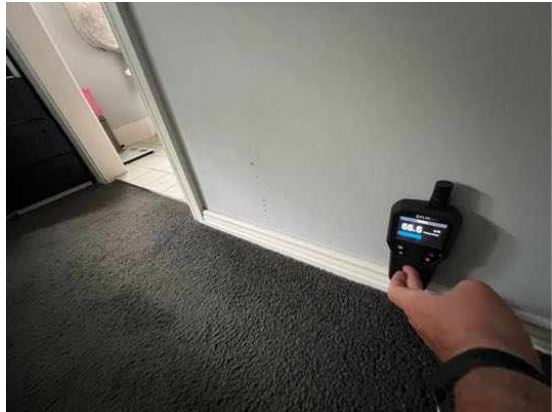
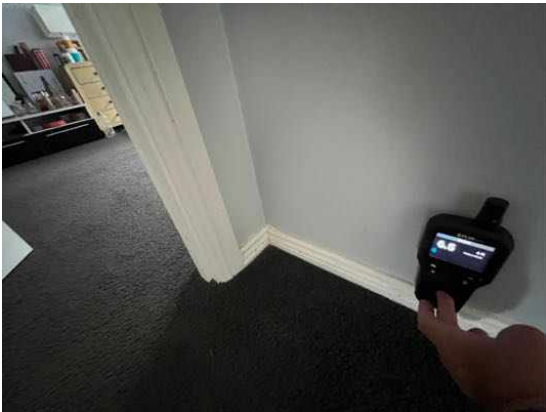
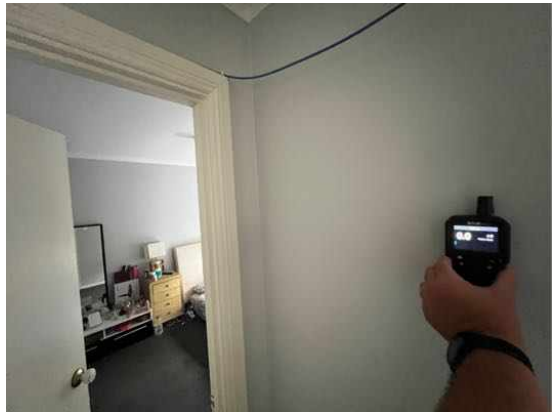
Noted Item

Building: Building 2
Location: 17B
Finding: FYI - Additional Photos
Information: Additional photos are provided for your general reference and may include obstructions, testing of water & windows, moisture readings or minor maintenance items.
