Building and Timber Pest Inspection Report

Inspection Date: Tue, 17 Mar 2026

Property Address: 38 Westminster Dr, Castle Hill NSW 2154,
Australia

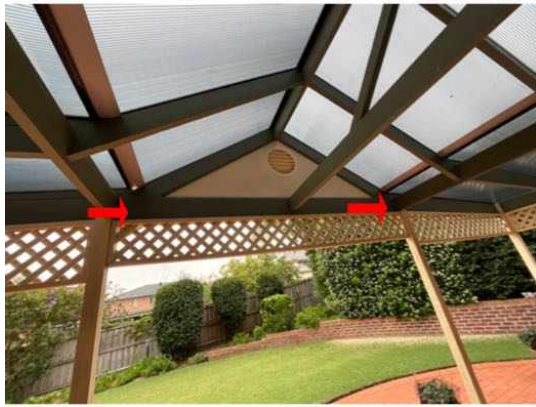
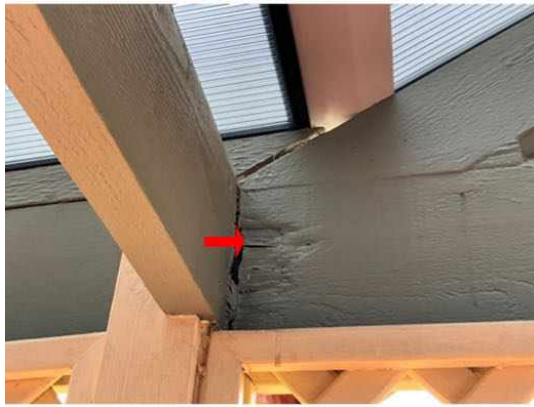
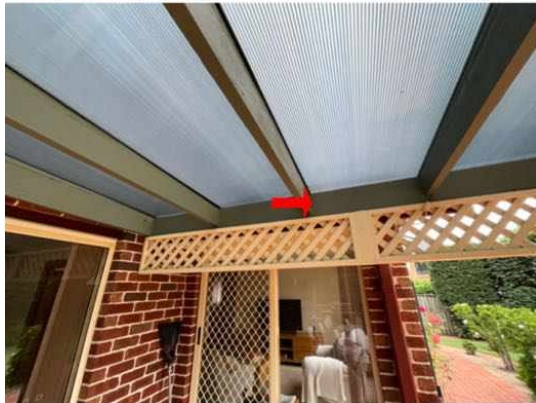
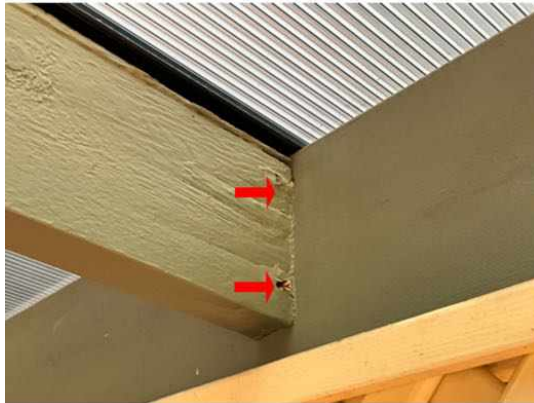
Finding: Wood decay / Rot

Information: This building element shows evidence of severe wood rot. Wood rot, also known as Fungal Decay, occurs when timbers and other cellulose building materials are exposed to damp conditions on an ongoing basis. This could be the result of exposure to weathering over a prolonged period of time.

If left unmanaged, damp conditions can lead to further health problems and the decay of timbers will continue.

Severe timber rot was identified to the alfresco timber structures. Immediate replacement must be carried out by a licensed carpenter to ensure further deterioration is stopped and hence prevented from collapse.

Early intervention and regular maintenance, particularly of exterior timbers, will prolong the useful life of these building elements. Prior to any works being performed, the cause of the moisture that has created the visible wood rot should be identified and addressed in a suitable manner. A licensed roof plumber should be appointed for this work. Replacement of affected timbers by a licensed carpenter is then a necessary step in protecting surrounding building elements from such deterioration.

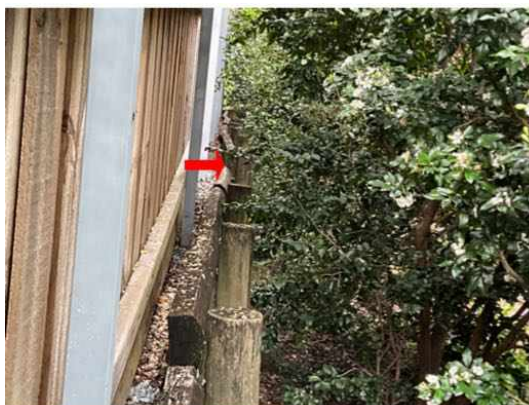
Building:	Main Building
Location:	Retaining Walls
Finding:	Timber retaining wall — Defective
Information:	The retaining wall in this area was found to be defective at the time of inspection. Generally, defective retaining walls are caused by poor original design or material use. However, deteriorated retaining walls may also be a result of substandard construction, poor site drainage or unmanaged stormwater flows.

Where retaining walls further rot and decay, an environment is created that is conducive to termite and pest infestation.

The structural engineer may draft a scope of works for a licensed trade to carry out

rectifications.

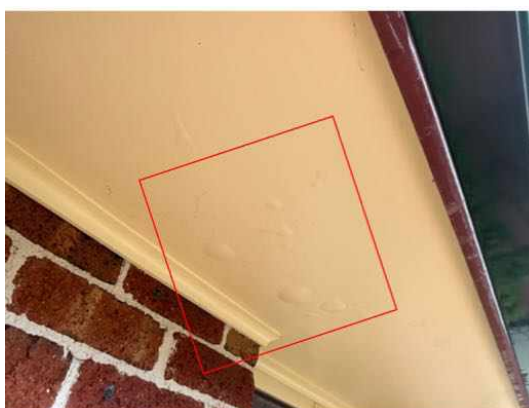
Finding 3.02

Building:	Main Building
Location:	Rear right corner
Finding:	Painted surface — Bubbling
Information:	Sections of paint in this area was found to have bubbled and deteriorated. Paint bubbling is generally an indication of excessive moisture in the area, that is currently hidden by the painted surface.

The presence of excessive moisture can have major implications on associated building elements if left unattended. While only seemingly minor at this stage, the damage cannot be determined due to the paint obstructing any further inspection of the damage.

A possible cause could be overflow of stormwater from the gutters due to gutters being blocked. It is highly advised that the affected paint be cleaned to allow a further, more invasive inspection by a licensed roof plumber. Failure to act on this defect may necessitate major works in the future.

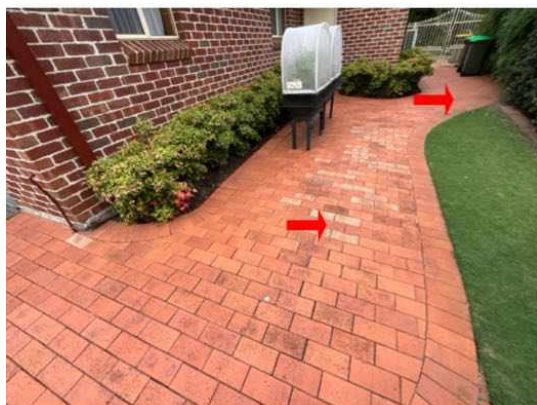
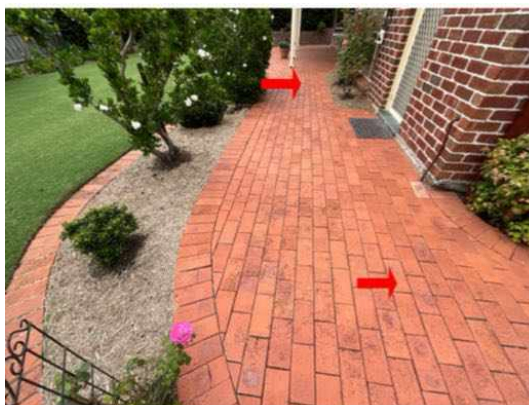
Finding 3.03

Building: Main Building
 Location: Multiple areas
 Finding: Paving — Uneven
 Information:

Sections of the external paved area are uneven, which may develop into a trip hazard. It appears as though the area has been subject to rough installation, or that paving sections have lifted due to movements in the foundation.

Left unmanaged, the May develop into a safety hazard due to trip and fall.

Re-paving of the area is required to remedy this situation. Further consultation with a specialist concreter is advised.

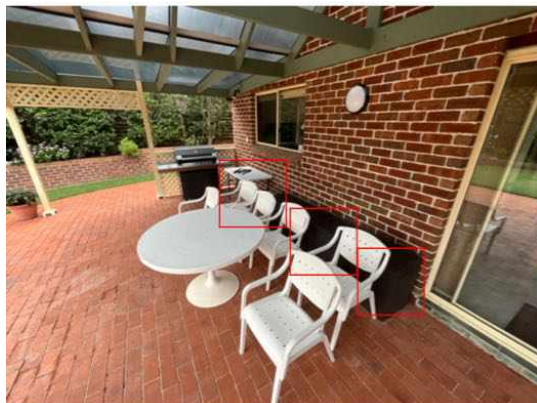
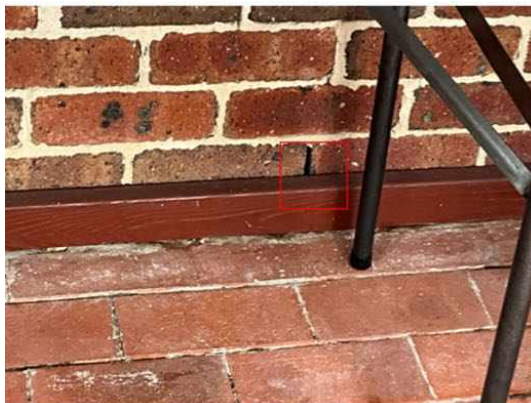
Weep holes in the exterior brickwork of the property are designed to allow condensation that may build up between the brickwork and subsequent timber framework to drain from within the wall hence preventing any deterioration of the timber building elements.

Additionally build-up of moisture is likely to occur if weep holes are covered further attracting termite activity to these areas.

It is highly recommended that weep holes are left exposed in all areas throughout the external property. Therefore if any termite activity leading into weep holes becomes easily detectable during frequent pest inspections.

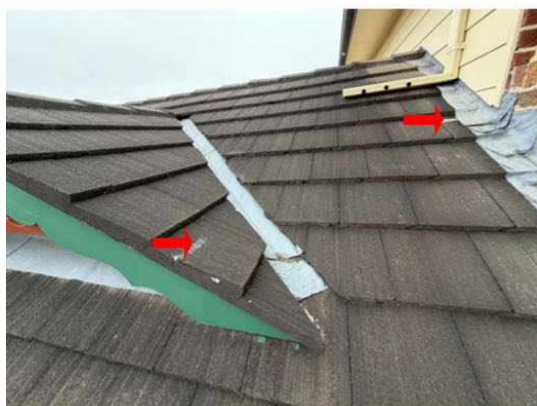
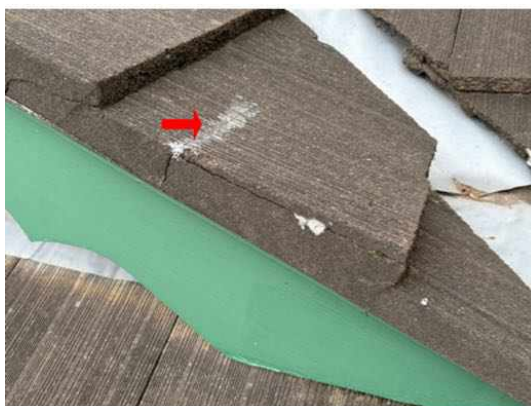
Finding 3.06

Building:	Main Building
Location:	Roof Exterior
Finding:	Cracked roof tile - Sealed (defective)
Information:	Cracked roofing tile was noted to have been sealed. This handyman work appears to have been completed to a substandard level and does not comply with regular building practices. Further deterioration will inevitably cause cracking at the seal allowing moisture penetration.

All cracked or damaged tiles must be replaced rather than repaired.

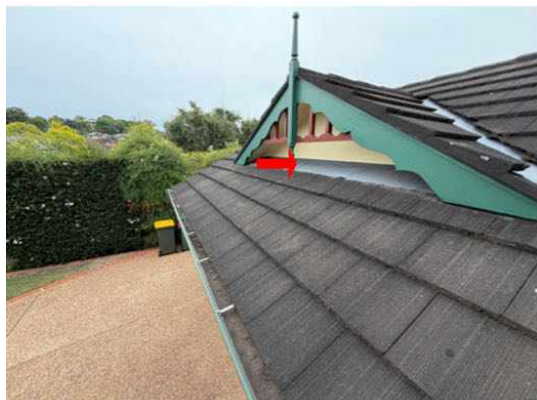
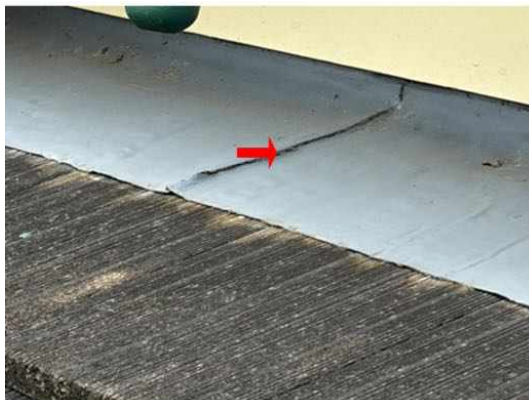
Finding 3.07

Building:	Main Building
Location:	Flashing
Finding:	Roof plumbing - Flashing cracked
Information:	Water leaks generally occur when a particular area of the property is not weather or water tight. Cracks were evident to the roof flashing in this area at the time of inspection.

Regardless of the location, if left unmanaged, even minor leaks can lead to serious damage of associated building elements, potentially resulting in the need for

replacement of building materials. Damage to ceilings, wood rot, mould and other hazards, such as electrical hazards, may also arise if left unmanaged.

Further inspection and repair by a roof specialist or a licensed roof plumber is advised to adequately rectify the potential leak.

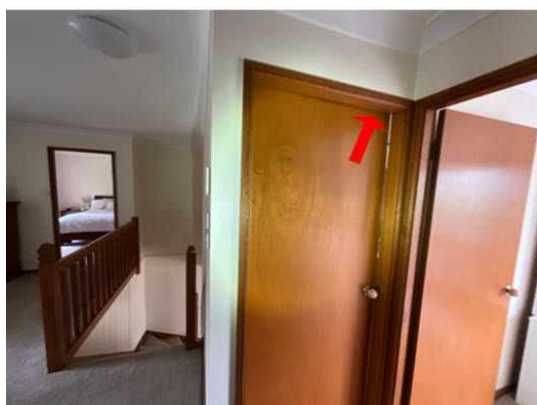
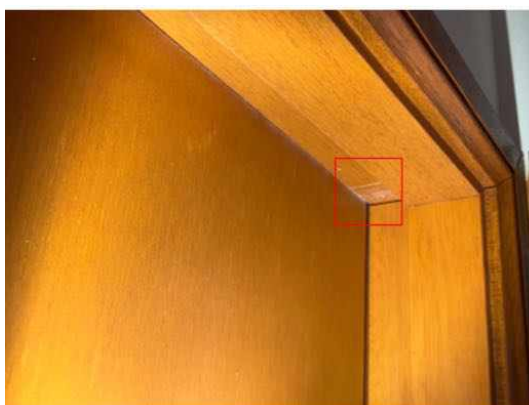
Finding 3.08

Building: Main Building
 Location: Office
 Finding: Door - Binding/jamming
 Information:

Binding and/or jamming of this door is evident during standard operation. This defect inhibits the functionality of the affected door as well as creating potential for secondary defects to associated building elements, such as damage to the floor covering or adjacent frame.

A door that binds to flooring or to the associated door frame may have several causes, ranging from minor defects, such as poor installation of the door or deteriorated hinges.

A licensed carpenter should be appointed to perform minor rectification works at client discretion.

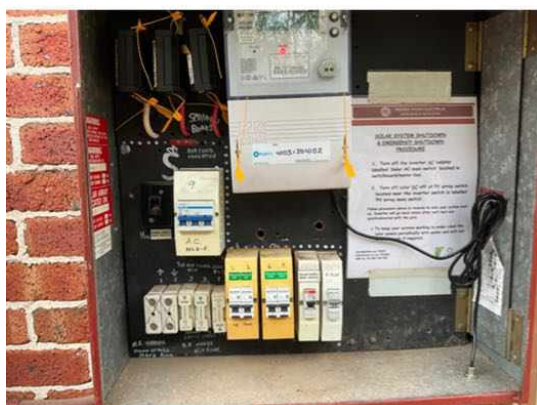
Building:	Main Building
Location:	Meterbox
Finding:	Termite Management System - no evidence of installation
Information:	The application of a post-construction chemical termite barrier is highly recommended for all properties, particularly if live termite activity has been found on the site previously. Such barriers are highly effective in preventing termite attack on any timber building elements throughout the property.

A durable notice should be placed in the switchboard unit to indicate current termite barriers. At the time of inspection, it appeared as though no termite management system has been installed, with no evidence to suggest preventative works taking place.

The client may consider gaining further advice from a pest controller as to the costs and procedures involved with this application. It is recommended that obtaining such advice be a short-term priority.

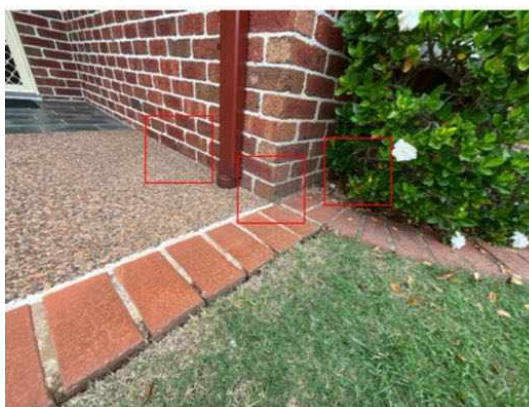
Damp proof course (DPC) is a barrier of impervious material built into a wall or pier to prevent moisture from moving to any part of the building. Where external ground levels are built up over this barrier ingress is provided for moisture from the exterior grounds into the base brickwork or other building material and allowed to rise.

Such conditions attract termites into these damp areas which is likely to lead to infestation if left untreated.

While retrospective fitting of DPC is considered to be impractical works are required in order to prevent the extraction of moisture from the external environment into exterior brickwork or wall materials. Landscaping or re-paving of external grounds may be

considered by the client. Regular annual inspections are strongly advised.

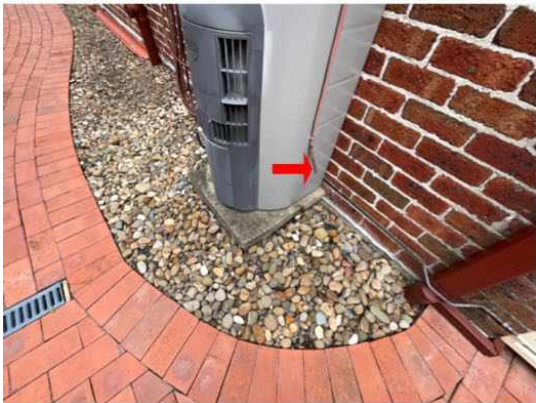
Finding 6.05

Building:	Main Building
Location:	Yard - Side
Finding:	Overflow - Not plumbed for drainage
Information:	The overflow is not plumbed or connected to suitable drainage, which can result in the surrounding area becoming excessively damp.

These damp conditions can lead to secondary defects such as rot, rust or corrosion of associated building elements, the formation of fungal decay, or even the creation of potential slip hazards. When coupled with poor site drainage, pooling of water may also attract termite activity to this area.

It is highly recommended that a licensed plumber be appointed to install adequate drainage to the overflow. These works will ensure that the area remains dry and free of any secondary defects.

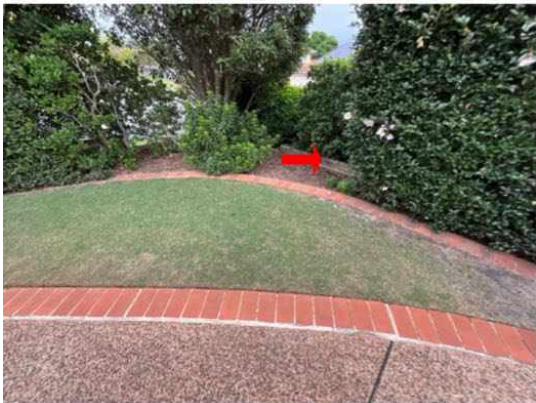
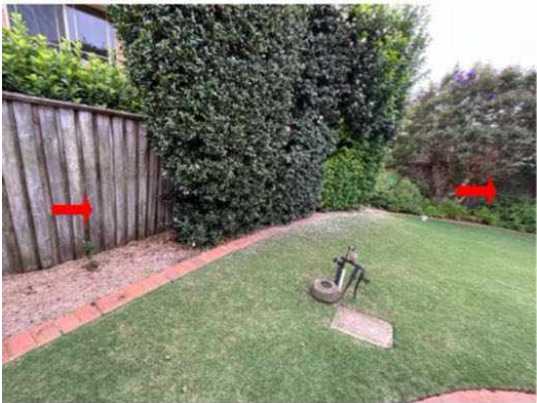
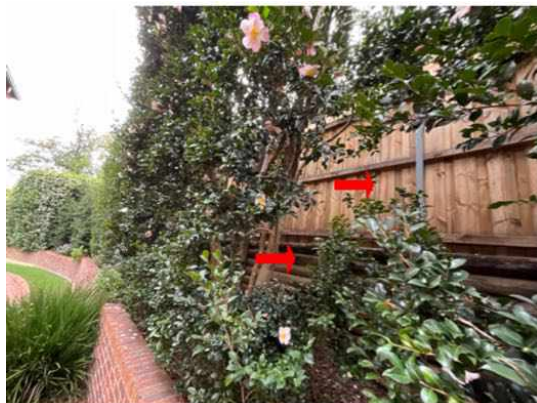
Finding 6.06

Building: Main Building
Location: Fencing & Landscaping
Finding: Building materials in direct ground contact - conducive to termites
Information: Where timber elements are in direct contact with the ground and consequently moisture or dampness they become conducive to termite activity. Whether timber is used as a building element part of a fencing structure or stored as an unused item they can provide an environment that is attractive to termite infestation.

When met with excessive moisture timber begins to decay and develop wood rot. Any timbers that are in direct contact with external grounds especially if left untreated or non-durable also provide ingress for subterranean termites into that particular element.

The removal of any such materials that may be conducive to termite activity should be removed as soon as possible to minimise the risk of termite attack.

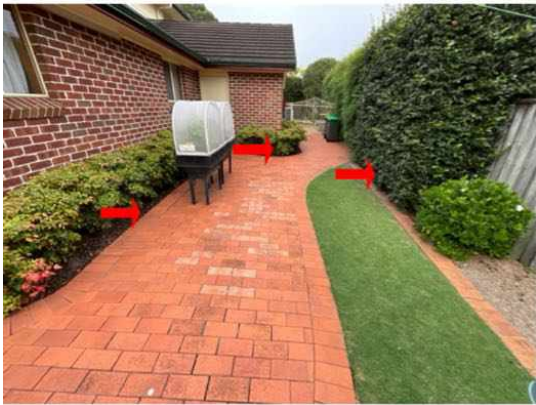
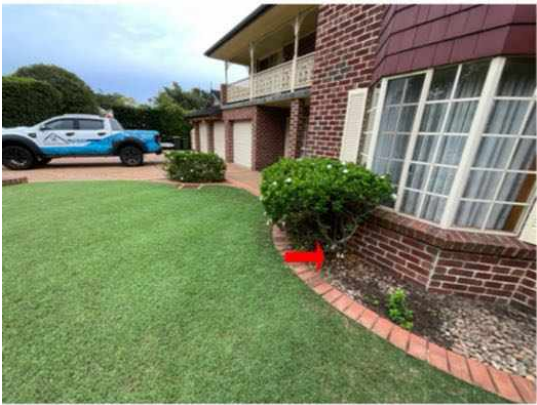
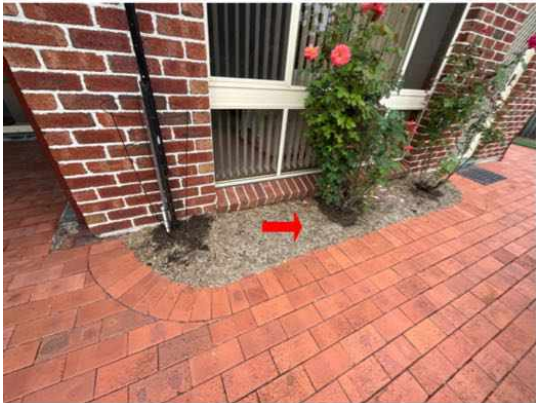
Finding 6.08

Building:	Main Building
Location:	Garden beds
Finding:	Garden Beds
Information:	Garden beds were found to be evident in the garden area. These garden beds can include untreated timber, and with a combination of moisture from watering hosing can make conditions conducive to termite activity and termite ingress.

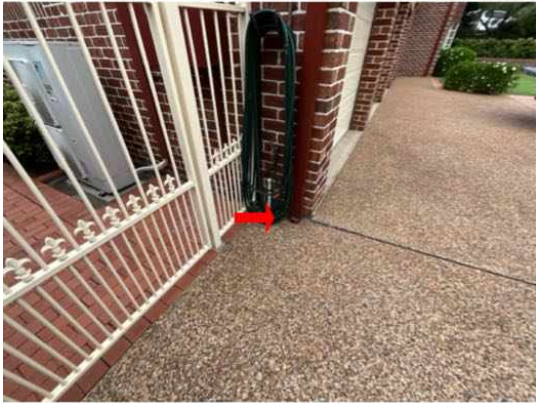
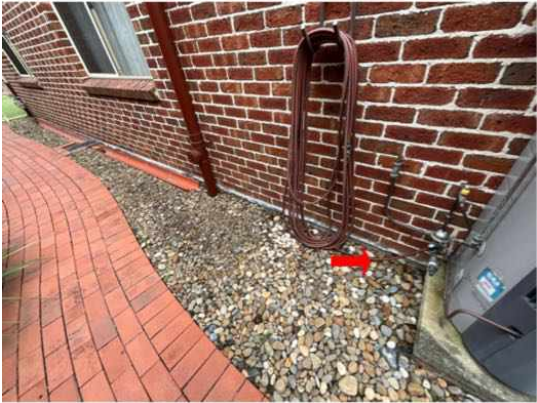
Finding 6.09

Building: Main Building
Location: External tap
Finding: Tap - No drain
Information: The external tap in this area was noted to have no drain at the time of inspection.

This keeps the surrounding surfaces damp while using the tap, which becomes conducive to termite activity.

A licensed plumber must be appointed to ensure an appropriate drain is installed.

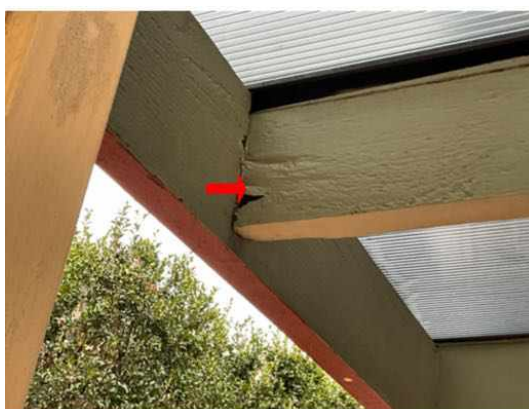
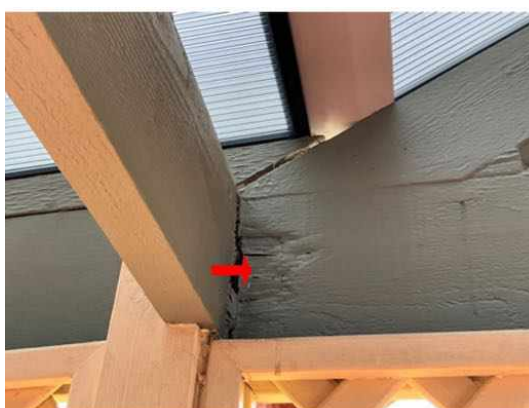
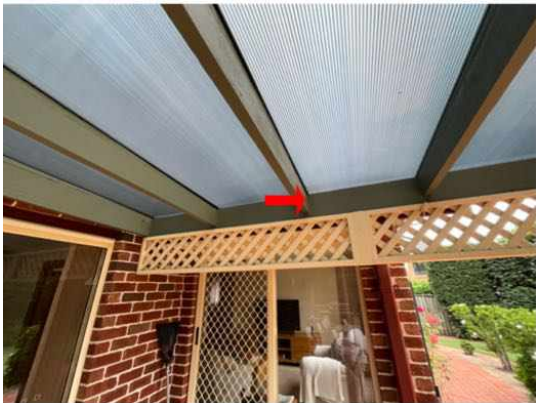
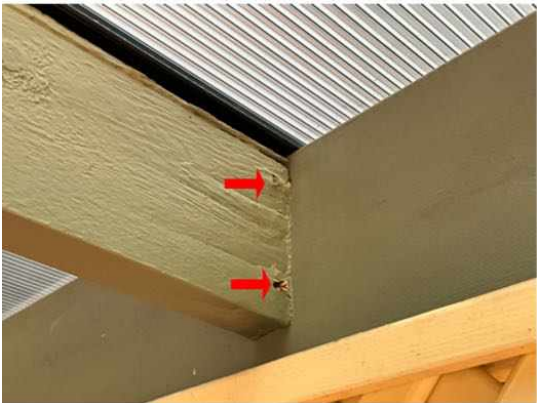
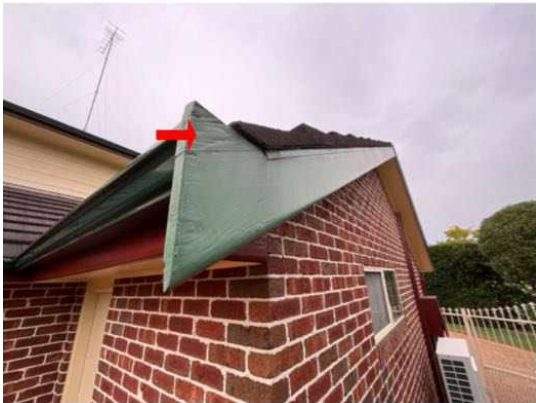
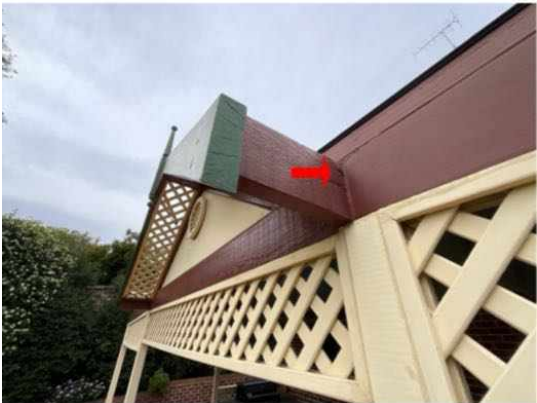
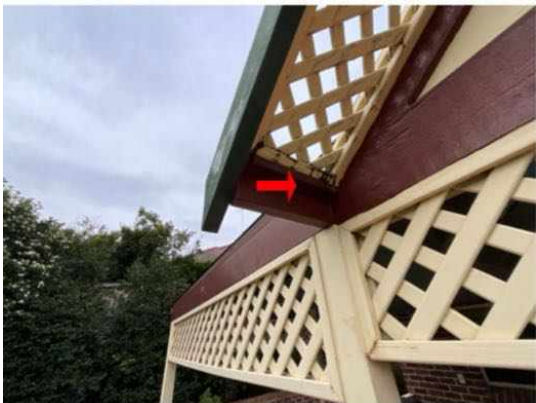
Finding 7.01

Building:	Main Building
Location:	Fascias
Finding:	Wood rot/decay
Information:	This building element shows evidence of severe wood rot. Wood rot, also known as Fungal Decay, occurs when timbers and other cellulose building materials are exposed to damp conditions on an ongoing basis. This could be the result of exposure to weathering over a prolonged period of time.

If left unmanaged, damp conditions can lead to further health problems and the decay of timbers will continue.

Early intervention and regular maintenance, particularly of exterior timbers, will prolong the useful life of these building elements. Prior to any works being performed, the cause of the moisture that has created the visible wood rot should be identified and addressed in a suitable manner. A licensed roof plumber should be appointed for this work. Replacement of affected timbers by a licensed carpenter is then a necessary step in protecting surrounding building elements from such deterioration.

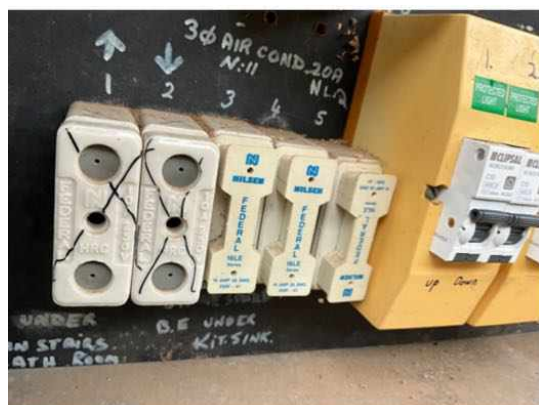
The electrical switchboard while appearing to have adequate safety switches installed has old ceramic fuses in place.

While this on its own on is not considered a defect it is noted for the clients consideration that a switchboard upgrade may be required in the short to mid term to improve the functionality of the electrical system. A licensed electrician could be appointed to provide quotation for the works at the client's discretion which may in turn expose other required works to bring the system up to a compliant state.

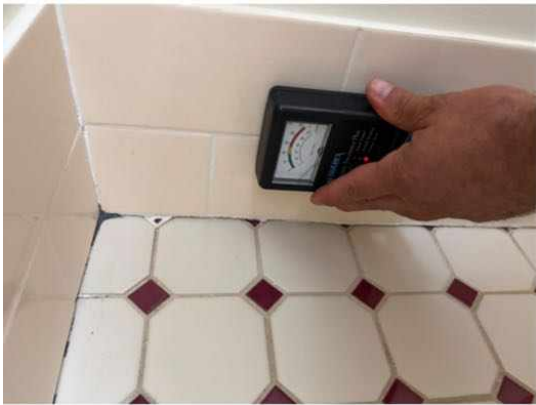
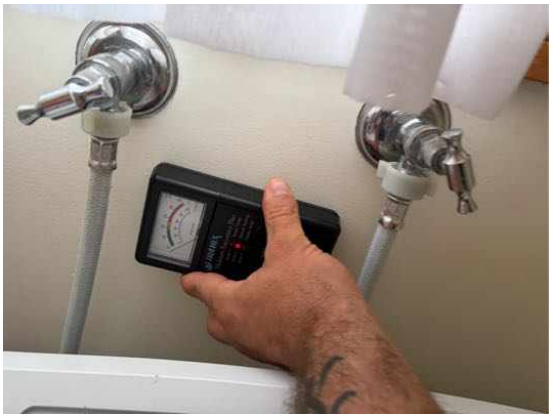
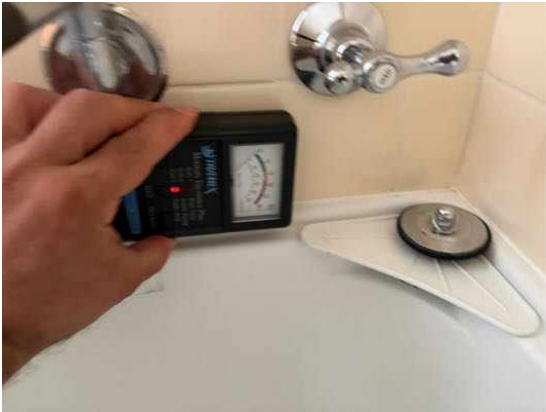
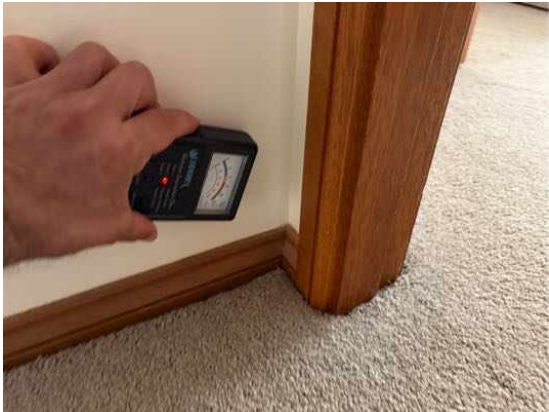
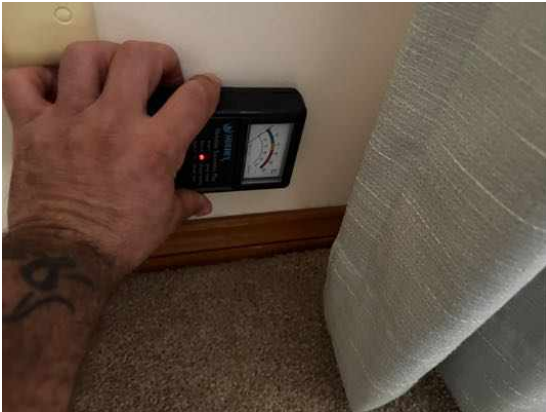
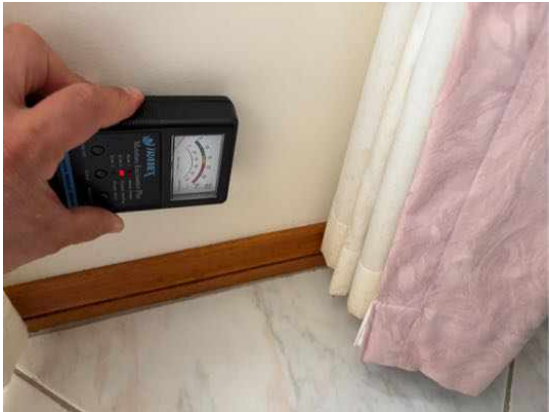
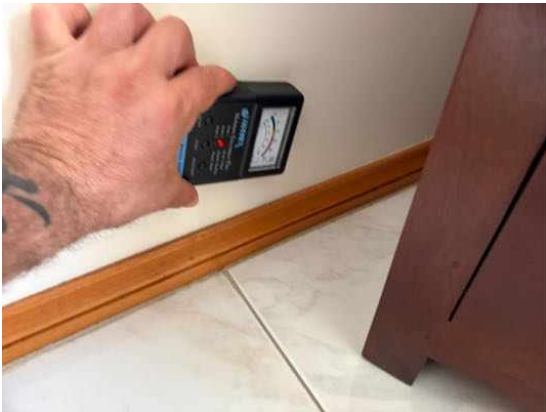
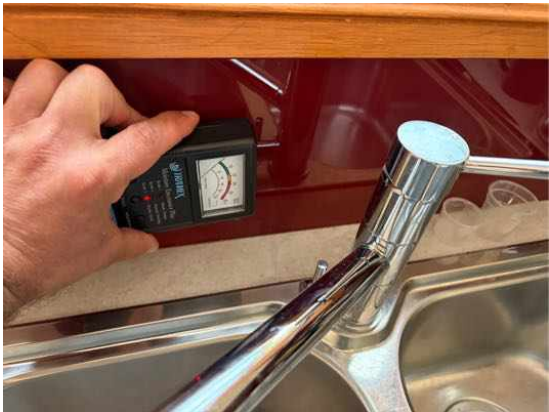
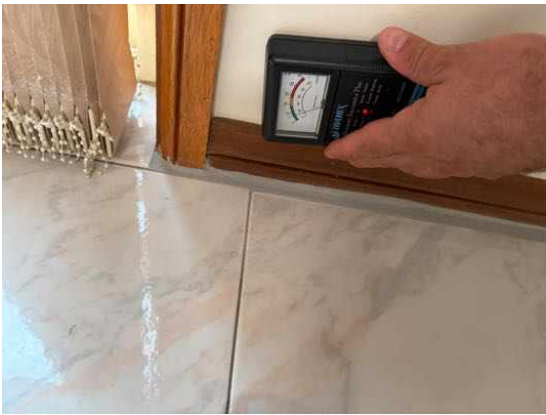
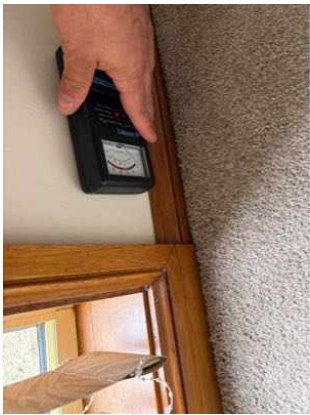
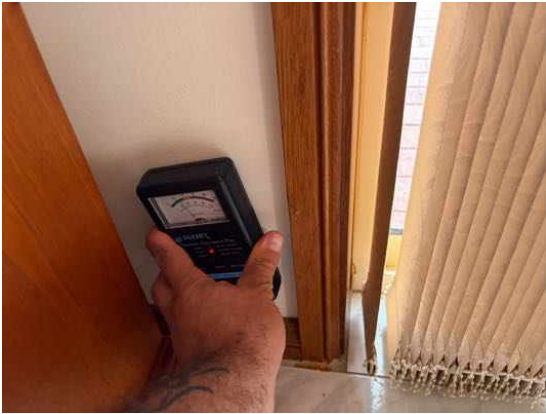
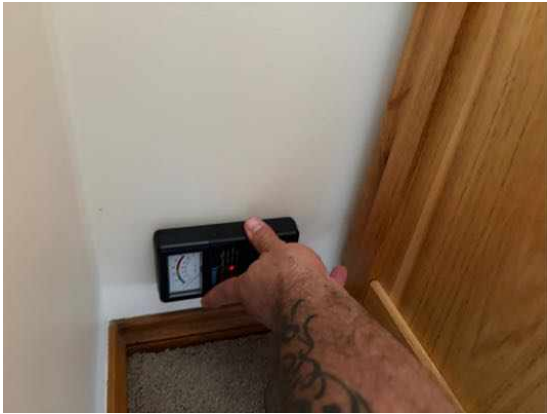
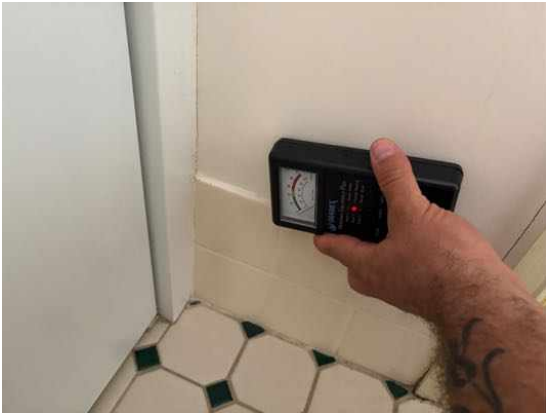
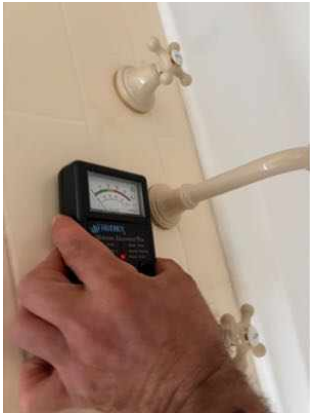
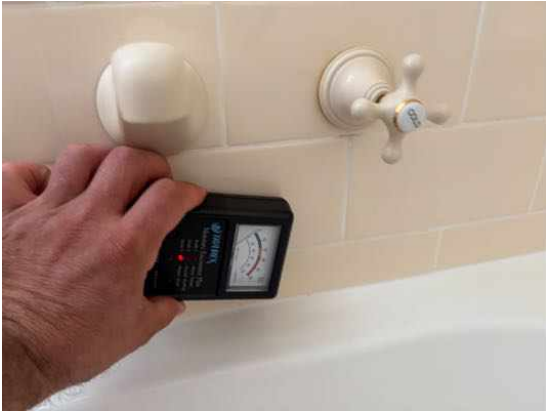
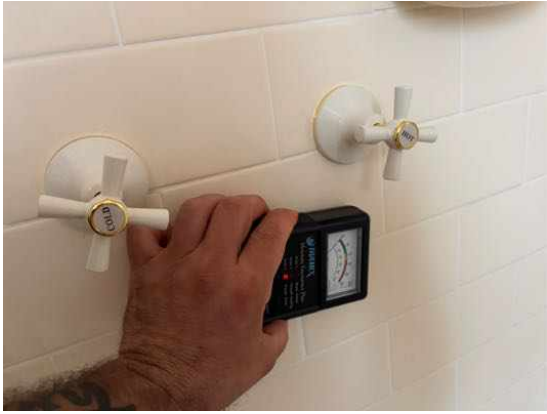
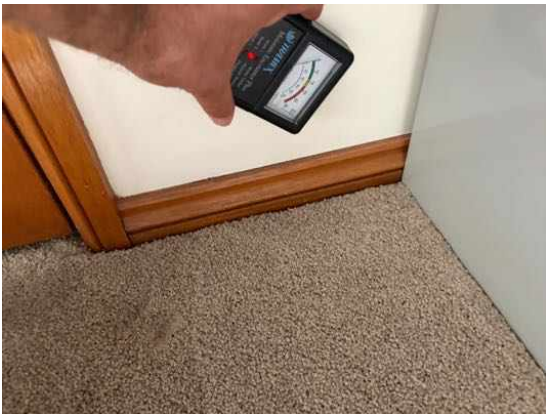
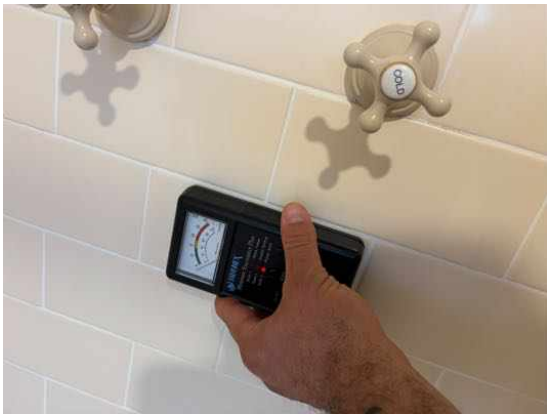
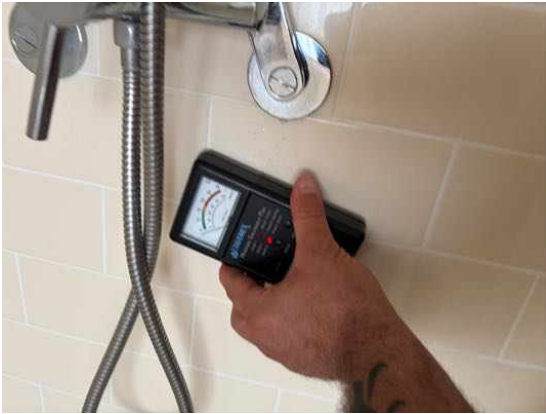
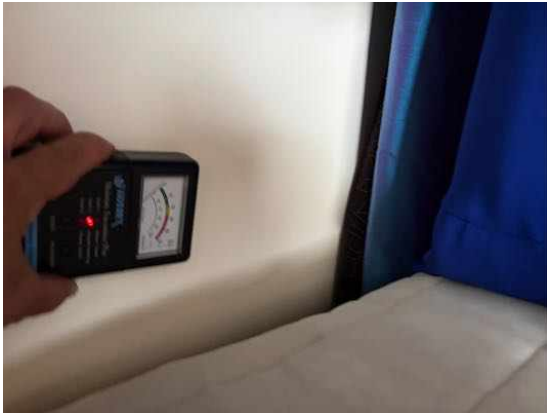
Finding: Moisture metre

Information: During the inspection the property was checked for moisture using a moisture metre.

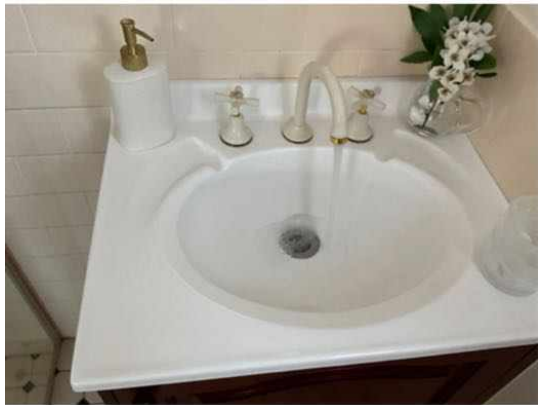
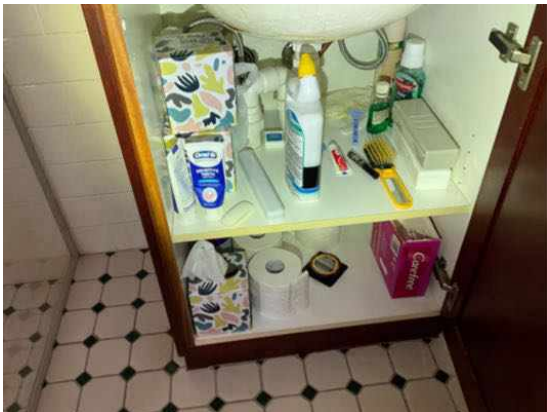
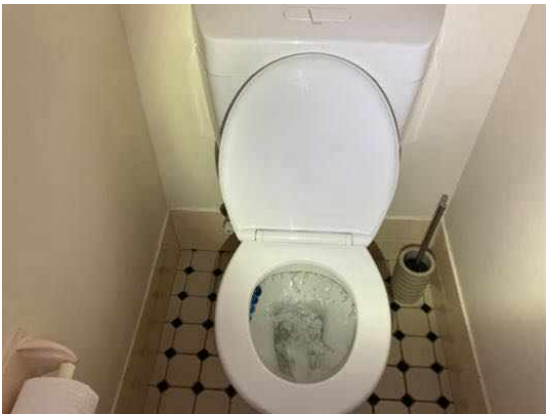
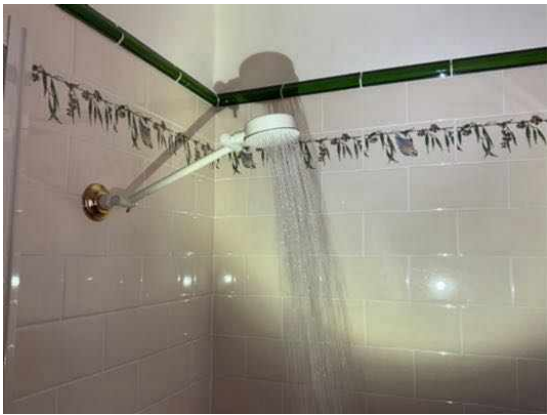
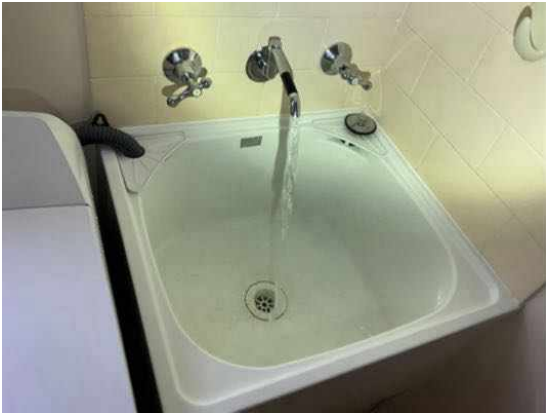
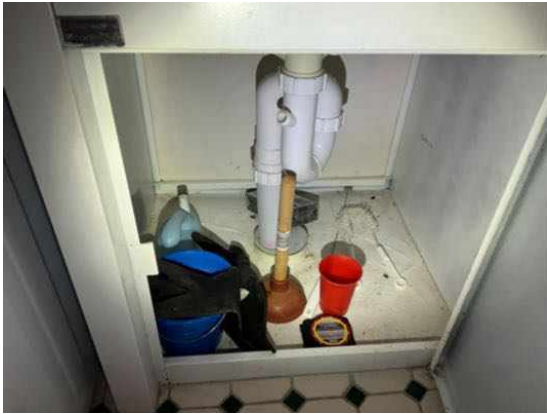
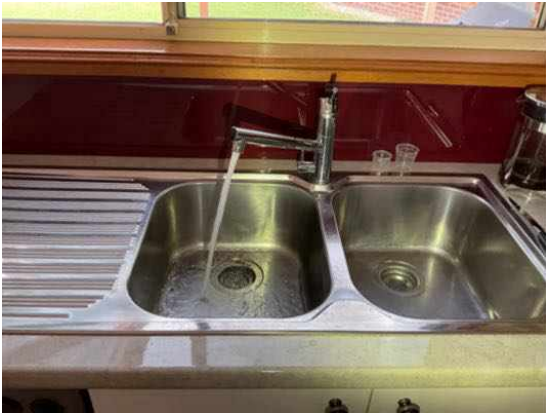
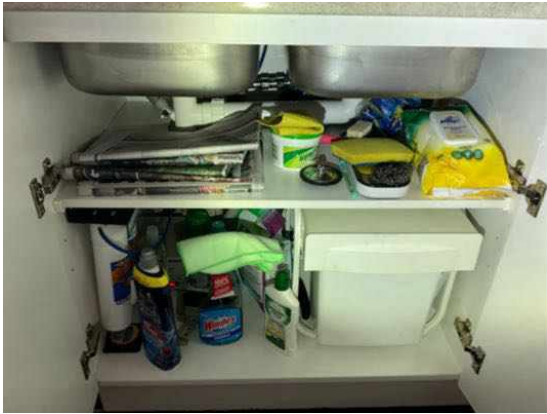
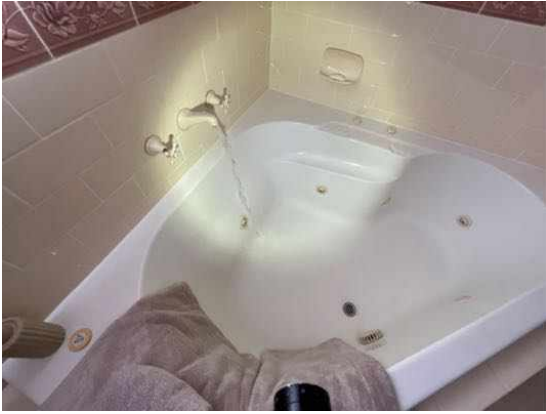
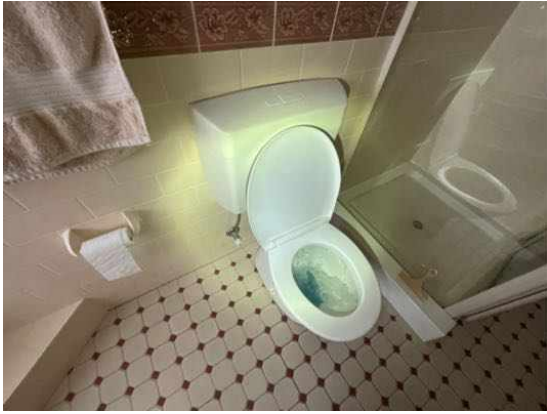
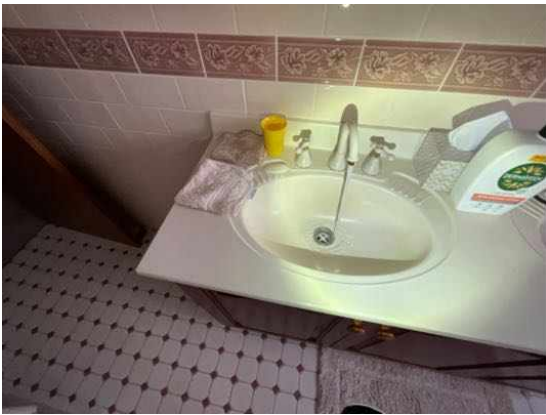
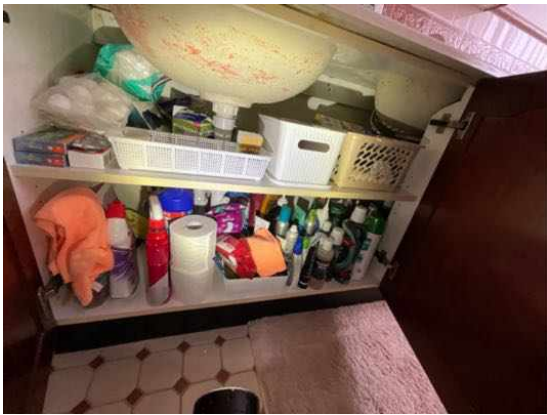
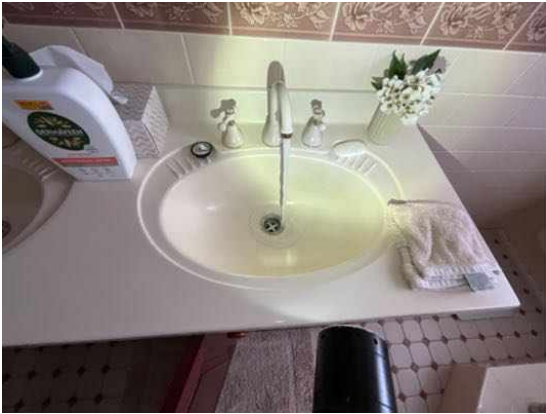
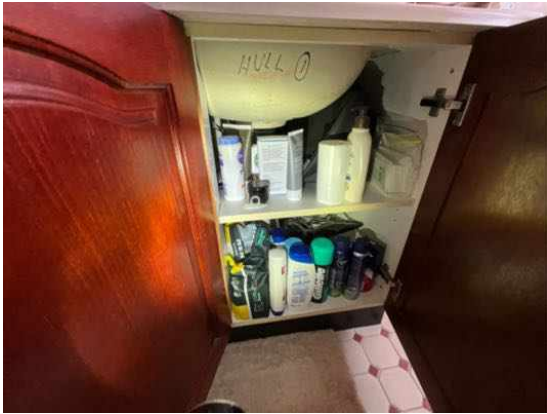
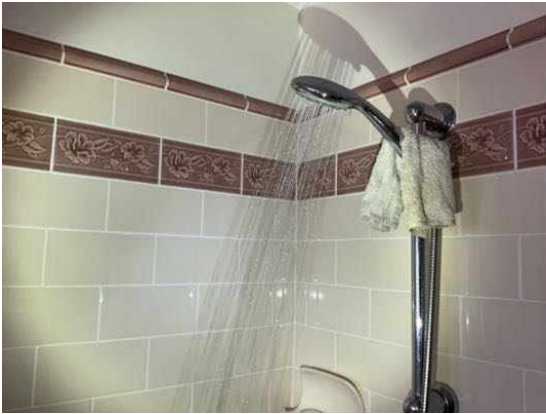
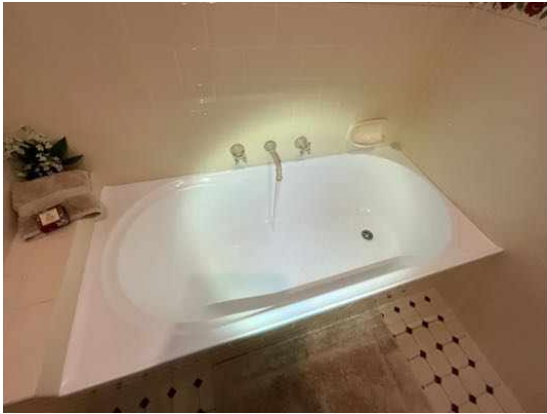
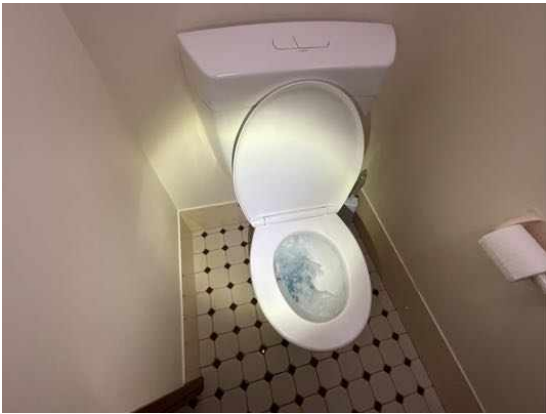
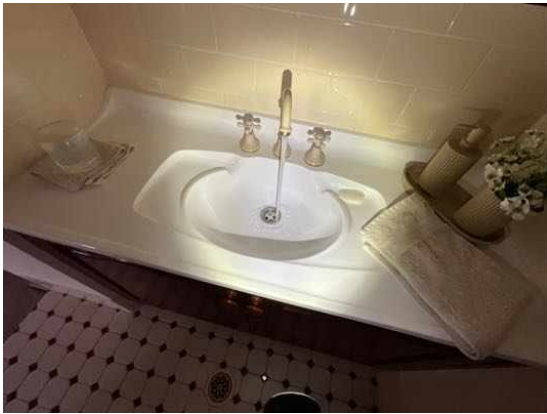
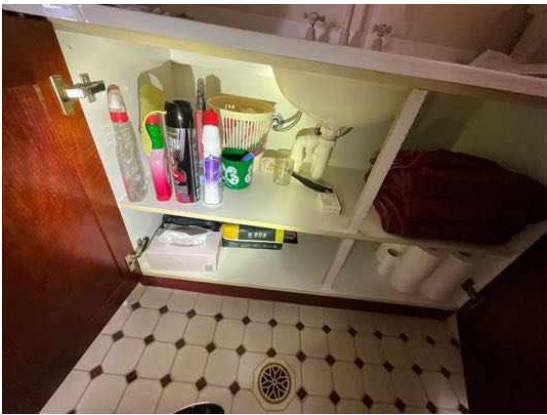
Building: Main Building
Location: All Wet Areas
Finding: Additional Photos
Information:

Additional photos are provided for your general reference.

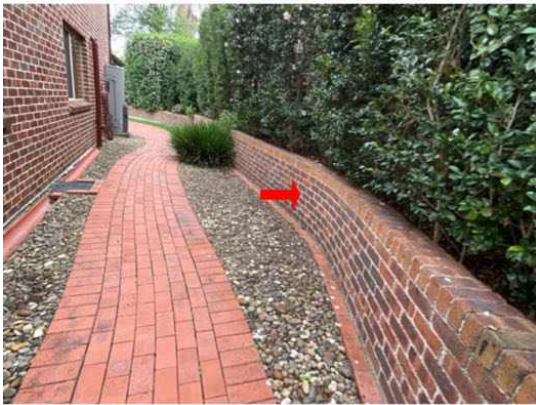
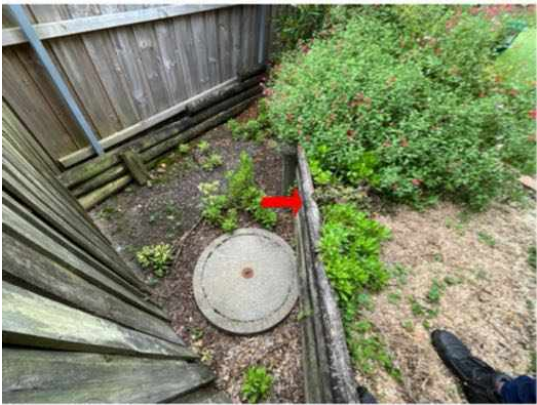
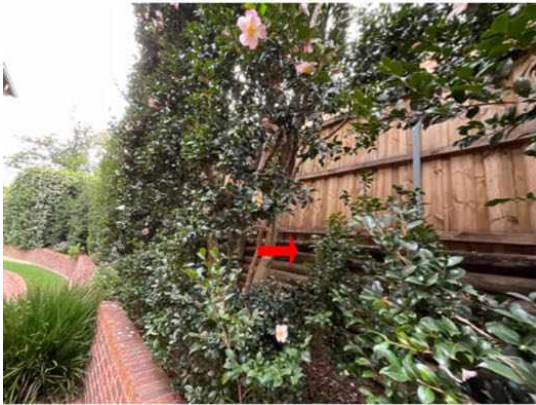
Building:	Main Building
Location:	Retaining walls
Finding:	Retaining walls
Information:	At the time of inspection the retaining walls were checked and no defects were observed other than those which May have been mentioned earlier in this report. AS4349.1-2007 requires all retaining walls in excess of 700mm to be inspected by a licensed and practicing structural engineer.
