Building and Timber Pest Inspection Report

Inspection Date: Tue, 17 Mar 2026

Property Address: 38 Westminster Dr, Castle Hill NSW 2154,
Australia

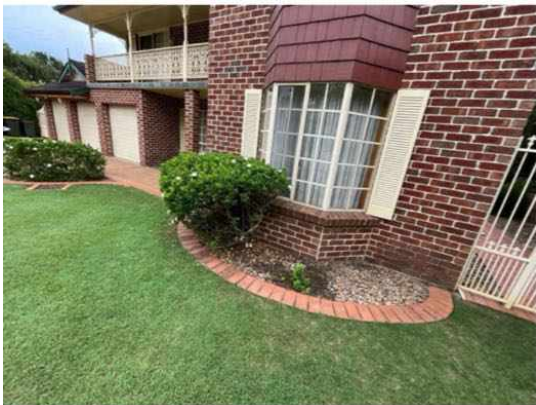
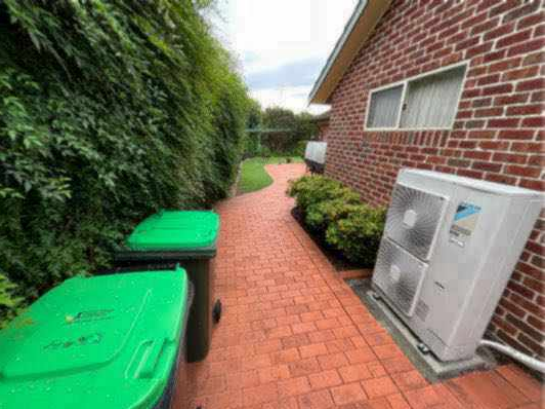
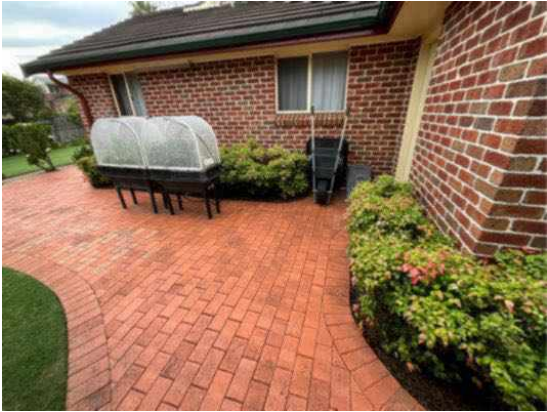
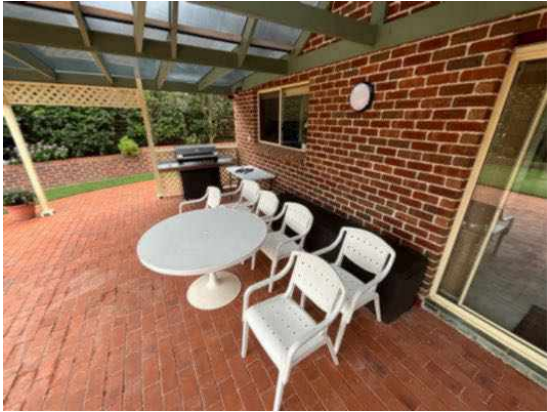
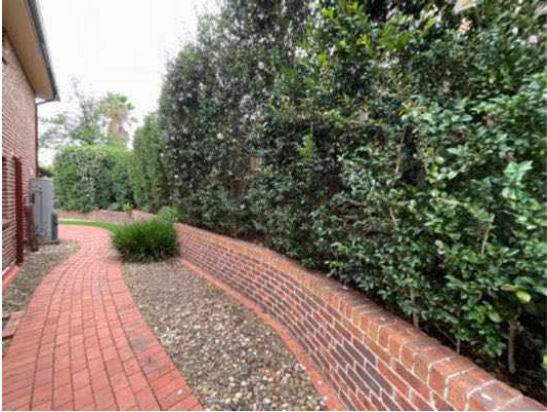
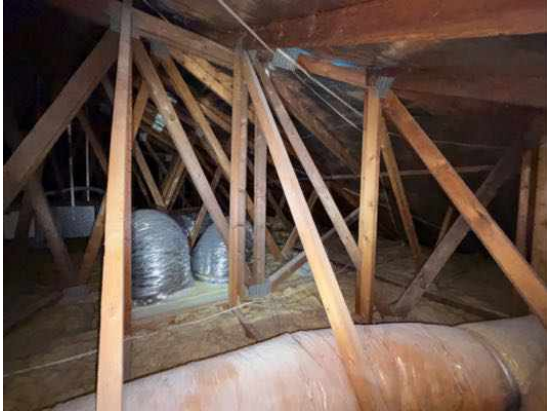
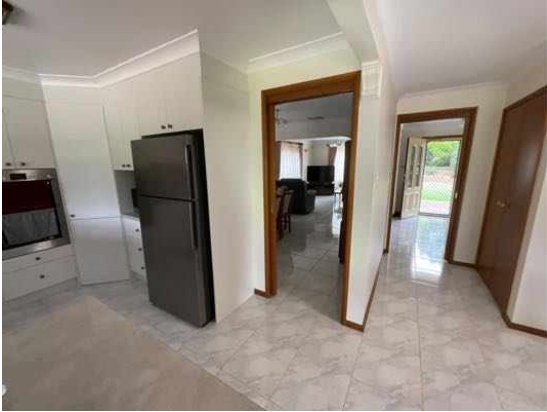
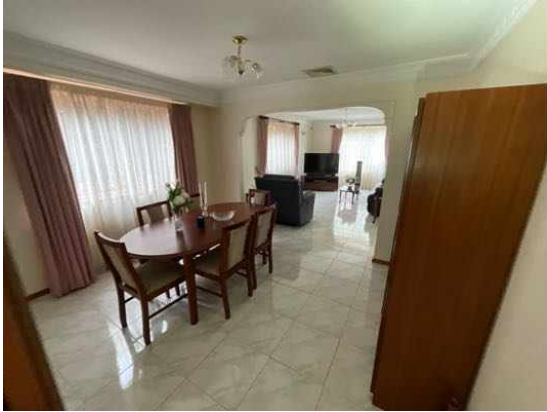
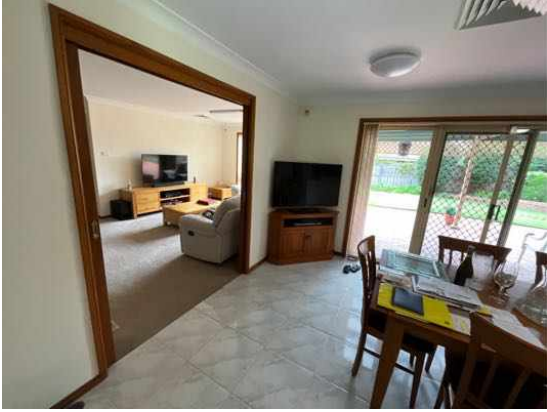
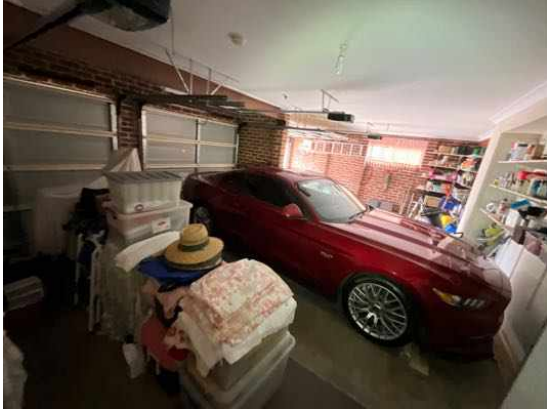
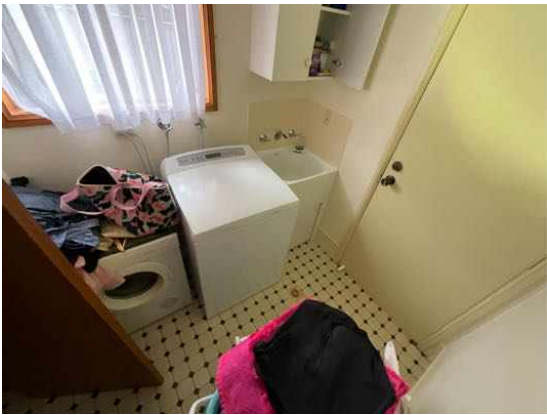
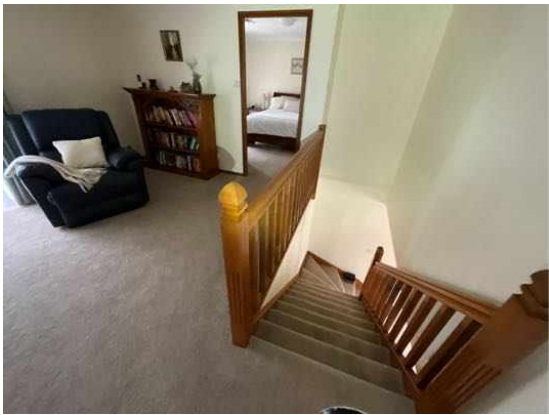
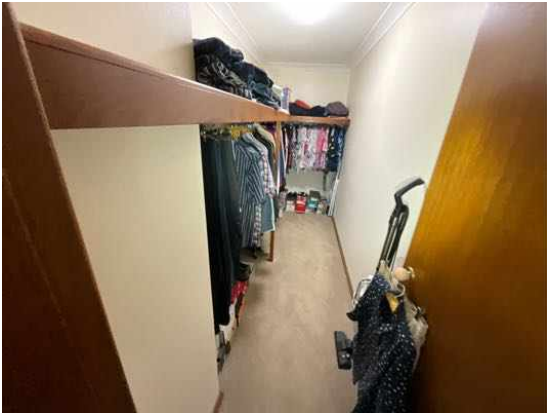
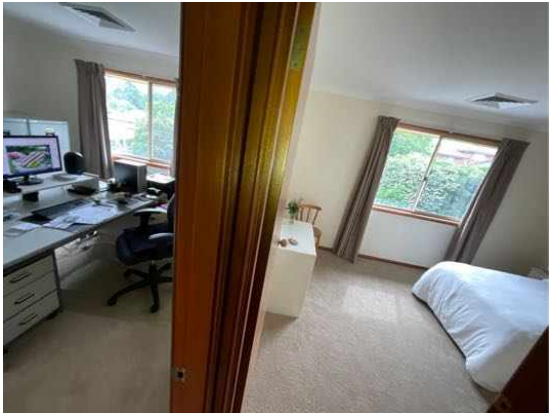
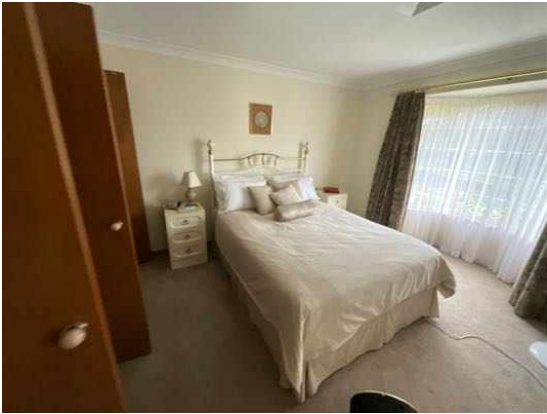
These photographs are an indication of the obstructions and limitations which impeded full inspection of the property at the time of inspection. These obstructions can hide an array of defects and should be removed to allow full inspection to be carried out. A re-inspection is recommended once the areas are made accessible.
