# Building and Timber Pest Inspection Report

Inspection Date: Wed, 18 Feb 2026

Property Address: 42 Hail St, Austral NSW 2179, Australia

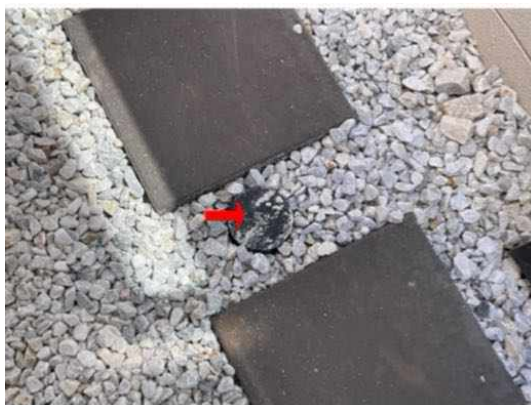
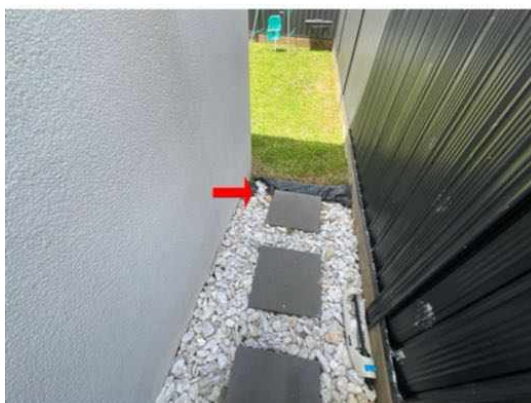
Building:	Main Building
Location:	Yard
Finding:	Site drainage— Inadequate
Information:	The site drainage in this area was found to be inadequate at the time of inspection, which is indicative of incomplete landscaping, creating potential for subsequent water damage to associated building elements. This is additionally conducive to termite activity.

ground levels should be sloped to drain water away from walls. Downpipes should not discharge stormwater onto lower walls or plinths. Stormwater should be carried away by large, regularly cleaned drains. Ground levels may need to be lowered to expose a buried DPC.

Where site drainage is inadequate, installation of an Agricultural (Aggie) Drain may be required. A landscaper should be appointed for this work. Water damage and secondary defects are likely to occur if left unmanaged.

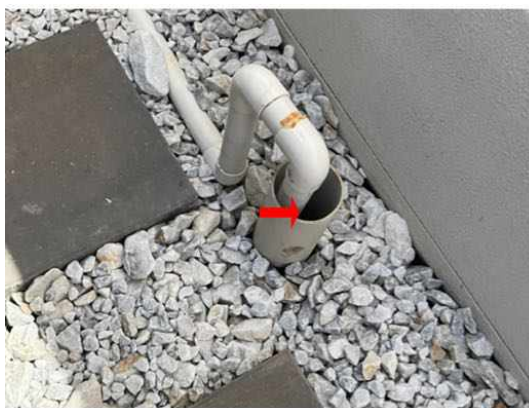
### Finding 3.02

Location: Yard - RHS  
 Finding: Plumbing - Point of connection non-compliant  
 Information: At the time of inspection it was noted that connections between above ground pipe work and below ground sewer/storm water systems were incomplete.

Additionally, where sewer pipes are concerned, gases can escape from unsealed connections which can pose a serious health risk.

Engagement of a certified plumber is strongly recommended to ensure all connection points are sealed in accordance with the plumbing construction guidelines.

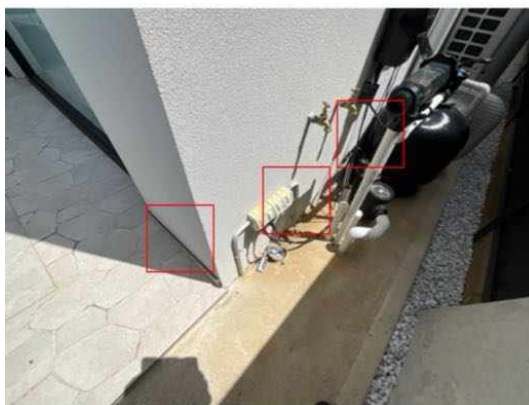
Building:	Main Building
Location:	Multiple areas
Finding:	Weepholes — inadequate
Information:	The weepholes to areas of the property are missing or inadequate.

Weepholes should be provided wherever it is necessary to drain moisture from or through masonry construction. Where flashings are incorporated in the masonry, weepholes shall be provided in the masonry course immediately above the flashing, at centres not exceeding 1200mm. The entire perimeter needs to be checked and repaired to comply with AS 3700-2011 Section 4.2.7.

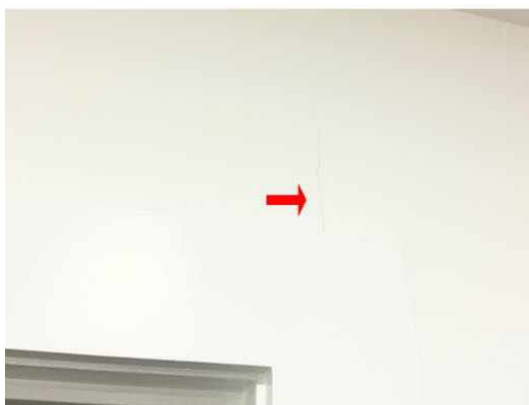
### Finding 3.05

Building:	Main Building
Location:	Bedroom 3
Finding:	Cracking - Damage Category 1 - Fine (up to 1mm)
Information:	Although fine cracks are quite noticeable, they are often only considered to be an appearance defect, and usually do not indicate any structural damage. Generally, the cause of a fine crack is indicative of a separation between building materials and finishes (e.g. paint, plaster, etc.) along joins.

Cracking of this nature can generally be repaired with minor sanding, filling and/or repainting. Such works should be performed by a qualified painter or a general handyman.

Monitoring of all cracking should be conducted frequently. Always contact a building inspector should cracks widen, lengthen, or become more numerous.

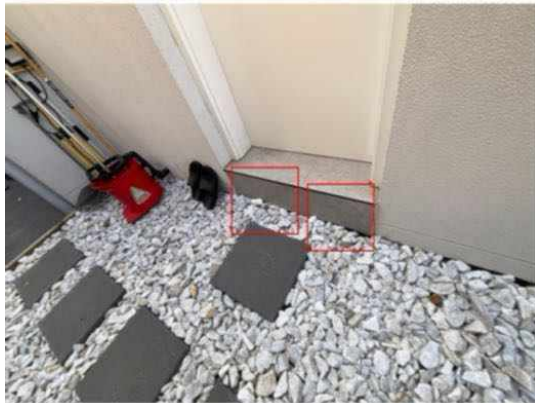
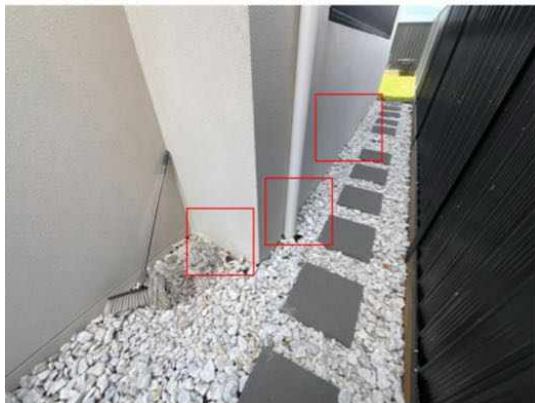
Damp proof course (DPC) is a barrier of impervious material built into a wall or pier to prevent moisture from moving to any part of the building. Where external ground levels are built up over this barrier ingress is provided for moisture from the exterior grounds into the base brickwork or other building material and allowed to rise.

Such conditions attract termites into these damp areas which is likely to lead to infestation if left untreated.

While retrospective fitting of DPC is considered to be impractical works are required in order to prevent the extraction of moisture from the external environment into exterior brickwork or wall materials. Landscaping or re-paving of external grounds may be considered by the client. Regular annual inspections are strongly advised.

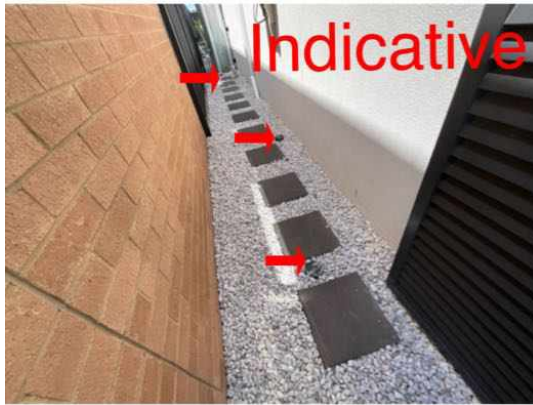
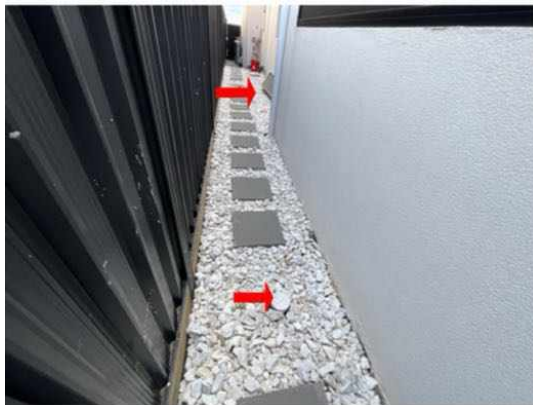
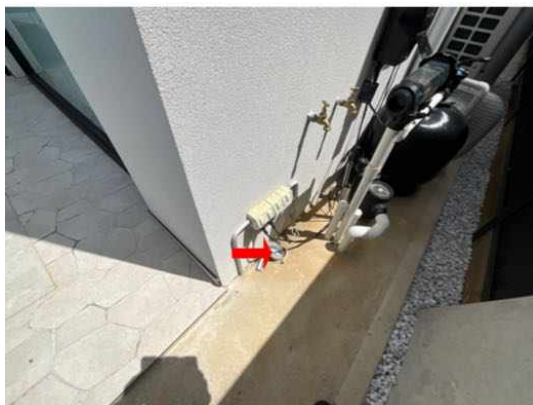
### Finding 6.05

Finding: Site drainage— Inadequate

by large, regularly cleaned drains. Ground levels may need to be lowered to expose a buried DPC.

Where site drainage is inadequate, installation of an Agricultural (Aggie) Drain may be required. A landscaper should be appointed for this work. Water damage and secondary defects are likely to occur if left unmanaged.

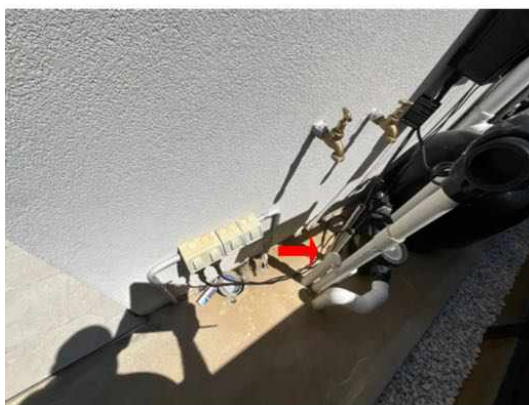
### Finding 6.06

Building:	Main Building
Location:	Fencing & Landscaping
Finding:	Building materials in direct ground contact - conducive to termites

This keeps the surrounding surfaces damp while using the tap, which becomes conducive to termite activity.

A licensed plumber must be appointed to ensure an appropriate drain is installed.

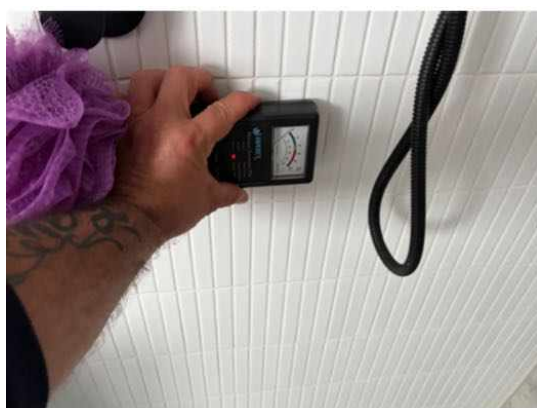
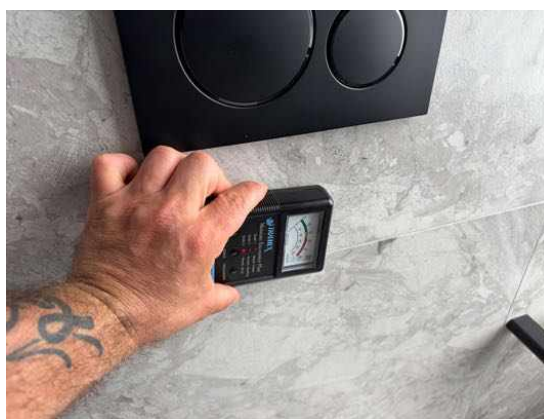
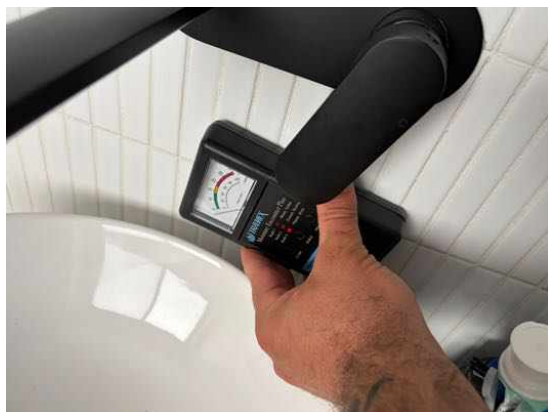
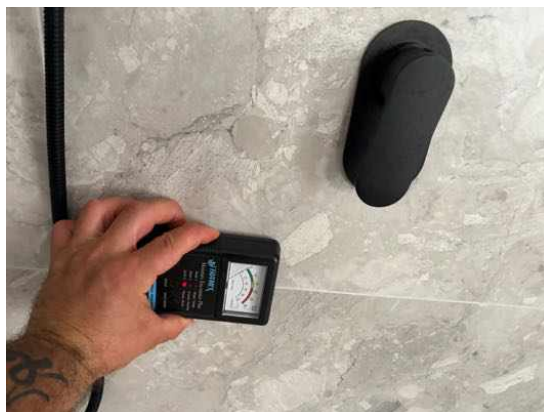
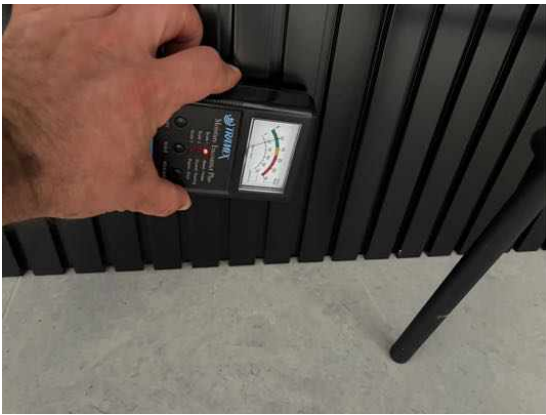
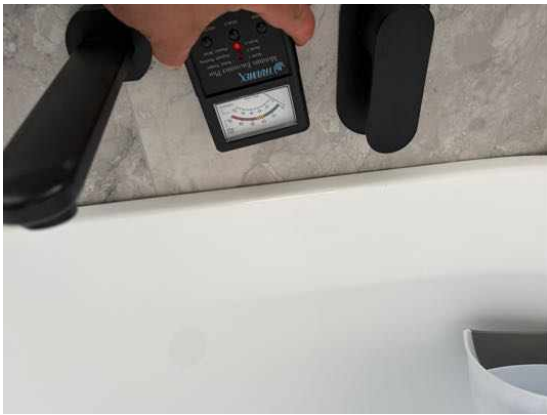
Building: Main Building  
Location: All Areas  
Finding: Moisture metre  
Information: During the inspection the property was checked for moisture using a moisture metre.

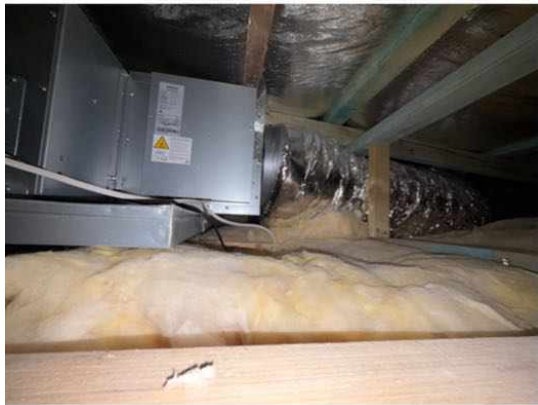
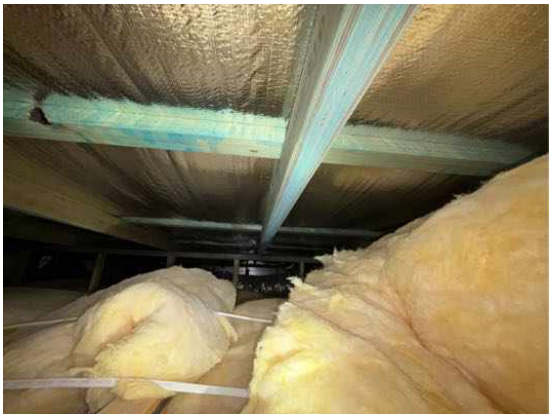
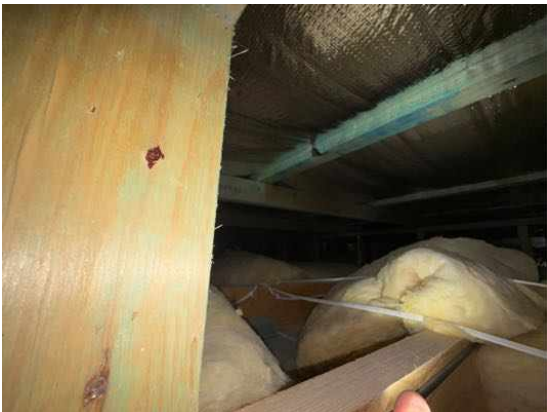
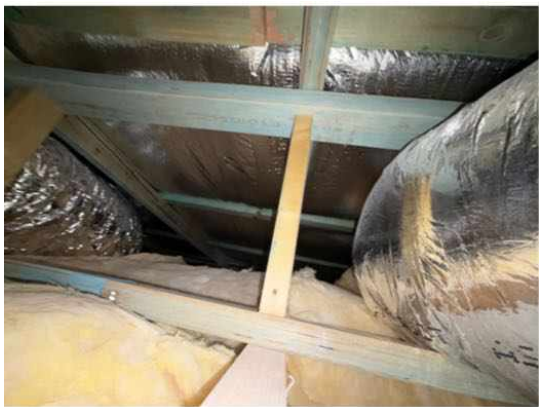
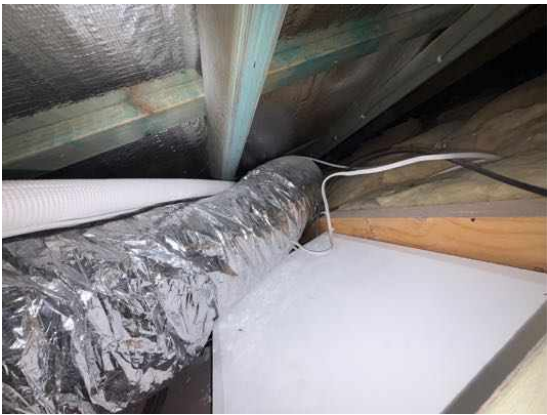
Finding: Additional Photos

Information: Additional photos are provided for your general reference.

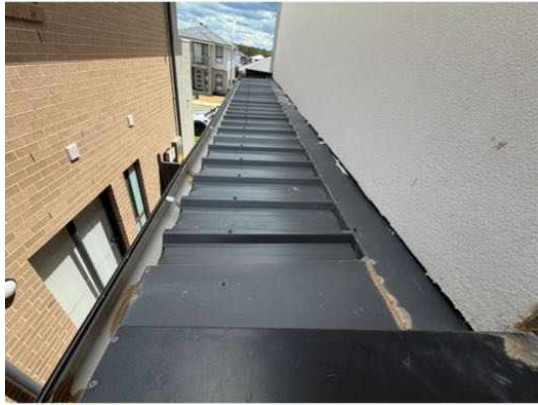
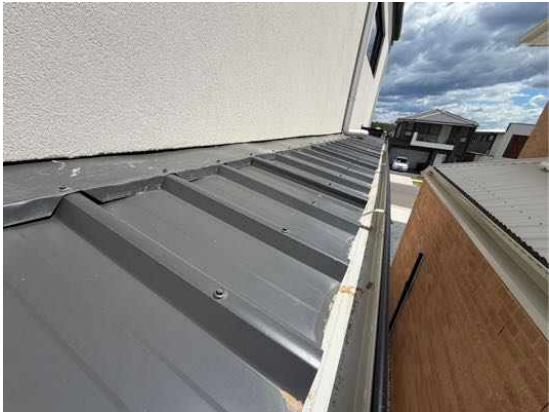
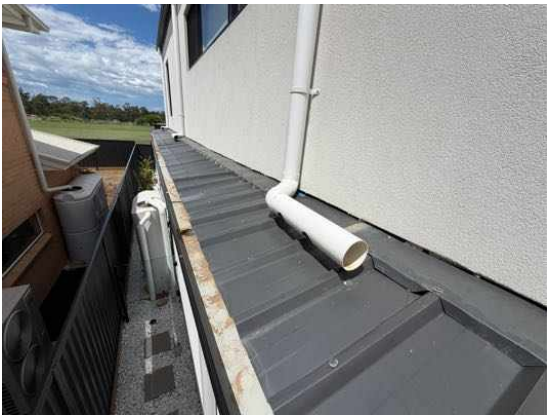
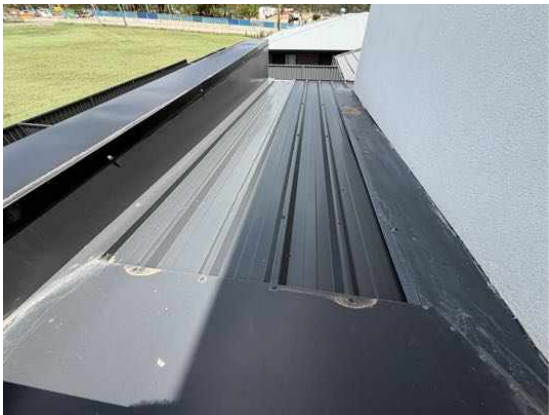
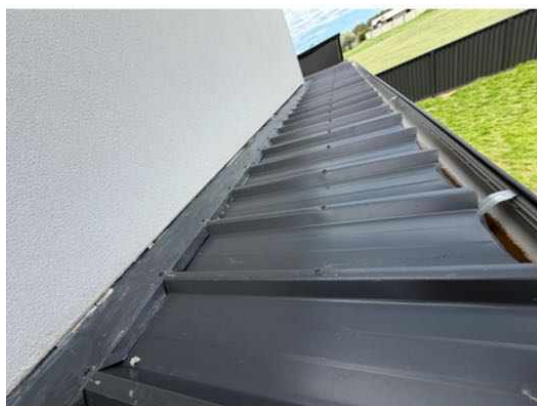
Building: Main Building  
Location: Roof Exterior  
Finding: Additional Photos  
Information:

Additional photos are provided for your general reference.

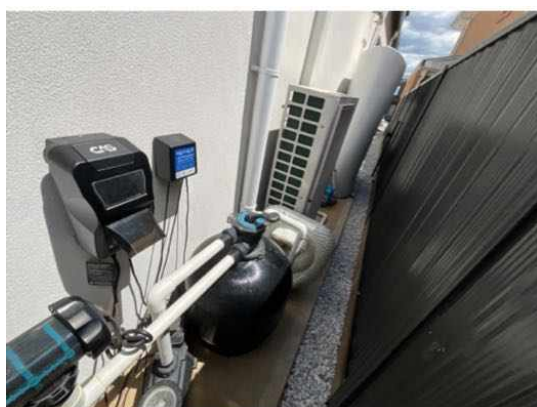
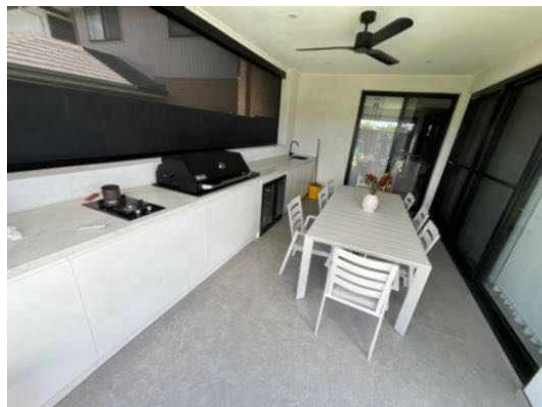
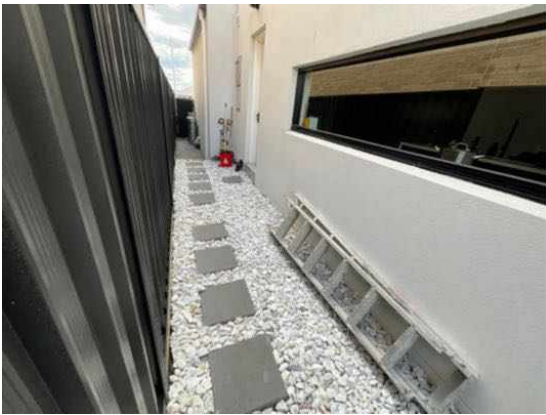
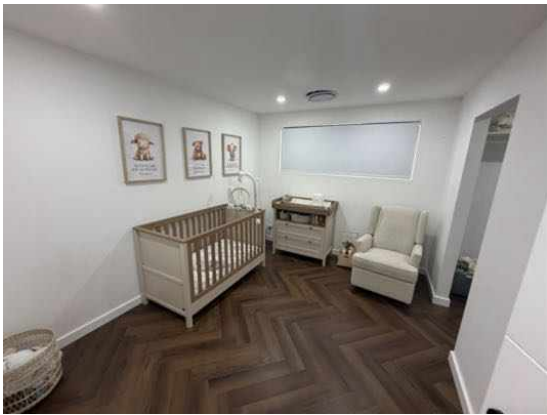
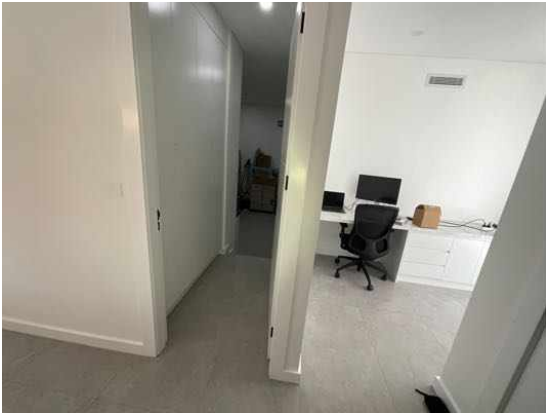
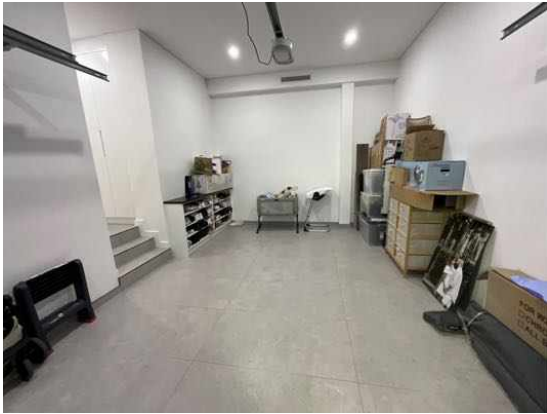
Building:	Main Building
Location:	All Areas
Finding:	Additional Photos - Obstructions and Limitations
Information:

These photographs are an indication of the obstructions and limitations which impeded full inspection of the property at the time of inspection. These obstructions can hide an array of defects and should be removed to allow full inspection to be carried out. A re-inspection is recommended once the areas are made accessible.
