## Building Inspection Report

Inspection Date: Thu, 12 Mar 2026

Property Address: 4/34 Barton St, Reservoir VIC 3073,  
Australia

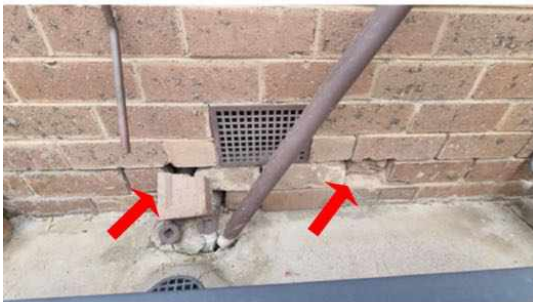
## Defects 2.02

Building:	Main Building
Location:	All External Areas > All Areas
Finding:	Brickwork cracking (Major Structural Defect)
Information:	At the time of the inspection, there were bricks cracked, broken and dislodged from the rear wall of the home.

Cracks of this type are likely to have been caused by movement of building elements, including movement in the foundations and may also have a structural cause that is more significant.

Consultation with a structural engineer is recommended to determine the cause of the cracking and method and cost of rectification works.

The client should attend to the above as a matter of priority.

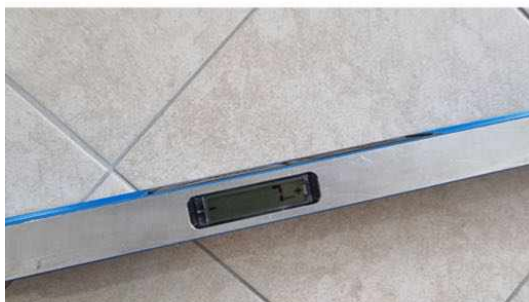
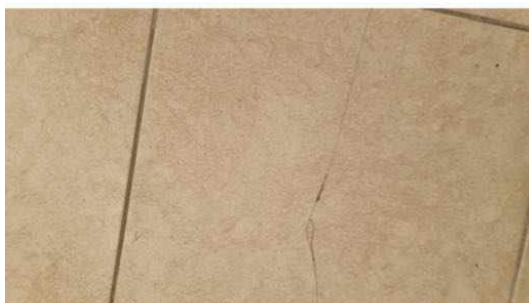
Information: The internal flooring throughout the home is out of level and uneven at time of inspection. Uneven flooring is likely to indicate minor defects such as expected movement of the foundations of the property, but may also indicate subsidence of the associated subfloor stumps.

There were floor areas of the home that were more uneven than others, and it was noticeable when walking across. The kitchen and laundry floor tiles have cracked and when walking across the tiles, you can feel that the support under the tiles is compromised.

However, where flooring is uneven further, potentially invasive inspection of the subfloor structures and stumps in this area is required. In this case, works to repair are likely to be required, and would be carried out by a registered builder specialising in re-stumping.

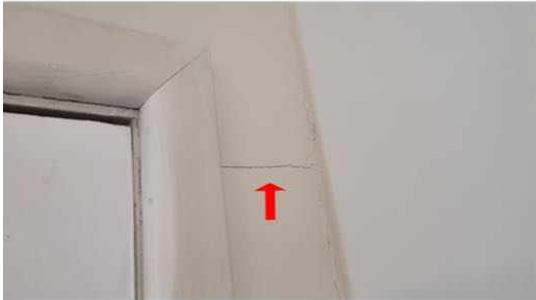
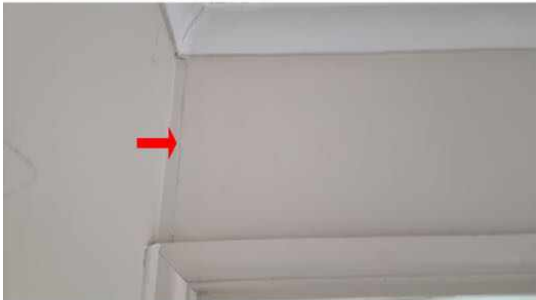
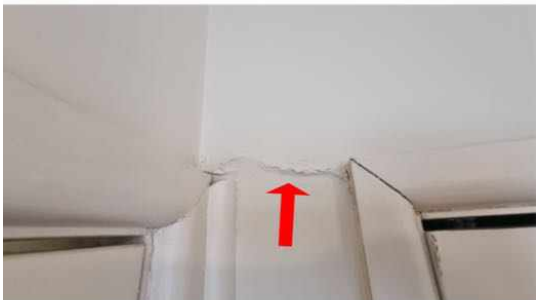
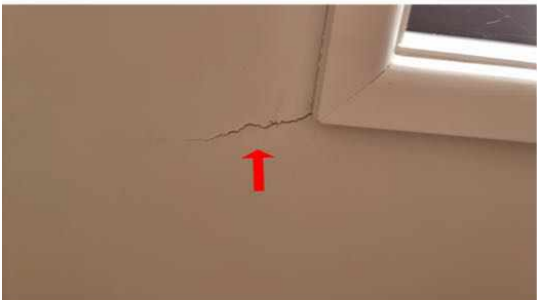
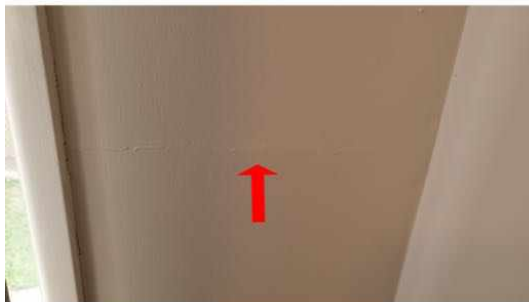
## Defects 3.02

Building:	Main Building
Location:	All Internal Areas > All Areas
Finding:	Cracks in Plaster Wall and Ceiling
Information:	It was found that at the time of the inspection cracks were visible to the walls, window architraves, skirtings and ceiling throughout the home.

In particular of concern are the cracks below and above all window openings and internal openings. These are suspected to be a result of

Movement in the foundations and subfloor structure over a long period of time.

Noticeable cracks may result in minor sticking or jamming of associated doors and windows, which require easement. However, noticeable cracks are easily filled and repaired. A plasterer can be consulted to install an expansion joint at this point to allow for this movement during different weather conditions.

Relevant tradespeople, such as carpenters, painters and plasterers, should be appointed to perform remedial works, as deemed necessary.

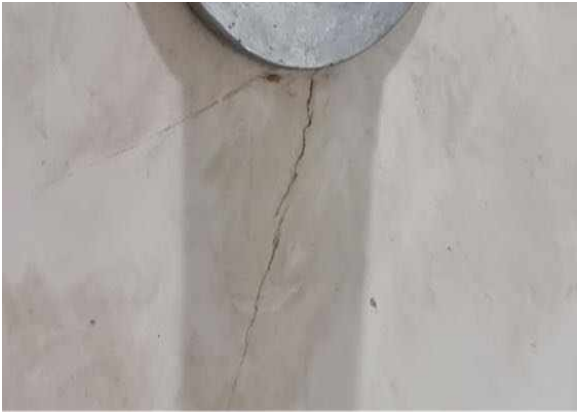
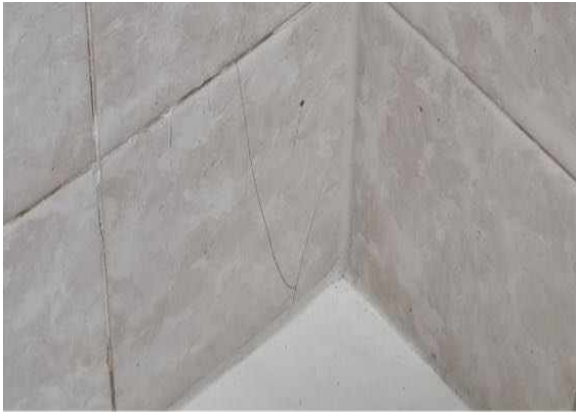
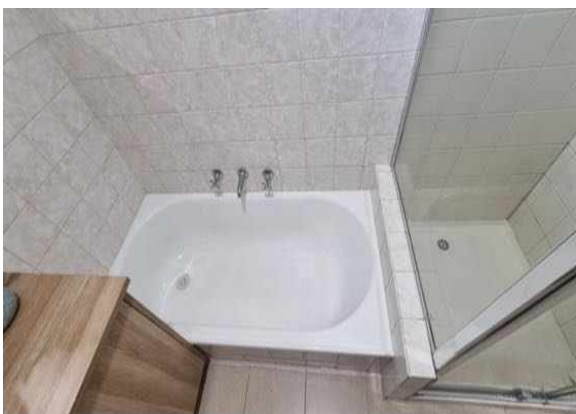
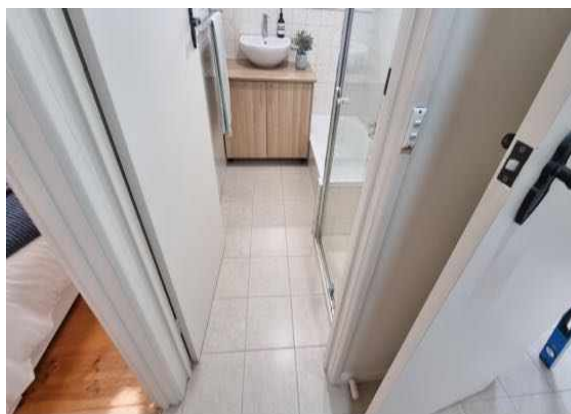
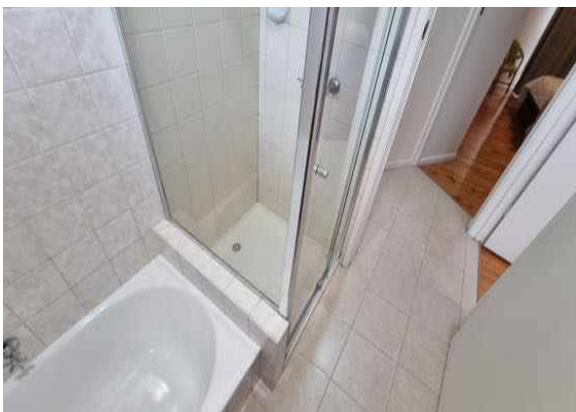
### Defects 3.03

Building:	Main Building
Location:	Bathroom > All Areas
Finding:	Bathroom - Shower leaking and other Minor defects
Information:	At the time of the inspection, the following defects were found,

1. the silicone around parts of the bathroom including shower has deteriorated.
2. Tiles have cracked and coming loose,
3. Grout to tiles have cracked along the wall/floor junction.
4. Moisture detected in shower walls and floor outside shower.

The above defects are generally due to wear and tear over long period of time, and it also is a sign that building elements have moved over time causing numerous defects.

The client should seek further advice from a qualified builder to determine extent of rectification works required.

These works should be done as a matter of priority.

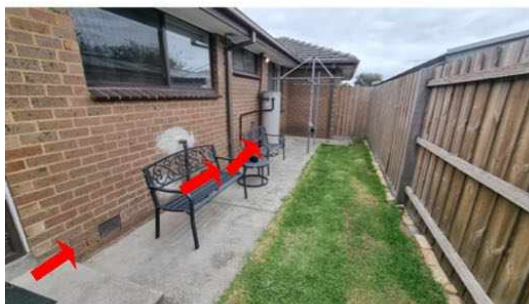
### Defects 3.04

Building:	Main Building
Location:	All External Areas > All Areas
Finding:	Brickwork - Deteriorated mortar
Information:	Mortar, or 'bedding', is the material which fills joints and intersections between bricks in masonry walls and structures.

Upon inspection of the external walls of the home, sections of mortar in the brickwork were identified as having deteriorated, which is generally expected for a property of this age and condition.

Mortar may deteriorate as a result of age of building materials, minor movement of bricks, or frequent exposure to weathering. Mortar should be replaced to ensure that bricks remain in their intended location and to prevent gaps, which would allow water or moisture ingress and secondary damage as a result.

Mortar deterioration can be addressed by a bricklayer where areas of deterioration are localised and easily accessible. Alternatively, appointment of a registered builder is advised, to repoint large areas of decaying mortar. Where secondary structural defects have become evident, consultation with a structural engineer may be required.

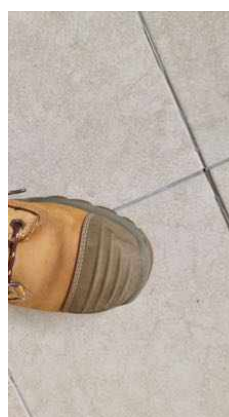
Bouncy floors generally indicate that the floorboards or the subfloor structures are coming loose from the joists that they are installed on. Bouncy flooring may also be the result of gaps between flooring and stumps or joist structures, which require packing.

Note, some areas of the home indicated more 'bounce' than others.

The client is advised to seek quotations for required repairs from a Registered Builder specialising in re-stumping. The potential resolution may range from packing gaps in subfloor structures through to replacement of subfloors stumps and refixing of flooring.

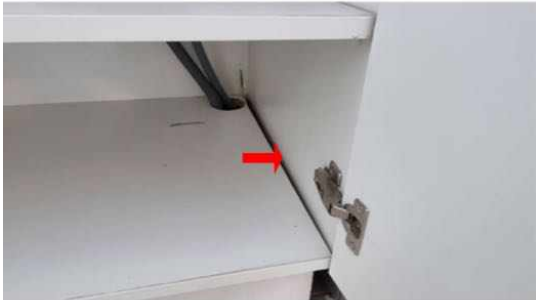
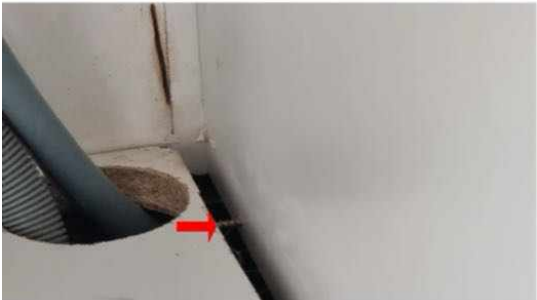
### Defects 3.07

Building:	Main Building
Location:	All Internal Areas > All Areas
Finding:	Incomplete or substandard works
Information:	The works to this area appear to be incomplete or have been completed to a substandard level.

It is highly recommended that the relevant trades such as a qualified carpenter or general handy person be appointed to complete these works and ensure the safety of the area and the longevity of all associated building elements.

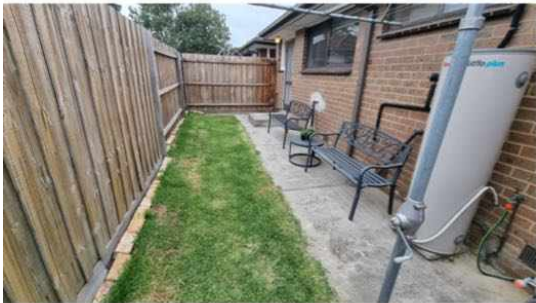
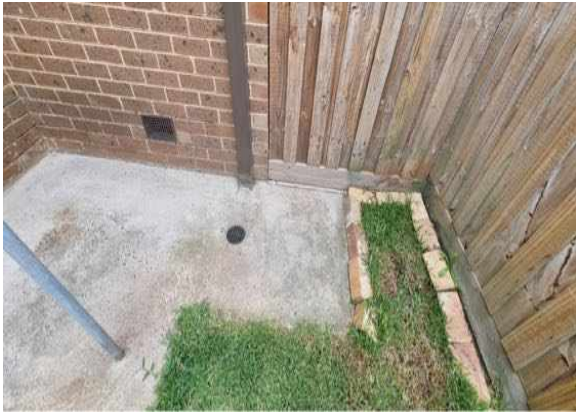
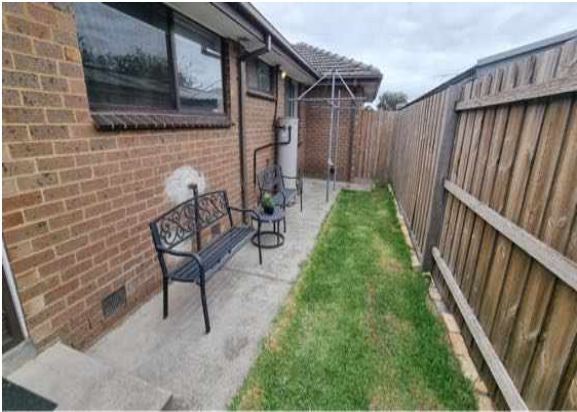
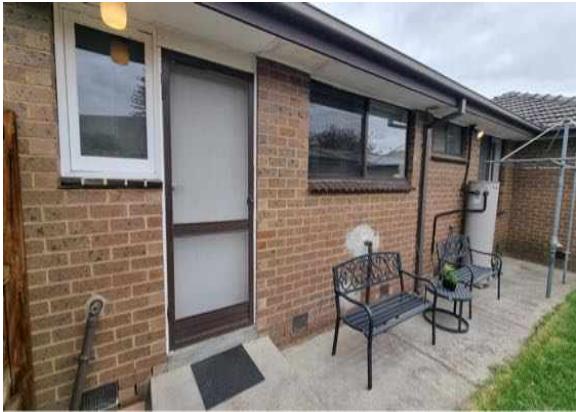
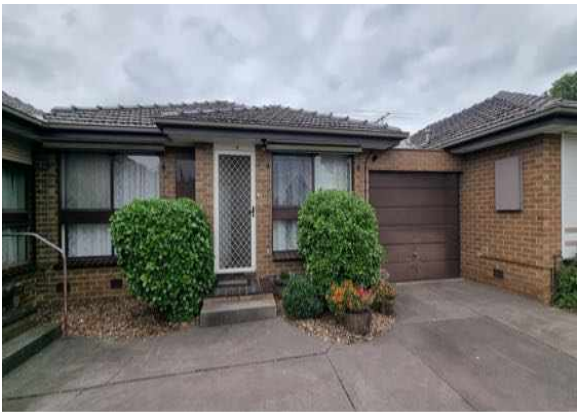
#### Noted Item

Building: Main Building  
Location: All External Areas > All Areas  
Finding: Additional Photos - Obstructions and Limitations  
Information: These photographs are an indication of the obstructions and limitations which impeded full inspection of the property at the time of inspection. These obstructions can hide an array of defects and should be removed to allow full inspection to be carried out. A re-inspection is recommended once the areas are made accessible.

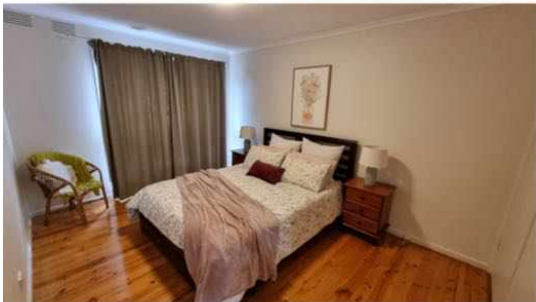
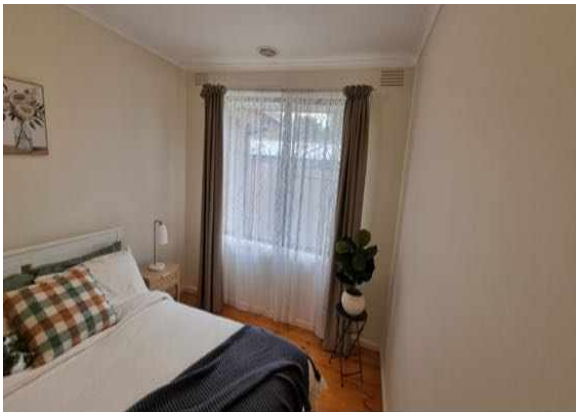
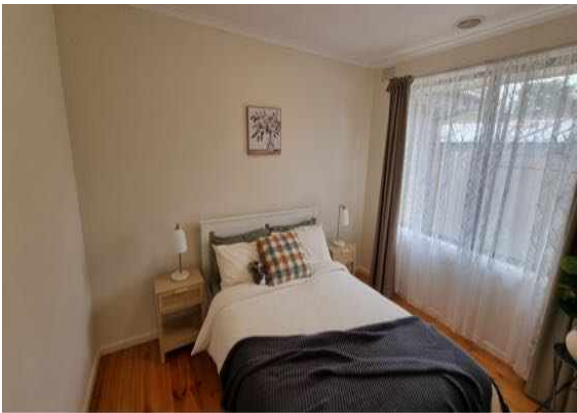
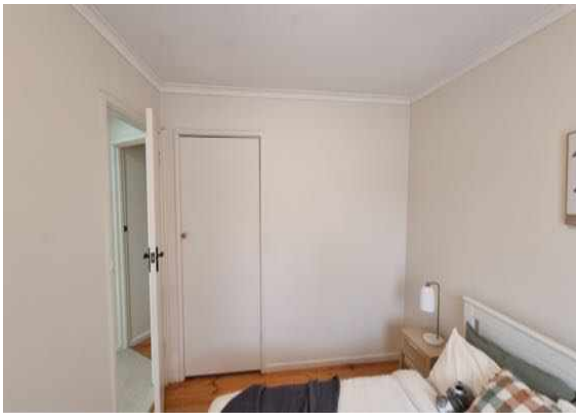
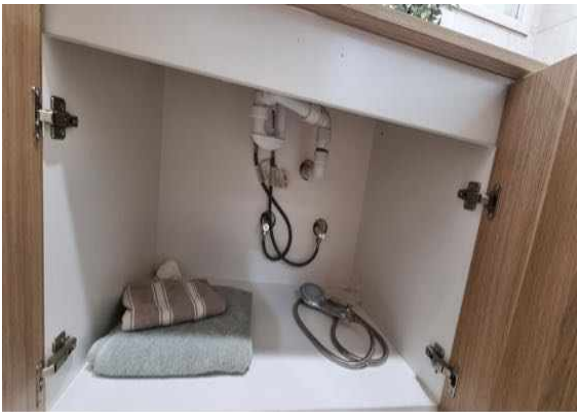
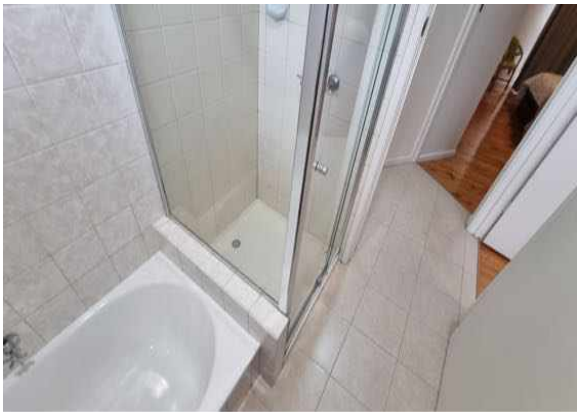
**Noted Item**

Building: Main Building  
Location: All Internal Areas > All Areas  
Finding: Additional Photos - Obstructions and Limitations  
Information: These photographs are an indication of the obstructions and limitations which impeded full inspection of the property at the time of inspection. These obstructions can hide an array of defects and should be removed to allow full inspection to be carried out. A re-inspection is recommended once the areas are made accessible.
