# Building and Timber Pest Inspection Report

Inspection Date: Tue, 10 Feb 2026

Property Address: 39A Nelson Rd, Earlwood NSW 2206,  
Australia

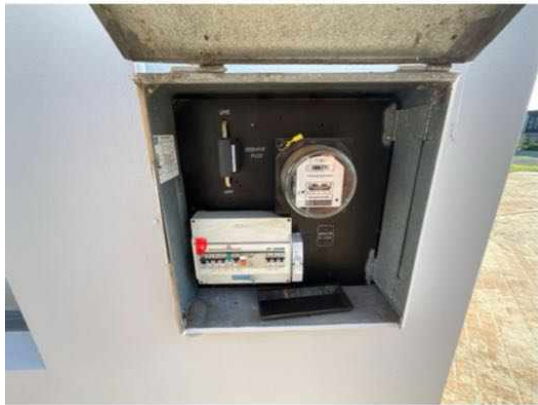
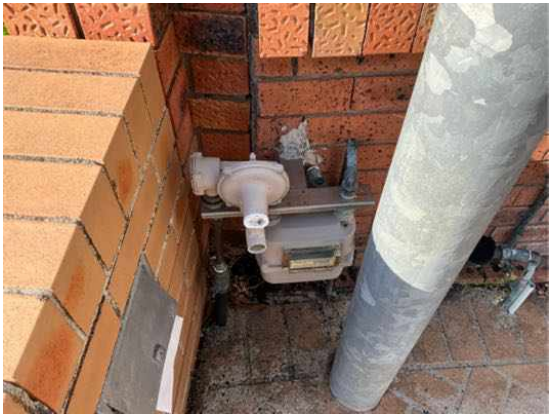
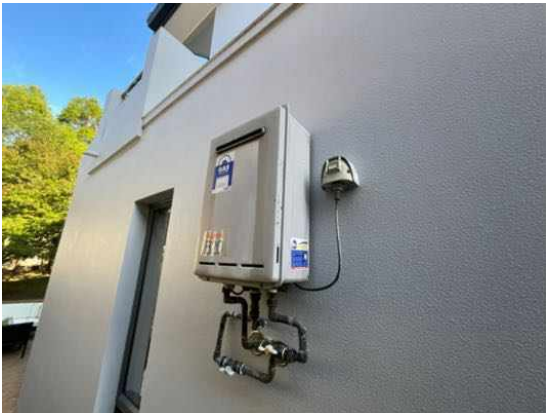
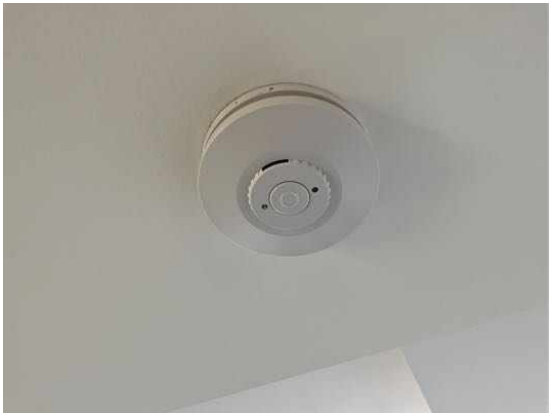
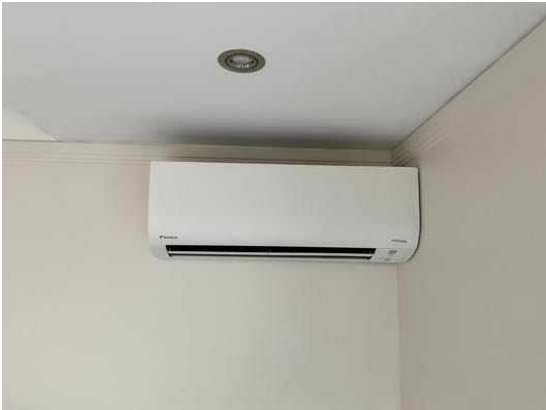
Building: Main Building  
Location: All Areas  
Finding: Photos Added  
Information: Additional photos are provided for your general reference.

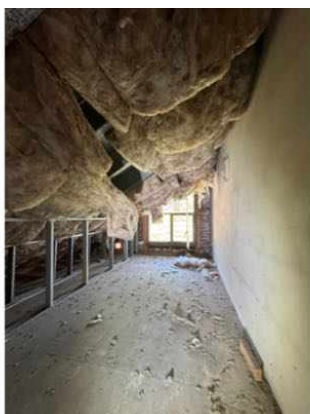
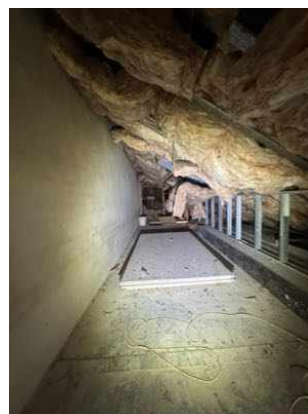
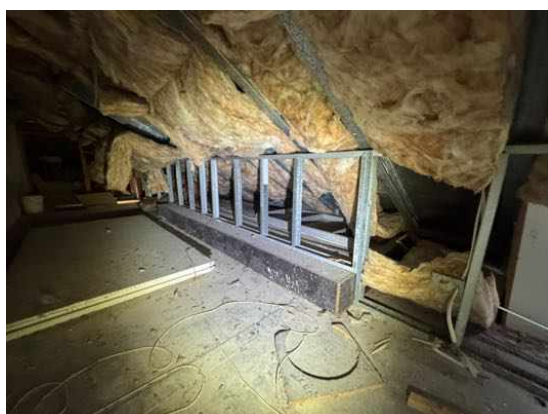
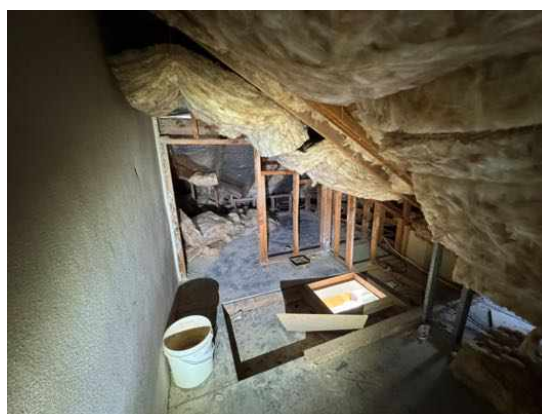
Building: Main Building  
 Location: Roof Void  
 Finding: Photos Added  
 Information: Additional photos are provided for your general reference.
