Building and Timber Pest Inspection Report

Inspection Date: Wed, 28 Jan 2026

Property Address: 65 Gipps St, Kiama NSW 2533, Australia

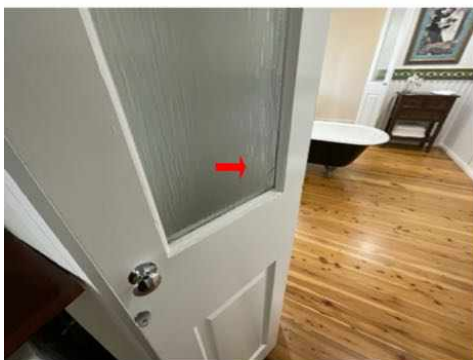
Building:	Building 1
Location:	Exterior front doors
Finding:	Windows - Cracked
Information:	Cracks were identified in the windows in these areas. Cracking in windows is generally the result of impact damage, and is likely to develop further when left unmanaged.

The likelihood of this windowpane further cracking and shattering is increased exponentially, providing a safety hazard in the area. The cracked window also impairs the weather tightness of the building, creating potential for minor water leaks.

A qualified glazier is required to repair the windows. Depending on the extent of the cracking, replacement of the window may be required. Please be advised that any persons coming into contact with the cracked window should do so with due caution to avoid any personal injury that may ensue.

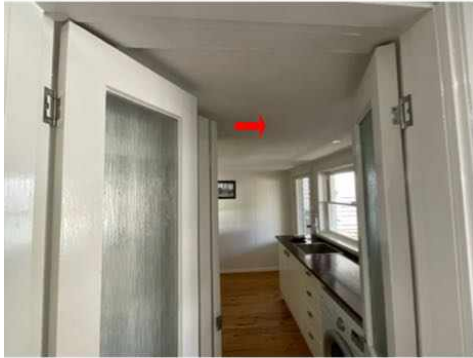
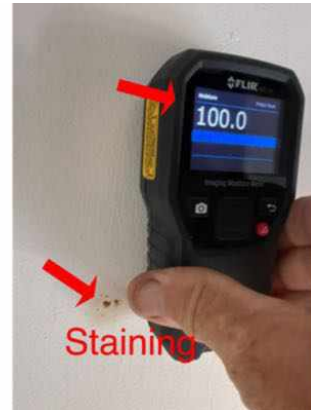
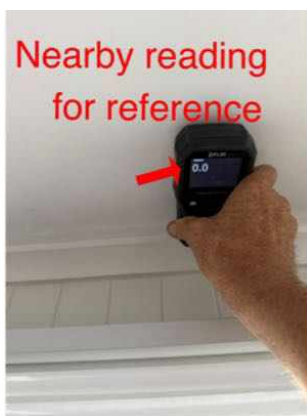
Building:	Building 1
Location:	Laundry ceiling
Finding:	Evidence of excessive moisture and staining in laundry ceiling
Information:	Excessive moisture was found in the laundry ceiling. It is not known where this may originate. A maximum reading of 100 was recorded. This moisture can attract termites and produce conditions that promote termite attack, fungal growth and wood decay.

This defect is listed in this report as a minor defect. If it is found by an invasive inspection that this moisture has lead to severe wood rot to the floor framing, then this would then be described as a major defect in this report.

An invasive inspection is required to determine the reason for the moisture ingress in the wall, then quotes for repairs should be sought.

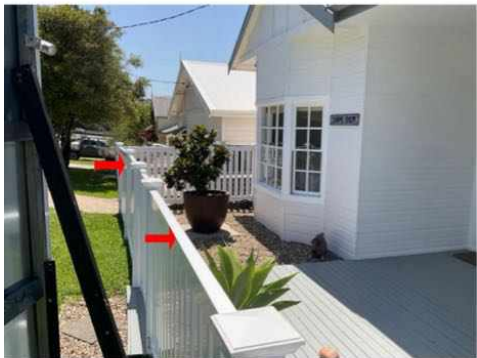
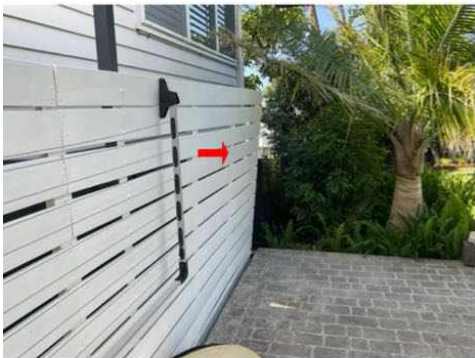
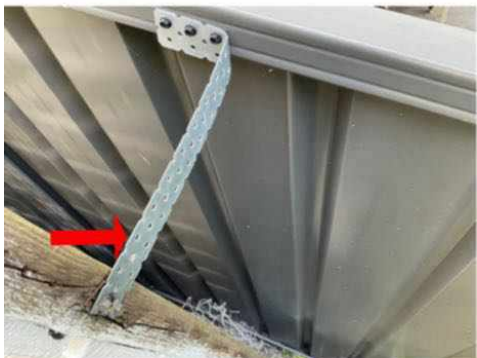
Finding 3.02

Building:	Building 1
Location:	Pictured fences
Finding:	Fences damaged - loose & leaning
Information:	Evidence of damage to the pictured fences was identified at the time of the inspection. The likely cause of both fences leaning and the front fence loose is not enough concrete used in the post footings. If left unmanaged this fence may deteriorate further.

It is suggest a fencing contractor be engaged for rectification when convenient.

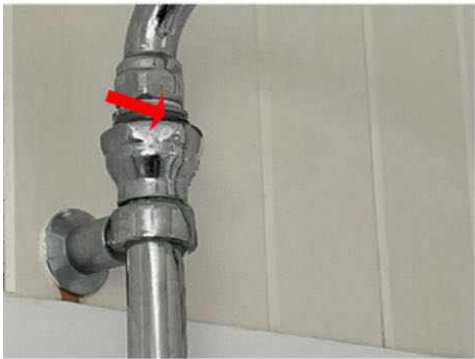
Finding 3.03

Building: Building 1
 Location: Bathroom
 Finding: Water leak into shower - Active
 Information: A water leak was found in the shower rail. Regardless of the location, even minor leaks that are left unmanaged can lead to damage of associated building elements and result in the need for replacement of building materials.

A licensed plumber can repair the leak in the near future.

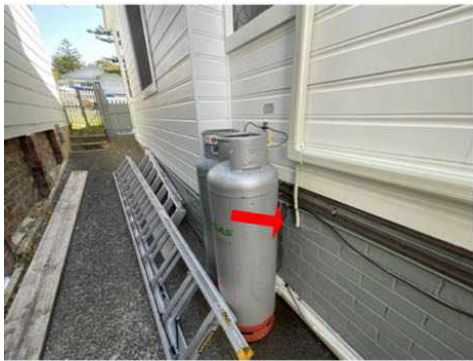
Finding 3.04

Building:	Building 1
Location:	Walls
Finding:	Site drainage - Inadequate
Information:	The site drainage in this area was found to be inadequate at the time of inspection, creating potential for subsequent water damage to associated building elements.

These air conditioner overflows run against the house walls.

It is important that water does not lie against the base of walls; surrounding paths and ground levels should be sloped to drain water away from walls. Downpipes should not discharge stormwater onto lower walls or plinths. Stormwater should be carried away by large, regularly cleaned drains. Ground levels may need to be lowered to expose a buried DPC.

Where site drainage is inadequate, installation of an Agricultural (Aggie) Drain may be required. A qualified plumber should be appointed to further inspect the property and perform any remedial works as necessary. Secondary defects are likely to occur if left unmanaged.

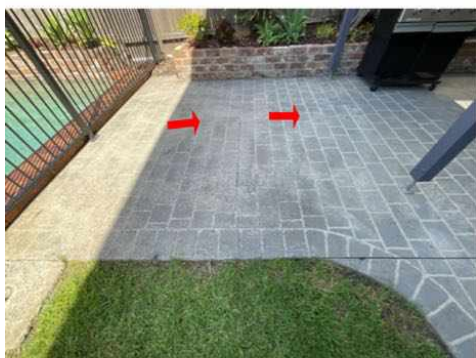
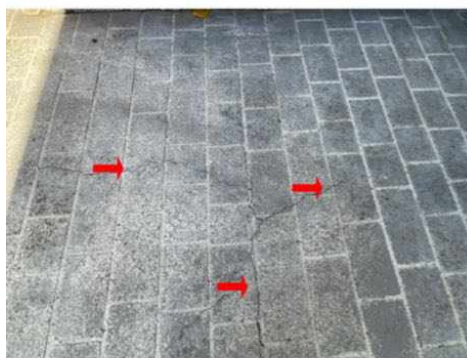
Building:	Building 1
Location:	Yard - rear
Finding:	Crack in concrete slabs - Category 1
Information:	Cracks coded as Category 1 was identified in these pictured slabs. A Category 1

crack is described as a fine but noticeable crack, with the slab at an otherwise reasonable level. To be considered Category 1, the approximate width of the crack is less than 1.0mm, or a less than 10mm change in offset when a 3m straight edge is placed over the defect.

Category 1 cracks should be monitored for a period of 12 months. At the end of the monitoring period, identified cracks that are rated greater than Category 2 are considered defects, and require rectification.

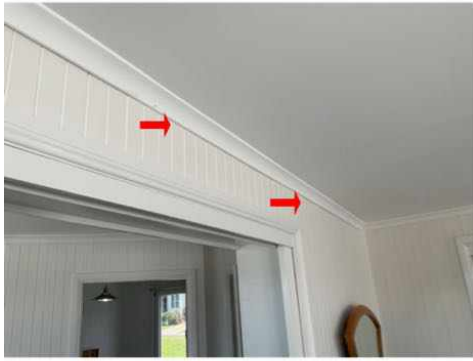
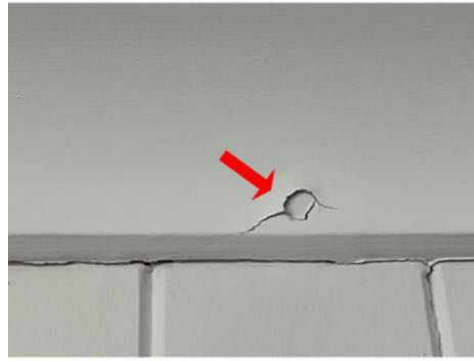
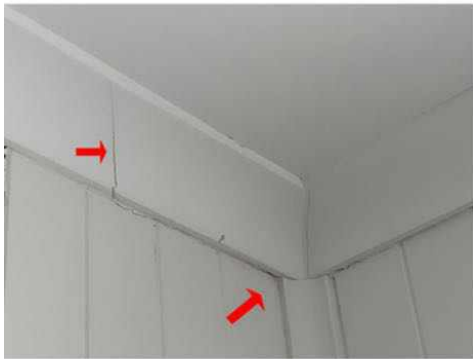
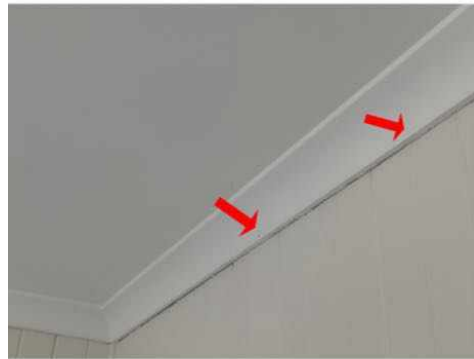
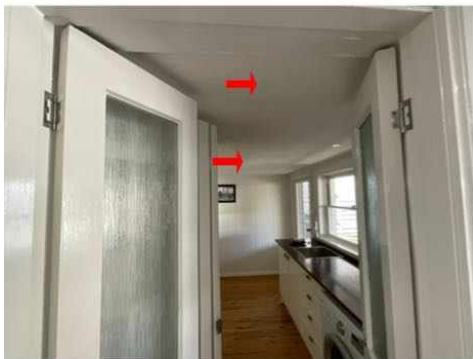
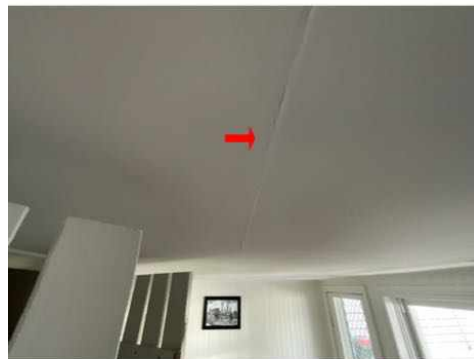
Finding 3.09

Building:	Building 1
Location:	Some rooms
Finding:	Cracking - Damage Category 1 - Fine (up to 1mm)
Information:	Although fine cracks are quite noticeable, they are often only considered to be an appearance defect, and usually do not indicate any structural damage. Generally, the cause of a fine crack is indicative of a separation between building materials and finishes (e.g. paint, plaster, etc.) along joints.

Cracking of this nature can generally be repaired with minor sanding, filling and/or repainting. Such works should be performed by a qualified painter or a general handyman.

Monitoring of all cracking should be conducted frequently. Always contact a building inspector should cracks widen, lengthen, or become more numerous.

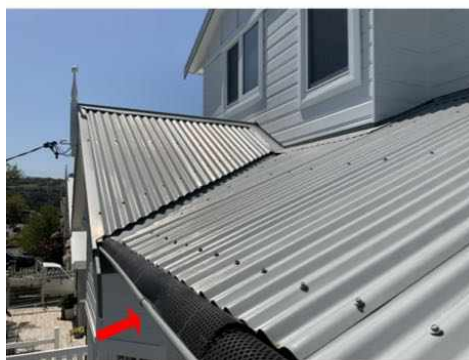
Finding 3.10

Building:	Building 1
Location:	Roof exterior Front
Finding:	Gutter - Insufficient fall
Information:	There is an insufficient fall in the verandah gutter, which means that the angle of this gutter is inadequate for rainwater to drain away. This may result in pooling of water in the area. This gutter should be checked in a high rainfall event for water pooling. Adjustment by a roofing contractor is required as soon as possible to prevent any damage to this area.

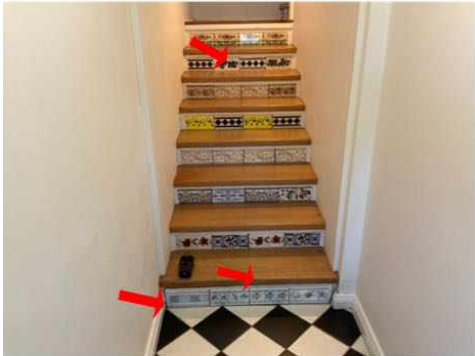
Building:	Building 1
Location:	Bathroom, stairs
Finding:	Tiles loose or cracked
Information:	Cracked and loose tiles was evident in these pictured areas at the time of inspection. It is suspected that this cracking has occurred as a result of minor settlement or impact

damage. Cracked tiles throughout the household detract from the overall appearance of the affected areas. In wet areas of kitchens and bathrooms, it can lead to water damage of adjoining walls and floors.

Replacement of cracked tiles and reglueing loose tiles is recommended as soon as possible. A tiling contractor may be appointed to perform these works. Where cracks become more numerous, contact a licensed building inspector for further investigation.

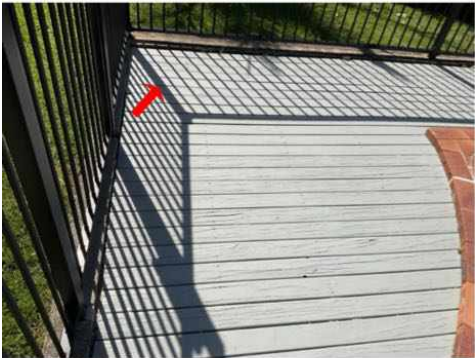
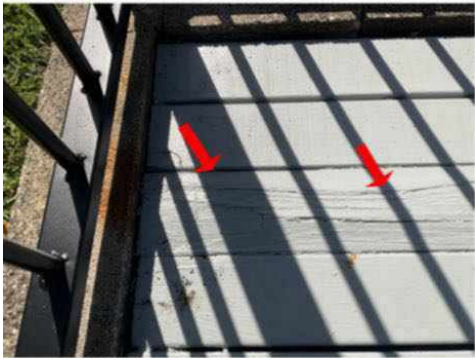
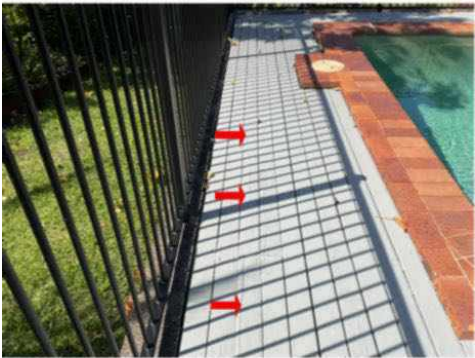
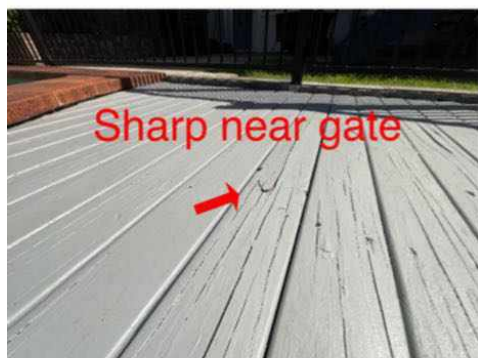
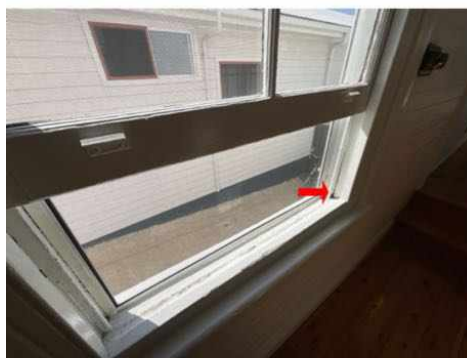
Finding 3.13

Building: Building 1
Location: Pictured areas

Finding: Wood rot
Information: The reardecking and kitchen window shows evidence of wood rot. Wood rot, also known as Fungal Decay, occurs when timbers and other cellulose building materials are exposed to damp conditions on an ongoing basis. This could be the result of exposure to weathering over a prolonged period of time, or the attraction of excessive moisture from other abutting building materials.

Early intervention and regular maintenance, particularly of exterior timbers, will prolong the useful life of these building elements. Prior to any works being performed, the cause of the moisture that has created the visible wood rot should be identified and addressed in a suitable manner. Replacement of affected timbers may then be a necessary step in protecting surrounding building elements from such deterioration.

A qualified carpenter or registered builder may also be required to replace affected building materials.

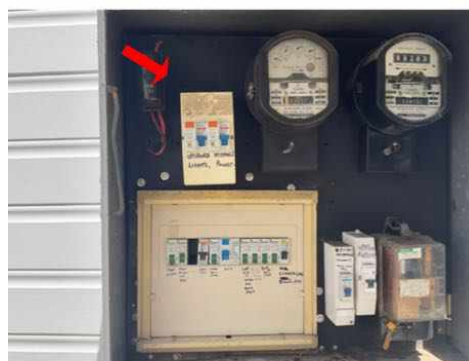
Building:	Building 1
Location:	Meter Box
Finding:	Termite Management System - no evidence of a chemical installation
Information:	The application of a post-construction chemical termite barrier is highly recommended for all properties. Such barriers are highly effective in preventing termite attack on any timber building elements throughout the property.

A durable notice should be placed in the switchboard unit to indicate current termite barriers. At the time of inspection, no durable notice was evident and it appeared as though no chemical termite management system has been installed, with no evidence to suggest preventative works taking place since the property was built.

The client may consider gaining further advice from a pest controller as to the costs and procedures involved with a 'chemical' application. It is recommended that obtaining such advice be a short-term priority.

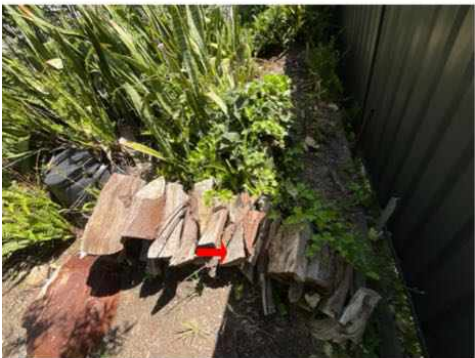
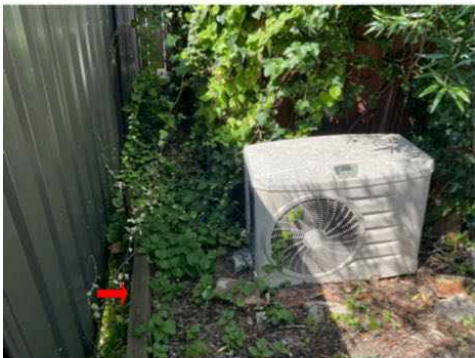
Building:	Building 1
Location:	Rear yard and subfloor
Finding:	Timber in contact with the ground
Information:	Any timbers in direct ground contact provide opportunity for concealed termite entry and are likely to be subject to premature rot and decay as the soil retains moisture or damp conditions against the timbers.

Removal of all waste timber that is in direct contact with ground is highly advised. This timber is promoting mould and wood rot and is very attractive to termites.

Frequent pest inspections are advised to readily identify any termite activity in these areas.

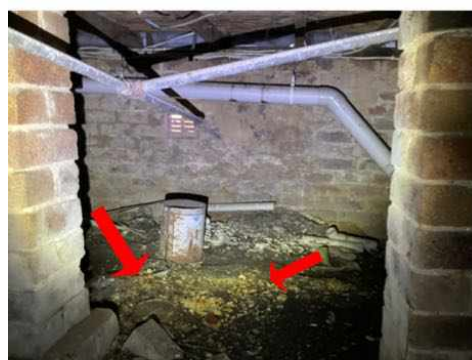
Building: Building 1
Location: Subfloor
Finding: Mould - Present in subfloor
Information: Where evidence of mould growth was noted, there may be environmental, biological or health issues associated with the report. A specialist inspection by a suitably qualified environmental health inspector is warranted, where mould is extensive or where any queries regarding air quality spores or other related issues apply.

Subfloor mould is generally caused by moisture ingress, lack of external drainage, lack of adequate ventilation and subfloor debris present. These issues need rectification

Generally, the client is advised to ensure that the general environment is free of moisture and humidity to aid in the prevention of mould formation and development.

to stop mould development. Any mould found during the inspection should be cleaned immediately by a cleaning contractor or the homeowner as applicable.

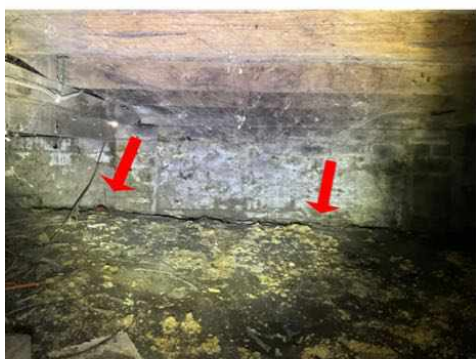
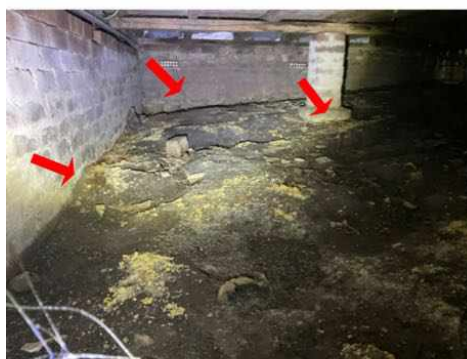
Finding 6.06

Building: Building 1
Location: Subfloor
Finding: Damp - Rising

Rising damp is generally managed by the installation of a damp proof course during construction. A Damp Proof Course (DPC) is an impermeable barrier at the base of the wall above ground level. However, many 19th Century buildings have no damp course installed, or the materials have failed. The DPC may have been omitted as a consequence of poor workmanship, or it may have been bridged where materials built up against the side of the house allow moisture ingress above the DPC level.

The first step in addressing rising damp is to diagnose the cause. The identified cause should be addressed first before addressing the appearance and other defects which have resulted from the rising damp. If the original cause is not resolved, further cases of damp are likely to ensue, resulting in secondary defects.

Consultation with a qualified plumber is advised immediately to identify the cause of the damp and perform remedial works as required.

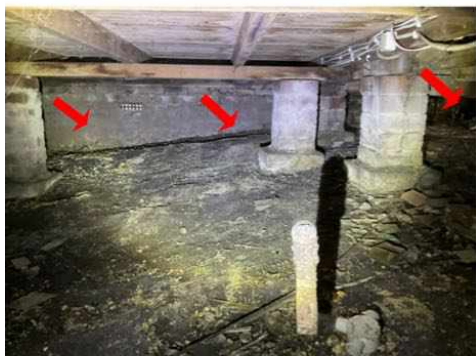
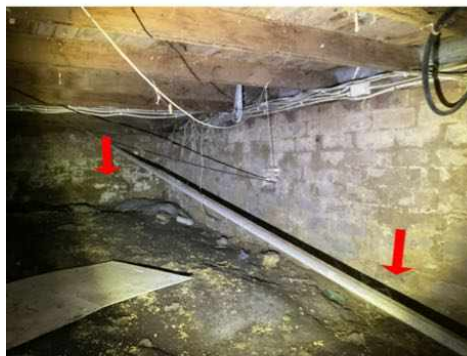
Finding 6.07

Building: Building 1
Location: Subfloor
Finding: Subfloor ventilation - Inadequate
Information: Adequate subfloor ventilation aids in preventing excessive moisture wood rot and termite activity by ensuring a dry subfloor environment.

Subfloor ventilation can be improved in most cases by addressing the causes such as exposing subfloor vents, installing additional vents, installing mechanical ventilation and removing debris from the subfloor.

A registered builder should be appointed as soon as possible to perform these works as necessary.

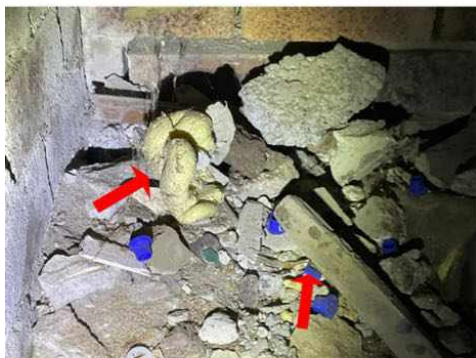
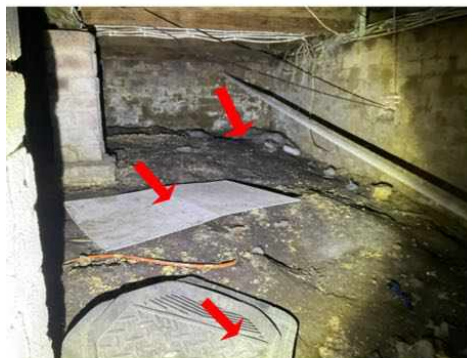
Finding 6.08

Building:	Building 1
Location:	Subfloor
Finding:	Subfloor - Debris
Information:	An array of debris was found in the subfloor area at the time of inspection. Debris in this area restricts subfloor ventilation and creates potential for concealed pest entry. Stored timbers and other materials may also make the area susceptible to termite activity and wood rot.

A clear and empty subfloor will be better ventilated and easier to maintain in a dry condition. The removal of any timber debris is vital in minimising the risk of termite or wood borer activity.

Debris in the subfloor should be removed as soon as possible. Depending on the location and amount of debris and stored items, the homeowner may elect to undertake this task. Alternatively there are a large number of rubbish removal subcontractors that could undertake these works.

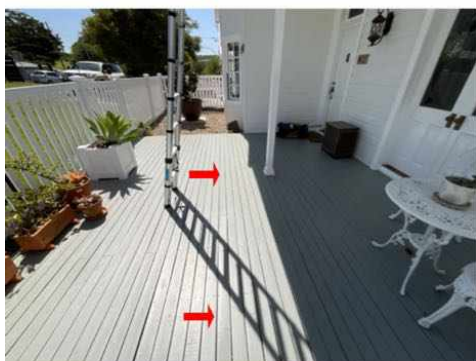
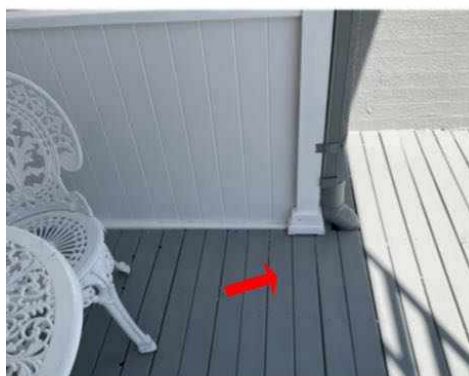
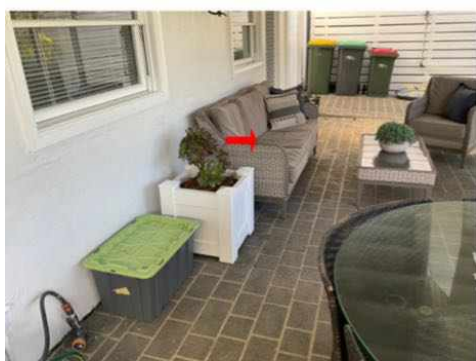
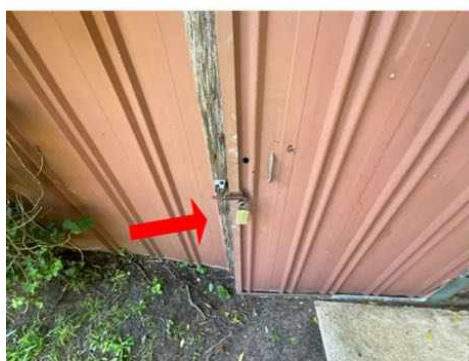
Building: Building 1
 Location: All External Areas
 Finding: Additional Photos - Obstructions and Limitations of EXTERNAL AREAS
 Information: These photographs are an indication of the obstructions and limitations which impeded full inspection of external areas at the time of inspection. These obstructions can hide an array of defects and should be removed to allow full inspection to be carried out. A re-inspection is recommended once the areas are made accessible.

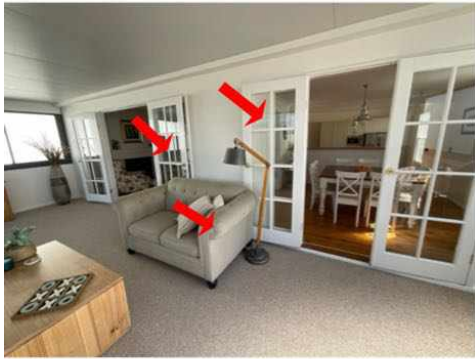
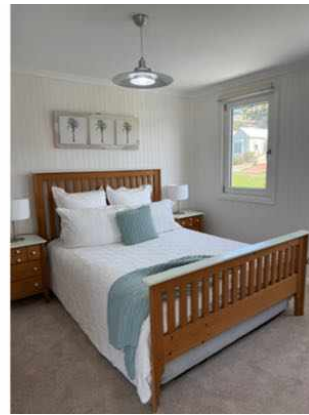
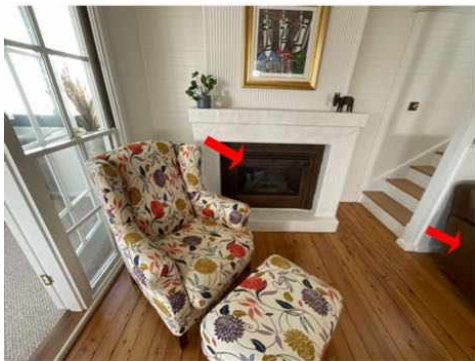
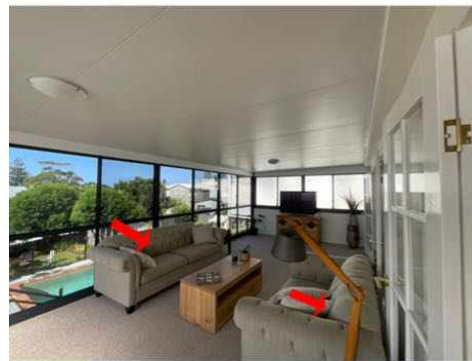
Building: Building 1
 Location: All Internal Areas
 Finding: Additional Photos - Obstructions and Limitations of INTERNAL AREAS
 Information: These photographs are an indication of the obstructions and limitations which impeded full inspection of Internal areas at the time of inspection. These obstructions can hide an array of defects and should be removed to allow full inspection to be carried out. A re-inspection is recommended once the areas are made accessible.

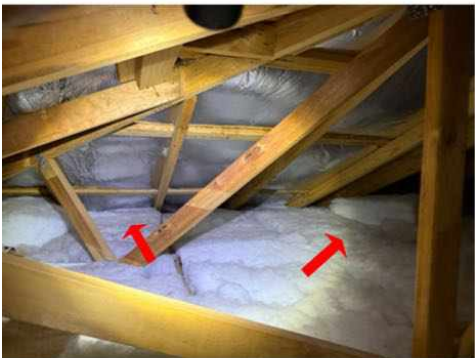
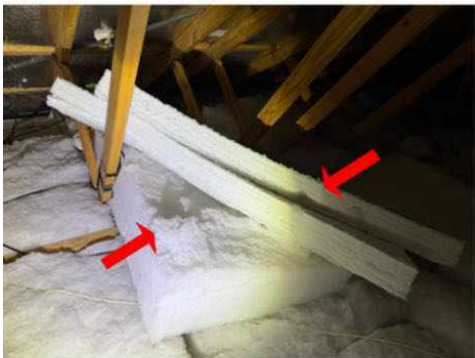
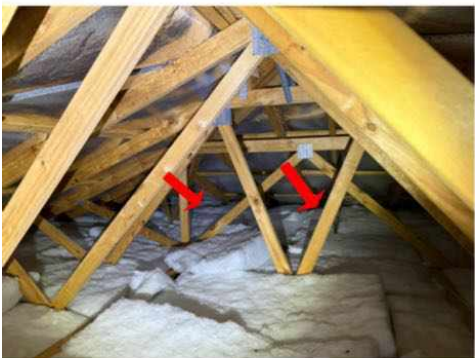
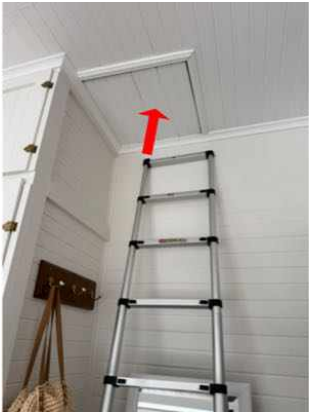
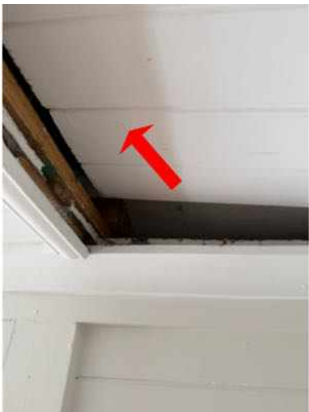
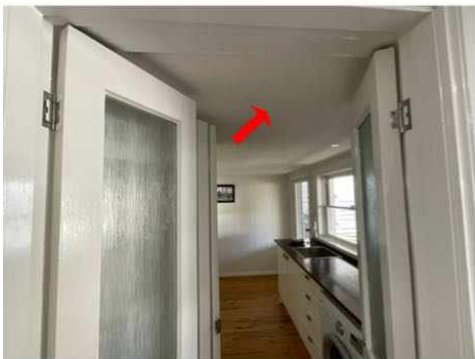
Building: Building 1
 Location: All Roof cavity areas
 Finding: Additional Photos - Obstructions and Limitations of the ROOF CAVITY
 Information: These photographs are an indication of the obstructions and limitations which impeded full inspection of roof cavity areas at the time of inspection. These obstructions can hide an array of defects and should be removed to allow full inspection to be carried out if applicable. A re-inspection is recommended once the areas are made accessible.

The inspection was also limited to areas with an allowable crawl space of 600mm x 600mm, in particular towards the external walls where the roof line diminishes, these areas were not accessible.

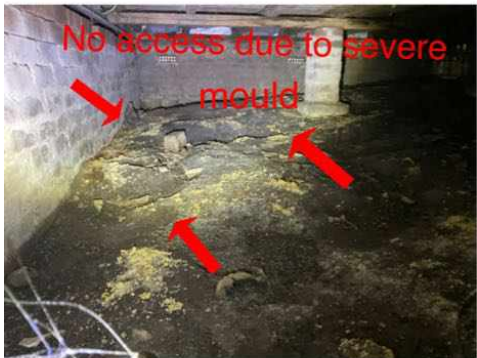
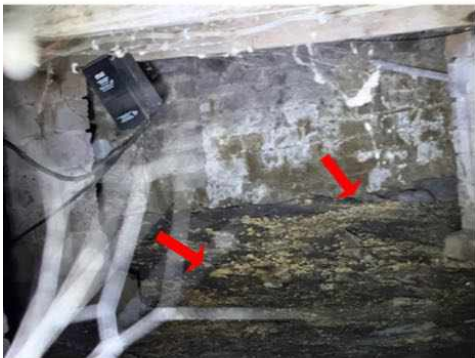
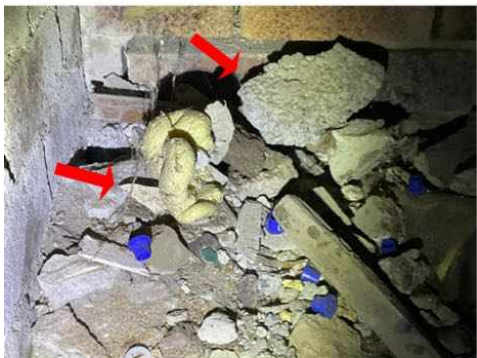
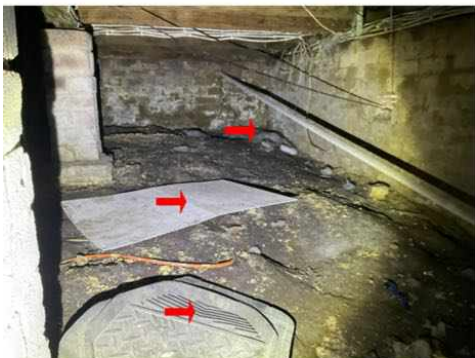
Building: Building 1
Location: All Subfloor Areas
Finding: Additional Photos - Obstructions and Limitations of SUBFLOOR AREAS
Information: These photographs are an indication of the obstructions and limitations which impeded full inspection of subfloor areas at the time of inspection. These obstructions can hide an array of defects and should be removed to allow full inspection to be carried out. A re-inspection is recommended once the areas are made accessible.

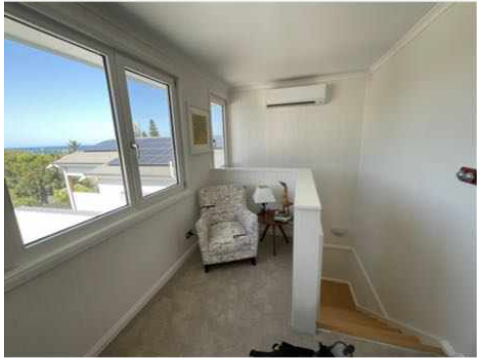
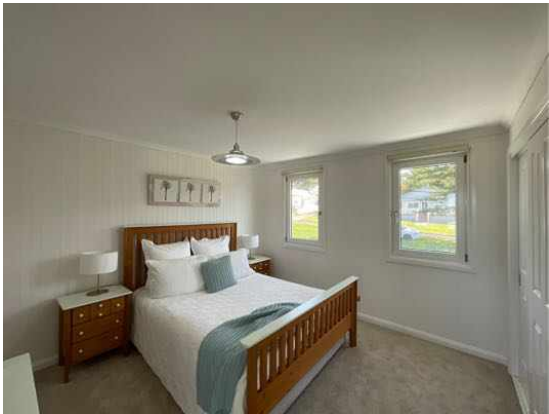
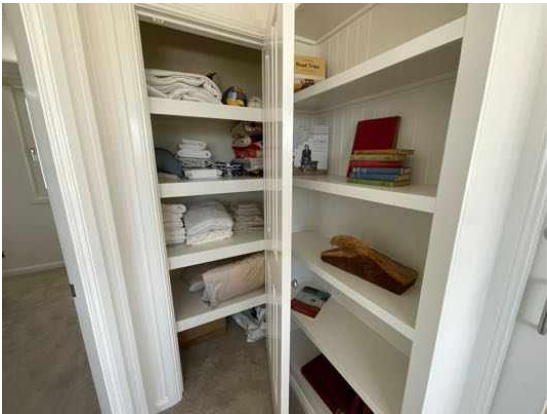
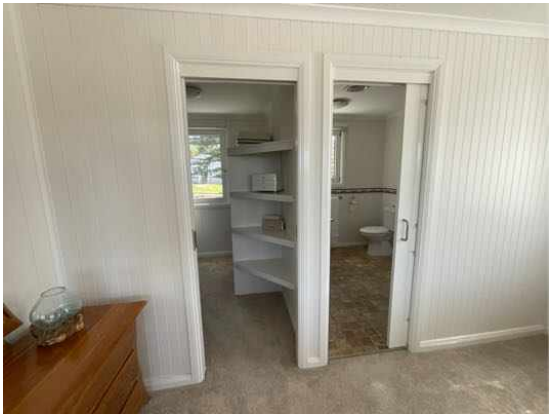
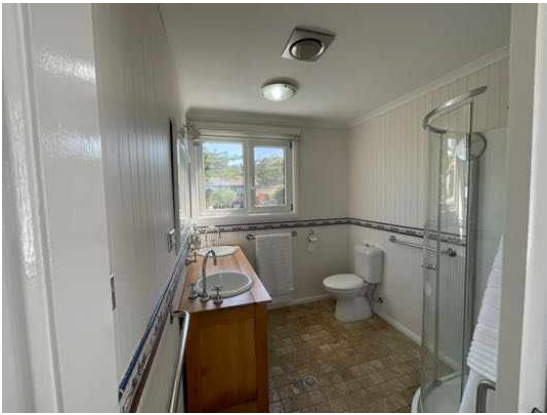
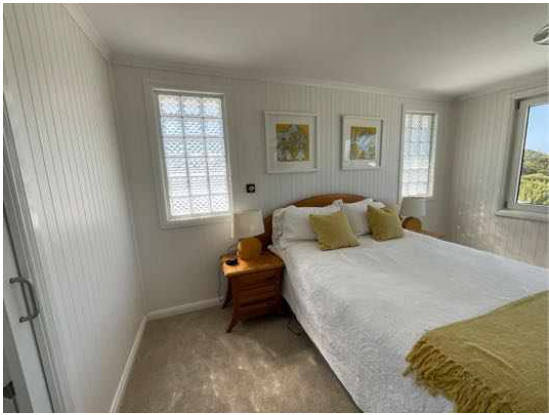
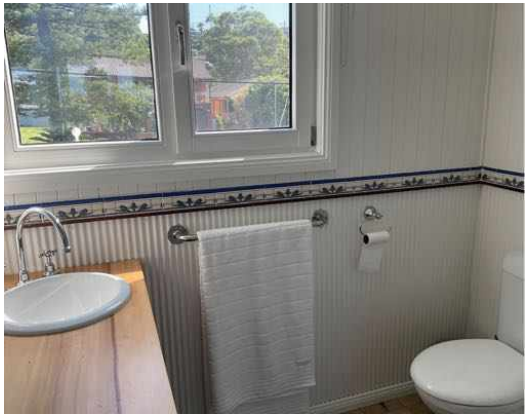
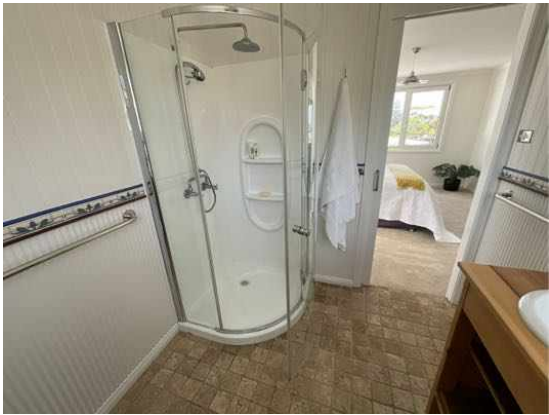
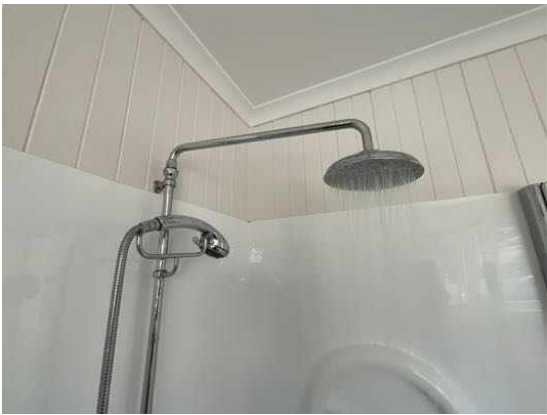
Building: Building 1
Location: All Internal Areas
Finding: Additional Photos
Information: Additional photos are provided for your general reference

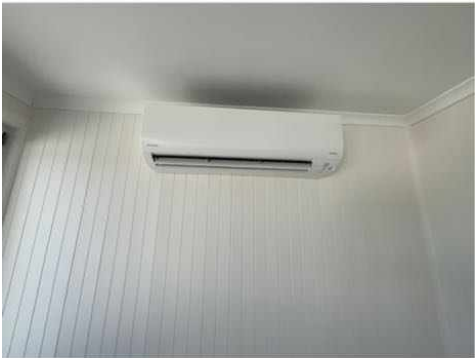
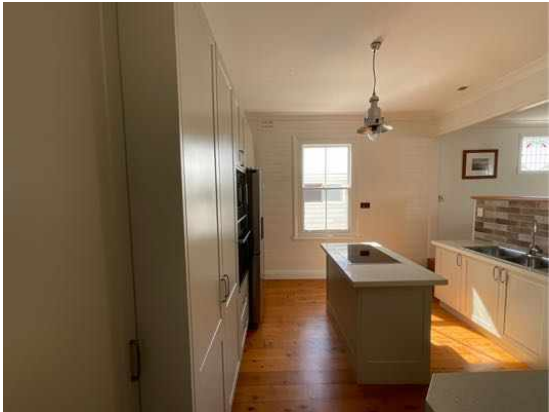
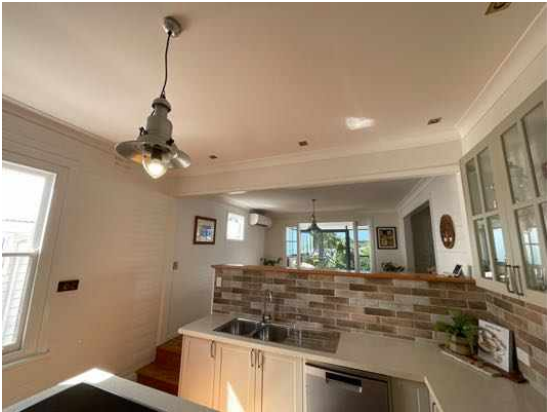
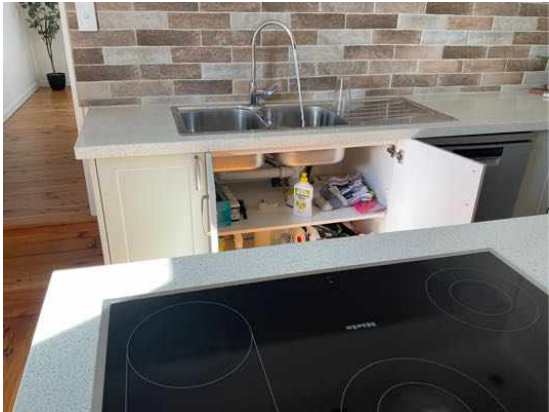
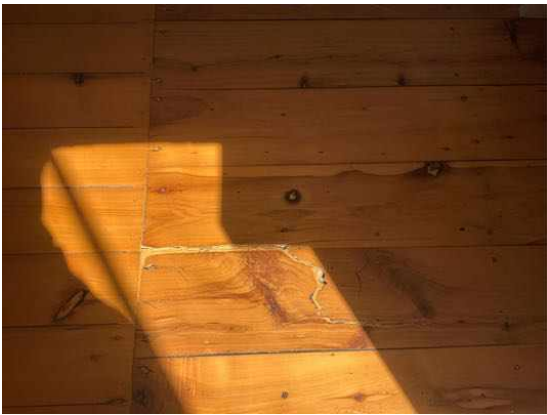
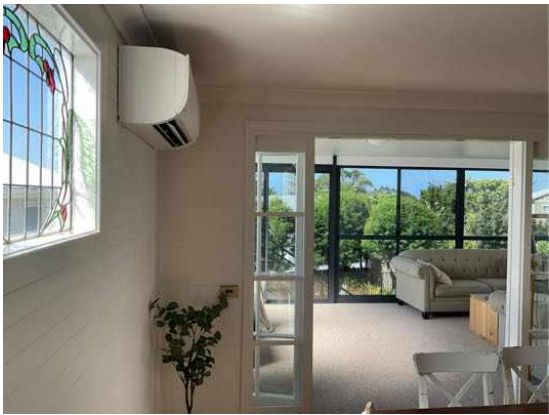
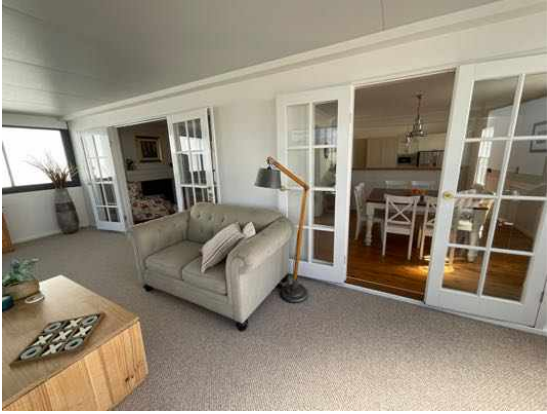
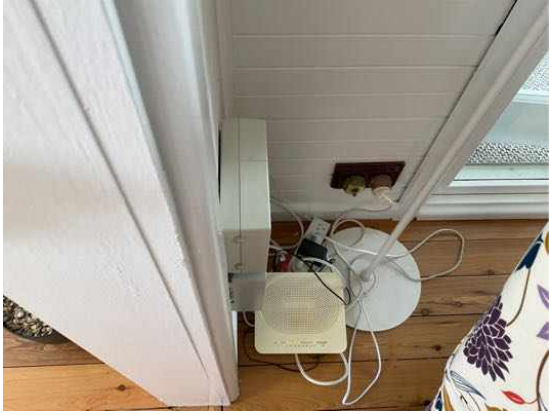
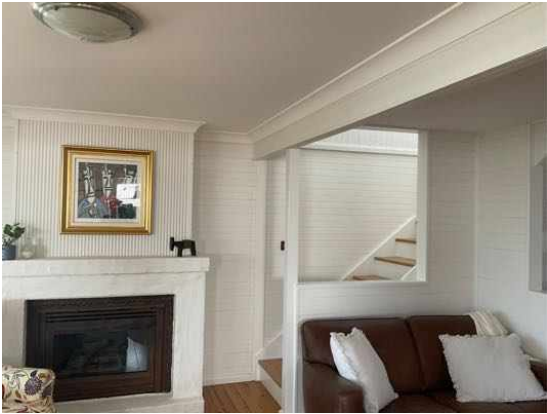
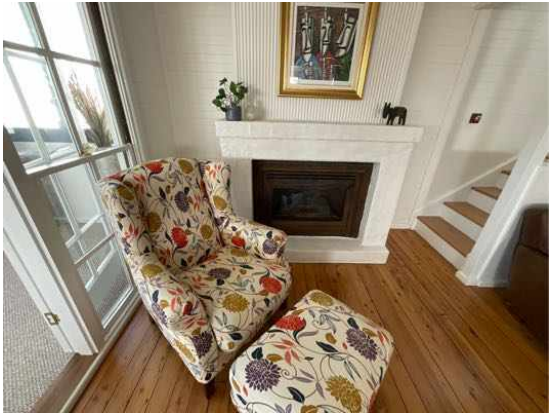
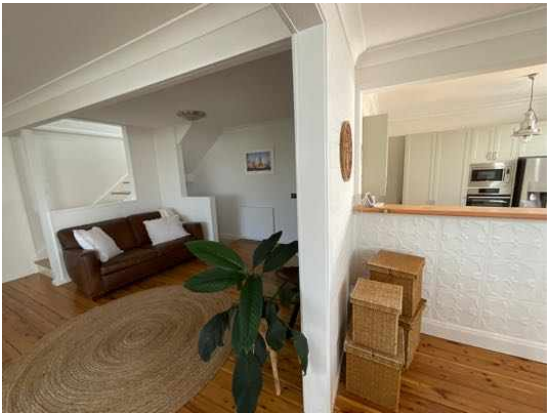
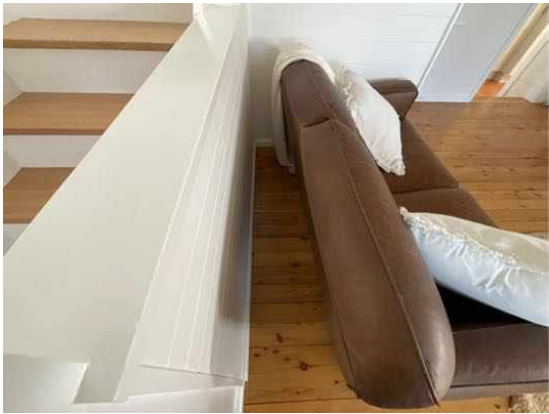
Building: Building 1
Location: All Internal Areas
Finding: Additional Photos
Information: Additional photos are provided for your general reference

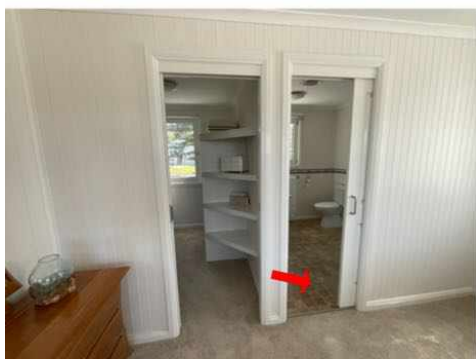
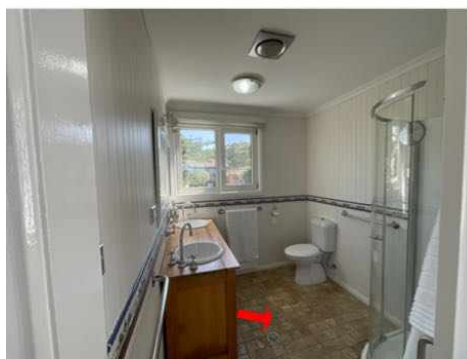
Building: Building 1
Location: Bathrooms and laundry
Finding: Waterproofing membranes - Information Only
Information: Internal Water Proofing Membranes, are crucial in preventing water ingress into the property is important to know that the Membrane System used is to Australian Standards and has been installed correctly.

With older property's where this information is unavailable all wet areas should be monitored. If any leaks, water staining, peeling or bubbling of the paint become evident to any adjacent walls or ceilings below a licensed builder or waterproofing specialist is recommended to investigate further.
