Building and Timber Pest Inspection Report

Inspection Date: Mon, 16 Feb 2026

Property Address: 7 Birdwood St, Corowa NSW 2646,
Australia

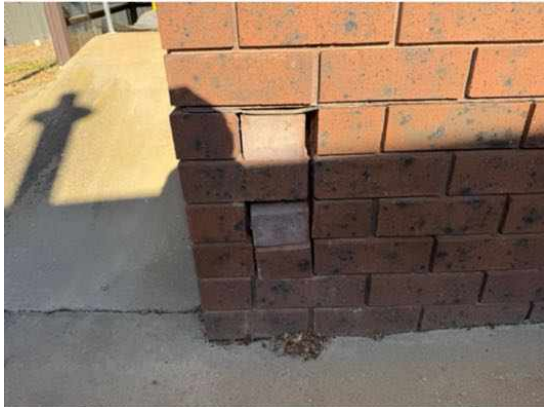
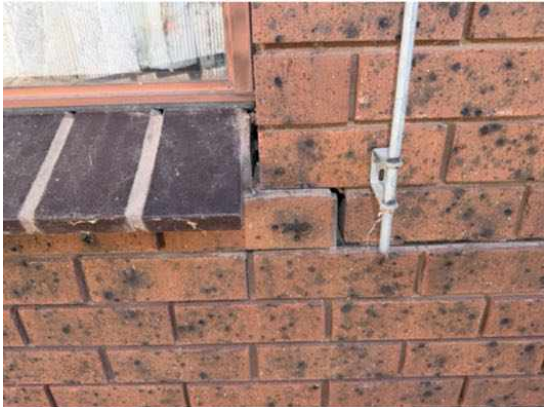
Building: Main Building
Location: All External Areas
Finding: Brickwork - Step cracking, Movement
Information: Step cracking & evidence of movement was identified to areas of the brickwork at the time of inspection. Step cracking, has a variety of possible causes. However, the most common is movement of adjacent footings.

The client should closely monitor the cracking & movement. Should the step cracking, lengthen, widen or become more numerous, the client should engage a structural engineer promptly, to provide further advice.

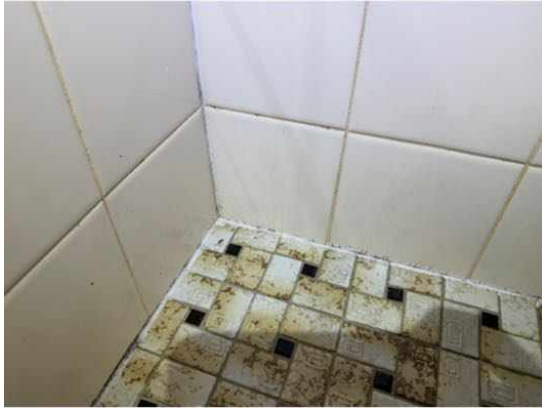
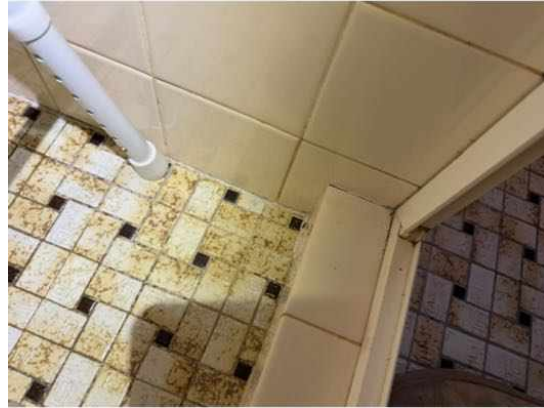
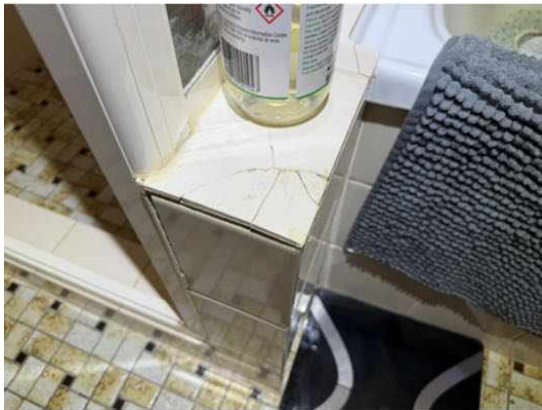
Building:	Main Building
Location:	Tiled Areas
Finding:	Sealant / grouting - deteriorated or missing & Cracked / Loose Tiles
Information:	It appears that the sealant and grout has deteriorated in some tiled areas, a common defect in buildings of a similar age. Areas of cracked & loose tiles were also noted, which can allow for moisture ingress behind the tiles, if neglected.

Sealant and grouting in areas that come into regular contact with water should be maintained for the long term care of your property.

Recommend engaging a licensed tiling contractor in the short term, to provide maintenance works where necessary.

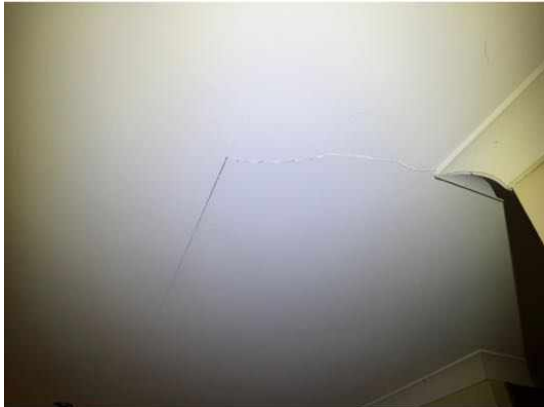
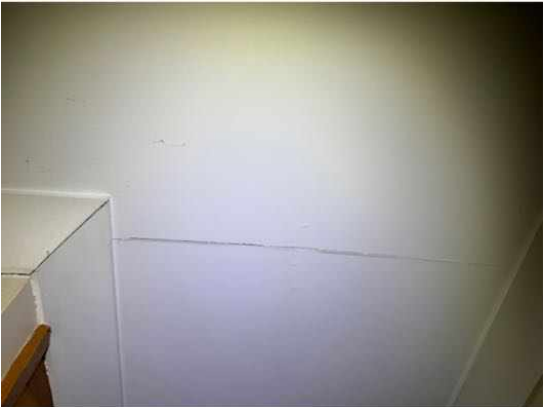
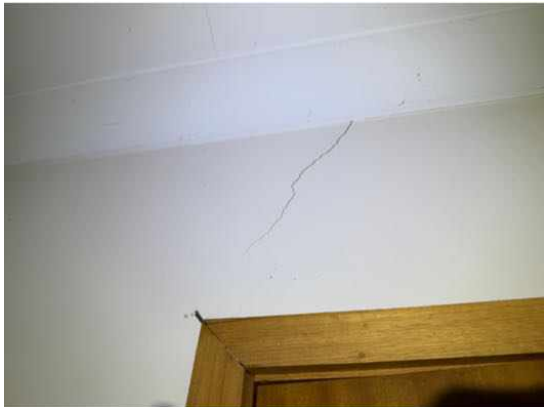
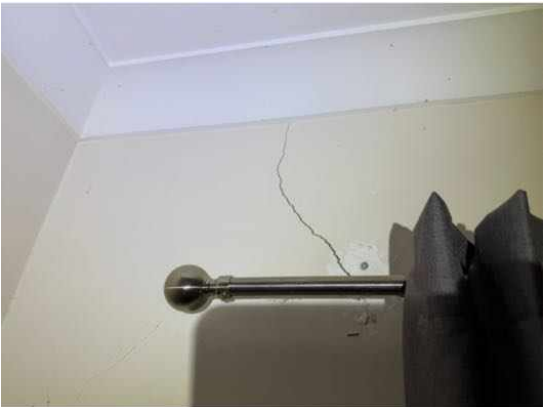
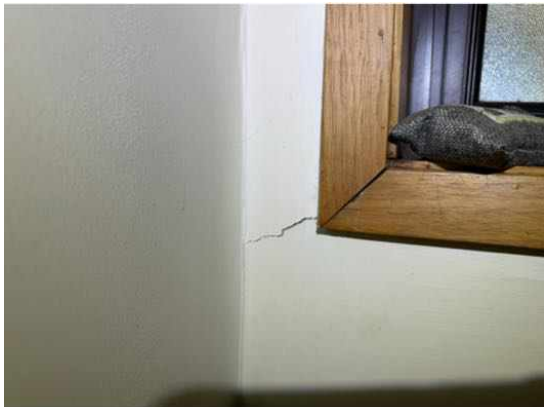
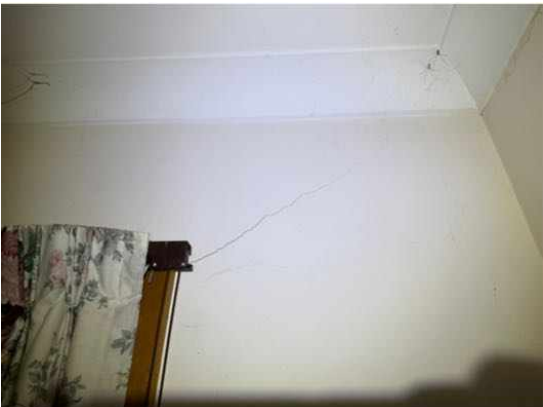
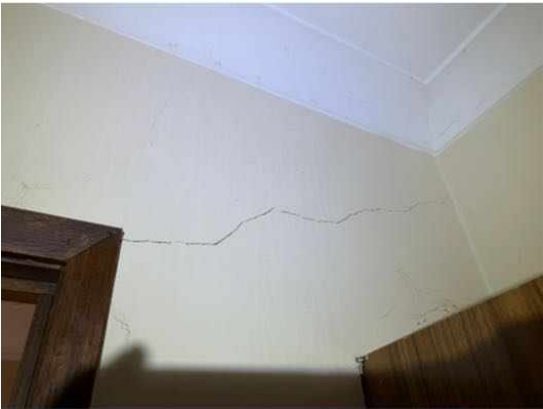
Finding 3.05

Building: Main Building
Location: All Internal Areas
Finding: Plaster - Cracking
Information: There appears to be several areas of cracking throughout the wall linings, indicating

movement of the building. The client should closely monitor these areas. Should cracking widen, lengthen, or become more numerous, the client should consult with a structural engineer promptly, for further advice & remedial works.

Several areas of cracking & evidence of movement were identified to the brickwork and internal wall linings. Recommend that the client closely monitor these areas to identify any further movement. Should cracking length, widen, or become more numerous, a structural engineer should be engaged promptly for further evaluation.

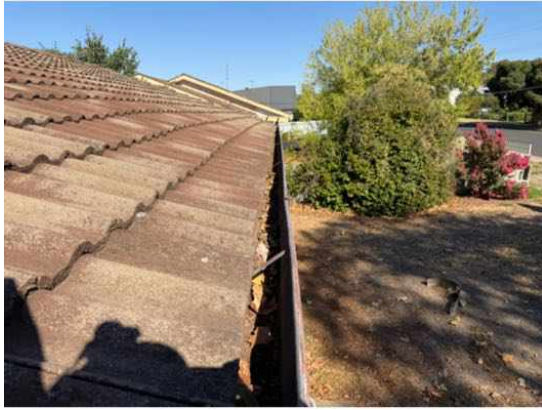
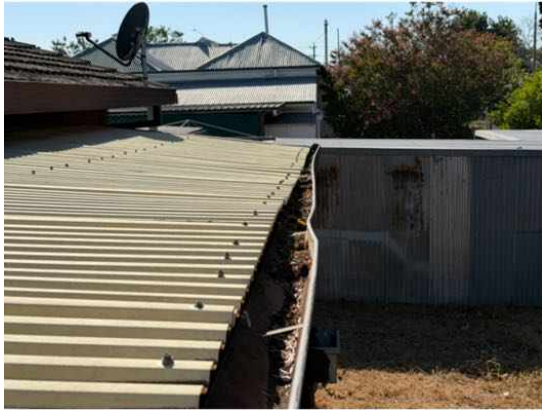
Finding 3.06

Building: Main Building
Location: Gutters
Finding: Debris in Gutters
Information: It appears that there is some debris in the gutters. Accumulation of debris can lead to blockages of the gutters & water overflows, if neglected.

Recommend engaging a general handyman to remove all debris from the gutters promptly to prevent overflows & blockages.

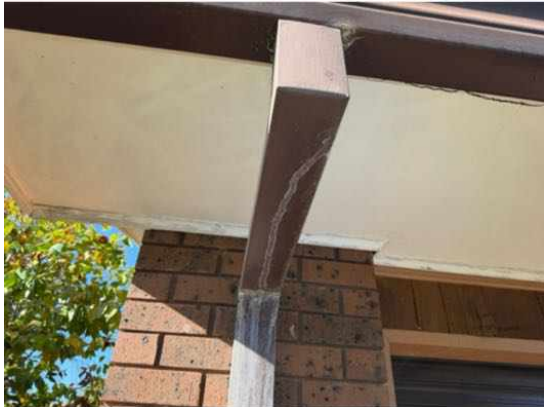
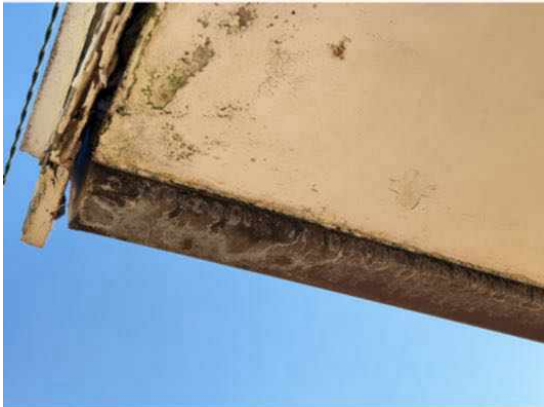
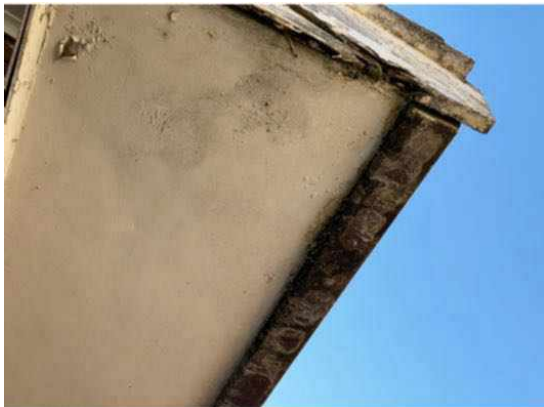
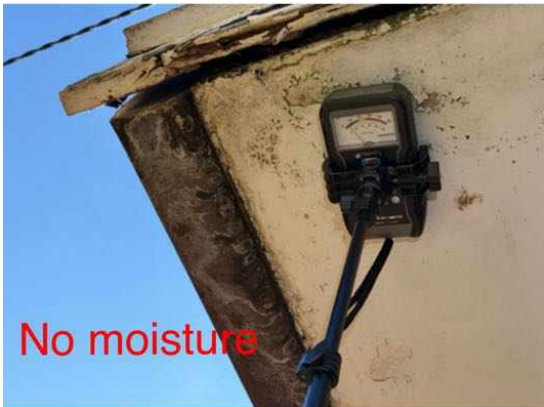
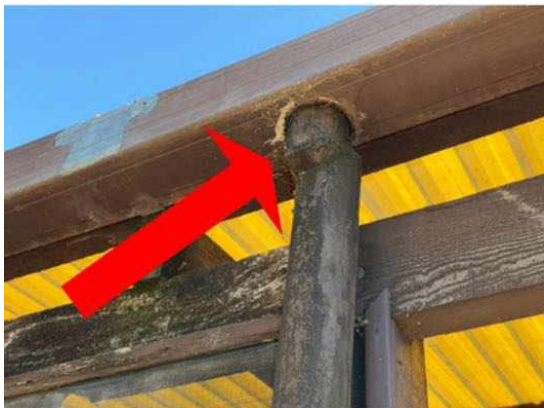
Finding 6.03

Building:	Main Building
Location:	Roof Plumbing
Finding:	Roof Plumbing - Rust & Leaking
Information:	It appears that areas of the roof plumbing were leaking & had areas of rust. Rusted & leaking roof plumbing could eventually develop holes overtime that can affect other building elements, and create water pooling in the area, creating an environment conducive to termite activity, if neglected. Recommend consulting with a licensed roof plumber in the short term, to provide further advice & remedial works where necessary.

Areas of rust and leaking were identified to the roof plumbing. Recommend engaging a licensed roof plumber in the short term to provide further advice and remedial works where necessary.

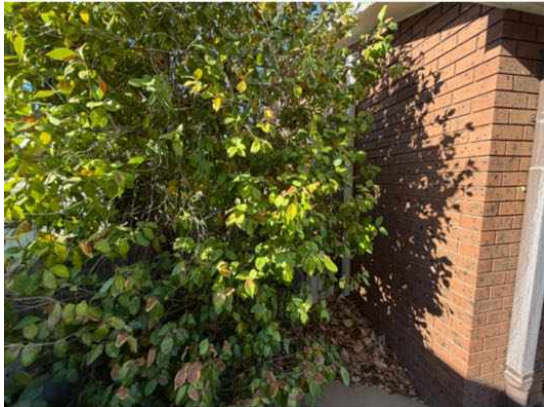
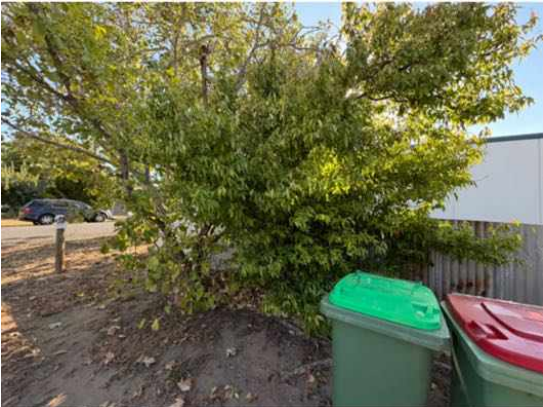
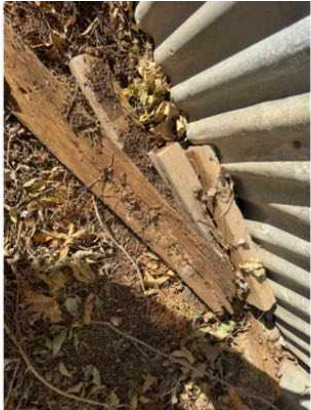
Finding 6.04

Building: Main Building
Location: All External Areas
Finding: Timber in direct ground contact & trees - conducive to termites
Information: Where timber materials are in direct contact with the ground and consequently moisture, they become conducive to termite activity. The timber debris, posts in contact with the ground, and trees surrounding the building create an environment conducive to termite activity.

Where feasible, any timbers in direct contact with the ground should be removed and

any trees in close proximity to the building should be removed or test drilled (inspected) at least annually to reduce the risk of termite infestation & detect any early signs of termite activity.

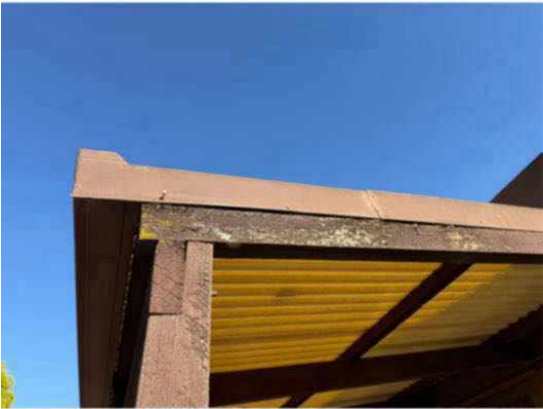
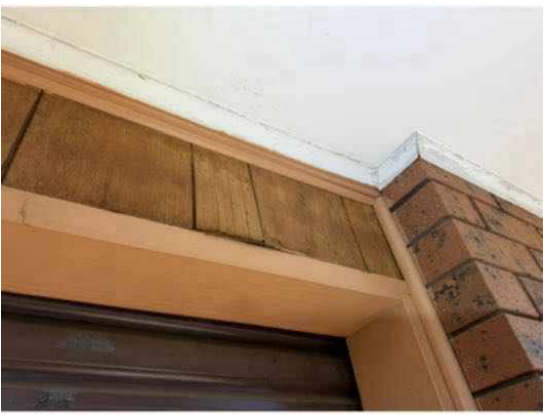
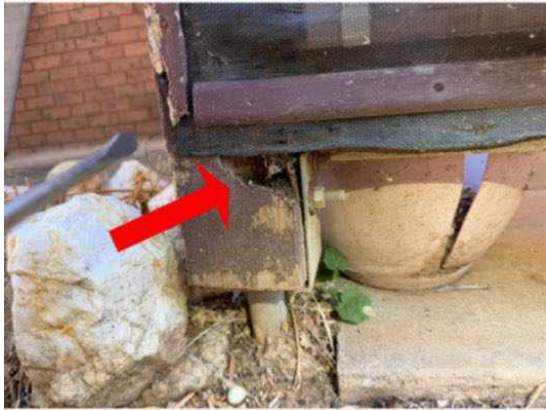
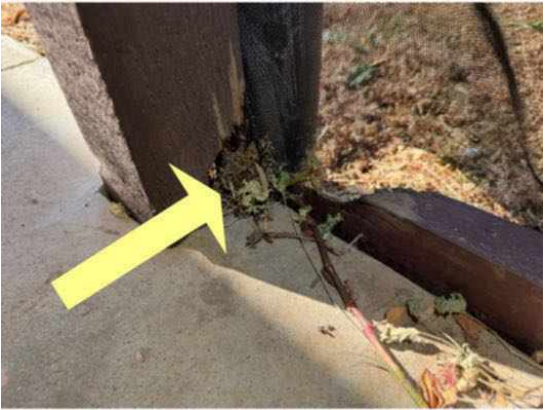
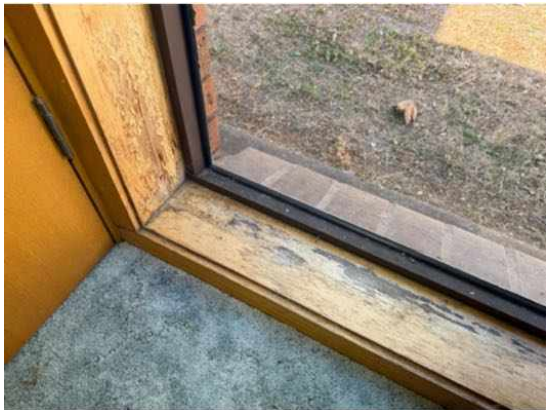
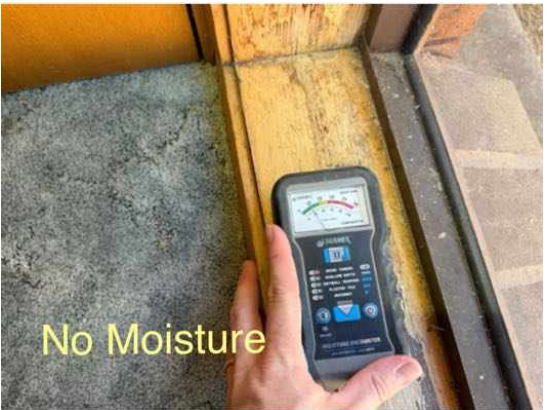
Finding 7.01

Building:	Main Building
Location:	Patio Framing, Posts, Fascias, External Trims, Window frames
Finding:	Fungal decay, weathering

Information: Areas of fungal decay (wood rot) were identified at but not limited the Patio framing, patio posts, fascias, external trims & window frames.

For areas of fungal decay, the client can engage a licensed carpenter at their discretion to replace affected materials.

For areas of general weathering, it is advised the client engage a licensed painter to apply protective sealant or coating to areas of weathered external timbers.

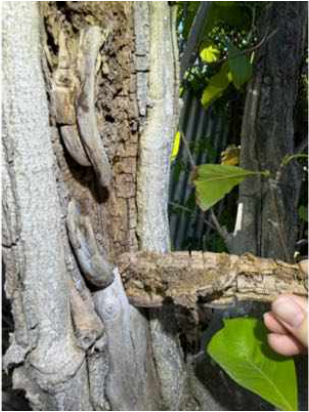
Finding 8.01

Building: Main Building
Location: Tree, Timber Debris
Finding: Evidence of wood borer damage identified (powder-post)
Information: Evidence of previous Lyctus Borer (powder-post beetle) damage was identified at but not limited to a front tree & timber debris. As no live wood borer activity was identified treatment is not required.

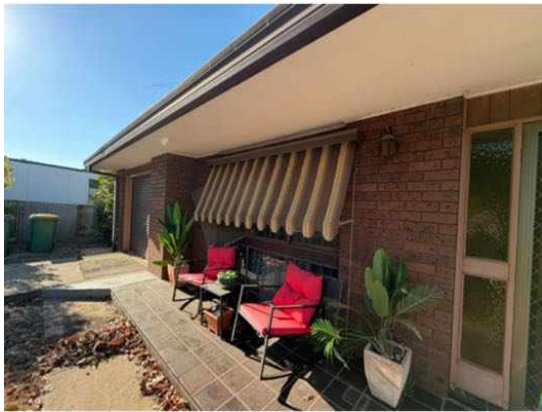
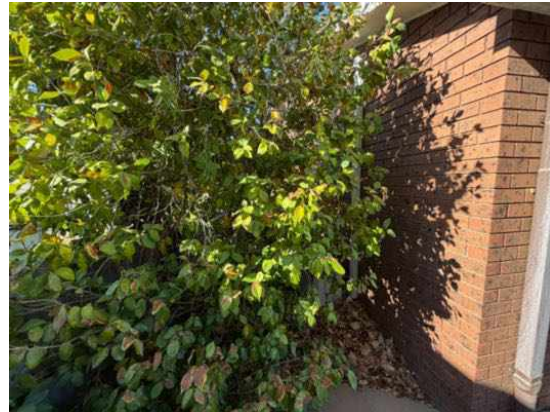
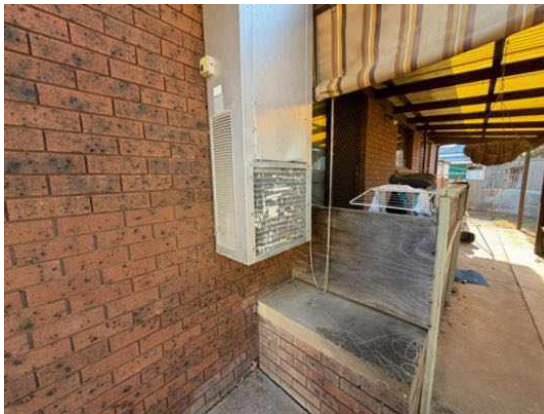
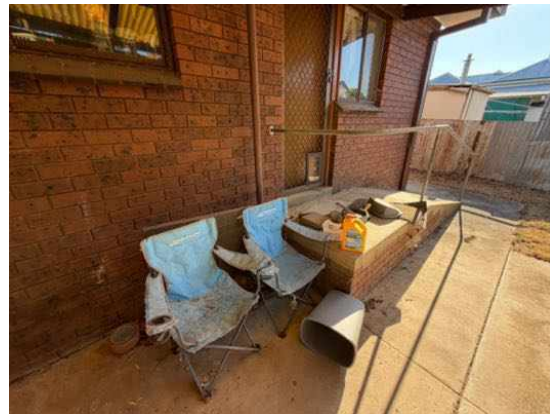
Building: Main Building
Location: All Areas
Finding: Additional Photos - Obstructions and Limitations
Information: These photographs are an indication of the obstructions and limitations which impeded full inspection of the property at the time of inspection. These obstructions can hide an array of defects and should be removed to allow full inspection to be carried out. A re-inspection is recommended once the areas are made accessible.

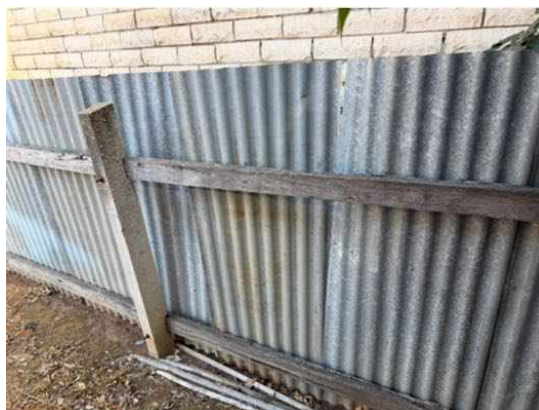
Building: Main Building
 Location: Fencing
 Finding: Fencing - Leaning
 Information: It was noted at the time of inspection that sections of the fencing appeared to be leaning and may require additional support or reinforcement.

The client could engage a licensed fencing contractor at their discretion, to provide remedial works where necessary.

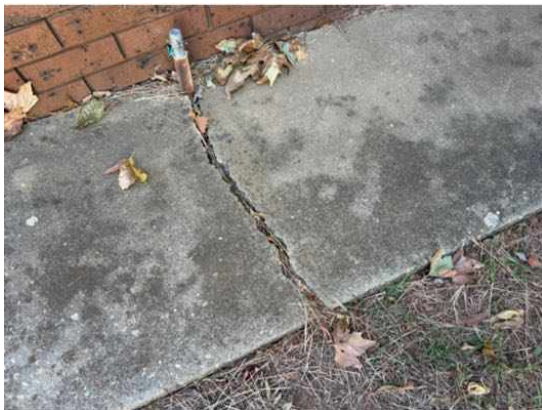
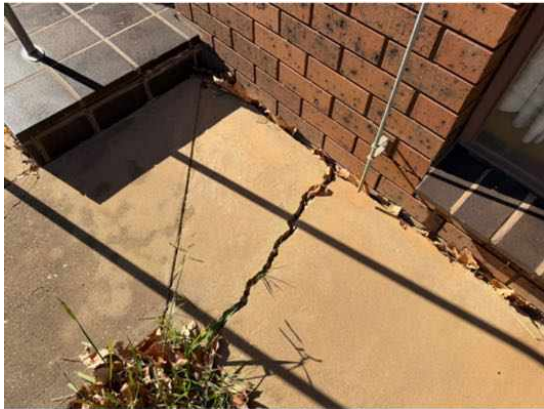
Building: Main Building
Location: Pavement, Garage Slab
Finding: Cracking - Pavement & Footpath
Information: It was noted there is cracking in areas of the pavement and driveway. Cracks in the pavement are a common occurrence in houses of a similar age.

Recommend that the client monitor the cracking. A licensed concreter can be engaged at clients discretion, should cracks widen, lengthen, or become more numerous.

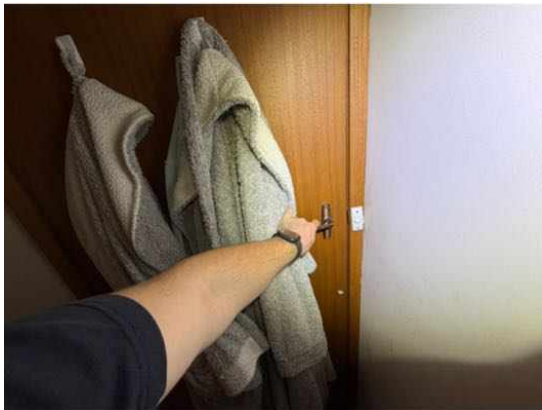
Building: Main Building
Location: Internal doors
Finding: Door - Binding/jamming
Information: It was noted at the time of inspection that some internal doors were binding against the door jamb & not shutting properly.

A qualified carpenter or general handyman can be engaged to perform minor rectification works at clients discretion.

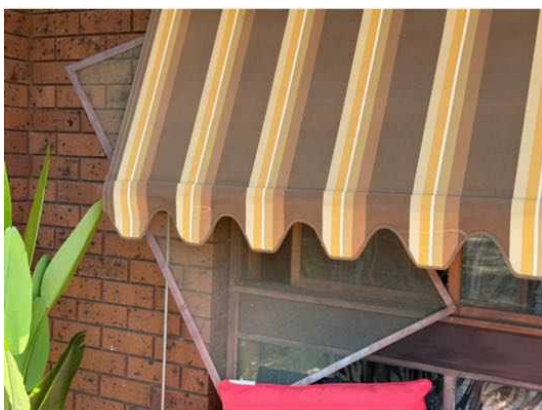
Building: Main Building
Location: Fly screens
Finding: Flyscreens - Missing
Information: Some fly screens were found to be loose & missing at the time of inspection. Recommend a general handyman to replace flyscreens at clients discretion.
