Building and Timber Pest Inspection Report

Inspection Date: Mon, 9 Mar 2026

Property Address: 1/35 Sandy Beach Rd, Korora NSW 2450, Australia

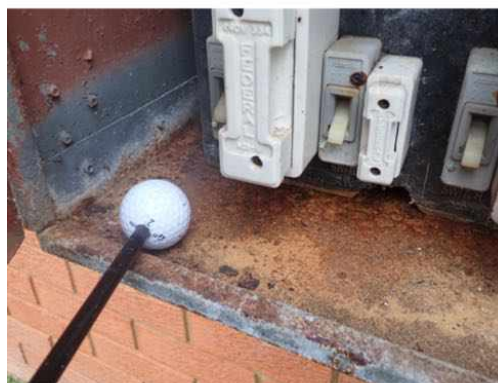
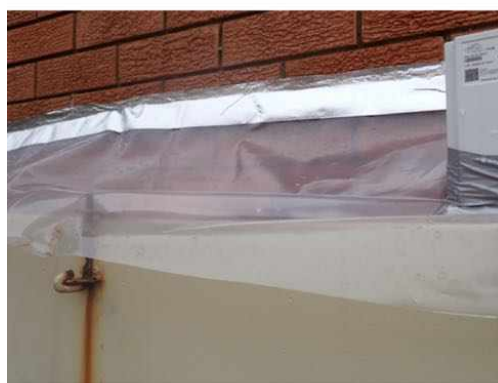
Finding 2.02

Finding: Rust to Electrical Meter Box

Information: Rust was identified to the electrical meter box at the time of inspection. Corrosion to

metal electrical enclosures can occur over time due to exposure to weather and moisture and may worsen if not addressed. Continued deterioration may affect the durability of the enclosure and its ability to protect the electrical components inside. It is recommended that a qualified electrician assess the meter box and carry out repairs, treatment, or replacement as required to maintain the integrity of the enclosure. Repairs should be carried out as deemed necessary.

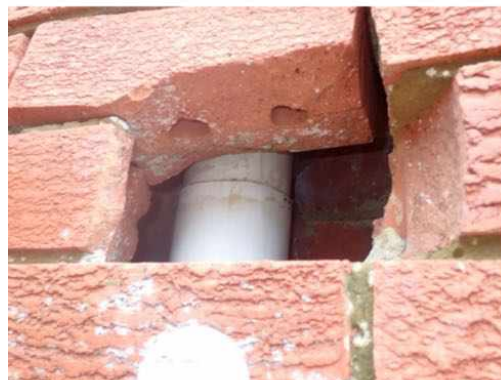
Finding 2.03

Building:	Main Building
Location:	Rear left hand column
Finding:	Brick Removed from Rear Right-Hand Side Column
Information:	A brick was observed to have been removed from the rear right-hand side column at the time of inspection. The brick may have been removed to allow access to plumbing pipework within the column. Missing masonry elements may allow moisture, pests, or debris to enter the cavity if left unsealed. It is recommended that a qualified bricklayer or builder assess the affected area and reinstate the brick or provide an appropriate repair as required to maintain the integrity of the column. Repairs should be carried out as deemed necessary.

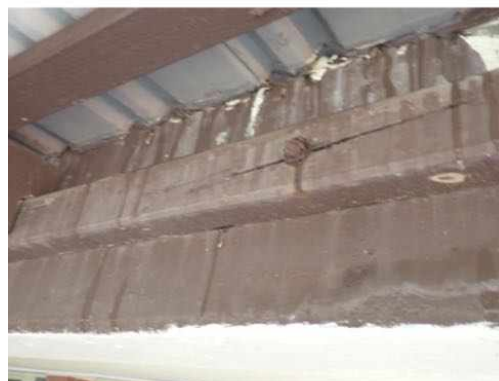
Building:	Main Building
Location:	Carport roof
Finding:	Water Leak Where Carport Roof Meets Concrete Deck Above
Information:	Leaking was identified where the carport roof meets the concrete deck to the unit above at the time of inspection. Water ingress at roof and deck junctions can occur due to deteriorated sealants, poor flashing installation, or defects in the roof connection and may lead to ongoing moisture damage if not addressed. The full

extent and source of the leak could not be determined during the visual inspection. It is recommended that a qualified builder or roofer assess the affected junction and carry out repairs as required to prevent further leaking. Repairs should be carried out as deemed necessary.

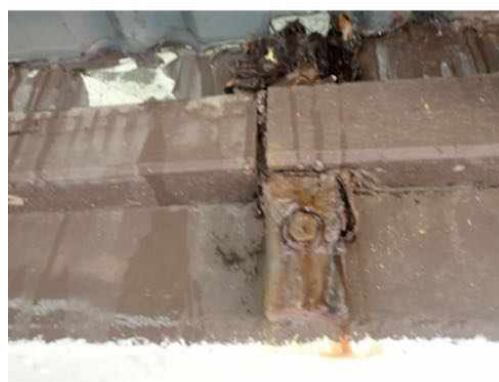
Finding 2.06

Building:	Main Building
Location:	Carport roof
Finding:	Rust to Metal Fixings Where Carport Roof Meets Structure
Information:	Rust was identified to the metal fixings where the carport roof meets the structure at the time of inspection. Corrosion to metal fixings can occur over time due to exposure to weather and moisture and may lead to loosening or deterioration of the roof connection if left unaddressed. It is recommended that a qualified roofer or suitably experienced handyman assess the affected fixings and carry out replacement or treatment as required to maintain the integrity of the roof connection. Repairs should be carried out as deemed necessary.

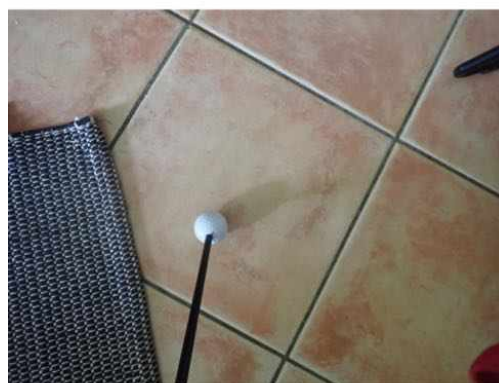
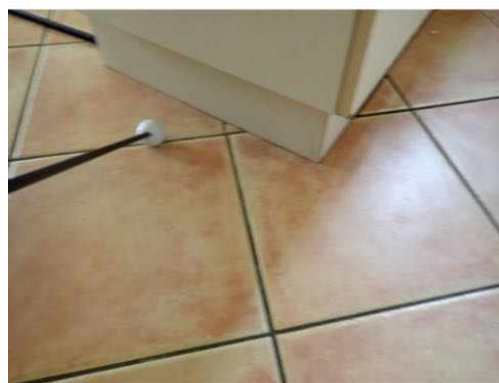
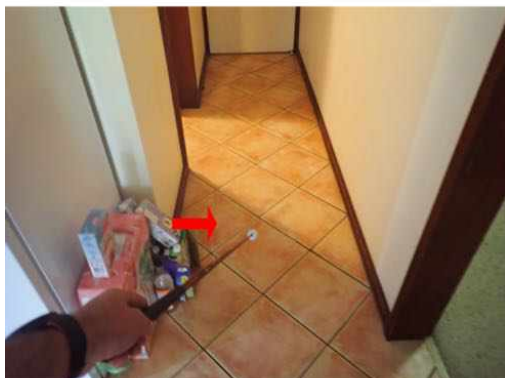
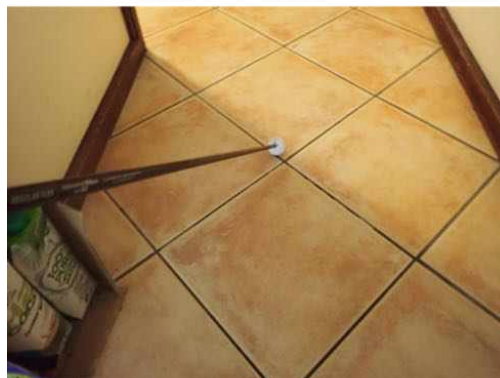
Finding 3.01

Building: Main Building
Location: Kitchen and entry hall.
Finding: Drummy Floor Tiles to Kitchen and Hallway
Information: Drummy floor tiles were identified around the kitchen breakfast bench and in the hallway near the bathroom at the time of inspection. In the same hallway area, missing grout and a loose tile were also observed. Drummy or loose tiles may indicate poor adhesion or movement in the substrate and may worsen over time if not addressed. Missing grout can allow moisture and debris to penetrate beneath the tiles which may contribute to further deterioration. This is a common defect with properties of this age and construction type. It is recommended that a qualified tiler assess the affected areas and carry out repairs, re-grouting, or replacement of tiles as required to prevent further deterioration. Repairs should be carried out as deemed necessary.

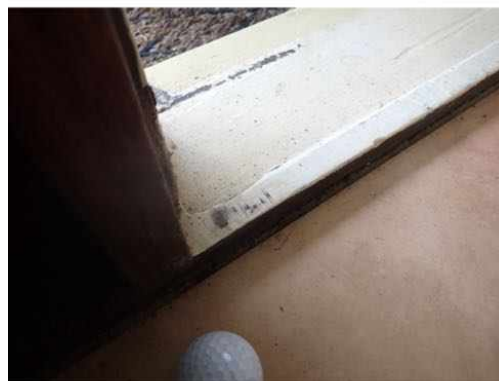
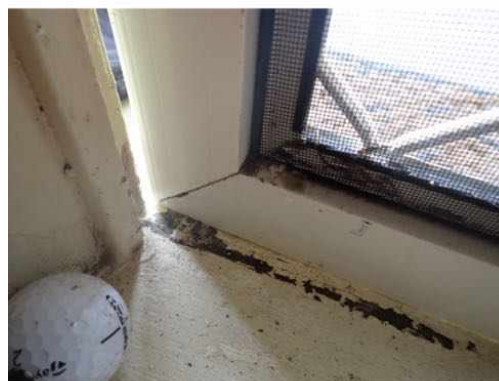
Building:	Main Building
Location:	Living room
Finding:	Entry Security Door and Timber Door Catching on Door Sill
Information:	The entry security door and timber entry door were observed to be catching on the door sill during normal operation at the time of inspection. Doors catching on the sill may be caused by minor movement in the building, door misalignment, swelling of timber components, or general wear over time. Continued use in this condition may lead to further wear or damage to the door or sill. It is recommended that a qualified

carpenter or suitably experienced handyman assess the doors and carry out adjustments or repairs as required to ensure smooth operation. Repairs should be carried out as deemed necessary.

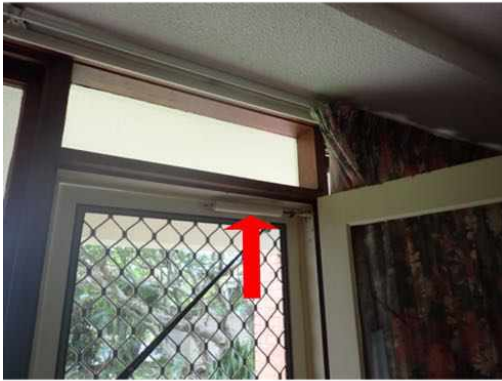
Finding 3.04

Building:	Main Building
Location:	Front and rear security doors
Finding:	Front Security Door Closer in Poor Condition and Rear Closer Missing
Information:	The automatic door closer to the front security door was found to be in poor condition at the time of inspection, and the door closer to the rear security door was missing. Door closers assist in ensuring doors close properly and remain secure. Missing or deteriorated closers may prevent the doors from functioning as intended. It is recommended that a suitably experienced handyman repair or replace the defective and missing door closers to ensure the doors operate correctly. Repairs should be carried out as deemed necessary.

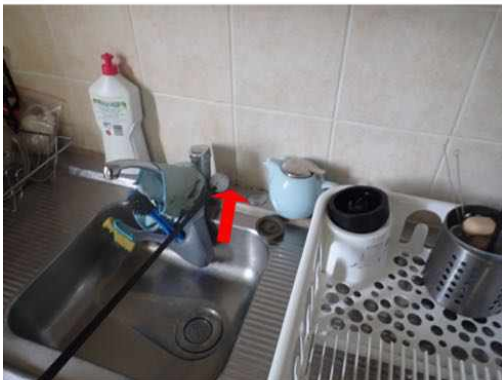
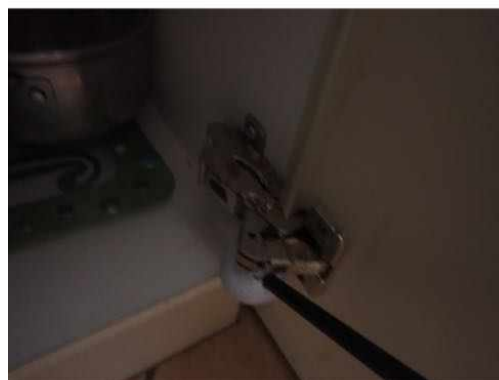
Finding 3.05

Finding: Kitchen in Fair Condition for Age with Minor Maintenance Required

Information: The kitchen was found to be in fair condition for the age of the property at the time of inspection. Minor defects observed included deteriorated silicone around the splash back and cabinet hinges requiring adjustment. These conditions are typical maintenance items and may occur over time due to normal use and ageing of materials. It is recommended that a suitably experienced handyman carry out re-sealing of the splash back and adjust the cabinet hinges as required to maintain the condition and functionality of the kitchen. Repairs and maintenance should be carried out as deemed necessary.

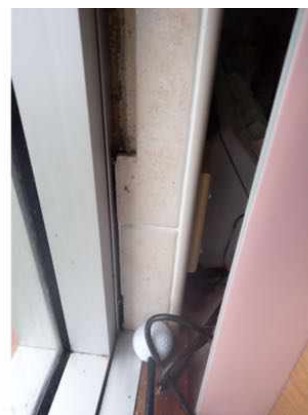
Finding 3.06

Building:	Main Building
Location:	Kitchen
Finding:	Poor Tile Work Around Replaced Kitchen Window
Information:	Poor tile work was identified around the replaced kitchen window at the time of inspection. The tiles in this area appeared to be poorly finished which may affect the durability and appearance of the tiled surface. This condition may be due to previous alterations or poor workmanship during installation. It is recommended that a qualified tiler assess the affected area and carry out repairs or re-tiling as required to achieve a proper finish and help prevent further deterioration. Repairs should be carried out as deemed necessary.

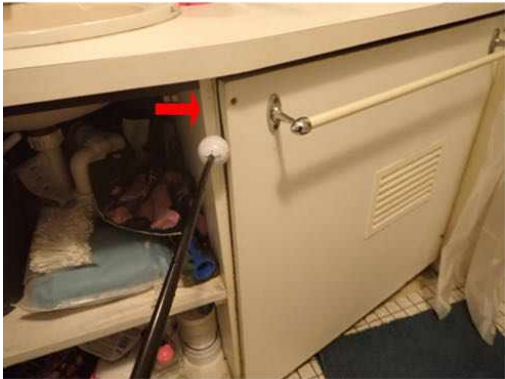
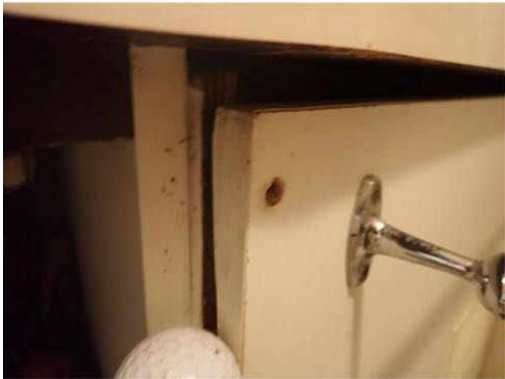
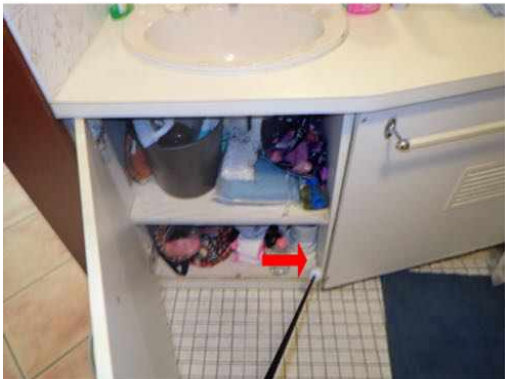
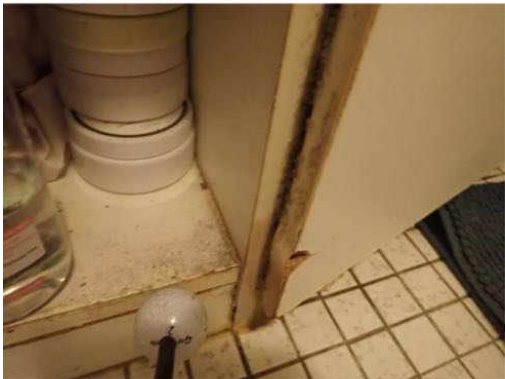
Finding 3.09

Building:	Main Building
Location:	Bathroom
Finding:	Bathroom Vanity Functional but in Average Condition with Age and Moisture-Related Deterioration
Information:	The bathroom vanity was found to be functional but in average condition at the time of inspection. Age and moisture-related damage were identified to the unit, which is common in wet areas where cabinetry is exposed to ongoing humidity and water splashing. Deterioration of this nature may worsen over time if not maintained. It is recommended that a qualified carpenter or suitably experienced handyman assess the vanity and carry out repairs or replacement of deteriorated components as required to maintain the unit and prevent further damage. Repairs should be carried out as deemed necessary.

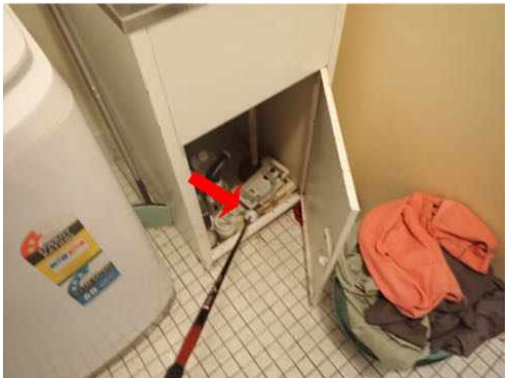
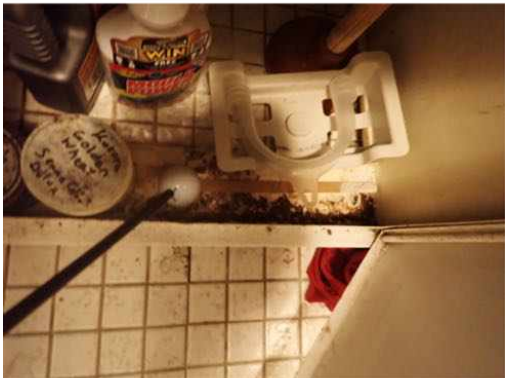
Finding 3.10

Building: Main Building
Location: Bathroom
Finding: Surface Rust to Laundry Tub Cabinet
Information: Surface rust was identified to the laundry tub cabinet at the time of inspection. Corrosion of this nature is commonly associated with moisture exposure in laundry areas and is a common defect with this type of cabinet and age of installation. Continued exposure to moisture may lead to further deterioration over time. It is recommended that a suitably experienced handyman repair, treat, or replace the affected cabinet as required to prevent further deterioration. Repairs should be carried out as deemed necessary.

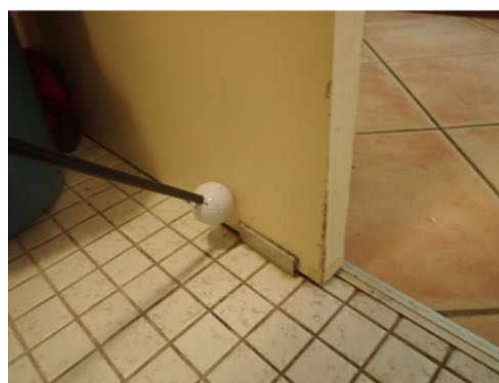
Finding 3.11

Building:	Main Building
Location:	Bathroom
Finding:	Bathroom Sliding Door Difficult to Operate
Information:	The bathroom sliding door was found to be difficult to operate during normal use at the time of inspection. Difficulty operating sliding doors can be caused by worn rollers, misalignment, debris in the track, or general wear over time. It is recommended that a qualified carpenter or suitably experienced handyman inspect the door and carry out adjustments, repairs, or replacement of worn components as required to ensure smooth operation. Repairs should be carried out as deemed necessary.

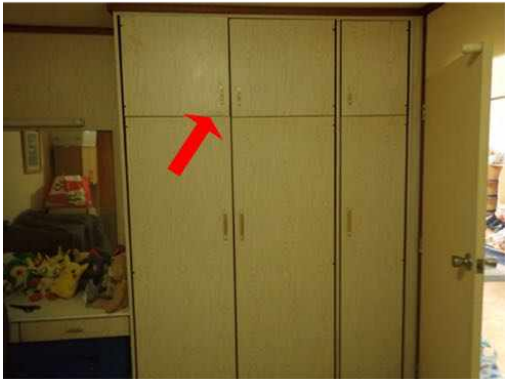
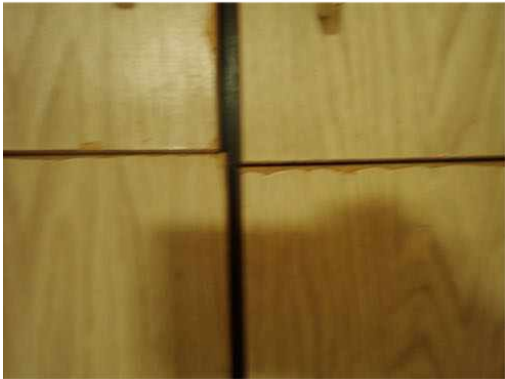
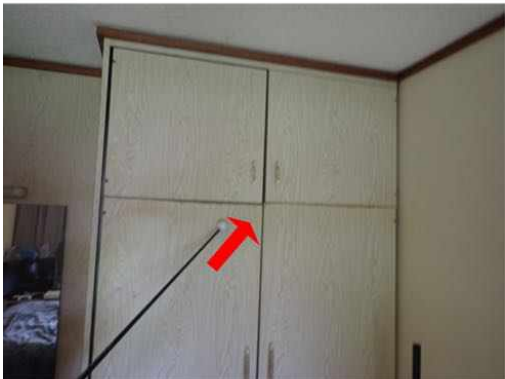
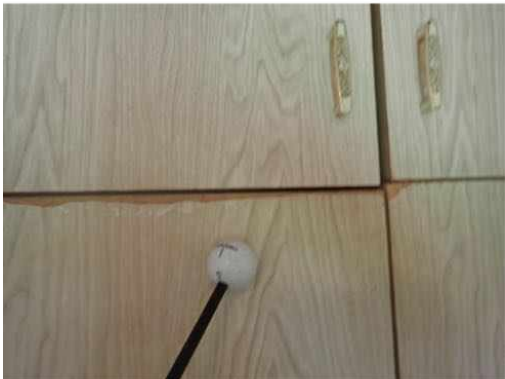
Finding 3.12

Building:	Main Building
Location:	Bedrooms
Finding:	Bedroom Wardrobes Functional but in Average Condition
Information:	The bedroom wardrobes were found to be functional but in average condition at the time of inspection. General wear and ageing of wardrobe components were noted, which is common with cabinetry of this age and type. It is recommended that a suitably experienced handyman carry out maintenance or minor repairs as required to maintain the functionality and condition of the wardrobes. Repairs should be carried out as deemed necessary.

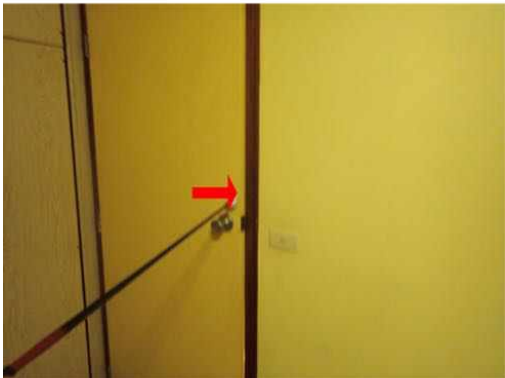
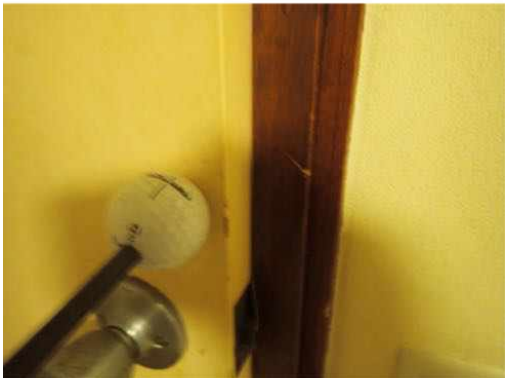
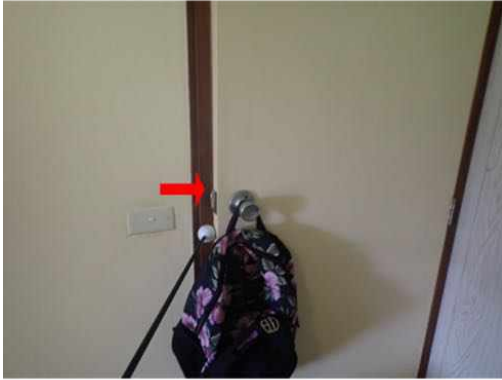
Finding 3.13

Building: Main Building
Location: Bedrooms
Finding: Bedroom Doors Catching on Door Jambs
Information: The bedroom doors were observed to be catching on the door jambs during normal operation at the time of inspection. Doors catching on jambs can be caused by minor movement in the building, door misalignment, swelling of timber components, or general wear over time. Continued use in this condition may lead to further wear or damage to the doors or jambs. It is recommended that a qualified carpenter or suitably experienced handyman adjust or repair the doors as required to ensure smooth operation. Repairs should be carried out as deemed necessary.

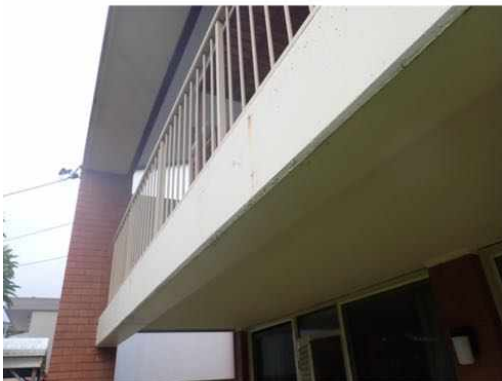
Finding 3.14

Building:	Main Building
Location:	Concrete above front porch area
Finding:	Flaking Paint to Concrete Above Front Porch Area
Information:	The paint finish to the concrete above the front porch area was observed to be starting to flake at the time of inspection. Flaking paint can occur due to ageing of the coating, moisture exposure, or deterioration of the painted surface over time. Continued deterioration may lead to further loss of the protective coating. It is recommended that a qualified painter prepare the surface and reapply an appropriate paint coating as required to prevent further deterioration. Repairs should be carried out as deemed necessary.

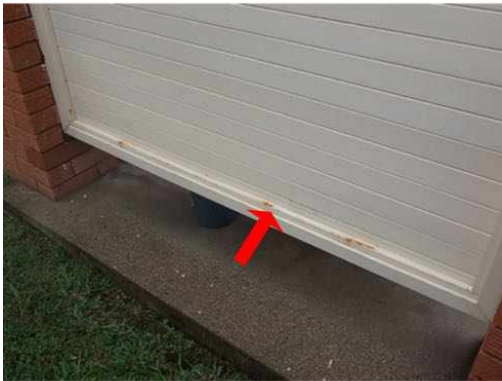
Finding 3.15

Building:	Main Building
Location:	Screen to left hand side of front porch area.
Finding:	Rusted Nails to Timber Trims Around Front Porch Privacy Screen
Information:	Rusted nails were identified to the timber trims around the front porch area privacy screen at the time of inspection. Corrosion to fixings can occur over time due to exposure to weather and moisture and may lead to loosening of the trims if deterioration continues. It is recommended that a qualified carpenter or suitably

experienced handyman replace the rusted fixings and re-secure the timber trims as required to maintain the stability of the privacy screen. Repairs should be carried out as deemed necessary.

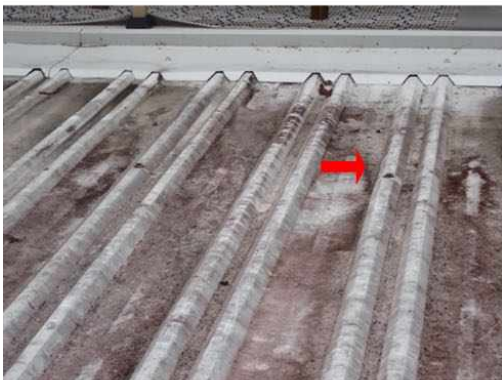
Finding 3.16

Finding: Rusted Screw Heads to Carport Roof Cladding

Information: Multiple rusted screw heads were identified to the carport roof cladding at the time of inspection. Corrosion to roof fixings can occur over time due to exposure to weather and moisture and may lead to deterioration of the fixings if not addressed. Continued corrosion may reduce the effectiveness of the roof cladding fixings and may contribute to leaks if deterioration continues. It is recommended that a qualified roofer or suitably experienced handyman replace the rusted fixings as required to maintain the integrity of the roof cladding. Repairs should be carried out as deemed necessary.

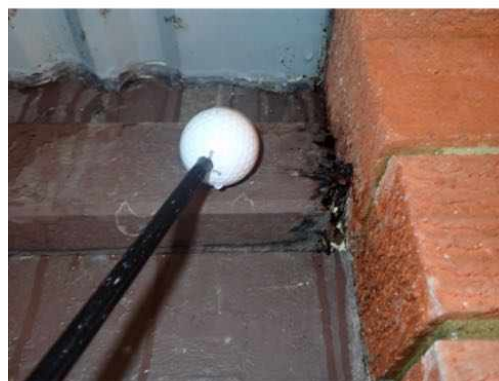
Finding 7.01

Building:	Main Building
Location:	Carport roof
Finding:	Wood Rot to Carport Timber Where It Meets Concrete Deck Above
Information:	Wood rot was identified to the carport timber where it meets the concrete deck above at the time of inspection. Deterioration of timber elements in this location is commonly associated with prolonged moisture exposure and may lead to further deterioration if not addressed. Continued decay may reduce the strength and durability of the affected timber components. It is recommended that a qualified carpenter or builder assess the affected timber and carry out repairs or replacement as required to prevent further deterioration. Repairs should be carried out as deemed necessary.

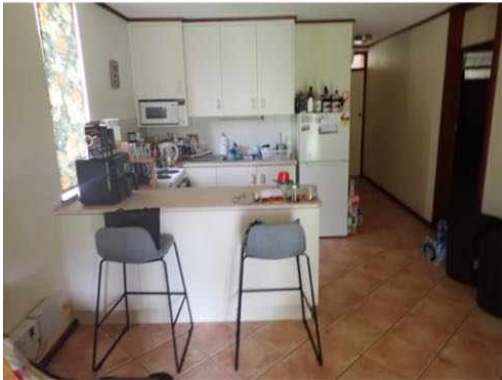
Noted Item

Building: Main Building
Location: All Areas
Finding: Additional Photos - Obstructions and Limitations
Information: These photographs are an indication of the obstructions and limitations which impeded full inspection of the area at the time of inspection. These obstructions can hide an array of defects and should be removed to allow full inspection to be carried out. A re-inspection is recommended once the areas are made accessible.
