Building and Timber Pest Inspection Report

Inspection Date: Wed, 4 Mar 2026

Property Address: 5A Innes Rd, Windsor Gardens SA 5087,
Australia

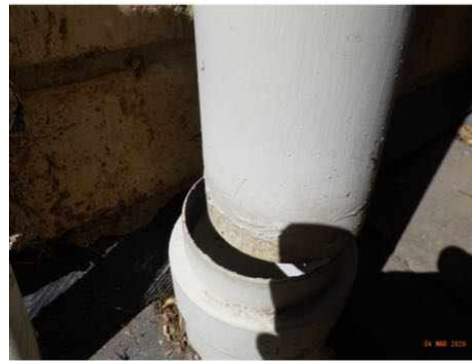
Building: Building 1
Location: Yard - Front
Finding: Stormwater drain - damaged/ leaking
Information: The roof plumbing is not adequately connected to stormwater drainage on the site with separation evident to a downpipe. Due to this damage the area could be prone to moisture related defects ranging from deterioration of pavements to damage of adjacent building elements.

Where roof plumbing doesn't drain adequately, the area at the base perimeter can become excessively damp, potentially creating an environment that is susceptible to rust and corrosion of surrounding building elements, as well as attracting termites and other pests.

It is highly recommended that a plumber be appointed to further inspect the area and to install adequate drainage equipment where necessary.

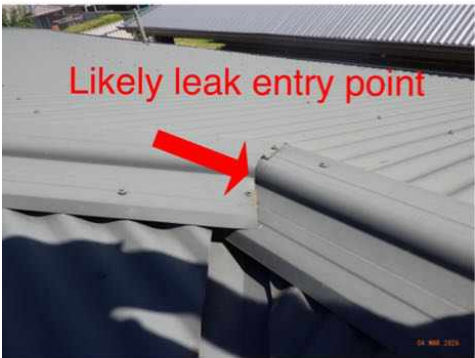
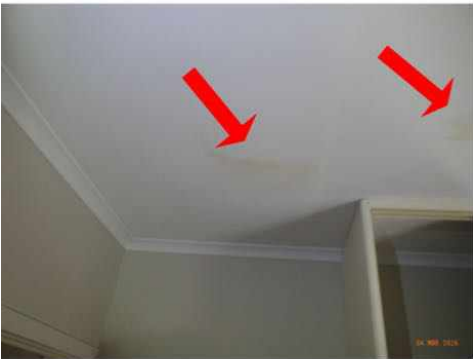
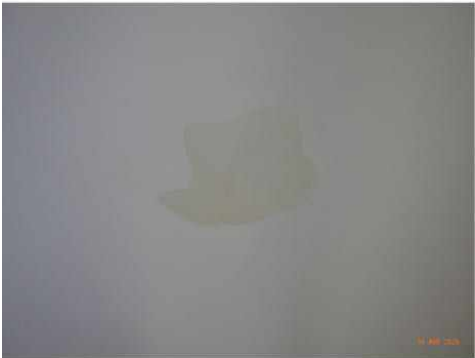
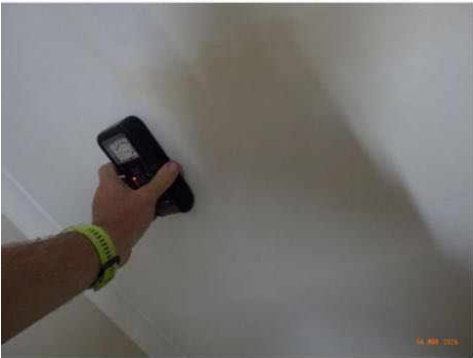
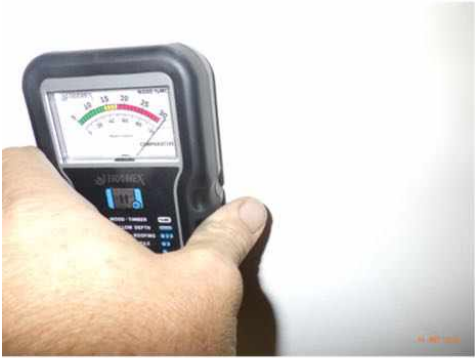
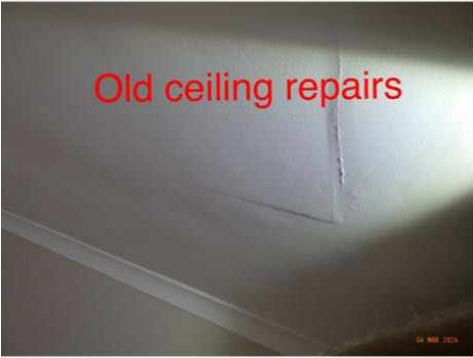
Finding 2.02

Building:	Building 1
Location:	Roof Exterior
Finding:	Water leaks evident to roofing
Information:	It appears that water leaks were evident to a section of the roof at the time of inspection high moisture staining evident to bedroom two.

While Access in the area was not possible due to air-conditioning ductwork the point where the leak appears to be occurring is at a junction in the ridge capping which requires further investigation and repair. .

High moisture and damage to the ceiling is evident while repairs also appear to have been carried out indicating that they leak may not have been addressed properly prior to repairs being carried out.

If the issue is not addressed further damage to all building elements is likely and as such immediate repair is recommended.

Moisture around timber elements also creates an environment that is highly conducive to termite activity.

A licensed roof plumber should be appointed immediately to address the roof leak issues to prevent further moisture damage in the future. Following this a licensed painting contractor should make repairs to the ceiling. Insulation may need to be removed to to ensure no mould exists in the area.

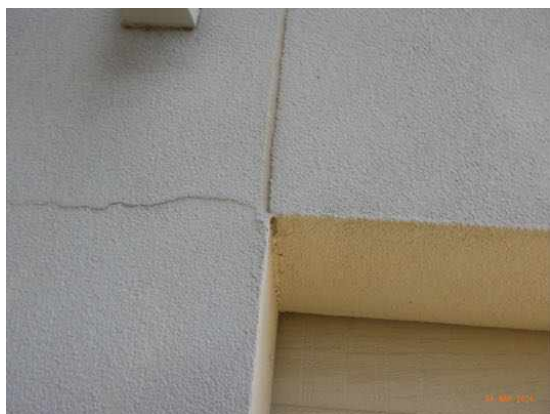
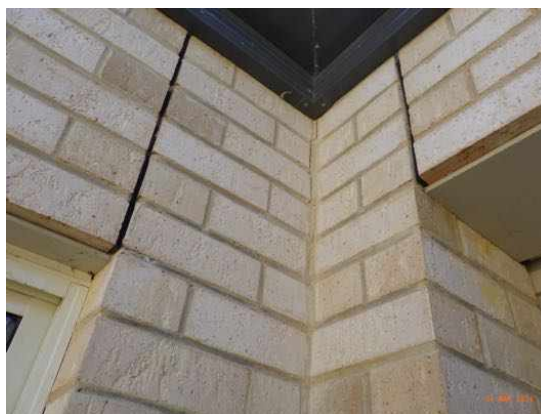
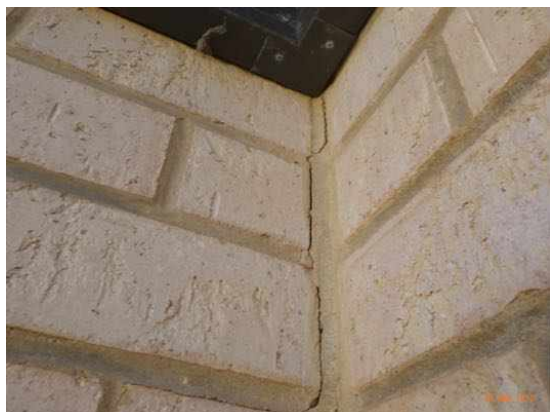
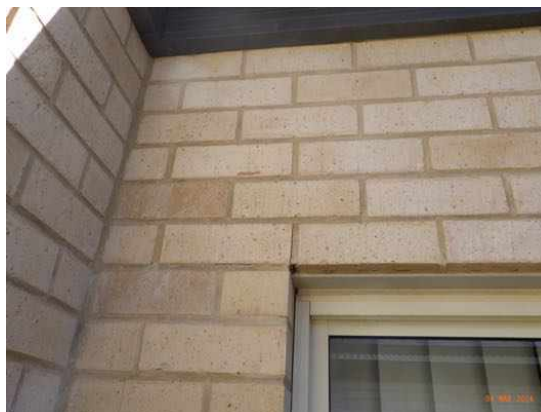
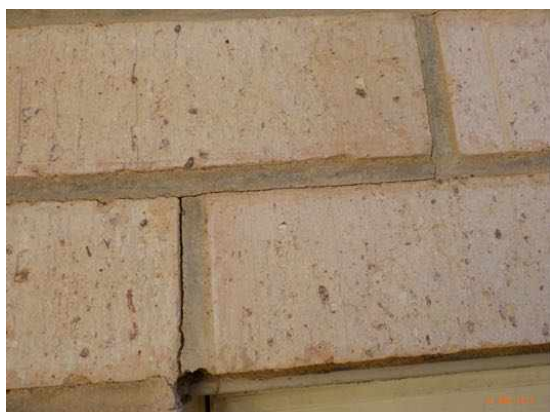
Building: Building 1
 Location: Exterior walls
 Finding: Brickwork - Articulation joint compressed, Subsidence
 Information: There were indications of footing movement around windows and doors at the centre of the dwelling on the perimeter walls at the time of inspection. No cracking was evident to the internal walls to these areas.

Other minor cracking is evident to external brickwork.

Movement of this nature can cause cracks in associated building elements along with the requirement to adjust doors over time due to seasonal movement. Pressure could also cause issues with windows and glazing and as such close monitoring of the movement is warranted.

Monitoring the areas is recommended and should any further cracking, or movement become evident then A structural engineer should be appointed immediately to inspect and nominate a scope of works required for rectification.

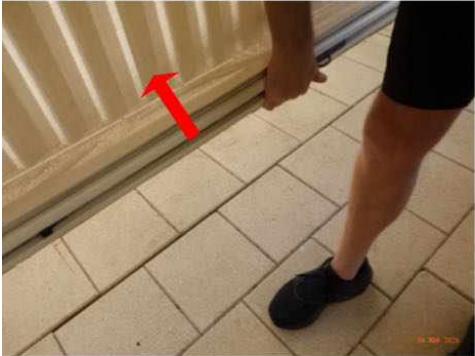
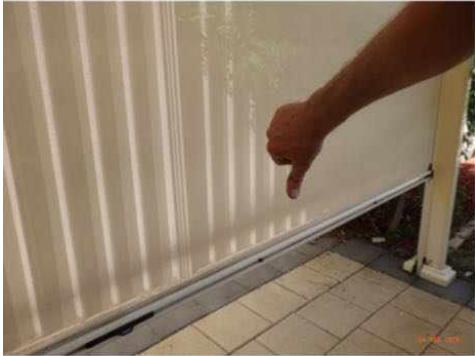
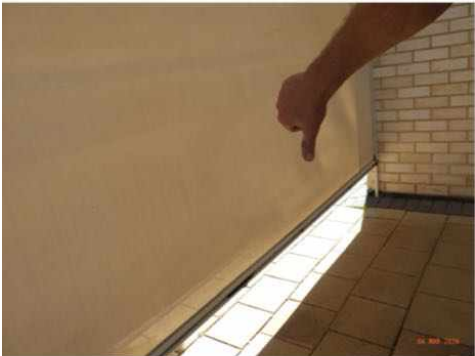
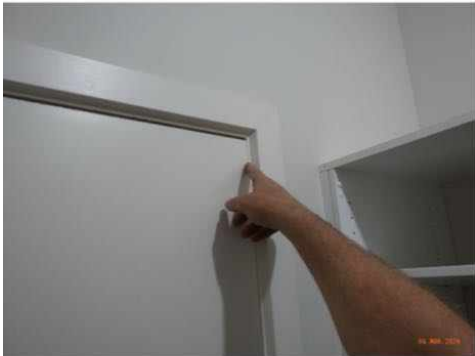
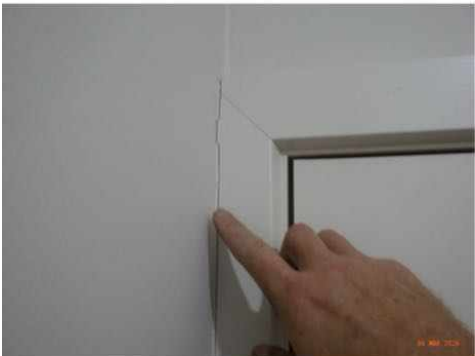
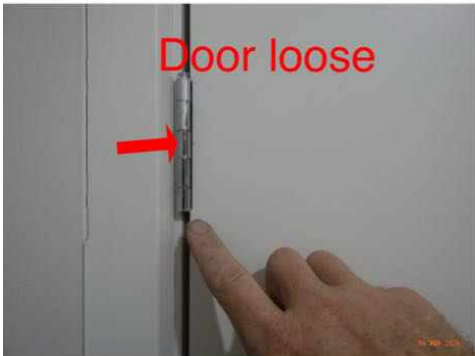
Finding 3.04

Building:	Building 1
Location:	All Areas
Finding:	Minor defects present
Information:	Minor defects were evident throughout the dwelling at the time of inspection, which are consistent with normal wear and tear and considered appropriate for a property of this age.

These defects are typical of ongoing material ageing, settlement, and general use over time, and include, but are not limited to

- Exterior blinds stiff to slide
- Minor cracking to internal wall and ceiling linings
- Robe door loose hinges
- Vanity drains not operating
- Main bathroom fan not operating
- Laundry taps not operating/ deteriorated
- Kitchen doors deteriorated.

While these defects are not considered structurally significant at present, they should be addressed as part of routine and ongoing property maintenance to prevent further deterioration. Repairs and maintenance works should be carried out by appropriately licensed and qualified tradespeople to ensure the continued serviceability and longevity of the dwelling.

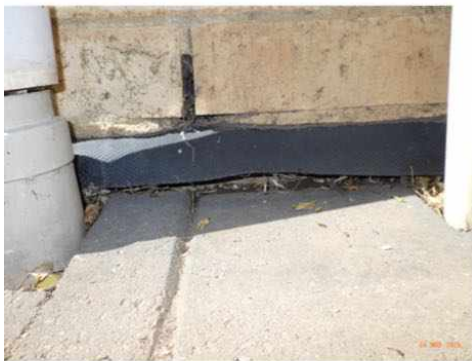
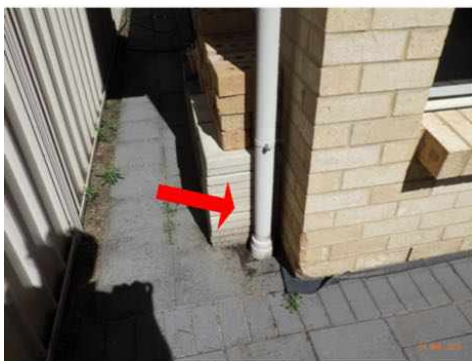
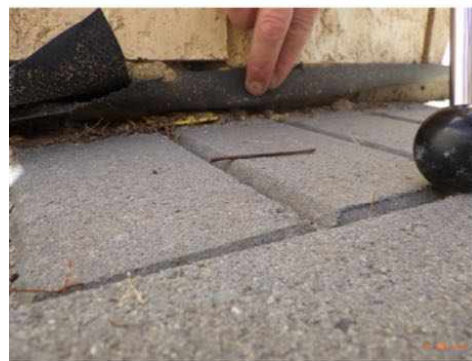
If the slab edge is not properly exposed there is a high risk of concealed termite attack which your inspector will likely not be able to see. Sometimes, in order to determine the type of slab, a suitably qualified person such as an architect or builder may be required to consult construction plans.

Where the slab edge cannot be properly inspected, it is highly recommended that termite or timber pest inspections be carried out every 6-12 months to aid protection of the property against infestation and termite treatment advice is followed closely.

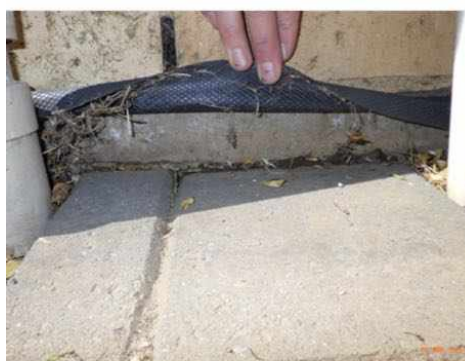
Finding 6.02

Building:	Building 1
Location:	All Areas
Finding:	Termite Management System - no evidence of a chemical installation
Information:	The application of a post-construction chemical termite barrier is highly recommended for all properties, particularly if live termite activity has been found on the site previously. Such barriers are highly effective in preventing termite attack on any timber building elements throughout the property.

At the time of inspection, it appeared as though no termite management system has been installed, with no evidence to suggest preventative works taking place.

The client may consider gaining further advice from a pest controller as to the costs and procedures involved with this application. It is recommended that obtaining such advice be a short-term priority.

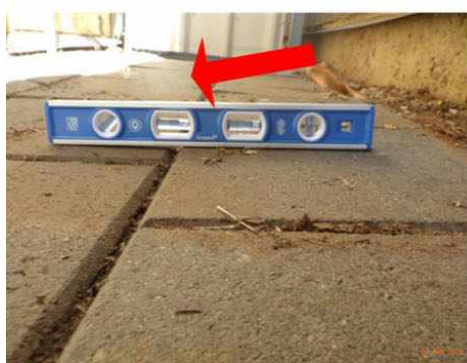
Finding 6.03

Building:	Building 1
Location:	Yard - Side

Information: The perimeter paving or ground levels were found to have an inadequate slope away from the adjoining building structure, creating potential for water pooling in this area.

This standard ensures that excessive moisture does not pool around the base of building structures, which creates potential for water and structural damage, as well as making the area susceptible to termite and timber pest activity.

Where paving or ground levels do not have adequate fall, a licensed paving contractor should be appointed to install or remove and re-level pavement.

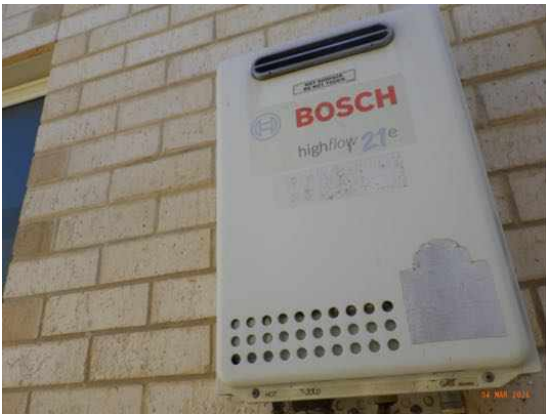
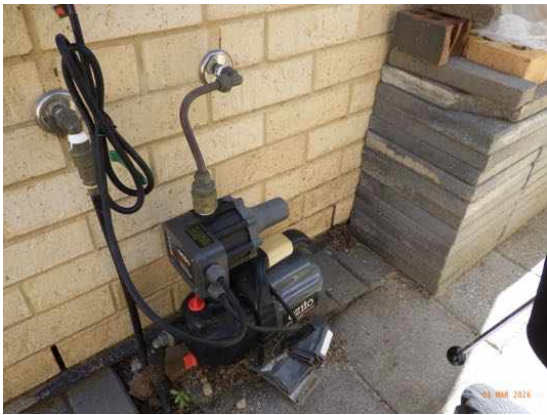
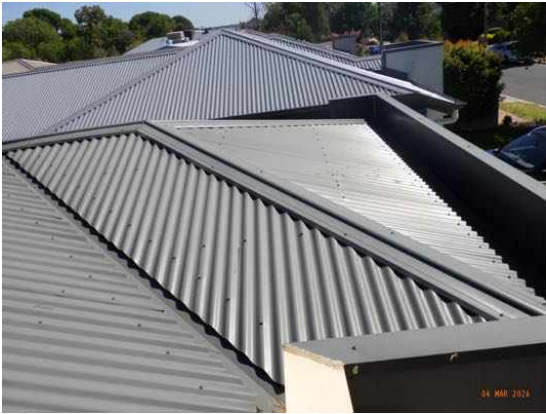
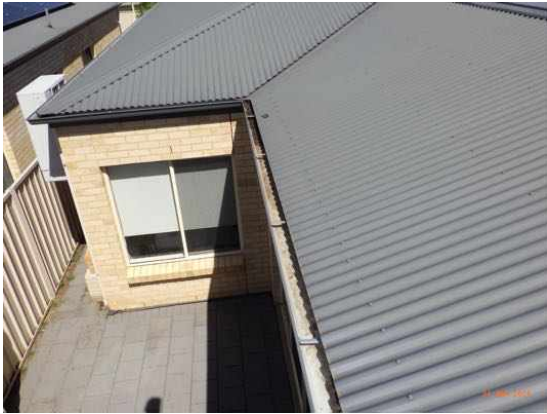
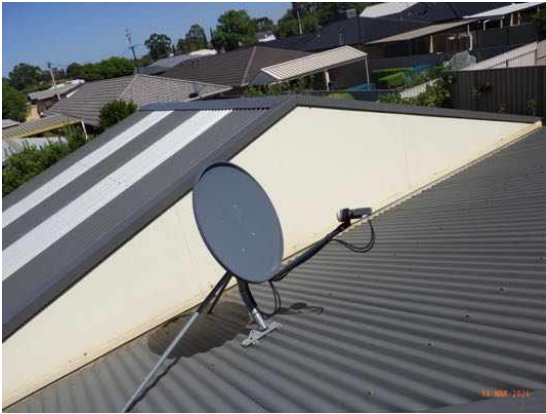
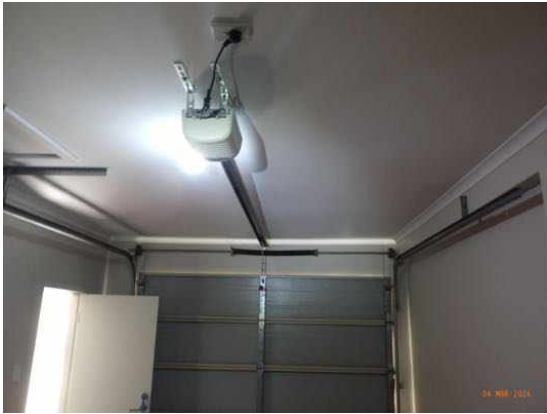
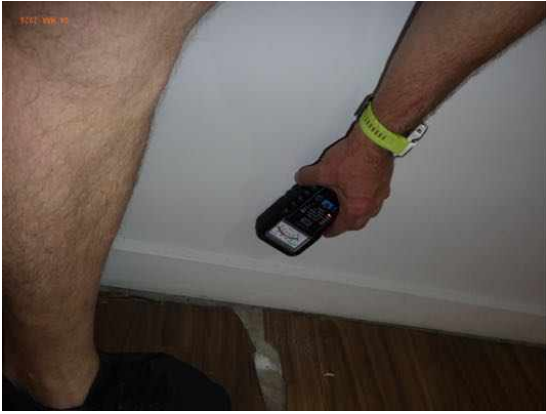
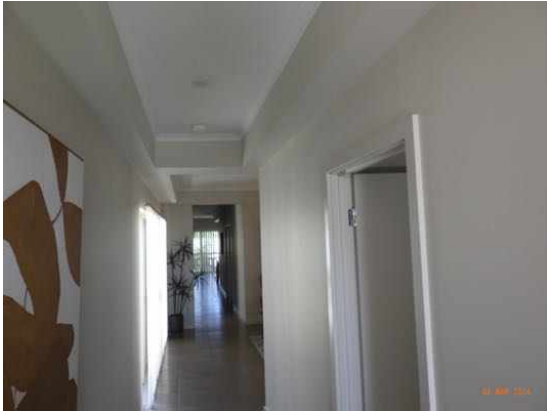
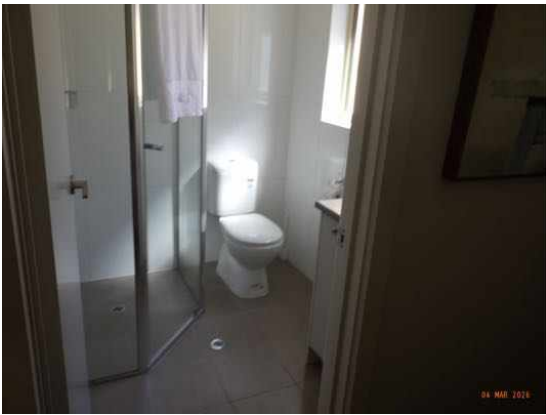
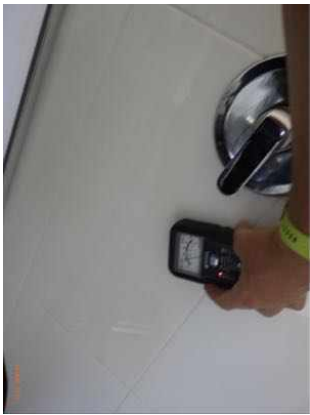
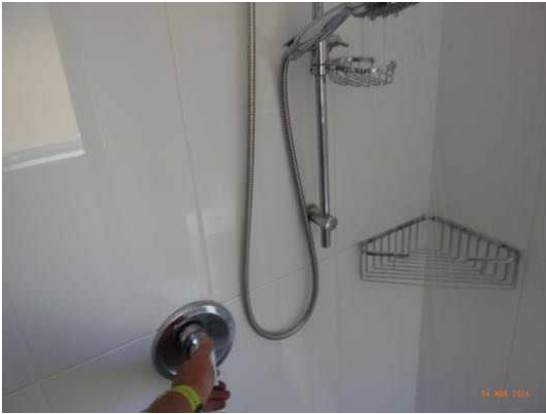
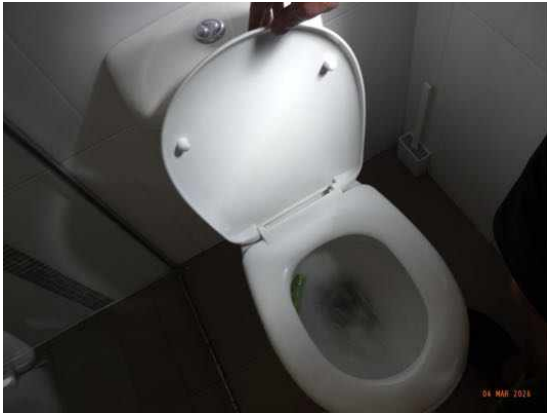
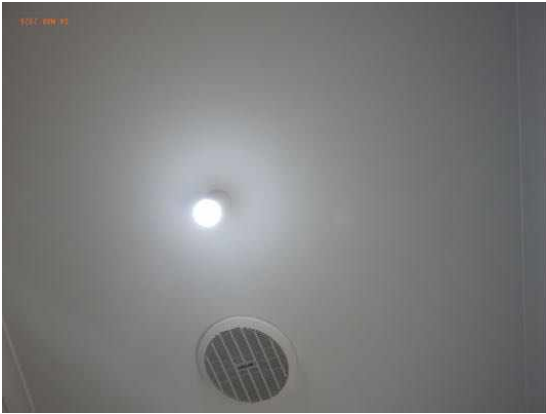
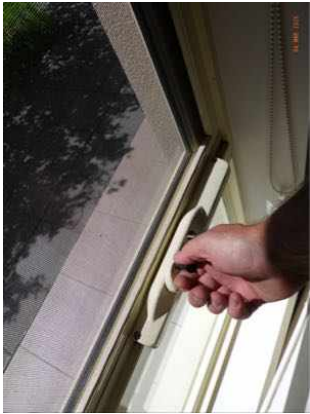
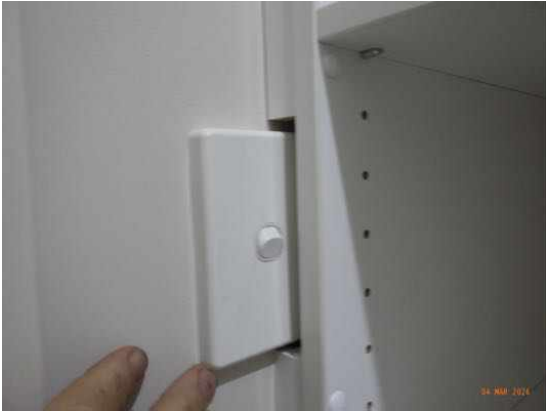
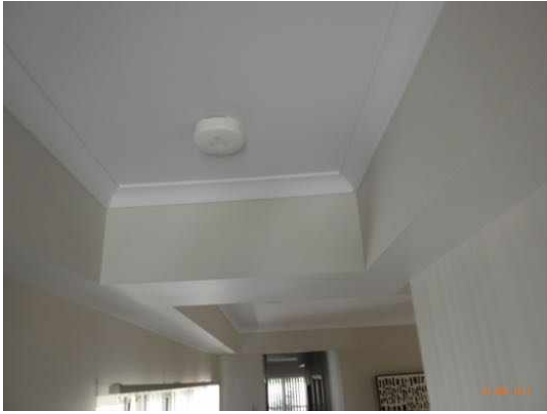
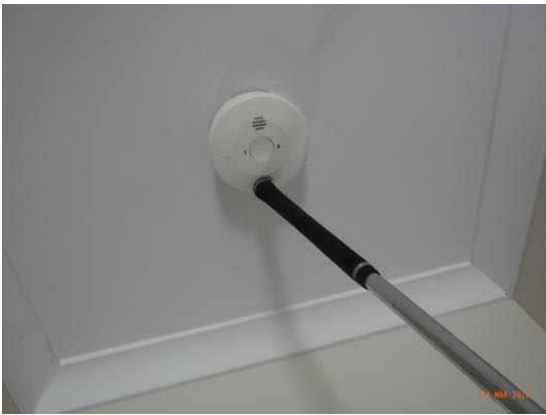
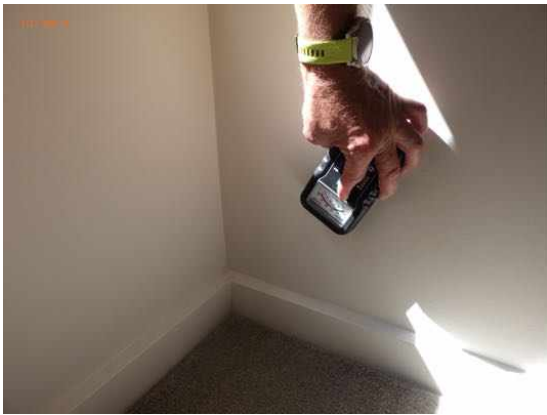
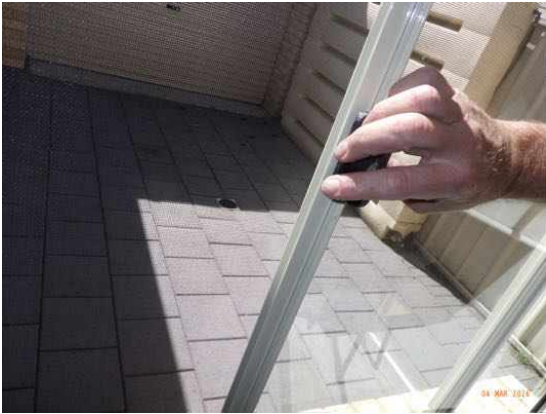
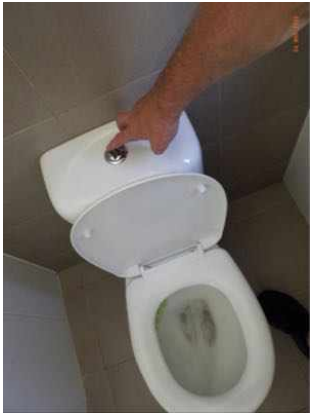
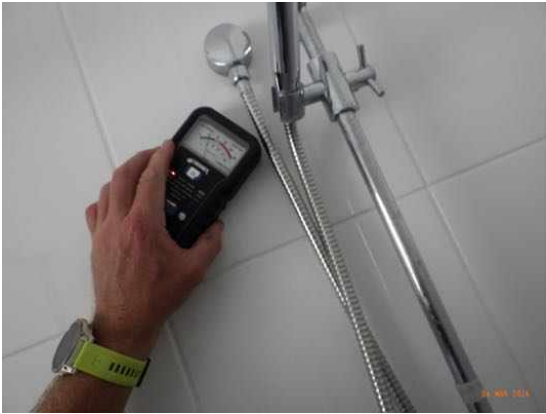
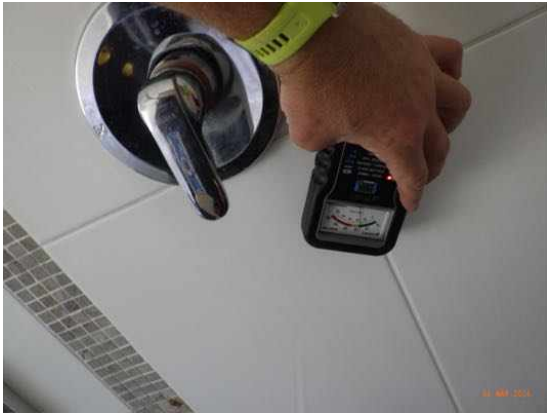
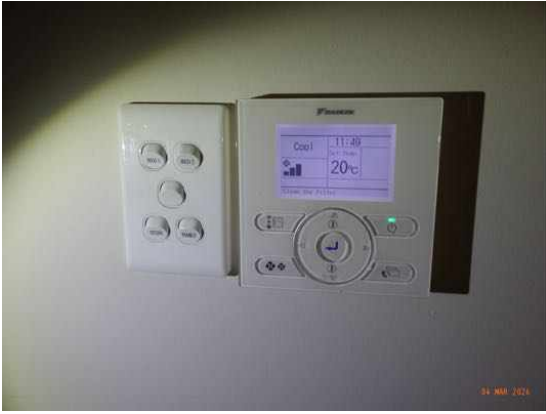
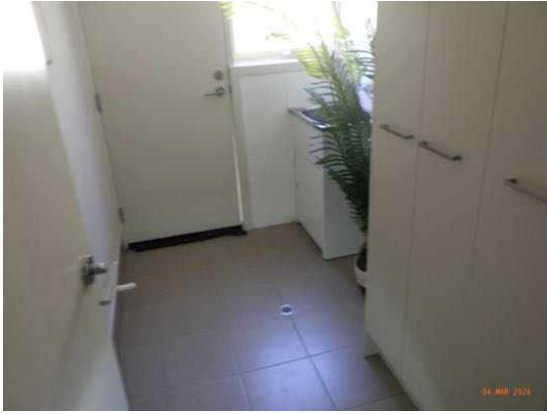
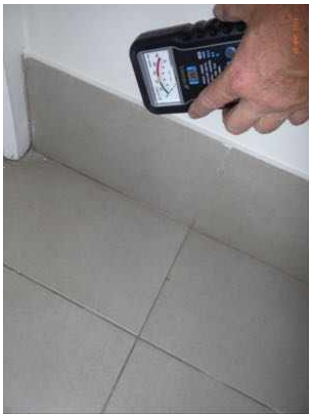
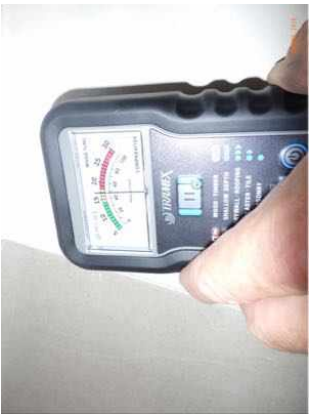
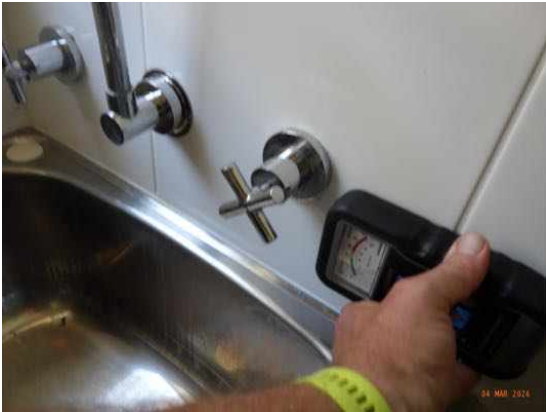
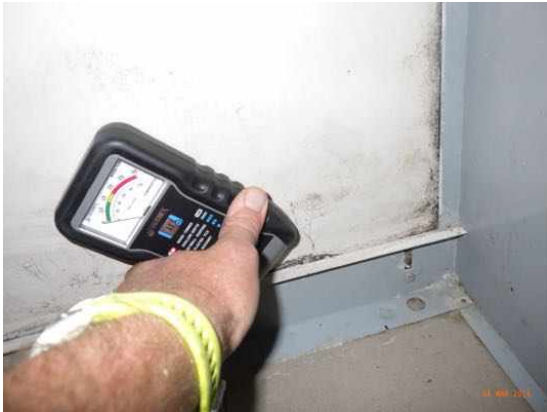
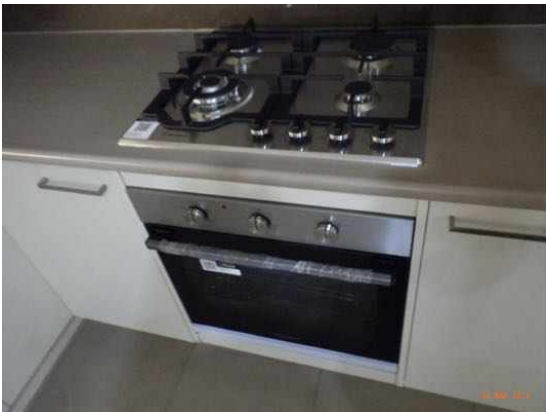
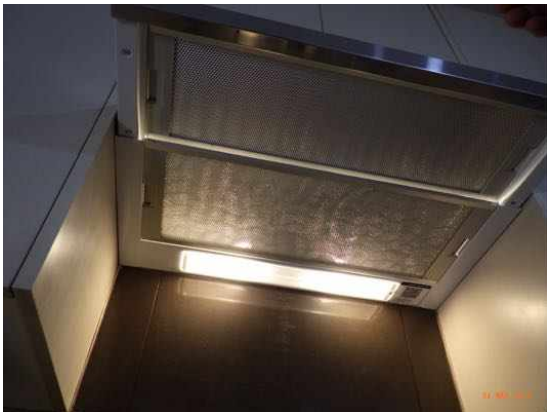
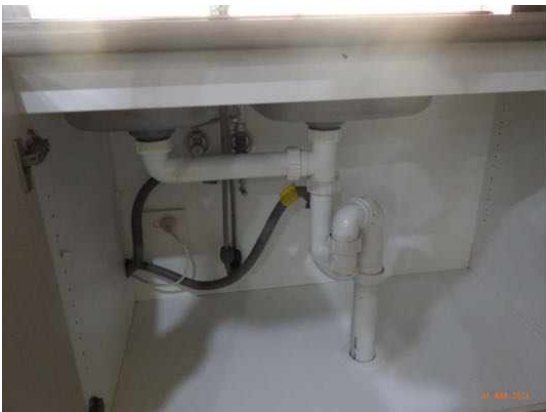
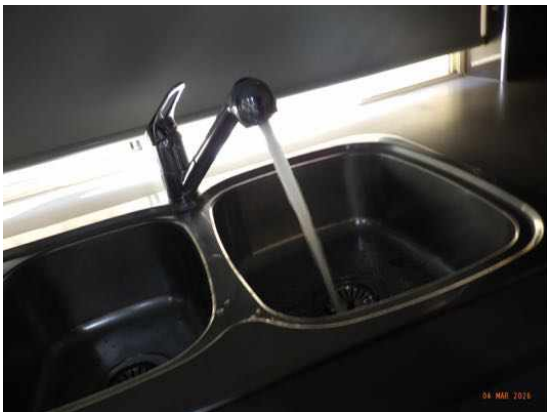
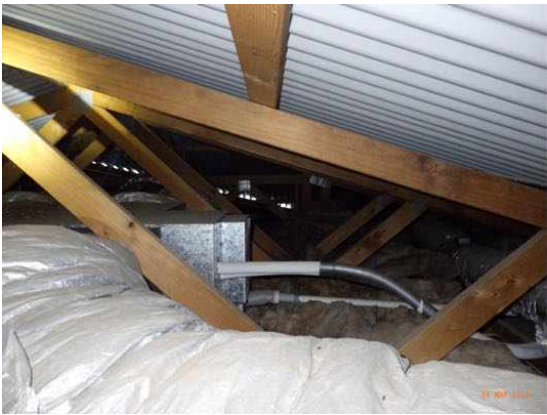
Building: Building 1
Location: All Areas
Finding: Additional Photos - Obstructions and Limitations
Information:

These photographs are an indication of the obstructions and limitations which impeded full inspection of the property at the time of inspection. These obstructions can hide an array of defects and should be removed to allow full inspection to be carried out.
