Building and Timber Pest Inspection Report

Inspection Date: Tue, 31 Mar 2026

Property Address: 195 Willigobung Rd, Willigobung NSW
2653, Australia

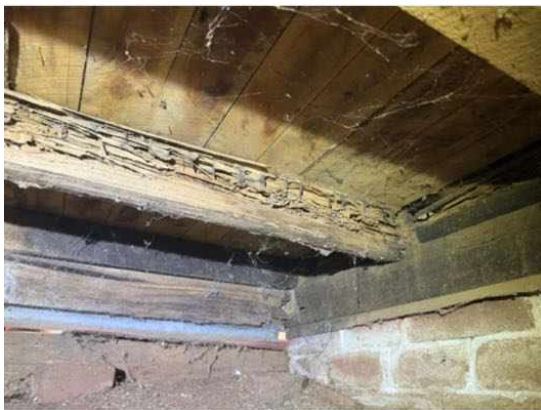
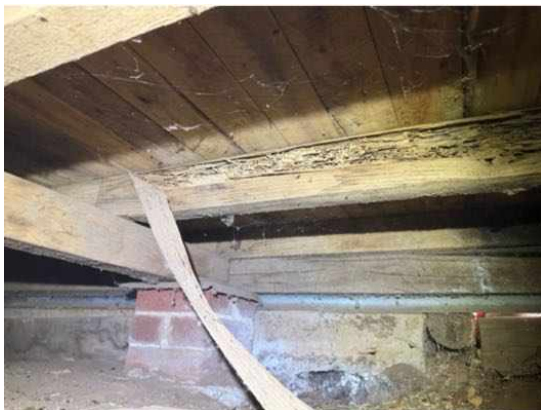
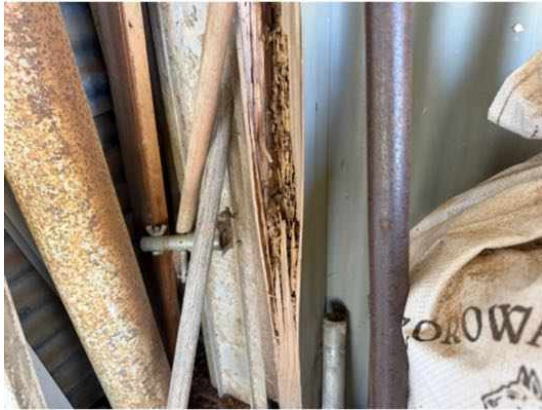
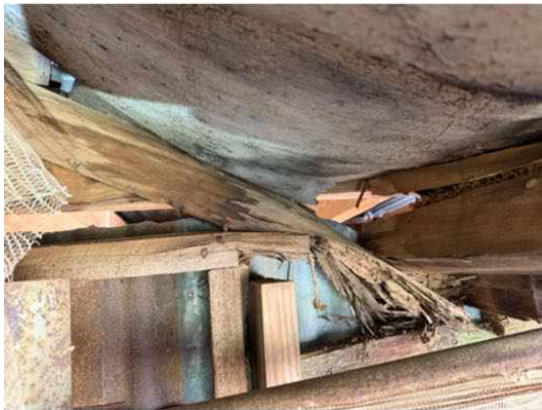
Building: Main Building
Location: Subfloor framing, Shed Framing & Beams
Finding: Evidence of termite damage - Subfloor & Shed Framing
Information: Termite damage was identified throughout some structural members in the subfloor area, toilet wall framing & the shed framing & beams. This affects the structural integrity of the building & shed and therefore should not be neglected. A more invasive inspection is recommended to identify the extend of the damage.

A registered builder should be engaged promptly, to conduct a more invasive inspection & replace all damaged structural building materials. A more invasive inspection may reveal secondary building defects.

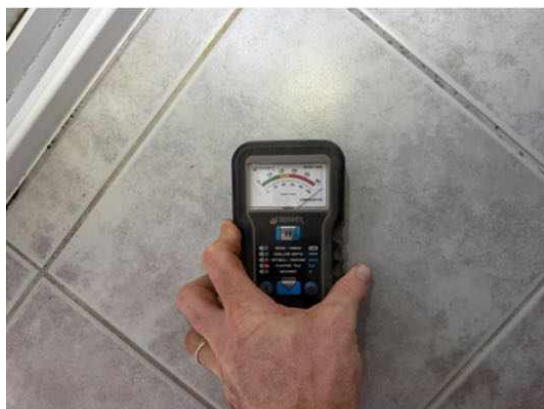
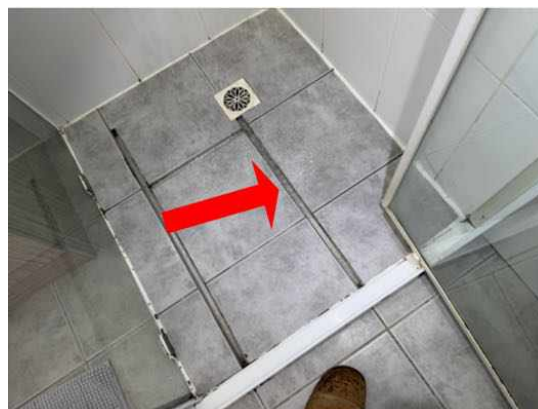
Building:	Main Building
Location:	Bathroom floor, Shower
Finding:	Bathroom Floor - High Moisture & Insufficient Shower Drainage
Information:	It appears that high moisture is present at but not limited to, the bathroom floor & poor drainage was also noted to the shower area, with water pooling evident in areas. This creates an environment conducive to termite activity & water damage to surrounding materials.

Recommend engaging a licensed plumber and/or tiling contractor promptly, to provide further advice & remedial works where necessary.

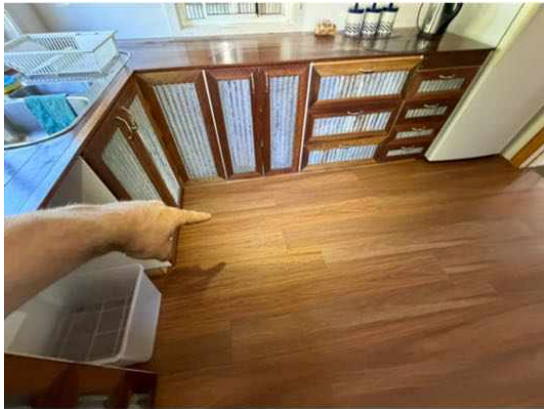
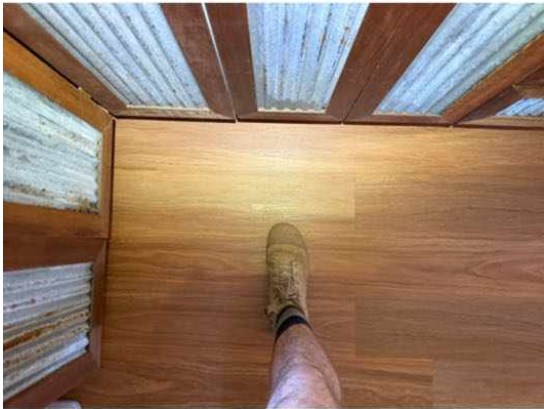
Finding 3.02

Building:	Main Building
Location:	Kitchen
Finding:	Flooring - Uneven
Information:	Some areas, of the flooring throughout the building appear to be slightly uneven. It is advised that the client monitor the flooring to identify any further movement. Where flooring remains relatively unchanged for an extended period of time, it is likely that this defect has been caused by expected movement of the foundations of the property.

However, where further movement and unevenness occurs, a structural engineer should be engaged promptly for further evaluation.

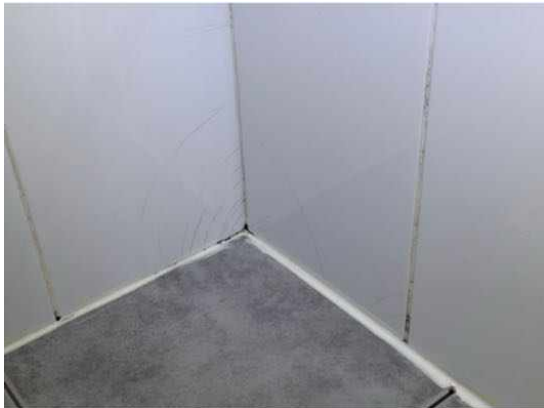
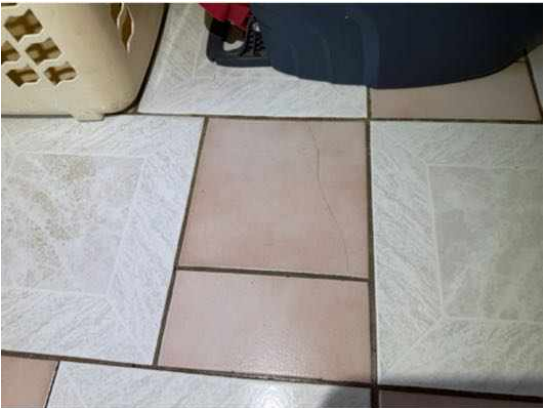
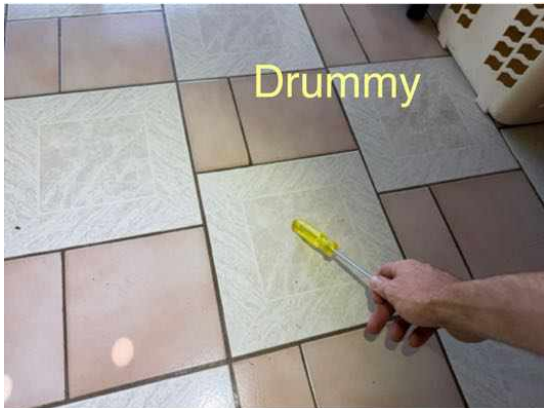
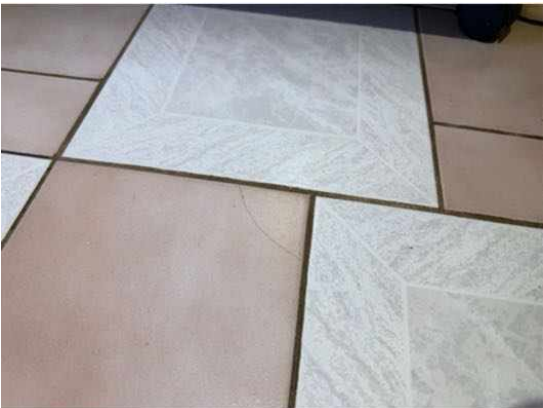
Building: Main Building
Location: Tiled Areas
Finding: Sealant / grouting - deteriorated or missing & Drummy / Cracked Tiles
Information: It appears that the sealant and grout has deteriorated in some tiled areas, a common defect in buildings of a similar age. Areas of cracked & drummy tiles were also noted, which can allow for moisture ingress behind the tiles, if neglected.

Sealant and grouting in areas that come into regular contact with water should be maintained for the long term care of your property.

Recommend engaging a licensed tiling contractor in the short term, to provide maintenance works where necessary.

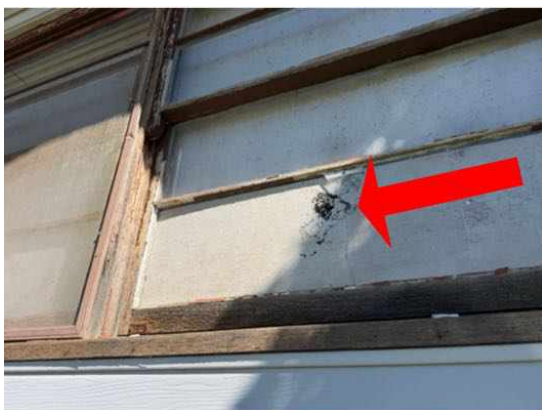
Finding 3.07

Building:	Main Building
Location:	Front elevation
Finding:	Window - Broken
Information:	It appears the window at but not limited to the front elevation was broken. Recommend engaging a qualified glazier promptly, to replace the window, to avoid creating an environment which is unsafe.

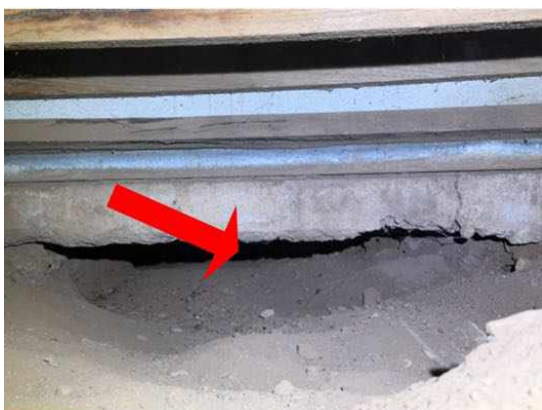
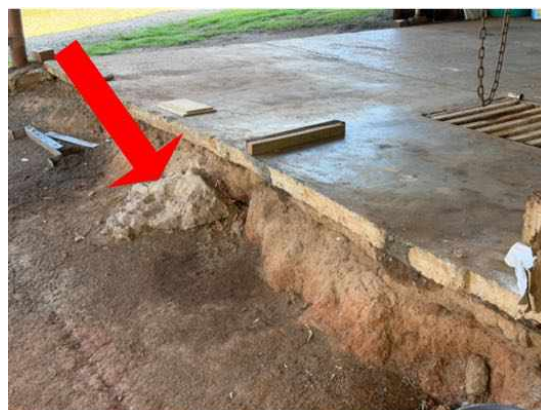
Finding 3.08

Building:	Main Building
Location:	Subfloor, Shed
Finding:	Shed & Rear Slab - Undermining
Information:	Undermining of the shed & rear slab appeared to be present at the time of inspection. Recommend engaging a landscaping contractor to backfill and compact the undermined area, to ensure no further undermining occurs. If neglected, further undermining and deterioration of the slab is likely to occur.

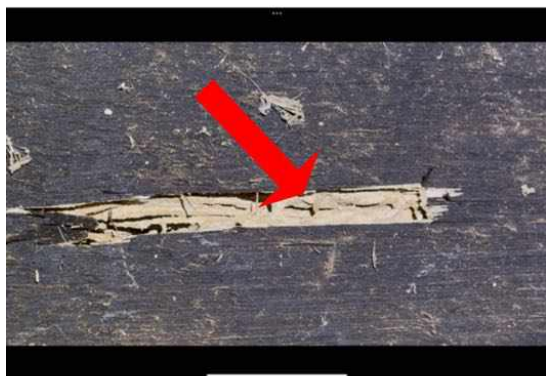
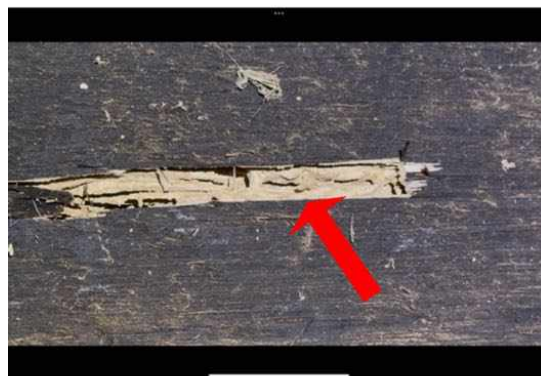
Finding 4.01

Building:	Main Building
Location:	Subfloor Framing
Finding:	Evidence of live termite activity was identified
Information:	Live termite activity was identified at, but not limited to the subfloor timbers towards the back right corner of the subfloor. A licensed pest controller should be engaged promptly, for further advice regarding application of a termite treatment and eradication of the colony, to prevent any further damage that will ensue.

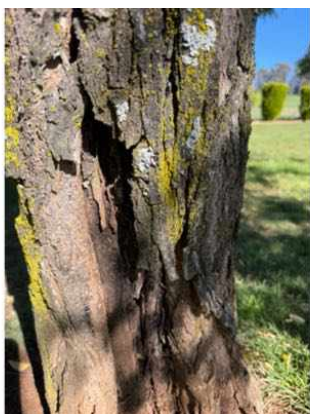
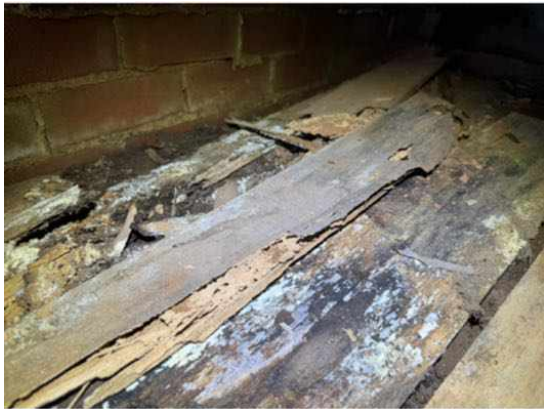
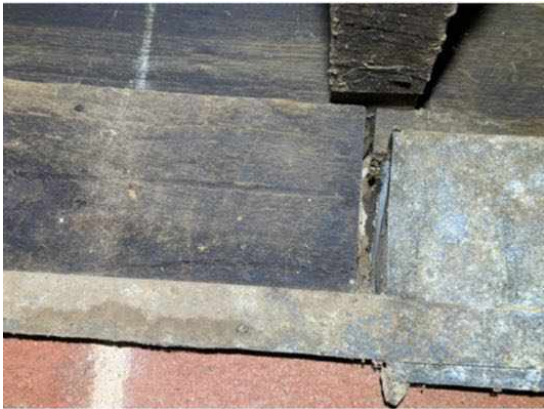
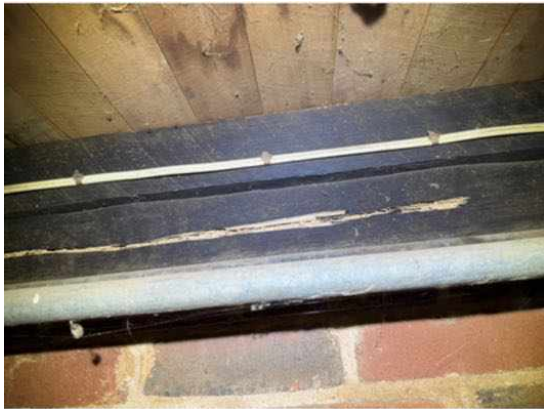
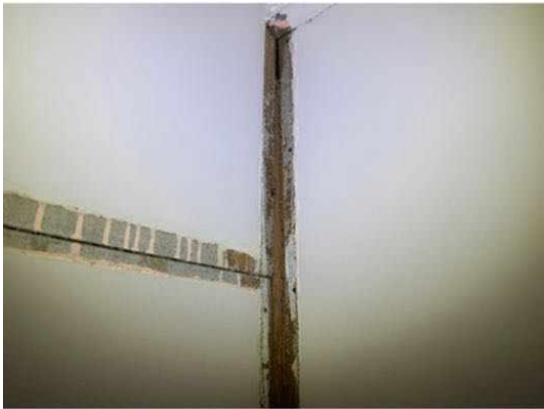
Finding 5.01

Building:	Main Building
Location:	Subfloor, Shed Framing, Toilet framing, Trees
Finding:	Evidence of termite workings & damage
Information:	Termite damage & workings were identified at, but not limited to, some subfloor timbers, areas of the shed framing, toilet wall framing and trees. For areas where structural damage has occurred (shed framing, subfloor framing, toilet wall framing) a registered builder should be engaged promptly to replace affected materials.

The client should engage a licensed pest controller promptly, to provide further advice regarding installation of a termite treatment. A more invasive inspection is also recommended to identify the extent of the damage. 6 monthly ongoing termite inspections, conducted by a qualified termite inspector, are also recommended

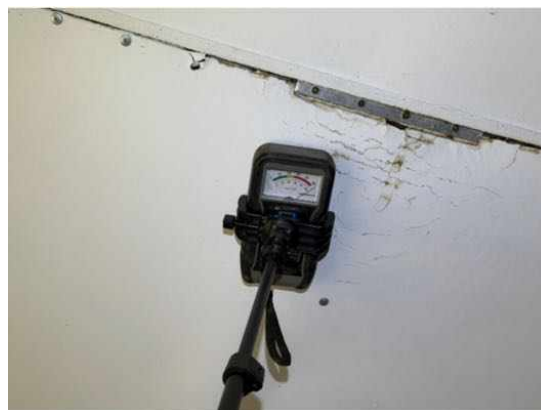
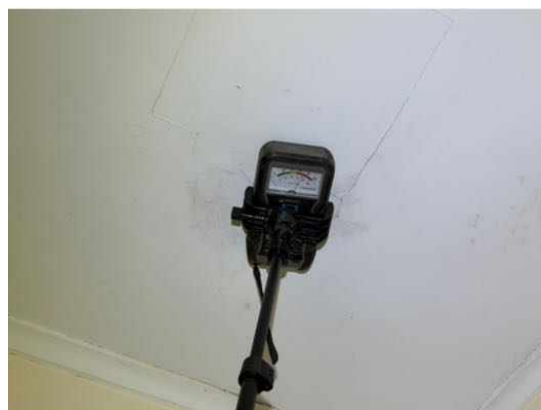
Finding 6.02

Building:	Main Building
Location:	Lounge Room Ceiling
Finding:	Ceiling Leaks
Information:	High moisture was identified at, but not limited to areas of the lounge room ceiling, which is suspected to be caused by the deterioration of the roof exterior. This creates an environment conducive to termite activity. Recommend engaging a licensed roof plumber or roofing contractor promptly to provide remedial works where necessary.

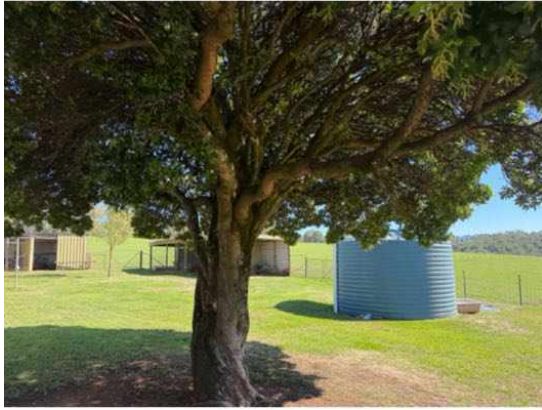
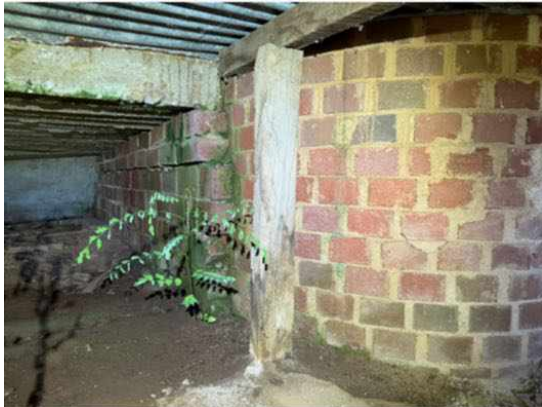
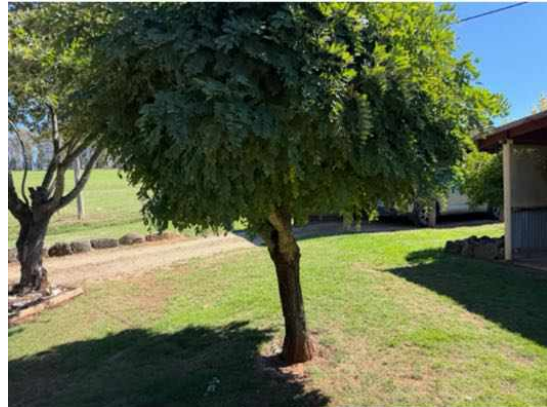
Finding 6.03

Building:	Main Building
Location:	All External Areas
Finding:	Timber in direct ground contact & trees - conducive to termites
Information:	Where timber materials are in direct contact with the ground and consequently moisture, they become conducive to termite activity. The tree stumps, shed framing, timber debris in the subfloor, and trees surrounding the building create an environment conducive to termite infestation.

Where feasible, any timbers in direct contact with the ground should be removed and any trees in close proximity to the building should be removed or test drilled (inspected) at least annually to reduce the risk of termite infestation & detect any early signs of termite activity.

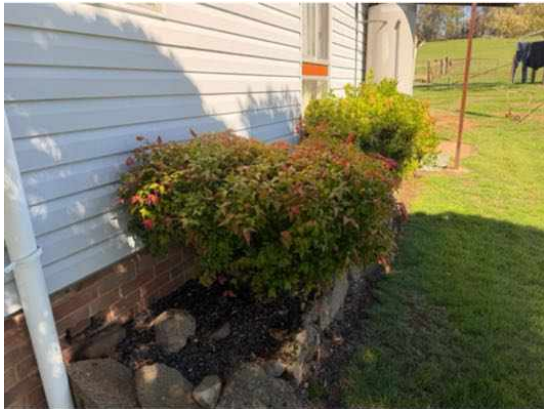
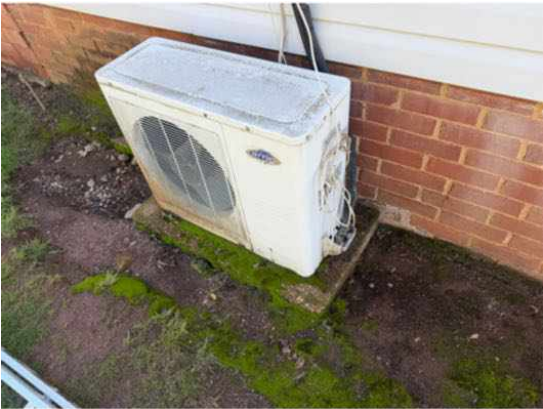
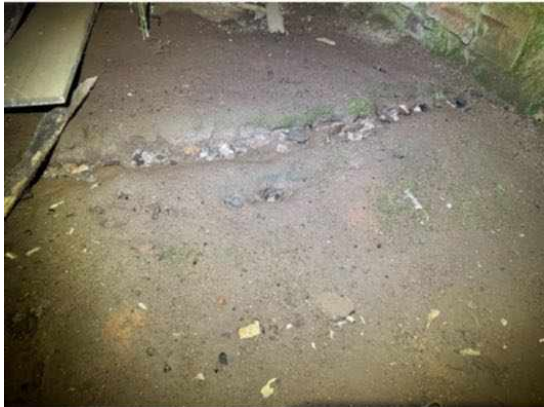
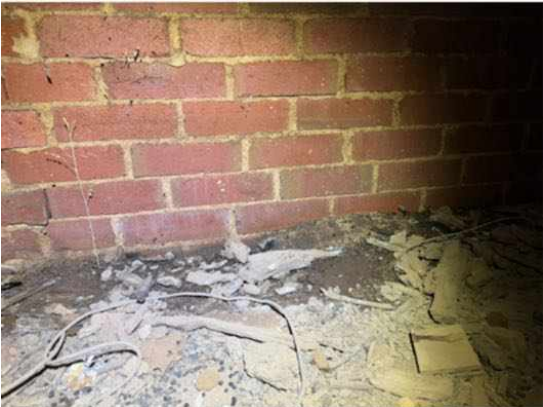
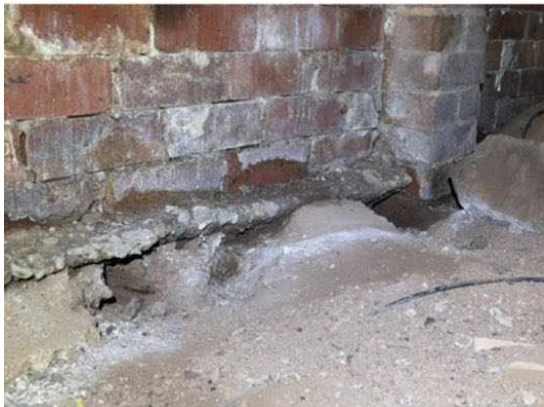
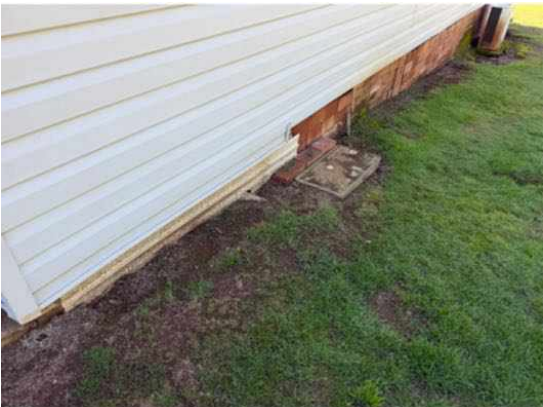
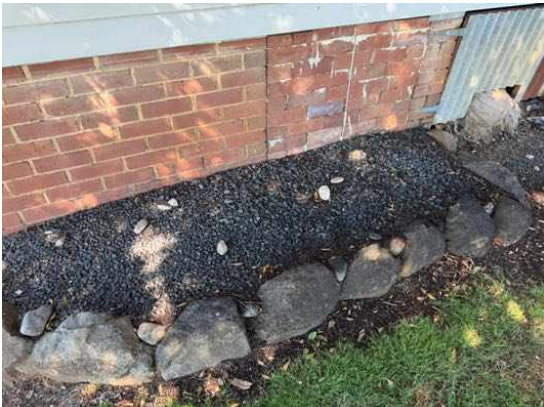
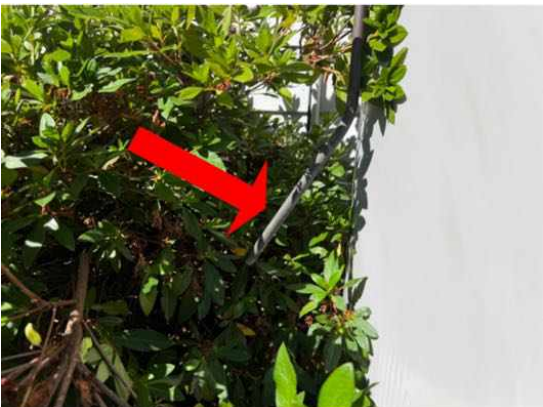
Finding 6.04

Building:	Main Building
Location:	All external areas
Finding:	Potential Water pooling - against property
Information:	It appears that there are potential areas around the perimeter of the property that could be susceptible to water pooling. Where insufficient drainage of taps, hot water system & aircon overflows, and garden beds against the house are present, water pooling is likely to occur, and can create areas conducive to timber pests and potential damage to the subfloor structure overtime, if neglected.

Recommend consulting with a licensed plumber and/or landscaping contractor in the short term to further assess and provide remedial advice.

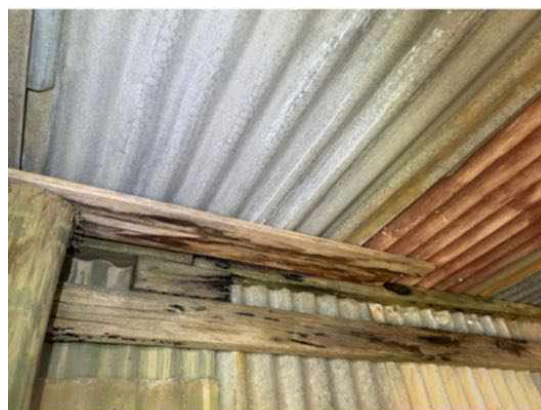
Finding 7.01

Building:	Main Building
Location:	Subfloor, shed frames, window frames, fascia's, beams
Finding:	Fungal decay & weathering
Information:	Areas of fungal decay (wood rot) & weathering were identified at but not limited to some subfloor timbers, shed framing & posts, window frames, fascia's, and the patio beam.

For areas where structural timbers are affected by wood rot (patio beam, shed posts, subfloor timbers) a registered builder should be engaged promptly to replace affected materials where necessary.

For areas where fungal decay is superficial, the client can engage a licensed carpenter at their discretion to replace affected materials. For areas of general weathering, it is advised the client engage a licensed painter to apply protective sealant or coating to areas of weathered external timbers.

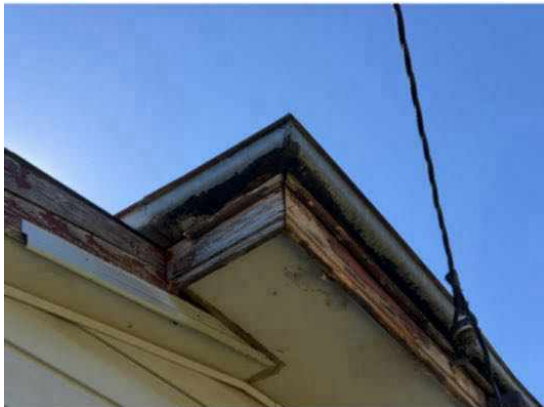
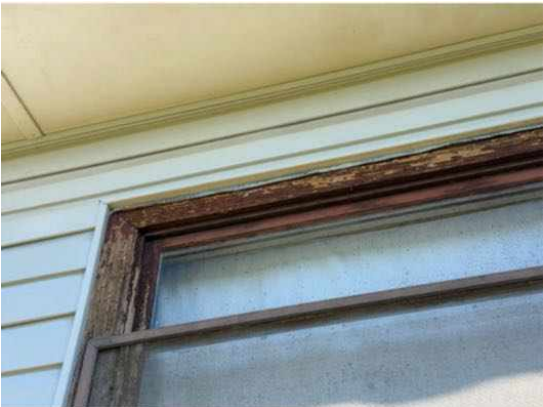
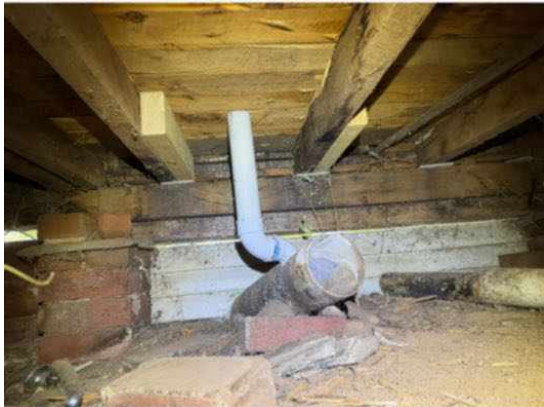
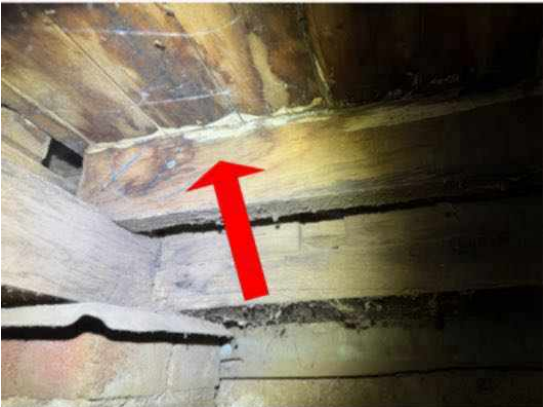
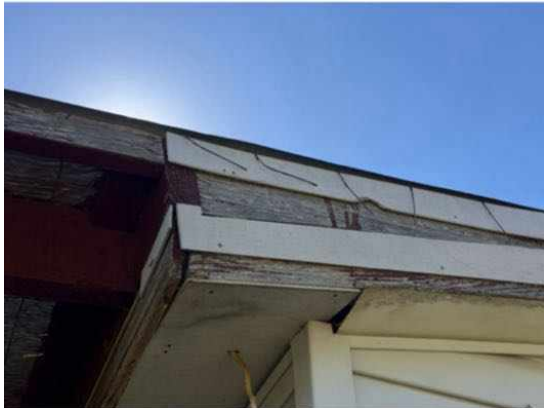
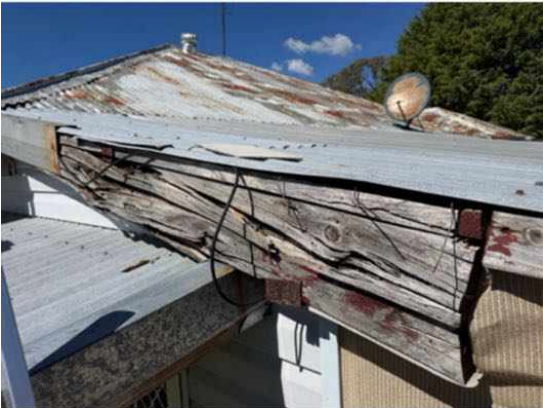
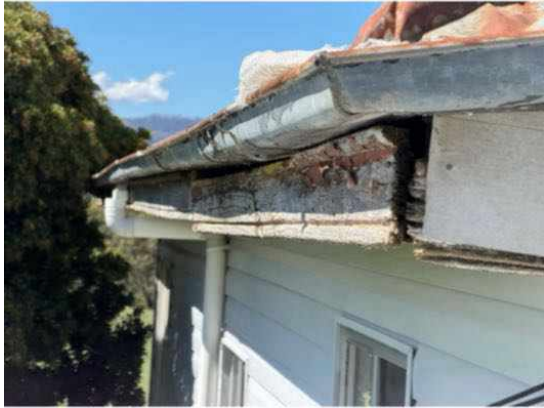
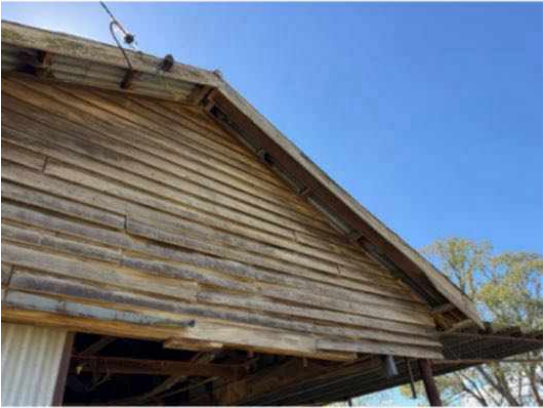
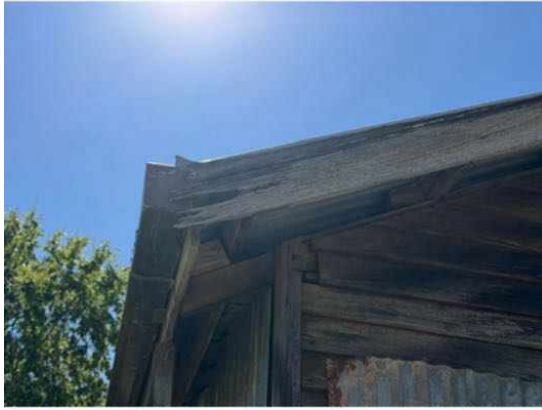
Evidence of fungal decay activity and/or damage

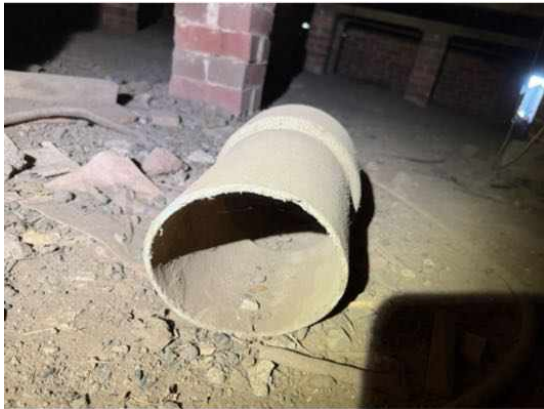
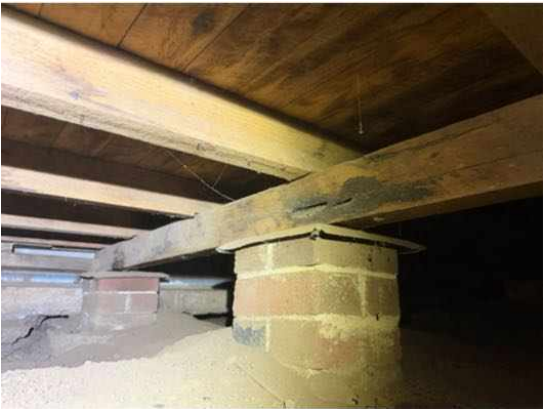
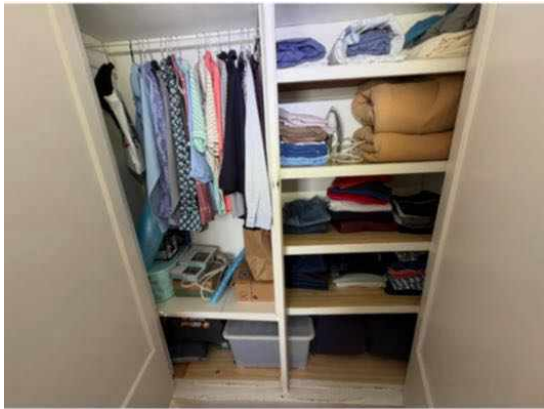
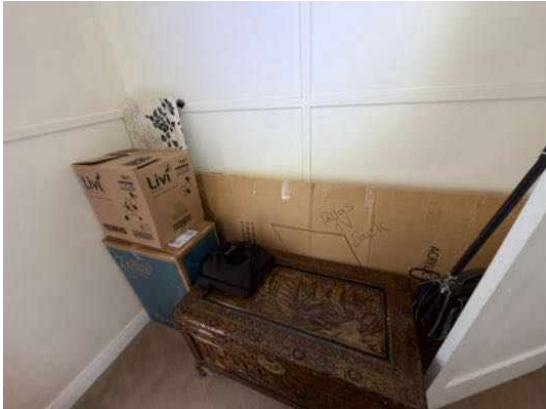
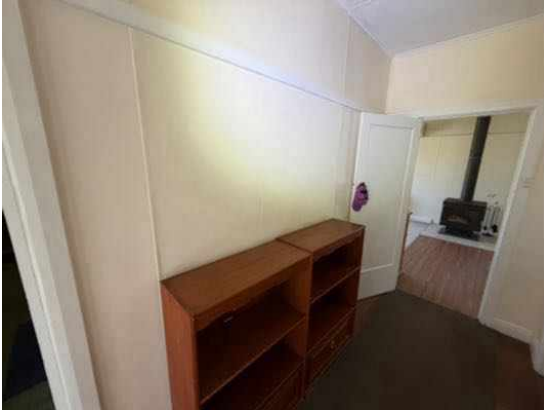
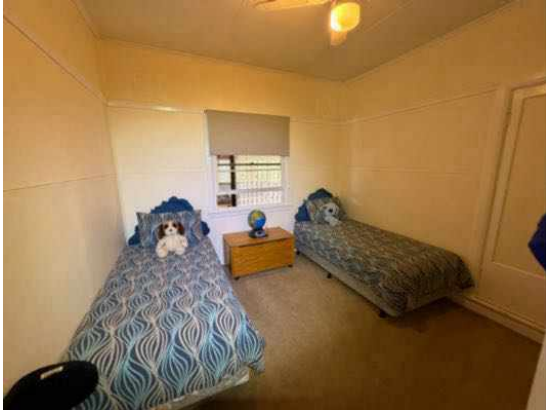
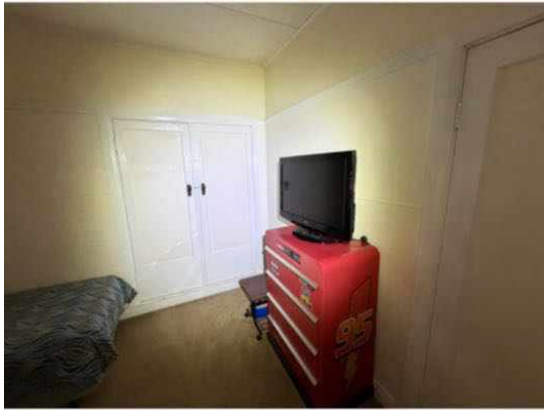
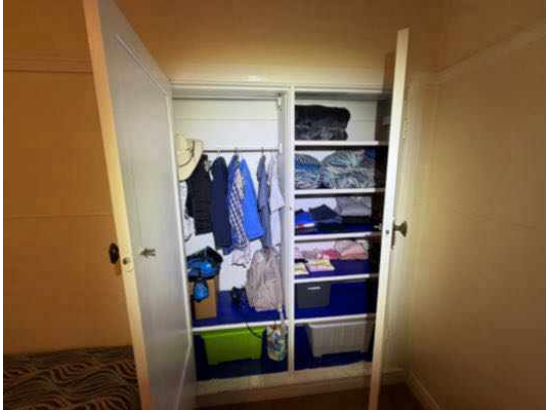
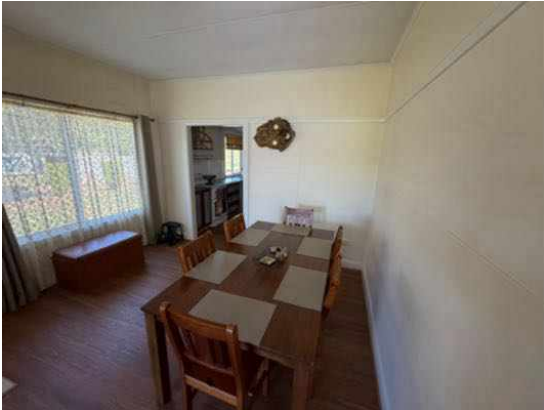
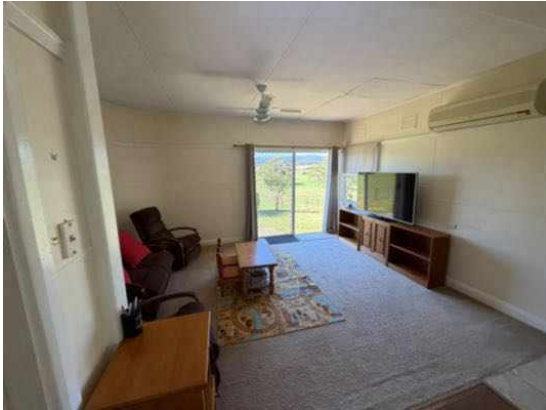
Building: Main Building
Location: All Areas
Finding: Additional Photos - Obstructions and Limitations
Information: These photographs are an indication of the obstructions and limitations which impeded full inspection of the property at the time of inspection. These obstructions can hide an array of defects and should be removed to allow full inspection to be carried out. A re-inspection is recommended once the areas are made accessible.

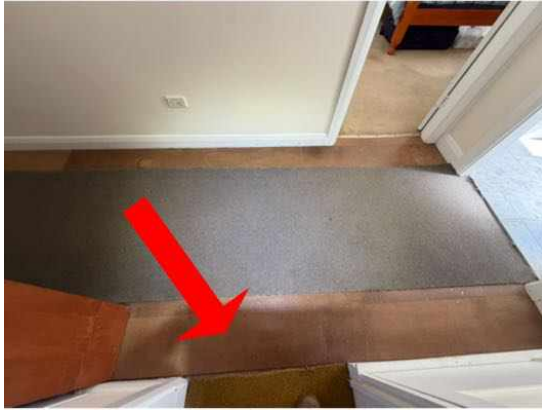
Building: Main Building
Location: Hallway
Finding: Carpet Missing
Information: It appears there is no carpet installed at, but not limited to the hallway. The client can engage a flooring contractor at their discretion to install carpet where needed.
