Building Inspection Report

Inspection Date: Wed, 4 Feb 2026

Property Address: 541 Glynburn Rd, Hazelwood Park SA 5066,
Australia

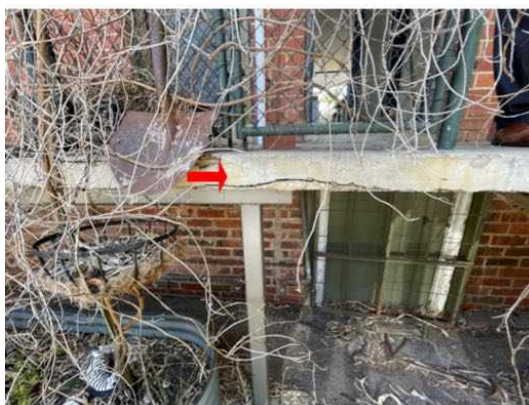
Concrete cancer is the common term used to describe a number of factors which cause concrete construction to deteriorate. Generally, water penetration causes the concrete reinforcement to rust and expand, creating stresses on the surrounding concrete and in turn causing it to spall (or break away). Alternatively, if the cement component is too alkaline, reactions with the general atmosphere occurs and star-shaped cracks appear which allow rainwater to penetrate. Concrete cancer may also originate from poor original water proofing.

Ultimately, the cause of the concrete cancer (e.g. poor water proofing) must also be addressed, otherwise the problem is likely to recur. Left unmanaged, the problem is likely to worsen over time, potentially leading to the development of major structural defects or safety hazards.

In some instances, repairs are possible. Repair works will generally involve removal of affected concrete and the treatment or replacement of any exposed steel. Some injection of resins or special mortars may also be possible, however this depends on the size and extent of consequent damage.

As the structure is a balcony, the concrete cancer may compromise the load capacity of the structure and immediately investigation by a licenced structural engineer is required to assess the area for safety and capacity. A specialist builder would then be appointed to repair the damaged area on the advice of the engineer.

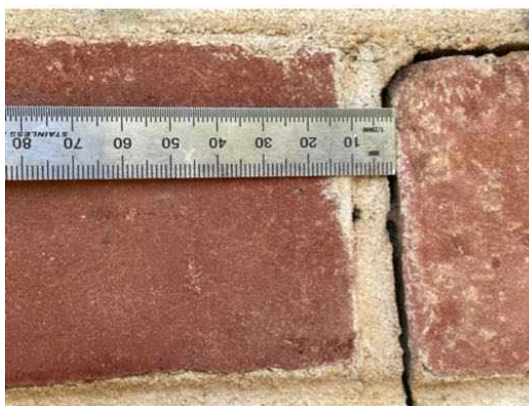
Defects 2.02

Building:	Main Building
Location:	Rear corner
Finding:	Brickwork - Step cracking
Information:	Step cracking was identified to the brickwork to the rear corner of the building at the time of inspection. Step cracking, which is similar to other forms of cracking, has a variety of possible causes. However, the most common is the subsidence of adjacent footings.

This cracking measures approximately 10mm in width and appears to spread from the corner of the building (behind the air conditioning unit) to the rear entry door frame.

Step cracking is a relatively common defect, and is most likely to occur adjacent to windows, doors and other openings. Mortar failure in the gaps between affected bricks indicates the stresses and tensions affecting the wall.

Where step cracking is extensive or severe, the client is advised to consult a structural engineer. Minor step cracking can be used as a warning sign to address factors causing stress to the wall, which can include the effect of surrounding trees, water leaks, soil erosion, or even the presence of reactive soils in the surrounding area.

Monitoring of all cracking should be conducted frequently. Always contact a building inspector should cracks widen, lengthen, or become more numerous. Additionally, your building inspector should also be contacted if associated building elements such as doors and windows become more difficult to operate over time.

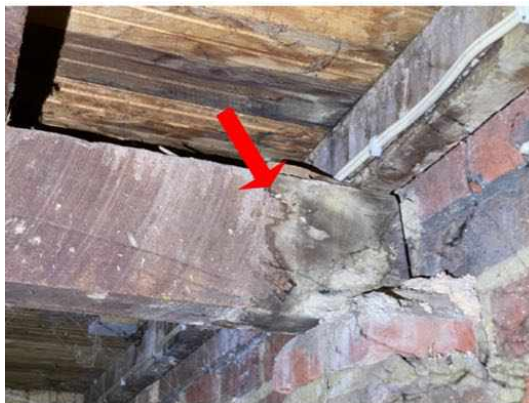
Defects 2.03

Building:	Main Building
Location:	Subfloor
Finding:	Subfloor structure - Wood rot
Information:	The subfloor has areas of wood rot (fungal decay) to the structure towards the rear of the accessible subfloor area. It is suspected that this defect may have developed as a result of damp conditions in the subfloor over time.

Damp conditions cause the timbers to fail, resulting in the subfloor structures failing to bear the load (or weight) of the building as originally intended. Without repairs and maintenance, including potential replacement of affected elements, it is likely that serious structural faults will result, as well as an array of minor defects.

The presence of wood rot to the subfloor structure is also conducive to termite infestation. As timber stumps are in direct contact with the ground, concealed termite is made possible. Such entry is made easier if the timbers become non-durable due to even slight wood rot.

Where wood rot is present to any structural timber, rectification or replacement of the affected timber building element is required. The adequate timeframe for such works are dependent on the severity of the rot. Where rot has developed to become widespread, replacement of sections of the subfloor structure may be required. Consultation with a structural engineer or registered builder specialising in re-stumping is highly advised as soon as possible.

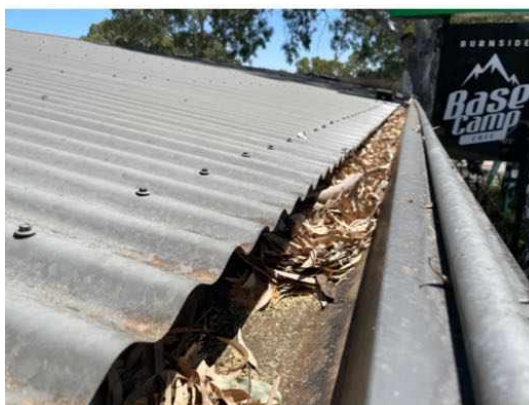
Defects 2.04

Building:	Main Building
Location:	Roof Exterior
Finding:	Gutters - Blocked
Information:	Significant degrees of debris build up was identified throughout the guttering at the time of inspection.

Blocked gutters and drainage is likely to lead to flooding, as well as high levels of moisture in the affected areas. Such moisture will not only cause rust and decay of the associated building materials, but can also provide conditions that are conducive to termite and timber pest activity. Blockages in gutters should therefore be removed immediately to ensure dry conditions are maintained.

Consult a Licensed Plumber for further specific advice on remedial works that may be required. In the interim, it is highly advised that blocked gutters and drainage be removed by a general handyperson as a matter of urgency.

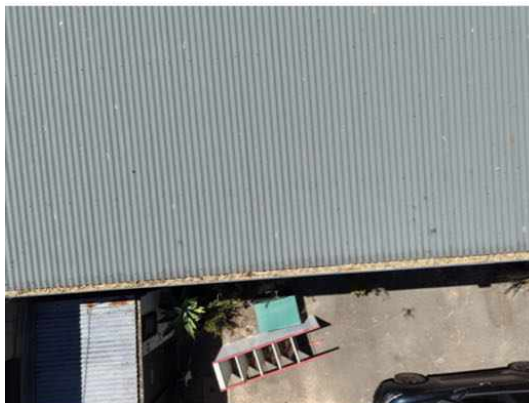
Defects 2.05

Building:	Main Building
Location:	Roof Exterior
Finding:	Roof plumbing - Rusted or corroded
Information:	The roof plumbing has areas of rust and corrosion, the extent of the damages could not be observed at the time of inspection due to significant debris build up throughout the guttering. It is suspected that this has been caused by blockages, resulting in pooling or standing water, that have prematurely rusted elements of the roof plumbing. Age is also a likely contributing factor.

Rusted roof plumbing will generally develop holes and leaks that can affect other building elements with poor drainage of storm water. Poorly drained roof areas will also lead to damp conditions surrounding the base perimeter of the building which, if left unmanaged, can lead to a range of secondary building defects.

It is advised to clean the gutters, assess the extent of the damages and treat the damaged areas as necessary. Should leaking develop and or further deterioration occur, repair and/or replacement of any significantly rusted elements of roof plumbing is required in order to reinstate the roof drainage system to a fully operational level. To further maintain these areas, gutters should be cleaned frequently, allowing the avoidance of any partial blockages.

undertake these works. It is advised that such works be completed as soon as possible to prevent any further damage and deterioration.

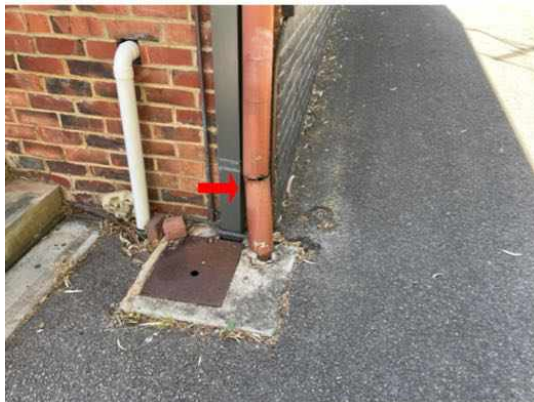
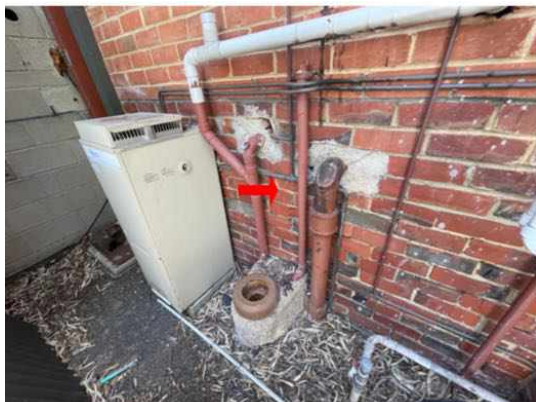
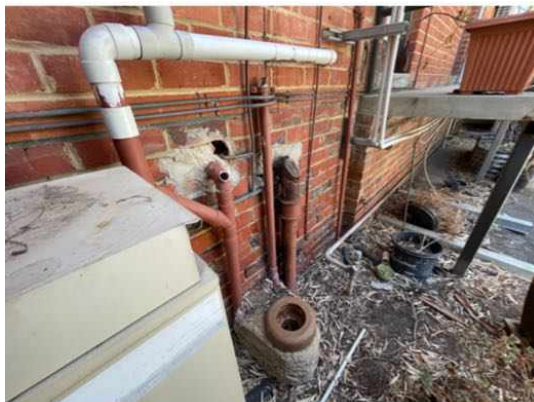
some older metal pipe work showing rust and deterioration.

The client should be aware that older buildings may have aged or outdated plumbing systems. Aged plumbing may be more prone to break down, deterioration and defects that affect the functionality of the plumbing system.

Where aged plumbing deteriorates, this can lead to cracks, holes and leaks in the plumbing that can affect other building elements due to poor drainage of waste water or storm water. Poorly drained areas will also lead to damp conditions surrounding the base perimeter of the building which, if left unmanaged, can lead to a range of secondary building defect as well as being conducive to termites.

A licensed plumber should be appointed as soon as possible to perform further inspection to the buildings internal and underground plumbing structures to assess for damages and potential weak points.

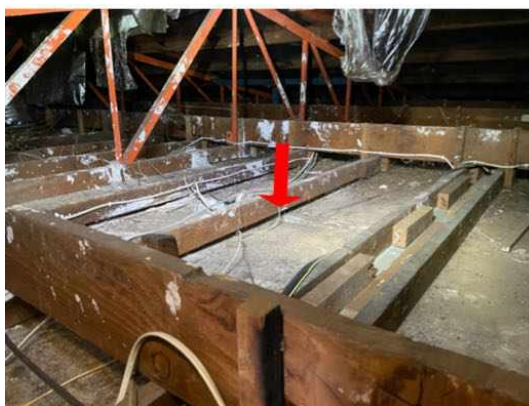
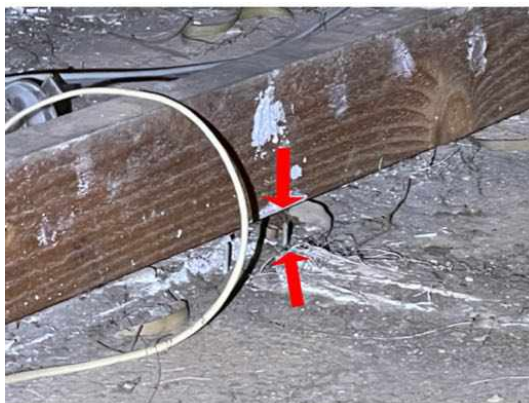
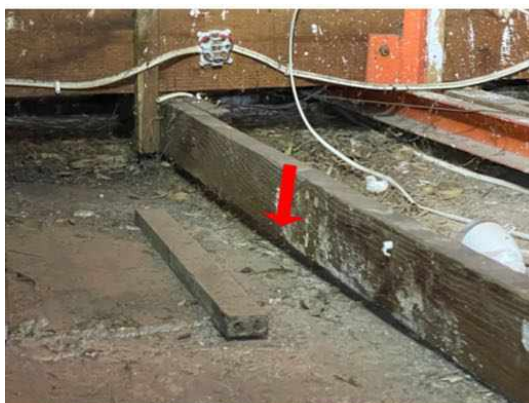
Defects 3.02

Information: Ceilings were found to be sagging throughout the building at the time of inspection. This was most notable to the main dining/bar area, however most ceilings showed some form of sagging to varying degrees. Sagging to the fixed ceiling structure generally indicates that the building materials have swollen, due to contact with water, or that fixings (e.g. nails or glue) have become loose and require reattachment.

Where minor sagging is evident, comparatively minor works, such as re-gluing of ceiling sheets, may be required. Such works may be performed by relevant tradespeople, such as plasterers and painters. Where excessive moisture has caused the roofing structure to swell and sag, the source of the water leak should primarily be identified prior to any remedial works being performed.

This level of sag requires immediate attention, to prevent further deterioration. A licenced builder should be appointed immediately to address the issue and the contributing factors.

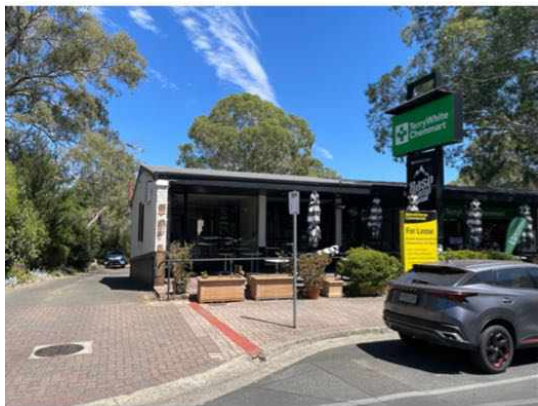
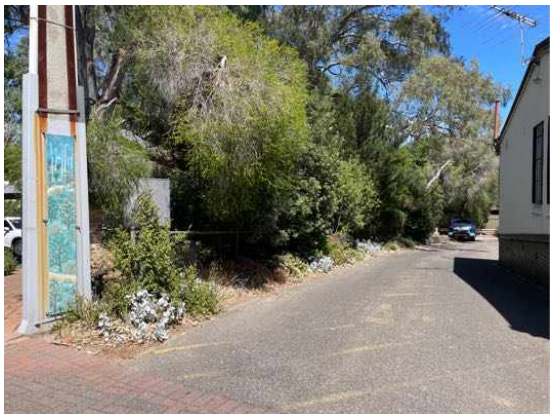
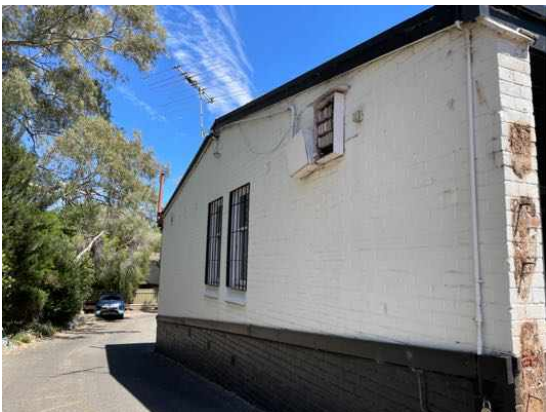
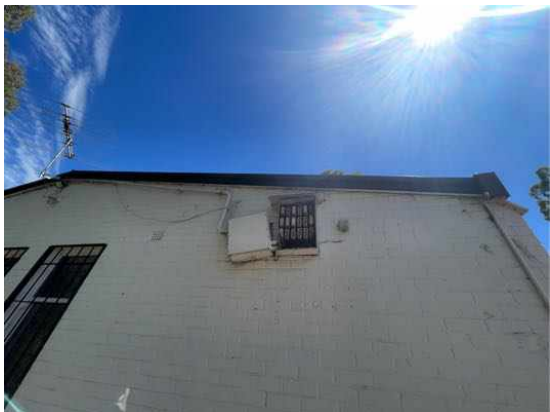
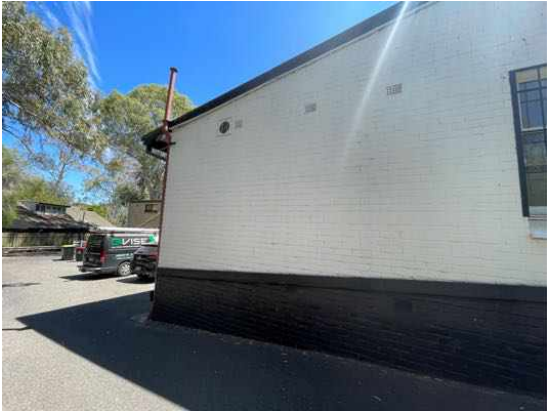
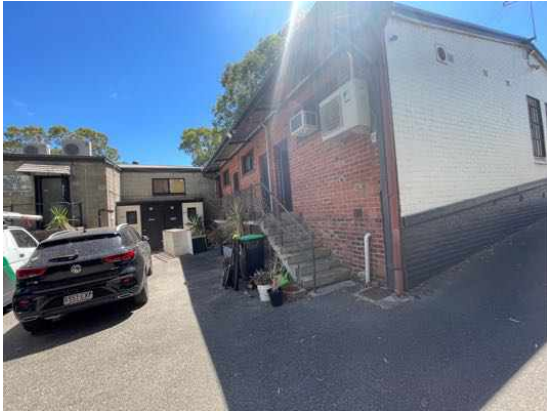
Building: Main Building
Location: All Areas >
Finding: Additional Photos - Obstructions and Limitations
Information: These photographs are provided for your general reference, but are also an indication of the obstructions and limitations which impeded full inspection of the property at the time of inspection. These obstructions can hide an array of defects and should be removed to allow full inspection to be carried out. A re-inspection is recommended once the areas are made accessible.
