Building and Timber Pest Inspection Report

Inspection Date: Sat, 14 Mar 2026

Property Address: 1/22 Chiswick Rd, Greenacre NSW 2190, Australia

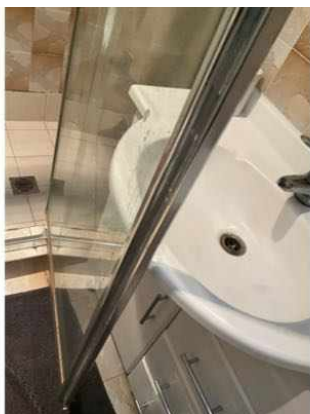
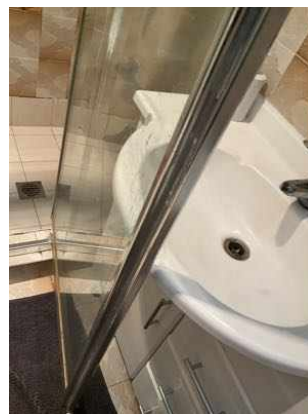
Finding 1.02

Building: Main Building
 Location: Bathroom
 Finding: shower screen door hitting vanity unit
 Information: The shower screen door makes contact with the edge of the vanity unit when opened. This indicates inadequate clearance between the shower screen and the fixed bathroom fixture. The door's operation is impeded and presents a safety concern.

- Potential for impact damage to the vanity and shower screen.
- Increased risk of glass breakage, posing a personal injury hazard.
- Ongoing stress may lead to hardware failure or misalignment of the door.

This condition does not comply with the intent of AS 4349.1-2007, Appendix C – Significant Items, under “Defects in the condition of secondary and finishing elements,” specifically where normal use may cause failure or injury.

Engage a licensed glazier or shower screen installer to adjust or replace the screen to ensure proper clearance and safe operation. A cabinetmaker may be consulted if modification to the vanity is more feasible.

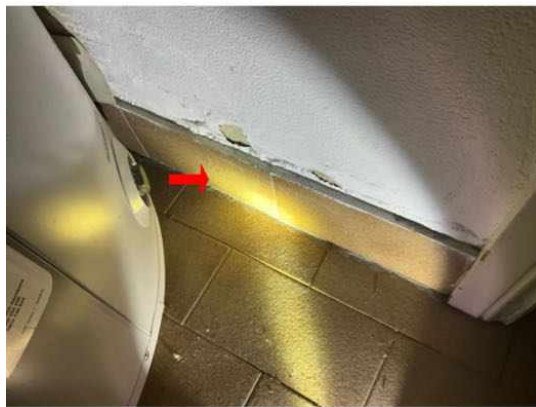
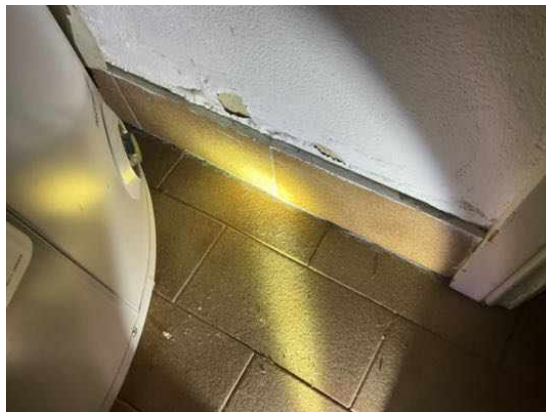
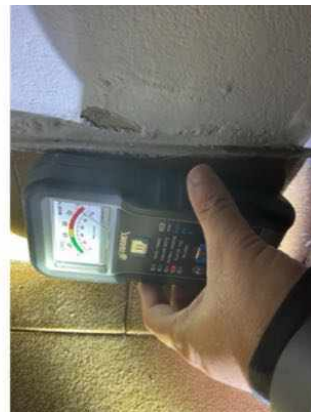
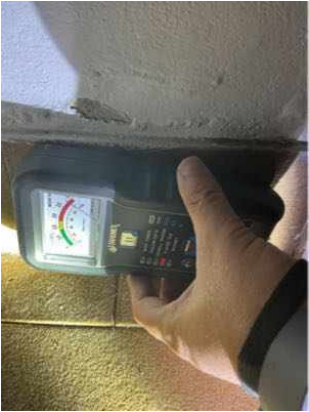
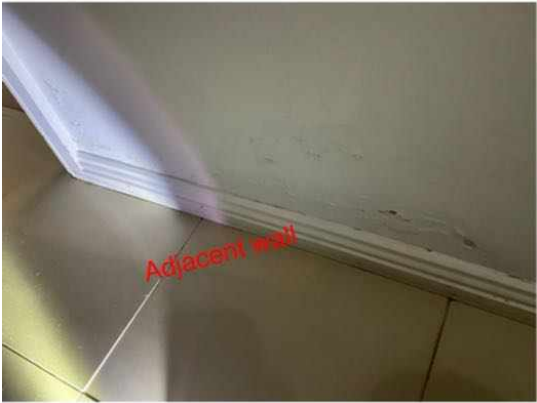
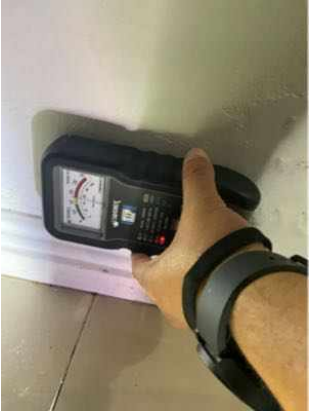
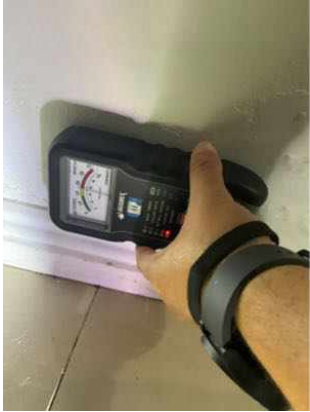
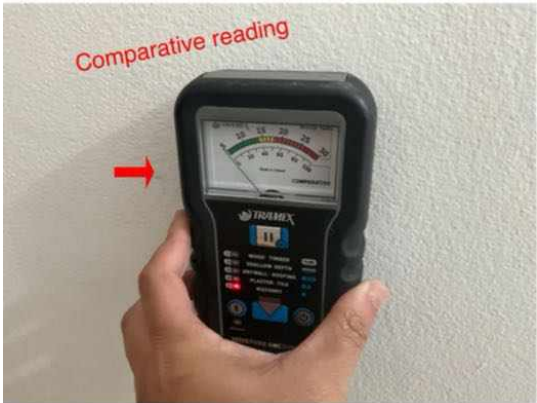
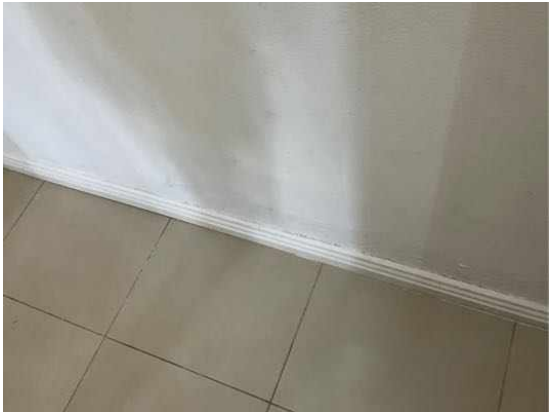
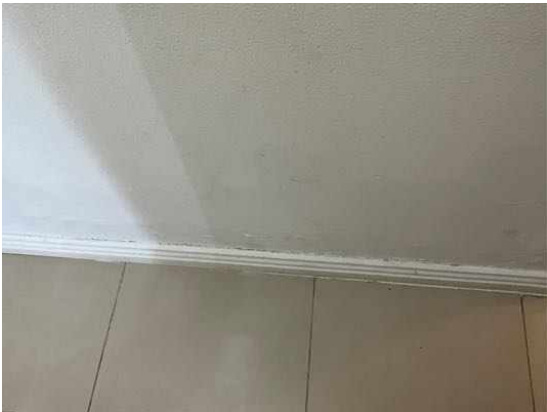
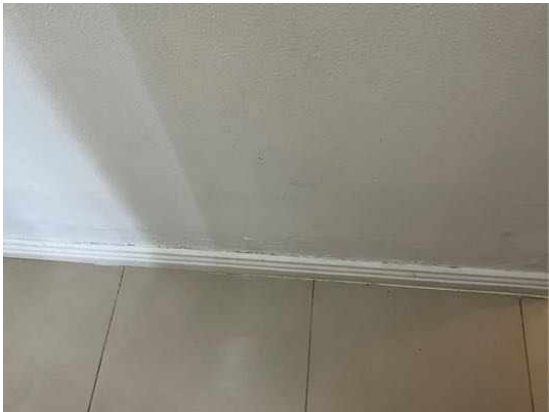
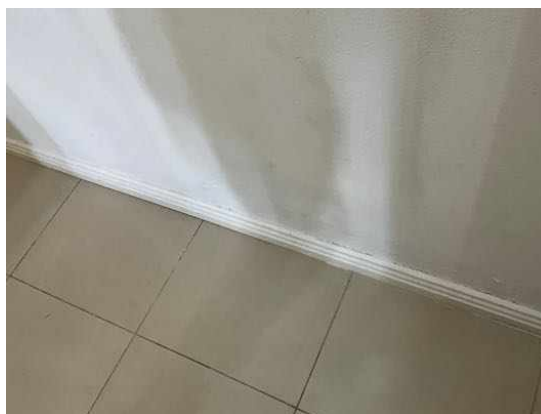
Finding 2.01

Building: Main Building
 Location: Laundry
 Finding: Water damage

Information: The area has sustained water damage resulting in potential structural issues. This damage compromises both the aesthetic and functional aspects.

1 **Plumber:** If the water damage is due to plumbing issues, a plumber can fix leaks and ensure there are no further water-related problems.

2 **General Contractor:** If the damage is extensive and affects the surrounding area, a general contractor can coordinate the repair work, including any related structural or cosmetic repairs.

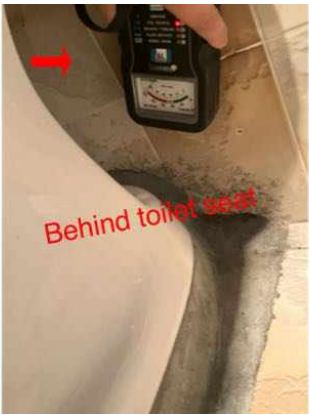
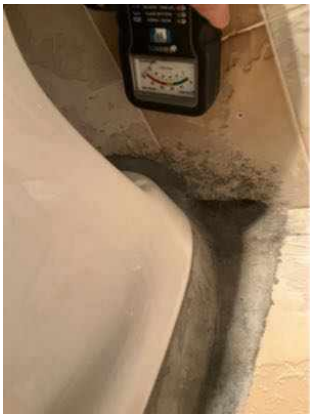
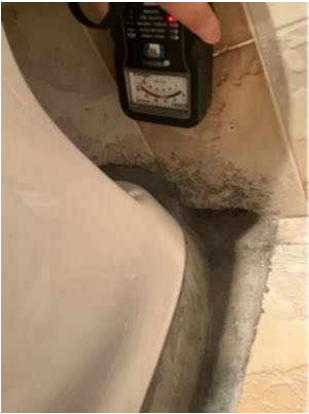
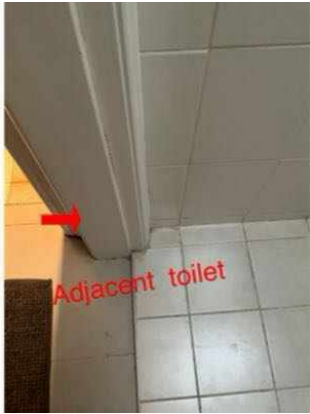
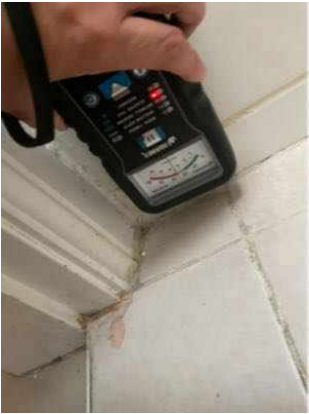
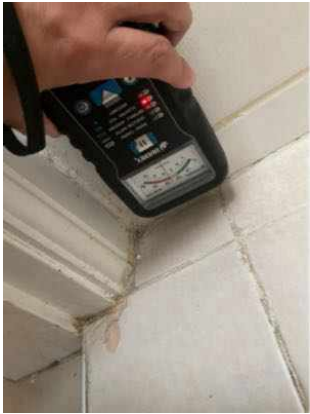
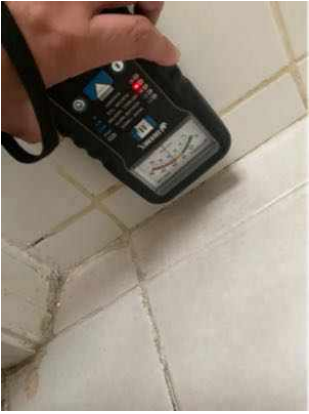
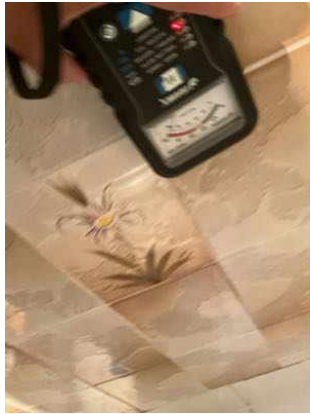
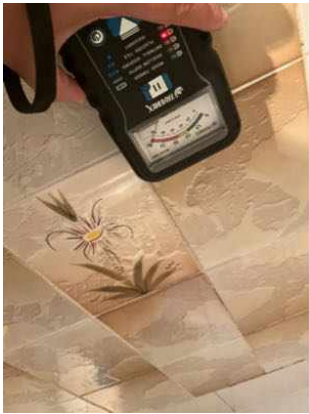
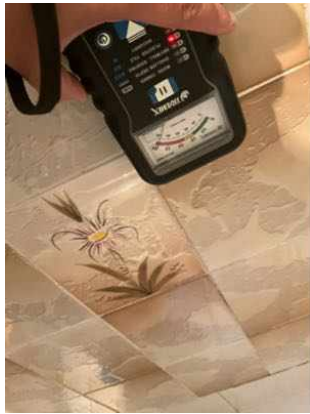
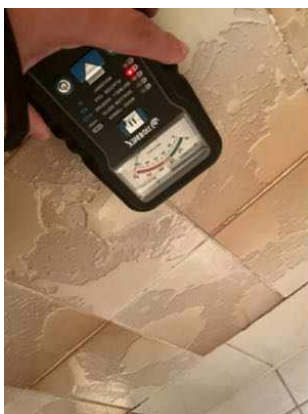
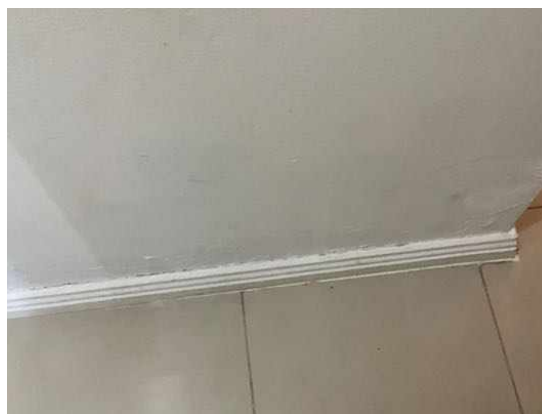
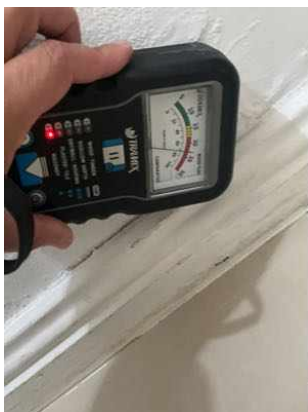
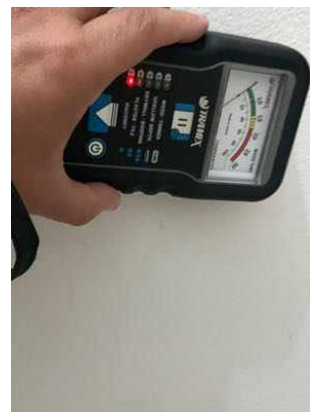
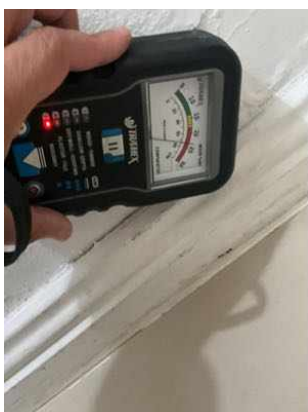
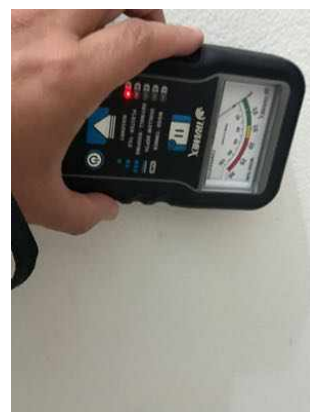
Finding 2.02

Building:	Main Building
Location:	Bathroom
Finding:	Evidence of excessive moisture was present at the time of inspection
Information:	Excessive moisture is present behind the bathroom tiles, indicating a potential water leakage issue within the wall.

The prolonged presence of moisture can lead to mold growth, deteriorate the structure, and create an environment conducive to health hazards. Additionally, it may compromise the adhesive holding the tiles, leading to their detachment.

A licensed plumber or a qualified contractor specializing in water damage remediation should investigate the source of the moisture, fix any leaks, and address the damage. Additionally, replacing affected tiles and ensuring proper waterproofing are crucial to preventing future issues.

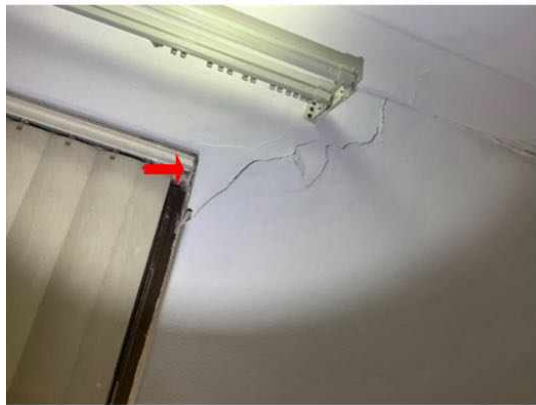
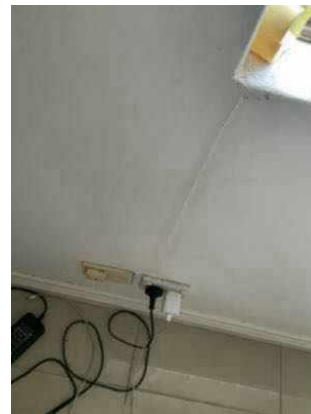
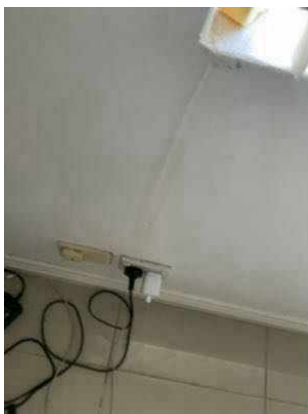
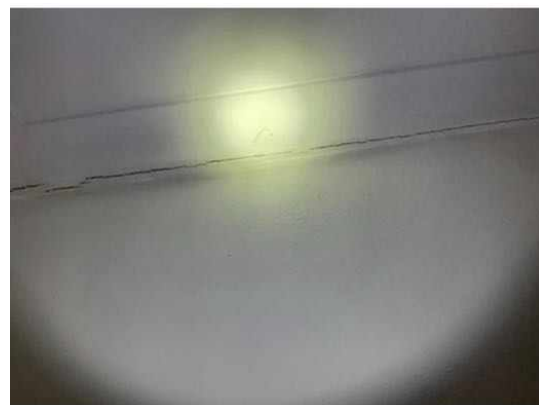
Finding 2.03

Building:	Main Building
Location:	All Areas
Finding:	Brickwork - Cracking [Repair required]
Information:	Major cracking was identified to the brickwork in this area. Cracks of this type are likely to have been caused by minor expected movement of building elements, but may also have a structural cause that is more significant.

A crack of this size may be repaired by extensive filling. Additionally, further remedial works to associated building elements, such as eave sheeting or external door frames, is likely to be required.

A qualified bricklayer should be contacted immediately to estimate and perform repair and restoration works. Consultation with a structural engineer may be required where structural instability is found to be the underlying cause of the cracking.

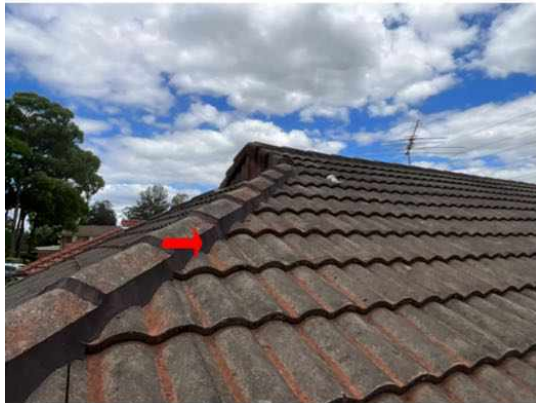
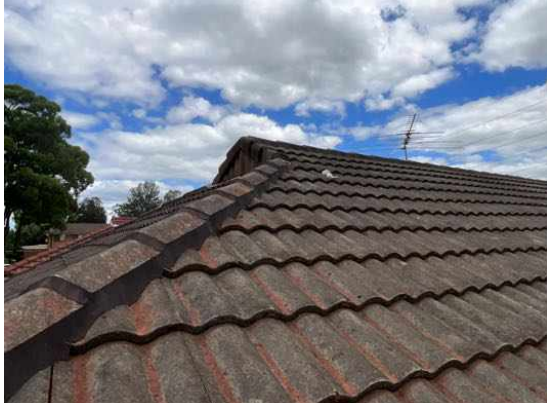
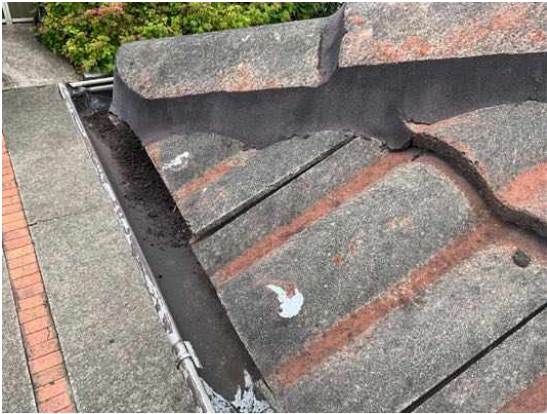
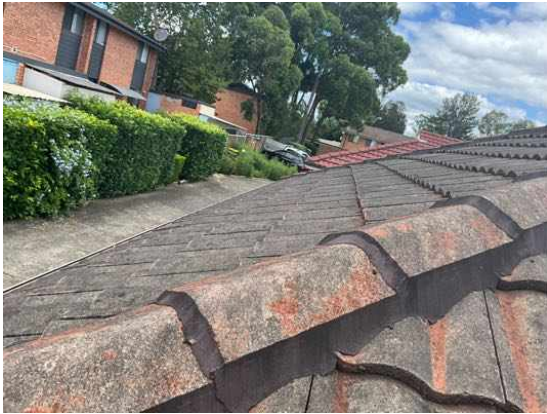
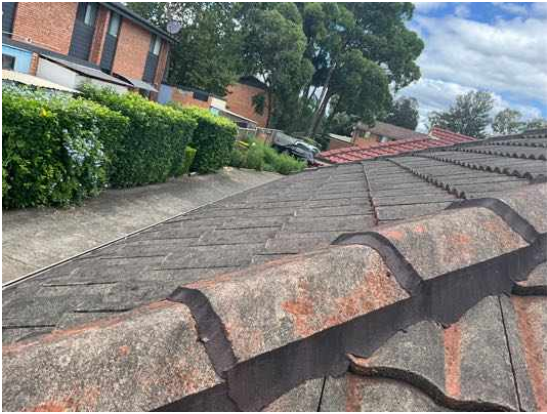
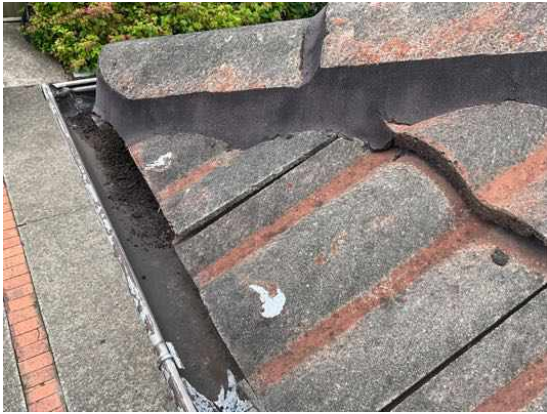
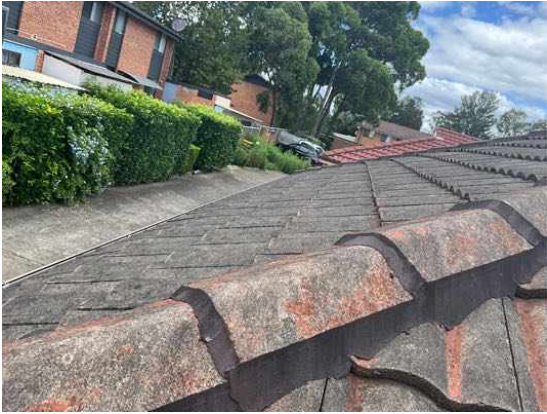
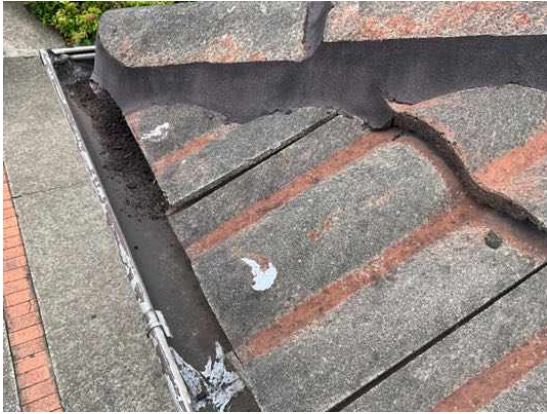
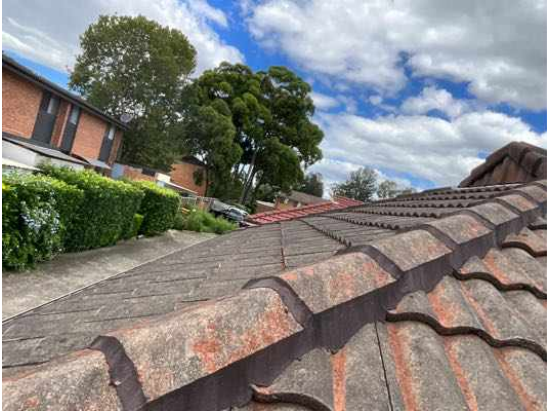
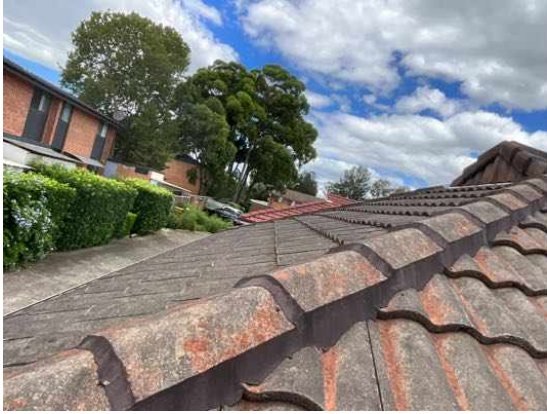
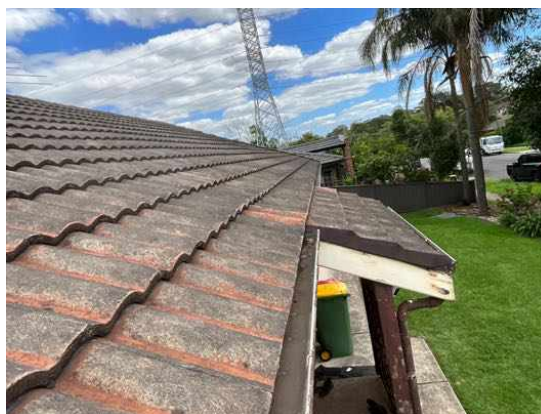
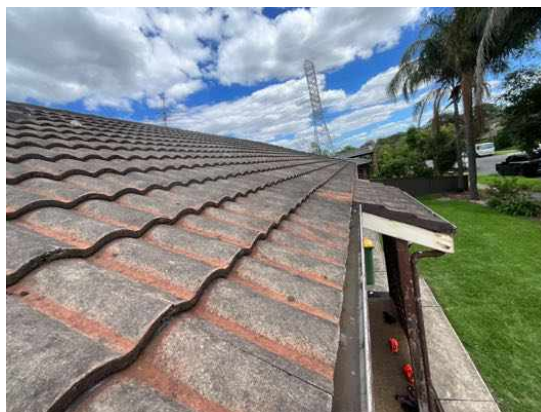
Finding 3.01

Building: Main Building
Location: All Areas
Finding: Roof Weathered
Information: Upon inspection of the exterior roofing, the majority of roof was not in a fair condition. While weathering of the roof is consistent with the age of the property, maintenance works are required.

Isolated areas of mortar have come loose in the valleys and minor cracking is also present. Re-pointing and re-sealing the may be considered as an interim solution by the client to help preserve and extend the life span of the tiles.

Where left unmanaged, deteriorating roof are likely to lead to a number of secondary defects, including minor water leaks and weather exposure to internal roofing structures.

Consultation with a roofing contractor is highly advised to gain advice on cost of remedial works that may be required in the short to medium term. Remedial works are likely to increase the longevity of the exterior roofing structure.

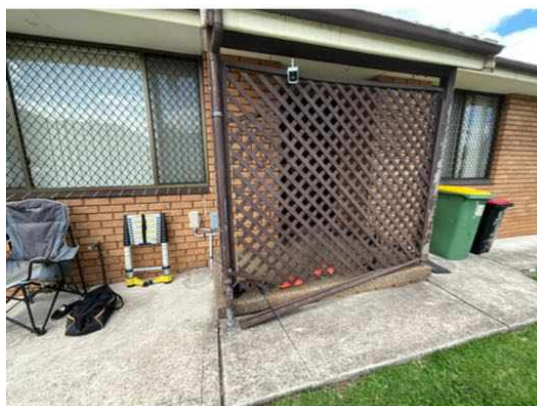
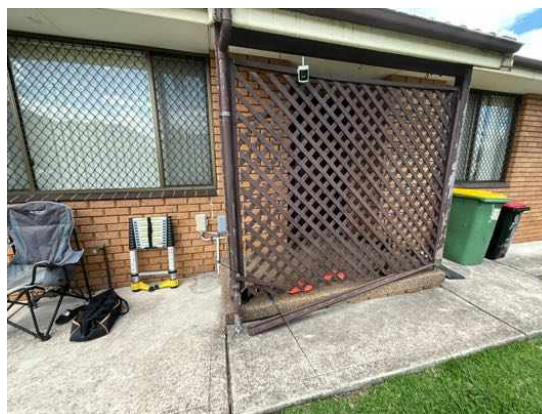
Finding 3.02

Building:	Main Building
Location:	All Areas
Finding:	Timber - exposed to weather
Information:	External timbers that are frequently exposed to harsh weather conditions require adequate protection in order to maintain their condition. Where timbers have not been painted or treated adequately, general deterioration is likely to occur at an accelerated rate.

If left unattended, replacement of these timbers is likely to be necessary in the short-term future. Adequate treatment of these timbers is required as soon as possible by a painting contractor or general handyman.

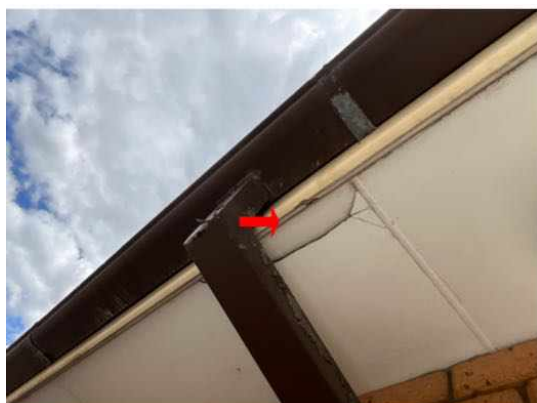
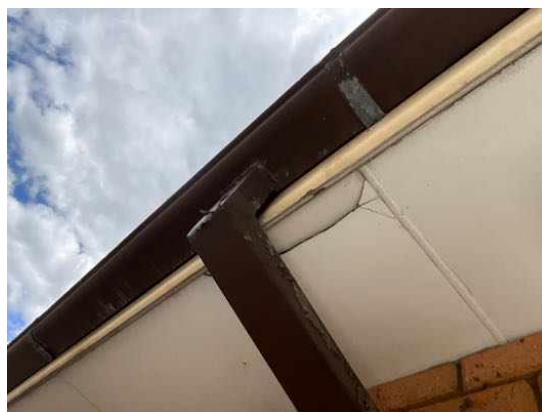
Finding 3.03

Finding: Eaves - Damaged

Information: The eaves around the external property were found to be in a visibly poor condition. The damage may have been sustained as a result of a number of possible causes, including poor roof drainage, leaking roof plumbing or minor impact damage.

The damage to the eave sheeting in this area detracts from the appearance of the structure, as well as potentially compromising the structural integrity of the roofing area.

Where eaves show moderate to severe damage, remedial works may be required. Where water damage is suspected as being the underlying cause, appointment of a licensed plumber is advised as a matter of urgency to identify the source of the water leak.

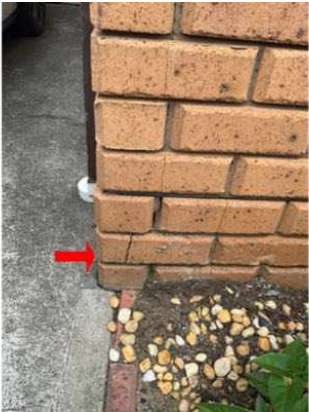
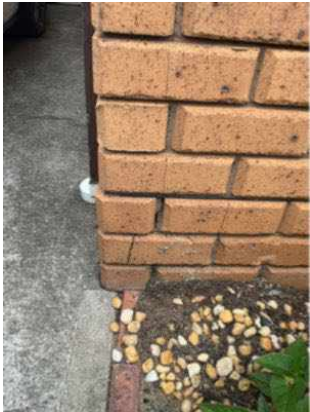
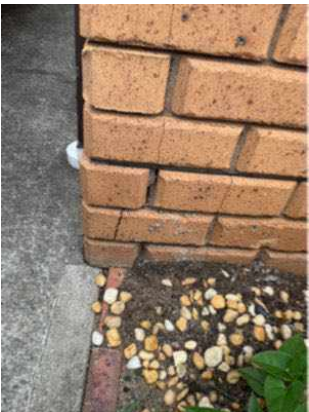
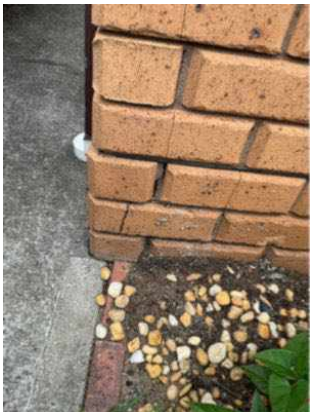
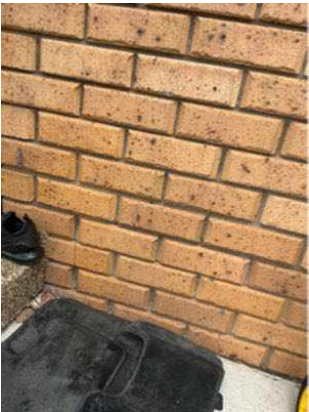
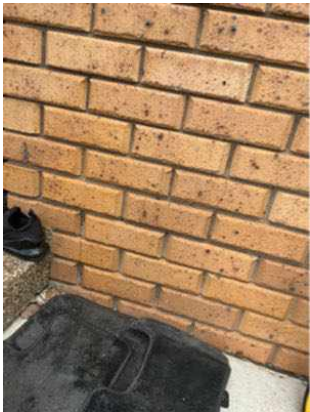
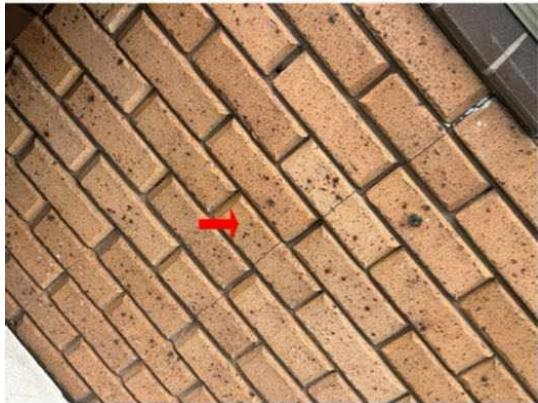
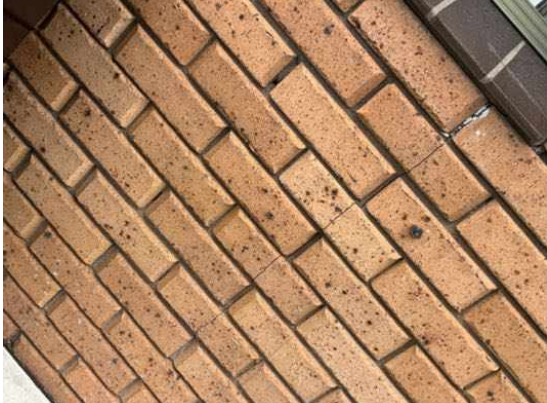
Finding 3.04

Finding: Brickwork - Cracking [Fine]

Although fine cracks are quite noticeable, they are often only considered to be an appearance defect and usually do not indicate any structural damage. Generally, the cause of a fine crack is indicative of a separation between brickwork and mortar throughout the structure, but single bricks may also show cracks of this nature.

Cracking of this nature can generally be repaired with minor filling and should be conducted by a qualified bricklayer.

Always contact a building inspector should cracks widen lengthen or become more numerous.

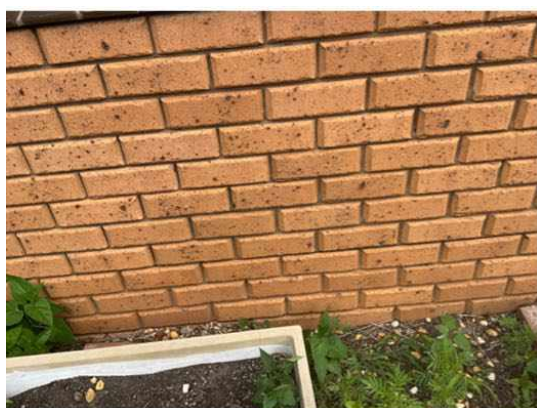
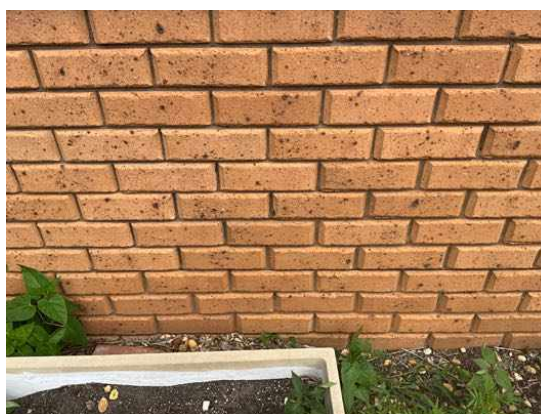
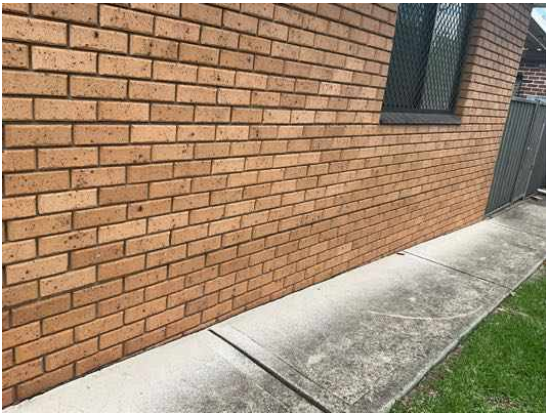
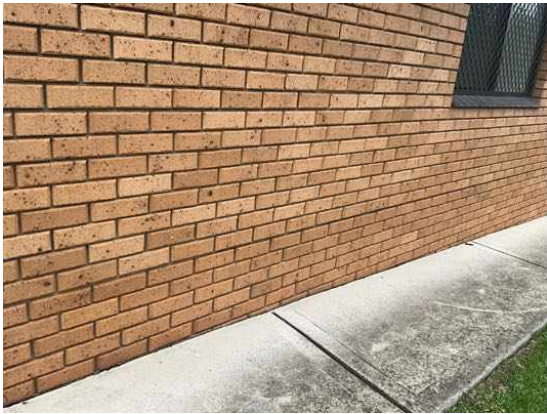
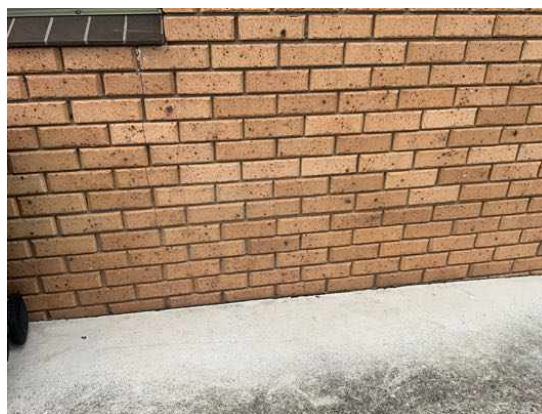
Finding 3.05

Finding: Weep holes - Missing

1. Moisture Accumulation: Without weepholes, moisture can accumulate within the wall cavity, leading to dampness and potential water damage to the building structure.

2. Mold and Mildew Growth: The trapped moisture creates an ideal environment for mold and mildew, which can cause health issues for occupants and degrade building materials.

3. Structural Damage: Prolonged exposure to moisture can weaken the structural integrity of the wall, causing deterioration of bricks, mortar, and internal framing.

4. Efflorescence: The absence of proper drainage can lead to the formation of efflorescence (white salt deposits) on the surface of the masonry, which can be unsightly and indicative of moisture problems.

5. Pest Infestation: Inadequate ventilation and moisture control can attract pests such as termites, leading to further damage and potential infestation.

A qualified bricklayer or masonry contractor should be contacted to assess and install the missing weepholes. They will:

- Drill or create gaps in the appropriate locations of the masonry wall to ensure effective drainage and ventilation.
- Ensure compliance with the Australian Standard AS 3700 (Masonry Structures) and the National Construction Code (NCC) requirements for weephole placement and spacing.
- Inspect the wall cavity for any existing moisture damage and recommend additional repairs if necessary.

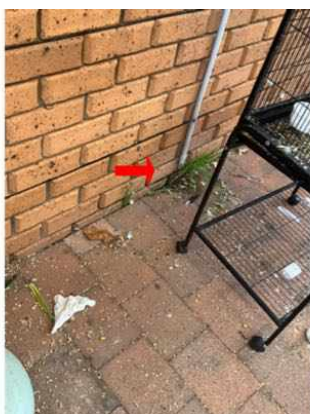
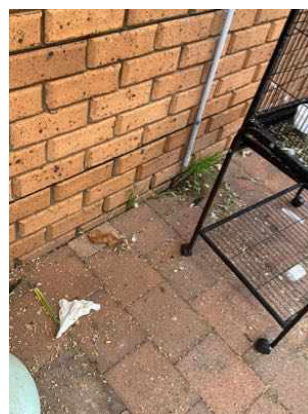
Finding 3.06

Building:	Main Building
Location:	Exterior walls - rear
Finding:	Air conditioner - Disconnected overflow
Information:	The Air Conditioner (A/C) overflow was found to be disconnected from storm water drainage and is creating excessive moisture in the surrounding area.

Such leaking creates an environment which is conducive to an array of defects, including water damage to associated building elements and the attraction of termite or timber pest infestation.

It is highly recommended that a licensed plumber be appointed to connect the A/C overflow in order to prevent such an environment from being created. These minor works should be carried out as soon as possible.

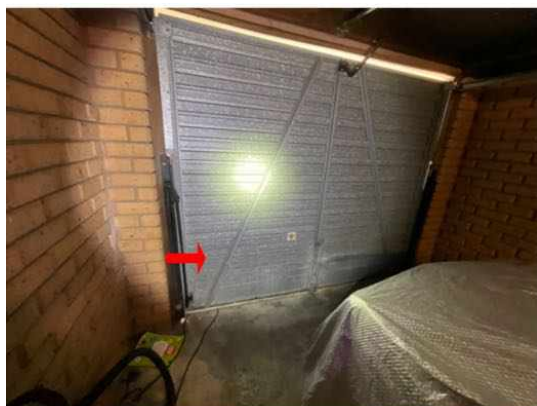
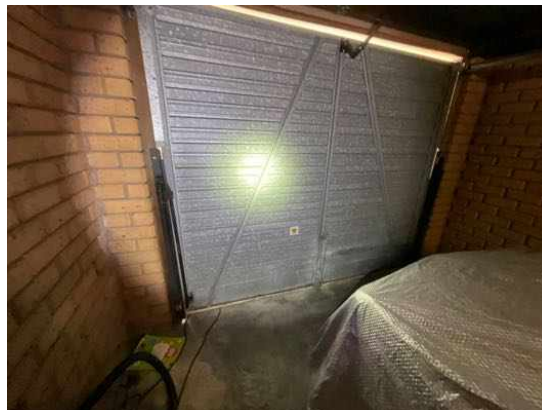
Finding 3.07

Building:	Main Building
Location:	Garage
Finding:	Garage door not operational
Information:	The garage door is not operational and fails to open or close properly.

pose safety hazards, and restrict access to the garage space.

****Recommended Action:**** A professional garage door technician should be hired to diagnose and repair the malfunction, ensuring the door operates smoothly and safely.

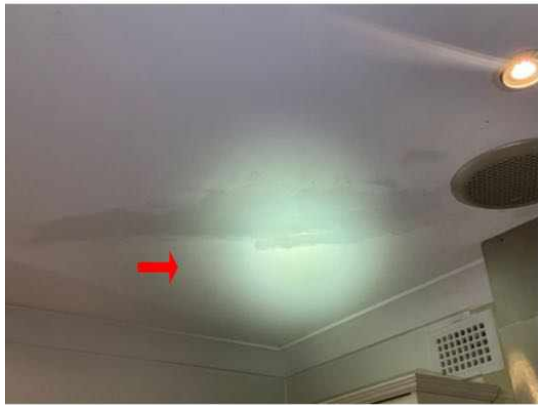
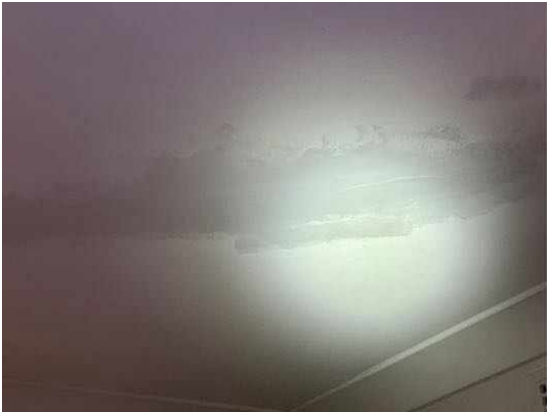
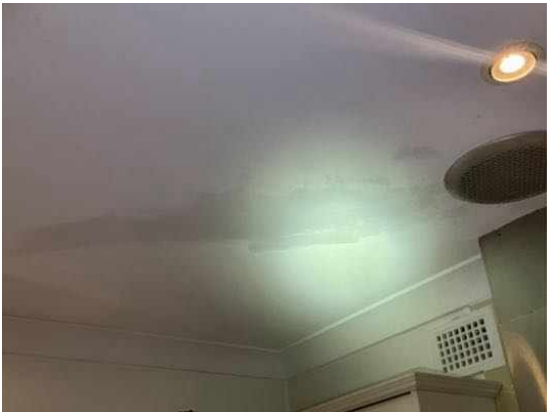
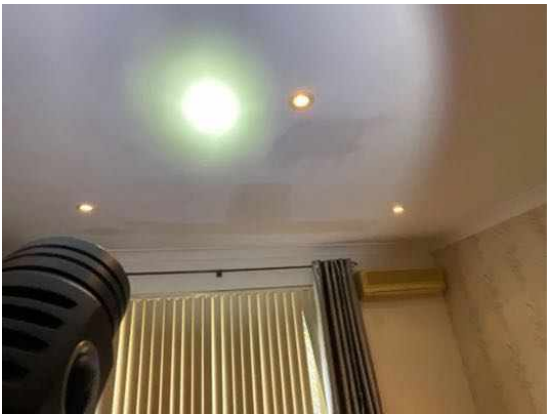
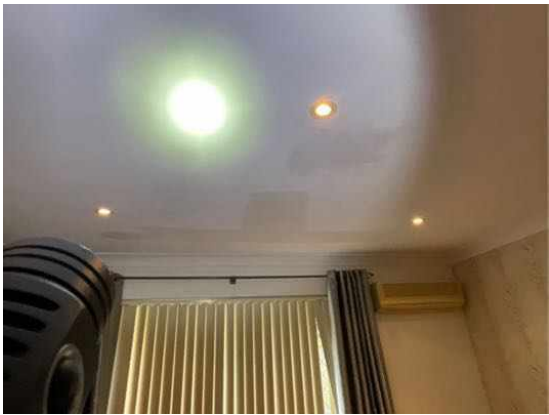
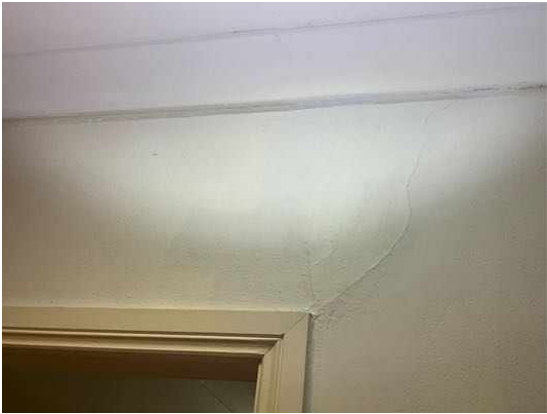
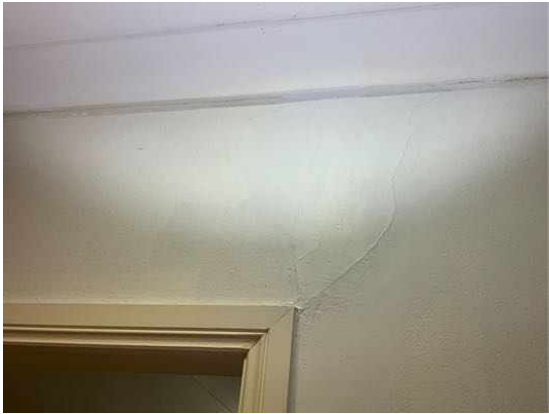
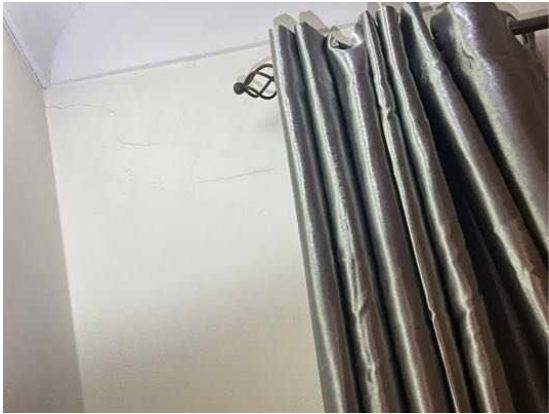
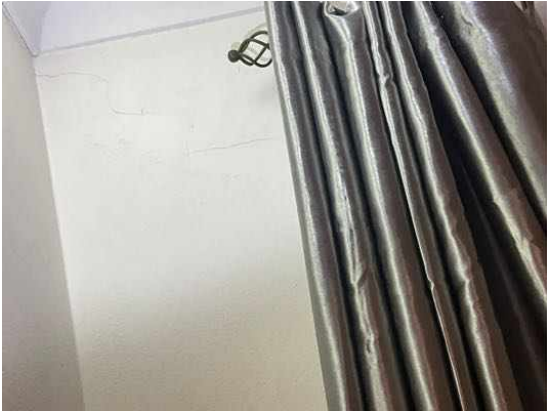
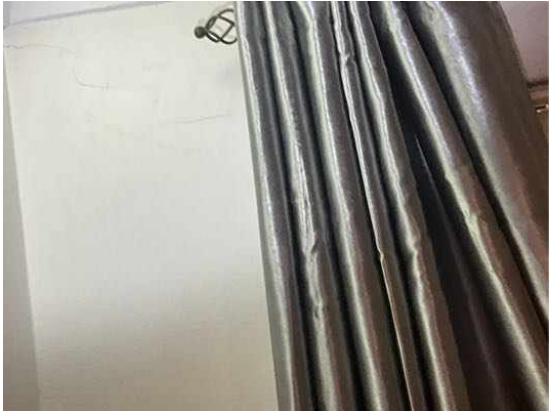
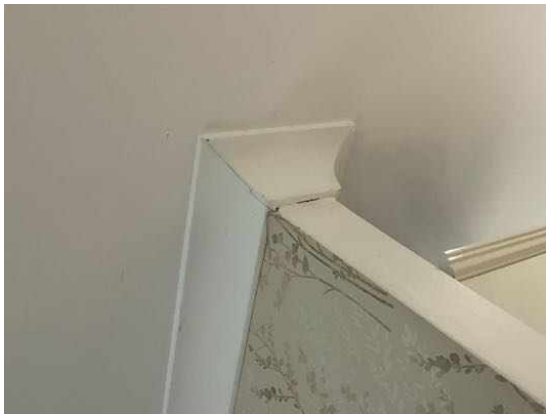
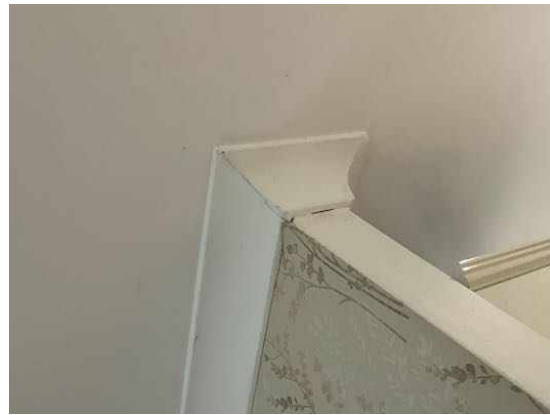
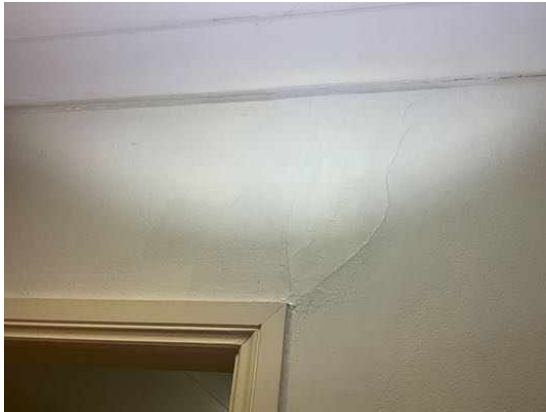
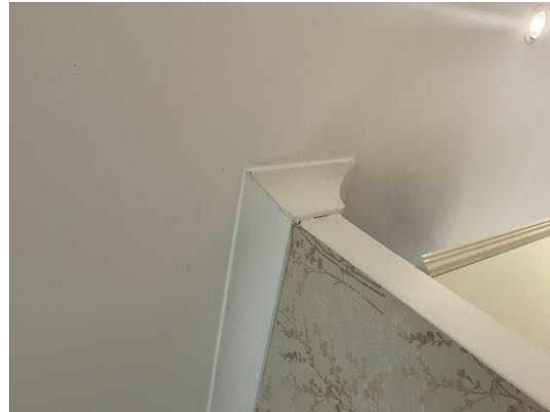
Finding 3.08

Building:	Main Building
Location:	All Areas
Finding:	Poor workmanship
Information:	The structure exhibits signs of poor workmanship, evident in various aspects of construction and finishing.

Risk: Poor workmanship poses a range of risks, including compromised structural integrity, potential safety hazards, and a decreased lifespan of the structure. It may also lead to aesthetic and functional issues.

Resolution: A qualified contractor or construction professional should be consulted to assess and address the poor workmanship. They can implement corrective measures to ensure structural soundness, safety, and overall quality of the construction.

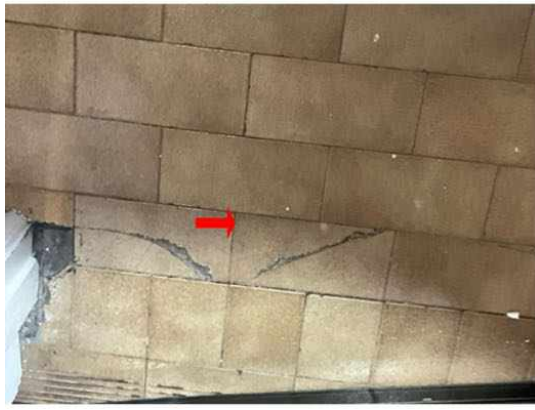
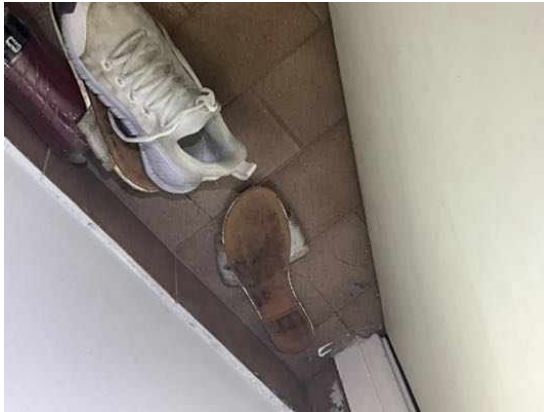
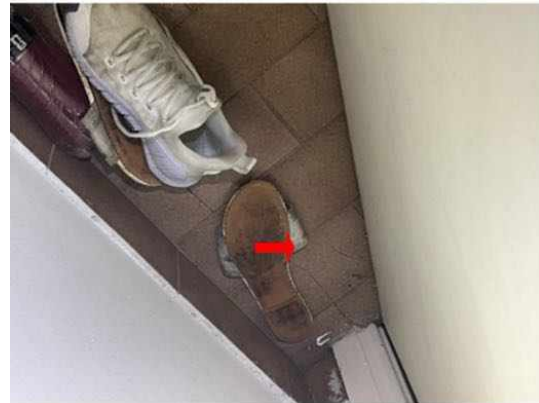
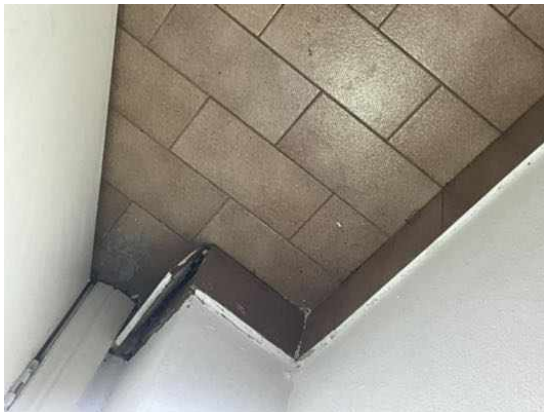
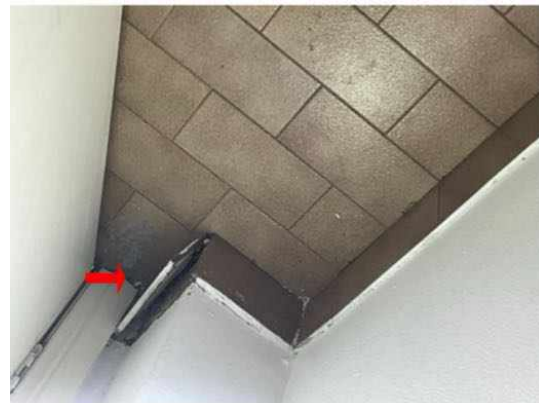
Finding 3.09

Building: Main Building
 Location: Laundry
 Finding: Tile - Floor Tile Damaged
 Information: A floor tile is visibly damaged, showing a chipped/broken section on the surface.

The damaged tile presents a trip hazard, may lead to cuts if stepped on barefoot, and can allow moisture ingress into the substrate, which may cause further deterioration or loosening of adjacent tiles. It also affects the overall appearance of the floor.

A licensed tiler should be engaged to remove the damaged tile and install a matching replacement. If spare tiles are unavailable, additional remedial work may be required to blend the repair with surrounding finishes.

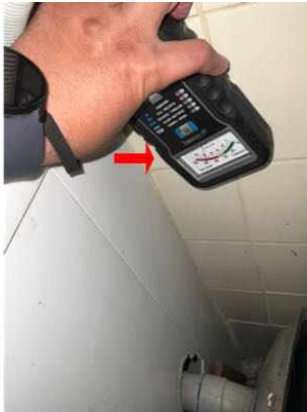
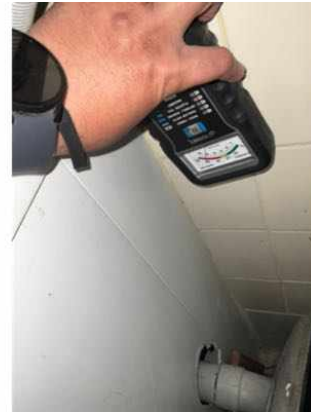
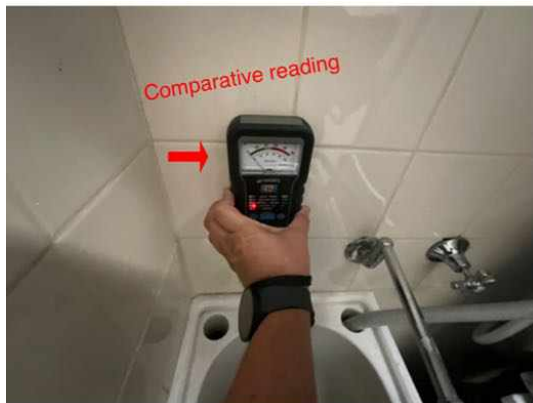
Finding 3.10

Building:	Main Building
Location:	Laundry
Finding:	Evidence of excessive moisture was present at the time of inspection
Information:	Excessive moisture is present behind the bathroom tiles, indicating a potential water leakage issue within the wall.

The prolonged presence of moisture can lead to mold growth, deteriorate the structure, and create an environment conducive to health hazards. Additionally, it may compromise the adhesive holding the tiles, leading to their detachment.

A licensed plumber or a qualified contractor specializing in water damage remediation

should investigate the source of the moisture, fix any leaks, and address the damage. Additionally, replacing affected tiles and ensuring proper waterproofing are crucial to preventing future issues.

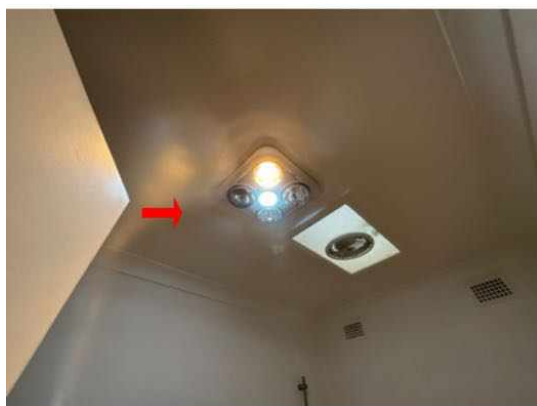
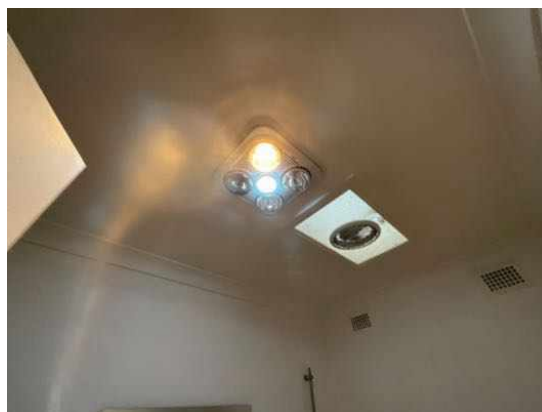
Finding 3.11

Building:	Main Building
Location:	Bathroom
Finding:	Heating light in exhaust fan not working / operating
Information:	"The heating light in the exhaust fan is not operating, failing to provide the intended heating function."

A qualified electrician or HVAC technician can fix the issue by inspecting the heating element, wiring, and controls to identify and repair any faults or damages.

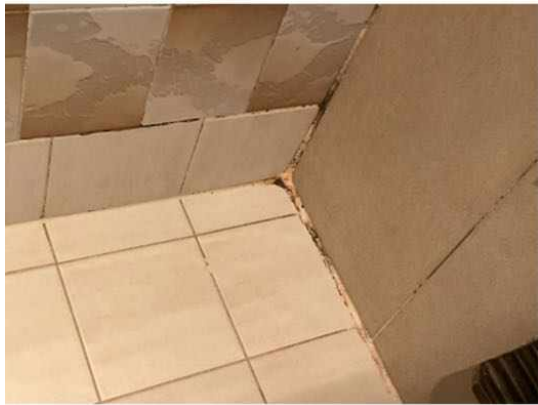
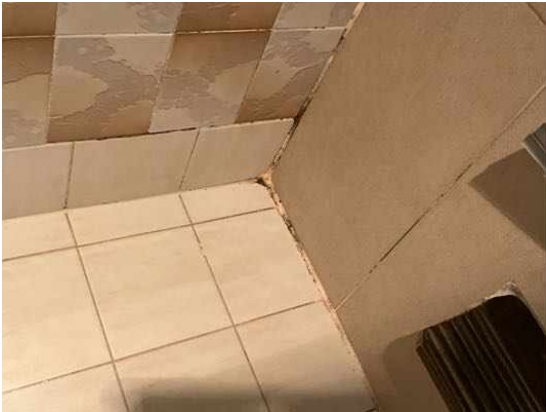
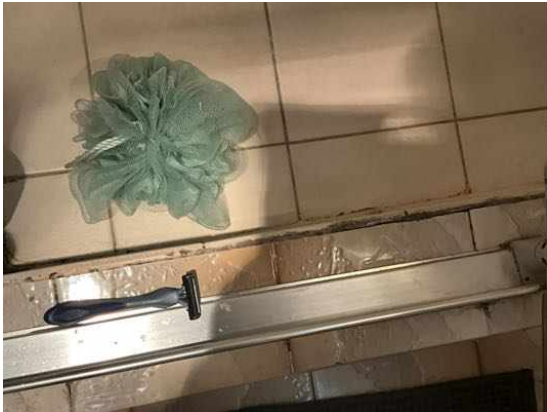
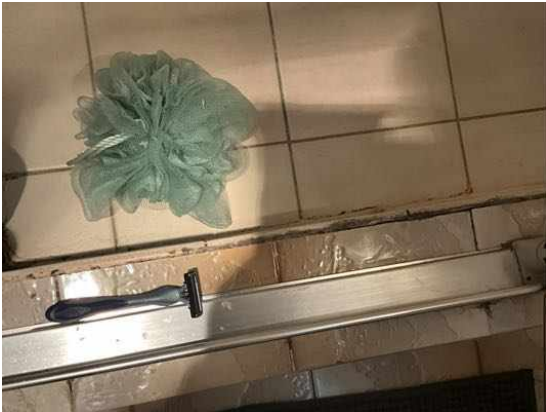
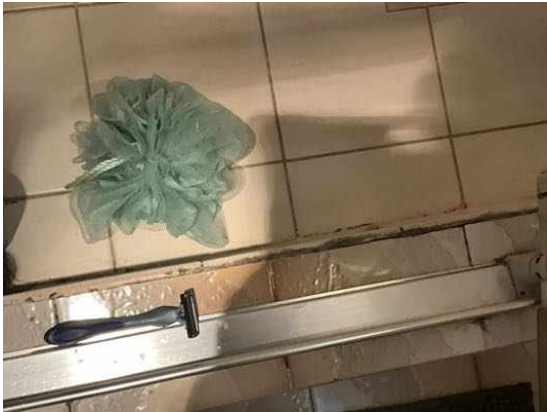
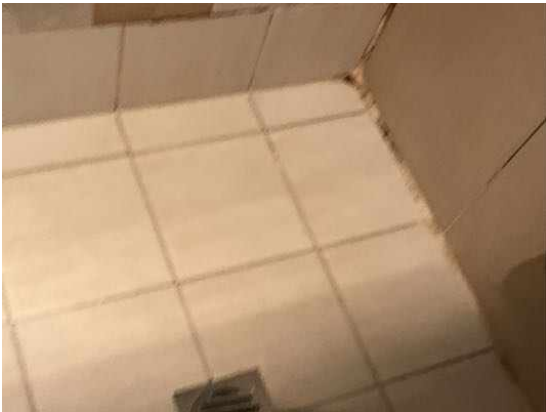
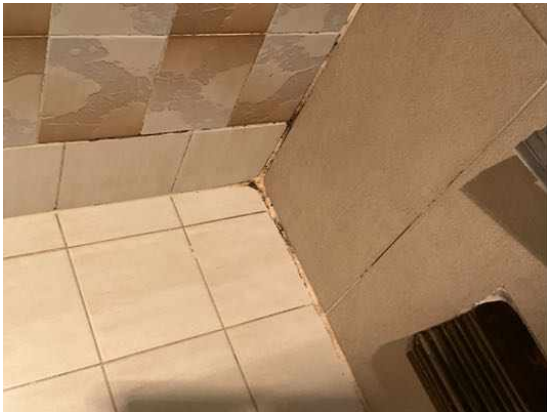
Building:	Main Building
Location:	Bathroom
Finding:	Sealant and grouting - Missing or damaged
Information:	It was noted on inspection that sealant or grout is degraded to the tiled shower alcove and or other areas of the bathroom.

Different materials and floor areas move at different rates, generally causing cracking to grout or sealant at this point. A flexible sealant is required to allow for expected expansion and contraction, while keeping the joint water tight and protective of all associated building materials.

There appears to be excessive mould to the sealant and grout which will likely require scraping out and replacement.

Flexible and mould resistant materials should be applied to affected areas to prevent any subsequent water damage that is likely to occur. Regular maintenance and replacement of damage or missing or damaged sealant and grout is highly recommended to the wet areas, as this is a regular wear and tear defect. Sealant and grouting in areas that come into regular contact with water should be maintained for the long term care of your property.

A sealant specialist or tiling contractor should be appointed to complete these works as soon as possible
