Building and Timber Pest Inspection Report

Inspection Date: Sat, 14 Mar 2026

Property Address: 1/22 Chiswick Rd, Greenacre NSW 2190, Australia

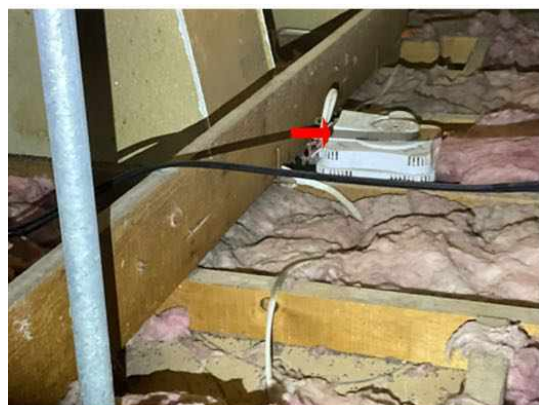
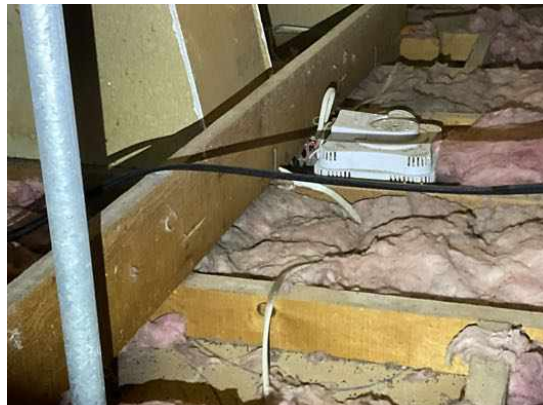
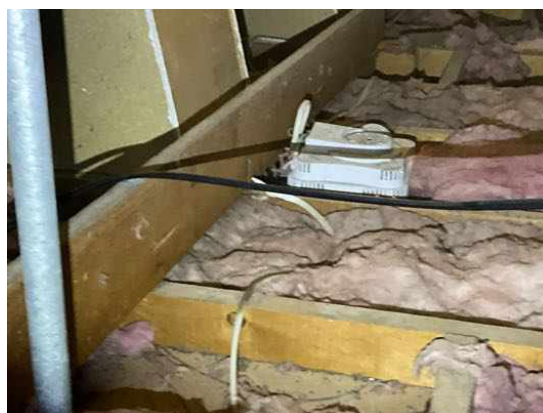
Finding 3.13

Building: Main Building
Location: Roof Void
Finding: Exhaust fan not vented out
Information: The exhaust fan located within the roof void is not appropriately ducted to the external atmosphere and is currently discharging moist air directly into the roof space. This is considered a defect under AS 4349.1, as it does not meet the minimum standard of residential building performance expected under normal residential building practices.

This condition may lead to excessive condensation within the roof void, increasing the risk of mould growth, deterioration of insulation, timber decay, and overall reduced durability of building elements. It may also result in poor indoor air quality, potentially affecting occupant health.

Recommended Action:

It is recommended that the exhaust fan be modified by a licensed HVAC contractor or qualified builder, ensuring it is properly ducted to discharge externally in accordance with manufacturer specifications, the National Construction Code (NCC), and applicable Australian Standards.

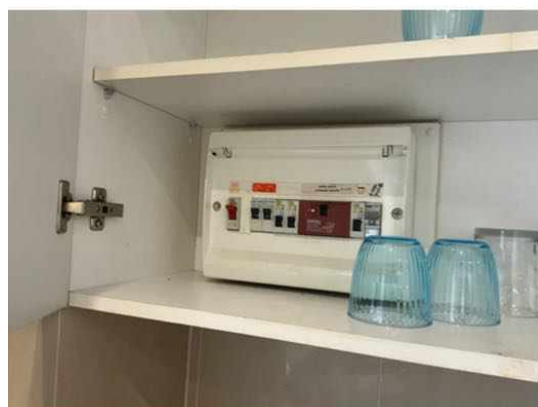
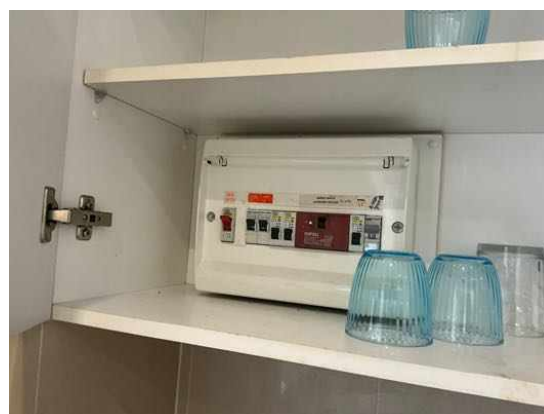
Building: Main Building
 Location: Kitchen
 Finding: No Evidence of Termite Management System - Durable notice / Legible Sticker
 Information: The application of a pre & post-construction chemical termite barrier is highly recommended for all properties. Such barriers are highly effective in preventing termite attack on any timber building elements throughout the property.

A durable notice was not placed in the switchboard unit to indicate current termite barriers is legible at the time of inspection.

Client must seek further information from the vendor or real estate agent if the conditions of termite management systems were maintained.

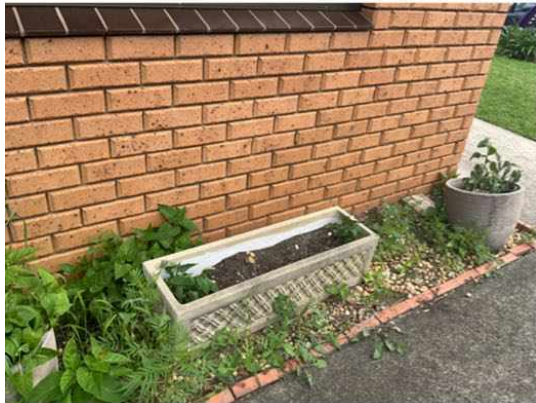
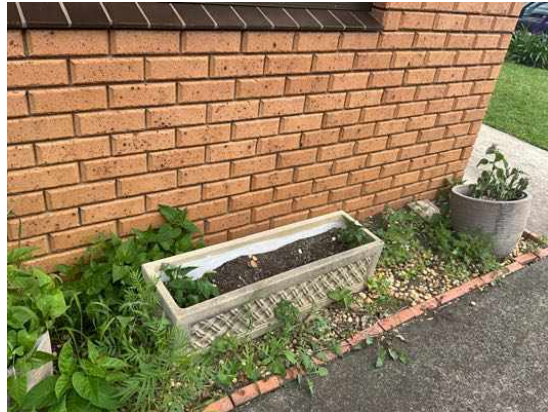
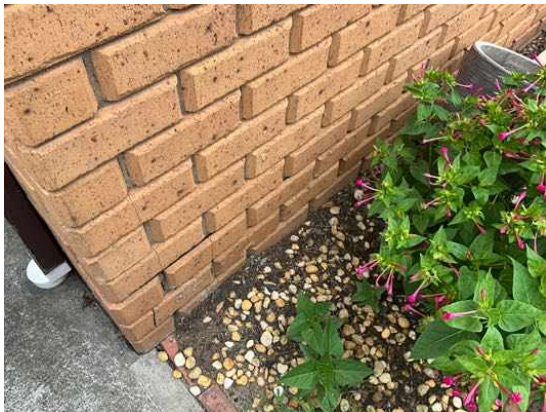
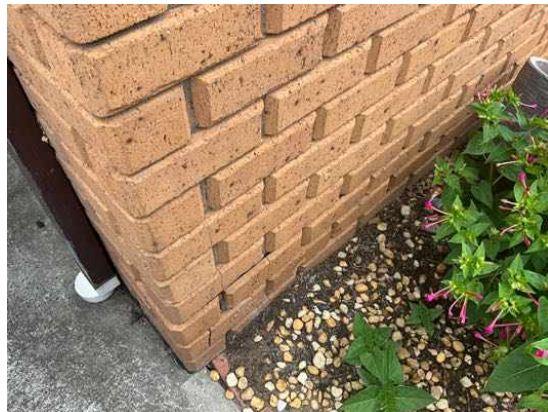
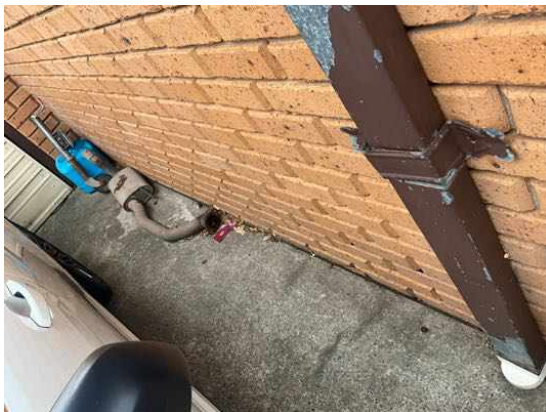
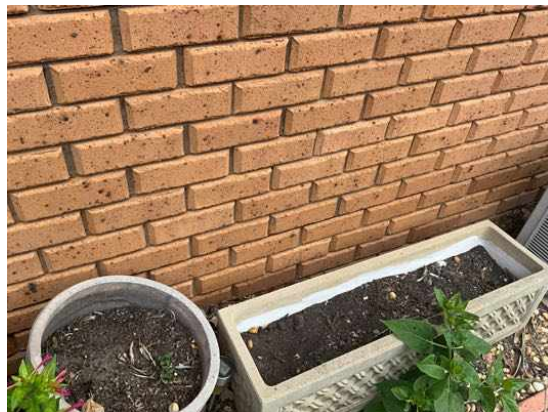
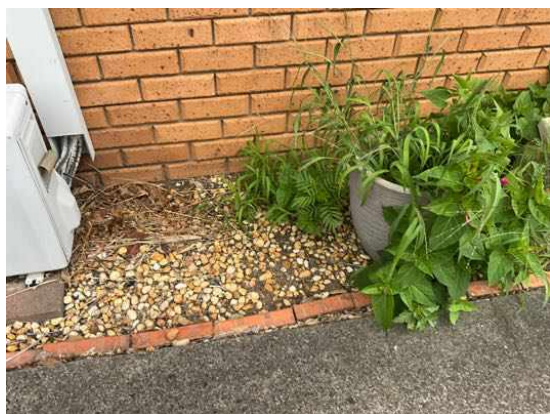
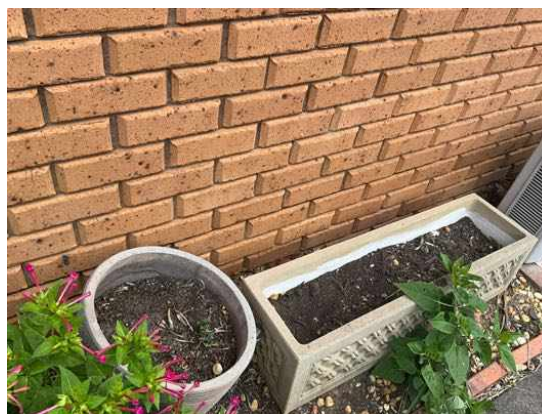
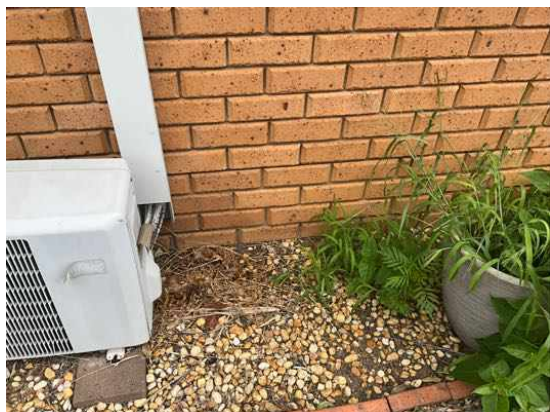
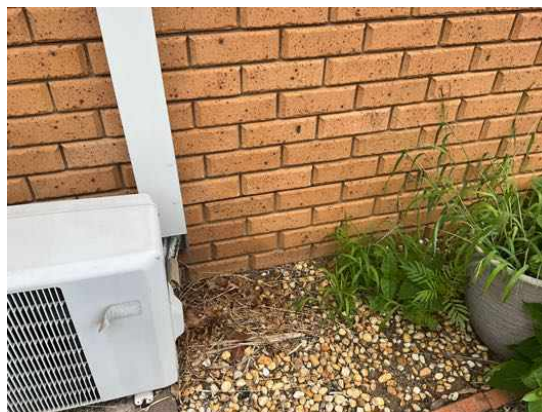
Finding 6.02

Building: Main Building
 Location: All Areas
 Finding: Slab Edge - Exposure
 Information: An inspection zone of at least 75mm in relation to the exposed slab edge, between the bottom brick and the perimeter pavement, is required. This inspection zone should be maintained in order to force termites into the open where they can be detected more readily during regular inspections. The slab edge should not be

If the slab edge is not properly exposed there is a high risk of termite attack. Sometimes, in order to determine the type of slab, a suitably qualified person such as an architect or builder may be required to consult the construction plans.

Where the slab edge cannot be properly inspected, it is highly recommended that termite or timber pest inspections be carried out every 6-12 months to aid protection of the property against infestation.

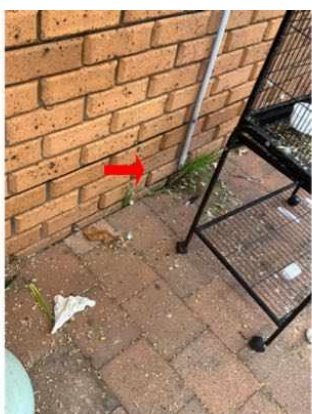
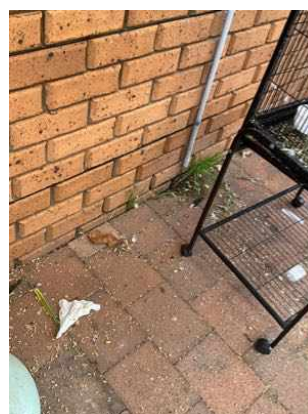
Finding 6.03

Building:	Main Building
Location:	Exterior walls - rear
Finding:	Aircon - Excessive moisture conducive condition near Air-conditioner
Information:	<p>Excessive moisture near an air conditioner can indeed create conducive conditions for termites. Termites are attracted to damp and decaying wood, which can be found in areas with high moisture levels. To fix this issue:</p> <ol style="list-style-type: none"> 1. Fix Leaks: Check for any leaks or condensation around your air conditioning unit. Repair any damaged pipes, drains, or insulation that may be causing moisture buildup. 2. Proper Drainage: Ensure that your air conditioner has proper drainage. Make sure the condensate drain line is clear and directed away from your home's foundation. 3. Ventilation: Improve ventilation around the unit. Ensure that the area is well-ventilated to reduce humidity levels. 4. Regular Maintenance: Schedule regular maintenance for your air conditioning system. This can help prevent leaks and ensure

5. Please consult a HVAC Technician: HVAC (Heating, Ventilation, and Air Conditioning) technicians are trained to diagnose and

repair a wide range of air conditioning problems. They can handle issues with the cooling system, refrigerant, electrical components, and more.

6. Consult an appropriate and Qualified Professional: For severe moisture issues or persistent termite problems, consult with a

pest control professional who can provide targeted solutions.

By addressing these issues, you can reduce the moisture levels around your air conditioner and minimize the attractiveness of the area to termites.

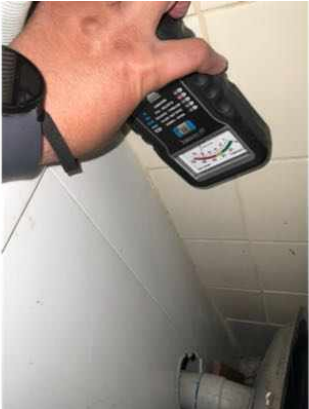
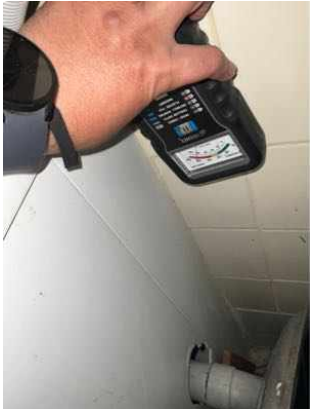
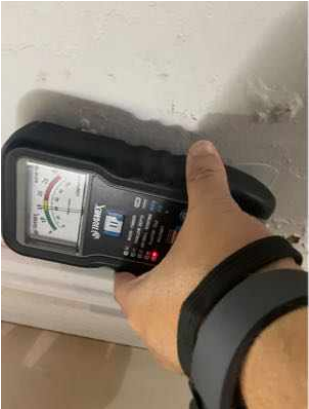
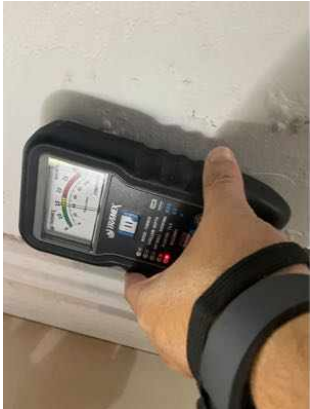
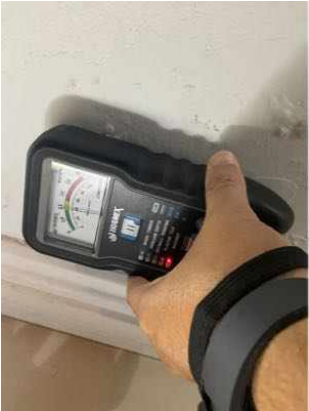
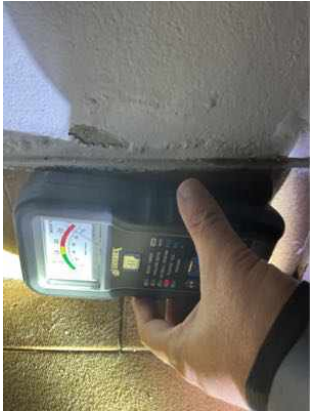
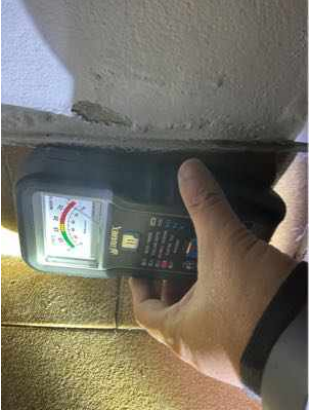
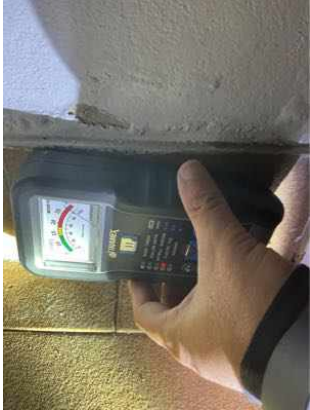
Finding 6.04

Building:	Main Building
Location:	Laundry
Finding:	Excessive moisture - Conducive to Timber pest
Information:	Excessive moisture can attract termites and produce conditions that promote fungal growth and wood decay.

Excessive moisture is generally caused by deteriorated inadequate or missing roof drainage leaking plumbing pipes or fixtures poorly plumbed HWS overflows or condenser units and poor site drainage.

If mould growth has been found there may be environmental biological or health issues involved. In these cases an appropriately qualified inspector should also be contacted.

Prior to any remedial works being performed a qualified plumber should be appointed to further inspect the property and to identify the cause of the excessive moisture. Works to remove affected building elements may then be necessary and should be performed by an appropriate tradesperson.

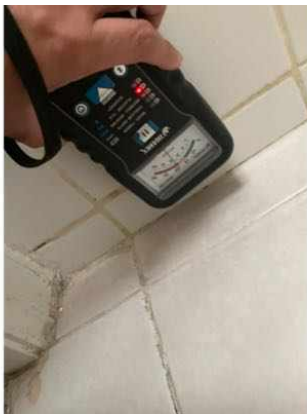
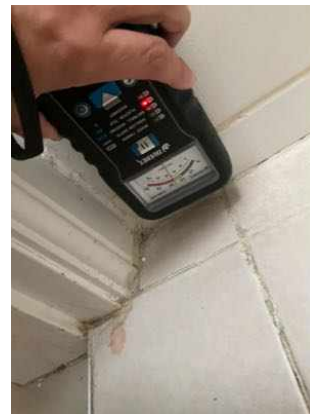
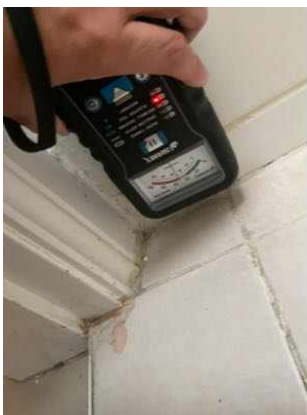
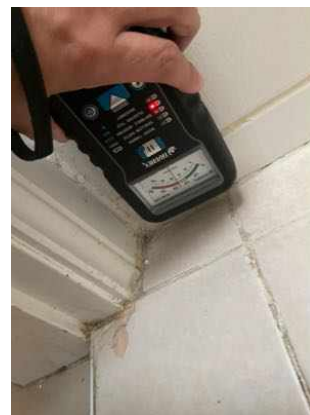
Finding 6.05

Building:	Main Building
Location:	Bathroom
Finding:	Excessive moisture - Conducive to Timber pest
Information:	Excessive moisture can attract termites and produce conditions that promote fungal growth and wood decay.

Excessive moisture is generally caused by deteriorated inadequate or missing roof drainage leaking plumbing pipes or fixtures poorly plumbed HWS overflows or condenser units and poor site drainage.

If mould growth has been found there may be environmental biological or health issues involved. In these cases an appropriately qualified inspector should also be contacted.

Prior to any remedial works being performed a qualified plumber should be appointed to further inspect the property and to identify the cause of the excessive moisture. Works to remove affected building elements may then be necessary and should be performed by an appropriate tradesperson.

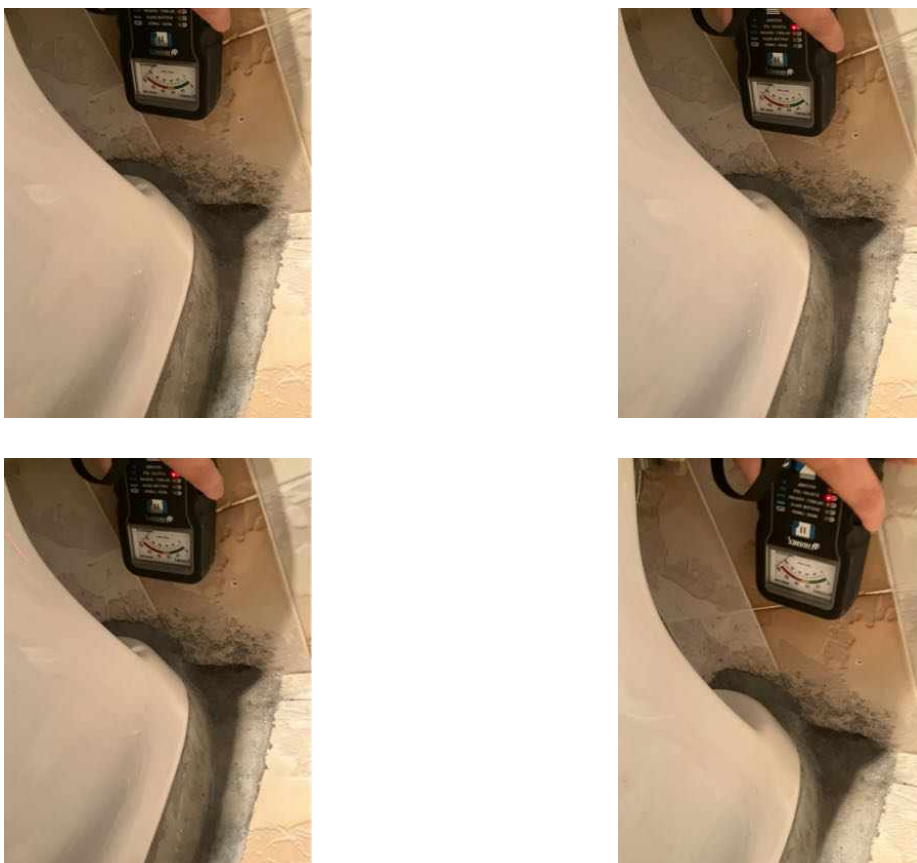
Finding 7.01

Building:	Main Building
Location:	All Areas
Finding:	Wood rot
Information:	This building element shows evidence of wood rot. Wood rot, also known as Fungal Decay, occurs when timbers and other cellulose building materials are exposed to damp conditions on an ongoing basis. This could be the result of exposure to weathering over a prolonged period of time, or the attraction of excessive moisture from other abutting building materials. Contributing factors also include poor air ventilation in the area.

Wood rot is often associated with general damp problems and is evidenced by a 'musty' smell or mould and mildew occurring on surfaces. If left unmanaged, damp conditions can lead to further health problems and the decay of timbers will continue.

Early intervention and regular maintenance, particularly of exterior timbers, will prolong the useful life of these building elements. Prior to any works being performed, the cause of the moisture that has created the visible wood rot should be identified and addressed in a suitable manner. Replacement of affected timbers may then be a necessary step in protecting surrounding building elements from such deterioration.

A qualified plumber may be appointed to assess the cause of excessive moisture and to provide advice on any remedial works as required. A qualified carpenter or registered builder may also be required to replace affected building materials.

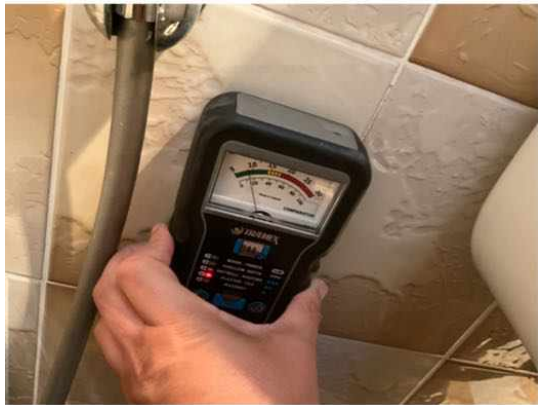
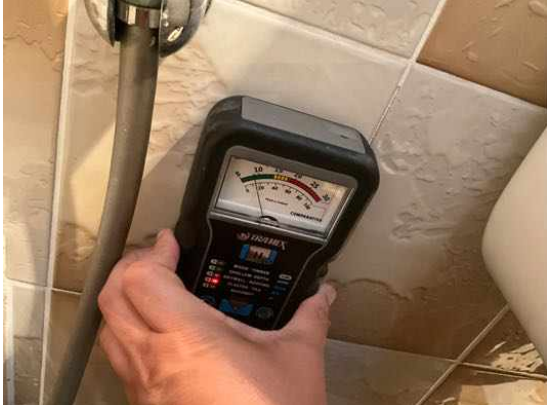
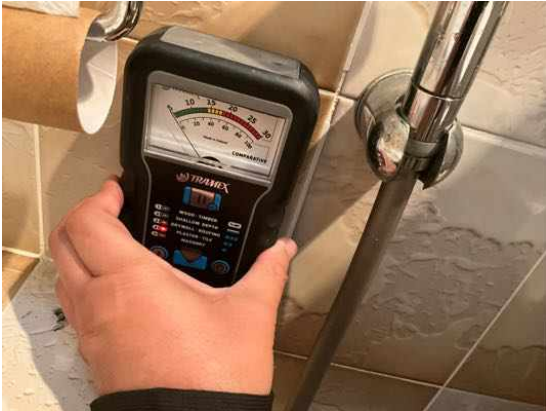
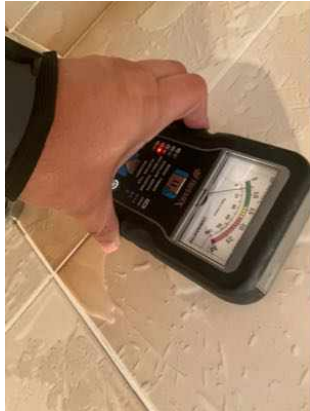
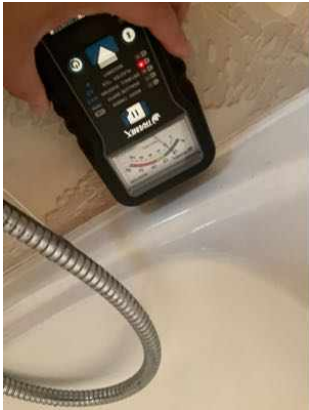
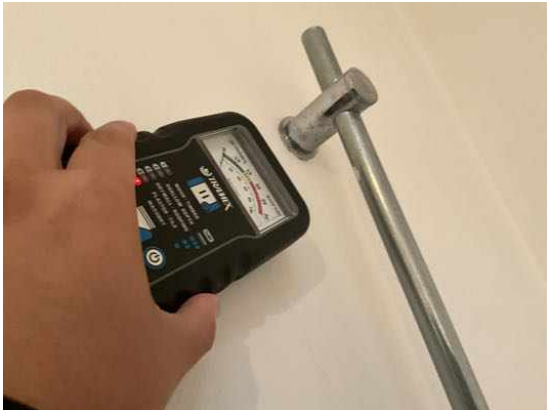
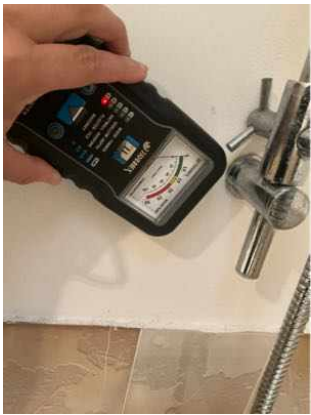
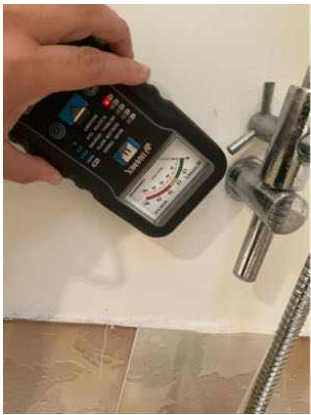
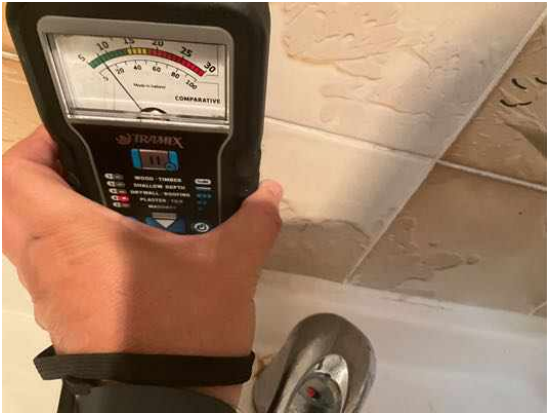
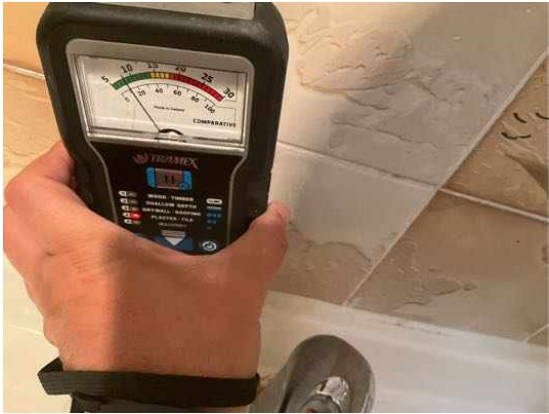
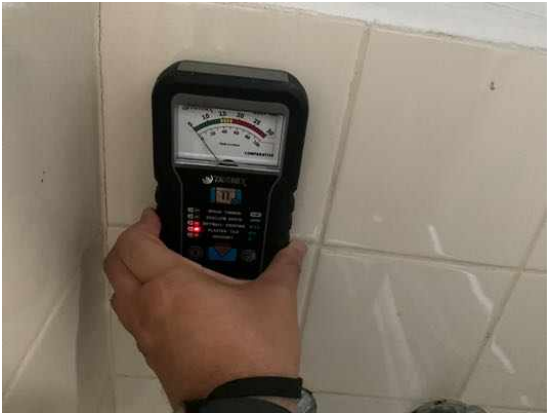
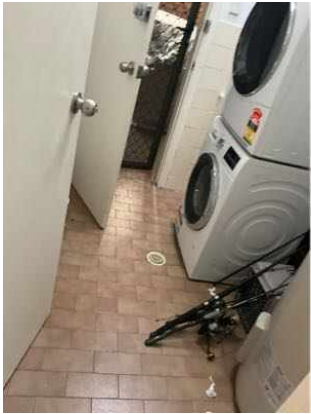
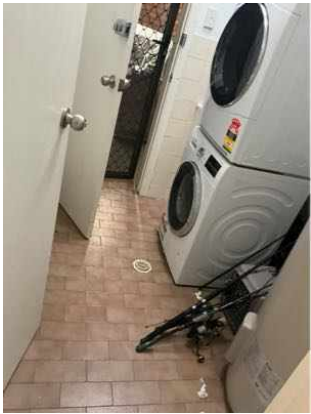
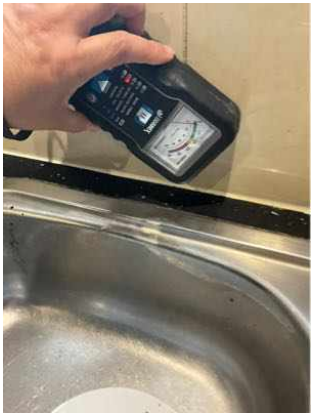
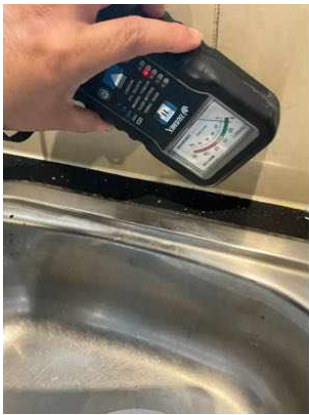
Building: Main Building
Location: All Areas
Finding: Additional Photos
Information: Additional photos are provided for your general reference

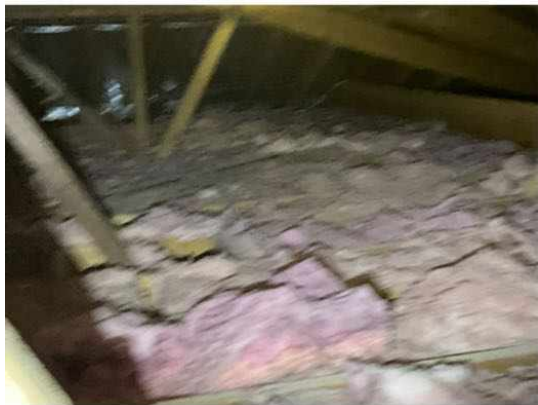
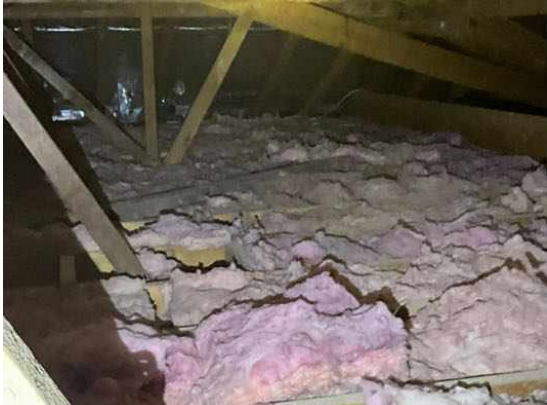
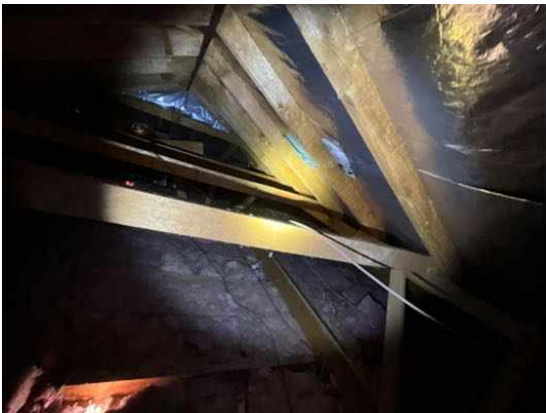
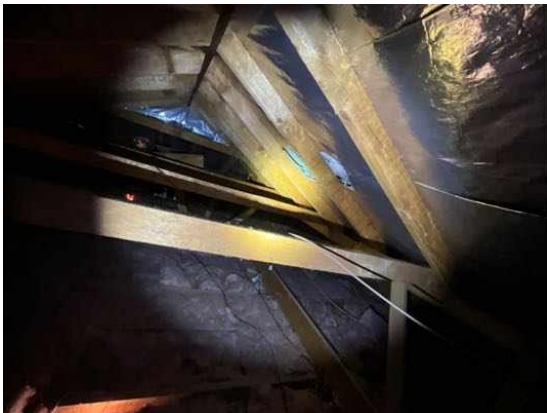
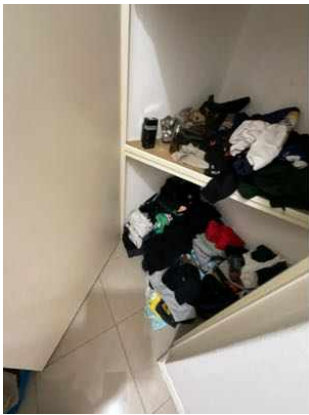
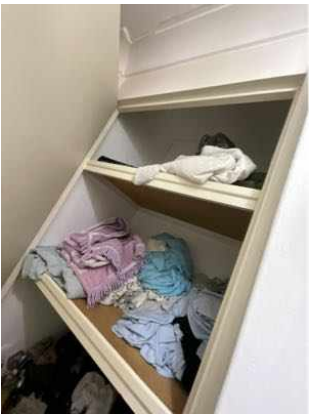
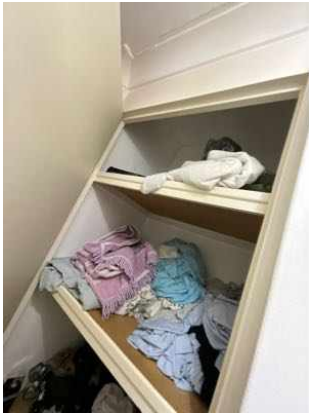
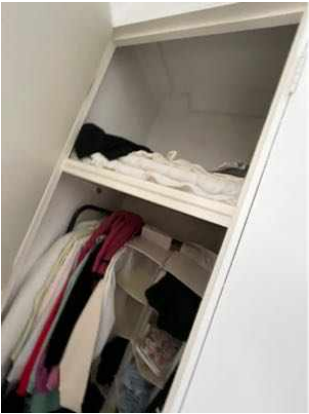
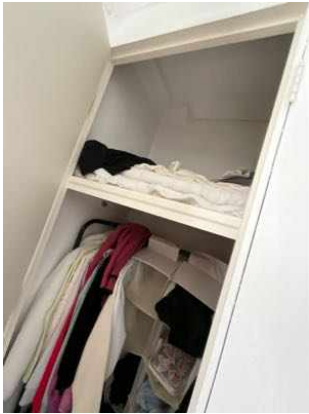
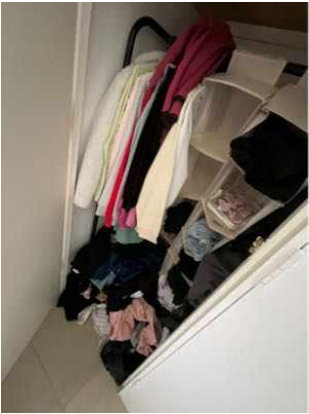
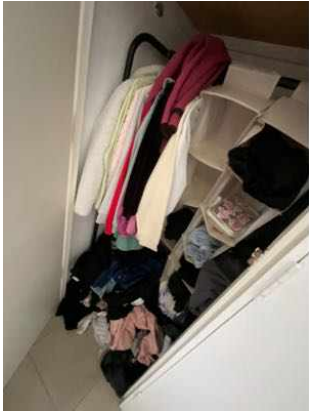
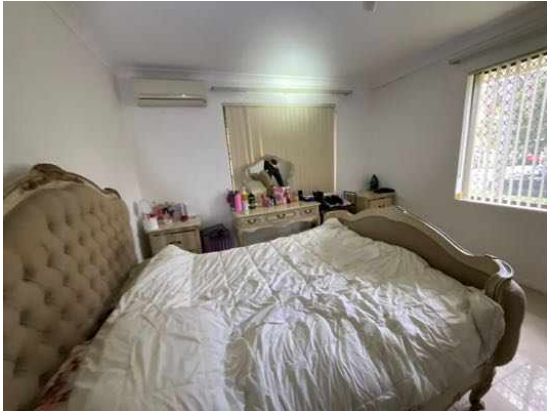
Building: Main Building
Location: All Areas
Finding: Additional Photos - Obstructions and Limitations
Information: These photographs are an indication of the obstructions and limitations which impeded full inspection of the property at the time of inspection. These obstructions can hide an array of defects and should be removed to allow full inspection to be carried out. A re-inspection is recommended once the areas are made accessible.
