# Building and Timber Pest Inspection Report

Inspection Date: Fri, 6 Mar 2026

Property Address: 11 President St, Croydon Park NSW 2133,  
Australia

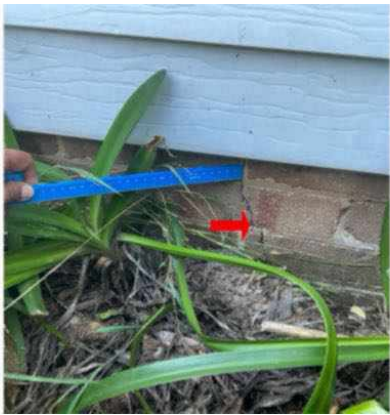
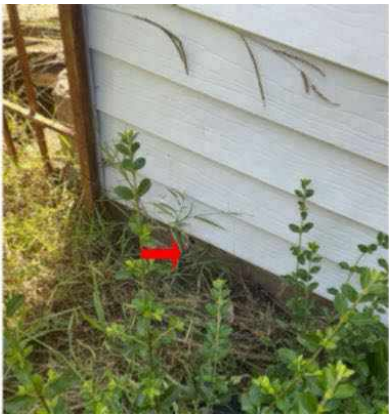
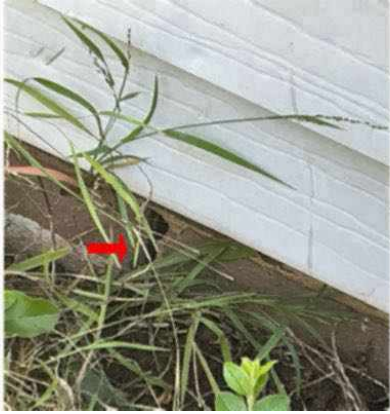
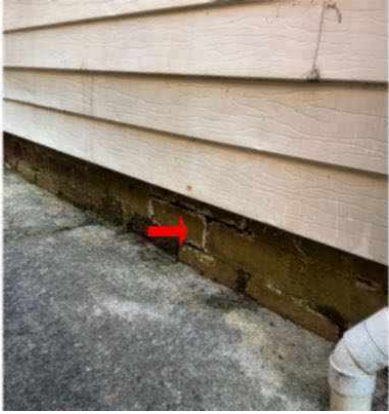
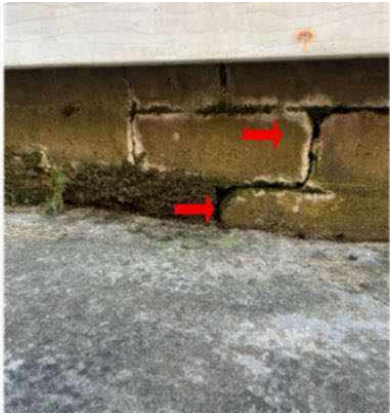
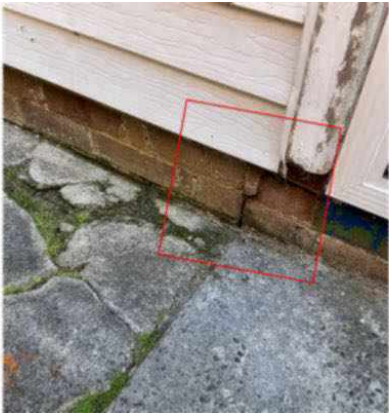
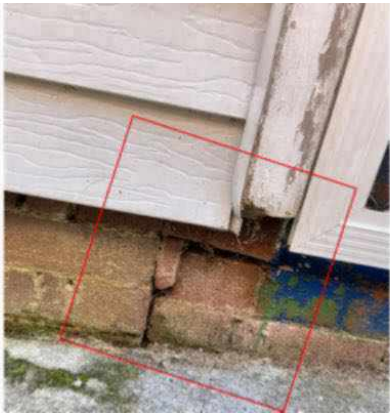
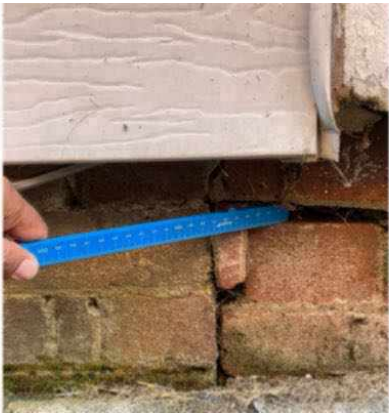
Building: Main Building  
Location: All External Areas and subfloor  
Finding: Brickwork - Cracking noticeable  
Information: There were several cracks and or crack repairs evident to external brickwork.

Noticeable cracks are a common occurrence in external brickwork and are a likely result of age expected building movement, general expansion, and/or contraction of building materials in different weather conditions. Noticeable cracks in brickwork may develop if left unattended, with potential for necessitating major remedial works or replacement of the brickwork.

It is highly advised that a qualified bricklayer be appointed to provide necessary works to cracked brickwork to prevent any further damage. Such works should be conducted as soon as possible.

Always monitor these cracks and contact a building inspector should cracks widen, lengthen, or become more numerous.

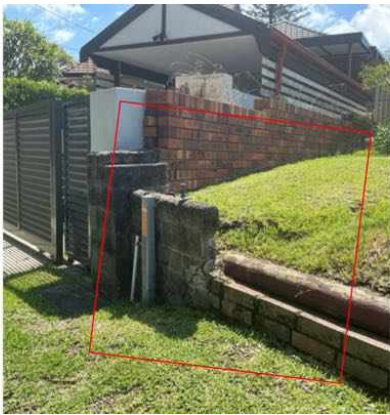
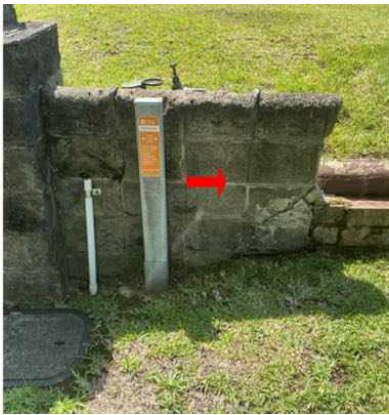
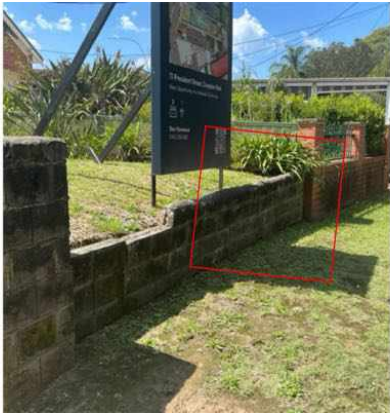
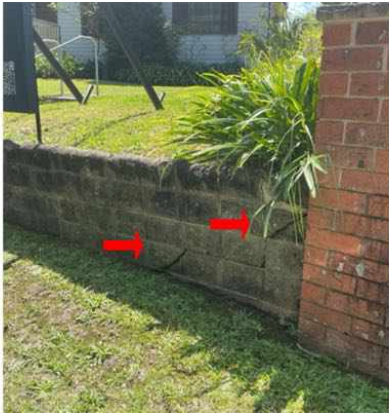
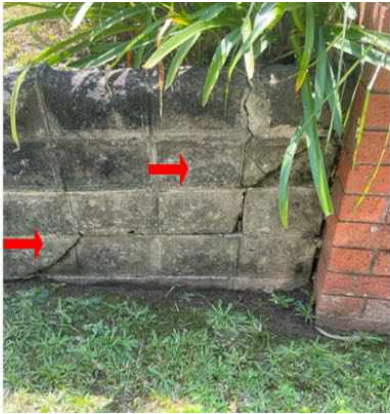
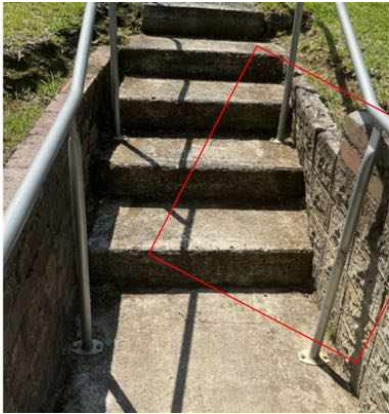
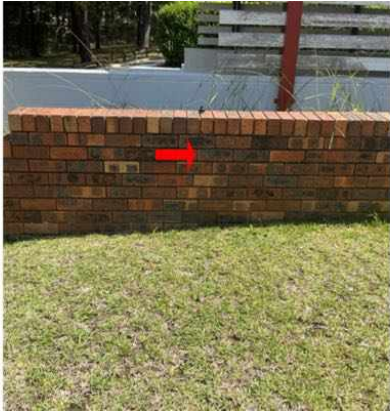
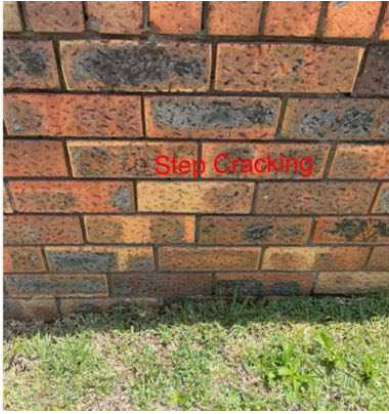
## Finding 2.02

If left unmanaged, the retaining wall may become a safety hazard if it continues to destabilise. Where retaining walls further rot and decay, an environment is created that is conducive to termite and pest infestation.

Significant repair and replacement should be expected. Where retaining walls are considered structural walls, a structural engineer / surveyor should be consulted regarding required remedial works. Otherwise, a landscaper or retaining wall installer may be appointed to repair or replace the wall, at the discretion of the client.

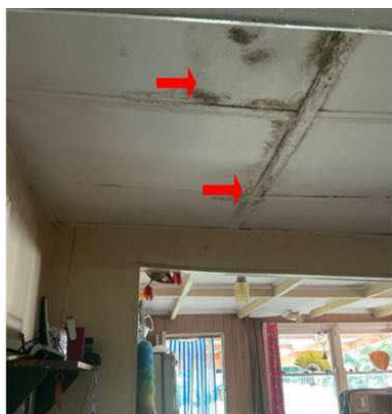
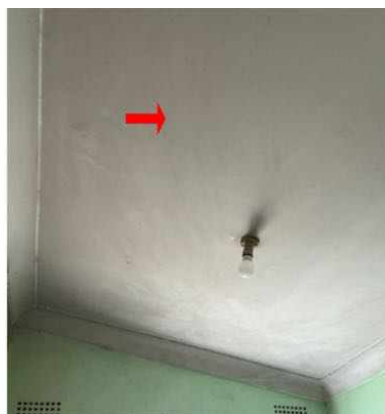
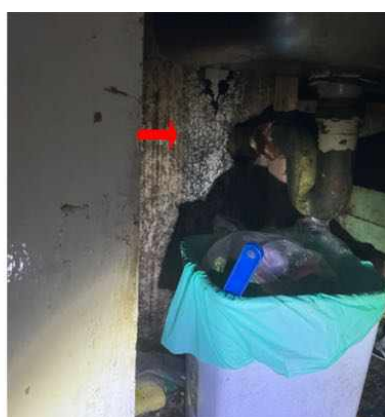
Finding 2.03

Building:	Main Building
Location:	All Internal Areas
Finding:	Mould - Present - Ceilings in poor condition with holes and sagging
Information:	Where evidence of mould growth was noted, there may be environmental, biological or health issues associated with the report. A specialist inspection by a suitably qualified environmental health inspector is warranted, where mould is extensive or where any queries regarding air quality spores or other related issues apply.

Generally, the client is advised to ensure that the general environment is free of moisture and humidity to aid in the prevention of mould formation and development. Any mould found during the inspection should be cleaned immediately by a cleaning contractor or the homeowner as applicable.

Please note that severely affected building elements may require replacement by a registered builder or qualified carpenter.

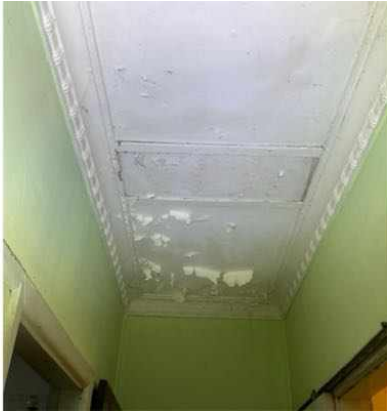
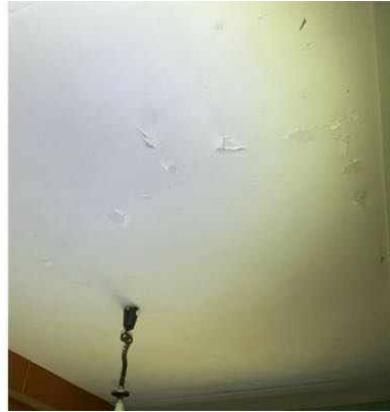
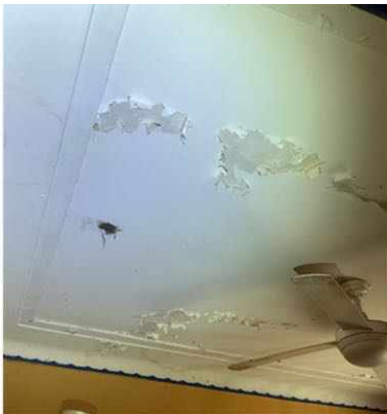
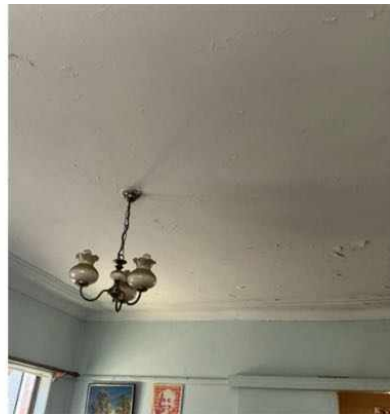
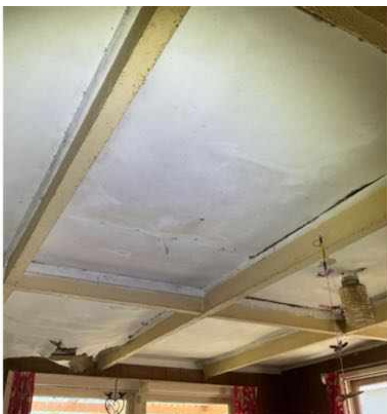
### Finding 2.04

Building:	Main Building
Location:	All Internal Areas
Finding:	Ceiling - Water damaged multiple areas
Information:	Water damage to the ceiling lining is generally an indication of excessive moisture being present in the roof void, usually via a leak to the roof covering.

Where water damage is evident to the ceiling, the primary requirement is to identify and rectify the source of the leak. A roofing plumber should be appointed as soon as possible to identify the leak and perform rectification works as necessary, ensuring the water damage is restricted.

Once the leak is repaired, consultation with relevant tradespeople, including plasterers and painters, is advised. Rectification works may include replacement of ceiling lining or minor repainting, depending on the extent of the damage.

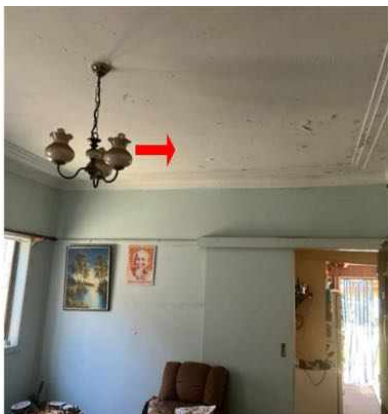
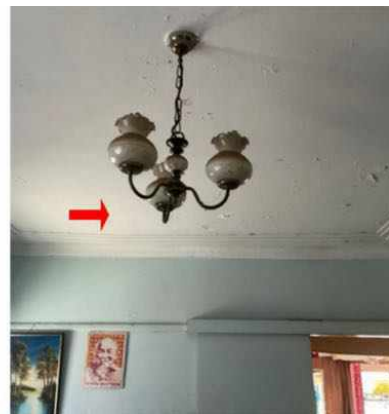
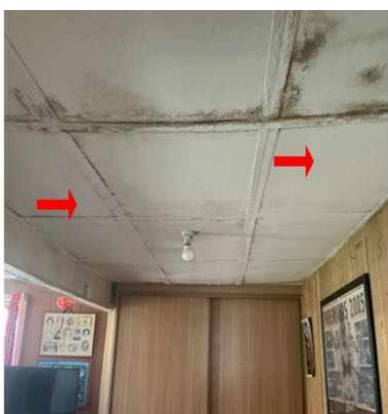
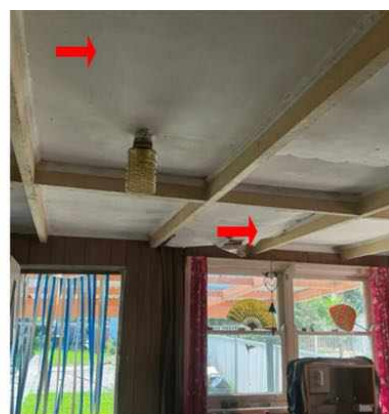
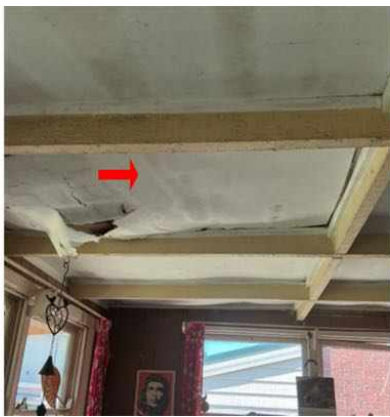
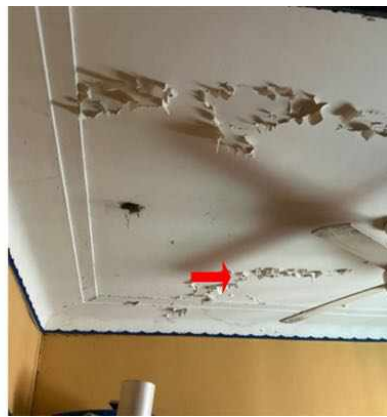
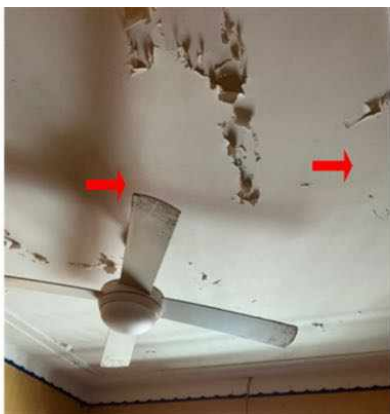
### Finding 2.05

In some cases, sagging ceiling linings may also indicate that there are structural issues, causing surfaces to warp, twist or sag. Where sagging appears to be major, appointment of a structural engineer is advised to further inspect the property and identify the source and rectification works required.

The appropriate action should be taken by the client as soon as possible to ensure that any potential further damage is limited.

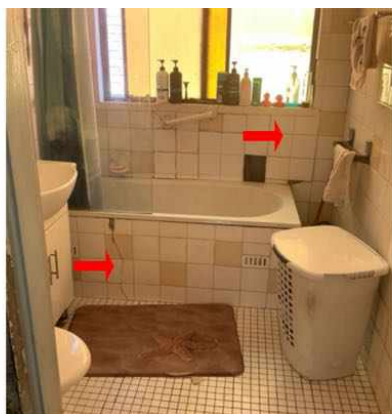
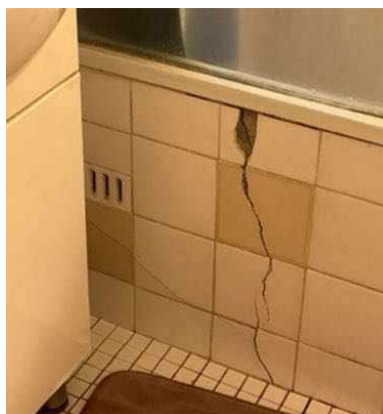
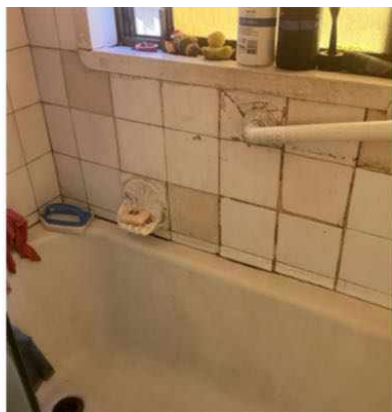
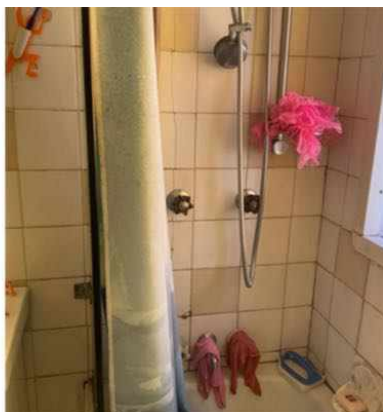
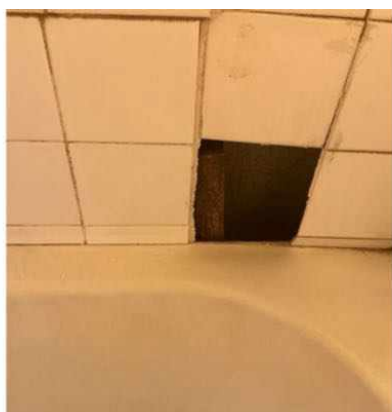
### Finding 2.06

Building:	Main Building
Location:	Bedroom
Finding:	Bathroom Deteriorated condition
Information:	The bathroom appears to be in poor and deteriorated condition, with several defects observed including cracked and missing wall tiles, deteriorated grout and sealant joints, damaged tile sections, and visible gaps in the tiled wall lining. These conditions may allow water penetration behind the wall and bath structure, increasing the risk of concealed moisture damage, timber decay, and deterioration of surrounding building materials. The overall presentation suggests the bathroom is aged and nearing the end of its serviceable life, and the waterproofing system is likely outdated or compromised.

Given the extent of deterioration observed, comprehensive repairs or full renovation of the bathroom should be expected, including replacement of damaged tiles, reinstatement of waterproofing, and rectification of associated plumbing and finishes by suitably licensed trades.

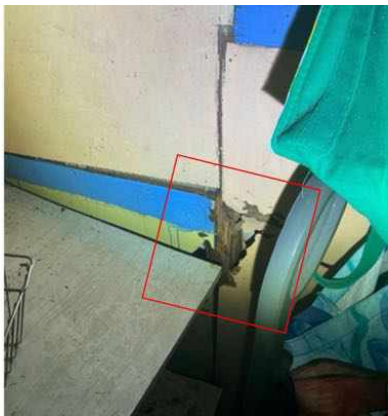
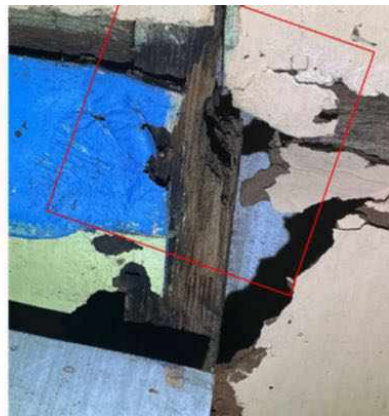
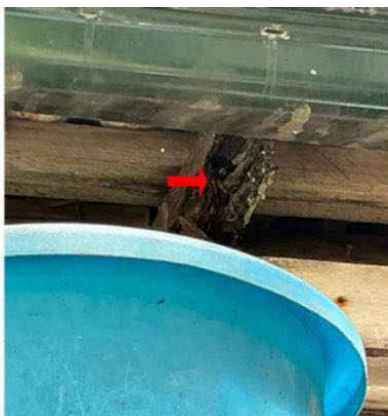
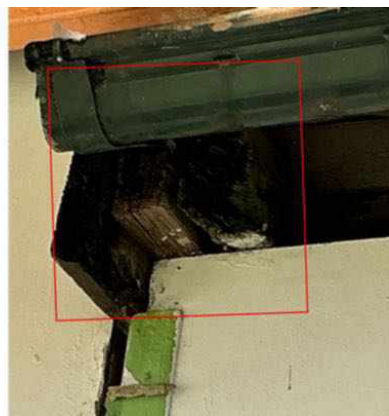
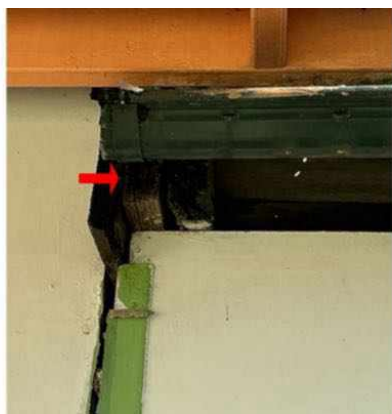
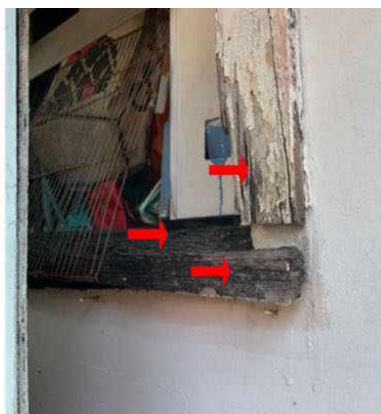
Building:	Main Building
Location:	All External Areas
Finding:	Wood rot to some areas (Also refer to D 3.1 & 6.1)
Information:	This building element shows evidence of wood rot. Wood rot, also known as Fungal Decay, occurs when timbers and other cellulose building materials are exposed to damp conditions on an ongoing basis. This could be the result of exposure to weathering over a prolonged period of time, or the attraction of excessive moisture from other abutting building materials. Contributing factors also include poor air ventilation in the area.

Wood rot is often associated with general damp problems and is evidenced by a

'musty' smell or mould and mildew occurring on surfaces. If left unmanaged, damp conditions can lead to further health problems and the decay of timbers will continue.

Early intervention and regular maintenance, particularly of exterior timbers, will prolong the useful life of these building elements. Prior to any works being performed, the cause of the moisture that has created the visible wood rot should be identified and addressed in a suitable manner. Replacement of affected timbers may then be a necessary step in protecting surrounding building elements from such deterioration.

A qualified plumber may be appointed to assess the cause of excessive moisture and to provide advice on any remedial works as required. A qualified carpenter or registered builder may also be required to replace affected building materials.

Even though Liverpool termite activity was not visible. A further invasive inspection by a licensed termite technician its also highly recommended to eliminate possibility of potential termite activity.

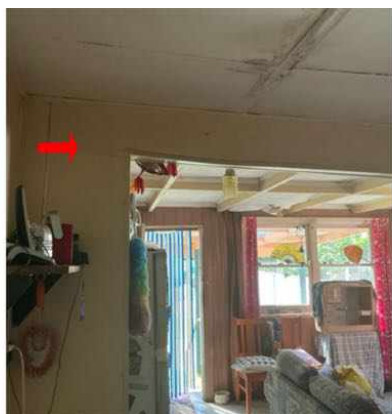
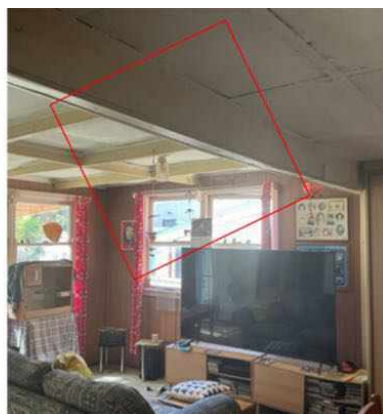
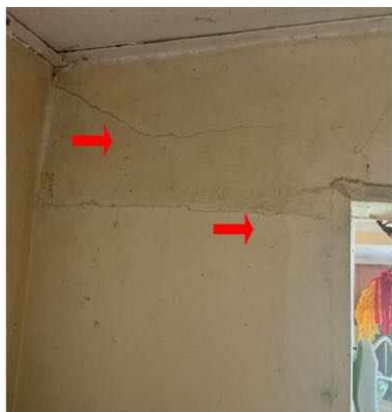
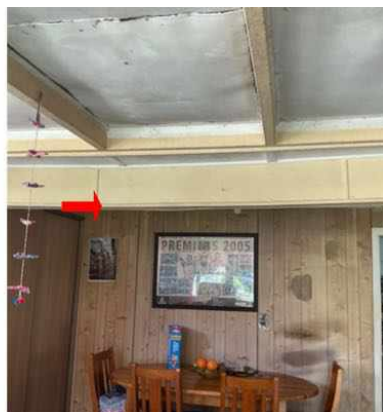
### Finding 3.02

Building:	Main Building
Location:	Lounge Room
Finding:	Ceiling Lining – Sagging - Further investigation required
Information:	Ceiling lining installed between exposed ceiling beams show visible sagging. This condition is commonly associated with ageing hardboard or fibre-cement ceiling sheets and loosening of fixings over time. While no structural failure of the supporting beams was evident, the lining panels appear to have deteriorated and may require refixing or replacement to restore a flat and secure ceiling surface. Further assessment by a carpenter or licensed builder is recommended to check for structural adequacy of the horizontal member.

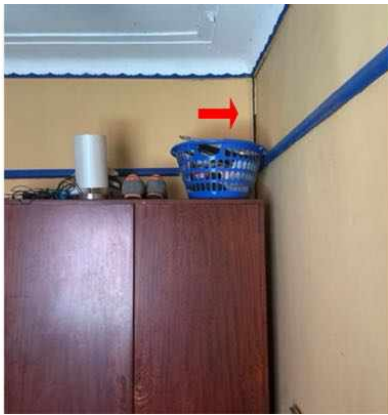
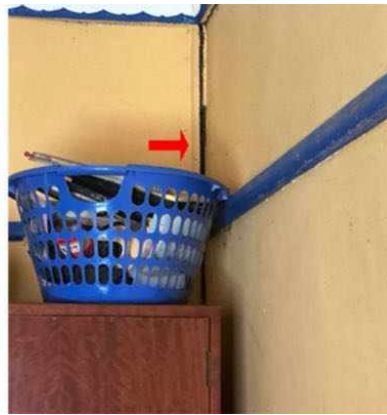
### Finding 3.03

Building:	Main Building
Location:	Bedroom
Finding:	Wall Out of Plumb / Separation at Wall–Ceiling Junction - Further investigation required
Information:	The wall surface appears to be out of plumb, with a visible separation gap noted at the junction between the wall and ceiling lining in the bedroom corner. Walls that are not vertically aligned can occur due to building movement, framing distortion, settlement, or previous structural alteration. The separation at the ceiling junction is likely a result of this misalignment and movement within the wall structure.

While no immediate structural failure was evident at the time of inspection, walls that are noticeably out of plumb may indicate movement of the wall framing or supporting structure and should be further assessed. A licensed builder should inspect the wall to determine the cause of the misalignment and whether rectification works are required.

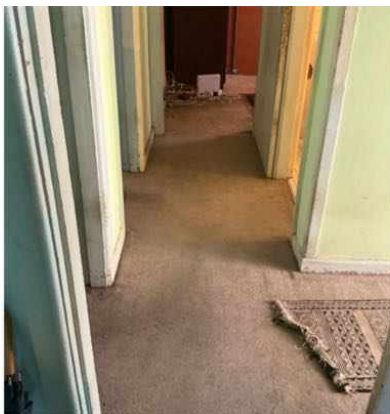
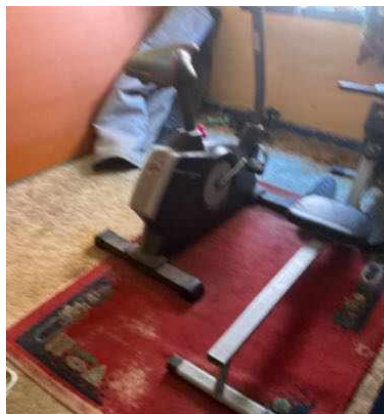
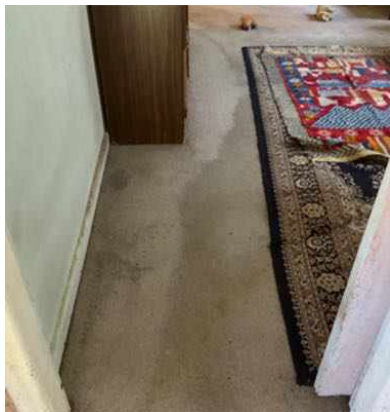
Bouncy floors generally indicate that the floorboards or the subfloor structures are coming loose from the joists that they are installed on. Bouncy flooring may also be the result of gaps between flooring and stumps or joist structures, which require packing.

The client is advised to seek quotations for required repairs from a Registered Builder specialising in re-stumping. The potential resolution may range from packing gaps in subfloor structures through to replacement of subfloors stumps and refixing of flooring.

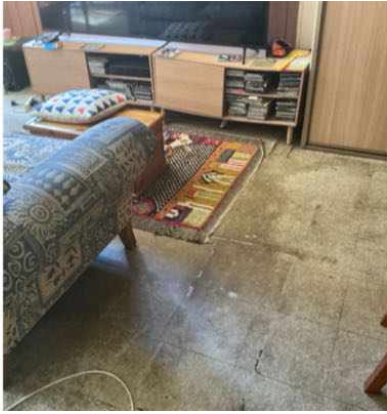
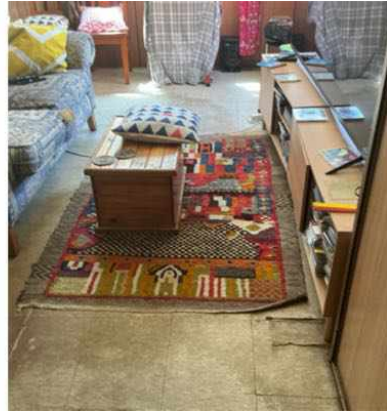
### Finding 3.06

Building:	Main Building
Location:	All Internal Areas
Finding:	Flooring - Uneven
Information:	The internal flooring in this area is out of level and uneven. Uneven flooring is likely to indicate minor defects such as expected movement of the foundations of the property, but may also indicate subsidence of the associated subfloor stumps.

It is advised that the flooring be closely monitored to identify any further movement. Where flooring remains relatively unchanged for an extended period of time (i.e. several months), it is likely that this defect has been caused by expected movement of the foundations of the property.

However, where flooring is uneven further, potentially invasive inspection of the subfloor structures and stumps in this area is required. In this case, works to repair are likely to be required, and would be carried out by a registered builder specialising in re-stumping.

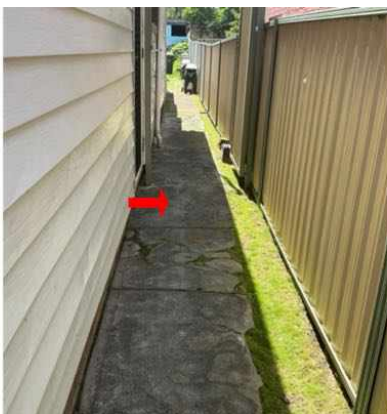
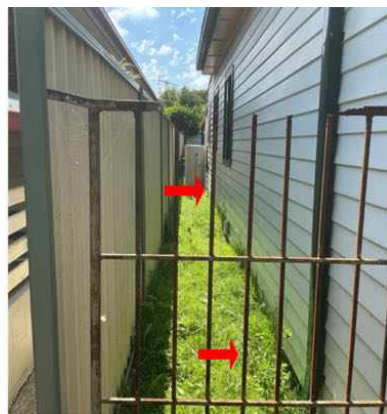
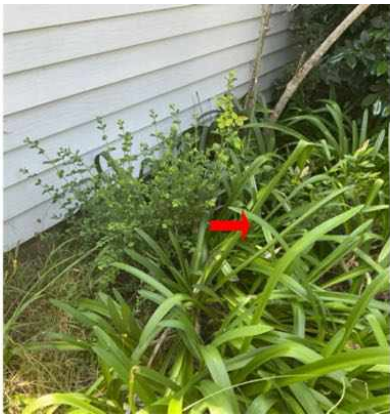
### Finding 3.07

Building:	Main Building
Location:	All External Areas
Finding:	Site drainage - Inadequate
Information:	The site drainage in this area was found to be inadequate at the time of inspection, creating potential for subsequent water damage to associated building elements.

It is important that water does not lie against the base of walls; surrounding paths and ground levels should be sloped to drain water away from walls. Downpipes should not discharge stormwater onto lower walls or plinths. Stormwater should be carried away by large, regularly cleaned drains. Ground levels may need to be lowered to expose a buried DPC.

Where site drainage is inadequate, installation of an Agricultural (Aggie) Drain may be required. A qualified plumber should be appointed to further inspect the property and perform any remedial works as necessary. Water damage and secondary defects are likely to occur if left unmanaged.

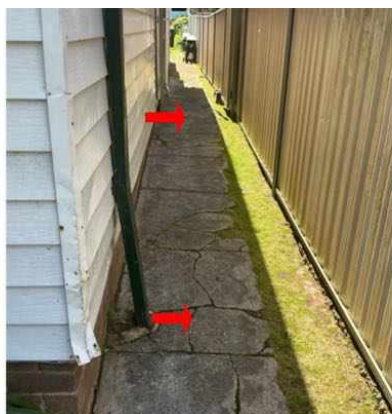
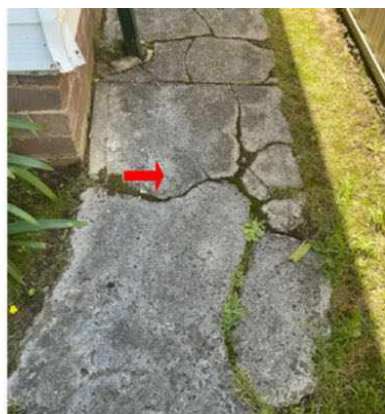
Building:	Main Building
Location:	All External Areas
Finding:	Cracking - External Concrete Paving Damage Category 4 - Gaps in Slab (4mm - 10mm +)
Information:	Gaps in the slab were identified in external concrete paving. Gaps in the slab are significant and are likely to lead to the development of safety hazards and secondary defects if left unmanaged, such as the creation of a trip hazard.

General age and expected deterioration of the paved areas is a common cause of this type of cracking. However, expansion and contraction of the slab may also have occurred due to environmental factors. Such factors include variable moisture and weather conditions, the presence of trees and their roots having a settling or lifting affect on the soil, or the effect of load bearing, e.g. heavy vehicles over a sustained period of time.

Cracking to this degree may also be due to poor original installation of the concrete. Factors such as poor compaction of the sub surface and/or inadequate reinforcing of the slab may create cracking and other secondary defects. Gaps in the concrete paving may also have a more significant structural cause, such as subsidence of soils.

Where gaps in the concrete paving are adjacent to structural elements of the building, the advice of a Structural Engineer is advisable before undertaking repairs. Significant repair and likely replacement of the concrete paving is probable.

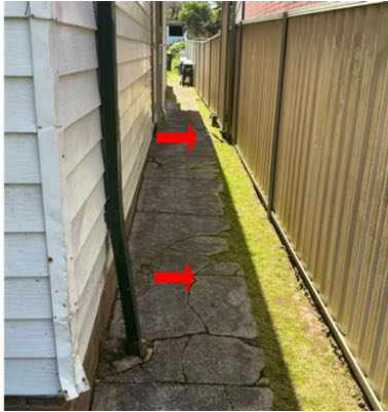
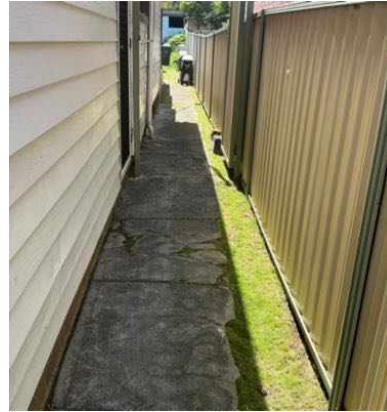
### Finding 3.10

Building:	Main Building
Location:	All External Areas
Finding:	Paving - Uneven
Information:	Sections of the external paved area are uneven, creating a potential trip hazard. It appears as though the area has been subject to rough installation, or that paving sections have lifted due to movements in the foundation of the property.

Where paving creates a trip hazard, personal injury may ensue if due caution is not taken by all persons within this area.

Re-paving of the area is required as soon as possible to remedy this situation. Further consultation with a specialist concreter is advised.

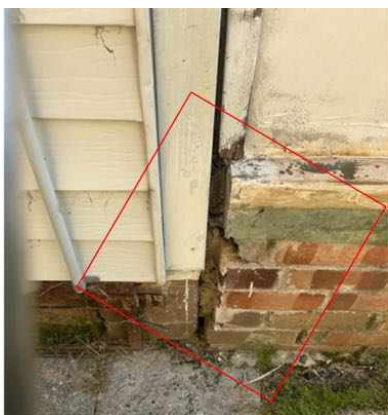
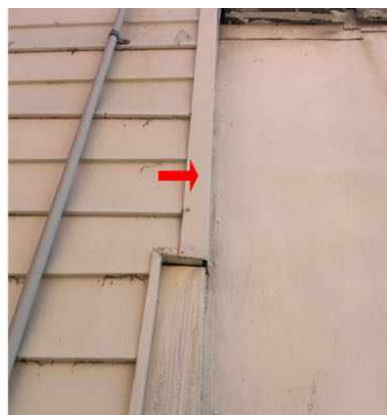
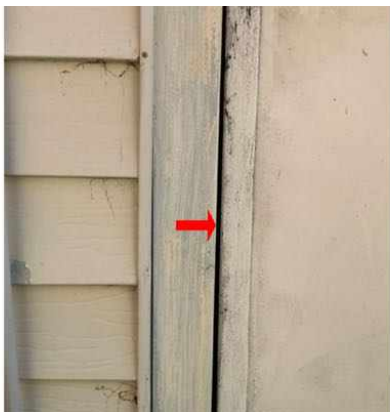
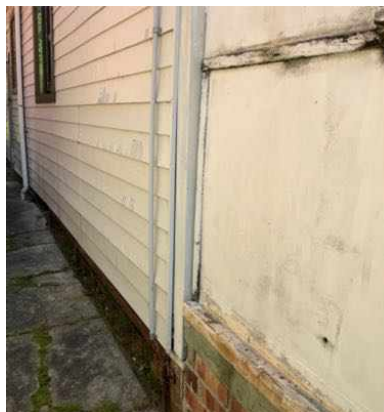
### Finding 3.11

Building:	Main Building
Location:	All External Areas
Finding:	Installation - substandard or incomplete - Poor joint detail
Information:	The installation of this building element appears to have been completed to a substandard level of workmanship or is incomplete. Generally substandard repairs or installation are related to poor workmanship, the use of inappropriate materials, or a failure to complete installation to a suitable standard.

Where installation is substandard and/or incomplete, the client should contact the responsible trade to undertake rectification. Unfinished and substandard building works are likely to degrade more quickly and may create potential for secondary defects to associated building elements.

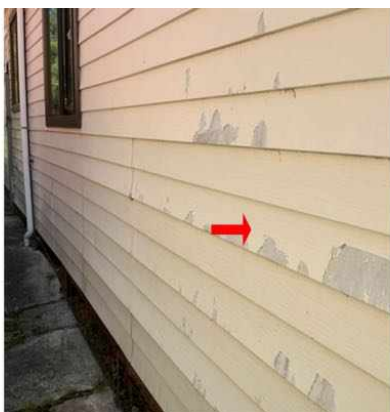
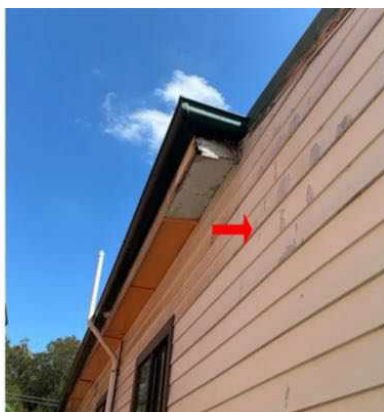
**Finding 3.12**

Building: Main Building  
 Location: All External Areas  
 Finding: External painting deteriorated to some areas  
 Information: Whilst incomplete or missing paint finish is generally an appearance defect, it can also lead to the development of secondary building defects over time. Incomplete areas of paint finish expose the area to moisture, potentially accelerating the deterioration of underlying building materials.

Degraded paint finishes should be sanded back, filled, leveled and painted, as applicable. Where inadequate or missing paint protection has led to the deterioration of the associated building element, repair and/or replacement of this building element may be required.

A painting contractor should be appointed as soon as possible to perform necessary works to aid the appearance of the affected area and to ensure the area is protected against further deterioration. Alternatively, the homeowner following manufacturer instructions may perform these works.

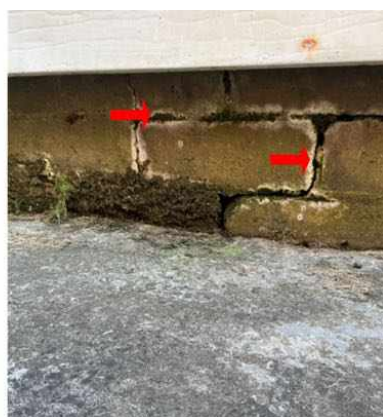
**Finding 3.13**

Finding: Brickwork - Deteriorated mortar to some areas  
 Information: Mortar, or 'bedding', is the material which fills joints and intersections between bricks in masonry walls and structures. Sections of mortar in this brickwork were identified as having deteriorated, which is generally expected for a property of this age and condition.

Mortar may deteriorate as a result of age of building materials, minor movement of bricks, or frequent exposure to weathering. Mortar should be replaced to ensure that bricks remain in their intended location and to prevent gaps, which would allow water or moisture ingress and secondary damage as a result.

Mortar deterioration can be addressed by a bricklayer where areas of deterioration are localised and easily accessible. Alternatively, appointment of a registered builder is advised, to repoint large areas of decaying mortar. Where secondary structural defects have become evident, consultation with a structural engineer may be required.

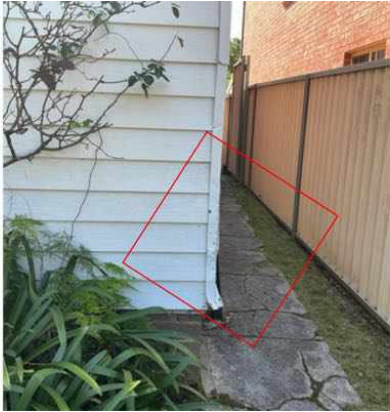
### Finding 3.14

Building: Main Building  
 Location: All External Areas  
 Finding: Building element - Damaged- Trim and weatherboards damaged , eaves damaged  
 Information: Breakage occurs generally when the building materials have either aged and decayed, or as a result of damage (accidental or deliberate).

Repair and/or replacement of broken elements is advised to ensure that additional secondary defects do not arise as a consequence. Such works are necessary, as all building elements play a key role in the operation and function of the overall structure and its performance.

A relevant tradesperson should be appointed to repair or replace the affected building element prior to any subsequent damage being caused.

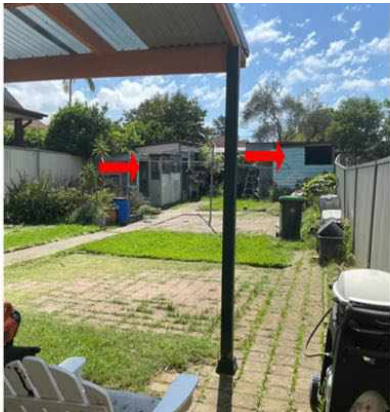
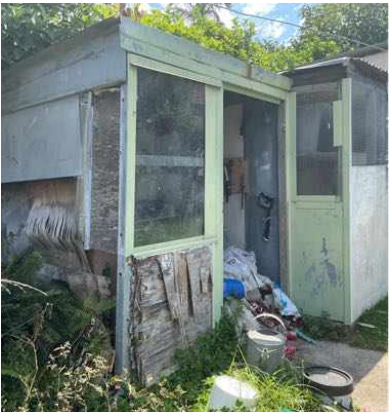
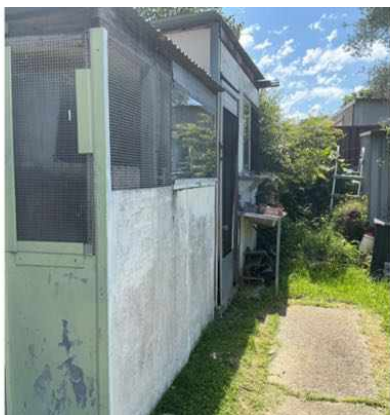
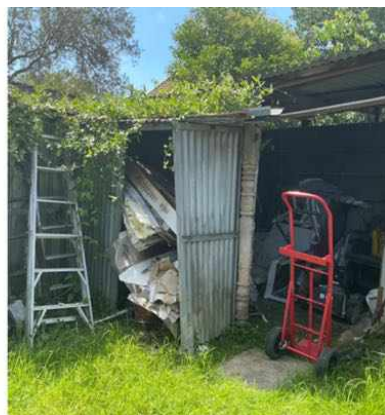
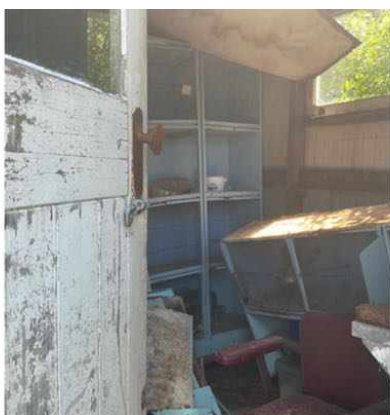
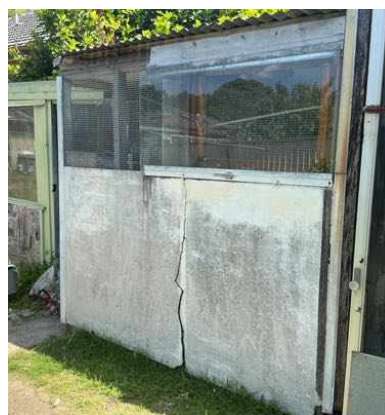
**Finding 3.15**

Building: Main Building  
 Location: All Internal Areas  
 Finding: Shed Condition - Poor  
 Information: The detached shed is considered to be in a poor and potentially non-serviceable state. Extensive repairs or replacement may be required. If retained, professional assessment and reconstruction in accordance with current NCC Volume Two and AS 1684 (Residential Timber Framing Code) is recommended. Advanced wood rot , debris, potential asbestos containing material was also found at the time of inspection. A further invasive inspection by a termite technician is highly recommended to check for concealed termite activity

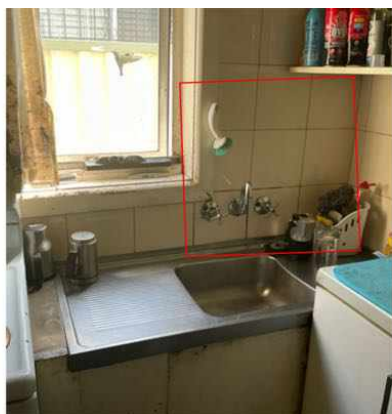
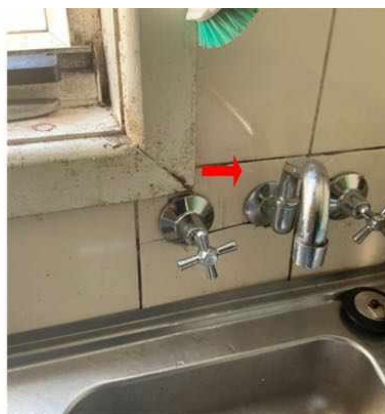
Finding: Tiles - Cracked or damaged and drummy in poor condition

Information: Cracking was evident to the tiling in this area at the time of inspection. While the cracking appears to be minor, this area is frequently exposed to water, allowing potential for water penetration into adjoining sections of walls or flooring.

If left unmanaged, water penetration to these areas may lead to subsequent water damage, which is likely necessitate repair work to affected building elements.

A tiling contractor should be appointed to ensure that no further water damage occurs. The re-application of silicone and grouting throughout remaining tile work is also advised, to further protect the area against water penetration.

Where water penetration has led to water damage, appointment of a relevant tradesperson may be required to repair damaged building elements.

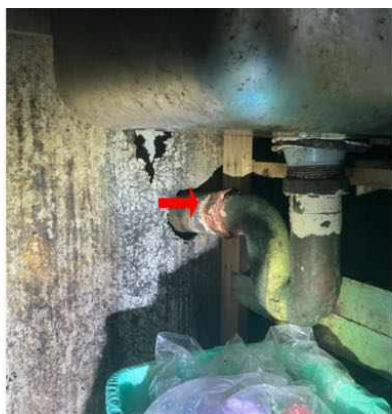
### Finding 3.17

Building:	Main Building
Location:	All Internal Areas
Finding:	Building element - Rusted or corroded - Plumbing rusted
Information:	This building element shows evidence of rusting and corrosion, which is likely to have developed as a result of excessive exposure to moisture and or inadequate coatings.

As surface rust provides no protection to the underlying iron, the deteriorating condition is likely to worsen if not addressed in the short-term future.

Where possible, the use of galvanized (treated) metals or aluminium coated metals aid in rust prevention, as does regular general maintenance. Rust formation can be controlled with coatings, such as paint, that isolate the iron from the environment.

Rusting and corrosion should be managed by ideally removing or limiting the affected surface from exposure to moisture. A registered builder may be appointed to replace any building elements that have been severely affected by rust or water damage.

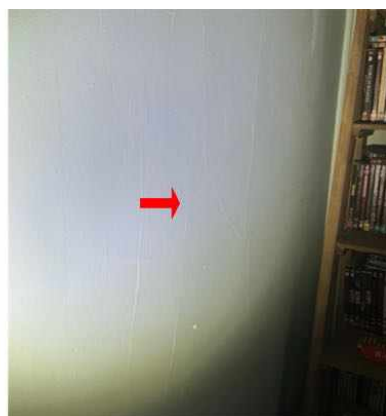
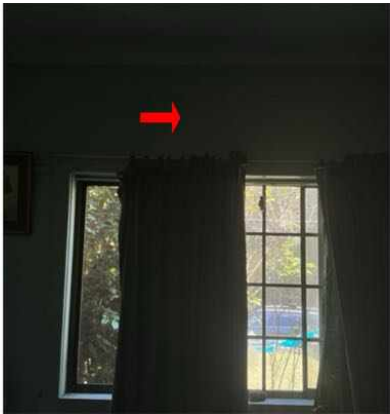
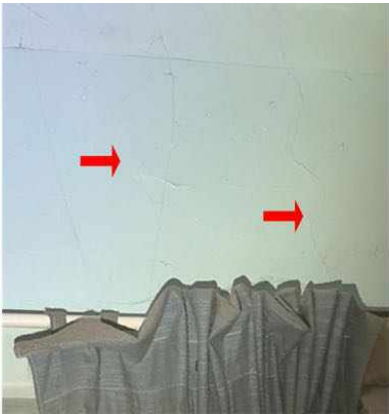
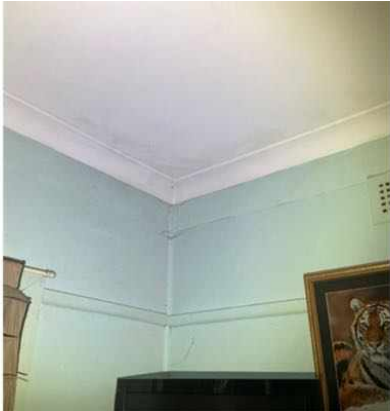
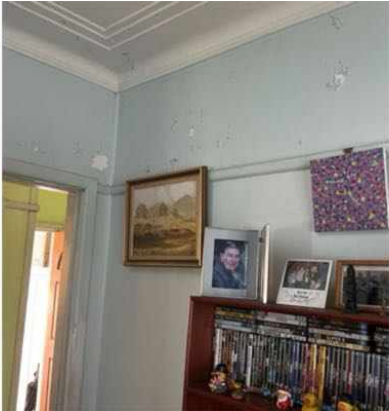
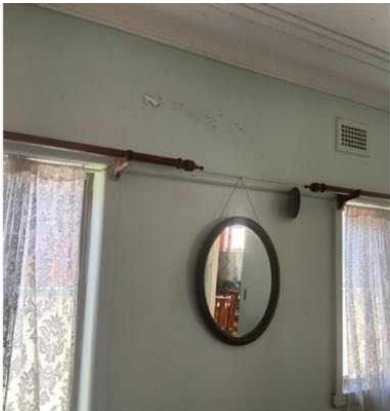
### Finding 3.18

Building:	Main Building
Location:	All Internal Areas
Finding:	Paint Finish & Hairline Cracking - To some areas
Information:	The paint finish in this area was identified as being incomplete or substandard at the time of inspection including some hairline minor cracking/separation. Monitoring is recommended where cracking and separation is evident.

Whilst incomplete or missing paint finish is generally an appearance defect, it can also lead to the development of secondary building defects over time. Incomplete areas of paint finish expose the area to moisture, potentially accelerating the deterioration of underlying building materials.

Incomplete paint finishes should be sanded back, filled, leveled and painted, as applicable. Where inadequate or missing paint protection has led to the deterioration of the associated building element, repair and/or replacement of this building element may be required.

A painting contractor should be appointed as soon as possible to perform necessary works to aid the appearance of the affected area and to ensure the area is protected against further deterioration. Alternatively, the homeowner following manufacturer instructions may perform these works.

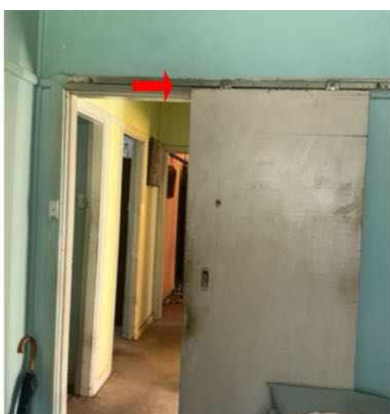
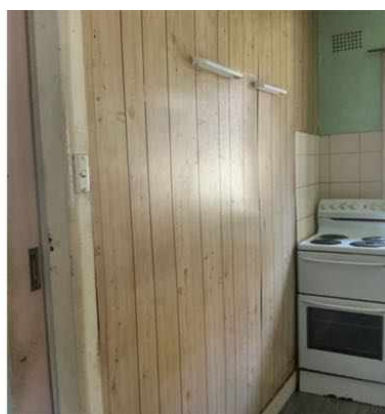
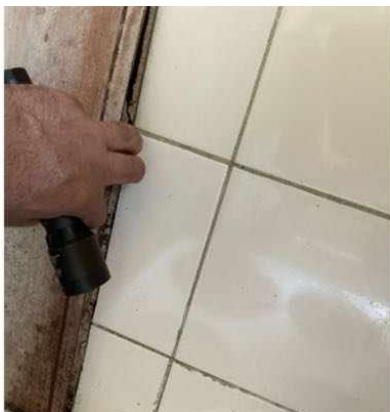
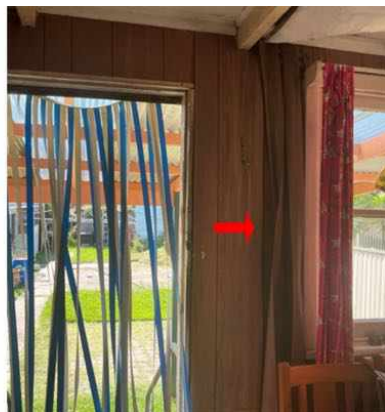
### Finding 3.19

Building:	Main Building
Location:	All Internal Areas
Finding:	Building element - Damaged - Door coming off hinges bedroom , wall panelling damaged or loose
Information:	Breakage occurs generally when the building materials have either aged and decayed, or as a result of damage (accidental or deliberate).

Repair and/or replacement of broken elements is advised to ensure that additional secondary defects do not arise as a consequence. Such works are necessary, as all building elements play a key role in the operation and function of the overall structure and its performance.

A relevant tradesperson should be appointed to repair or replace the affected building element prior to any subsequent damage being caused.

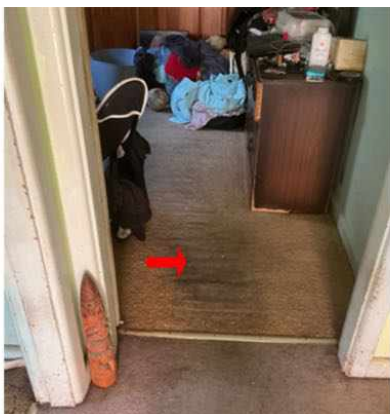
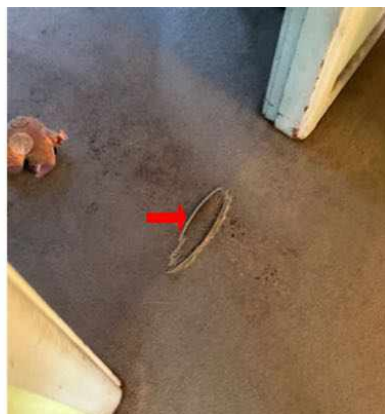
### Finding 3.20

Building:	Main Building
Location:	All Internal Areas
Finding:	Building element - Damaged - Carpet poor condition
Information:	Breakage occurs generally when the building materials have either aged and decayed, or as a result of damage (accidental or deliberate).

Repair and/or replacement of broken elements is advised to ensure that additional secondary defects do not arise as a consequence. Such works are necessary, as all building elements play a key role in the operation and function of the overall structure and its performance.

A relevant tradesperson should be appointed to repair or replace the affected building element prior to any subsequent damage being caused.

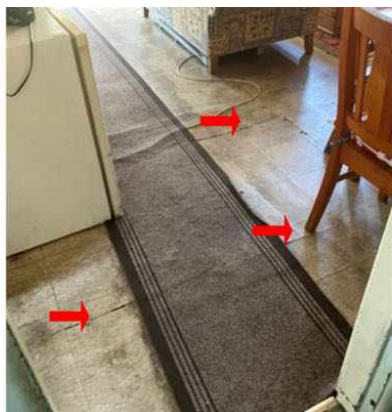
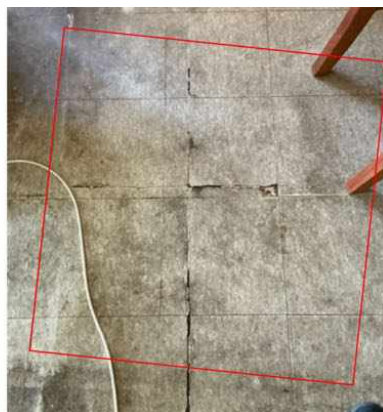
### Finding 3.21

Building:	Main Building
Location:	All Internal Areas
Finding:	Building element - Damaged - vinyl flooring in poor condition
Information:	Breakage occurs generally when the building materials have either aged and decayed, or as a result of damage (accidental or deliberate).

Repair and/or replacement of broken elements is advised to ensure that additional secondary defects do not arise as a consequence. Such works are necessary, as all building elements play a key role in the operation and function of the overall structure and its performance.

A relevant tradesperson should be appointed to repair or replace the affected building element prior to any subsequent damage being caused.

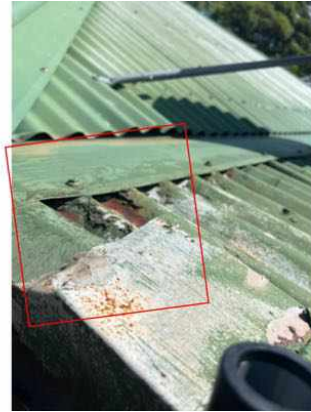
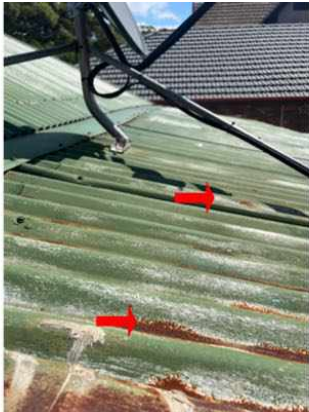
### Finding 3.22

Building:	Main Building
Location:	Roof Exterior
Finding:	Building element - Rusted or corroded - Roof to some areas
Information:	This building element shows evidence of rusting and corrosion, which is likely to have developed as a result of excessive exposure to moisture and or inadequate coatings.

As surface rust provides no protection to the underlying iron, the deteriorating condition is likely to worsen if not addressed in the short-term future.

Where possible, the use of galvanized (treated) metals or aluminium coated metals aid in rust prevention, as does regular general maintenance. Rust formation can be controlled with coatings, such as paint, that isolate the iron from the environment.

Rusting and corrosion should be managed by ideally removing or limiting the affected surface from exposure to moisture. A registered builder may be appointed to replace any building elements that have been severely affected by rust or water damage.

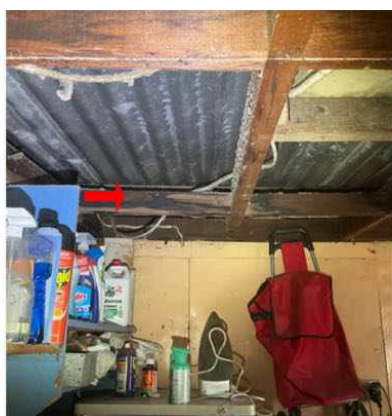
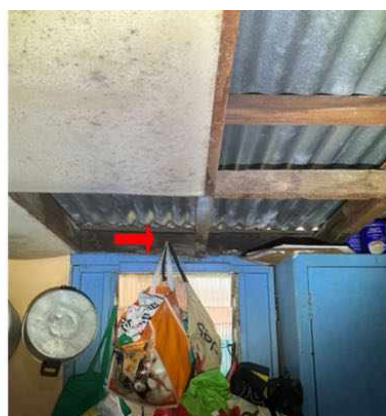
### Finding 3.27

Building:	Main Building
Location:	Laundry
Finding:	Water staining - timbers
Information:	Water staining was evident in this area at the time of inspection. Water staining indicates that surfaces have been exposed to excessive moisture over time. The minerals and other elements in the water lead to staining, which may graduate to corrosion and deterioration if left unmanaged.

While mostly an appearance defect, water staining can be indicative of more serious defects, which may be currently concealed by other building elements.

Where water staining is active, a licensed plumber must be consulted to identify the cause of the staining and to provide advice on any reparation works that may be required. Replacement of any broken or damaged structures is advised.

Conversely, where water staining is old and inactive, affected building materials may be repaired or replaced at client discretion. A qualified carpenter or registered builder may be appointed to perform these works.

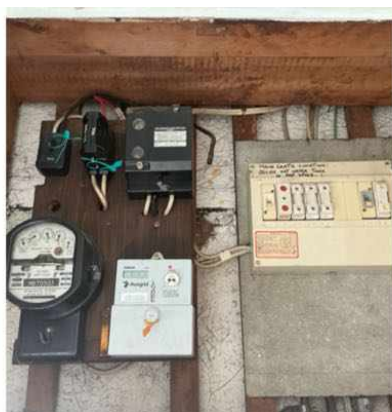
Building:	Main Building
Location:	All External Areas
Finding:	Termite Management System - no evidence of a chemical installation
Information:	The application of a post-construction chemical termite barrier is highly recommended for all properties, particularly if live termite activity has been found on the site previously. Such barriers are highly effective in preventing termite attack on any timber building elements throughout the property.

A durable notice should be placed in the switchboard unit to indicate current termite barriers. At the time of inspection, it appeared as though no termite management system has been installed, with no evidence to suggest preventative works taking place.

The client may consider gaining further advice from a pest controller as to the costs and procedures involved with this application. It is recommended that obtaining such advice be a short-term priority.
