# Building and Timber Pest Inspection Report

Inspection Date: Fri, 6 Mar 2026

Property Address: 11 President St, Croydon Park NSW 2133,  
Australia

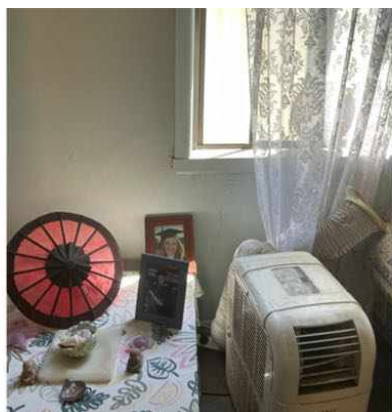
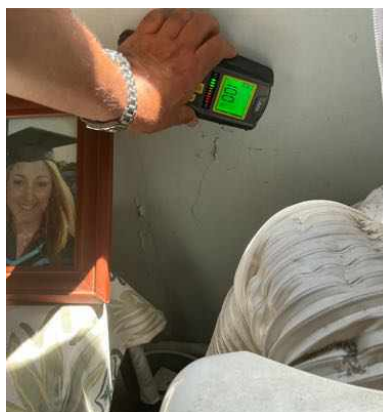
### Finding 6.02

Building:	Main Building
Location:	All Internal Areas - Lounge
Finding:	Elevated moisture - identified - Further invasive inspection required to check for concealed termite activity
Information:	Elevated moisture can attract termites and produce conditions that promote fungal

growth and wood decay.

Elevated moisture is generally caused by deteriorated, inadequate or missing roof drainage, leaking plumbing pipes or fixtures, poorly plumbed HWS overflows or condenser units and poor site drainage.

Prior to any remedial works being performed a qualified plumber should be appointed to further inspect the property and to identify the cause of the excessive moisture. Works to remove affected building elements may then be necessary and should be performed by an appropriate tradesperson.

A further invasive inspection by a licensed timber pest technician is highly recommended to check for concealed activity.

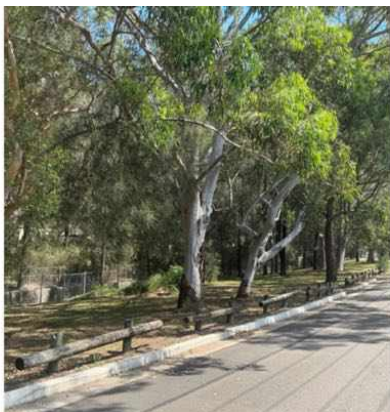
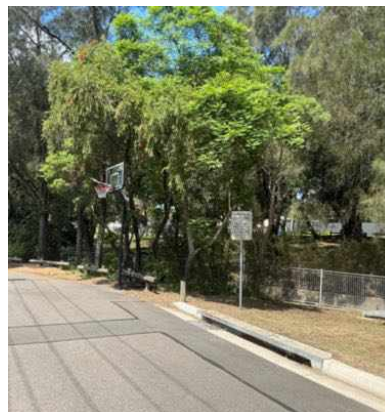
### Finding 6.03

Building:	Main Building
Location:	All External Areas
Finding:	Trees within 50m
Information:	Trees within 50m of the property can be conducive to termite activity. It is recommended an invasive inspection of all trees with 50m to the property be carried out by a qualified pest control expert.

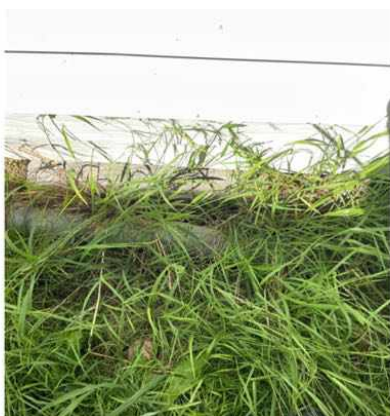
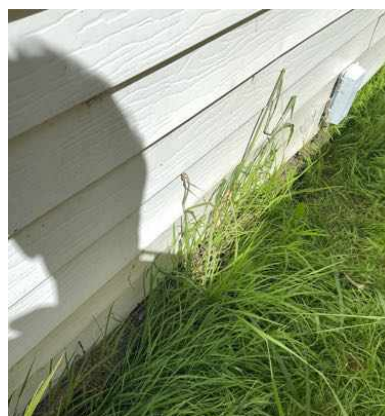
### Finding 6.04

Building:	Main Building
Location:	All External Areas
Finding:	In ground contact - Timber
Information:	Any timbers in direct ground contact provide opportunity for concealed termite entry and are likely to be subject to premature rot and decay as the soil retains moisture or damp conditions against the timbers.

Remove untreated timber that is in direct contact with external grounds. Consider replacement with more durable materials i.e. treated timber or non timber elements. Frequent pest inspections are advised to readily identify any termite activity in these areas.

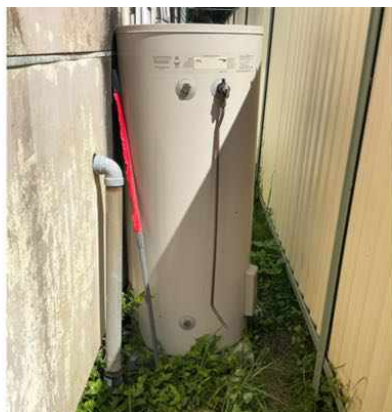
### Finding 6.05

Building:	Main Building
Location:	All External Areas
Finding:	HWS Overflow - Not Connected
Information:	The Hot Water System (HWS) overflow was found to be disconnected from storm water drainage and is creating excessive moisture in the surrounding area.

These damp conditions can lead to secondary defects such as rot, rust or corrosion

of associated building elements, the formation of fungal decay, or even the creation of potential slip hazards. When coupled with poor site drainage, pooling of water may also attract termite activity to this area.

It is highly recommended that a licensed plumber be appointed to connect the HWS overflow in order to prevent such an environment from being created. These minor works should be carried out as soon as possible.

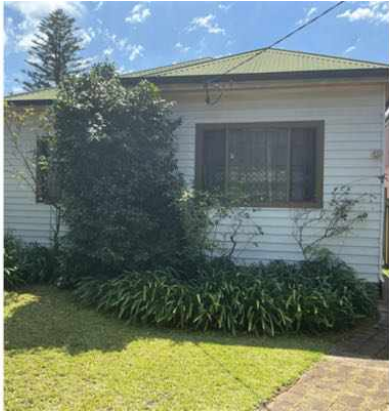
### Finding 6.06

Building:	Main Building
Location:	All External Areas
Finding:	Bridging - Vegetation
Information:	Where vegetation obstructs inspection of building elements, also known as bridging as it provides a bridging point for the access of termites, full inspection can not be achieved. Consequently moisture or dampness may be present and the areas becomes conducive to termite activity. Plants against or very close to buildings provide cover, shade and can provide an environment that is attractive to termite infestation.

The removal and replanting of species that do not provide "cover" or cutting back of existing vegetation will assist greatly in preventing Bridging from occurring.

The removal of any such materials that may be conducive to termite activity should be carried out as soon as possible and arrange re inspection to minimize the risk of termite attack.

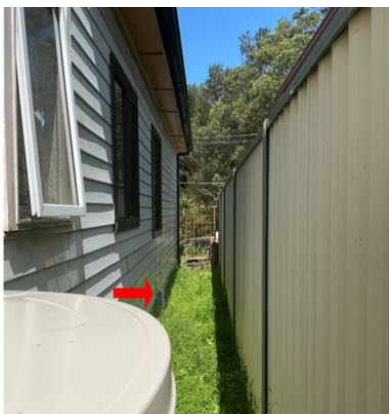
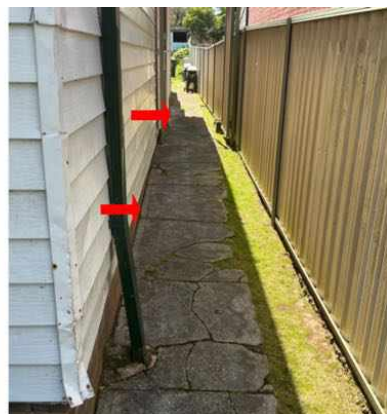
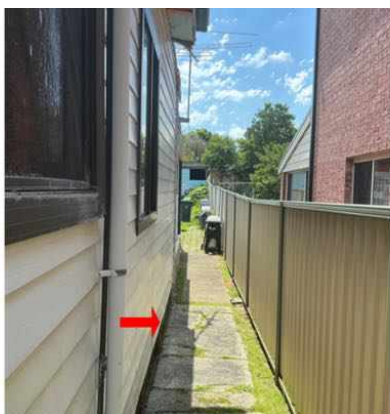
### Finding 6.07

Building:	Main Building
Location:	Subfloor
Finding:	Subfloor ventilation - Inadequate
Information:	Adequate subfloor ventilation aids in preventing excessive moisture wood rot and termite activity by ensuring a dry subfloor environment.

Where ventilation is substandard it is usually caused by factors such as failure to install adequate vents during construction subsequent building works or earth and vegetation covering over vents low subfloor clearance and items or debris in the subfloor restricting airflow.

Subfloor ventilation can be improved in most cases by addressing the causes such as exposing subfloor vents installing additional new vents installing mechanical (forced airflow) ventilation and removing debris from the subfloor.

A registered builder should be appointed as soon as possible to perform these works as necessary.

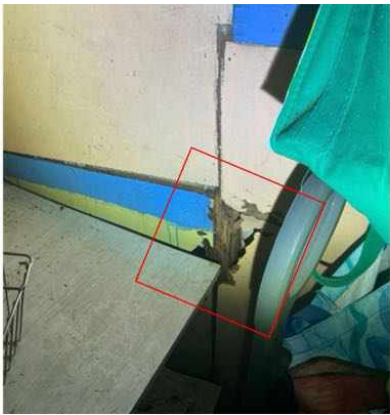
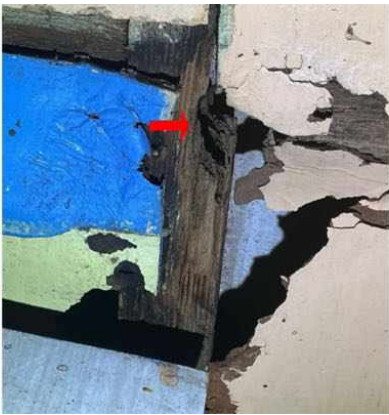
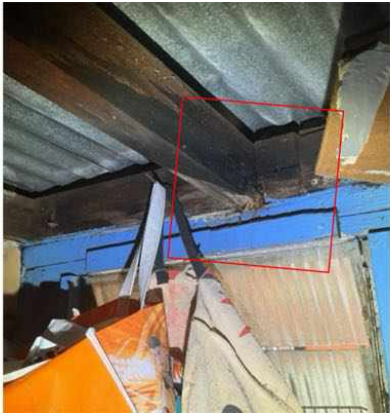
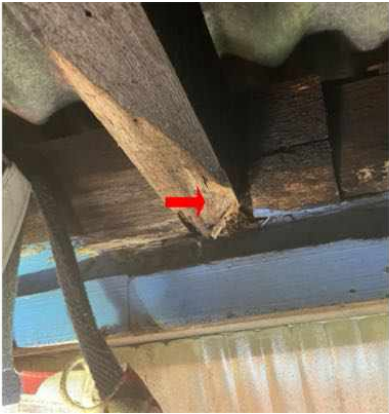
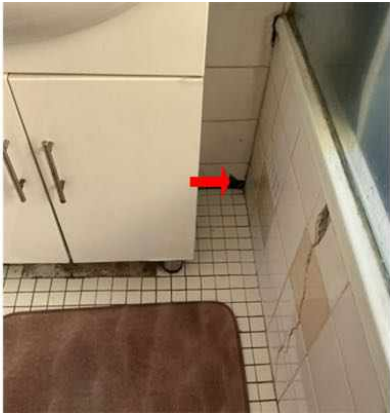
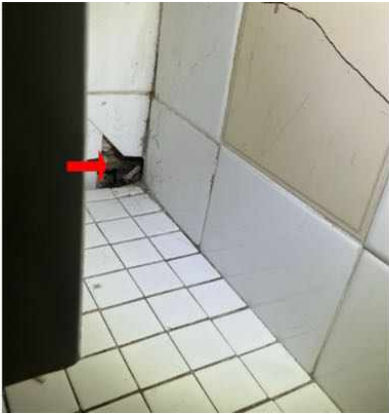
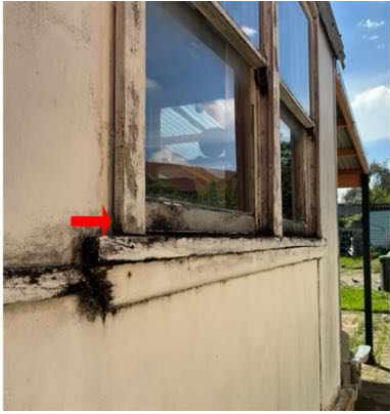
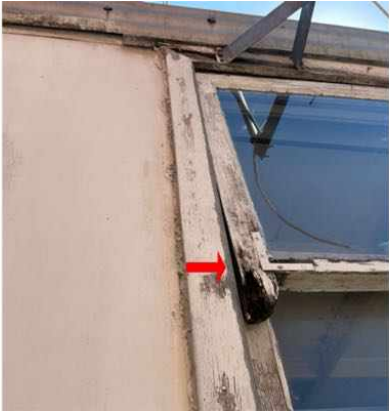
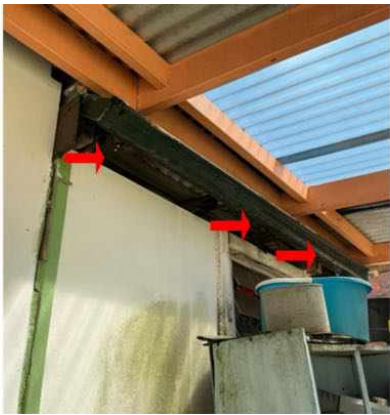
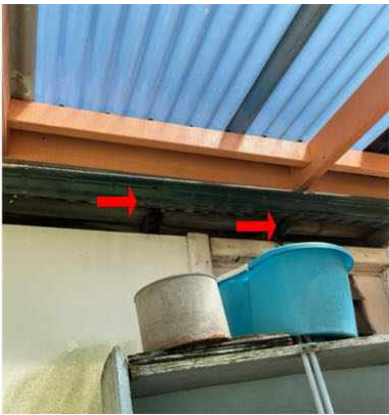
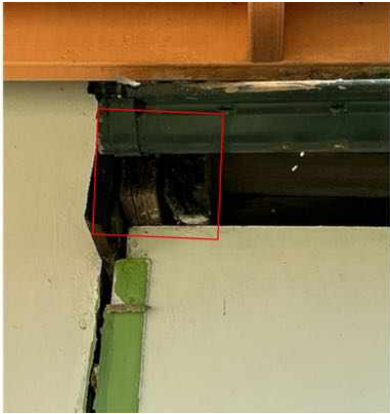
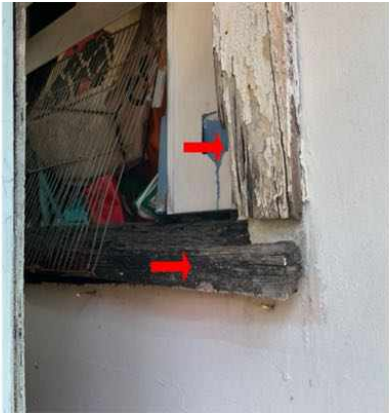
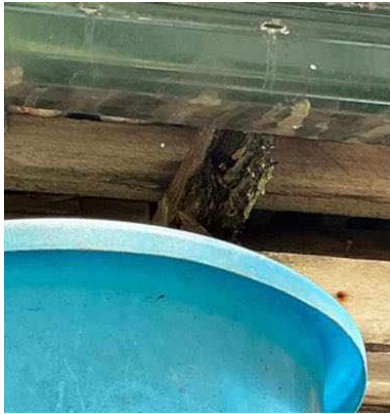
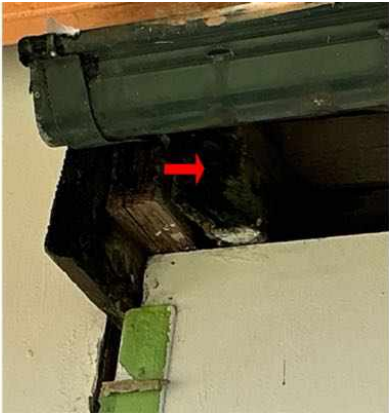
## Evidence of fungal decay activity and/or damage

In this case although the affected timber element is in a decaying state the extent of any visible damage appears to be localised to a specific area and is yet to spread to other parts of the building element or affect adjoining structures. The fungal decay is therefore likely to be of a relatively superficial nature with minimal impact on the structural integrity or tensile strength of the timber element.

A further invasive inspection by a licensed timber pest technician is highly recommended to check for concealed activity.

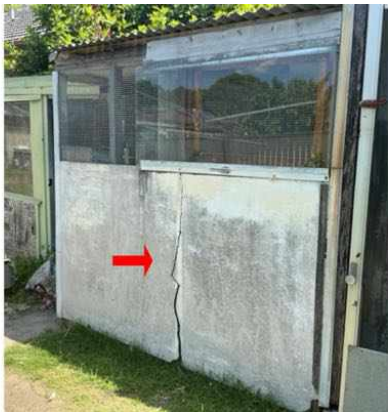
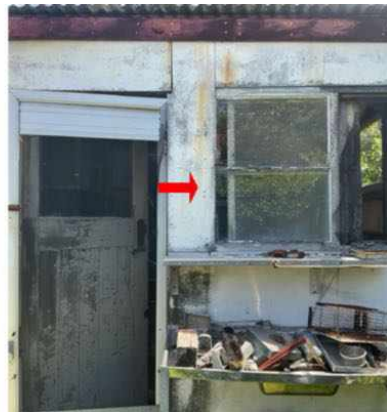
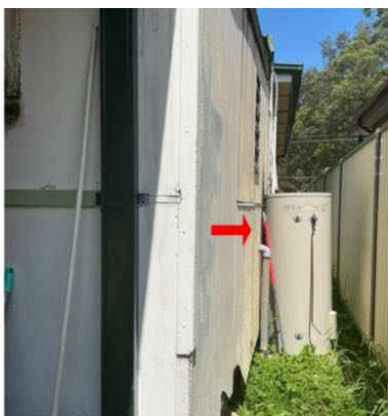
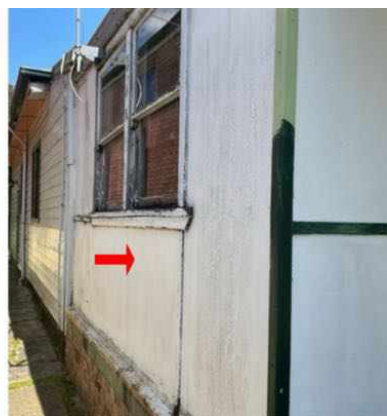
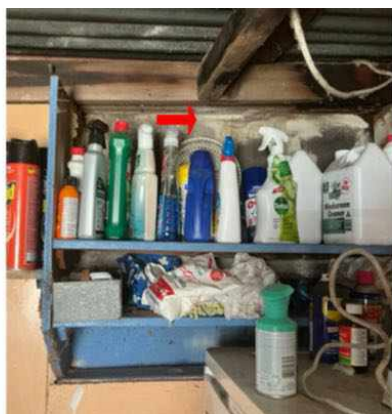
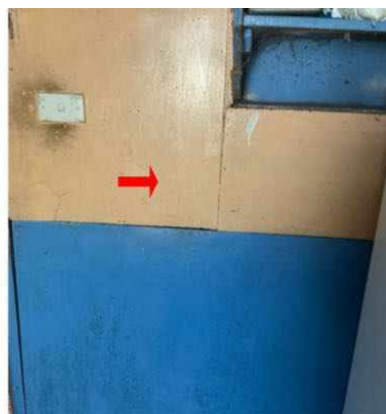
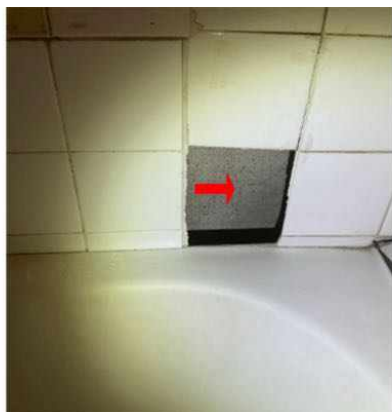
As Asbestos Reporting is outside the scope of this report, we advise that you consider a separate Asbestos Inspection and Condition Audit, which can include the taking of samples for definitive confirmation of the presence of Asbestos.

In the interim, the client is advised to act with caution, especially when considering any damage to building materials general wear and tear renovations extensions demolition and general maintenance activities due to the suspected presence of Asbestos.

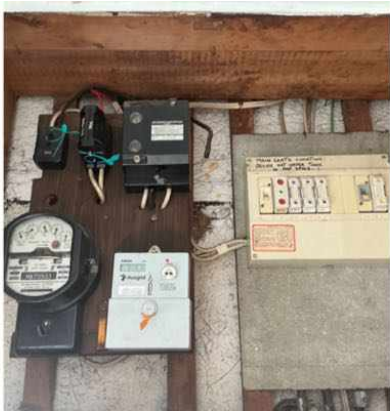
Building:	Main Building
Location:	All External Areas
Finding:	Electrical switchboard - Old ceramic fuses
Information:	The electrical switchboard while appearing to have adequate safety switches installed has old ceramic fuses in place.

While this on its own on is not considered a defect it is noted for the clients consideration that a switchboard upgrade may be required in the short to mid term to improve the functionality of the electrical system. A licensed electrician could be appointed to provide quotation for the works at the client's discretion which may in turn expose other required works to bring the system up to a compliant state.

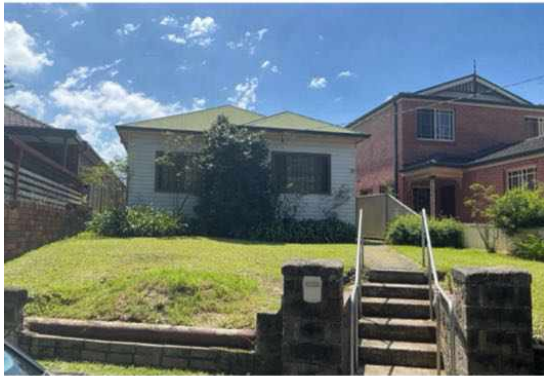
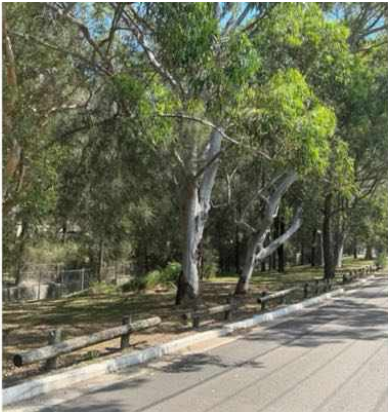
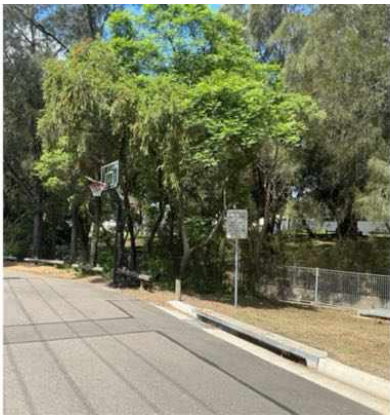
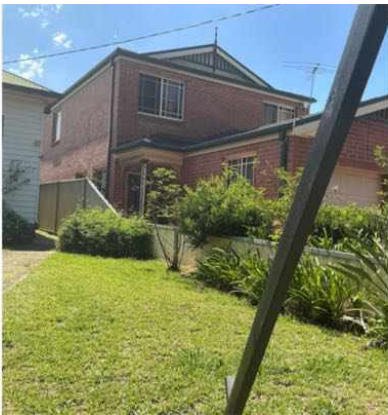
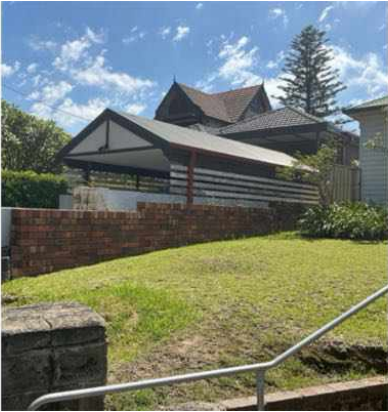
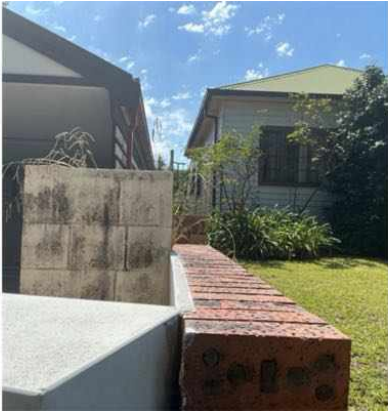
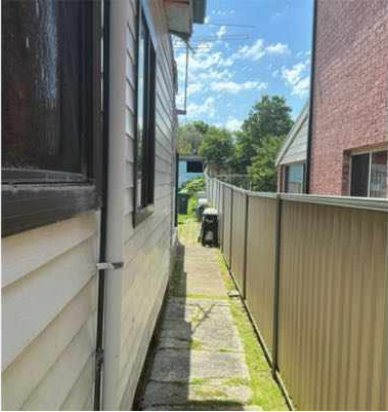
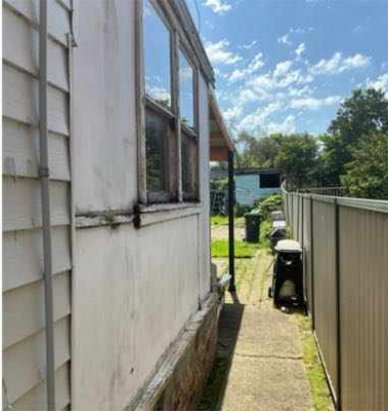
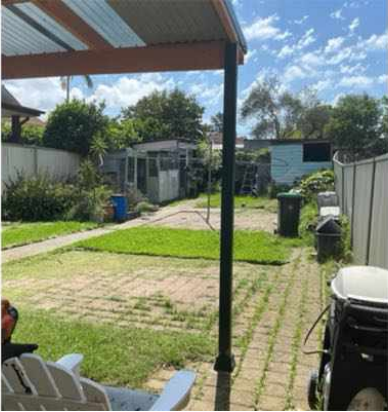
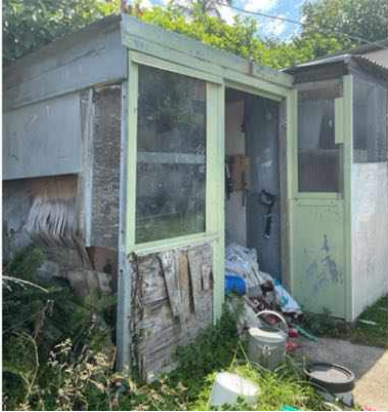
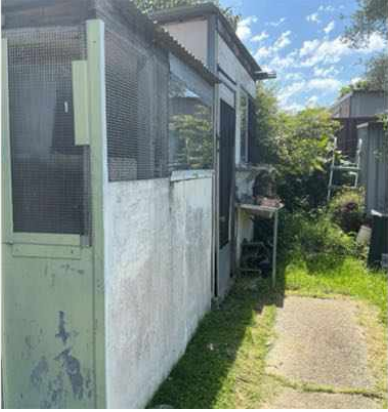
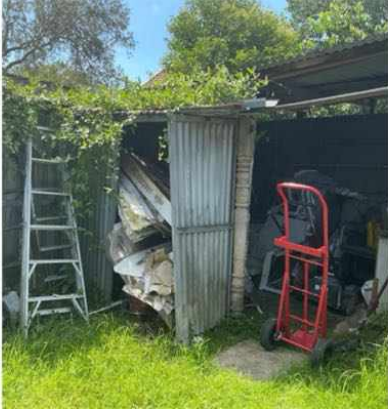
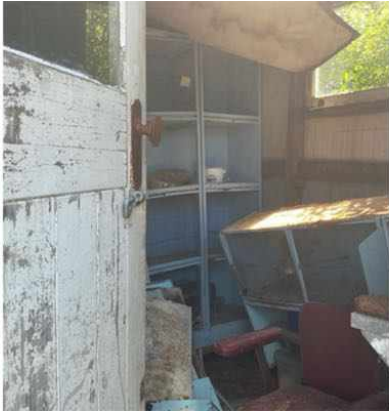
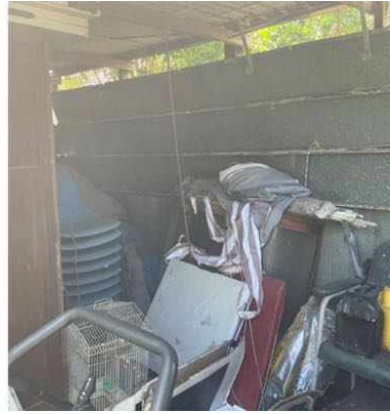
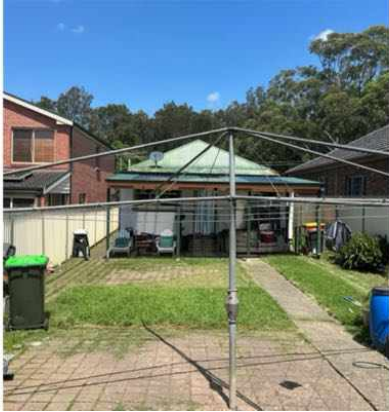
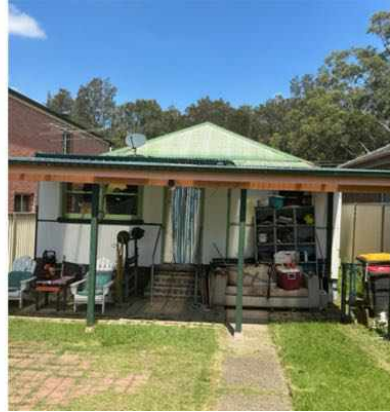
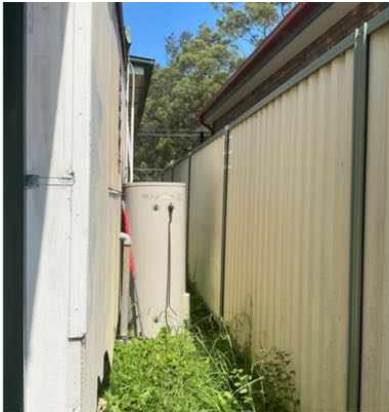
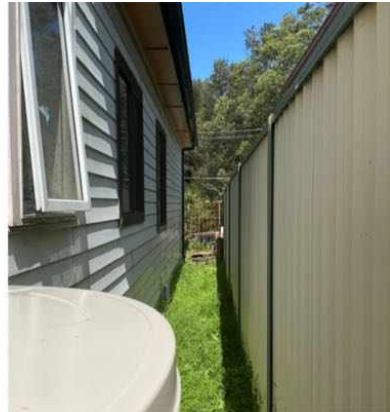
Building: Main Building  
Location: All External Areas  
Finding: Additional Photos - Obstructions and Limitations  
Information: These photographs are an indication of the obstructions and limitations which impeded full inspection of the property at the time of inspection. These obstructions can hide an array of defects and should be removed to allow full inspection to be carried out. A re-inspection is recommended once the areas are made accessible.

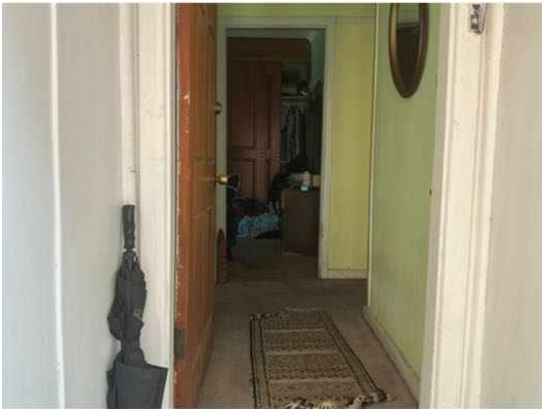
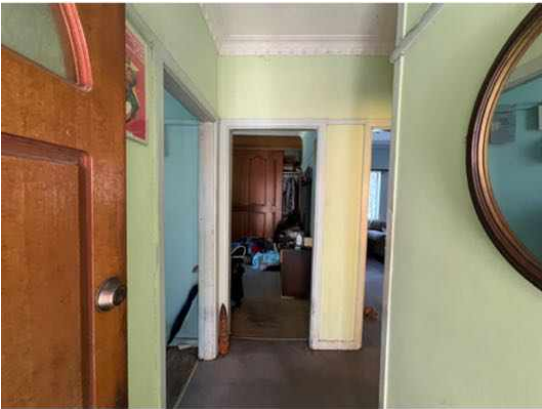
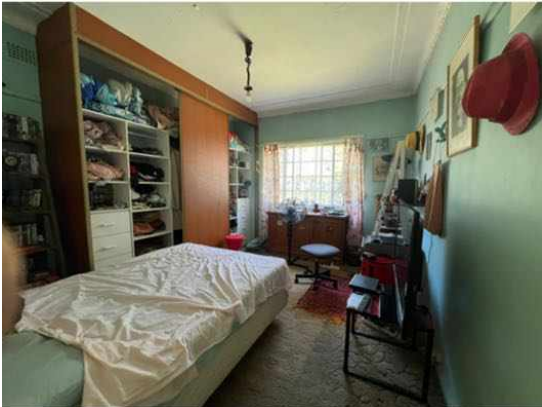
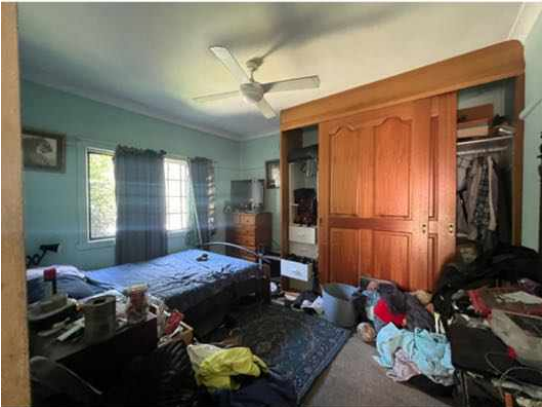
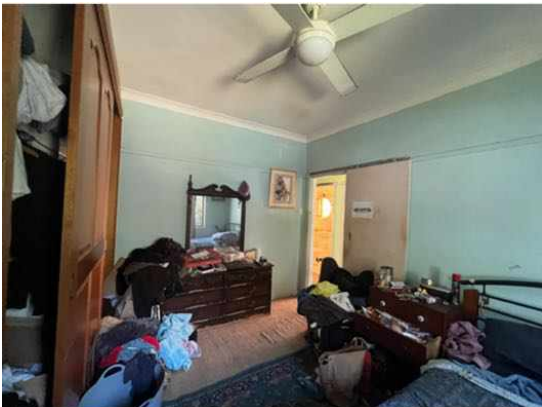
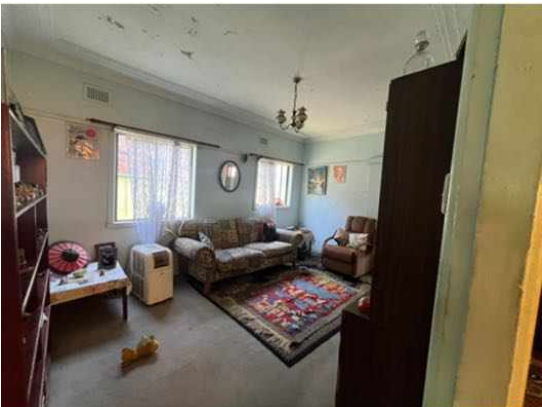
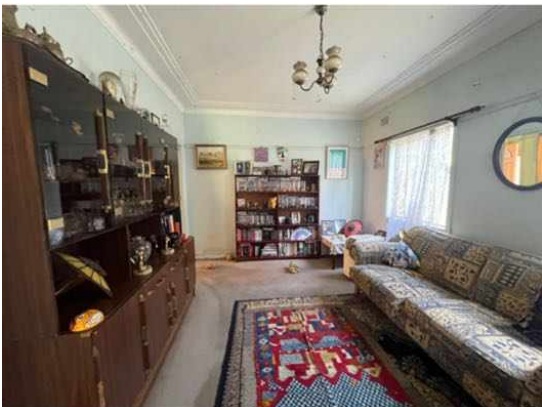
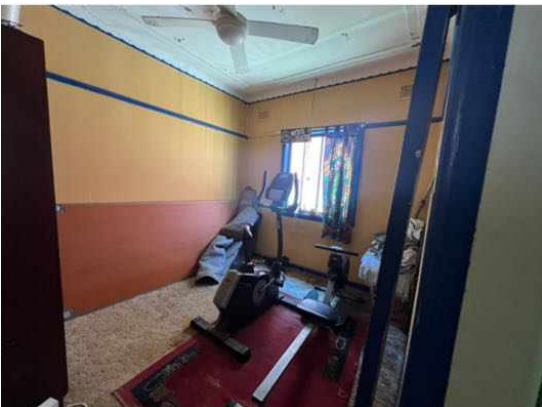
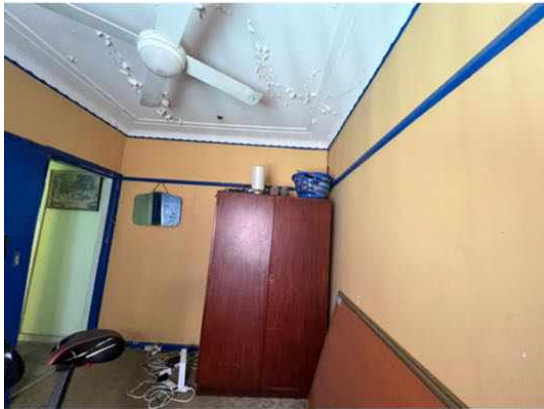
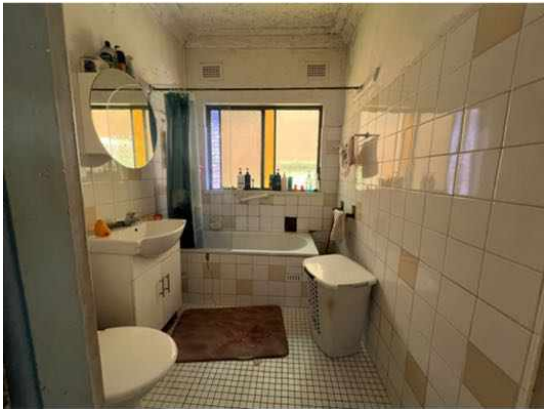
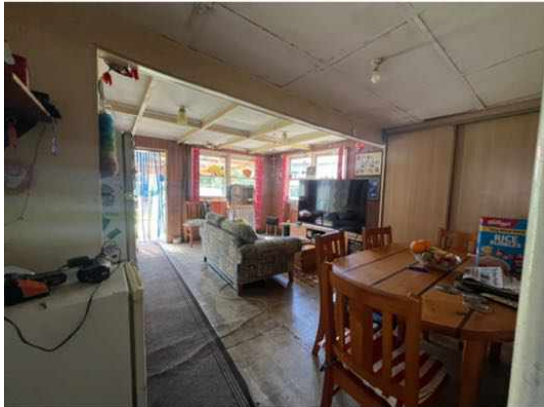
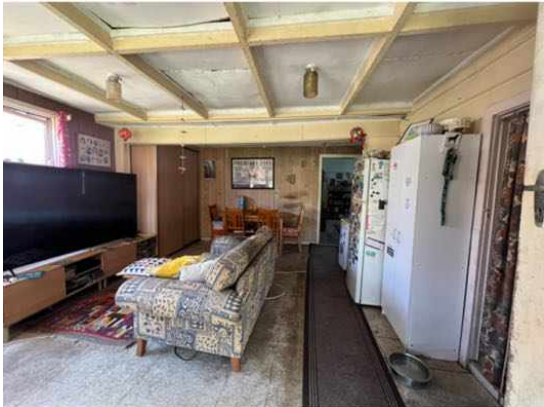
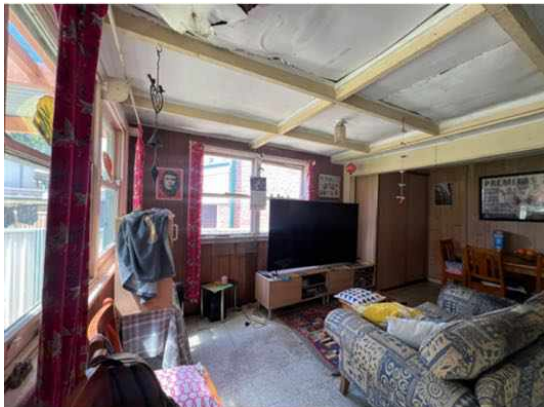
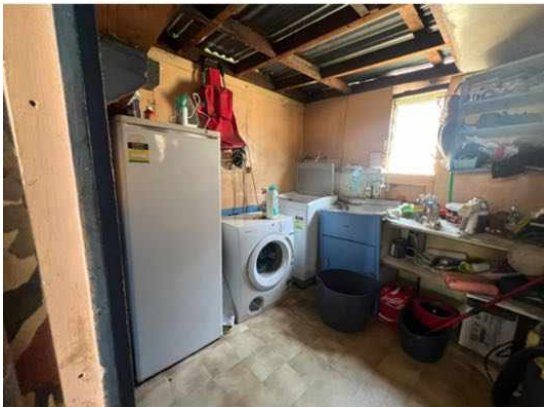
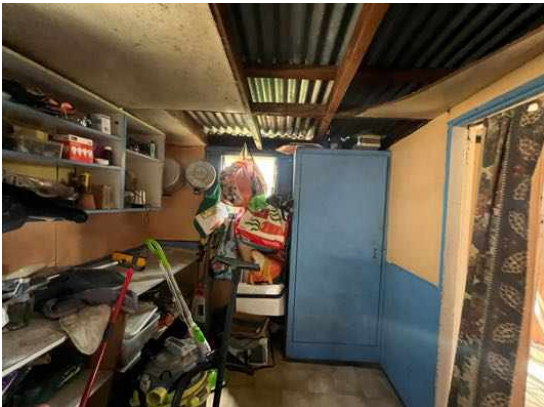
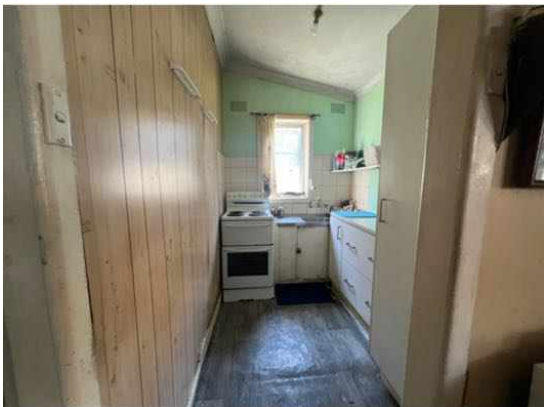
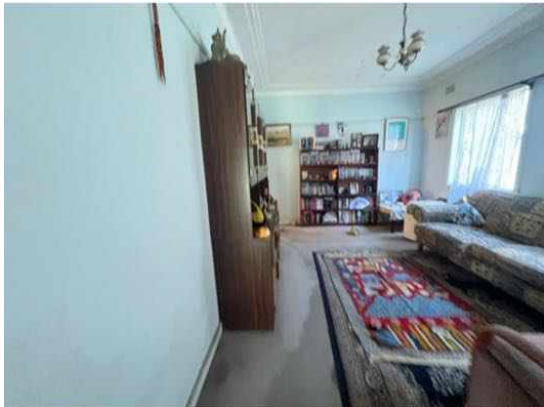
Building:	Main Building
Location:	All Internal Areas
Finding:	Additional Photos - Obstructions and Limitations
Information:	These photographs are an indication of the obstructions and limitations which impeded full inspection of the property at the time of inspection. These obstructions can hide an array of defects and should be removed to allow full inspection to be carried out. A re-inspection is recommended once the areas are made accessible.

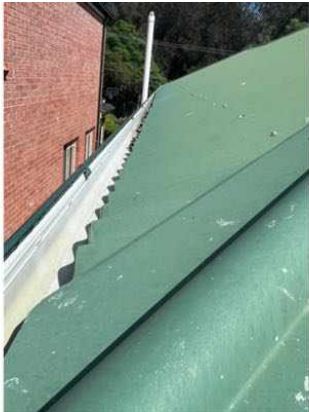
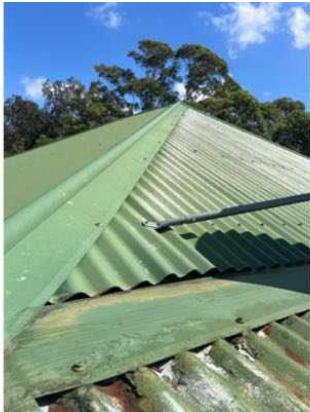
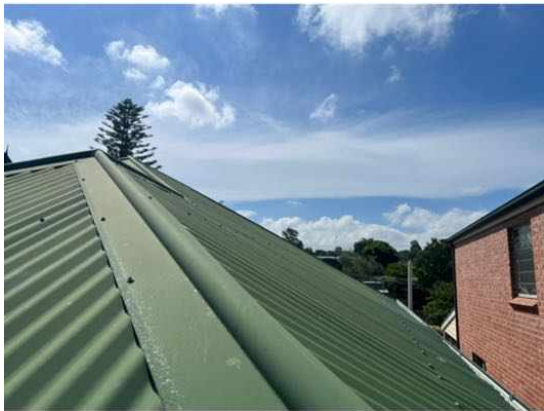
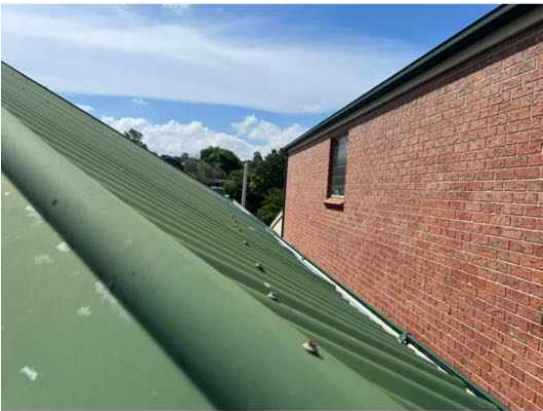
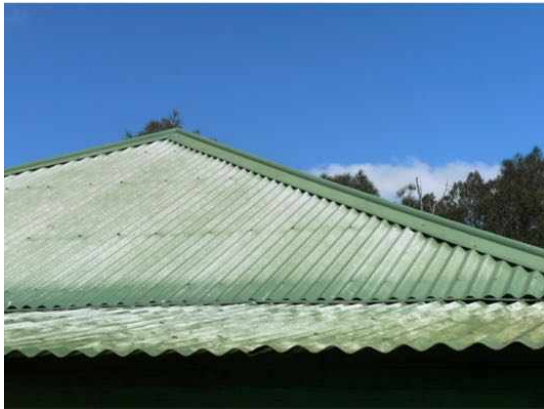
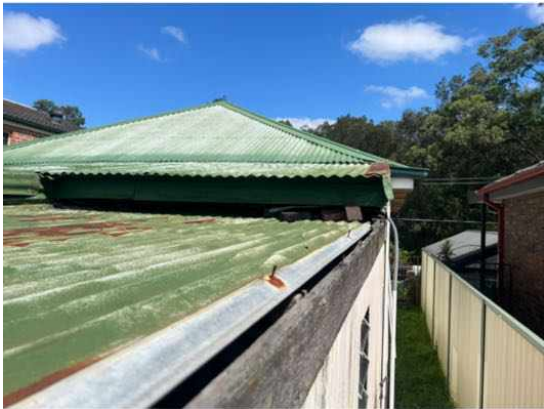
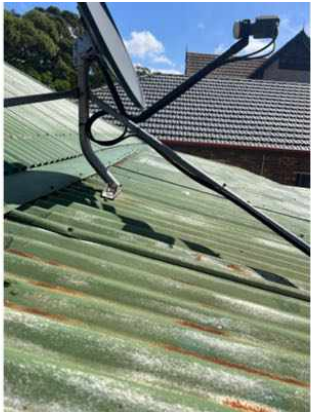
Building: Main Building  
Location: Roof Exterior  
Finding: Additional Photos - Obstructions and Limitations  
Information: These photographs are an indication of the obstructions and limitations which impeded full inspection of the property at the time of inspection. These obstructions can hide an array of defects and should be removed to allow full inspection to be carried out. A re-inspection is recommended once the areas are made accessible.

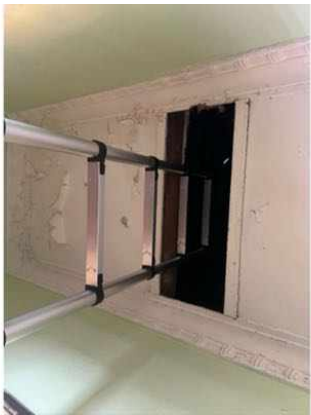
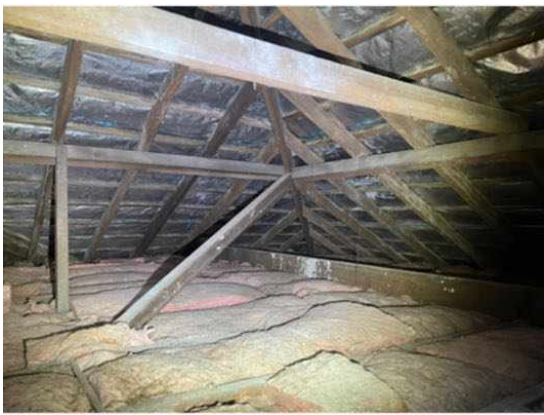
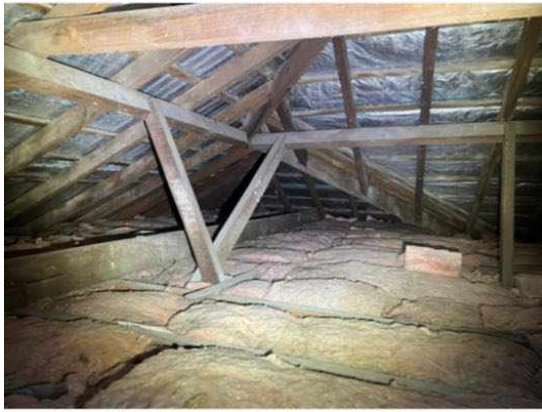
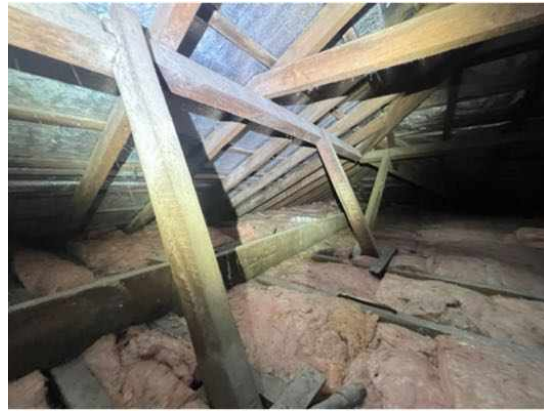
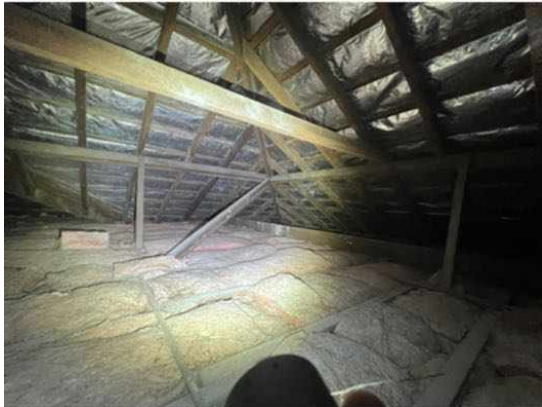
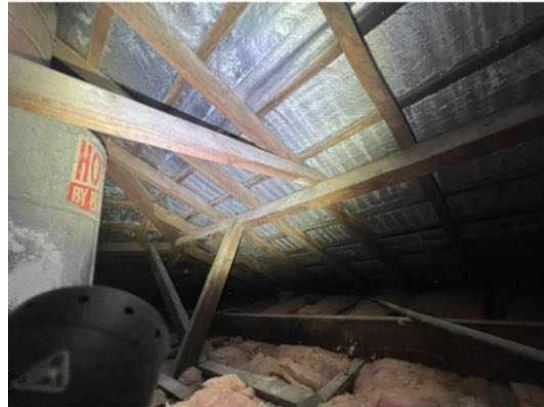
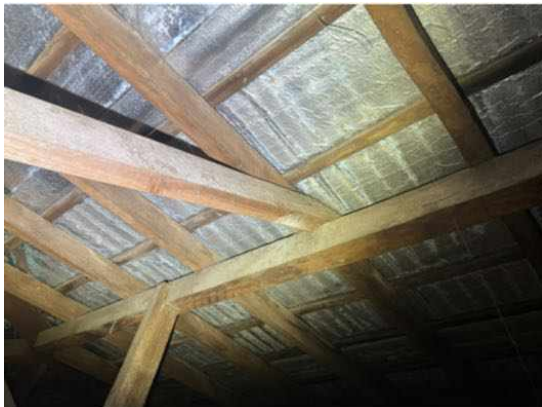
Building: Main Building  
Location: Roof Void  
Finding: Additional Photos - Obstructions and Limitations  
Information: These photographs are an indication of the obstructions and limitations which impeded full inspection of the property at the time of inspection. These obstructions can hide an array of defects and should be removed to allow full inspection to be carried out. A re-inspection is recommended once the areas are made accessible.

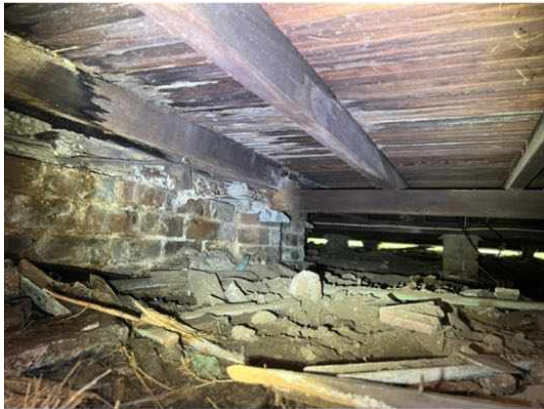
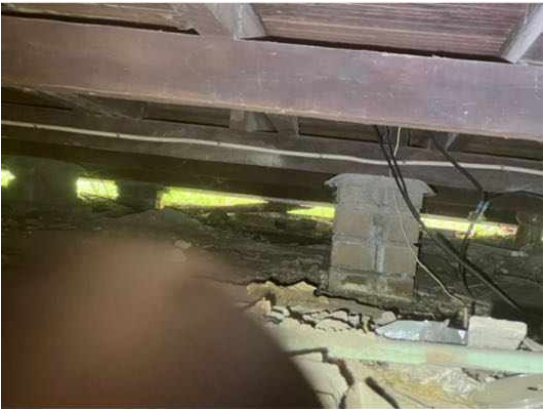
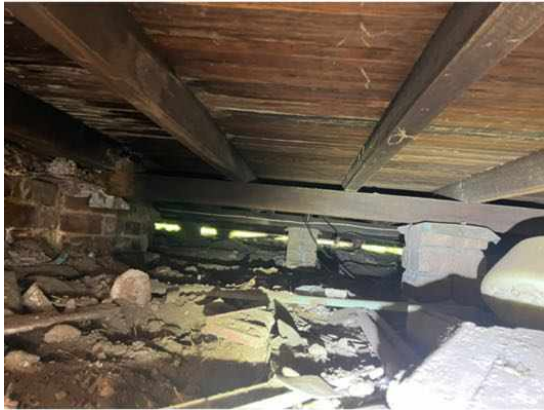
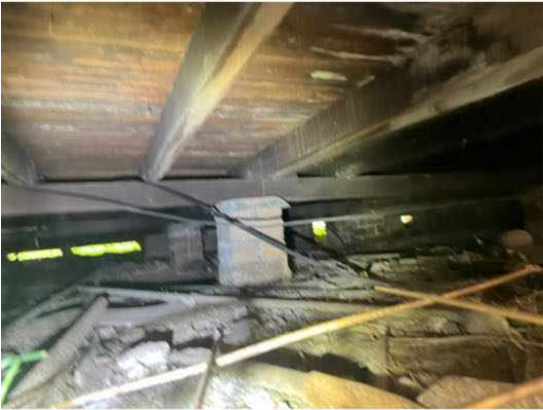
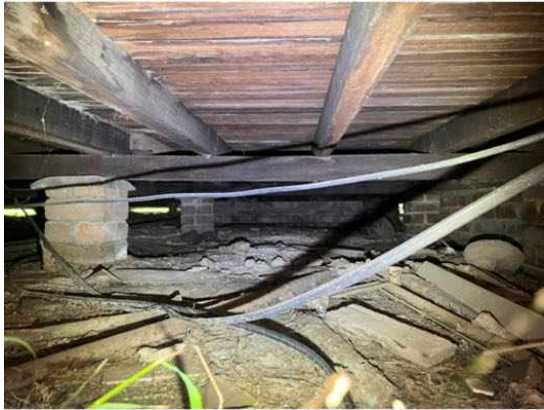
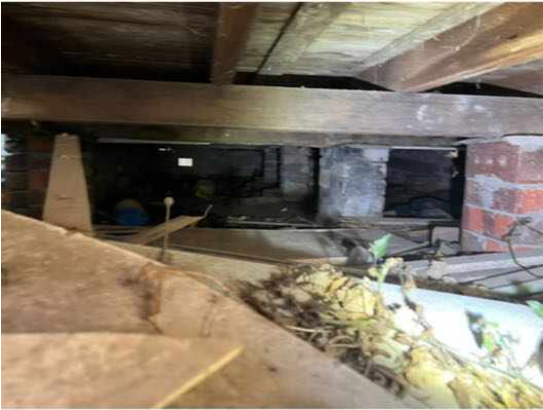
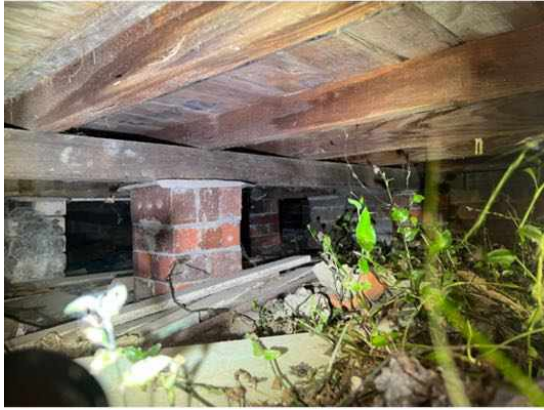
Building:	Main Building
Location:	Subfloor
Finding:	Additional Photos - Obstructions and Limitations
Information:	These photographs are an indication of the obstructions and limitations which impeded full inspection of the property at the time of inspection. These obstructions can hide an array of defects and should be removed to allow full inspection to be carried out. A re-inspection is recommended once the areas are made accessible.
