Building and Timber Pest Inspection Report

Inspection Date: Tue, 3 Mar 2026

Property Address: 31 Debrincat Avenue, North St Marys, NSW
2760

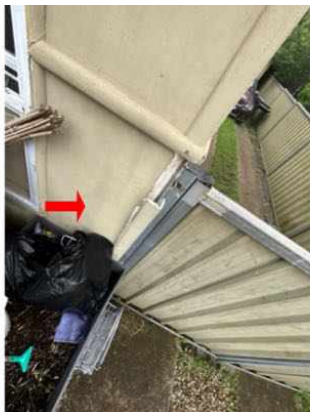
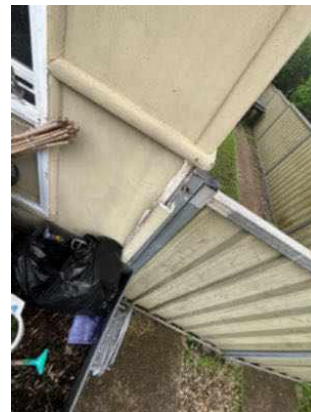
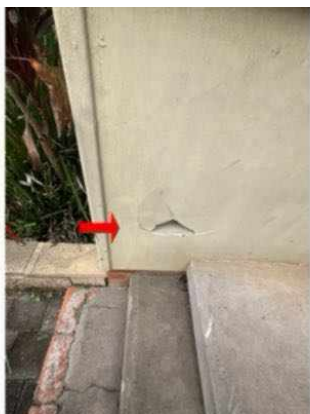
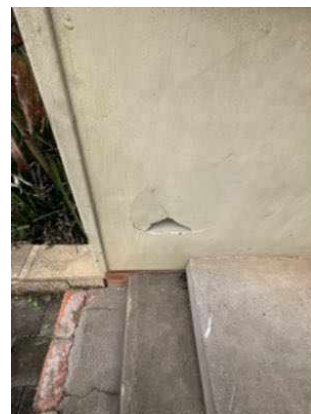
Building:	Main Building
Location:	All Areas
Finding:	Asbestos - Suspected ACM Identified on Site
Information:	Reporting on Asbestos is outside the Scope of this Report. This suspected defect is highlighted as a caution only. We suspect, based on our experience in the building industry, that there is a higher risk of the identified building element containing asbestos.

As Asbestos Reporting is outside the scope of this report, we advise that you consider a separate Asbestos Inspection and Condition Audit, which can include the taking of samples for definitive confirmation of the presence of Asbestos.

In the interim, the client is advised to act with caution, especially when considering any damage to building materials general wear and tear renovations extensions demolition and general maintenance activities due to the suspected presence of Asbestos.

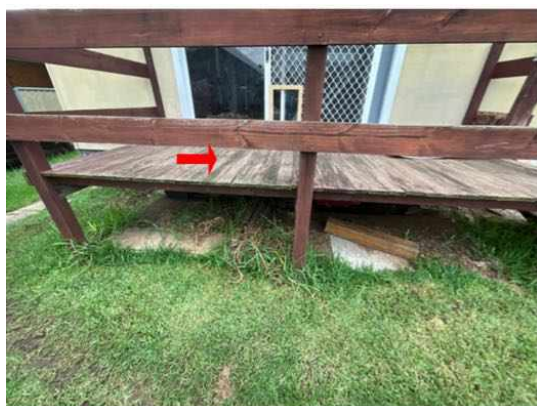
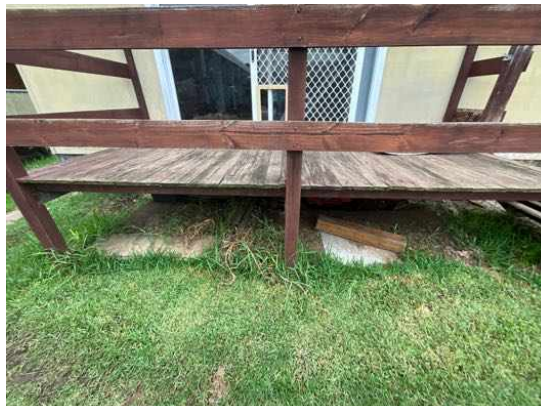
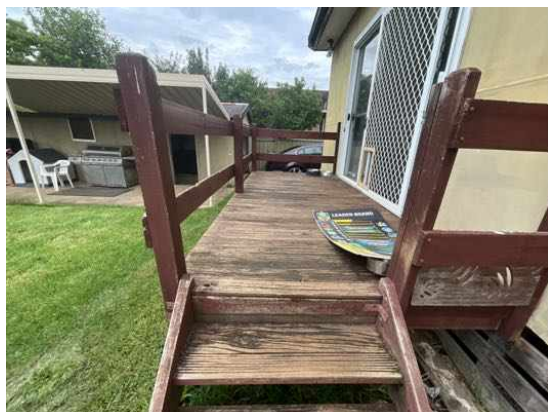
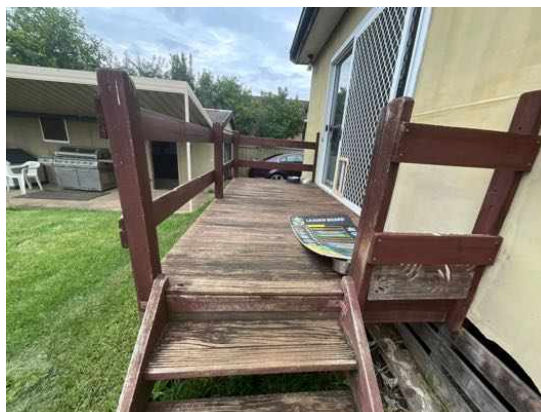
Finding 1.02

Building:	Main Building
Location:	Deck
Finding:	External timber balcony or deck-structural stability
Information:	The load capacity of the external balcony or deck could not be verified during the inspection.

External timber structures are also constantly exposed to weather deteriorates in an exhilarate manner, ongoing assessments are required.

It is highly recommended that a structural engineer further, assess the external timber balcony or a deck to inform the client of its load capacity.

Regular maintenance inspections by competent practitioners is needed.

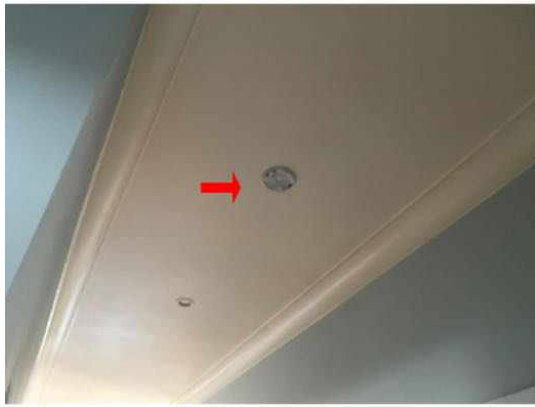
Finding 1.03

Building:	Main Building
Location:	All Areas
Finding:	Smoke Detectors and Alarms
Information:	Reporting on Smoke Detectors or Alarms, including hard wired smoke detection systems and their legislative requirements, is outside the Scope of this Report.

Please note that this defect is highlighted as a caution only. We suspect, based on our experience in the building industry, that the absence of smoke detectors, or their poor condition, should be addressed as a matter of urgency to improve occupant safety.

Always ensure sufficient working and suitable smoke detectors are installed prior to occupying any building. Additionally, it is advised that all smoke detectors be tested by the homeowner on a monthly basis.

Please refer to AS3786 and state based legislation, which may also apply.

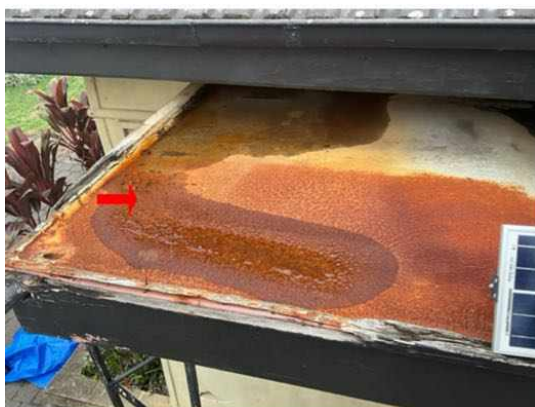
Finding 2.01

Building:	Main Building
Location:	All Areas
Finding:	Roof Weathered
Information:	Upon inspection of the exterior roofing, the majority of roof was not in a fair condition. While weathering of the roof is consistent with the age of the property, maintenance works are required.

Isolated areas of mortar have come loose in the valleys and minor cracking is also present. Re-pointing and re-sealing the may be considered as an interim solution by the client to help preserve and extend the life span of the tiles.

Where left unmanaged, deteriorating roof are likely to lead to a number of secondary defects, including minor water leaks and weather exposure to internal roofing structures.

Consultation with a roofing contractor is highly advised to gain advice on cost of remedial works that may be required in the short to medium term. Remedial works are likely to increase the longevity of the exterior roofing structure.

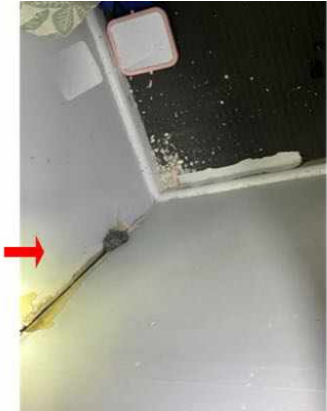
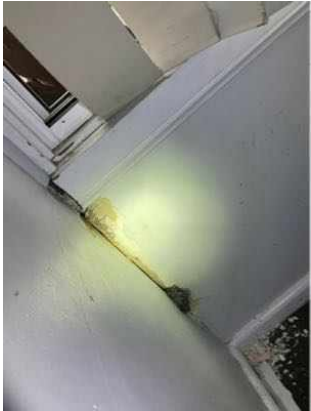
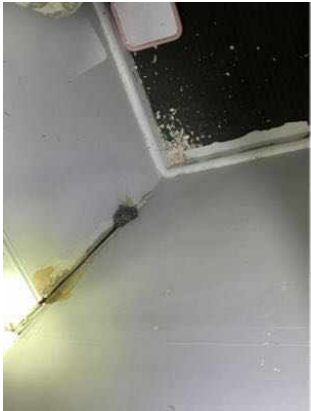
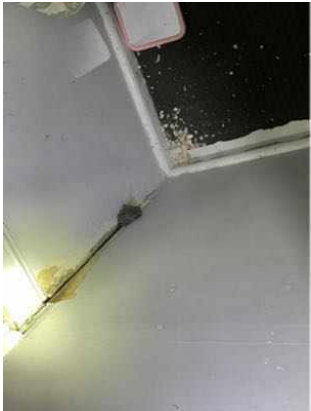
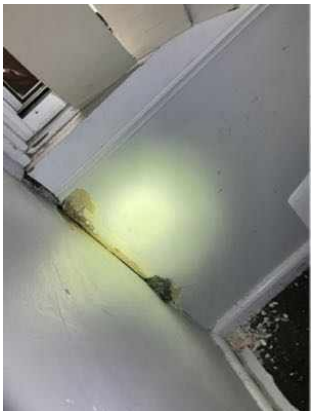
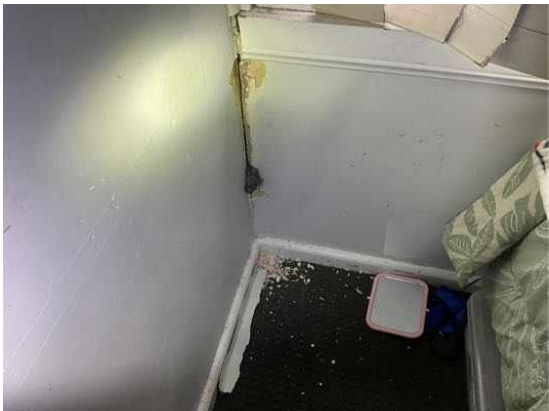
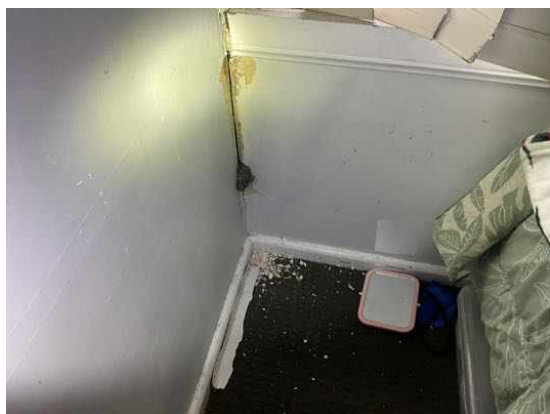
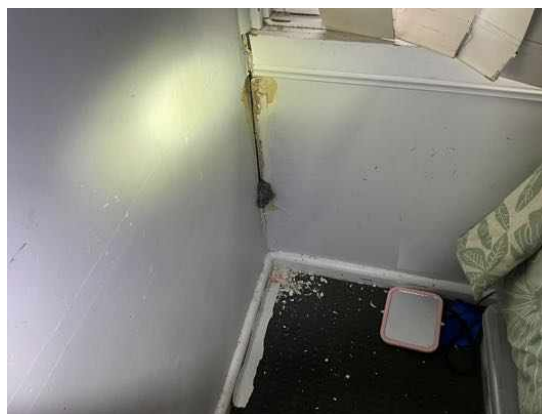
Finding 2.02

Finding: Water damage

Information: The area has sustained water damage resulting in potential structural issues. This damage compromises both the aesthetic and functional aspects.

1 ****Plumber:**** If the water damage is due to plumbing issues, a plumber can fix leaks and ensure there are no further water-related problems.

2 **General Contractor:** If the damage is extensive and affects the surrounding area, a general contractor can coordinate the repair work, including any related structural or cosmetic repairs.

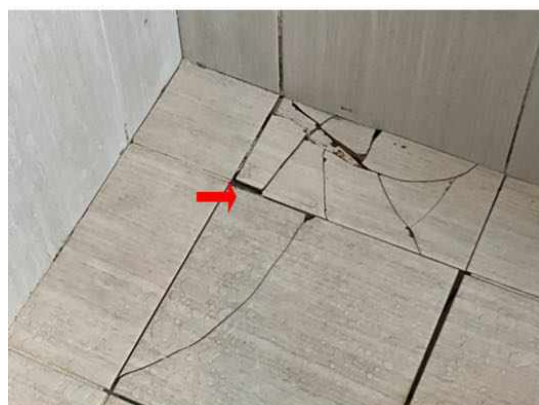
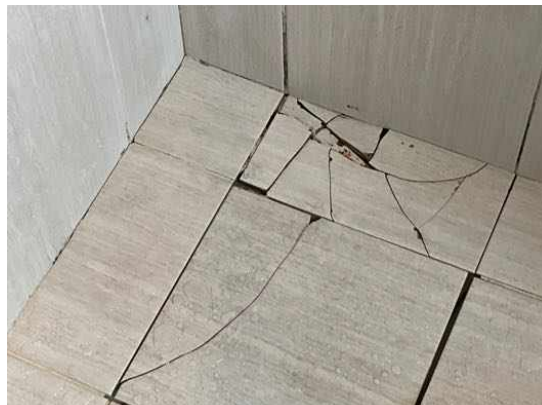
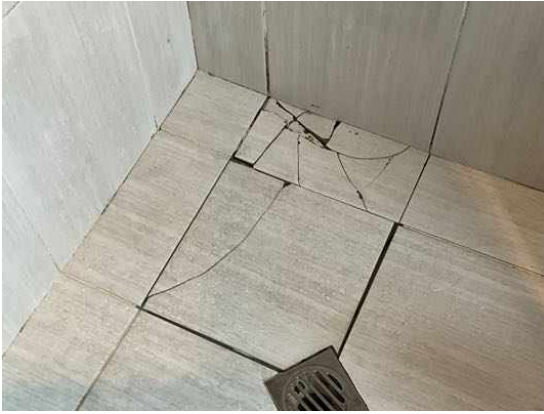
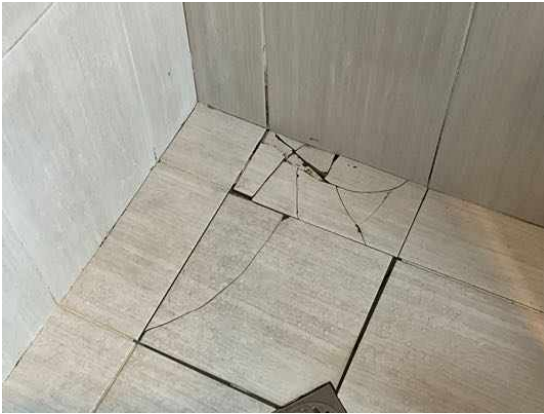
Finding 2.03

Finding: Tiles - shower Cracked floor tile

Information: A floor tile within the shower area is severely cracked, showing multiple fracture lines extending from the centre. This indicates either substrate movement, inadequate tile bed support, or impact damage. The defect compromises the waterproofing integrity of the wet area.

Cracked tiles in wet areas allow water penetration beneath the surface, potentially causing damage to the waterproof membrane, tile adhesive failure, and water seepage to adjoining areas. If left unrepaired, it may result in mould growth and structural moisture damage.

Engage a licensed tiler to remove and replace the damaged tile(s). The underlying substrate and waterproof membrane should be inspected and repaired if damaged, in accordance with AS 3740 Waterproofing of domestic wet areas.

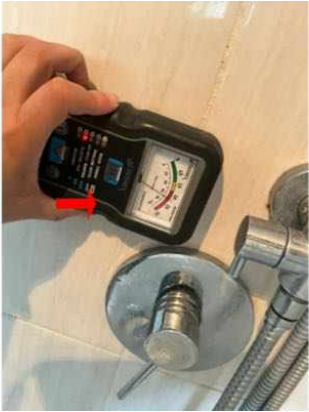
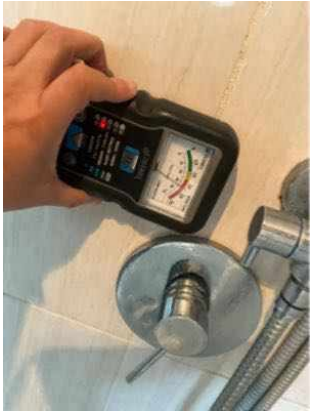
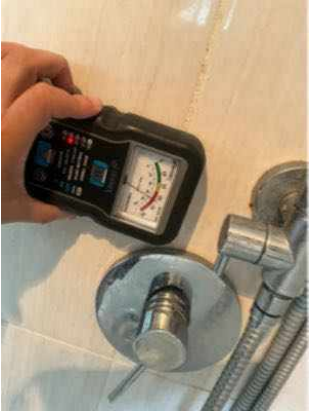
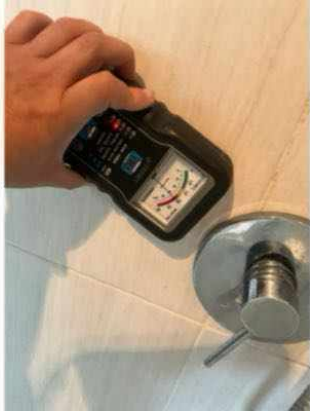
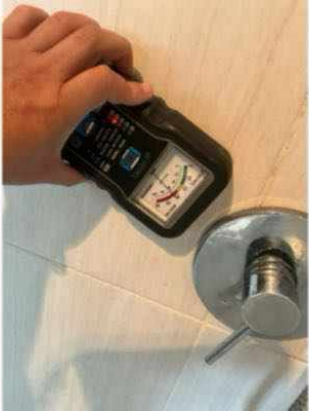
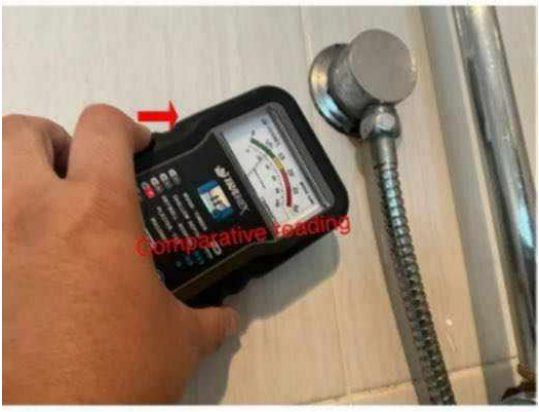
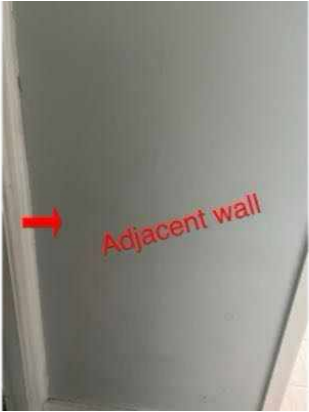
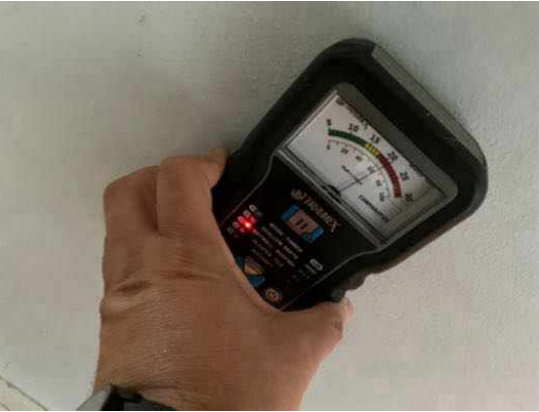
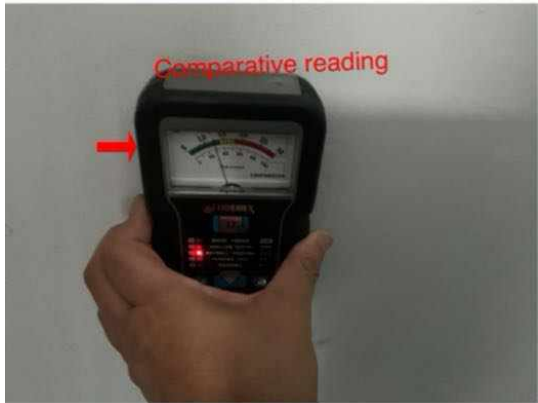
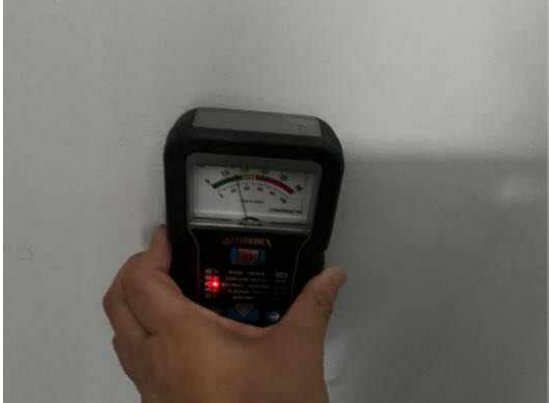
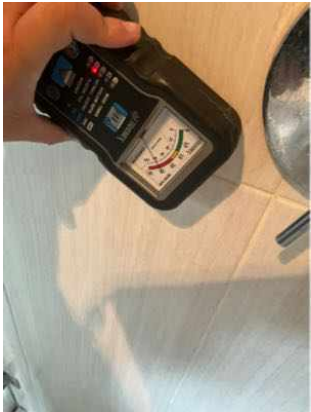
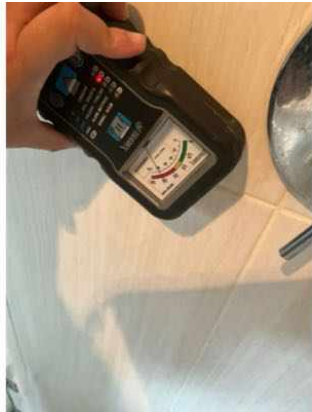
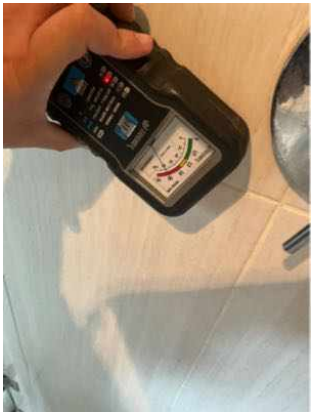
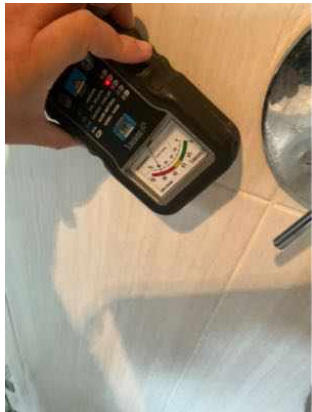
Finding 2.04

Building:	Main Building
Location:	Bathroom
Finding:	Evidence of excessive moisture was present at the time of inspection
Information:	Excessive moisture is present behind the bathroom tiles, indicating a potential water leakage issue within the wall.

The prolonged presence of moisture can lead to mold growth, deteriorate the structure, and create an environment conducive to health hazards. Additionally, it may compromise the adhesive holding the tiles, leading to their detachment.

A licensed plumber or a qualified contractor specializing in water damage remediation should investigate the source of the moisture, fix any leaks, and address the damage. Additionally, replacing affected tiles and ensuring proper waterproofing are crucial to preventing future issues.

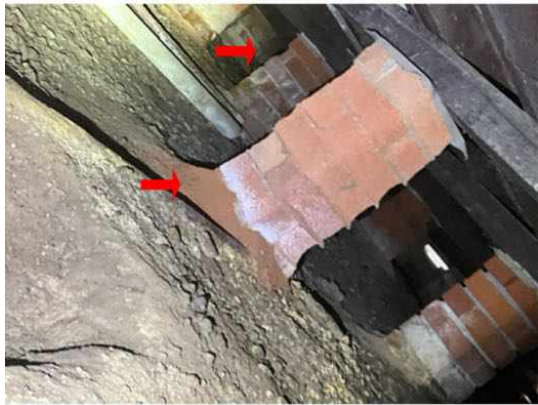
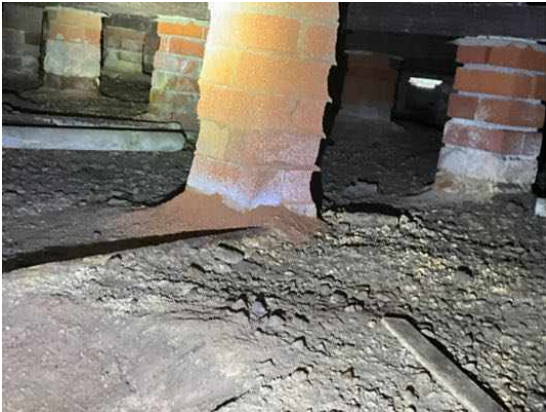
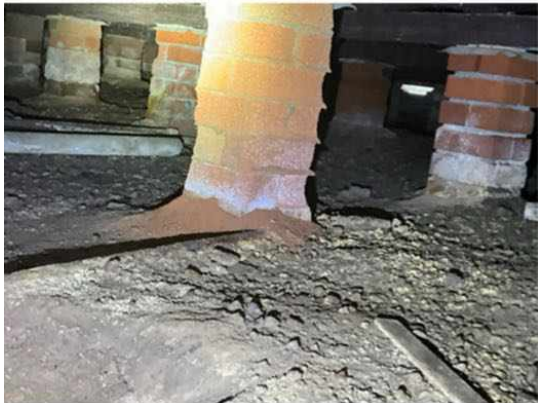
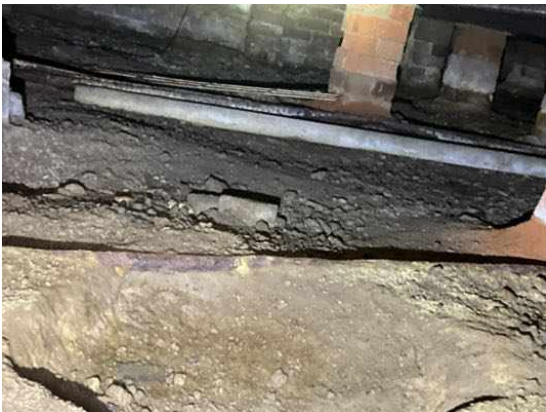
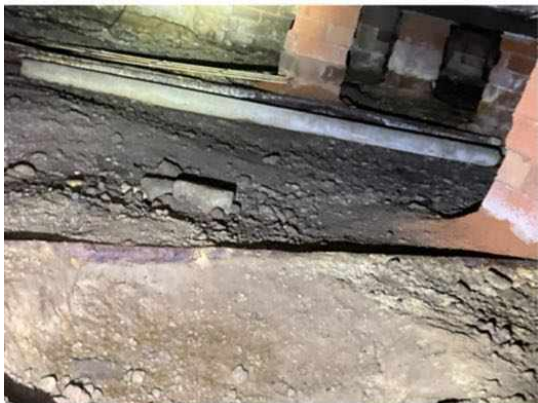
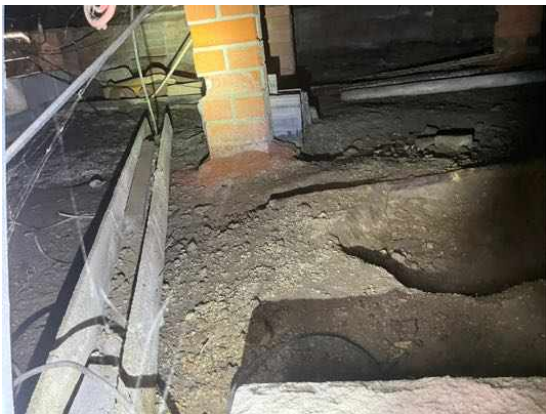
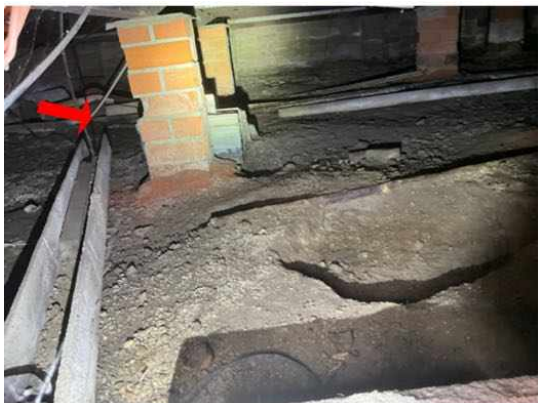
Building:	Main Building
Location:	Subfloor
Finding:	Subfloor Piers - Unstable or deteriorated
Information:	Piers to the subfloor structure are unstable, indicating that their structural integrity has been affected. The cause of this instability is likely to be movement by which piers deteriorate at a rapid rate.

The piers are suspected to be failing in their structural purpose, which is likely to lead to a range of major and minor defects. Further (potentially major) damage to the piers and structure may be imminent if left unattended.

Appointment of a Registered Builder specialising in re-stumping is required immediately to assess the condition of the stumps and provide advice on remedial works. This defect should not be left unmanaged.

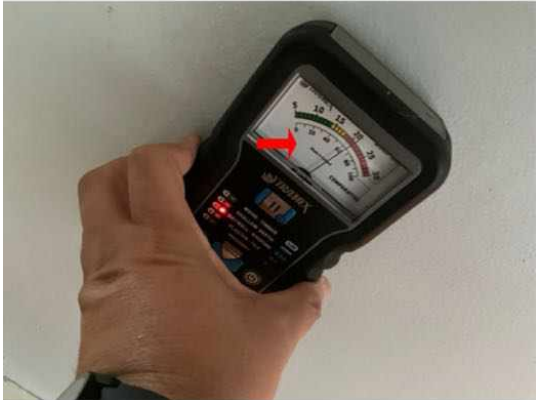
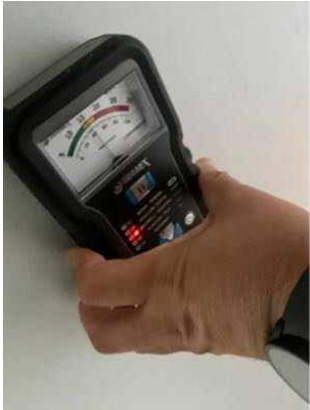
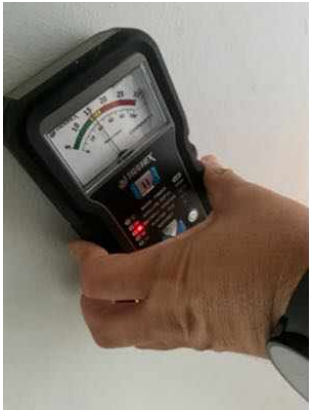
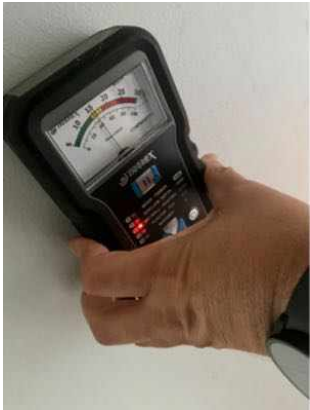
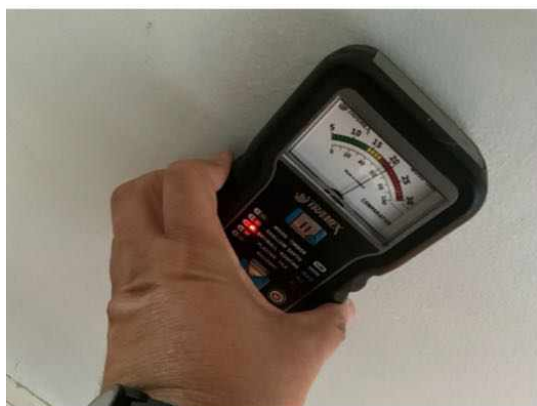
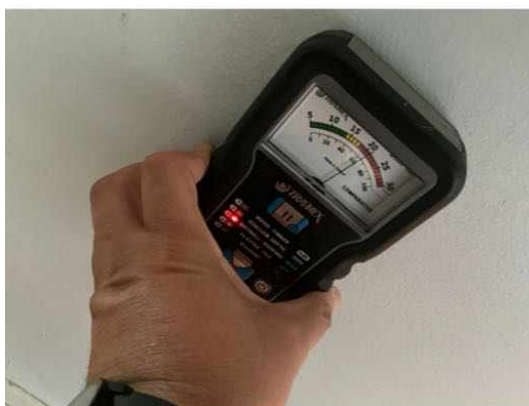
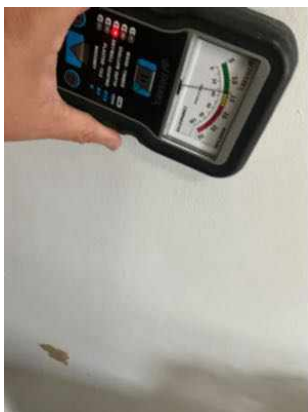
Finding 2.07

Building: Main Building
Location: All Areas
Finding: Evidence of excessive moisture - Drywall
Information: Excessive moisture is present at the time of , indicating a potential water leakage issue within the wall.

The prolonged presence of moisture can lead to mold growth, deteriorate the structure, and create an environment conducive to health hazards. Additionally, it may compromise the adhesive holding the tiles, leading to their detachment.

A licensed plumber or a qualified contractor specializing in water damage remediation should investigate the source of the moisture, fix any leaks, and address the damage. Additionally, replacing affected tiles and ensuring proper waterproofing are crucial to preventing future issues.

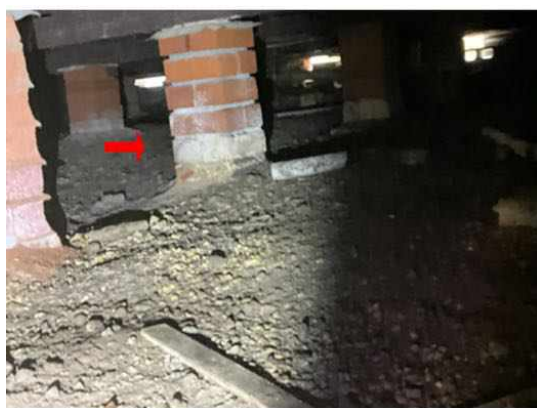
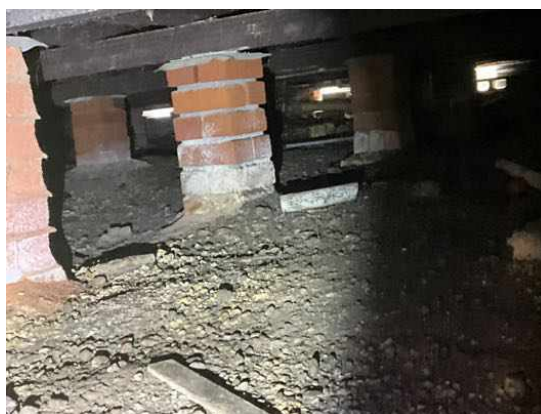
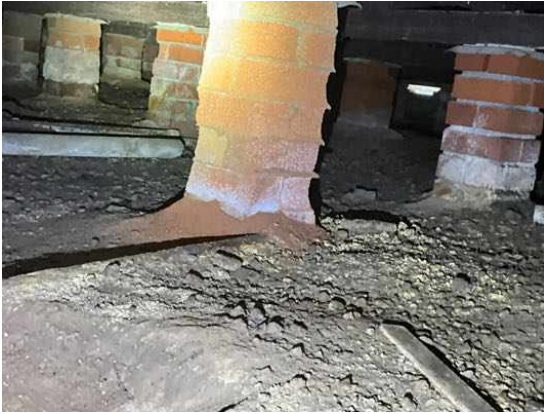
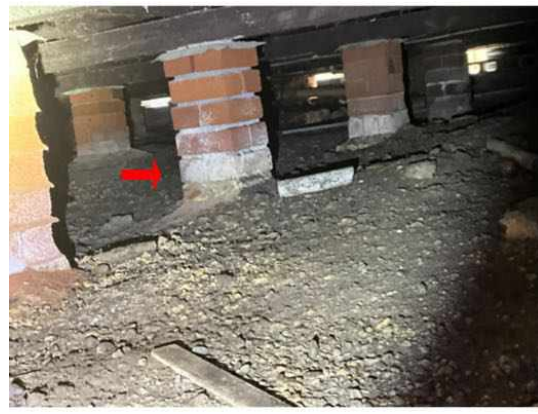
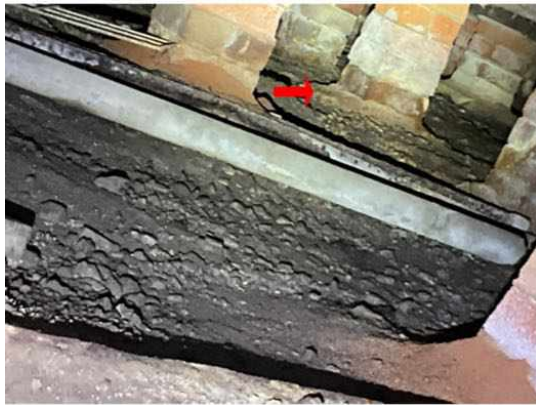
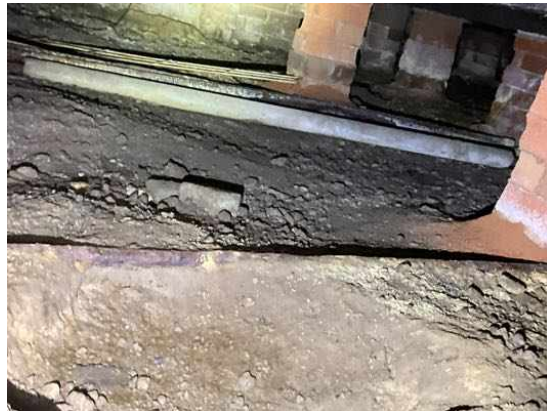
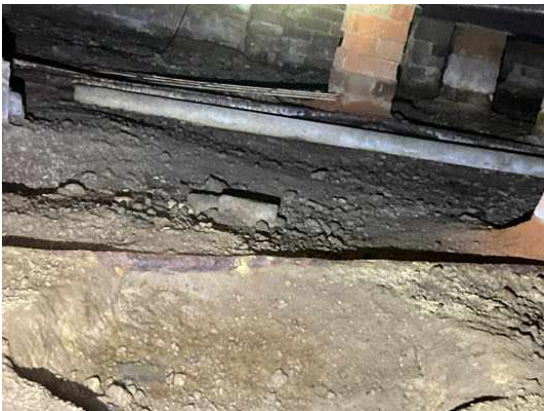
Finding 2.08

Building: Main Building
 Location: Subfloor
 Finding: Rising Damp - Subfloor
 Information: Rising damp has been identified in the subfloor area. This condition is characterized by moisture seeping upward through the foundation and into the subfloor structures. The presence of dampness has been confirmed by visible signs such as discoloration, efflorescence, and potential mold growth on the lower sections of walls and subfloor timbers.

1. Structural Damage: Prolonged exposure to moisture can weaken the structural integrity of timber and masonry, potentially leading to rot, decay, and compromised load-bearing capacity.
2. Health Hazards: Damp conditions can foster the growth of mold and mildew, which can cause respiratory issues, allergies, and other health problems for the occupants.
3. Decreased Property Value: Rising damp can significantly reduce the property's value and appeal to potential buyers.
4. Increased Energy Costs: Damp conditions can make it more challenging to heat or

Recommended Action:

1. Identify and Address the Source: A thorough inspection should be conducted to identify the source of the rising damp. This could involve checking for inadequate drainage, poor waterproofing, or damage to the damp-proof course (DPC).

2. Improve Drainage: Ensure that the property has adequate drainage systems in place to divert water away from the foundation. This may involve installing or repairing gutters, downpipes, and surface drains.

3. Damp-Proofing: Implement appropriate damp-proofing measures such as the installation or repair of a damp-proof course or damp-proof membrane. In some cases, chemical damp-proofing injections may be necessary.

4. Ventilation: Improve subfloor ventilation to reduce moisture buildup. This could involve installing additional vents or fans to promote air circulation.

5. Repair Damaged Areas: Replace or repair any timber or masonry that has been damaged by rising damp.

- Damp Proofing Specialists: Professionals who specialize in treating rising damp and implementing damp-proofing solutions.
- Plumbers: To ensure proper drainage systems are in place and functioning correctly.
- Carpenters/Builders: To repair or replace any structural elements that have been damaged by damp.

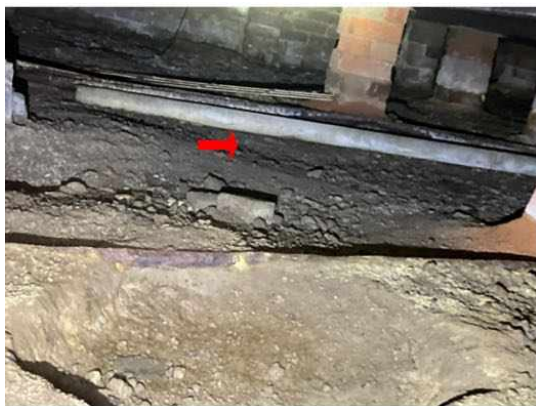
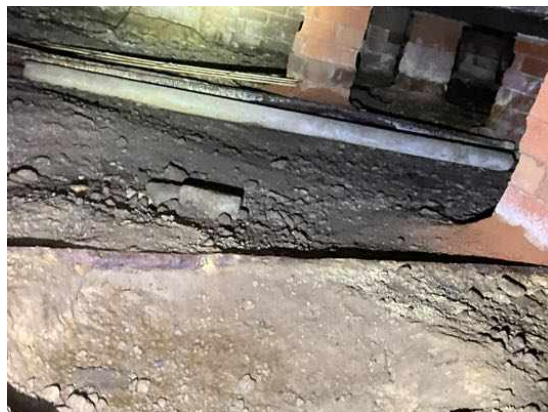
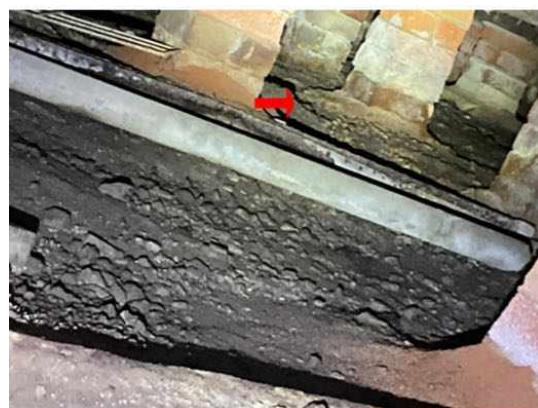
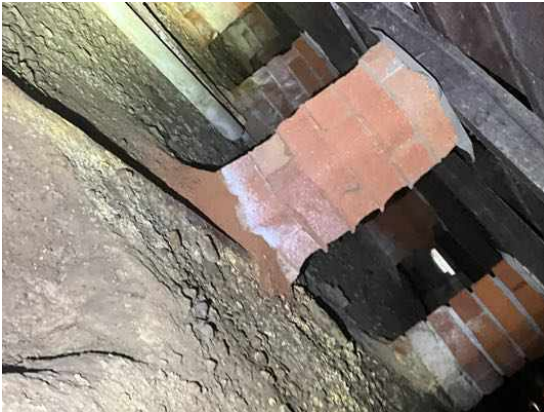
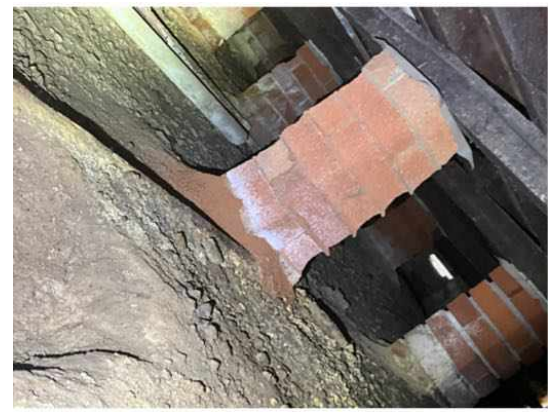
Finding 2.09

Building:	Main Building
Location:	Subfloor
Finding:	Subfloor - Site drainage - Inadequate
Information:	The site exhibits poor drainage under the subfloor, leading to several critical issues. Water accumulates and does not properly drain away from the subfloor area, creating a hazardous condition.
Problem:	1. Frequent water pooling and stagnation under the subfloor.

2. Risk of subfloor structural damage due to prolonged moisture exposure.
3. Potential for mold and mildew growth, compromising indoor air quality and a potential of Termite attack.
4. Safety hazard for occupants due to slippery surfaces and potential electrical hazards.

The poor site drainage under the subfloor poses a significant safety risk to the occupants, as it can lead to structural damage and health hazards.

This issue requires immediate attention and rectification. A licensed and experienced plumber or licensed builder specialising in drainage and foundation work should be engaged to assess the problem and implement necessary drainage solutions, such as improved grading, installation of drainage systems, and moisture barrier enhancements. Regular maintenance and inspections should also be scheduled to prevent future occurrences. Water damage and secondary defects are likely to occur if left unmanaged.

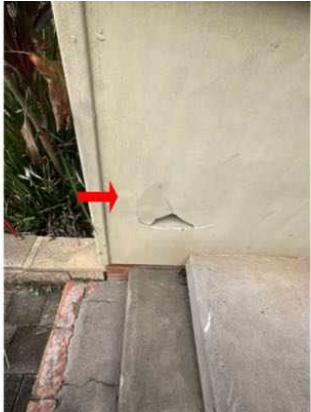
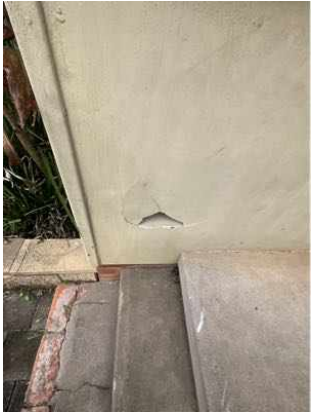
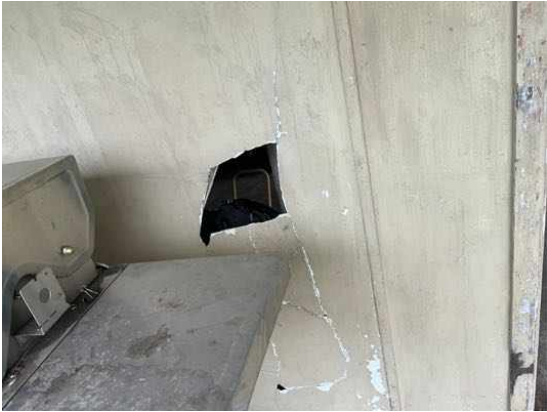
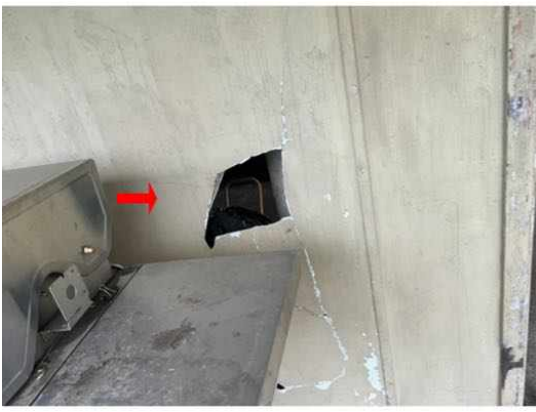
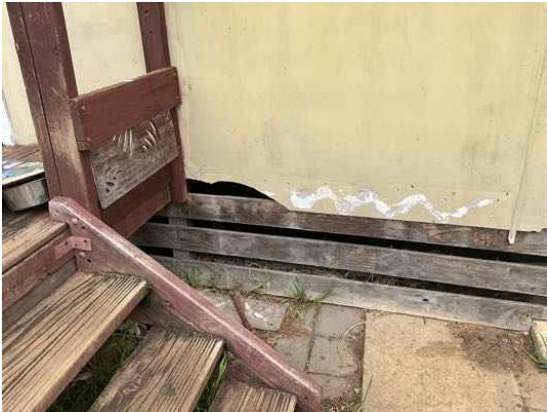
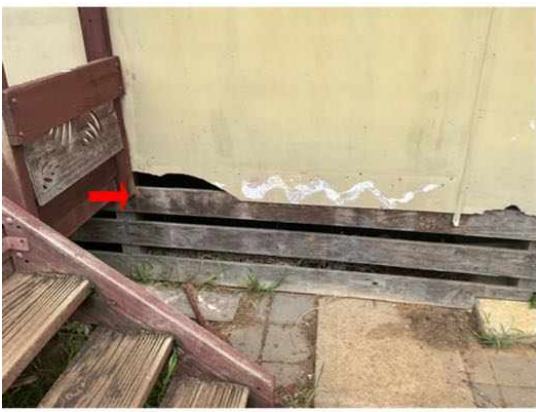
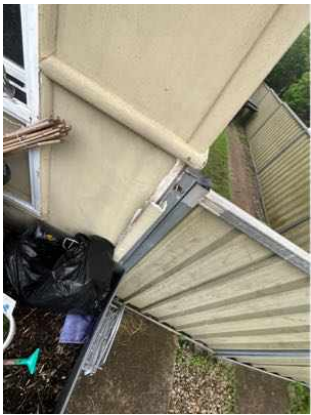
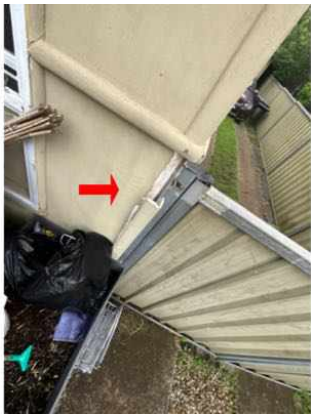
Finding 3.01

Building:	Main Building
Location:	All Areas
Finding:	Damaged Cladding
Information:	The cladding is damaged, displaying cracks, peeling, and disintegration, compromising its structural integrity and aesthetic appeal.

1. Structural instability: The damaged cladding can weaken the structure, leading to potential collapse or safety hazards.
2. Water ingress: Gaps in the cladding allow water to penetrate, leading to moisture damage, mold growth, and potential deterioration of the underlying structure.
3. Aesthetic degradation: Damaged cladding diminishes the visual appeal of the building, affecting its market value and reputation.

A qualified construction contractor specializing in cladding repair and replacement can fix the damaged cladding. Additionally, an architect or structural engineer may be required to assess the extent of the damage and recommend appropriate repair methods.

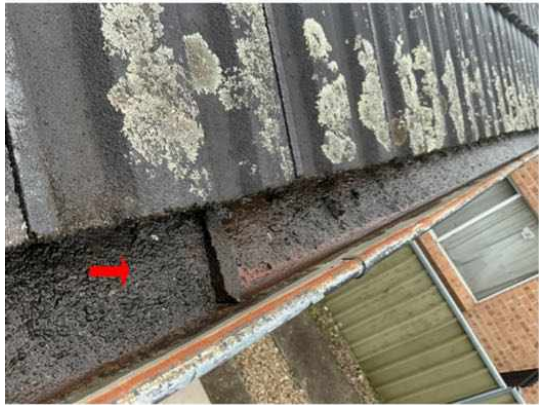
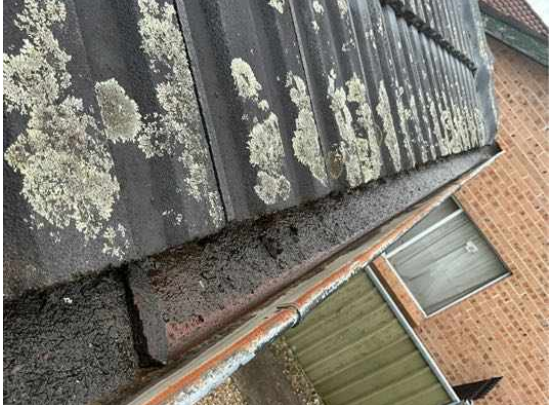
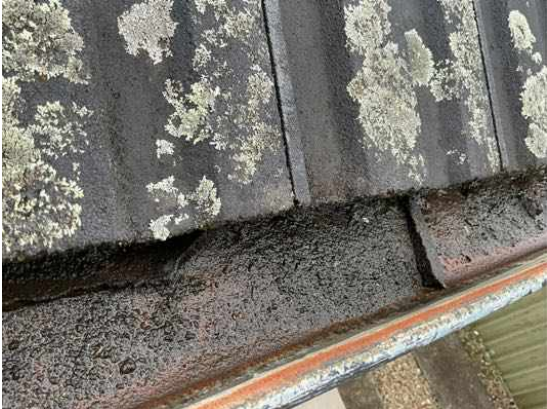
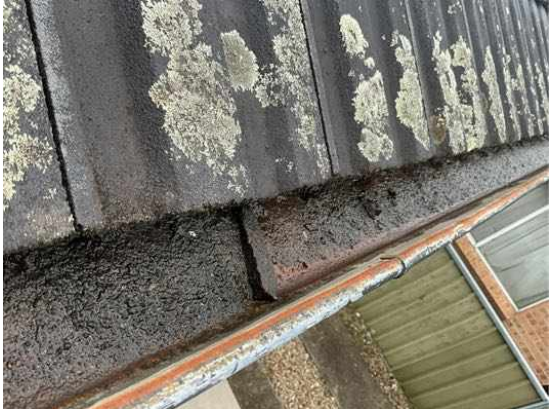
Finding 3.02

Building: Main Building
Location: All Areas
Finding: Blocked Gutters
Information: Blocked gutters , observed vegetation grown in the gutter , advised gutter to be cleaned.

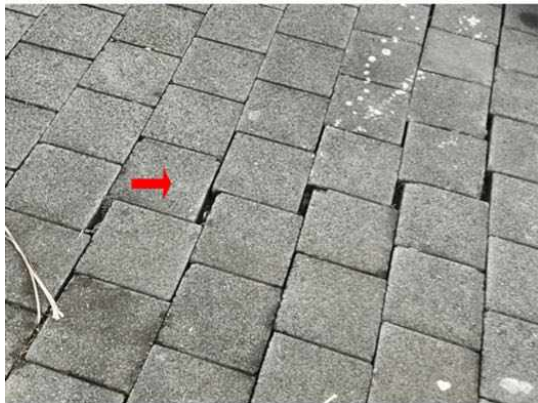
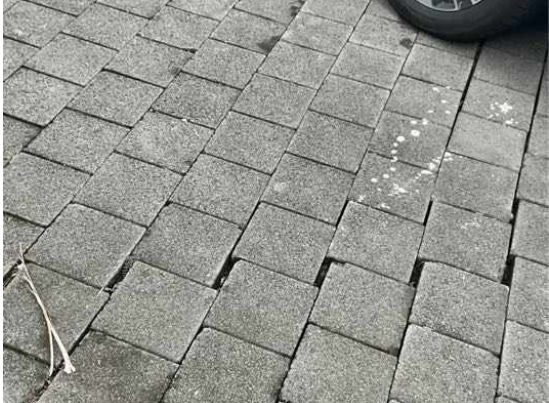
Finding 3.03

Building: Main Building
 Location: All Areas
 Finding: Pavers uneven and displaced
 Information: Cracked, uneven, and displaced pavers were observed. Several pavers appear loose, misaligned, or deteriorated.

Risk:
 The uneven surface poses a significant trip hazard for pedestrians and may impact the usability of the driveway. Displacement and cracking can worsen over time due to vehicle traffic, poor subbase compaction, or water ingress. Wall cracking may lead to moisture entry or structural wear if left untreated.

- Recommendation:
- A qualified paving contractor should be engaged to lift, relevel, and relay the affected pavers with proper bedding and compaction.
 - A licensed builder or bricklayer should repair and seal the masonry wall crack around the pipe to prevent further water ingress and deterioration.
 - Drainage should also be checked to ensure water is not contributing to the issue.

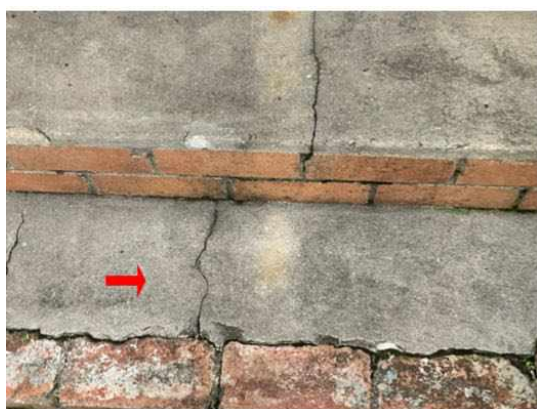
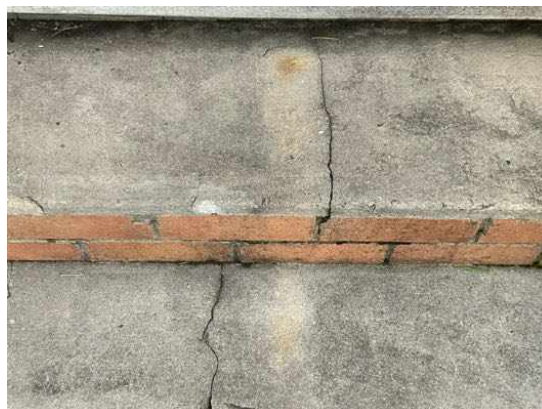
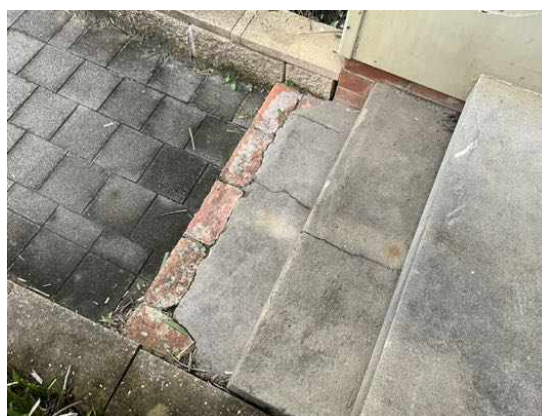
Building:	Main Building
Location:	All Areas
Finding:	Brickwork - Cracking [Fine]
Information:	Although fine cracks are quite noticeable, they are often only considered to be an appearance defect and usually do not indicate any structural damage. Generally, the cause of a fine crack is indicative of a separation between brickwork and mortar throughout the structure, but single bricks may also show cracks of this nature.

Cracking of this nature can generally be repaired with minor filling and should be conducted by a qualified bricklayer.

Always contact a building inspector should cracks widen lengthen or become more numerous.

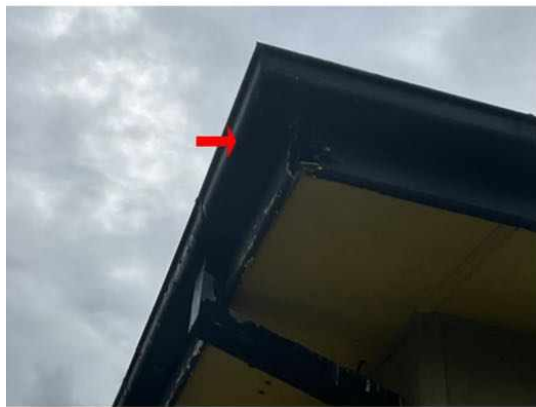
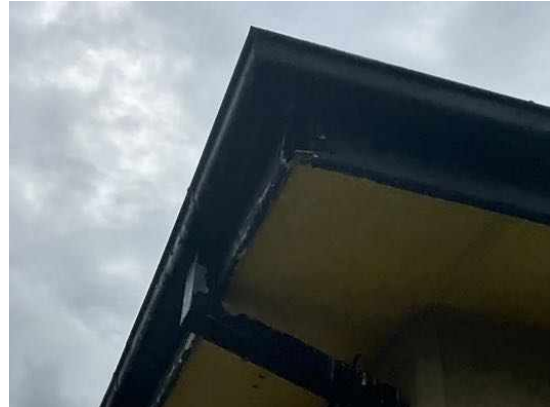
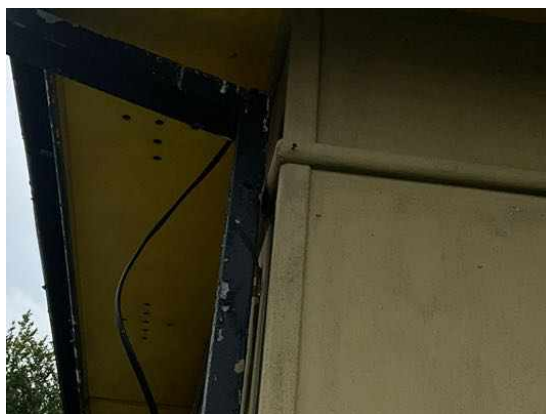
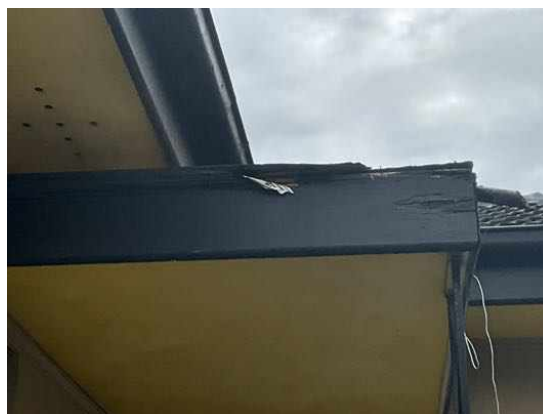
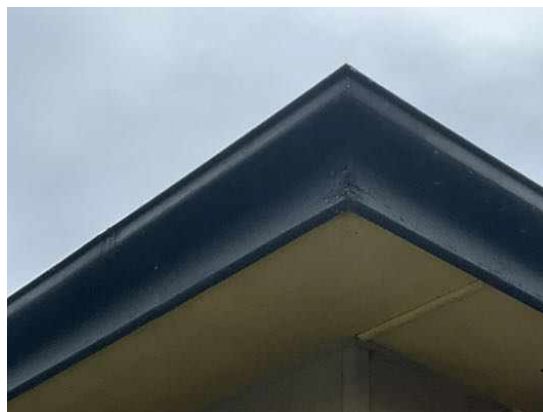
Finding 3.05

Building:	Main Building
Location:	All Areas
Finding:	Fascias - Wood rot
Information:	Wood rot was found to be affecting fascias and barges in this area, evidenced by the presence of mould on the surface in some areas. Wood rot, also known as Fungal Decay, occurs when timbers and other cellulose building materials are exposed to damp conditions on an ongoing basis.

It is likely that this wood rot has developed as a result of faults in the roof plumbing, creating excessive moisture in this areas. Frequent exposure to rain and other weather conditions also make fascias and barges susceptible to accelerated deterioration.

Early intervention and regular maintenance will prolong the useful life of these building elements. Prior to any works being performed, the cause of the moisture that has created the visible wood rot should be identified and addressed in a suitable manner.

It is advised that a roof plumber be appointed to inspect all roof plumbing and subsequently identify the cause of the wood rot. Replacement of affected fascias and barges may then be a necessary step in protecting surrounding building elements from such deterioration.

A qualified plumber may be appointed to assess the cause of excessive moisture and to provide advice on any remedial works as required. A qualified carpenter or registered builder may also be required to replace affected building materials.

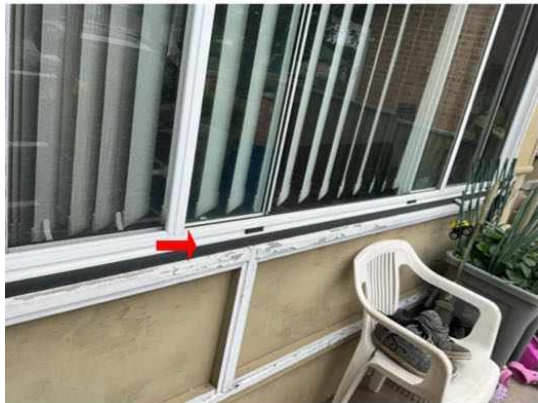
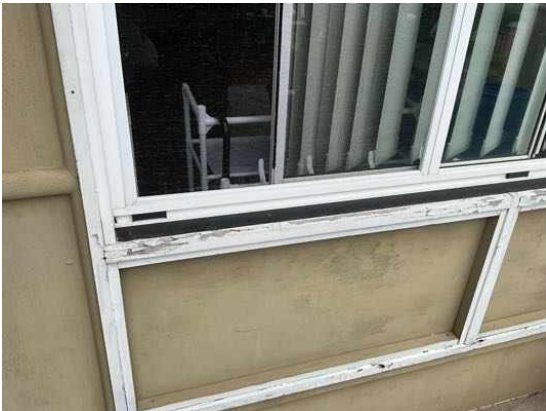
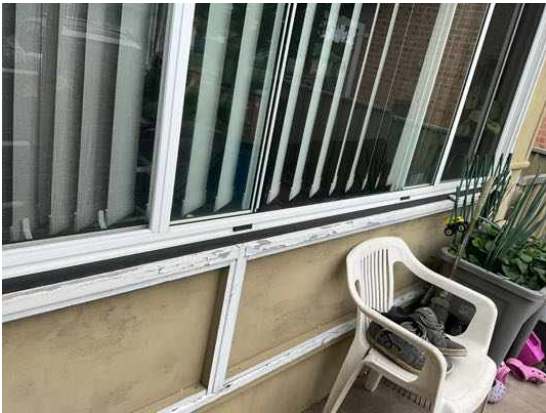
Finding 3.06

Building:	Main Building
Location:	All Areas
Finding:	Timber - exposed to weather
Information:	External timbers that are frequently exposed to harsh weather conditions require adequate protection in order to maintain their condition. Where timbers have not been painted or treated adequately, general deterioration is likely to occur at an accelerated rate.

If left unattended, replacement of these timbers is likely to be necessary in the short-term future. Adequate treatment of these timbers is required as soon as possible by a painting contractor or general handyman.

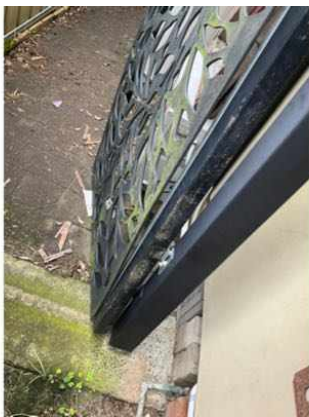
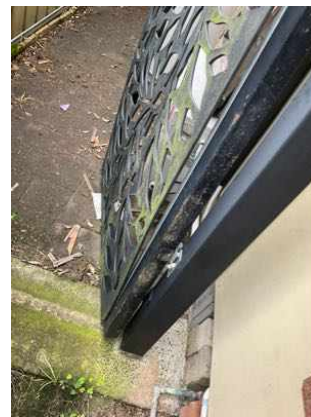
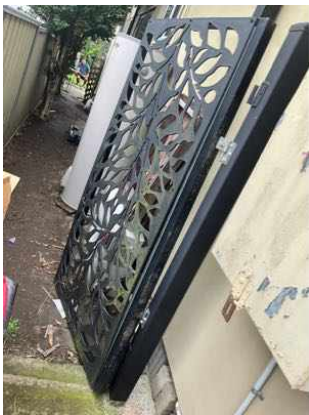
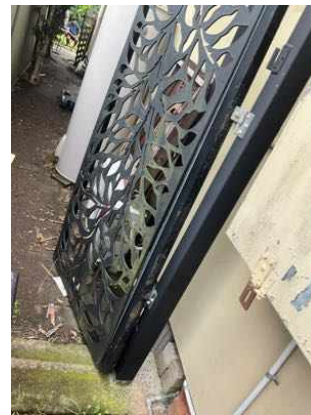
Finding 3.07

Building: Main Building
Location: Yard - Side
Finding: Gate Detached and Damaged
Information: The gate is observed to be detached from its original hinges and fencing post. The gate shows signs of corrosion, particularly at the base and hinge points. It is stored against the side boundary fence and is not operational. The supporting post appears bent and compromised, making reinstillation unfeasible without repair or replacement.

- Safety Hazard: Risk of physical injury from sharp edges or falling if disturbed.
- Security Concern: Reduced security and control of access to the property.
- Ongoing Deterioration: Continued exposure to weather will likely worsen corrosion and structural integrity.

Engage a licensed fencing contractor or metal fabricator to assess the extent of the damage. Repair or replacement of the gate and hinge mechanism is recommended to restore both security and aesthetic function. All works should comply with local fencing standards and guidelines.

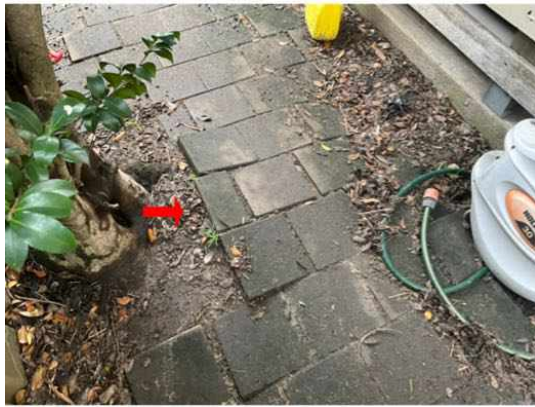
Finding 3.08

Building:	Main Building
Location:	Yard - Side
Finding:	Tree roots have uplifted & displaced the pavers
Information:	Tree roots have uplifted and displaced the pavers along the side walkway, creating an uneven surface and trip hazard. Movement appears ongoing and may impact drainage and adjacent structures. Visual inspection only as per AS 4349.1. Recommend further assessment by an arborist and rectification by a qualified paving contractor.

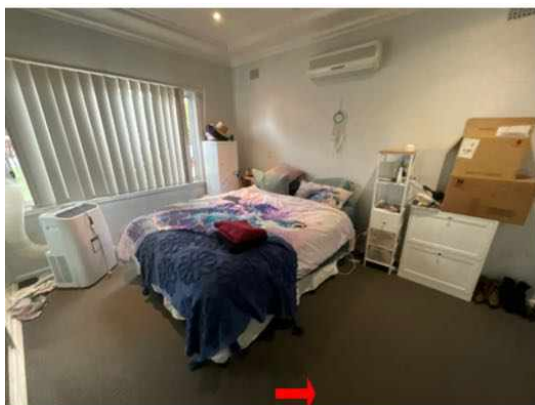
Finding 3.09

The risk associated with aging carpets includes diminished appearance, decreased comfort, potential tripping hazards due to frayed edges, and a negative impact on indoor air quality if fibers begin to degrade and release particles into the air.

Professional carpet cleaning and restoration services can address issues such as deep cleaning to rejuvenate colors, repairing frayed edges, and restoring fibers. Additionally, replacing the carpets entirely may be necessary in severe cases of aging or damage beyond repair.
