Building and Timber Pest Inspection Report

Inspection Date: Tue, 3 Mar 2026

Property Address: 31 Debrincat Avenue, North St Marys, NSW
2760

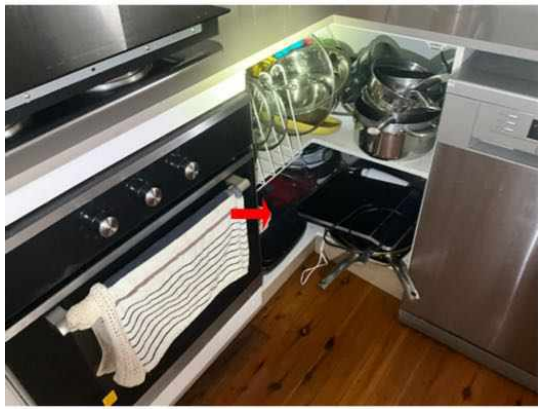
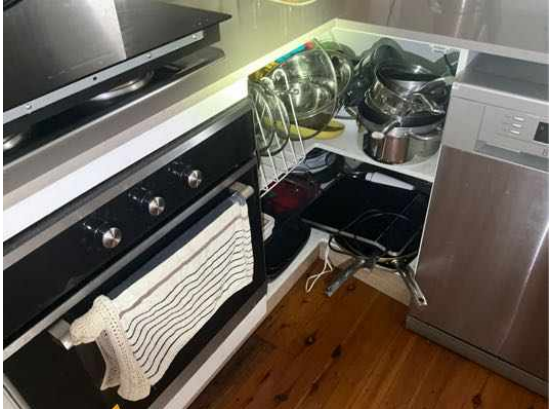
Finding 3.10

Building: Main Building
Location: Kitchen
Finding: Damaged cabinetry
Information: A damaged cabinetry poses a risk of functional issues, reduced aesthetics, and potential further deterioration if left unaddressed.

Seeking assistance from a skilled carpenter or cabinet repair specialist is advisable to assess and repair the damaged cabinet door, ensuring proper restoration and maintaining the functionality and appearance of the cabinetry.

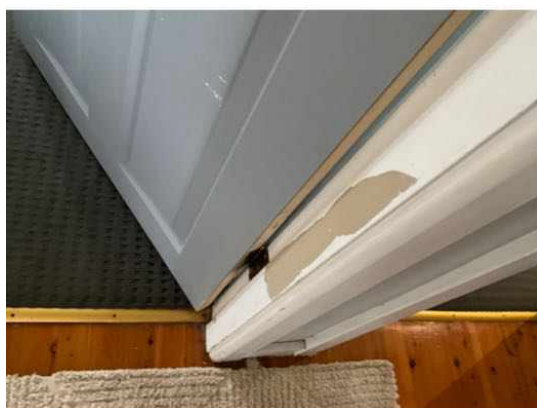
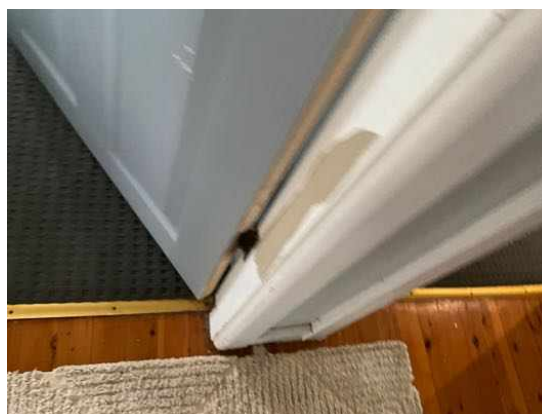
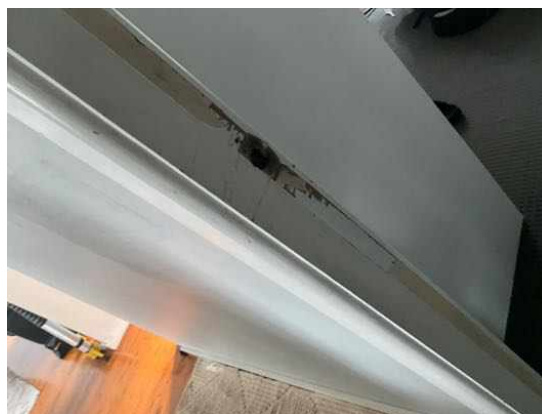
Finding 3.11

Building:	Main Building
Location:	All Areas
Finding:	Paint surface - Scratches
Information:	Scratches have been identified on the paint surface, detracting from the overall appearance and quality of the painted surface.

1. Aesthetic Degradation: Scratches mar the appearance of the painted surface, diminishing its visual appeal and potentially lowering property value.
2. Corrosion Vulnerability: Exposed areas of bare metal due to scratched paint are susceptible to corrosion, leading to structural damage and compromised durability.
3. Environmental Hazards: Scratched paint can release hazardous chemicals into the environment, posing risks to both human health and the ecosystem.

A qualified painter should address the issue promptly to repair the scratched paint. Depending on the severity of the scratches, repair options may include sanding, priming, and repainting the affected area to restore the integrity and appearance of the paint surface.

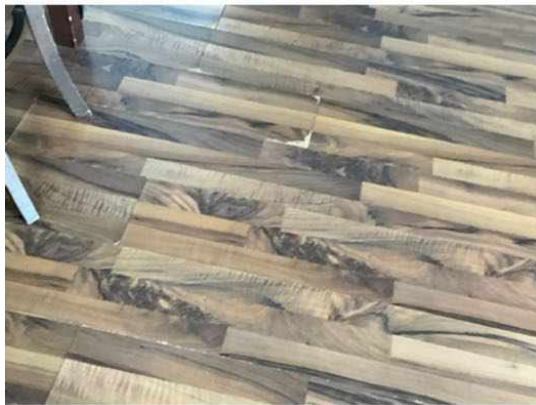
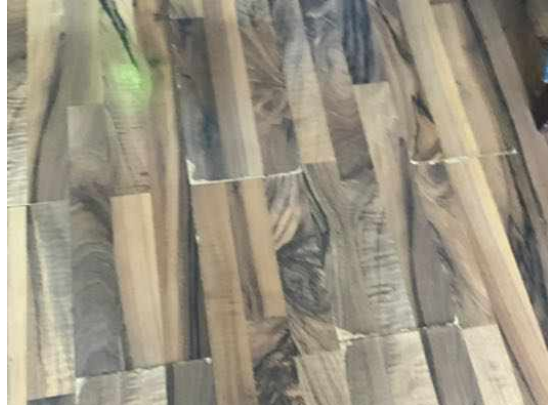
Finding 3.12

Building:	Main Building
Location:	All Areas
Finding:	Timber Floor Damage
Information:	The timber floor in the property displays visible signs of damage, including scratches, dents, or warping. This defect compromises the aesthetic appeal of the flooring and raises concerns about the long-term durability and structural integrity of the timber.

1. Aesthetic Deterioration: Visible damage diminishes the overall visual appeal of the timber floor, impacting the aesthetics of the space.
2. Structural Compromise: Severe damage, such as warping or deep scratches, may compromise the structural integrity of the timber, affecting its load-bearing capacity and stability.
3. Acceleration of Wear: Ignoring initial signs of damage can lead to accelerated wear and further deterioration, potentially necessitating costly repairs or replacements.

- Engage a professional flooring specialist or carpenter to assess the extent of the damage and recommend appropriate repair or restoration methods.

- Depending on the severity of the damage, options may include refinishing the surface to address minor issues or replacing damaged sections for more extensive damage.

- Implement preventive measures, such as placing protective pads under furniture and regularly cleaning the floor, to minimize the risk of future damage.

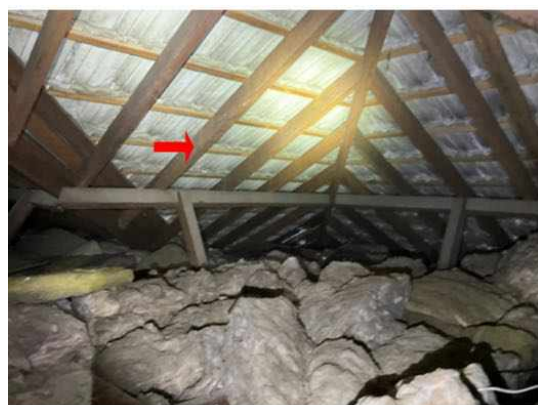
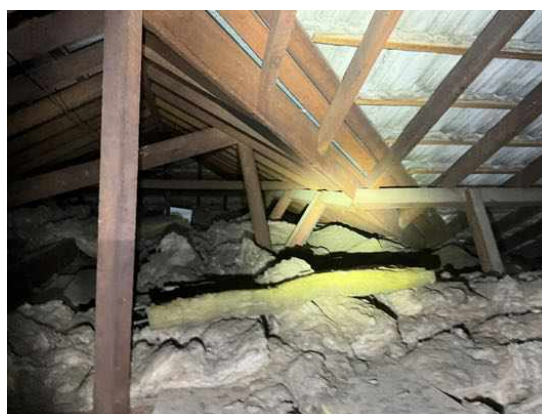
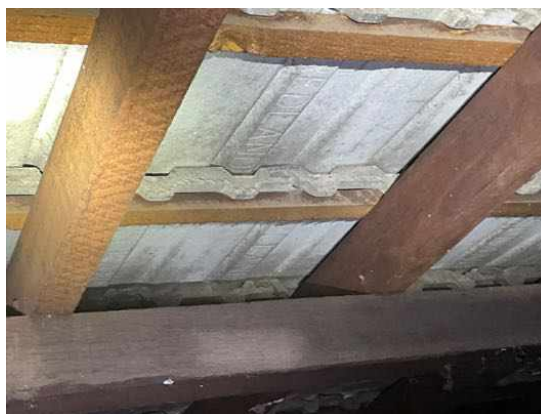
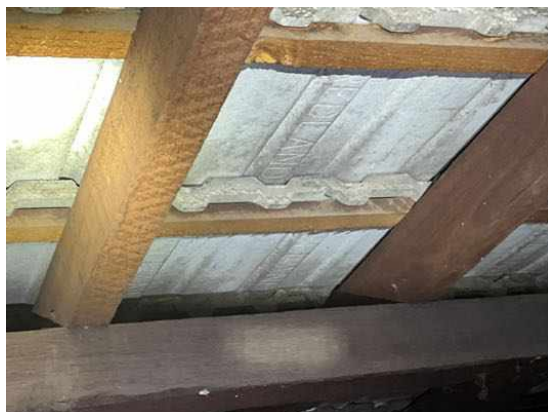
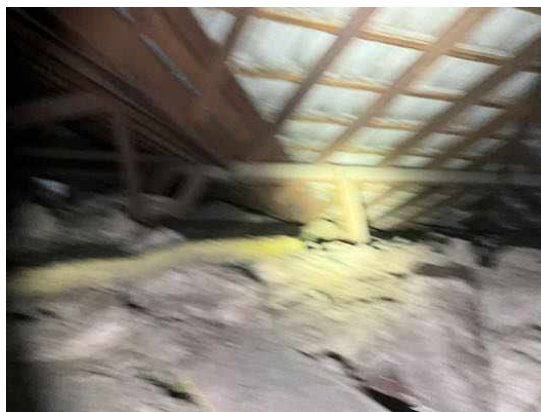
Finding 3.13

Building:	Main Building
Location:	Roof Void
Finding:	Sarking - Missing
Information:	Sarking is missing under the roof sheeting. Sarking acts as an insulator that helps with noise reduction and protects against water penetration. Sarking plays a key role in the operation and function of the overall roofing structure and its performance.

Although not a requirement at the time of construction, replacement of any missing building element is advisable (although this can be quite expensive to do after the time of construction). Where sarking is missing, regular inspections of the roof tiles for cracking and potential moisture penetration is required.

Sarking may be retrospectively fitted by a registered builder at the discretion of the client.

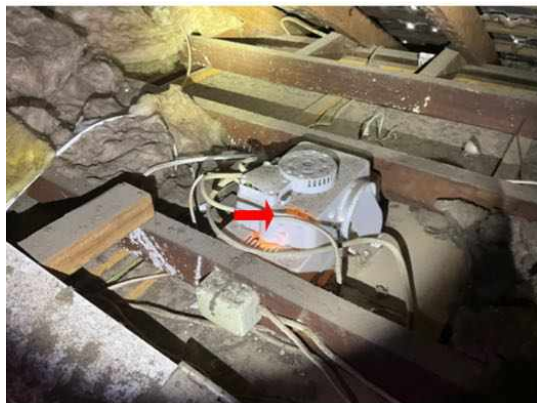
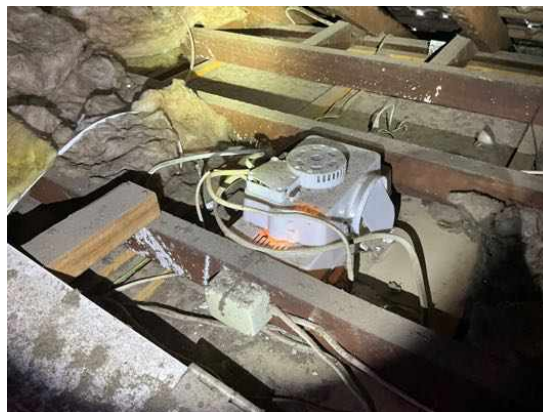
Finding 3.14

Building:	Main Building
Location:	Roof Void
Finding:	Exhaust fan not vented out
Information:	The exhaust fan located within the roof void is not appropriately ducted to the external atmosphere and is currently discharging moist air directly into the roof space. This is considered a defect under AS 4349.1, as it does not meet the minimum standard of residential building performance expected under normal residential building practices.

This condition may lead to excessive condensation within the roof void, increasing the risk of mould growth, deterioration of insulation, timber decay, and overall reduced durability of building elements. It may also result in poor indoor air quality, potentially affecting occupant health.

It is recommended that the exhaust fan be modified by a licensed HVAC contractor or qualified builder, ensuring it is properly ducted to discharge externally in accordance with manufacturer specifications, the National Construction Code (NCC), and applicable Australian Standards.

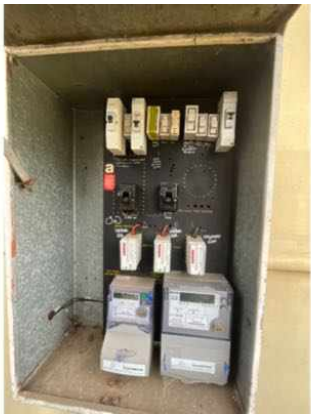
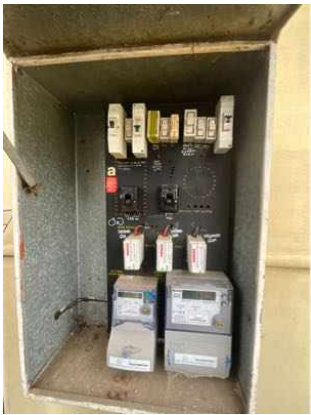
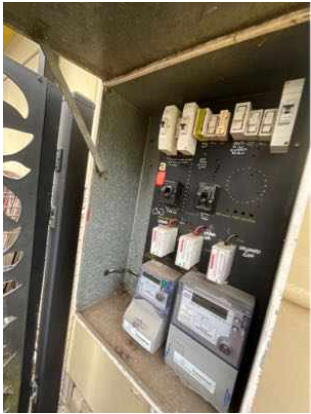
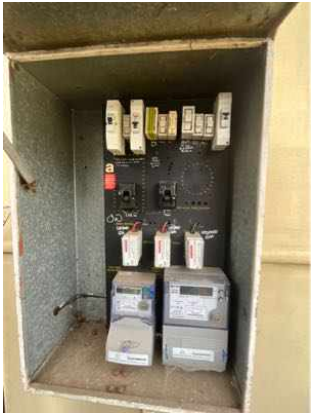
Building: Main Building
 Location: Exterior walls - left side
 Finding: No Evidence of Termite Management System - Durable notice / Legible Sticker
 Information: The application of a pre & post-construction chemical termite barrier is highly recommended for all properties. Such barriers are highly effective in preventing termite attack on any timber building elements throughout the property.

A durable notice was not placed in the switchboard unit to indicate current termite barriers is legible at the time of inspection.

Client must seek further information from the vendor or real estate agent if the conditions of termite management systems were maintained.

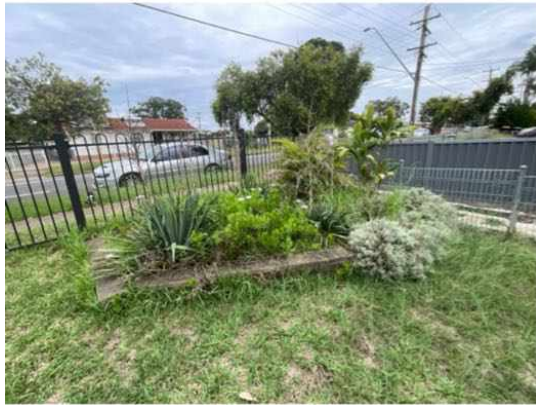
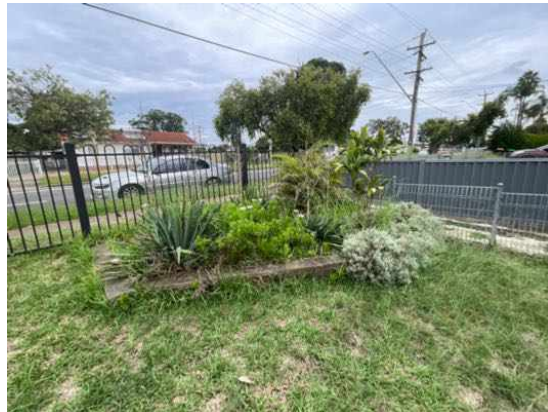
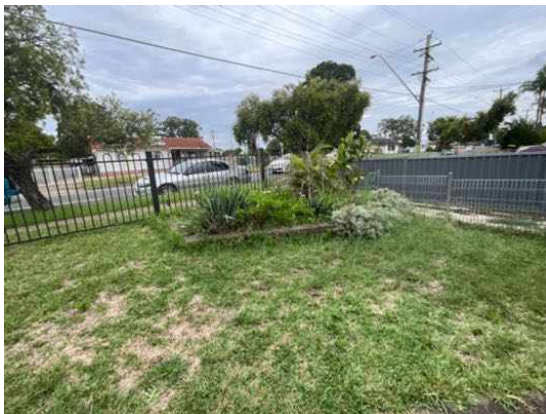
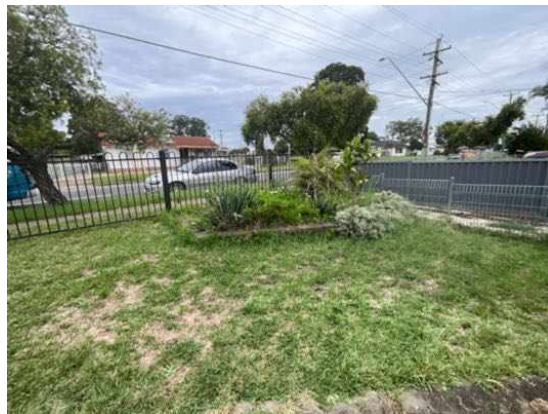
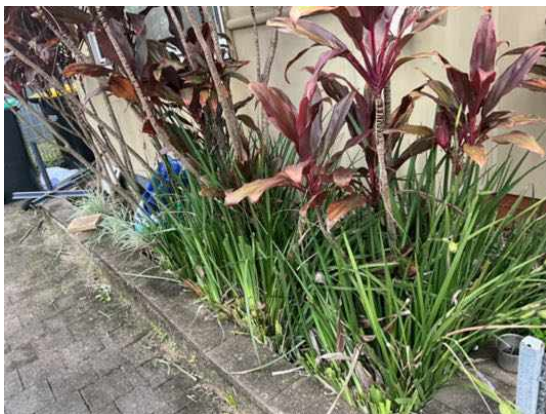
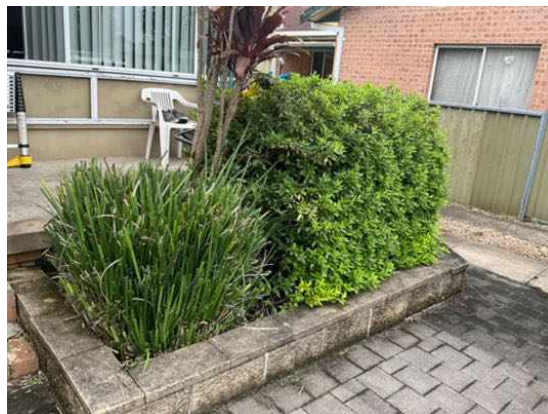
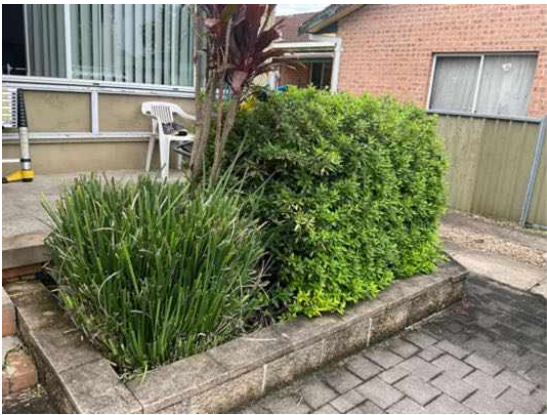
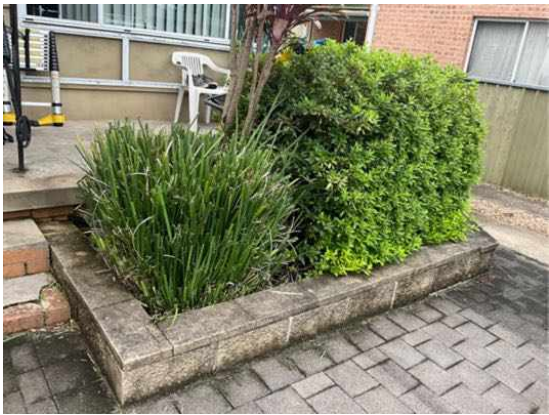
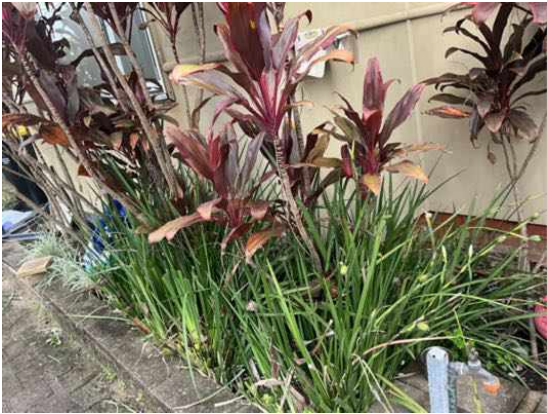
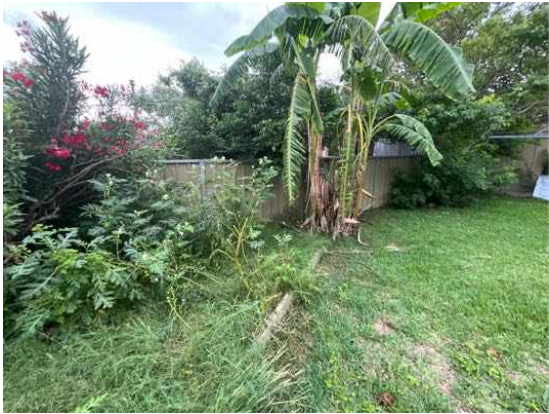
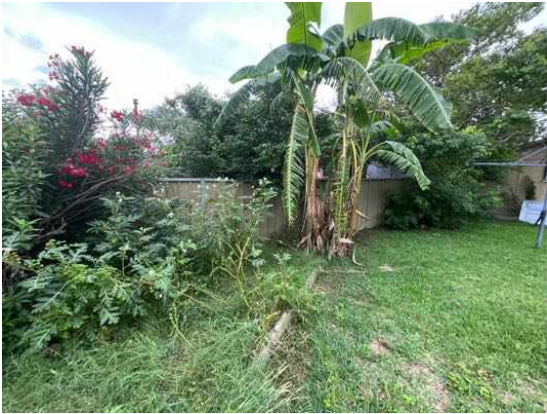
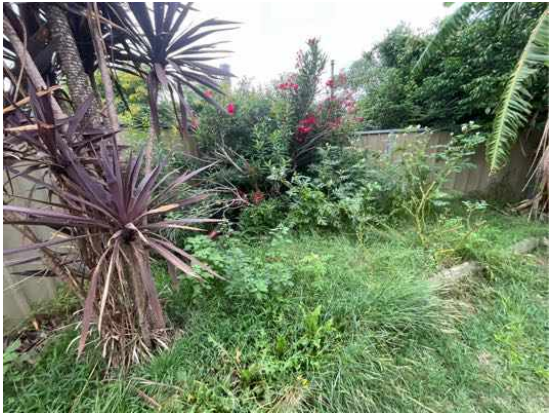
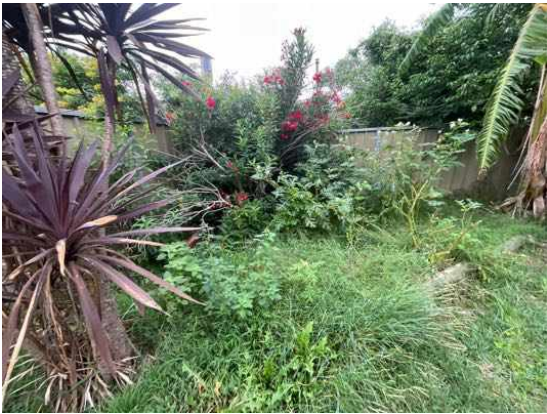
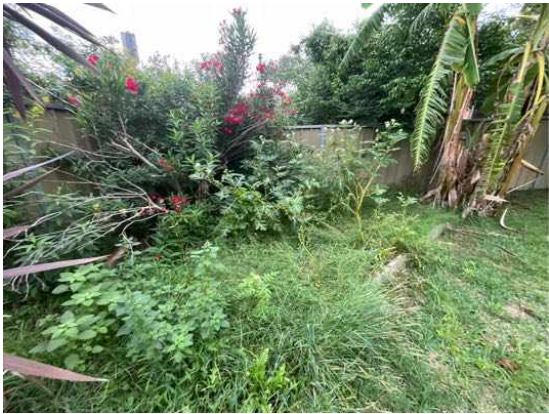
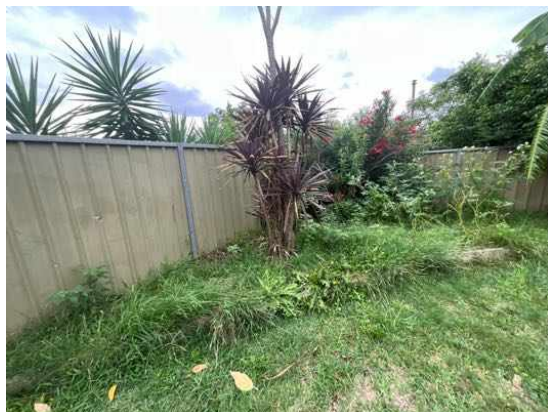
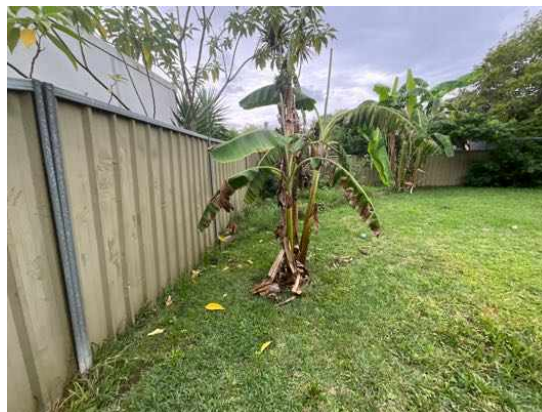
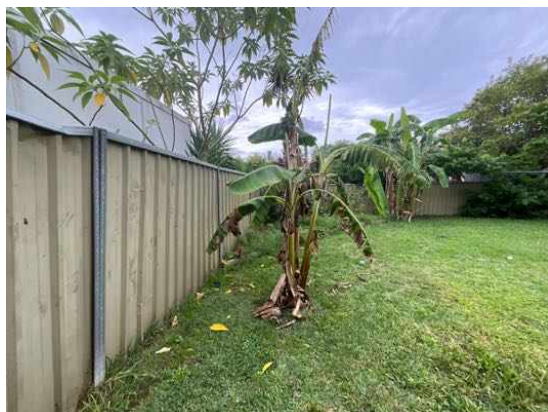
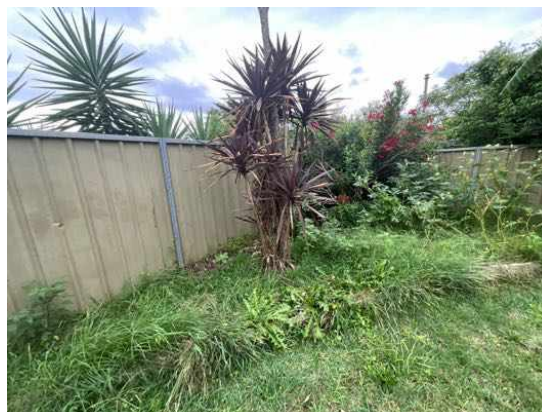
Finding: Dense vegetation around a property can increase the risk of termite infestation

Information: The presence of dense vegetation around a property can increase the risk of termite infestation, as it provides a conducive environment for them. To address this, consider maintaining a clear space between the vegetation and your home. If you suspect a termite issue, it's advisable to consult with a licensed pest control professional for inspection and treatment.

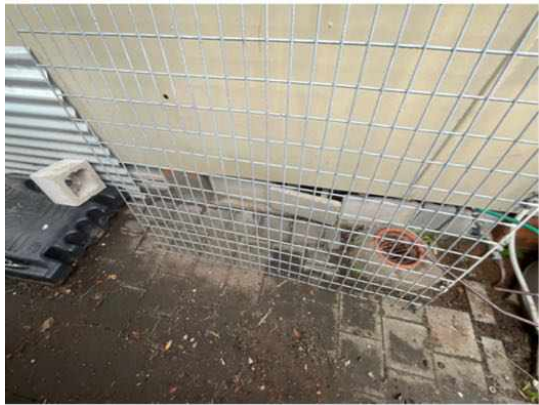
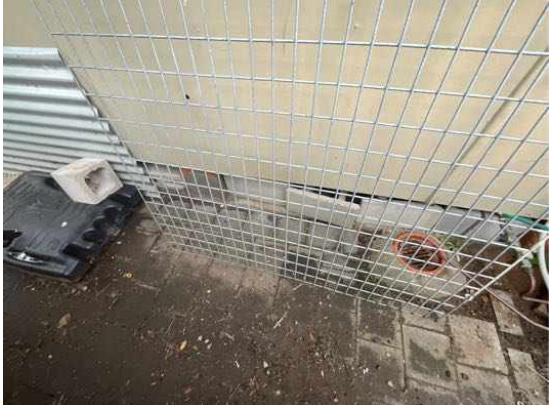
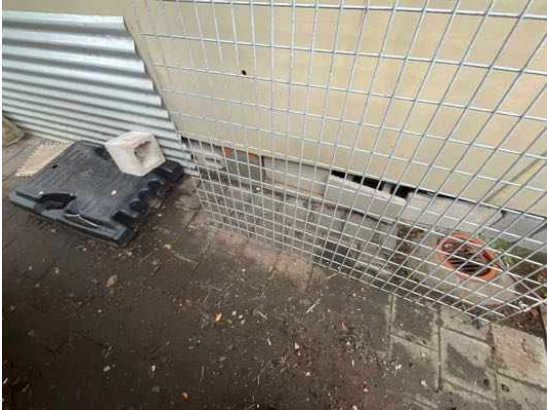
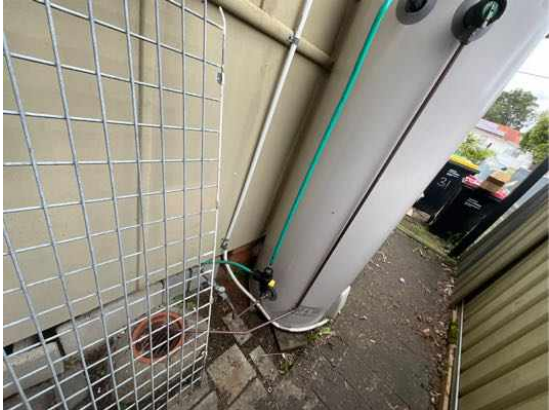
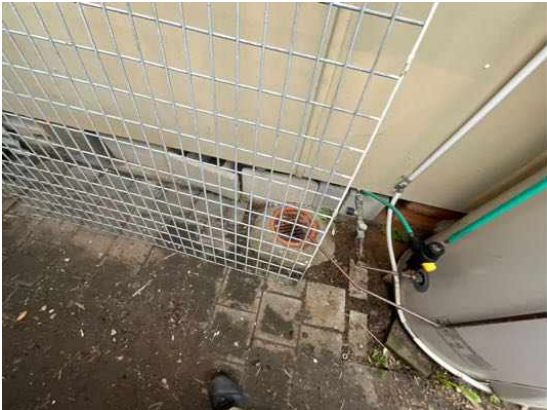
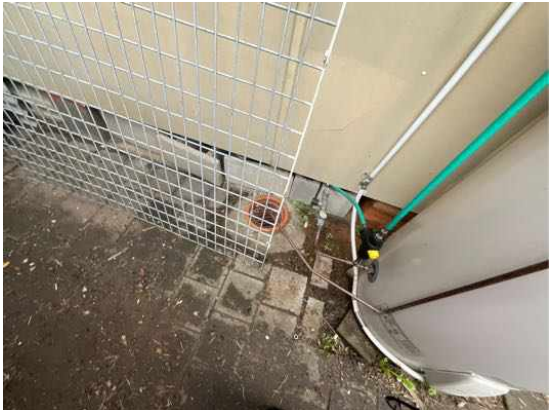
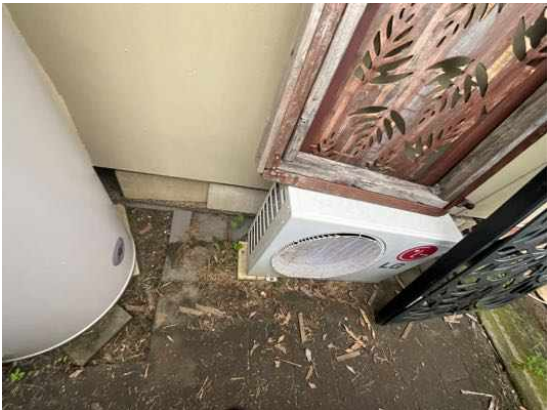
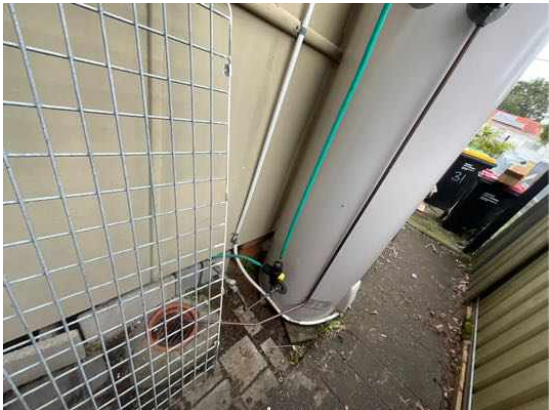
Finding 6.03

Building:	Main Building
Location:	All Areas
Finding:	Bridging or Obstruction Conducive environment for Termites
Information:	Bridging of termite barriers occurs when termites bridge (usually by building a mud tunnel) a termite barrier or inspection inspection zone or where termites have a passage, allowing them to bridge the barrier.

Where bridging has occurred full inspection is prevented and termites may enter a property in a concealed or undetected manner.

Recommended moving obstructions away from the external walls for further and future inspections.

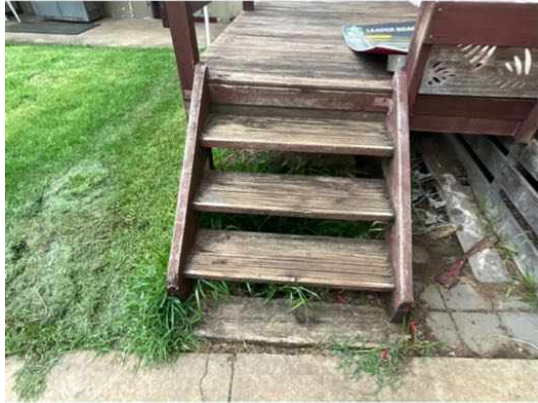
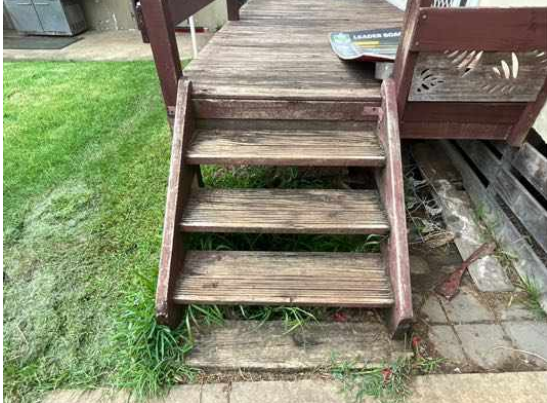
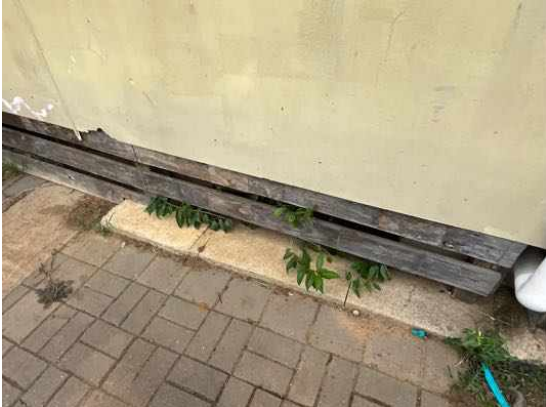
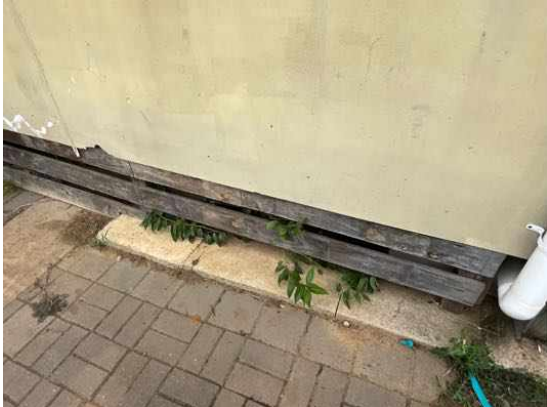
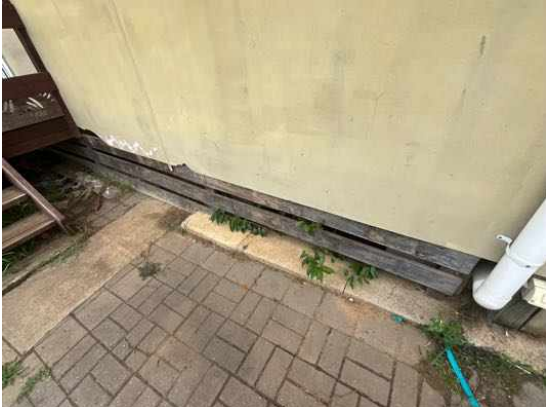
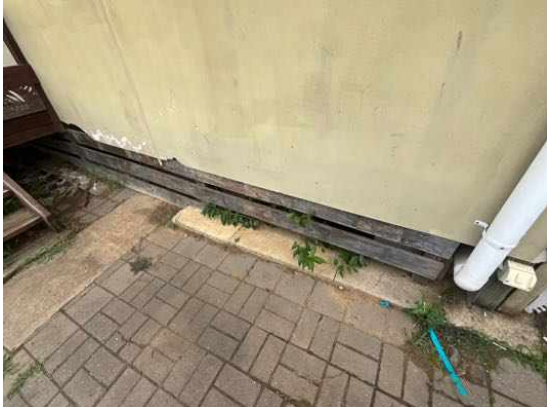
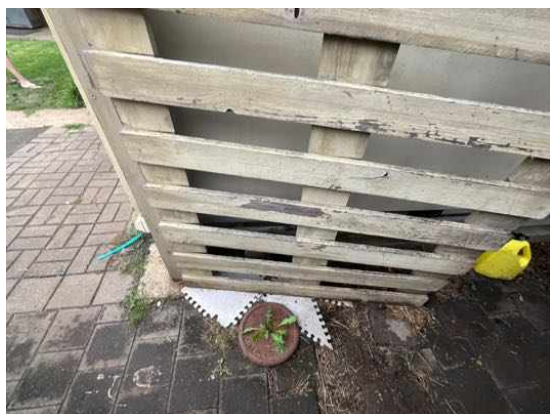
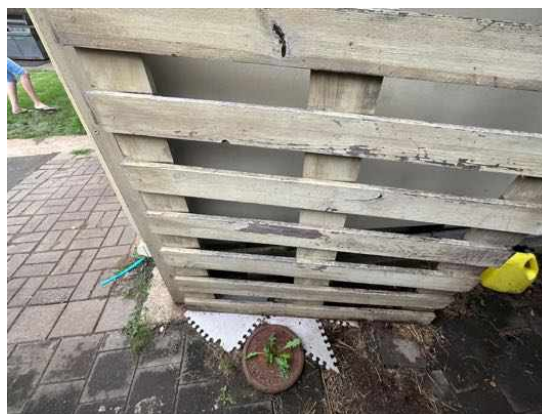
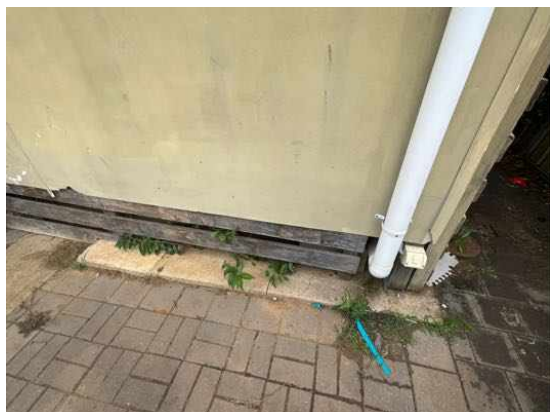
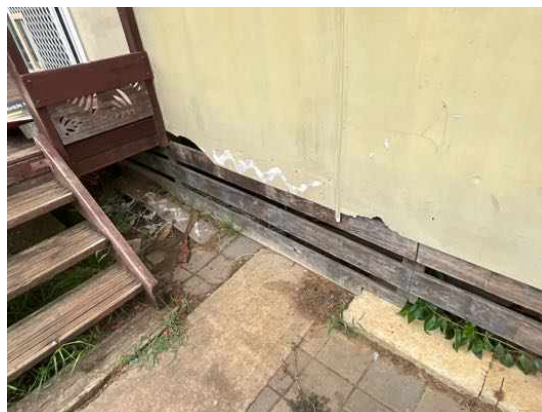
Finding 6.04

Building: Main Building
Location: All Areas
Finding: Timber on ground / conducive conditions to termite damage
Information: Timber on the ground is indeed conducive to termite damage. Termites are known to thrive in moist environments, and wood in contact with soil or moisture is more susceptible to infestation.

To prevent this, it's important to keep timber elevated and away from direct ground contact. Regular inspections and proper termite control measures are also essential to protect your wooden structures from termite damage.

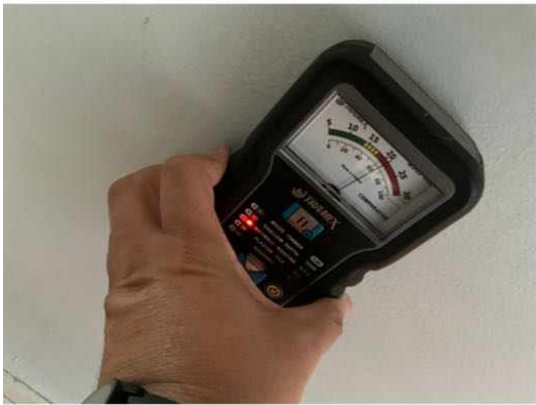
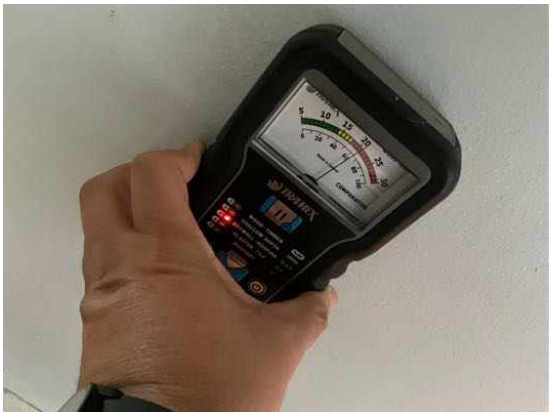
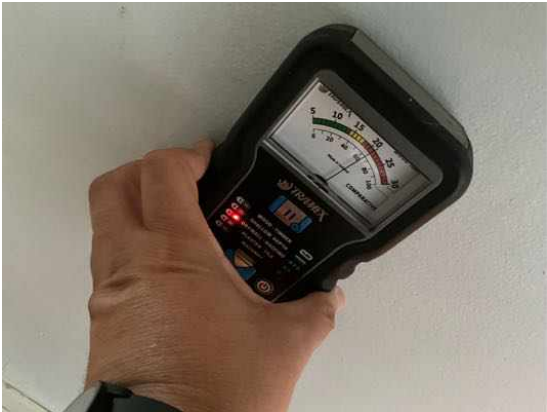
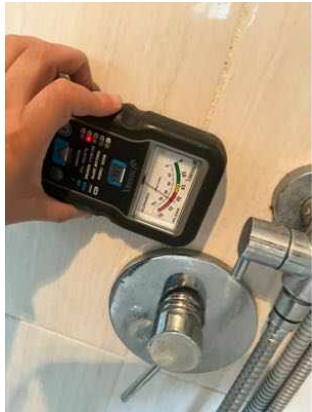
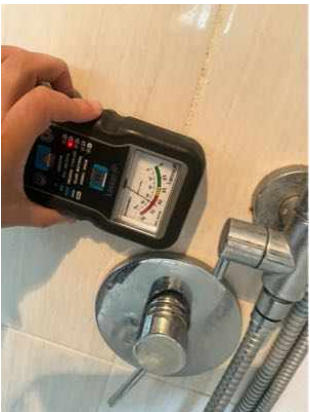
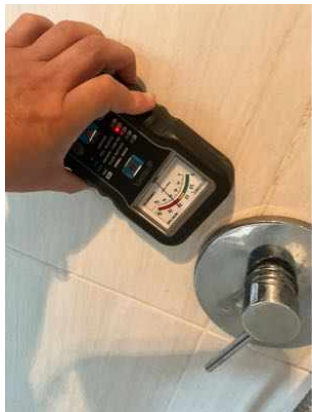
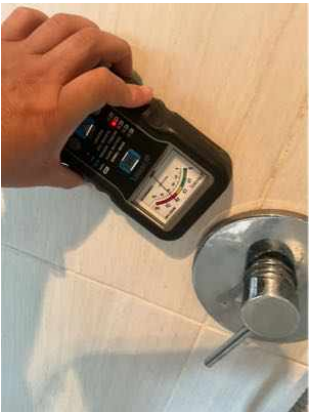
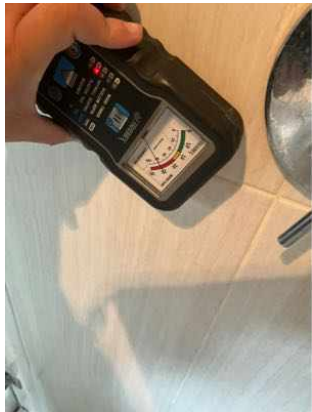
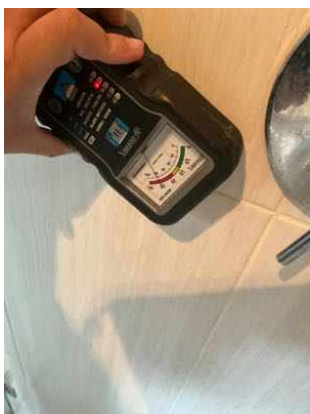
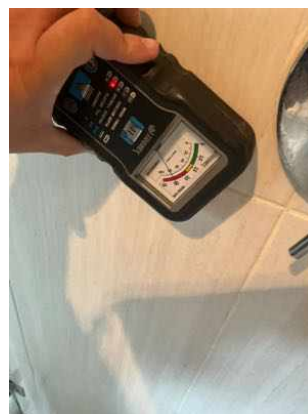
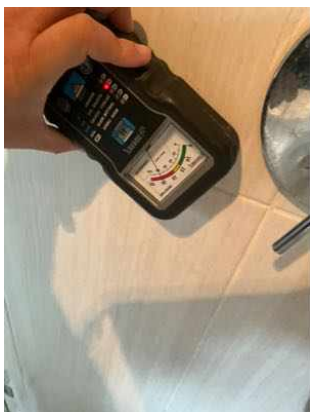
Building:	Main Building
Location:	Bathroom
Finding:	Excessive moisture - Conducive to Timber pest
Information:	Excessive moisture can attract termites and produce conditions that promote fungal growth and wood decay.

Excessive moisture is generally caused by deteriorated inadequate or missing roof drainage leaking plumbing pipes or fixtures poorly plumbed HWS overflows or condenser units and poor site drainage.

Prior to any remedial works being performed a qualified plumber should be appointed to further inspect the property and to identify the cause of the excessive moisture. Works to remove affected building elements may then be necessary and should be performed by an appropriate tradesperson.

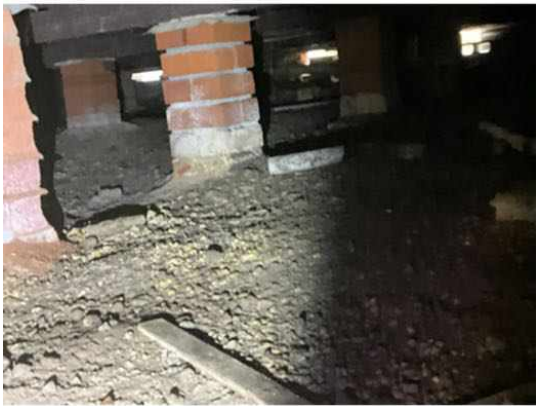
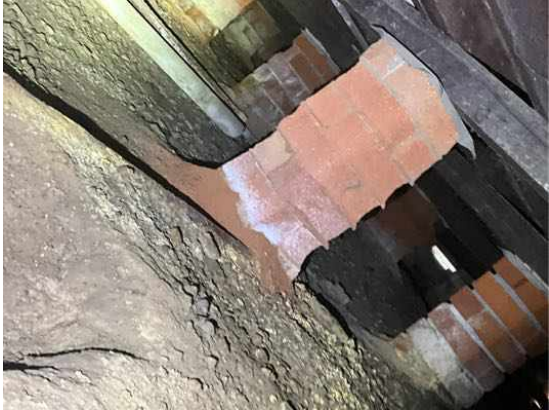
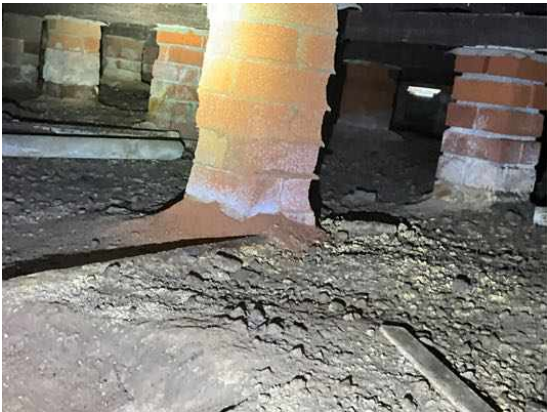
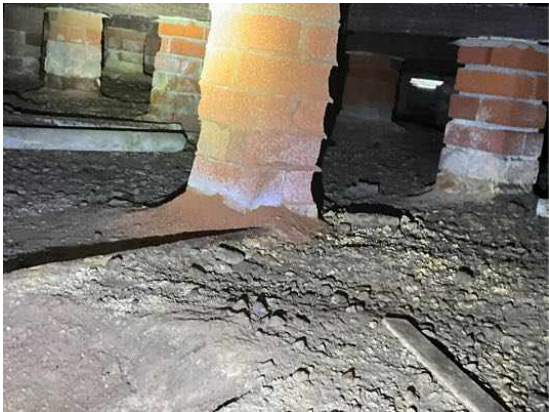
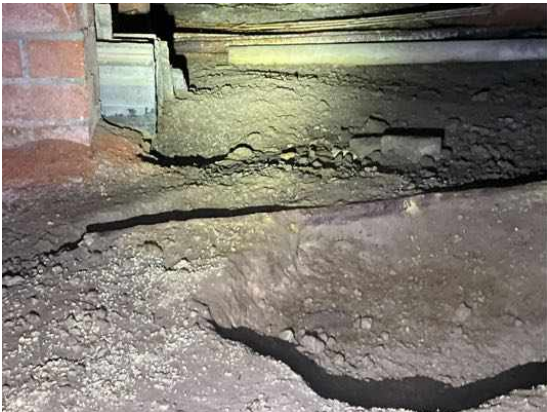
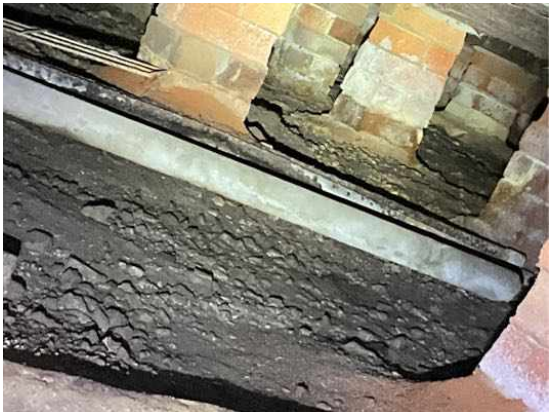
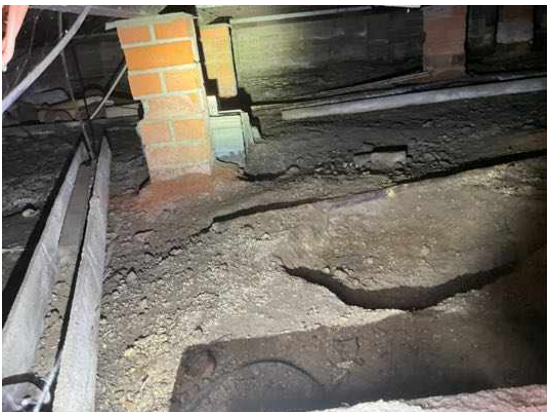
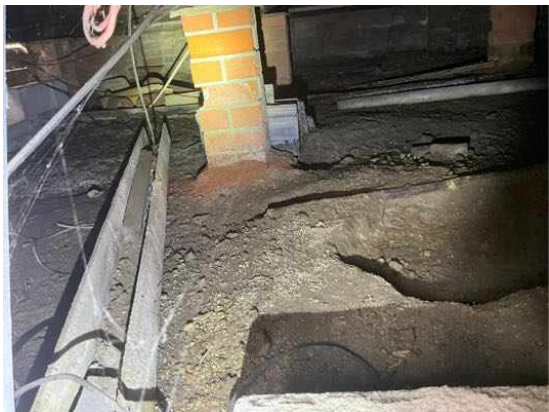
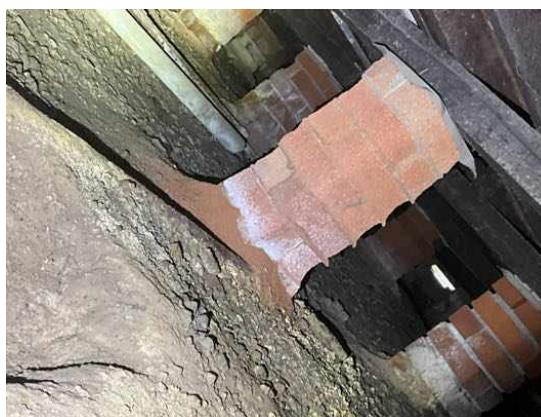
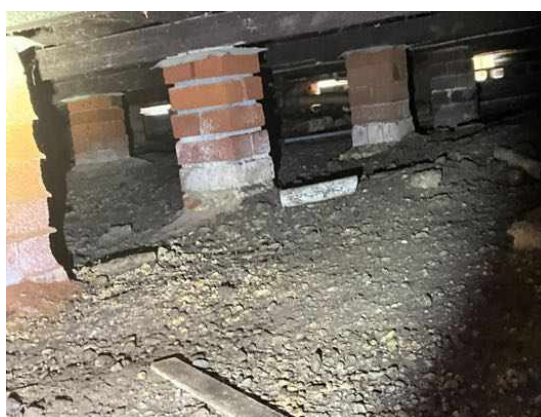
Finding 6.06

Building:	Main Building
Location:	Subfloor
Finding:	Subfloor - poor ventilation, inadequate site drainage, water stains
Information:	The subfloor lacks adequate ventilation, suffers from inadequate site drainage, exhibits water stains, creating conducive conditions for timber pests such as termites.

Risk: The combination of poor ventilation, inadequate drainage, water stains significantly increases the risk of timber pest infestations. Termites are attracted to moist environments and can thrive in subfloors with high humidity levels and water damage. The lack of proper ventilation and drainage exacerbates moisture retention, providing an ideal habitat for timber pests to establish colonies and cause extensive damage to the subfloor structure. Additionally, water stains indicate previous or ongoing moisture issues, which further attract timber pests and contribute to the deterioration of timber materials.

A licensed pest control professional specializing in timber pest management should be consulted to assess the extent of the infestation and develop a comprehensive treatment plan. They can implement strategies to eliminate existing timber pests, such as termites and prevent future infestations by addressing underlying moisture issues. Additionally, a qualified plumber or builder may be needed to improve subfloor ventilation, enhance site drainage, repair water-damaged areas. Regular inspections and maintenance are essential to ensure ongoing protection against timber pests and

maintain the structural integrity of the subfloor.

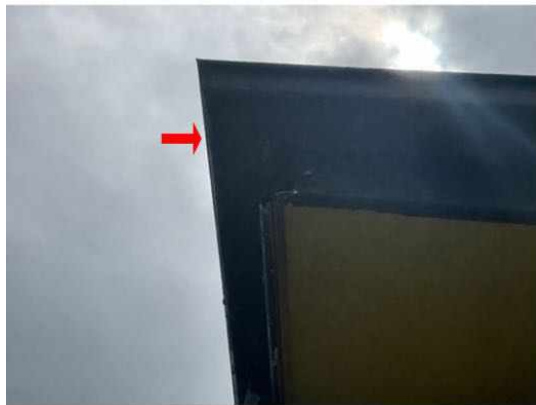
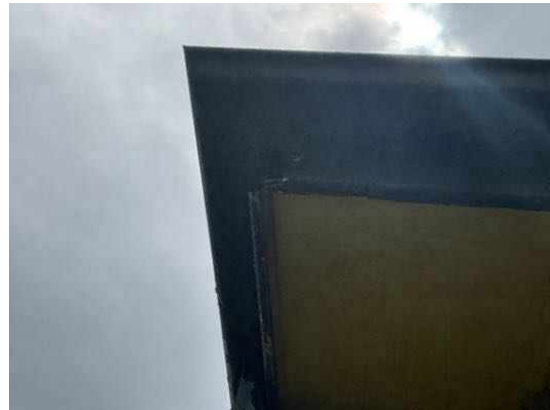
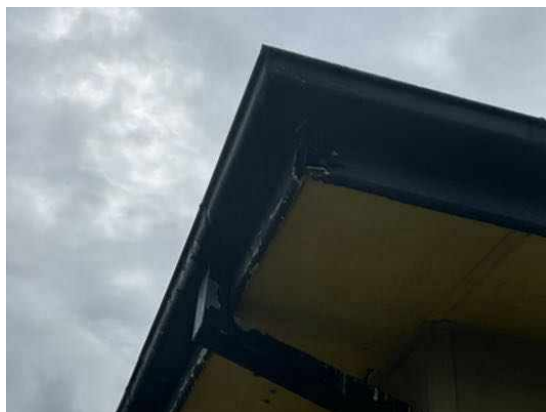
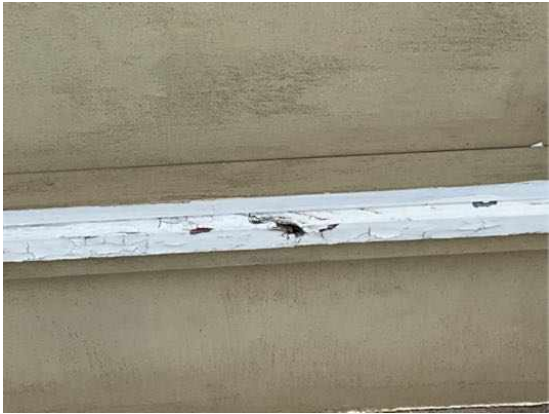
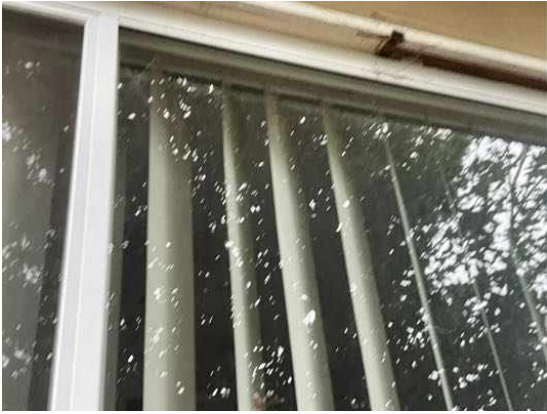
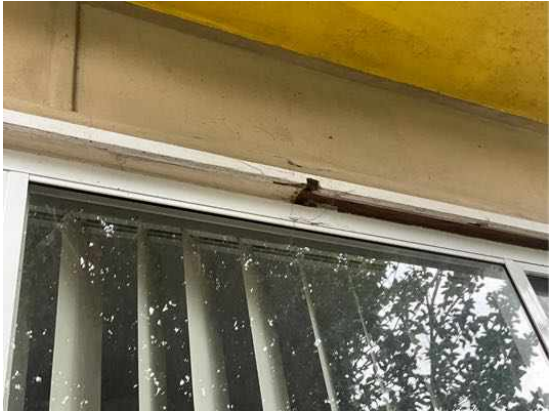
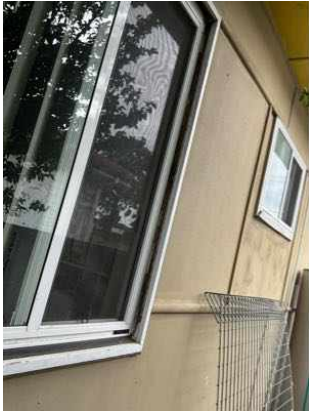
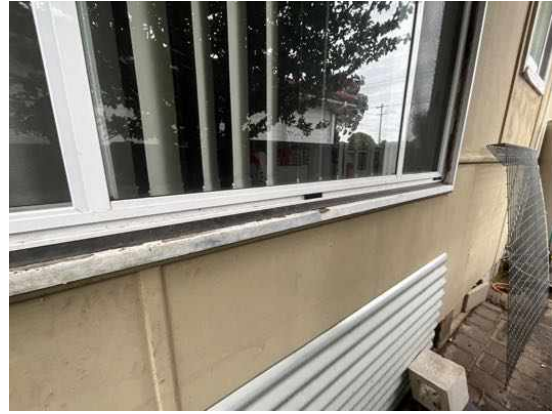
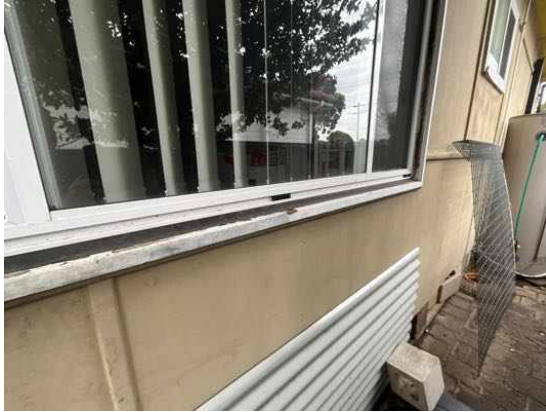
Finding 7.01

Building:	Main Building
Location:	All Areas
Finding:	Wood rot
Information:	This building element shows evidence of wood rot. Wood rot, also known as Fungal Decay, occurs when timbers and other cellulose building materials are exposed to damp conditions on an ongoing basis. This could be the result of exposure to

weathering over a prolonged period of time, or the attraction of excessive moisture from other abutting building materials. Contributing factors also include poor air ventilation in the area.

Wood rot is often associated with general damp problems and is evidenced by a 'musty' smell or mould and mildew occurring on surfaces. If left unmanaged, damp conditions can lead to further health problems and the decay of timbers will continue.

Early intervention and regular maintenance, particularly of exterior timbers, will prolong the useful life of these building elements. Prior to any works being performed, the cause of the moisture that has created the visible wood rot should be identified and addressed in a suitable manner. Replacement of affected timbers may then be a necessary step in protecting surrounding building elements from such deterioration.

A qualified plumber may be appointed to assess the cause of excessive moisture and to provide advice on any remedial works as required. A qualified carpenter or registered builder may also be required to replace affected building materials.

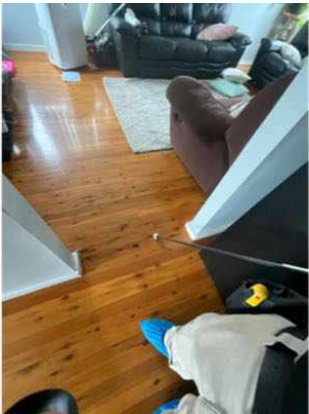
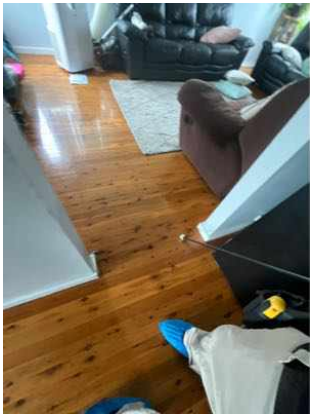
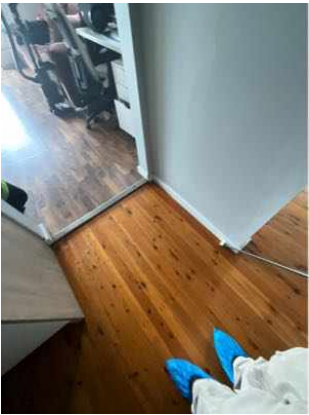
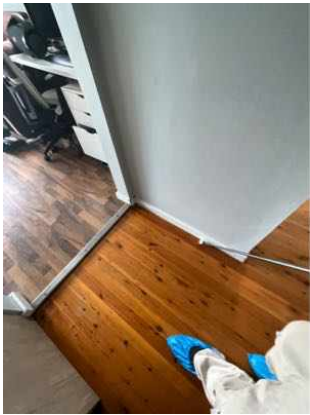
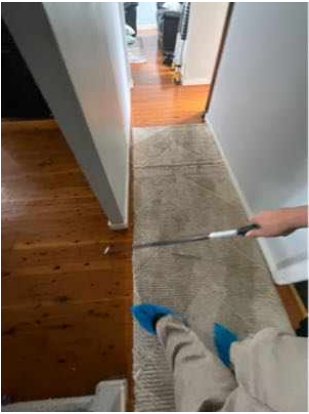
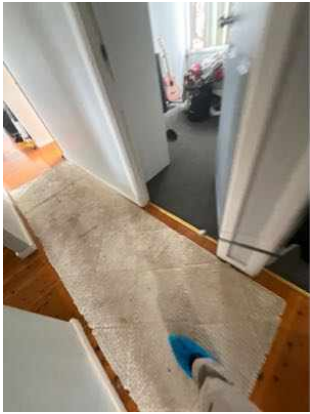
Noted Item

Building: Main Building
Location: All Areas
Finding: Additional Photos
Information: Additional photos are provided for your general reference
