Building and Timber Pest Inspection Report

Inspection Date: Tue, 3 Mar 2026

Property Address: 31 Debrincat Avenue, North St Marys, NSW
2760

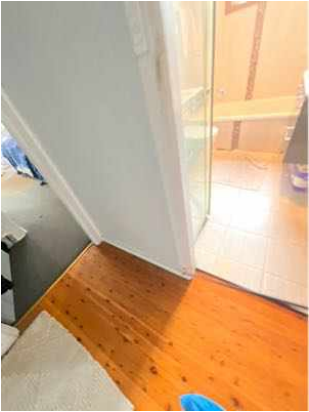
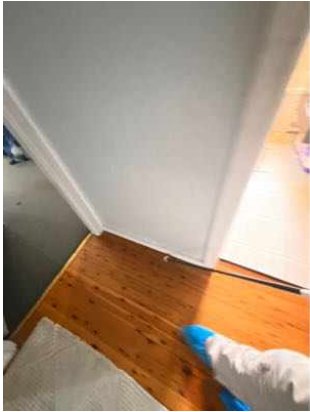
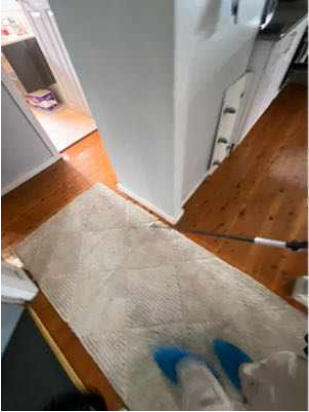
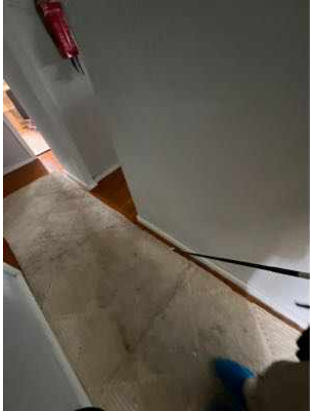
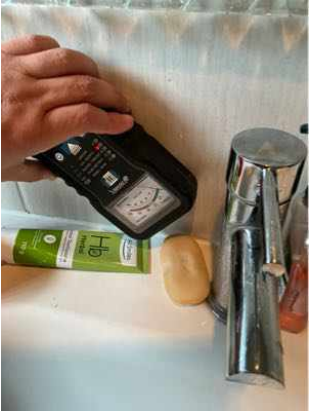
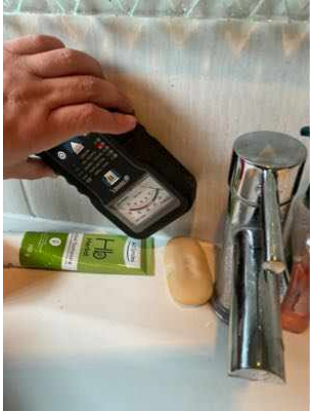
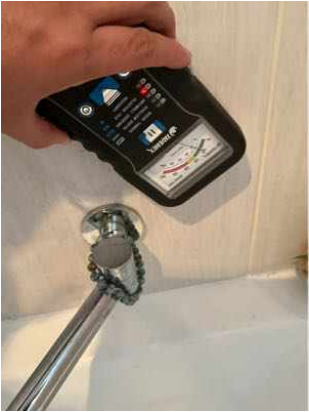
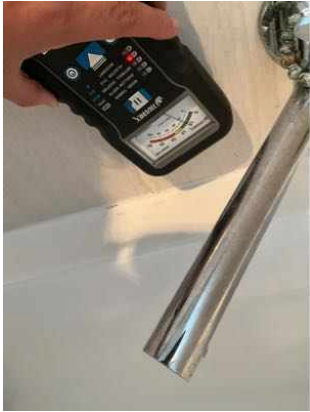
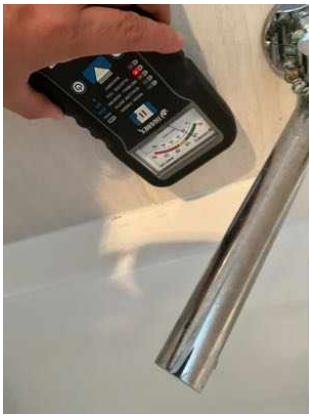
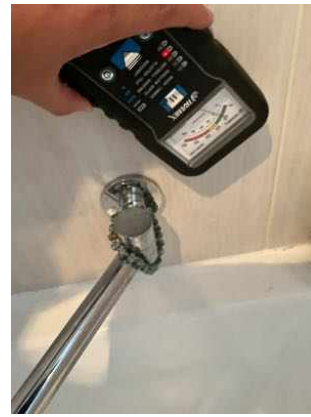
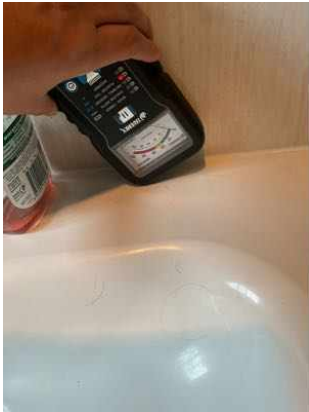
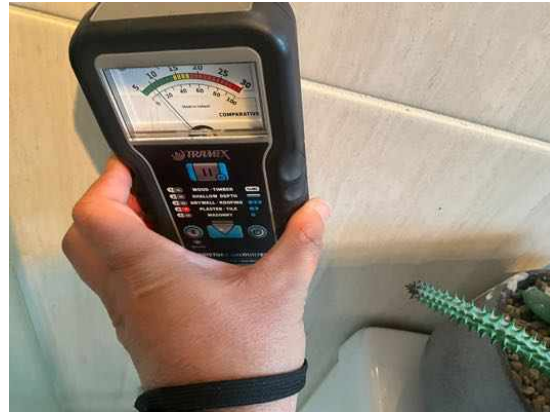
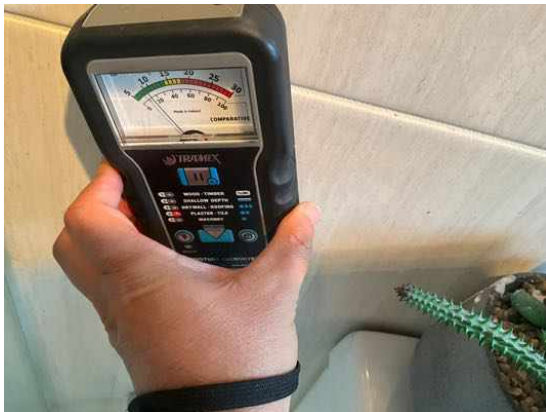
Building: Main Building
Location: All Areas
Finding: Additional Photos
Information: Additional photos are provided for your general reference

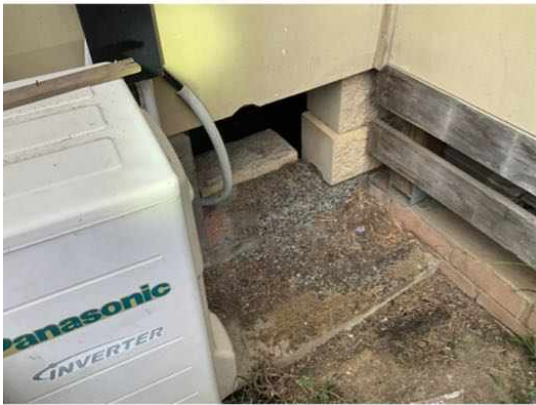
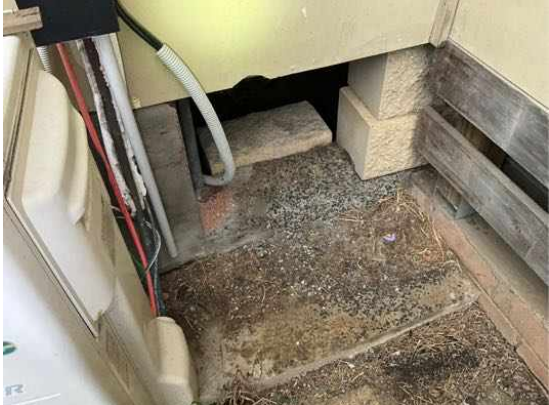
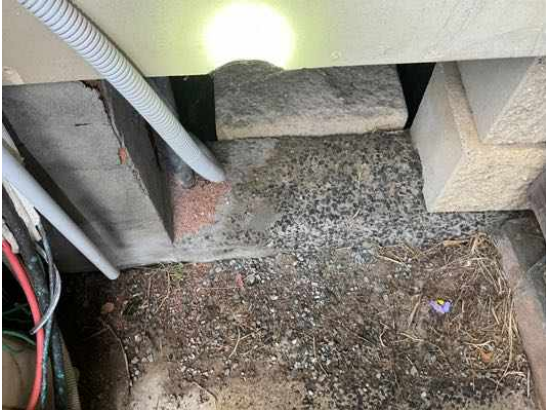
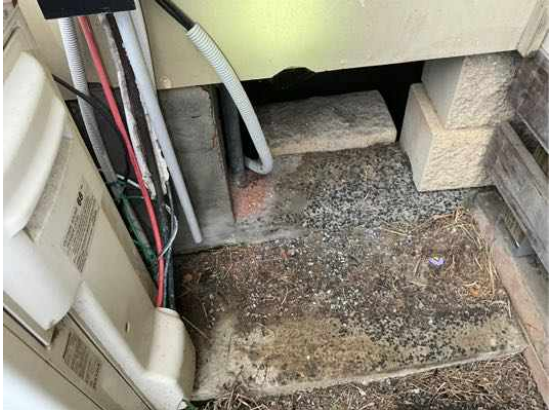
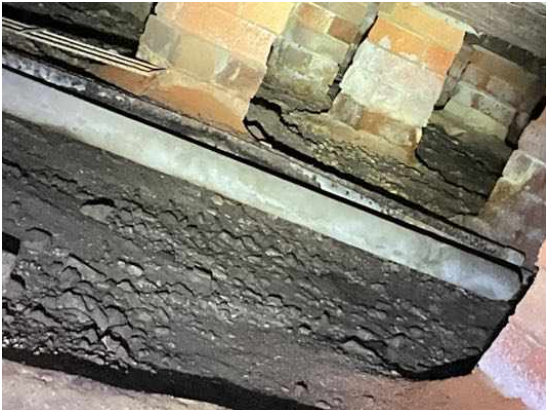
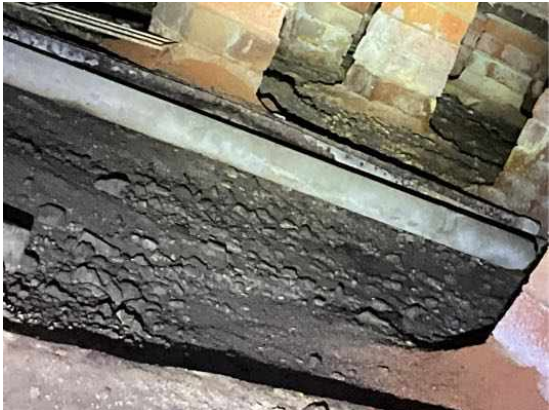
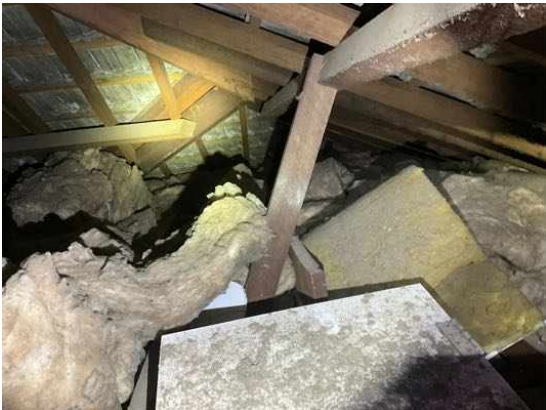
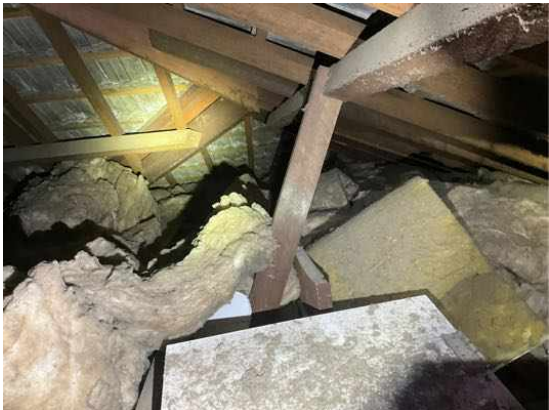
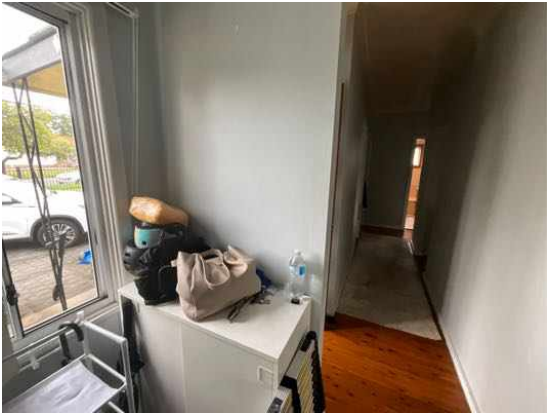
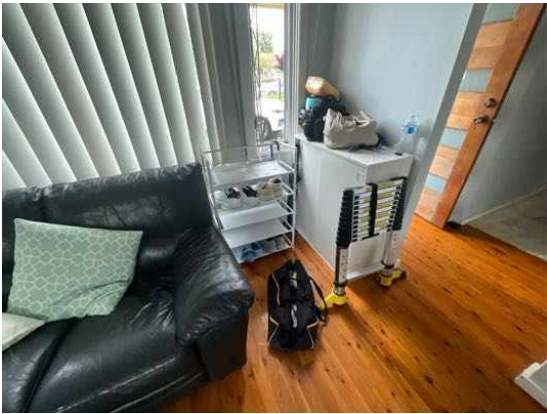
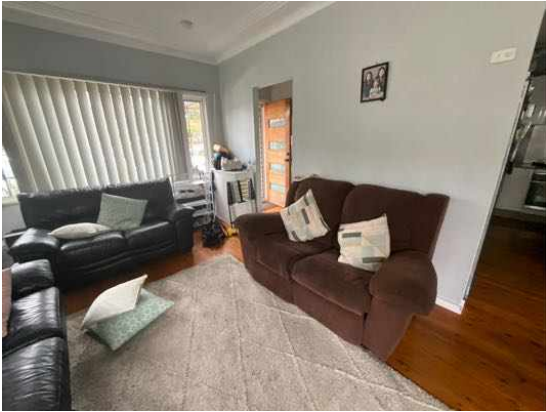
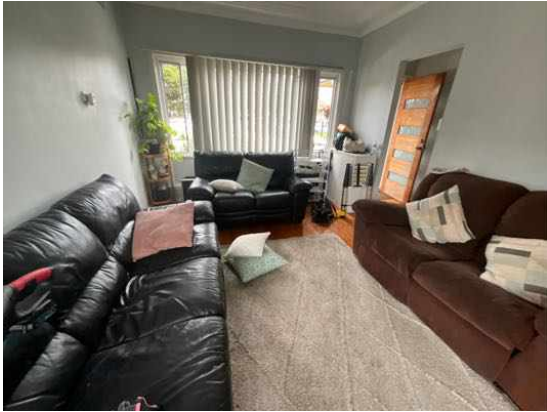
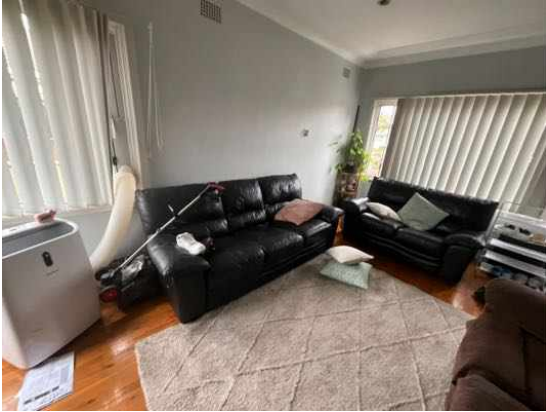
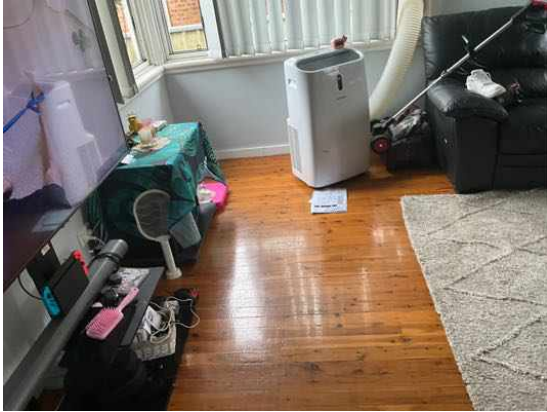
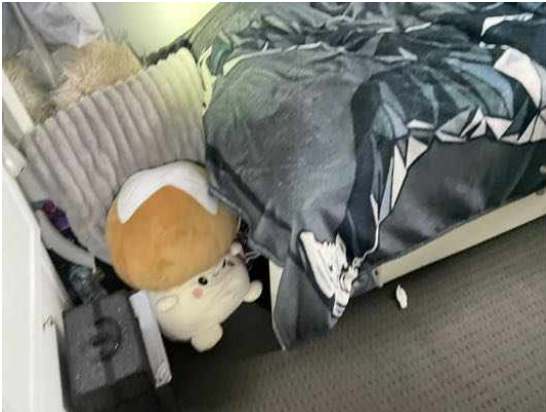
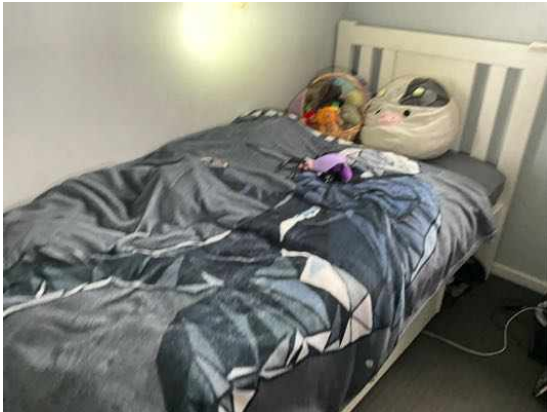
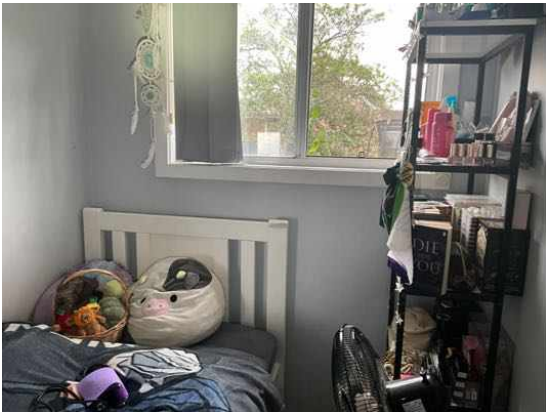
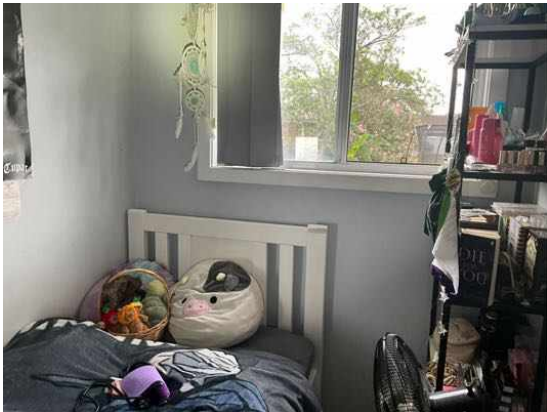
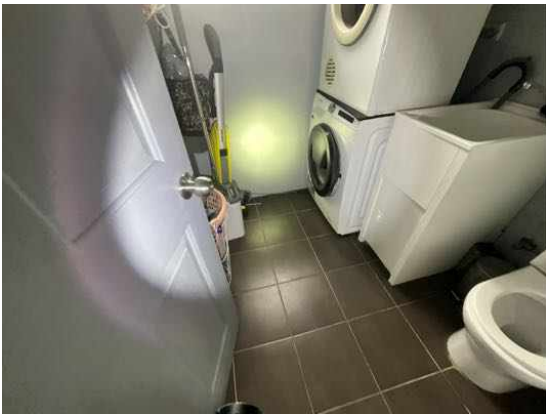
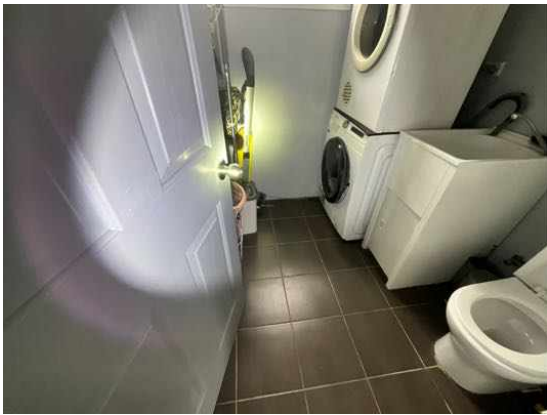
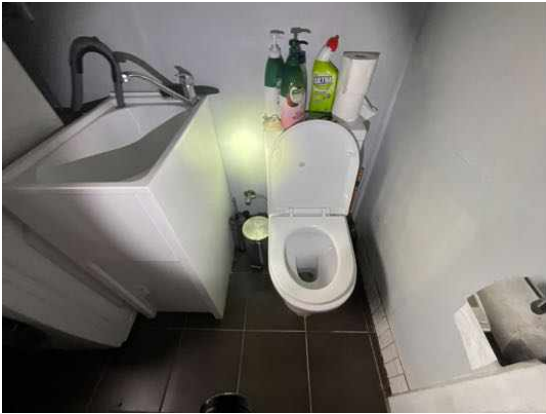
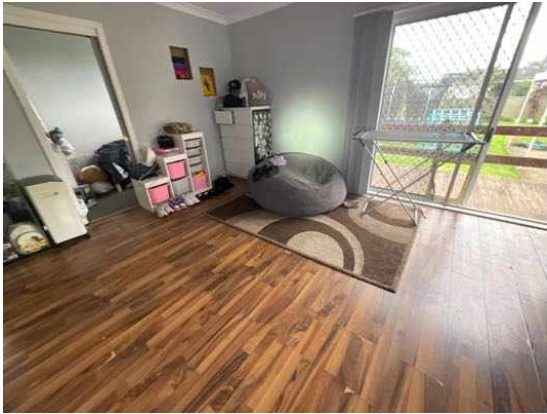
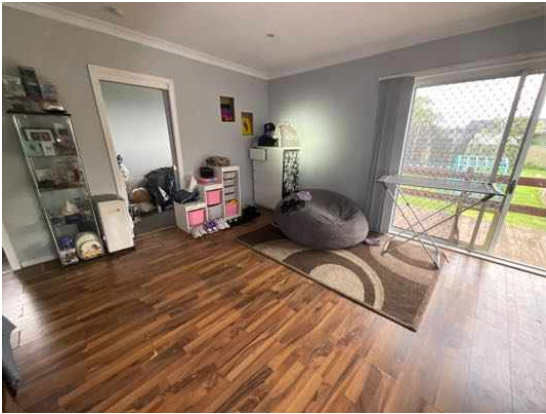
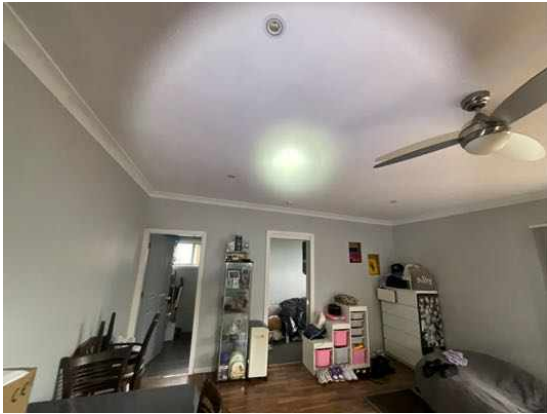
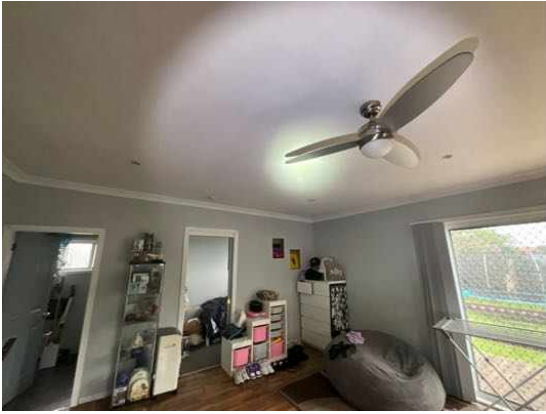
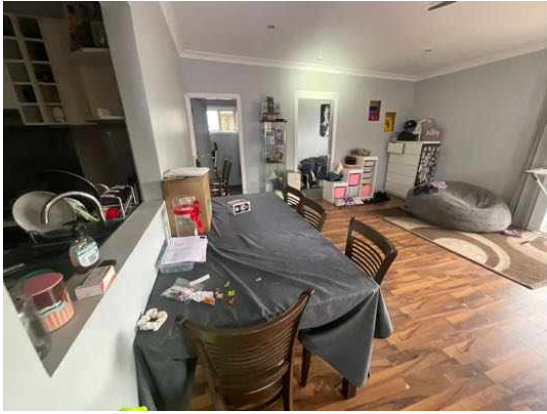
Building:	Main Building
Location:	All Areas
Finding:	Additional Photos - Obstructions and Limitations
Information:	These photographs are an indication of the obstructions and limitations which impeded full inspection of the property at the time of inspection. These obstructions can hide an array of defects and should be removed to allow full inspection to be carried out. A re-inspection is recommended once the areas are made accessible.
