Building and Timber Pest Inspection Report

Inspection Date: Tue, 27 Jan 2026

Property Address: 5-1a Edward St, Mordialloc VIC 3195,
Australia

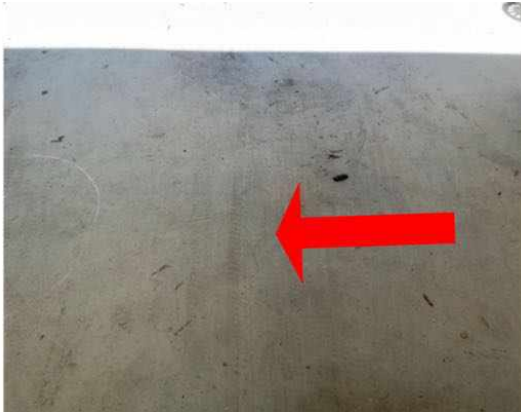
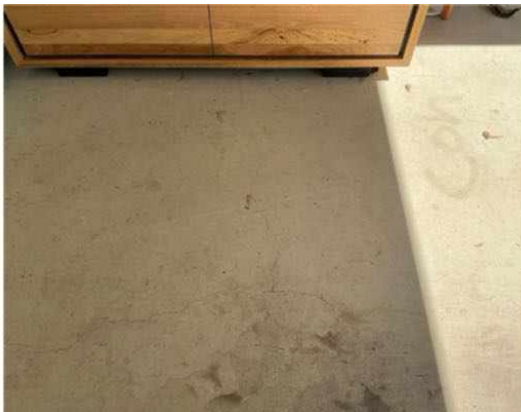
Finding: Garage Cracking - Concrete Paving Damage Category 1 - Fine (less than 2mm)

Information: Fine cracks were identified in the garage concrete paving. Although fine cracks are quite noticeable, they are often only considered to be an appearance defect, and usually do not indicate any structural damage. To be considered a Category 1 or fine crack, the crack is found to be less than 2mm in width.

Generally the cause of a hairline crack in existing concrete paving such as driveways and pathways is indicative of the expansion and contraction of the concrete. Such causes are generally due to environmental factors, such as moisture levels, weather conditions, root systems of nearby trees or the soil types on which they are laid.

Fine cracks may also be due to poor original installation of the concrete. Factors such as poor compaction of the sub surface and/or inadequate reinforcing of the slab may create cracking and other secondary defects.

Monitoring of all cracking should be conducted frequently. Always contact a building inspector should cracks widen, lengthen, or become more numerous.

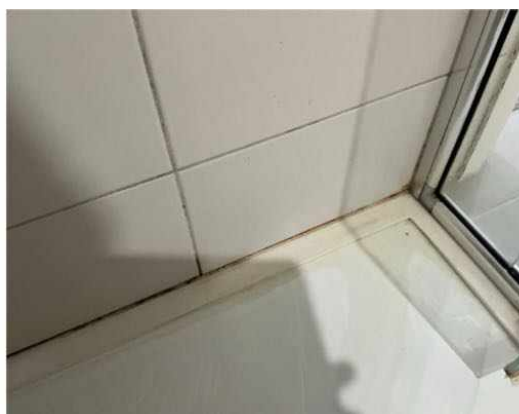
Finding 3.03

Building: Main Building
 Location: Bathroom
 Finding: Bathroom Sealant and grouting - Missing or damaged
 Information: It was noted on inspection that sealant or grout is degraded to the tiled shower alcove and or other areas of the bathroom.

Different materials and floor areas move at different rates, generally causing cracking to grout or sealant at this point. A flexible sealant is required to allow for expected expansion and contraction, while keeping the joint water tight and protective of all associated building materials.

Flexible and mould resistant materials should be applied to affected areas to prevent any subsequent water damage that is likely to occur. Regular maintenance and replacement of damage or missing or damaged sealant and grout is highly recommended to the wet areas, as this is a regular wear and tear defect. Sealant and grouting in areas that come into regular contact with water should be maintained for the long term care of your property.

A sealant specialist or tiling contractor should be appointed to complete these works as soon as possible

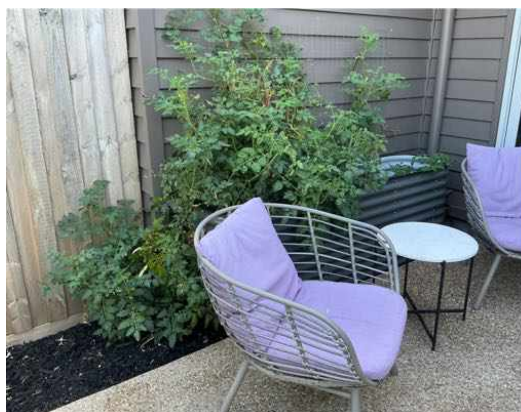
Building:	Main Building
Location:	Yards
Finding:	Garden Beds Conditions Conducive to Termites
Information:	Garden beds were found to be evident in close proximity to the building. Garden beds immediately adjacent to the perimeter of the building block the visual inspection of these areas, providing a concealed termite entry point.

These garden beds can include untreated timber, and with a combination of moisture from watering hosing can make conditions conducive to termite activity and termite ingress.

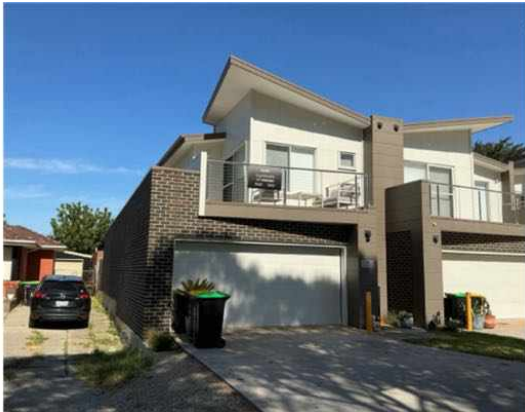
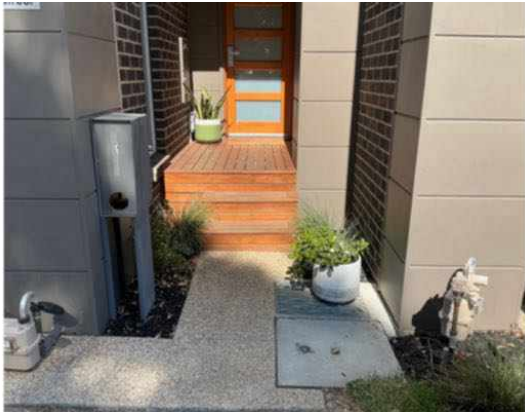
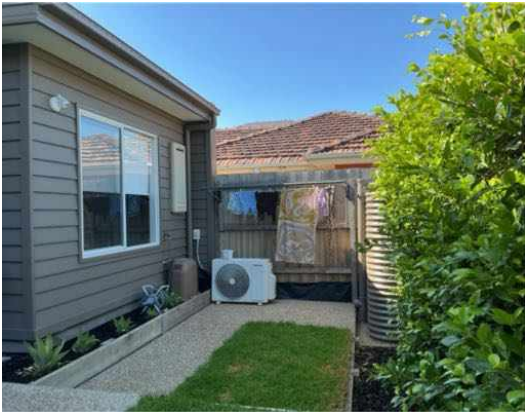
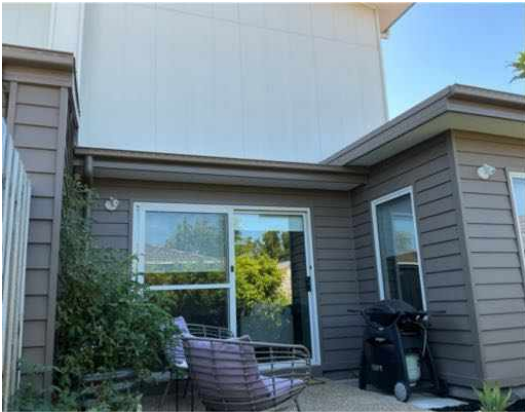
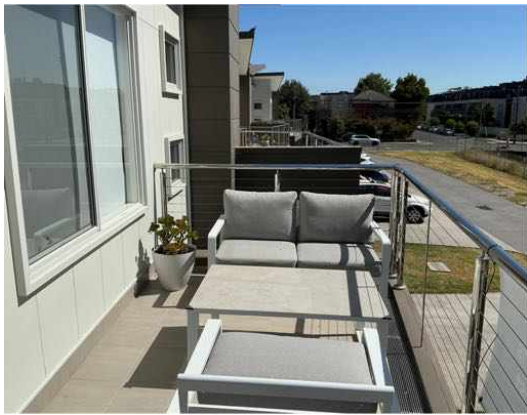
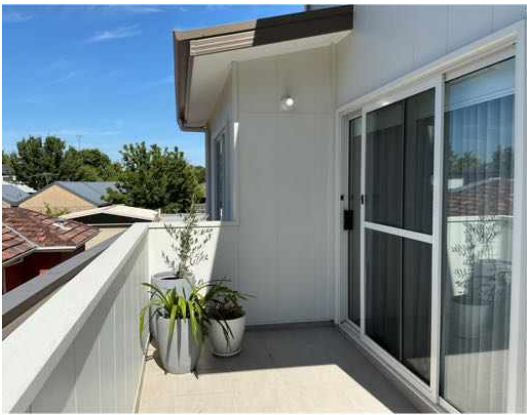
Noted Item

Building: Main Building
Location: All External Areas
Finding: Additional Photos - Obstructions and Limitations
Information: These photographs are an indication of the obstructions and limitations which impeded full inspection of the property at the time of inspection. These obstructions can hide an array of defects and should be removed to allow full inspection to be carried out. A re-inspection is recommended once the areas are made accessible.

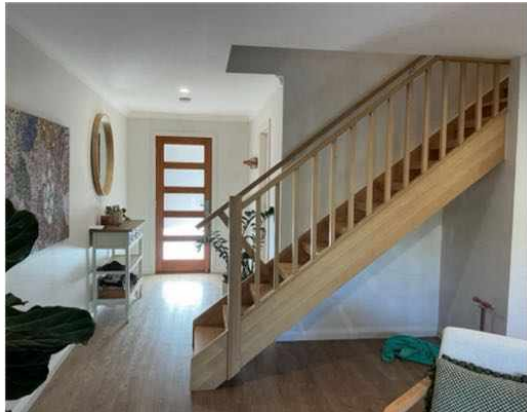
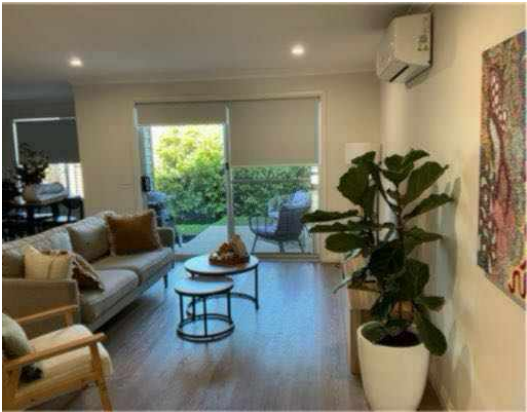
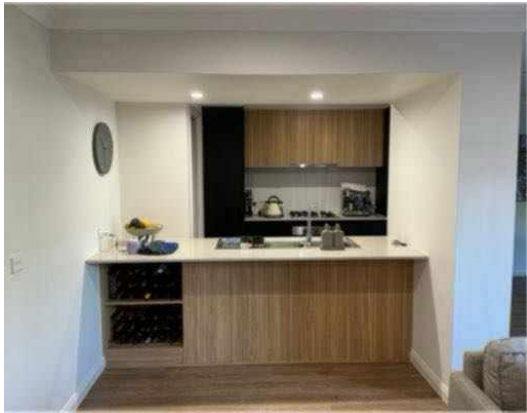
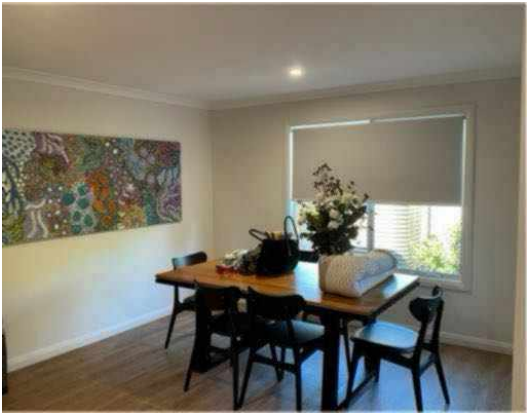
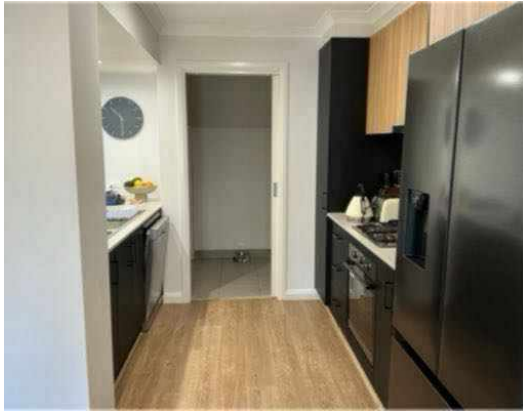
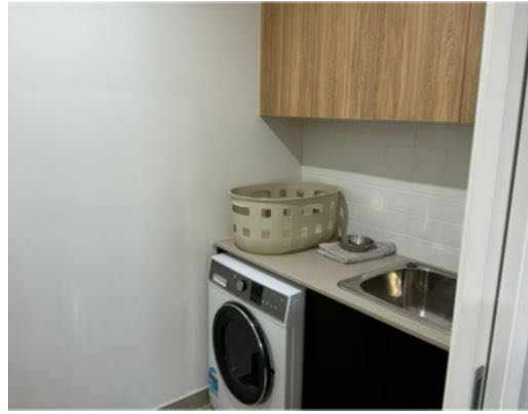
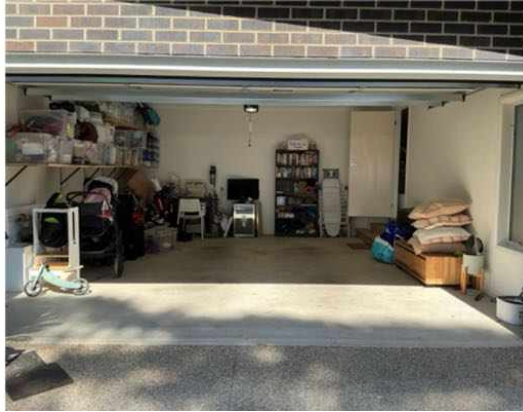
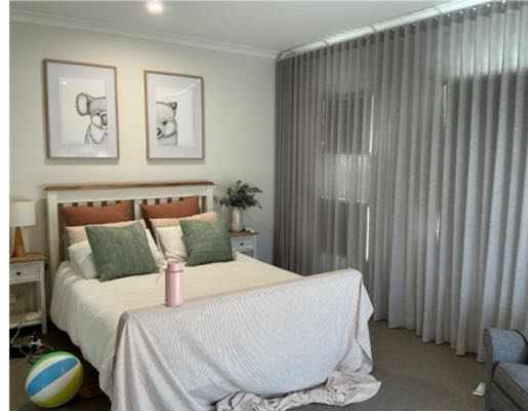
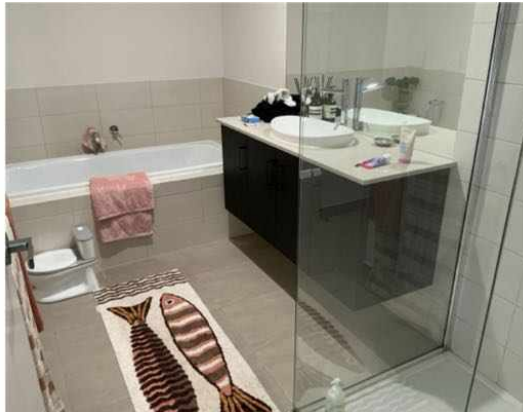
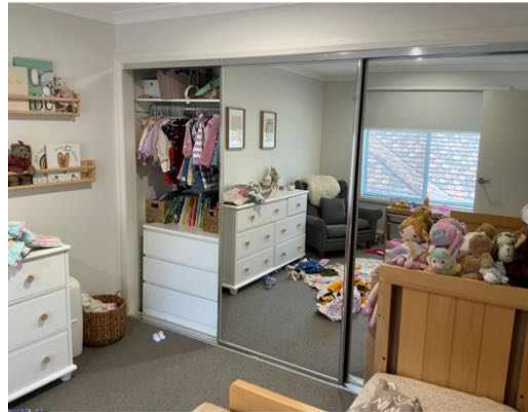
Noted Item

Building: Main Building
Location: All Internal Areas
Finding: Additional Photos - Obstructions and Limitations
Information: These photographs are an indication of the obstructions and limitations which impeded full inspection of the property at the time of inspection. These obstructions can hide an array of defects and should be removed to allow full inspection to be carried out. A re-inspection is recommended once the areas are made accessible.

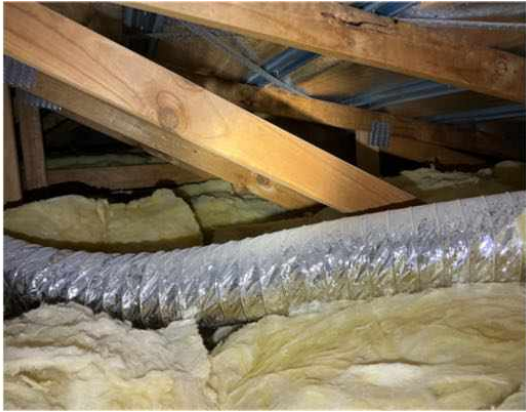
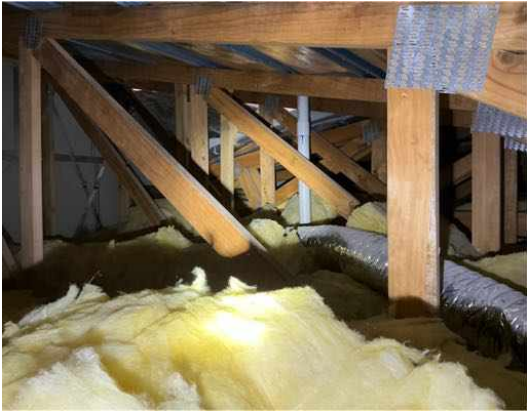
Noted Item

Building:	Main Building
Location:	Roof Void
Finding:	Obstructions and Limitations -roof cavity
Information:	These photographs are an indication of the obstructions and limitations which impeded full inspection of the roof cavity at the time of inspection. These obstructions can hide an array of defects and should be removed to allow full inspection to be carried out. A re-inspection is recommended once the areas are made accessible.

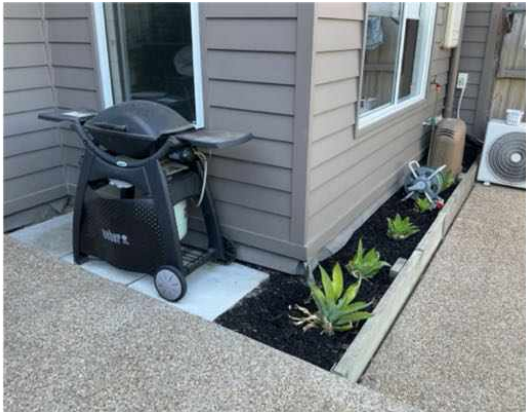
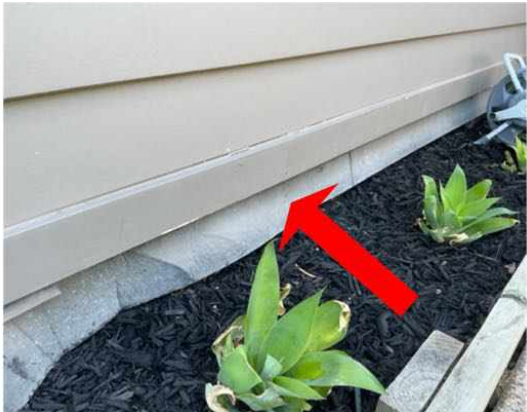
Noted Item

The following items were noted as - Evidence of a previous termite management program

Where a Termite Management System has been identified you should refer to the barrier date of installation and warranty conditions and any documentation provided by a builder or past owner. Consult the company who installed the barrier to confirm whether the system is still under warranty.

Most chemical termite management systems are primarily designed to prevent concealed entry.
