Building and Timber Pest Inspection Report

Inspection Date: Wed, 25 Feb 2026

Property Address: 170 Boronia Rd, Greenacre NSW 2190,
Australia

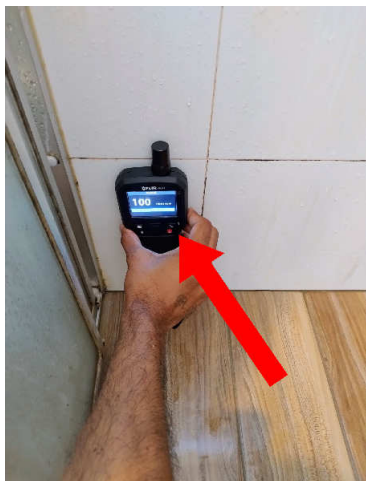
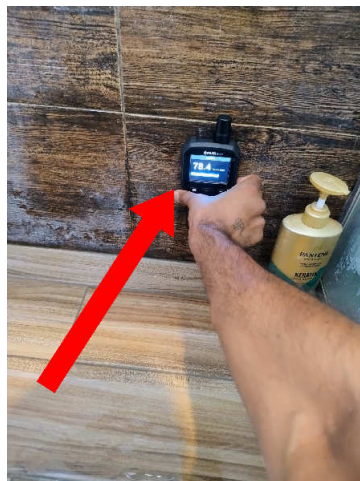
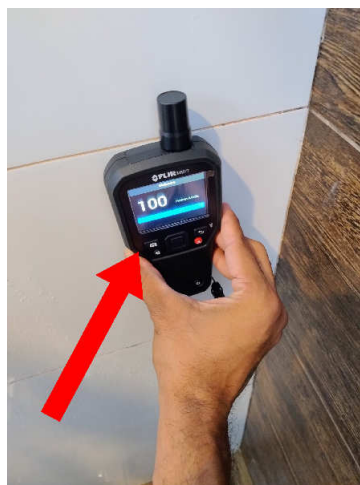
Finding 2.01

Finding: Evidence of Excessive moisture - identified - Major Defect

Information: Evidence of excessive moisture recorded by moisture meter in the shower wall of the bathroom.

Excessive moisture can attract termites and produce conditions that promote fungal growth and wood decay.

Excessive moisture is generally caused by deteriorated, inadequate or missing roof drainage, leaking plumbing pipes or fixtures, poorly plumbed HWS overflows or condenser units and poor site drainage.

Prior to any remedial works being performed a qualified plumber should be appointed to further inspect the property and to identify the cause of the excessive moisture. Works to remove affected building elements may then be necessary and should be performed by an appropriate tradesperson.

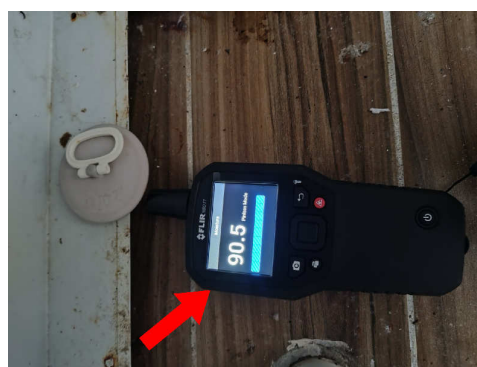
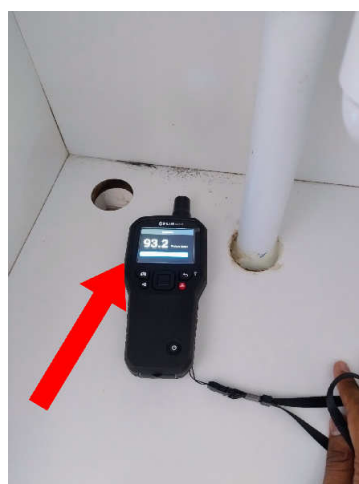
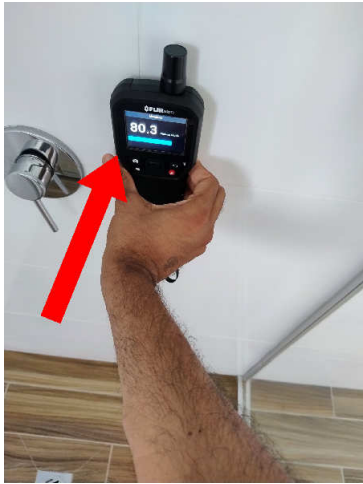
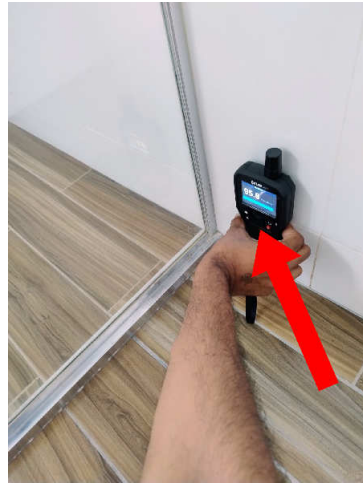
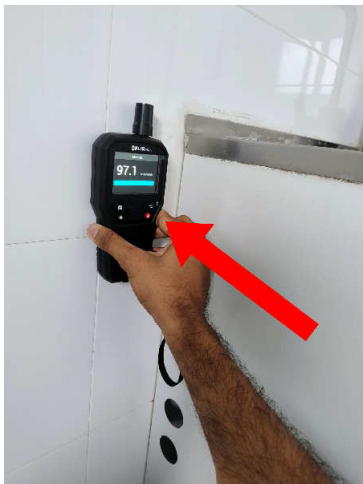
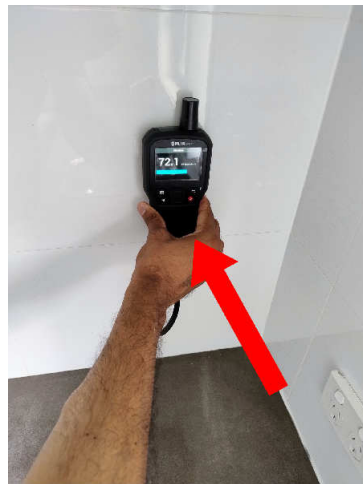
Finding 2.02

Building: Granny-Flat
Location: Bathroom walls and other areas
Finding: Evidence of Excessive moisture - identified in bathroom

Evidence of excessive moisture recorded by moisture meter at multiple locations in Bathroom and shower area walls at the time of inspection in granny flat. Excessive moisture can attract termites and produce conditions that promote fungal growth and wood decay.

Excessive moisture is generally caused by deteriorated, inadequate or missing roof drainage, leaking plumbing pipes or fixtures, poorly plumbed HWS overflows or condenser units and poor site drainage.

Prior to any remedial works being performed a qualified plumber should be appointed to further inspect the property and to identify the cause of the excessive moisture. Works to remove affected building elements may then be necessary and should be performed by an appropriate tradesperson as soon as possible.

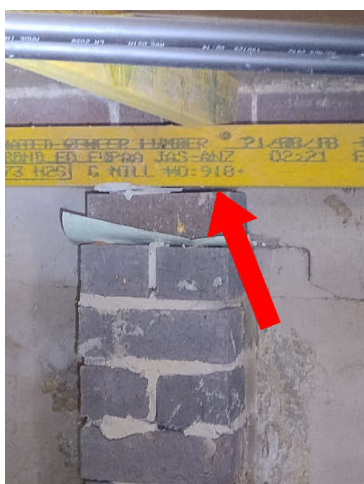
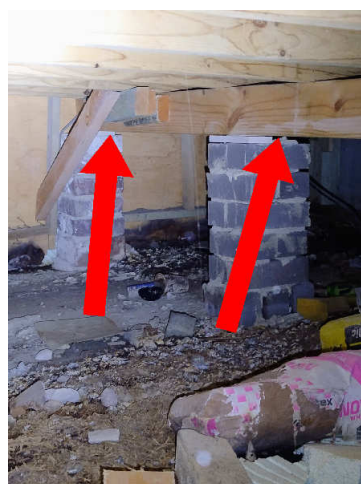
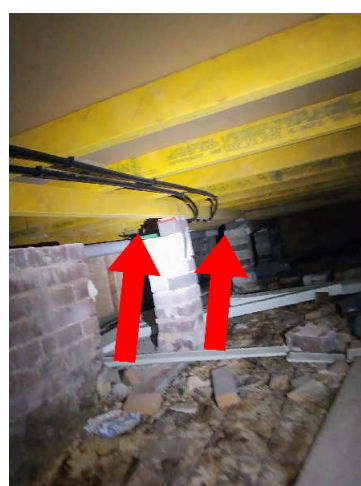
Finding 2.03

Information: Upon inspection of the subfloor area, it was noted that there is a Gap between structural timber and the brick piers at number of location in subfloor structures.

The absence of adequate subfloor stability indicates non-compliance with contemporary building practices and is likely to result in numerous minor defects, such as uneven and noisy floors. Over time, insufficient subfloor structures are likely to result in structural deterioration, as the structures do not have the capacity to bear the weight of the building.

The client is advised to seek quotations for required repairs as the potential resolution may range from packing gaps in subfloor structures through to replacement of subfloors stumps and refixing of flooring. Consultation with a registered builder specialising in re-stumping is advised immediately.

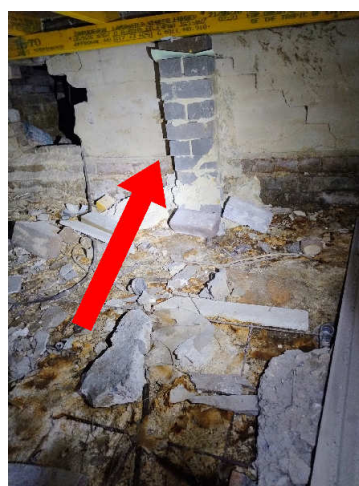
Finding 2.04

Finding: Subfloor stumps - Unstable or deteriorated

Information: Stumps to the subfloor structure was observed unstable at the time of inspection, indicating that their structural integrity has been affected. The cause of this instability is likely to be movement or extensive wood rot, both of which may deteriorate stumps at a rapid rate.

The stumps are suspected to be failing in their structural purpose, which is likely to lead to a range of major and minor defects. Further (potentially major) damage to the stumps and structure may be imminent if left unattended.

Appointment of a Registered Builder specialising in re-stumping is required immediately to assess the condition of the stumps and provide advice on remedial works. This defect should not be left unmanaged.

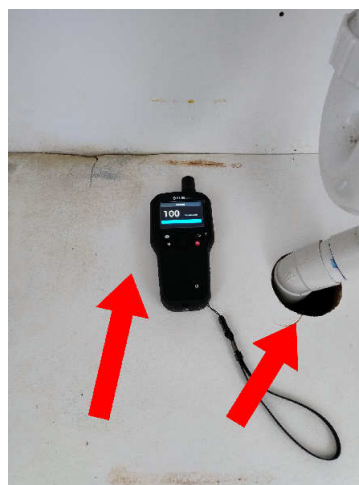
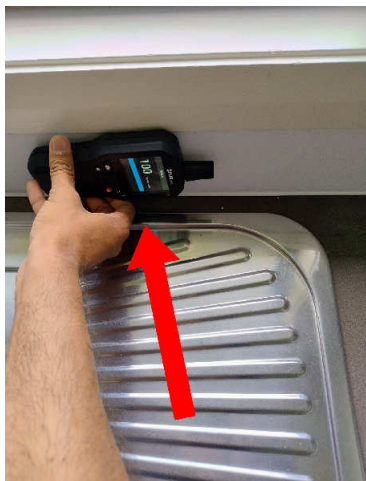
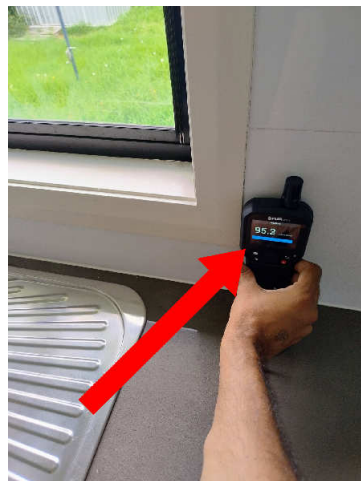
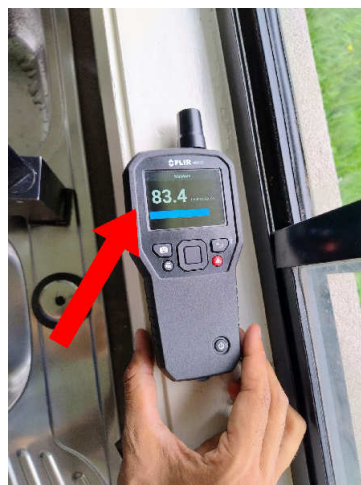
Finding 2.05

Finding: Kitchen joinery - Swollen and high moisture reading - Major defect

Kitchen joinery below wash basin was observed to be swollen, has mould impressions and recorded higher reading at the time of inspection. Swollen building elements generally indicate that the building materials have been affected by excessive moisture over a prolonged period of time, and have swollen as a result. The formation and development of mould/fungi or mildew is also a likely consequence of excessive moisture, which may pose major respiratory issues for occupants, particularly the elderly, the very young and those with existing illnesses and could be potential health safety hazards. In these cases an appropriately qualified inspector/tester should also be contacted for advice and/or technical assistance.

The structural integrity of swollen building elements can not be guaranteed, and further damage is likely to develop if left unmanaged. Excessive moisture is likely to lead to the development of secondary damage to any associated building elements, which may necessitate major reparation works if prolonged.

Rectification of the cause of the water leak should be addressed prior to any remedial works to the swollen building elements. A licensed plumber should be appointed immediately to identify the cause of the leak and provide advice on remedial works as necessary, Repair and/or replacement of swollen building elements should be conducted as a matter of urgency by a registered builder or qualified carpenter.

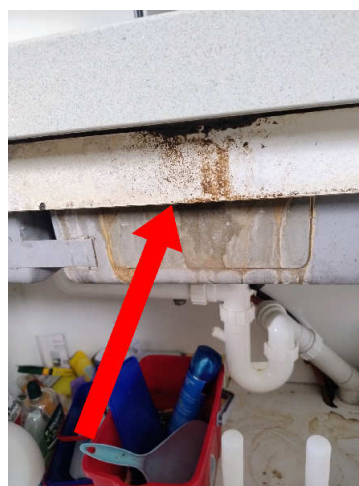
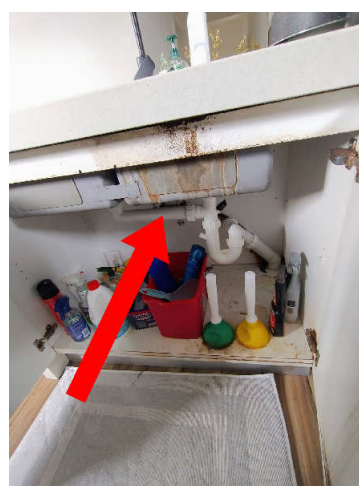
Finding 3.01

Building: Main Building
Location: Kitchen
Finding: Joinery Damage - Water stained and deteriorated

Water staining and deterioration of bolts and connections to joinery in kitchen area was evident at the time of inspection. Water staining and rusting indicates that surfaces have been exposed to excessive moisture over time. The minerals and other elements in the water lead to staining, which may graduate to corrosion and deterioration if left unmanaged.

While mostly an appearance defect, water staining can be indicative of more serious defects, which may be currently concealed by interior ceilings.

Where water staining is active, a licensed plumber must be consulted to identify the cause of the staining and to provide advice on any repair work that may be required. Replacement of any damaged structures is advised.

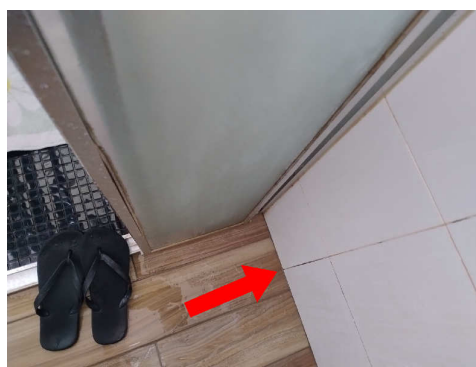
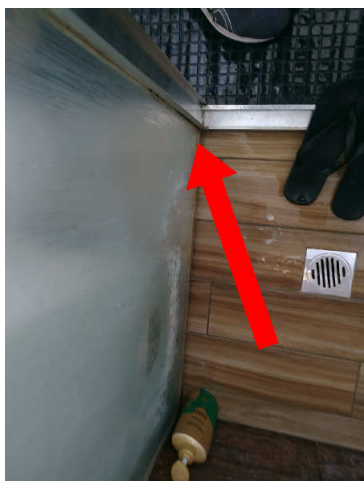
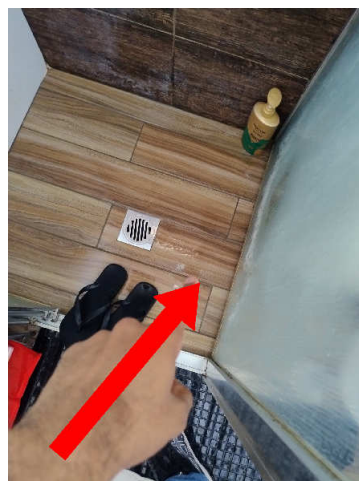
**Finding 3.02**

Finding: Sealant and Grouting - Damaged or Detoriorated

Information: It was noted on inspection that sealant or grout is degraded to the tiled shower alcove and or other areas of the bathroom.

Different materials and floor areas move at different rates, generally causing cracking to grout or sealant at this point. A flexible sealant is required to allow for expected expansion and contraction, while keeping the joint water tight and protective of all associated building materials.

There mould to the sealant and grout which will likely require scraping out and replacement.

This can lead to water ingress into the shower base and creates conducive condition to termite activity. If left unmanaged can cause further deterioration to building elements.

Flexible and mould resistant materials should be applied to affected areas to prevent any subsequent water damage that is likely to occur. Regular maintenance and replacement of damage or missing or damaged sealant and grout is highly recommended to the wet areas, as this is a regular wear and tear defect. Sealant and grouting in areas that come into regular contact with water should be maintained for the long term care of your property.

Qualified trade person or plumber must be appointed for rectification on priority.

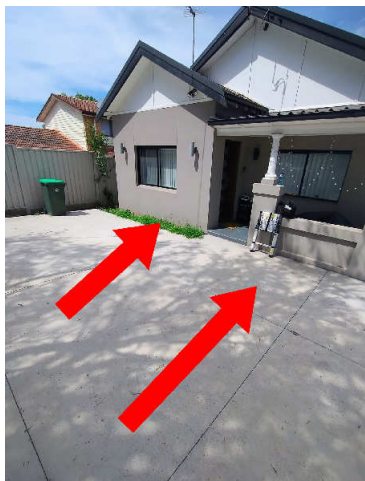
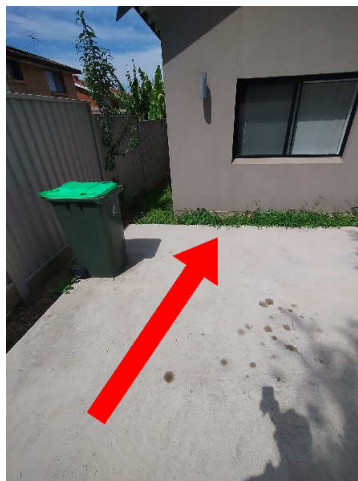
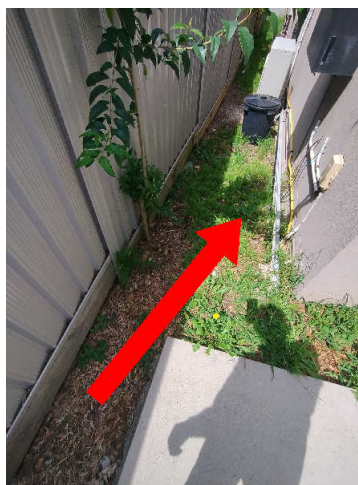
Finding 3.03

Finding: Site drainage - Inadequate

Information: The site drainage in front area was found to be inadequate at the time of inspection, creating potential for subsequent water damage to associated building elements.

Where site drainage is inadequate, installation of an Agricultural (Aggie) Drain may be required. A qualified plumber should be appointed to further inspect the property and perform any remedial works as necessary. Water damage and secondary defects are likely to occur if left unmanaged.

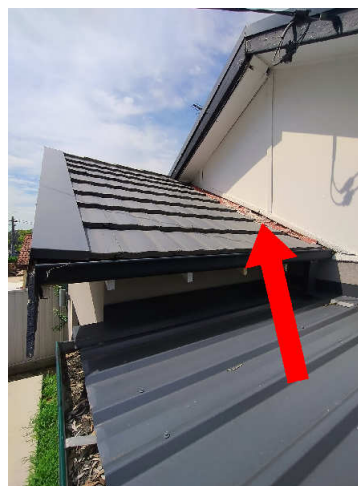
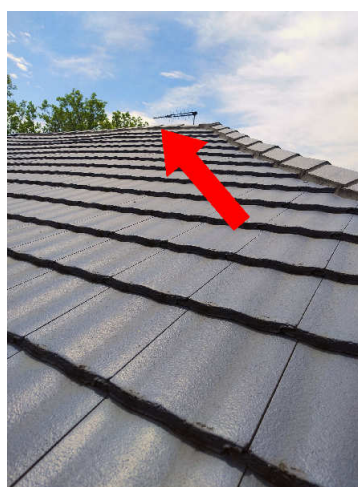
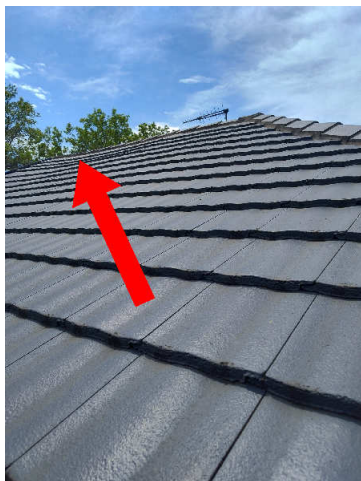
Finding 3.04

Upon inspection of the exterior roofing, the some of roof tiles were considered to be in a fair condition also roof exterior seems to be sagging at ridge. While weathering of the tiles is consistent with the age of the property, maintenance works are required.

Isolated areas of mortar have come loose in the valleys and minor cracking is also present. Re-pointing and re-sealing the may be considered as an interim solution by the client to help preserve and extend the life span of the tiles.

Where left unmanaged, deteriorating roof tiles are likely to lead to a number of secondary defects, including minor water leaks and weather exposure to internal roofing structures.

Consultation with a roofing contractor is highly advised to gain advice on cost of remedial works that may be required in the short to medium term. Remedial works are likely to increase the longevity of the exterior roofing structure.

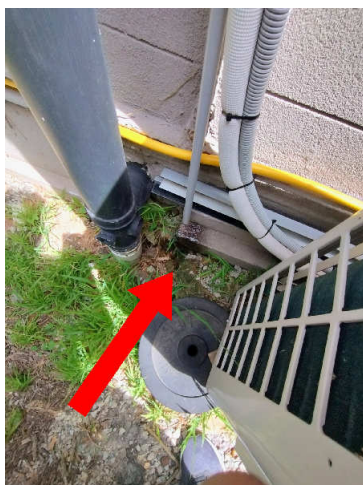
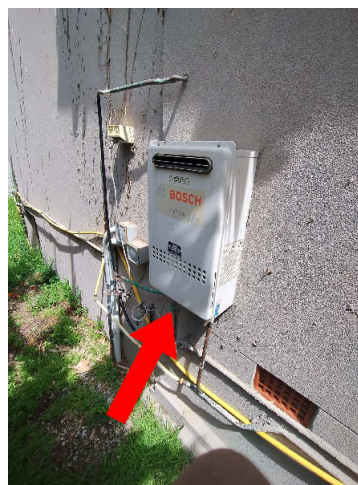
Finding 3.05

Finding: Air conditioner and hot water unit - Not connected overflow

Such leaking creates an environment which is conducive to an array of defects, including water damage to associated building elements and the attraction of termite or timber pest infestation.

It is highly recommended that a licensed plumber be appointed to connect the A/C and hot water overflow in order to prevent such an environment from being created. These minor works should be carried out as soon as possible.

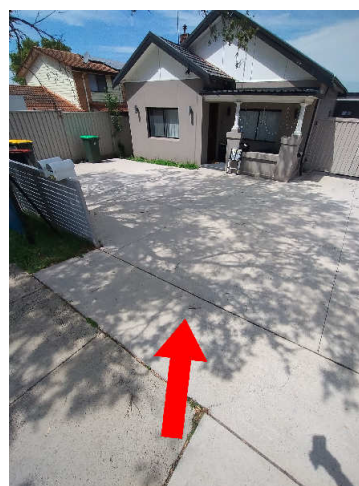
Finding 3.06

To be considered Category 2, the approximate width of the crack is less than 2.0mm, or a change in offset of less than 15mm when a 3m straight edge is placed over the defect.

Category 2 cracks to slabs should be monitored for a period of 12 months. At the end of the monitoring period, cracks rated greater than Category 2 are considered defects that require rectification.

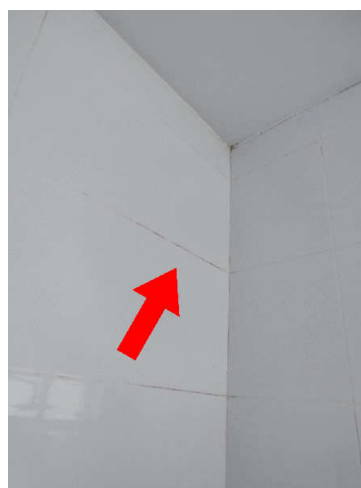
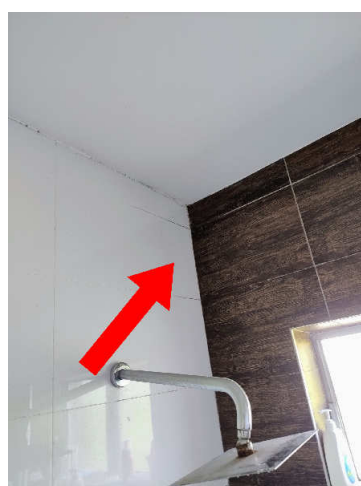
Finding 3.08

Building: Main Building
 Location: Bathroom
 Finding: Tiles grouting - Cracked and damaged

A tiling contractor should be appointed to ensure that no further water damage occurs. The re-application of silicone and grouting throughout remaining tile work is also advised, to further protect the area against water penetration.

Where water penetration has led to water damage, appointment of a relevant tradesperson may be required to repair damaged building elements.

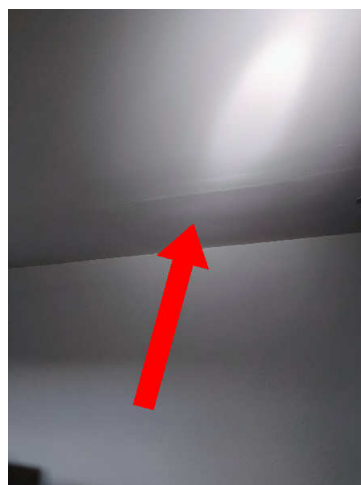
Finding 3.10

In some cases, sagging ceiling linings may also indicate that there are structural issues, causing surfaces to warp, twist or sag. Where sagging appears to be major, appointment of a structural engineer is advised to further inspect the property and identify the source and rectification works required.

The appropriate action should be taken by the client as soon as possible to ensure that any potential further damage is limited.

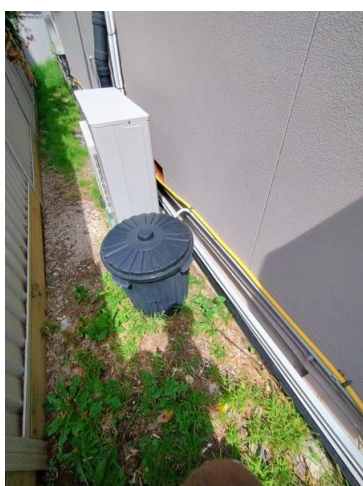
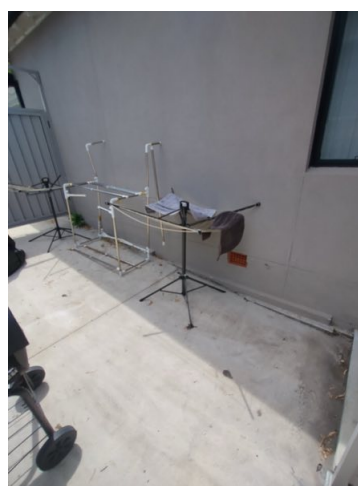
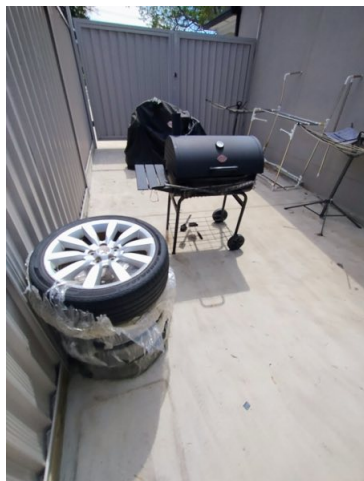
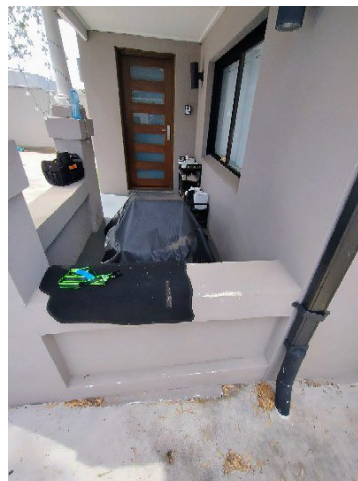
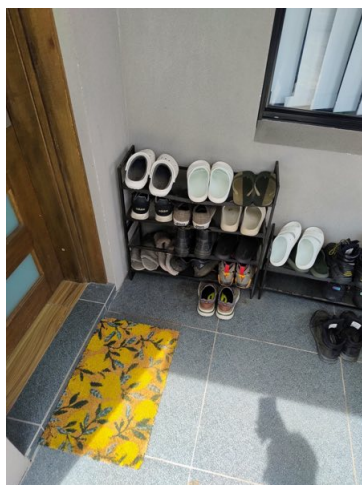
Finding 6.03

Building: Main Building
Location: All External Areas
Finding: Site drainage - Inadequate

The site drainage in front and left side area was found to be inadequate at the time of inspection, creating potential for subsequent water damage to associated building elements.

Where site drainage is inadequate, installation of an Agricultural (Aggie) Drain may be required. A qualified plumber should be appointed to further inspect the property and perform any remedial works as necessary. Water damage and secondary defects are likely to occur if left unmanaged.

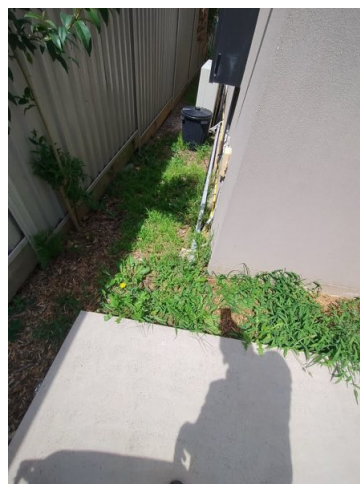
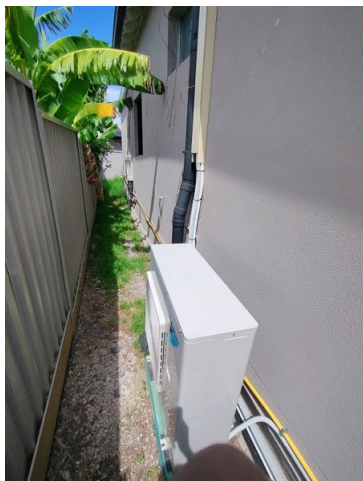
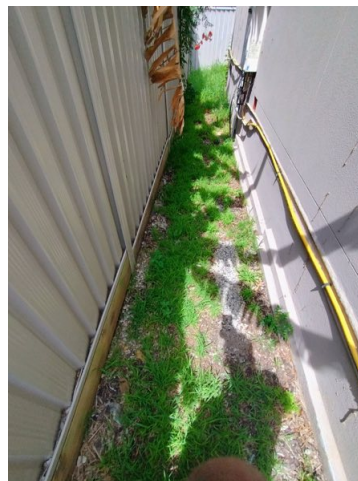
Finding 6.06

Finding: Overflow for air condition unit and hot water unit - Not plumbed for drainage

Information: The overflow for air condition and hot water unit is not plumbed or connected to suitable drainage, which has resulted in the surrounding area becoming excessively damp at the time of inspection.

These damp conditions can lead to secondary defects such as rot, rust or corrosion of associated building elements, the formation of fungal decay, or even the creation of potential slip hazards.

When coupled with poor site drainage, pooling of water may also attract termite activity to this area. It is highly recommended that a qualified plumber be appointed to install adequate drainage to the overflow. These works will ensure that the area remains dry and free of any secondary defects.

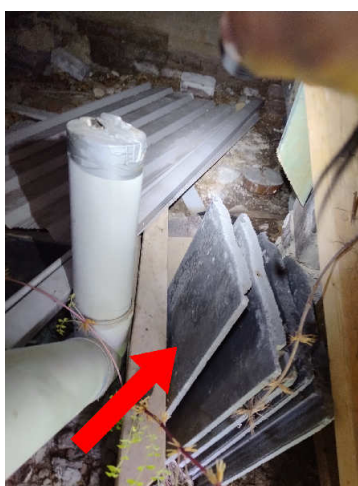
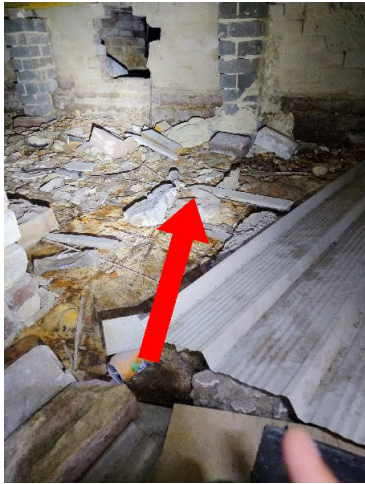
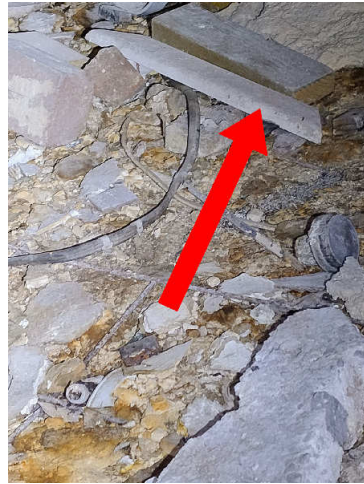
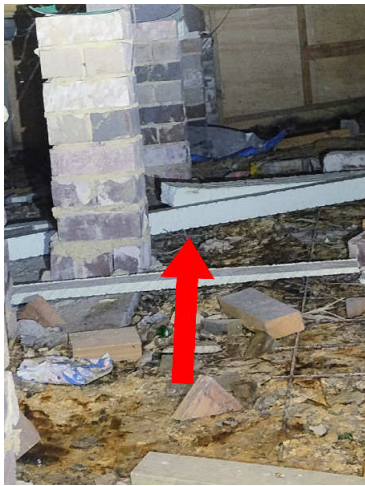
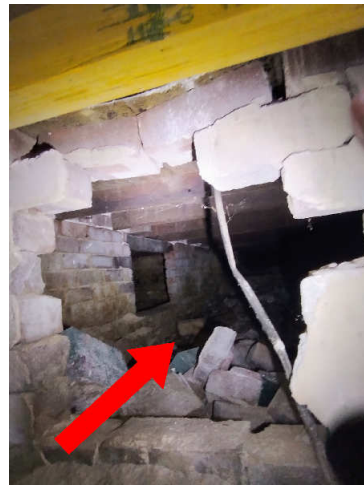
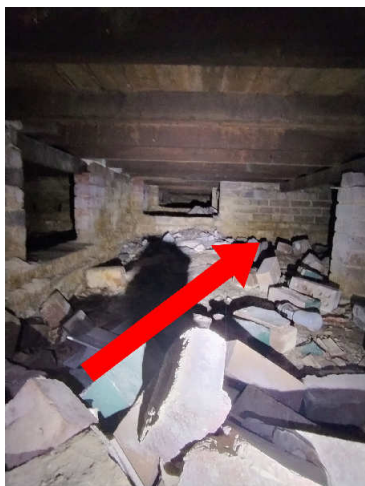
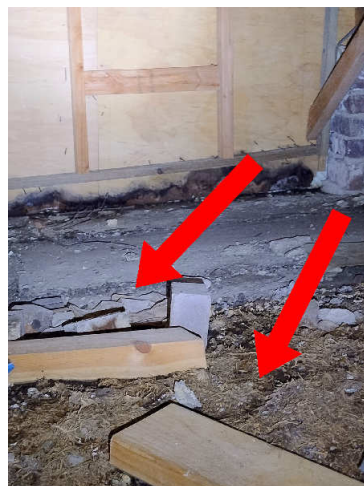
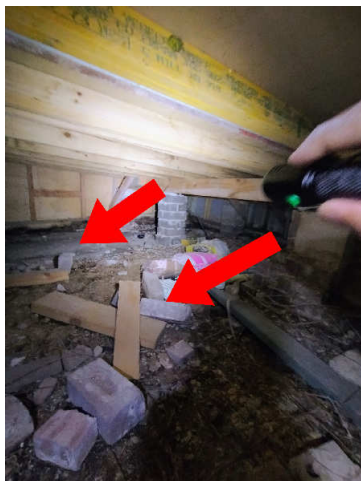
Finding 6.08

Finding: Subfloor drainage - Inadequate

Information: The Subfloor drainage in all area was found to be inadequate at the time of inspection, creating potential for subsequent water damage to associated building elements.

It is important that water does not lie against the base; surrounding paths and ground levels should be sloped to drain water away from footing and building structure.

Where sub floor drainage is inadequate, installation of an Drain may be required. A qualified plumber should be appointed to further inspect the property and perform any remedial works as necessary. Water damage and secondary defects are likely to occur if left unmanaged.

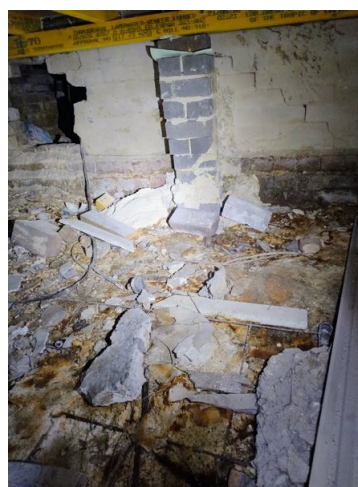
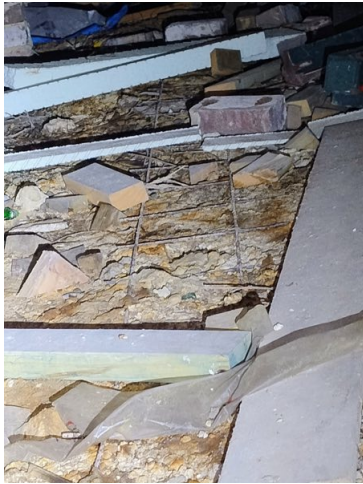
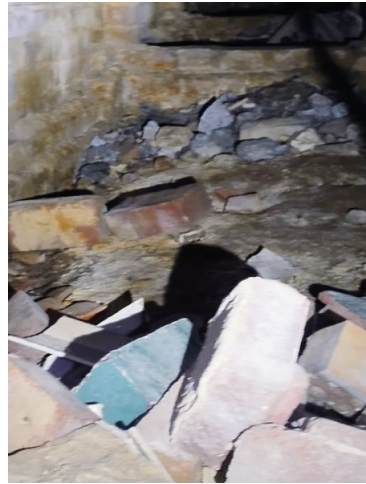
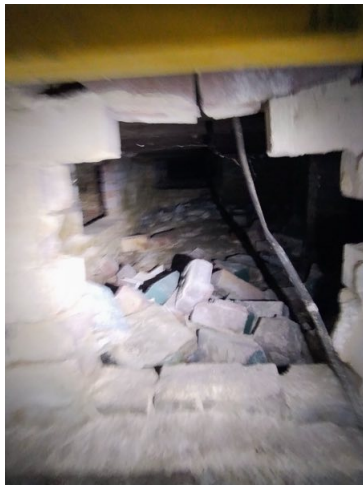
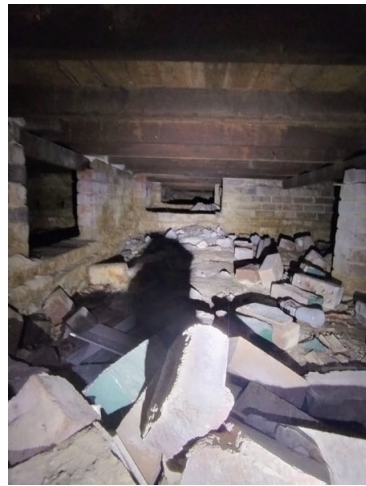
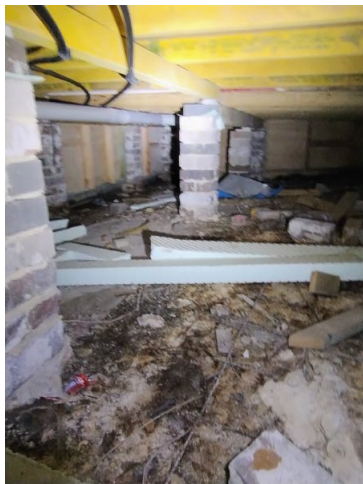
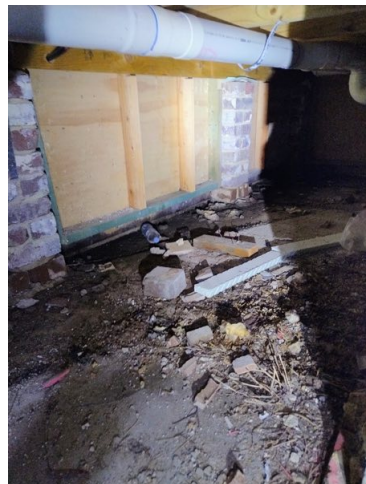
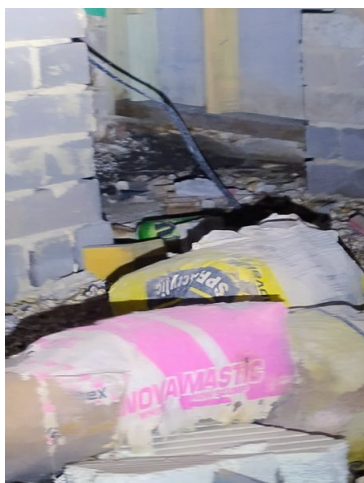
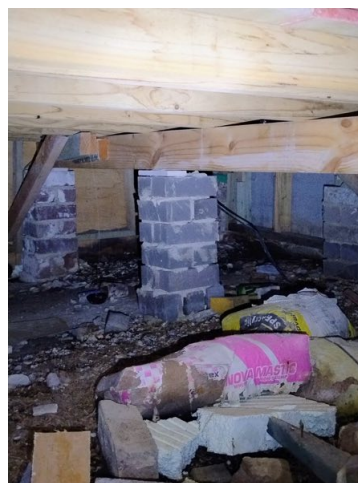
Finding 6.09

Information: It was noted at the time of inspection that the subfloor area lacks adequate ventilation. Also most of ventilation openings were found to be obstructed or blocked to allow the air circulation in subfloor.

Ventilation can be restricted by a variety of minor defects, including obstructions in the subfloor space, a lack of vents or a low clearance.

A well ventilated subfloor aids in maintaining dry conditions, preventing secondary damage such as wood rot and pest activity, as well as preventing the development of mould and mildew (which can lead to respiratory safety hazards for occupants).

The initial step in improving ventilation is to ensure that the subfloor area is free of any debris or stored items. Where ventilation is still inadequate, it is advised to ensure that all vents are clear of blockages, and additional vents may be installed.

The client may also consider mechanical ventilation (powered fans) to improve subfloor airflow. Remedial works should be conducted as a matter of urgency to protect against the development of potentially harmful subfloor conditions.

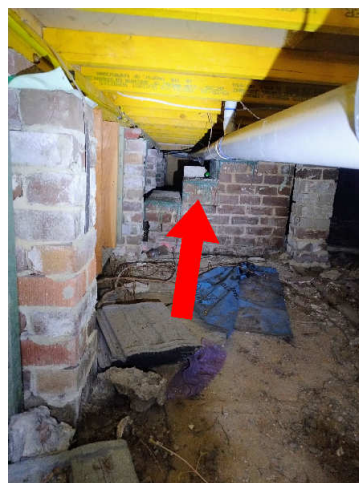
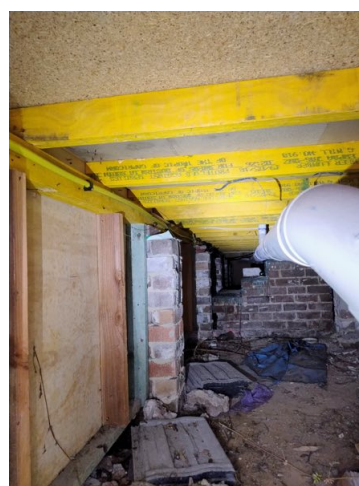
Finding 6.10

Finding: Ant caps - missing and poorly installed at other location

Information: Ant caps were missing and some location have not been installed as per the Australian standard to the subfloor structure at the time of inspection. Generally, ant caps are installed to the intersection between the top of the stumps (or piers) and the subfloor structures sloping down wards.

Installed during the construction process, ant caps are designed to easily identify termite or pest ingress from stumps to the adjoining bearers.

Where ant caps have not installed or been poorly installed, frequent monitoring of these areas should be carried out in order to identify any signs of termite or timber pest workings.

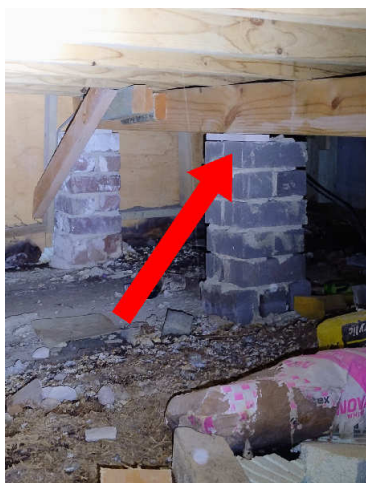
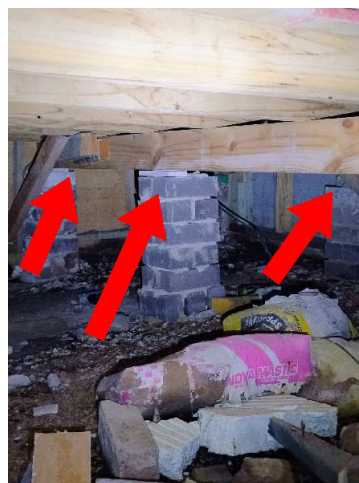
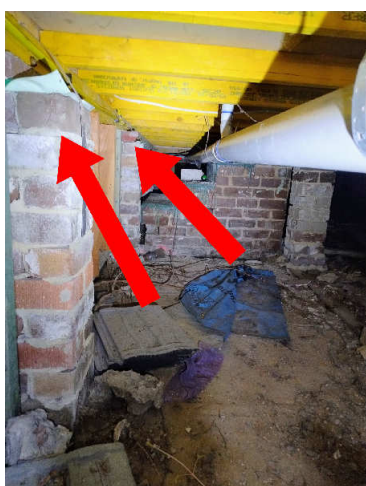
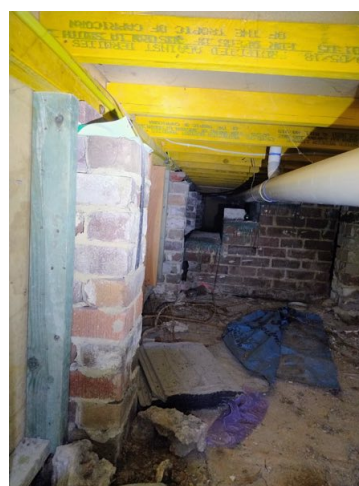
Finding 6.11

Finding: Excessive Subfloor moisture

Information: Excessive subfloor moisture was present at the time of inspection. Excessive moisture can attract termites and produce conditions that promote termite attack, fungal growth and wood decay. Excessive moisture is generally caused by deteriorated, inadequate or missing roof drainage, leaking plumbing pipes or fixtures, poorly plumbed HWS overflows or condenser units and poor site drainage. It is highly recommended that all plumbing and drainage fixtures and fittings be maintained regularly in order to prevent excessive moisture being present in the external / internal property.

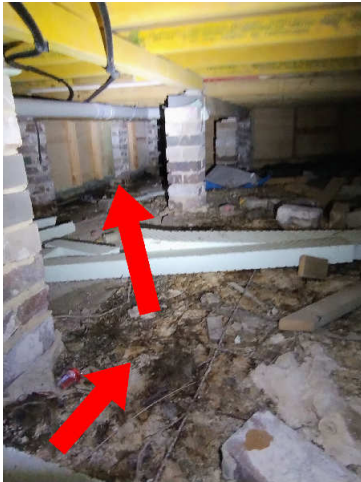
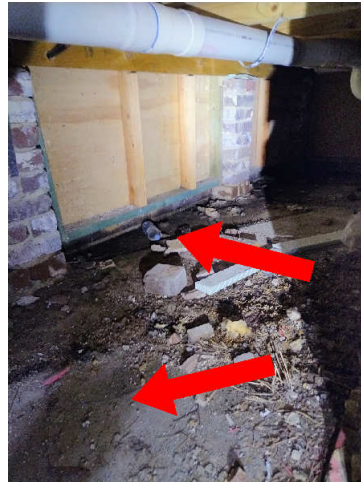
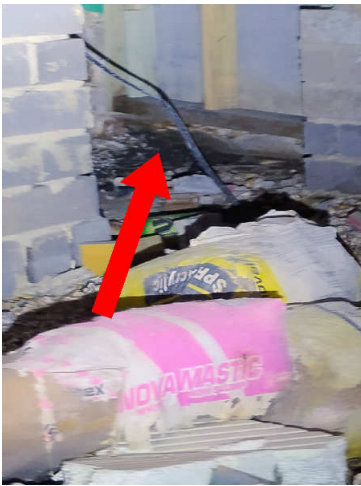
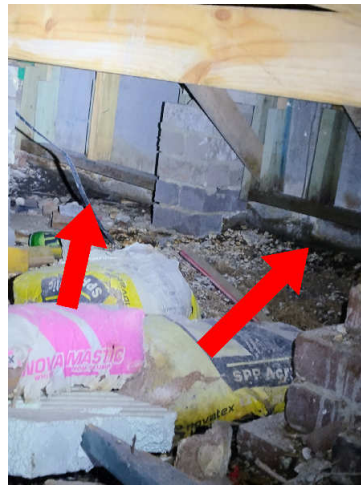
Finding 6.12

Building: Granny-Flat
Location: All External Areas
Finding: Site drainage - Inadequate

The site drainage in Granny flat area was found to be inadequate at the time of inspection, creating potential for subsequent water damage to associated building elements.

It is important that water does not lie against the base of walls; surrounding paths and ground levels should be sloped to drain water away from walls. Downpipes should not discharge stormwater onto lower walls or plinths. Stormwater should be carried away by large, regularly cleaned drains. Ground levels may need to be lowered to expose a buried DPC.

Where site drainage is inadequate, installation of an Agricultural (Aggie) Drain may be required. A qualified plumber should be appointed to further inspect the property and perform any remedial works as necessary. Water damage and secondary defects are likely to occur if left unmanaged.

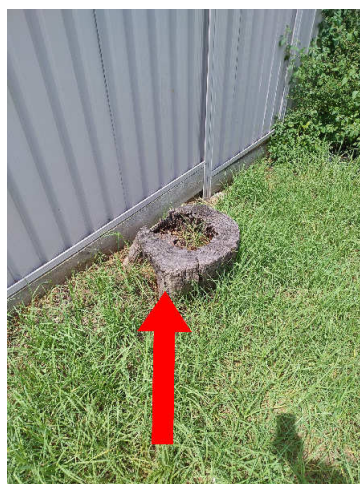
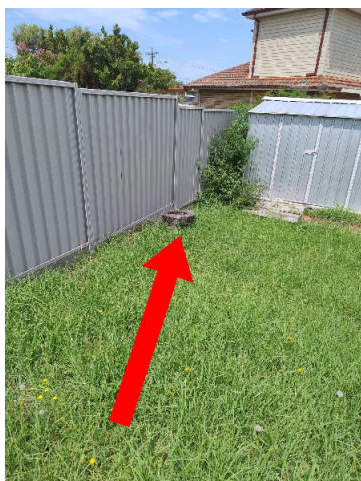
Finding 7.01

Finding: Fungal decay - present

Information: Fungal decay and timber deterioration was observed at the time of inspection in front elevation of the property.
Fungal decay also known as wood decay or wood rot generally refers to the deterioration of timber elements when in contact with excessive levels of moisture for a prolonged period of time.

The development of fungal decay is accelerated by temperatures in the range of 5degreeC to 40degreeC as well as the presence of oxygen. Generally fungal decay develops on timber elements that are in use in an external environment which are exposed to rain penetration.

In this case although the affected timber element is in a decaying state the extent of any visible damage appears to be localised to a specific area and is yet to spread to other parts of the building element or affect adjoining structures. The fungal decay is therefore likely to be of a relatively superficial nature with minimal impact on the structural integrity or tensile strength of the timber element.

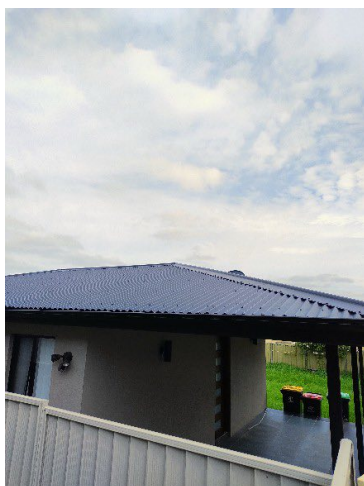
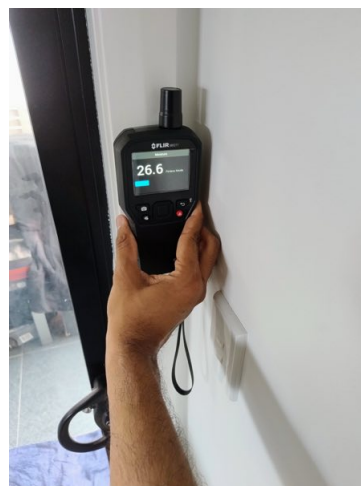
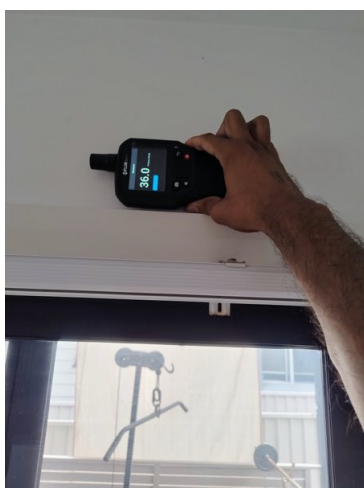
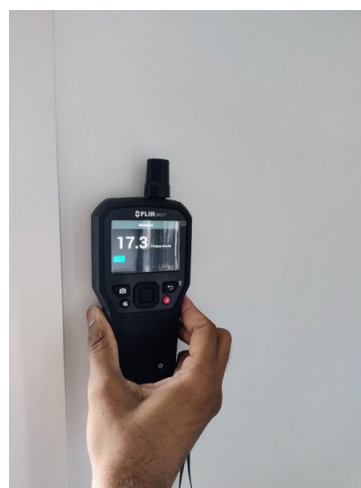
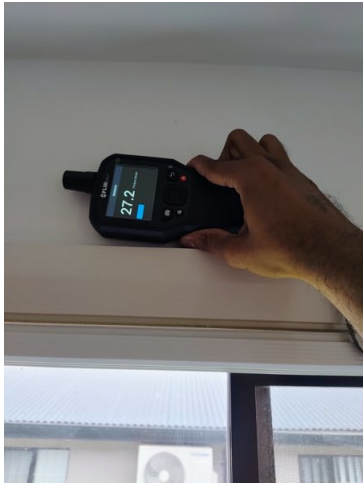
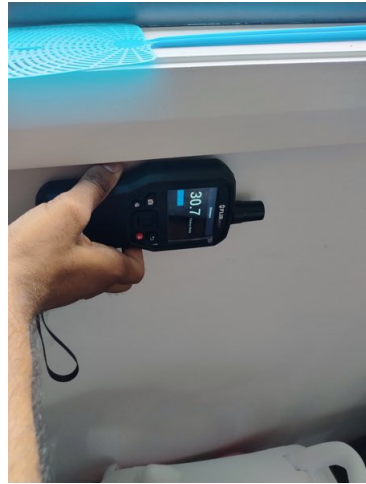
Building: Main Building
Location: All Areas
Finding: Moisture reading taken at different locations
Information: All area moisture reading for reference.

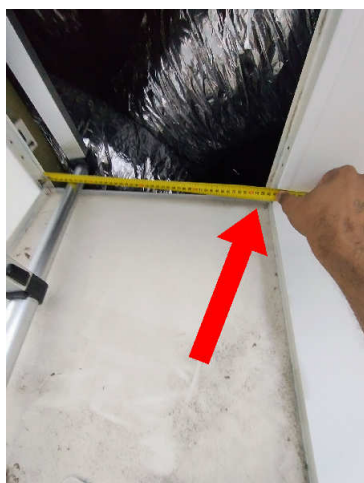
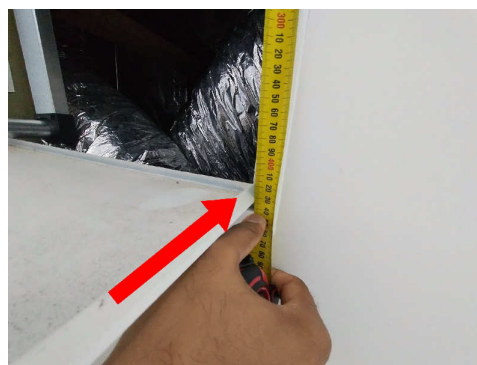
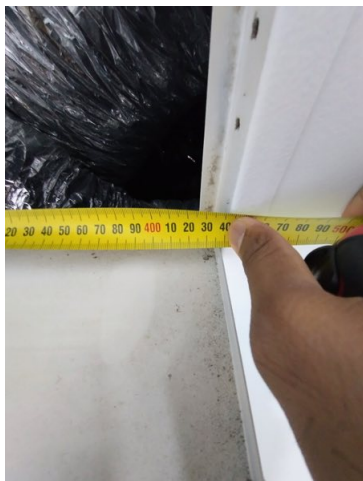
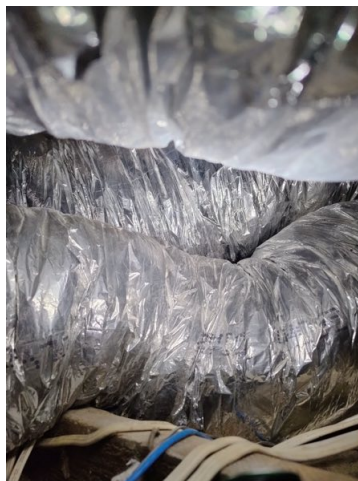
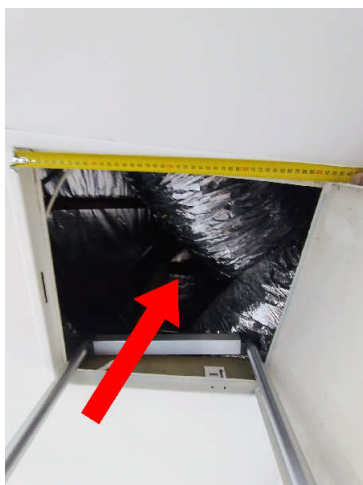
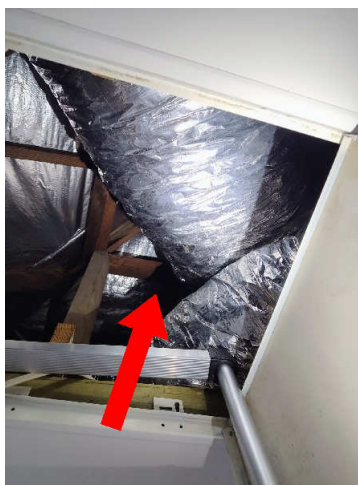
Noted Item

Building: Main Building

Finding: Roof void access limitations

Information: Very Limited access to the roof void was present due to facts including but not limited to access hatch size or placement and obstructions at the entry of roof space, for this reason access to the roof void was minimal.

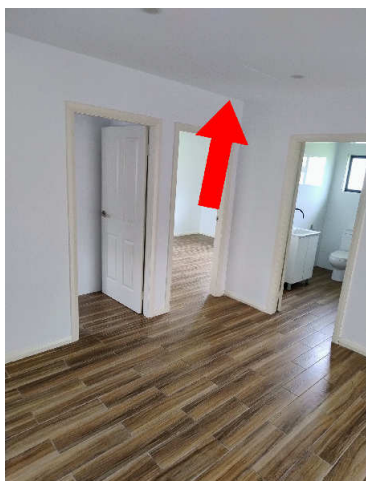
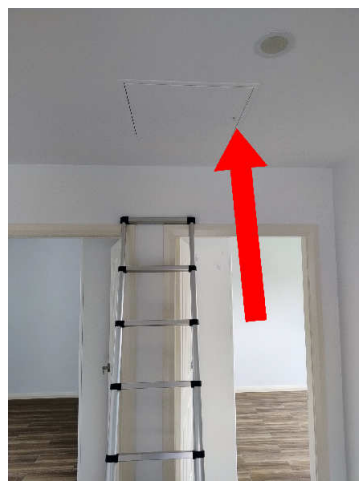
Noted Item

Building: Granny-Flat
Location: Roof Void
Finding: Roof void access limitations
Information: No access to the roof void was present due to Not opening of roof void door due to rusted bolt jammed at the time of inspection, for this reason access to the roof void was not possible.

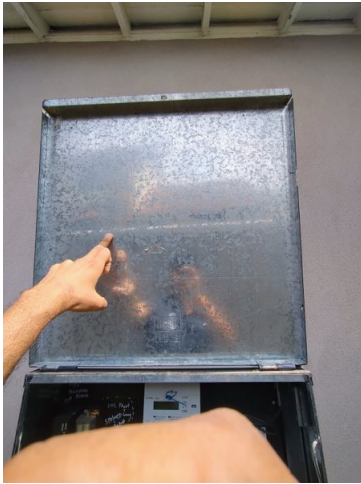
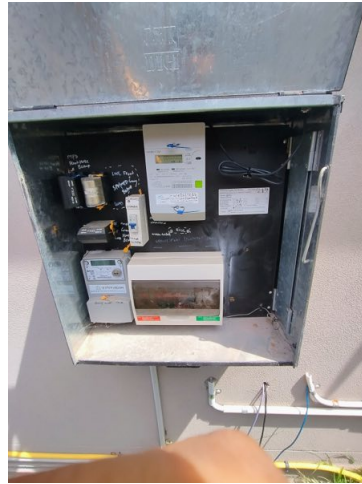
Noted Item

Building:	Main Building
Location:	Meter Box
Finding:	Termite Management System - no evidence of a Termite Management system or Durable notice
Information:	At the time of inspection, it was noted that there is no visible durable notice indicating the installation of a termite management treatment system, as required by current building regulations.

A durable notice, usually in the form of a sticker, found in the main switchboard, should be provided by a licensed pest control contractor upon the installation of a termite management system to inform future occupants or owners of the treatment.

The absence of such a notice may compromise the effectiveness of termite control measures and could lead to potential risks related to termite infestations and damage. It is noted that without further information from the current owner or real estate agent regarding the installation of a termite management treatment system, it is then assumed that there is no termite treatment system installed to the property.

It is strongly recommended that a licensed pest control contractor be engaged to assess the property and to install an appropriate termite management system as a matter of urgency.
