Building and Timber Pest Inspection Report

Inspection Date: Thu, 19 Feb 2026

Property Address: 2/29 Dunmore St, Croydon Park NSW 2133, Australia

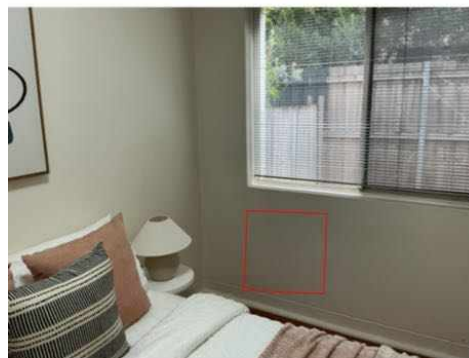
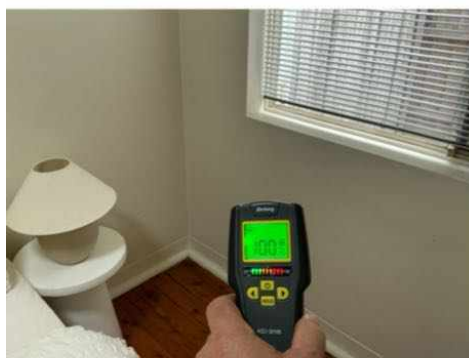
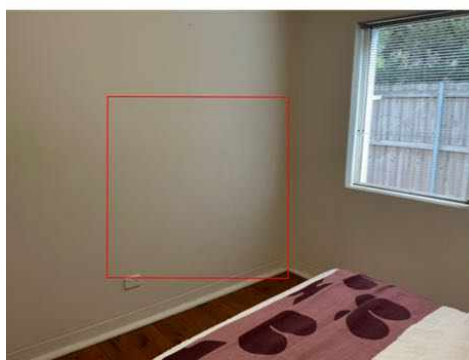
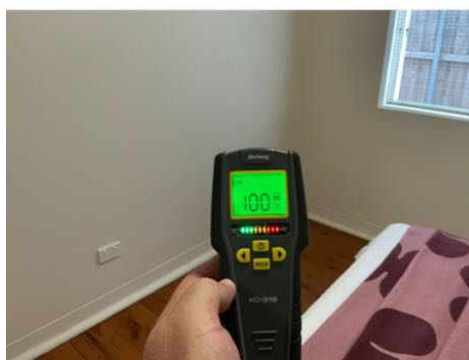
Building: Main Building
Location: Both bedrooms
Finding: Excessive Moisture Identified.
Information: Excessive moisture can attract termites and produce conditions that promote fungal growth and wood decay.

Excessive moisture is generally caused by deteriorated, inadequate or missing roof drainage, leaking plumbing pipes or fixtures, poorly plumbed HWS overflows or condenser units and poor site drainage.

If mould growth has been found there may be environmental biological or health issues involved. In these cases an appropriately qualified inspector should also be contacted.

Prior to any remedial works being performed a qualified plumber should be appointed to further inspect the property and to identify the cause of the excessive moisture. Works to remove affected building elements may then be necessary and should be performed by an appropriate tradesperson.

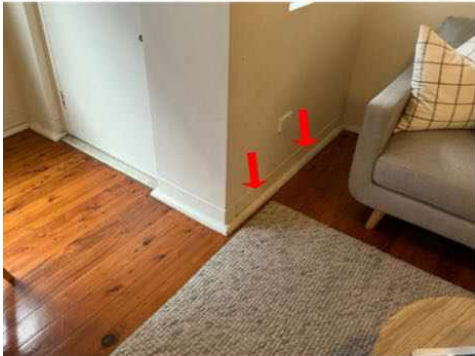
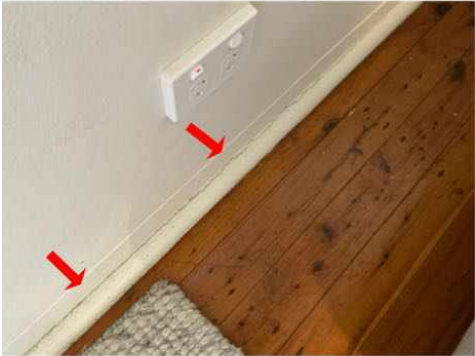
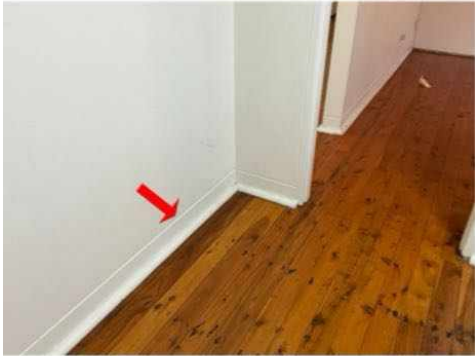
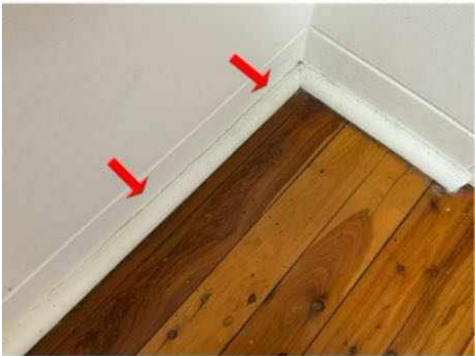
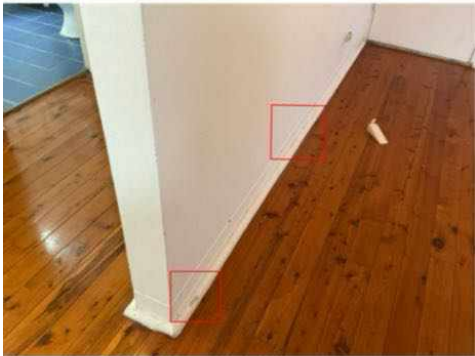
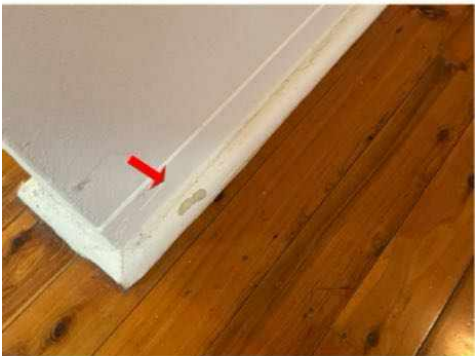
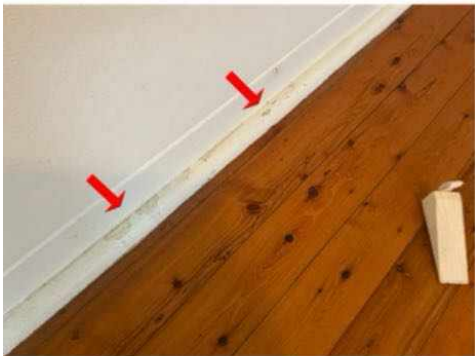
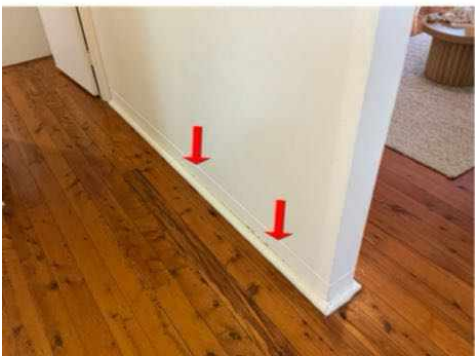
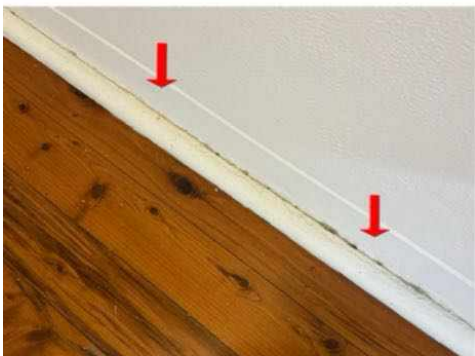
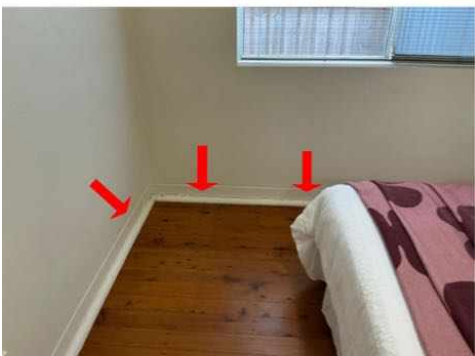
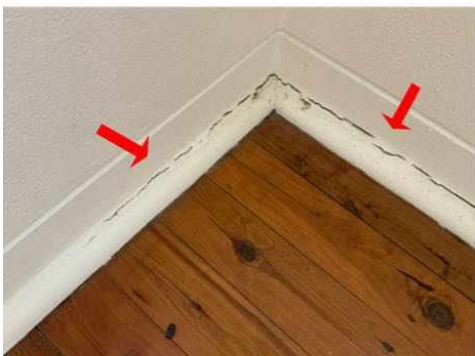
Finding 3.02

Building:	Main Building
Location:	Lounge, hall, bedrooms
Finding:	Paint finish - Substandard- skirting boards
Information:	The paint finish in this area was found to have been completed to a substandard level. Substandard painting is generally classified as an appearance defect. However, the substandard appearance may also be indicative of poor surface preparation and substandard workmanship.

Substandard paint finishes should be sanded back, filled, leveled and repainted, as applicable. Where inadequate paint protection has led to the deterioration of the associated building element, repair and/or replacement of this building element may be required.

A painting contractor should be appointed as soon as possible to perform necessary works to aid the appearance of the affected area and to ensure that the area is protected against further deterioration. Alternatively, the homeowner following manufacturer instructions may be able to provide this service.

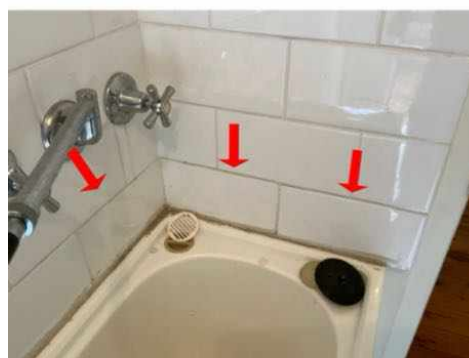
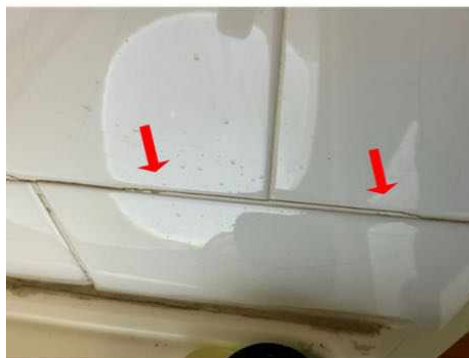
Finding 3.03

Tiled areas may swell and shrink with changes in air humidity if the area has sustained moisture damage. Any exposure to moisture is capable of causing tiled areas to become drummy and/or cracked over a prolonged period of time. Drummy tiled areas generally require removal and replacement of affected tiles, with adequate sealant and grouting.

Specialist trades are available for these types of services. A registered builder may be required to undertake works if damage is extensive or if secondary building defects have resulted. Otherwise, it is advised that a tiling contractor be appointed to perform works as necessary. Immediate action is recommended to ensure that no further damage is sustained in the affected area.

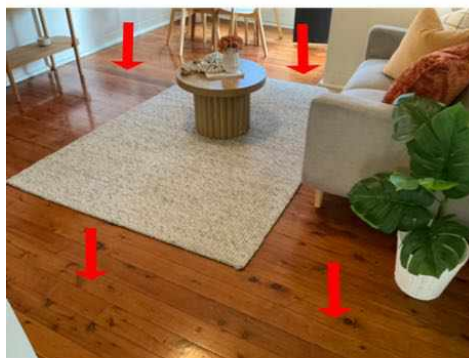
Finding 3.04

Building:	Main Building
Location:	All areas- lounge room, kitchen, hallway, bedrooms
Finding:	Floors - bouncy
Information:	The internal flooring in this area was identified as being bouncy at the time of inspection. A bouncy floor surface generally presents as a discernible change in level as they are walked across, in noisy or creaking flooring, or in consequent movement of surrounding furniture and fixtures.

Bouncy floors generally indicate that the floorboards or the subfloor structures are coming loose from the joists that they are installed on. Bouncy flooring may also be the result of gaps between flooring and stumps or joist structures, which require packing.

The client is advised to seek quotations for required repairs from a Registered Builder specialising in re-stumping. The potential resolution may range from packing gaps in subfloor structures through to replacement of subfloors stumps and refixing of flooring.

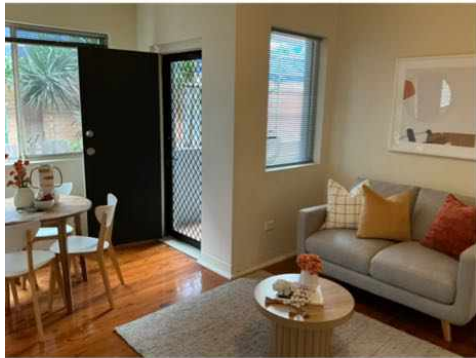
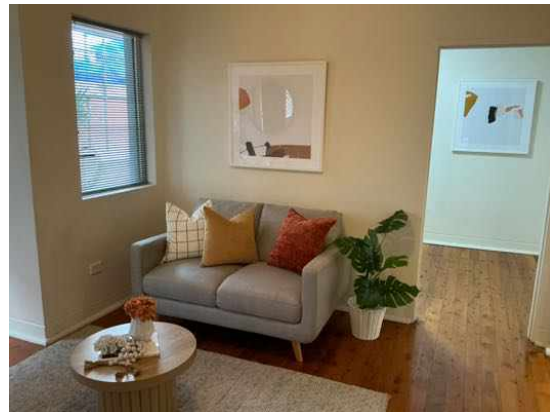
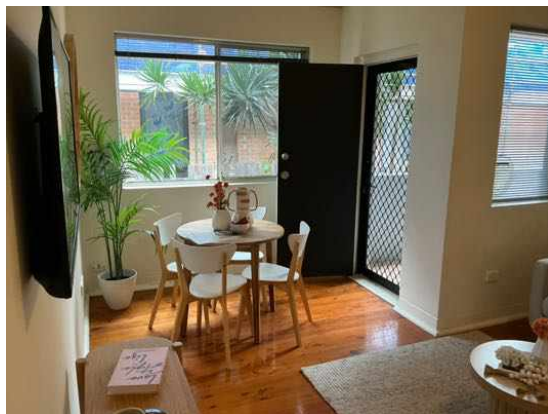
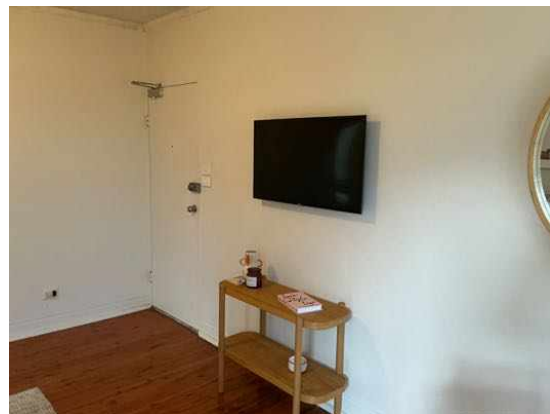
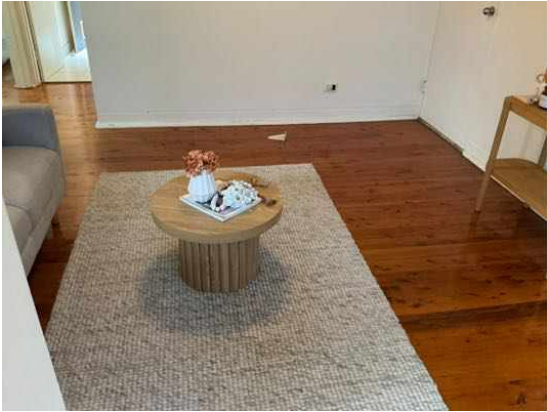
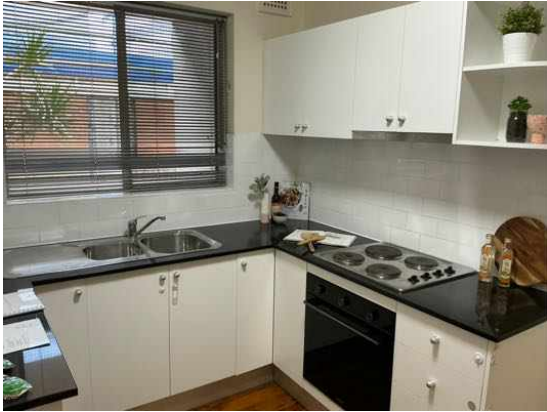
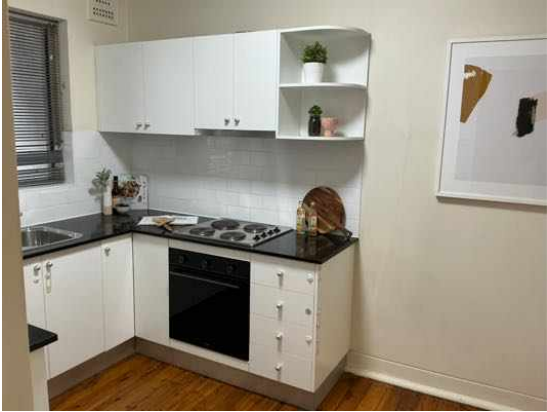
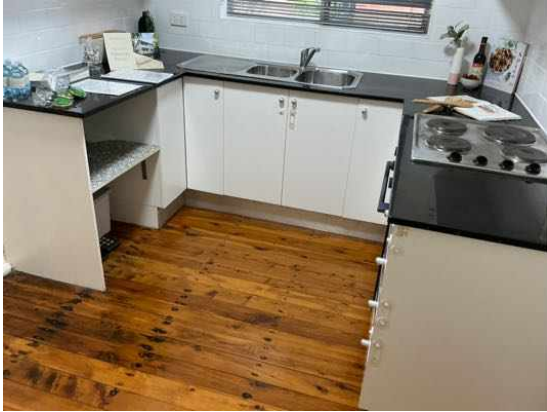
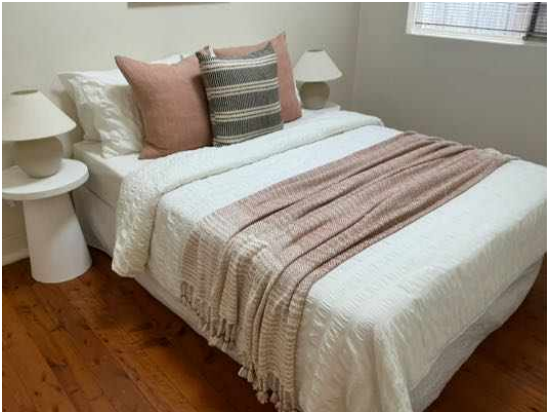
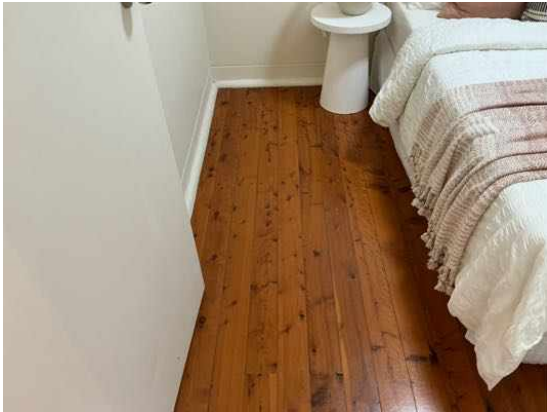
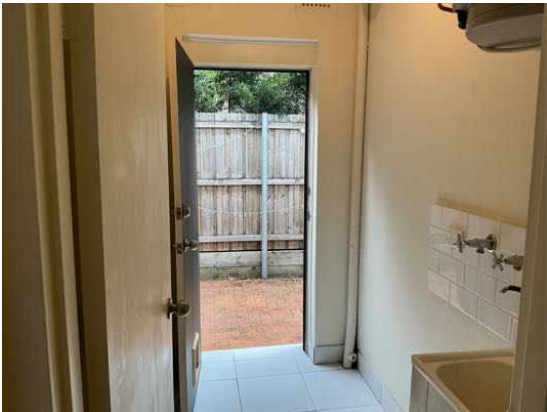
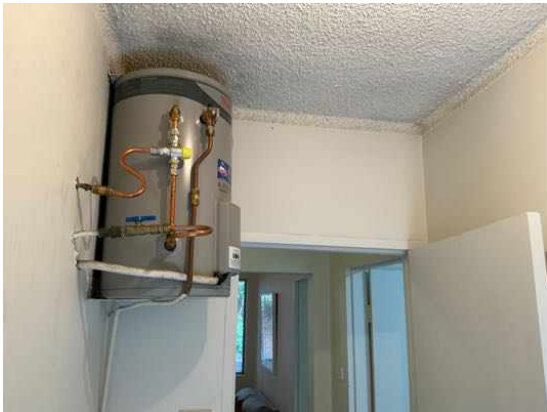
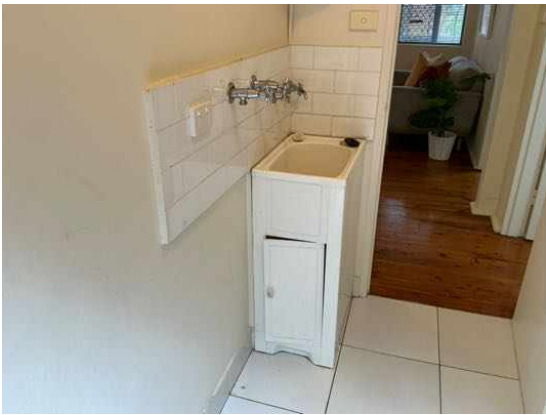
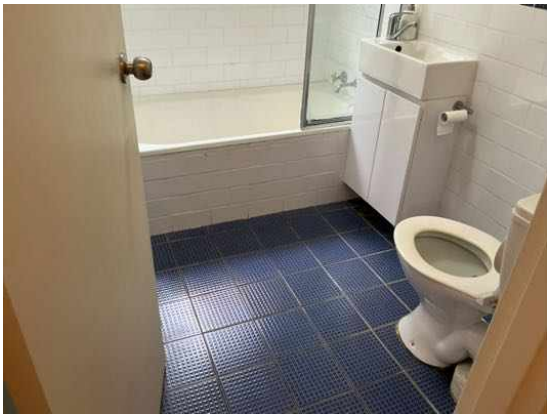
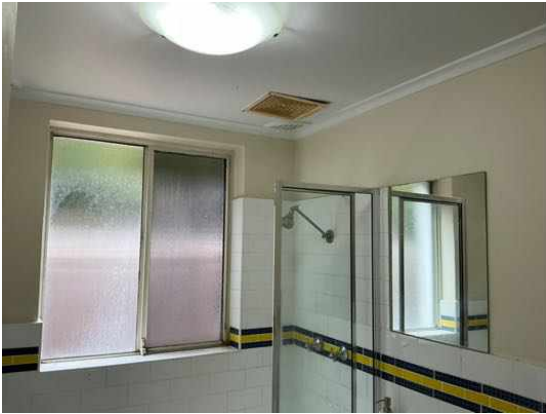
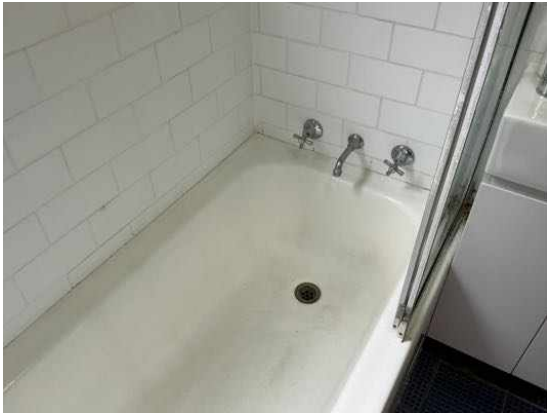
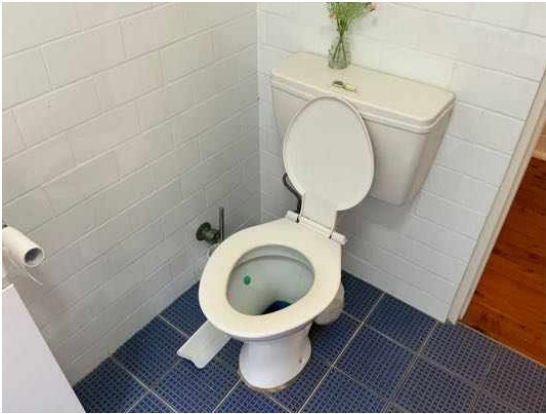
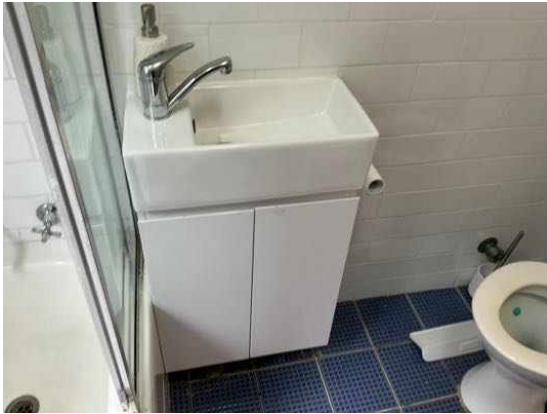
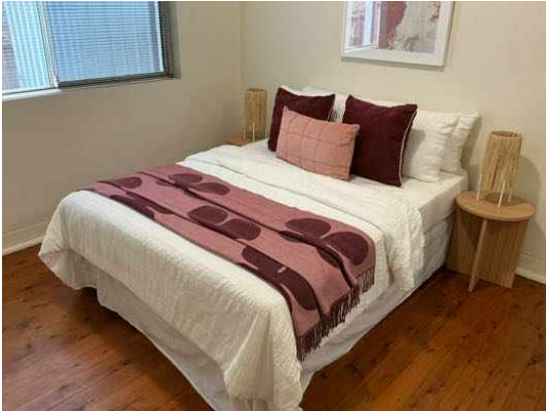
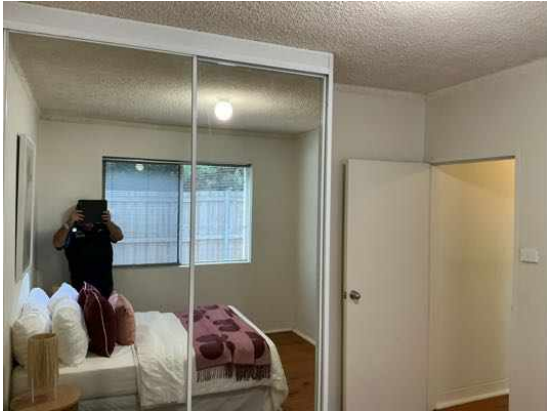
Noted Item

Building: Main Building
Location: All Areas- internal
Finding: Additional Photos - Obstructions and Limitations
Information: These photographs are an indication of the obstructions and limitations which impeded full inspection of the property at the time of inspection. These obstructions can hide an array of defects and should be removed to allow full inspection to be carried out. A re-inspection is recommended once the areas are made accessible.

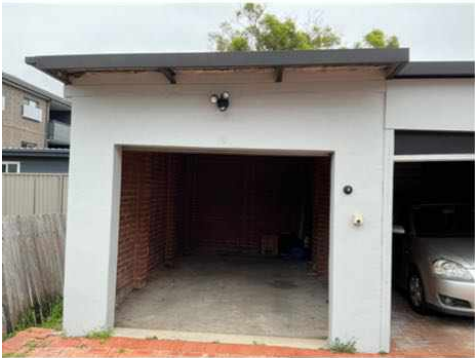
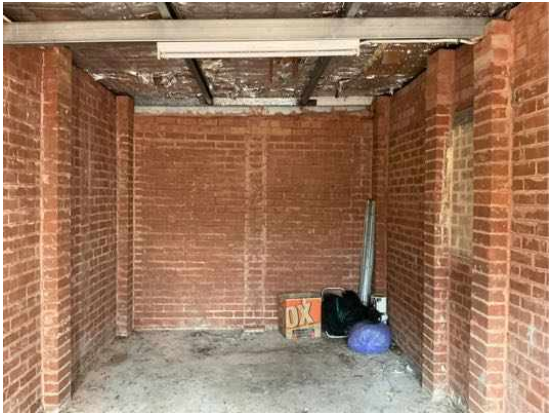
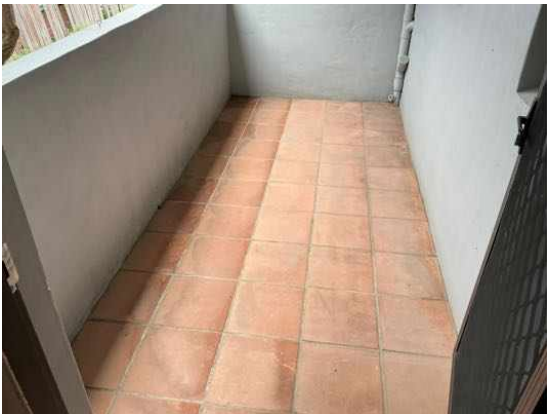
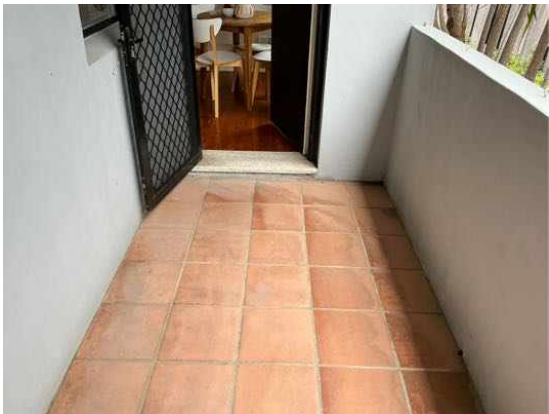
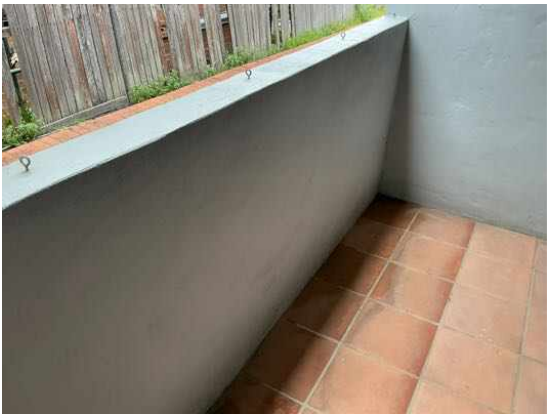
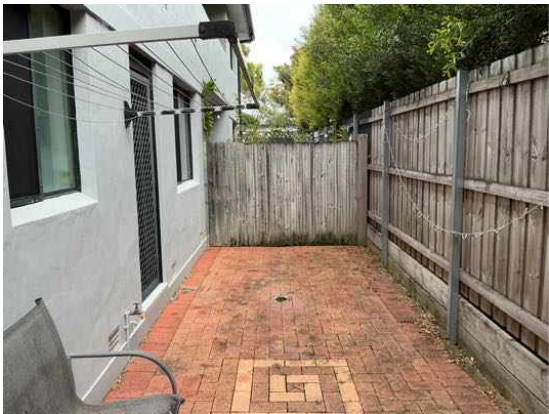
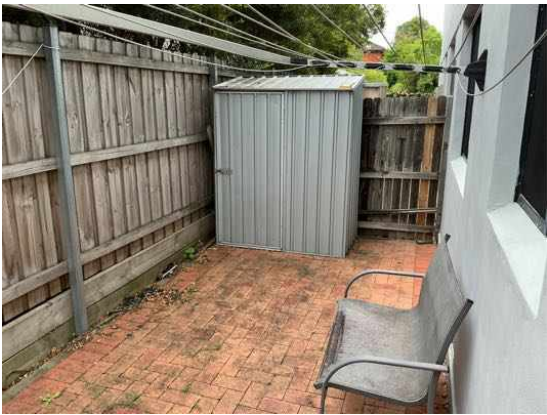
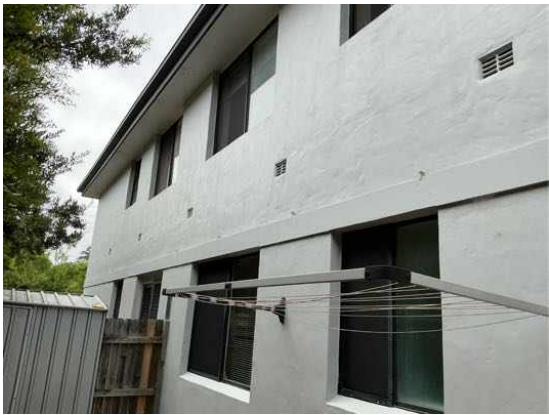
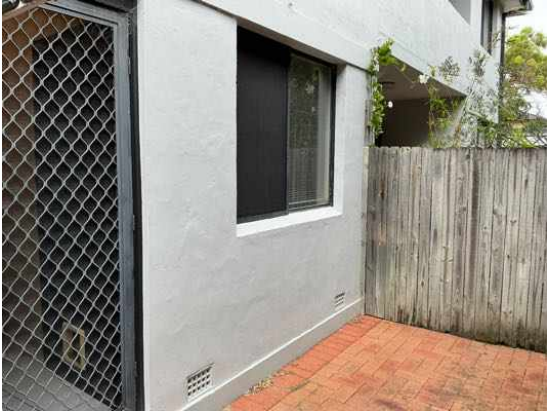
Building: Main Building
Location: All Areas- external
Finding: Additional Photos - Obstructions and Limitations
Information: These photographs are an indication of the obstructions and limitations which impeded full inspection of the property at the time of inspection. These obstructions can hide an array of defects and should be removed to allow full inspection to be carried out. A re-inspection is recommended once the areas are made accessible.
