# Building and Timber Pest Inspection Report

Inspection Date: Thu, 22 Jan 2026

Property Address: 129 & 129A Maple Rd, North St Marys NSW  
2760, Australia

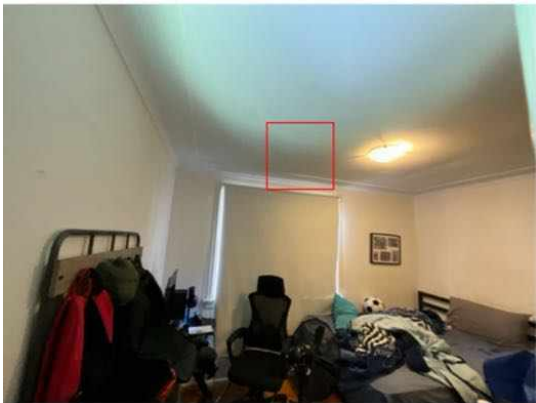
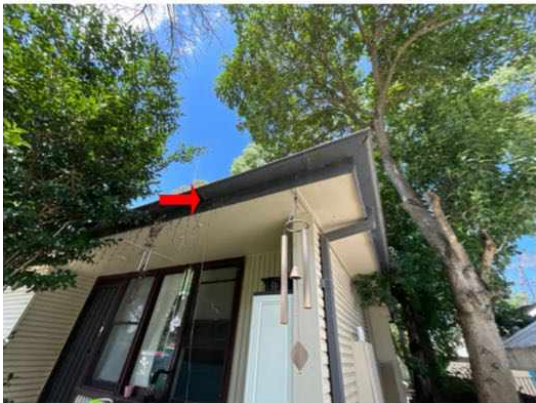
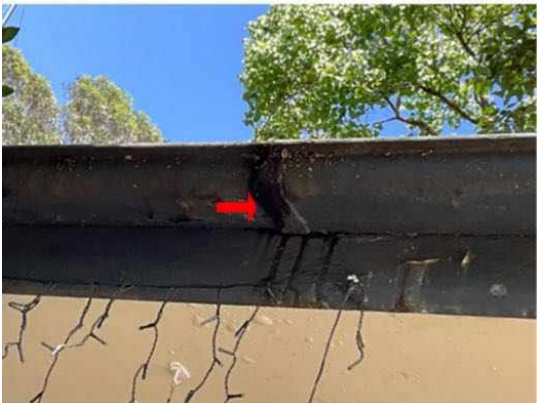
**Finding 3.02**

Building: Main Building  
Location: Multiple areas of roof plumbing  
Finding: Eaves/Roof plumbing -- water damages  
Information: Water damage is generally an indication of excessive moisture being present, usually via a leak. It is suspected that gutter blockages causing stormwater to backflow into the eaves causing water damages. This is additionally conducive to termite activity due to the damp conditions.

Where water damage is evident, the primary requirement is to identify and rectify the source of the leak. Gutters must be kept clear of any blockages moving forward. A roofing plumber should be appointed for further assessment if the problem persists.

Once the leak is repaired, consultation with relevant tradespeople, including carpenters, plasterers and painters, is advised.

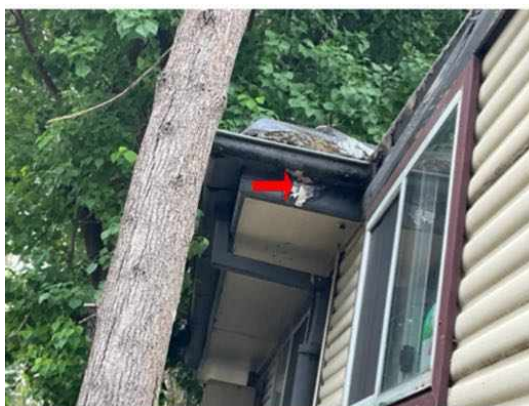
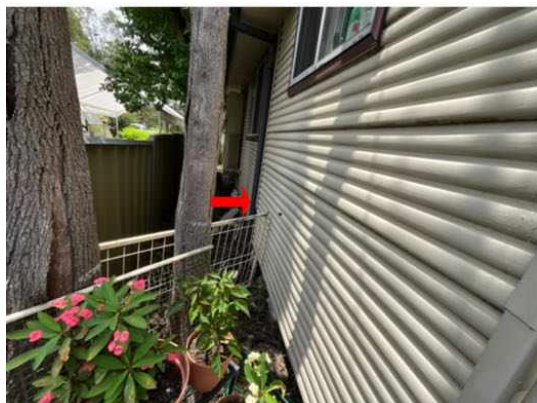
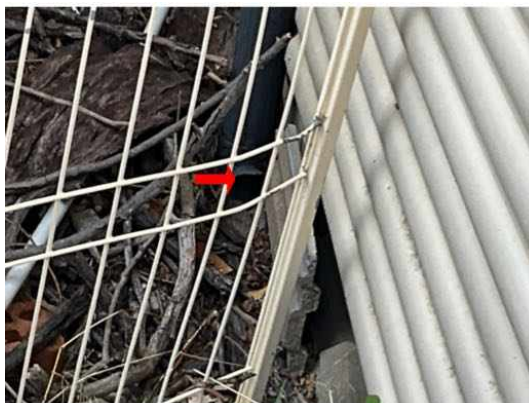
### Finding 3.04

Building:	Main Building
Location:	Multiple areas
Finding:	Building element - Damaged
Information:	Breakage occurs generally when the building materials have either aged and decayed, or as a result of damage (accidental or deliberate).

Repair and/or replacement of broken elements is advised to ensure that additional secondary defects do not arise as a consequence. Such works are necessary, as all building elements play a key role in the operation and function of the overall structure and its performance.

A relevant tradesperson should be appointed to repair or replace the affected building element prior to any subsequent damage being caused.

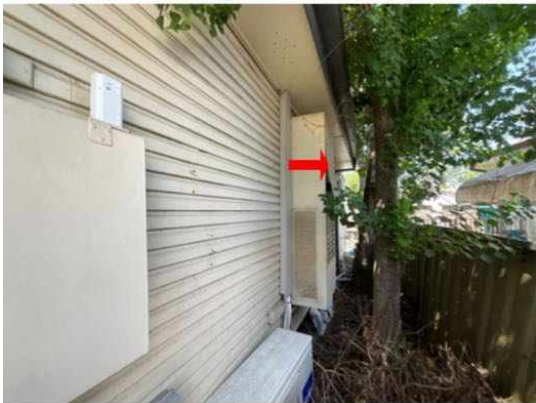
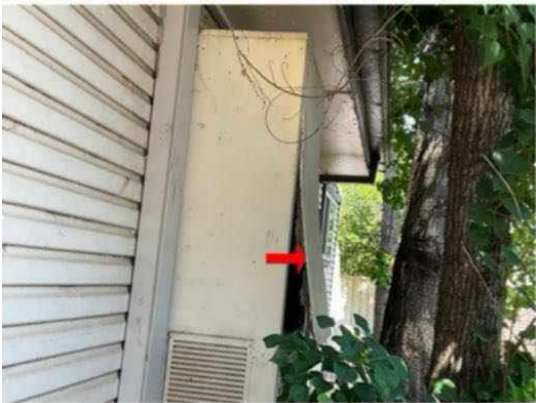
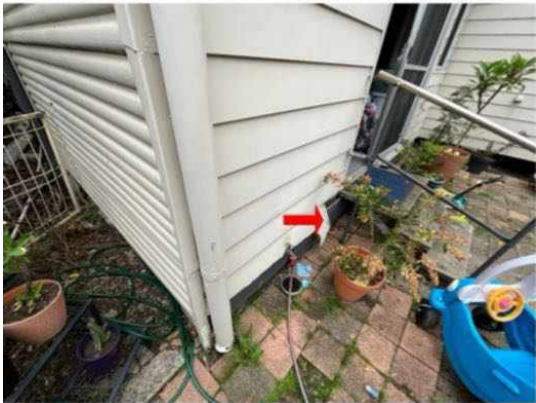
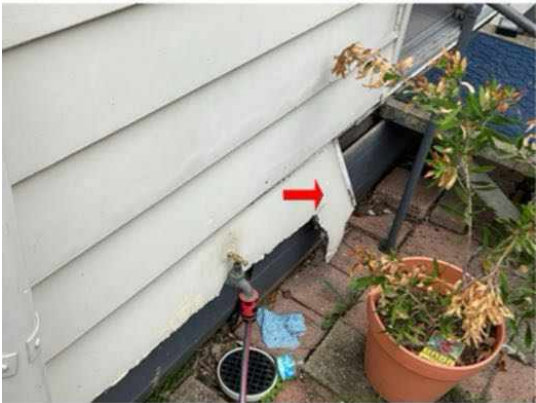
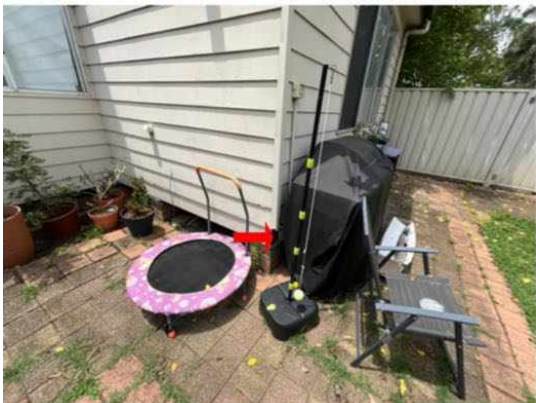
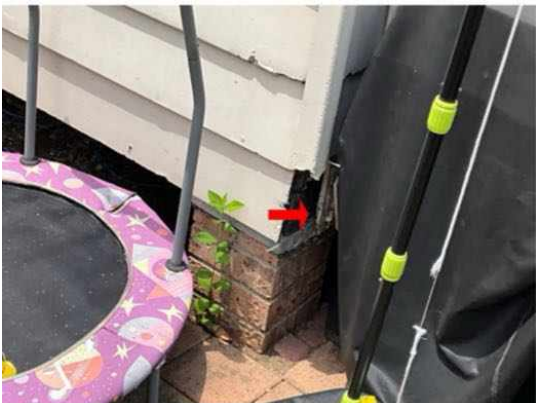
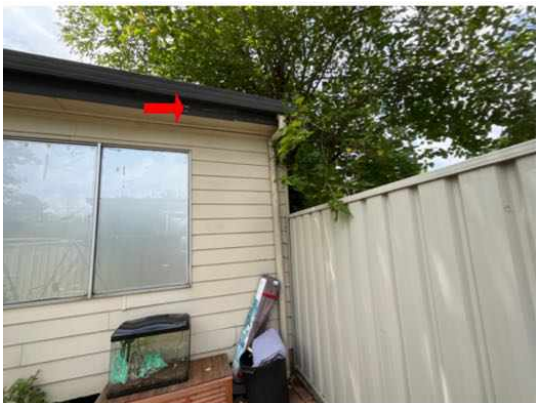
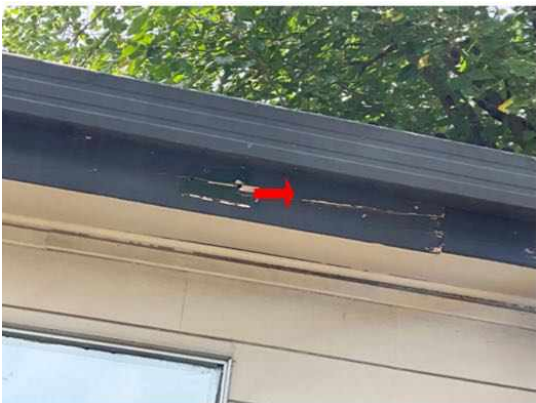
Finding 3.05

Building:	Main Building
Location:	Exterior walls - left side
Finding:	External surfaces — Holes
Information:	Significant holes and penetrations were identified in this area.

Whether intentional or not, gaps and holes to external surfaces are susceptible to insect and vermin ingress, as well as allowing water penetration to the cavity wall. As such, associated building elements are likely to deteriorate at an accelerated rate, and major implications are expected if holes around the pipework are left unmanaged.

All excessive holes, gaps or cracks should be adequately filled by a suitable sealant or trimmings as soon as possible to prevent any further damage. Such works may be conducted by a general handyperson or licensed carpenter.

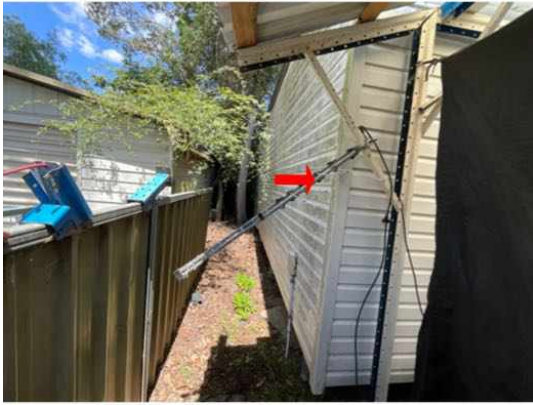
### Finding 3.07

Finding: Fencing - Deteriorated

Information: It was noted at the time of inspection that sections of the fencing in this area has deteriorated. Typically fencing deteriorates due to age and or wear, rot and or rust which is generally expected for a structure of this age, due to prolonged exposure to weather conditions. Sometimes inadequate installation or maintenance can be to blame.

If left unattended, it is likely that further damage will occur. It is suspected that repair of several elements of the fencing may be required however replacement may be a consideration of the client also.

A licensed fencing contractor should be appointed to provide further advice and perform rectification works as necessary.

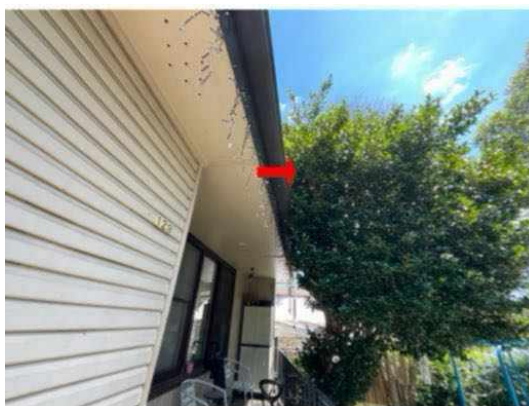
### Finding 3.09

Building:	Main Building
Location:	Roof Exterior
Finding:	Trees - Overhanging and filling gutters
Information:	Overhanging trees often result in excessive amounts of leaf debris accumulating in gutters.

Gutters are a critical part of the building's management of storm water and rain. It is therefore important that they be kept clear to prevent secondary damage to associated building elements, including exterior and interior walls, ceiling linings and any adjoining building elements. Where gutters are blocked, pooling of rainwater is likely to occur, fast-tracking rust and corrosion of the roof plumbing elements.

It is highly advised that all overhanging tree branches be removed as soon as possible to prevent any further damage. Repair and/or replacement of sections of damaged guttering may also be required where the extent of the damage necessitates.

Such works should be performed by the homeowner; however, appointment of a landscape contractor or an arborist may be required. Consultation with a licensed roof plumber is required where guttering has been damaged.

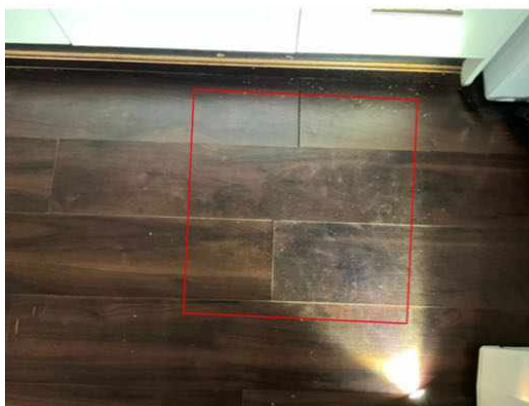
Building: Main Building  
 Location: Granny kitchen  
 Finding: Building element - Swollen  
 Information: Swollen building elements generally indicate that the building materials have been affected by excessive moisture over a prolonged period of time, and have swollen as a result.

Repair and/or replacement of swollen building elements may be conducted by a licensed carpenter.

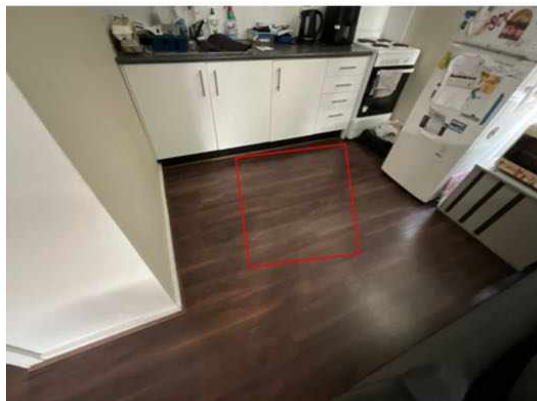
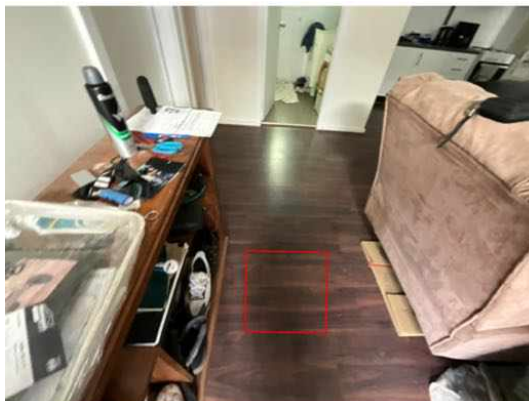
### Finding 3.12

Building: Main Building  
 Location: Granny - Multiple areas  
 Finding: Floors - Squeaky  
 Information: The internal flooring in this area was identified as being squeaky at the time of inspection. This generally presents as a discernible change in level as they are walked across.

Although structural defects such as settlement could also be possible, however squeaky floors generally indicate that nails are coming loose from the joists that they

are installed on, which is generally cosmetic rather than structural.

The client should appoint a licensed carpenter to undertake repairs.

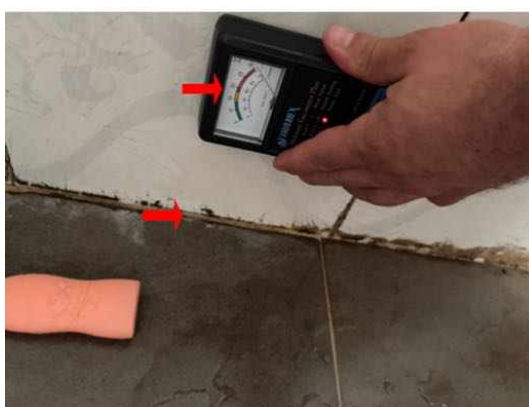
Finding: Shower damp - Sealant and grout  
 Information: Damp is evident to the lower 400mm of wall to the shower alcove. This defect is quite common, and is suspected to have been caused by moisture permeating or leaching through the grouting and sealant in this area, which shows evidence of deterioration. Leaking pipes within the wall is also a possible cause however this seems unlikely in this instance as there is no moisture build up around the taps or transferring to the other side of the wall. There appears to be no sealant around the tap spindles which may be a small contributing factor.

Unmanaged damp in the shower recess is likely to facilitate the formation and development of mould and fungi growth, decaying associated building materials and compromising their structural integrity of associated elements. It is important to address damp conditions, as the World Health Organisation notes that excess moisture leads - on almost all indoor materials - to growth of microbes such as moulds, fungi and bacteria, which subsequently emit spores and other matter into the indoor air. Exposure to these contaminants is associated with a wide range of respiratory and other health-related problems. Damp conditions also create a conducive environment for termite infestation.

Consultation with a bathroom sealant specialist is advised immediately to identify the cause of damp and to perform remedial works as required.

Always ensure that sealant and grout is in good condition to prevent any moisture issues occurring in the future.

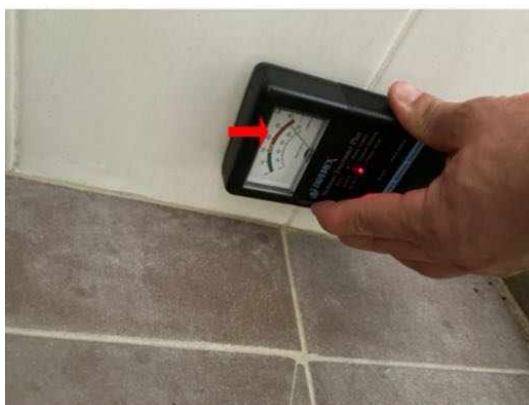
### Finding 3.15

Building: Main Building  
 Location: Granny bathroom  
 Finding: Shower damp - Monitor

Information: Damp is evident to the lower 400mm of wall to the shower alcove. There is no high reading around the taps nor are there high readings transferring to the other side of the wall. Sealant appears to have been repaired recently and both sealant and grout appear in acceptable condition at present.

This defect is quite common, and is suspected to have been caused by moisture permeating or leaching through the grouting and perhaps gaps in the sealant prior to repair.

Monitoring the area is advised and if any visual signs of excessive moisture appear (peeling paint, mould) then consultation with a qualified plumber or bathroom specialist would be advised to identify the cause of damp and to perform remedial works as required.

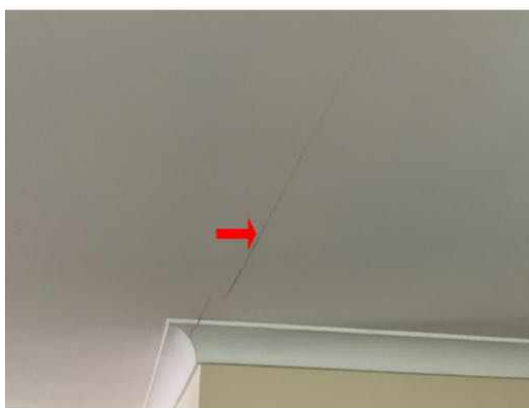
Building:	Main Building
Location:	Multiple areas
Finding:	Cracking - Damage Category 1 - Fine (up to 1mm)
Information:	Although fine cracks are quite noticeable, they are often only considered to be an appearance defect, and usually do not indicate any structural damage. Generally, the cause of a fine crack is indicative of a separation between building materials and finishes (e.g. paint, plaster, etc.) along joins.

Cracking of this nature can generally be repaired with minor sanding, filling and/or repainting. Such works should be performed by a qualified painter or a general handyman.

Monitoring of all cracking should be conducted frequently. Always contact a building inspector should cracks widen, lengthen, or become more numerous.

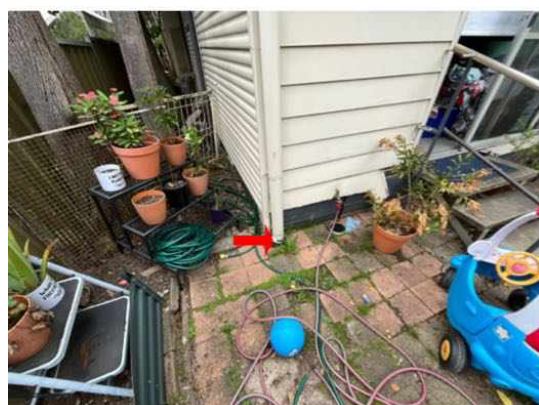
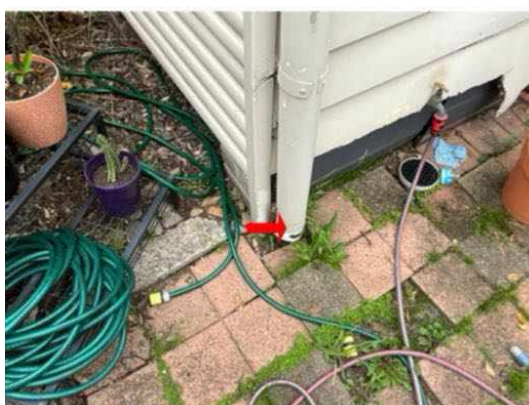
Where roof plumbing doesn't drain adequately, the area at the base perimeter can become excessively damp, potentially creating an environment that is susceptible to rust and corrosion of surrounding building elements, as well as attracting termites and other pests.

It is highly recommended that a plumber be appointed to further inspect the area and to install adequate drainage equipment where necessary.

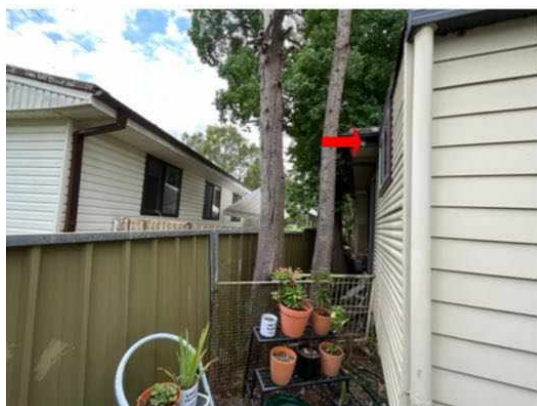
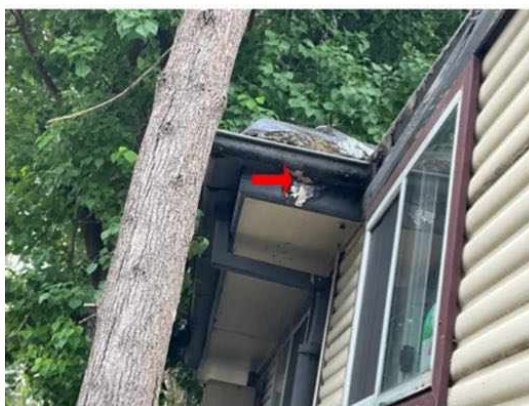
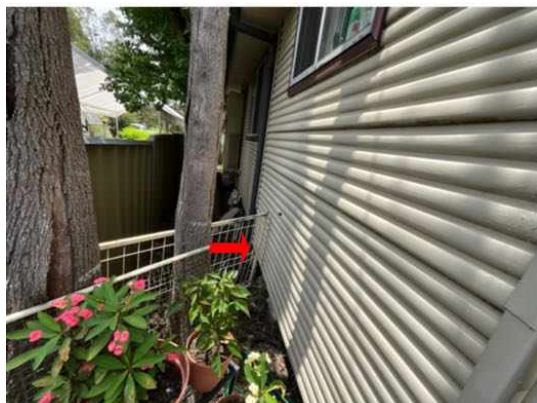
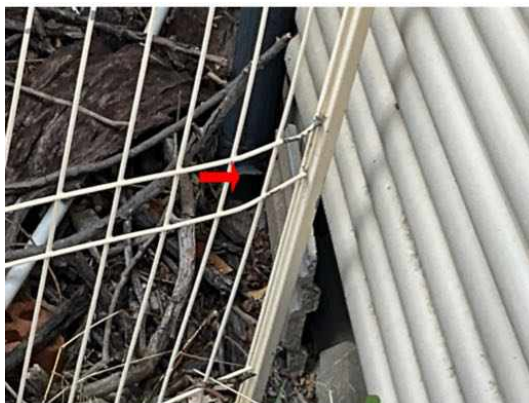
### Finding 6.02

Building:	Main Building
Location:	Multiple areas of roof plumbing
Finding:	Water leak - External
Information:	Water leaks were found to be present to exterior plumbing work. Leaks are generally caused by deterioration of the plumbing elements over time, due to exposure to weather conditions, but may have also been caused by minor impact damage.

Such leaking creates damp conditions in the affected area, causing potential for water pooling and subsequent water damage if left unattended. These conditions may also attract termite attack, particularly if the area is subject to minimal levels of sun throughout daylight hours.

It is highly advised that a licensed plumber be appointed to rectify any water leaks that may be present. Areas of repair and replacement of plumbing fittings and fixtures may be required and, as such, a quotation should be sought.

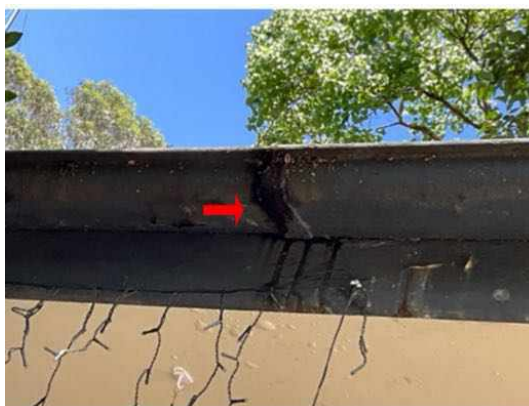
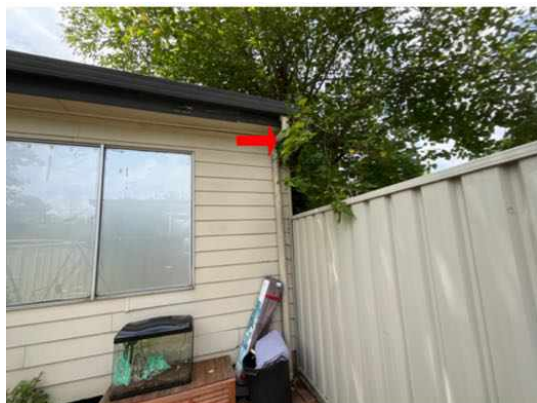
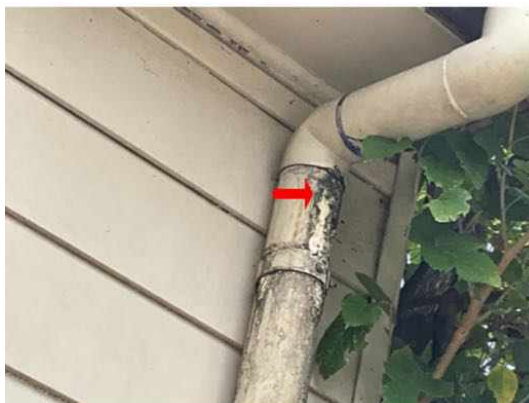
### Finding 6.03

Building:	Main Building
Location:	Yard
Finding:	Site drainage— Inadequate
Information:	The site drainage in this area was found to be inadequate at the time of inspection, creating potential for subsequent water damage to associated building elements. This is additionally conducive to termite activity.

It is important that water does not lie against the base of walls; surrounding paths and ground levels should be sloped to drain water away from walls. Downpipes should not discharge stormwater onto lower walls or plinths. Stormwater should be carried away by large, regularly cleaned drains. Ground levels may need to be lowered to expose a buried DPC.

Where site drainage is inadequate, installation of an Agricultural (Aggie) Drain may be required. A licensed plumber should be appointed to further inspect the property and perform any remedial works as necessary. Water damage and secondary defects are likely to occur if left unmanaged.

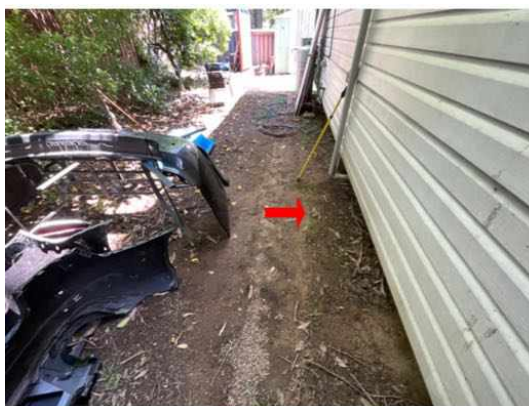
### Finding 6.04

Building:	Main Building
Location:	Exterior walls - right side
Finding:	Bridging - Vegetation
Information:	Where vegetation obstructs inspection of building elements, also known as bridging as it provides a bridging point for the access of termites, full inspection can not be achieved. Consequently moisture or dampness may be present and the areas becomes conducive to termite activity. Plants against or very close to buildings provide cover, shade and can provide an environment that is attractive to termite infestation.

The removal and replanting of species that do not provide "cover" or cutting back of existing vegetation will assist greatly in preventing Bridging from occurring.

The removal of any such materials that may be conducive to termite activity should be carried out as soon as possible and arrange re inspection to minimize the risk of termite attack.

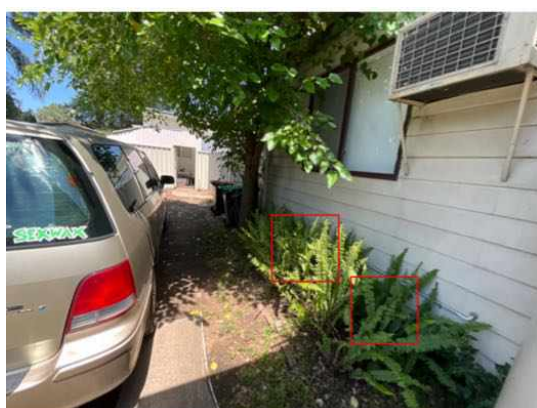
### Finding 6.05

Building:	Main Building
Location:	Meterbox

**Finding:** Termite Management System - no evidence of installation  
**Information:** The application of a post-construction chemical termite barrier is highly recommended for all properties, particularly if live termite activity has been found on the site previously. Such barriers are highly effective in preventing termite attack on any timber building elements throughout the property.

The client may consider gaining further advice from a pest controller as to the costs and procedures involved with this application. It is recommended that obtaining such advice be a short-term priority.

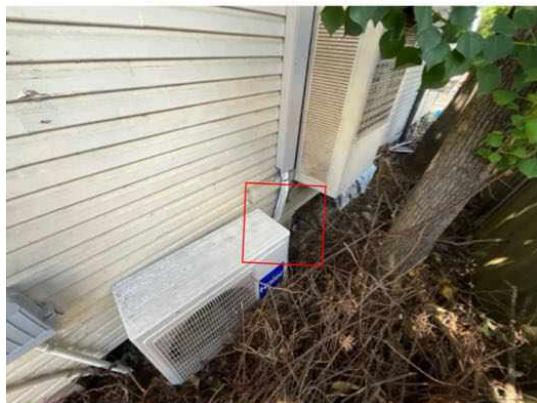
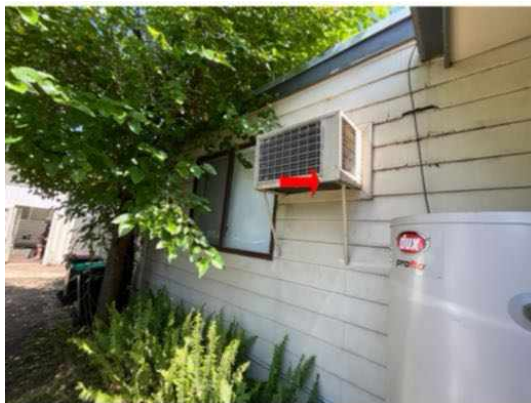
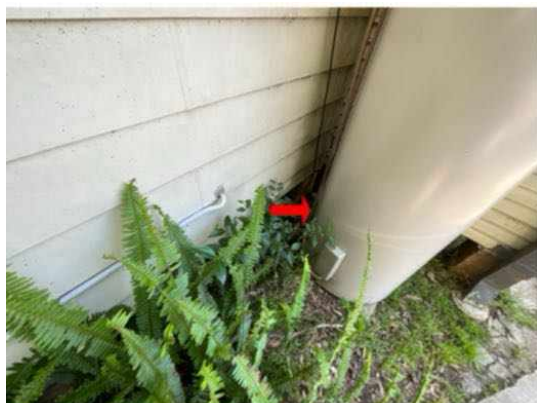
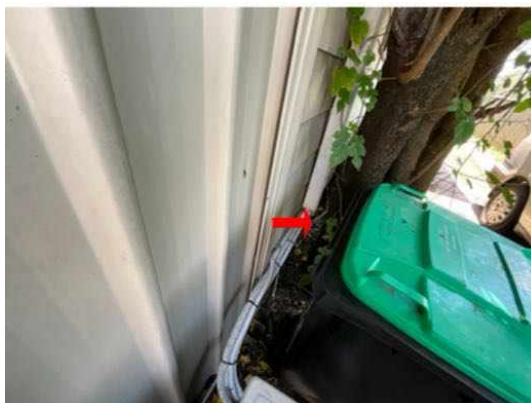
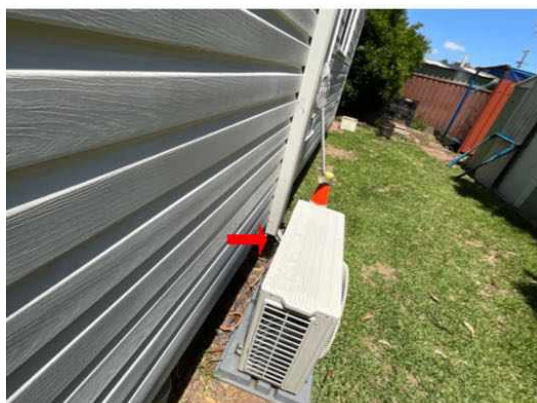
These damp conditions can lead to secondary defects such as rot, rust or corrosion of associated building elements, the formation of fungal decay, or even the creation of potential slip hazards. When coupled with poor site drainage, pooling of water may also attract termite activity to this area.

It is highly recommended that a licensed plumber be appointed to install adequate drainage to the overflow. These works will ensure that the area remains dry and free of any secondary defects.

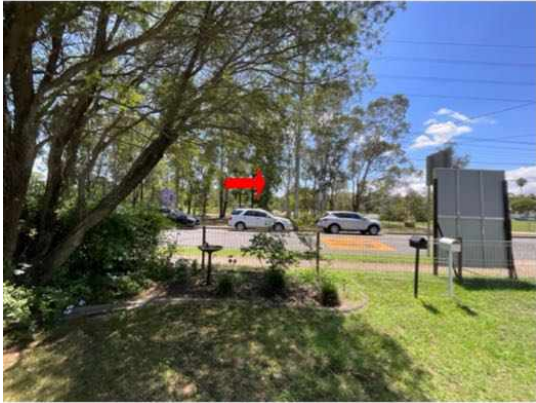
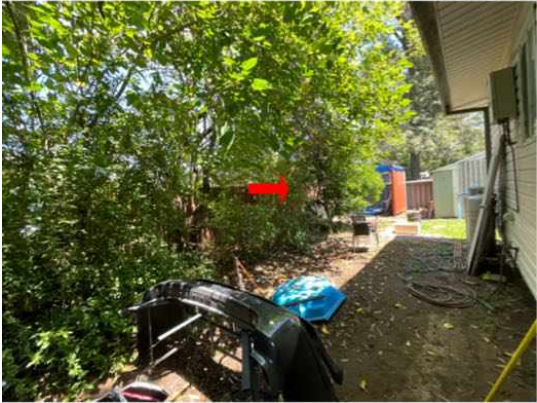
Location:  
Finding: Surrounding bushland - Conductive  
Information: Home and or building is situated in a high risk area for termite activity, due to close proximity to surrounding bushland.

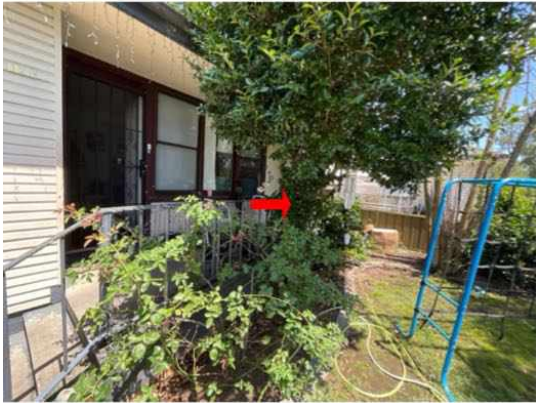
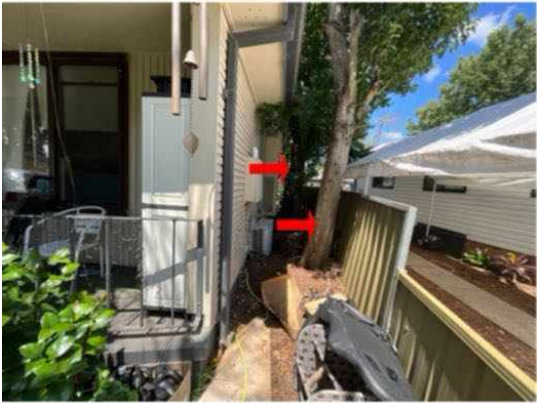
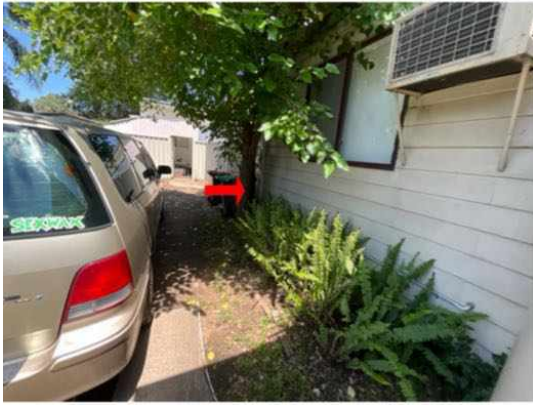
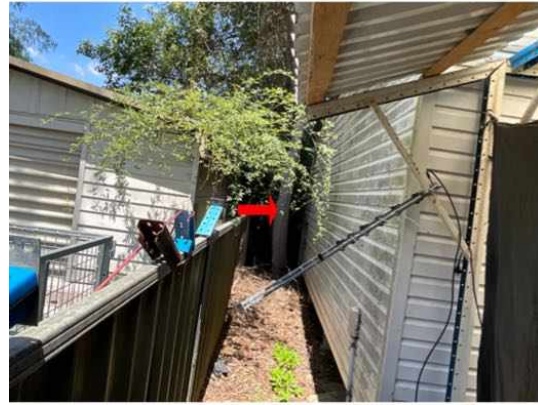
**Finding 6.10**

Building: Main Building  
Location: Vegetation  
Finding: Vegetation - Abutting property  
Information: Vegetation against external wall may have an invasive root system. If there are weak points in the brick work or concrete slab, it is possible for the roots to gain entry into these areas. Once the roots have gained entry, it is possible for termites to gain concealed entry via these roots. It is recommended to remove the vegetation and root system where possible.

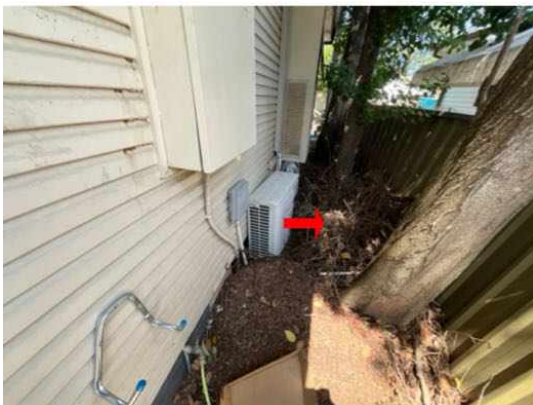
### Finding 6.11

Building:	Main Building
Location:	Garden beds
Finding:	Garden Beds
Information:	Garden beds were found to be evident in the garden area. These garden beds can include untreated timber, and with a combination of moisture from watering or hosing can make conditions conducive to termite activity and termite ingress.

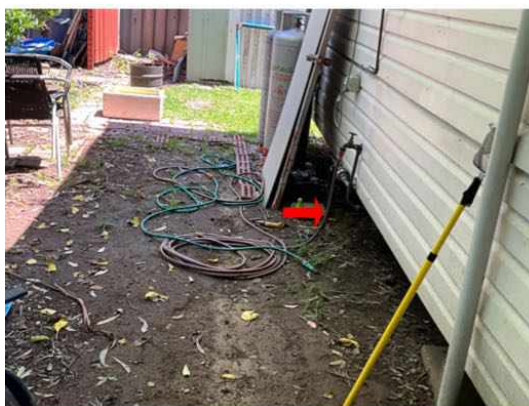
### Finding 6.12

Building:	Main Building
Location:	External tap
Finding:	Tap - No drain
Information:	The external tap in this area was noted to have no drain at the time of inspection.  This keeps the surrounding surfaces damp while using the tap, which becomes conducive to termite activity.  A licensed plumber must be appointed to ensure an appropriate drain is installed.

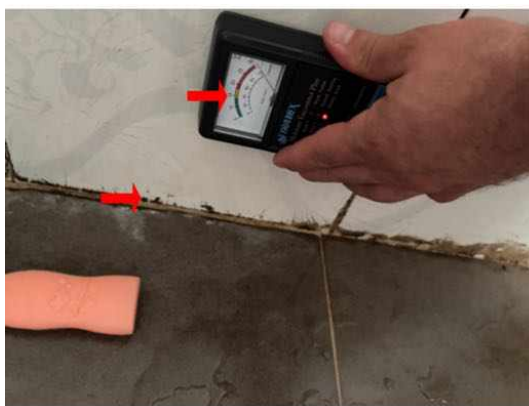
### Finding 6.13

Building:	Main Building
Location:	Bathroom
Finding:	Shower damp - Sealant and grout
Information:	Damp is evident to the lower 400mm of wall to the shower alcove. This defect is quite common, and is suspected to have been caused by moisture permeating or leaching through the grouting and sealant in this area, which shows evidence of deterioration. Leaking pipes within the wall is also a possible cause however this seems unlikely in this instance as there is no moisture build up around the taps or transferring to the other side of the wall. There appears to be no sealant around the tap spindles which may be a small contributing factor.

Unmanaged damp in the shower recess is likely to facilitate the formation and development of mould and fungi growth, decaying associated building materials and compromising their structural integrity of associated elements. It is important to address damp conditions, as the World Health Organisation notes that excess moisture leads - on almost all indoor materials - to growth of microbes such as moulds, fungi and bacteria, which subsequently emit spores and other matter into the indoor air. Exposure to these contaminants is associated with a wide range of respiratory and other health-related problems. Damp conditions also create a conducive environment for termite infestation.

Consultation with a bathroom sealant specialist is advised immediately to identify the cause of damp and to perform remedial works as required.

Always ensure that sealant and grout is in good condition to prevent any moisture issues occurring in the future.

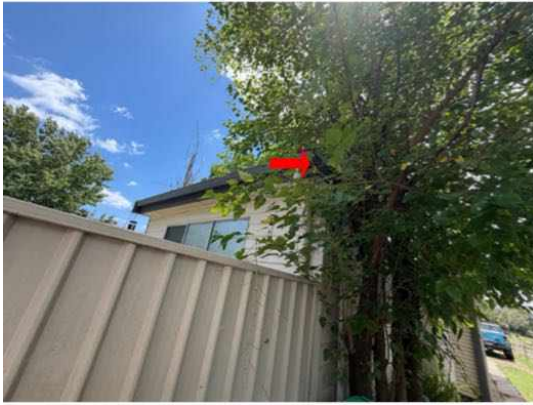
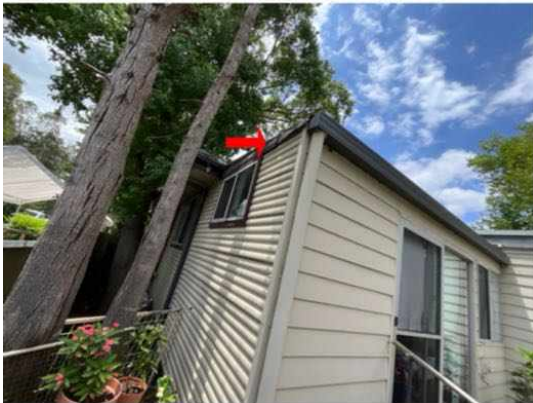
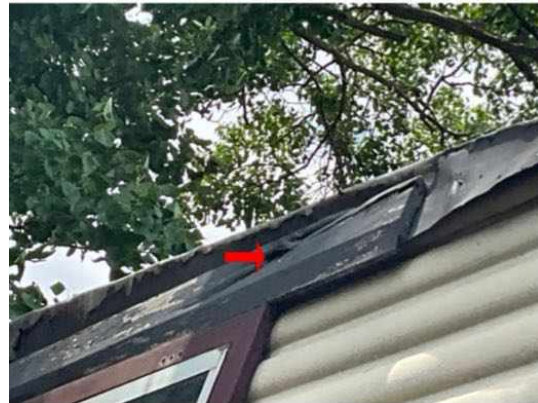
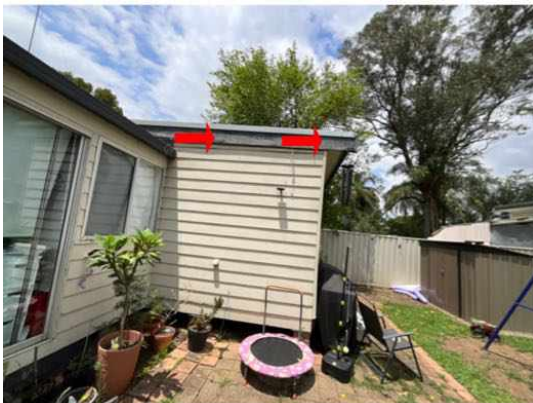
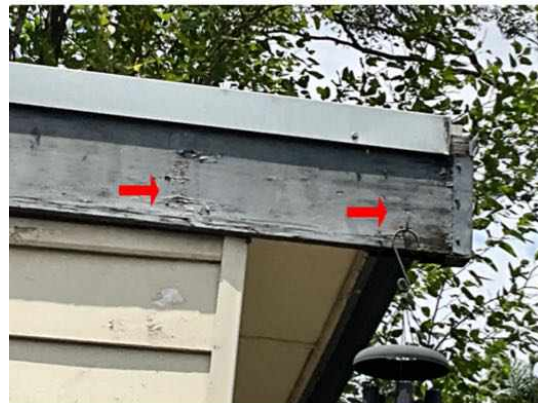
Building:	Main Building
Location:	Fascias
Finding:	Fascias - Wood rot/decay
Information:	Wood rot was found to be affecting fascias and barges in this area, evidenced by the presence of mould on the surface in some areas. Wood rot, also known as Fungal Decay, occurs when timbers and other cellulose building materials are exposed to damp conditions on an ongoing basis.

It is likely that this wood rot has developed as a result of faults in the roof plumbing, creating excessive moisture in this areas. Otherwise frequent exposure to rain and other weather conditions also make fascias and barges susceptible to accelerated deterioration.

Early intervention and regular maintenance will prolong the useful life of these building elements. Prior to any works being performed, the cause of the moisture that has created the visible wood rot should be identified and addressed in a suitable manner.

It is advised that a roof plumber be appointed to inspect all roof plumbing and subsequently identify the cause of the wood rot. Replacement of affected fascias and barges may then be a necessary step in protecting surrounding building elements from such deterioration.

A licensed plumber may be appointed to assess the cause of excessive moisture and to provide advice on any remedial works as required. A licensed carpenter may also be required to replace affected building materials.

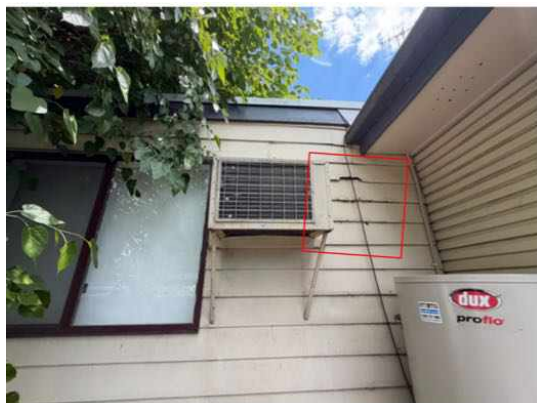
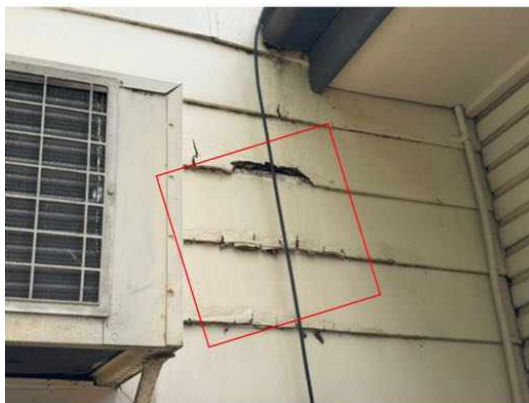
### Finding 7.02

Building:	Main Building
Location:	Exterior walls - right side
Finding:	Weatherboards - Rotting
Information:	The external weatherboards show signs of fungal decay (wood rot) in several sections. This wood rot is suspected to have developed over a prolonged period of time due to frequent weather exposure, which is expected in a property of this age and condition

Weatherboards are sealed and protected by paint and other sealants. When these sealants deteriorate over time, they allow water penetration to the weatherboards, causing wood rot. If left unmanaged, the wood rot is likely to develop further, possibly necessitating major repair or replacement works in the long-term future.

To maintain the condition of the external wall cladding, any severely affected weatherboards should be substituted as soon as possible with pre-treated replacements. Where weatherboards have rotted due to excessive moisture other than rain penetration, the cause of the moisture should be identified immediately by a licensed plumber. A qualified carpenter should be appointed to repair and replace rotting weatherboards.

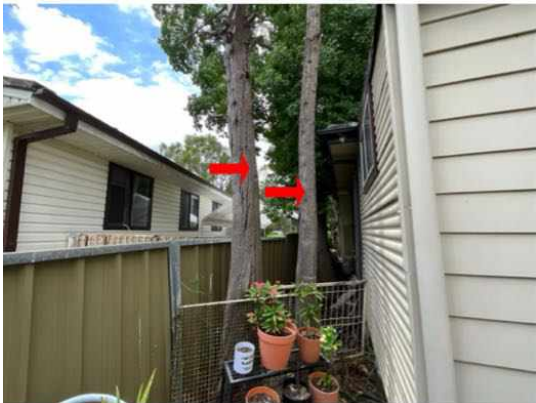
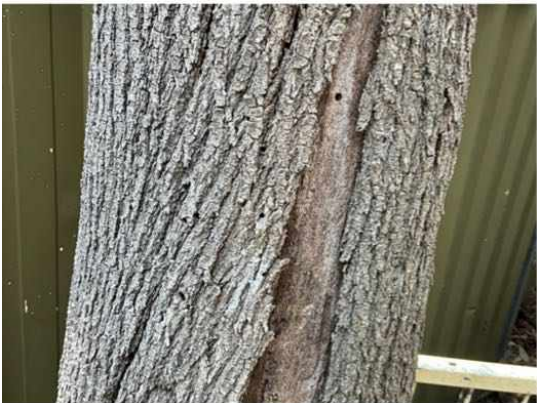
### Finding 8.01

Building:	Main Building
Location:	Trees
Finding:	Evidence of wood borer activity identified
Information:	Wood borers small beetles that colonise in exposed timber elements are a common timber pest that are regularly mistaken for termites. Although wood borer activity is generally not detrimental to the affected timber they may lead to serious damage and necessitate replacement of certain building elements if left unattended.

As no live wood borer activity was identified treatment is not required at this time. Replacement of affected timbers may be considered by the client for superficial reasons.

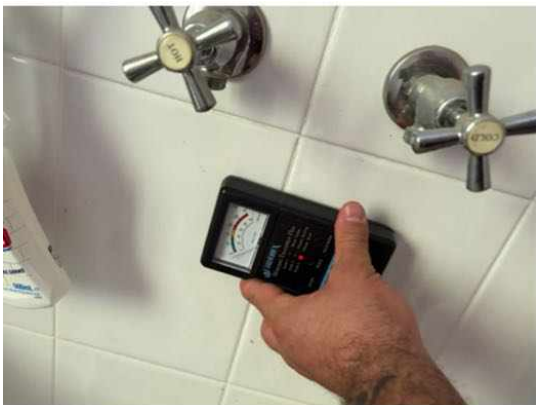
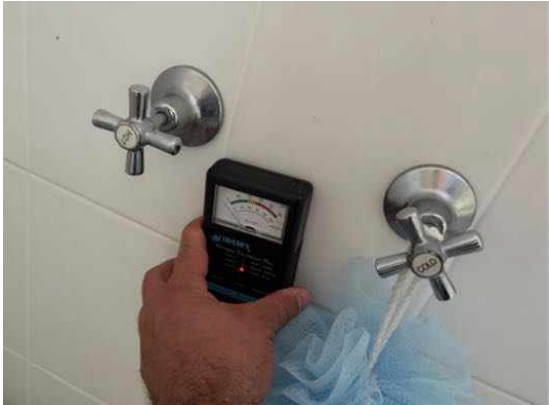
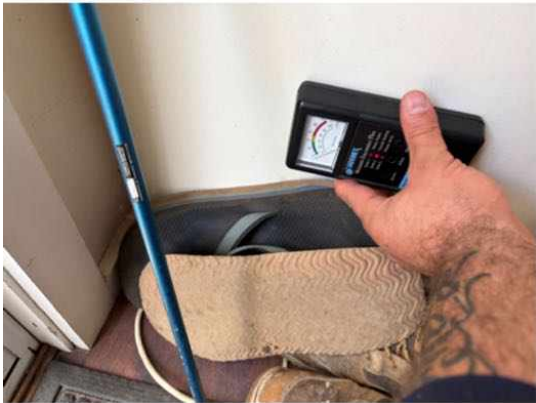
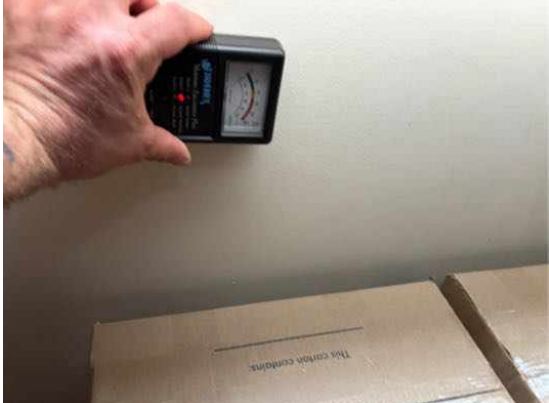
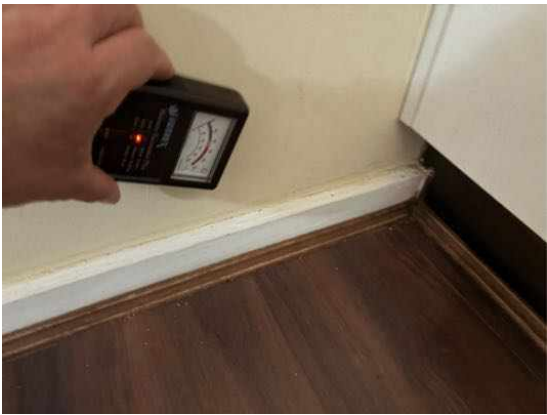
Building: Main Building  
Location: All Areas  
Finding: Moisture metre  
Information: During the inspection the property was checked for moisture using a moisture metre.

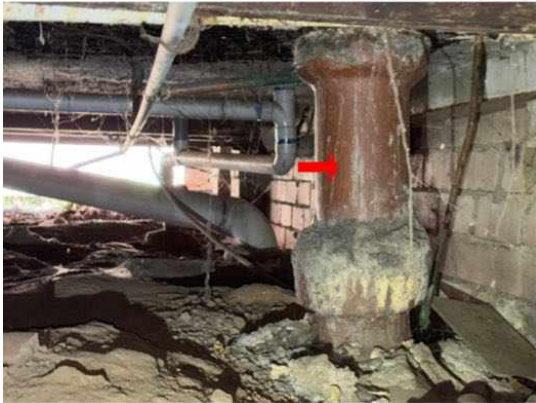
Building: Main Building  
Location:  
Finding: Pipework - Old urban wear pipes  
Information: Old urban wear pipes were identified at the time of inspection.

Consultation with a licensed plumber is advised. CCTV inspection on pipes may be required.

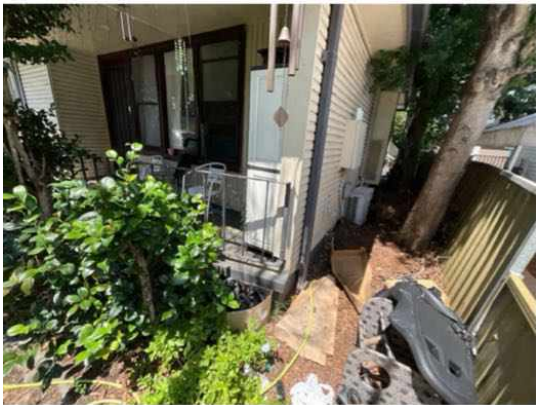
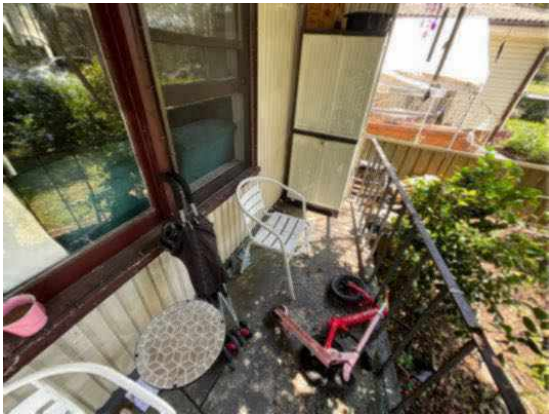
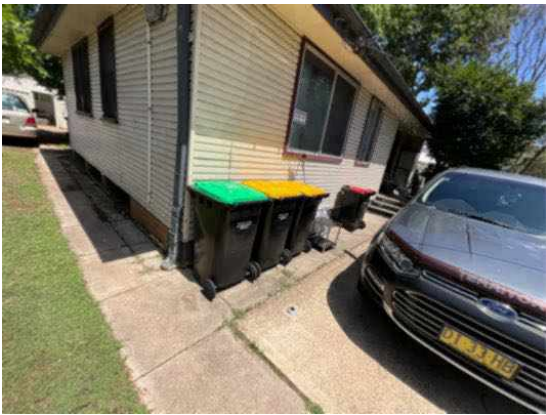
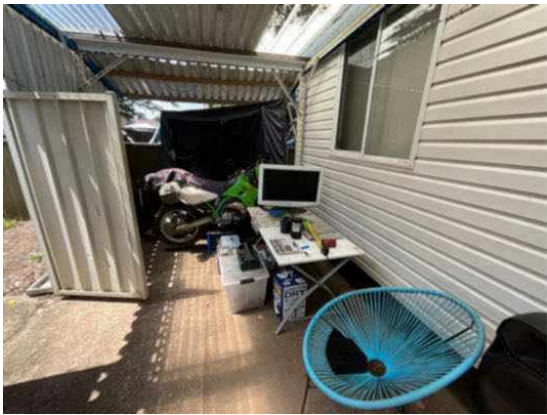
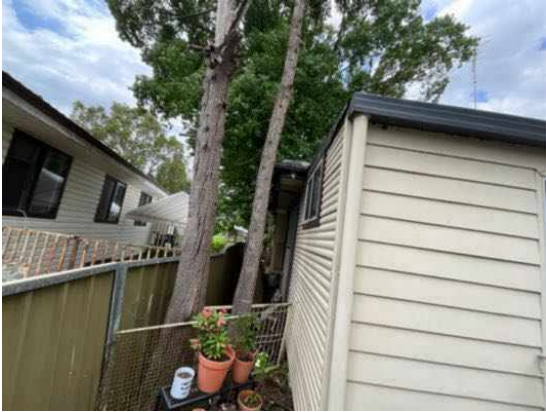
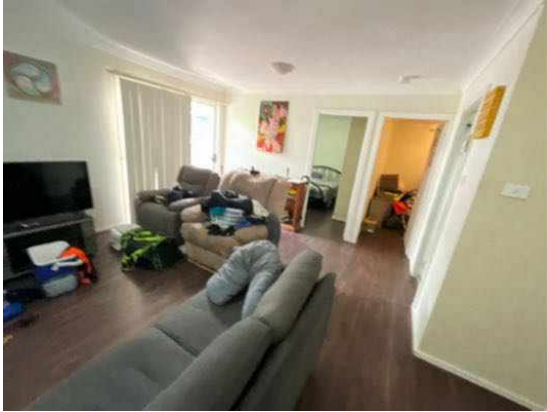
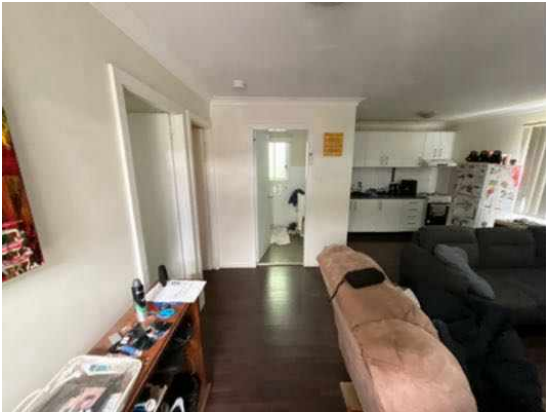
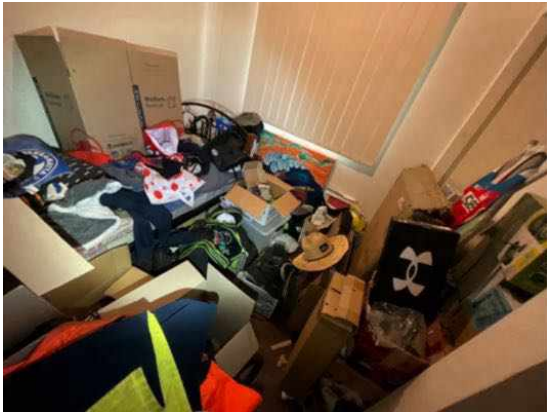
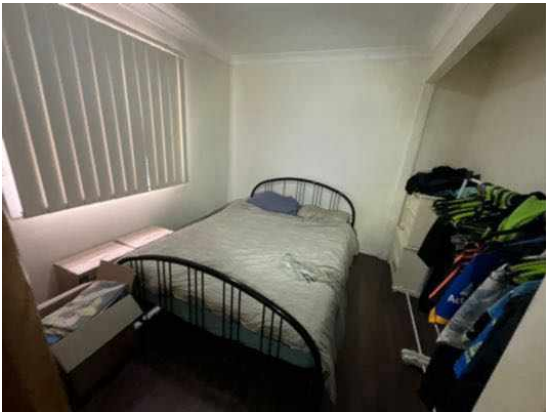
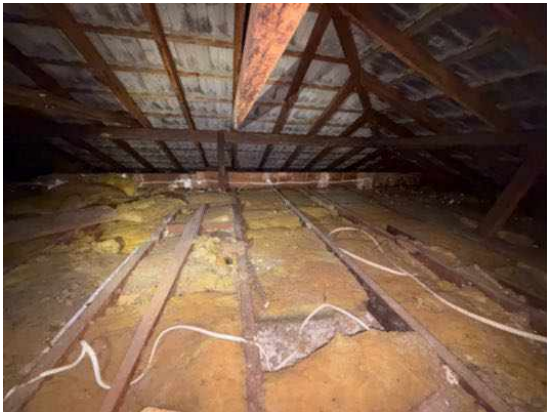
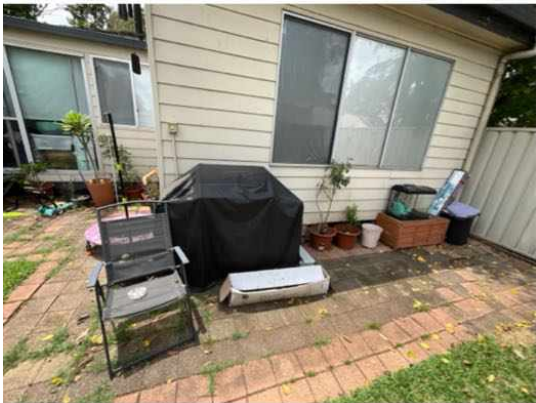
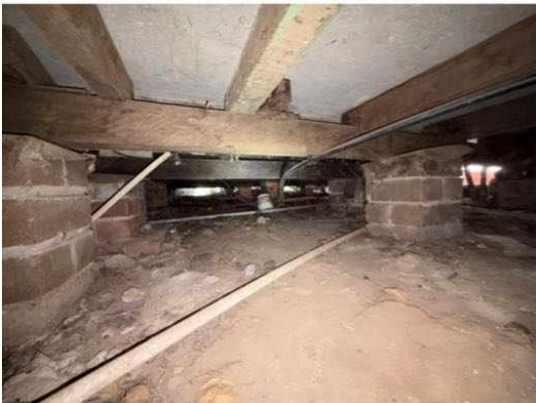
Building: Main Building  
Location: All Areas  
Finding: Additional Photos - Obstructions and Limitations  
Information:

These photographs are an indication of the obstructions and limitations which impeded full inspection of the property at the time of inspection. These obstructions can hide an array of defects and should be removed to allow full inspection to be carried out. A re-inspection is recommended once the areas are made accessible.
