Building and Timber Pest Inspection Report

Inspection Date: Tue, 17 Mar 2026

Property Address: 18 Cabinda Dr, Keysborough VIC 3173,
Australia

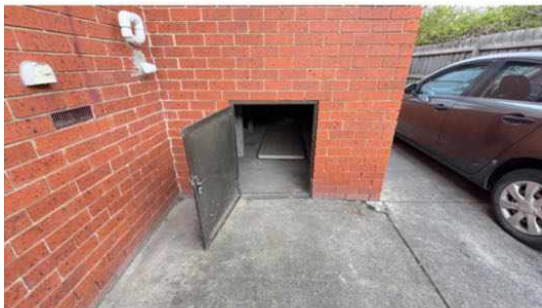
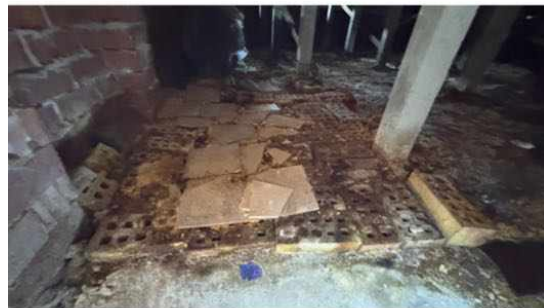
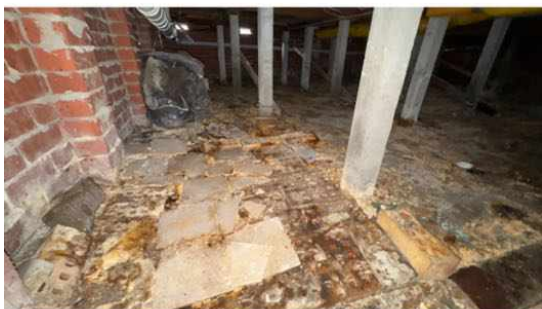
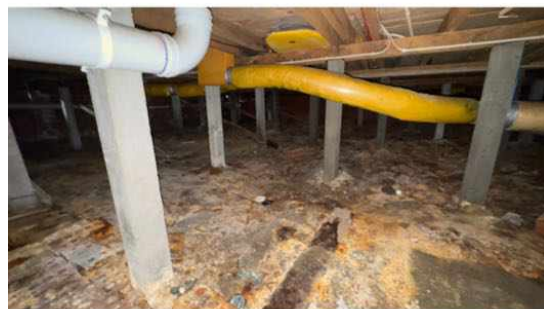
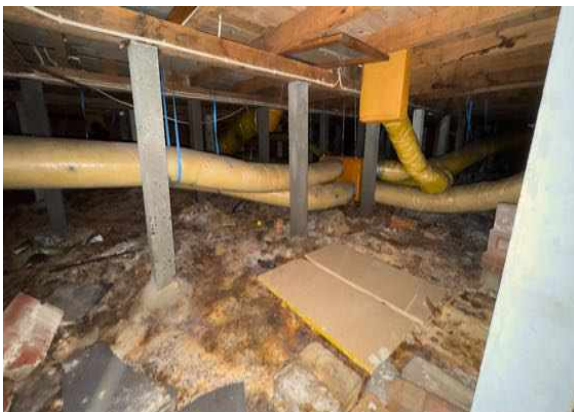
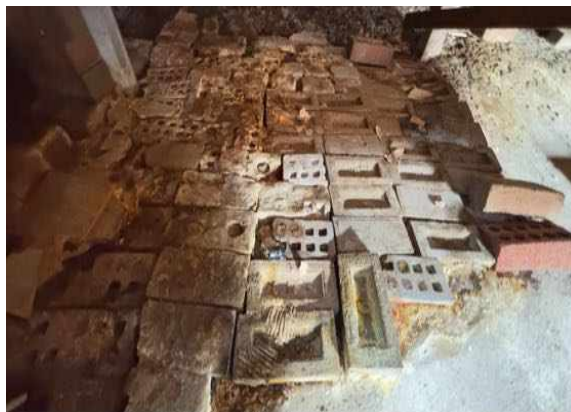
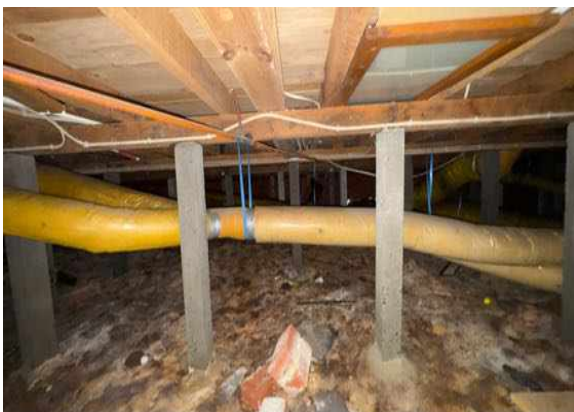
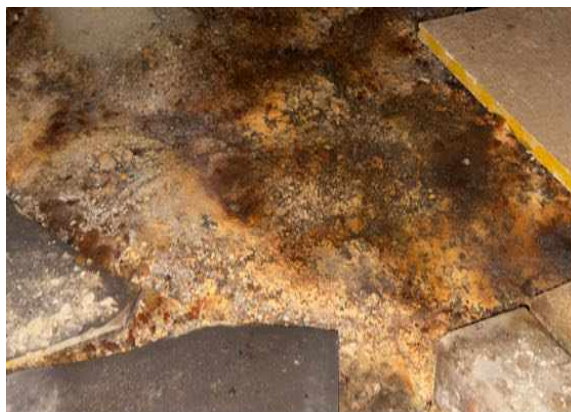
Building: Main Building
Location: Subfloor >
Finding: Sub - Floor - Excessive Moisture Identified
Information: Excessive moisture can attract termites and produce conditions that promote fungal growth and wood decay.

Excessive moisture is generally caused by deteriorated or leaking plumbing pipes or excessive subfloor moisture to the subfloor where a qualified plumber or a mechanical ventilation specialist should be engaged immediately to further inspect the property to identify the cause of the excessive moisture and carry out any necessary repairs.

This is advised to be carried out as soon as possible.

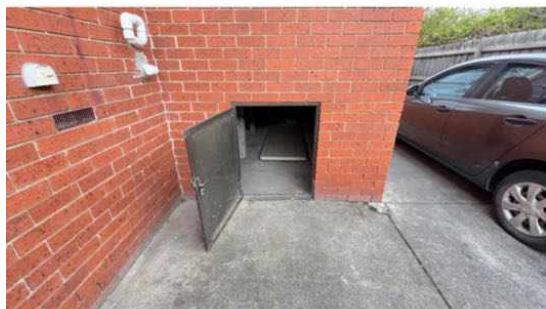
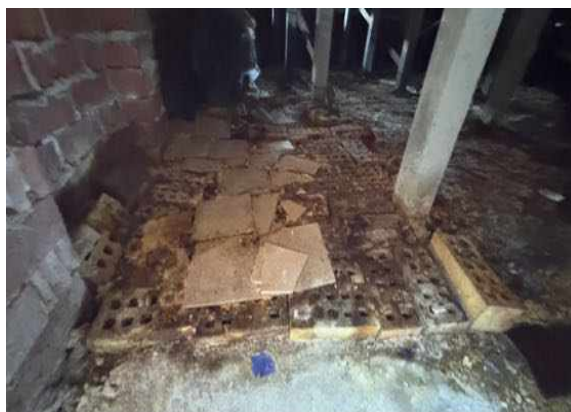
Finding 2.02

Building:	Main Building
Location:	Subfloor
Finding:	Sub Floor - Suspected Mould
Information:	Suspected mould growth was observed in the subfloor in this area.

This has likely occurred due to water ingress, poor ventilation, and persistent damp conditions. Mould can damage building materials, reduce indoor air quality, and pose health risks to occupants.

A registered builder or mould remediation specialist is required to inspect the subfloor, identify the source of moisture, and remediate the mould. Works may include removal of affected materials and treatment of surfaces. This should be rectified immediately to prevent further damage and health risks.

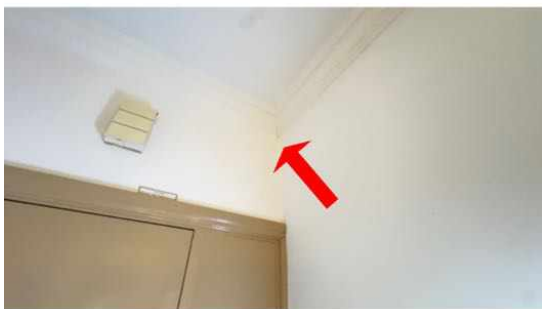
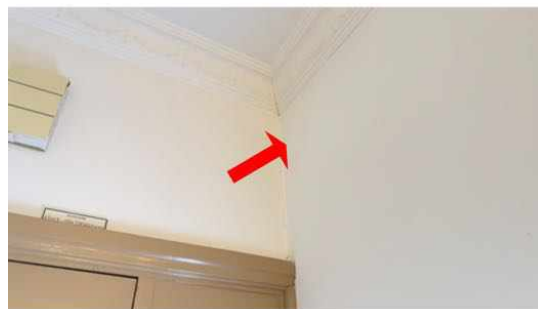
Finding 3.01

Building:	Main Building
Location:	All Areas
Finding:	Ceilings - Historic Damp Damage
Information:	The ceilings were inspected and dampness and moisture-related damage were observed in this area. Damp ceilings can weaken ceiling linings, cause mould growth, damage paint, and in severe cases may lead to partial collapse, creating a safety risk.

This may be due to roof leaks, defective roof coverings, plumbing leaks from above, condensation from poor ventilation, faulty flashings, or lack of timely maintenance and repair.

No elevated moisture levels were present at the time of inspection. The area should be monitored, and if any signs of moisture, deterioration, or related issues arise, a registered builder or licensed plumber should be engaged immediately to further investigate and rectify as required.

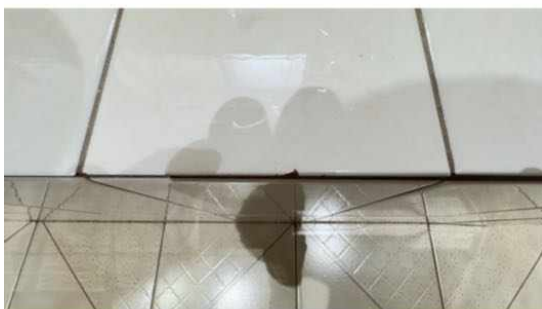
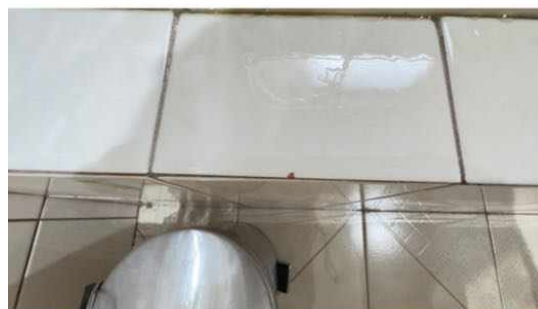
Finding 3.02

Finding: Tiles - Cracked

Information: Cracked tiles were observed in this area. Cracked tiles can reduce durability and appearance and, if left unaddressed, may result in further detachment or damage.

This condition may be due to inadequate adhesive during installation, movement of the substrate, age-related deterioration of the tile bonding, or impact from normal use.

A qualified tiler or competent handyman should be engaged immediately to secure or replace the affected tiles. Prompt attention will restore surface integrity, maintain hygiene, and protect the long-term appearance of the tiled area.

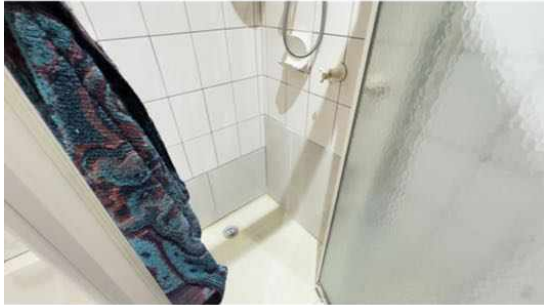
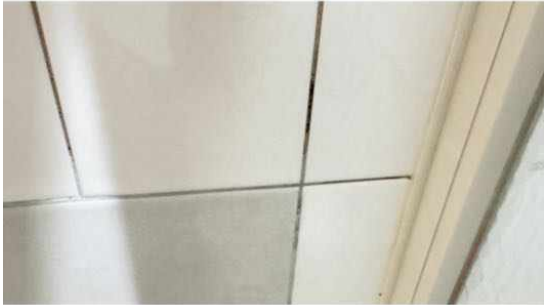
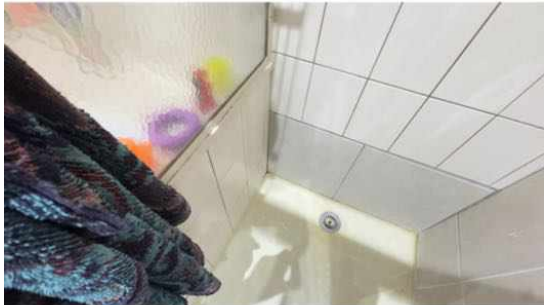
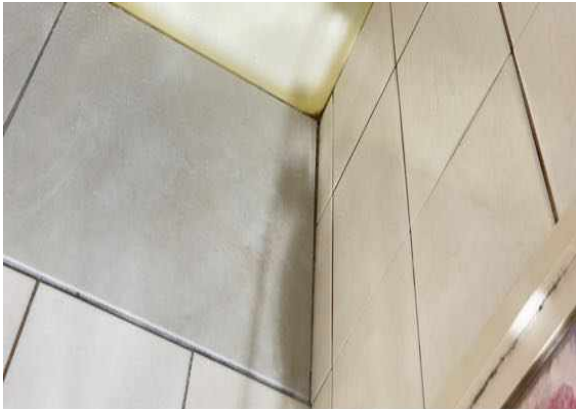
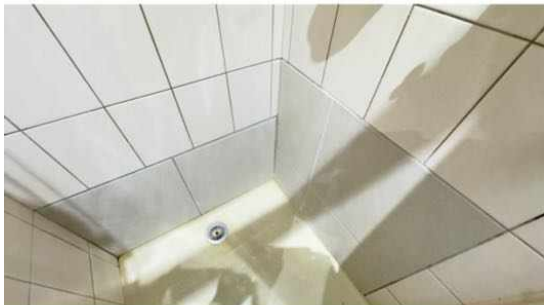
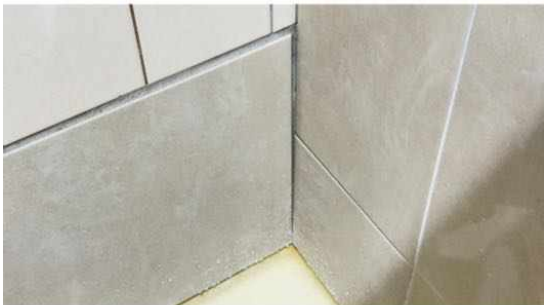
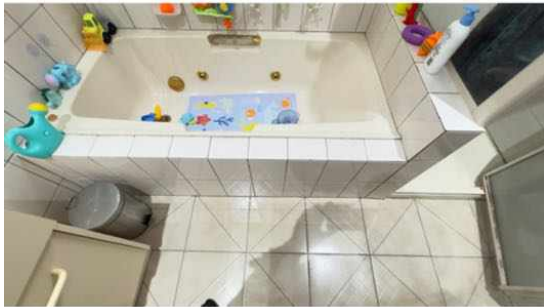
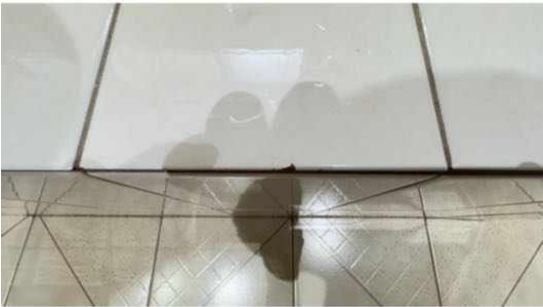
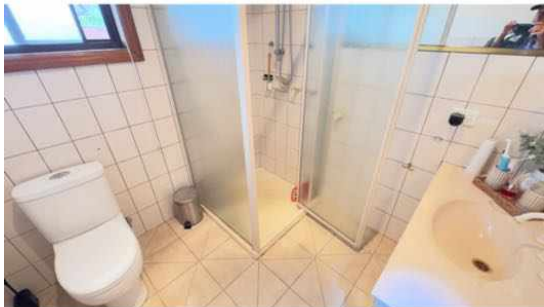
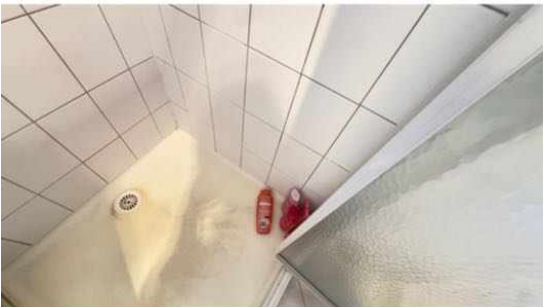
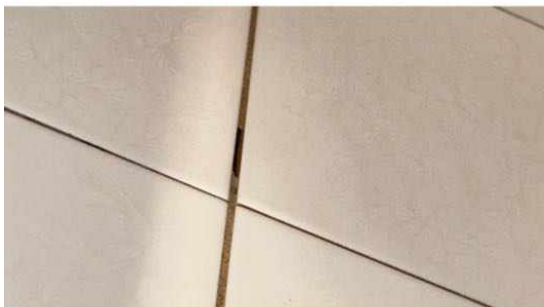
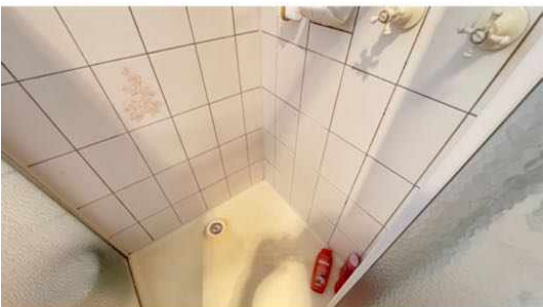
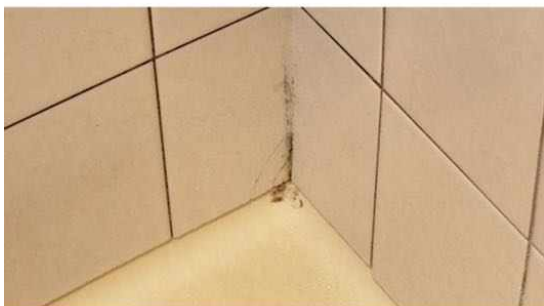
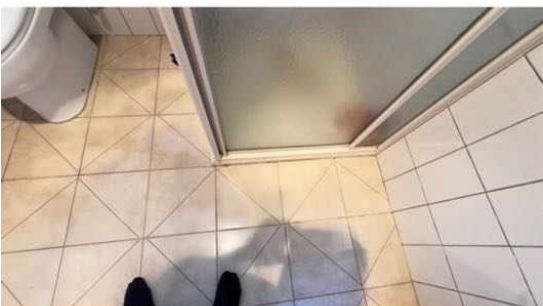
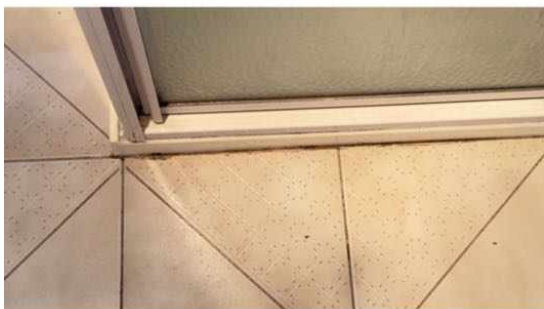
Finding 3.03

Finding: Tiles - Inadequate Grout

Information: Tiles were observed to have inadequate and deteriorated grout between joints in this area. Insufficient grout can allow water penetration, lead to tile movement, and contribute to substrate deterioration or mould growth.

Possible causes include poor original installation, age-related wear, or moisture exposure.

A qualified tiler should be engaged immediately to re-grout the affected areas. Prompt remediation will restore water resistance, maintain tile stability, and prolong the life of the flooring.

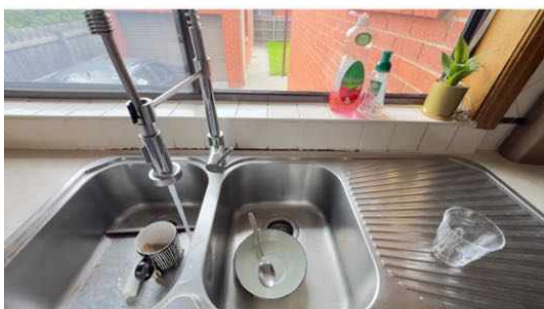
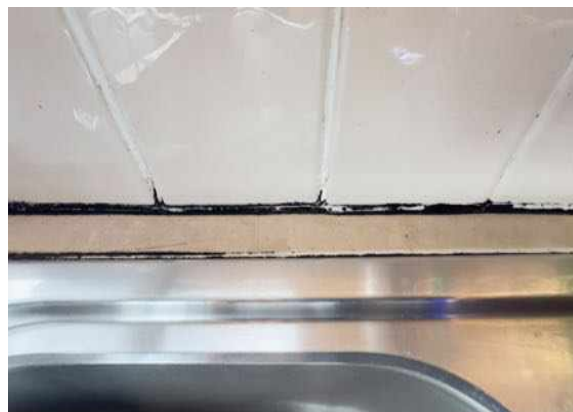
Finding 3.04

Building:	Main Building
Location:	All Areas
Finding:	Tiles - Inadequate Sealant
Information:	Tiles were inspected, and inadequate and deteriorated sealant was observed in this area. Missing or compromised sealant can allow moisture ingress, promote mould growth, and reduce the durability of tiled surfaces and underlying substrates.

This condition may be due to age-related wear, poor initial application, or lack of maintenance.

A qualified tiler or competent caulking specialist should be engaged immediately to remove old sealant and apply new, compliant materials. Prompt rectification will protect the flooring, maintain hygiene, and prevent possible water-related damage.

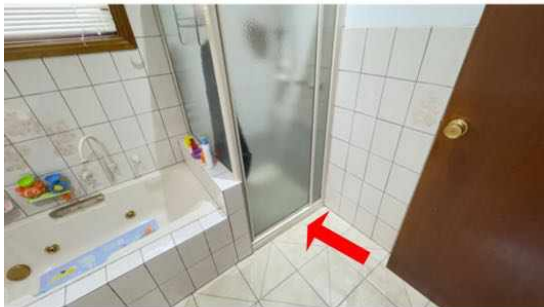
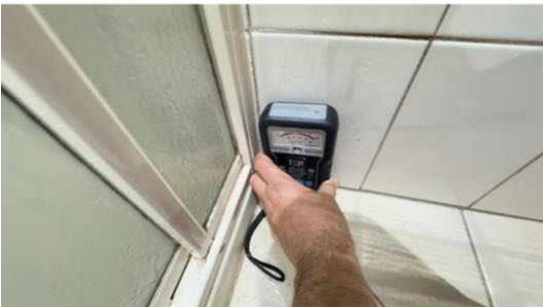
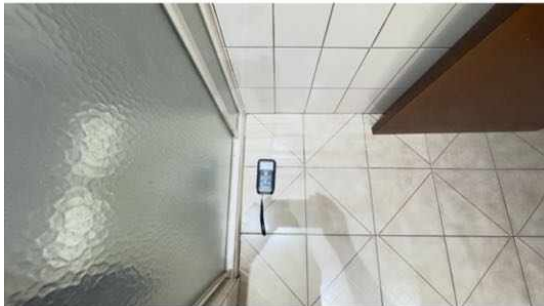
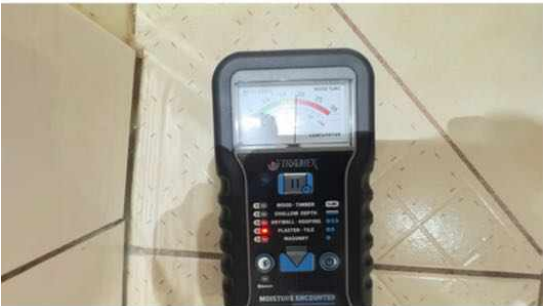
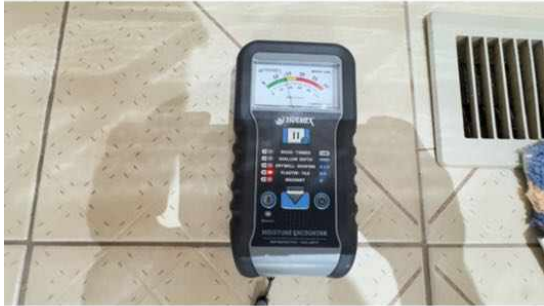
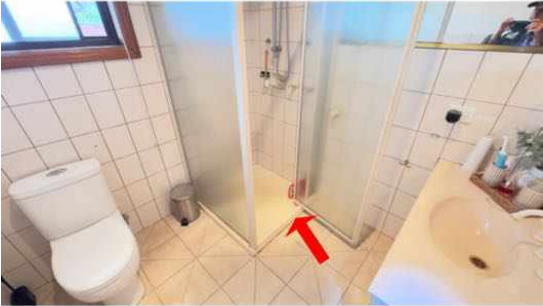
Finding 3.05

Building:	Main Building
Location:	All Showers >
Finding:	Shower Damp - To Be Monitored & Epoxy Grout
Information:	Damp is evident to the lower wall to the shower alcove and acceptable level moisture readings were found to the reverse side of the shower. Moisture readings were not

It is advised to engage an epoxy grout specialist to remove and replace the grout with epoxy grout and install epoxy to all floor wall corner joints.

Always ensure that sealant and grout is in good condition to prevent any moisture issues occurring in the future

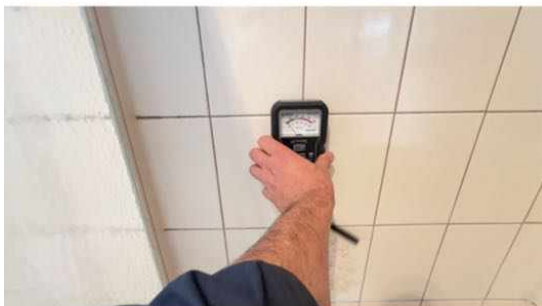
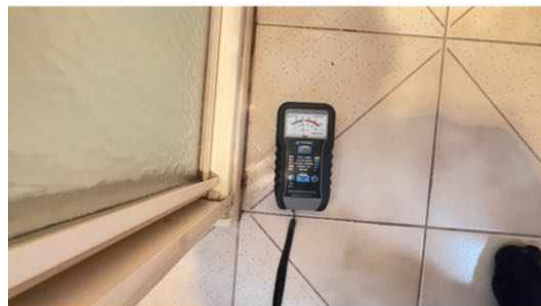
found to the wall adjacent to the shower.

Damp (or structural damp) refers to the presence of unwanted moisture in the structure of a building, either as the result of intrusion from outside, or condensation from within the structure. In the shower area, internal water leaks or other sources of excessive moisture are generally the cause of damp.

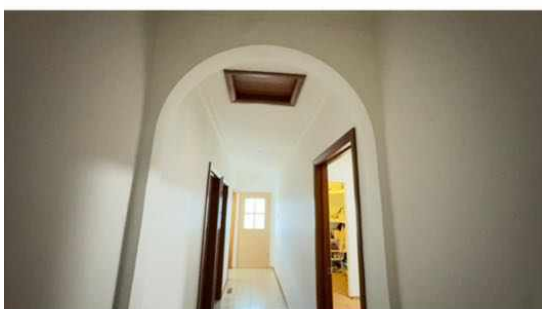
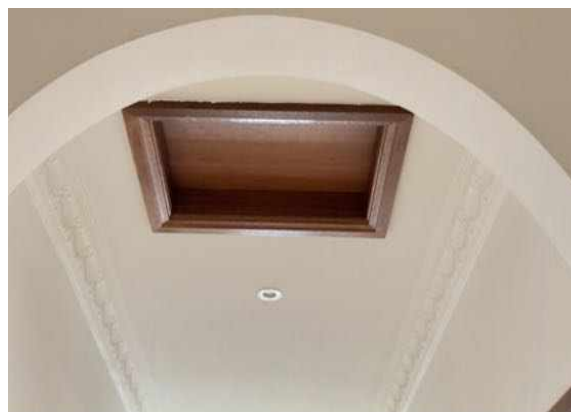
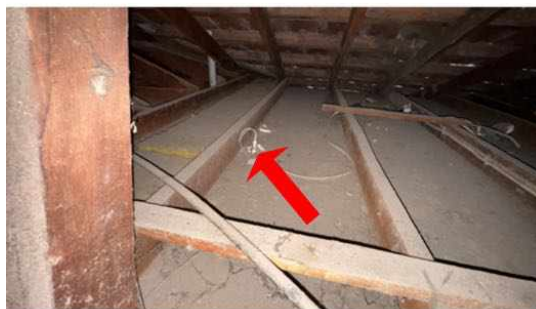
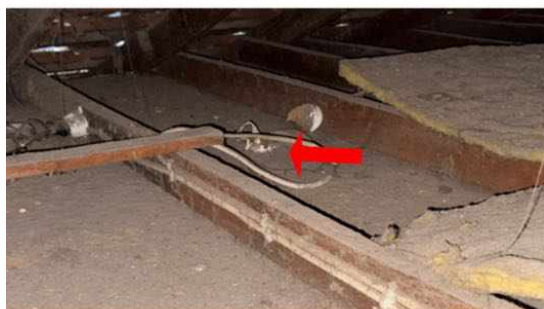
Finding 3.06

Building:	Main Building
Location:	Roof Void
Finding:	Roof Void - Electrical - Downlight Fittings - No Cover
Information:	Downlight fittings within the roof space were observed to not have covers. This is an unsafe condition, as combustible materials in close proximity to light fittings can increase the risk of overheating and fire.

This condition may have resulted from poor insulation installation.

A licensed electrician should be engaged immediately to assess the downlight installation. The fitting should be made safe, which may include installing an appropriate fire-rated downlight cover or replacing the fitting to ensure safe operation and reduce fire risk.

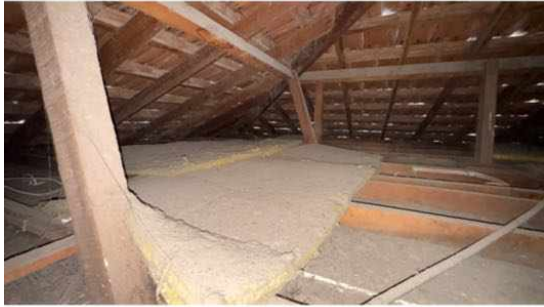
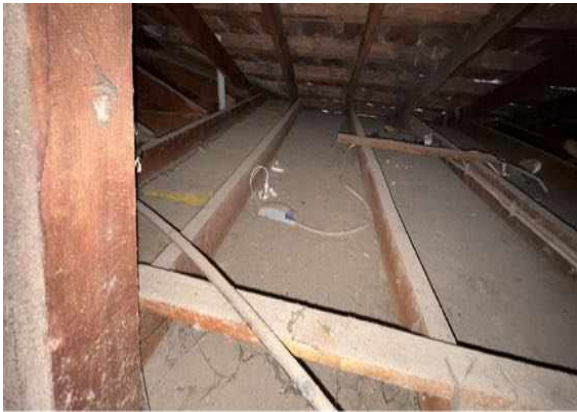
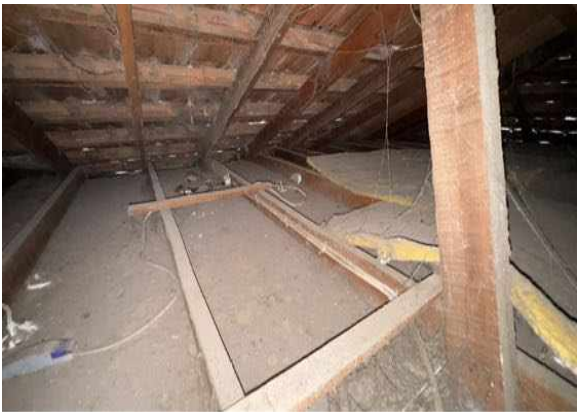
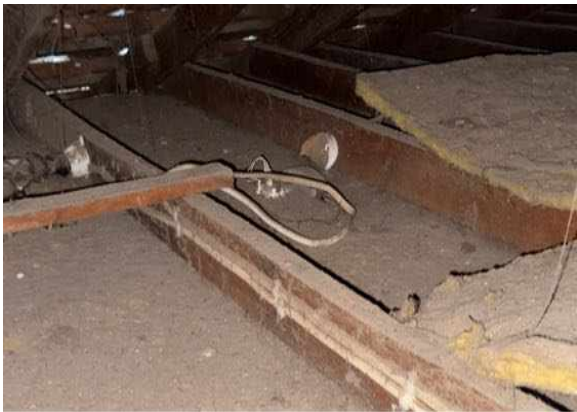
Finding 3.07

Building:	Main Building
Location:	Roof Void >
Finding:	Roof Void - Inadequate Insulation Installation
Information:	Insulation in the roof void was found to be unevenly installed, with gaps, inconsistent coverage, and some displaced sections. This reduces its effectiveness in maintaining thermal efficiency.

The issue may result from poor workmanship during installation or movement of insulation after installation. If not corrected, the reduced insulation can increase heating and cooling costs and may create cold spots that lead to localized condensation or moisture issues.

A qualified insulation installer should be engaged promptly to assess the roof void and reposition or add insulation as needed to ensure full, even coverage without compression. Regular monitoring is recommended to maintain thermal performance.

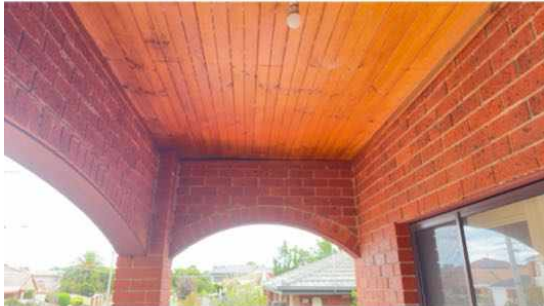
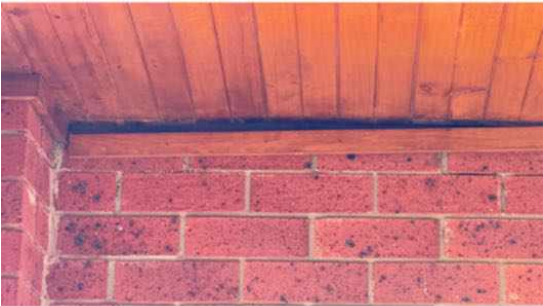
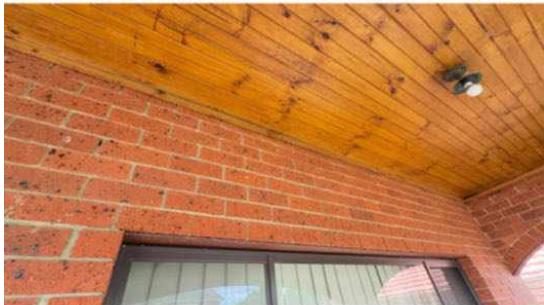
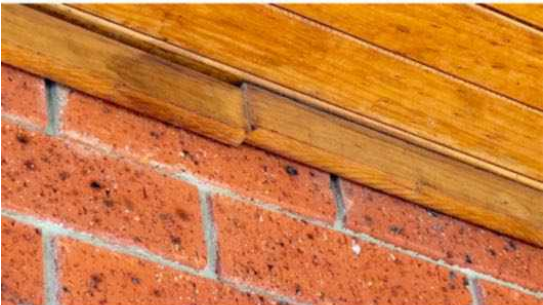
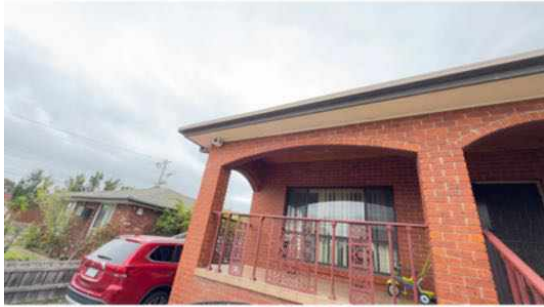
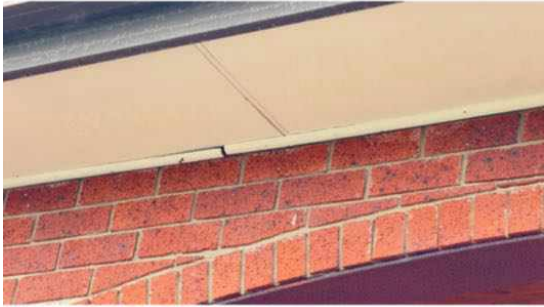
Finding 3.08

Building: Main Building
Location: All Areas
Finding: Building element - Damaged
Information: [MUST EDIT]

Evidence of damage was identified. Include findings, identify causes, potential implications if left unmanaged and suggest trade responsible for rectification.

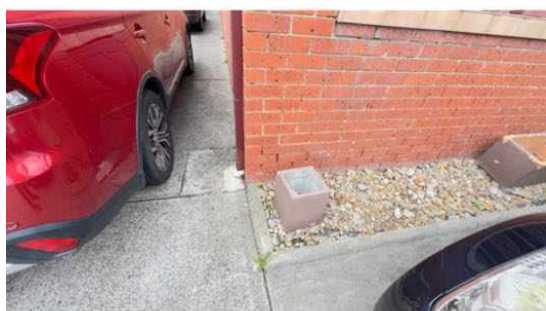
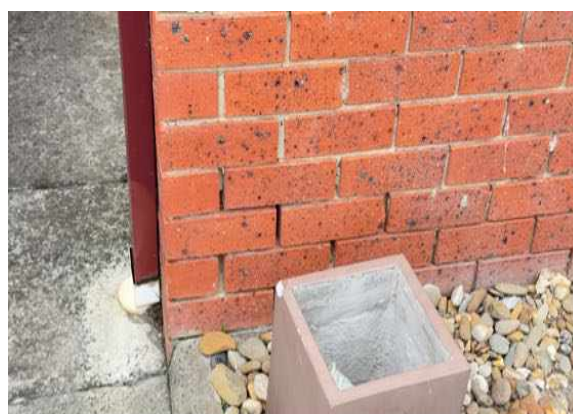
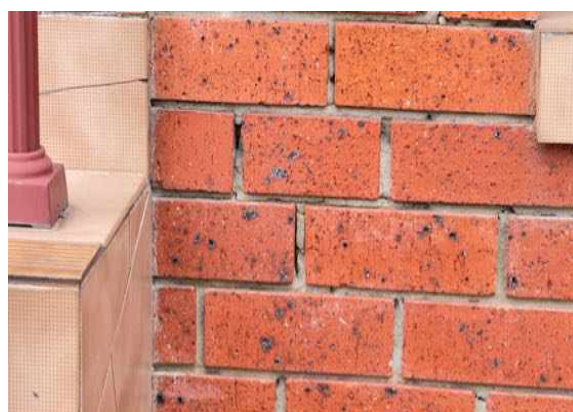
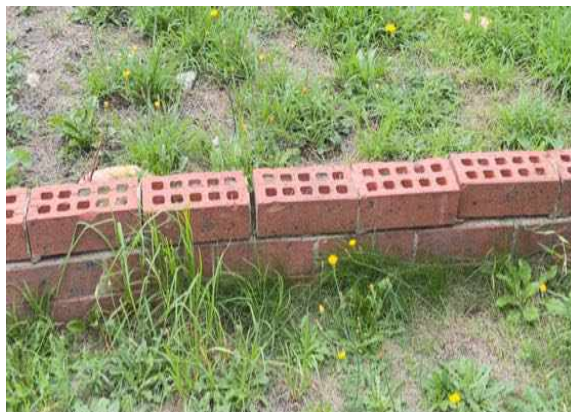
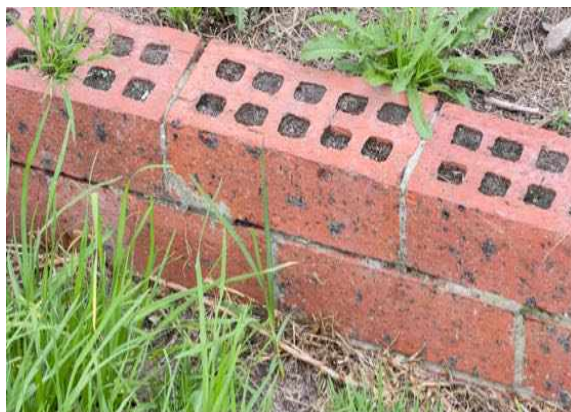
Finding 3.11

Building:	Main Building
Location:	All External Areas >
Finding:	Building element - Rusted or corroded
Information:	This building element shows evidence of rusting and corrosion, which is likely to have developed as a result of excessive exposure to moisture and or inadequate coatings.

As surface rust provides no protection to the underlying iron, the deteriorating condition is likely to worsen if not addressed in the short-term future.

Where possible, the use of galvanized (treated) metals or aluminium coated metals aid in rust prevention, as does regular general maintenance. Rust formation can be controlled with coatings, such as paint, that isolate the iron from the environment.

Rusting and corrosion should be managed by ideally removing or limiting the affected surface from exposure to moisture. A registered builder may be appointed to replace any building elements that have been severely affected by rust or water damage.

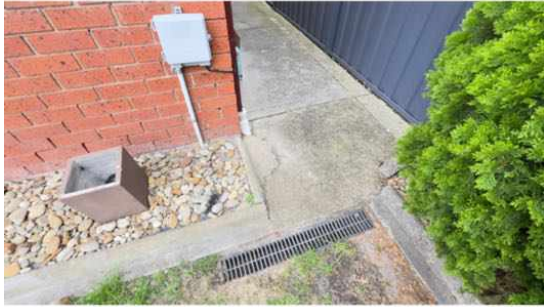
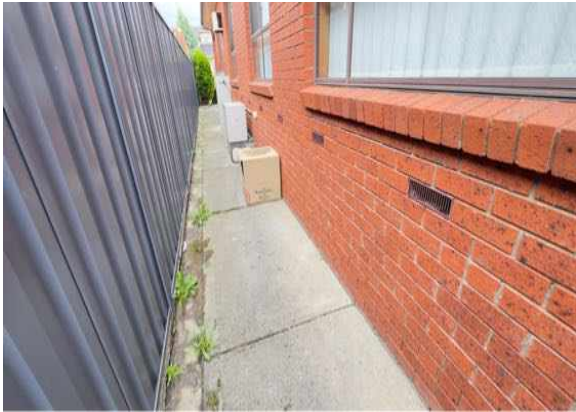
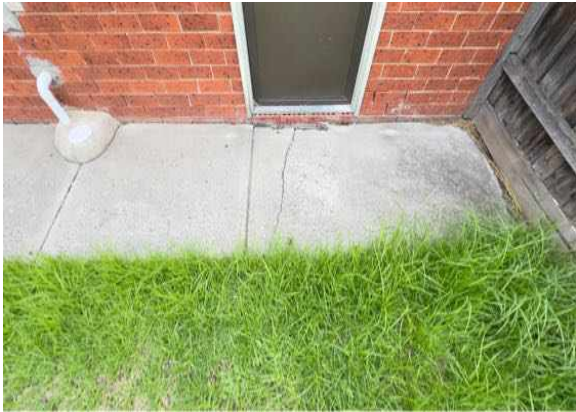
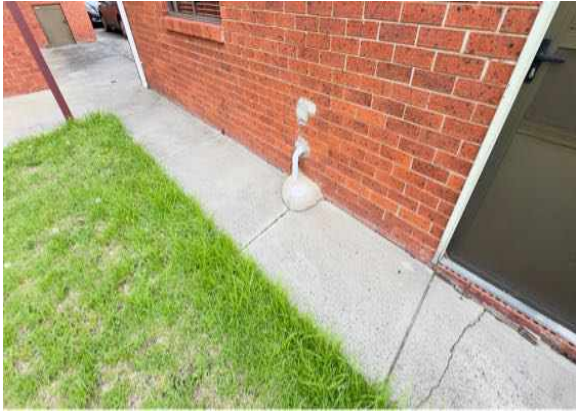
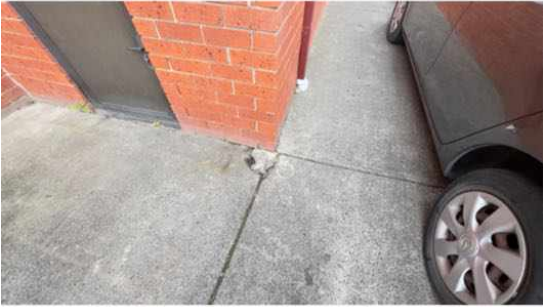
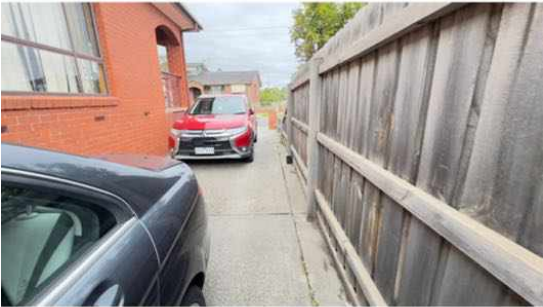
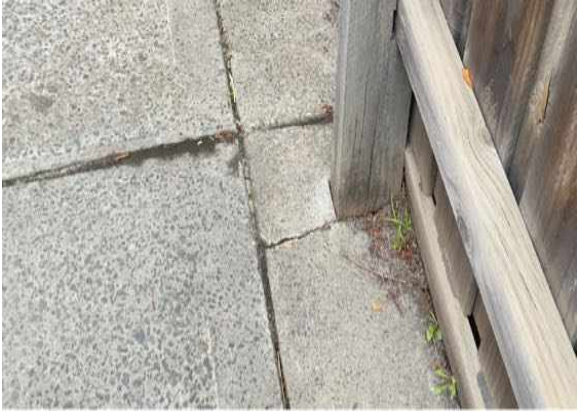
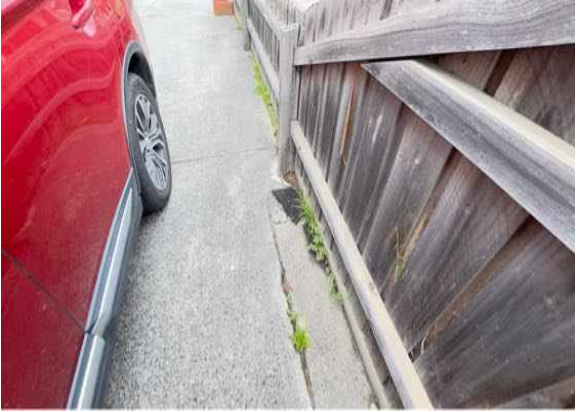
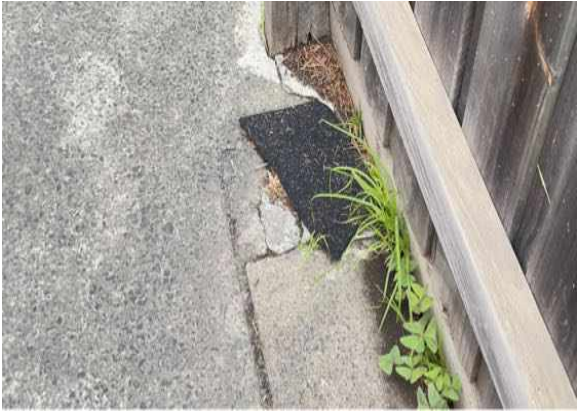
Finding 3.16

Building:	Main Building
Location:	All External Areas >
Finding:	Paving - Minor Cracking
Information:	The external paved areas were visually inspected. Minor cracking, uneven surfaces, and general wear were observed in this area. These defects do not currently affect structural safety but may reduce durability, appearance, and safe pedestrian access.

This may be caused by age-related deterioration of concrete, pavers, or other materials, soil movement or settlement beneath paved surfaces, tree root intrusion or erosion, or inadequate original installation or sub-base compaction.

A qualified landscaper should be engaged as soon as possible to repair or resurface sections as required. Rectification will restore even surfaces, reduce trip hazards, and improve the serviceability and appearance of the paved areas.

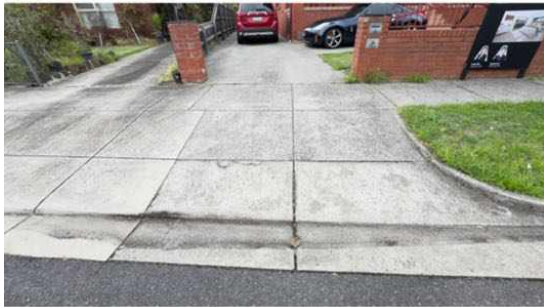
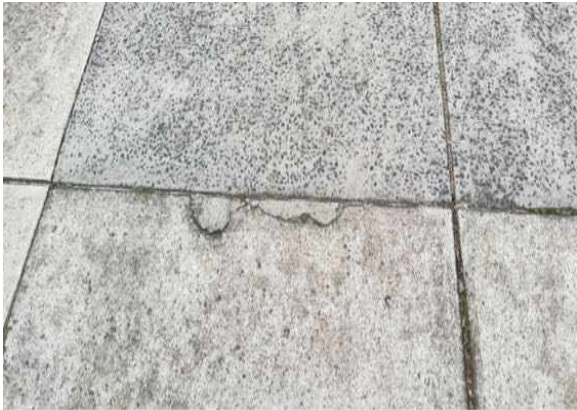
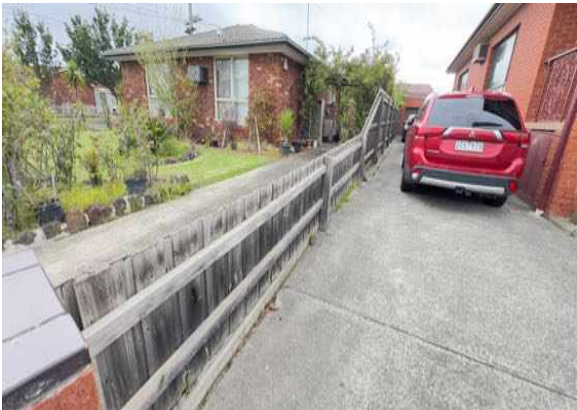
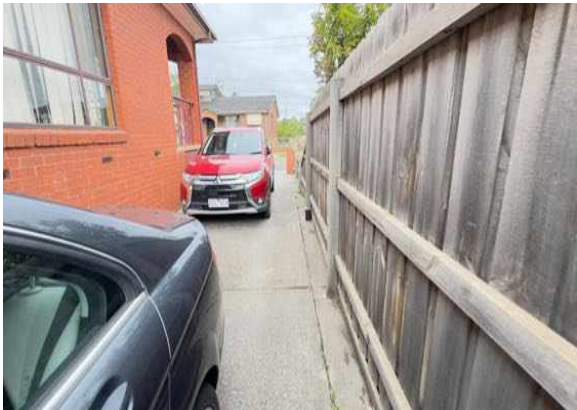
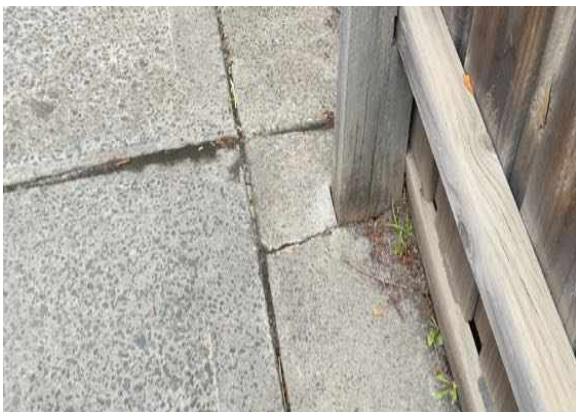
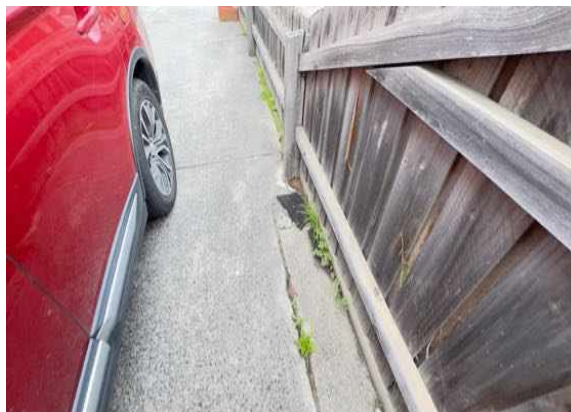
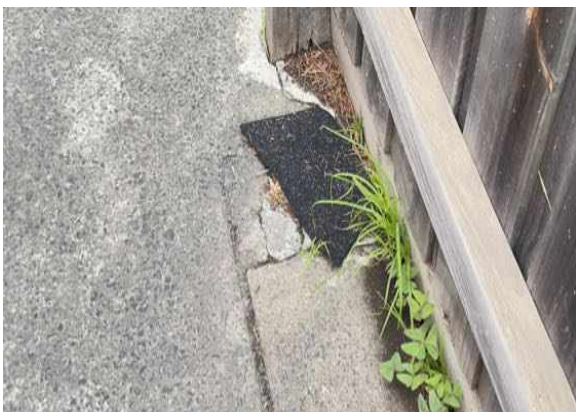
Finding 3.17

Building: Main Building
Location: Driveway >
Finding: Driveway - Minor Cracking & Surface Imperfections
Information: The external driveway was visually inspected. Minor cracking, surface settlement, and minor unevenness was observed in this area. While these defects do not currently compromise structural safety, they may affect long-term durability, appearance, and vehicle access.

These issues may be caused by age-related wear, soil movement or settlement beneath the driveway, possible tree root intrusion, or inadequate original construction or reinforcement.

A qualified concreter should be engaged when practical to repair or resurface affected areas. Prompt rectification will restore a smooth surface, improve appearance, and prevent further deterioration.

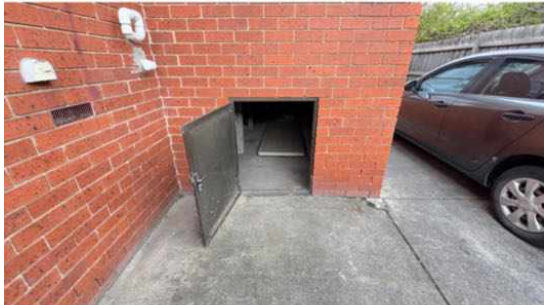
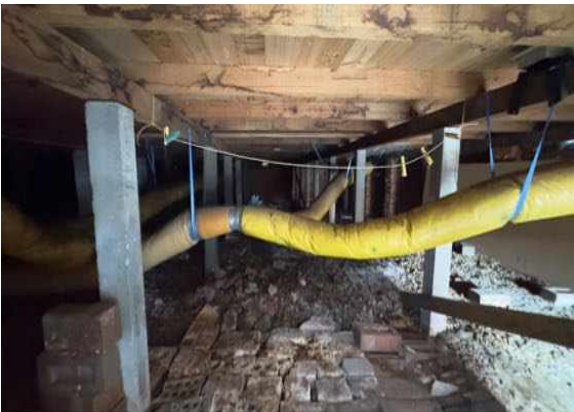
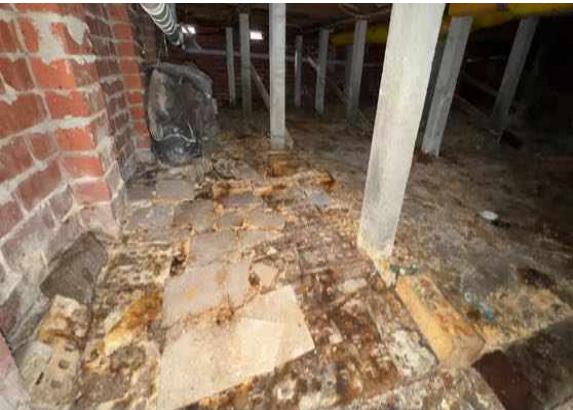
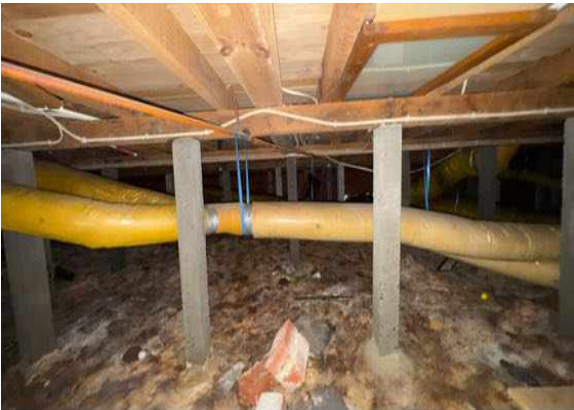
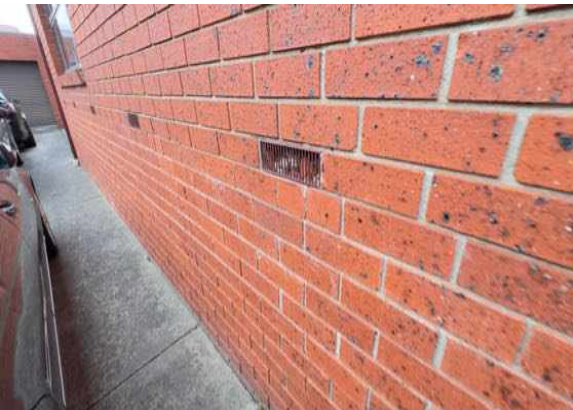
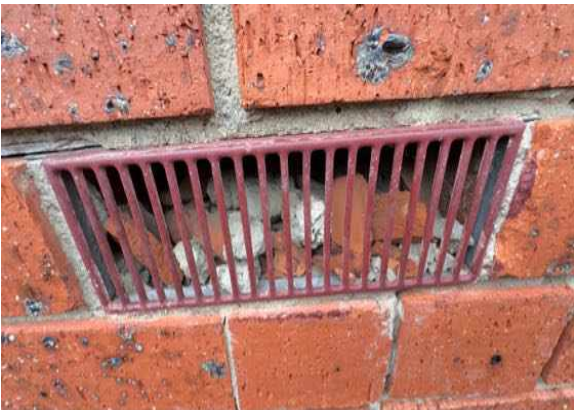
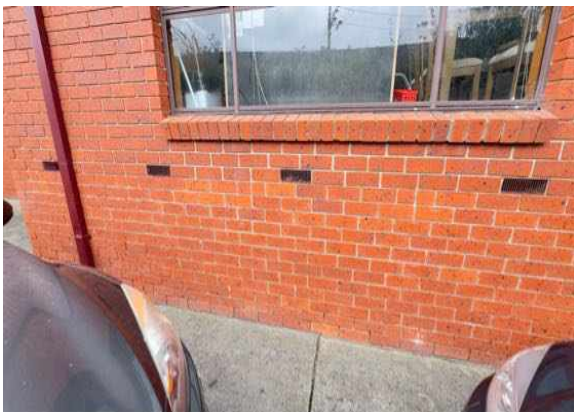
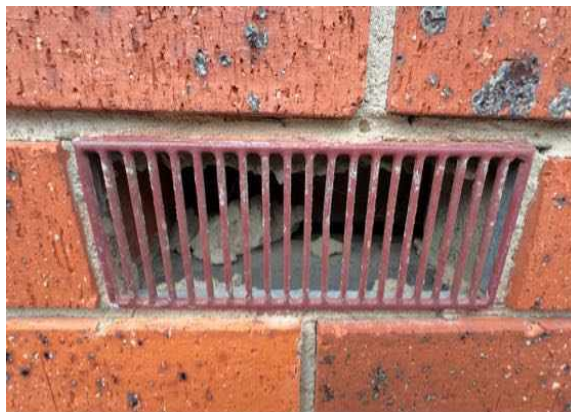
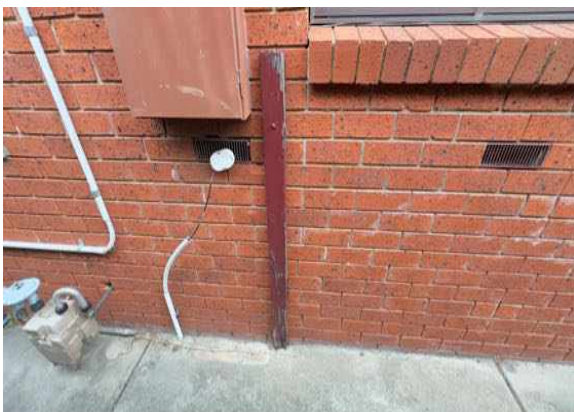
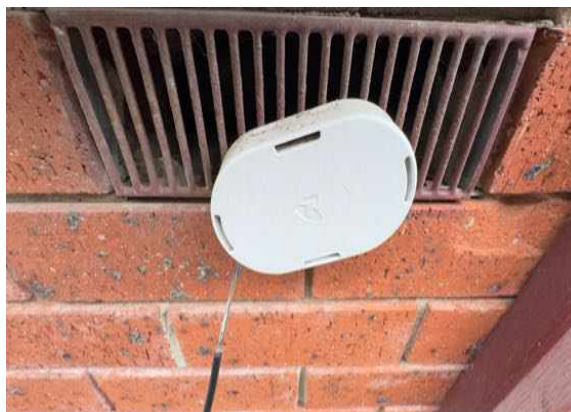
Finding 3.18

Building:	Main Building
Location:	Subfloor
Finding:	Sub - Floor - Lack Of Ventilation
Information:	It was noted at the time of inspection that the subfloor area lacks adequate ventilation. Ventilation can be restricted by a variety of minor defects, including obstructions in the subfloor space, a lack of vents or a low clearance, no mechanical ventilation and insufficient external site drainage.

A well ventilated subfloor aids in maintaining dry conditions, preventing secondary damage such as wood rot and pest activity, as well as preventing the development of mould and mildew (which can lead to respiratory safety hazards for occupants).

Where ventilation is substandard it is usually caused by factors such as failure to install adequate vents during construction subsequent building works or earth and vegetation covering over vents low subfloor clearance and items or debris in the subfloor restricting airflow.

The initial step in improving ventilation is to ensure that the subfloor area is free of any debris or stored items. Where ventilation is still inadequate, it is advised to ensure that all vents are clear of blockages, additional vents may be installed and external surface and subsurface drainage is reviewed.

The client may also consider mechanical ventilation (powered fans) to improve subfloor airflow. Remedial works should be conducted as a matter of urgency to protect against the development of potentially harmful subfloor conditions.

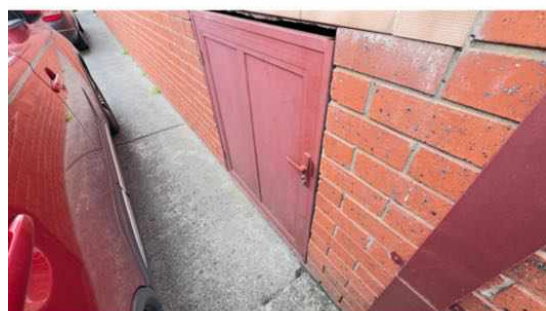
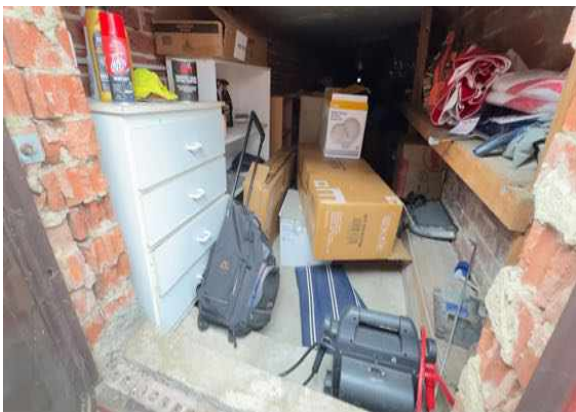
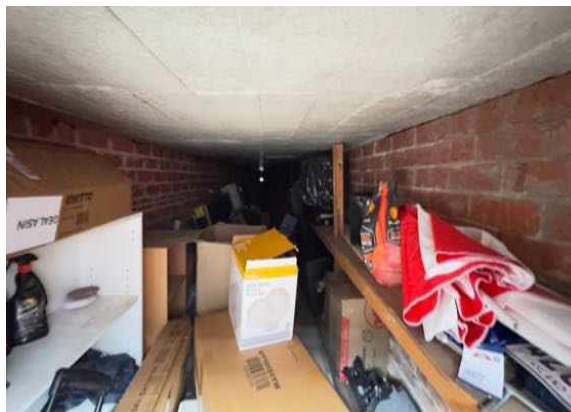
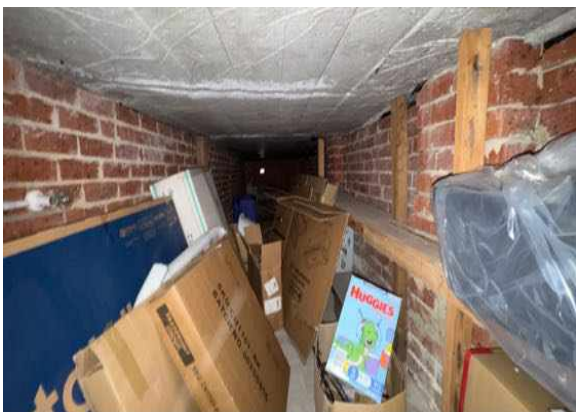
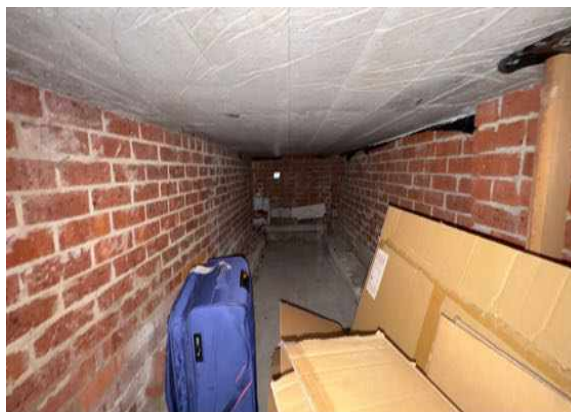
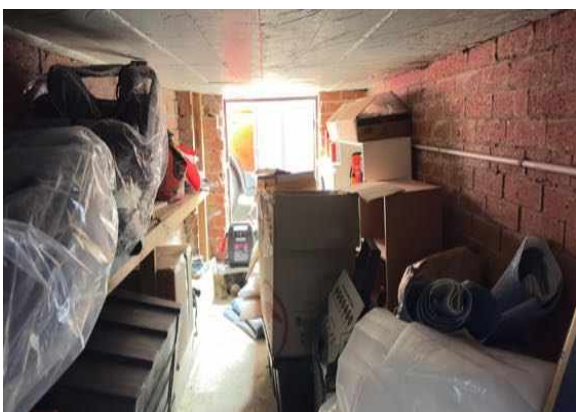
Building:	Main Building
Location:	Subfloor
Finding:	Sub - Floor - Stored Items, Rubbish & Debris
Information:	The subfloor was observed to contain stored items, rubbish, and debris. The issue is present where clutter restricts access and covers surfaces beneath the building.

This has likely occurred due to accumulation of materials over time or inadequate cleaning. Excess items can conceal defects, restrict inspections and maintenance, increase pest activity, and create fire or safety hazards.

This observation is provided for information only. When practical, a competent handyman should be engaged to remove all rubbish and clear access to ensure safe inspection, maintenance, and ongoing monitoring of the subfloor.

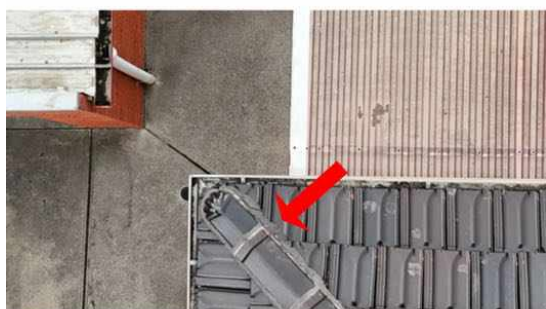
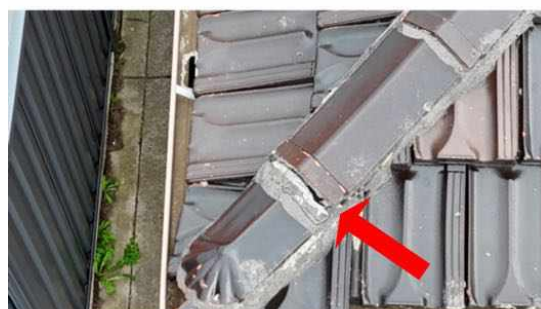
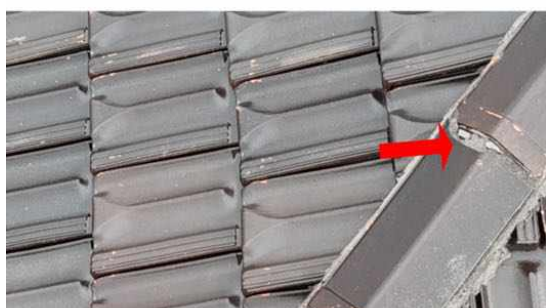
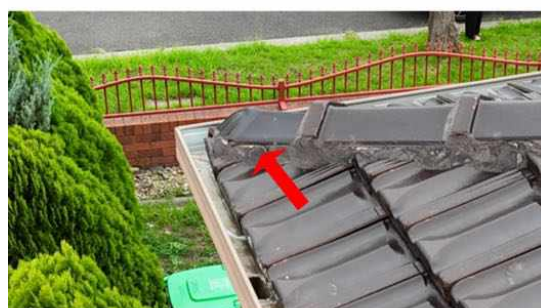
Finding 3.23

Building:	Main Building
Location:	Roof Exterior
Finding:	Roof Plumbing - Rusted & Corroded
Information:	The roof plumbing has areas of rust and corrosion. It is suspected that this has been caused by blockages, resulting in pooling or standing water, that have prematurely rusted elements of the roof plumbing.

Rusted roof plumbing will generally develop holes and leaks that can affect other building elements with poor drainage of storm water. Poorly drained roof areas will also lead to damp conditions surrounding the base perimeter of the building which, if left unmanaged, can lead to a range of secondary building defects.

Repair and/or replacement of rusted roof plumbing is highly required in order to reinstate the roof drainage system to a fully operational level. To further maintain these areas, gutters should be cleaned frequently, allowing the avoidance of any partial blockages.

A licensed plumber or specialist roof restoration company should be appointed to undertake these works. It is advised that such works be completed as soon as

possible to prevent any further damage and deterioration.
