Building and Timber Pest Inspection Report

Inspection Date: Tue, 17 Mar 2026

Property Address: 18 Cabinda Dr, Keysborough VIC 3173,
Australia

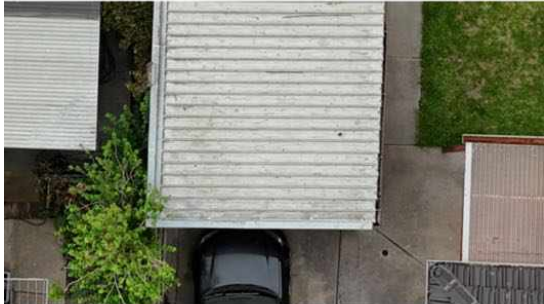
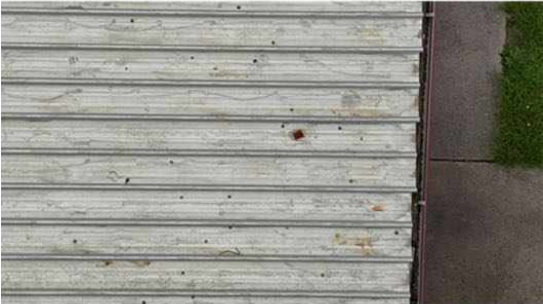
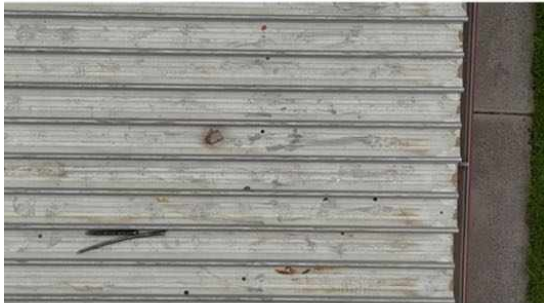
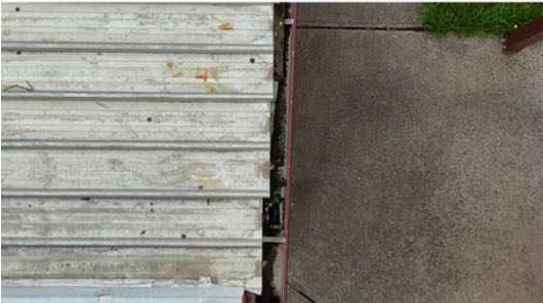
Finding 3.24

Building: Main Building
Location: Roof Exterior
Finding: Roof Plumbing - Metal Sheets Deteriorated
Information: The inspection identified metal roof sheets that are showing signs of deterioration. Deteriorated metal sheets can compromise the roof’s water-tightness, potentially leading to leaks, corrosion, and damage to the underlying structure.

The deterioration may be due to age, prolonged exposure to weather, corrosion, or lack of maintenance.

It is recommended that a licensed plumber or roofing specialist be engaged immediately to assess the condition of the roof sheets and undertake necessary repairs or replacement. Prompt action will help maintain the structural integrity and longevity of the roof.

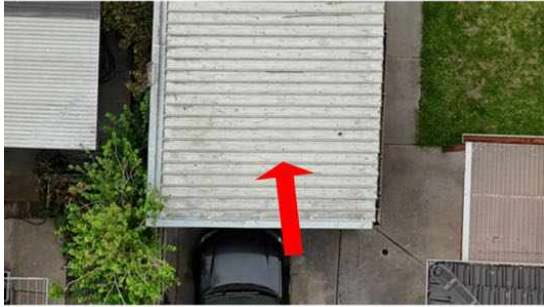
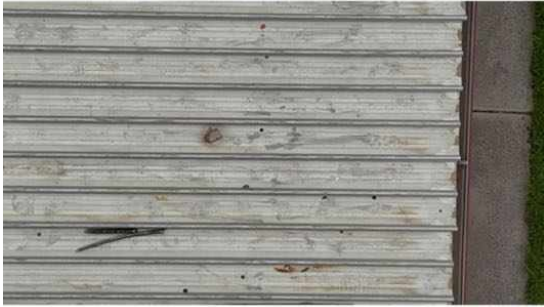
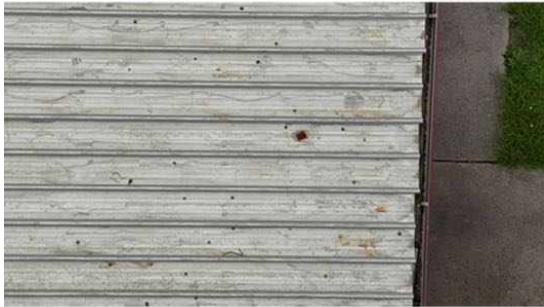
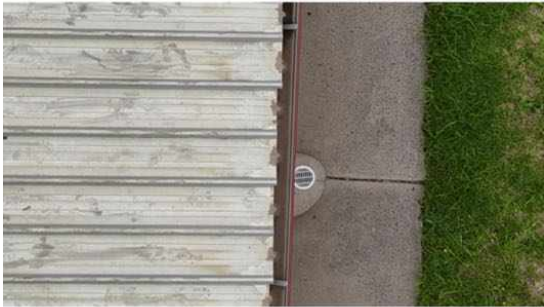
Finding 3.25

Building: Main Building
Location: Roof Exterior
Finding: Roof Plumbing - Flashings Deteriorated
Information: The roof flashings in this area are deteriorated, showing signs of corrosion, cracking, and wear. The issue is observed where the flashings meet roof surfaces and junctions.

This has likely occurred due to long-term exposure to weather, poor installation, or aging materials. Deteriorated flashings may allow water to penetrate the roof or walls, causing leaks, water damage, or structural deterioration.

A licensed roof plumber is required to inspect and repair or replace the deteriorated flashings in this area. This should be rectified immediately to prevent water ingress and further damage to the building.

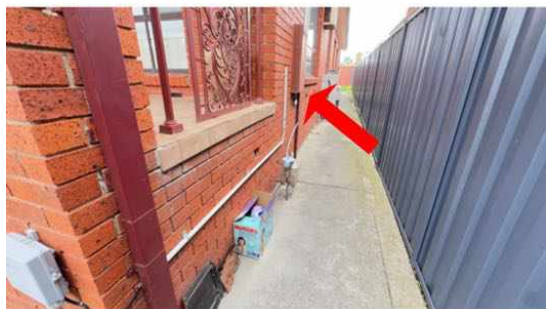
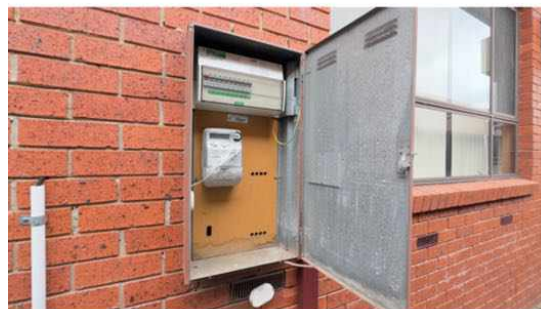
Finding 6.02

Building:	Main Building
Location:	All External Areas
Finding:	Timber Pests - Conducive Conditions - Poor Site Drainage
Information:	During the inspection, poor site drainage was identified in this area. Inadequate drainage allows water to accumulate near footings, external walls, and subfloor areas, creating persistently damp conditions. These conditions are highly conducive to termite activity and other timber pests, as moisture is essential for their survival and movement.

Poor drainage may be caused by incorrect site grading, blocked or damaged stormwater systems, inadequate surface water diversion, or landscaping that directs water toward the building. Over time, this excess moisture can soften surrounding soils and timber elements, reduce the effectiveness of termite barriers, and provide concealed access pathways for termites to enter the structure.

If left unrectified, poor site drainage significantly increases the risk of termite infestation, fungal decay, and timber deterioration. Prolonged exposure to moisture can also contribute to structural movement, subfloor dampness, and ongoing maintenance issues, potentially leading to costly repairs and safety concerns.

It is recommended that a licensed plumber, drainage contractor, or registered builder be engaged immediately to assess and improve site drainage. Remedial works may include regrading the ground, clearing or upgrading stormwater drainage, installing surface drains, and ensuring water is directed away from the building perimeter.

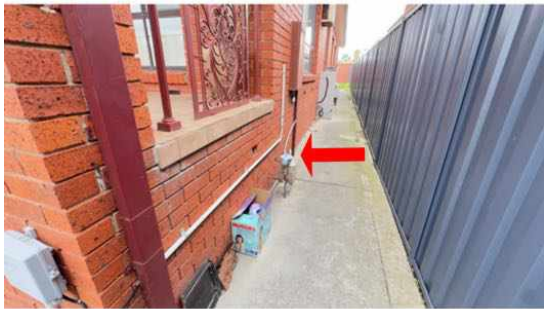
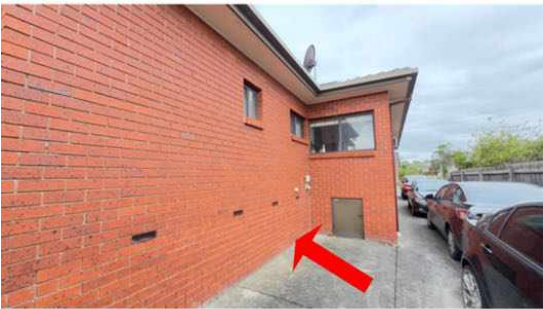
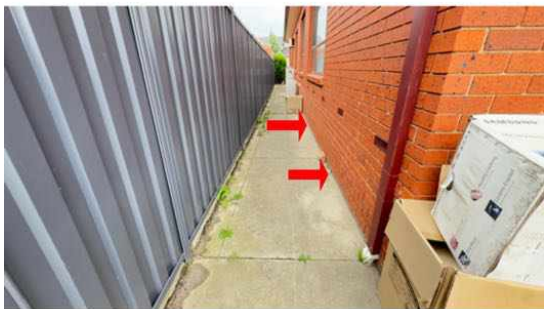
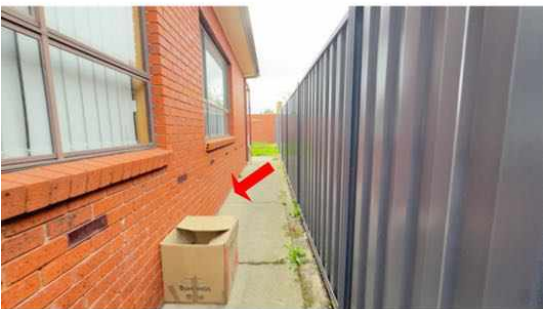
Finding 6.03

Building: Main Building
Location: All External Areas
Finding: AC Condensate Drain - Not Connected To Storm Water
Information: The air conditioning condensate drain in this area was observed to be disconnected from stormwater drainage.

When condensate is not properly directed to a stormwater outlet, water can accumulate around the building or air conditioning unit, creating damp conditions that may lead to secondary defects such as timber rot, corrosion of nearby metal components, mould growth, or slippery surfaces. Prolonged pooling of water may also attract termites and contribute to long-term deterioration of surrounding building elements.

A qualified HVAC technician or licensed plumber should be engaged immediately to connect the condensate drain to a suitable stormwater outlet. Prompt rectification will ensure proper drainage, protect the building fabric, and reduce potential health and safety risks.

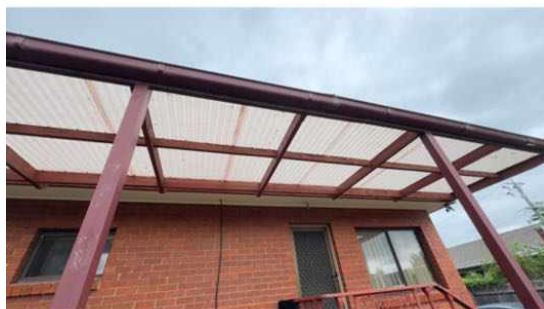
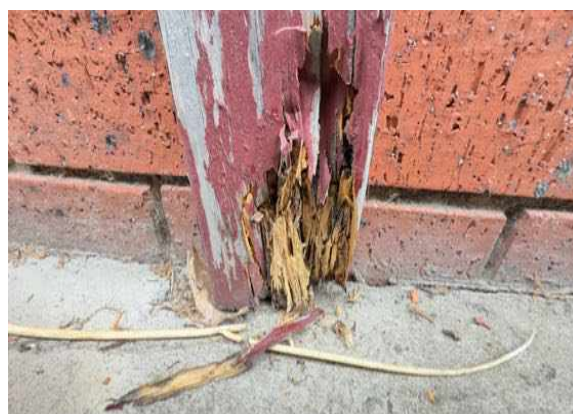
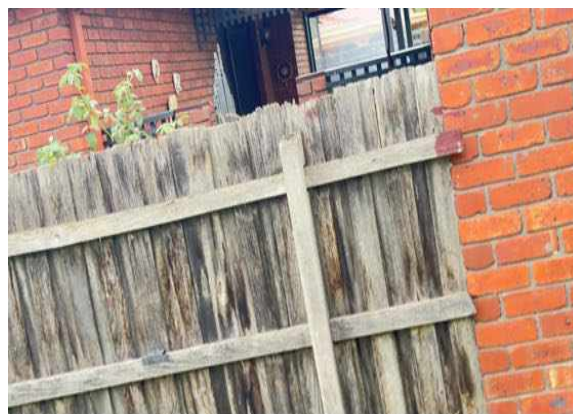
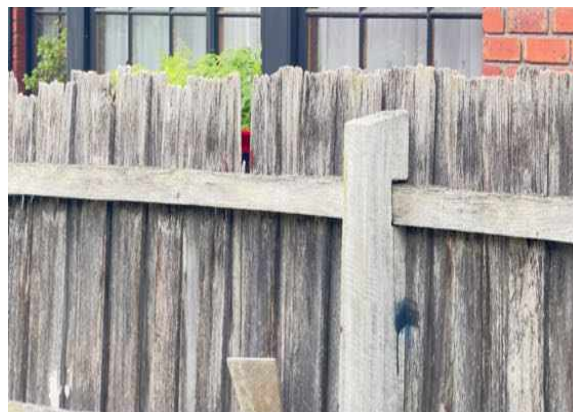
Finding: Timber Pests - Conducive Conditions - Timber Rot
Information: Timber elements on the exterior, including wall cladding, landscaping timbers, and other surfaces were inspected and show signs of rot, decay and fungal attack. Softening, discoloration, splitting, and moisture penetration indicate ongoing timber degradation.

This is likely caused by prolonged moisture exposure, inadequate protective coatings or maintenance, direct contact with soil or water, or poor detailing that traps water or limits ventilation.

If left unaddressed, the affected timber may lose structural integrity, leading to progressive decay, potential collapse of walls, decks, or landscaping features, mould growth, and reduced durability and appearance of the building exterior.

A registered builder or timber specialist should inspect the affected areas immediately to determine the extent of damage. Damaged timbers should be repaired or replaced, protective treatments applied, and drainage or detailing corrected to prevent recurrence. Ongoing monitoring and urgent remedial action are required to prevent further deterioration.

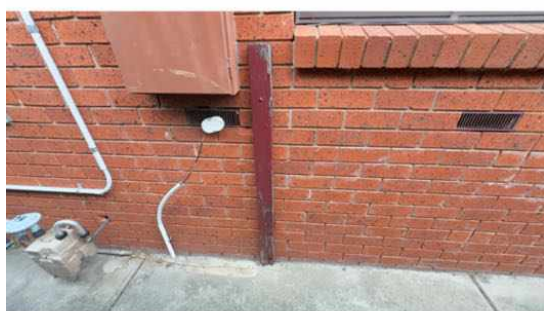
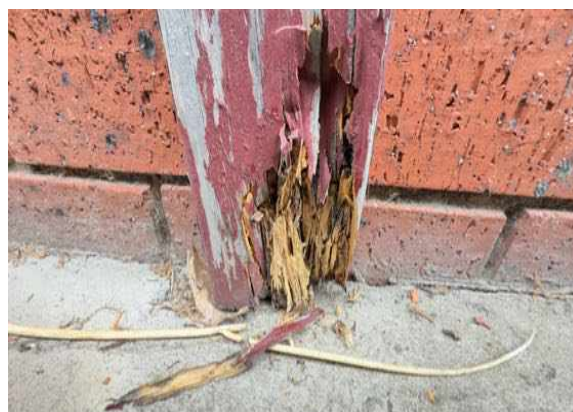
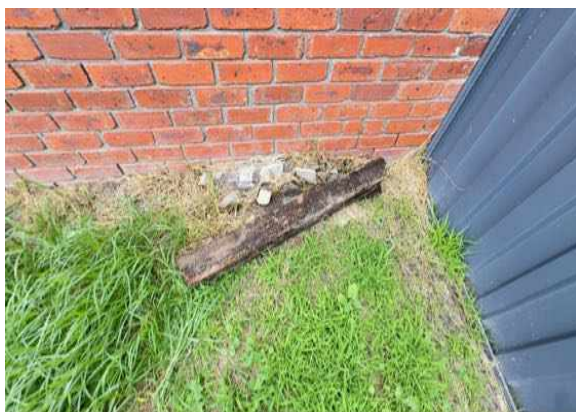
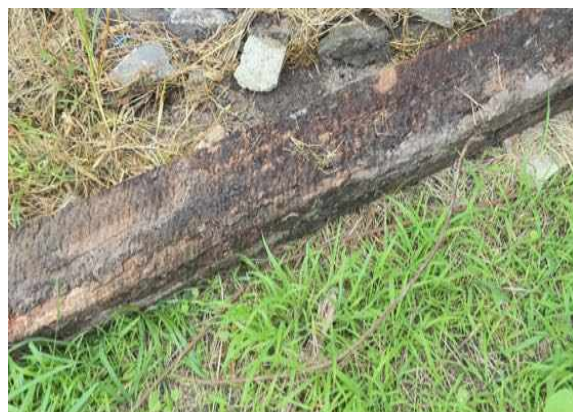
Finding 7.01

Building:	Main Building
Location:	All Areas
Finding:	Timber Pests - Evidence of Fungal Decay & Damage
Information:	During the inspection, evidence of fungal decay was identified in certain timber elements within the property. Signs of this include discolouration, softened timber, and visible fungal growth. The presence of these indicators suggests that moisture has been trapped in the affected timber for an extended period, creating a conducive environment for fungal decay. Over time, this type of damage can weaken the timber significantly, compromising its structural integrity and potentially leading to further deterioration if not addressed.

The possible causes of fungal decay are often linked to excess moisture in the environment. Common sources include leaks, condensation, or poor drainage, which can all contribute to sustained dampness in timber. Poor ventilation in areas such as subfloors or ceiling spaces can further exacerbate the issue, as it prevents moisture from evaporating and creates a breeding ground for fungal growth. Additionally, timber-to-soil contact can allow moisture to permeate the timber, accelerating decay.

If left unchecked, fungal decay can lead to serious implications for the property's

safety and structural integrity. The affected timber may become so weakened that it is unable to support the load it was originally designed to carry, increasing the risk of collapse or further structural damage. Moreover, continued decay can lead to the spread of mould spores, which pose potential health risks to the building's occupants, especially those with respiratory conditions.

It is strongly recommended that a licensed pest management technician or timber specialist be engaged to assess the extent of the damage and identify the source of moisture causing the issue. Depending on the findings, remedial actions could involve repairing or replacing decayed timber, improving drainage around the property, and addressing any ventilation issues. Regular monitoring and maintenance should be scheduled to prevent future occurrences of fungal decay.

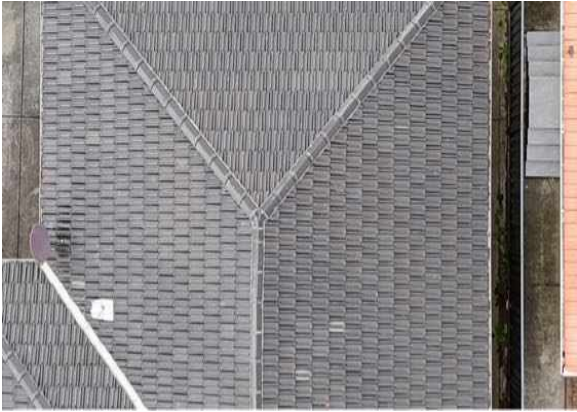
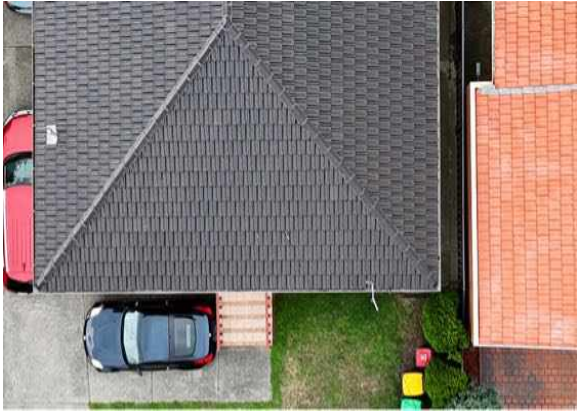
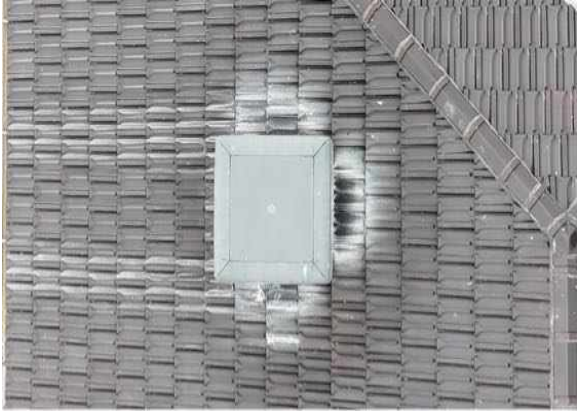
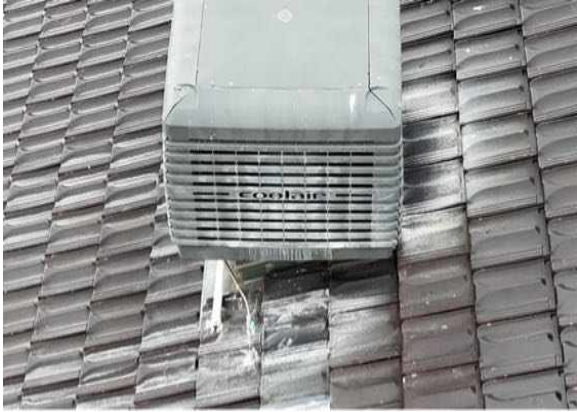
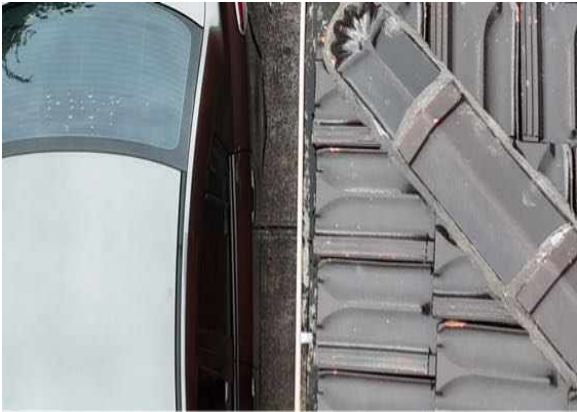
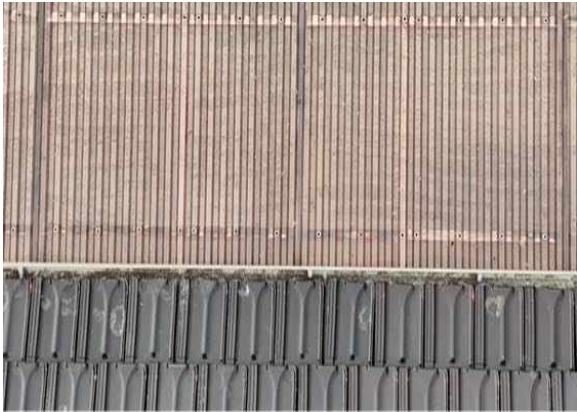
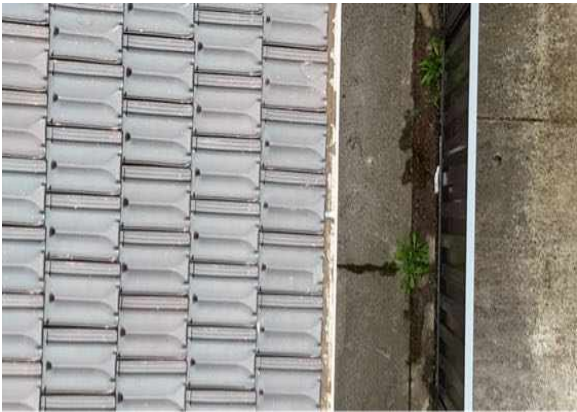
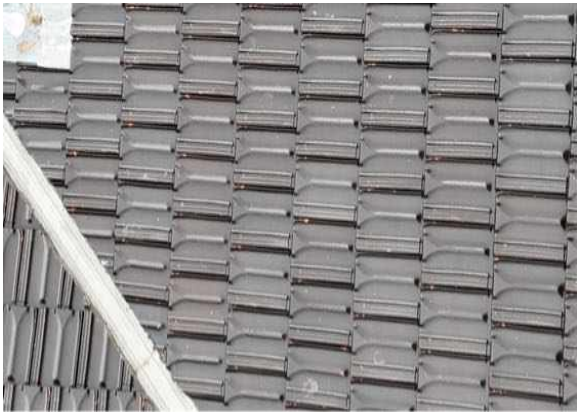
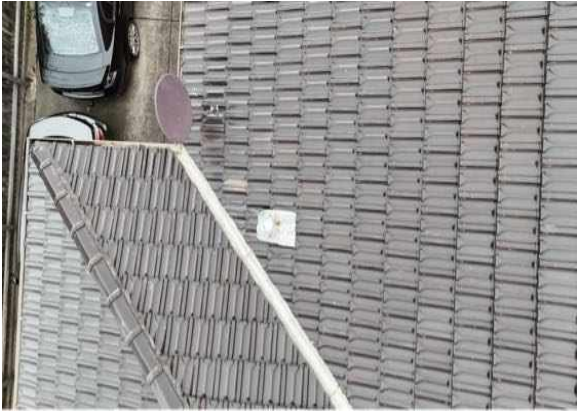
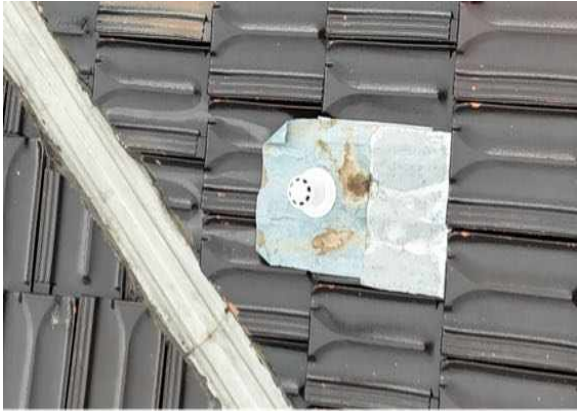
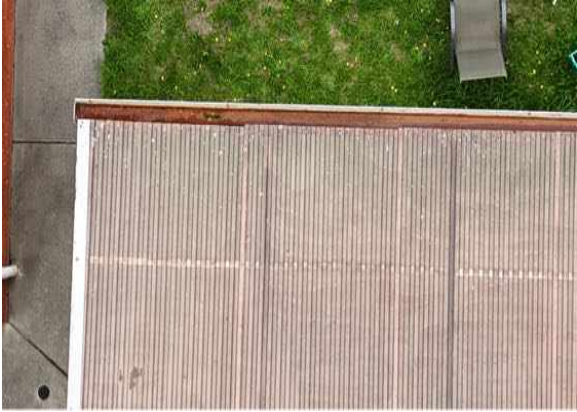
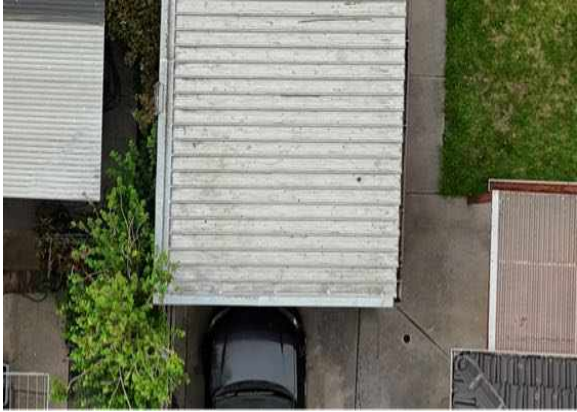
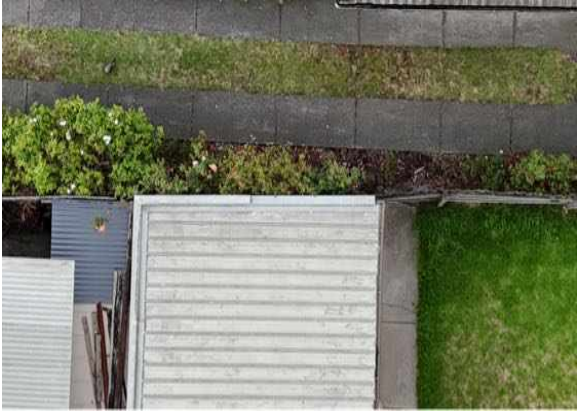
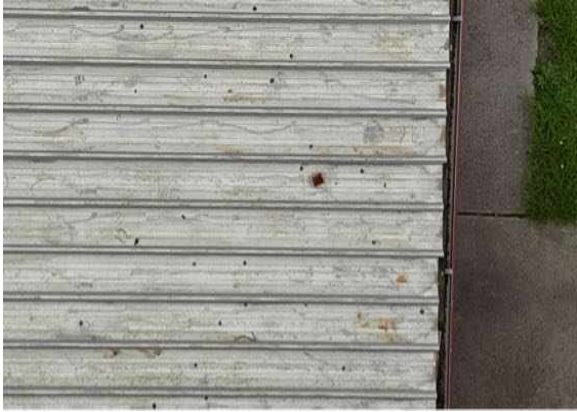
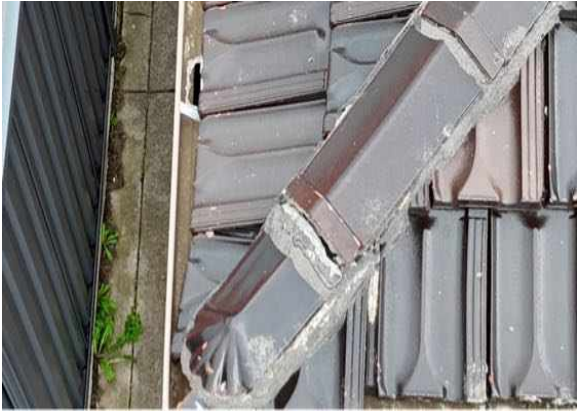
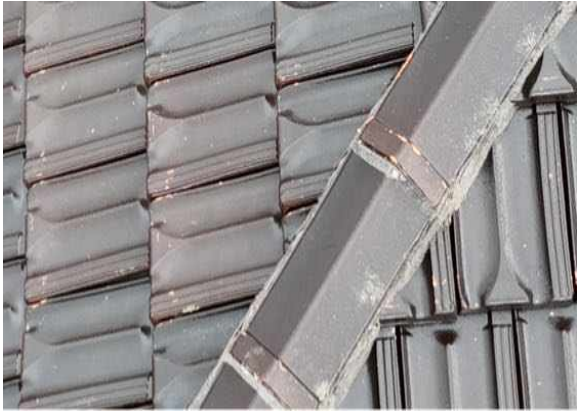
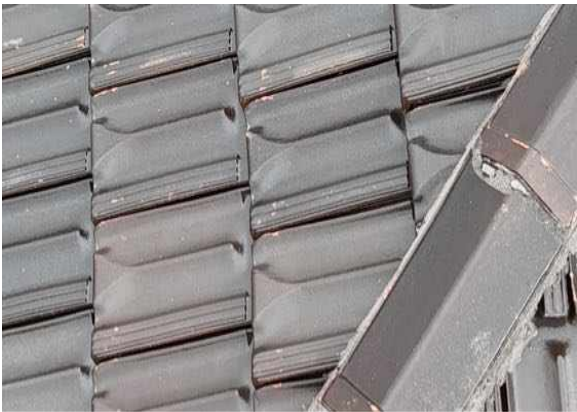
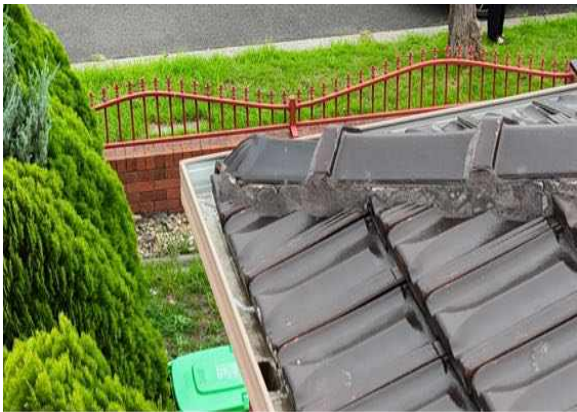
Building: Main Building
 Location: All Areas
 Finding: Building Approvals – Prior Renovations Advisory
 Information: For your information, the dwelling has undergone several renovations over the past years. Evidence of multiple alterations and upgrades was observed at the time of inspection. The inspection did not include verification of council approvals, permits, or compliance documentation for these works.

Unapproved or undocumented renovations may present compliance, safety, insurance, or resale risks if not properly approved or certified.

It is strongly recommended to make enquiries with the relevant local council immediately and engage appropriately qualified professionals, where necessary, to confirm that all historic renovations were carried out with the required permits, approvals, and certifications.

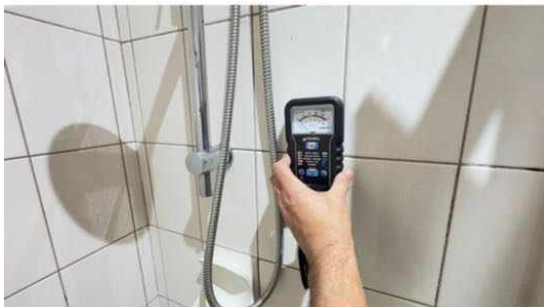
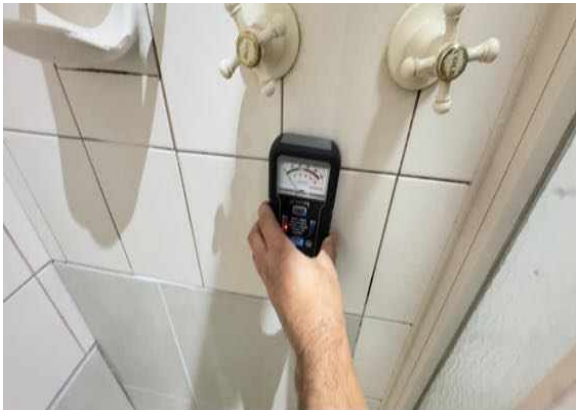
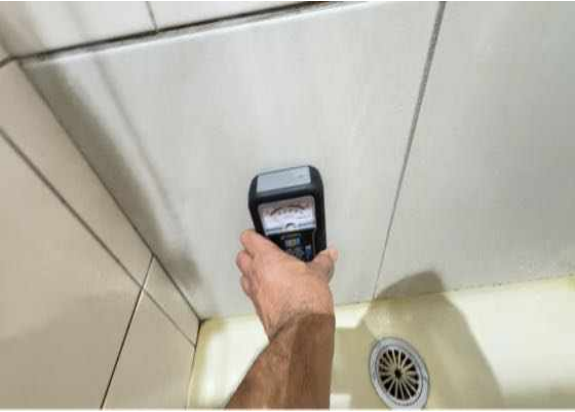
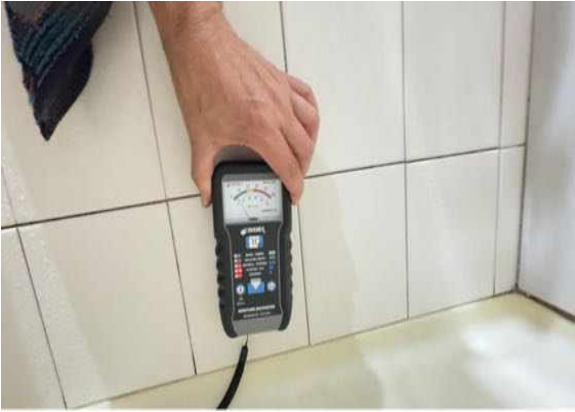
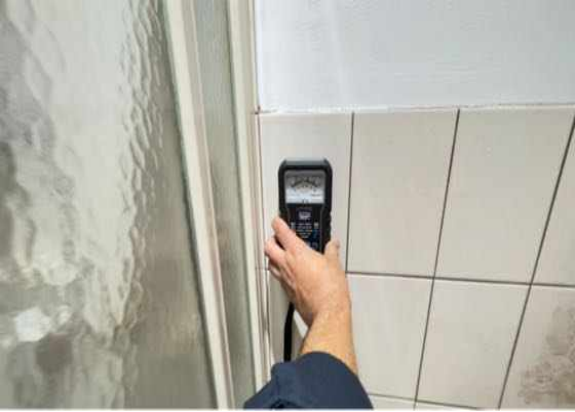
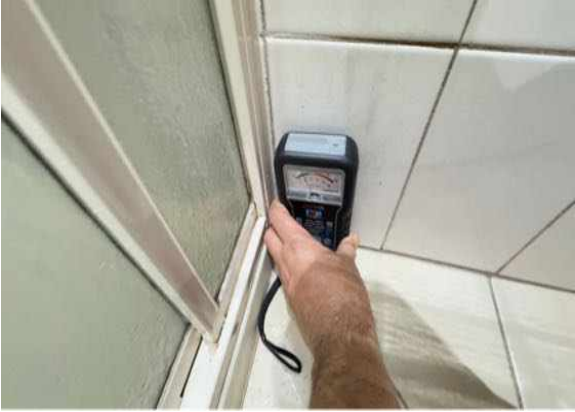
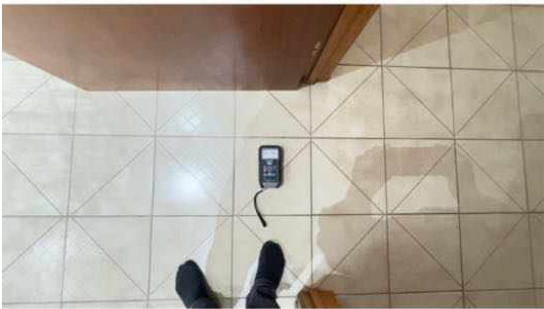
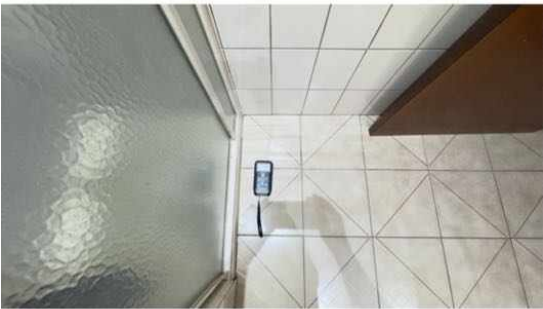
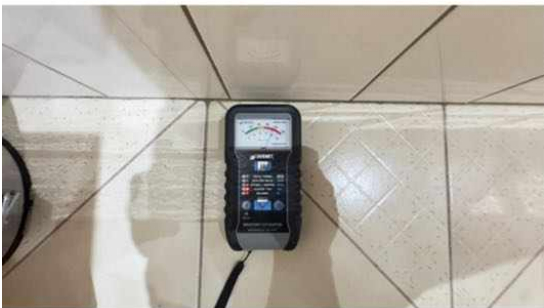
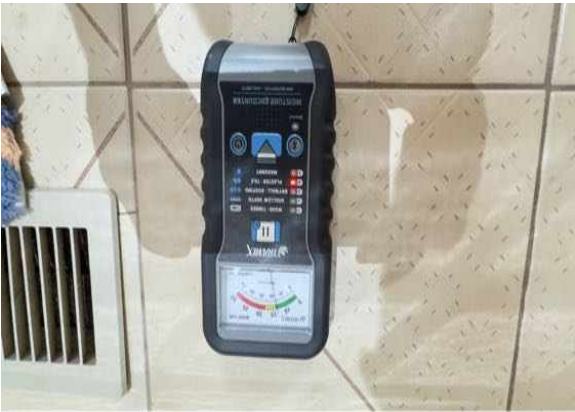
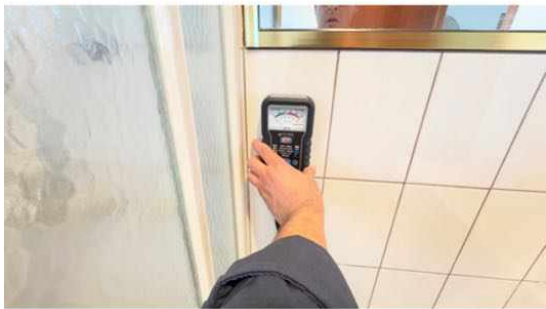
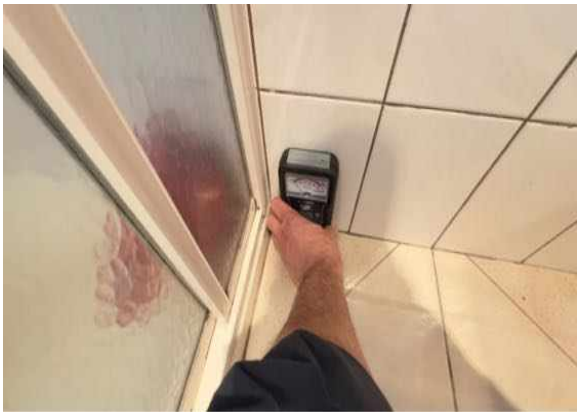
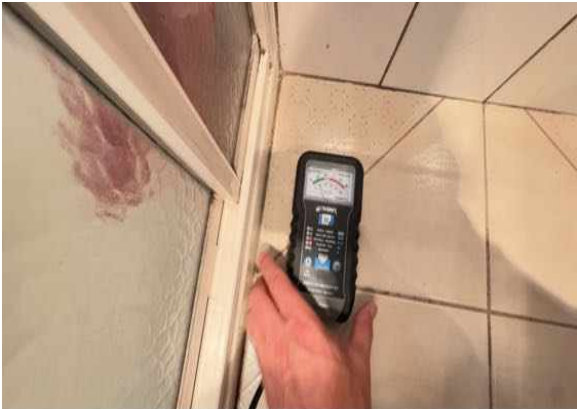
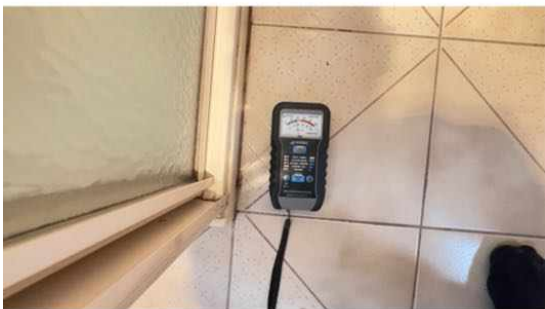
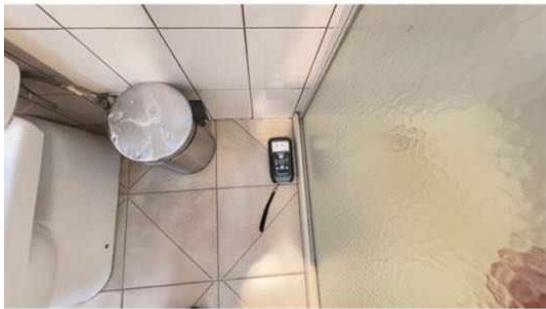
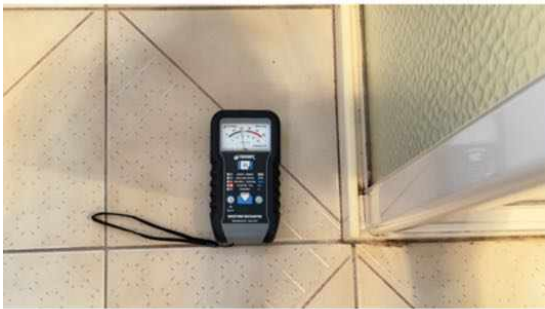
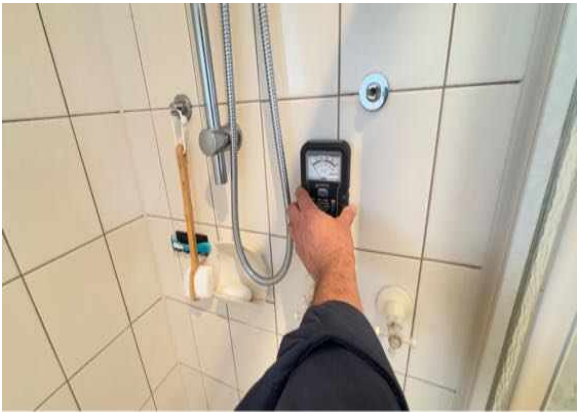
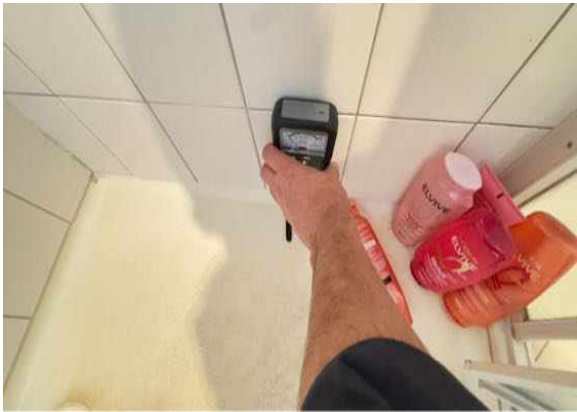
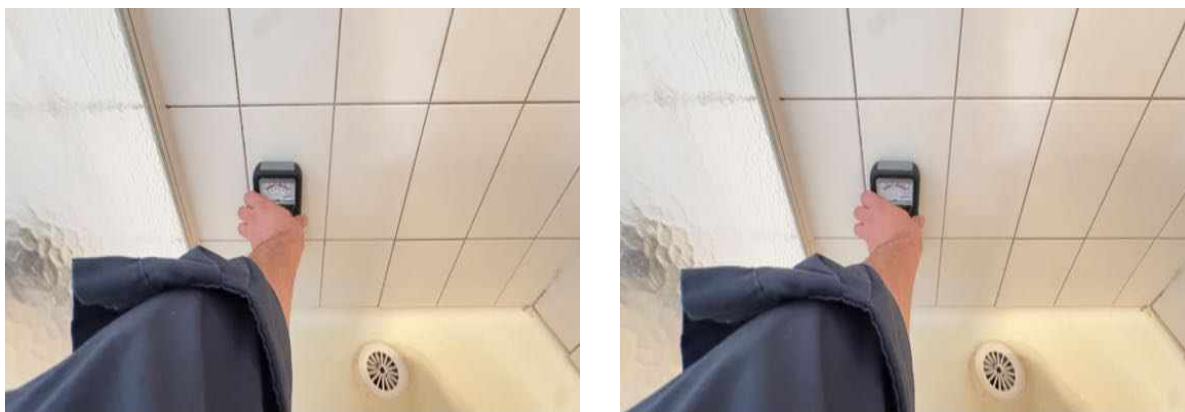
Noted Item

Building: Main Building
 Location: All Areas Interior & Exterior
 Finding: Thermal Scanning & Diagnostic - Advisory - No Elevated Moisture Levels Present
 Information: During the inspection, a thermal imaging camera was utilised as a non-invasive diagnostic tool to assist in identifying potential irregularities associated with moisture ingress, heat loss, insulation deficiencies, or concealed building defects. Thermal imaging detects surface temperature variations that may indicate abnormal conditions within building elements.

Any thermal anomalies identified during the inspection were further assessed where accessible using visual inspection methods and moisture testing. It is noted that thermal imaging is an indicative tool only and does not confirm the presence of defects or moisture without supporting evidence.

Due to the concealed nature of building construction and the limitations inherent in non-invasive inspection methods, the absence of significant thermal anomalies at the time of inspection does not guarantee that concealed defects or moisture issues are not present. Ongoing monitoring and further investigation are recommended should concerns arise.

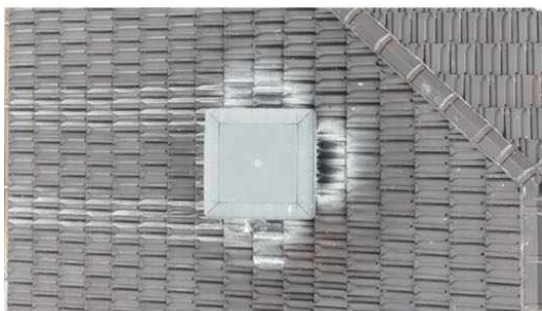
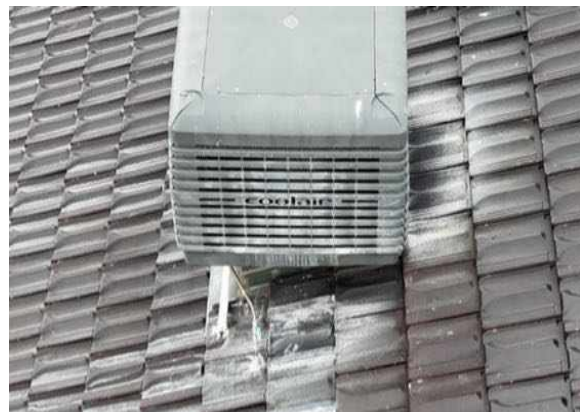
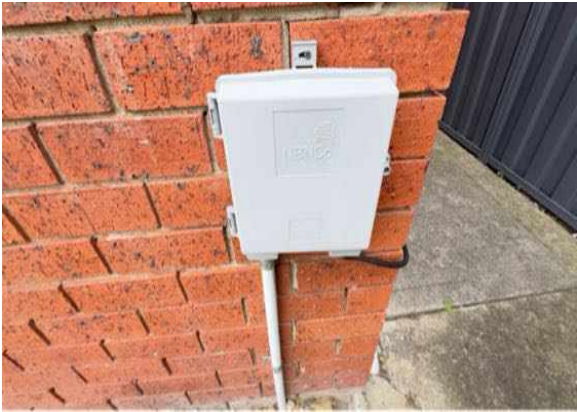
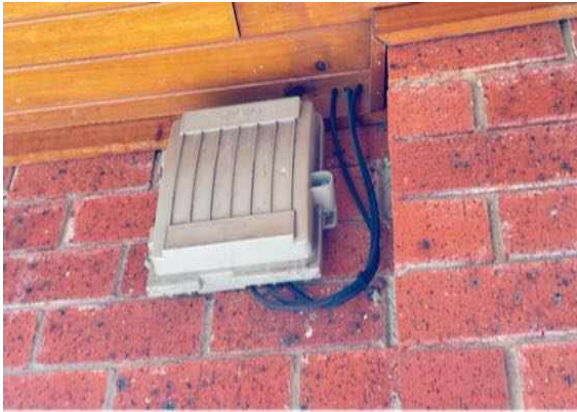
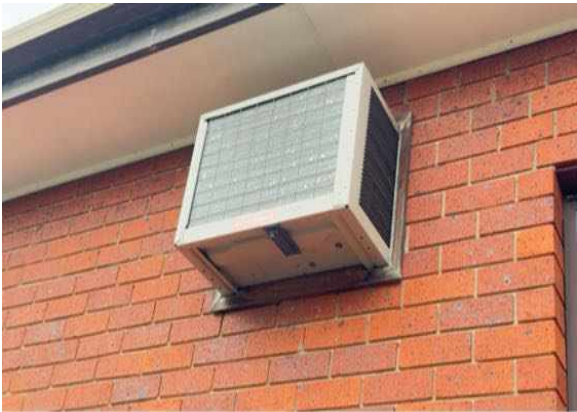
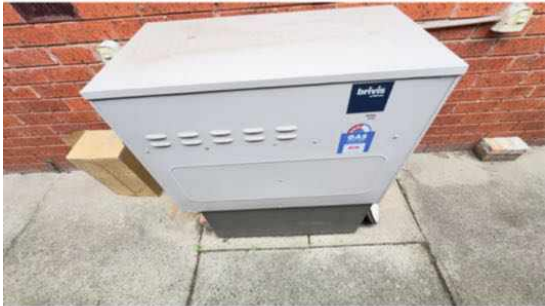
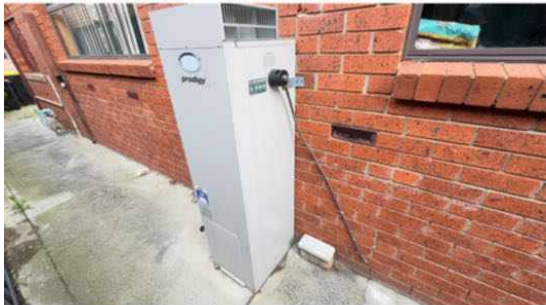
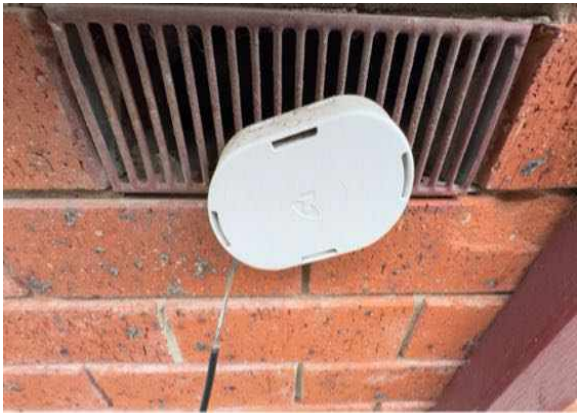
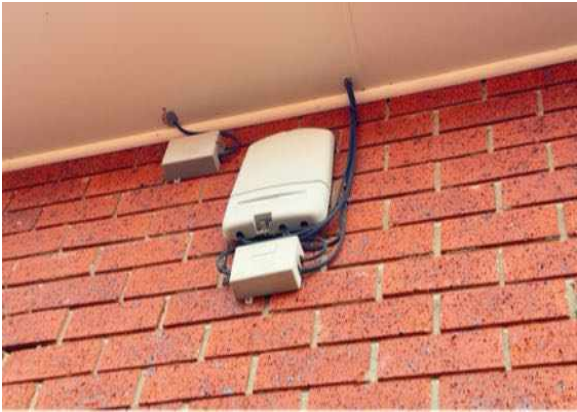
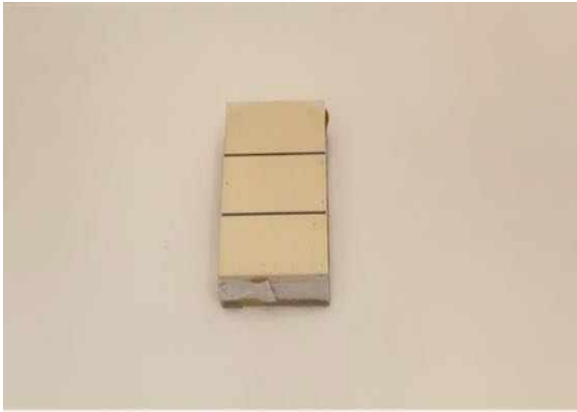
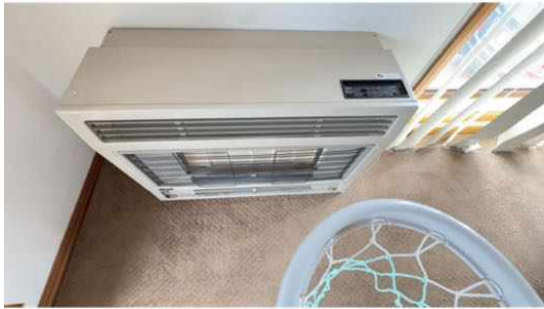
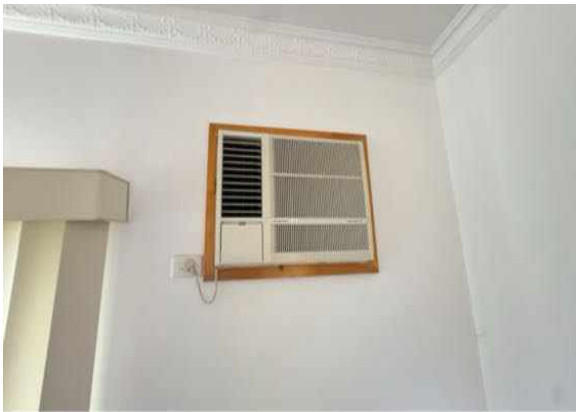
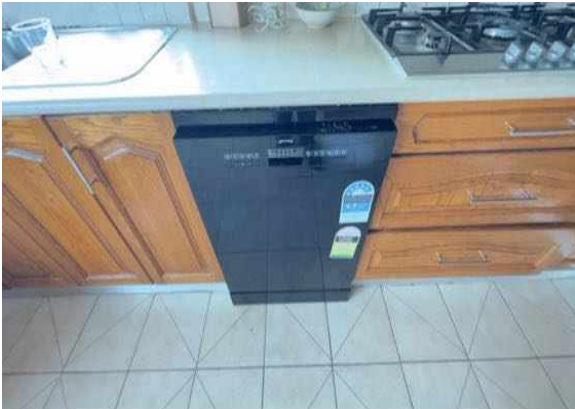
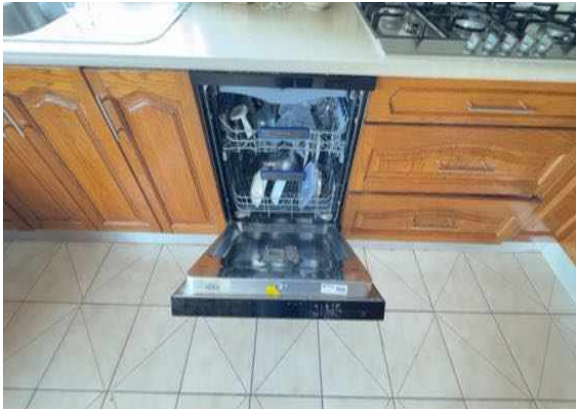
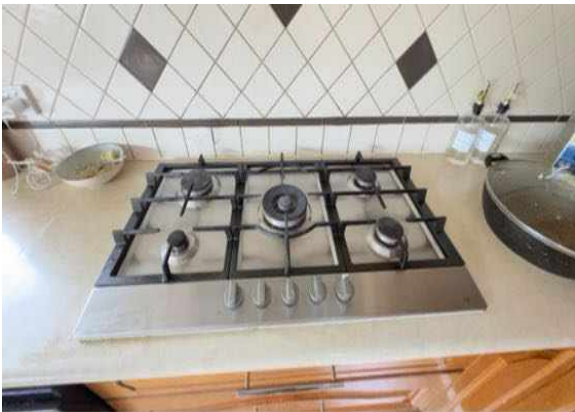
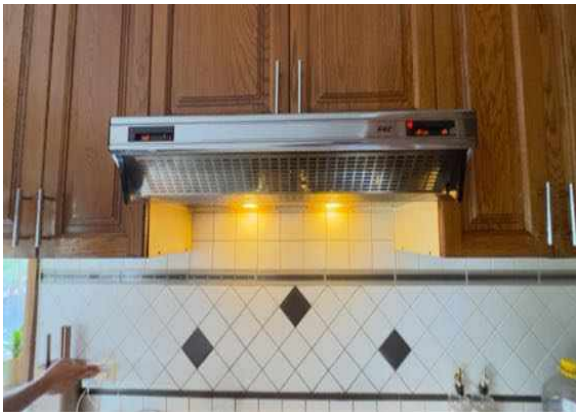
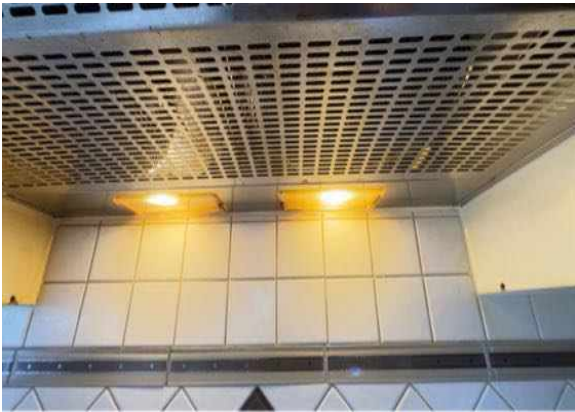
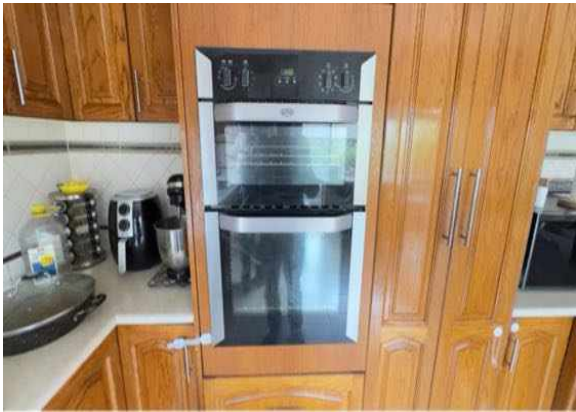
Noted Item

Building: Main Building
 Location: All Areas, Interior & Exterior
 Finding: Appliances, Heating & Cooling Systems, Mechanical Systems, Plumbing, Electrical, Fireplaces - Advisory
 Information: The inspection did not include testing, operation, safety, or assessment of any installed or portable appliances or mechanical systems. This includes, but is not limited to, ovens, cooktops, microwaves, rangehoods, dishwashers, ducted vacuum systems, air-conditioning units, heating systems, hot water services, ceiling fans, exhaust fans, intercoms, security systems, fireplaces, and solid fuel heaters.

Appliances may be worn, damaged, or malfunctioning. Electrical or gas appliances can pose serious safety hazards if incorrectly installed or maintained.

Service, repair, or replace equipment as necessary, particularly where service history or warranty coverage is unknown.

Inspect any water, gas, or electrical connections associated with appliances to ensure safety and compliance.

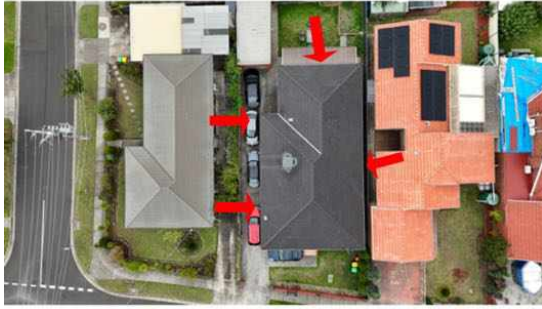
Building: Main Building
 Location: All External Areas
 Finding: Electrical Switch Board - Location
 Information: For your information, the main electrical switchboard was visually inspected. No intrusive testing or detailed electrical assessment was performed as part of this inspection.

For full compliance and safety verification, a licensed electrician should be engaged to inspect the switchboard, test all circuits, and ensure all components are functioning correctly. This will help maintain electrical safety and prevent potential hazards.

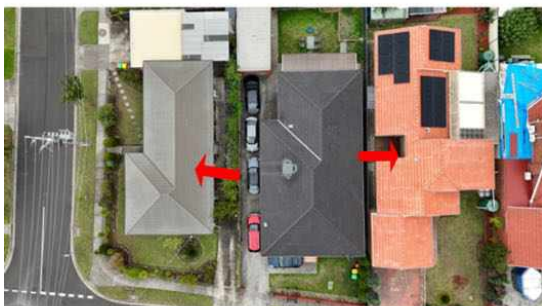
Building:
Location: Limited Areas
Finding: Council Assets - Footpaths, Crossovers, & Adjacent Infrastructure
Information: For your information, council-owned assets located on or adjacent to the property, including footpaths, vehicle crossovers, kerbs, drainage pits, street signage, and other infrastructure, were visually inspected where accessible.

During the inspection, minor cracking, surface wear, or uneven sections were observed on footpaths or crossovers. Some accessible metal components, such as street signage or grates, showed signs of rust or deterioration. Debris accumulation and vegetation encroachment were also noted around council infrastructure. Access or visibility was limited to certain council-owned assets.

These areas should be monitored, and for detailed assessment, maintenance, or compliance verification, the relevant local council authority should be contacted immediately. Regular monitoring of adjacent council assets is recommended to ensure ongoing safety and proper maintenance.
