Building and Timber Pest Inspection Report

Inspection Date: Wed, 14 Jan 2026

Property Address: 10 Warwick Cl, Blaxland NSW 2774,
Australia

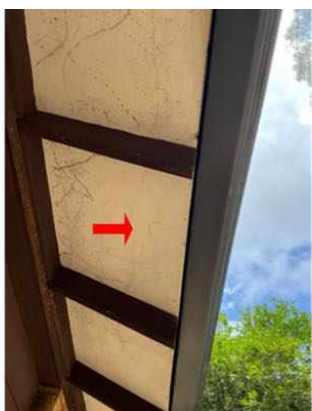
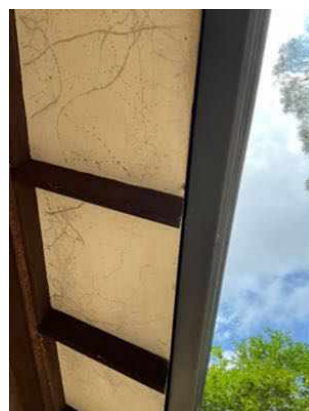
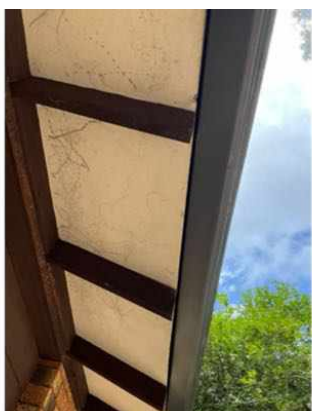
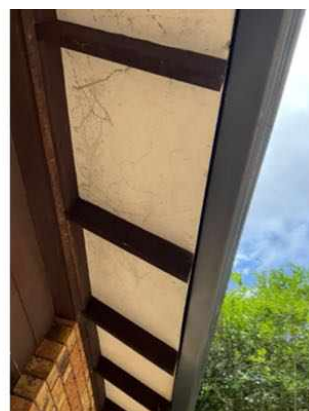
Building:	Main Building
Location:	Eaves
Finding:	Asbestos - Suspected ACM Identified on Site
Information:	Reporting on Asbestos is outside the Scope of this Report. This suspected defect is highlighted as a caution only. We suspect, based on our experience in the building industry, that there is a higher risk of the identified building element containing asbestos.

As Asbestos Reporting is outside the scope of this report, we advise that you consider a separate Asbestos Inspection and Condition Audit, which can include the taking of samples for definitive confirmation of the presence of Asbestos.

In the interim, the client is advised to act with caution, especially when considering any damage to building materials general wear and tear renovations extensions demolition and general maintenance activities due to the suspected presence of Asbestos.

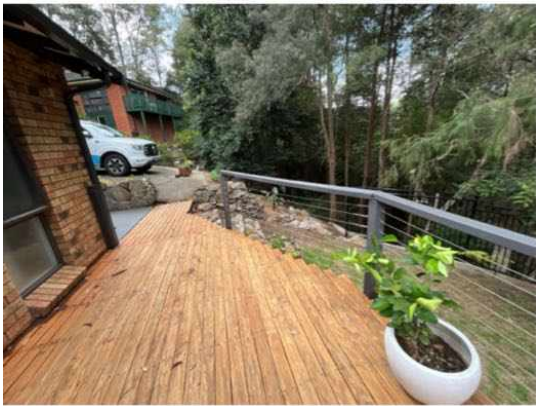
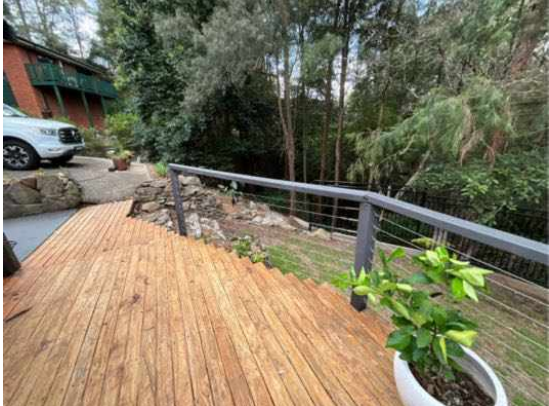
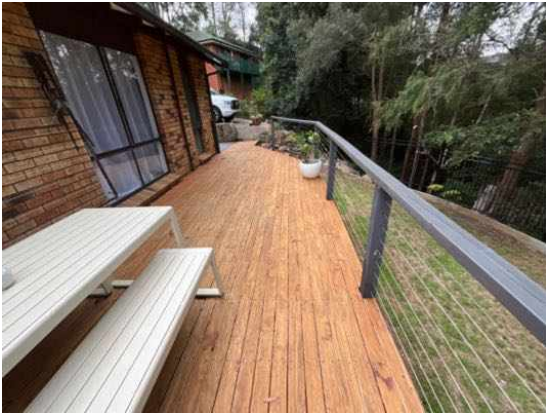
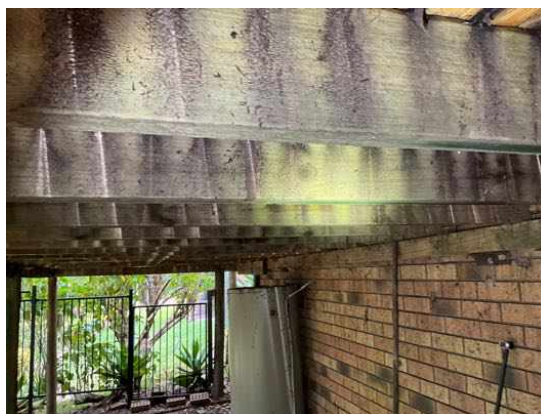
Finding 1.02

Building: Main Building
Location: Deck
Finding: External timber balcony or deck-structural stability
Information: The load capacity of the external balcony or deck could not be verified during the inspection.

External timber structures are also constantly exposed to weather deteriorates in an exhilarate manner, ongoing assessments are required.

It is highly recommended that a structural engineer further, assess the external timber balcony or a deck to inform the client of its load capacity.

Regular maintenance inspections by competent practitioners is needed.

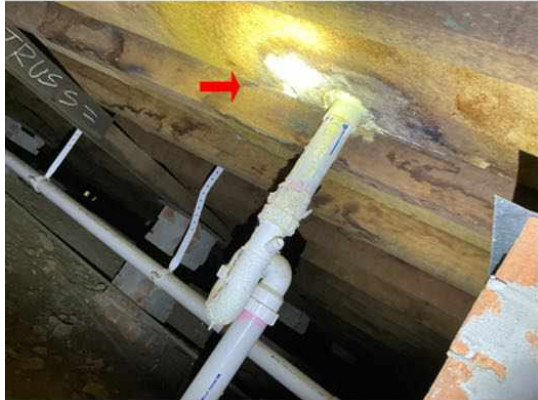
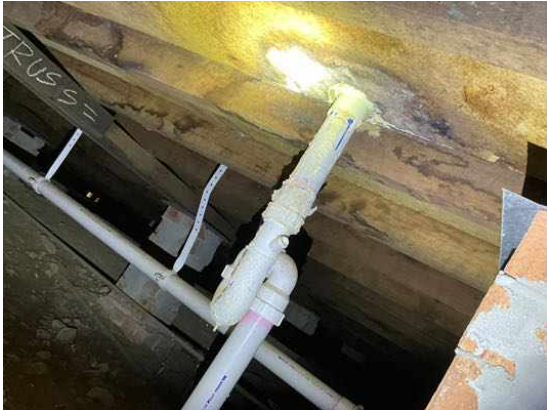
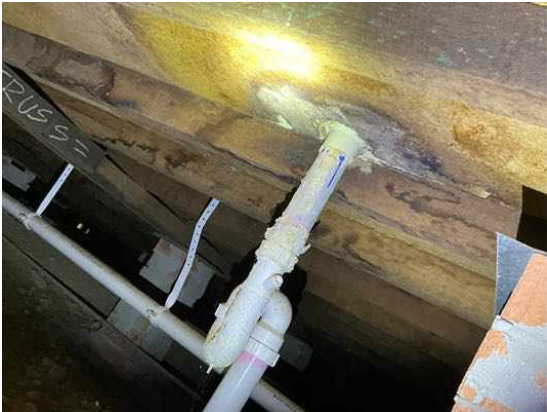
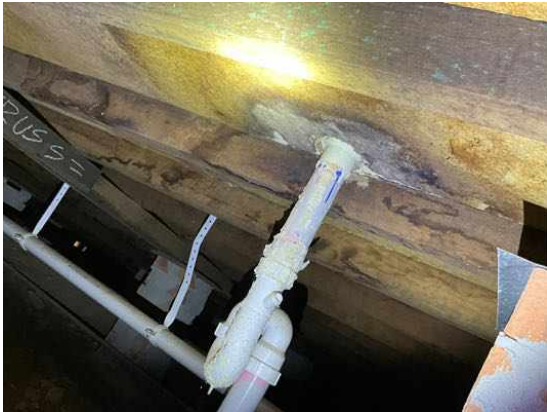
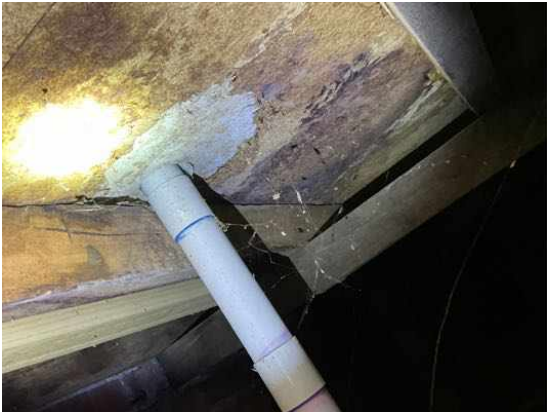
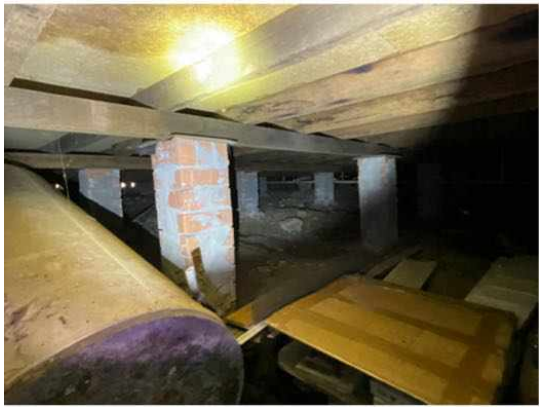
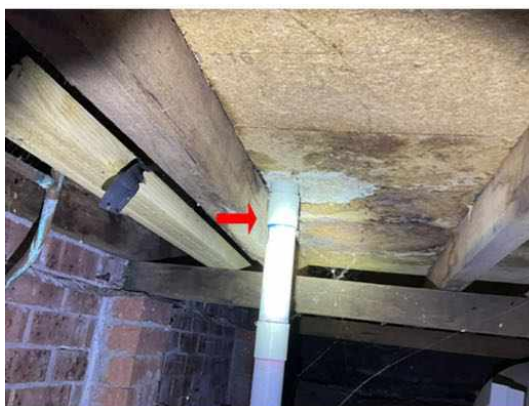
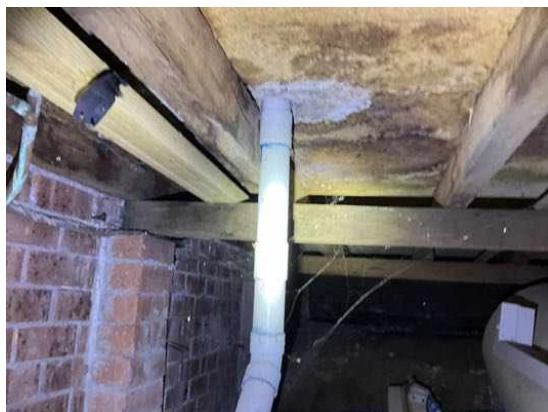
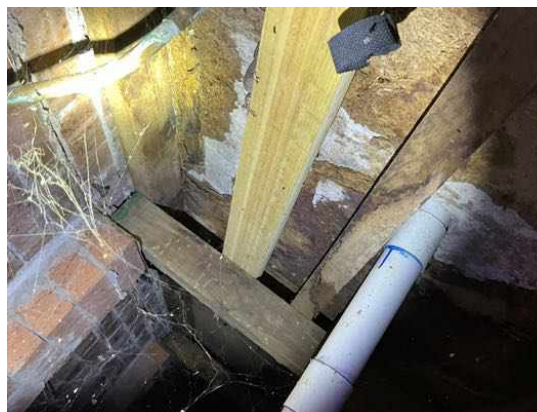
Finding 2.01

Building:	Main Building
Location:	Subfloor
Finding:	Subfloor- leaking plumbing fittings
Information:	Evidence of leaking plumbing fittings was observed within the subfloor area. Moisture staining and timber deterioration suggest prolonged water exposure from faulty pipe joints or fixtures.
Risk:	<ul style="list-style-type: none"> • Structural damage to timber framing and flooring due to continuous moisture exposure. • Mould growth and decay, posing potential health risks and further degradation of building materials. • Pest attraction, as damp environments are conducive to termites and other pests. • Non-compliance with plumbing standards and risk of escalation if not addressed promptly.

- A licensed plumber should be engaged to identify the exact source of leakage, repair or replace faulty fittings, and confirm watertight integrity. A builder may also be required to assess and rectify any structural damage.

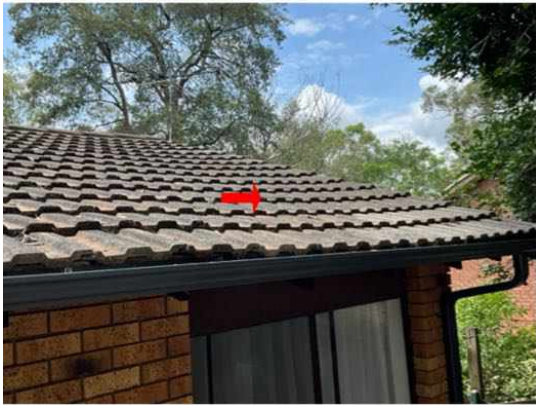
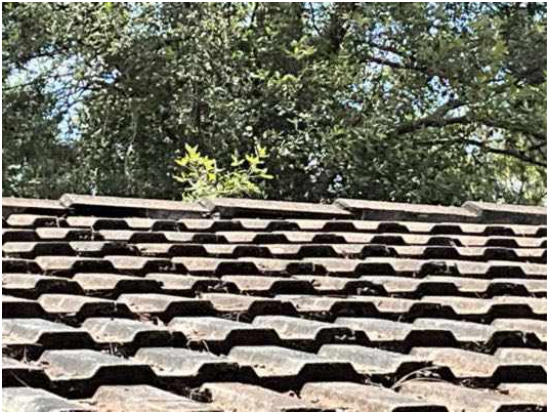
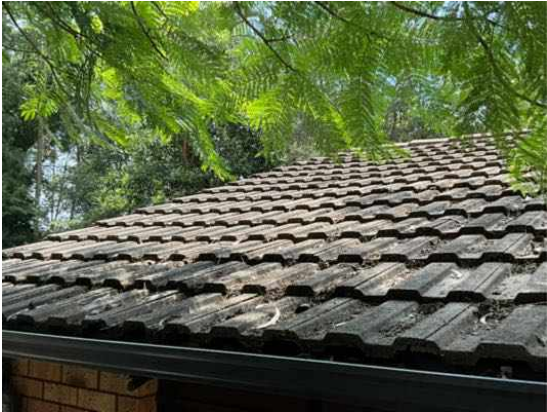
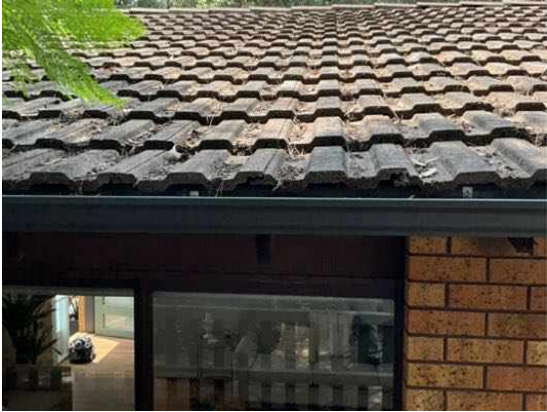
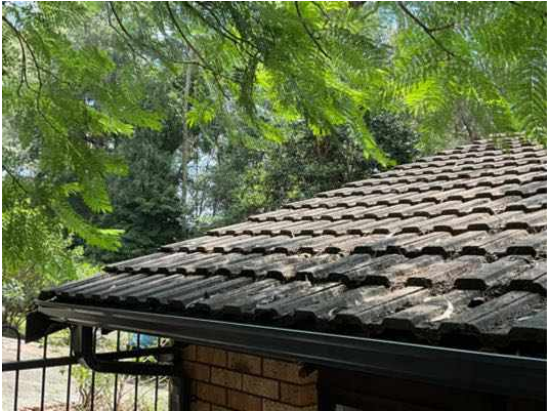
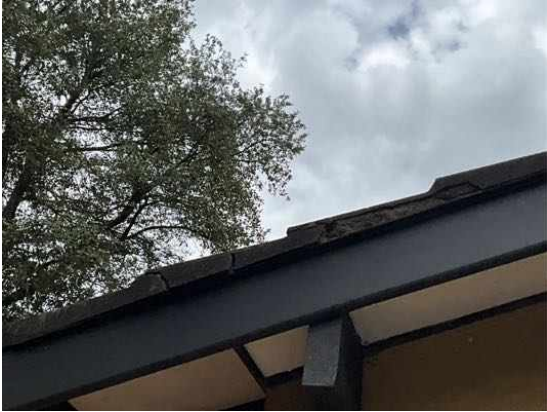
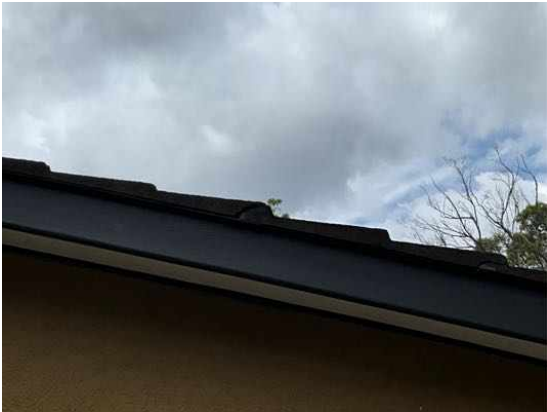
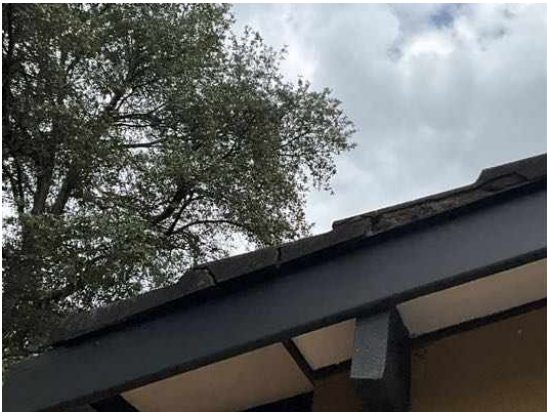
Finding 3.01

Building:	Main Building
Location:	All Areas
Finding:	Roof Weathered
Information:	Upon inspection of the exterior roofing, the majority of roof was not in a fair condition. While weathering of the roof is consistent with the age of the property, maintenance works are required.

Isolated areas of mortar have come loose in the valleys and minor cracking is also present. Re-pointing and re-sealing the may be considered as an interim solution by the client to help preserve and extend the life span of the tiles.

Where left unmanaged, deteriorating roof are likely to lead to a number of secondary defects, including minor water leaks and weather exposure to internal roofing structures.

Consultation with a roofing contractor is highly advised to gain advice on cost of remedial works that may be required in the short to medium term. Remedial works are likely to increase the longevity of the exterior roofing structure.

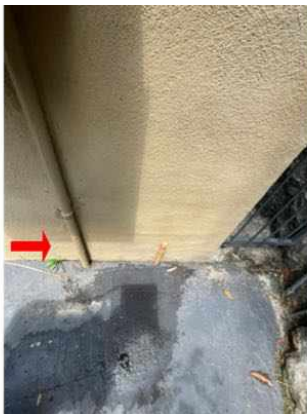
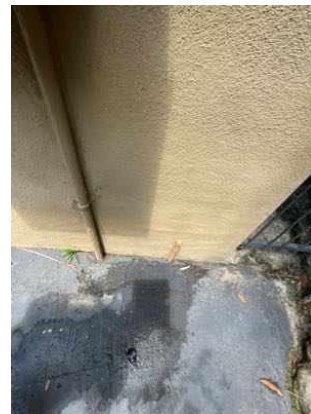
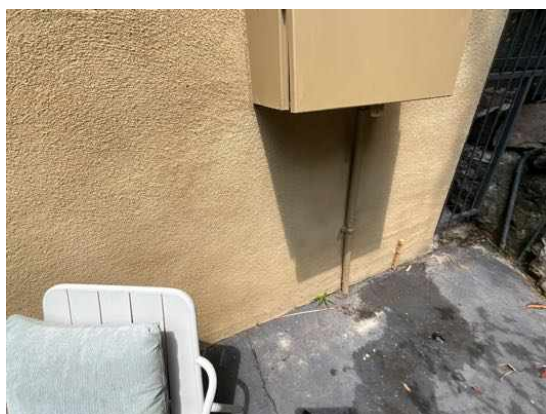
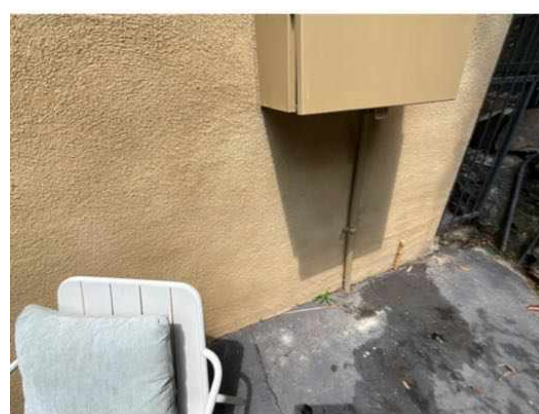
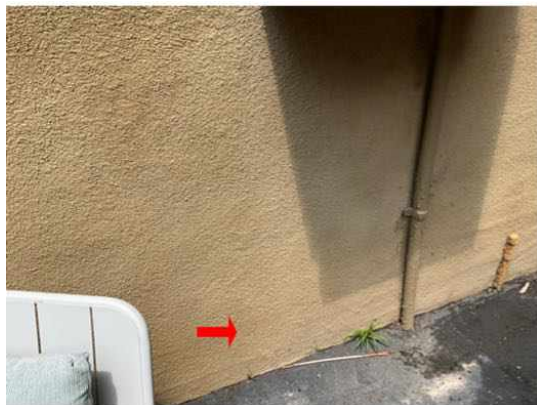
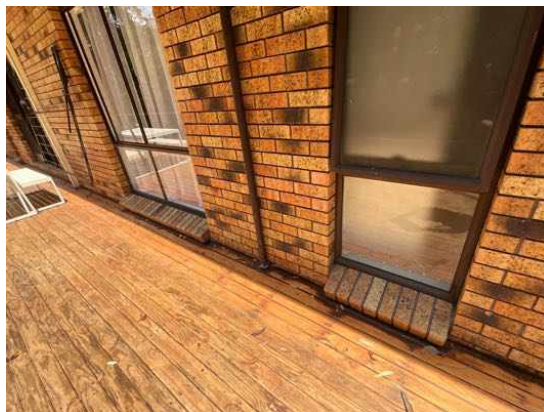
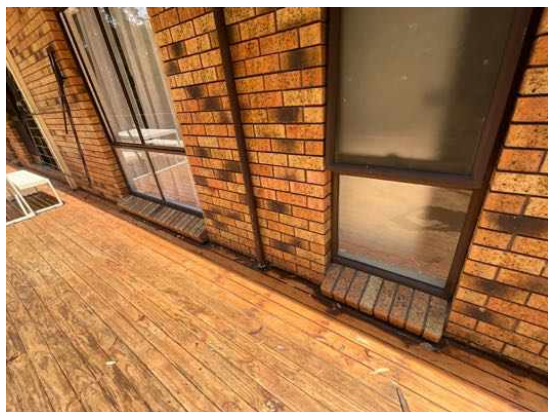
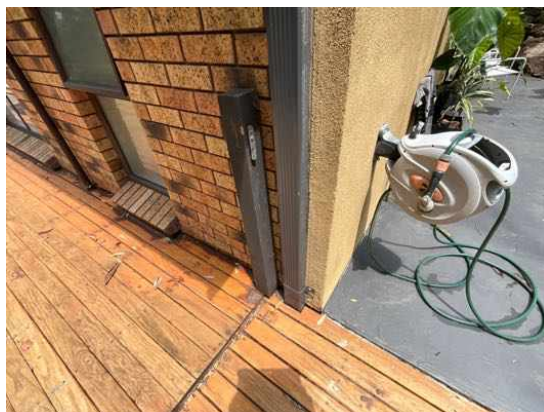
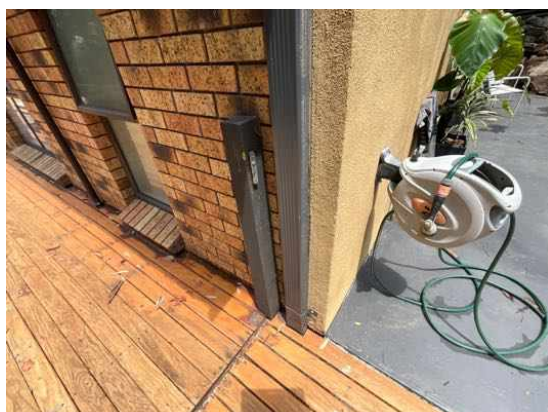
Finding 3.02

Building: Main Building
Location: All Areas
Finding: Weep holes - Blocked
Information: It was noted during the time of inspection that some of the weep holes to the brickwork were blocked. Weep holes are designed to allow water from leaks or seepages in brickwork to be directed to the external environment, prior to entering the wall cavity or associated building materials. Weep holes should therefore be kept clean and free of debris or blockages.

Blocked weep holes are likely to result in the presence of excessive moisture within the brickwork and associated structures, creating potential for water damage and moisture problems.

Depending on the nature of the blockage, the homeowner may be able to undertake remedial works to remove blockages. Alternatively, appointment of a registered builder may be required to remove blockages. Preventative works are necessary in ensuring the structural integrity of the affected brickwork and should be performed as soon as possible.

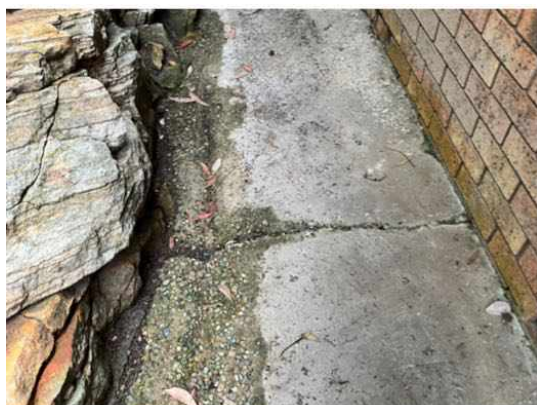
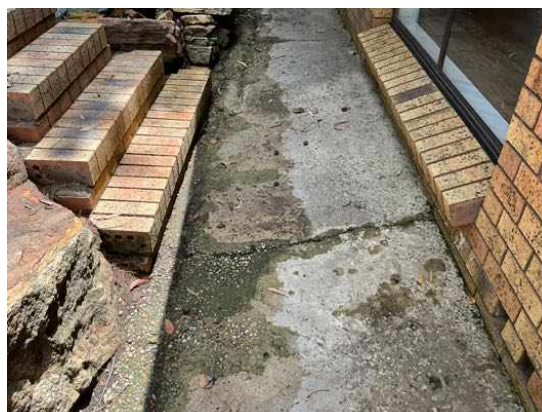
Finding 3.03

Building: Main Building
Location: All Areas
Finding: Noticeable Cracking in Concrete Slab
Information: Noticeable cracking has been observed in the concrete slab, failing to meet the required construction and quality standards.

- Cracks are visible on the surface and may extend through the depth of the slab.

- Evidence of improper curing or inadequate reinforcement leading to cracking.

- Compromised structural integrity of the slab, potentially leading to failure under load.
- Water ingress through cracks, causing corrosion of reinforcement and further weakening the structure.
- Potential trip hazards and aesthetic issues, reducing the overall value and safety of the property.
- Increased maintenance and repair costs due to ongoing deterioration.

- A structural engineer should be engaged to assess the extent of the cracking and recommend appropriate repair methods.
- A licensed contractor or concrete repair specialist should carry out the recommended repairs under the guidance of the structural engineer.

A detailed inspection should be conducted post-repair to confirm compliance with the required standards and to ensure that the structural integrity of the concrete slab has been restored.

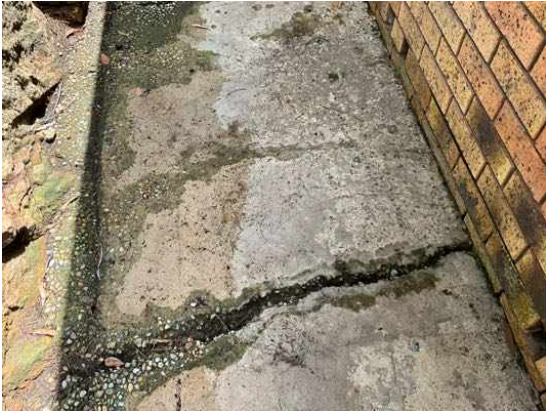
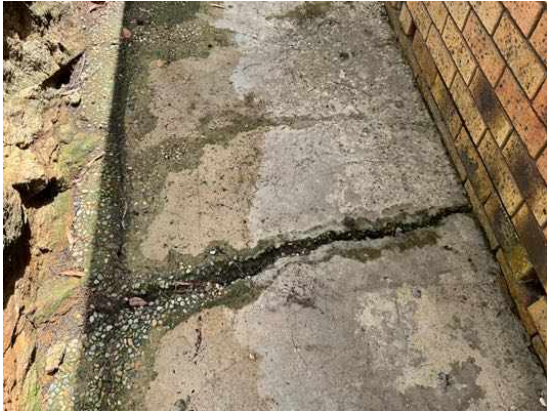
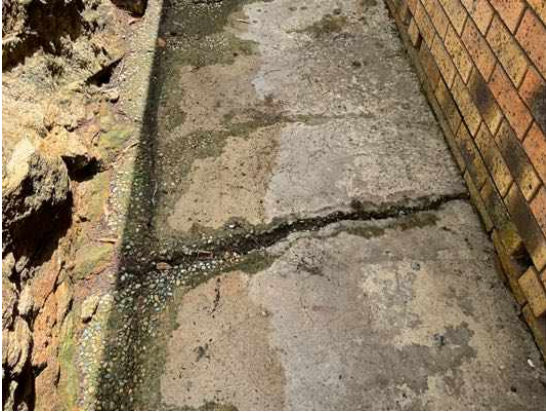
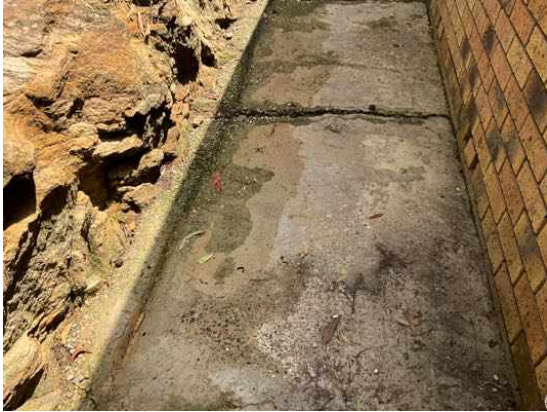
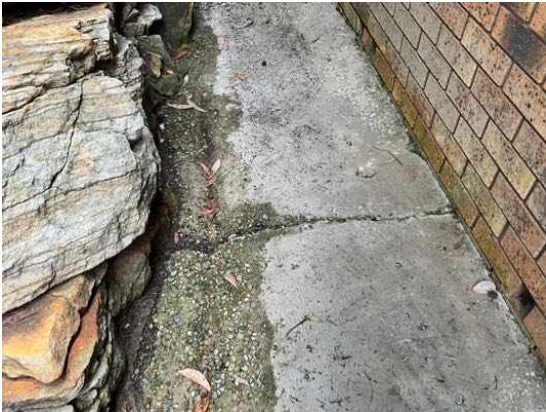
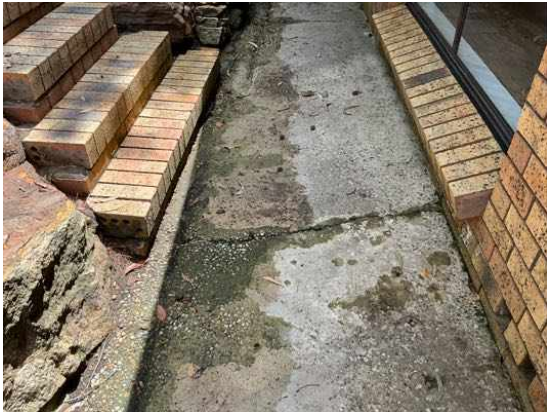
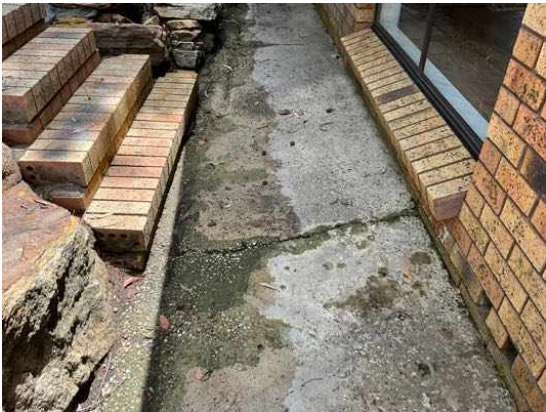
The presence of noticeable cracks in the concrete slab can result in:

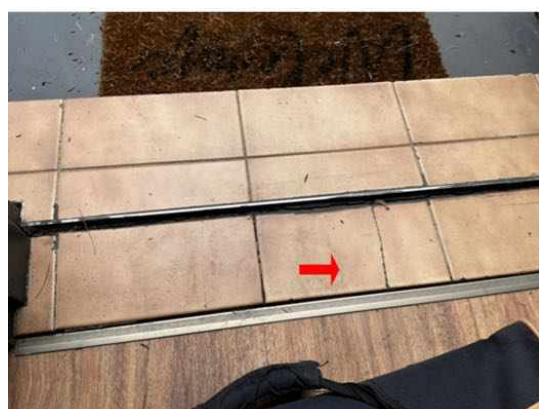
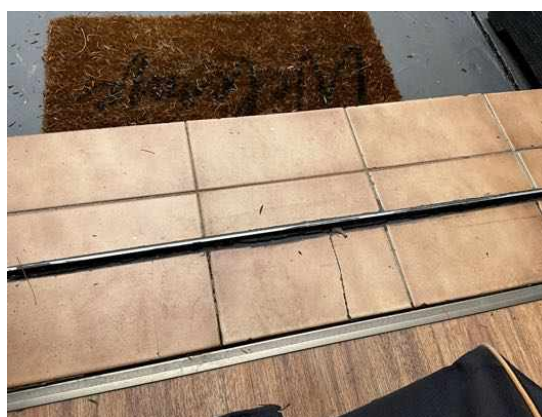
Finding 3.09

Building: Main Building
 Location: Ensuite
 Finding: Tiles - Cracked or damaged
 Information: Cracking was evident to the tiling in this area at the time of inspection. While the cracking appears to be minor, this area is frequently exposed to water, allowing potential for water penetration into adjoining sections of walls or flooring.

If left unmanaged, water penetration to these areas may lead to subsequent water damage, which is likely necessitate repair work to affected building elements.

A tiling contractor should be appointed to ensure that no further water damage occurs. The re-application of silicone and grouting throughout remaining tile work is also advised, to further protect the area against water penetration.

Where water penetration has led to water damage, appointment of a relevant tradesperson may be required to repair damaged building elements.

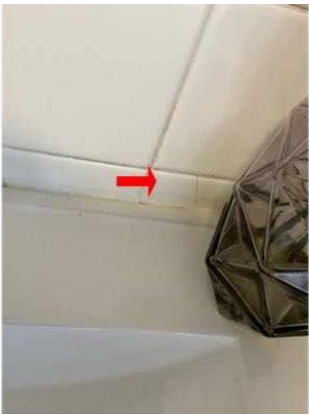
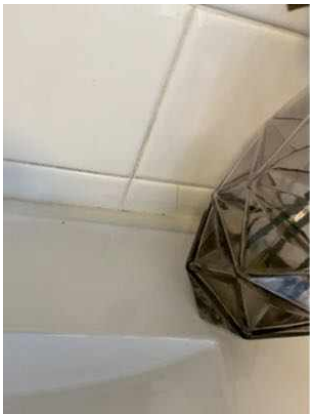
Finding 3.10

Building: Main Building
Location: Ensuite
Finding: Evidence of excessive moisture was present at the time of inspection
Information: Excessive moisture is present behind the bathroom tiles, indicating a potential water leakage issue within the wall.

The prolonged presence of moisture can lead to mold growth, deteriorate the structure, and create an environment conducive to health hazards. Additionally, it may compromise the adhesive holding the tiles, leading to their detachment.

A licensed plumber or a qualified contractor specializing in water damage remediation should investigate the source of the moisture, fix any leaks, and address the damage. Additionally, replacing affected tiles and ensuring proper waterproofing are crucial to preventing future issues.

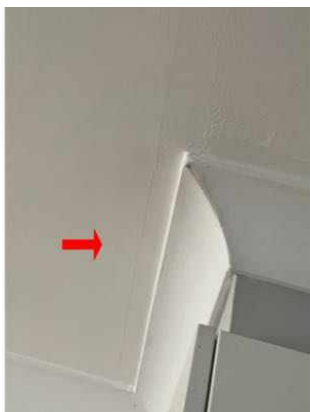
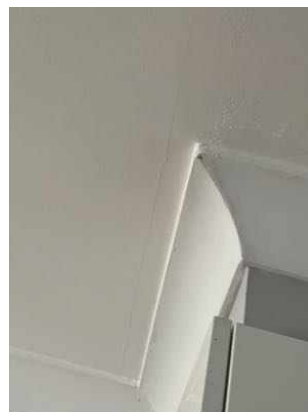
Finding 3.14

Building:	Main Building
Location:	Kitchen
Finding:	Ceilings gyprock - Crack (Fine)
Information:	Fine cracks have appeared in the gyprock of the ceiling, suggesting potential issues with settling or structural movement.

The fine cracks in the gyprock ceiling pose a risk of further widening, compromising the aesthetic appeal of the space, and potentially indicating underlying structural problems.

A skilled plasterer or a contractor specializing in drywall repairs should assess the

extent of the cracks and address them promptly. Identifying and fixing the root cause of the issue, whether related to settling or structural concerns, is essential to prevent further damage and maintain the integrity of the ceiling.

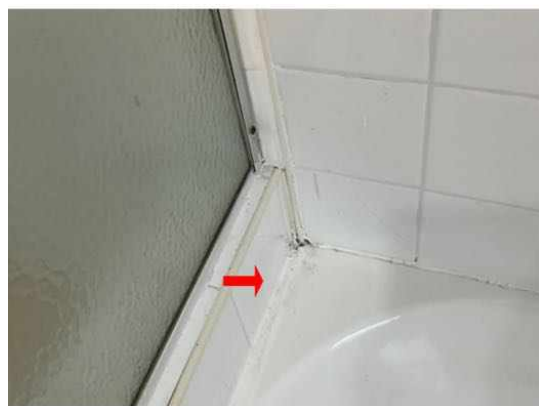
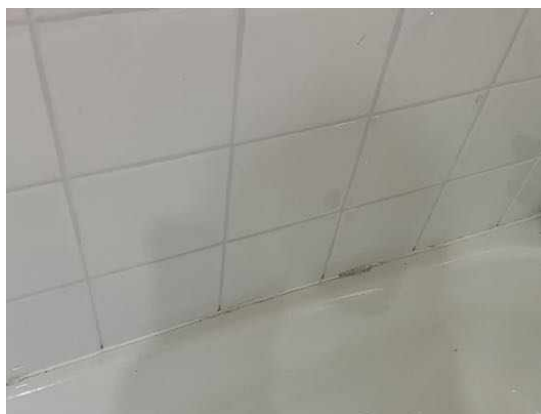
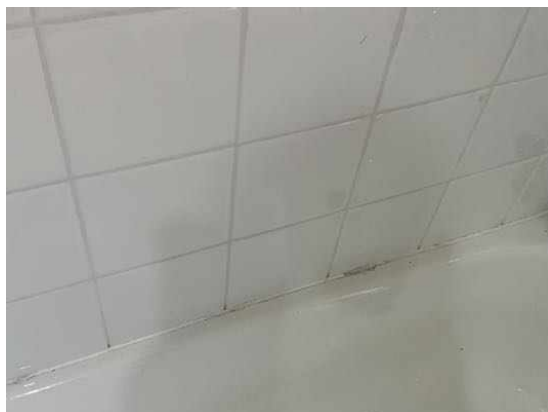
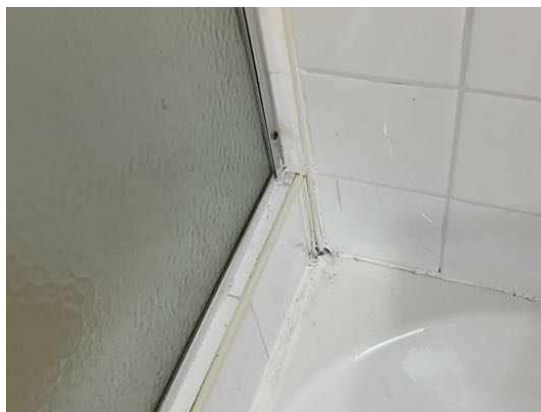
Finding 3.15

Building:	Main Building
Location:	Bathroom
Finding:	Sealant and grouting - Missing or damaged
Information:	It was noted on inspection that sealant or grout is degraded to the tiled shower alcove and or other areas of the bathroom.

Different materials and floor areas move at different rates, generally causing cracking to grout or sealant at this point. A flexible sealant is required to allow for expected expansion and contraction, while keeping the joint water tight and protective of all associated building materials.

There appears to be excessive mould to the sealant and grout which will likely require scraping out and replacement.

Flexible and mould resistant materials should be applied to affected areas to prevent any subsequent water damage that is likely to occur. Regular maintenance and replacement of damage or missing or damaged sealant and grout is highly recommended to the wet areas, as this is a regular wear and tear defect. Sealant and grouting in areas that come into regular contact with water should be maintained for the long term care of your property.

A sealant specialist or tiling contractor should be appointed to complete these works as soon as possible

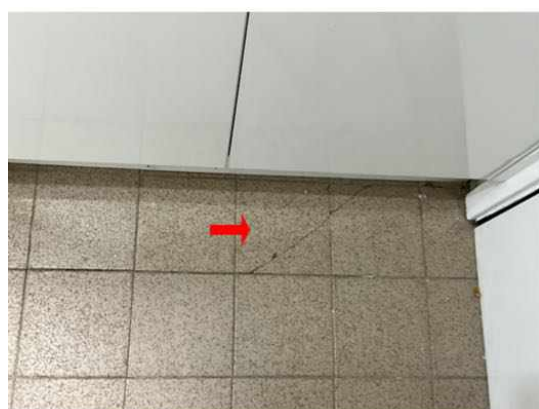
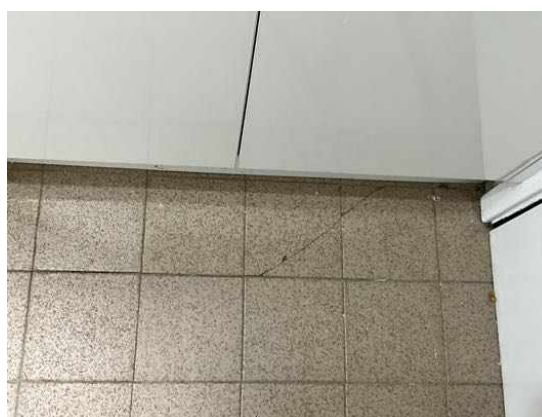
Finding: Floor Tile crack
 Information: A floor tile has a visible crack on the surface.

The damaged tile presents a trip hazard, may lead to cuts if stepped on barefoot, and can allow moisture ingress into the substrate, which may cause further deterioration or loosening of adjacent tiles. It also affects the overall appearance of the floor.

A licensed tiler should be engaged to remove the damaged tile and install a matching replacement. If spare tiles are unavailable, additional remedial work may be required to blend the repair with surrounding finishes.

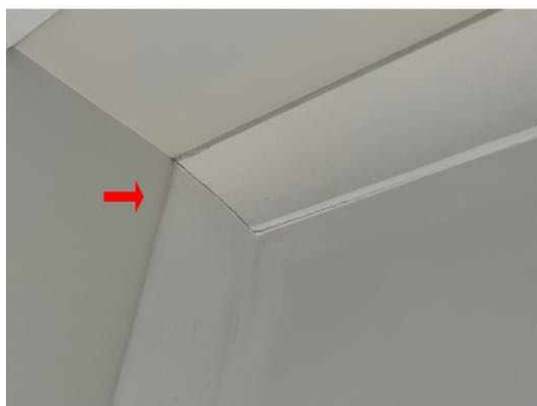
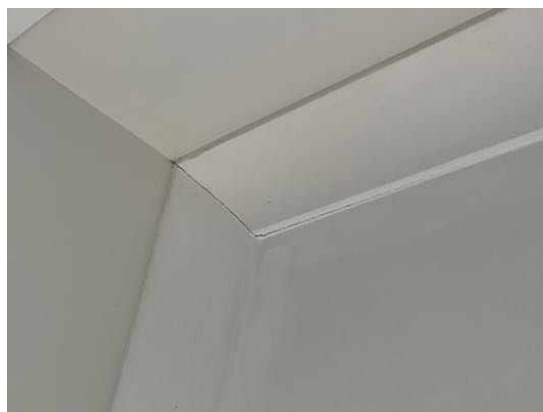
Finding 3.18

Building: Main Building
 Location: Bedroom 3
 Finding: Cornice - Cracking [Fine]
 Information: Fine cracking observed in the cornice, indicating potential structural issues or settling concerns.

Fine cracks in the cornice may lead to aesthetic deterioration and, if left unaddressed, could contribute to more significant structural problems over time.

Engaging the services of a skilled plasterer or home renovation specialist is recommended to assess and repair the fine cracking in the cornice, ensuring proper restoration and preventing further issues.

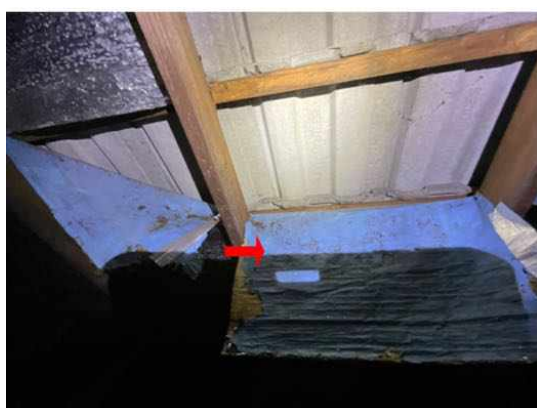
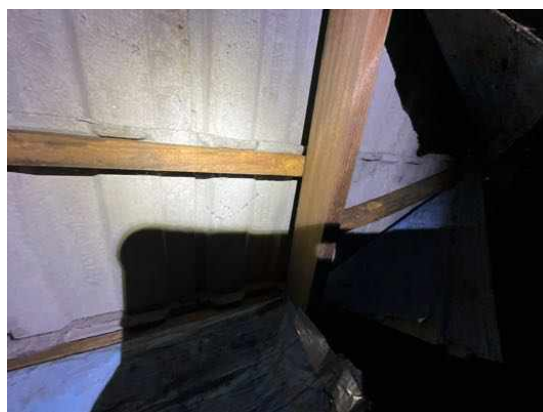
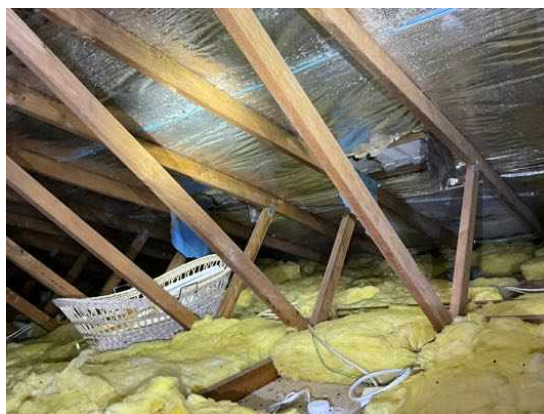
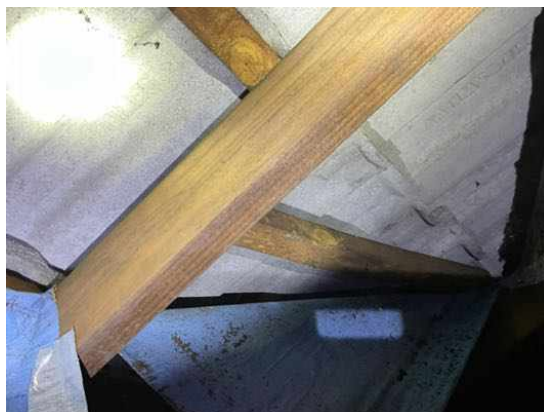
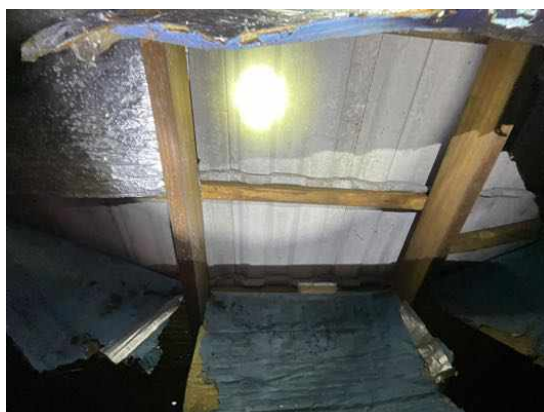
Finding 3.19

Building:	Main Building
Location:	Roof Void
Finding:	Sarking - Damaged
Information:	Sarking, a laminated aluminium foil applied to the interior of the roof covering, assists in insulating the property and acting as a vapour-barrier to the roof void and, subsequently, to the household.

Where sarking is damaged, both insulation and moisture protection of the property are inhibited. This creates a loss of energy and thus negatively impacts the energy efficiency of the property, allowing potential for moisture ingress from condensation or leaking roof tiles.

It is important to repair any holes or damaged sections of sarking to ensure that the building material is fully functional. A registered builder or qualified carpenter should be consulted to provide further advice on this defect and to perform rectification works at client discretion.

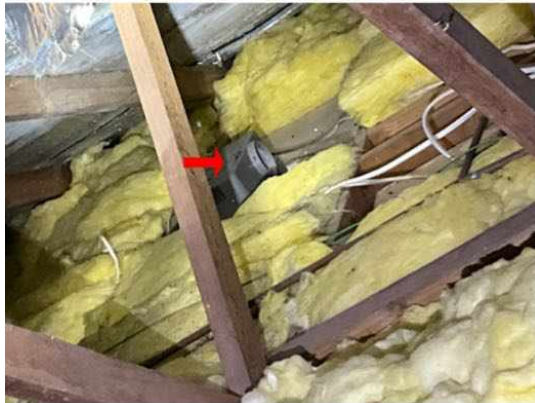
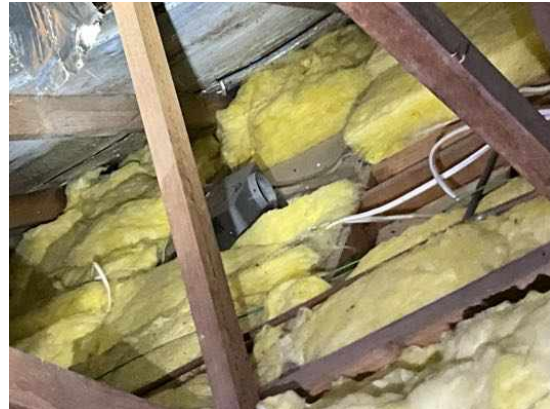
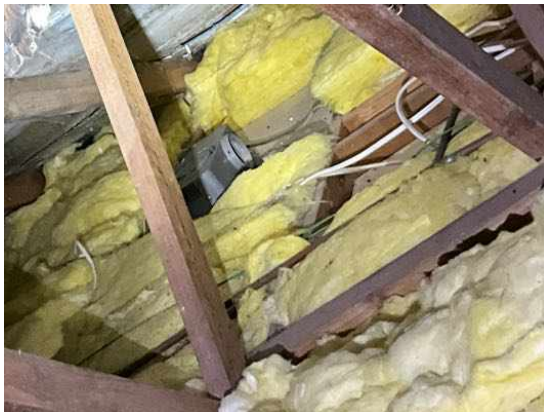
Finding 3.20

Building:	Main Building
Location:	Roof Void
Finding:	Exhaust fan not vented out
Information:	The exhaust fan located within the roof void is not appropriately ducted to the external atmosphere and is currently discharging moist air directly into the roof space. This is considered a defect under AS 4349.1, as it does not meet the minimum standard of residential building performance expected under normal residential building practices.
Risk Implication:	This condition may lead to excessive condensation within the roof void, increasing the

risk of mould growth, deterioration of insulation, timber decay, and overall reduced durability of building elements. It may also result in poor indoor air quality, potentially affecting occupant health.

It is recommended that the exhaust fan be modified by a licensed HVAC contractor or qualified builder, ensuring it is properly ducted to discharge externally in accordance with manufacturer specifications, the National Construction Code (NCC), and applicable Australian Standards.

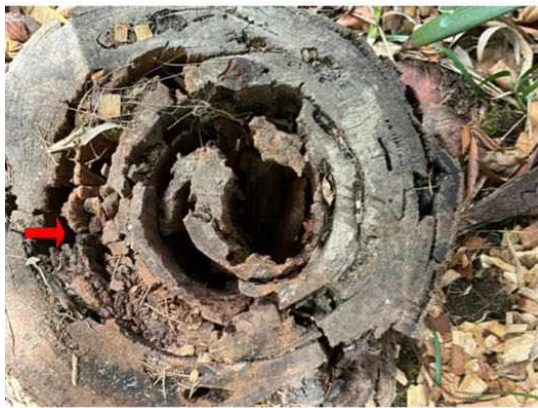
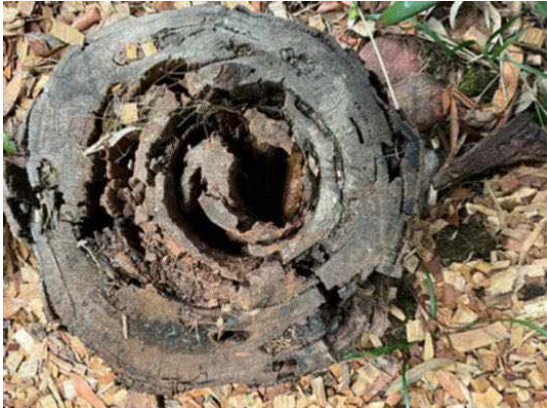
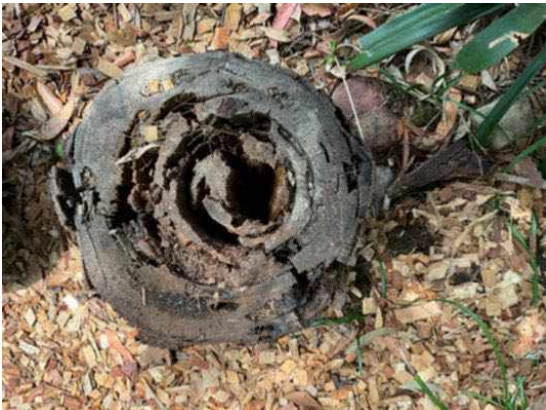
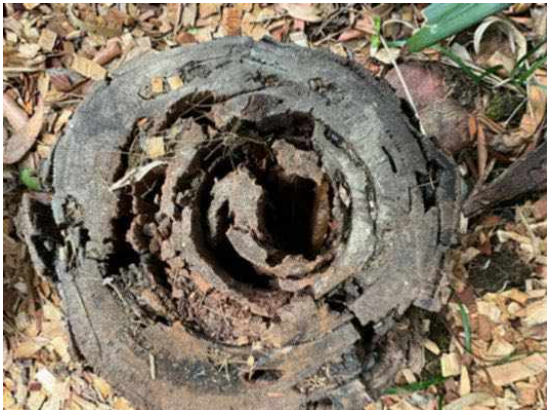
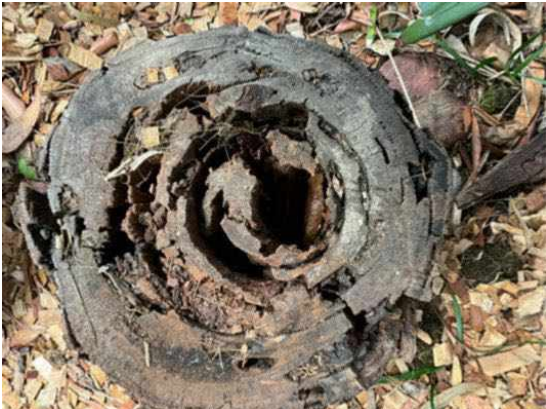
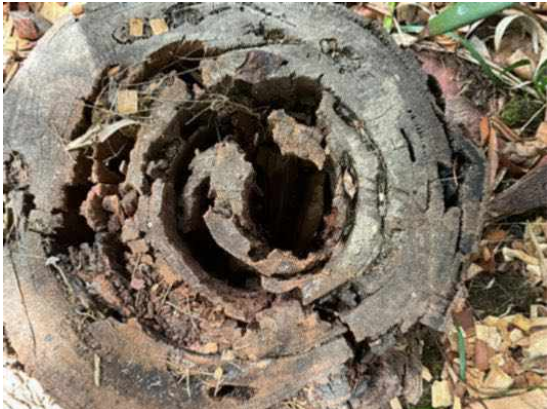
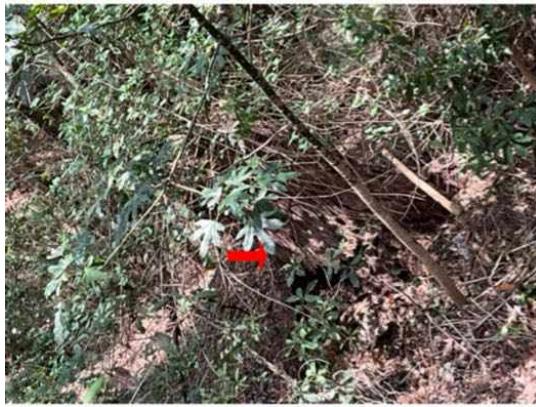
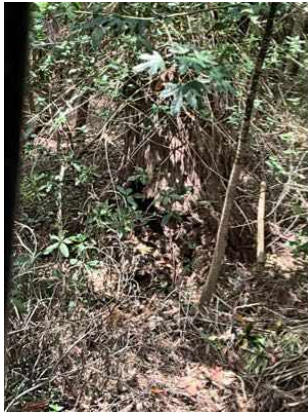
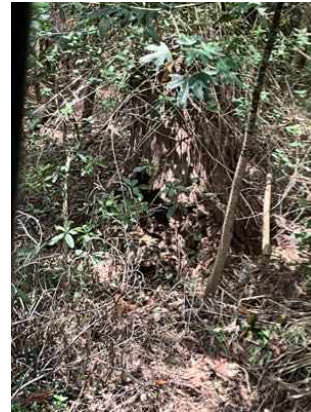
Building: Main Building
Location: Yard - Back
Finding: Suspected - Timber pest damage

Despite no live termite or timber pest activity being indicated, suspected previous timber pest damage was found to have affected this area. This damage is considered to be inactive at the time of inspection.

It is advised that the area be visually inspected frequently to ensure that the condition of affected building materials does not worsen.

A licensed pest controller must be appointed to provide a further invasive inspection.

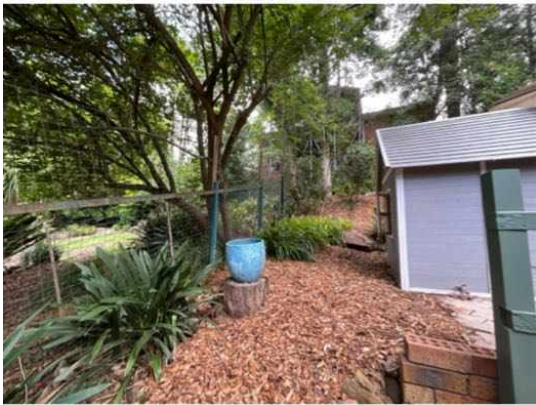
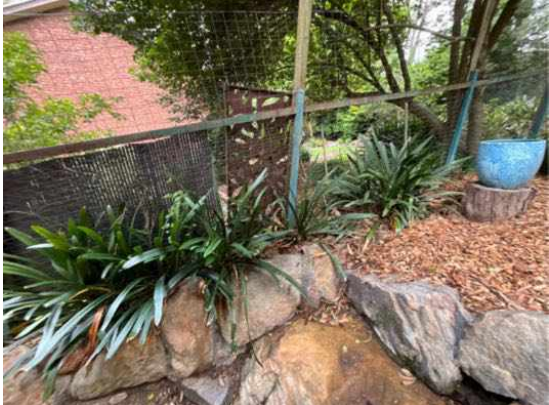
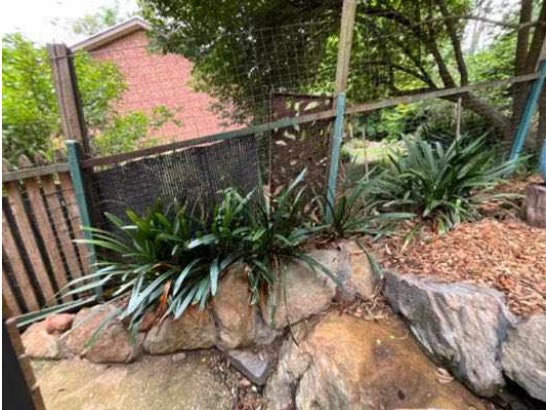
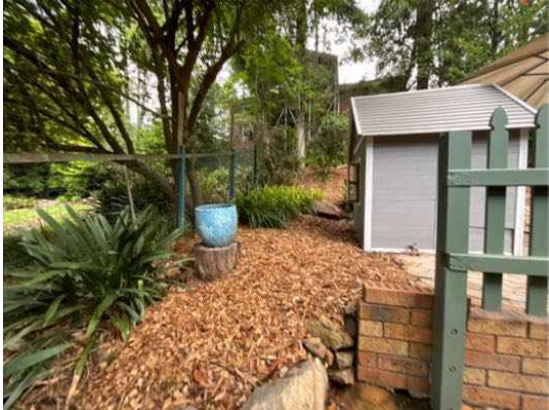
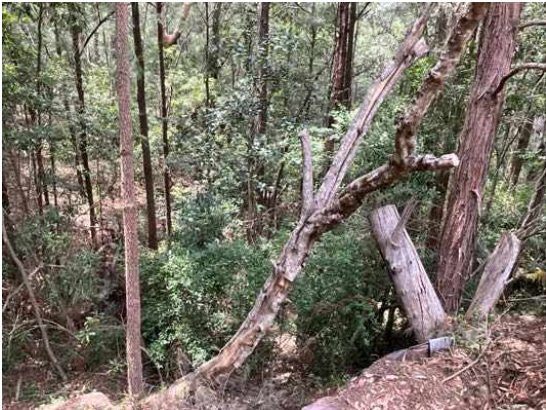
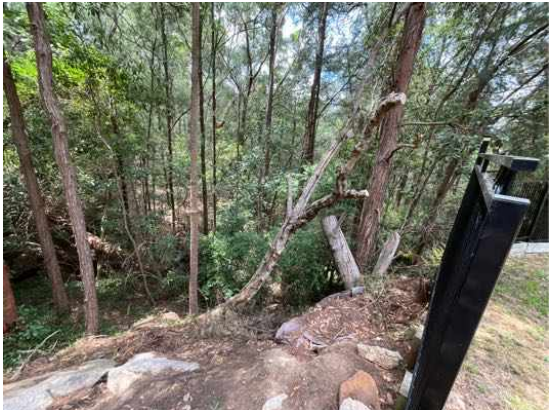
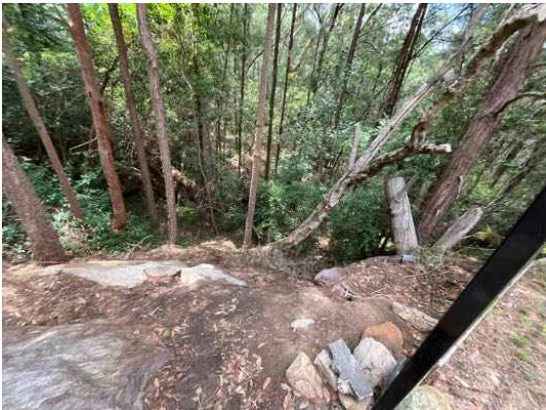
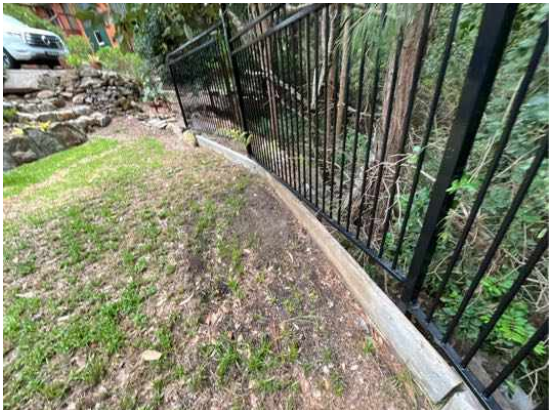
Finding 6.01

Building:	Main Building
Location:	All Areas
Finding:	Dense vegetation around a property can increase the risk of termite infestation
Information:	The presence of dense vegetation around a property can increase the risk of termite infestation, as it provides a conducive environment for them. To address this, consider maintaining a clear space between the vegetation and your home. If you suspect a termite issue, it's advisable to consult with a licensed pest control professional for inspection and treatment.

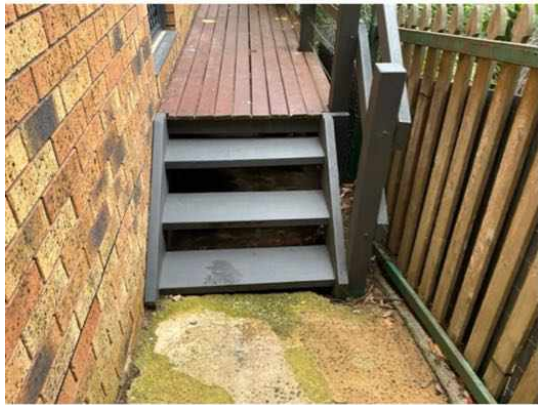
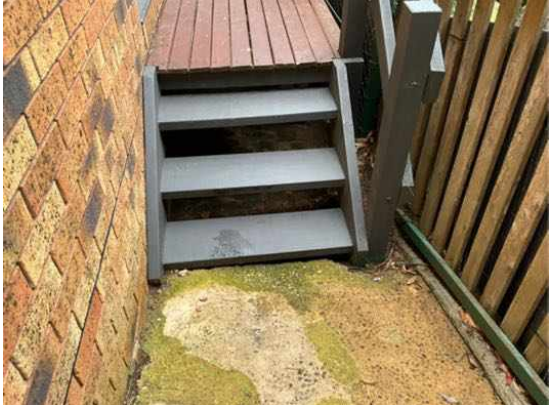
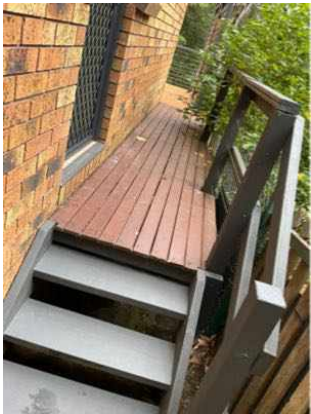
Finding 6.02

Building: Main Building
 Location: All Areas
 Finding: Timber on ground / conducive conditions to termite damage
 Information: Timber on the ground is indeed conducive to termite damage. Termites are known to thrive in moist environments, and wood in contact with soil or moisture is more susceptible to infestation.

To prevent this, it's important to keep timber elevated and away from direct ground contact. Regular inspections and proper termite control measures are also essential to protect your wooden structures from termite damage.

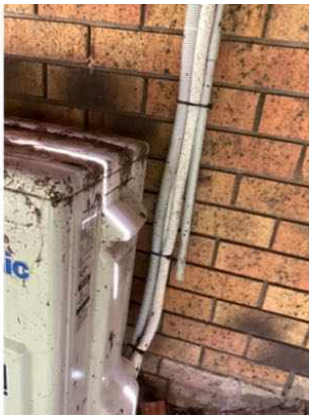
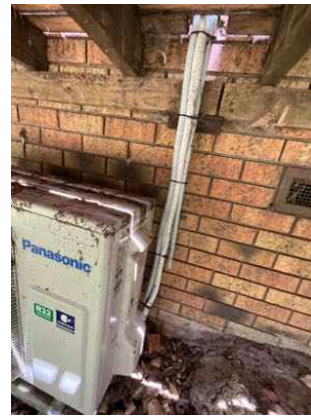
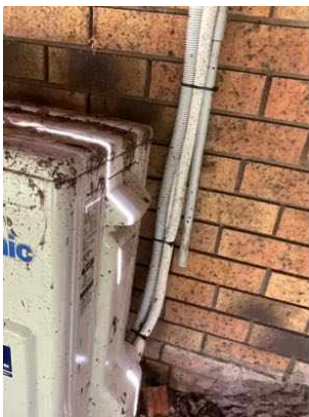
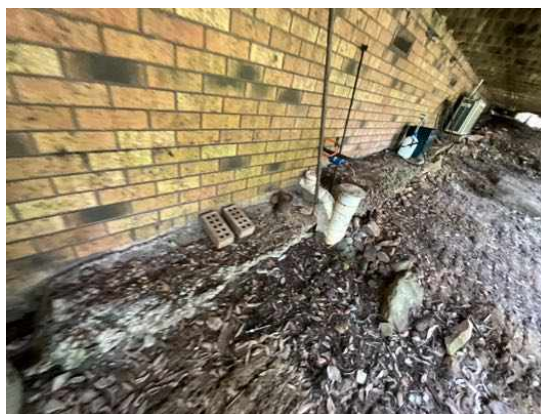
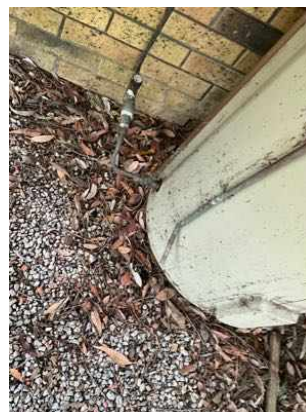
Finding 6.03

Building: Main Building
Location: Under Deck
Finding: Bridging or Obstruction Conducive environment for Termites
Information: Bridging of termite barriers occurs when termites bridge (usually by building a mud tunnel) a termite barrier or inspection inspection zone or where termites have a passage, allowing them to bridge the barrier.

Where bridging has occurred full inspection is prevented and termites may enter a property in a concealed or undetected manner.

Recommended moving obstructions away from the external walls for further and future inspections.
