Building and Timber Pest Inspection Report

Inspection Date: Wed, 14 Jan 2026

Property Address: 10 Warwick Cl, Blaxland NSW 2774,
Australia

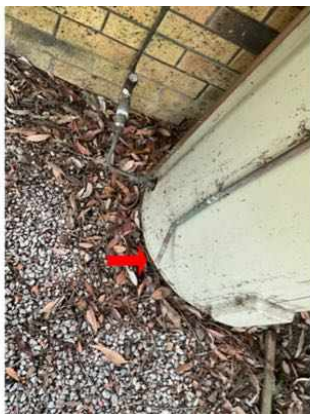
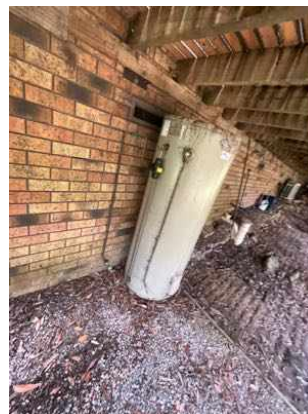
Finding 6.04

Building:	Main Building
Location:	Under Deck
Finding:	HWS not connected - conducive conditions for timber pest attacks
Information:	The hot water system (HWS) is not connected, leaving exposed pipes and creating conducive conditions for timber pest attacks.

Risk of Timber Pest Attack: The risk of timber pest attack is heightened when the hot water system is not connected. Exposed pipes provide easy access points for timber pests like termites and ants to infiltrate the building structure. These pests are attracted to moisture, and the absence of flowing water through the system can lead to moisture buildup, creating an ideal environment for pests to thrive and cause damage to timber components within the building.

A licensed plumber or qualified plumbing technician should be engaged to reconnect the hot water system. They will assess the existing plumbing infrastructure, determine the appropriate connection points, and ensure proper installation and functionality of the HWS. Additionally, they may inspect for any signs of timber pest activity and recommend preventive measures, such as installing physical barriers or implementing moisture control measures, to deter pest infestations and protect the building from damage. Regular maintenance and inspections by homeowners or property managers are also essential to detect and address potential issues before they escalate.

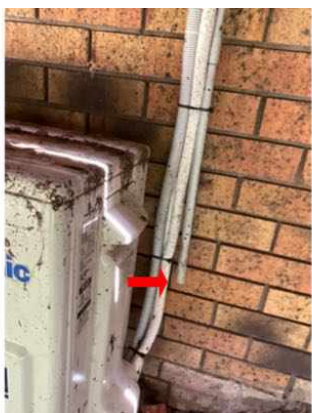
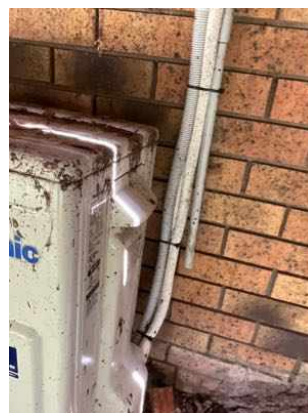
Finding 6.05

Building: Main Building
 Location: Under Deck
 Finding: Aircon - Excessive moisture conducive condition near Air-conditioner
 Information: Excessive moisture near an air conditioner can indeed create conducive conditions for termites. Termites are attracted to damp and decaying wood, which can be found in areas with high moisture levels. To fix this issue:

1. Fix Leaks: Check for any leaks or condensation around your air conditioning unit. Repair any damaged pipes, drains, or insulation

2. Proper Drainage: Ensure that your air conditioner has proper drainage. Make sure the condensate drain line is clear and directed

3. Ventilation: Improve ventilation around the unit. Ensure that the area is well-ventilated to reduce humidity levels.

5. Please consult a HVAC Technician: HVAC (Heating, Ventilation, and Air Conditioning) technicians are trained to diagnose and

6. Consult an appropriate and Qualified Professional: For severe moisture issues or persistent termite problems, consult with a

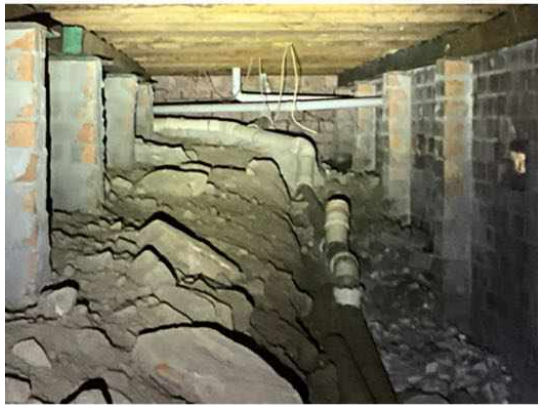
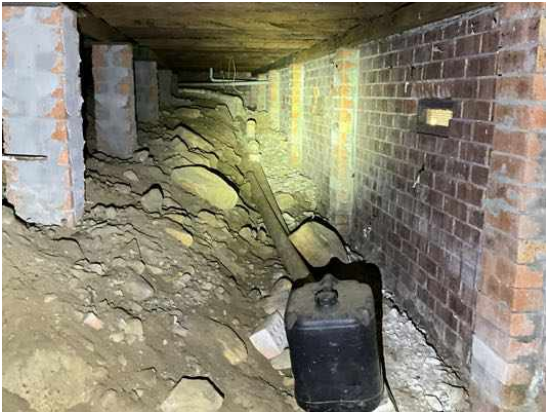
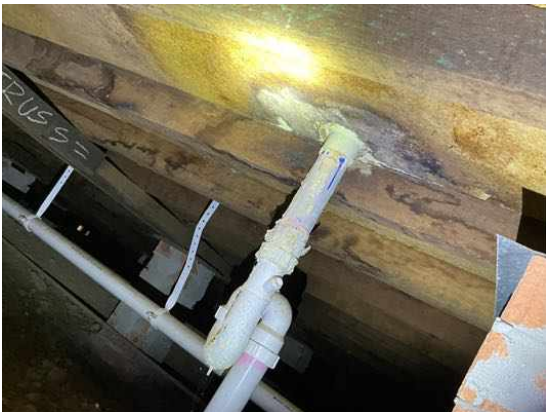
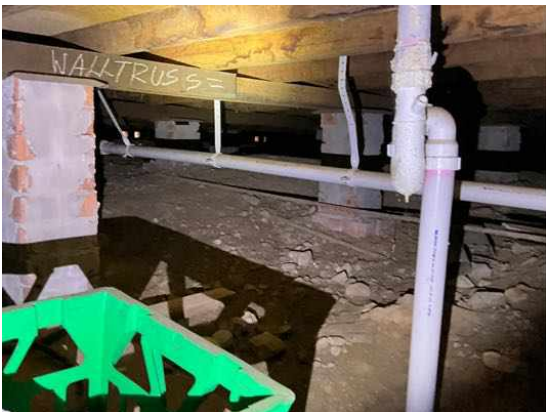
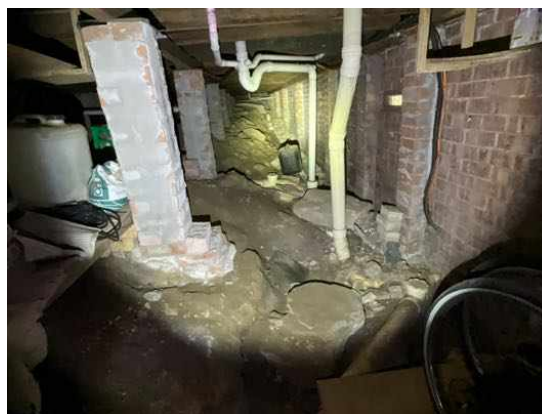
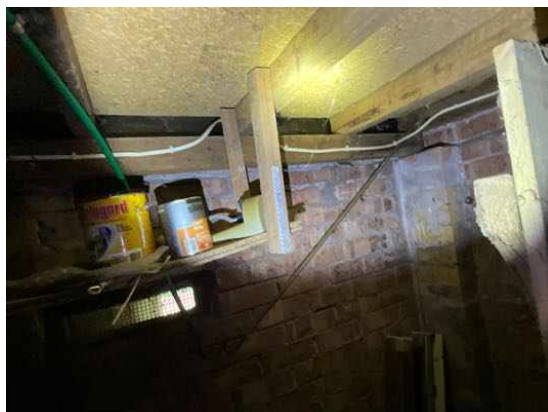
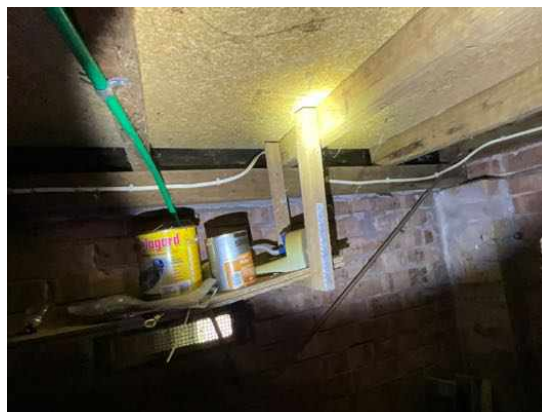
Finding 6.06

Building:	Main Building
Location:	Subfloor
Finding:	Subfloor - poor ventilation, inadequate site drainage, water stains
Information:	The subfloor lacks adequate ventilation, suffers from inadequate site drainage, exhibits water stains, creating conducive conditions for timber pests such as termites.

Risk: The combination of poor ventilation, inadequate drainage, water stains significantly increases the risk of timber pest infestations. Termites are attracted to moist environments and can thrive in subfloors with high humidity levels and water damage. The lack of proper ventilation and drainage exacerbates moisture retention, providing an ideal habitat for timber pests to establish colonies and cause extensive damage to the subfloor structure. Additionally, water stains indicate previous or ongoing moisture issues, which further attract timber pests and contribute to the deterioration of timber materials.

A licensed pest control professional specializing in timber pest management should be consulted to assess the extent of the infestation and develop a comprehensive treatment plan. They can implement strategies to eliminate existing timber pests, such as termites and prevent future infestations by addressing underlying moisture issues. Additionally, a qualified plumber or builder may be needed to improve subfloor ventilation, enhance site drainage, repair water-damaged areas. Regular inspections and maintenance are essential to ensure ongoing protection against timber pests and maintain the structural integrity of the subfloor.

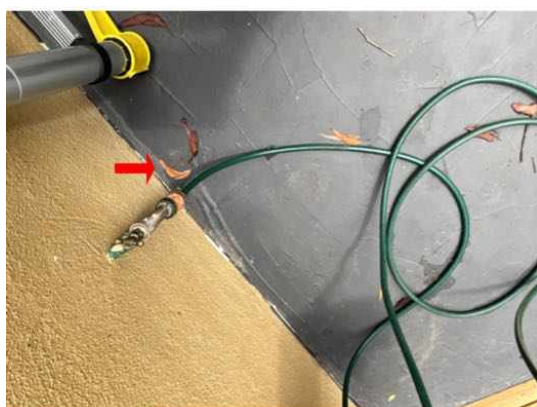
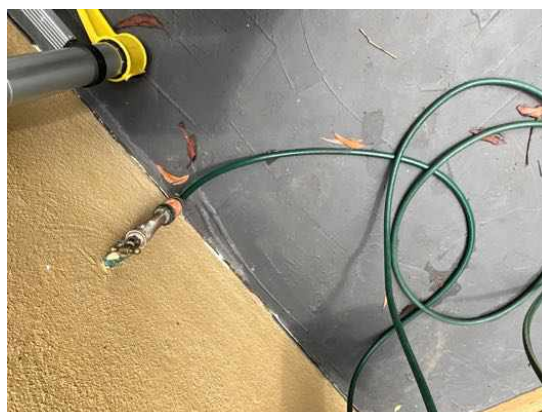
Finding 6.07

Building:	Main Building
Location:	All Areas
Finding:	No Drain under tap
Information:	There is no drain installed under the tap, leading to water accumulation and creating conducive conditions for timber pests. This defect needs immediate attention to prevent potential damage and pest infestation.

1. Water Accumulation: Without proper drainage, water can accumulate around the base of the tap, leading to persistent dampness in the surrounding area.
2. Timber Pest Infestation: The damp environment created by standing water is highly conducive to timber pests, such as termites and wood borers, which thrive in moist conditions and can cause significant damage to wooden structures.
3. Structural Damage: Prolonged exposure to moisture can lead to wood rot and deterioration of structural timber, compromising the integrity of the building.
4. Health Hazards: Persistent dampness can also promote mold and mildew growth, posing health risks to occupants.
5. Aesthetic Damage: Water stains and damage to finishes and materials around the

A licensed plumber or a qualified building contractor can address this defect by:

1. Assessment: Evaluating the area to determine the best approach for installing a proper drainage system under the tap.
2. Installation: Installing a drain that effectively channels water away from the base of the tap, preventing water accumulation and dampness.
3. Repair and Prevention: Inspecting and repairing any existing water damage and implementing measures to prevent future water accumulation and pest infestations.

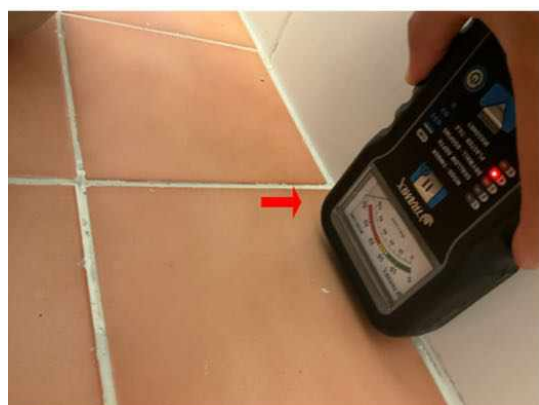
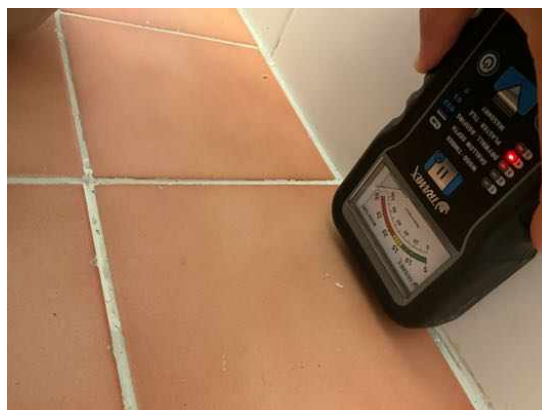
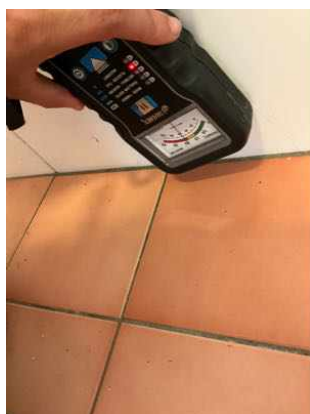
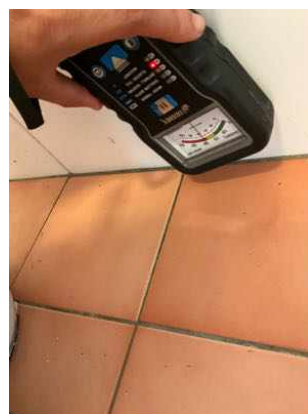
Finding 6.08

Building:	Main Building
Location:	Ensuite
Finding:	Excessive moisture - Conducive to Timber pest
Information:	Excessive moisture can attract termites and produce conditions that promote fungal growth and wood decay.

Excessive moisture is generally caused by deteriorated inadequate or missing roof drainage leaking plumbing pipes or fixtures poorly plumbed HWS overflows or condenser units and poor site drainage.

Prior to any remedial works being performed a qualified plumber should be appointed

to further inspect the property and to identify the cause of the excessive moisture. Works to remove affected building elements may then be necessary and should be performed by an appropriate tradesperson.

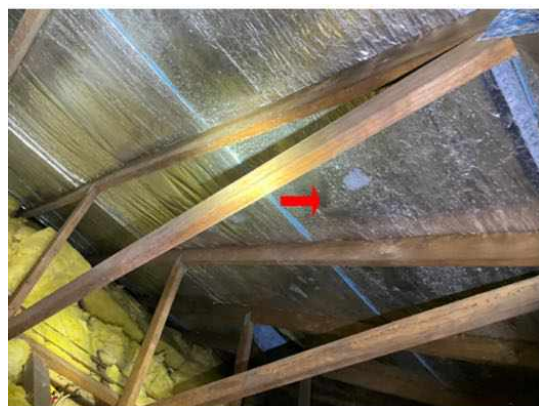
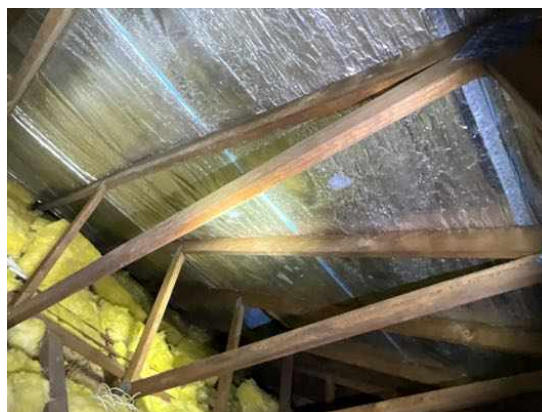
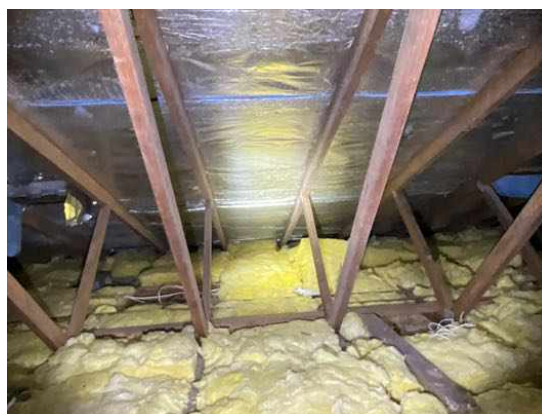
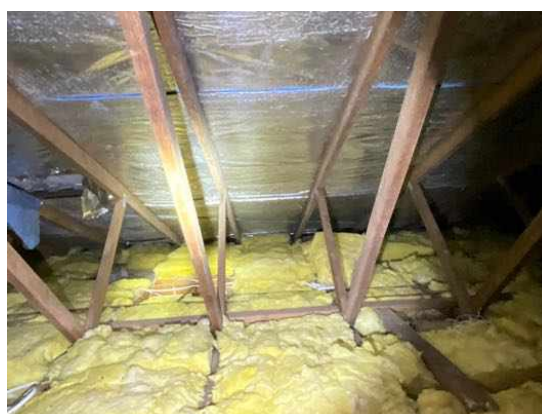
Building:	Main Building
Location:	Roof Void
Finding:	Roof void exhibits conspicuous signs of excessive moisture
Information:	The roof void exhibits conspicuous signs of excessive moisture, evident through water staining within the sarking material.

Risk in Terms of Timber Pest: The excessive moisture within the roof void poses a significant risk for timber pests such as termites, as it creates an ideal environment for infestation and proliferation. The damp conditions promote wood decay, making the structure susceptible to damage by these pests.

A qualified roofing contractor and a professional pest control service specialized in timber pest management should be engaged to rectify the issue. They can assess the extent of moisture damage, address any underlying structural issues, and implement effective solutions to mitigate the risk of timber pest infestation.

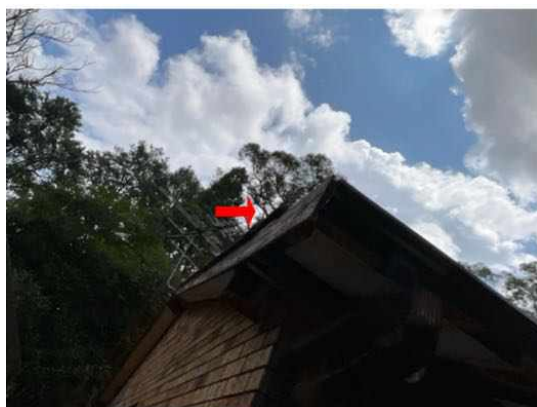
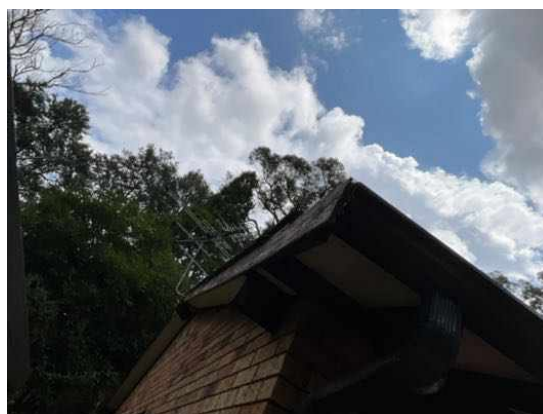
Finding 7.01

Building:	Main Building
Location:	All Areas
Finding:	Wood rot
Information:	This building element shows evidence of wood rot. Wood rot, also known as Fungal Decay, occurs when timbers and other cellulose building materials are exposed to damp conditions on an ongoing basis. This could be the result of exposure to weathering over a prolonged period of time, or the attraction of excessive moisture

Wood rot is often associated with general damp problems and is evidenced by a 'musty' smell or mould and mildew occurring on surfaces. If left unmanaged, damp conditions can lead to further health problems and the decay of timbers will continue.

Early intervention and regular maintenance, particularly of exterior timbers, will prolong the useful life of these building elements. Prior to any works being performed, the cause of the moisture that has created the visible wood rot should be identified and addressed in a suitable manner. Replacement of affected timbers may then be a necessary step in protecting surrounding building elements from such deterioration.

A qualified plumber may be appointed to assess the cause of excessive moisture and to provide advice on any remedial works as required. A qualified carpenter or registered builder may also be required to replace affected building materials.

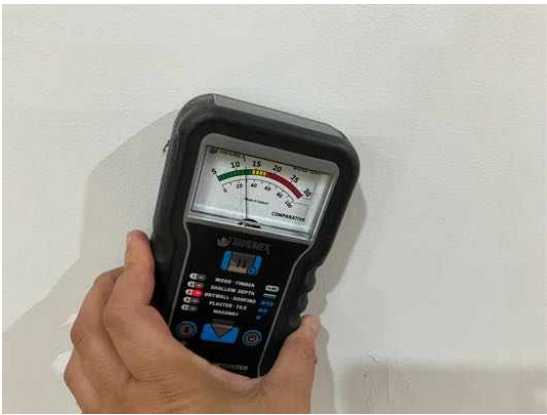
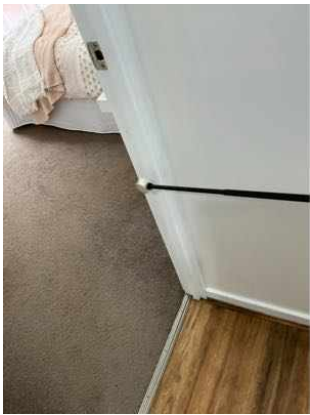
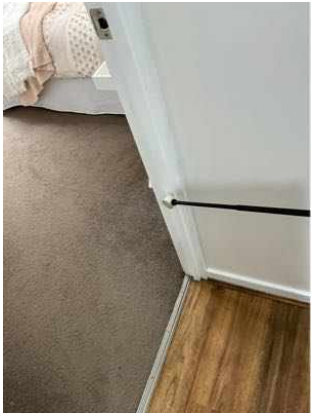
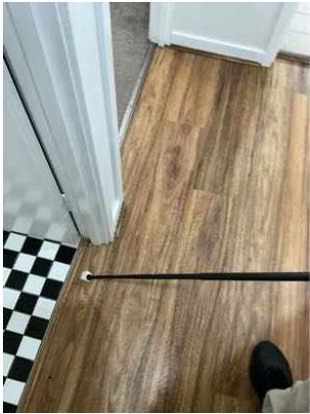
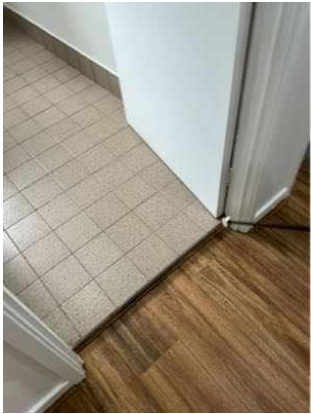
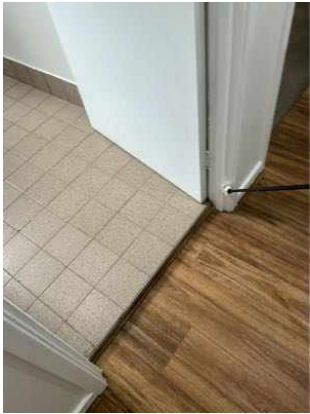
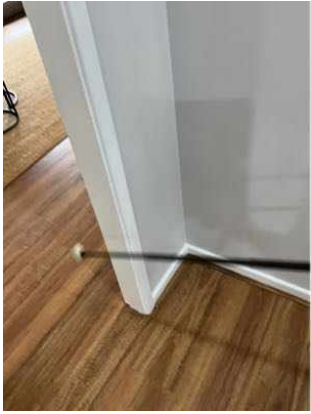
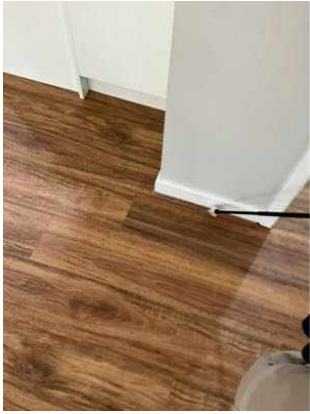
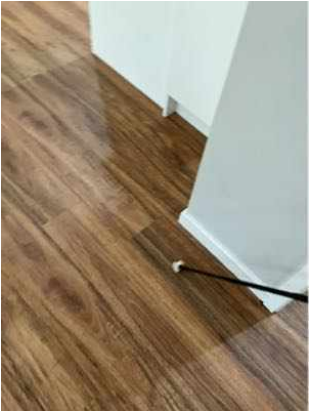
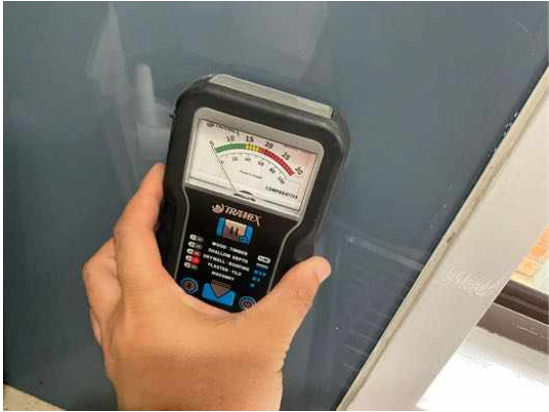
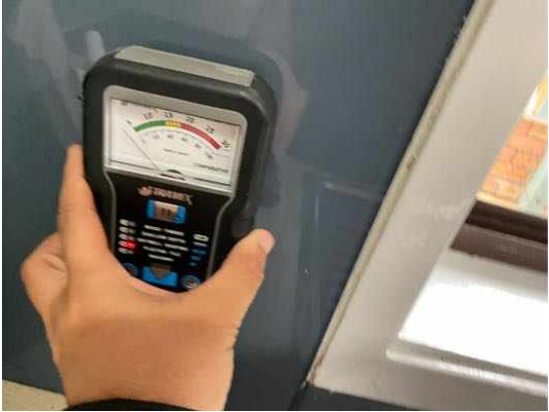
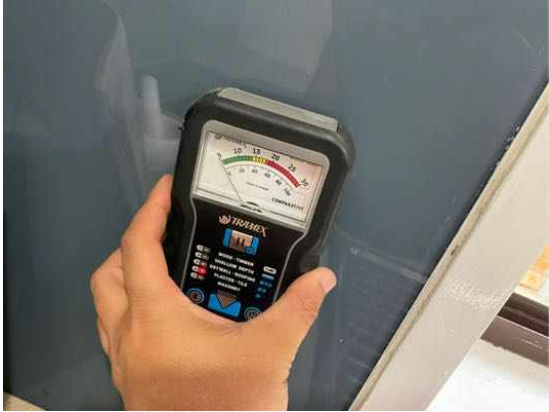
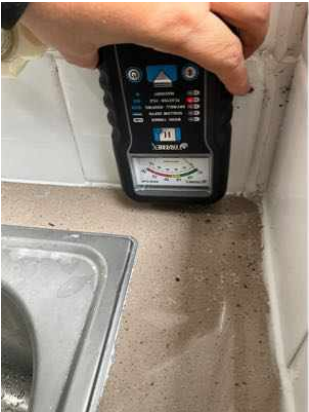
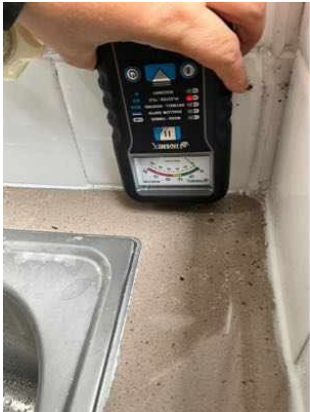
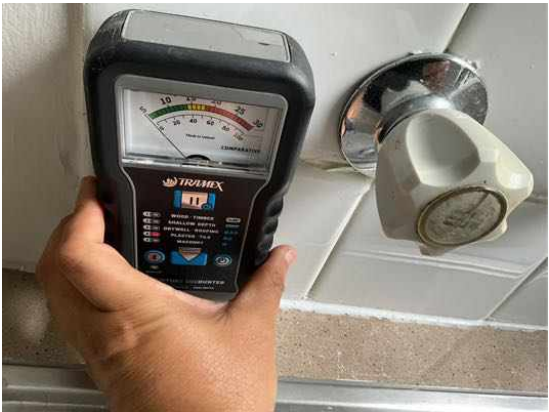
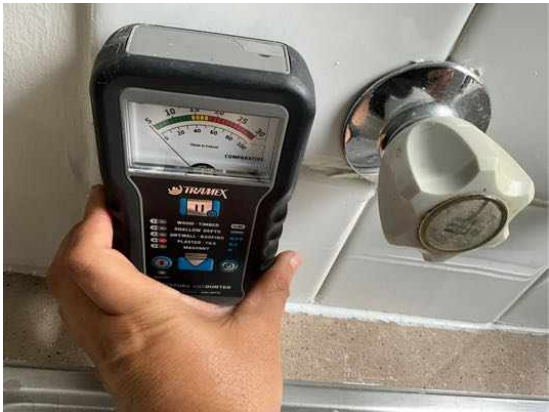
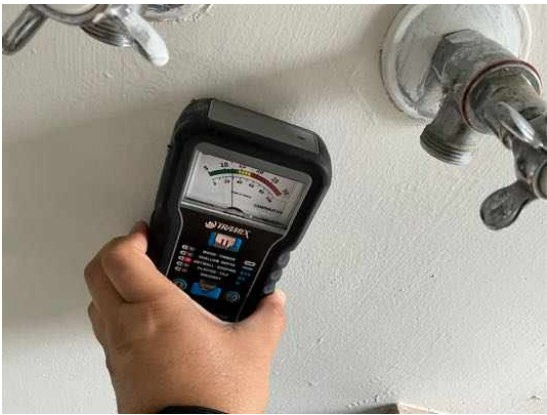
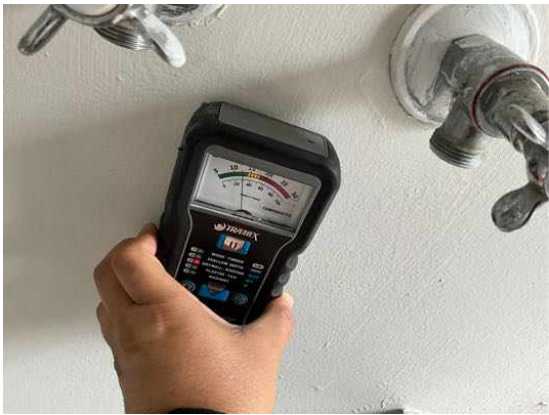
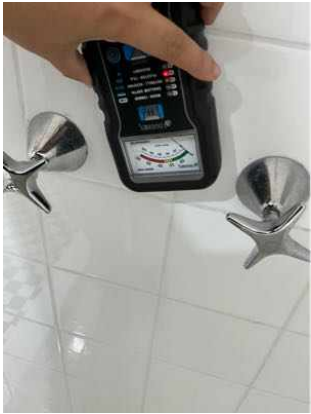
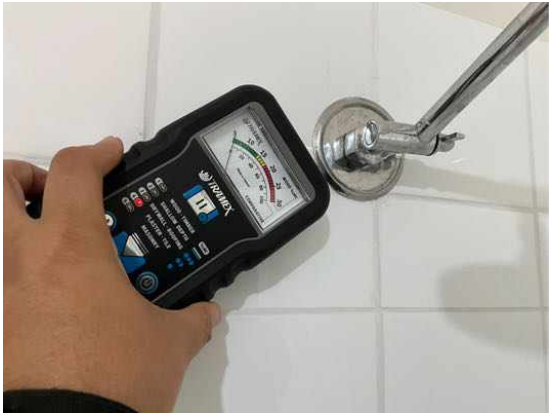
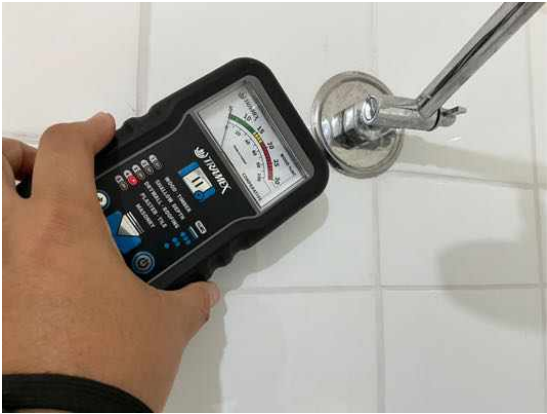
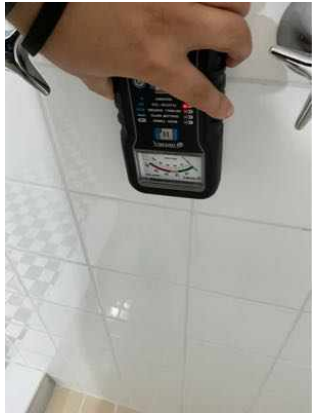
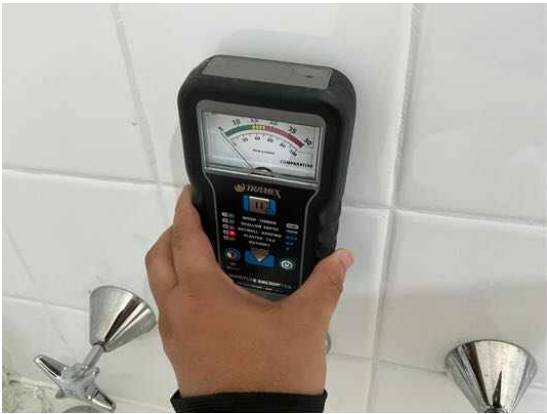
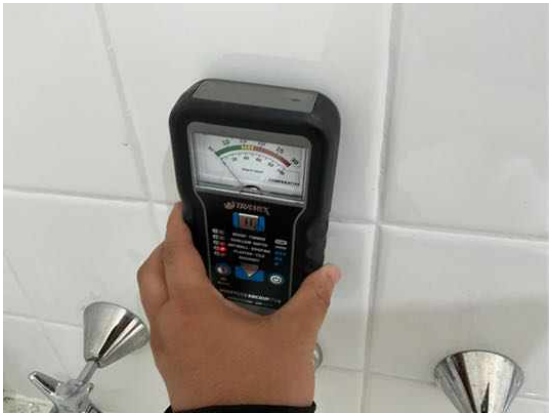
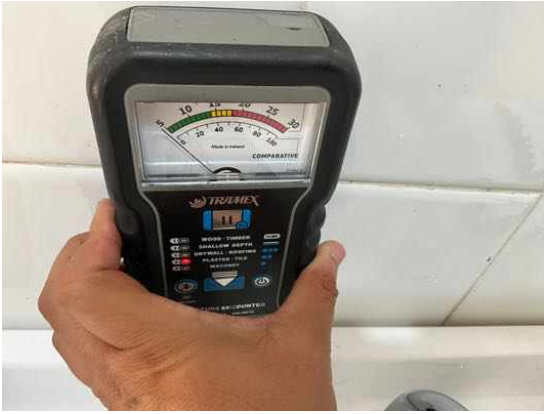
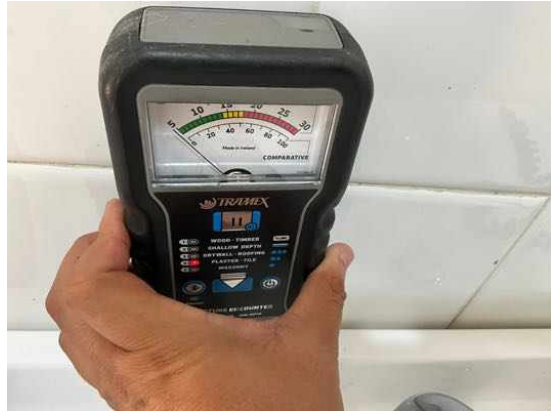
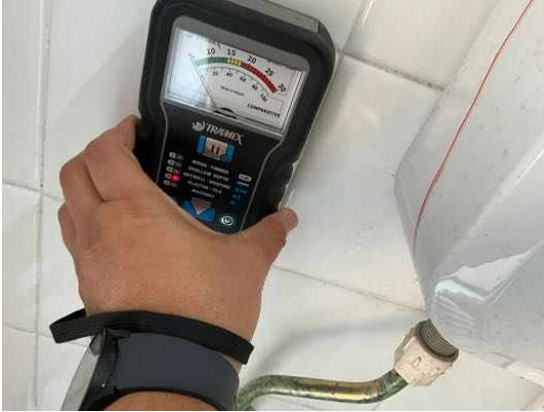
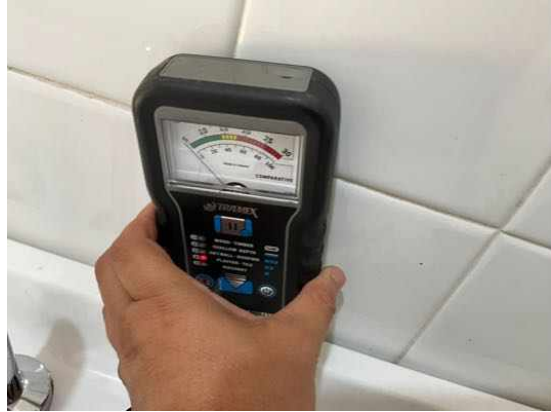
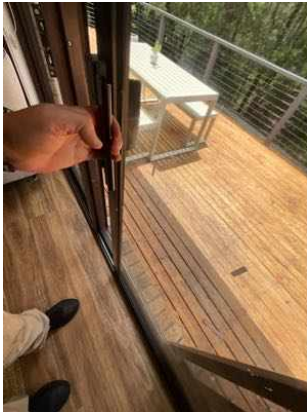
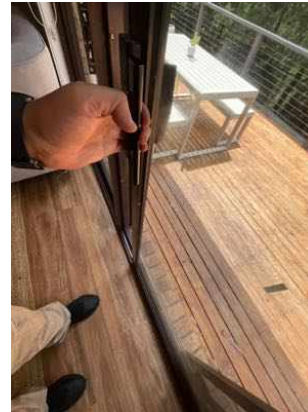
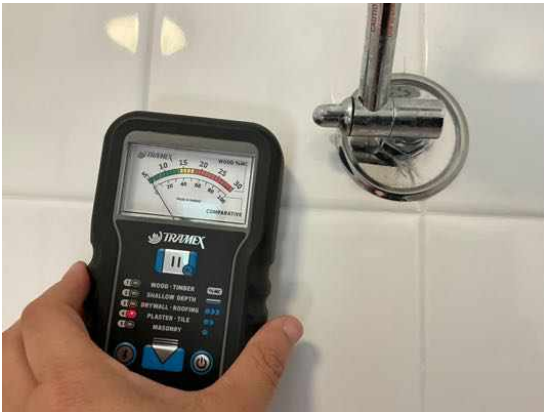
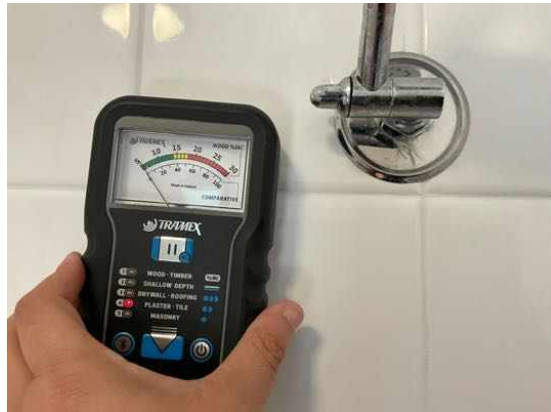
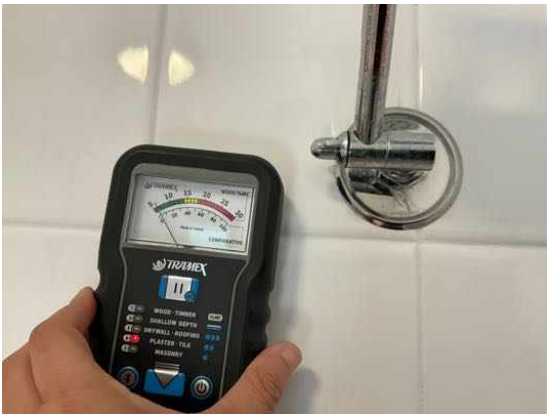
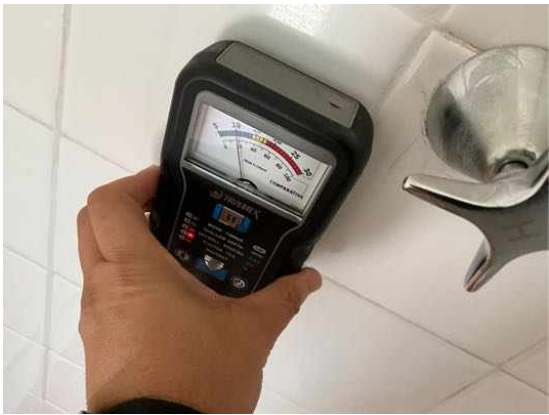
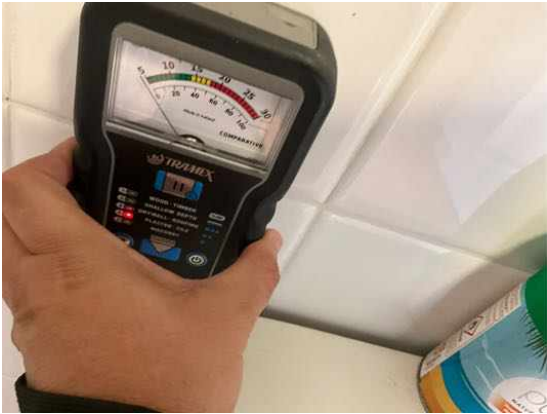
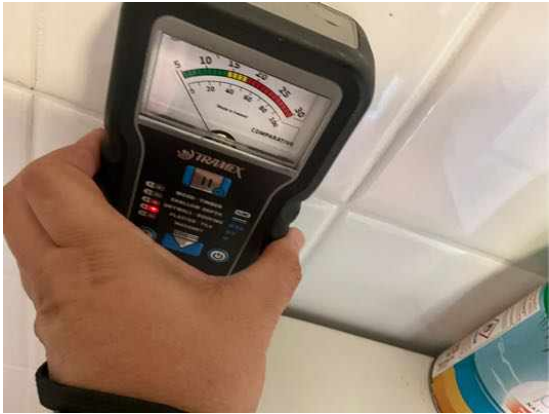
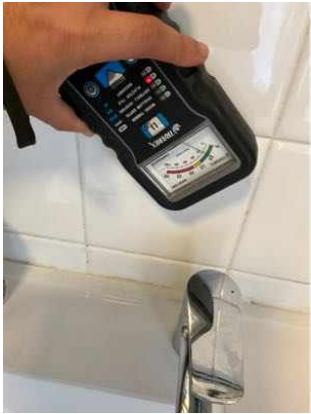
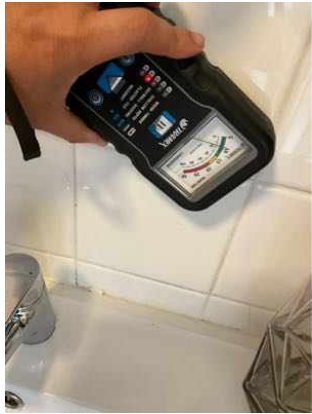
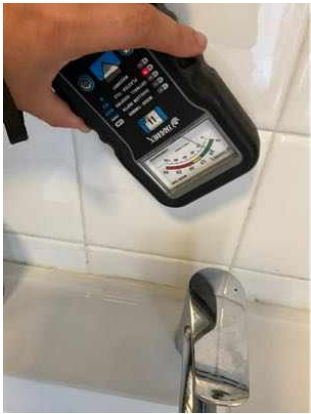
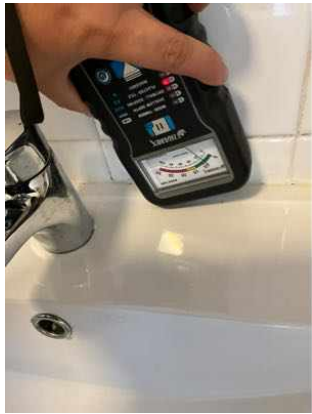
Building: Main Building
Location: All Areas
Finding: Additional Photos
Information: Additional photos are provided for your general reference

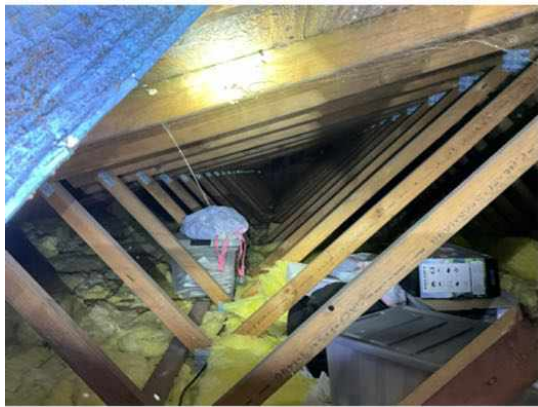
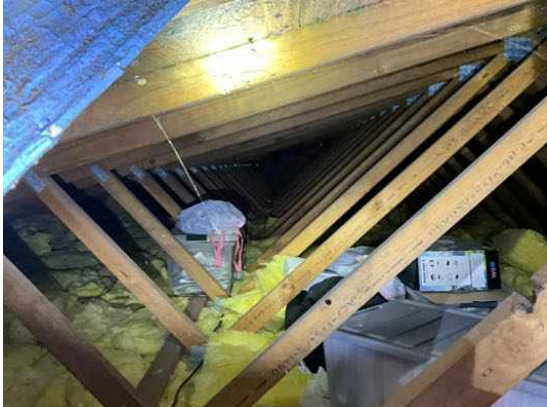
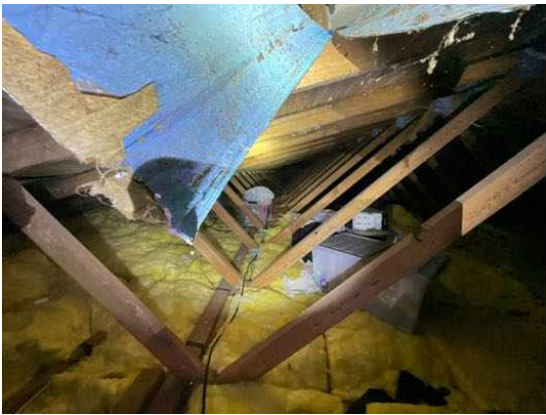
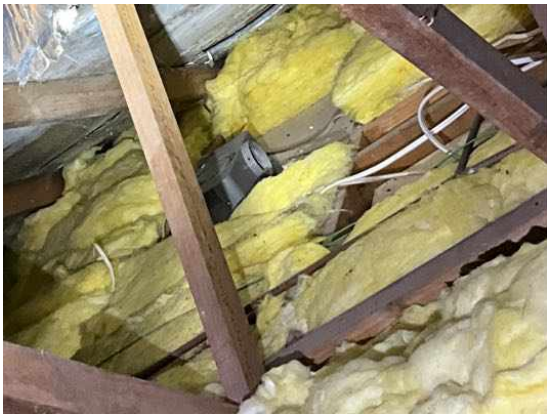
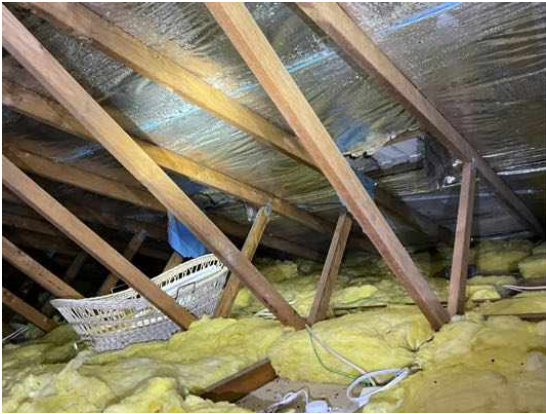
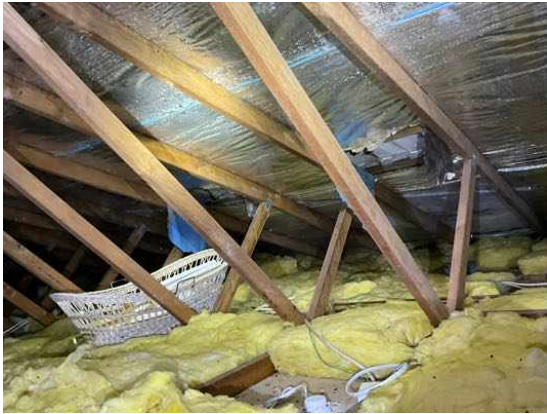
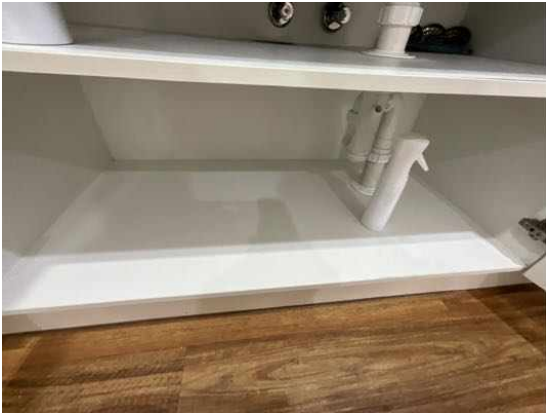
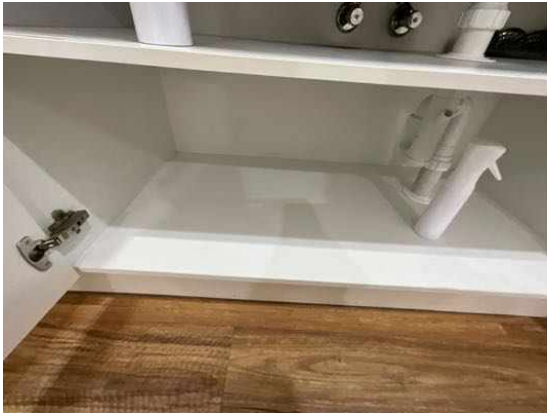
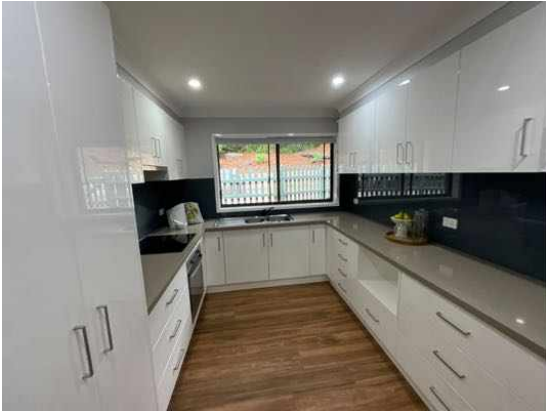
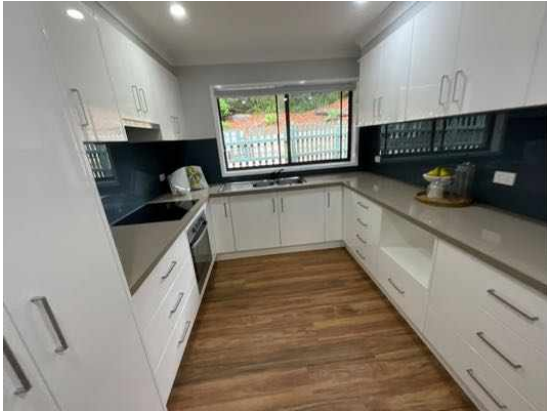
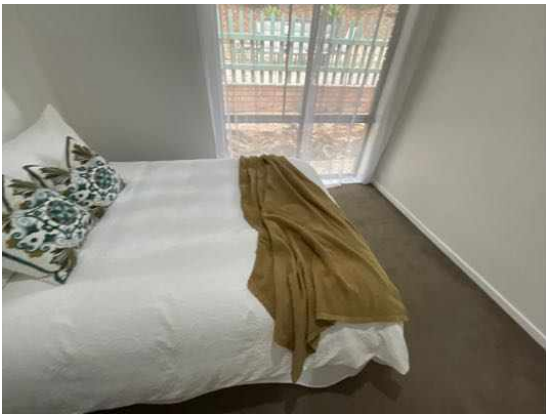
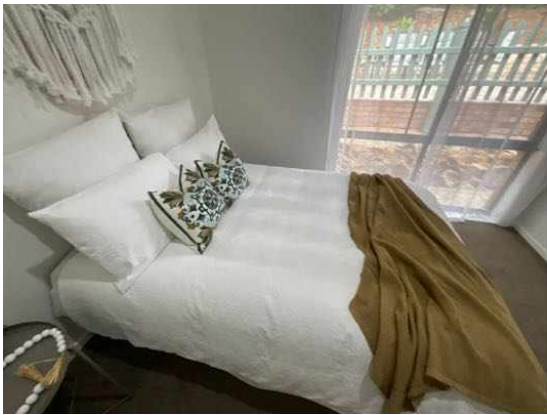
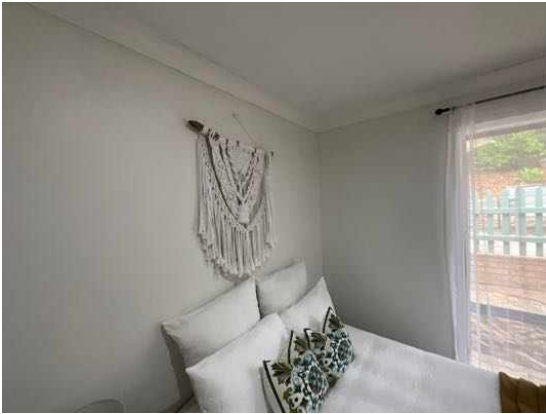
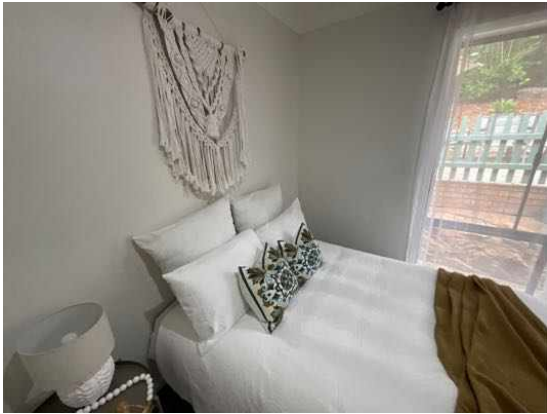
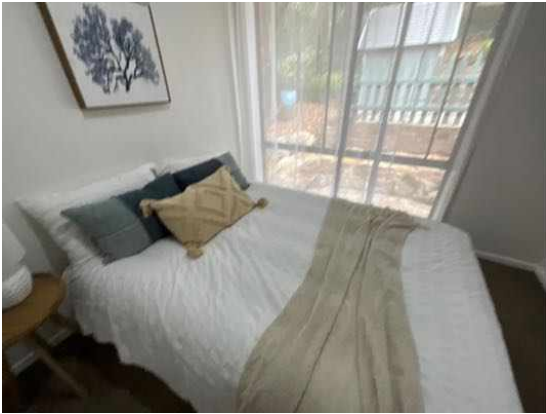
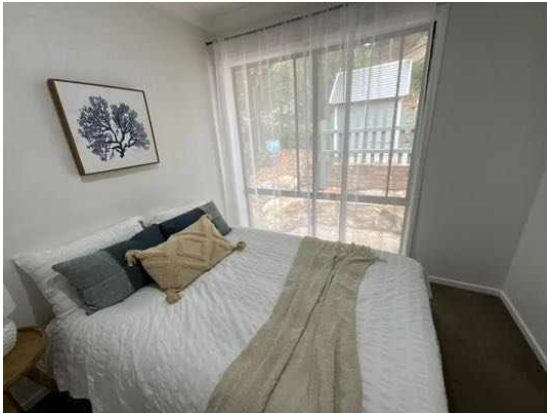
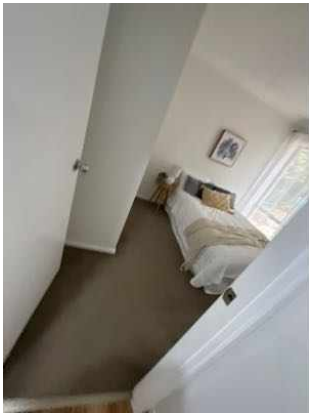
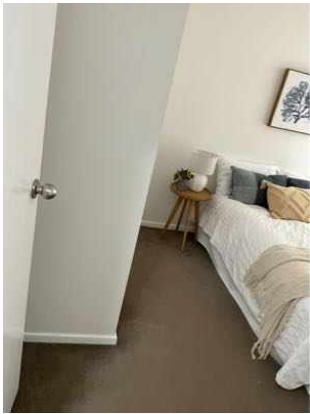
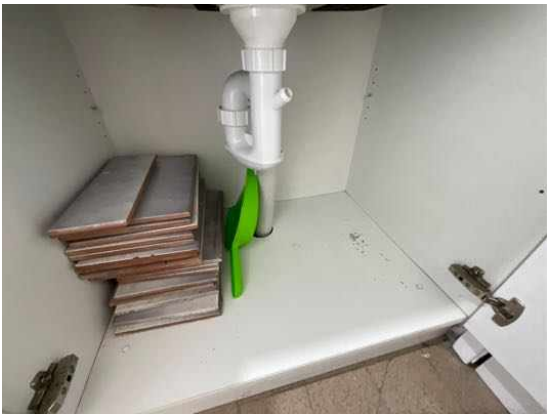
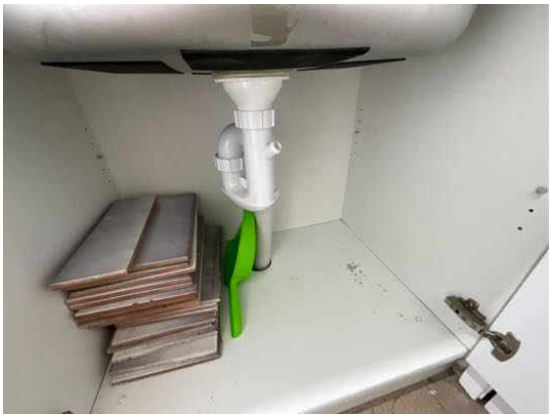
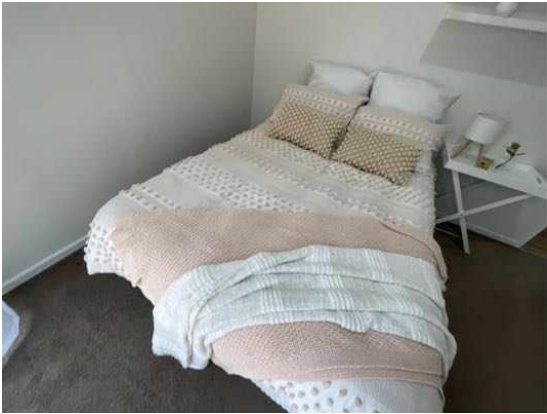
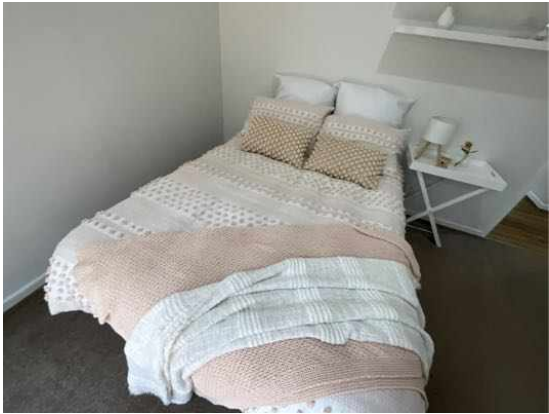
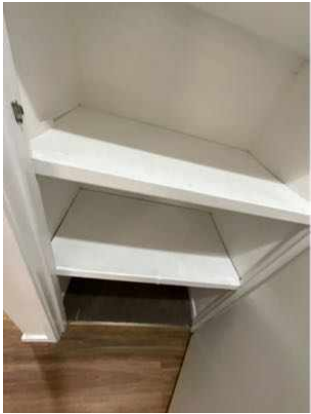
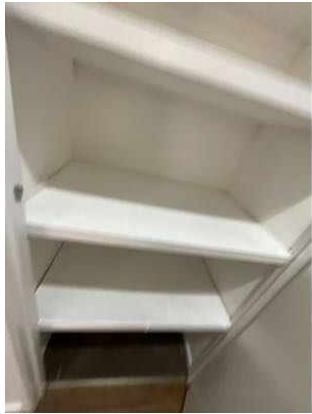
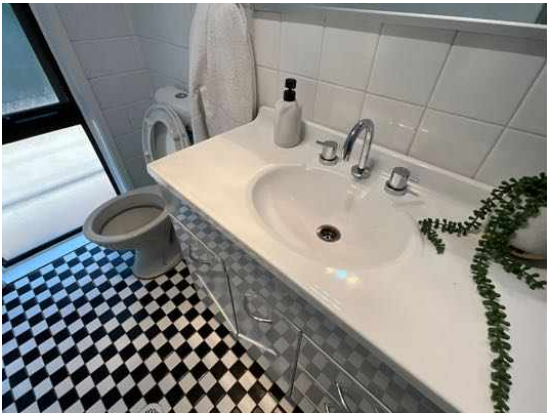
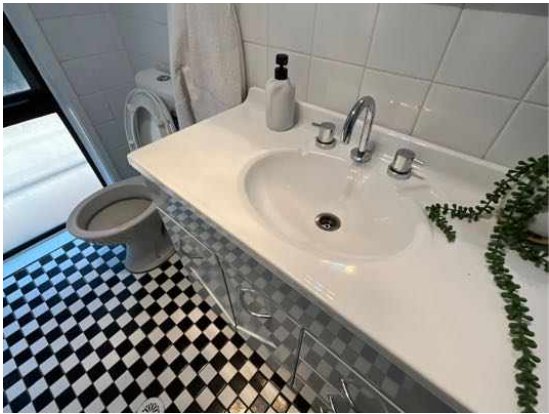
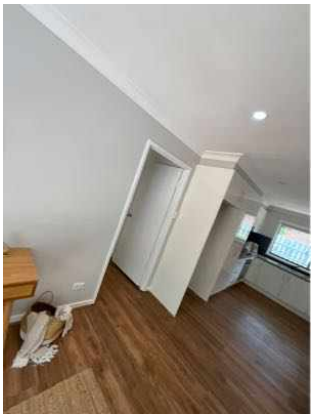
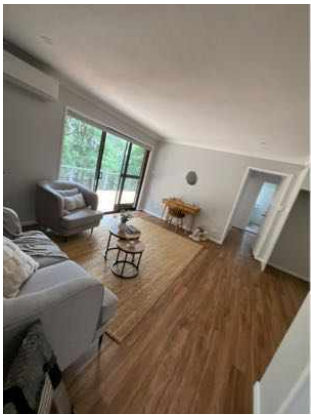
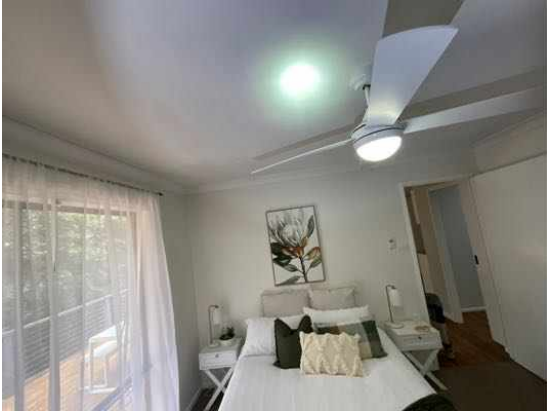
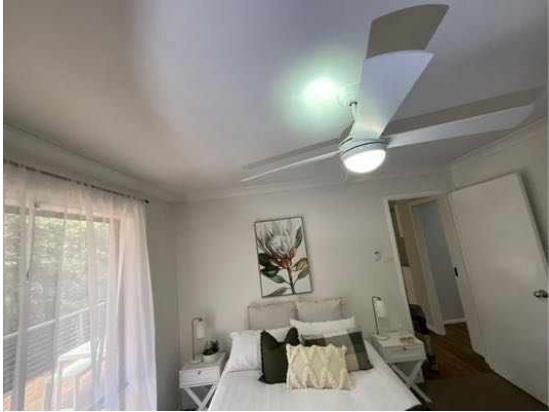
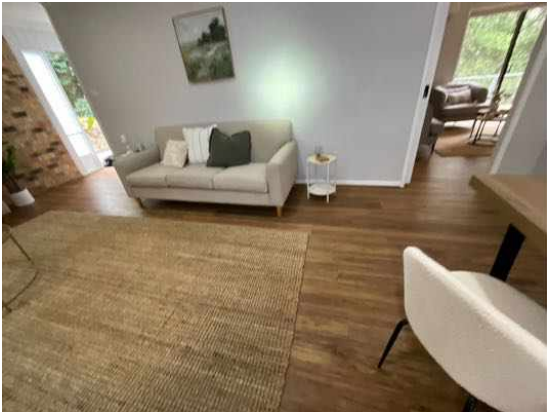
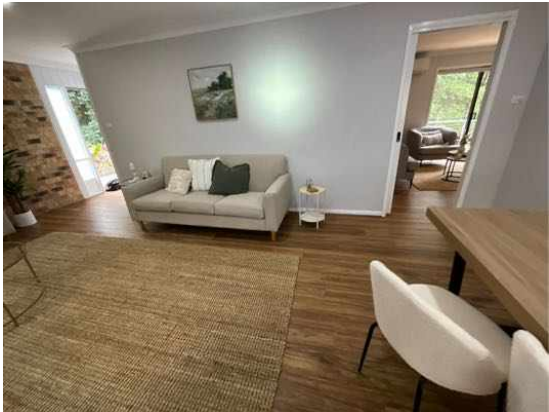
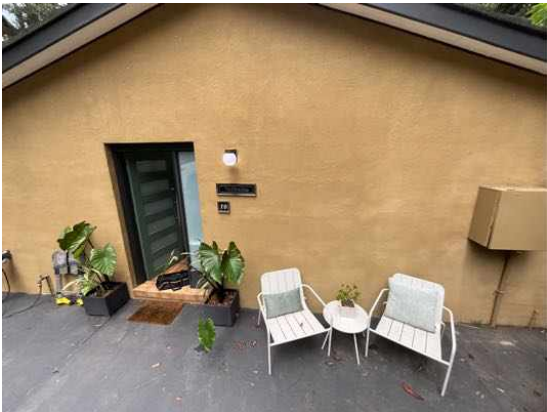
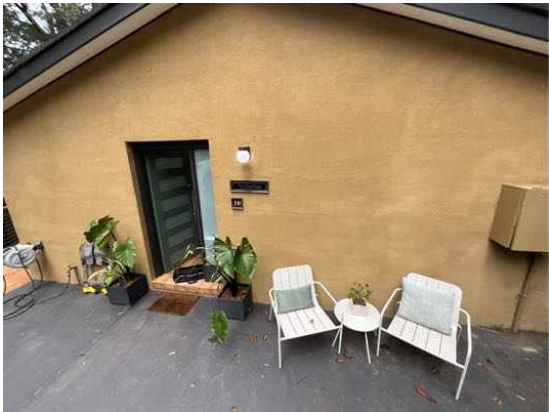
Building: Main Building
Location: All Areas
Finding: Additional Photos - Obstructions and Limitations
Information: These photographs are an indication of the obstructions and limitations which impeded full inspection of the property at the time of inspection. These obstructions can hide an array of defects and should be removed to allow full inspection to be carried out. A re-inspection is recommended once the areas are made accessible.

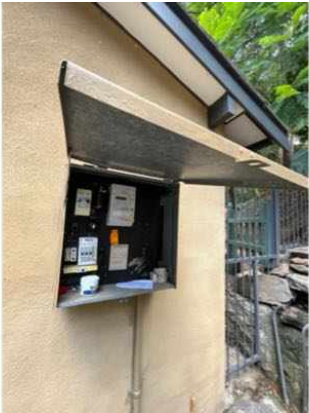
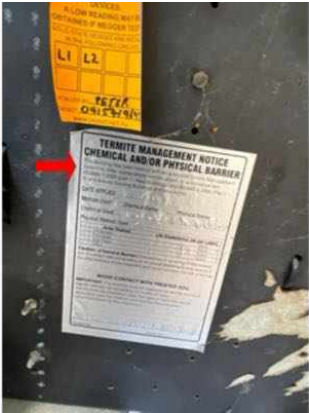
Building: Main Building
 Location: Front Elevation
 Finding: Evidence of Termite Management System - Durable notice / Legible Sticker - seek further information
 Information: The application of a pre & post-construction chemical termite barrier is highly recommended for all properties. Such barriers are highly effective in preventing termite attack on any timber building elements throughout the property.

A durable notice placed in the switchboard unit to indicate termite barriers at the time of inspection.

Client must seek further information from the vendor or real estate agent if the conditions of termite management systems were maintained as per the label or seek advise from licensed pest controller.
