Building Inspection Report

Inspection Date: Tue, 17 Feb 2026

Property Address: 13/54-55 Park Avenue, Kingswood NSW
2747

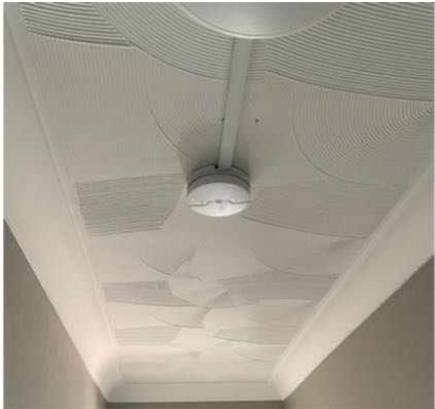
Building:	Main Building
Location:	All Areas
Finding:	Smoke Detectors / Alarms.
Information:	Reporting on the presence, type, location, or compliance of smoke detectors or alarms, including hard-wired smoke detection systems and their legislative requirements, is outside the scope of this inspection report.

Failure to comply with these requirements may pose a serious risk to occupant safety.

- All smoke detectors be tested monthly by the homeowner.
- All systems comply with the requirements of AS 3786 and any applicable state-based legislation.
