# Building and Timber Pest Inspection Report

Inspection Date: Mon, 30 Mar 2026

Property Address: 212/20 Hilly St, Mortlake NSW 2137,  
Australia

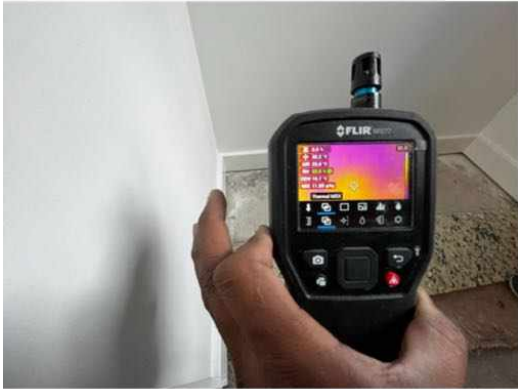
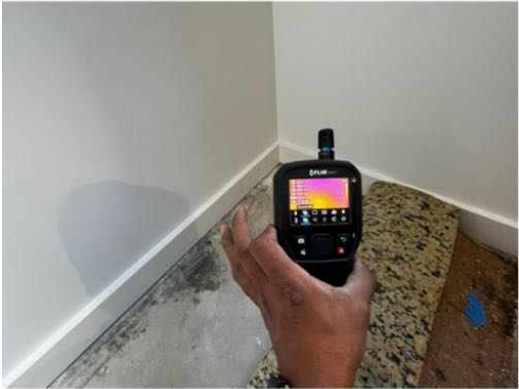
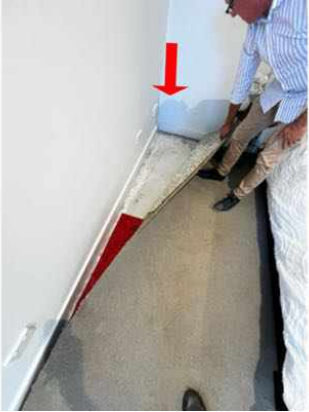
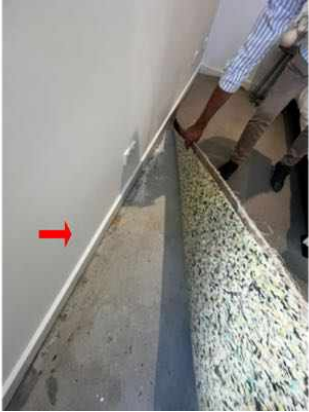
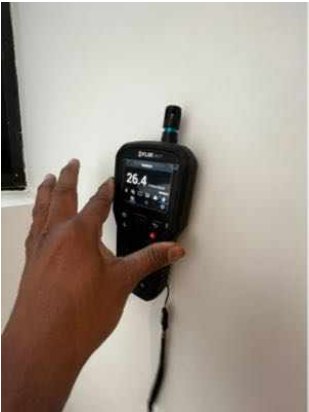
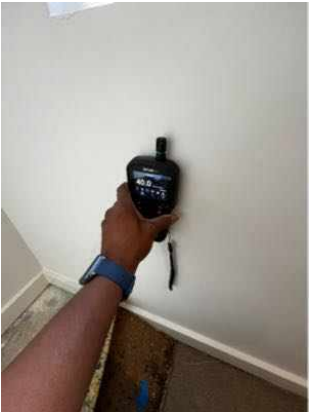
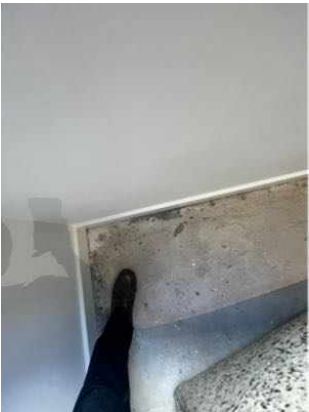
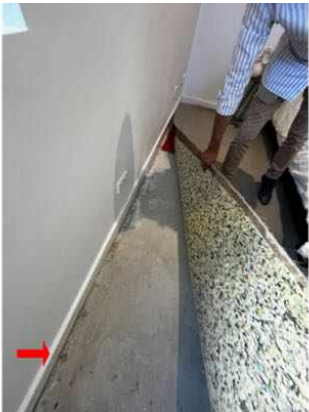
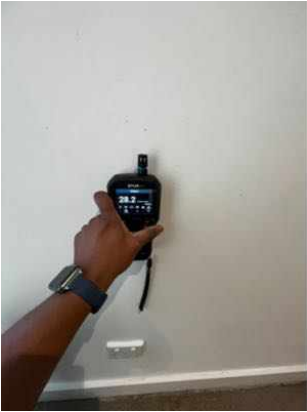
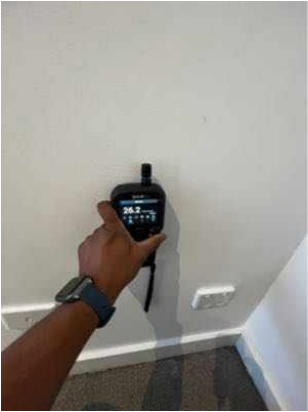
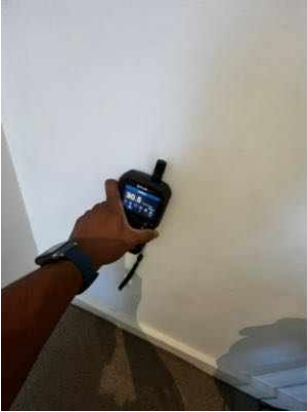
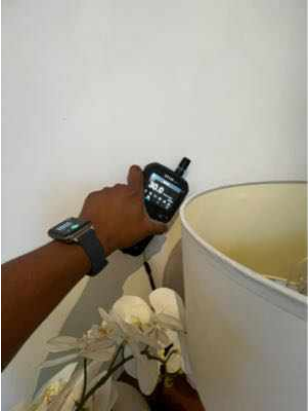
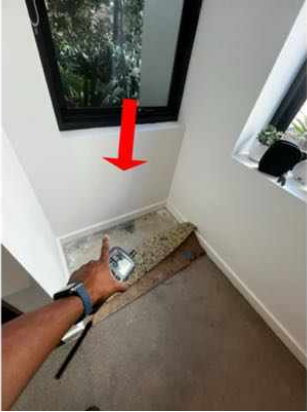
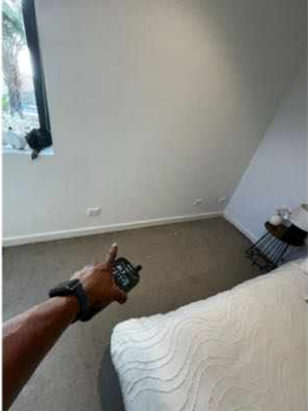
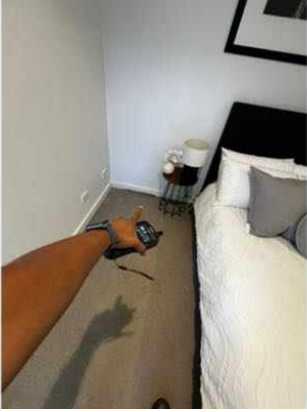
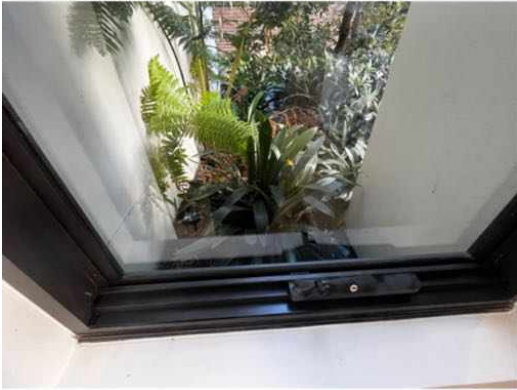
Building: Main Building  
Location: Bedroom >  
Finding: Evidence of Previous water leakage was present at the time of inspection  
Information: Evidence of Previous Water Leak was found during Inspection in the walls below the window area in the second bedroom. Missing roof drainage, leaking plumbing pipes or fixtures, poorly plumbed HWS overflows or condenser units and poor site drainage / Landscaping water disposal, Excessive Moisture may generally be the causes of the leakage. It is highly recommended that all plumbing and drainage fixtures and fittings be maintained regularly in order to prevent excessive moisture being present in the external / internal property.

Request the buyer to verify on the same and do due delegalance from the strata.

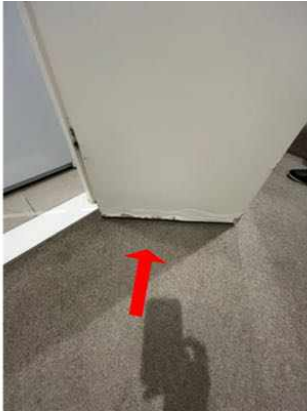
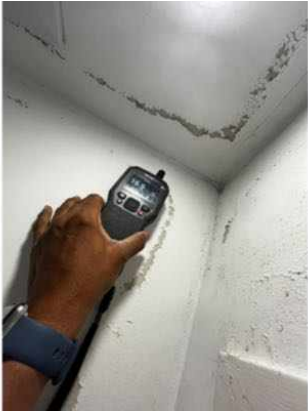
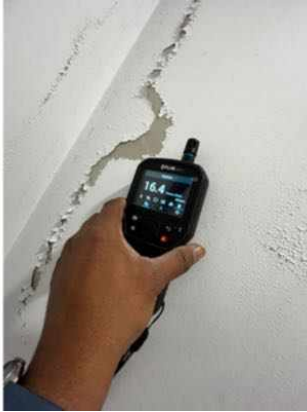
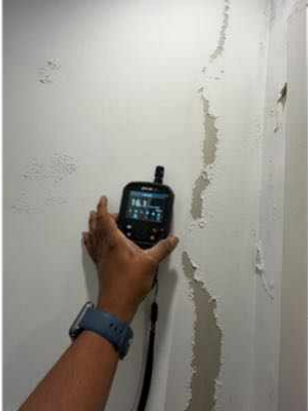
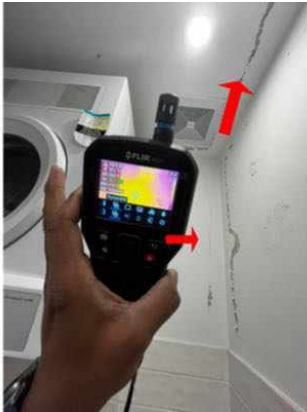
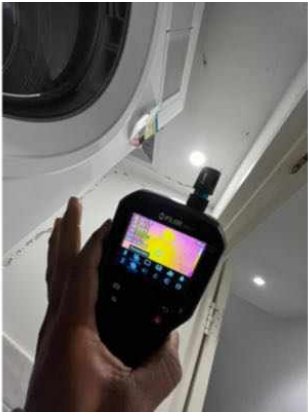
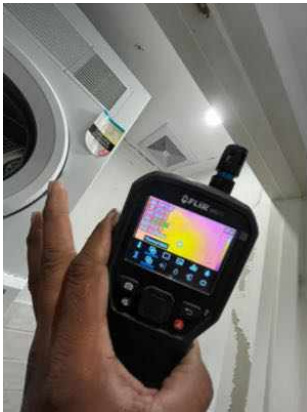
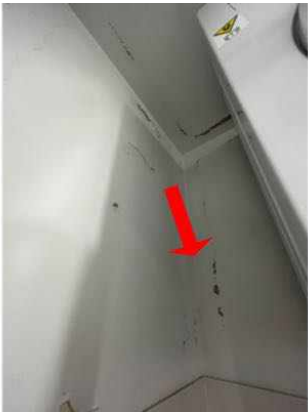
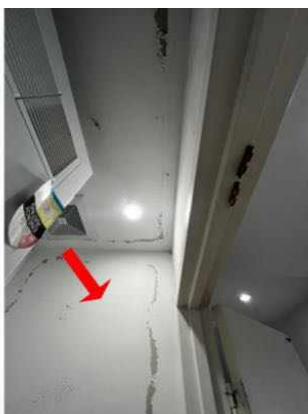
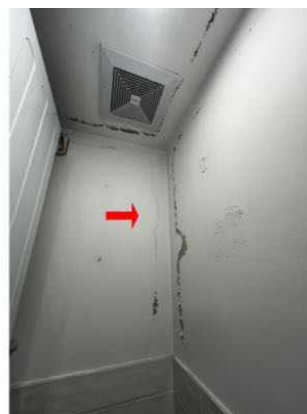
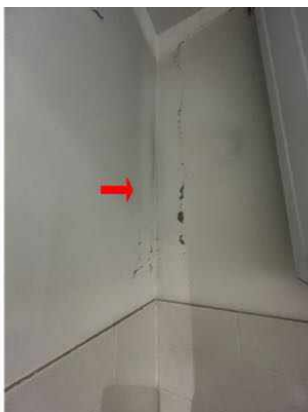
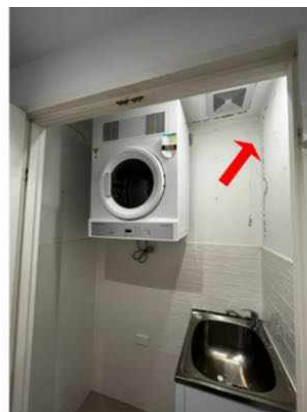
## Finding 2.02

Heavy condensation likely to produce damp conditions in the surrounding area conditions which are conducive. If left unattended, such leaking can develop into water pooling, creating potential for subsequent water damage to associated building elements.

A more powerful exhaust fan is recommended or doors with louveres are recommended where there is cross ventilation required for preventing condensation from happening. Due to the damage, The doors have warped, and damaged, all surrounding walls need to be scraped, sanded and to be painted to perfection with mould restraint paint to keep a dry atmosphere.

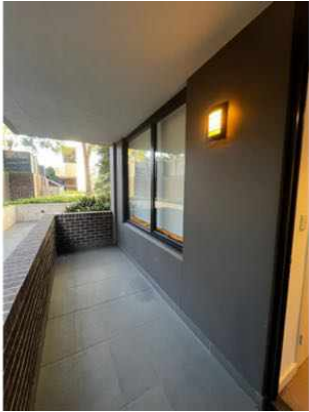
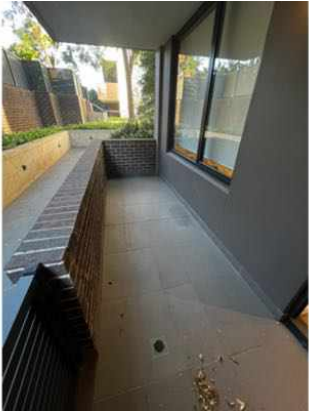
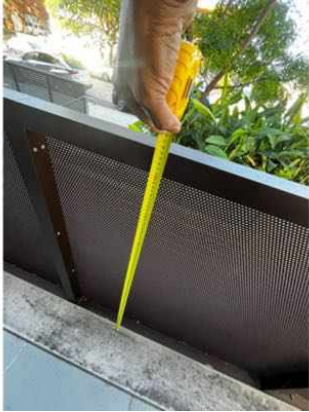
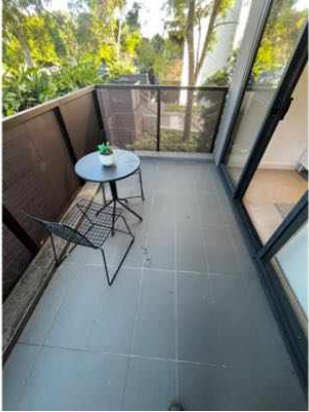
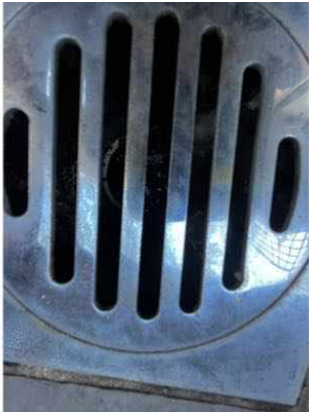
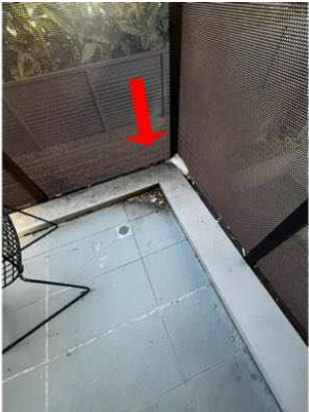
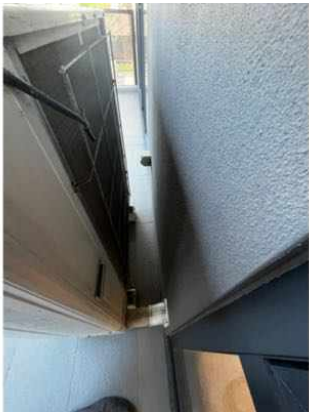
### Finding 3.01

The area being exposed to different weather is also a Cause for the grout/ silicone to dry up. Regular maintenance and replacement of damage or missing or damaged sealant and grout is highly recommended to the wet areas, as this is a regular wear and tear defect. Sealant and grouting in areas that come into regular contact with water should be maintained for the long term care of your property.

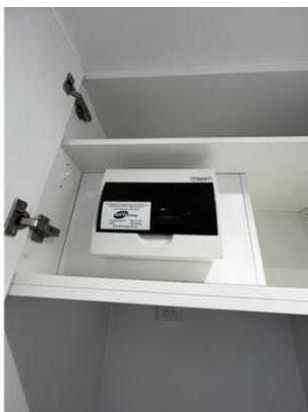
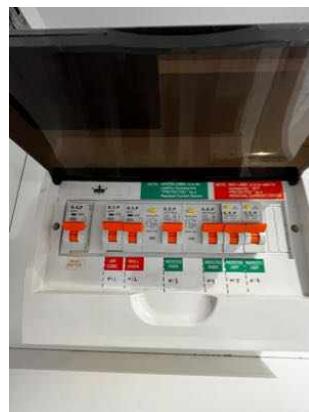
Building: Main Building  
Location: Electrical Switchboard  
Finding: Termite Management System - no evidence of a chemical installation no Durable Notice  
Information: The application of a post-construction chemical termite barrier is highly recommended for all properties, particularly if live termite activity has been found on the site previously. Such barriers are highly effective in preventing termite attack on any timber building elements throughout the property.

barriers. At the time of inspection, it appeared as though no termite management system has been installed, with no evidence to suggest preventative works taking place.

The client may consider gaining further advice from a pest controller as to the costs and procedures involved with this application. It is recommended that obtaining such advice be a short-term priority.

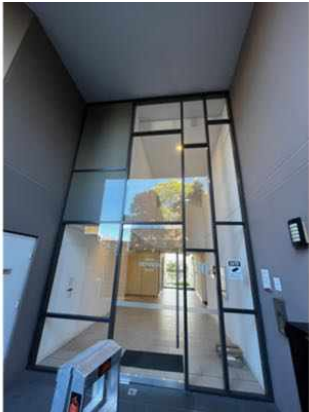
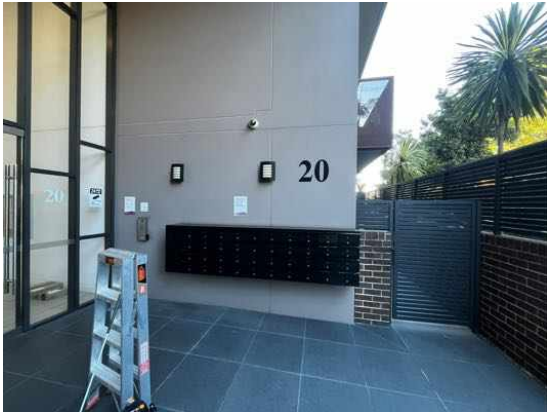
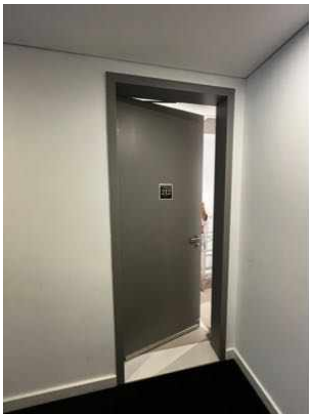
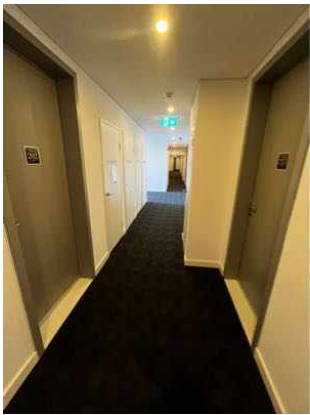
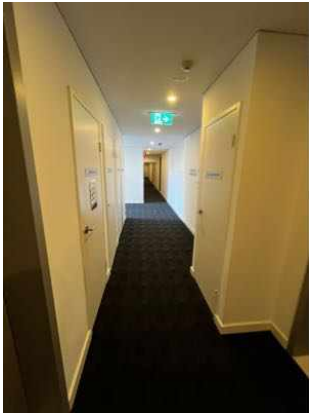
Building: Main Building  
Location: Common Areas  
Finding: Additional Photos of common Areas  
Information: Additional photos are provided for your general reference

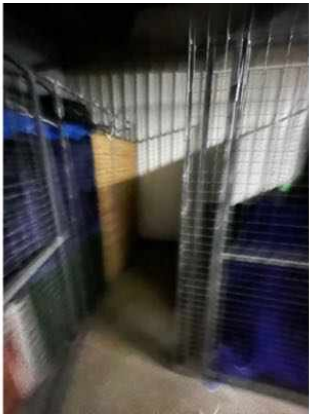
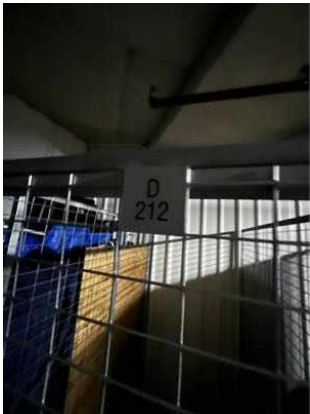
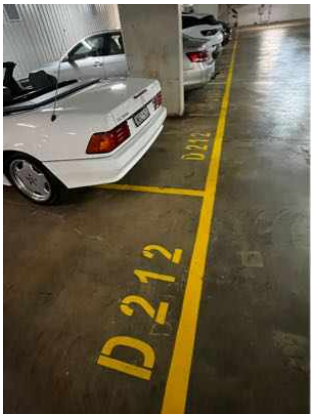
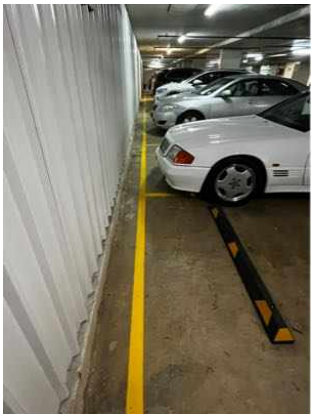
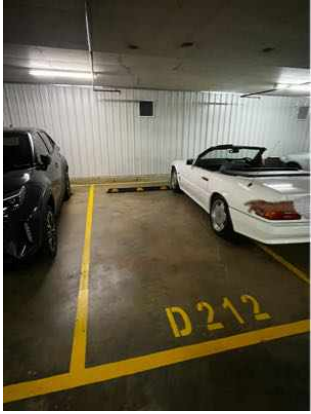
Building: Main Building  
Location: Car Park - Basement  
Finding: Car park - Basement Floor  
Information: Inspected the Carpark on the basement and the photos attached during inspection for your information.
