# Building and Timber Pest Inspection Report

Inspection Date: Tue, 31 Mar 2026

Property Address: 17 De Boos St, Euroa VIC 3666, Australia

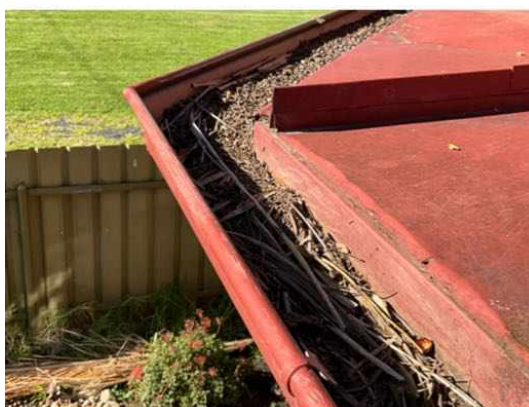
Blocked gutters are likely to lead to high levels of moisture in the affected areas. Such moisture will not only cause rust and decay of the associated building materials, but can also provide conditions that are conducive to termite and timber pest activity. Blockages in gutters should therefore be removed immediately to ensure dry conditions are maintained.

Consult a Licensed Plumber for further specific advice on remedial works that may be required. In the interim, it is highly advised that blocked gutters be removed by the homeowner or a general handyperson as a matter of urgency.

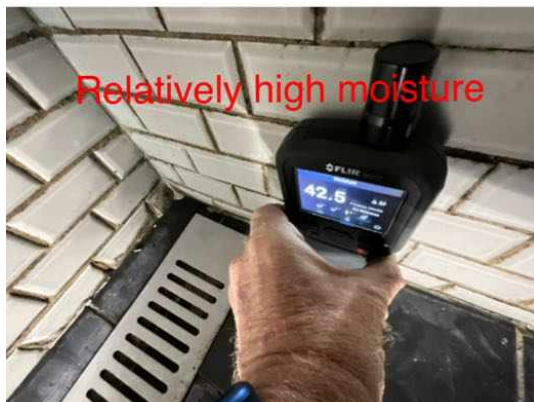
Building: Building 1  
Location: Bathroom  
Finding: Inadequate sealant or Grout  
Information: This area has a lack of effective Sealant or Grout. This is allowing the ingress of water to the structure inside the wall.

The presence of water encourages Termite attack, Mould and Fungal Decay.

A Tiler or General Handy person must be contacted as soon as possible to effect repairs and prevent further deterioration.

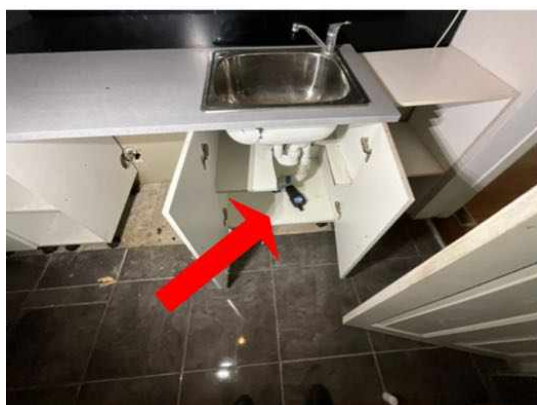
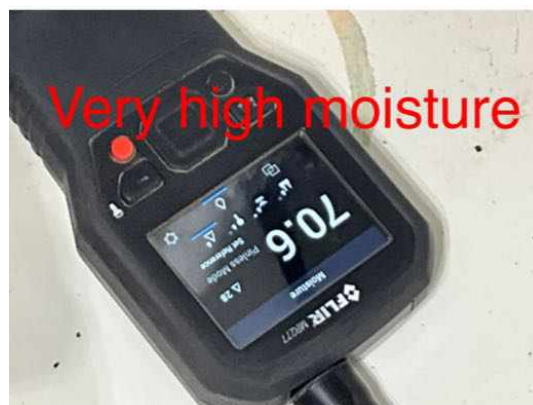
**Finding 6.05**

Building: Building 1  
 Location: Laundry  
 Finding: Evidence of excessive moisture- present at the time of inspection.  
 Information: Excessive moisture can attract termites and produce conditions that promote termite attack fungal growth and wood decay. Excess damp in this area may create further deterioration.

Appropriate trades should be contacted soon to restore the area and prevent further deterioration.

In this case the drain may be loose or poorly installed. A plumber should be contacted to restore the area and prevent further deterioration.

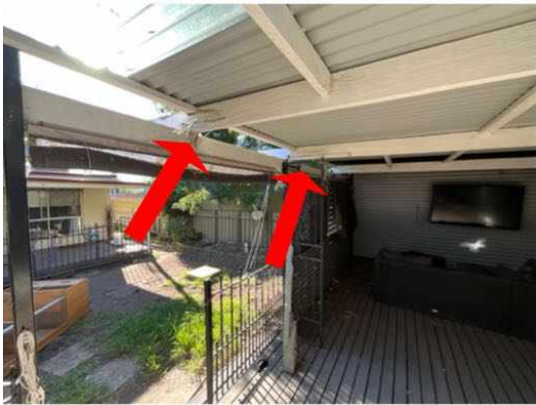
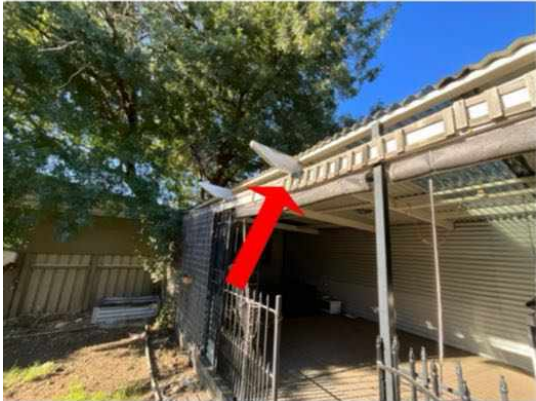
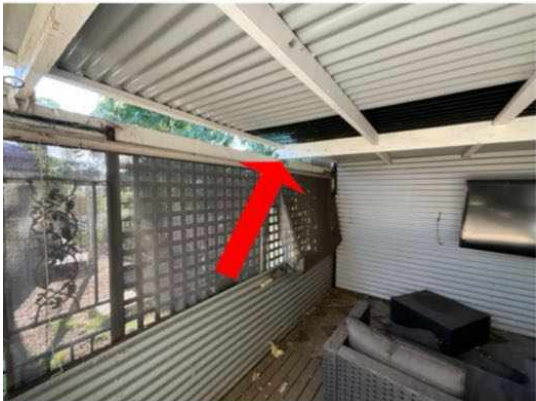
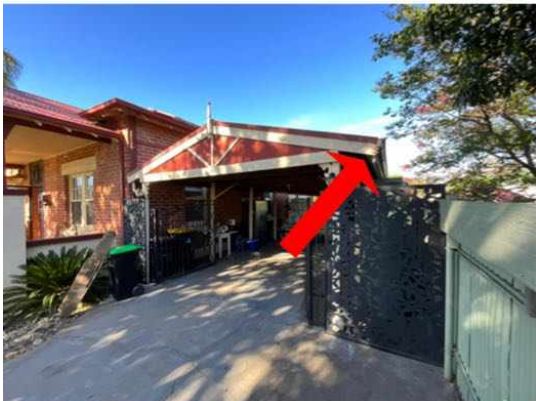
Building:	Building 1
Location:	Alfresco, carport
Finding:	Fungal decay - present (localised)
Information:	Fungal decay also known as wood decay or wood rot generally refers to the deterioration of timber elements when in contact with excessive levels of moisture for a prolonged period of time.

The development of fungal decay is accelerated by temperatures in the range of 5degreeC to 40degreeC as well as the presence of oxygen. Generally fungal decay develops on timber elements that are in use in an external environment which are exposed to rain penetration.

In this case although the affected timber element is in a decaying state the extent of any visible damage appears to be localised to a specific area and is yet to spread to other parts of the building element or affect adjoining structures. The fungal decay is therefore likely to be of a relatively superficial nature with minimal impact on the structural integrity or tensile strength of the timber element.

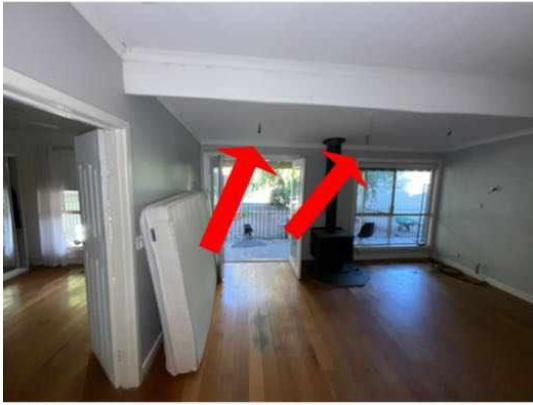
Building: Building 1  
 Location: Family Room  
 Finding: Plumbing and Electrical  
 Information: Some installations appear of poor quality. A plumber should be contacted at client discretion, to improve the installation and prevent further deterioration.

It is highly recommended that the client makes immediate arranges to have the gas appliances checked by a licensed gas plumber to ensure that the appliances are working safely and efficiently.

We recommend all other installations be checked also.

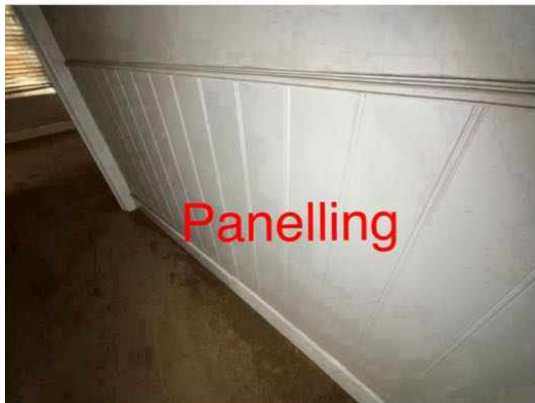
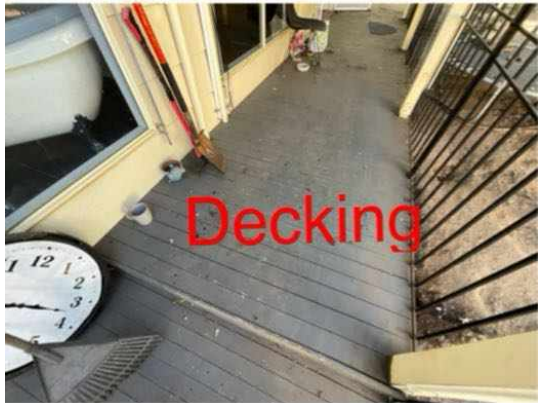
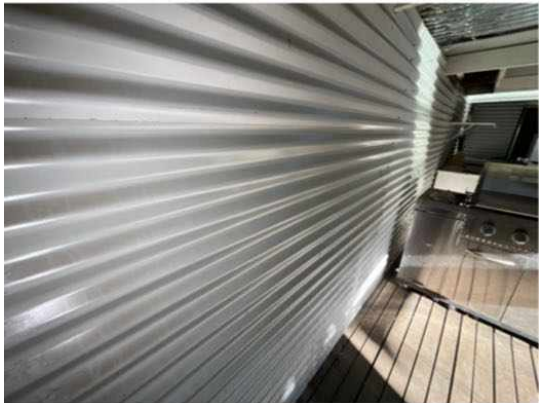
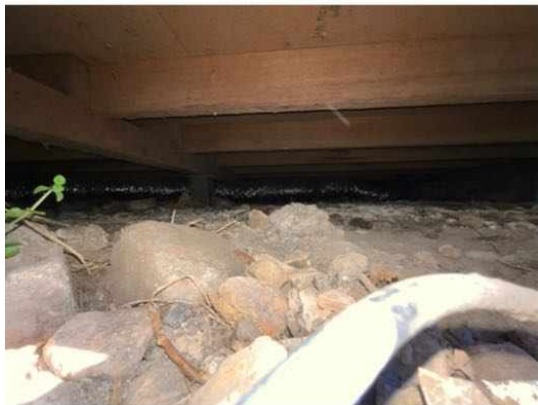
Building: Building 1  
 Location: All Areas  
 Finding: Additional Photos - Obstructions and Limitations  
 Information: These photographs are an indication of the obstructions and limitations which impeded full inspection of the property at the time of inspection. These obstructions can hide an array of defects and should be removed to allow full inspection to be carried out. A re-inspection is recommended once the areas are made accessible.
