# Building and Timber Pest Inspection Report

Inspection Date: Wed, 18 Feb 2026

Property Address: 27 Minories St, Port Adelaide SA 5015,  
Australia

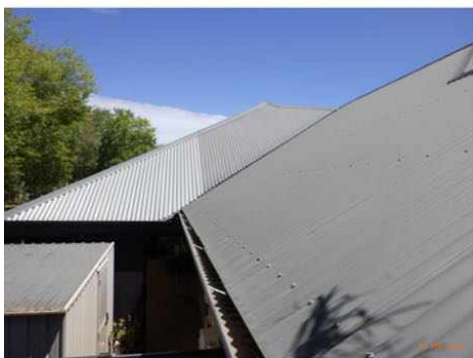
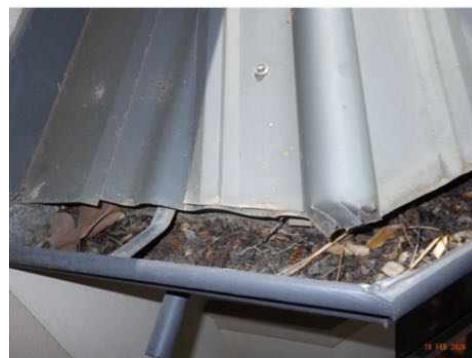
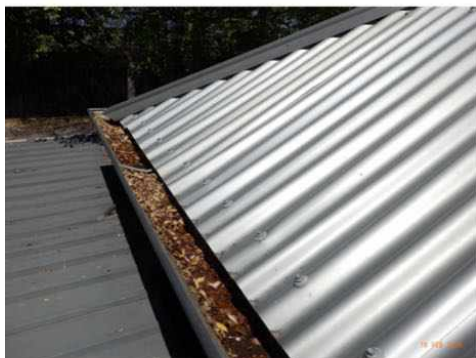
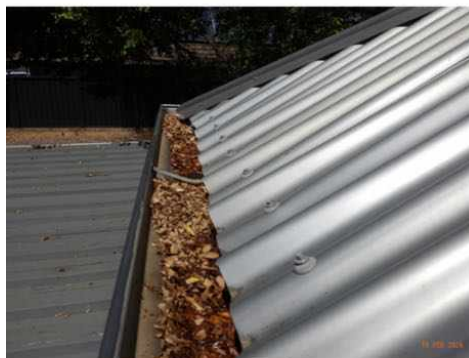
Blocked gutters are likely to lead to high levels of moisture in the affected areas. Such moisture will not only cause rust and decay of the associated building materials, but can also provide conditions that are conducive to termite and timber pest activity. Blockages in gutters should therefore be removed immediately to ensure dry conditions are maintained.

Consult a Licensed Plumber for further specific advice on remedial works that may be required. In the interim, it is highly advised that blocked gutters be removed by the homeowner or a general handyperson as a matter of urgency.

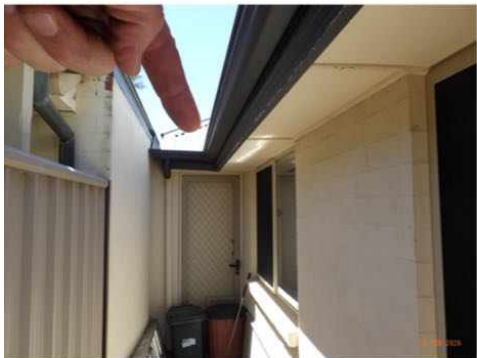
## Finding 2.02

Building:	Building 1
Location:	Roof Exterior
Finding:	Roof plumbing - Rusted or corroded
Information:	The roof plumbing has areas of rust and corrosion. It is suspected that this has been caused by incorrect fall to the gutter and the proximity of the air-conditioner drainage pipe to the area, that have prematurely rusted elements of the roof plumbing.

Rusted roof plumbing will generally develop holes and leaks that can affect other building elements with poor drainage of storm water.

Poorly drained roof areas will also lead to damp conditions surrounding the base perimeter of the building which, if left unmanaged, can lead to a range of secondary building defects.

Repair and/or replacement of rusted roof plumbing is highly required in order to reinstate the roof drainage system to a fully operational level.

To further maintain these areas, gutters should be cleaned frequently, allowing the avoidance of any partial blockages.

A licensed plumber or specialist roof restoration company should be appointed to undertake these works. It is advised that such works be completed as soon as possible to prevent any further damage and deterioration.

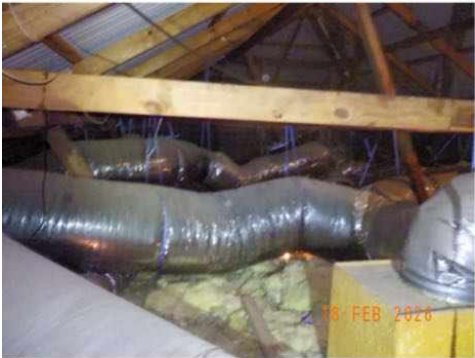
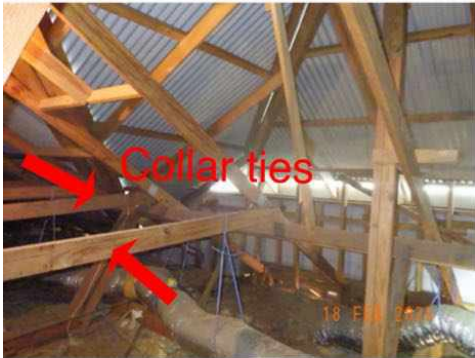
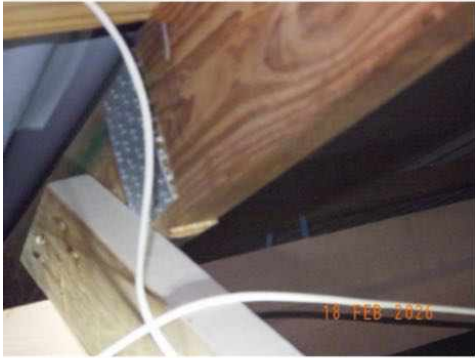
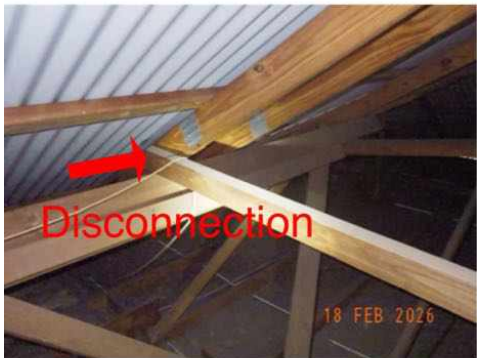
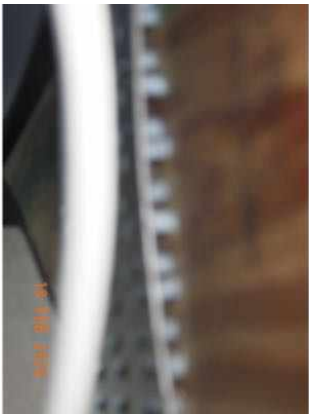
Finding 2.03

Building: Building 1  
Location: Roof Void  
Finding: Roof structure - Collar ties loose/ deteriorated  
Information: Upon inspection of the roofing structure, it was noted that a collar tie has become dislodged from their original fixings bracing and requires bolting in position.

There was also one gang nail that was noted to be backing out and as such all should be checked and repairs carried out.

These collar ties are very long due to the large span and reasonable high pitch and as such they should be braced in the centre and bolted at the ends to prevent further sag and degradation. Additional loads from the AC installation is a small contributing factor also.

Damage to roofing members can create secondary defects, ranging from sagging of the roof to degradation of ceiling linings.

A licensed carpenter should be appointed immediately to install bolts to collar ties and provide further remedial works to ensure no further movement in the future. As these are a structural element advice key be required from a structural engineer. Any loose gang nails should be repaired at the same time.

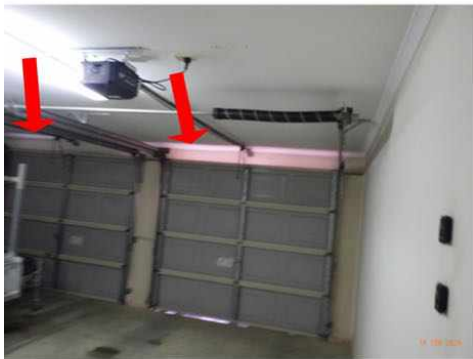
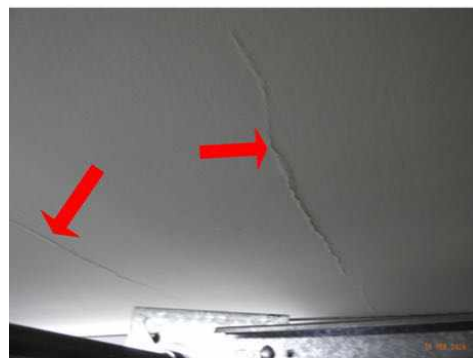
**Finding 3.01**

Building:	Building 1
Location:	Carport
Finding:	Ceiling sagging - Garage (minor)
Information:	Sections of the garage ceiling were found to be sagging and cracking at the time of inspection. Sagging to the fixed ceiling structure generally indicates that the building materials have swollen, due to contact with water, or that fixings (e.g. nails or glue) have become loose and require reattachment.

This is a very common defect in garages due to their lack of insulation, vibration from automatic doors and or their susceptibility to moisture.

Such works may be performed by relevant tradespeople, such as carpenters, plasterers and painters along with repairing the cracks.

It is recommended to insulate the area also to prevent further damage in the future.

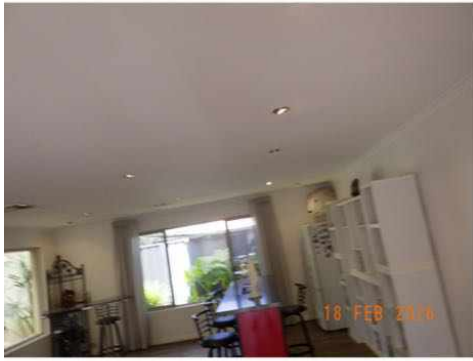
Building:	Building 1
Location:	All Internal Areas
Finding:	Cracking - Damage Category 1 - Fine (up to 1mm)
Information:	There were fine cracks evident to the walls and ceilings throughout the dwelling at the time of inspection.

Although fine cracks are quite noticeable, they are often only considered to be an appearance defect, and usually do not indicate any structural damage. Generally, the cause of a fine crack is indicative of a separation between building materials and finishes (e.g. paint, plaster, etc.) along joints.

Cracking of this nature can generally be repaired with minor sanding, filling and/or repainting. Such works should be performed by a qualified painter or a general handyman.

Monitoring of all cracking should be conducted frequently. Always contact a building inspector should cracks widen, lengthen, or become more numerous.

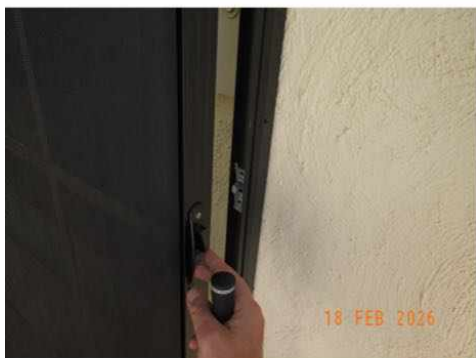
### Finding 3.04

Building:	Building 1
Location:	All Areas
Finding:	Minor defects present
Information:	Minor defects were evident throughout the dwelling at the time of inspection, which are consistent with normal wear and tear and considered appropriate for a property of this age.

These defects are typical of ongoing material ageing, settlement, and general use over time, and include, but are not limited to:

- Gate latch damaged

- Electrical labels are coming loose. Relabelling recommended.

While these defects are not considered structurally significant at present, they should be addressed as part of routine and ongoing property maintenance to prevent further deterioration. Repairs and maintenance works should be carried out by appropriately licensed and qualified tradespeople to ensure the continued serviceability and longevity of the dwelling.

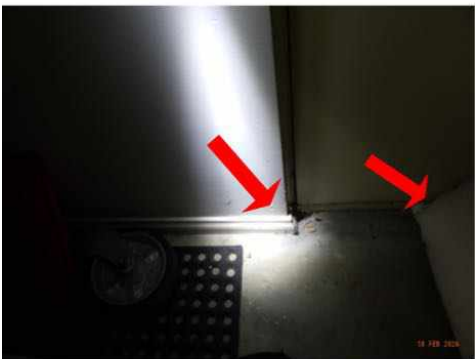
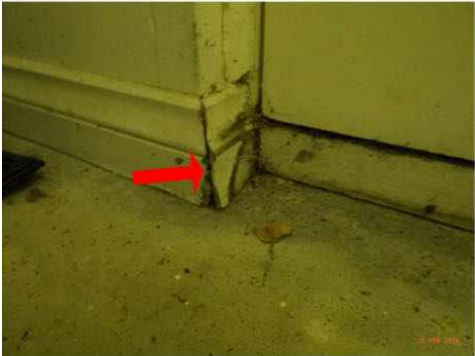
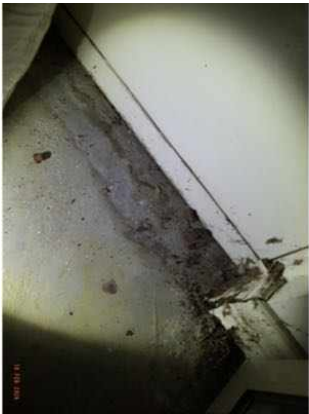
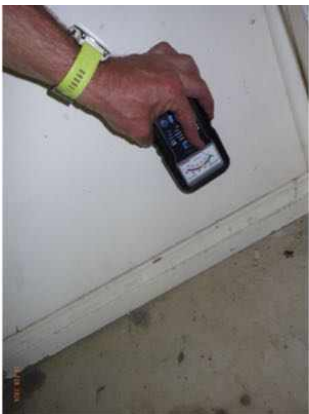
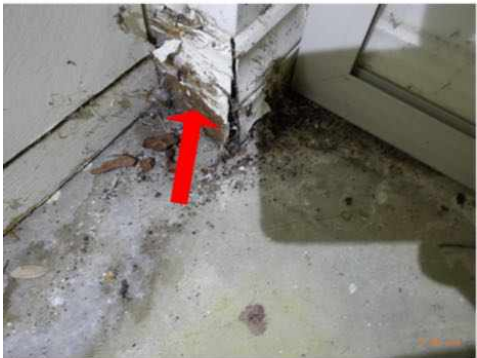
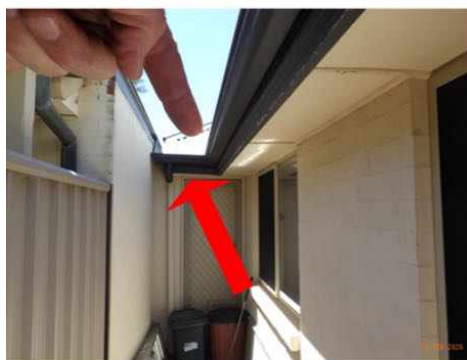
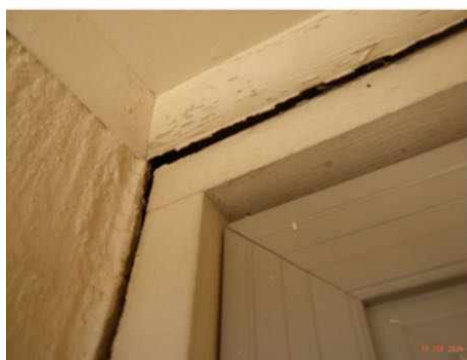
### Finding 6.02

Building: Building 1  
 Location: All Areas  
 Finding: Damp or wet - leak  
 Information: There was damage to the timber skirting evident to the sides of the garage side entry door at the time of inspection.

It appears that moisture is entering through poor seals to this door and as such repair is required.

Damp or wet conditions are generally a direct result of an active leak.. Dry conditions should be maintained to prevent secondary building defects from developing.

If left unattended damp or wet conditions may have many consequences including the development of fungal decay and/or wood rot as well as providing an environment that may be conducive to termite or timber pest attack. Further invasive investigation will likely uncover currently concealed defects.

A qualified carpenter should be appointed immediately to identify the cause of the excessive moisture and make repairs in order to prevent further damage.

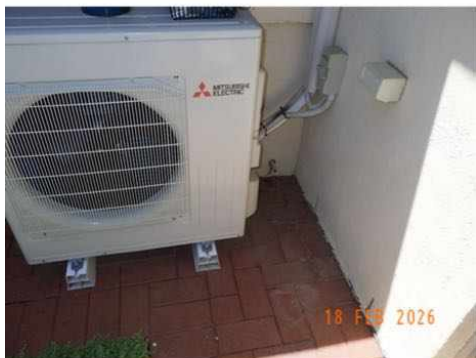
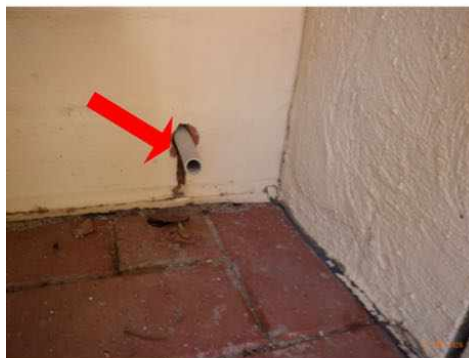
### Finding 6.03

Building:	Building 1
Location:	All External Areas
Finding:	Air conditioner and or external tap - No drainage
Information:	Moisture around the perimeter of the building should be minimised to ensure that the area is kept dry and stable which in turn reduces the risk of water damage and termite infestation.

There appears to be no drainage points set up to the air conditioning unit, and or the external tap. While this is not a legal requirement it is recommended to reduce the risk of moisture related issues and the creation of an environment conducive to termite activity.

It is recommended that a licensed plumber be appointed to set up drainage in order to prevent such an environment from being created.

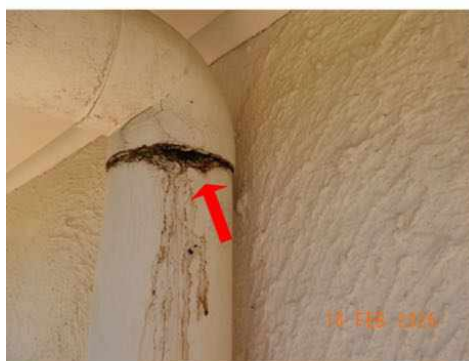
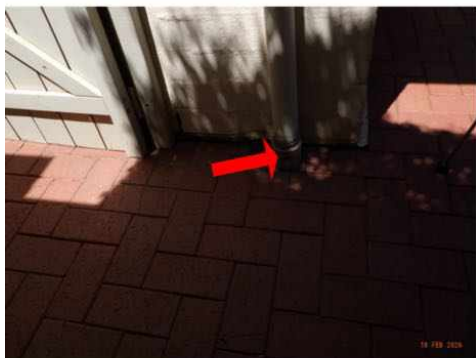
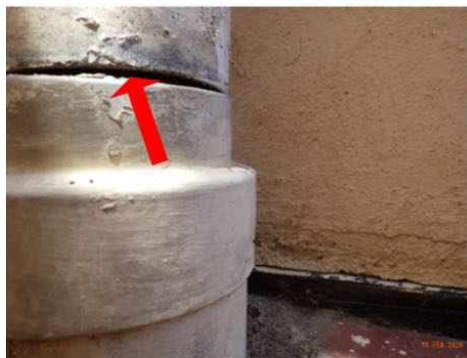
### Finding 6.04

Building:	Building 1
Location:	All External Areas
Finding:	Stormwater drain - damaged/ leaking
Information:	The roof plumbing is not adequately connected to stormwater drainage on the site with damaged evident to several downpipes. Due to this damage the area could be prone to moisture related defects ranging from deterioration of pavements to damage of adjacent building elements.

Where roof plumbing doesn't drain adequately, the area at the base perimeter can become excessively damp, potentially creating an environment that is susceptible to rust and corrosion of surrounding building elements, as well as attracting termites and other pests.

It is highly recommended that a plumber be appointed to further inspect the area and to install adequate drainage equipment where necessary.

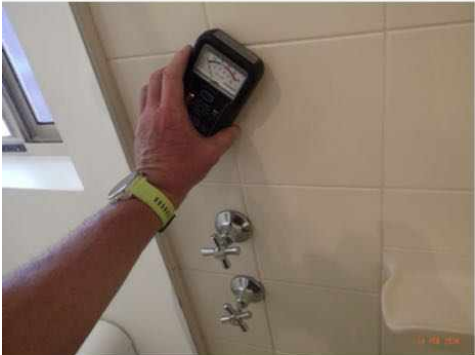
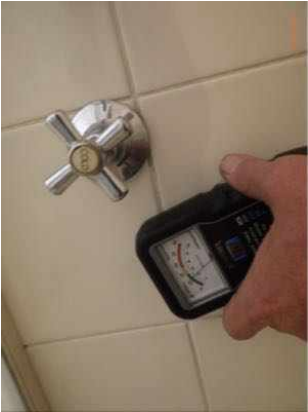
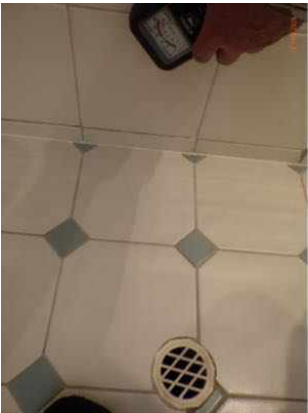
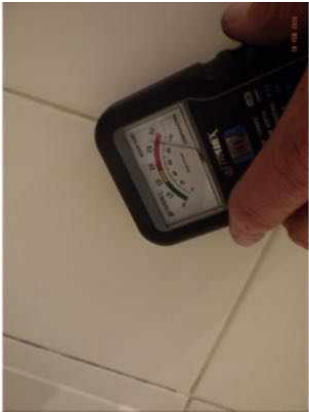
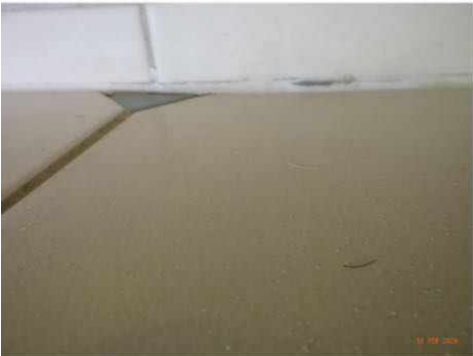
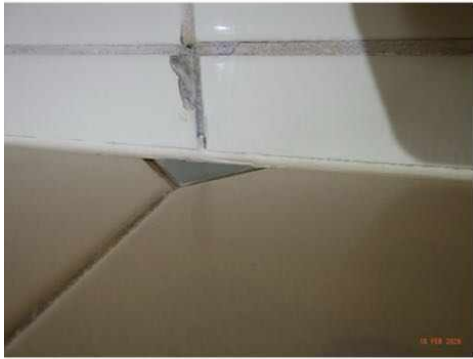
There were no high moisture readings around the taps no were there high readings transferring to the other side of the wall.

Unmanaged damp in the shower recess is likely to facilitate the formation and development of mould and fungi growth, decaying associated building materials and compromising their structural integrity of associated elements.

Damp conditions also create a conducive environment for termite infestation.

Further invasive inspection could uncover currently concealed defects however the issue is localised to very small areas and as such further defects are unlikely as long as repairs are carried out to sealant and grout at regular intervals

Consultation with a bathroom sealant specialist is advised immediately to make repairs to the shower alcove.

Always ensure that sealant and grout is in good condition to prevent any moisture issues occurring in the future.

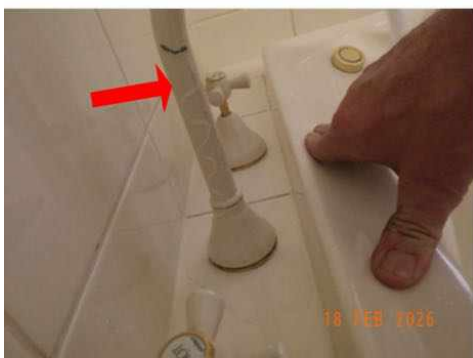
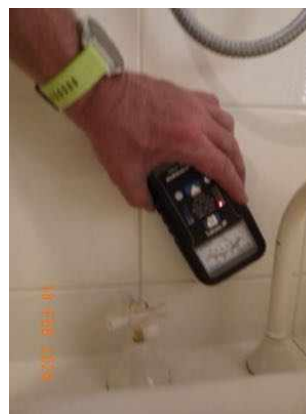
### Finding 6.06

Building:	Building 1
Location:	Bathroom
Finding:	Bath - Leaking
Information:	At the time of inspection, the bath tap showed evidence of leaking during operation likely due to general old age and corrosion as it is leaking out of the spout.

Although common, water leaks can be detrimental to surrounding building elements. Rust, corrosion, decay and water damage are all potential outcomes of a water leak that is left unattended, which are then likely to develop into more serious defects and may necessitate major repair works.

Additionally, water leaks may significantly increase the termite risk to the dwelling.

It is highly advised that water leak be addressed by a licensed plumber as soon as possible. Use of the leaking bath should be minimised until such time as the spout is replaced. .

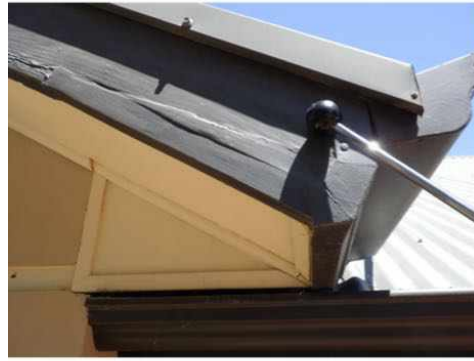
### Finding 7.01

Building:	Building 1
Location:	All External Areas
Finding:	Fascias - Wood rot
Information:	Wood rot was found to be affecting the front barge to the roof, evidenced by the presence of deterioration on the surface. Wood rot, also known as Fungal Decay, occurs when timbers and other cellulose building materials are exposed to damp conditions on an ongoing basis.

It appears that the rot has been repaired however closely monitoring the area to ensure no gutter leak exists is recommended.

It is likely that this wood rot has developed as a result of faults in the roof plumbing, creating excessive moisture in this areas.

Frequent exposure to rain and other weather conditions also make fascias and barges susceptible to accelerated deterioration.

It is advised to monitor the area and should a leak be present then a roof plumber be appointed to inspect all roof plumbing and subsequently identify the cause of the wood rot.

Replacement of affected fascias and barges may then be a necessary step in protecting surrounding building elements from such deterioration and would be carried out by a qualified carpenter.

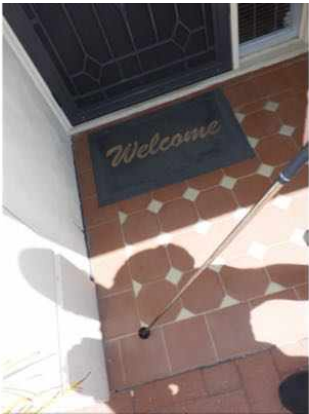
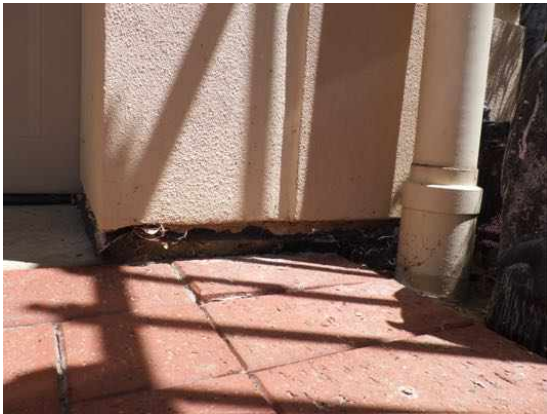
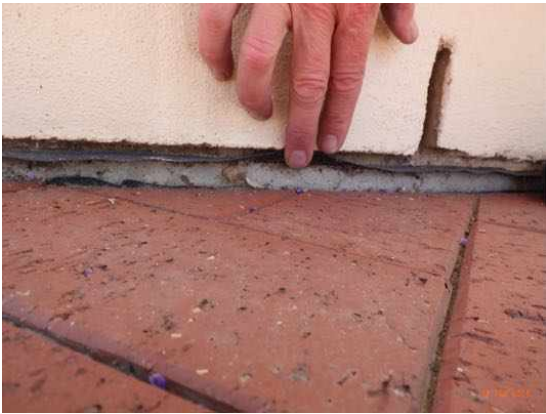
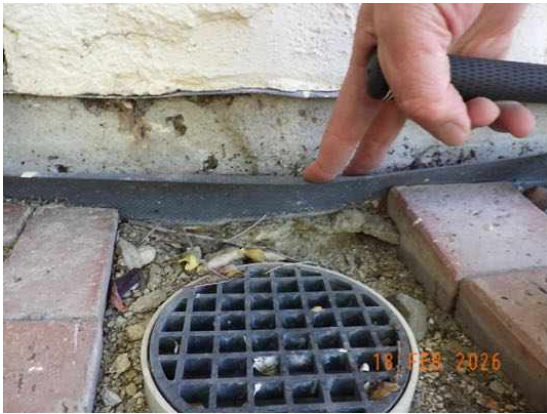
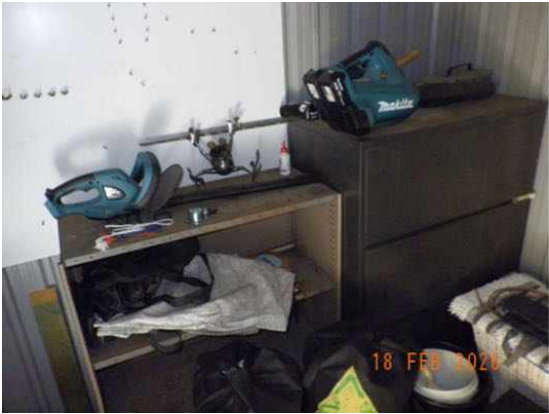
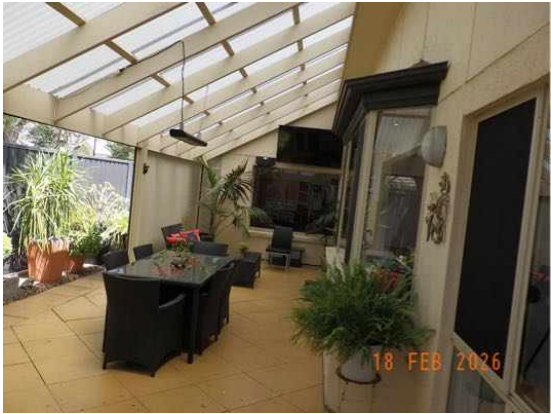
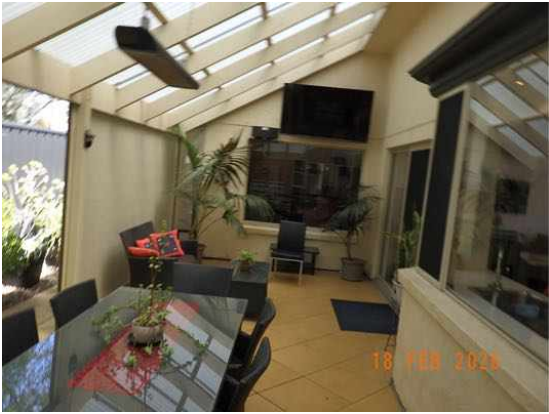
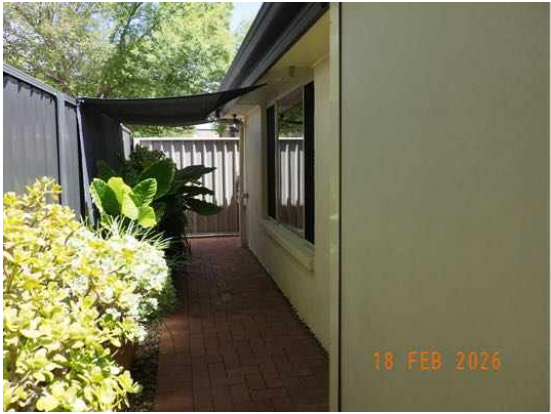
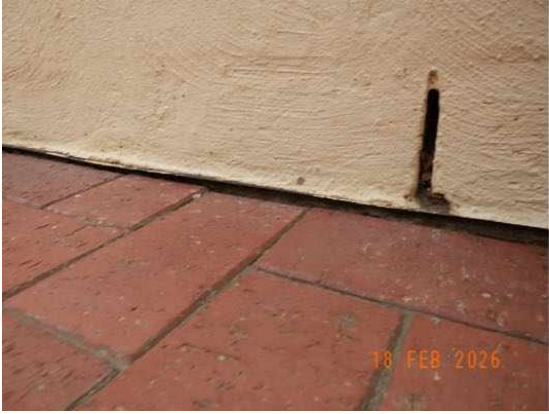
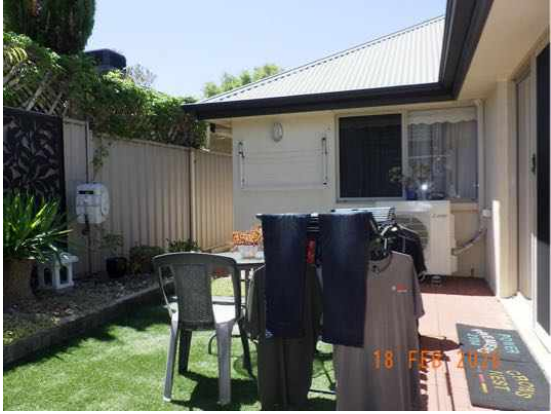
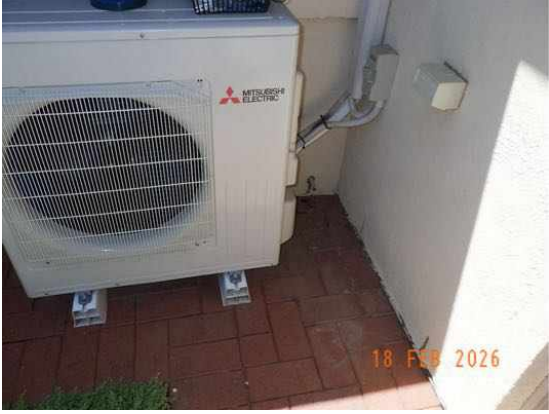
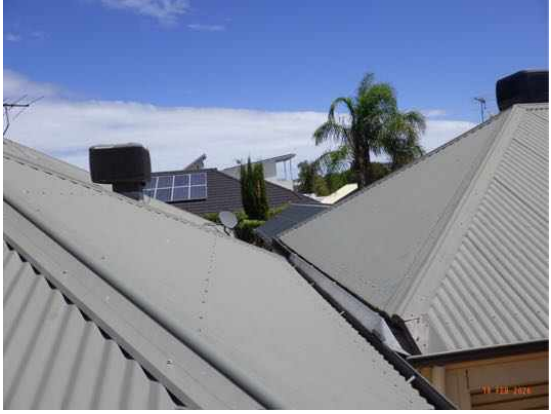
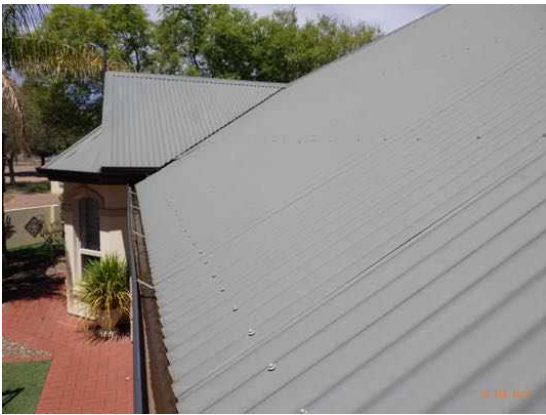
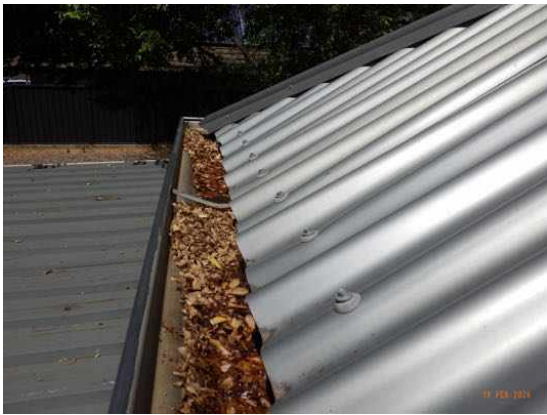
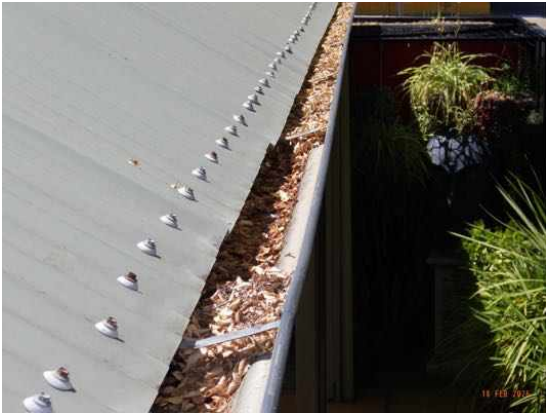
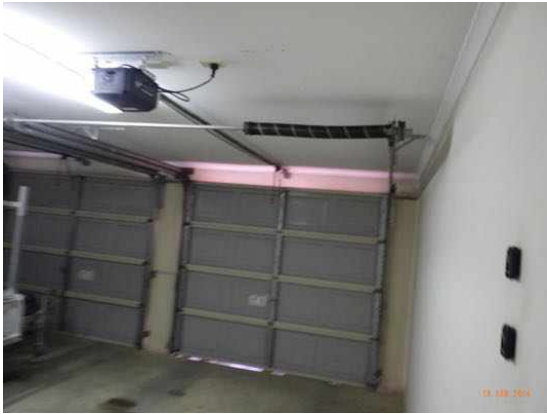
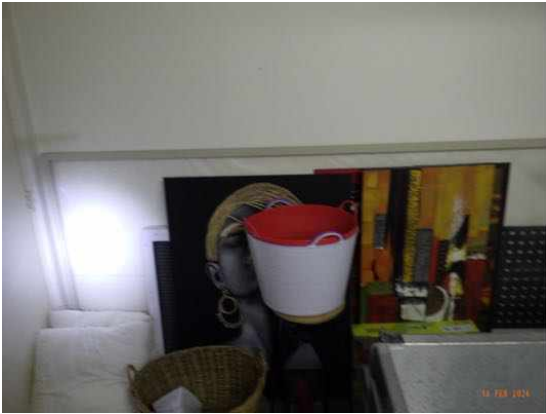
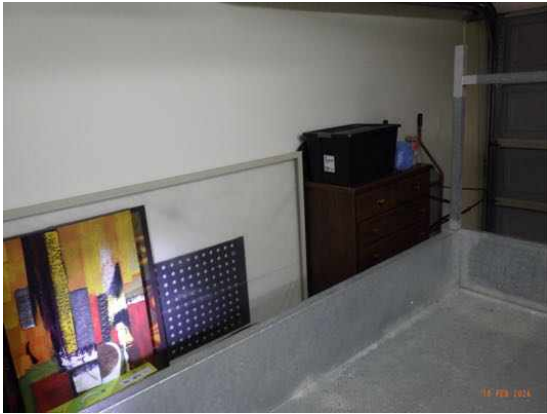
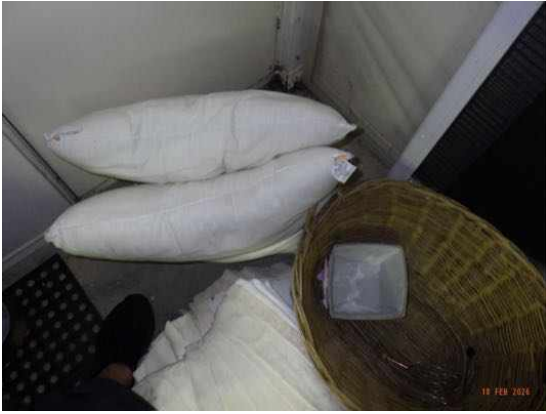
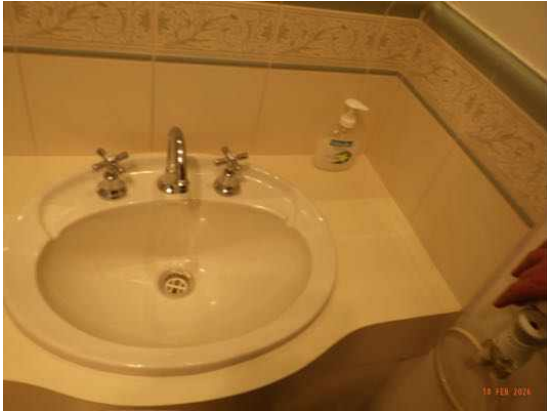
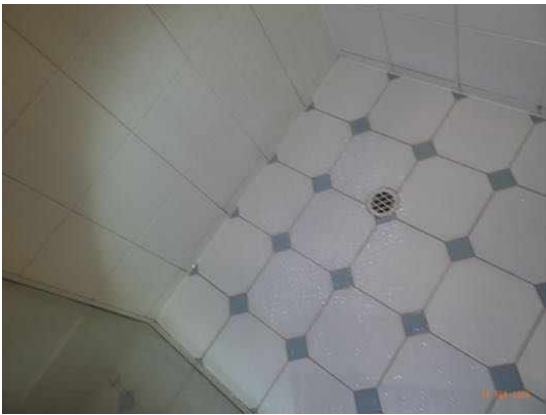
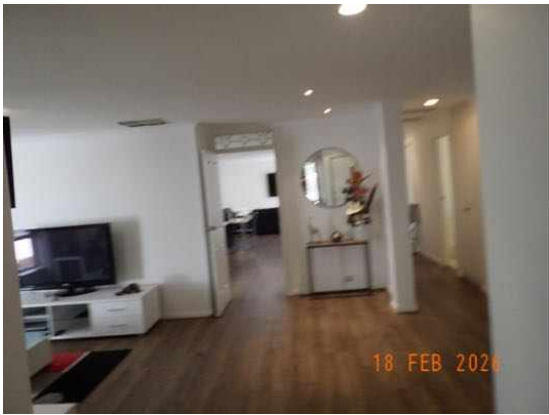
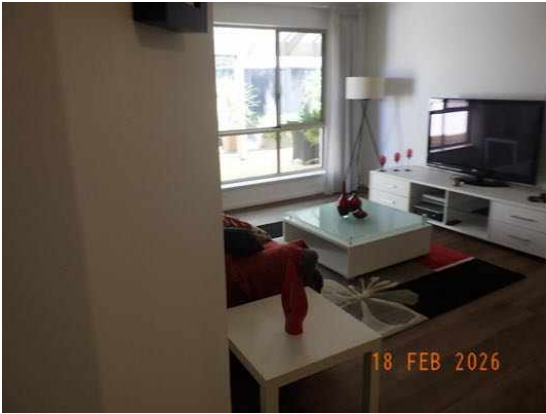
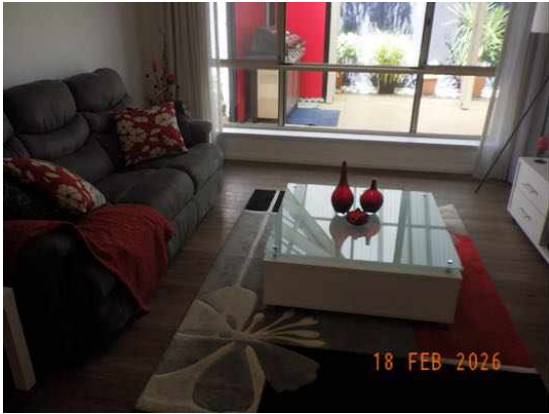
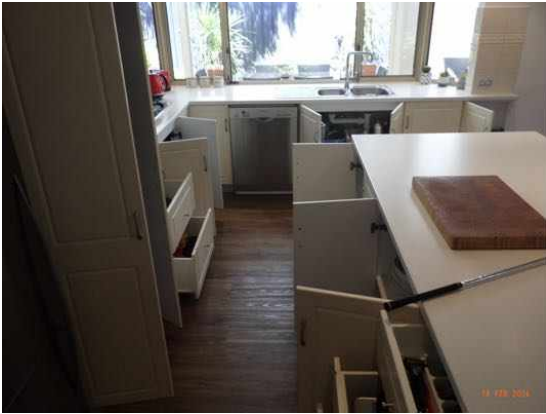
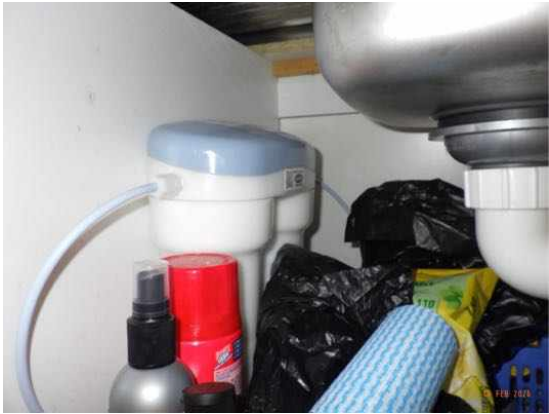
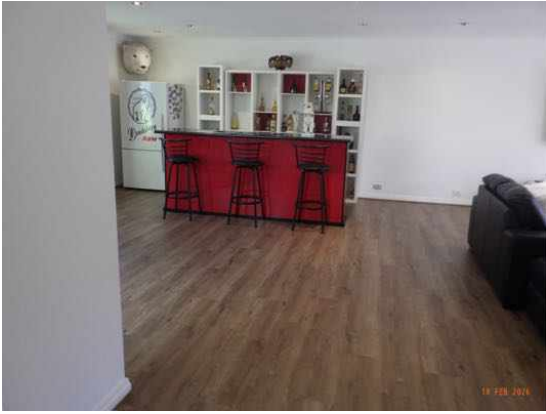
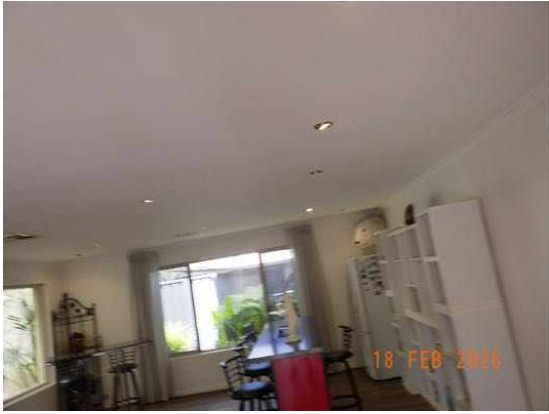
Building: Building 1  
Location: All Areas  
Finding: Additional Photos - Obstructions and Limitations  
Information: These photographs are an indication of the obstructions and limitations which impeded full inspection of the property at the time of inspection. These obstructions can hide an array of defects and should be removed to allow full inspection to be carried out.

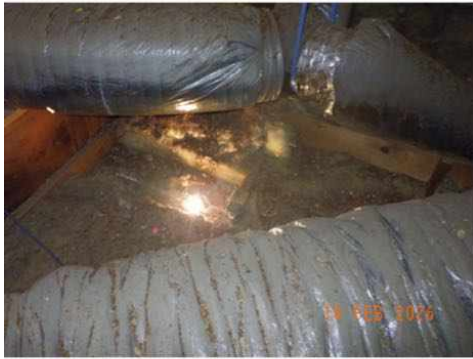
Building:	Building 1
Location:	Roof Void
Finding:	Down-lights, Halogen no protective covers
Information:	There were several lights that appear to be halogen down lights noted throughout the property.

Alternatively the lights could be swapped for LED equivalents which burn cooler and use considerably less power.

A qualified electrician should be appointed to provide further advice and quotation for replacement immediately.
