Building and Timber Pest Inspection Report

Inspection Date: Thu, 12 Feb 2026

Property Address: 70 Lochinvar Parade, Carlingford NSW
2118, Australia

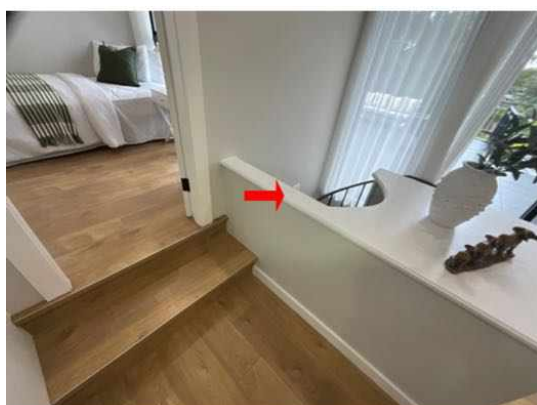
Building: Main Building
Location: Staircase
Finding: Handrail height — Non-compliant
Information: The handrail height in this area was found to be lower than that required in the current standard. Although at the time of construction this may have been compliant, however based on the current standards, this is a non-compliant defect and thus a safety hazard.

This poses a risk and persons coming in contact may fall from heights, thus causing severe injury.

A licensed builder must be appointed as soon as possible to rectify any non-compliance.

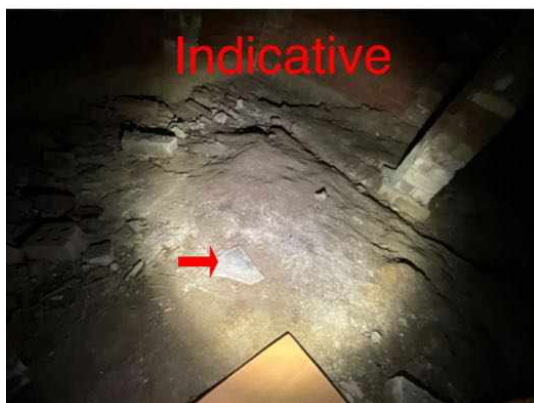
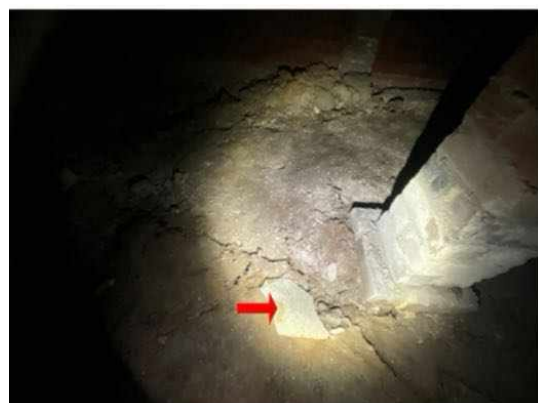
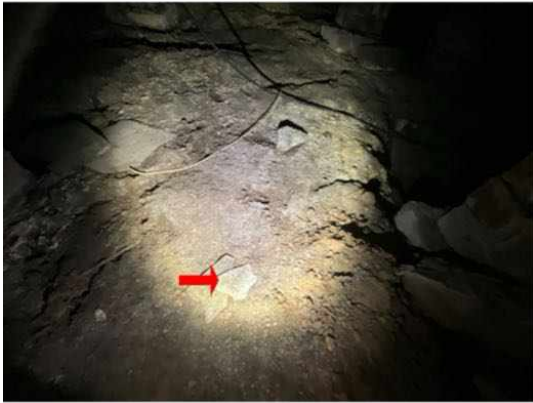
Finding 1.03

Information: Reporting on Asbestos is outside the Scope of this Report. This suspected defect is highlighted as a caution only. We suspect, based on our experience in the building industry, that there is a higher risk of the identified building element containing asbestos.

As Asbestos Reporting is outside the scope of this report, we advise that you consider a separate Asbestos Inspection and Condition Audit, which can include the taking of samples for definitive confirmation of the presence of Asbestos.

In the interim, the client is advised to act with caution, especially when considering any damage to building materials general wear and tear renovations extensions demolition and general maintenance activities due to the suspected presence of Asbestos.

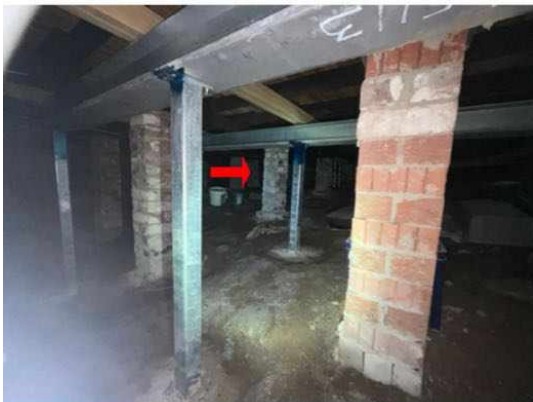
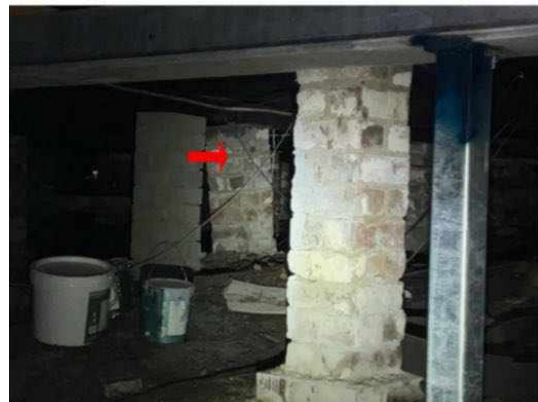
Finding 2.01

Building:	Main Building
Location:	Subfloor
Finding:	Piers -- Leaning (major)
Information:	Some piers to the subfloor are not supporting the suspended structure adequately, indicating that their structural integrity have been affected. The cause of this instability is likely to be caused by movement / subsidence of the pier due to moisture and inadequate site drainage.

Inadequate support is likely to lead to a range of other secondary major and minor defects and hence immediate rectification to these piers are required by a licensed builder. Monitoring and when required improving site drainage is recommended to avoid further movement / subsidence of the affected piers.

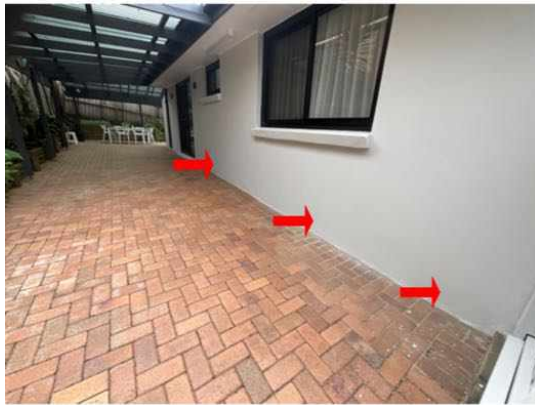
Finding 3.05

Building: Main Building
 Location: Rear Elevation
 Finding: Stormwater drain - Not connected
 Information: The roof plumbing is not adequately connected to stormwater drainage on the site. This disconnection negatively impacts the functional capacity of the roof plumbing.

Where roof plumbing doesn't drain adequately, the area at the base perimeter can become excessively damp, potentially creating an environment that is susceptible to rust and corrosion of surrounding building elements, as well as attracting termites and other pests.

It is highly recommended that a plumber be appointed to further inspect the area and to install adequate drainage equipment where necessary.

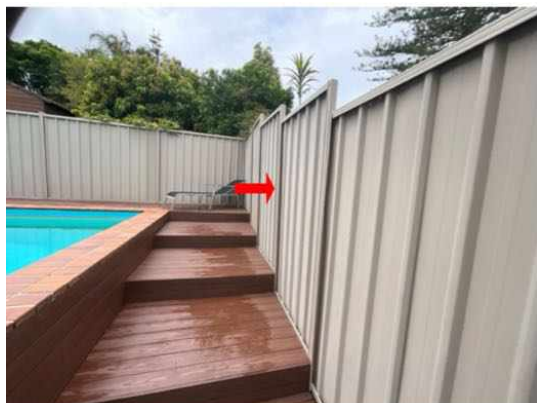
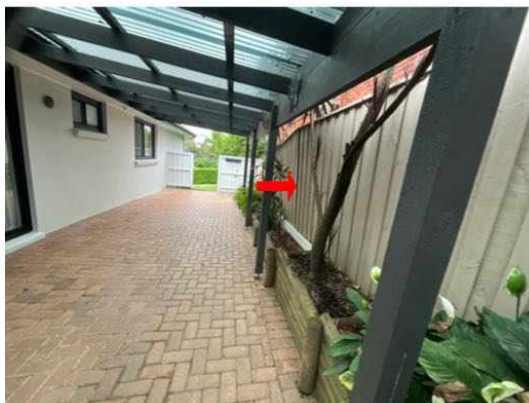
Finding 3.07

Building:	Main Building
Location:	Roof Exterior
Finding:	Trees - Overhanging and filling gutters
Information:	Overhanging trees often result in excessive amounts of leaf debris accumulating in gutters.

Gutters are a critical part of the building's management of storm water and rain. It is therefore important that they be kept clear to prevent secondary damage to associated building elements, including exterior and interior walls, ceiling linings and any adjoining building elements. Where gutters are blocked, pooling of rainwater is likely to occur, fast-tracking rust and corrosion of the roof plumbing elements.

It is highly advised that all overhanging tree branches be removed as soon as possible to prevent any further damage. Repair and/or replacement of sections of damaged guttering may also be required where the extent of the damage necessitates.

Such works should be performed by the homeowner; however, appointment of a landscape contractor or an arborist may be required. Consultation with a licensed roof plumber is required where guttering has been damaged.

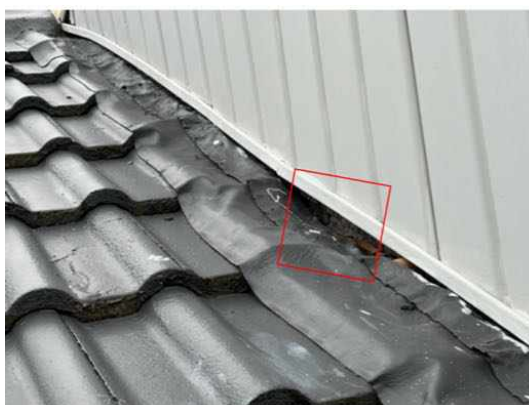
Finding 3.09

Building:	Main Building
Location:	Alfresco
Finding:	Roof plumbing - Missing
Information:	Some sections of the roof are not adequately drained via gutters and downpipes. Gutters and downpipes that are not installed adequately are likely to result in excessively damp conditions against the exterior surfaces and around the base perimeter of the building.

Excessive moisture creates an environment which accelerates the deterioration of building elements in the area, as well as being conducive to termite and pest infestation. Such an environment is likely to necessitate repair and/or replacement of building elements, which are prone to sustaining wood rot, rust or corrosion.

A roofing plumber should be appointed as soon as possible to install relevant roof plumbing materials. Depending on the extent of the damage, repair and/or replacement of damaged building elements may be required.

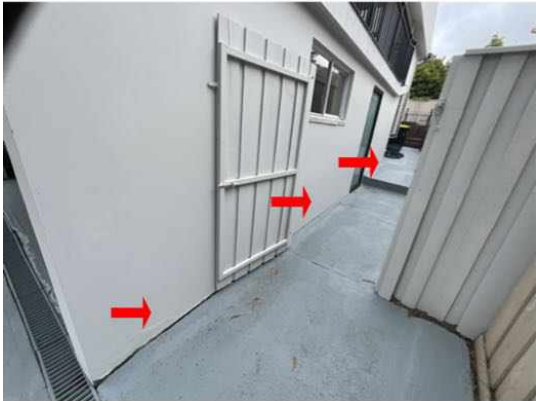
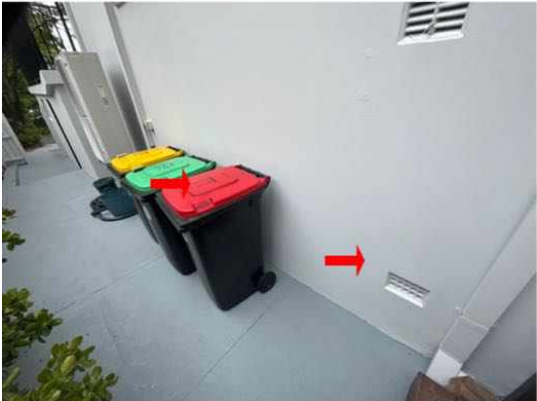
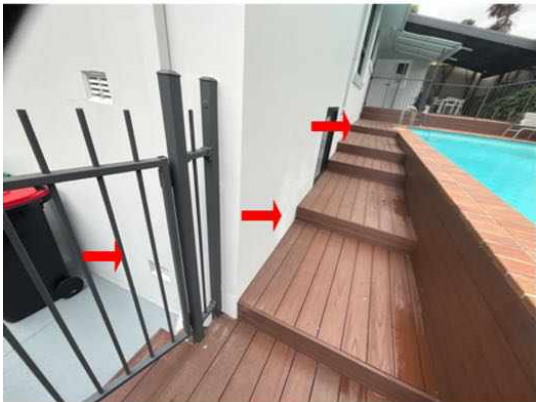
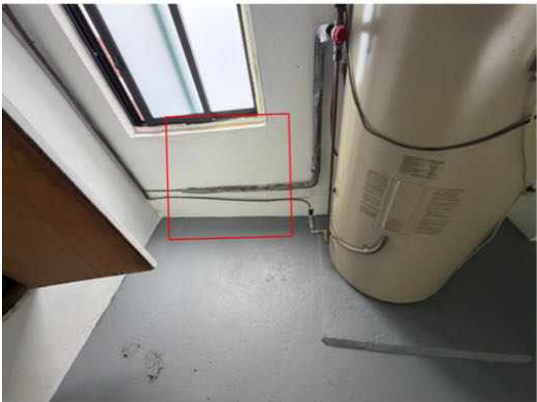
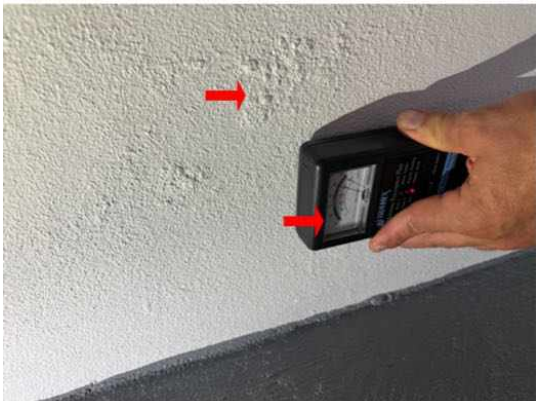
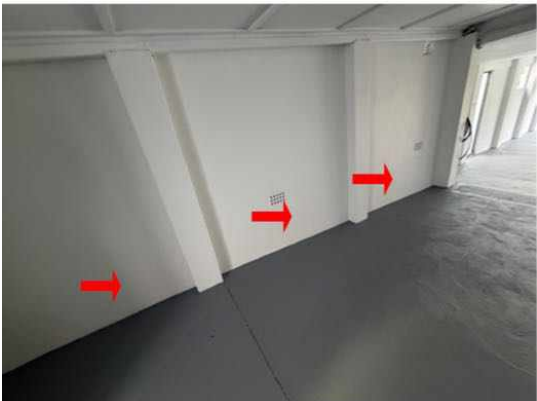
Building:	Main Building
Location:	Garage
Finding:	Exterior walls - Lateral damp
Information:	Lateral penetrating damp refers to the sideways movement of moisture, predominantly from the surrounding ground, which tends to affect basement walls and other earth-retaining walls. The implications of unmanaged damp range from mould fungi growth, wood rot and decaying building materials, to finishes including lifting, bubbling, peeling and staining of paint, plaster and wallpaper.

It is important to address damp conditions as the World Health Organisation notes that excess moisture leads - on almost all indoor materials - to the growth of microbes such as moulds, fungi and bacteria, which subsequently emit spores and other matter into the indoor air. Exposure to these contaminants is associated with a wide range of respiratory and other health-related problems. Additionally, the development of damp in timber building elements also provides an environment that is conducive to termite / timber pest attack.

Structural waterproofing barriers or tanking barriers are often used to protect internal surfaces against the effects of lateral penetrating dampness. These types of work are generally undertaken where the source of the penetrating damp cannot be prevented.

Immediate consultation with a licensed plumber is advised to address the cause of the damp and to perform remedial works as necessary.

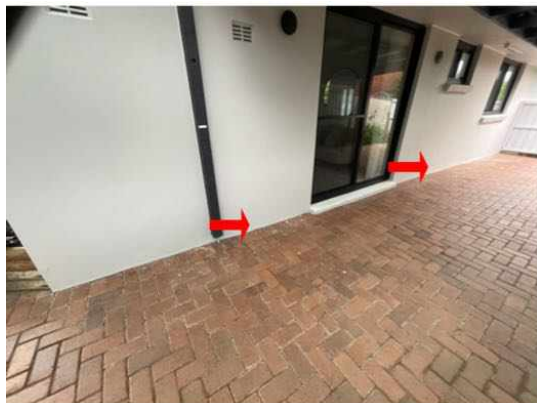
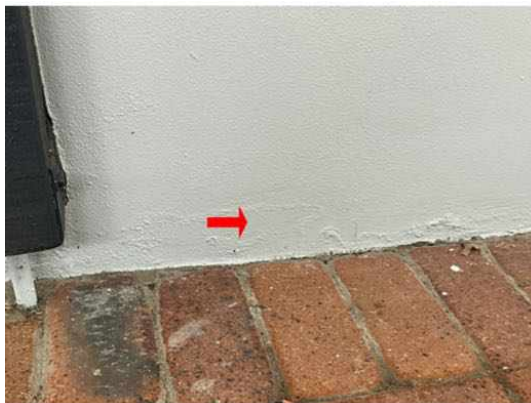
Finding 6.02

Building:	Main Building
Location:	Exterior walls - right side
Finding:	Damp rising / Bridging DPC with render
Information:	Rising damp was identified to multiple areas, which appears to have caused surface render and paint damage.

Rising damp is generally managed by the installation of a damp proof course (DPC) during construction. A Damp Proof Course (DPC) is an impermeable barrier at the base of the wall above ground level. Hence having dampness below the DPC level is normal. However and furthermore the DPC appears to have been bridged with render, which allows moisture travel above the DPC level.

Left unmanaged, rising damp can lead to health problems resulting from mould growth and can have negative implications on affected building elements, including wall finishes like paint and render.

Consultation with a licensed builder and a qualified renderer is advised immediately to perform remedial works as required. It is advised the render under the DPC to be stripped back to the substrate.

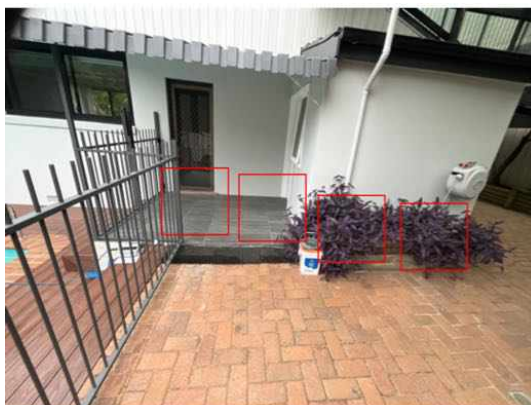
Finding 6.03

Building: Main Building
 Location: Walls - Right & Rear
 Finding: Bridging or breaching of termite barriers - damp course level
 Information: Bridging is the spanning of a termite barrier or inspection zone so that subterranean termites are provided with passage over or around that barrier.

Damp proof course (DPC) is a barrier of impervious material built into a wall or pier to prevent moisture from moving to any part of the building. Where external ground levels are built up over this barrier ingress is provided for moisture from the exterior grounds into the base brickwork or other building material and allowed to rise.

Such conditions attract termites into these damp areas which is likely to lead to infestation if left untreated.

While retrospective fitting of DPC is considered to be impractical works are required in order to prevent the extraction of moisture from the external environment into exterior brickwork or wall materials. Landscaping or re-paving of external grounds may be considered by the client. Regular annual inspections are strongly advised.

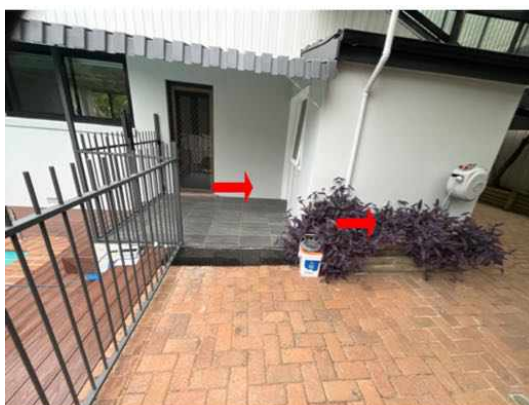
Finding 6.04

Building:	Main Building
Location:	Walls - Right & Rear
Finding:	Air vents - Blocked or inadequate
Information:	It was noted at the time of inspection that the subfloor area lacks adequate ventilation. The cause of this inadequate ventilation is the state of the air vents to the subfloor area. Where air vents are insufficient in number or are blocked, either fully or partially, subfloor ventilation is decreased.

A well ventilated subfloor aids in maintaining dry conditions, preventing secondary damage such as wood rot and pest activity, as well as preventing the development of mould/fungi and mildew (which can lead to major respiratory issues or safety hazards for occupants, particularly the elderly, the very young and those with existing illnesses).

All air vents should be cleared of blockages to promote adequate air flow to the area. Where ventilation is still insufficient, retrospective installation of air vents may be required. Appointment of a registered builder may be required to perform these works as necessary.

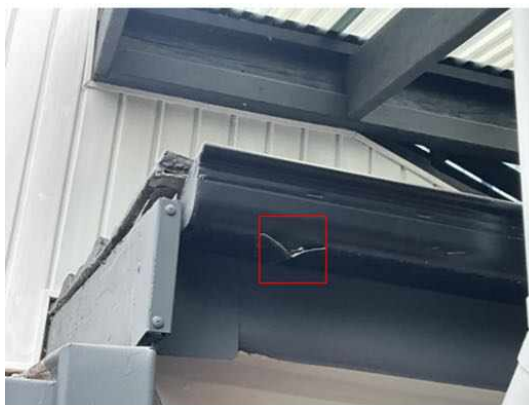
Finding 6.05

Building:	Main Building
Location:	Rear Elevation
Finding:	Stormwater drain - Not connected
Information:	The roof plumbing is not adequately connected to stormwater drainage on the site. This disconnection negatively impacts the functional capacity of the roof plumbing.

Where roof plumbing doesn't drain adequately, the area at the base perimeter can become excessively damp, potentially creating an environment that is susceptible to rust and corrosion of surrounding building elements, as well as attracting termites and other pests.

It is highly recommended that a plumber be appointed to further inspect the area and

to install adequate drainage equipment where necessary.

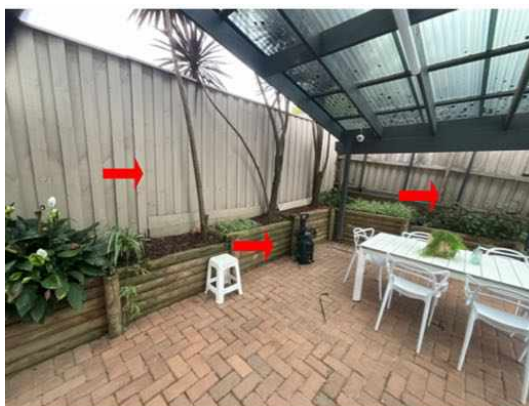
Building:	Main Building
Location:	Fencing & Landscaping
Finding:	Building materials in direct ground contact - conducive to termites
Information:	Where timber elements are in direct contact with the ground and consequently moisture or dampness they become conducive to termite activity. Whether timber is used as a building element part of a fencing structure or stored as an unused item they can provide an environment that is attractive to termite infestation.

When met with excessive moisture timber begins to decay and develop wood rot. Any timbers that are in direct contact with external grounds especially if left untreated or non-durable also provide ingress for subterranean termites into that particular element.

The removal of any such materials that may be conducive to termite activity should be removed as soon as possible to minimise the risk of termite attack.

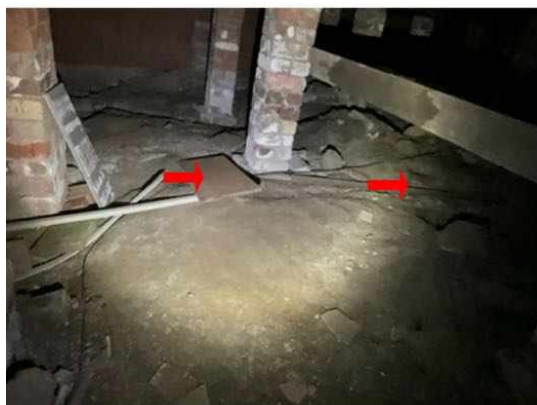
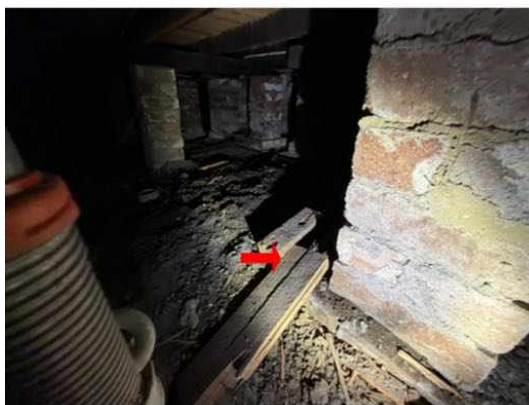
Finding 6.09

Information: The storing of timbers in the subfloor space or around the external property increases the risk of termite activity being present. As they are likely to come into contact with weather conditions or excessive moisture wood rot is likely to develop on timbers that are not treated.

It is highly recommended that any stored timbers be immediately removed from areas in which they may attract any termite / timber pest attack. Minimisation of risk / prevention of termite attack is far more adequate than dealing with the presence of termite activity.

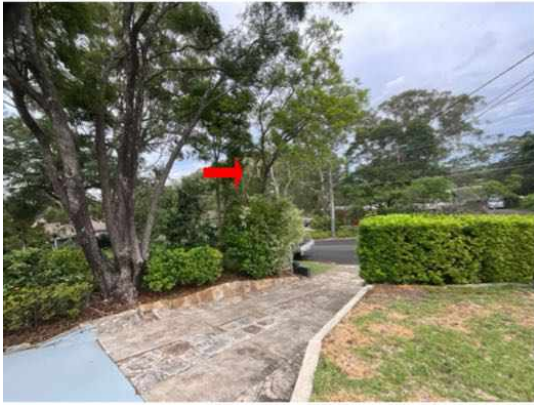
Finding 6.10

Finding: Surrounding bushland - Conductive

Information: Home and or building is situated in a high risk area for termite activity, due to close proximity to surrounding bushland.

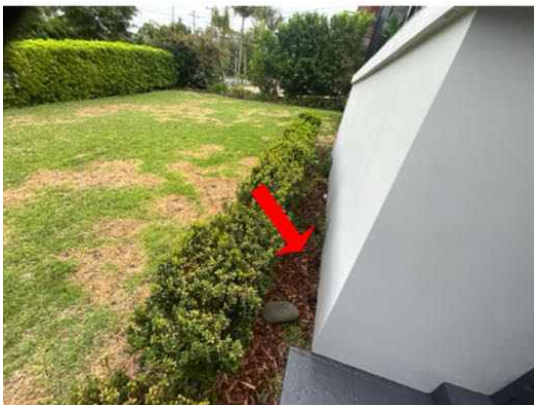
Finding 6.11

Building:	Main Building
Location:	Garden beds
Finding:	Garden Beds
Information:	Garden beds were found to be evident in the garden area. These garden beds can include untreated timber, and with a combination of moisture from watering or hosing can make conditions conducive to termite activity and termite ingress.

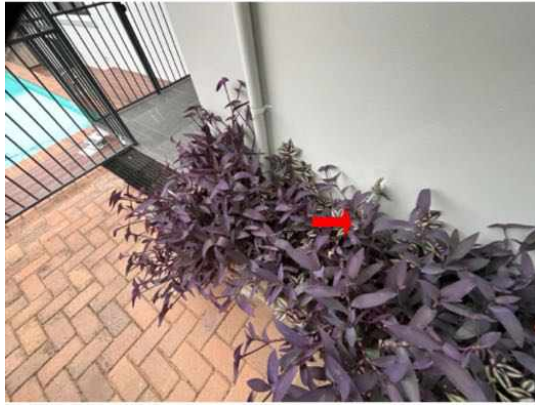
Finding 6.12

Building:	Main Building
Location:	External tap
Finding:	Tap - No drain
Information:	<p>The external tap in this area was noted to have no drain at the time of inspection.</p> <p>This keeps the surrounding surfaces damp while using the tap, which becomes conducive to termite activity.</p> <p>A licensed plumber must be appointed to ensure an appropriate drain is installed.</p>

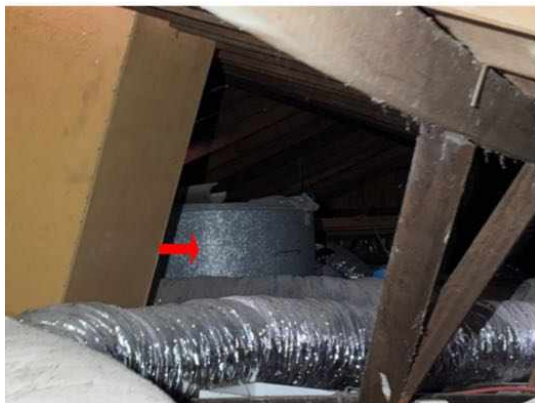
Finding 6.13

Building:	Main Building
Location:	Roof Void
Finding:	Gravity-Fed HWS - Disconnected
Information:	It was noted at the time of inspection that a disconnected gravity-fed hot water system (HWS) remains in this area.

Despite this plumbing structure being unused, it is likely to be storing residual water, and is therefore susceptible to rust and corrosion. If allowed to continue, rust and corrosion is likely to lead to damage to adjoining building elements, and may also make the area susceptible to termite or timber pest activity.

While it is a costly exercise to remove the disused gravity-fed HWS, it is advisable in the short-term future to prevent any further damage to the area. Further consultation with a licensed plumber is required to gain further advice on removal of the structure.

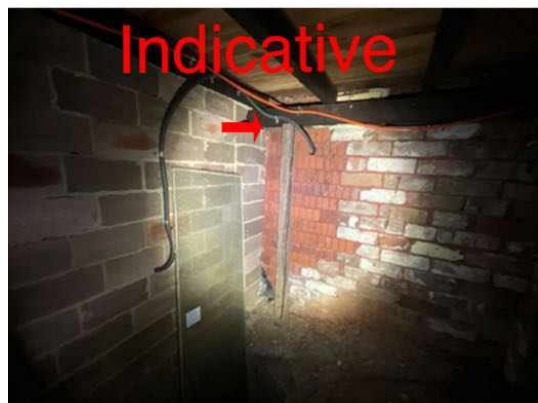
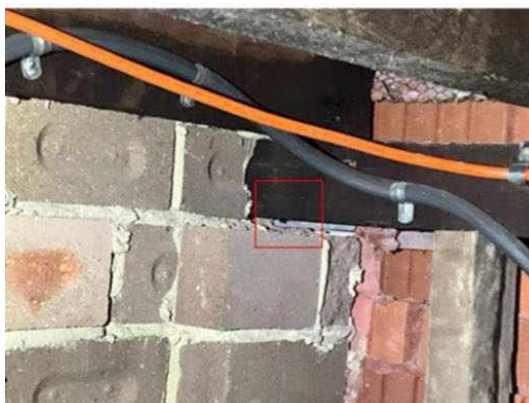
Finding 6.14

Building:	Main Building
Location:	Subfloor
Finding:	Ant caps - Not installed
Information:	Ant caps have not been installed to multiple areas of the subfloor structure at the time

Where ant caps have not been installed, frequent monitoring of these areas should be carried out in order to identify any signs of termite or timber pest workings.

A licensed builder must be appointed urgently to replace any missing ant caps.

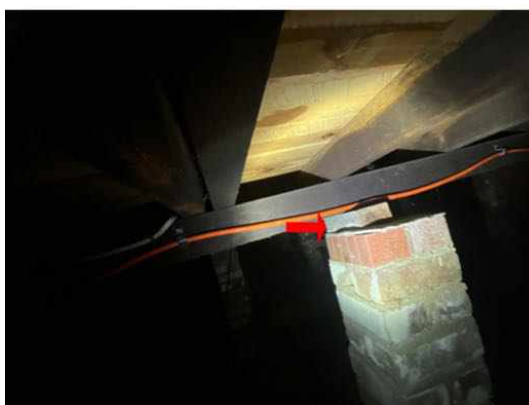
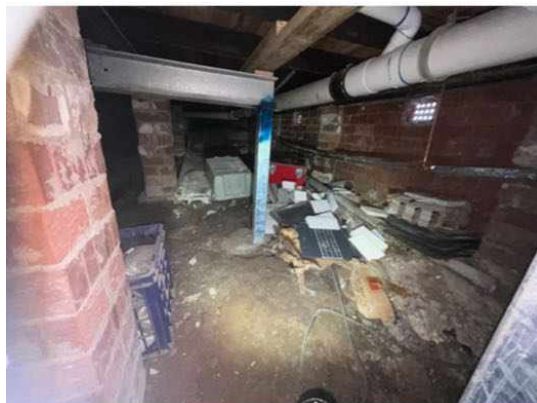
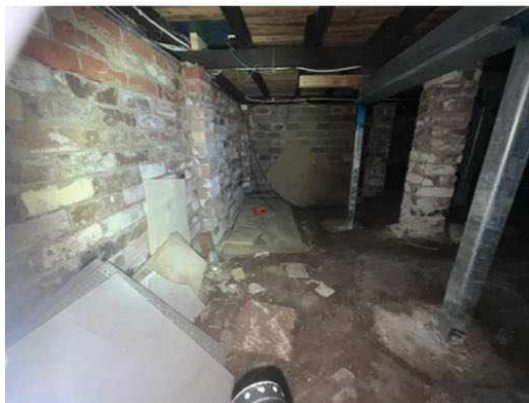
Finding 6.15

Information: An array of debris was found in the subfloor area at the time of inspection. Debris in this area restricts subfloor ventilation and creates potential for concealed pest entry. Stored timbers and other materials may also make the area susceptible to termite activity and wood rot.

A clear and empty subfloor will be better ventilated and easier to maintain in a dry condition. The removal of any timber debris is vital in minimising the risk of termite or wood borer activity.

Debris in the subfloor should be removed as soon as possible. Depending on the location and amount of debris and stored items, the homeowner may elect to undertake this task. Alternatively there are a large number of rubbish removal subcontractors that could undertake these works.

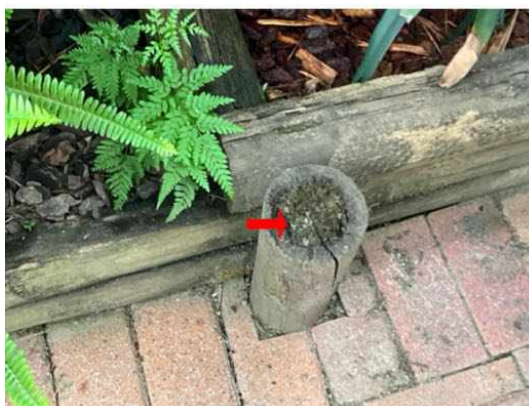
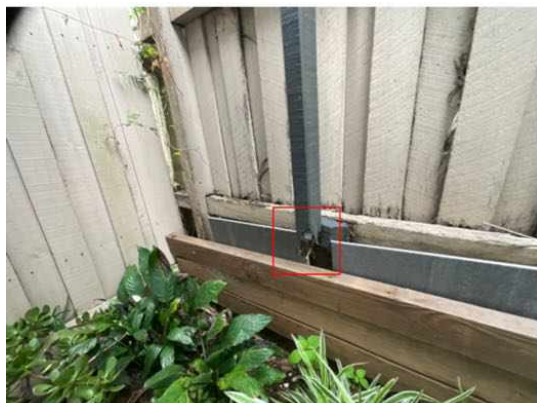
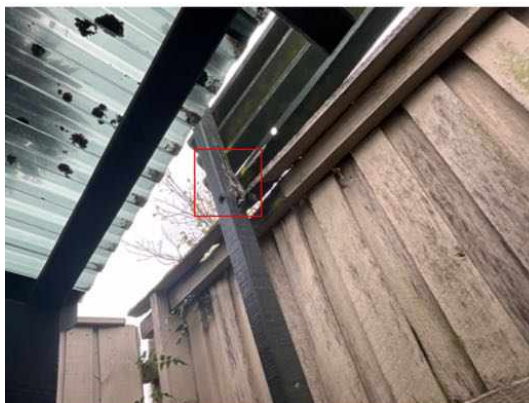
Finding 7.01

Building:	Main Building
Location:	Landscaping
Finding:	Wood rot/decay
Information:	This building element shows evidence of wood rot. Wood rot, also known as Fungal Decay, occurs when timbers and other cellulose building materials are exposed to damp conditions on an ongoing basis. This could be the result of exposure to weathering over a prolonged period of time, or the attraction of excessive moisture from other abutting building materials. Contributing factors also include poor air ventilation in the area.

Wood rot is often associated with general damp problems and is evidenced by a `musty` smell or mould and mildew occurring on surfaces. If left unmanaged, damp conditions can lead to further health problems and the decay of timbers will continue.

Early intervention and regular maintenance, particularly of exterior timbers, will prolong the useful life of these building elements. Prior to any works being performed, the cause of the moisture that has created the visible wood rot should be identified and addressed in a suitable manner. Replacement of affected timbers may then be a necessary step in protecting surrounding building elements from such deterioration.

A licensed plumber may be appointed to assess the cause of excessive moisture and to provide advice on any remedial works as required. A licensed carpenter may also be required to replace affected building materials.

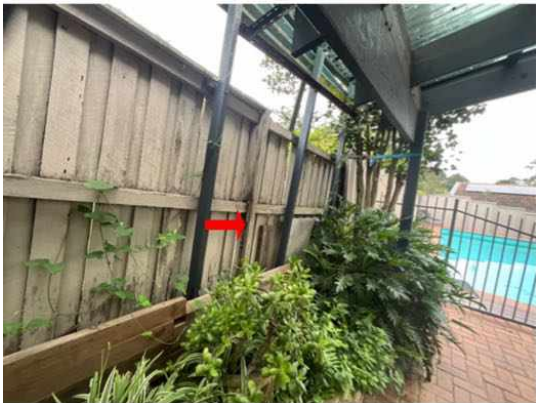
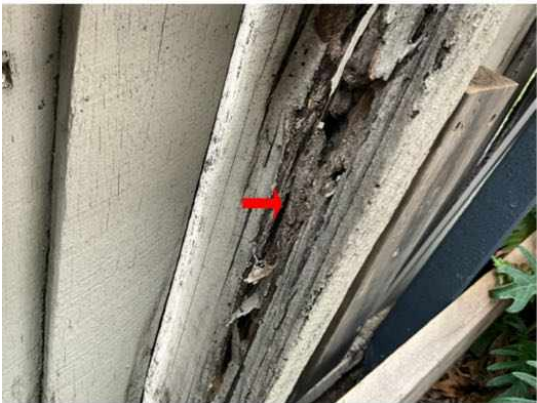
Finding 8.01

Building:	Main Building
Location:	Fencing
Finding:	Evidence of wood borer activity identified
Information:	Wood borers small beetles that colonise in exposed timber elements are a common timber pest that are regularly mistaken for termites. Although wood borer activity is generally not detrimental to the affected timber they may lead to serious damage and necessitate replacement of certain building elements if left unattended.

The other commonly known borer the Anobium borer is more likely to attack floorboards and may cause severe structural damage to flooring areas.

As no live wood borer activity was identified treatment is not required at this time. Replacement of affected timbers may be considered by the client for superficial reasons.

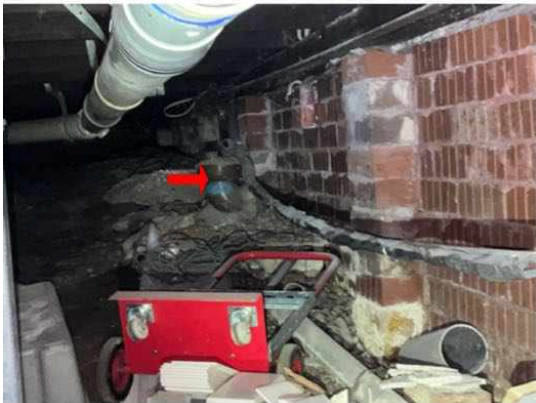
Building:	Main Building
Location:	
Finding:	Pipework - Old urban wear pipes
Information:	Old urban wear pipes were identified at the time of inspection.

Consultation with a licensed plumber is advised. CCTV inspection on pipes may be required.

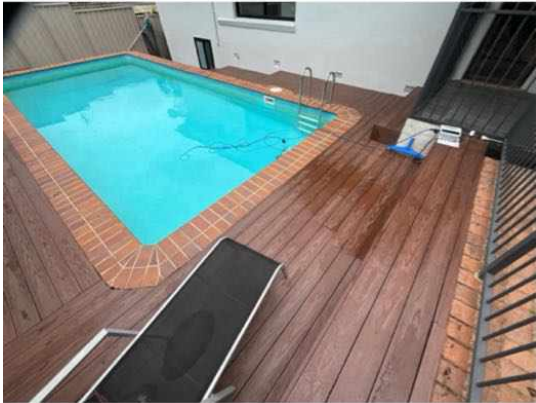
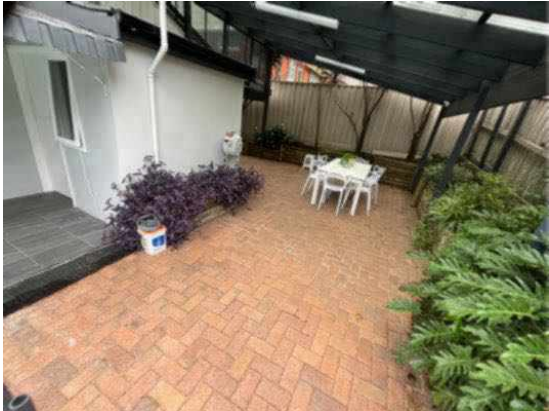
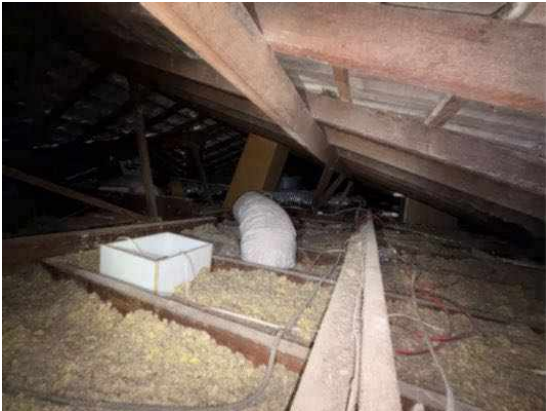
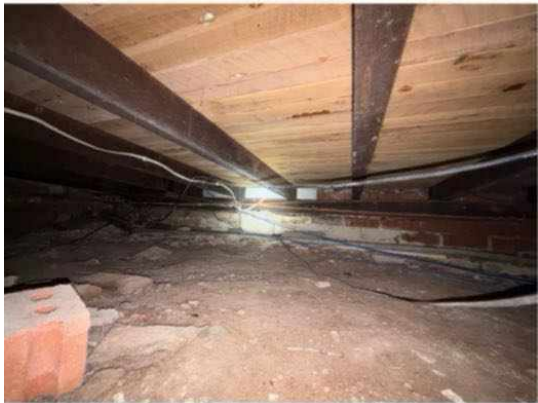
Building: Main Building
Location: All Areas
Finding: Additional Photos - Obstructions and Limitations
Information:

These photographs are an indication of the obstructions and limitations which impeded full inspection of the property at the time of inspection. These obstructions can hide an array of defects and should be removed to allow full inspection to be carried out. A re-inspection is recommended once the areas are made accessible.
