Building and Timber Pest Inspection Report

Inspection Date: Tue, 7 Apr 2026

Property Address: 134 West St, Casino NSW 2470, Australia

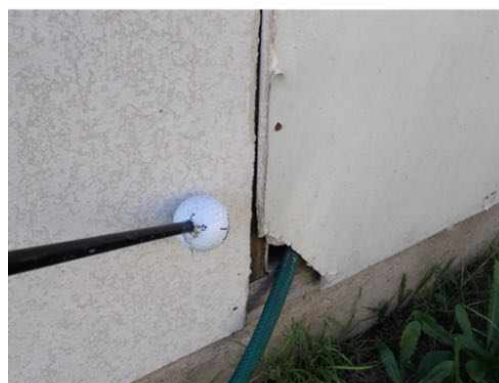
Finding 1.01

Building:	Main Building
Location:	Left hand elevation
Finding:	Damaged External Cladding Suspected To Contain Asbestos
Information:	External cladding suspected to contain asbestos has been identified as damaged. This may be due to age-related deterioration, impact damage, or previous works. Disturbance of asbestos-containing materials can pose a health risk if fibres become airborne. It is recommended that a licensed asbestos professional assess the material, confirm its composition, and carry out any necessary repairs or removal in accordance with relevant regulations. Repairs should be undertaken in a controlled manner to minimise risk.

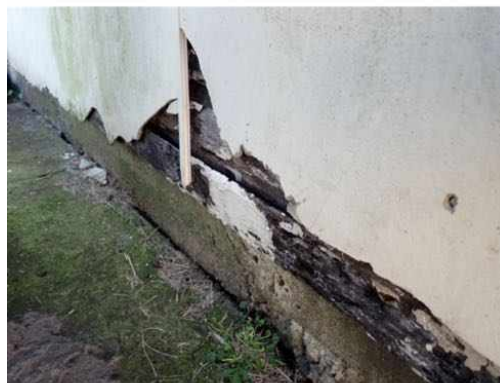
Finding 1.02

Building:	Garage
Location:	External cladding
Finding:	Damaged External Cladding Suspected To Contain Asbestos

Information: External cladding suspected to contain asbestos has been identified as damaged. This may be due to age-related deterioration, impact damage, or previous works. Disturbance of asbestos-containing materials can pose a health risk if fibres become airborne. It is recommended that a licensed asbestos professional assess the material, confirm its composition, and carry out any necessary repairs or removal in accordance with relevant regulations. Repairs should be undertaken in a controlled manner to minimise risk.

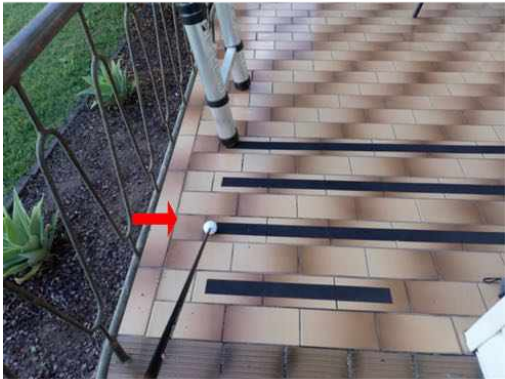
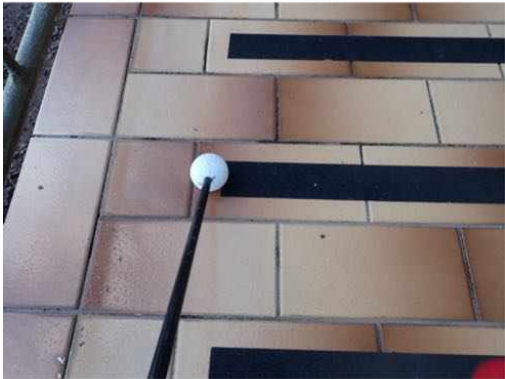
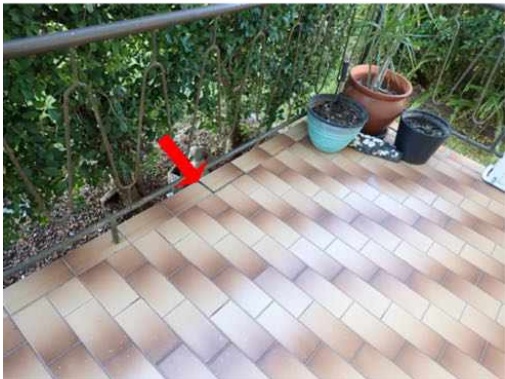
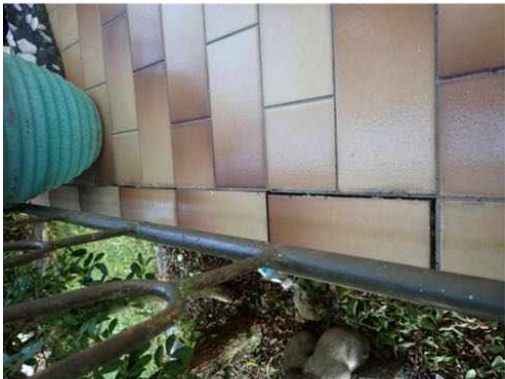
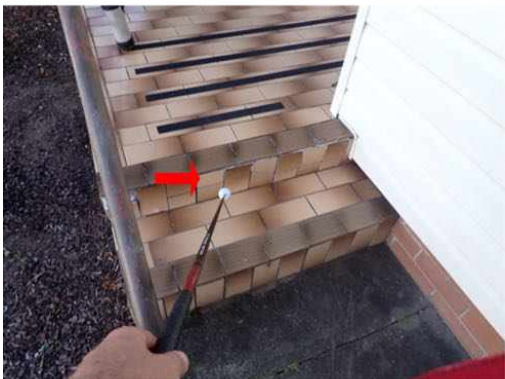
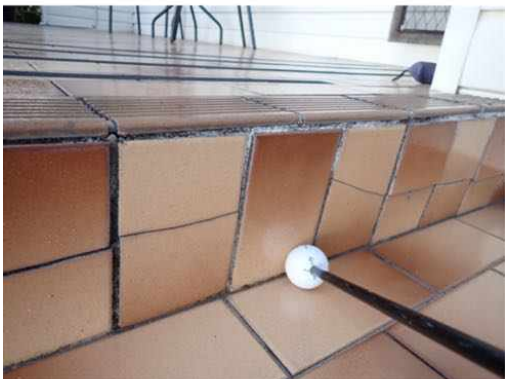
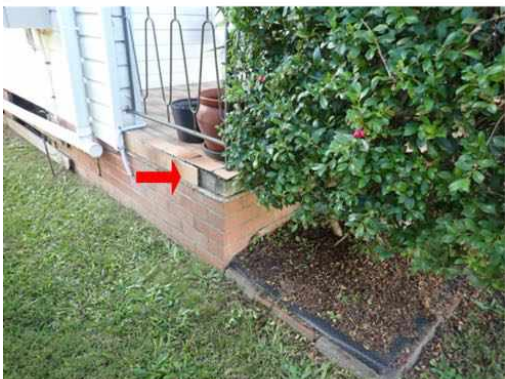
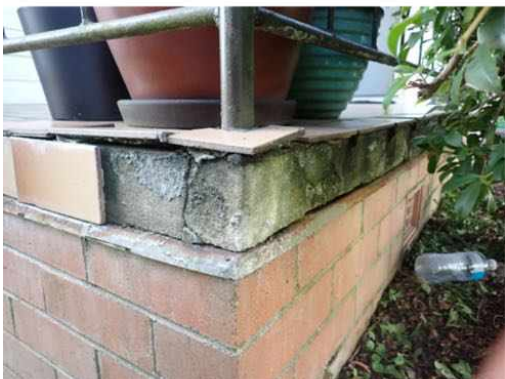
Finding 2.01

Building: Main Building
 Location: Front porch
 Finding: Drummy, Cracked And Missing Tiles To Front Patio Area
 Information: Drummy, cracked, and missing tiles have been identified to the front patio area. This is typically associated with poor installation, inadequate adhesion, substrate movement, or age-related deterioration. Loose or damaged tiles may worsen over time if left unaddressed. It is recommended that a tiler or suitably experienced handyman remove and replace the affected tiles. A builder may be required to assess the condition of the substrate and carry out repairs as required. Repairs can be carried out at the owner's discretion.

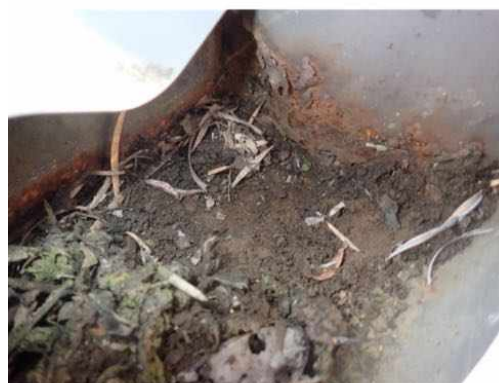
Finding 2.02

Building:	Main Building
Location:	Gutter front right hand side of roof
Finding:	Rust To Front Right Hand Side Gutter
Information:	Significant rust has been identified to the front right-hand side gutter. This is typically associated with advanced age-related deterioration, prolonged moisture exposure, and failure of protective coatings. The condition indicates the guttering is likely compromised and may leak or fail, leading to uncontrolled water discharge and potential damage to adjacent building elements. It is recommended that a licensed plumber replace the affected gutter sections to ensure proper drainage and prevent further deterioration.

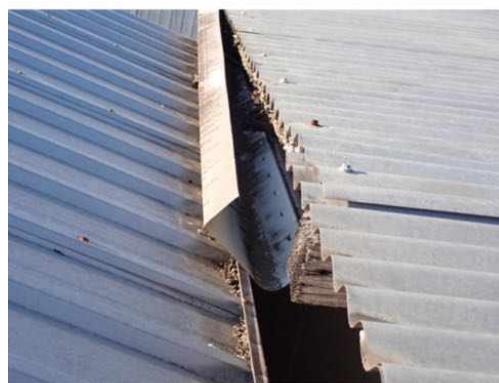
Finding 2.03

Building:	Garage
Location:	Roof
Finding:	Missing Gutter To Garage Roof
Information:	A gutter is missing to the garage roof. This may be due to removal, damage, or incomplete installation. The absence of a gutter can result in uncontrolled water discharge, potentially leading to water ingress, erosion, or damage to adjacent building elements. It is recommended that a licensed plumber or suitably experienced handyman install an appropriate gutter system to manage roof water effectively. Repairs can be carried out at the owner's discretion.

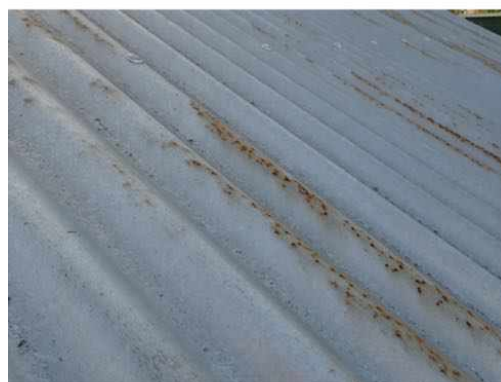
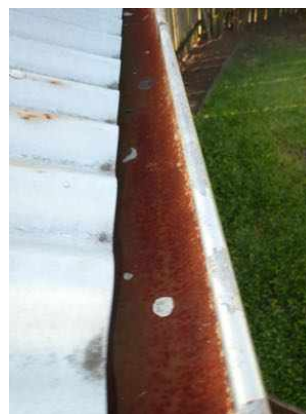
Finding 2.04

Building:	Garage
Location:	Roof
Finding:	Rust To Garage Roof Cladding And Guttering
Information:	Rust has been identified to the garage roof cladding and guttering. This is typically associated with age-related deterioration, prolonged weather exposure, and breakdown of protective coatings. If left untreated, corrosion may progress and lead to leaks or failure of the affected components. It is recommended that a licensed roofer or suitably experienced handyman treat or replace the affected sections and ensure the roof and drainage system are functioning correctly. Repairs can be carried out at the owner's discretion.

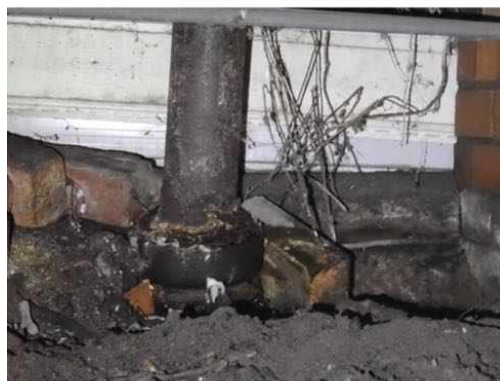
Finding 2.05

Building:	Main Building
Location:	Subfloor
Finding:	Leaking Plumbing To Subfloor Below Toilet
Information:	Plumbing has been identified as leaking within the subfloor below the toilet. This is typically associated with failed seals, pipe deterioration, or connection issues. Ongoing leakage may lead to moisture build-up, deterioration of surrounding building materials, and conditions conducive to termite activity if left unaddressed. It is recommended

that a licensed plumber locate and repair the source of the leak and ensure the area is adequately dried. Prompt repairs are strongly recommended to prevent further damage.

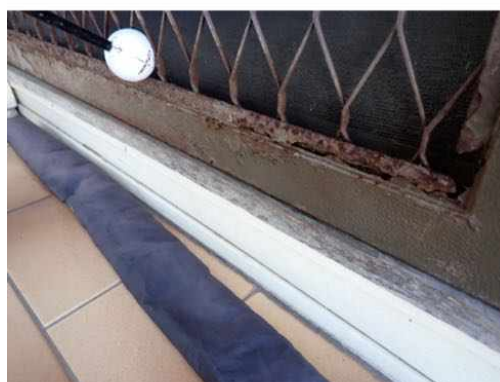
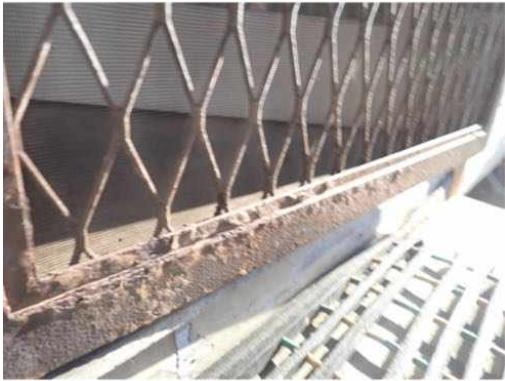
Finding 3.01

Building:	Main Building
Location:	Front and rear entry doors
Finding:	Rust To Bottom Of Front And Rear Security Doors
Information:	Rust has been identified to the bottom sections of the front and rear security doors. This is typically associated with age-related deterioration, moisture exposure, and breakdown of protective coatings. If left untreated, corrosion may worsen and lead to further deterioration of the door frames. It is recommended that a painter, metal fabricator, or suitably experienced handyman treat the affected areas, remove corrosion, and apply protective coatings, or replace components as required. Repairs can be carried out at the owner's discretion.

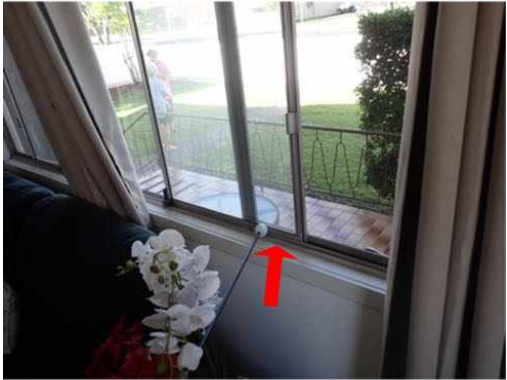
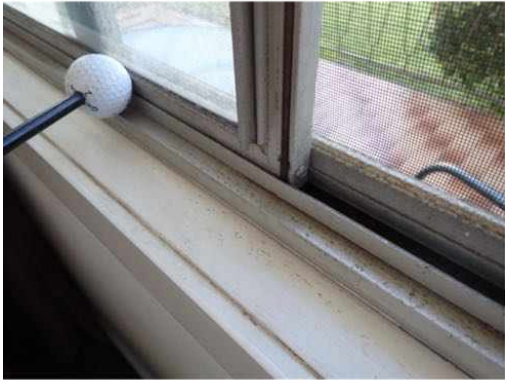
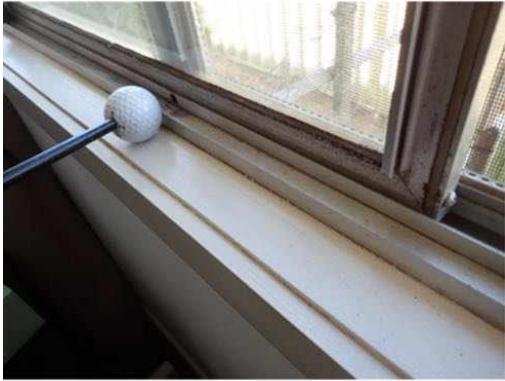
Finding 3.02

Building: Main Building
Location: All windows
Finding: Sliding Windows Require General Maintenance
Information: All sliding windows throughout the main building were operational at the time of inspection, however general maintenance is required. This is typically associated with age-related deterioration and is considered a common defect. Ongoing wear may affect ease of operation over time if not maintained. It is recommended that a carpenter or suitably experienced handyman service the windows, including cleaning tracks, lubricating moving parts, and adjusting components as required. Maintenance can be carried out at the owner’s discretion.

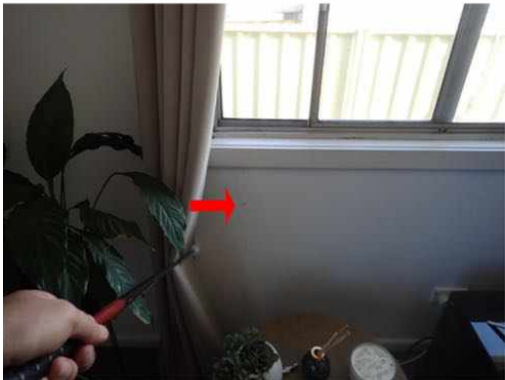
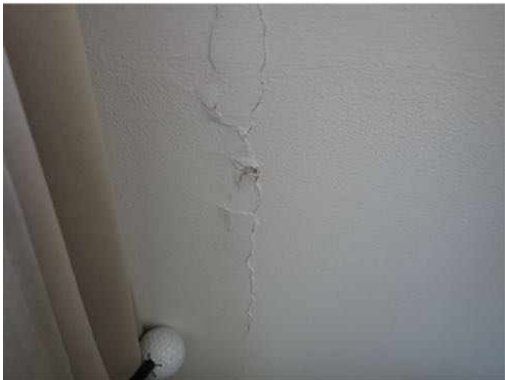
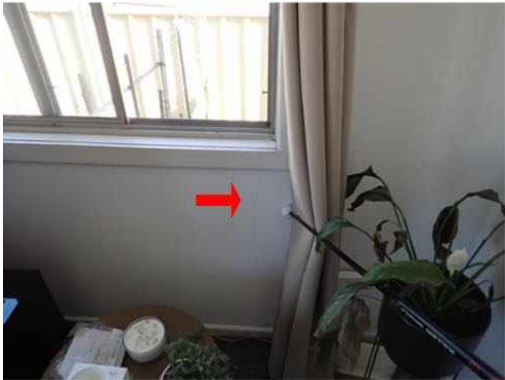
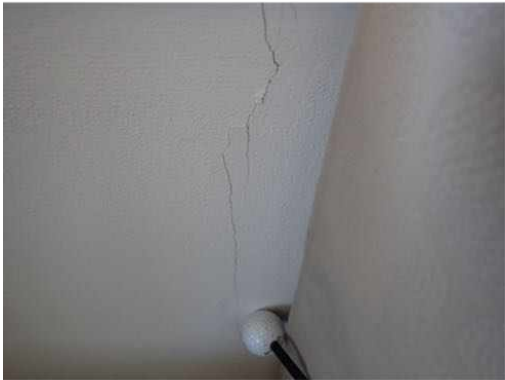
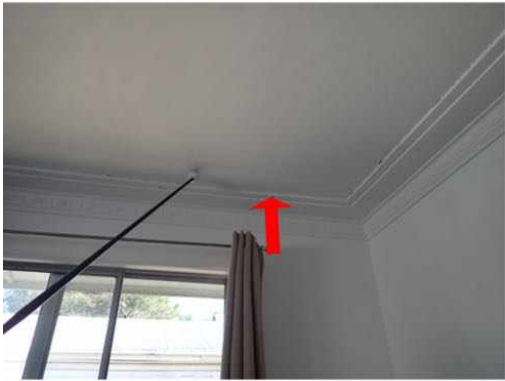
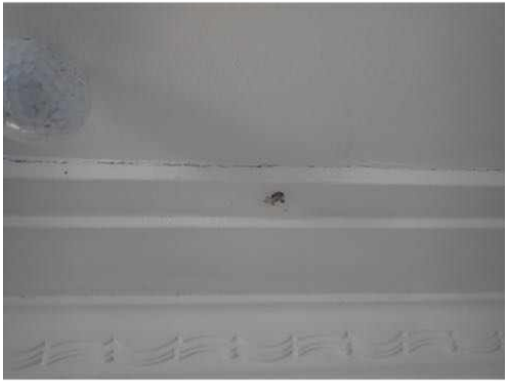
Finding 3.03

Building: Main Building
Location: Living room
Finding: Minor Internal Lining Cracking To Living Room
Information: Minor cracking has been identified to the internal wall lining within the living room. This is typically associated with normal settlement, minor movement, or age-related deterioration and is considered a common defect. If cracks increase in size over time, further assessment may be required. It is recommended that a plasterer or suitably experienced handyman repair and make good the affected areas as required. Repairs can be carried out at the owner's discretion.

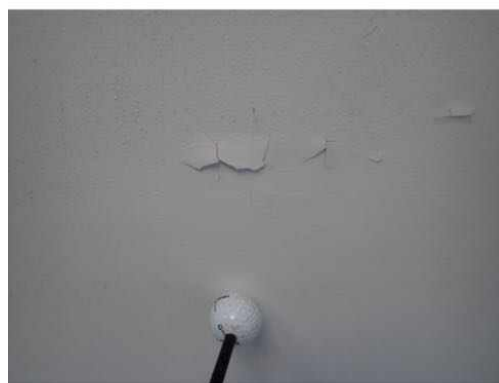
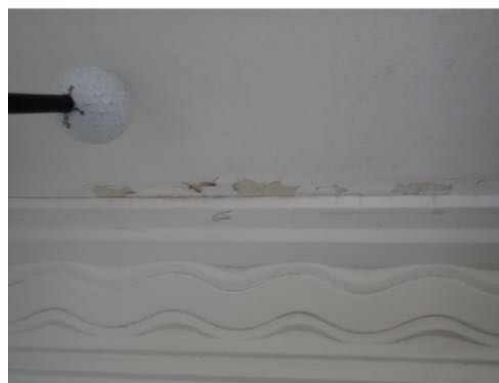
Finding 3.04

Building:	Main Building
Location:	Ceilings
Finding:	Flaking Paint To Ceilings At Isolated Locations
Information:	Paintwork is flaking to ceiling areas at several isolated locations. This is typically associated with age-related deterioration, moisture exposure, or inadequate surface preparation during previous painting works. Continued deterioration may result in further paint loss and potential exposure of underlying surfaces. It is recommended that a painter or suitably experienced handyman prepare the affected areas and repaint as required. Repairs can be carried out at the owner's discretion.

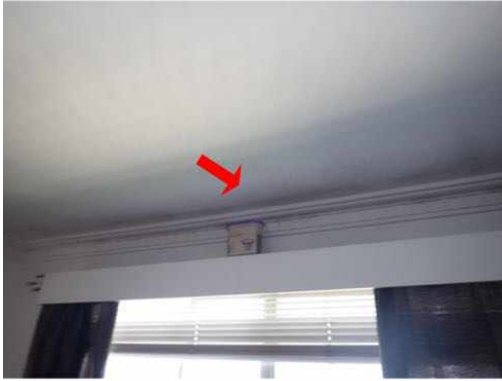
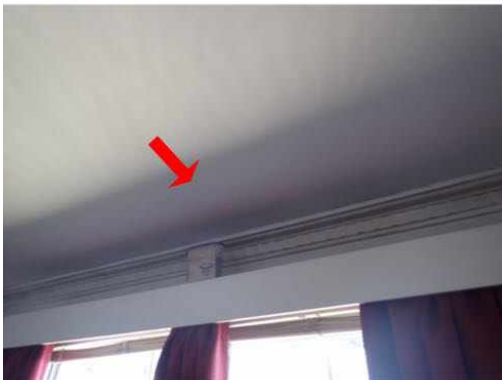
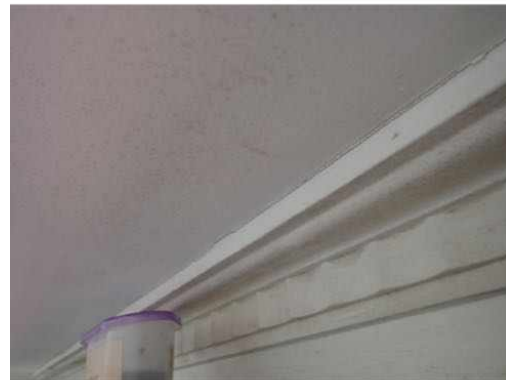
Finding 3.05

Building:	Main Building
Location:	Bedrooms and living room
Finding:	Minor Mould Spots To Bedroom And Living Room Ceilings (Southern Corner)
Information:	Small mould spots have been identified to the ceilings of the bedrooms and living room, predominantly to the southern corner. No elevated moisture readings were detected at the time of inspection using a moisture meter. This condition is typically associated with condensation, limited ventilation, or cooler internal surface temperatures rather than active moisture ingress. If left unaddressed, mould growth

may increase and affect indoor air quality and surface finishes. It is recommended that a suitably experienced handyman or cleaning specialist treat and remove the mould, and that ventilation to affected areas be improved where possible. Repairs and maintenance can be carried out at the owner's discretion.

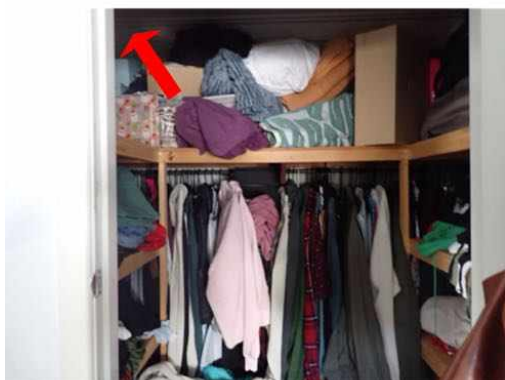
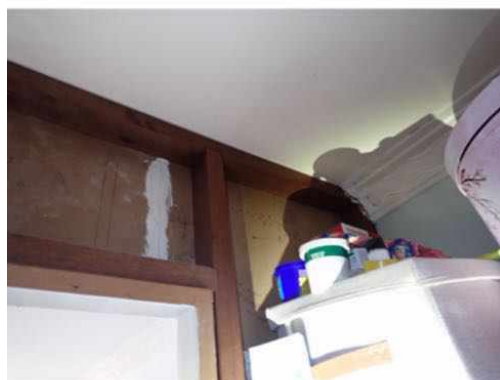
Finding 3.06

Building:	Main Building
Location:	Bedroom
Finding:	Missing Cladding To Rear Of Walk-In Robe In Master Bedroom
Information:	No wall cladding has been installed to the back side of the walk-in robe in the master bedroom. This may be due to incomplete installation or previous alterations. The absence of cladding can expose internal framing and may allow dust ingress or damage to underlying materials. It is recommended that a carpenter or suitably experienced handyman install appropriate wall cladding to enclose and protect the area. Repairs can be carried out at the owner's discretion.

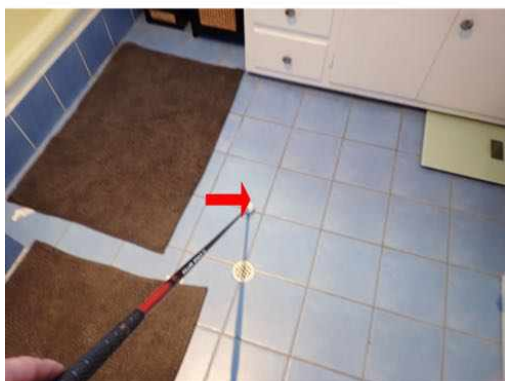
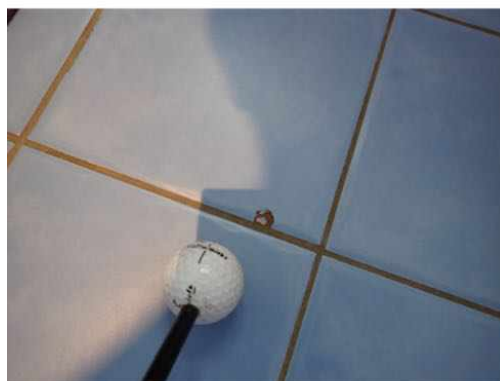
Finding 3.07

Finding: Chip To Bathroom Floor Tile

Information: A small chip has been identified to a floor tile in the bathroom. This is likely due to minor impact damage or general wear and tear. While currently minor, the defect may worsen over time and affect the finish of the tile. It is recommended that a tiler or suitably experienced handyman repair or replace the affected tile as required. Repairs can be carried out at the owner's discretion.

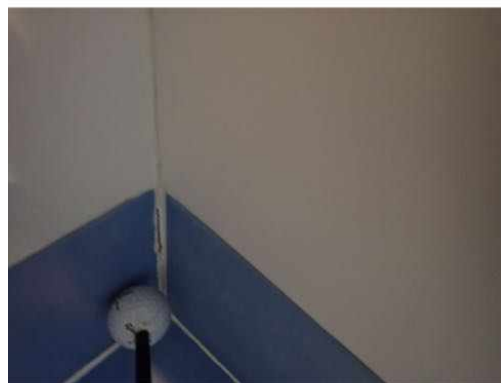
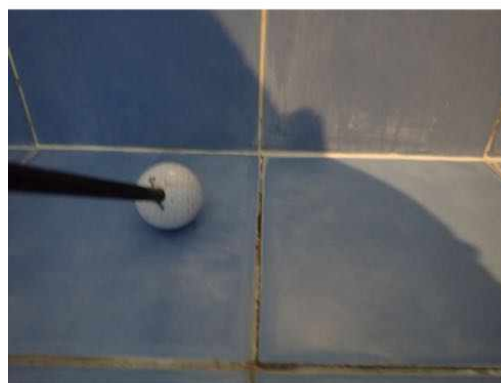
Finding 3.08

Finding: Deteriorated Grout And Silicone To Shower Area

Information: Deterioration of grout and silicone has been identified to the shower area. This is typically associated with age-related wear, moisture exposure, and breakdown of sealants over time. Defective grout and silicone may allow water ingress into surrounding building materials, potentially leading to further deterioration if left unaddressed. It is recommended that a tiler or suitably experienced handyman remove and replace the affected grout and silicone to ensure a watertight seal. Repairs can be carried out at the owner's discretion.

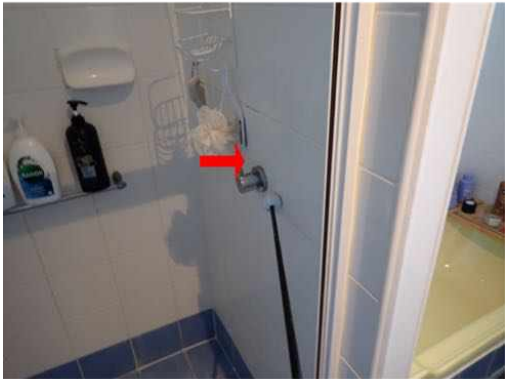
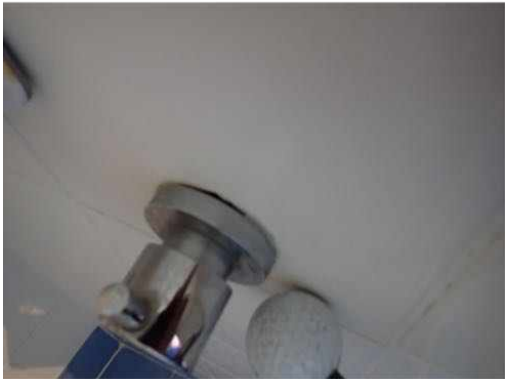
Finding 3.09

Building:	Main Building
Location:	Bathroom
Finding:	Shower Tap And Spout Wall Penetrations Not Sealed Appropriately
Information:	Wall penetrations around the shower tap and spout have not been sealed appropriately. This is typically due to incomplete installation or deterioration of sealant. Unsealed penetrations may allow water ingress into the wall cavity, potentially leading to damage of surrounding building materials over time. It is recommended that a plumber or suitably experienced handyman apply appropriate sealant to all penetrations to ensure a watertight finish. Repairs can be carried out at the owner's discretion.

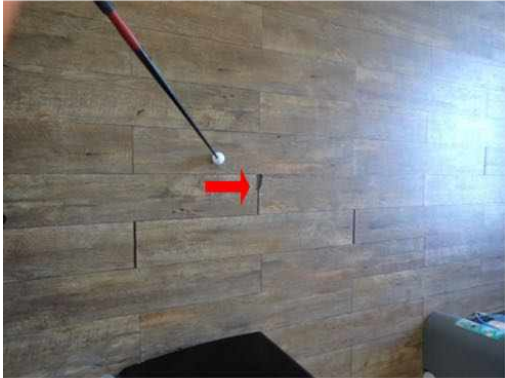
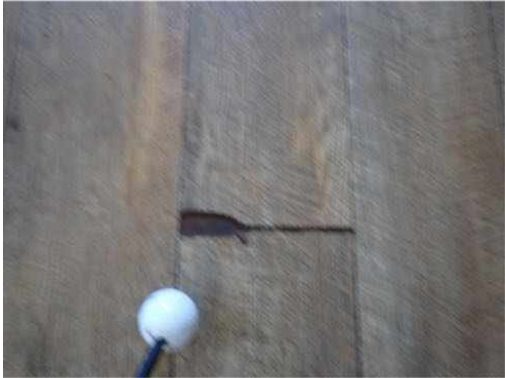
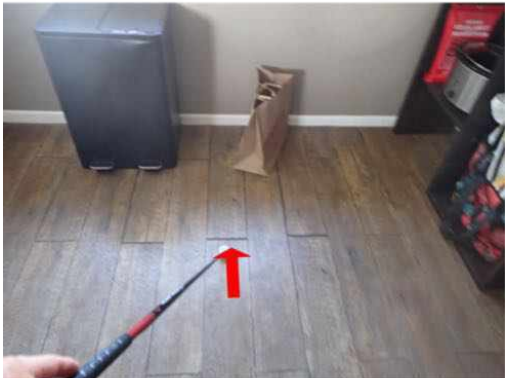
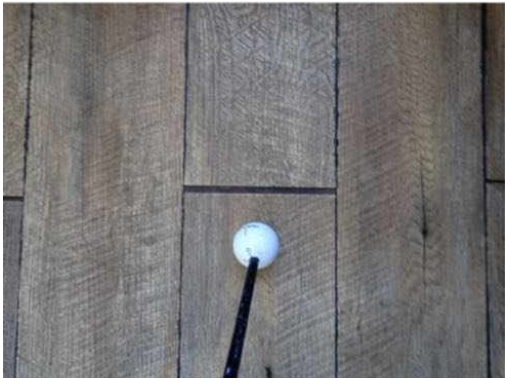
Finding 3.10

Building: Main Building
Location: Kitchen
Finding: Gaps To Kitchen Timber Look Flooring End Joins
Information: Several gaps have been identified to the end joins of the timber look flooring in the kitchen. This is typically associated with installation tolerances, material movement, or age-related shrinkage and is considered a common defect. If gaps increase over time, they may allow debris ingress and affect the finish of the flooring. It is recommended that a flooring contractor or suitably experienced handyman assess and repair the affected areas as required. Repairs can be carried out at the owner's discretion.

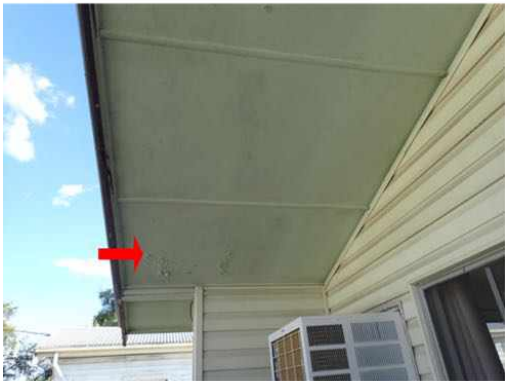
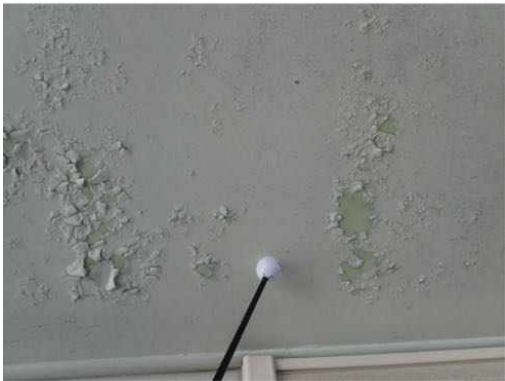
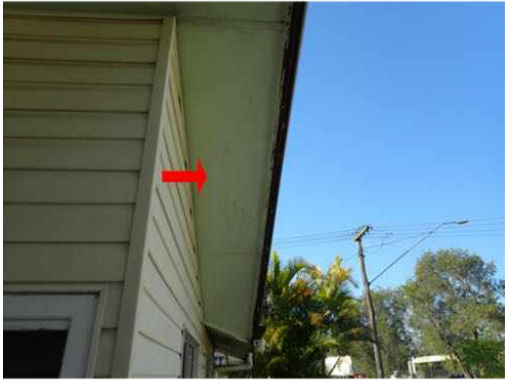
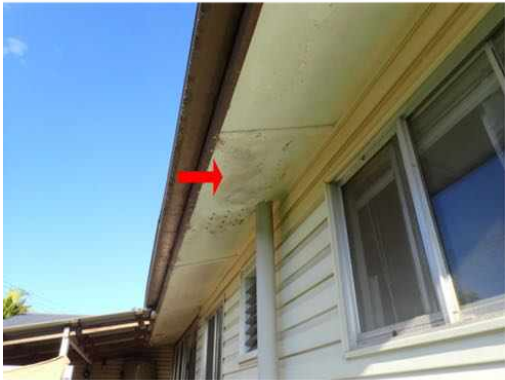
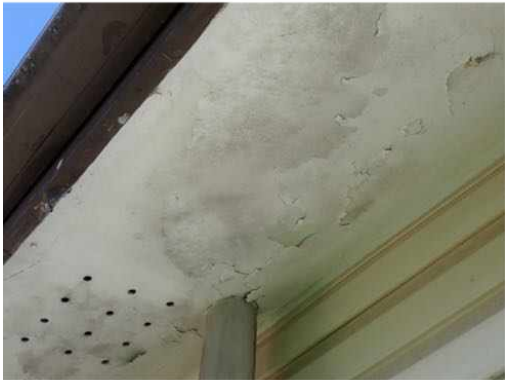
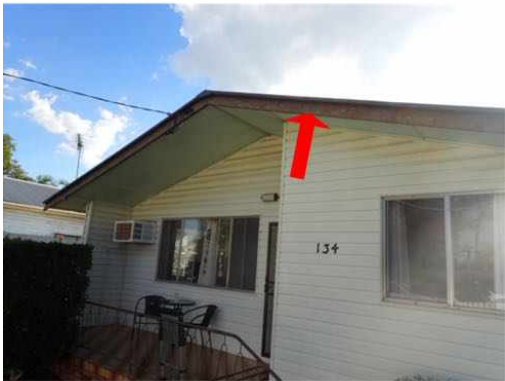
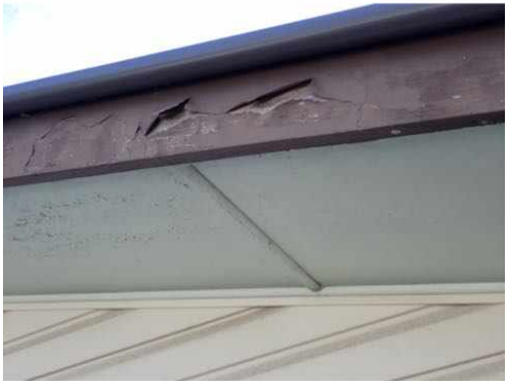
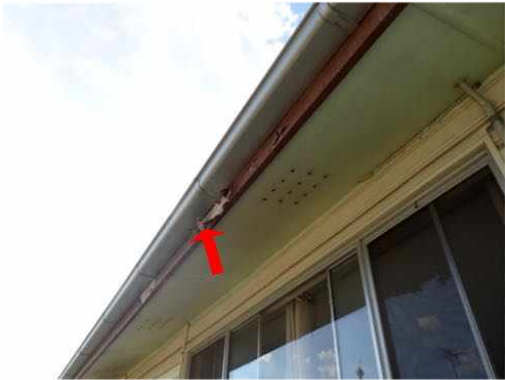
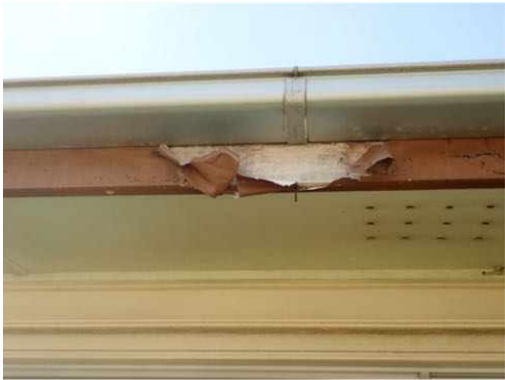
Finding 3.11

Building: Main Building
Location: Eaves and fascia boards
Finding: Deteriorated And Flaking Paint To Fascia Boards And Eaves
Information: Deteriorated and flaking paint has been identified to the fascia boards and eaves. This is typically associated with age-related wear, weather exposure, and breakdown of protective coatings. If left unaddressed, exposed timber may be susceptible to moisture ingress and further deterioration. It is recommended that a painter or suitably experienced handyman prepare the surfaces and repaint to provide adequate protection. Repairs can be carried out at the owner’s discretion.

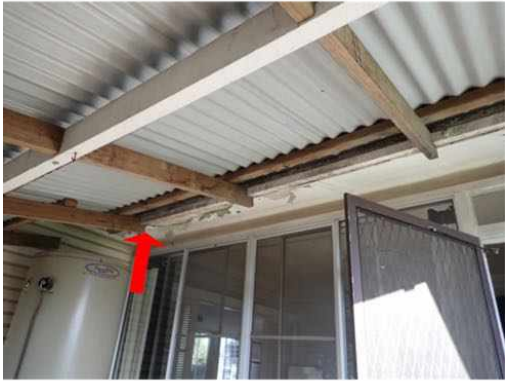
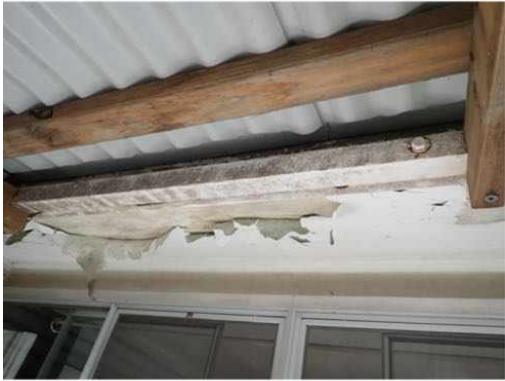
Finding 3.12

Building: Main Building
Location: Rear patio roof
Finding: Possible Leak At Junction Of Rear Patio And Main Roof
Information: A possible leak has been identified where the rear patio area meets the roof of the main building. This is typically associated with inadequate flashing, poor sealing, or age-related deterioration at the junction. If left unaddressed, water ingress may occur and lead to damage of surrounding building materials. It is recommended that a licensed roofer inspect the junction, rectify any defects, and ensure the area is properly sealed. Repairs can be carried out at the owner's discretion.

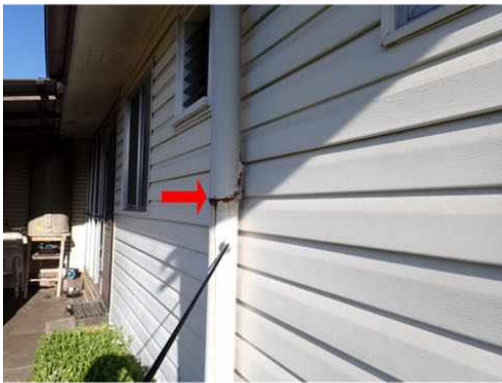
Finding 3.13

Building:	Main Building
Location:	Right hand side elevation
Finding:	Rusted Plumbing Vent Pipe
Information:	The plumbing ventilation pipe has been identified as rusted. This is typically associated with age-related deterioration, weather exposure, and breakdown of protective coatings. If left untreated, corrosion may progress and lead to failure of the pipe. It is recommended that a licensed plumber replace or repair the affected pipe and apply appropriate protective measures. Repairs can be carried out at the owner's discretion.

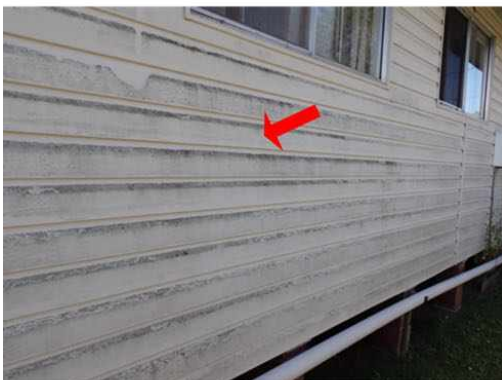
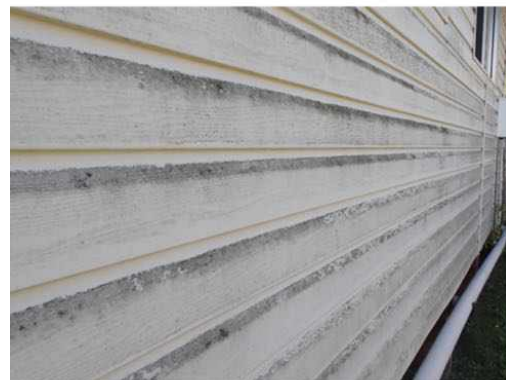
Finding 3.14

Building:	Main Building
Location:	External cladding
Finding:	External Cladding Requires Cleaning And Painting
Information:	The external cladding is in need of cleaning and repainting. This is typically associated with age-related wear, weather exposure, and deterioration of protective coatings. If left unaddressed, the condition may lead to further deterioration of the cladding material over time. It is recommended that a painter or suitably experienced handyman clean, prepare, and repaint the surfaces to restore protection and appearance. Repairs and maintenance can be carried out at the owner's discretion.

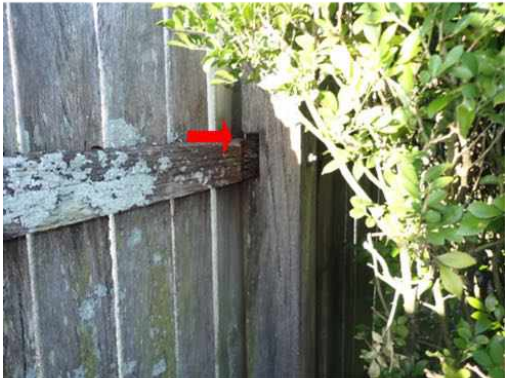
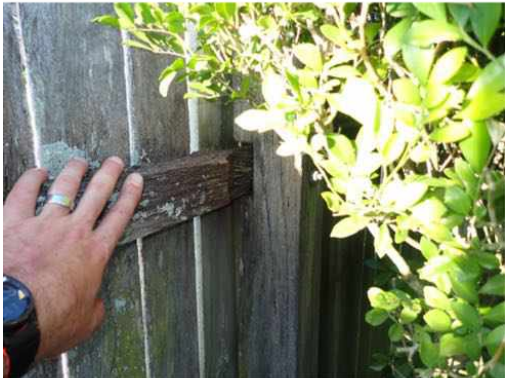
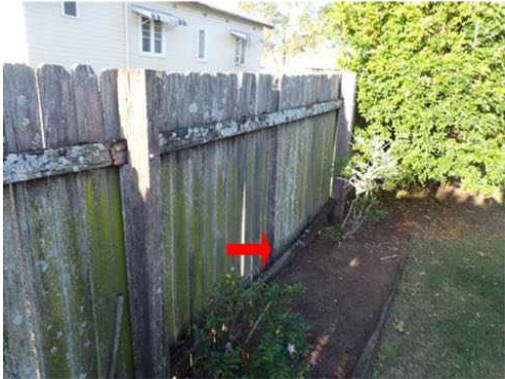
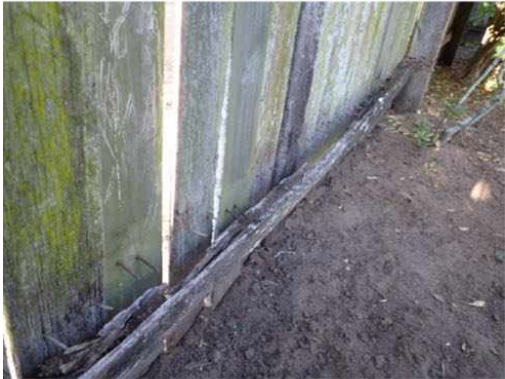
Finding 3.15

Building: Yard
Location: Boundary fencing
Finding: Timber Boundary Fencing In Poor Condition
Information: The timber boundary fencing was observed to be generally in poor condition. This is typically associated with age-related deterioration, weather exposure, and lack of maintenance. Sections may continue to deteriorate over time if left unaddressed. It is recommended that a carpenter or suitably experienced handyman repair or replace the affected sections as required to maintain functionality and stability. Repairs can be carried out at the owner’s discretion.

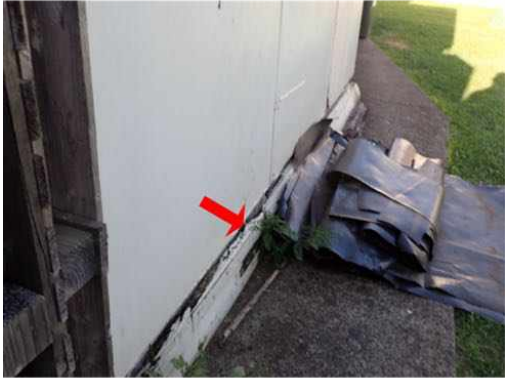
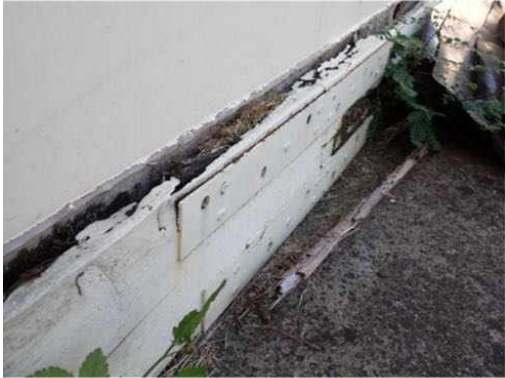
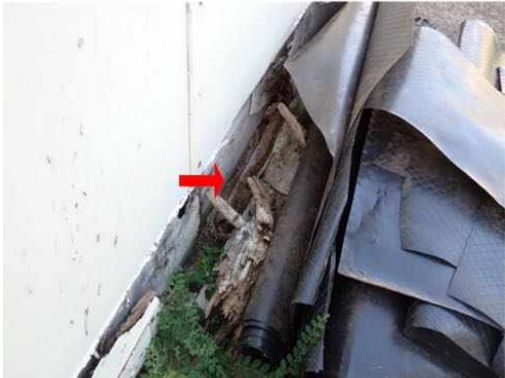
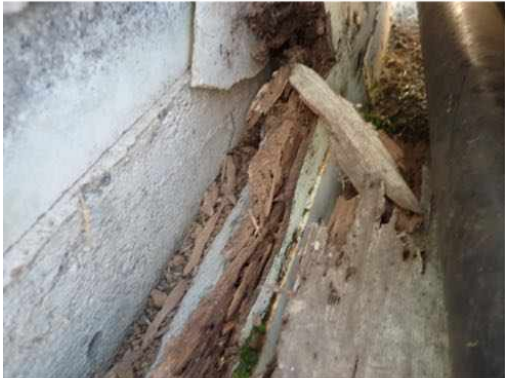
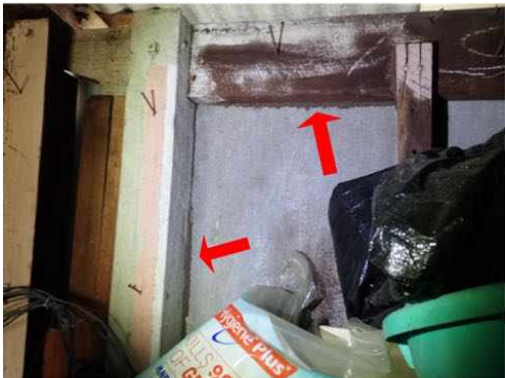
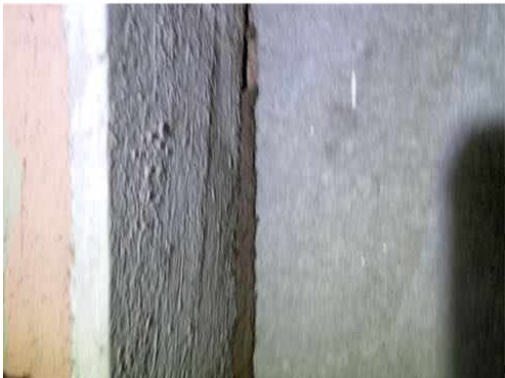
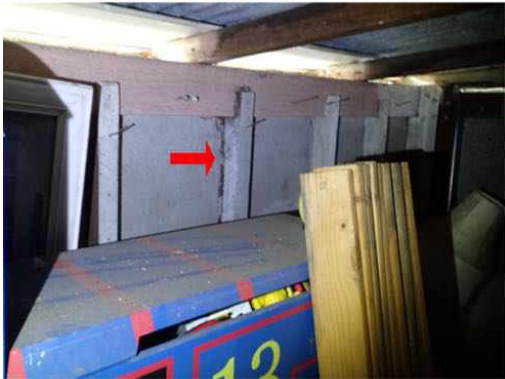
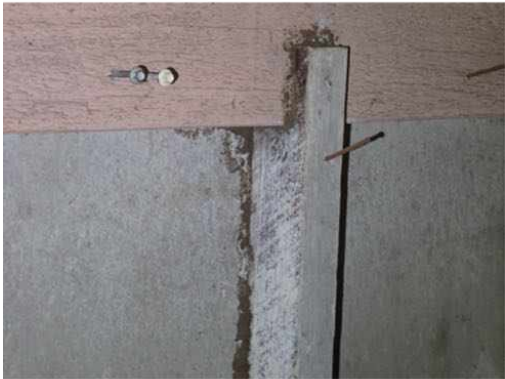
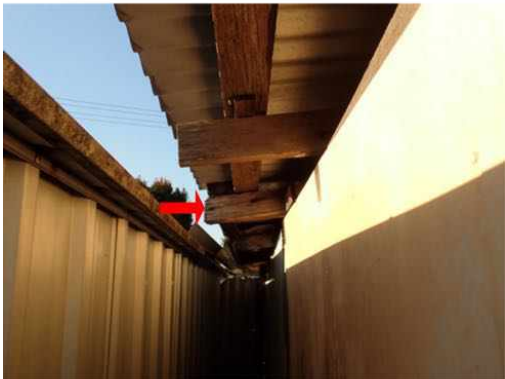
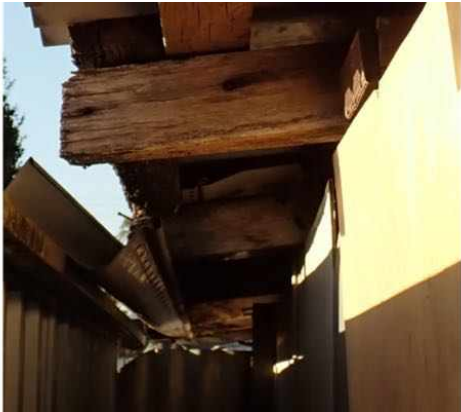
Finding 4.01

Building: Garage
Location: Timber framing
Finding: Termite Damage And Mud Tunnels To Garage And Shed Timber Framing
Information: Termite damage and mud tunnels have been identified to the timber framing within the garage and shed at several locations. This is indicative of active or previous termite

activity. The majority of the shed contained stored items at the time of inspection, which obstructed a full inspection of all accessible areas. It is recommended that stored items be removed to allow a full and unrestricted inspection of all timber elements. Affected timber may continue to deteriorate over time if left unaddressed. It is recommended that a licensed timber pest controller be engaged to assess for active infestation and implement appropriate treatment measures. A carpenter or suitably experienced handyman should then repair or replace the damaged timber as required. Prompt action is strongly recommended to prevent further damage.

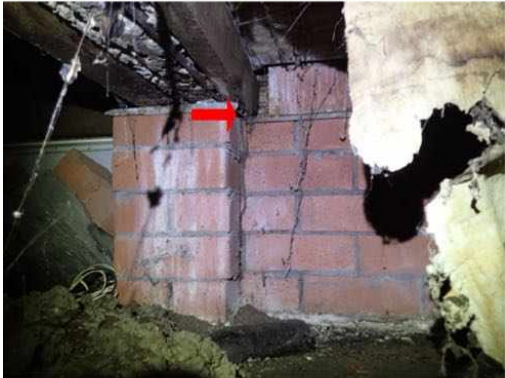
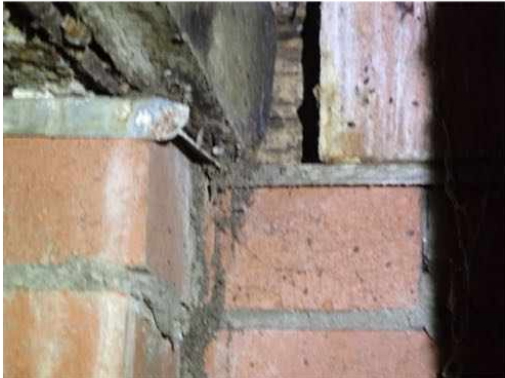
Finding 4.02

Building: Main Building
 Location: Subfloor rear of building
 Finding: Termite Damage And Mud Tunnels To Subfloor At Rear Of Building
 Information: Termite damage and mud tunnels have been identified within the subfloor at the rear of the building. This is indicative of active or previous termite activity. Affected timber may continue to deteriorate over time if left unaddressed. It is recommended that a licensed timber pest controller be engaged to assess for active infestation and implement appropriate treatment measures. A carpenter or suitably experienced handyman should then repair or replace the damaged timber as required. Prompt action is strongly recommended to prevent further damage.

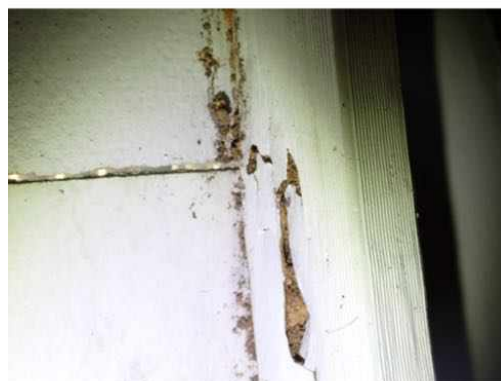
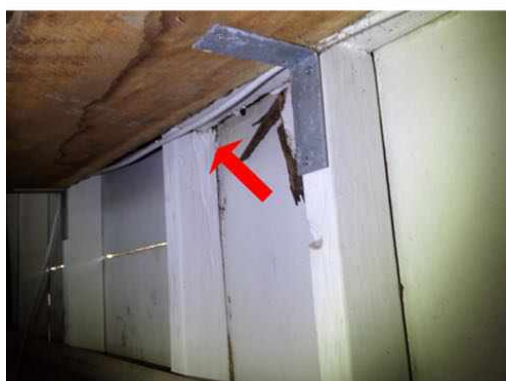
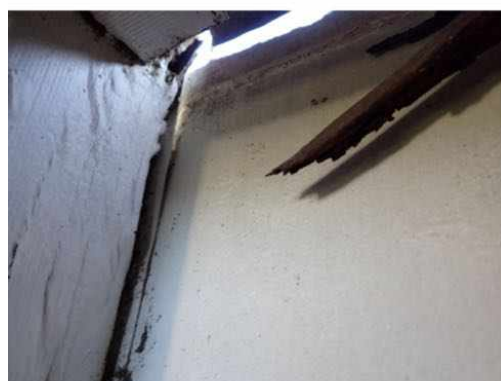
Finding 5.01

Building:	Main Building
Location:	Rear covered area
Finding:	Termite Damage To Framework And Window At Rear Covered Area
Information:	Termite damage has been identified to the framework and window within the rear covered area. This is typically associated with previous or ongoing termite activity. Damaged timber may continue to deteriorate over time if left unaddressed. It is recommended that a licensed builder or suitably experienced handyman repair or replace the affected timber and ensure the area is reinstated appropriately. It is also recommended that a licensed timber pest controller be engaged to assess for active infestation and implement appropriate treatment measures. Prompt action is strongly recommended to prevent further damage.

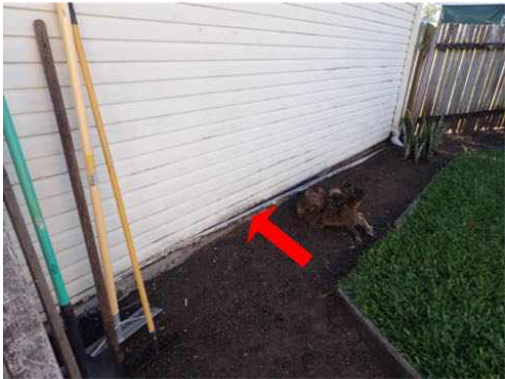
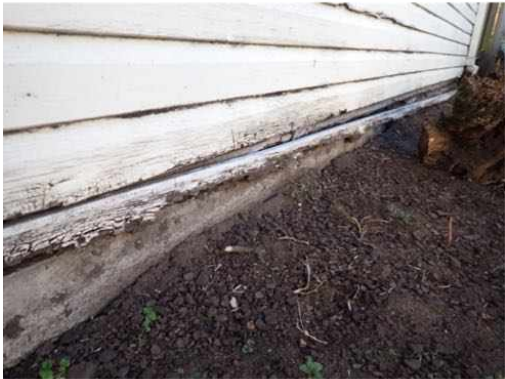
Finding 6.01

Building:	Garage
Location:	Front wall
Finding:	Wood Rot To External Weatherboard Cladding Of Shed At Lower Section
Information:	Wood rot has been identified to the external weatherboard cladding of the shed towards the bottom run. This is typically associated with prolonged moisture exposure and breakdown of protective coatings. Timber in this condition may continue to deteriorate over time and is conducive to termite attack if left unaddressed. It is recommended that a carpenter or suitably experienced handyman repair or replace the affected cladding and apply appropriate protective finishes to prevent recurrence. Repairs can be carried out at the owner's discretion.

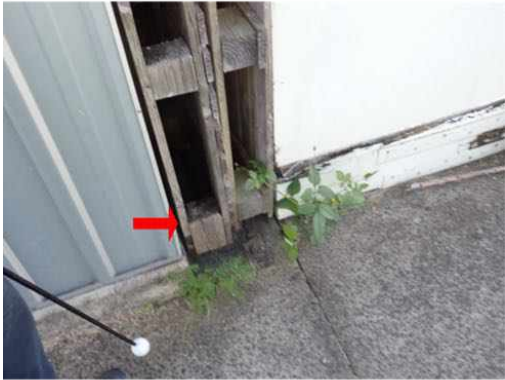
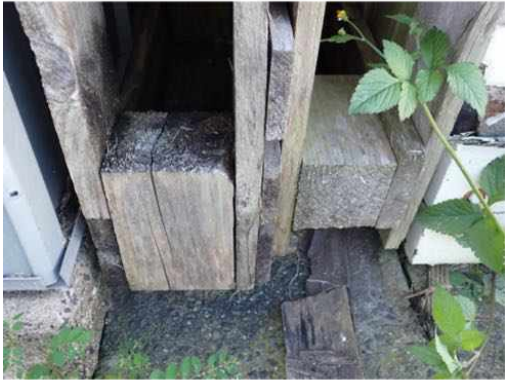
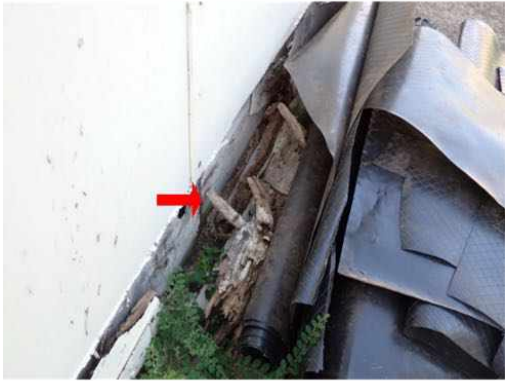
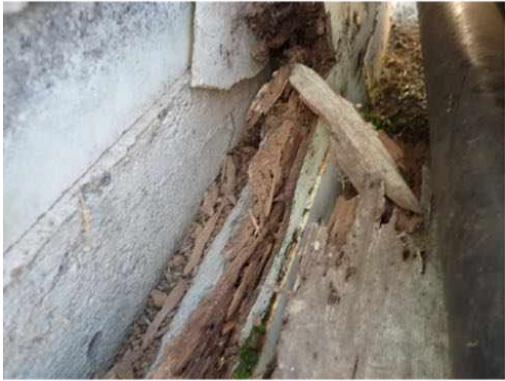
Finding 6.02

Building: Garage
Location: Around base of building
Finding: Stored Rotten Timber Around Garage Conducive To Termite Attack
Information: Stored rotten timber has been identified around the base of the garage, which is conducive to termite attack. This is typically associated with poor site maintenance and accumulation of deteriorated materials. Such conditions can attract termites and increase the risk of infestation to nearby structures. It is recommended that a suitably experienced handyman remove and dispose of the timber and maintain clear separation from the building. Maintenance can be carried out at the owner's discretion.

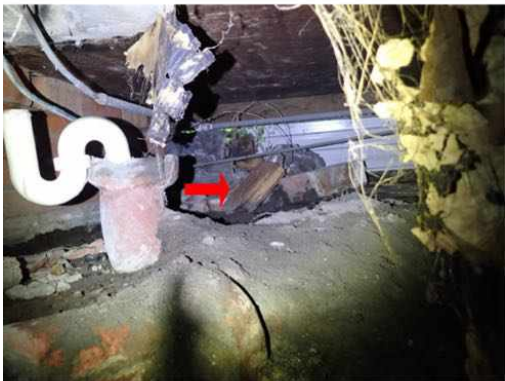
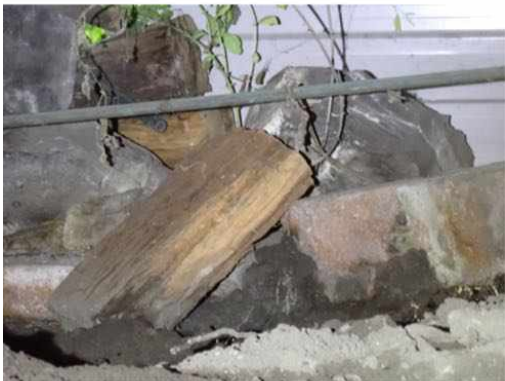
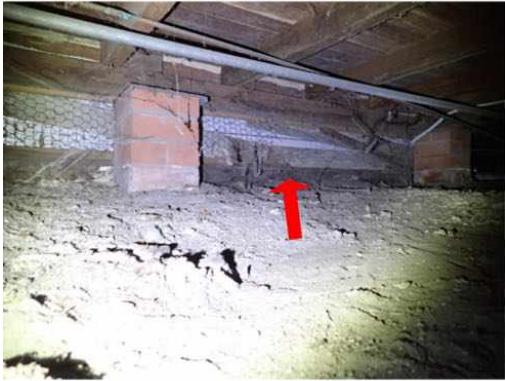
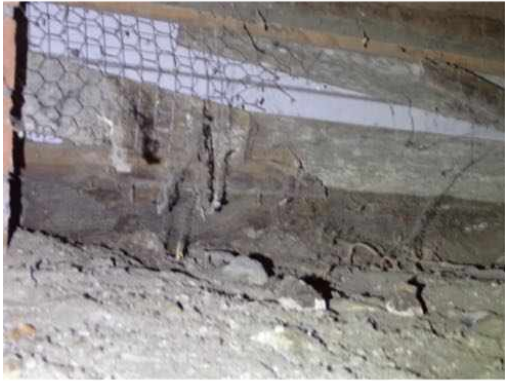
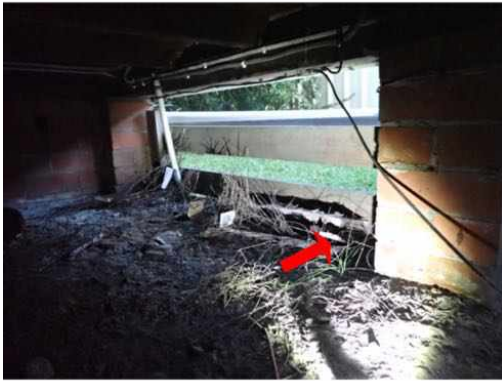
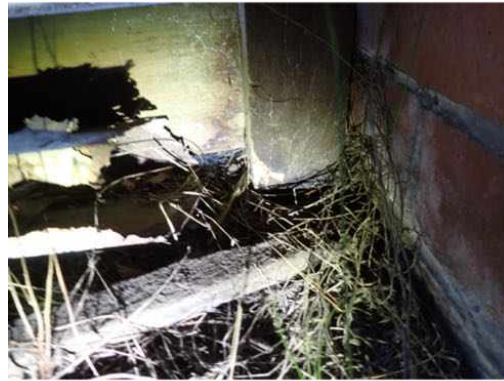
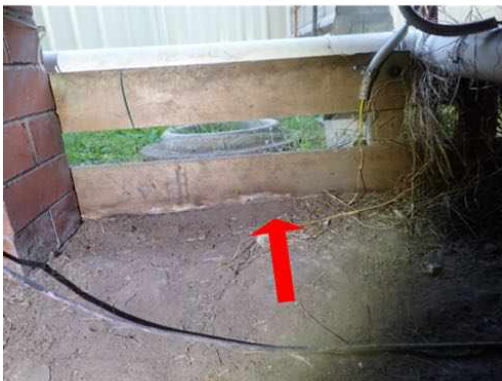
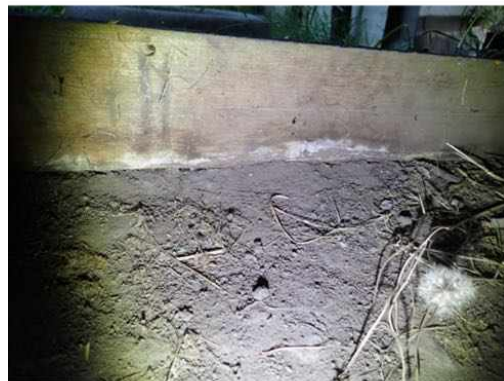
Finding 6.03

Building: Main Building
Location: Subfloor
Finding: Timber In Contact With Ground Within Subfloor Area
Information: Timber has been identified in contact with the ground within the subfloor area at multiple locations. This is typically associated with poor installation or site conditions and is conducive to termite attack. Ground contact can allow concealed termite entry and may lead to timber deterioration over time if left unaddressed. It is recommended that a carpenter or suitably experienced handyman modify the installation to provide adequate clearance from the ground. Prompt rectification is strongly recommended to reduce the risk of termite activity and further deterioration.
