Building and Timber Pest Inspection Report

Inspection Date: Tue, 7 Apr 2026

Property Address: 134 West St, Casino NSW 2470, Australia

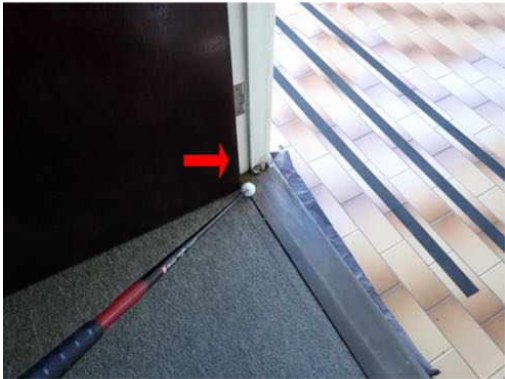
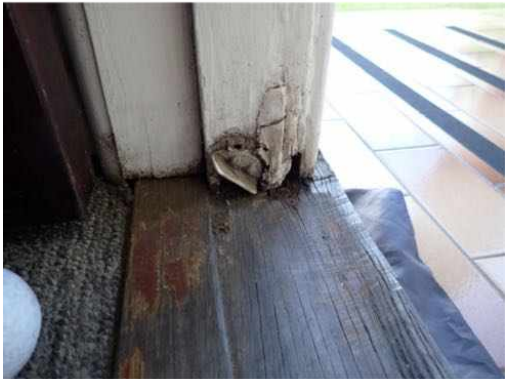
Finding 7.01

Building:	Main Building
Location:	Front entry door
Finding:	Wood Rot To Front Entry Door Jambs At Base
Information:	Wood rot has been identified to the base of the front entry door jambs. This is typically associated with prolonged moisture exposure and breakdown of protective coatings. Timber in this condition may continue to deteriorate and is conducive to termite attack if left unaddressed. It is recommended that a carpenter or suitably experienced handyman repair or replace the affected timber and apply appropriate protective finishes to prevent recurrence. Repairs can be carried out at the owner's discretion.

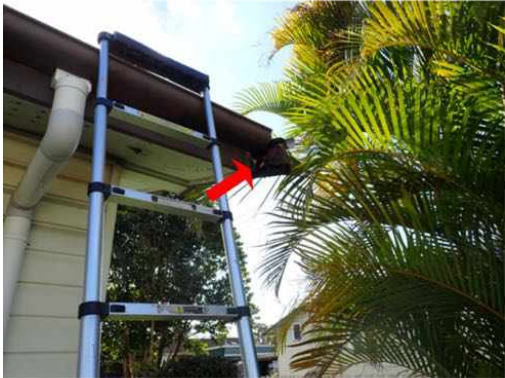
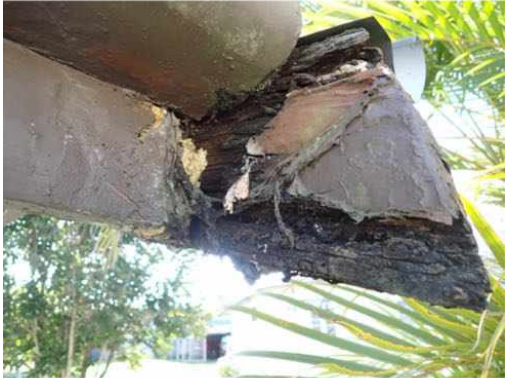
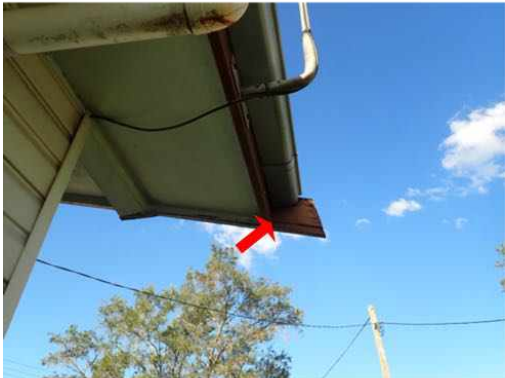
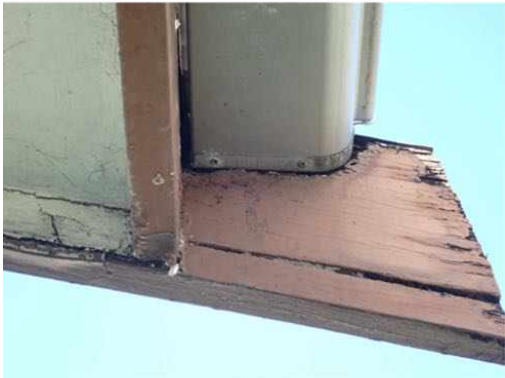
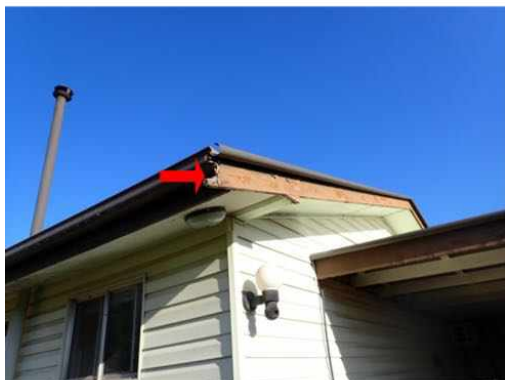
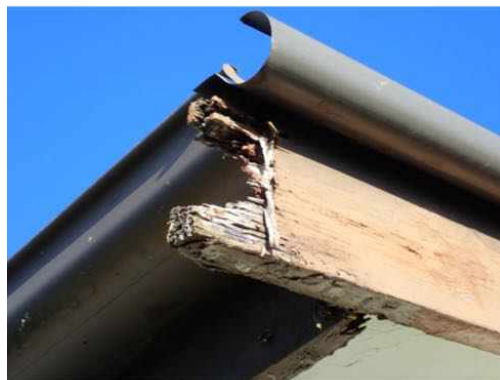
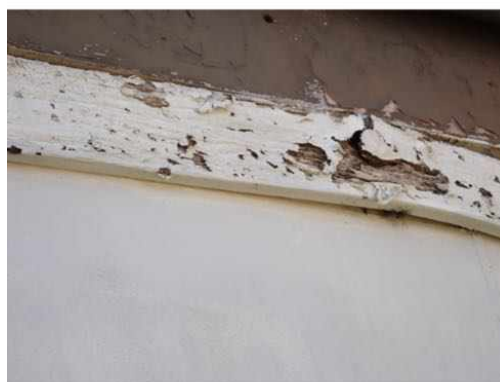
Finding 7.02

Building: Main Building
 Location: Fascia boards
 Finding: Wood Rot To Fascia Boards At Multiple Locations
 Information: Wood rot has been identified to the fascia boards at multiple locations. This is typically associated with prolonged moisture exposure and breakdown of protective coatings. Timber in this condition may continue to deteriorate and is conducive to termite attack if left unaddressed. It is recommended that a carpenter or suitably experienced handyman repair or replace the affected timber and apply appropriate protective finishes to prevent recurrence. Repairs can be carried out at the owner’s discretion.

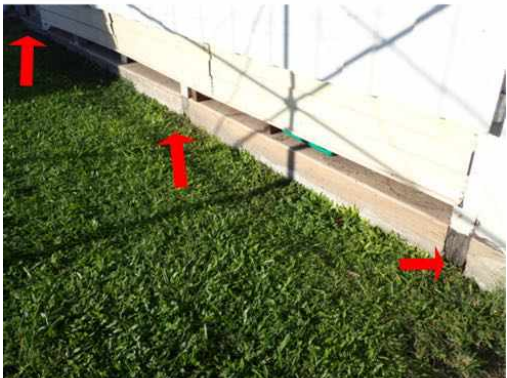
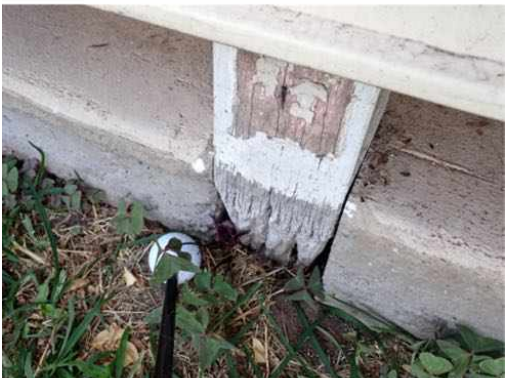
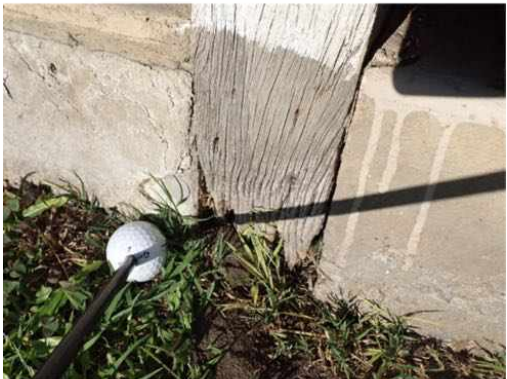
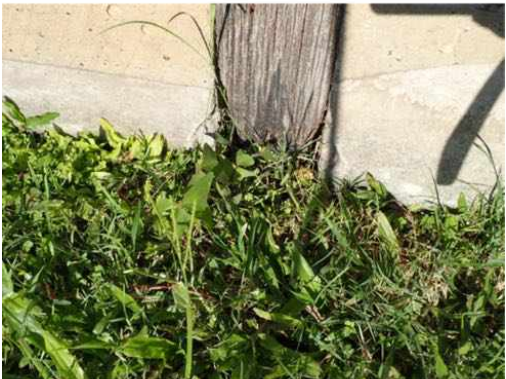
Finding 7.03

Building:	Main Building
Location:	Rear covered area
Finding:	Wood Rot To Timber Posts At Rear Covered Area Roof
Information:	Wood rot has been identified to the base of the timber posts supporting the roof of the rear covered area. Timber is in contact with the ground, which is conducive to termite attack. This is typically associated with prolonged moisture exposure and poor installation practices. Timber in this condition may continue to deteriorate over time if left unaddressed. It is recommended that a carpenter or suitably experienced handyman repair or replace the affected posts and ensure adequate clearance from the ground is provided. Prompt repairs are strongly recommended to prevent further deterioration and potential damage.

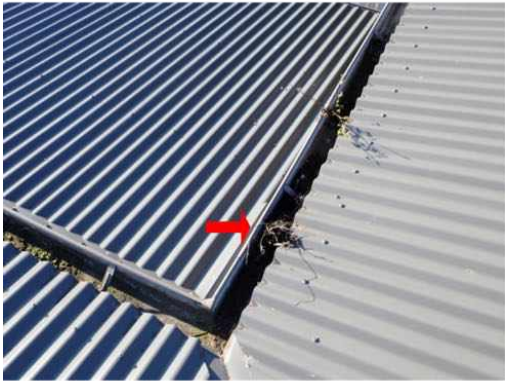
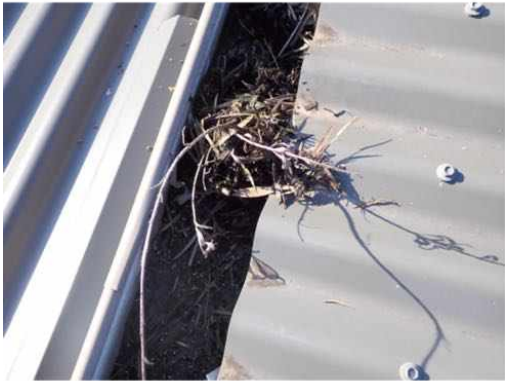
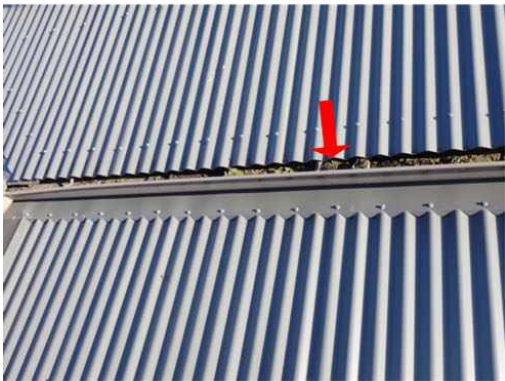
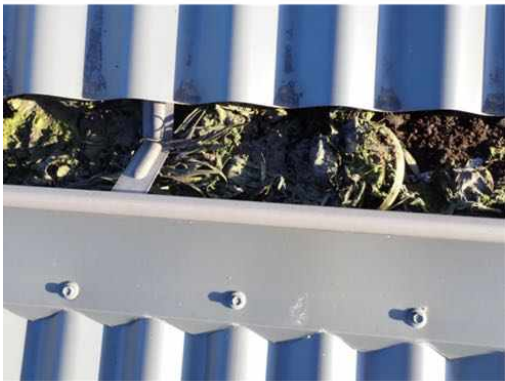
Building: Main Building
 Location: Roof
 Finding: Debris In Gutters
 Information: Debris has been identified in the gutters. This is typically associated with leaf buildup and general environmental accumulation over time. Blocked gutters can impede proper water flow and may lead to overflow, moisture ingress, or damage to surrounding building elements. It is recommended that a suitably experienced handyman or gutter cleaning service remove debris and ensure the system is functioning correctly. Maintenance can be carried out at the owner’s discretion.

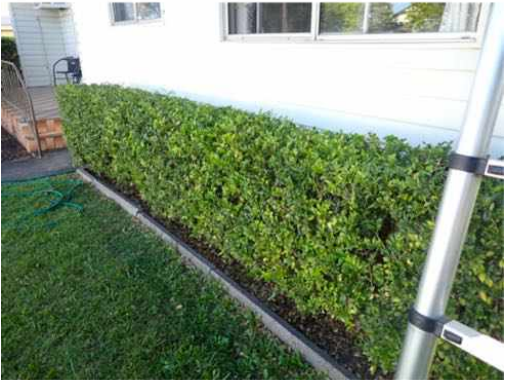
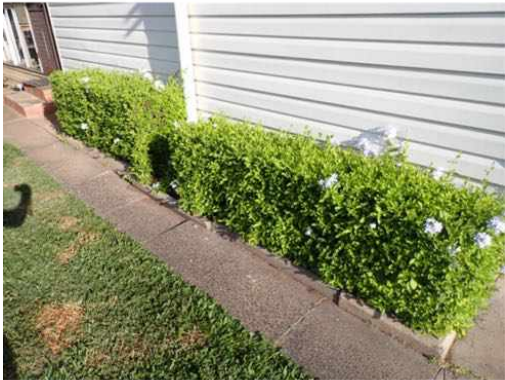
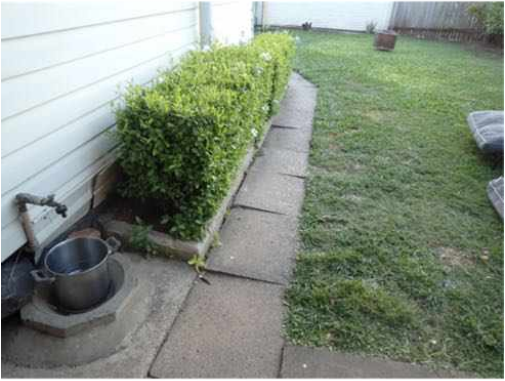
Building: Main Building
 Location: All Areas
 Finding: Additional Photos - Obstructions and Limitations
 Information: These photographs are an indication of the obstructions and limitations which

impeded full inspection of the area at the time of inspection. These obstructions can hide an array of defects and should be removed to allow full inspection to be carried out. A re-inspection is recommended once the areas are made accessible.

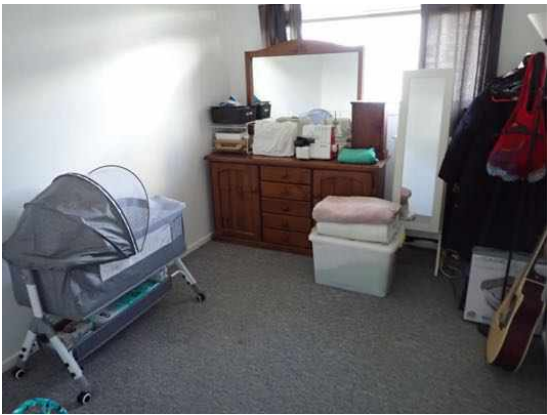
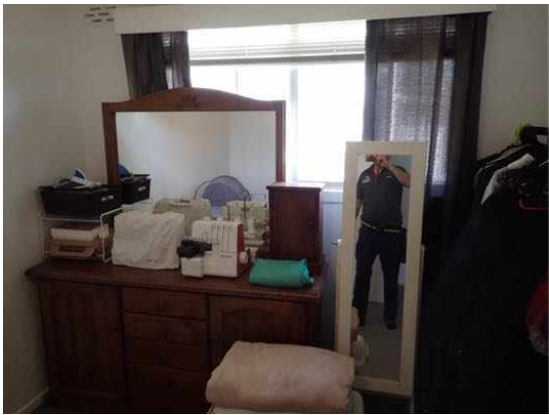
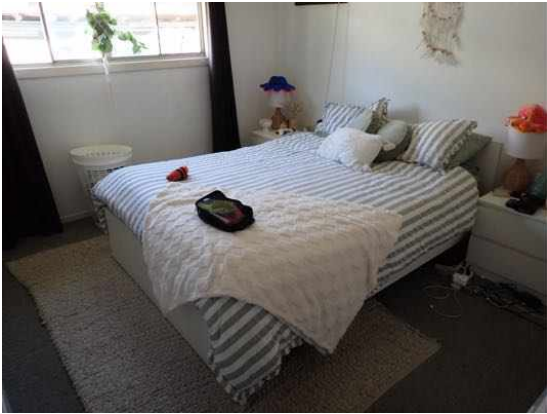
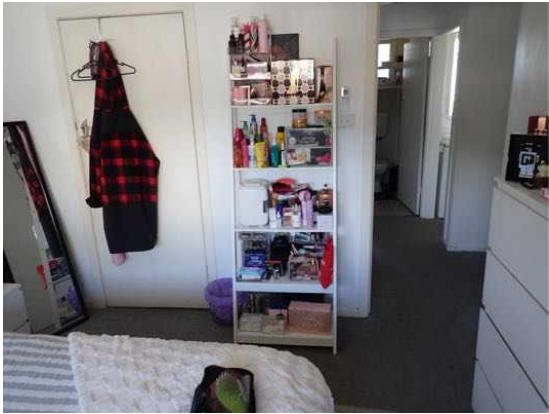
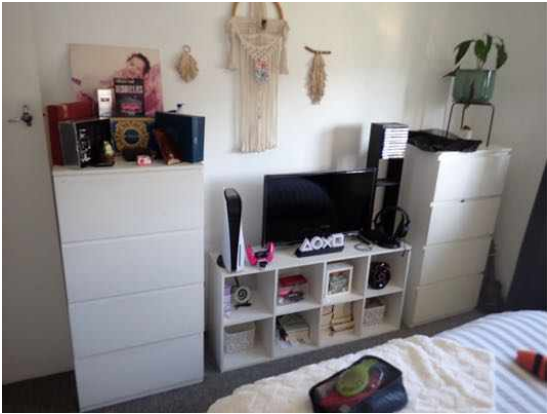
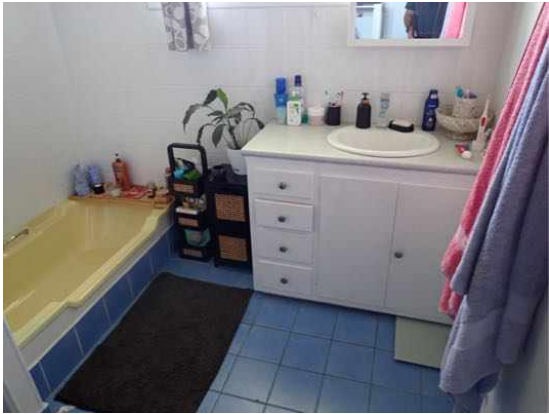
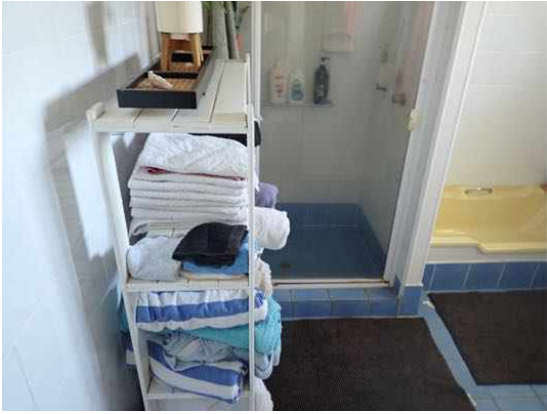
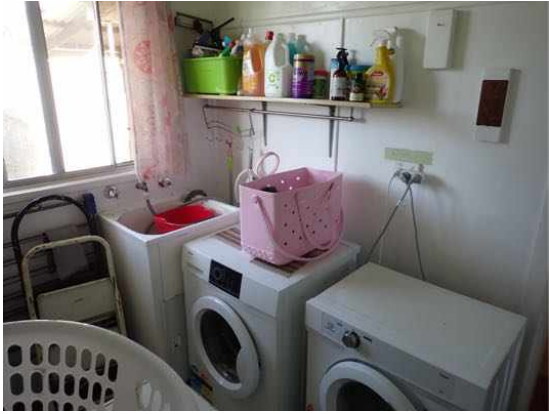
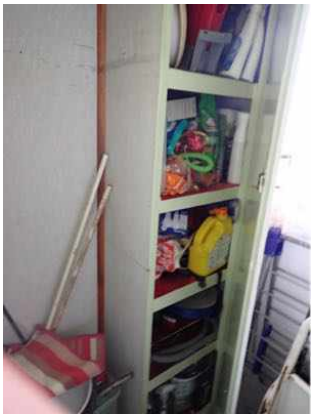
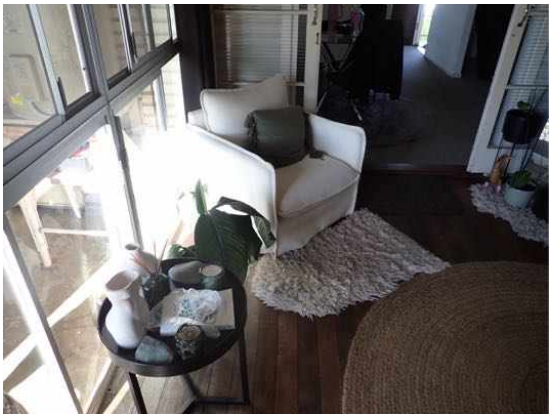
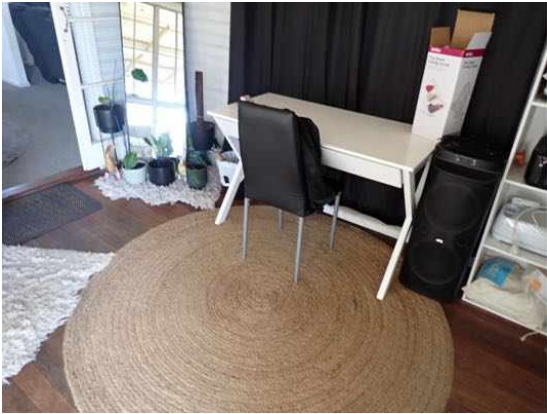
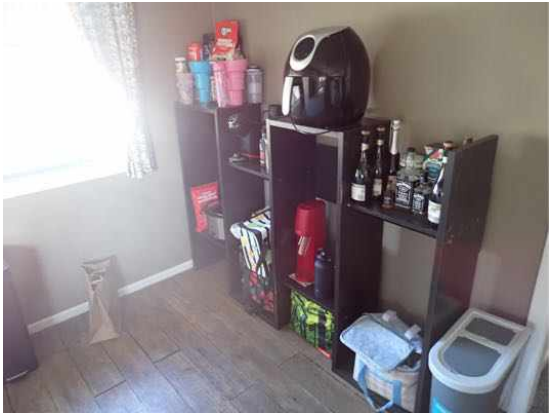
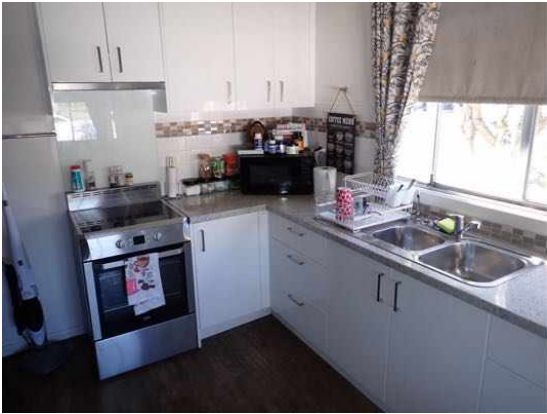
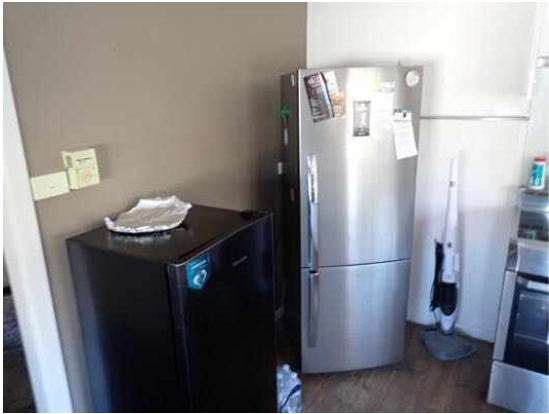
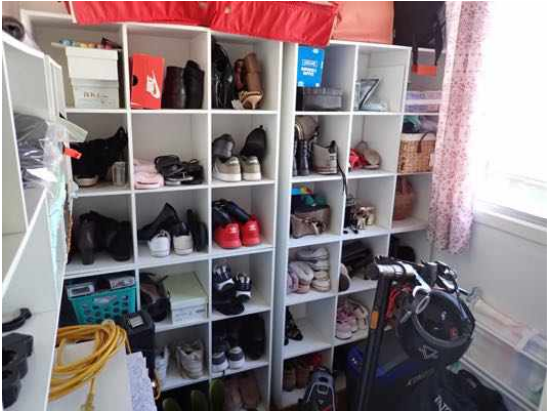
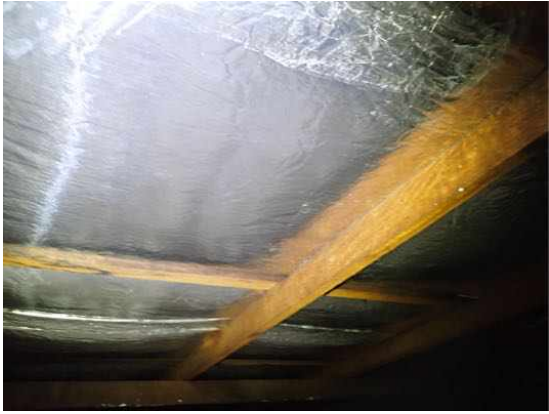
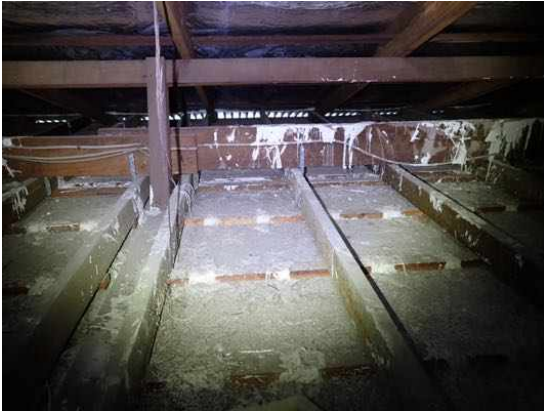
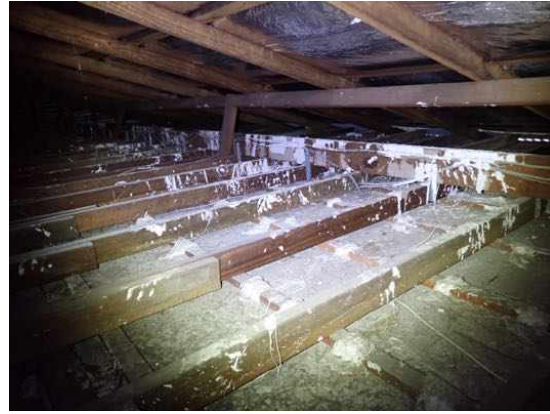
Building: Main Building
Location: All Areas
Finding: Additional Photos - Obstructions and Limitations
Information: These photographs are an indication of the obstructions and limitations which impeded full inspection of the area at the time of inspection. These obstructions can hide an array of defects and should be removed to allow full inspection to be carried out. A re-inspection is recommended once the areas are made accessible.

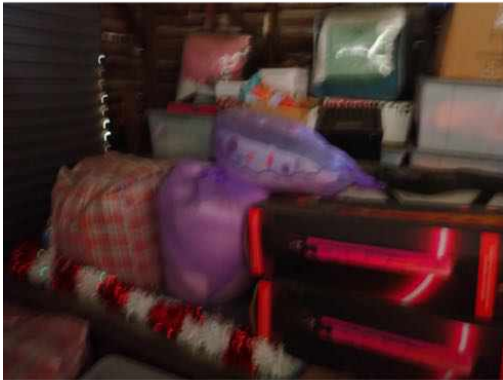
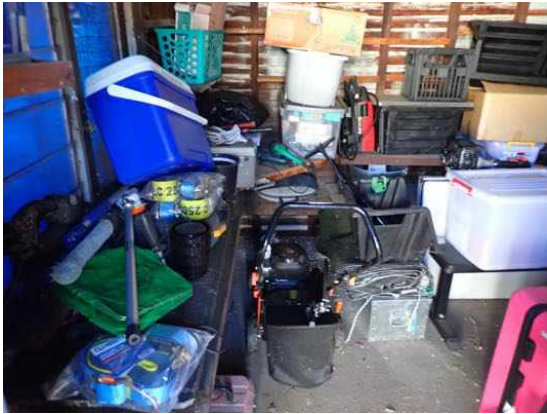
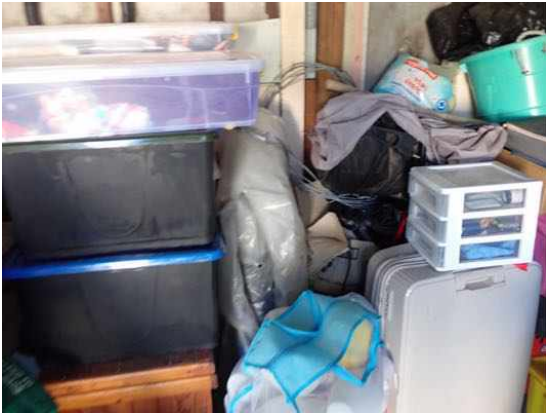
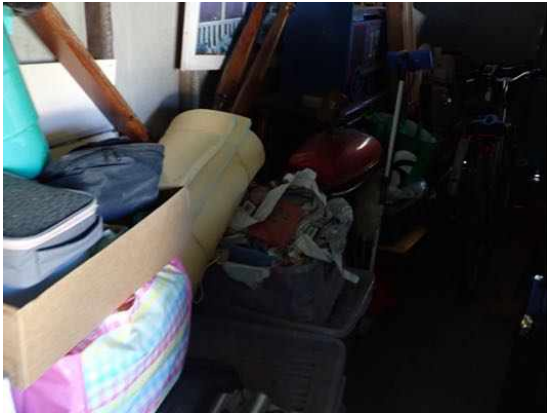
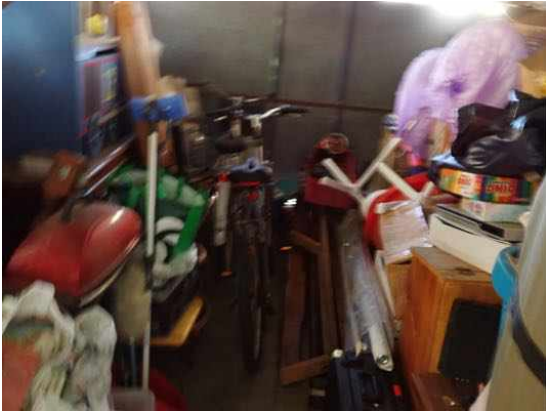
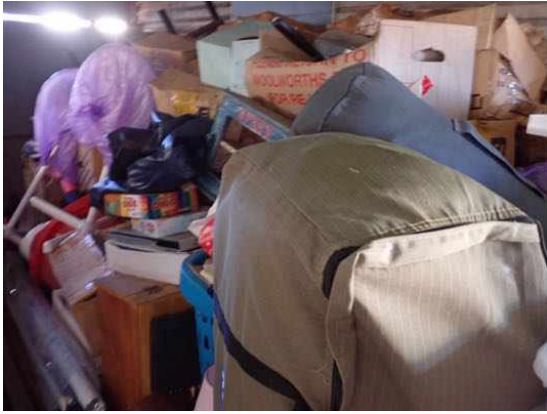
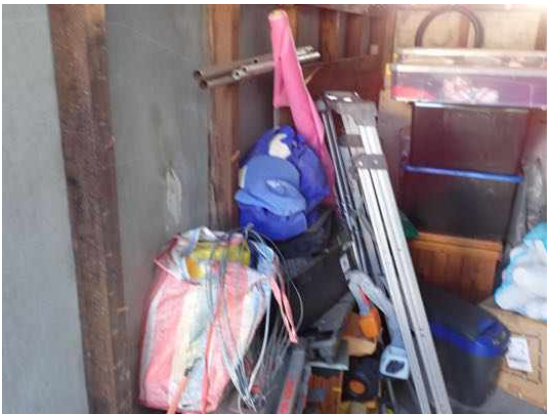
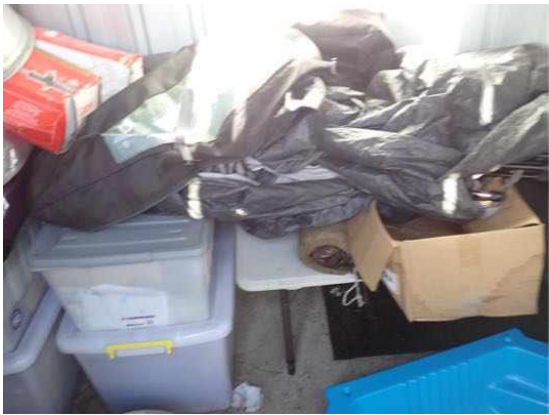
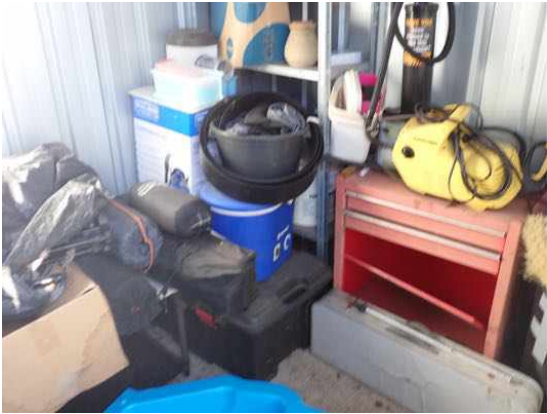
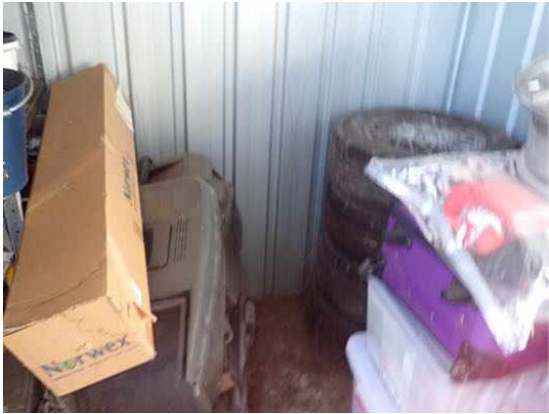
Building: Garage
 Location: All Areas
 Finding: Additional Photos - Obstructions and Limitations
 Information: These photographs are an indication of the obstructions and limitations which impeded full inspection of the area at the time of inspection. These obstructions can hide an array of defects and should be removed to allow full inspection to be carried out. A re-inspection is recommended once the areas are made accessible.
