# Building and Timber Pest Inspection Report

Inspection Date: Wed, 18 Feb 2026

Property Address: 40 Oriole Street, Glenmore Park NSW 2745

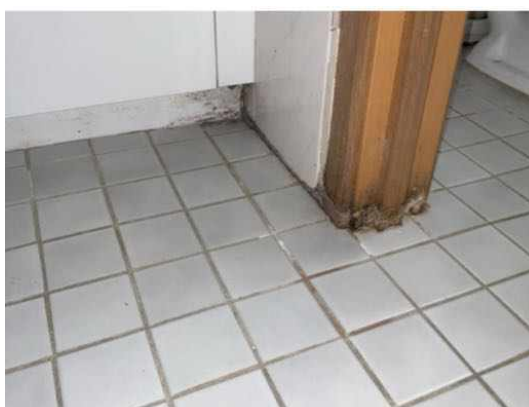
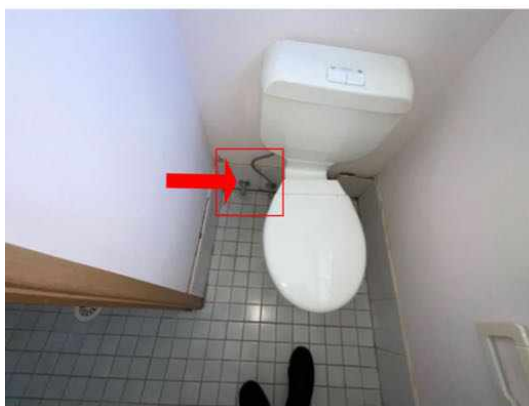
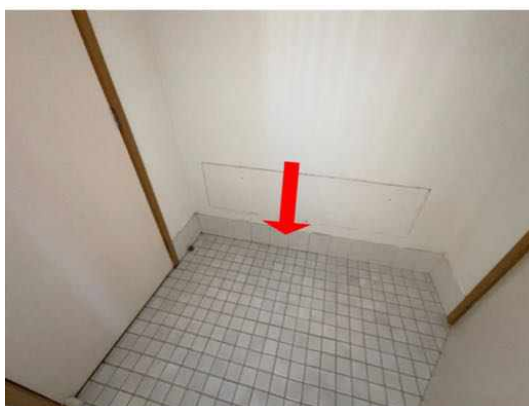
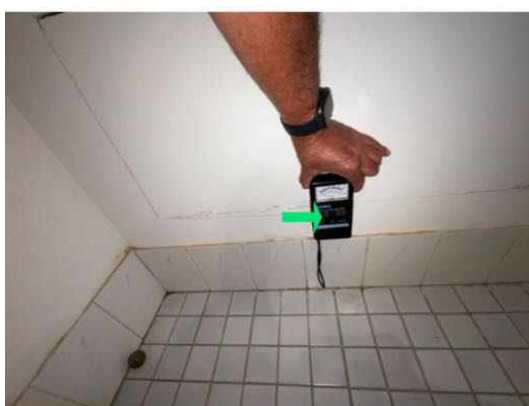
Building:	Main Building
Location:	Bathroom
Finding:	Major Defect – Moisture Ingress and Associated Deterioration (Toilet & Adjacent Areas)
Information:	Observation:

Elevated moisture readings were recorded to the lower wall linings and skirting tiles within the toilet and adjacent vanity area at the time of inspection. The skirting wall tiles were noted to be loose and drummy in sections, consistent with prolonged moisture exposure and loss of adhesive bond. Visible signs of moisture staining and mould-like growth were observed to the base/kickboard of the vanity cabinetry.

Minor fungal decay/early-stage timber rot was identified to the lower section of the toilet door frame, indicating sustained damp conditions. In the adjoining laundry area, a substantial section of plasterboard behind the toilet has previously been cut out and replaced or partially removed, which is suggestive of prior leak rectification works. However, the extent, cause, and adequacy of these repairs could not be confirmed at the time of inspection.

Despite apparent previous works, moisture readings remain elevated in the affected skirting and lower wall areas, indicating that the moisture source may still be active or that materials have not fully dried.

The presence of loose tiles, decayed timber, and active moisture readings indicates that this issue is more than cosmetic and requires further investigation. Without rectification, continued deterioration and increased repair costs are likely.

This matter should be treated as a major defect requiring prompt investigation and rectification. It is recommended that:

- A licensed plumber be engaged to undertake leak detection testing to identify and rectify the moisture source (e.g., plumbing penetrations, waterproofing failure, concealed pipework, or drainage issues).
- A qualified builder assess the extent of internal damage and carry out necessary repairs, including replacement of affected wall linings, tiles, door frame sections, and cabinetry components as required.
- Damaged or moisture-affected materials be removed and the area allowed to fully dry prior to reinstatement works.
- Mould remediation be undertaken where required in accordance with appropriate standards.

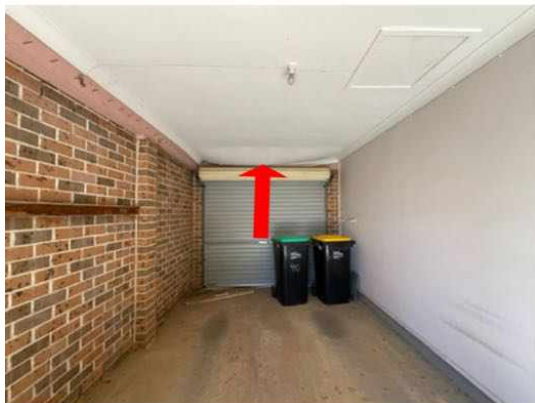
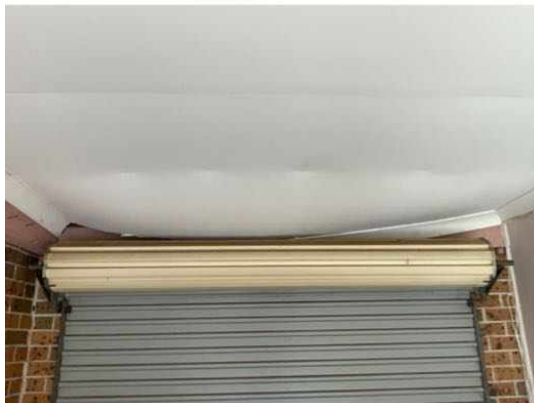
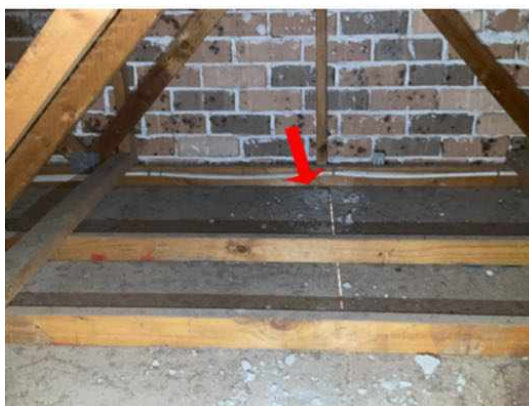
## Finding 2.02

Building:	Main Building
Location:	Garage
Finding:	Ceiling lining - Localised Ceiling Sagging (Garage Area).
Information:	During the inspection, isolated sections of ceiling lining were found to be sagging or detached, particularly near the rear garage doorway. This type of defect is commonly observed in garage areas and is typically attributed to general wear over time.

While the defect is currently considered minor to moderate and does not appear to compromise the structural integrity of the ceiling, it may worsen over time if left untreated and impedes on the roller door. Early signs such as sagging may eventually lead to detachment of ceiling sheets or visible cracking along joins or edges.

Repairs may involve re-gluing and re-fixing the ceiling sheets to the joists, a task generally undertaken by qualified plasterers or general interior trades. In some cases, repainting with moisture-resistant coatings may also be appropriate, particularly in garages where humidity levels can fluctuate.

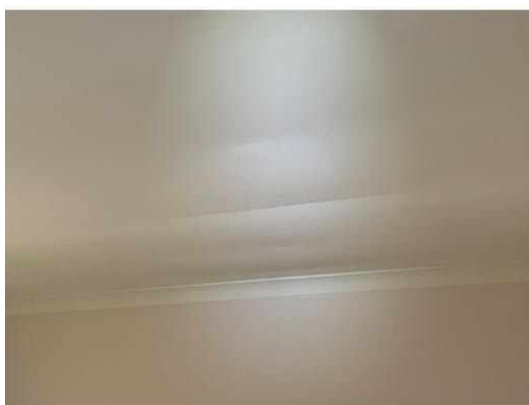
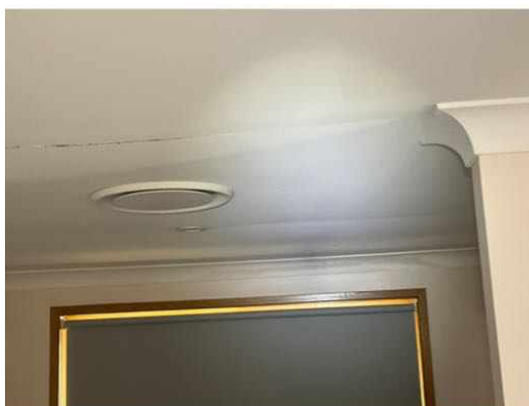
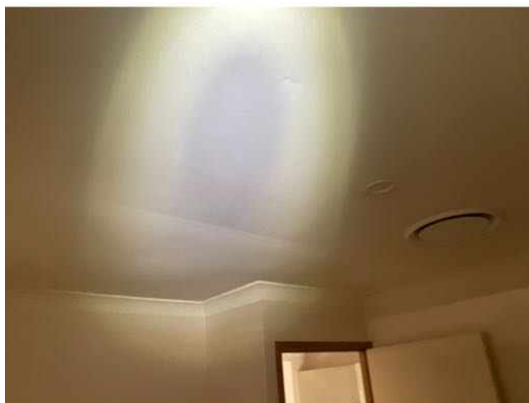
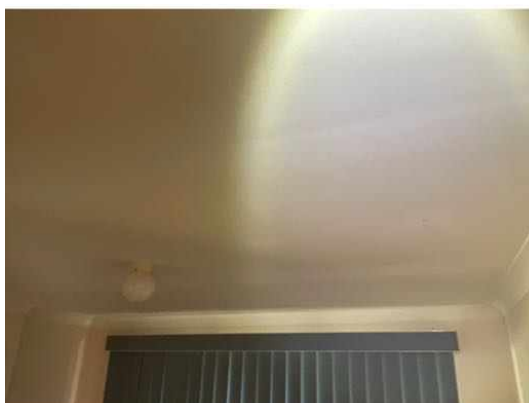
Finding 3.05

Building: Main Building  
Location: All Internal Areas  
Finding: Ceiling Linings – Uneven or Sagging Surfaces.  
Information: Observation:

- Re-gluing or re-adhering the ceiling sheeting
- Re-securing sheets using appropriate modern fixings
- These works can be carried out by a qualified plasterer or painter,
- Ongoing monitoring is advised to detect any worsening of the condition or further movement over time.

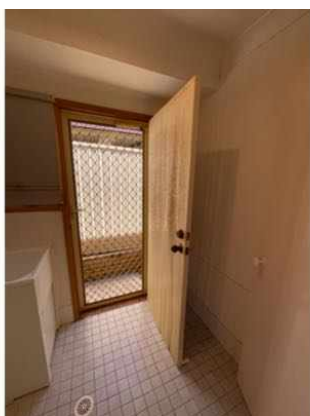
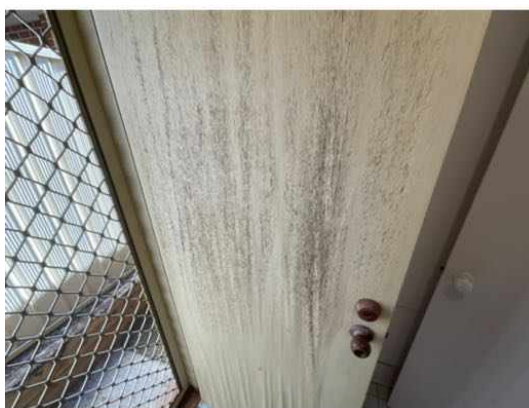
### Finding 3.06

Building: Main Building

- Sanding or filling superficial surface damage
- Resealing or repainting to protect against moisture
- Adjusting or rehangng the door if alignment is affected
- Replacing the door if damage is beyond economical repair

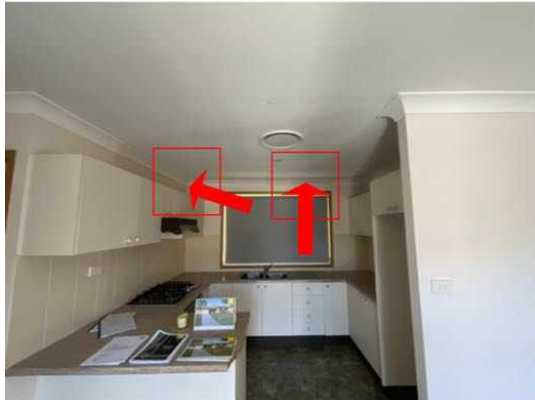
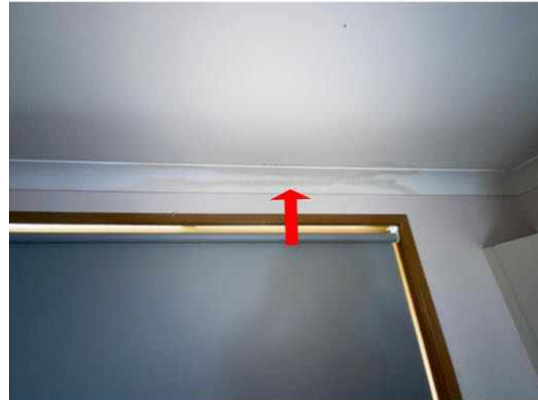
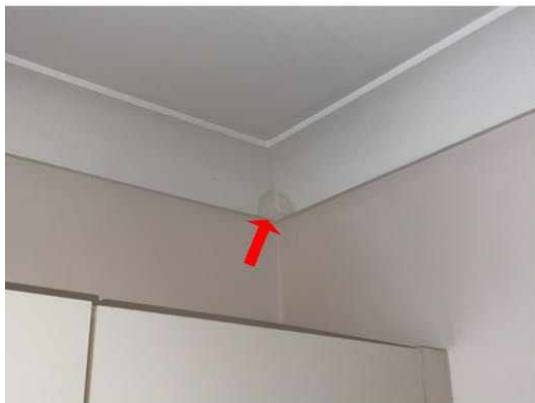
### Finding 3.07

Building: Main Building  
Location: Kitchen  
Finding: Ceiling - Water stained.  
Information: Observation:

conclusively determine whether water staining is active or inactive at the time of inspection. Further assessment under a special-purpose inspection is recommended if a more detailed diagnosis is required.

Additionally, it is important to note that even minor damage to roofing materials—such as lifted flashings, cracked tiles, or poorly sealed penetrations—can allow water ingress that may lead to costly internal damage. Close-up inspection by a roofing contractor is advised to assess the condition of the roof coverings and associated fixtures more accurately.

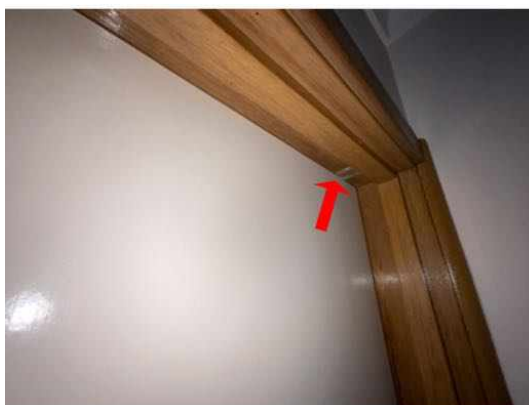
### Finding 3.08

Building: Main Building  
 Location: Bedroom  
 Finding: Door - Binding and/or Jamming.  
 Information: Functional Defect Identified

- If the issue appears to be related to major structural movement, it is recommended that a registered builder with experience in re-stumping or subfloor repairs be engaged to assess the extent of the movement and provide a quotation for necessary remedial works.
- Where the issue is minor in nature, a qualified carpenter or general handyperson may be appointed to carry out corrective works at the client's discretion.

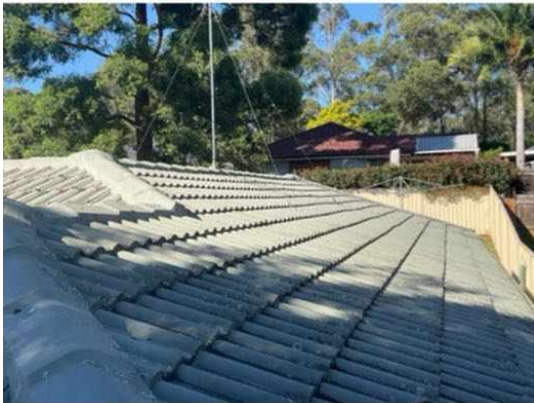
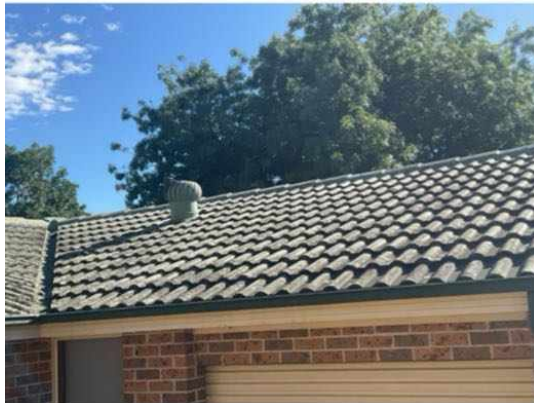
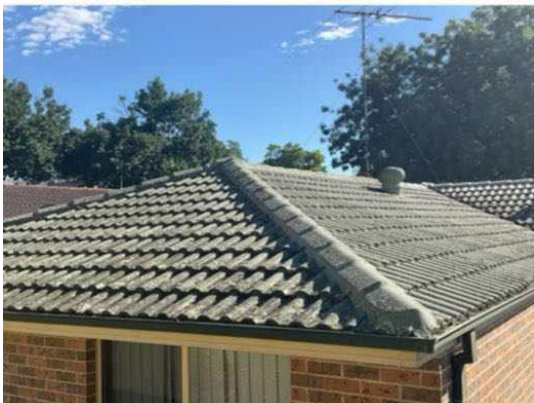
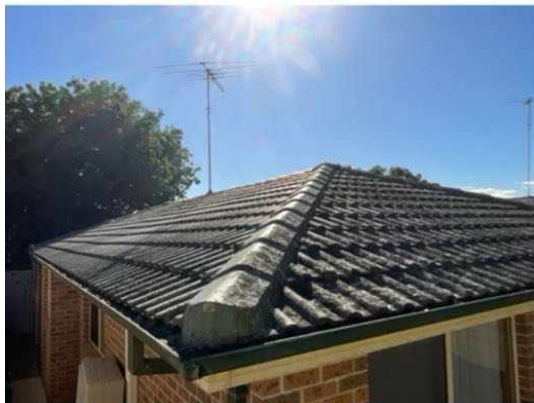
Building:	Main Building
Location:	Roof Exterior
Finding:	Roof Tiles – General Condition.
Information:	Condition Overview:

Based on the limited visual inspection, the roof and guttering system appears to be in a generally serviceable condition. A further investigation by a roofing specialist to ensure the integrity of non-visible areas.

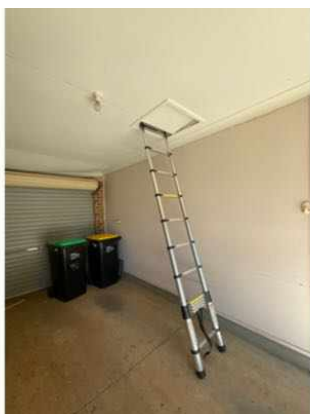
Building: Main Building  
Location: Roof Void  
Finding: Roof Void – Limited Accessibility..  
Information: Observation:

Installation of an additional manhole is recommended to facilitate a re-inspection and enable a more thorough assessment of the roof void in the future. This will help ensure that all structural elements and concealed areas are properly evaluated.

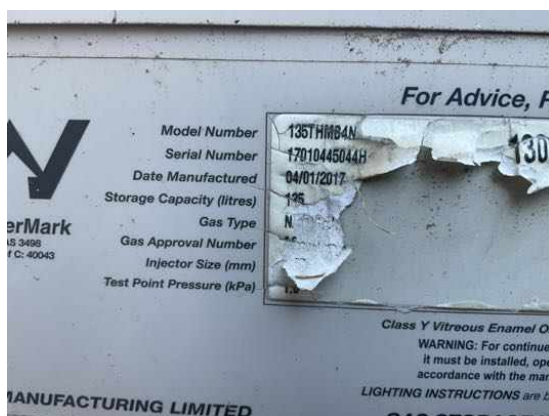
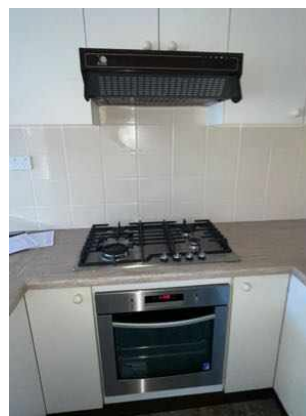
Building: Main Building  
 Location: All Areas  
 Finding: Plumbing, Electrical & Gas Installations – Scope and Recommendations.

While this inspection includes observations of visually apparent defects relating to plumbing and electrical elements, it does not assess compliance with current regulations. Legislation requires that any such assessment be undertaken and documented by licensed electricians and plumbers.

- Any gas appliances (if applicable) must be inspected by a licensed gas plumber to confirm they are operating safely and efficiently.
- We also recommend that all other plumbing and electrical installations be thoroughly checked by qualified professionals to ensure they are functioning correctly and meet current safety and compliance standards.

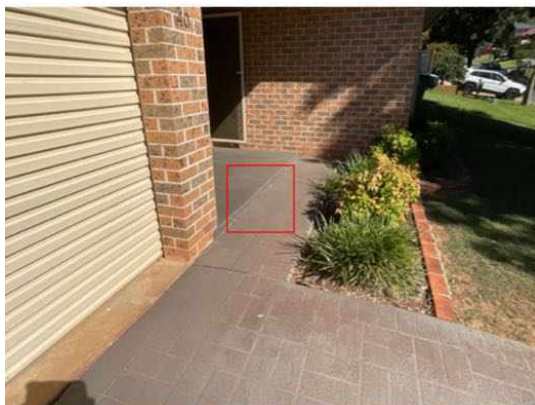
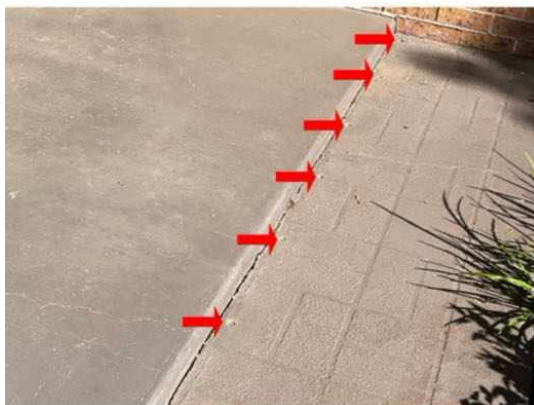
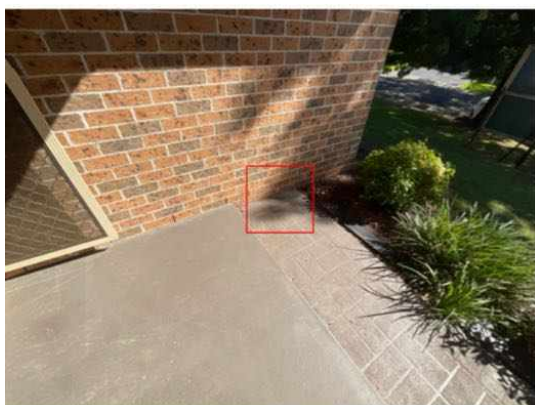
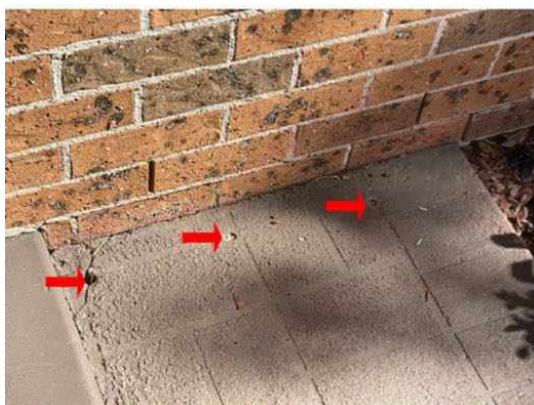
Building:	Main Building
Location:	All Areas
Finding:	Termite Management System – Previous Barrier Noted..
Information:	Observation:

At the time of inspection, evidence of a previous termite management system was noted, the presence drill holes to the external paving indicates a chemical treatment. At the time of inspection, no durable notice or sticker was found within the switchboard unit or other accessible areas to indicate the presence of a chemical treatment, termite management system currently installed.

- The installation of a termite management system is strongly recommended for all properties, particularly those with timber building elements. These systems provide a proactive defence against termite attack and are effective in minimising the risk of concealed termite entry and structural damage.
- The client is advised to contact the pest control provider listed on the durable notice (if identifiable) to obtain further information regarding:
  - The type of system installed (e.g., chemical barrier, baiting system, or physical barrier)
  - The installation date
  - Any warranty conditions, service history, or ongoing maintenance requirements

- If no reliable information can be obtained, or if the existing system is found to be outdated or non-functional, it is recommended that a new termite management system be installed by a licensed pest control professional.
