Building and Timber Pest Inspection Report

Inspection Date: Wed, 4 Mar 2026

Property Address: 4 Mortimer St, Minto NSW 2566, Australia

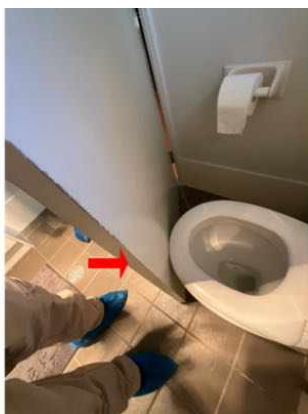
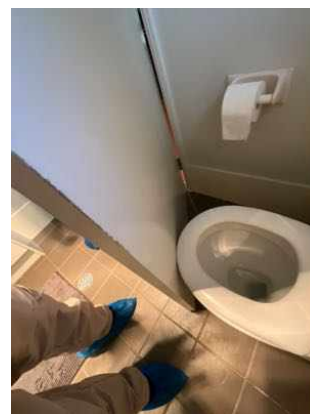
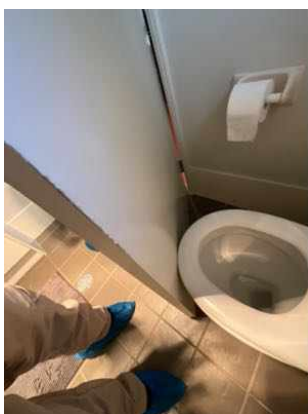
Information: A safety hazard was identified in the bathroom of the property. The issue pertains to the door, which, when fully opened, makes contact with the adjacent toilet. This situation poses an immediate risk to the safety and well-being of occupants due to the potential for accidents and injuries.

Collision between the door and the toilet can cause injury to individuals using the bathroom.

The repeated contact between the door and the toilet can also result in damage to both fixtures, leading to costly repairs or replacements.

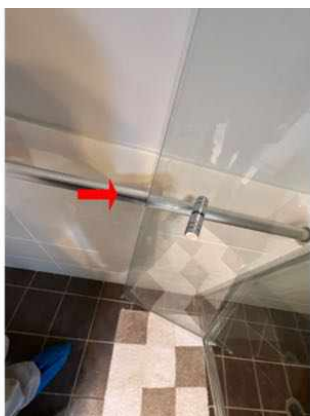
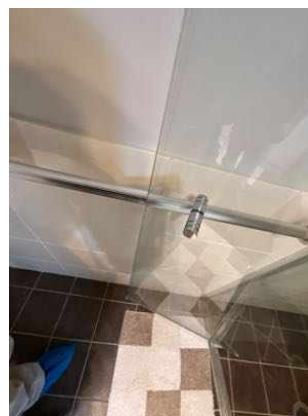
Finding 1.02

Location: Bathroom
 Finding: shower screen door hitting fixed towel rail/bar
 Information: The shower screen door was found to make contact with the fixed towel rail/bar upon opening. This indicates poor placement or alignment of fittings.

This condition is considered a potential safety hazard. Ongoing impact may lead to loosening of fittings or damage to the shower glass, which carries a risk of glass breakage and injury to occupants.

It is recommended that a licensed glazier or bathroom renovator further evaluate and rectify this issue. Adjustment of the shower screen door alignment or relocation of the towel rail is required to prevent contact and ensure safe operation.

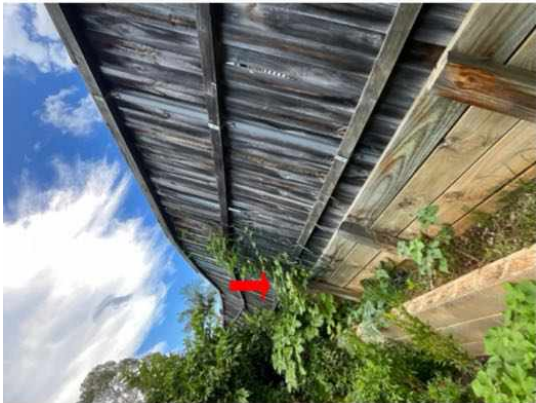
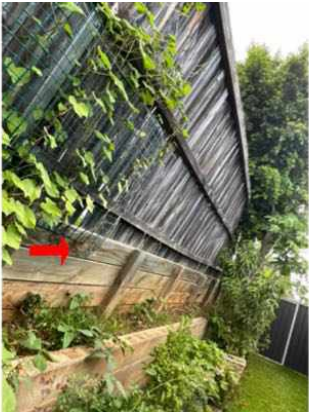
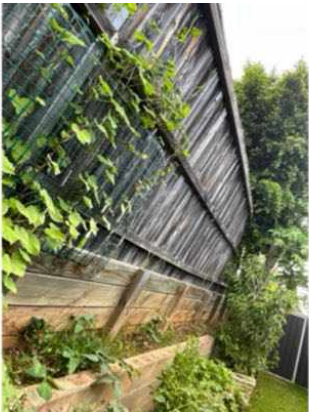
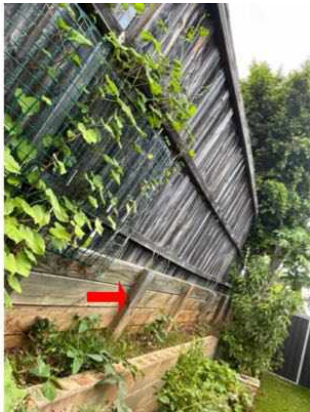
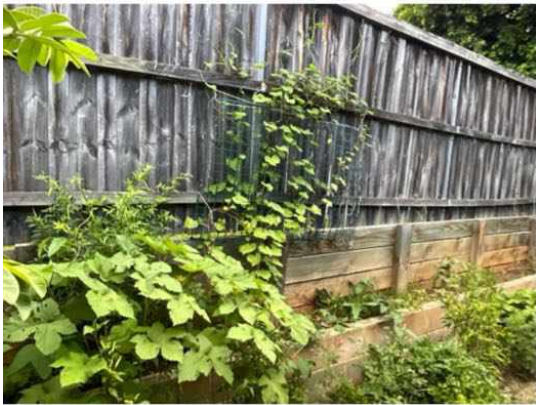
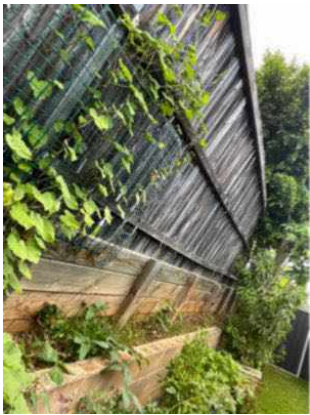
Finding 2.01

This is classified as a major structural defect under AS 4349.1-2007, as it affects the stability and load-bearing capacity of the retaining wall. There is a risk of collapse, posing a hazard to nearby structures, occupants, and vegetation. Failure of the wall may also result in soil displacement and drainage issues.

- Inspection: A qualified structural engineer should conduct a detailed assessment to determine the cause and extent of movement.
- Repair: Rectification work should be performed by a licensed builder or landscaper with experience in retaining structures, following engineering specifications.
- Prevention: Ensure proper drainage, footing depth, and wall anchorage in the rebuild to prevent recurrence.

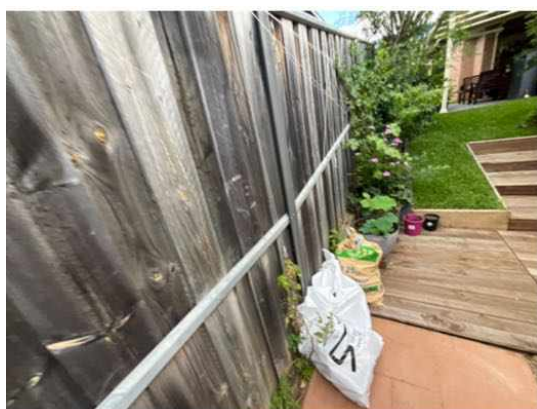
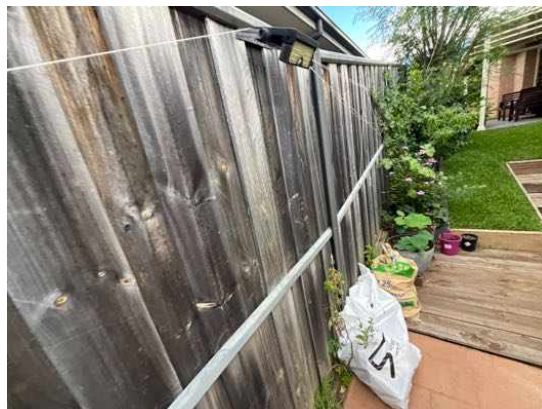
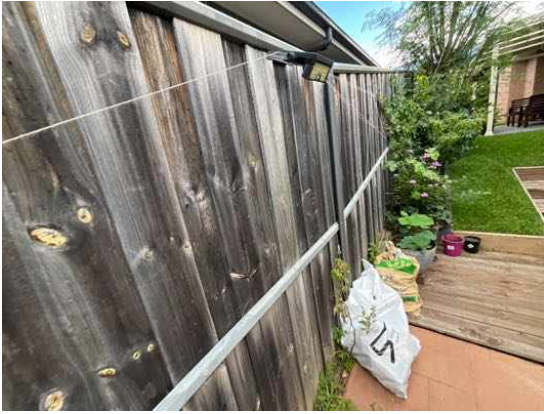
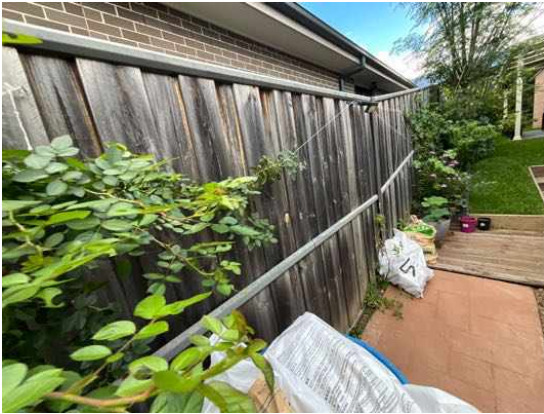
Finding 3.01

Building: Main Building
Location: All Areas
Finding: Detoriated fence
Information: The fence along the property boundary has deteriorated significantly, showing signs of rot, rust, and structural weakness. Several sections are leaning or have become detached, compromising the integrity of the fence and its ability to perform its intended function.

1. **Safety Hazard:** The unstable fence may collapse, posing a risk of injury to residents, visitors, and passersby.
2. **Security Concern:** The compromised fence may allow unauthorized access to the property, increasing the risk of theft, vandalism, or trespassing.
3. **Property Damage:** Falling sections of the fence could damage nearby structures, plants, or other property features.

- **Licensed Fencing Contractor:** A professional fencing contractor should be hired to assess the extent of the damage and either repair or replace the deteriorated sections.
- **Handyman Services:** For minor repairs, a qualified handyman could be engaged to reinforce or repair specific sections of the fence.
- **Landscaper (if the fence is part of a larger garden feature):** If the fence is integrated into the landscape design, a landscaper with experience in fencing could be involved in the repair or replacement process.

It's important to ensure that whoever is hired is experienced and qualified to ensure the fence is restored to a safe and functional condition, compliant with local regulations.

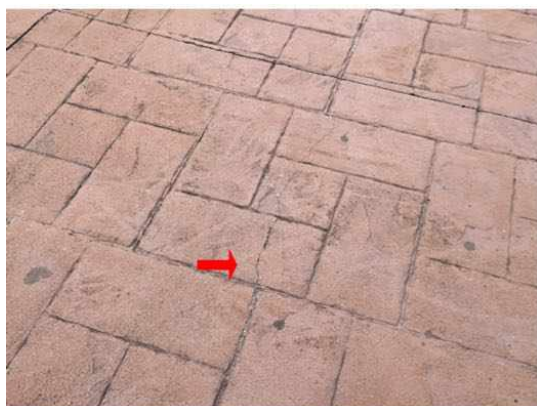
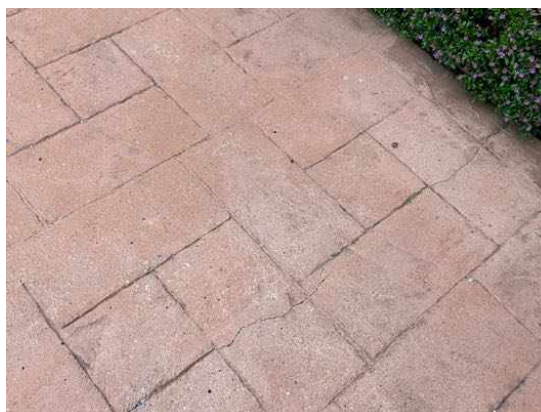
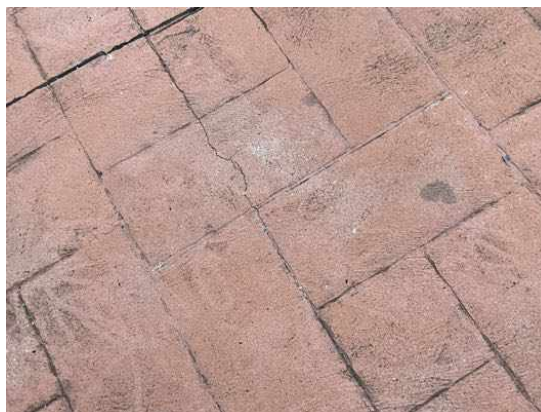
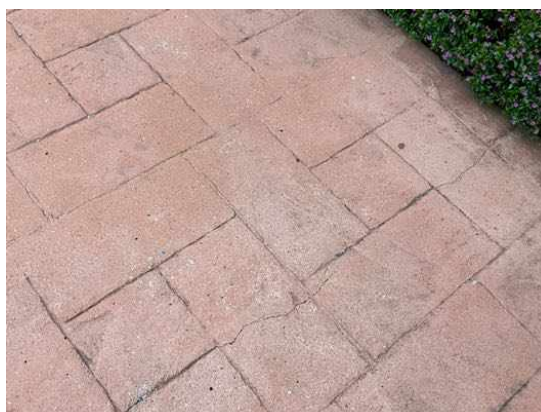
Finding 3.02

Building:	Main Building
Location:	All Areas
Finding:	Crack in concrete slab - Category 0
Information:	A crack coded as Category 0 was identified in the slab. A Category 0 crack is described as a hairline crack, representing insignificant movement of slab from level.

The approximate width of the crack to be considered Category 0 is 0.3mm, or change in offset of less than 8mm when a 3m straight edge is placed over the defect.

No rectification is required at this time. However, all cracking should be monitored over a 12 month period to identify any further damage in the area.

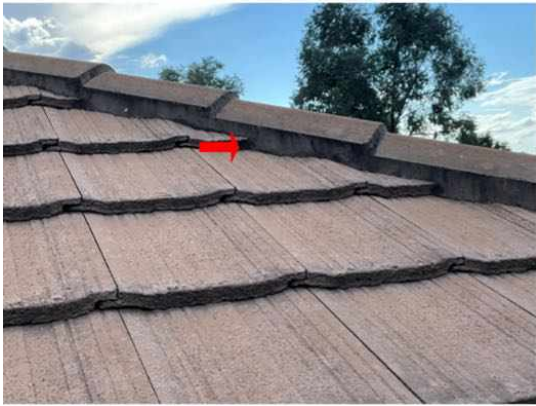
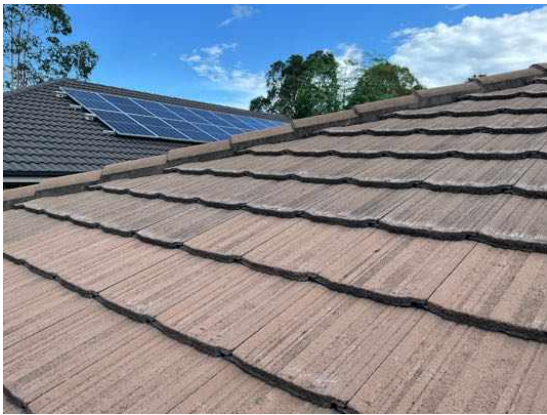
Finding 3.03

Information: Inspection of the roof revealed widespread weathering to the tiled roof surface. The tiles show loss of surface finish, colour fading, and age-related deterioration typical of older roof coverings. Although no significant cracking was noted, weathering can lead to increased porosity, reduced water-shedding capability, and a higher risk of future cracking or displacement during adverse weather conditions.

A licensed roofer should be engaged to undertake a closer inspection, carry out routine maintenance, and replace any tiles that may be compromised. Ongoing

monitoring is recommended due to the age and condition of the roof covering.

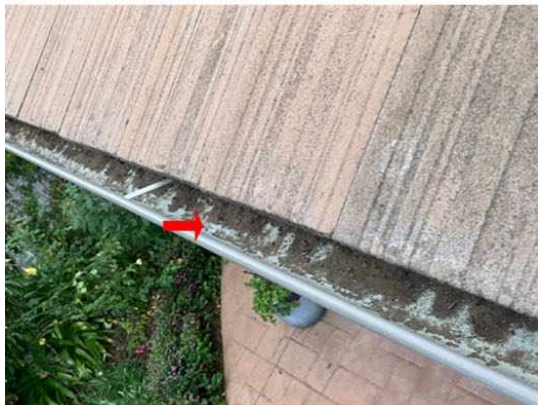
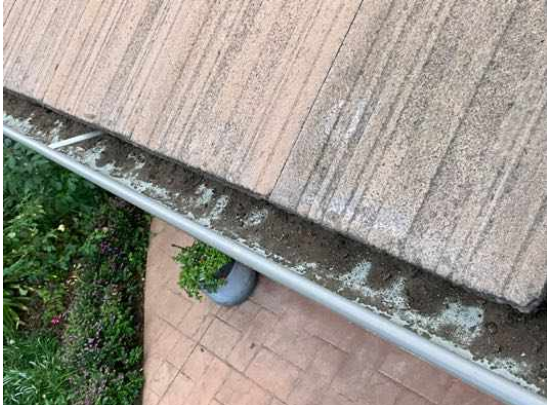
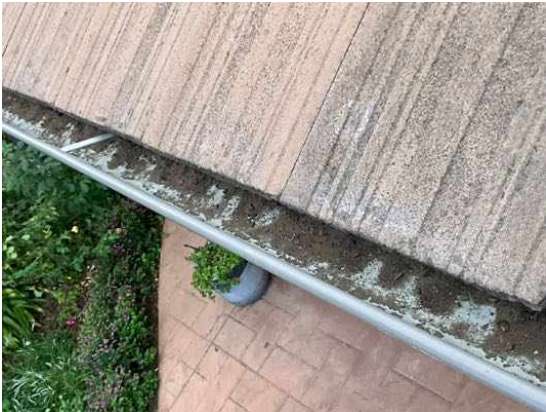
Finding 3.04

Building: Main Building
Location: All Areas
Finding: Blocked Gutters
Information: Blocked gutters , advised gutter to be cleaned.

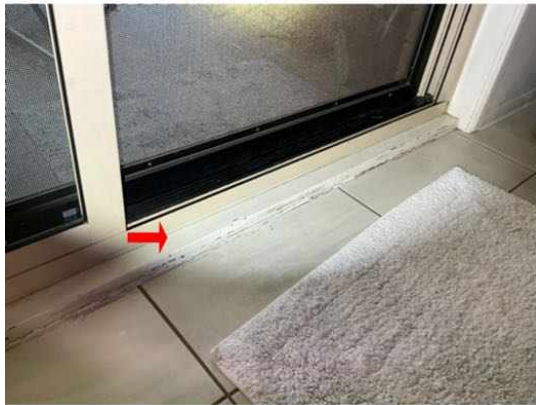
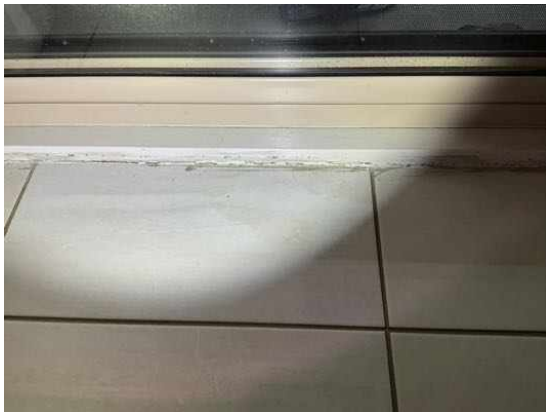
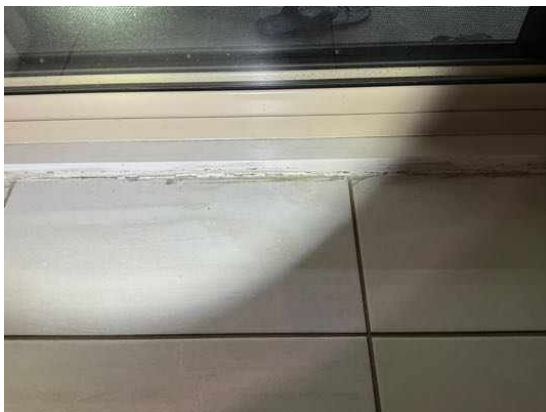
Finding 3.05

Building: Main Building
Location: Dining Room
Finding: Paint surface deteriorated

Information: Sections of the paint in this area was found to have bubble and deteriorated. Paint bubbling is generally an indication of excessive moisture in the area that is currently hidden by the painted surface.

The presence of excessive moisture can have major implications on associated building elements if left unattended. While only seemingly minor at this stage, the damage cannot be determined due to the paint, obstructing any further inspection of the damage.

It is highly advised that the affected paint to be cleaned to allow a further, more invasive inspection by a licensed builder/painter. Failure to act on this defect may necessitate major works in the future.

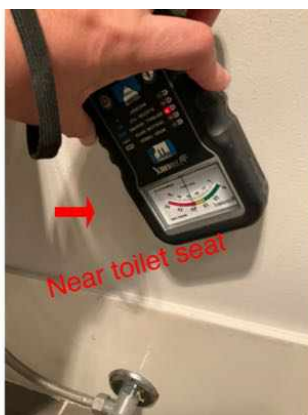
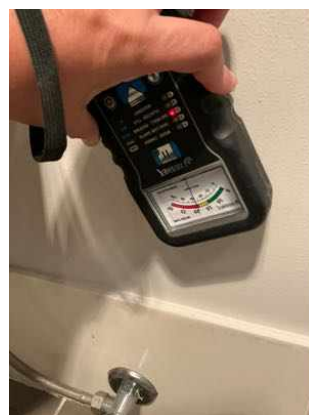
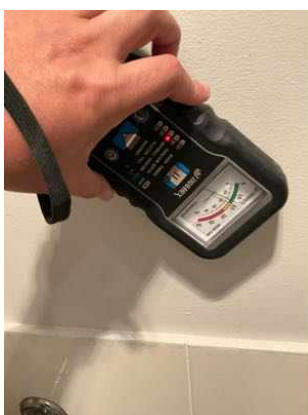
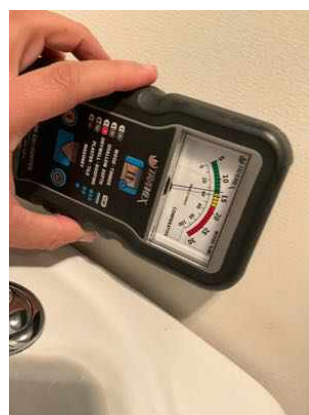
Finding 3.06

Building:	Main Building
Location:	Ensuite
Finding:	Evidence of excessive moisture - Drywall
Information:	Excessive moisture is present at the time of , indicating a potential water leakage issue within the wall.

The prolonged presence of moisture can lead to mold growth, deteriorate the structure, and create an environment conducive to health hazards. Additionally, it may compromise the adhesive holding the tiles, leading to their detachment.

A licensed plumber or a qualified contractor specializing in water damage remediation should investigate the source of the moisture, fix any leaks, and address the damage. Additionally, replacing affected tiles and ensuring proper waterproofing are crucial to preventing future issues.

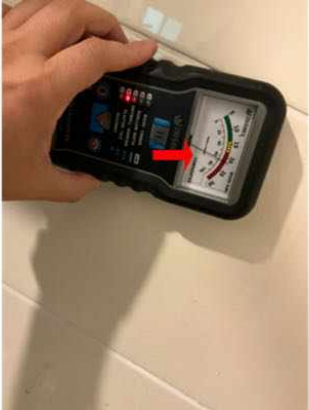
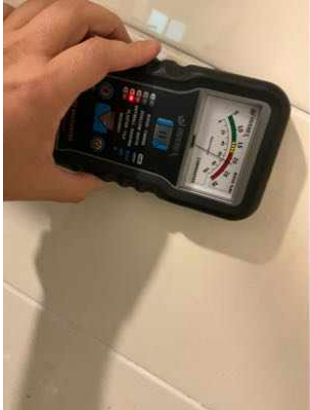
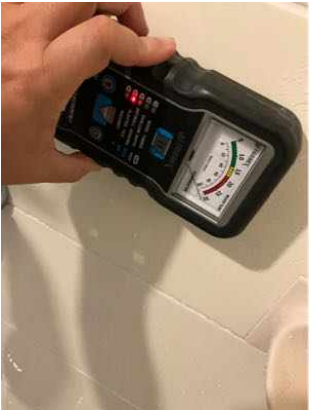
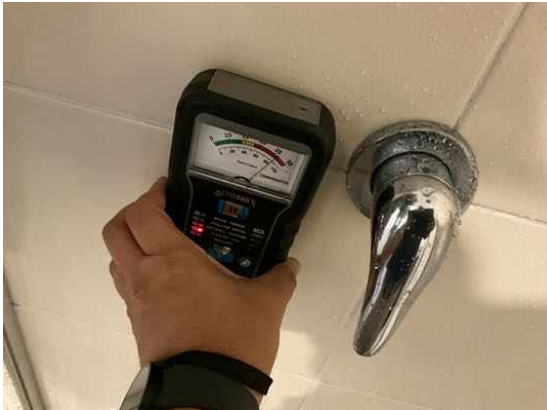
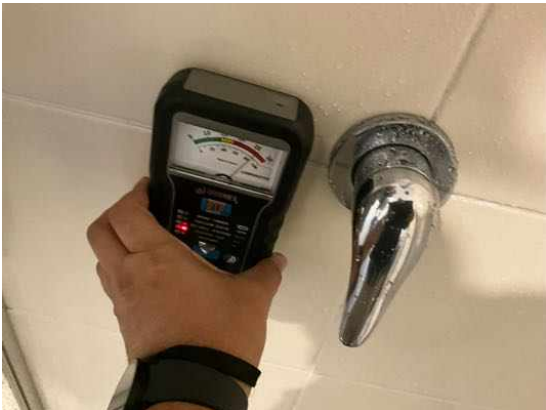
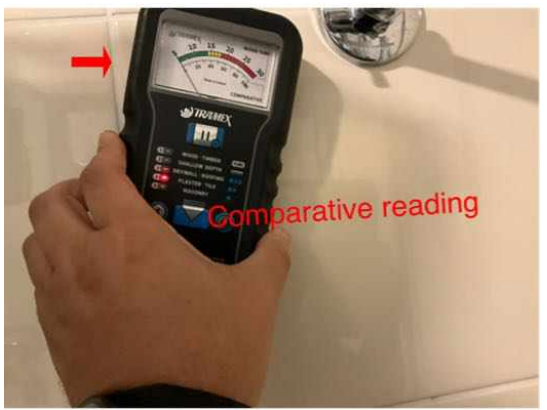
Building:	Main Building
Location:	Ensuite
Finding:	Evidence of excessive moisture was present at the time of inspection
Information:	Excessive moisture is present behind the bathroom tiles, indicating a potential water

leakage issue within the wall.

The prolonged presence of moisture can lead to mold growth, deteriorate the structure, and create an environment conducive to health hazards. Additionally, it may compromise the adhesive holding the tiles, leading to their detachment.

A licensed plumber or a qualified contractor specializing in water damage remediation should investigate the source of the moisture, fix any leaks, and address the damage. Additionally, replacing affected tiles and ensuring proper waterproofing are crucial to preventing future issues.

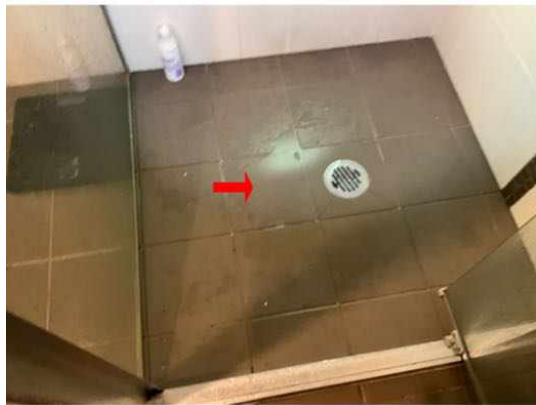
Finding 3.08

Building: Main Building
 Location: Ensuite
 Finding: Shower base - Water pooling
 Information: Evidence of water pooling around the floor waste in the shower recess was noticed at the time of inspection. It is suspected that this excessive moisture is attributed to insufficient fall in the shower floor tiles.

This pooling is minor overall but is still considered unsatisfactory, as standard tiling practices would not permit this situation to occur. Pooling water around floor wastes can create a slip hazard in extreme cases and create conditions that are conducive to mould growth over time. Where left unmanaged, the degradation of sealant and grouting is also likely to occur, possibly necessitating further repair works.

Remedial works may involve some sections of tiling and flooring repair and replacement. A tiling contractor or bathroom specialist should be appointed to provide further advice on reparation options and to perform works as necessary.

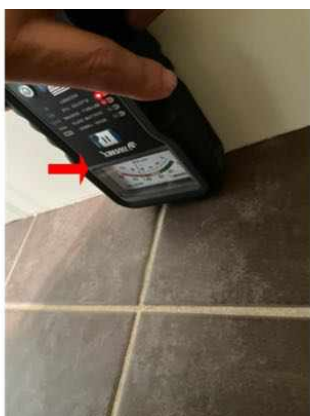
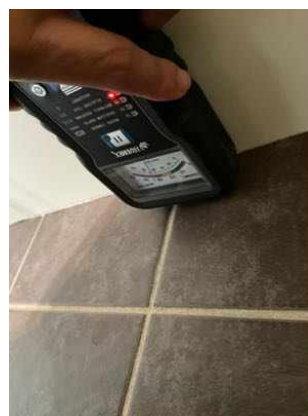
Finding 3.09

Building: Main Building
 Location: Bathroom
 Finding: Shower - Damp
 Information: Damp is evident to the lower 300mm of wall to the shower alcove. This defect is quite

common, and is suspected to have been caused by moisture permeating through the grouting in this area, which shows evidence of deterioration. Leaking pipes within the adjoining wall is also a possible cause.

Damp (or structural damp) refers to the presence of unwanted moisture in the structure of a building, either as the result of intrusion from outside, or condensation from within the structure. In the shower area, internal water leaks or other sources of excessive moisture are generally the cause of damp.

Unmanaged damp in the shower recess is likely to facilitate the formation and development of mould and fungi growth, decaying associated building materials and compromising their structural integrity. It is important to address damp conditions, as the World Health Organisation notes that excess moisture leads - on almost all indoor materials - to growth of microbes such as moulds, fungi and bacteria, which subsequently emit spores and other matter into the indoor air. Exposure to these contaminants is associated with a wide range of respiratory and other health-related problems.

Consultation with a qualified plumber or bathroom specialist is advised immediately to identify the cause of damp and to perform remedial works as required. Where excessive mould growth is present, further inspection by a specialist environmental health inspector should also be considered.

Always ensure that sealant and grout is in good condition to prevent any moisture issues occurring in the future.

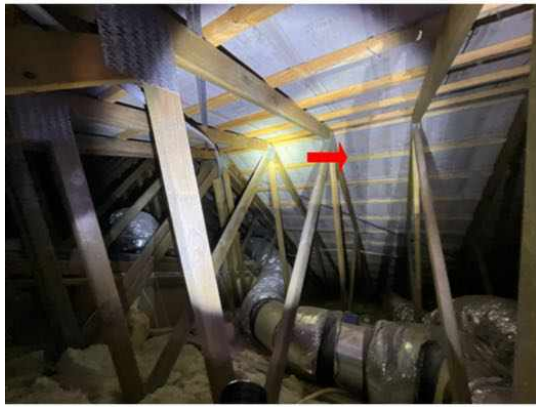
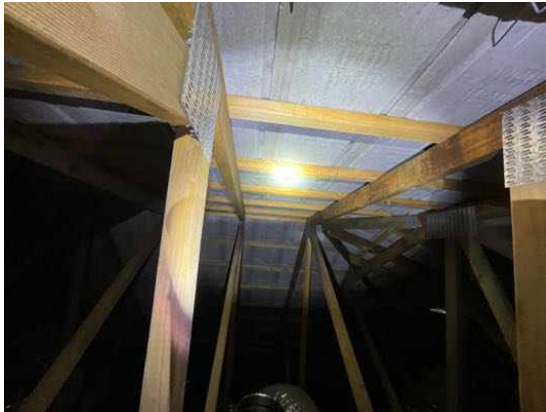
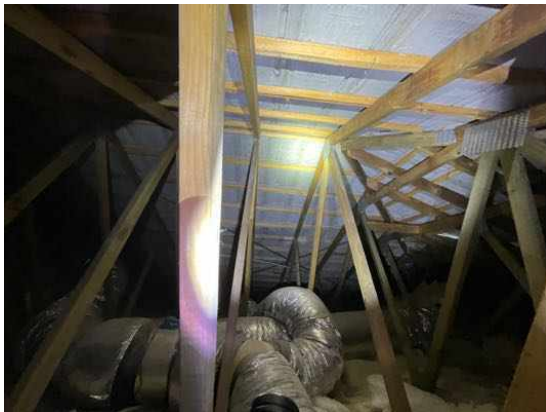
Finding 3.10

Building:	Main Building
Location:	Roof Void
Finding:	Sarking - Missing
Information:	Sarking is missing under the roof sheeting. Sarking acts as an insulator that helps with noise reduction and protects against water penetration. Sarking plays a key role in the operation and function of the overall roofing structure and its performance.

Although not a requirement at the time of construction, replacement of any missing building element is advisable (although this can be quite expensive to do after the time of construction). Where sarking is missing, regular inspections of the roof tiles for cracking and potential moisture penetration is required.

Sarking may be retrospectively fitted by a registered builder at the discretion of the client.

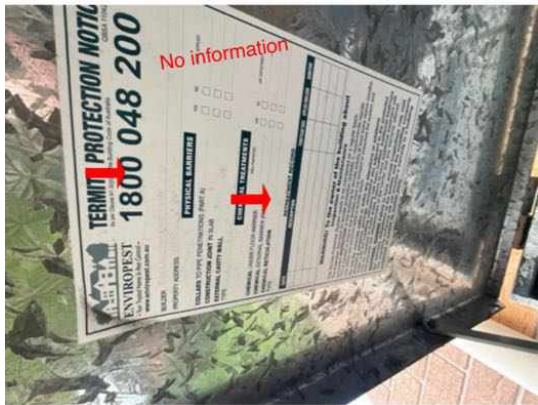
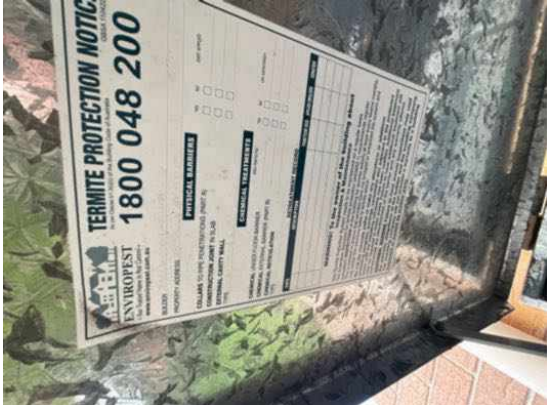
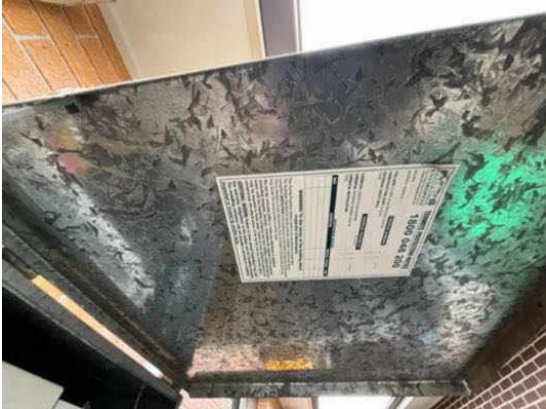
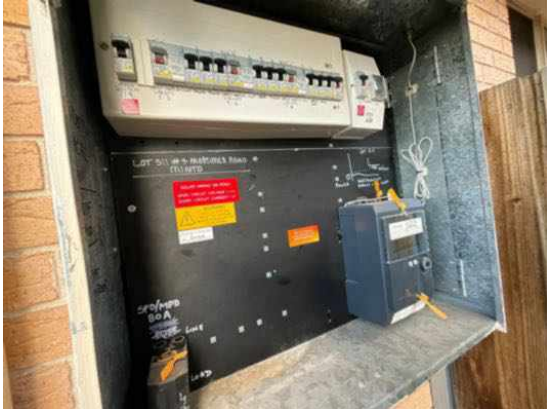
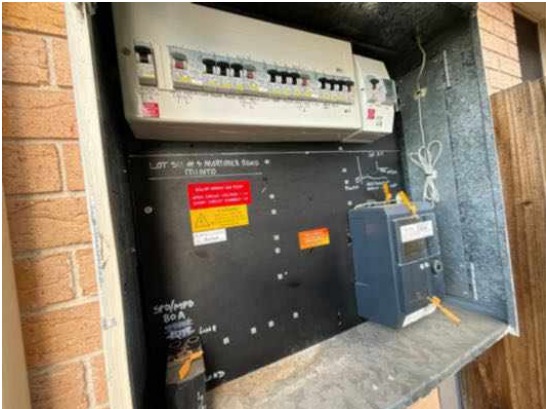
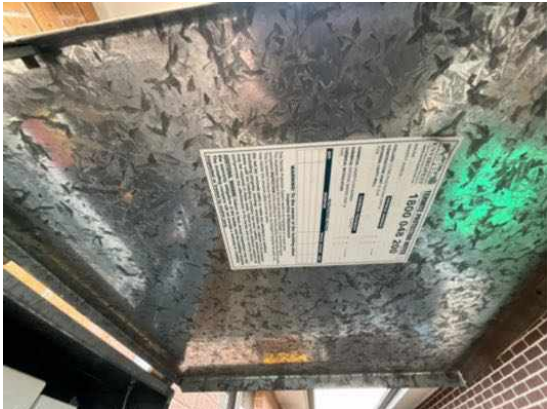
Building: Main Building
 Location: Exterior walls - right side
 Finding: No Evidence of Termite Management System - Durable notice / Legible Sticker
 Information: The application of a pre & post-construction chemical termite barrier is highly recommended for all properties. Such barriers are highly effective in preventing termite attack on any timber building elements throughout the property.

A durable notice was not placed in the switchboard unit to indicate current termite barriers is legible at the time of inspection.

Client must seek further information from the vendor or real estate agent if the conditions of termite management systems were maintained.

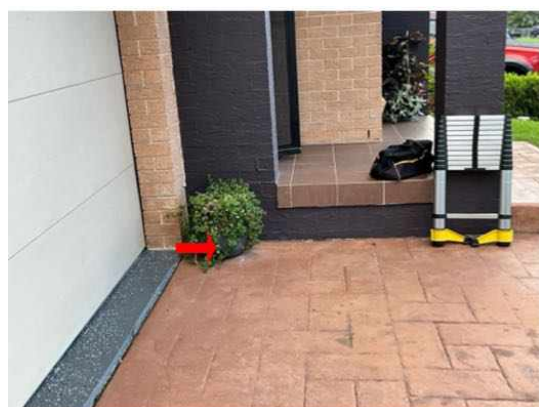
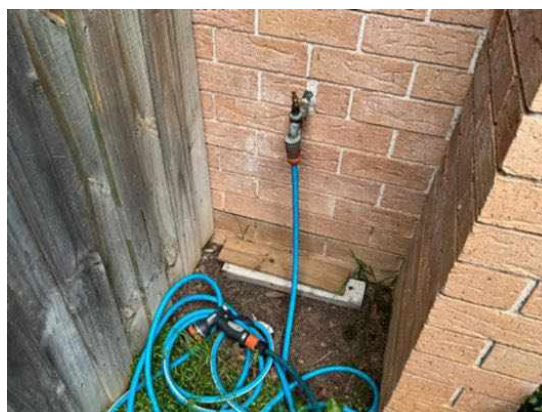
Finding 6.02

If the slab edge is not properly exposed there is a high risk of termite attack. Sometimes, in order to determine the type of slab, a suitably qualified person such as an architect or builder may be required to consult the construction plans.

Where the slab edge cannot be properly inspected, it is highly recommended that termite or timber pest inspections be carried out every 6-12 months to aid protection of the property against infestation.

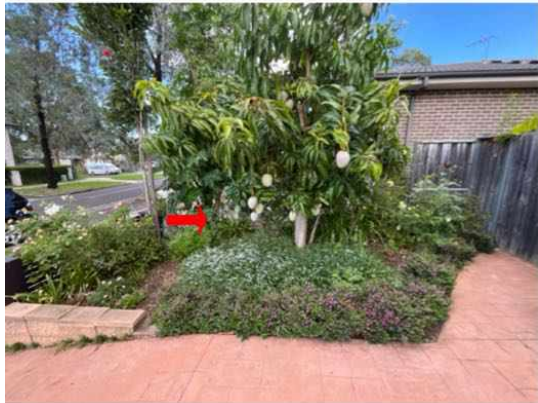
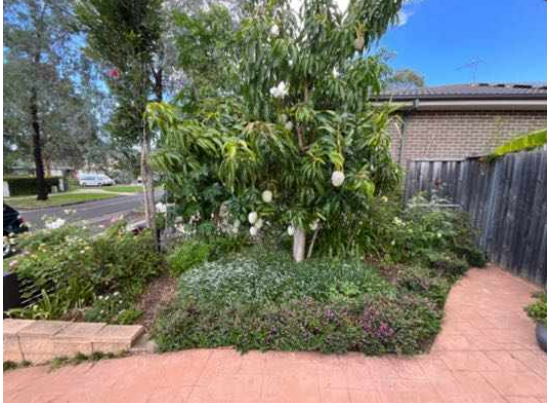
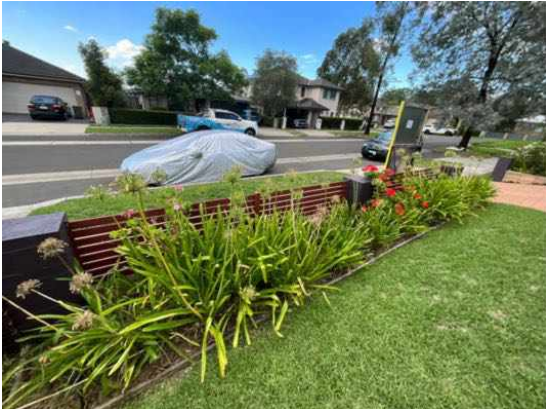
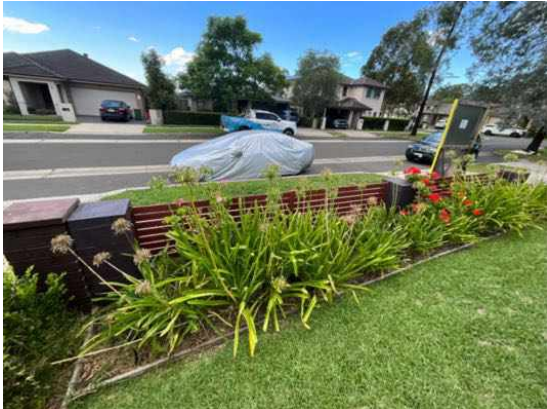
Finding 6.03

Building: Main Building
Location: All Areas
Finding: Dense vegetation around a property can increase the risk of termite infestation
Information: The presence of dense vegetation around a property can increase the risk of termite infestation, as it provides a conducive environment for them. To address this, consider maintaining a clear space between the vegetation and your home. If you suspect a termite issue, it's advisable to consult with a licensed pest control professional for inspection and treatment.

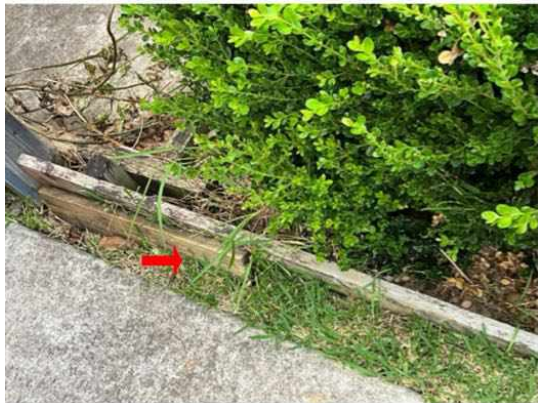
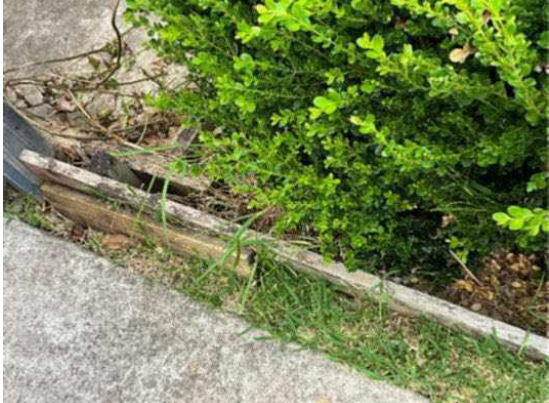
Finding 6.04

Building: Main Building
Location: All Areas
Finding: Timber on ground / conducive conditions to termite damage
Information: Timber on the ground is indeed conducive to termite damage. Termites are known to thrive in moist environments, and wood in contact with soil or moisture is more susceptible to infestation.

To prevent this, it's important to keep timber elevated and away from direct ground contact. Regular inspections and proper termite control measures are also essential to protect your wooden structures from termite damage.

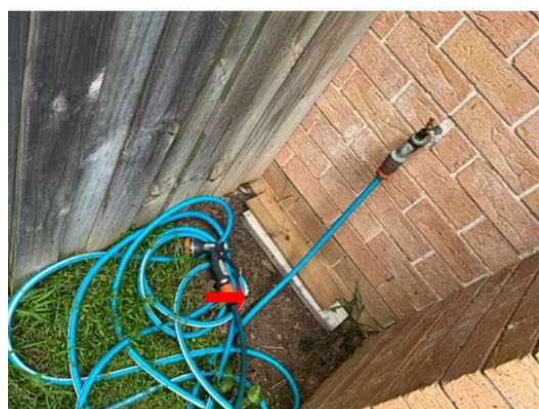
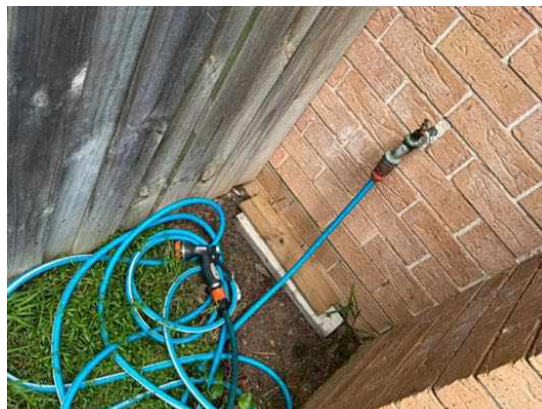
Finding 6.05

Building: Main Building
Location: All Areas
Finding: No Drain under tap
Information: There is no drain installed under the tap, leading to water accumulation and creating conducive conditions for timber pests. This defect needs immediate attention to prevent potential damage and pest infestation.
Risk:
1. Water Accumulation: Without proper drainage, water can accumulate around the base of the tap, leading to persistent dampness in the surrounding area.

2. Timber Pest Infestation: The damp environment created by standing water is highly conducive to timber pests, such as termites and wood borers, which thrive in moist conditions and can cause significant damage to wooden structures.

3. Structural Damage: Prolonged exposure to moisture can lead to wood rot and deterioration of structural timber, compromising the integrity of the building.

4. Health Hazards: Persistent dampness can also promote mold and mildew growth, posing health risks to occupants.

5. Aesthetic Damage: Water stains and damage to finishes and materials around the tap area can detract from the appearance of the building and lead to costly repairs.

A licensed plumber or a qualified building contractor can address this defect by:

1. Assessment: Evaluating the area to determine the best approach for installing a proper drainage system under the tap.
2. Installation: Installing a drain that effectively channels water away from the base of the tap, preventing water accumulation and dampness.
3. Repair and Prevention: Inspecting and repairing any existing water damage and implementing measures to prevent future water accumulation and pest infestations.

By addressing this issue promptly, you can mitigate the risks associated with water accumulation and timber pest infestation, ensuring the longevity and safety of the building.

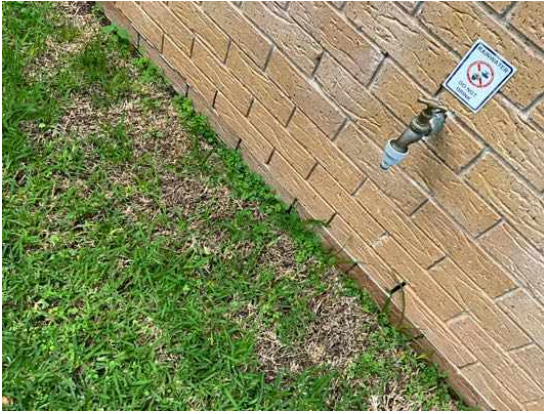
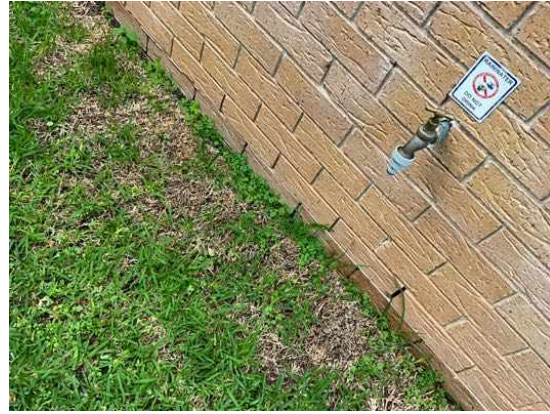
Finding 6.06

Building: Main Building
 Location: All Areas
 Finding: Bridging or Obstruction Conducive environment for Termites
 Information: Bridging of termite barriers occurs when termites bridge (usually by building a mud tunnel) a termite barrier or inspection inspection zone or where termites have a passage, allowing them to bridge the barrier.

Where bridging has occurred full inspection is prevented and termites may enter a property in a concealed or undetected manner.

Recommended moving obstructions away from the external walls for further and future inspections.

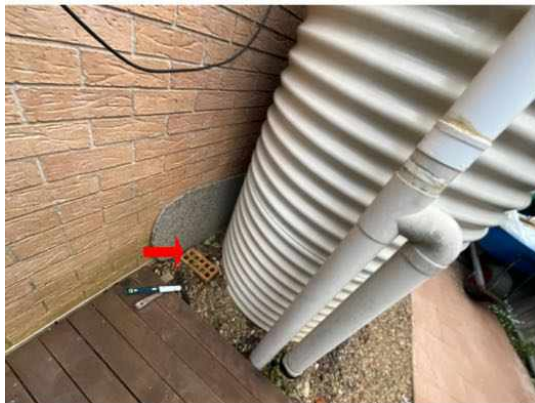
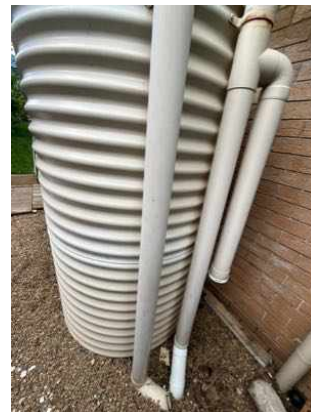
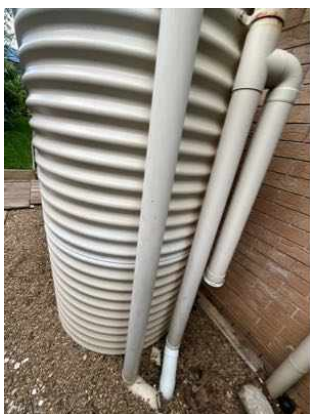
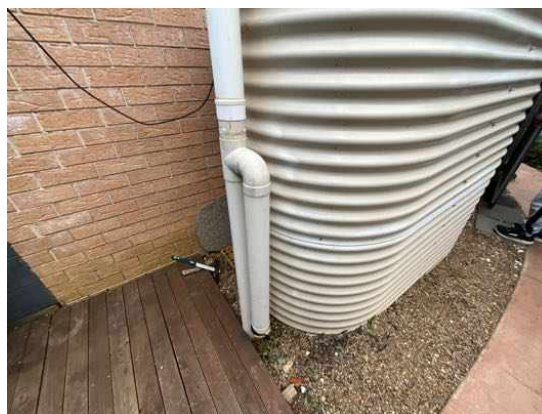
Finding 6.07

Building:	Main Building
Location:	Ensuite
Finding:	Excessive moisture - Conducive to Timber pest
Information:	Excessive moisture can attract termites and produce conditions that promote fungal growth and wood decay.

Excessive moisture is generally caused by deteriorated inadequate or missing roof drainage leaking plumbing pipes or fixtures poorly plumbed HWS overflows or condenser units and poor site drainage.

If mould growth has been found there may be environmental biological or health issues involved. In these cases an appropriately qualified inspector should also be contacted.

Prior to any remedial works being performed a qualified plumber should be appointed to further inspect the property and to identify the cause of the excessive moisture. Works to remove affected building elements may then be necessary and should be performed by an appropriate tradesperson.

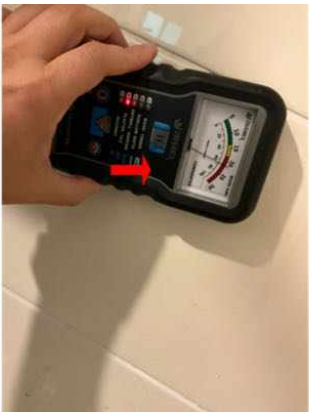
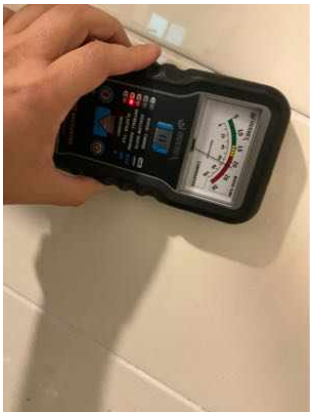
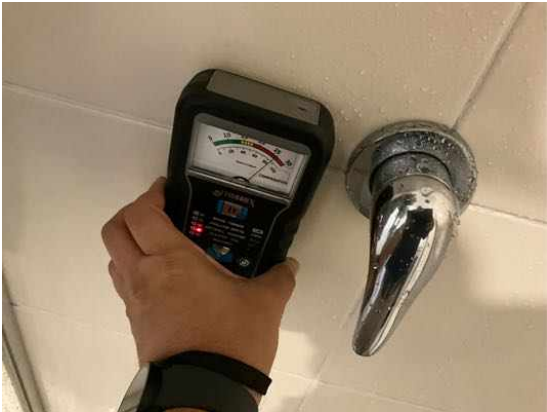
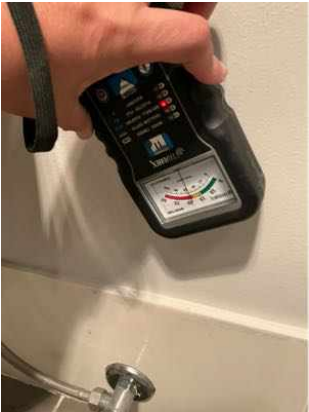
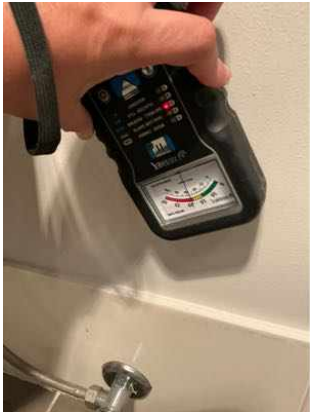
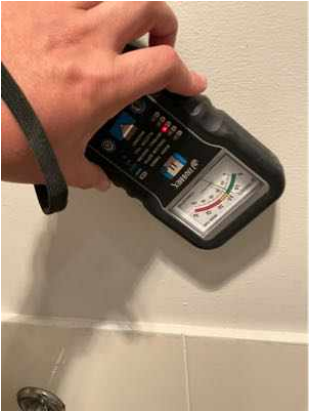
Finding 6.08

Building:	Main Building
Location:	Bathroom
Finding:	Excessive moisture - Conducive to Timber pest
Information:	Excessive moisture can attract termites and produce conditions that promote fungal growth and wood decay.

Excessive moisture is generally caused by deteriorated inadequate or missing roof drainage leaking plumbing pipes or fixtures poorly plumbed HWS overflows or condenser units and poor site drainage.

If mould growth has been found there may be environmental biological or health issues involved. In these cases an appropriately qualified inspector should also be contacted.

Prior to any remedial works being performed a qualified plumber should be appointed to further inspect the property and to identify the cause of the excessive moisture. Works to remove affected building elements may then be necessary and should be performed by an appropriate tradesperson.

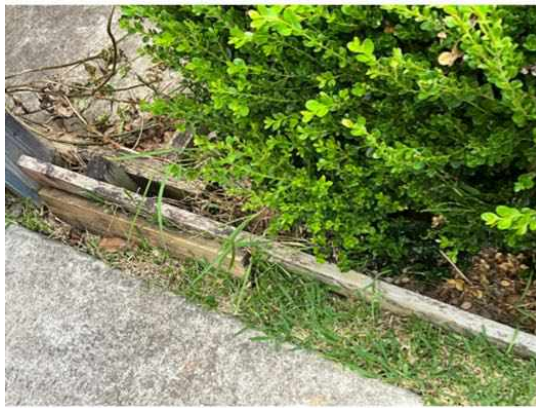
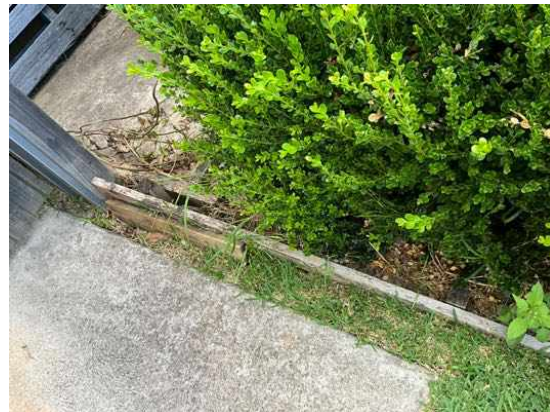
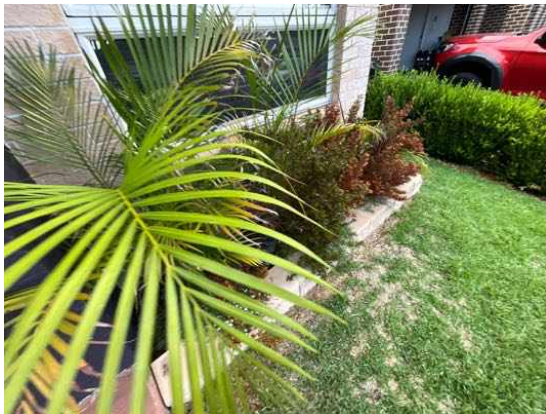
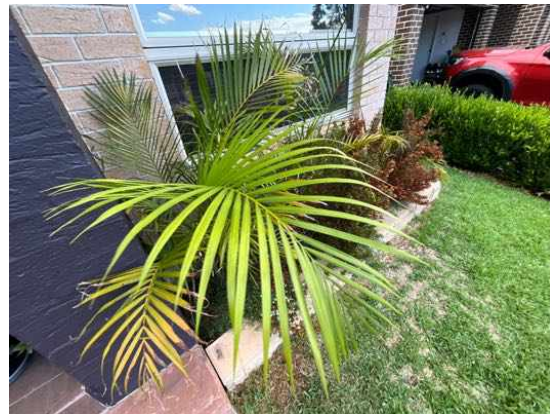
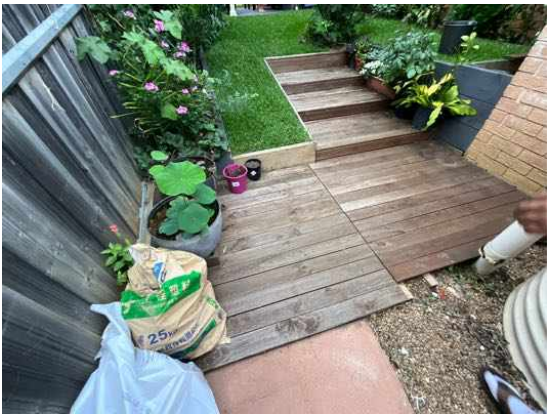
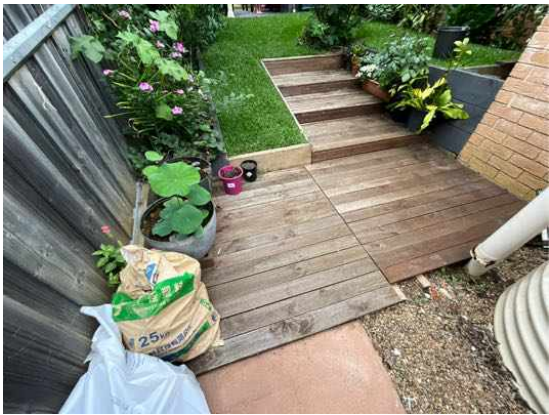
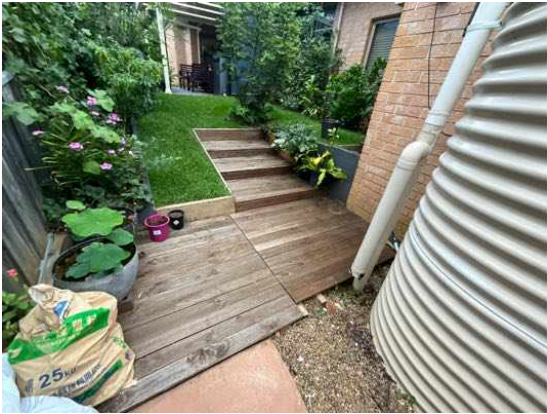
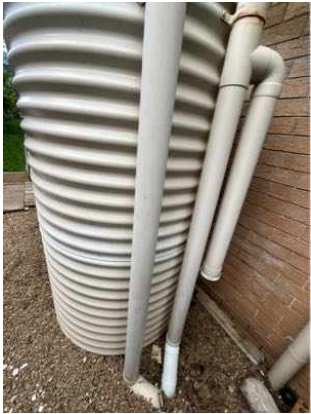
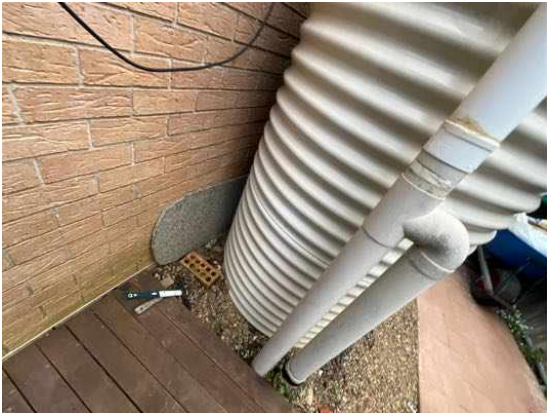
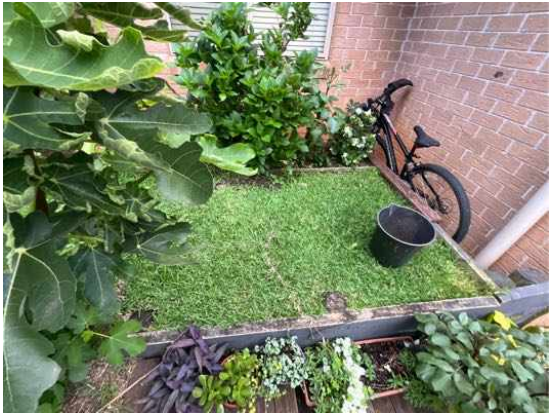
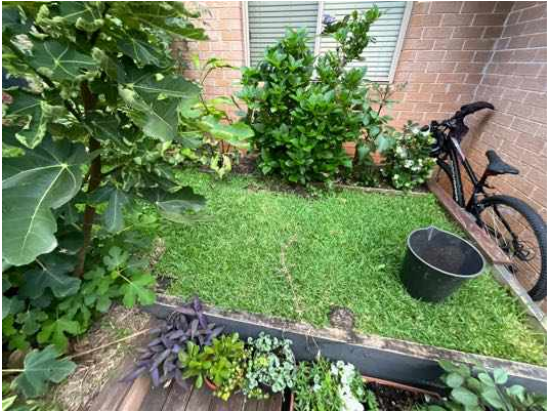
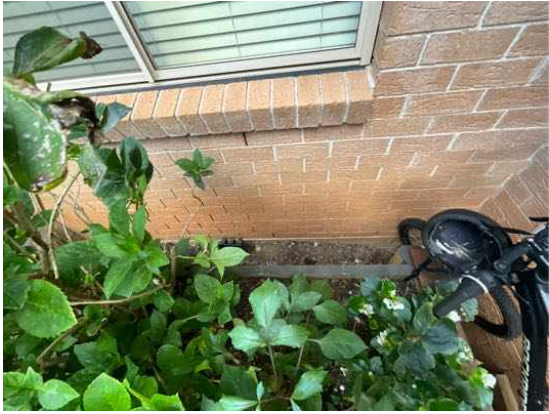
Noted Item

Building: Main Building
Location: All Areas
Finding: Additional Photos - Obstructions and Limitations
Information: These photographs are an indication of the obstructions and limitations which impeded full inspection of the property at the time of inspection. These obstructions can hide an array of defects and should be removed to allow full inspection to be carried out. A re-inspection is recommended once the areas are made accessible.
