Building and Timber Pest Inspection Report

Inspection Date: Wed, 4 Mar 2026

Property Address: 4 Mortimer St, Minto NSW 2566, Australia

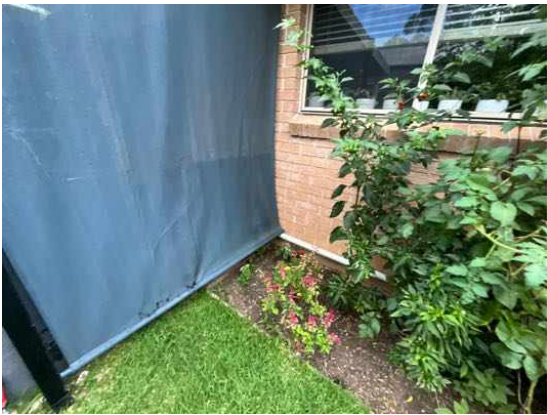
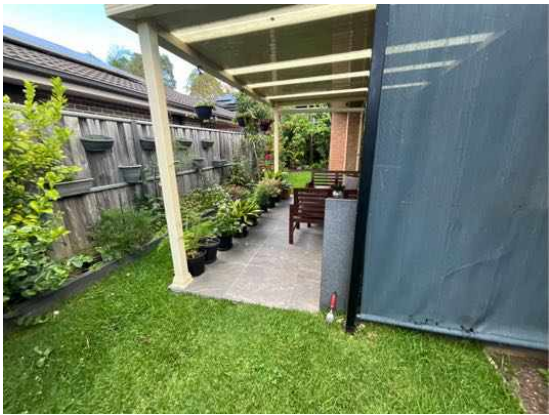
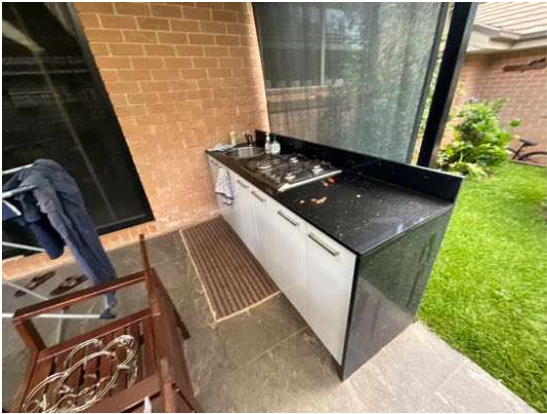
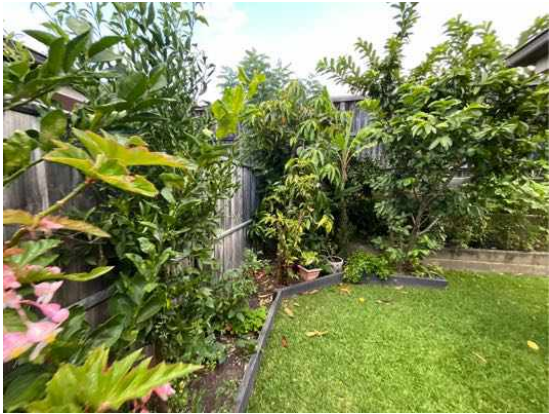
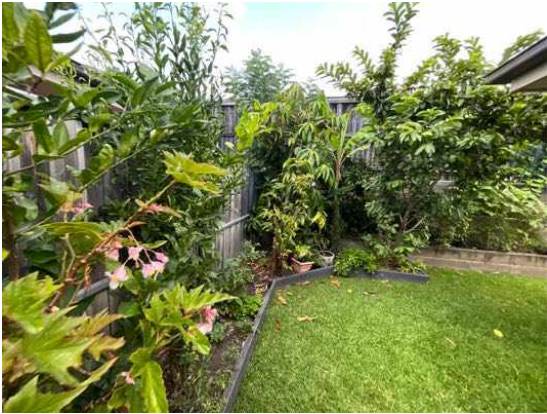
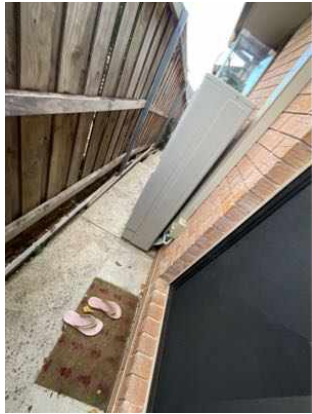
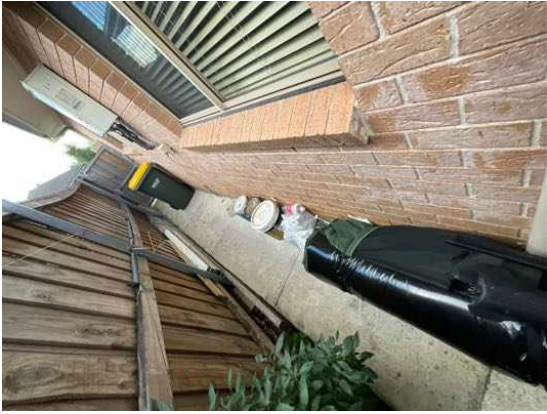
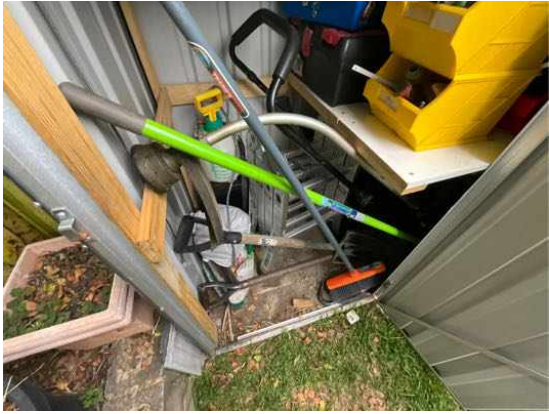
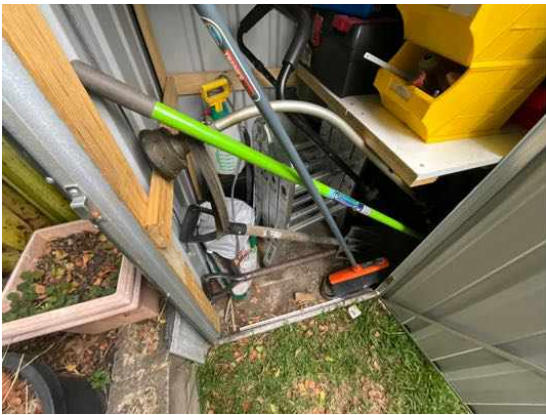
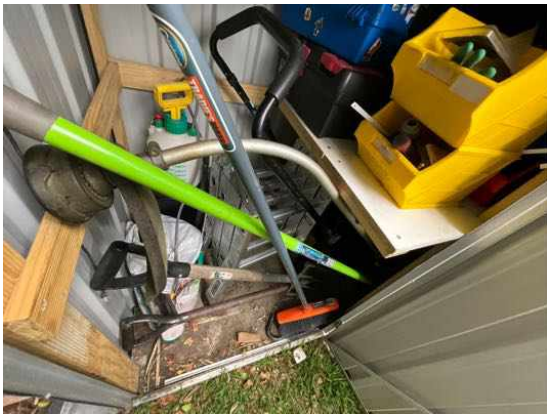
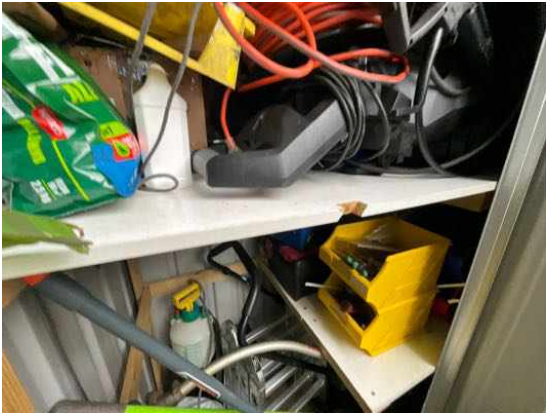
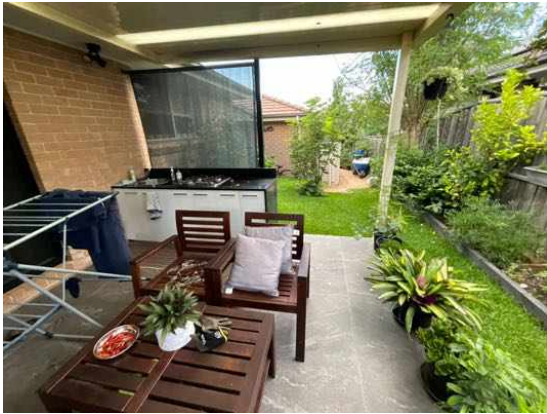
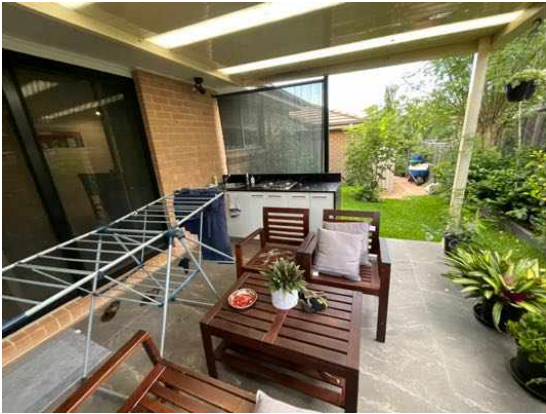
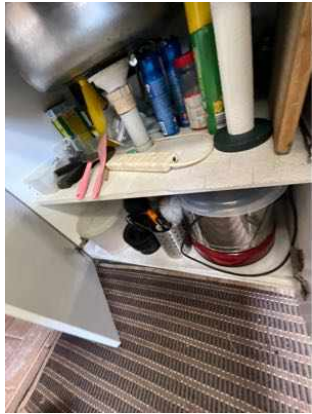
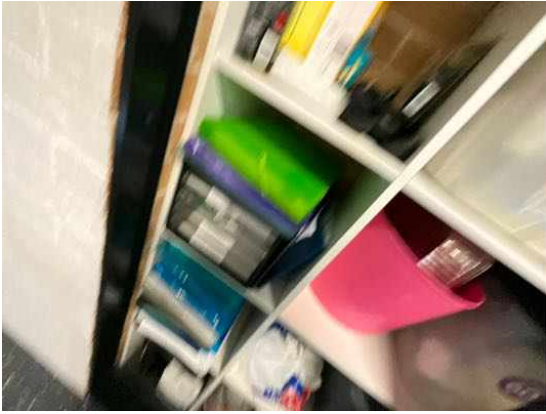
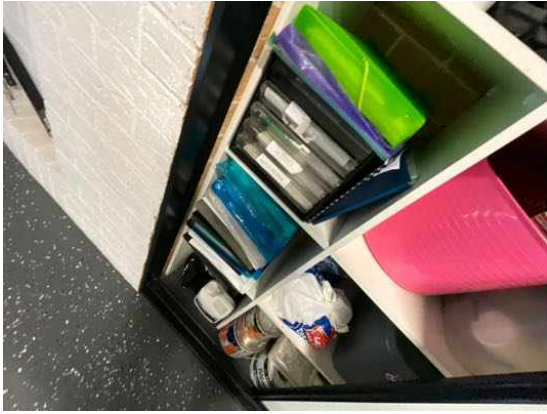
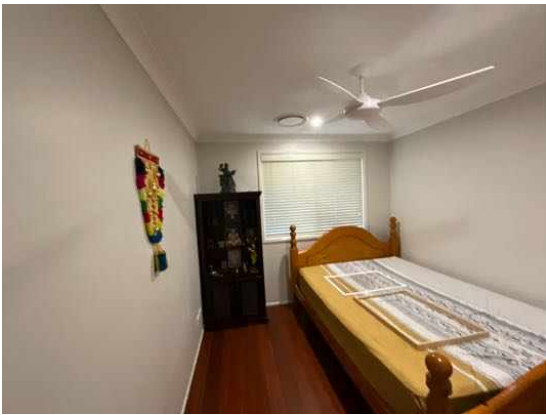
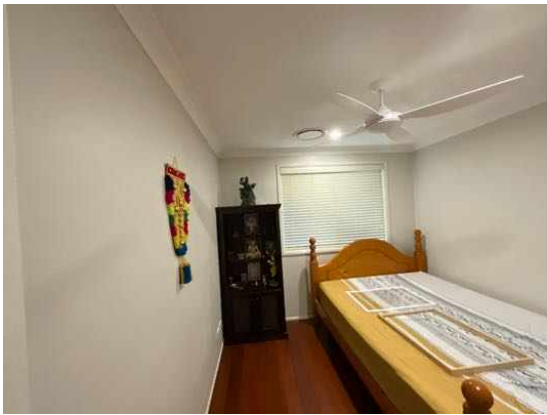
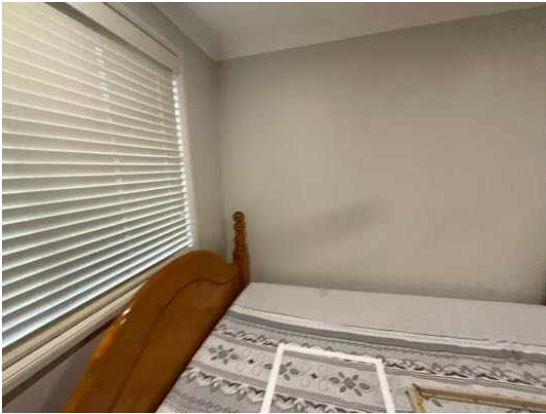
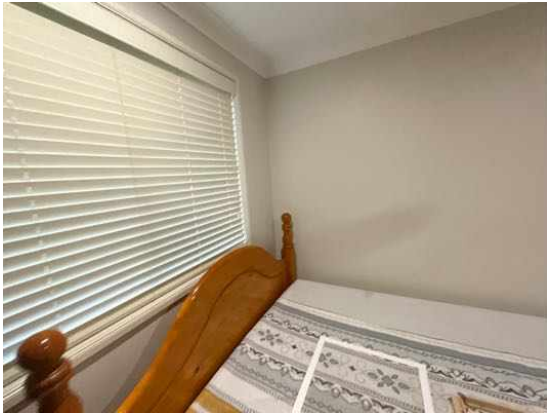
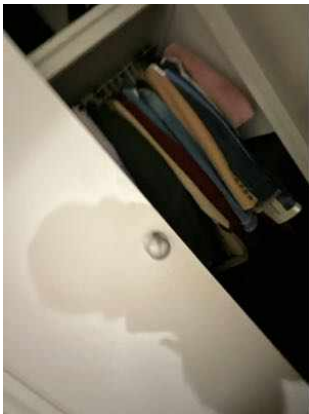
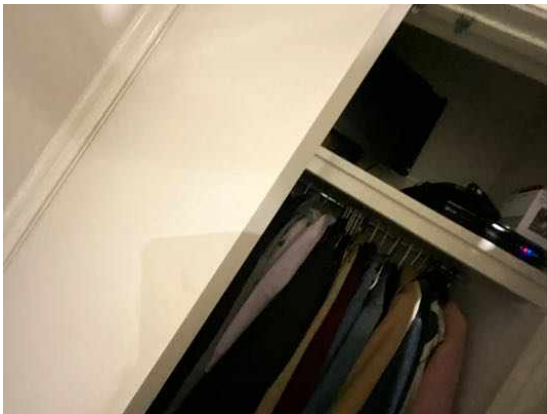
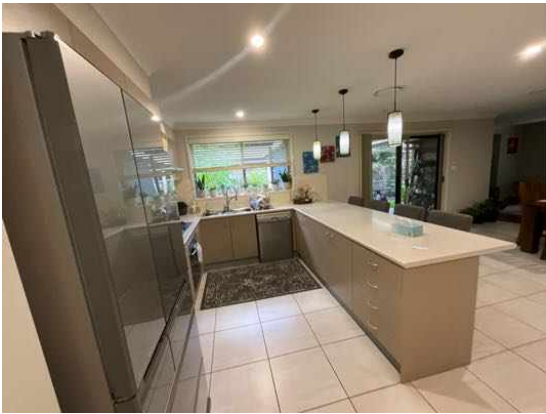
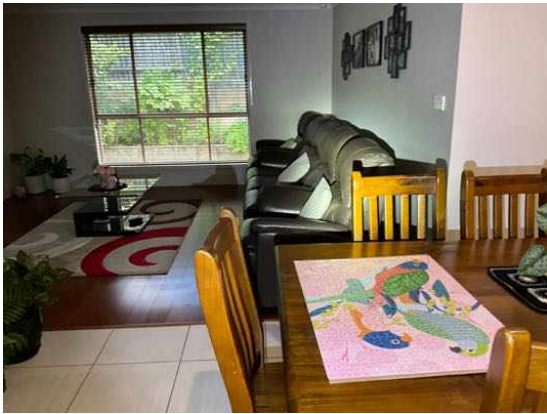
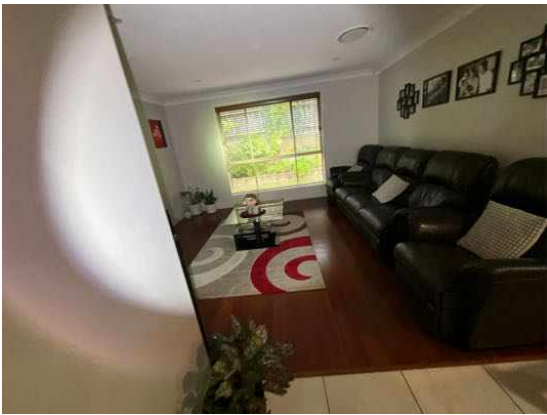
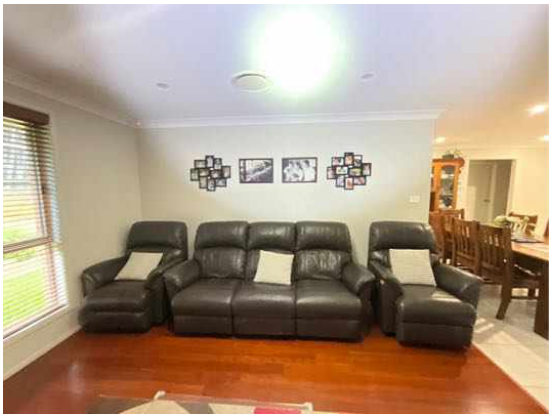
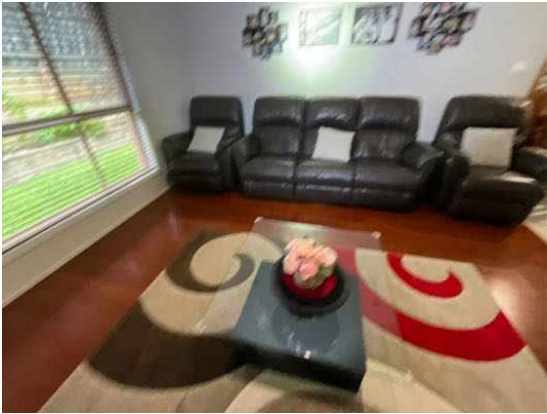
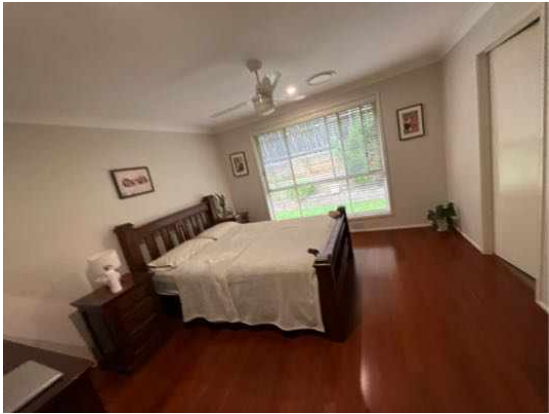
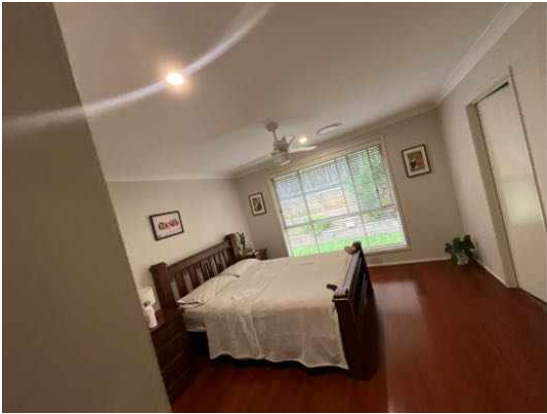
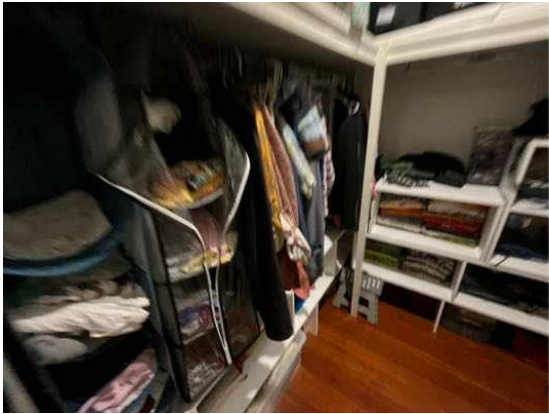
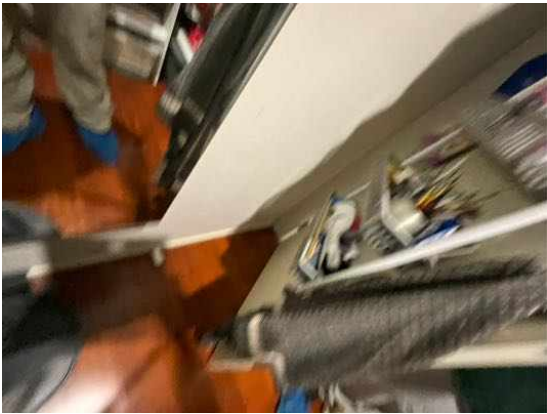
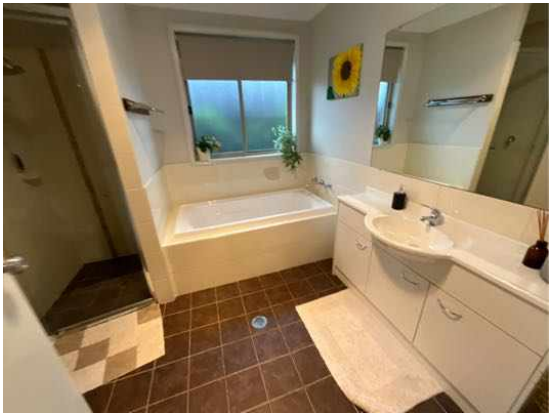
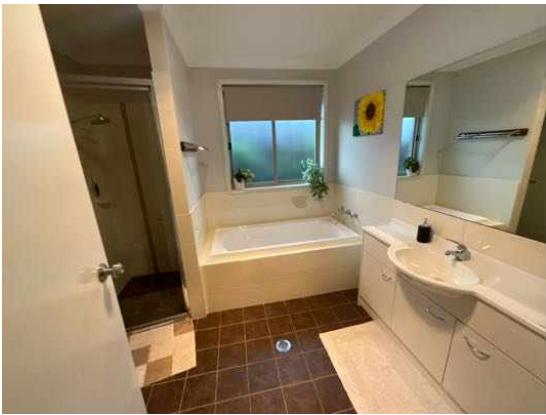
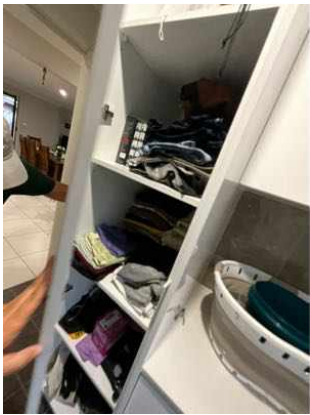
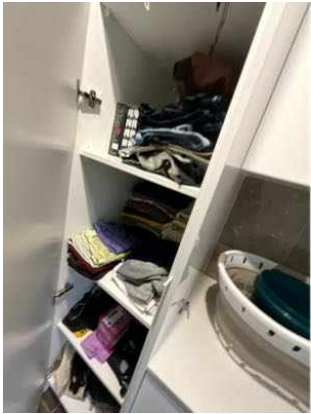
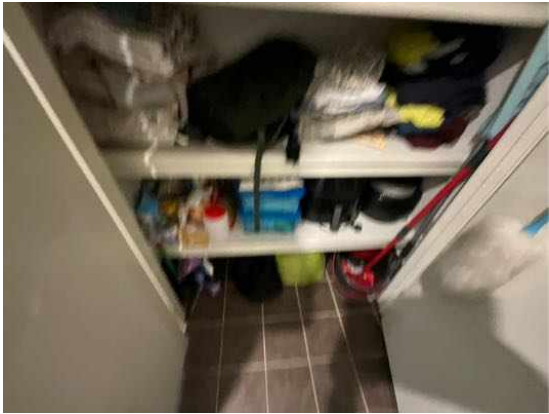
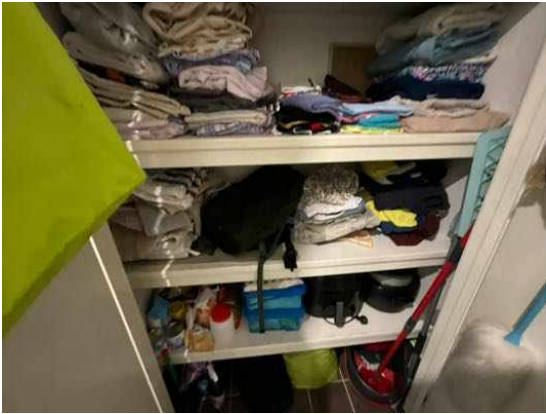
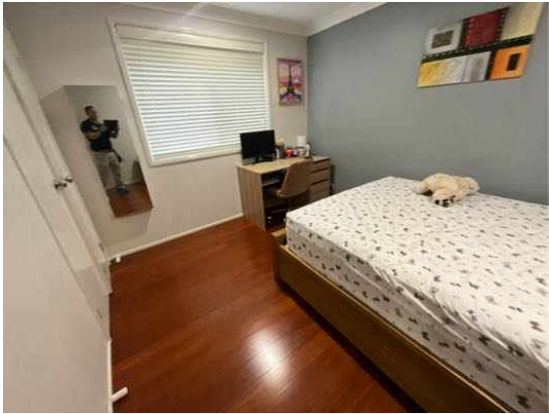
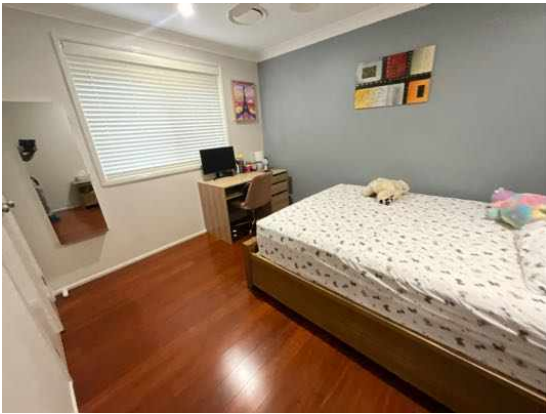
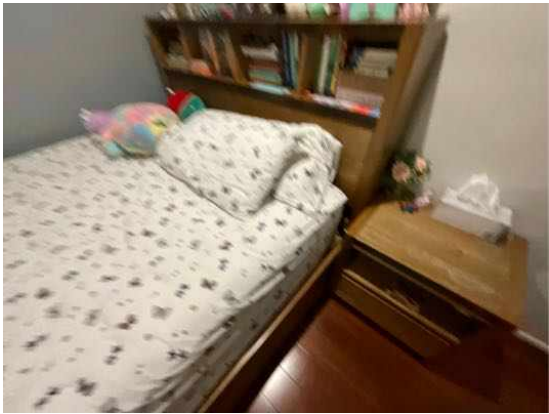
Building: Main Building
Location: All Areas
Finding: Additional Photos - Obstructions and Limitations
Information: These photographs are an indication of the obstructions and limitations which impeded full inspection of the property at the time of inspection. These obstructions can hide an array of defects and should be removed to allow full inspection to be carried out. A re-inspection is recommended once the areas are made accessible.
