Building and Timber Pest Inspection Report VR

Inspection Date: Fri, 20 Feb 2026

Property Address: 11 Lucy St, Ashfield NSW 2131, Australia

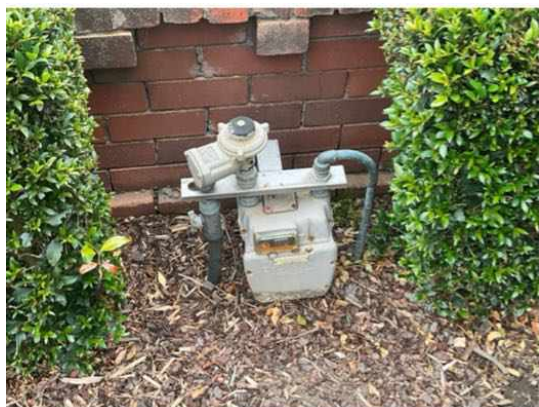
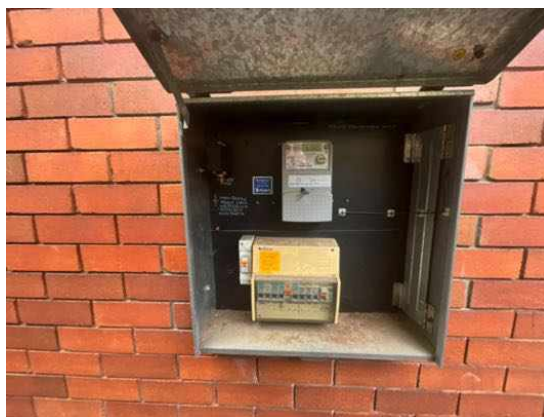
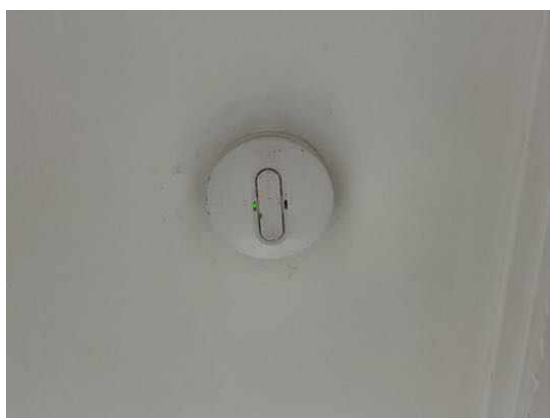
Building: Main Building
Location: All Areas
Finding: Photos Added
Information: Additional photos are provided for your general reference.

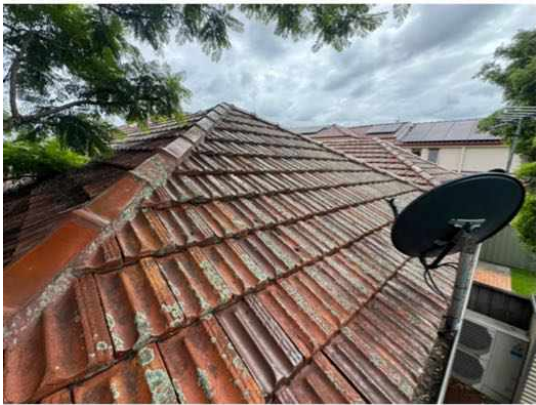
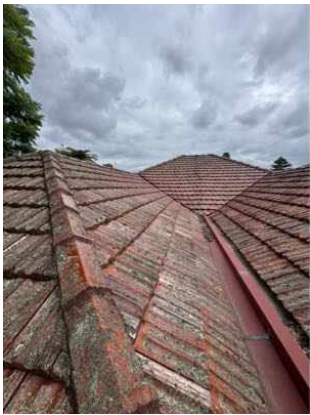
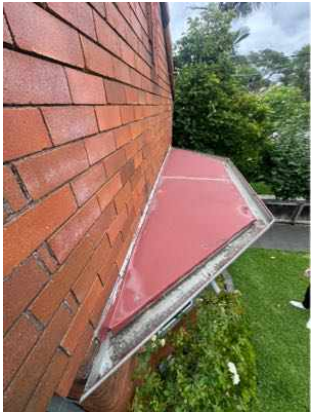
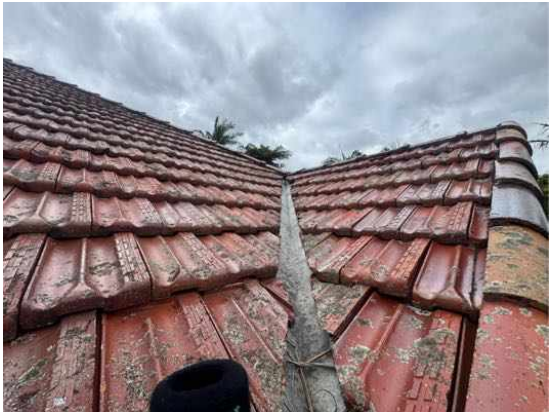
Building: Main Building
Location: Roof Exterior
Finding: Photos Added
Information: Additional photos are provided for your general reference.

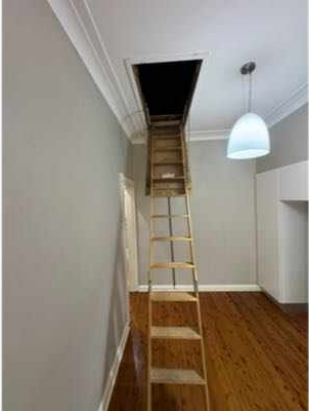
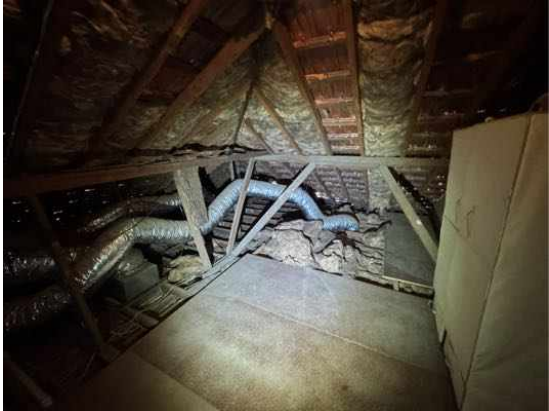
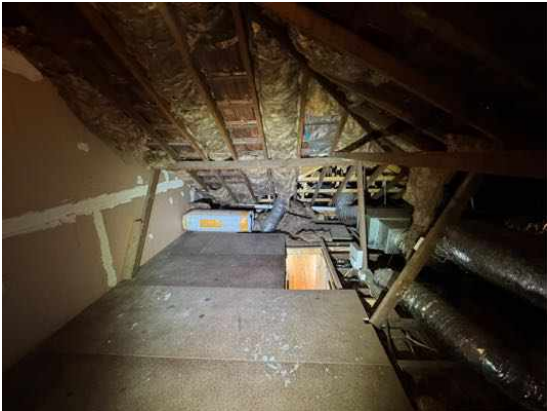
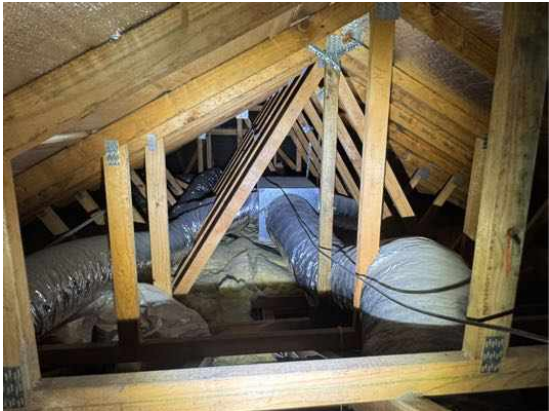
Building: Main Building
Location: Roof Void
Finding: Photos Added
Information: Additional photos are provided for your general reference.
