# Building and Timber Pest Inspection Report

Inspection Date: Wed, 25 Mar 2026

Property Address: 21/12-18 Lane Cove Rd, Ryde NSW 2112, Australia

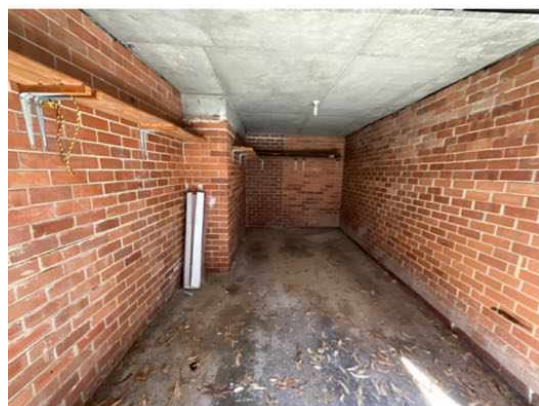
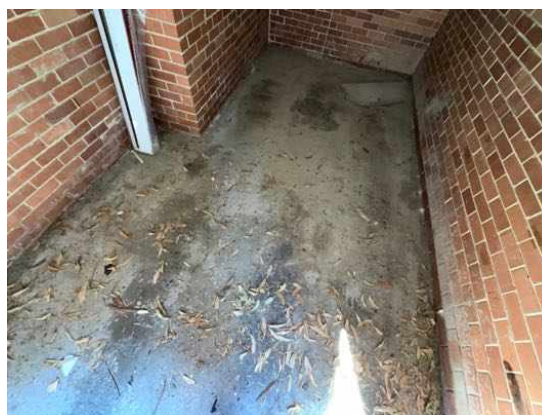
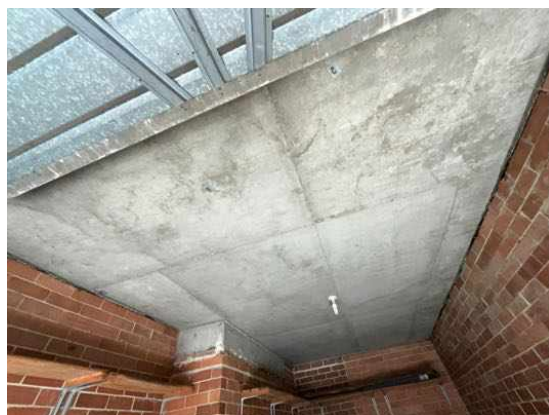
Building: Main Building  
 Location: Garage  
 Finding: Additional Photos- Garage  
 Information: Additional photos are provided for your general reference. Arrows may have been included to highlight areas of importance. Please discuss these photos with your building consultant for clarification.

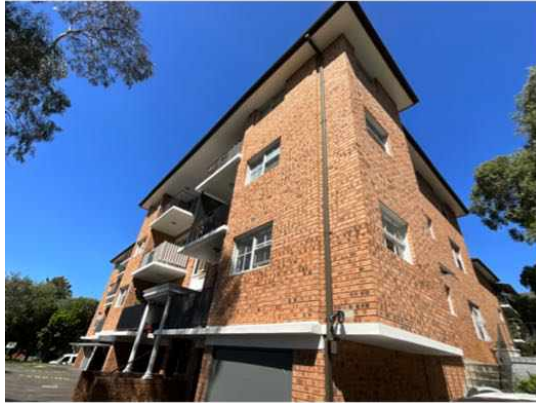
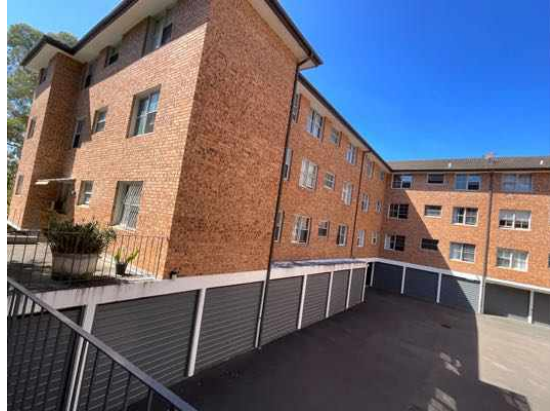
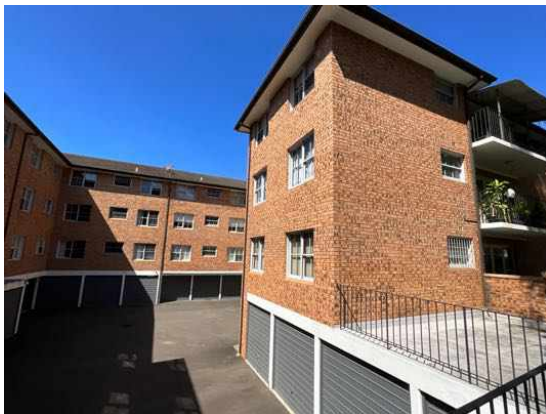
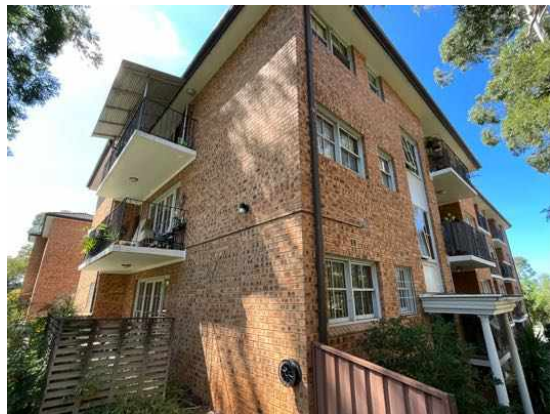
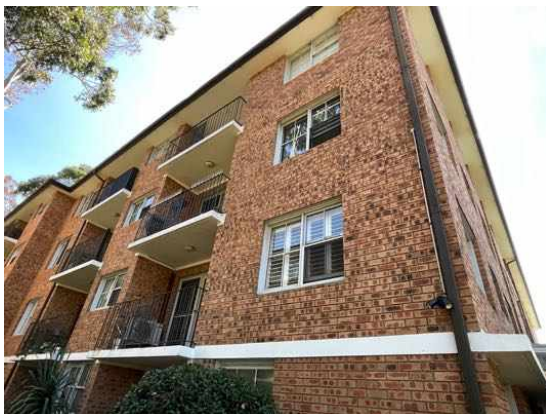
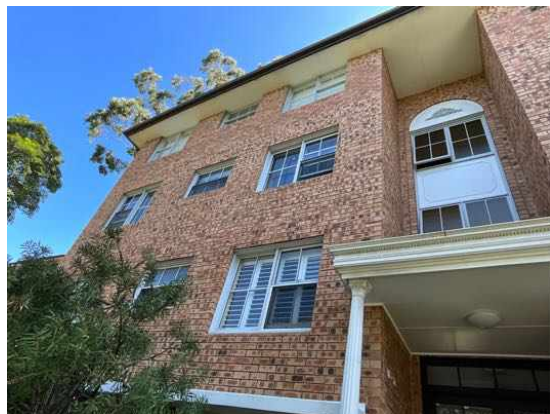
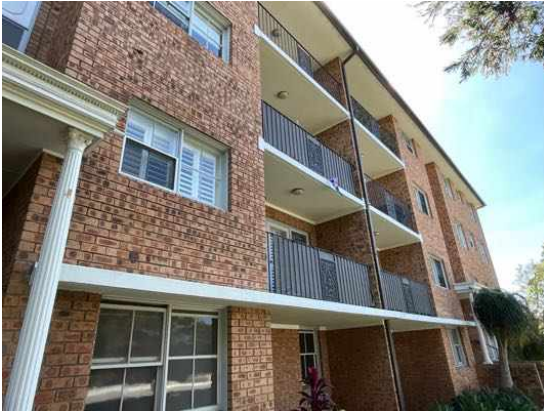
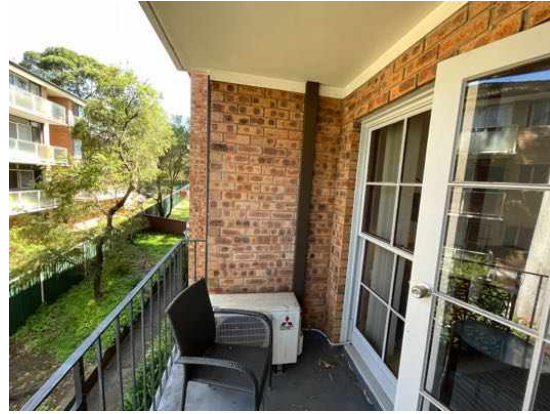
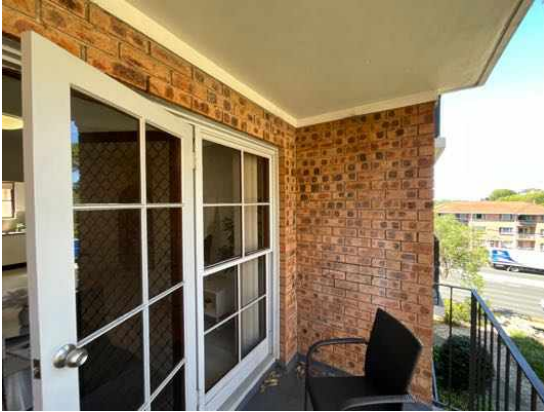
Finding: Additional Photos

Information: Additional photos are provided for your general reference.

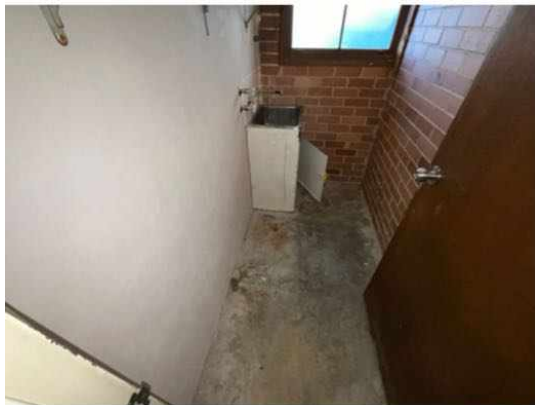
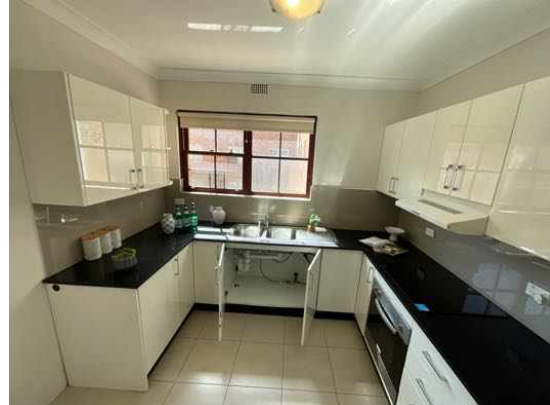
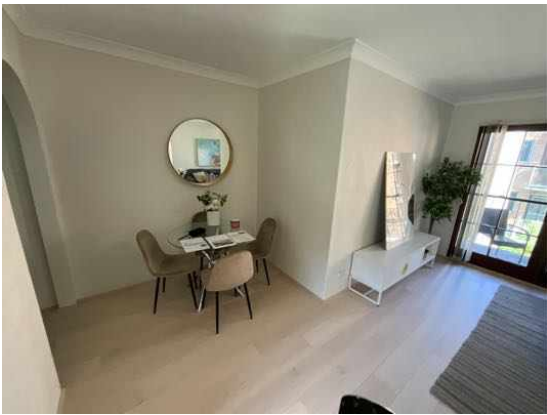
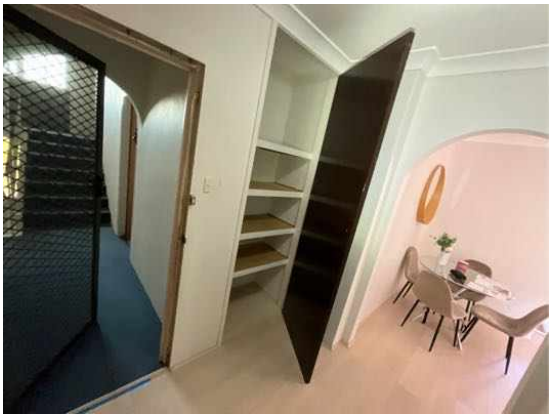
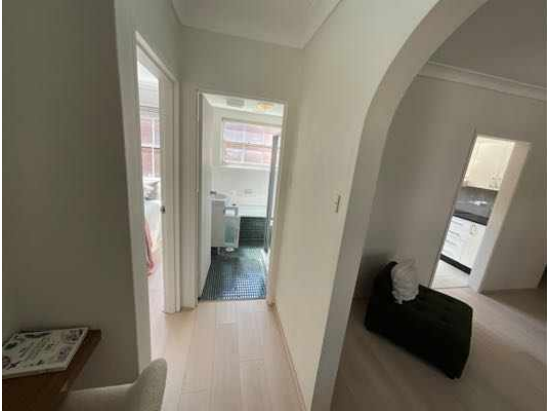
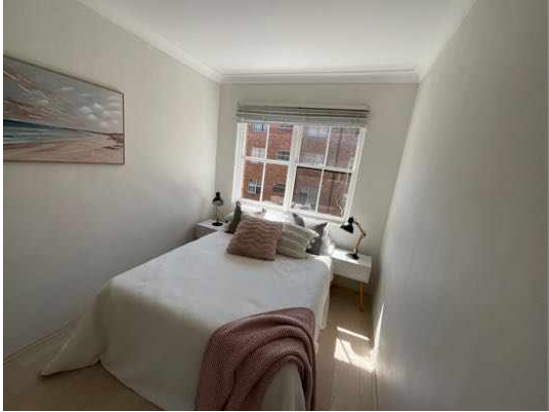
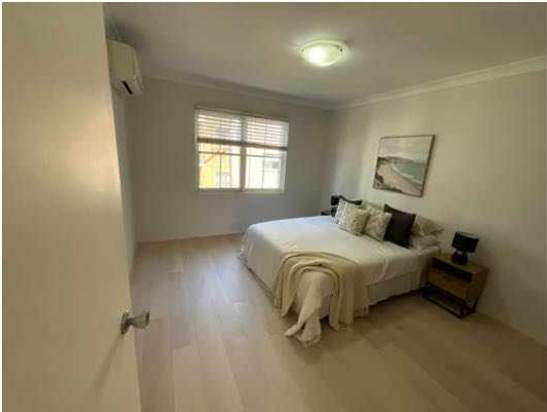
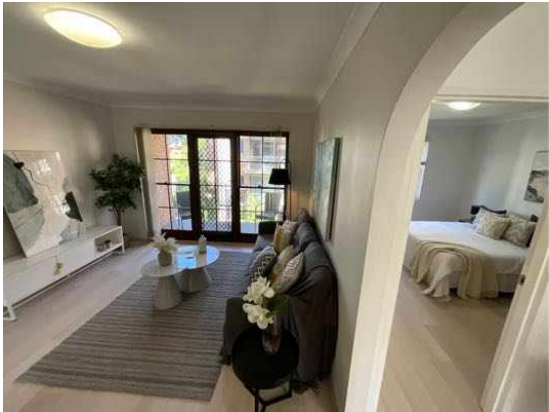
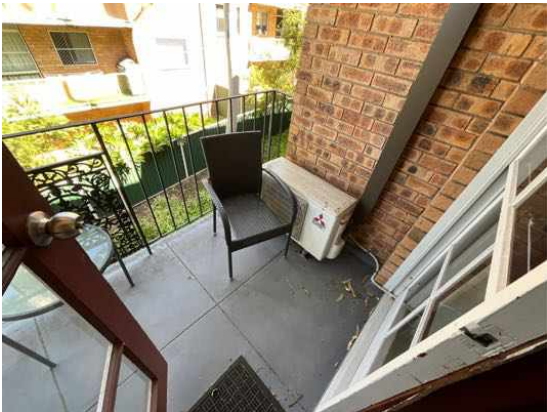
Building: Main Building  
 Location: All Areas  
 Finding: Additional Photos - Obstructions and Limitations  
 Information:

These photographs are an indication of the obstructions and limitations which impeded full inspection of the property at the time of inspection. These obstructions can hide an array of defects and should be removed to allow full inspection to be carried out. A re-inspection is recommended once the areas are made accessible.
