Timber Pest Inspection Report

Inspection Date: Thu, 26 Mar 2026

Property Address: 4 Timble Cl Wollert

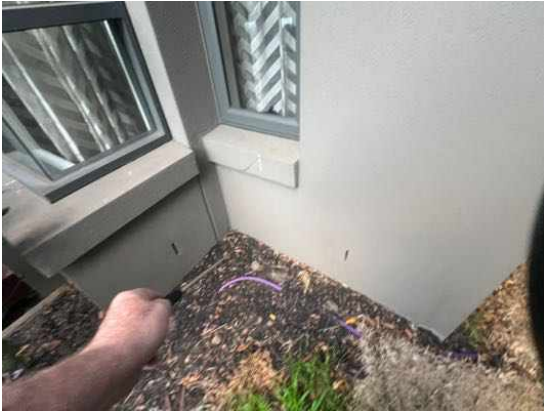
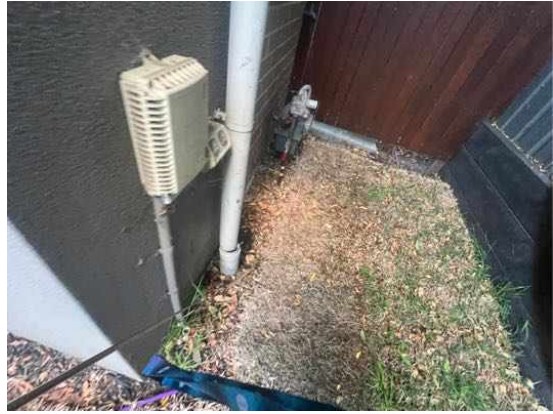
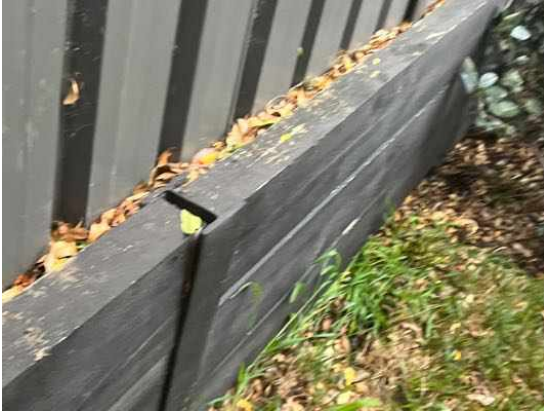
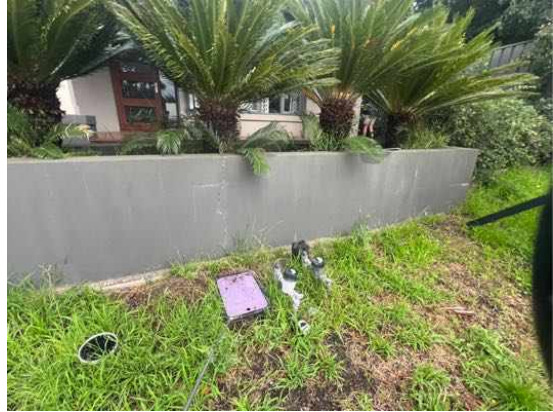
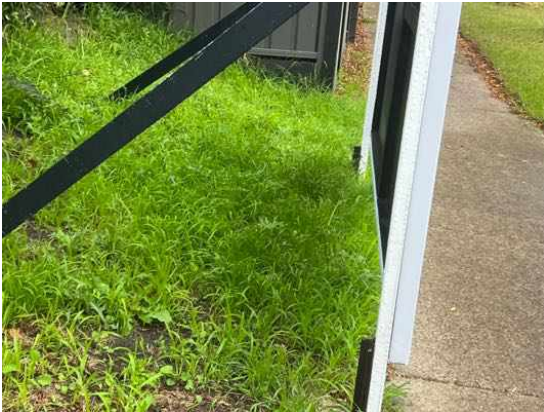
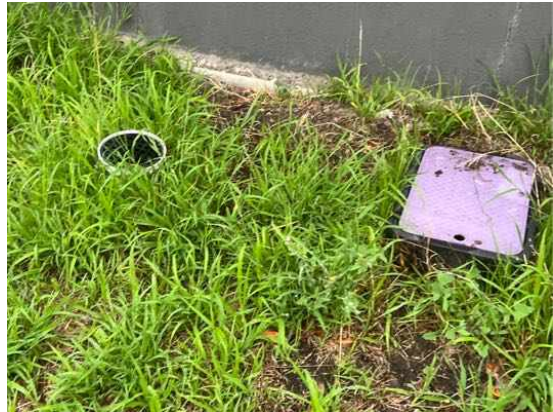
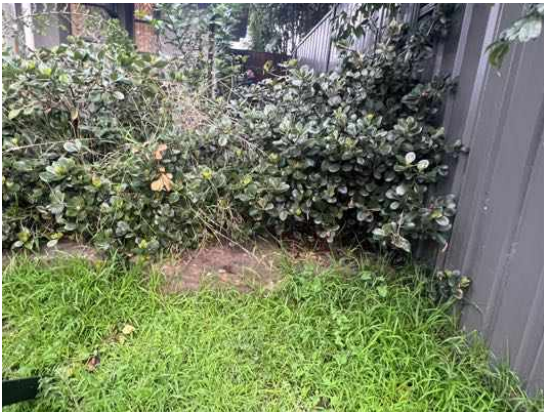
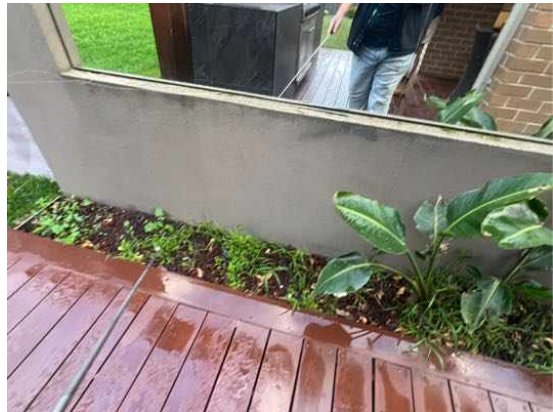
Building:	Main Building
Location:	All Areas > All Areas
Finding:	Building materials in direct ground contact - conducive to termites
Information:	Where timber elements are in direct contact with the ground and consequently moisture or dampness they become conducive to termite activity. Whether timber is used as a building element part of a fencing structure or stored as an unused item they can provide an environment that is attractive to termite infestation.

When met with excessive moisture timber begins to decay and develop wood rot. Any timbers that are in direct contact with external grounds especially if left untreated or non-durable also provide ingress for subterranean termites into that particular element.

The removal of any such materials that may be conducive to termite activity should be removed as soon as possible to minimise the risk of termite attack.

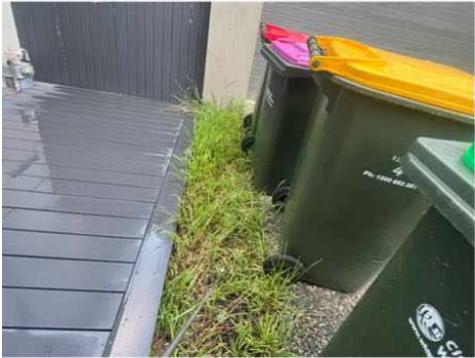
Termite and Timber Pest 4.02

Building: Yard
Location: All Areas > All Areas
Finding: Garden Beds - Conditions Conducive to Termites
Information: Garden beds were found to be evident in the garden area. These garden beds can include untreated timber, and with a combination of moisture from watering hosing can make conditions conducive to termite activity and termite ingress.

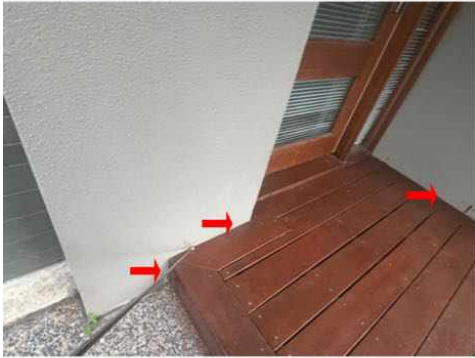
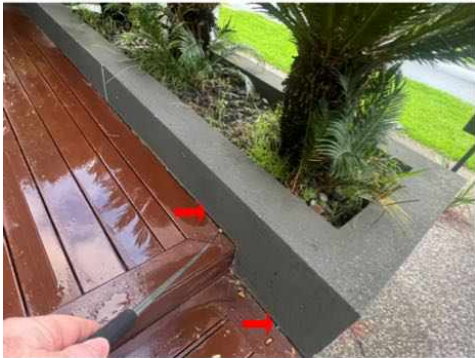
Termite and Timber Pest 4.03

Building: Main Building
Location: All Areas > Front Left
Finding: Pest -Attachments to buildings-structures-EG steps, verandahs, porches, carports, trellises, decks-down pipes-
Information: 5.4.3 Attachments to buildings Attachments to buildings such as downpipes and service pipes mounted on external walls shall have a nominal gap, which provides clear and uninterrupted visual inspection across the inspection zone. Structures such as steps, verandahs, porches, access ramps, carports, trellises, decks, hot- water systems, air-conditioners, or similar, which are not provided with a termite management system in accordance with AS 3660.1, shall be separated from the building by gap of at least 25 mm, to allow clear and uninterrupted visual inspection across the inspection zone.

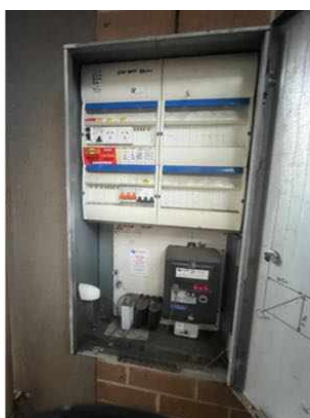
Termite and Timber Pest 4.04

Building: Main Building
Location: Front Elevation > Front Right
Finding: Timber Pest-meterbox no durable notice-found
Information: Meter Box

There was NO durable notices found in the meter box at the time of the inspection

The application of a post-construction chemical termite barrier is highly recommended for all

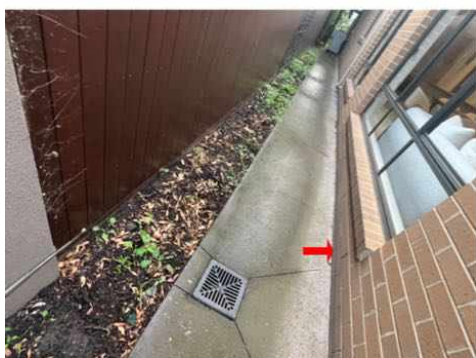
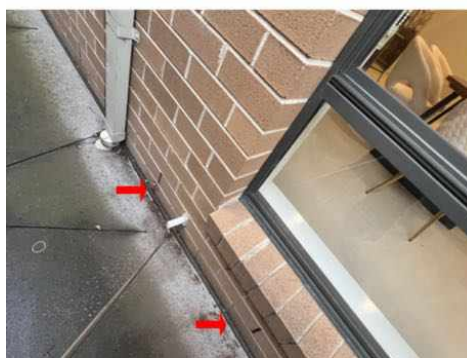
Termite and Timber Pest 4.05

Building:	Main Building
Location:	Exterior walls - right side > All Areas
Finding:	Gaps in perimeter pavement
Information:	Gaps in the external concrete paving were identified at the time of inspection. Gaps in the slab are significant and are likely to lead to the development of secondary defects if left unmanaged, such as the creation of a trip hazard and water entry points.

With reactive clay soils, it is extremely important to ensure that all stormwater flows including roof and ground flows, contained and continually maintained. High moisture also creates an environment that is conducive to termite attack.

A licensed Plumber should be appointed immediately to ensure that the stormwater pipework is intact and adequate, and all gaps to concrete, driveways and paths should be sealed by a licensed builder or a general handy person to keep moisture from entering.

A licensed concretor may be required to replace pavements that are beyond repair.

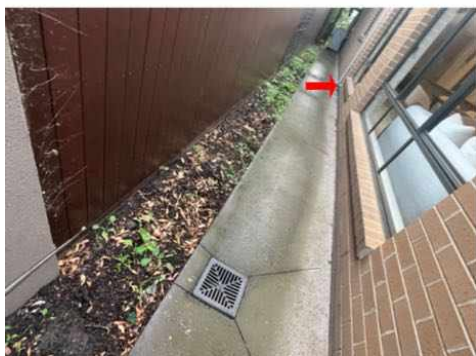
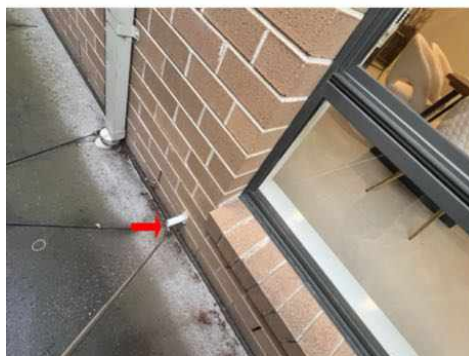
Termite and Timber Pest 4.06

Building:	Main Building
Location:	Exterior walls - right side > Centre
Finding:	Air-conditioning unit - Leak
Information:	Leaking from an external air-conditioning unit may be a result of several causes, including poor installation, blockages in internal drains, or a blockage to the drain hole.

Heavy leaking from the air-conditioning unit is likely to produce damp conditions in the surrounding area conditions which are conducive to termite attack. If left unattended, such leaking can develop into water pooling below the unit, creating potential for subsequent water damage to associated building elements.

A refrigeration mechanic or licensed plumber should be appointed to assess the

condition of the unit and to perform any remedial works as necessary. While discharge from an air-conditioning unit can generally be managed through basic plumbing work, such appointments are deemed necessary to identify any major issues.

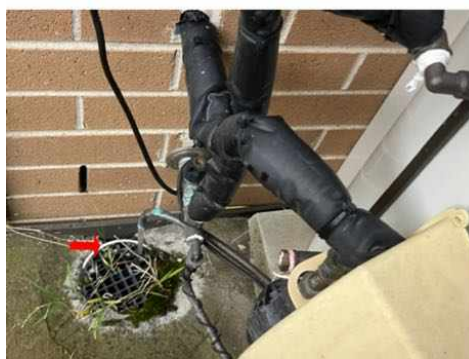
Termite and Timber Pest 4.07

Building: Main Building
Location: Exterior walls - left side > Front
Finding: HWS Overflow - Not Connected
Information: The Hot Water System (HWS) overflow was found to be disconnected from storm water drainage and is creating excessive moisture in the surrounding area.

These damp conditions can lead to secondary defects such as rot, rust or corrosion of associated building elements, the formation of fungal decay, or even the creation of potential slip hazards. When coupled with poor site drainage, pooling of water may also attract termite activity to this area.

It is highly recommended that a licensed plumber be appointed to connect the HWS overflow in order to prevent such an environment from being created. These minor works should be carried out as soon as possible.

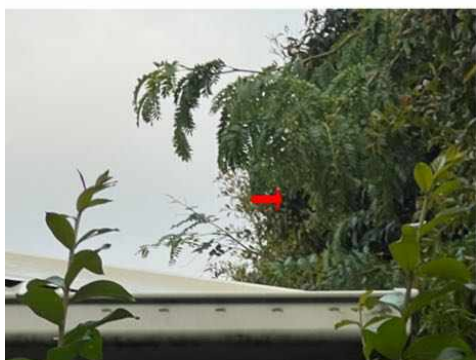
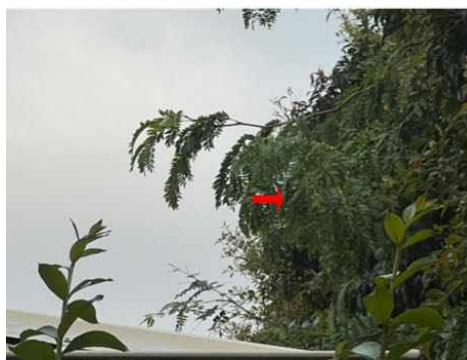
Termite and Timber Pest 4.08

Building: Main Building
 Location: All Areas > Front Right, Centre Right
 Finding: Bridging vegetation
 Information:

Where vegetation obstructs inspection of building elements, also known as bridging as it provides a bridging point for the access of termites, full inspection can not be achieved. Consequently moisture or dampness may be present and the areas becomes conducive to termite activity. Plants against or very close to buildings provide cover, shade and can provide an environment that is attractive to termite infestation.

The removal and replanting of species that do not provide "cover" or cutting back of existing vegetation will assist greatly in preventing Bridging from occurring.

The removal of any such materials that may be conducive to termite activity should be carried out as soon as possible and arrange re inspection to minimize the risk of termite attack.

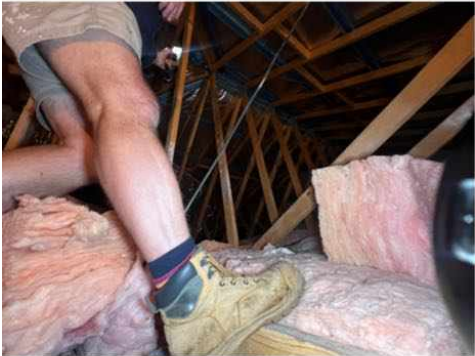
Termite and Timber Pest 4.09

Building: Main Building
 Location: All Areas > Front, All Areas
 Finding: Pest -Obstructions & Limitations-roof void-
 Information:

These photographs are an indication of the obstructions and limitations which impeded full inspection of the property at the time of inspection. These obstructions can hide an array of defects and should be removed to allow full inspection to be carried out. A re-inspection is recommended once the areas are made accessible.

Therefore, It is critical that before proceeding further, an inspection and possibly a treatment or advice regarding a treatment, be sourced form a Licenced Termite Timber Pest Controller.

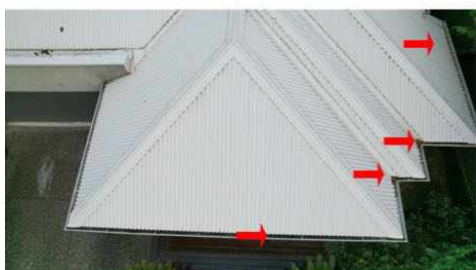
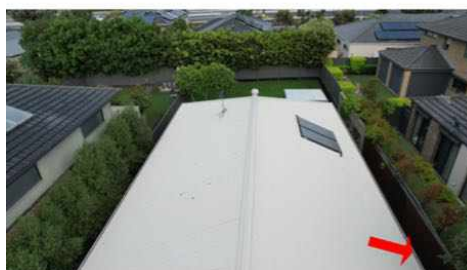
Blocked gutters are likely to lead to high levels of moisture in the affected areas. Such moisture will not only cause rust and decay of the associated building materials, but can also provide conditions that are conducive to termite and timber pest activity. Blockages in gutters should therefore be removed immediately to ensure dry conditions are maintained.

Consult a Licensed Plumber for further specific advice on remedial works that may be required. In the interim, it is highly advised that blocked gutters be removed by the homeowner or a general handyperson as a matter of urgency.

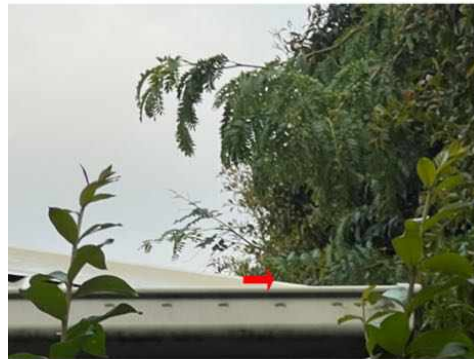
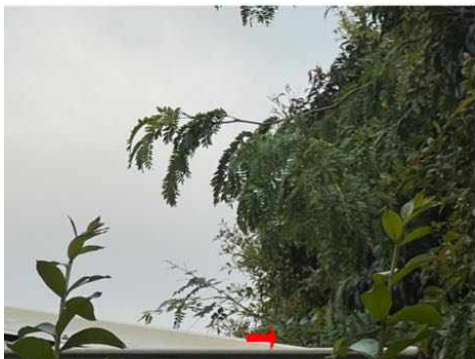
Termite and Timber Pest 4.12

Building:	Main Building
Location:	Yard - Side > All Areas, Front
Finding:	Pest - Attachments to buildings-structures-EG steps, verandahs, porches, carports, trellises, decks-down pipes-
Information:	5.4.3 Attachments to buildings Attachments to buildings such as downpipes and service pipes mounted on external walls shall have a nominal gap, which provides clear and uninterrupted visual inspection across the inspection zone. Structures such as steps, verandahs, porches, access ramps, carports, trellises, decks, hot- water systems, air-conditioners, or similar, which are not provided with a termite management system in accordance with AS 3660.1, shall be separated from the

building by gap of at least 25 mm, to allow clear and uninterrupted visual inspection across the inspection zone.

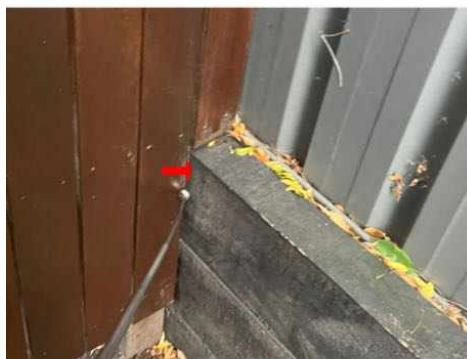
Termite and Timber Pest 4.13

Building:	Garage
Location:	Front Elevation > Front Left, Front Right
Finding:	Evidence of excessive moisture was present at the time of inspection
Information:	Excessive moisture can attract termites and produce conditions that promote termite attack, fungal growth and wood decay. Excessive moisture is generally caused by deteriorated, inadequate or missing roof drainage, leaking plumbing pipes or fixtures, poorly plumbed HWS overflows or condenser units and poor site drainage. It is highly recommended that all plumbing and drainage fixtures and fittings be maintained regularly in order to prevent excessive moisture being present in the external / internal property.

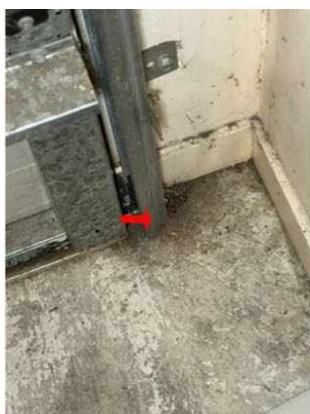
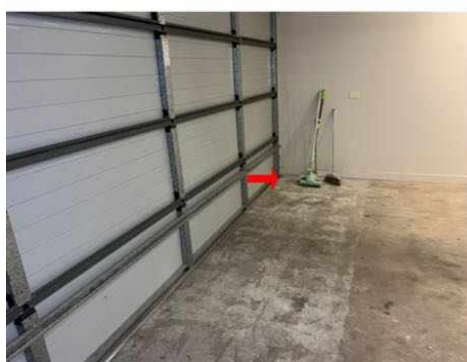
Termite and Timber Pest 7.01

Building:	Main Building
Location:	Exterior walls - left side > Rear
Finding:	Fungal decay - present (localised)-to door frame
Information:	Fungal decay also known as wood decay or wood rot generally refers to the deterioration of timber elements when in contact with excessive levels of moisture for a prolonged period of time.

The development of fungal decay is accelerated by temperatures in the range of 5degreeC to 40degreeC as well as the presence of oxygen. Generally fungal decay develops on timber elements that are in use in an external environment which are exposed to rain penetration.

In this case although the affected timber element is in a decaying state the extent of any visible damage appears to be localised to a specific area and is yet to spread to other parts of the building element or affect adjoining structures. The fungal decay is therefore likely to be of a relatively superficial nature with minimal impact on the structural integrity or tensile strength of the timber element.

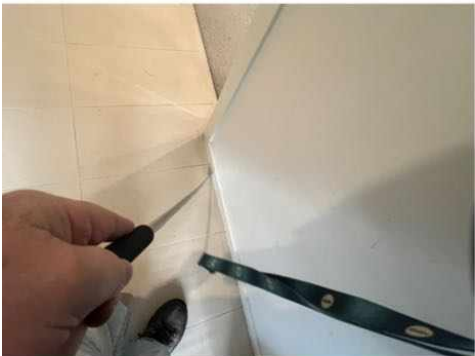
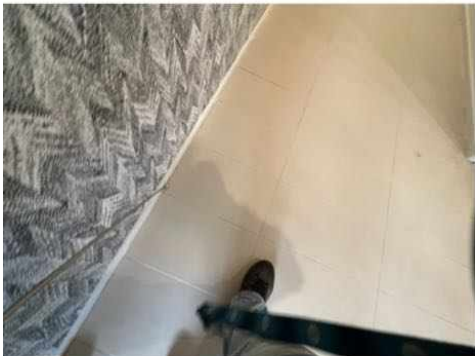
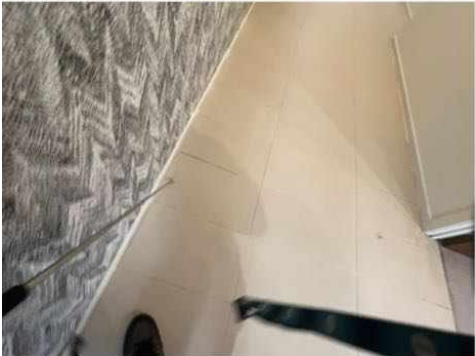
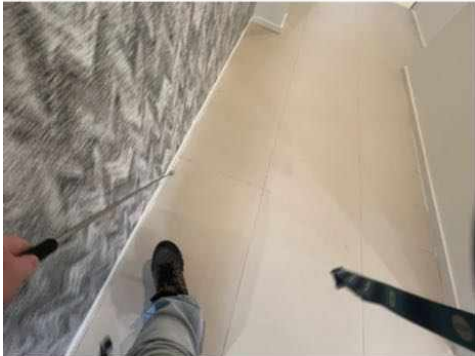
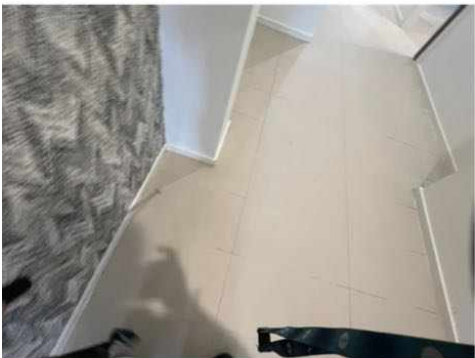
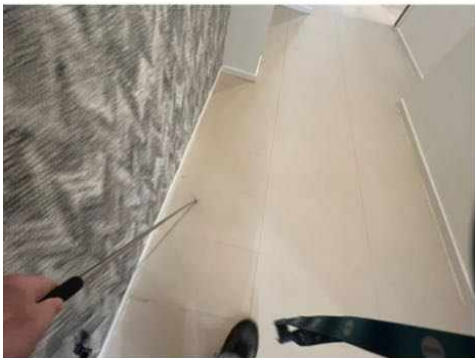
Building: Main Building
Location: All Areas > All Areas
Finding: Pest inspection-FYI-Methodology-and inspection of cabinetry
Information: As part of the course of the Pest Inspection-we /knock on skirting boards and architraves to determine if Pests are present-we also visually examine in and around internal cabinetry-as note in images supplied-

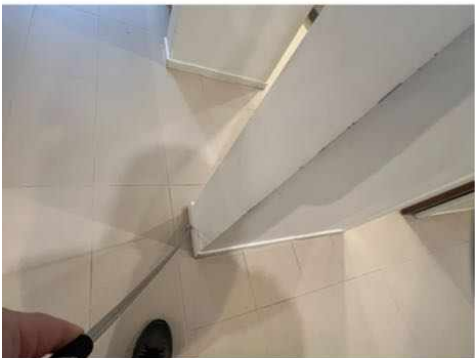
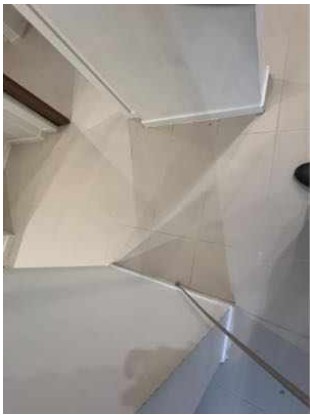
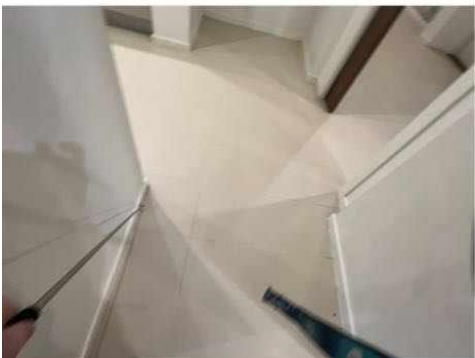
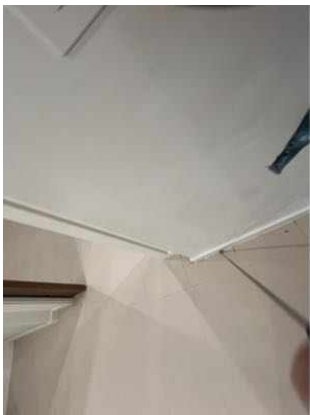
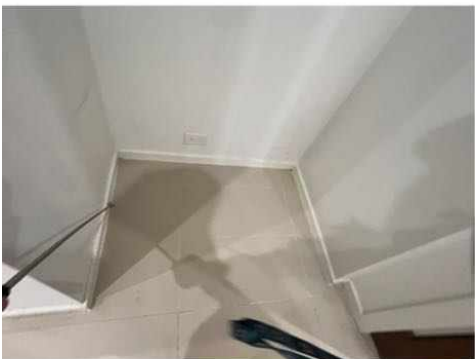
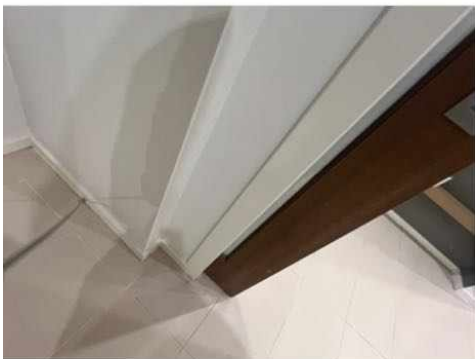
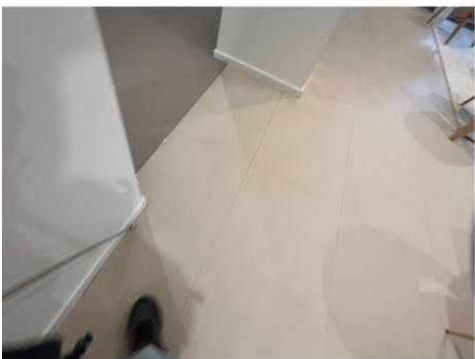
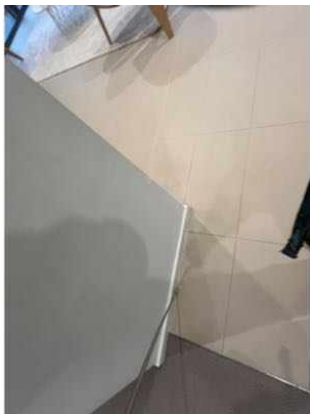
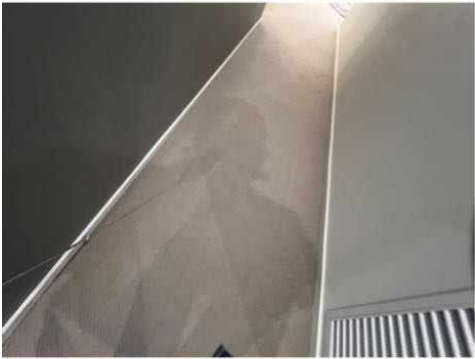
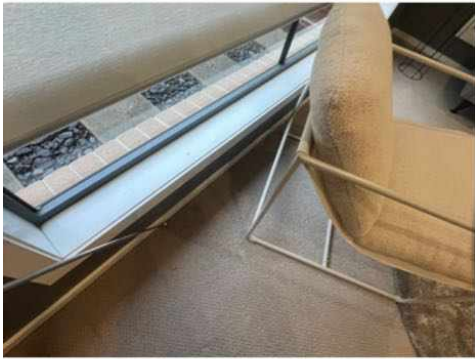
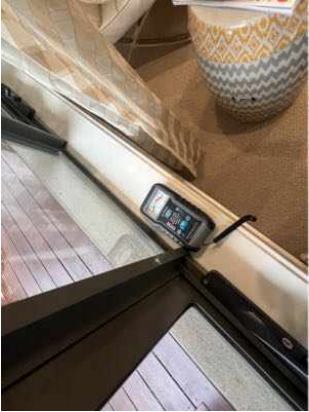
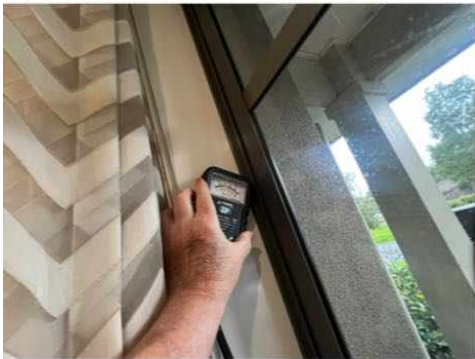
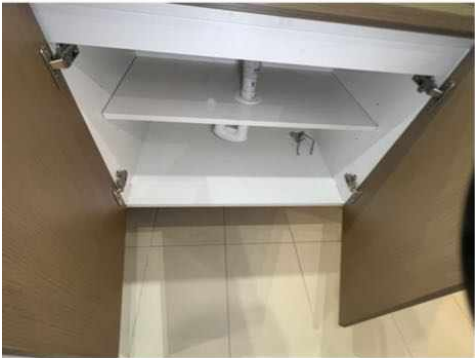
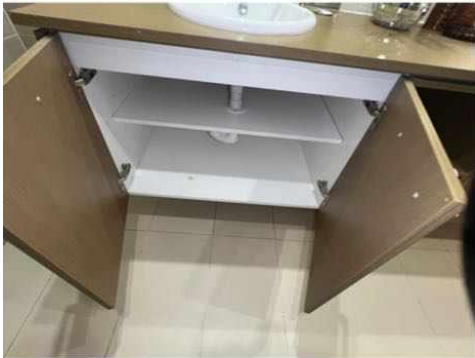
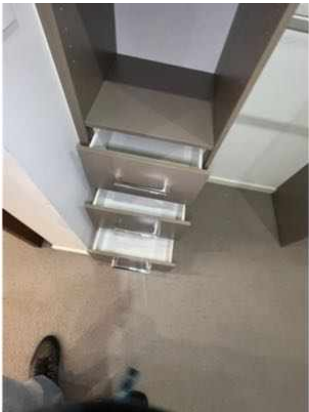
Building: Main Building
Location: Bathroom > Front Right
Finding: Additional Photos-moisture readings taken from all wet area walls & floors-and found to be within tolerance
Information: Additional photos are provided for your general reference. Arrows have been included to highlight areas of importance. Please discuss these photos with your building consultant for clarification.

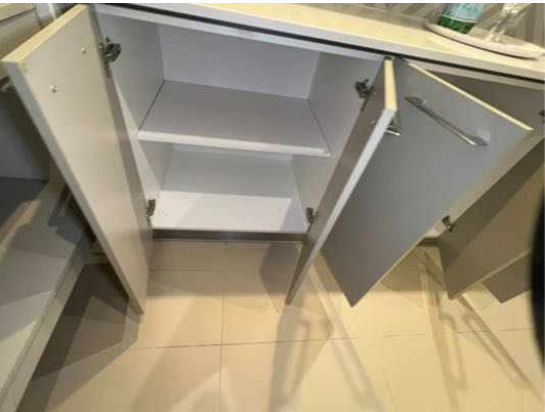
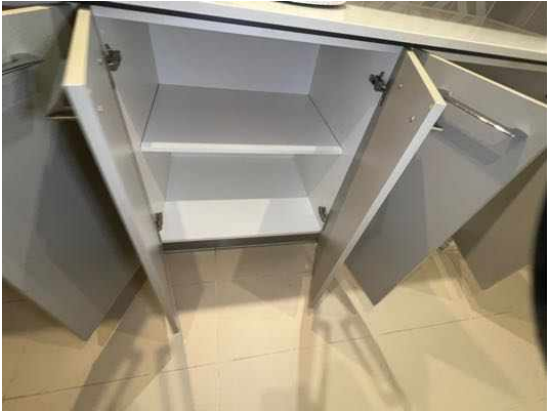
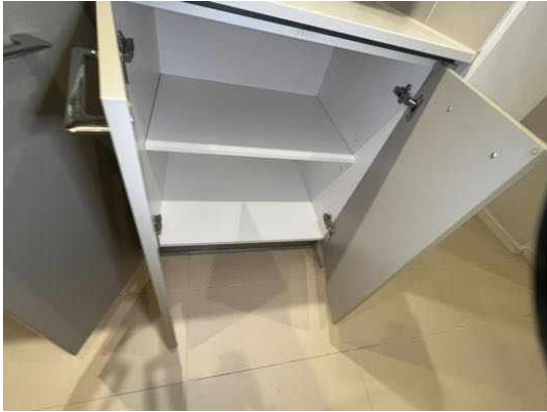
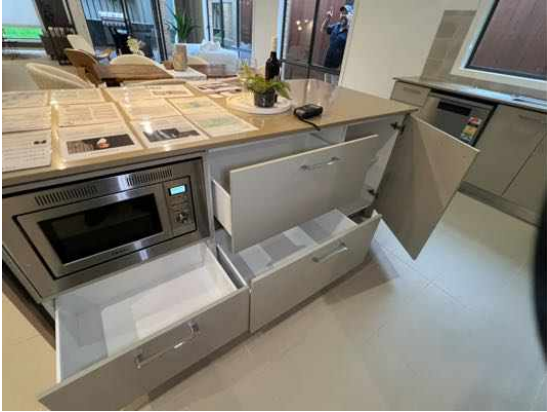
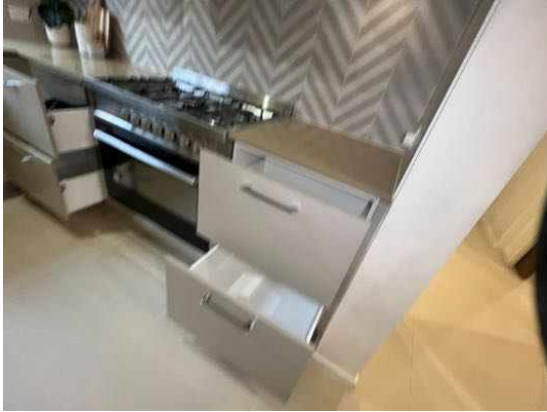
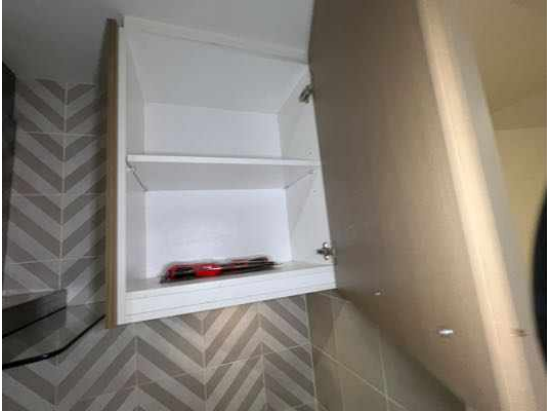
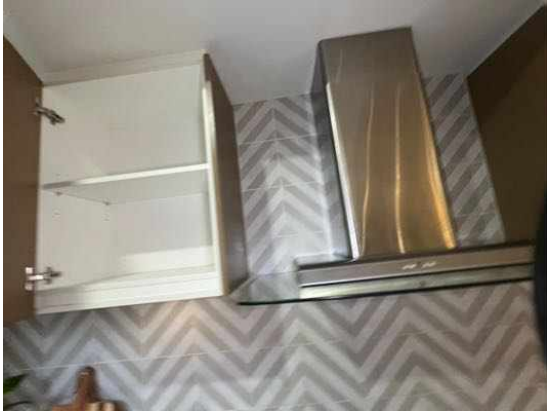
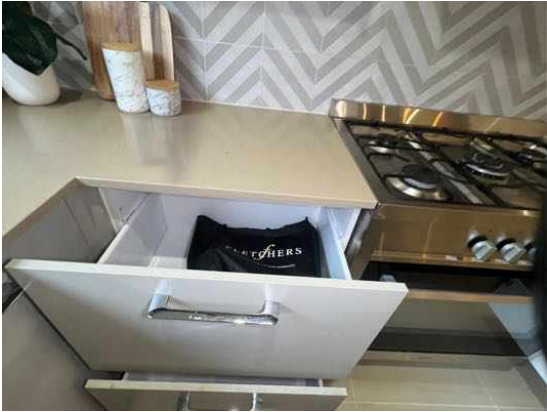
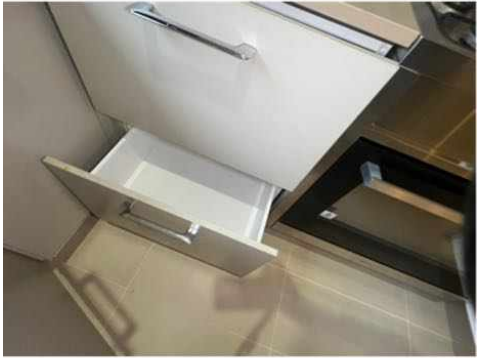
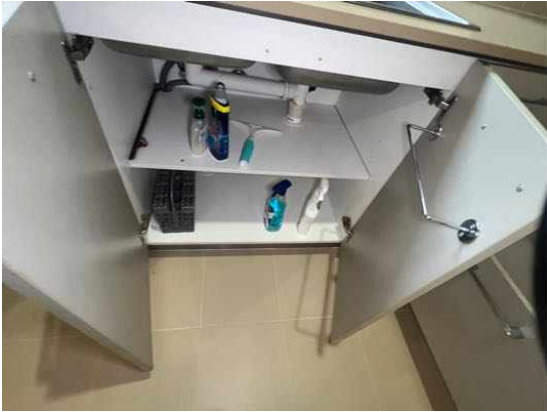
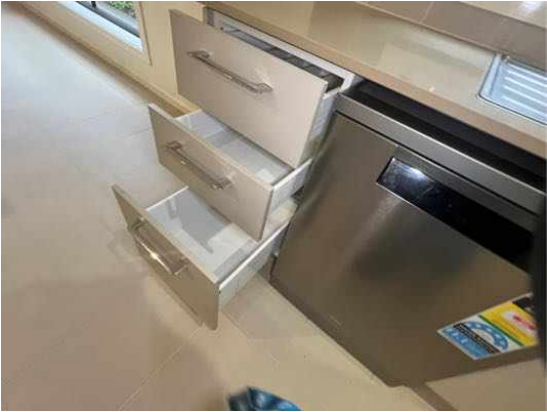
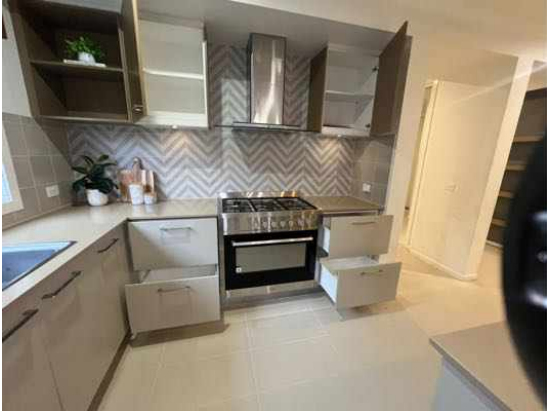
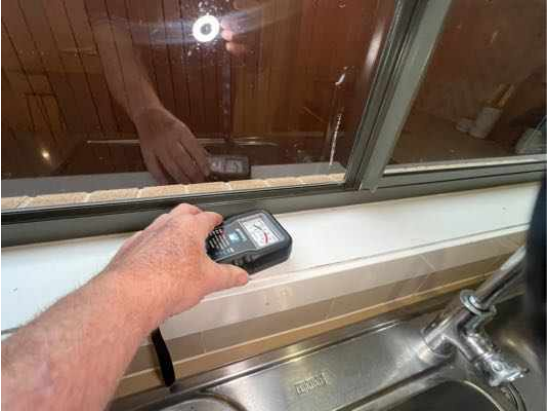
Building: Main Building
 Location: All Areas > All Areas
 Finding: Additional Photos - Obstructions and Limitations
 Information: These photographs are an indication of the obstructions and limitations which impeded full inspection of the property at the time of inspection. These obstructions can hide an array of defects and should be removed to allow full inspection to be carried out. A re-inspection is recommended once the areas are made accessible.

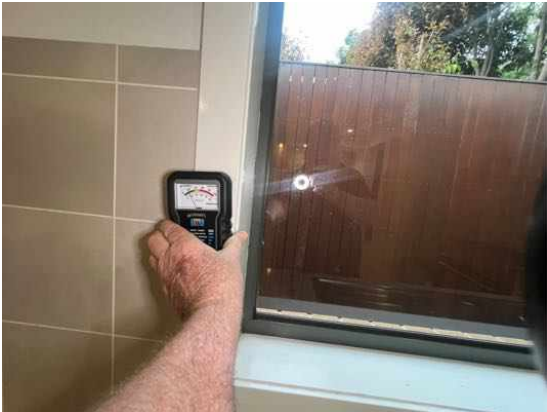
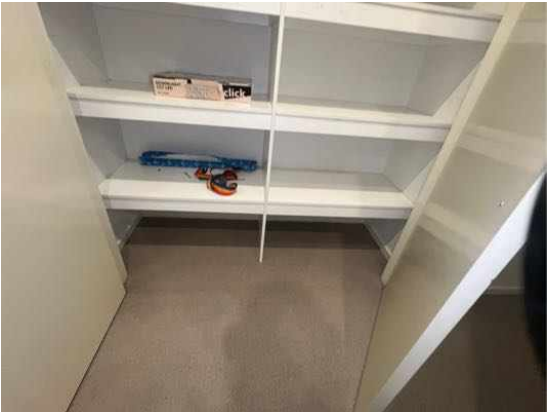
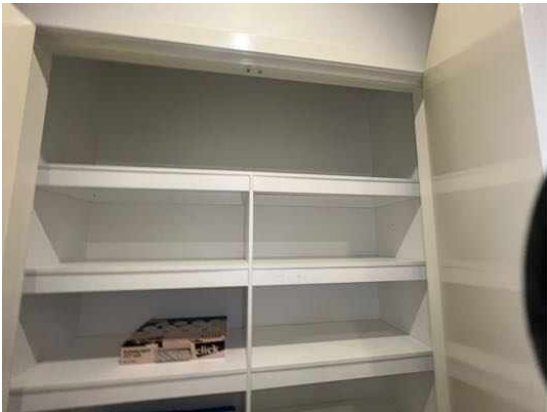
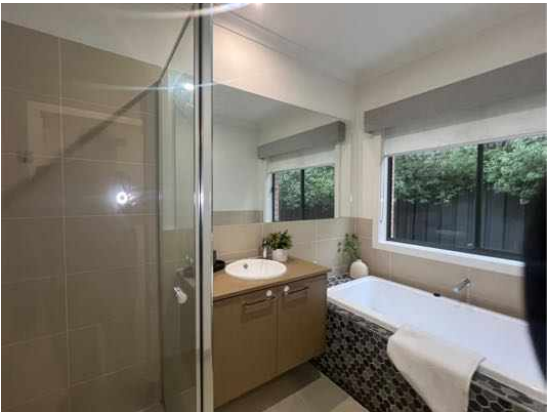
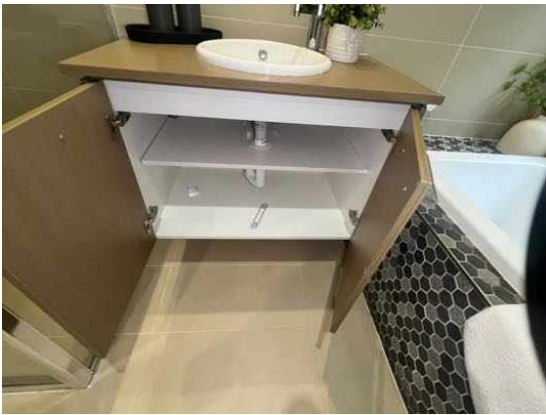
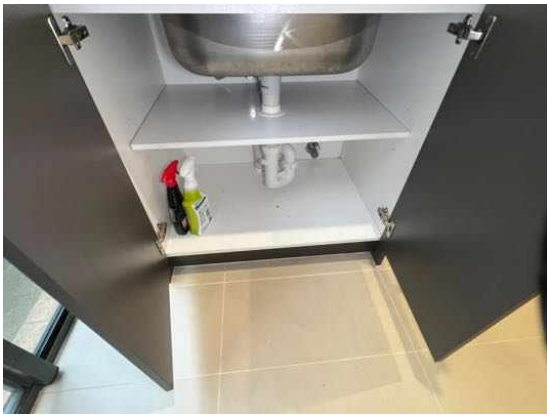
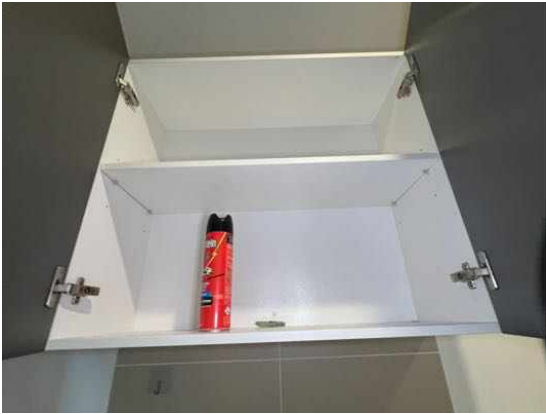
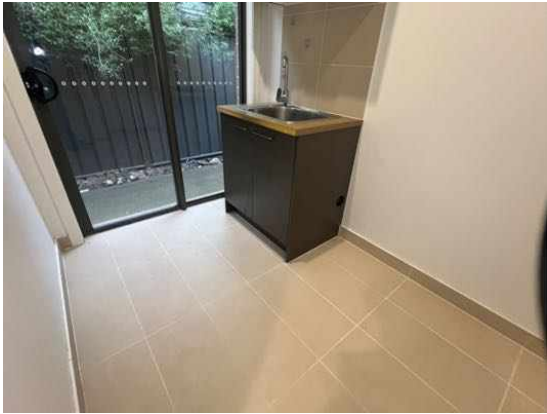
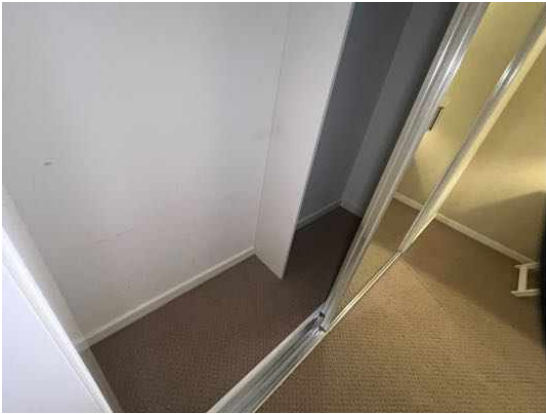
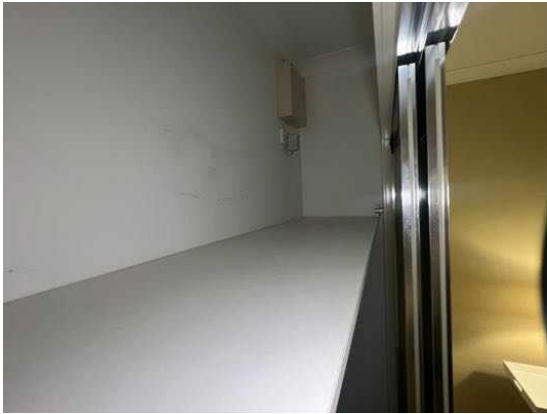
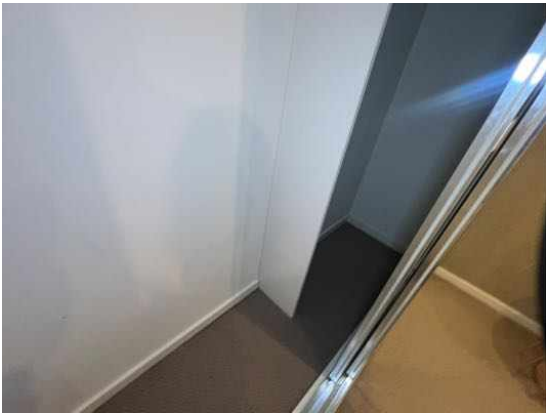
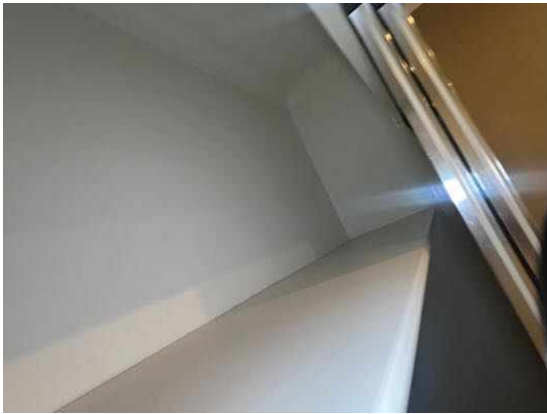
Building: Main Building
Location: Ensuite - Master > Centre
Finding: Additional Photos-moisture readings taken from all wet area walls & floors-and found to be within tolerance
Information: Additional photos are provided for your general reference. Arrows have been included to highlight areas of importance. Please discuss these photos with your building consultant for clarification.
