Building Inspection Report

Inspection Date: Wed, 8 Apr 2026

Property Address: 18 Flemington Pkwy, Box Hill NSW 2765,
Australia

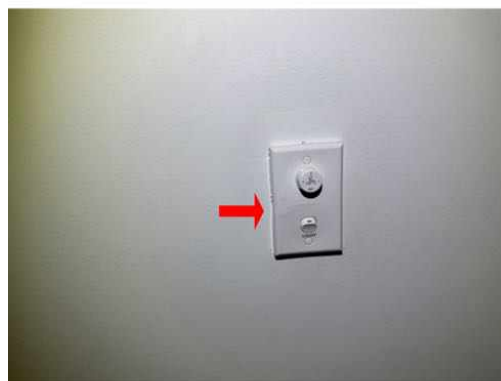
Defects 1.01

Building:	Main Building
Location:	All Areas > All Areas
Finding:	Electrical fittings: Deteriorated damage.
Information:	The electrical fitting in this area was found to be showing signs of deterioration at the time of inspection.

Left unmanaged, the fitting is unlikely to cause further damage to surrounding building elements. However, the broken fitting may create a safety hazard if there is potential contact with persons in the area.

Repair and/or replacement of the broken fitting is advised. A Licensed electrician should be appointed to repair/replace the fitting immediately.

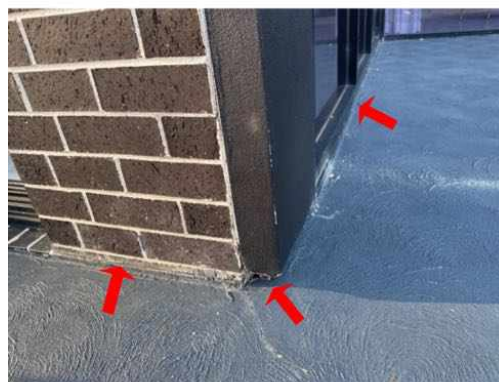
Defects 2.01

Building:	Main Building
Location:	Exterior walls - rear > Rear Left
Finding:	Perimeter Paving - Insufficient weather proofing.
Information:	The perimeter paving or ground levels were found to have an inadequate weather proofing from the adjoining building structure, creating potential for water pooling in this area.

Perimeter paving is required to fall from the building by a minimum of 25mm in the first metre and bare ground should fall away from the house by 50mm in the first meter. This standard ensures that excessive moisture does not pool around the base of building structures, which creates potential for water and structural damage, as well as making the area susceptible to termite and timber pest activity.

Where paving or ground levels do not have adequate fall, a licensed paving contractor should be appointed to install or remove and re-level pavement.

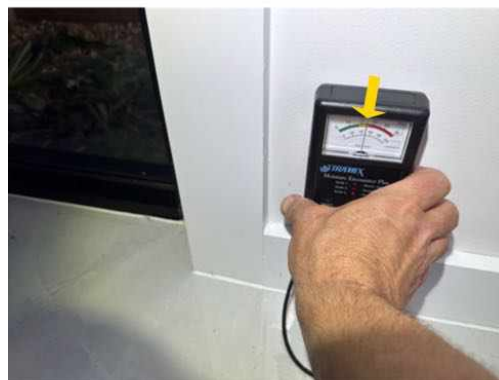
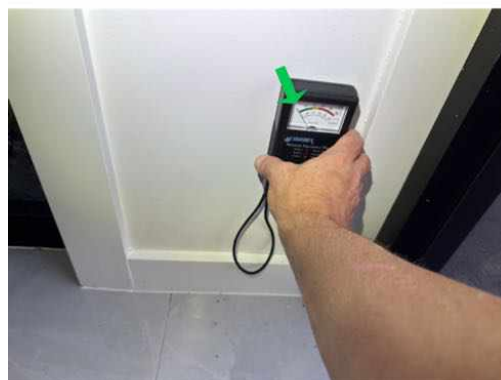
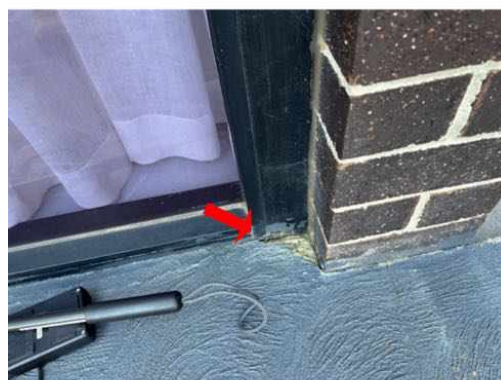
Defects 2.02

Building:	Main Building
Location:	Living Room > Rear Left
Finding:	Damp
Information:	Damp (or structural damp) refers to the presence of unwanted moisture in the structure of a building, either as the result of intrusion from outside, or condensation

from within the structure. Generally, structural damp is caused by rain penetration, rising damp, and leaks from plumbing pipes.

Unmanaged damp facilitates the formation and development of mould, fungi growth and wood rot, decaying associated building materials and compromising their structural integrity. Damage to finishes is also likely to occur, including lifting, bubbling, peeling and staining of paint, plaster and wallpaper.

A moisture meter was used on all accessible walls during the inspection and a limited amount of excessive moisture was detected to living room wall on the lower rear left wall, possibly due to the exterior concrete height to the internal floor height with no barrier between the two.

Consultation with a qualified plumber is advised immediately to identify the cause of damp and perform remedial works as required. Where excessive mould growth is present, further inspection by a specialist environmental health inspector should also be considered.

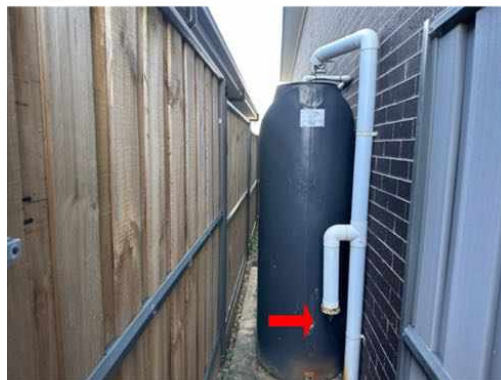
Defects 3.01

Building:	Main Building
Location:	Exterior walls - left side > Front Left
Finding:	Rain Water Tank: first flush not connected.
Information:	The first flush overflow was found to be disconnected from storm water drainage and is creating excessive moisture in the surrounding area.

Such leaking creates an environment which is conducive to an array of defects, including water damage to associated building elements and the attraction of termite or timber pest infestation.

It is highly recommended that a licensed plumber be appointed to connect the first flush overflow in order to prevent such an environment from being created. These minor works should be carried out as soon as possible.

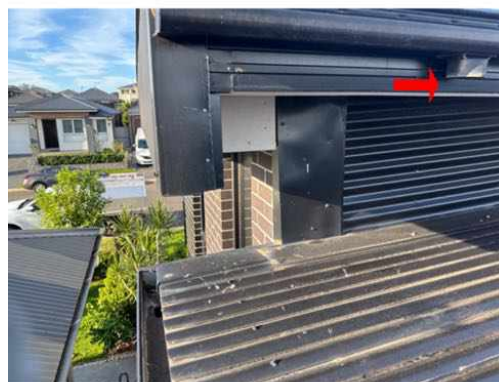
Defects 3.03

Building:	Main Building
Location:	All Areas > Level 2, Veranda
Finding:	Roof plumbing - Missing
Information:	Some sections of the roof are not adequately drained via gutters and downpipes. Gutters and downpipes that are not installed adequately are likely to result in excessively damp conditions against the exterior surfaces and around the base perimeter of the building.

Excessive moisture creates an environment which accelerates the deterioration of building elements in the area, as well as being conducive to termite and pest infestation. Such an environment is likely to necessitate repair and/or replacement of building elements, which are prone to sustaining wood rot, rust or corrosion.

A roofing plumber should be appointed as soon as possible to install relevant roof plumbing materials. Depending on the extent of the damage, repair and/or replacement of damaged building elements may be required.

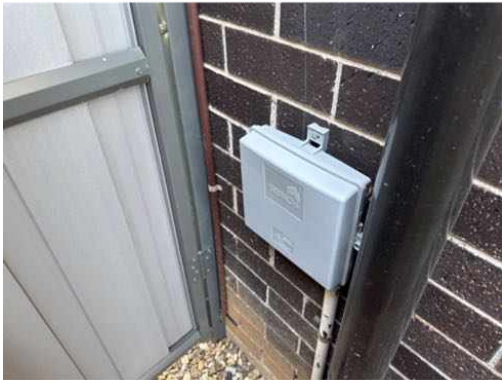
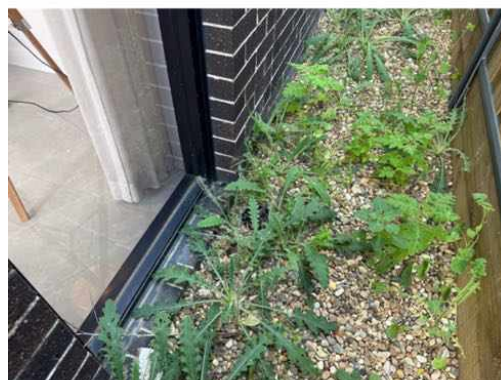
Building: Main Building
Location: All Areas > All Areas
Finding: Additional Photos - Obstructions and Limitations
Information: These photographs are an indication of the obstructions and limitations which impeded full inspection of the property at the time of inspection. These obstructions can hide an array of defects and should be removed to allow full inspection to be carried out. A re-inspection is recommended once the areas are made accessible.

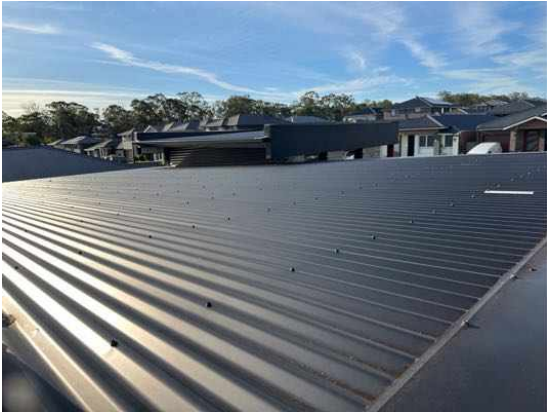
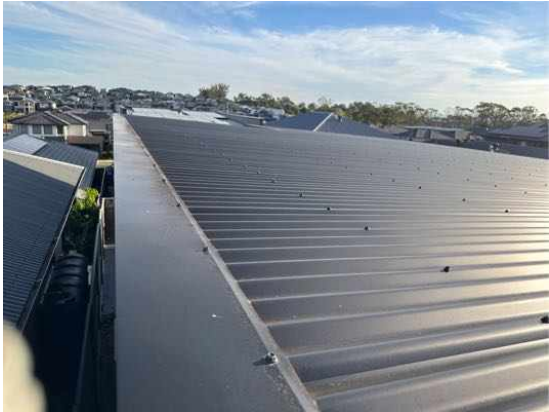
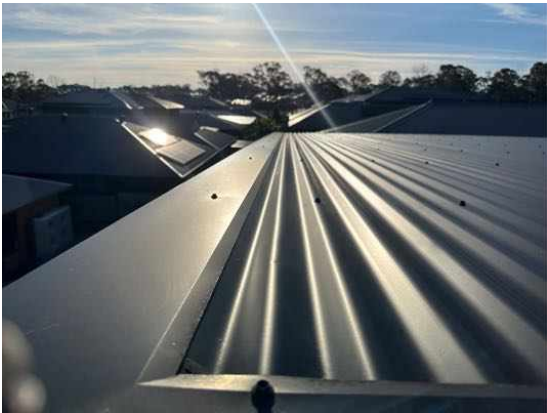
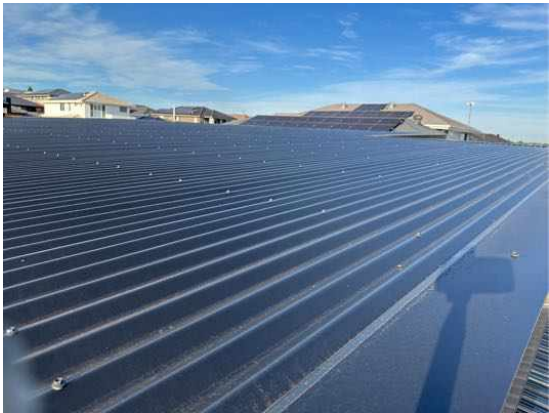
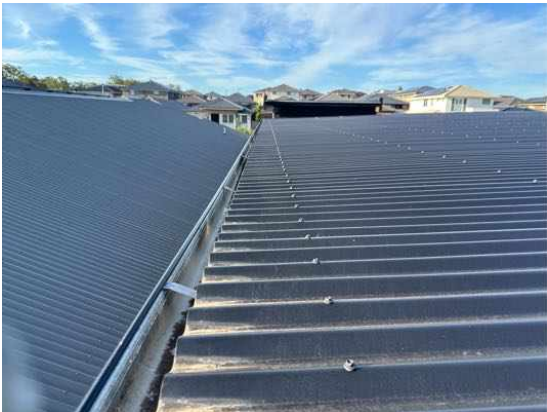
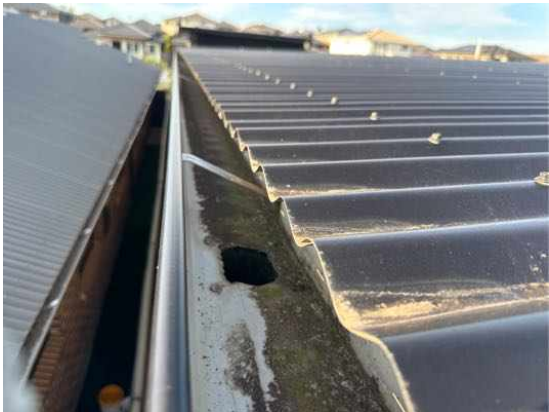
Building: Main Building
 Location: Roof Exterior > All Areas

Finding: Additional Photos
Information: Additional photos are provided for your general reference

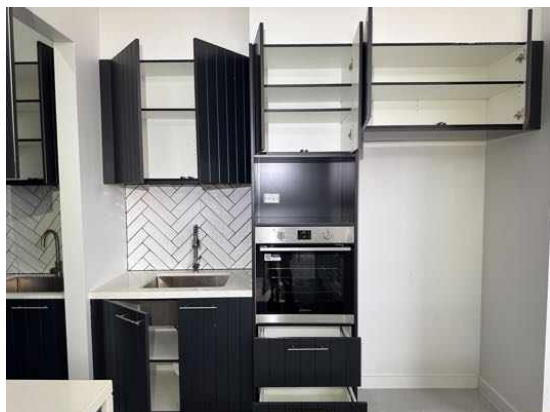
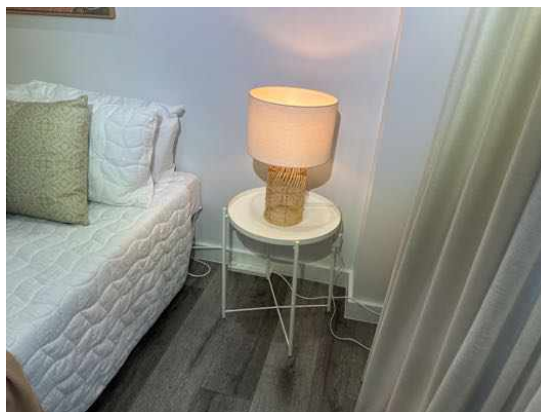
Building: Main Building
Location: All Areas > All Areas
Finding: Additional Photos - Obstructions and Limitations
Information: These photographs are an indication of the obstructions and limitations which impeded full inspection of the property at the time of inspection. These obstructions can hide an array of defects and should be removed to allow full inspection to be carried out. A re-inspection is recommended once the areas are made accessible.

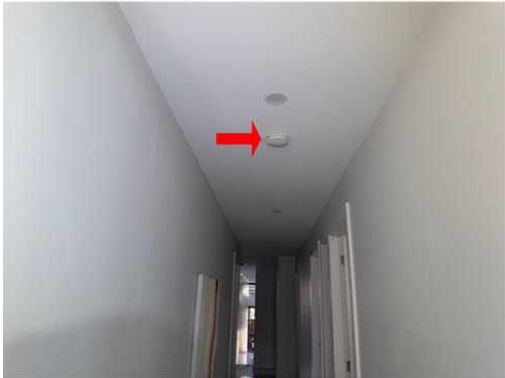
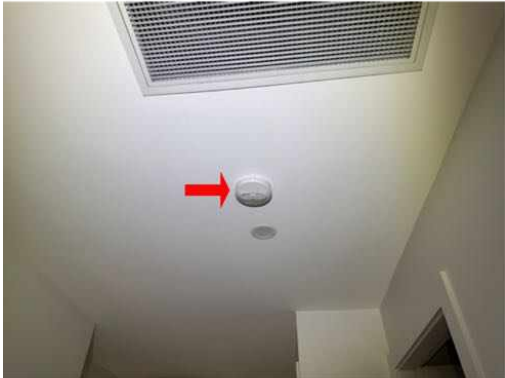
Always ensure sufficient working and suitable smoke detectors are installed prior to occupying any building. Additionally, it is advised that all smoke detectors be tested by the homeowner on a monthly basis.

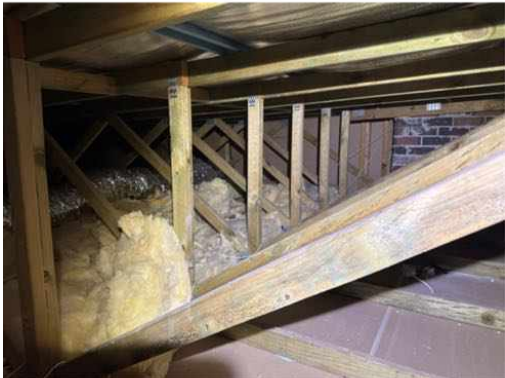
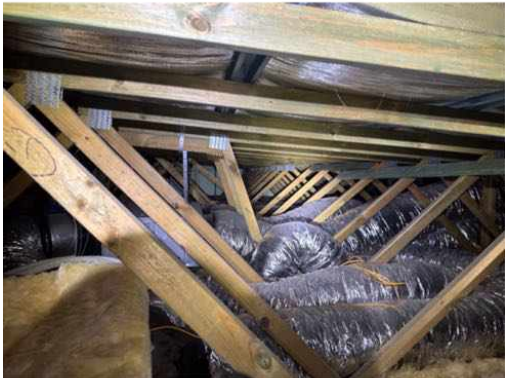
Building: Main Building
Location: Roof Void > All Areas
Finding: Roof void: limited access.
Information: Limited access to the roof void was present due to facts including but not limited to access hatch size or placement, insulation for this reason inspection to the roof void was minimal and a range of defect's from minor to major may not be visible at the time of inspection.
