Building and Timber Pest Inspection Report

Inspection Date: Wed, 11 Mar 2026

Property Address: 6 Chippers Glade Blacktown NSW 2148

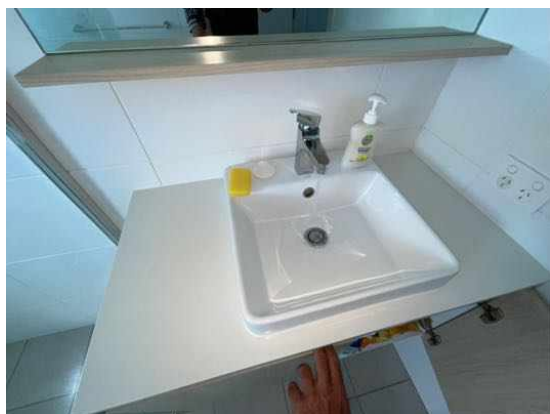
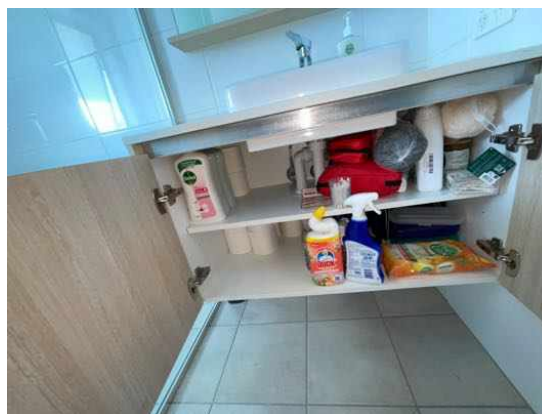
Building: Main Building
 Location: Ensuite
 Finding: Wet Areas - Bathroom(s) - Overall Condition & Recommendations.
 Information: Overall Condition & Recommendations

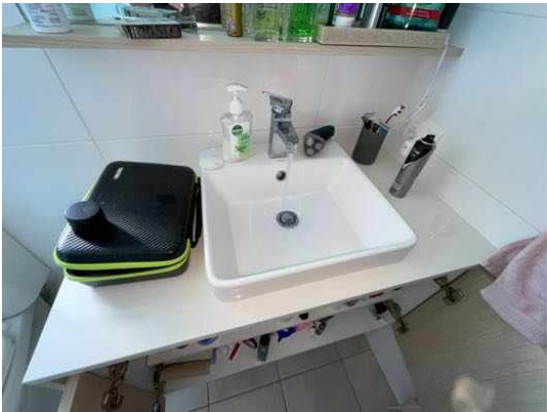
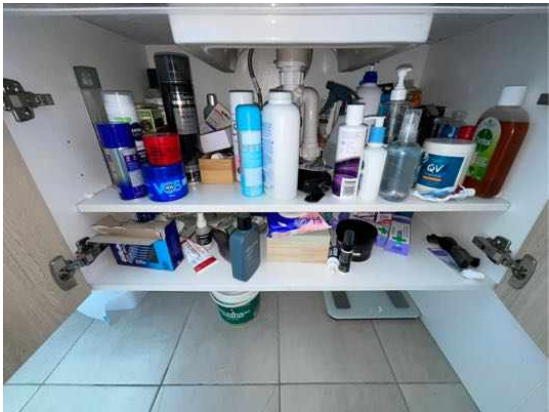
Building: Main Building
Location: Toilet (WC)
Finding: Overall Condition: Toilet & Basin.
Information: TOILET & BASIN ASSESSMENT
