Building and Timber Pest Inspection Report

Inspection Date: Fri, 27 Feb 2026

Property Address: 51 Crowley Bvd, Claymore NSW 2559,
Australia

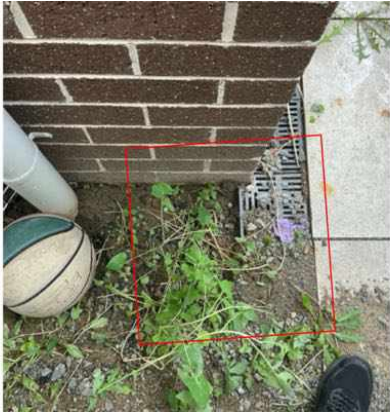
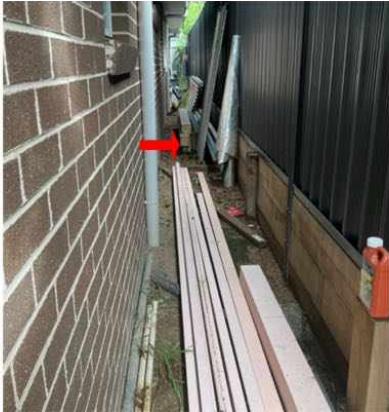
Finding: Site drainage - Inadequate

Information: The site drainage in this area was found to be inadequate at the time of inspection, creating potential for subsequent water damage to associated building elements.

Where site drainage is inadequate, installation of an Agricultural (Aggie) Drain may be required. A qualified plumber should be appointed to further inspect the property and perform any remedial works as necessary. Water damage and secondary defects are likely to occur if left unmanaged.

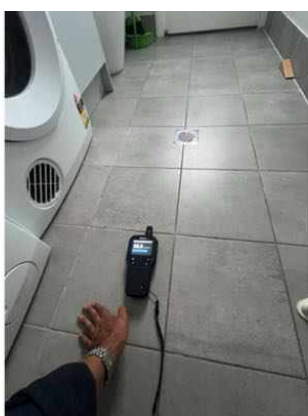
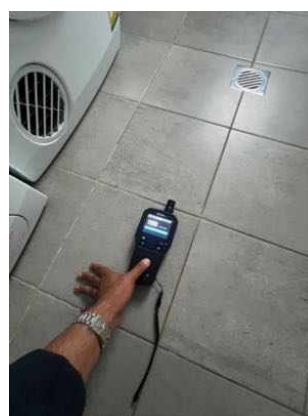
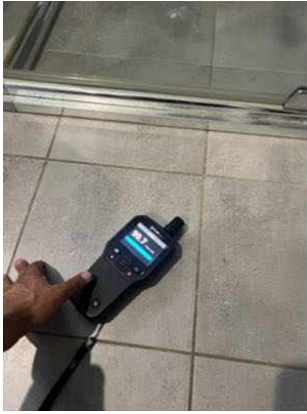
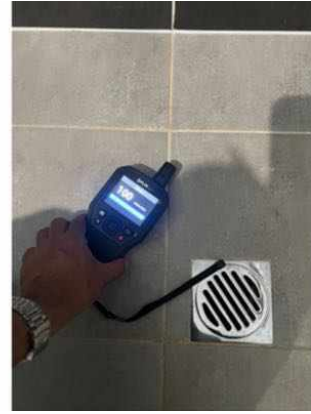
Finding 3.04

Building:	Main Building
Location:	Rear near sliding door and external rear wall
Finding:	Elevated Moisture Detected – No Visual Deterioration Observed
Information:	Moisture readings taken indicated elevated levels above typical thresholds. However, at the time of inspection, no visible signs of water damage, staining, timber decay, or mould growth were identified. While this may be due to recent exposure or concealed moisture, further monitoring is recommended. If concerns persist, a licensed builder or water ingress specialist should be engaged to assess concealed areas and verify the source, especially given the expectations of durability and weatherproofing.

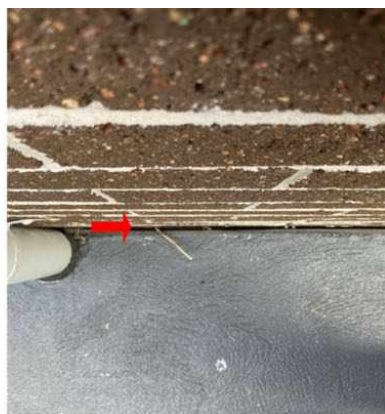
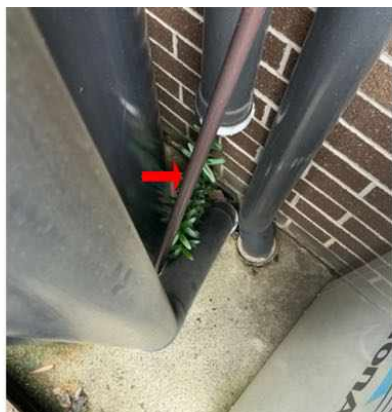
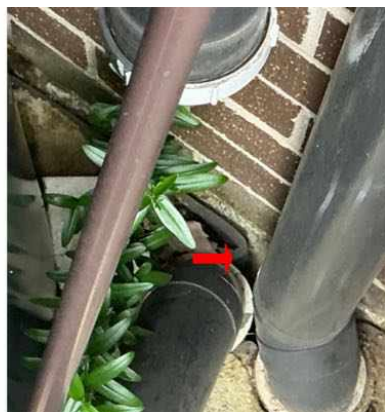
Finding 3.06

Building:	Main Building
Location:	All External Areas
Finding:	DPC & Weep Holes
Information:	The ground level is nearly flushed or level with no visible step-down or separation from the weep holes or the damp-proof course (DPC). This presents a moisture risk, as AS 2870 and NCC Volume 2 Part 3.1.2 require ground levels or hard surfaces to be at least 75 mm below the DPC or the lowest course of brickwork with weep holes to prevent rising damp or lateral moisture ingress. Monitoring is recommended along with creating a 75 mm clearance or isolation gap along the wall line as required by NCC Vol 2 Part 3.1.2.3 and AS 2870 Clause 5.3.3. Monitor for any signs of rising damp or efflorescence.

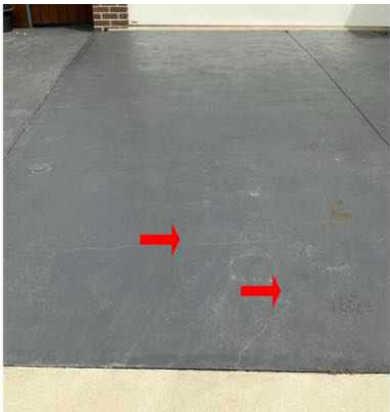
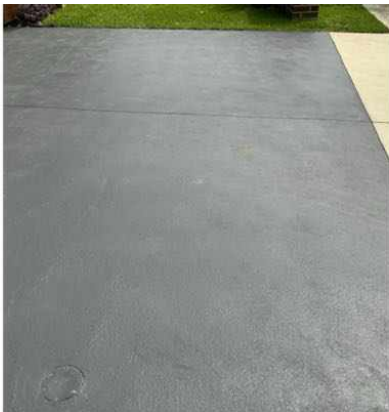
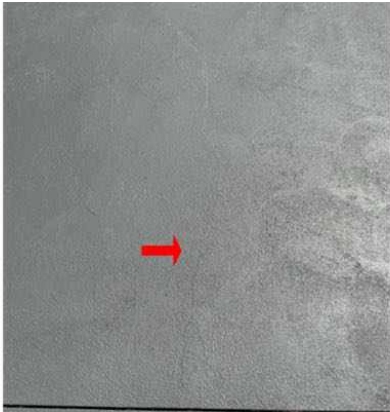
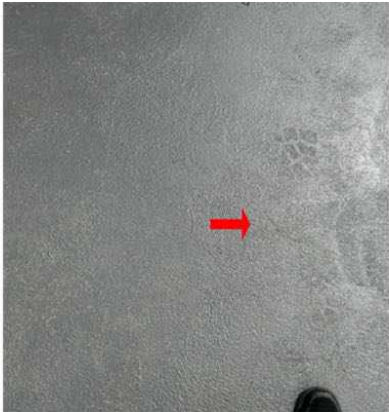
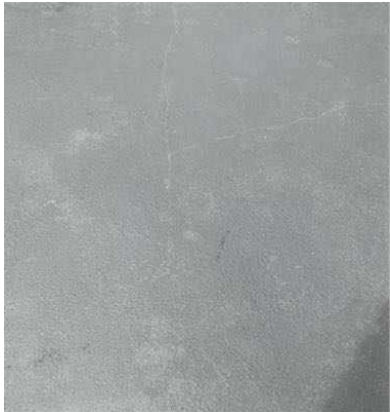
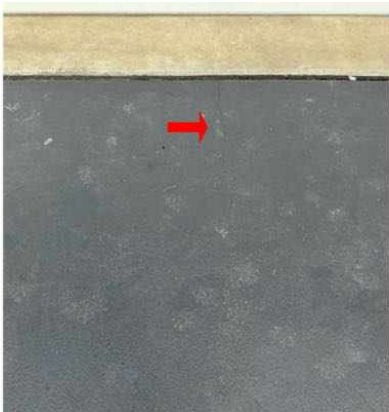
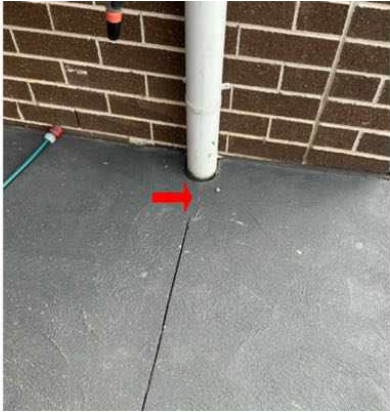
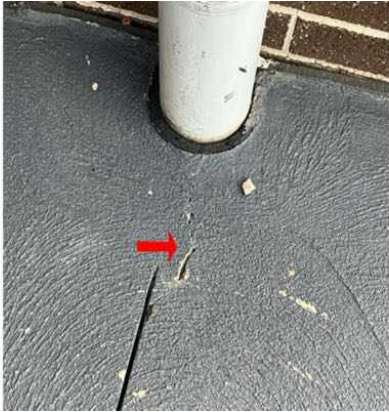
Finding 3.09

Building:	Main Building
Location:	All External Areas
Finding:	Paving - Uneven
Information:	Sections of the external paved area are uneven, creating a potential trip hazard. It appears as though the area has been subject to rough installation, or that paving sections have lifted due to movements in the foundation of the property.

Where paving creates a trip hazard, personal injury may ensue if due caution is not taken by all persons within this area.

Re-paving of the area is required as soon as possible to remedy this situation. Further consultation with a specialist concreter is advised.

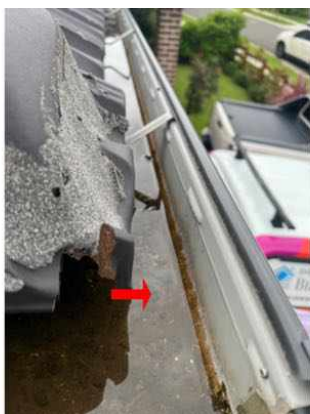
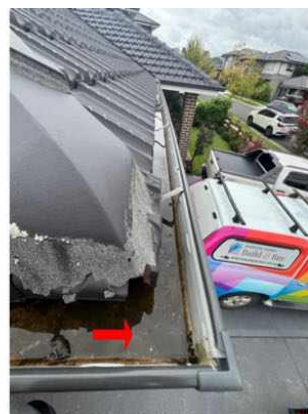
Building:	Main Building
Location:	All External Areas
Finding:	Gutters - Water pooling and debris
Information:	Water was found to be pooling in sections of the roof guttering. This is generally a secondary defect caused by blocked or partially blocked gutters. Such blockages and subsequent water pooling are likely to lead to rust and water damage to associated structures if left unattended.

Any areas of guttering that shows evidence of water pooling should be checked for partial or full blockages and any secondary damage that may have occurred as a result. Depending on the extent of the damage, building elements may require repair and/or replacement to ensure adequate roof drainage and function of exterior plumbing system.

A roofing plumber should be appointed as soon as possible to rectify this issue. It is highly advised that all gutters be maintained on a frequent basis to ensure the condition of roof plumbing.

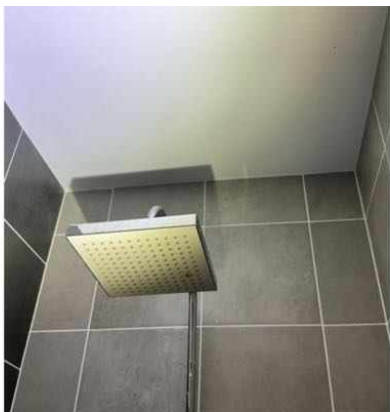
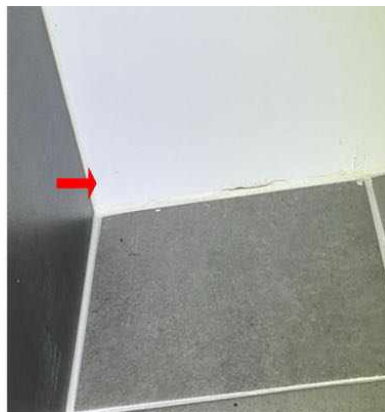
Finding 3.18

Building: Main Building
 Location: Ensuite
 Finding: Water Staining - Humidity or Ventilation
 Information: The ceiling surface shows faint darkened spotting or shadowing, commonly consistent with surface mould or humidity-related staining, often found in bathroom or wet area ceilings with insufficient ventilation. While there is no visible sagging or major water damage, the pattern suggests prolonged moisture exposure, possibly due to steam accumulation or minor condensation issues. According to AS 4349.1–2007 (Appendix C), this would be classified as a minor defect unless further deterioration or active leaks are found. Recommend improving mechanical or natural ventilation, cleaning the surface with mould treatment, and monitoring for recurrence.

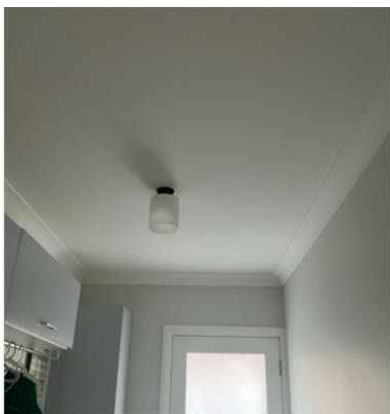
Finding 3.19

Building:	Main Building
Location:	Laundry
Finding:	Building element - Missing - No ventilation
Information:	Although some building elements may seem irrelevant or unnecessary, all building elements play a key role in the operation and function of the overall structure and its performance.

Replacement of any missing building element should be conducted as soon as possible to ensure that no damage or functional issues occur to associated building materials.

The appropriate tradesperson should be appointed as soon as possible to replace the missing building element.

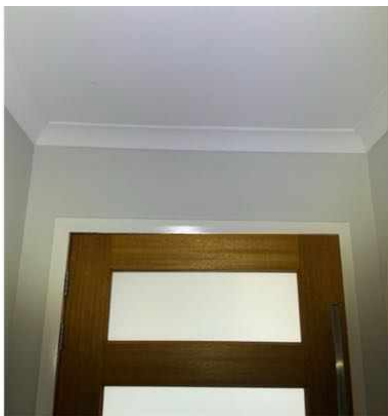
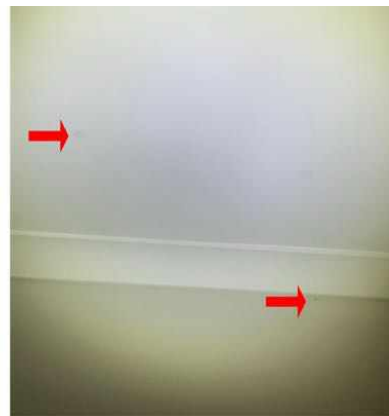
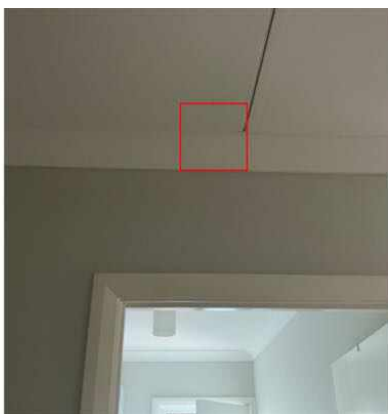
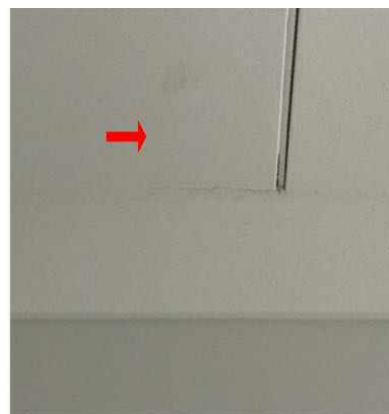
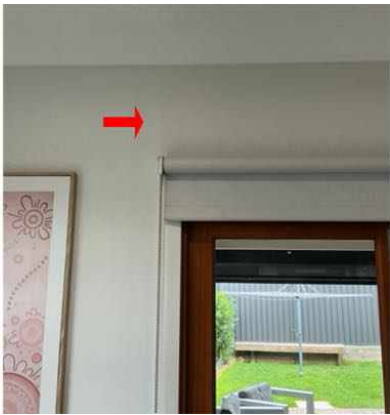
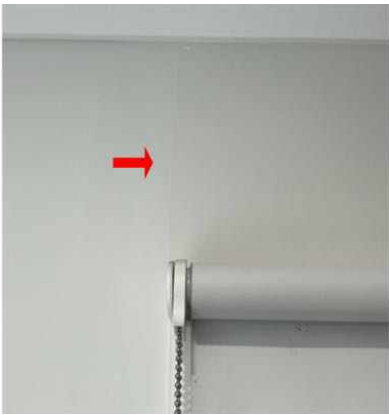
Finding 3.20

Building:	Main Building
Location:	All Internal Areas
Finding:	Paint Finish & Hairline Cracking - To some areas
Information:	The paint finish in this area was identified as being incomplete or substandard at the time of inspection including some hairline minor cracking/separation. Monitoring is

recommended where cracking and separation is evident.

Whilst incomplete or missing paint finish is generally an appearance defect, it can also lead to the development of secondary building defects over time. Incomplete areas of paint finish expose the area to moisture, potentially accelerating the deterioration of underlying building materials.

Incomplete paint finishes should be sanded back, filled, leveled and painted, as applicable. Where inadequate or missing paint protection has led to the deterioration of the associated building element, repair and/or replacement of this building element may be required.

A painting contractor should be appointed as soon as possible to perform necessary works to aid the appearance of the affected area and to ensure the area is protected against further deterioration. Alternatively, the homeowner following manufacturer instructions may perform these works.

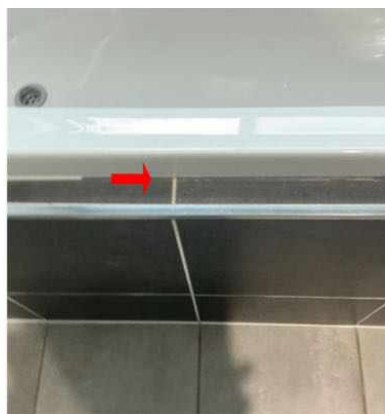
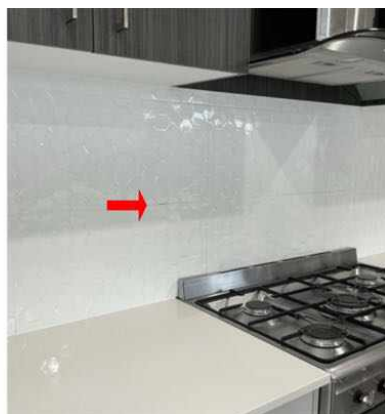
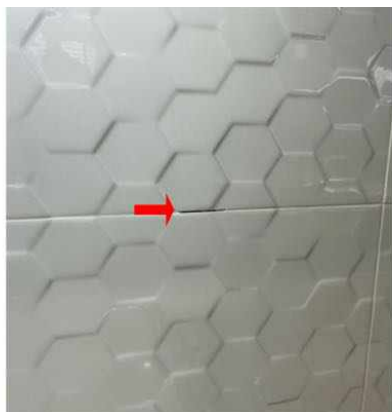
Finding 3.21

Building:	Main Building
Location:	All Internal Areas
Finding:	Sealant and grouting - Missing or degraded to some areas
Information:	It was noted on inspection that sealant or grout is degraded.

Different materials and floor areas move at different rates, generally causing cracking to grout or sealant at this point. A flexible sealant is required to allow for expected expansion and contraction, while keeping the joint water tight and protective of all associated building materials.

Excessive mould to the sealant and grout may require scraping out and replacement.

Flexible and mould resistant materials should be applied to affected areas to prevent any subsequent water damage that is likely to occur. Regular maintenance and replacement of damage or missing or damaged sealant and grout is highly recommended to the wet areas, as this is a regular wear and tear defect. Sealant and grouting in areas that come into regular contact with water should be maintained for the long term care of your property.

A sealant specialist or tiling contractor should be appointed to complete these works as soon as possible

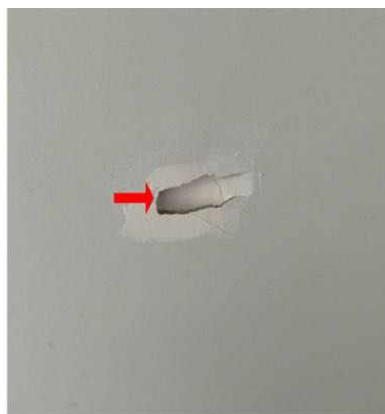
Finding 3.22

Building:	Main Building
Location:	All Internal Areas
Finding:	Building element - Damaged - plaster damaged laundry
Information:	Breakage occurs generally when the building materials have either aged and decayed, or as a result of damage (accidental or deliberate).

Repair and/or replacement of broken elements is advised to ensure that additional secondary defects do not arise as a consequence. Such works are necessary, as all building elements play a key role in the operation and function of the overall structure and its performance.

A relevant tradesperson should be appointed to repair or replace the affected building element prior to any subsequent damage being caused.

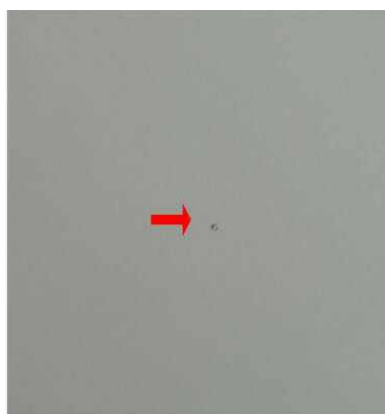
Finding 3.23

Building:	Main Building
Location:	All Internal Areas, Garage
Finding:	Ceiling nails - Popping To some areas
Information:	Numerous popped nails were identified in the internal ceiling at the time of inspection. Nails and screws hold simply by the friction between them and the surface they are applied to. Over time, the nails and screws can back out, which is often a result of general ageing and deterioration of the building structure.

If left unmanaged, the ceiling sheets may become loose and unstable, increasing the rate of deterioration of the internal ceiling and creating potential for the development of secondary defects.

Re-fastening of popped nails will help to maintain the stability of the internal ceiling and associated building elements. Such minor works will also help to improve the appearance of the affected area and secure the ceiling sheets, so as to prevent the onset of ceiling sagging. These works should be performed by a qualified carpenter or plasterer at client discretion.

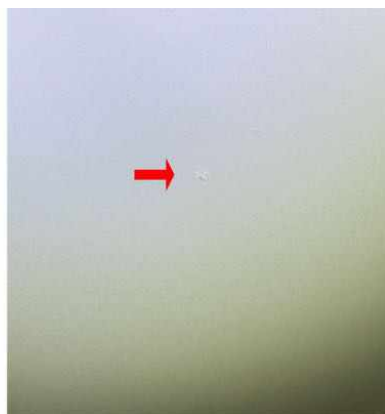
Finding 3.24

Building:	Main Building
Location:	All Internal Areas
Finding:	Door stop - Missing to some areas
Information:	The door stop is missing or is inadequate to stop the door handle from damaging the wall. Although some building elements may seem irrelevant or unnecessary, all building elements play a key role in the operation and function of the overall structure and its performance.

Re-installation or replacement of the door stop is advised as soon as possible to prevent any subsequent damage to the door or associated structures. A general handyman may be appointed to perform these works at client discretion.

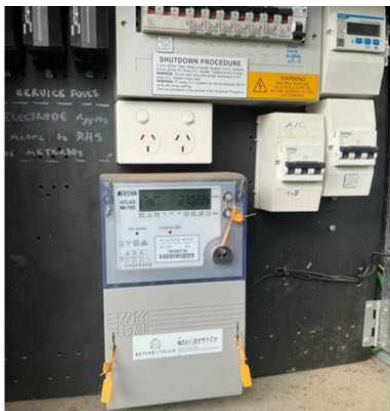
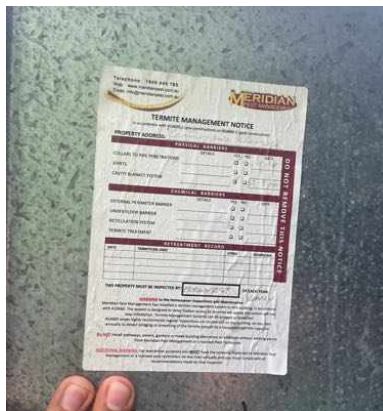
Building:	Main Building
Location:	All External Areas
Finding:	Termite Management System - no evidence of a chemical installation
Information:	The application of a post-construction chemical termite barrier is highly recommended for all properties, particularly if live termite activity has been found on the site previously. Such barriers are highly effective in preventing termite attack on any timber building elements throughout the property.

system has been installed, with no evidence to suggest preventative works taking place.

The client may consider gaining further advice from a pest controller as to the costs and procedures involved with this application. It is recommended that obtaining such advice be a short-term priority.

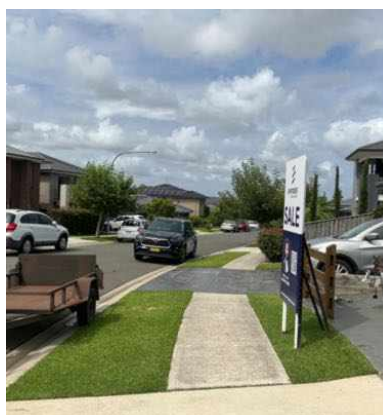
Finding 6.02

Building: Main Building
 Location: All External Areas
 Finding: Trees within 50m
 Information: Trees within 50m of the property can be conducive to termite activity. It is recommended an invasive inspection of all trees with 50m to the property be carried out by a qualified pest control expert.

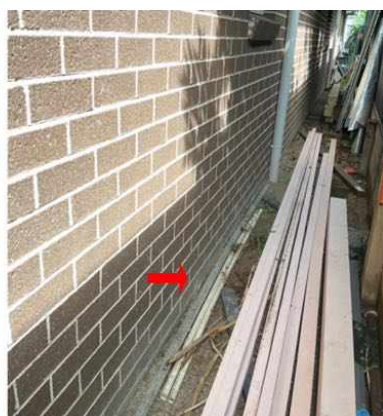
Finding 6.03

Building: Main Building
 Location: All External Areas
 Finding: Slab Edge - Exposure
 Information: An inspection zone of at least 75mm in relation to the exposed slab edge, between the bottom brick and the perimeter pavement, is required. This inspection zone

If the slab edge is not properly exposed there is a high risk of termite attack. Sometimes, in order to determine the type of slab, a suitably qualified person such as an architect or builder may be required to consult the construction plans.

Where the slab edge cannot be properly inspected, it is highly recommended that termite or timber pest inspections be carried out every 6-12 months to aid protection of the property against infestation.

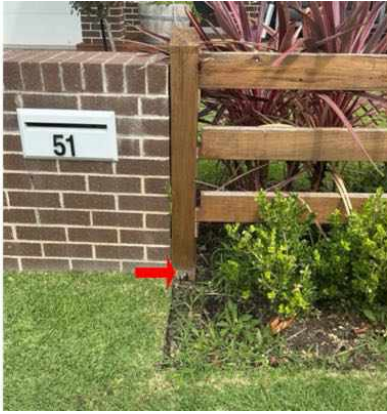
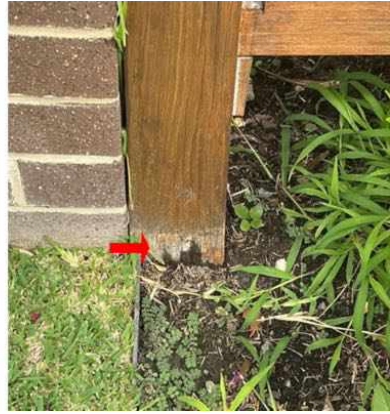
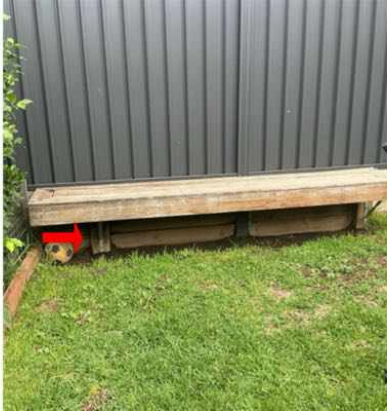
Finding 6.04

Building:	Main Building
Location:	All External Areas
Finding:	In ground contact - Timber
Information:	Any timbers in direct ground contact provide opportunity for concealed termite entry and are likely to be subject to premature rot and decay as the soil retains moisture or damp conditions against the timbers.

Remove untreated timber that is in direct contact with external grounds. Consider replacement with more durable materials i.e. treated timber or non timber elements. Frequent pest inspections are advised to readily identify any termite activity in these areas.

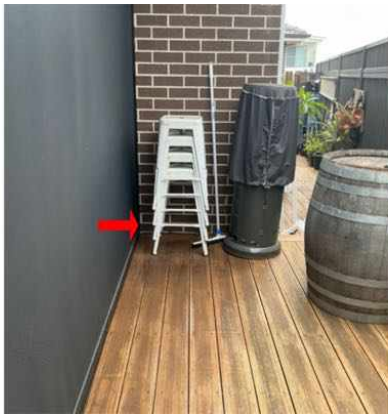
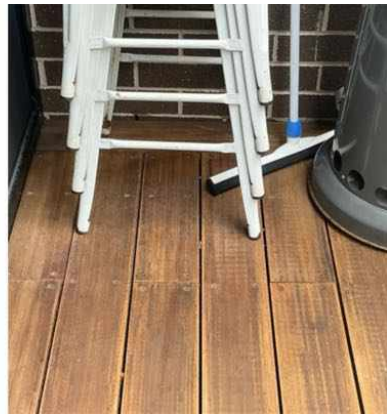
Finding 6.05

Building:	Main Building
Location:	All External Areas
Finding:	Bridging of termite barrier
Information:	Bridging of termite barriers occurs when termites bridge (usually by building a mud tunnel) a termite barrier or inspection zone or where termites have a passage allowing them to bridge the barrier.

Generally this takes the form of finished ground levels external paving or concrete being retrospectively installed above the damp course level the adjacent internal floor level or weep and ventilation holes.

Where bridging has occurred full inspection is prevented and termites may enter a property in a concealed or undetectable manner.

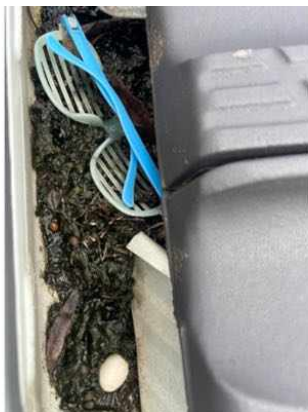
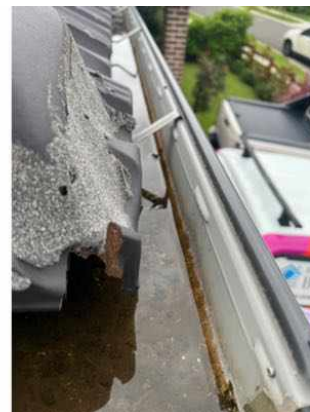
Finding 6.06

Building:	Main Building
Location:	All External Areas
Finding:	Gutters - Blocked/water pooling
Information:	Roof plumbing structures, such as guttering and downpipes, should be free of all debris to prevent blockages. Blockages of the guttering and downpipes will lead to pooling and accumulated water overflows, which is likely to subsequently flood eaves and exterior walls.

Blocked gutters are likely to lead to high levels of moisture in the affected areas. Such moisture will not only cause rust and decay of the associated building materials, but can also provide conditions that are conducive to termite and timber pest activity. Blockages in gutters should therefore be removed immediately to ensure dry conditions are maintained.

Consult a Licensed Plumber for further specific advice on remedial works that may be required. In the interim, it is highly advised that blocked gutters be removed by the homeowner or a general handyperson as a matter of urgency.

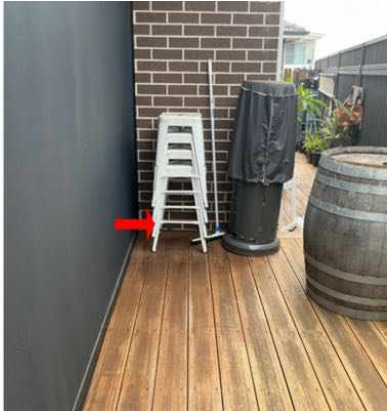
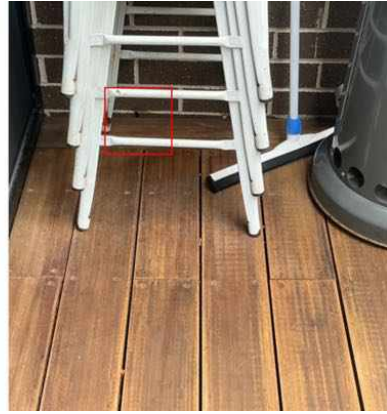
Building: Main Building
 Location: Subfloor
 Finding: Weep holes blocked
 Information: The weep holes to the brickwork are blocked. Weep holes are designed to allow water to escape the cavity from leaks or seepages in brickwork before the water enters in or damages the wall cavity and in particular to windows and doorways. Weep holes should be kept clean and free of debris or blockages

Depending on the nature of the blockage the homeowner may be able to undertake remedial works. Where weepholes are extensively blocked the registered builder on site should perform such works.

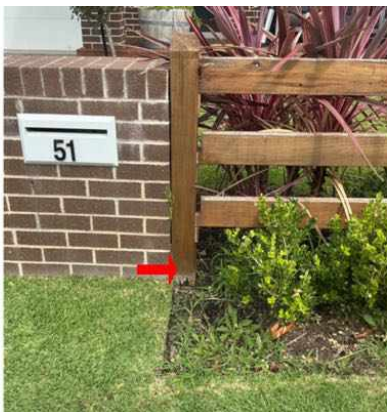
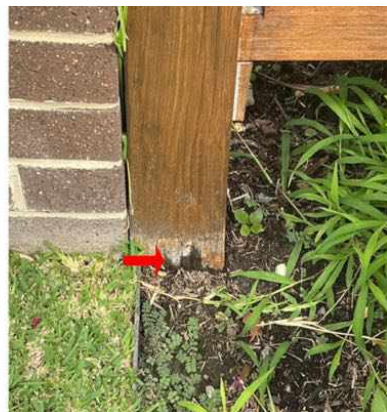
Finding 7.01

Building:	Main Building
Location:	All External Areas
Finding:	Fungal decay - present
Information:	Fungal decay also known as wood decay or wood rot generally refers to the deterioration of timber elements when in contact with excessive levels of moisture for a prolonged period of time.

The development of fungal decay is accelerated by temperatures in the range of 5degreeC to 40degreeC as well as the presence of oxygen. Generally fungal decay develops on timber elements that are in use in an external environment which are exposed to rain penetration.

In this case although the affected timber element is in a decaying state the extent of any visible damage appears to be localised to a specific area and is yet to spread to other parts of the building element or affect adjoining structures. The fungal decay is therefore likely to be of a relatively superficial nature with minimal impact on the structural integrity or tensile strength of the timber element.

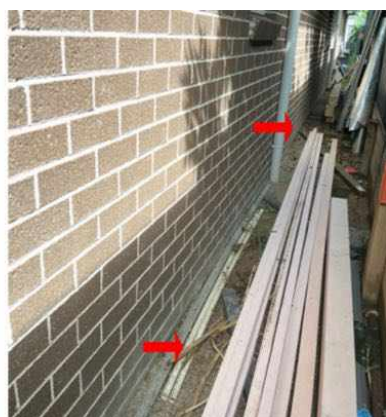
Building:	Main Building
Location:	All External Areas
Finding:	Surface Drainage - Gravel
Information:	The setback is finished with loose aggregate. While gravel can assist with surface dispersion of water, it is not a controlled drainage system. The adequacy of falls and stormwater connection could not be confirmed at the time of inspection. Monitoring during rainfall is recommended to ensure no ponding or water discharge occurs toward the slab edge. Further inspection by a licensed plumber is recommended.

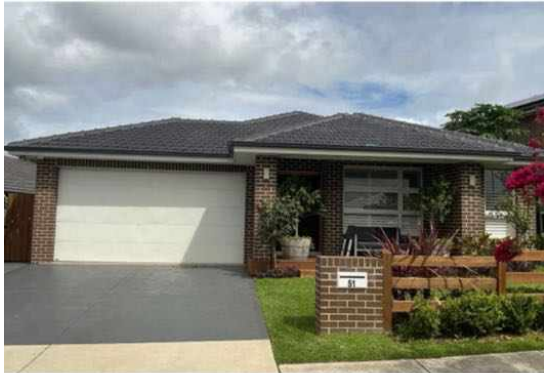
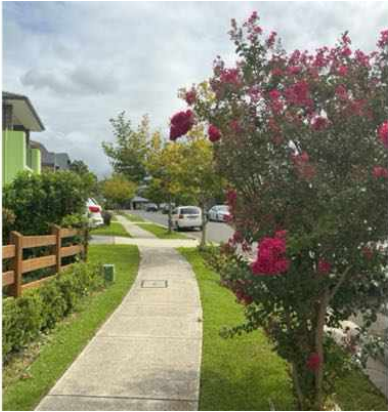
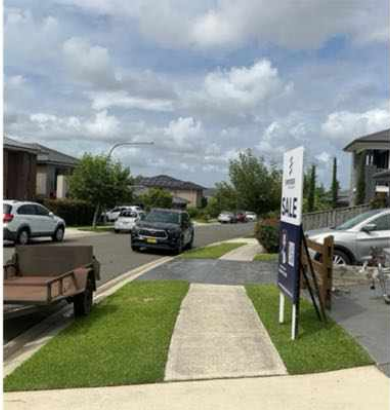
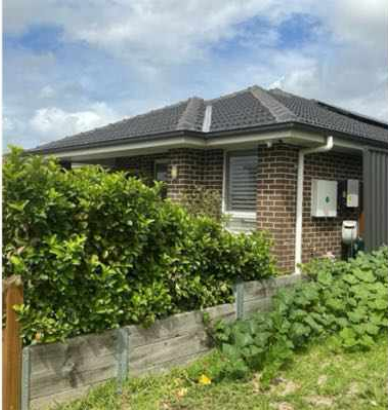
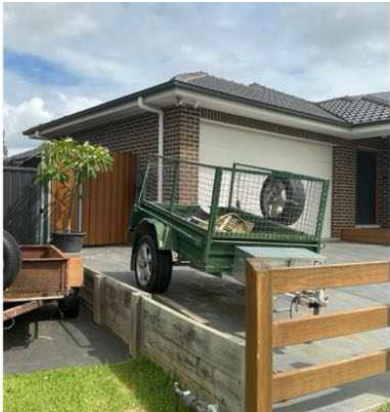
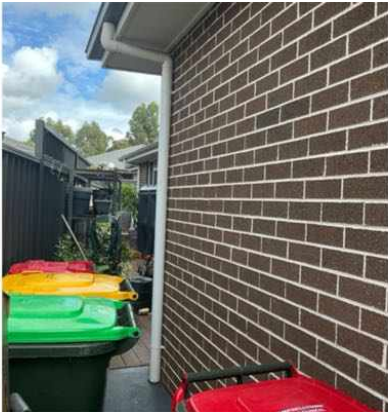
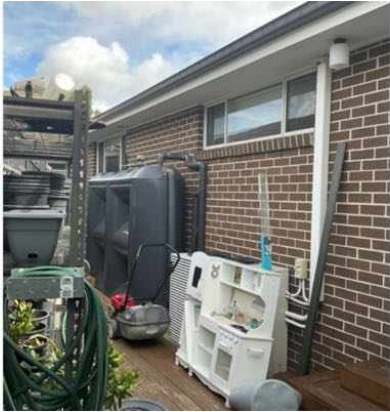
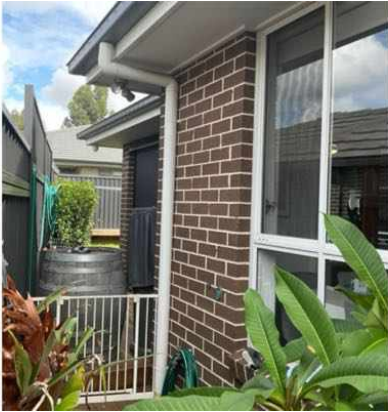
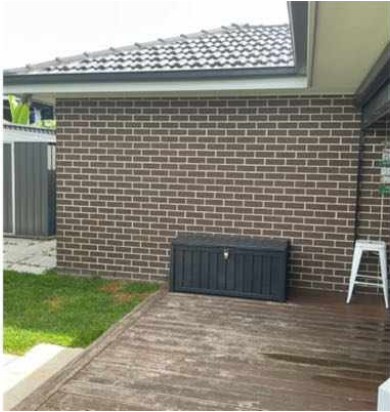
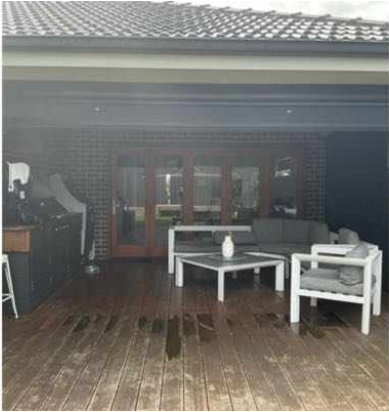
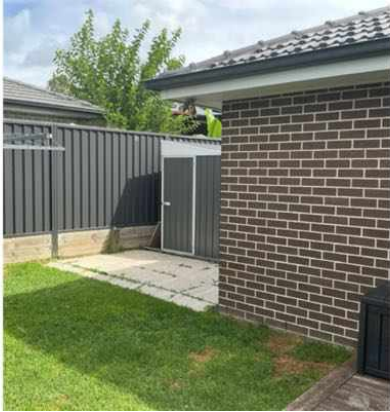
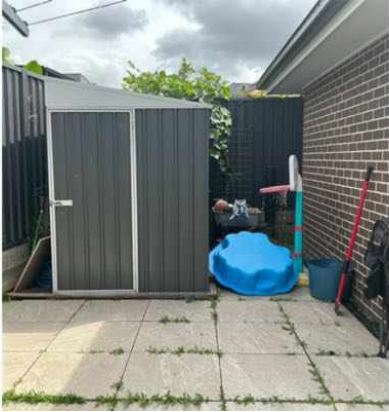
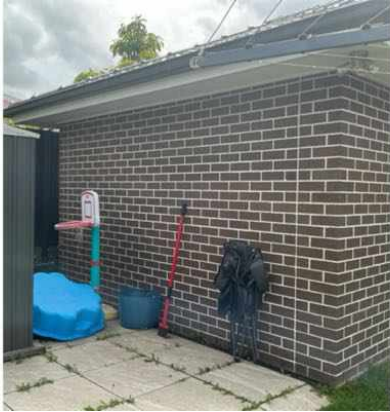
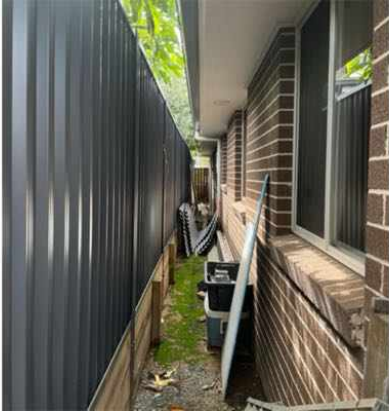
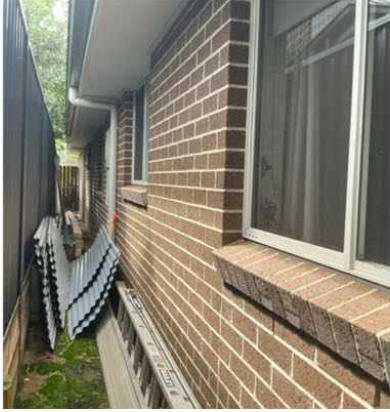
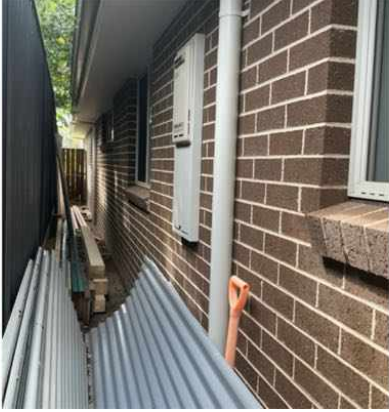
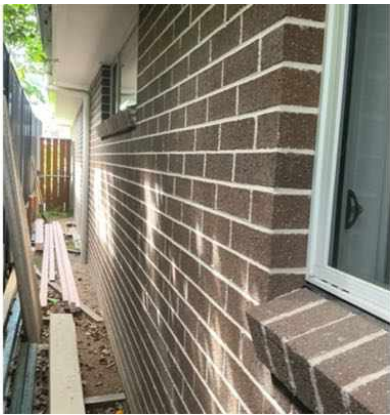
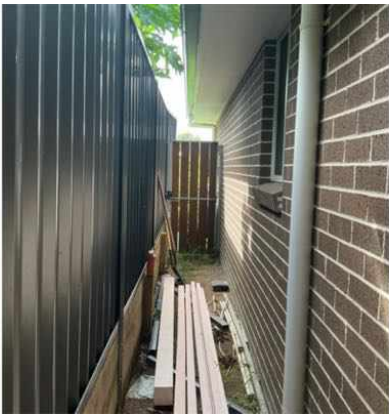
Building:	Main Building
Location:	All External Areas
Finding:	Additional Photos - Obstructions and Limitations
Information:	These photographs are an indication of the obstructions and limitations which impeded full inspection of the property at the time of inspection. These obstructions can hide an array of defects and should be removed to allow full inspection to be carried out. A re-inspection is recommended once the areas are made accessible.

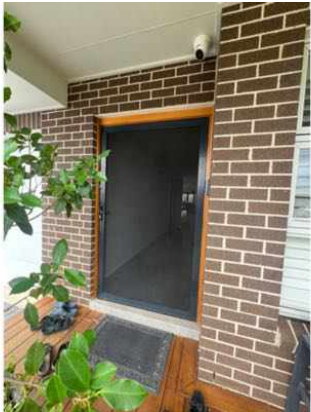
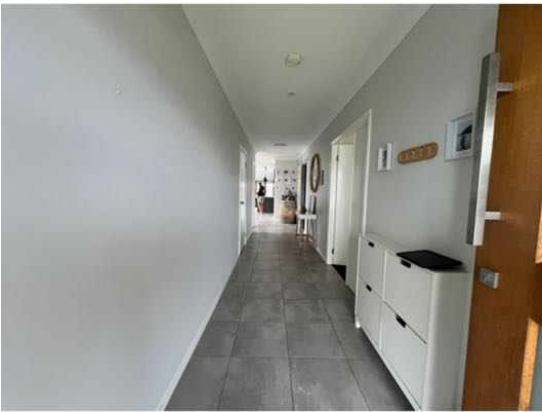
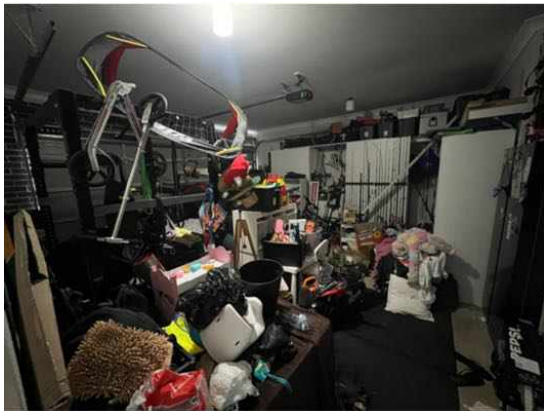
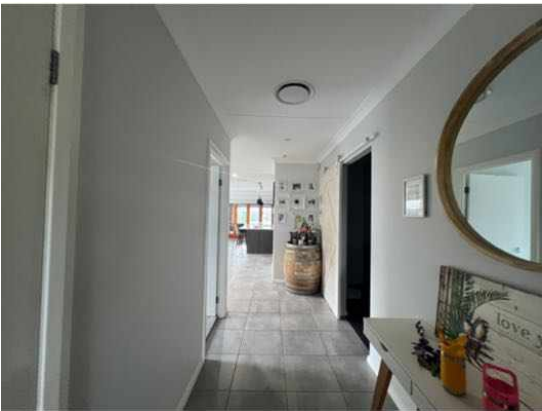
Building: Main Building
Location: All Internal Areas
Finding: Additional Photos - Obstructions and Limitations
Information: These photographs are an indication of the obstructions and limitations which impeded full inspection of the property at the time of inspection. These obstructions can hide an array of defects and should be removed to allow full inspection to be carried out. A re-inspection is recommended once the areas are made accessible.

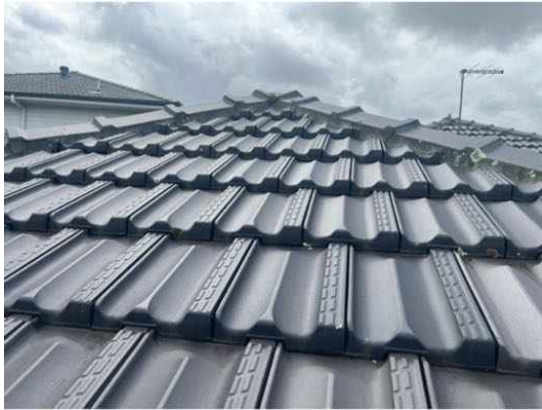
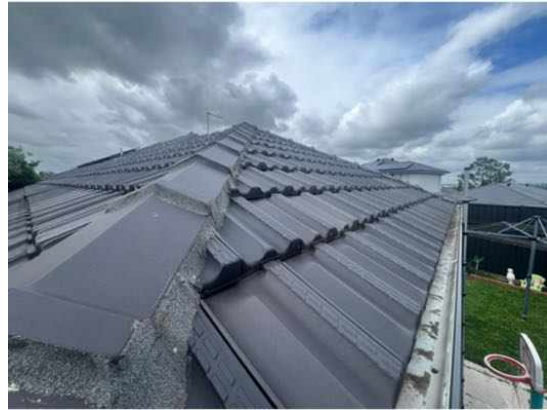
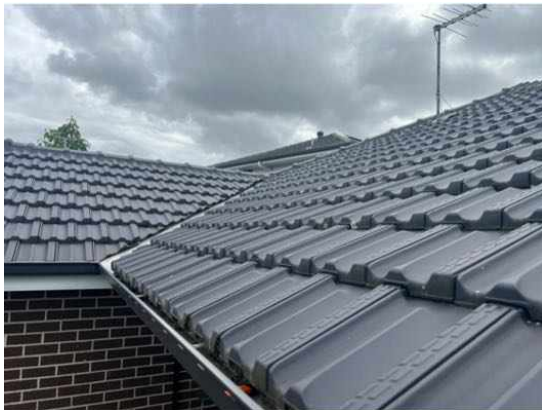
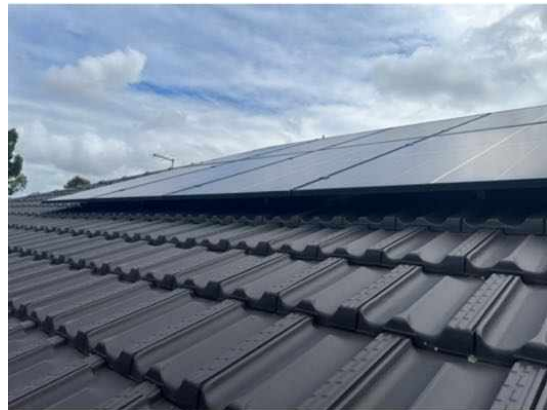
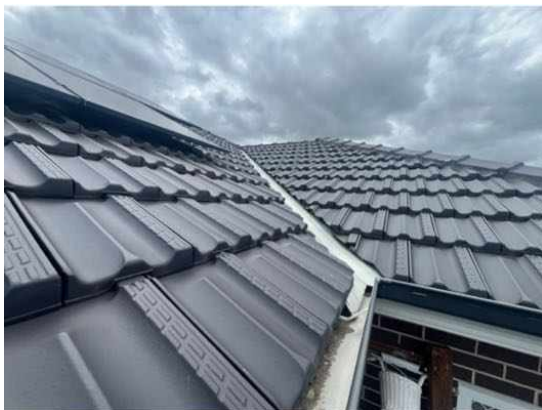
Building: Main Building
 Location: Roof Exterior
 Finding: Additional Photos - Obstructions and Limitations
 Information: These photographs are an indication of the obstructions and limitations which impeded full inspection of the property at the time of inspection. These obstructions can hide an array of defects and should be removed to allow full inspection to be carried out. A re-inspection is recommended once the areas are made accessible.

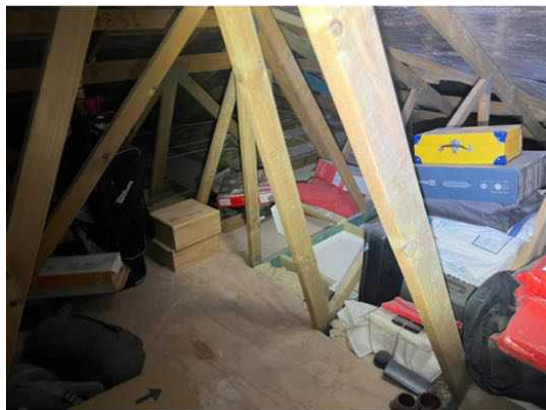
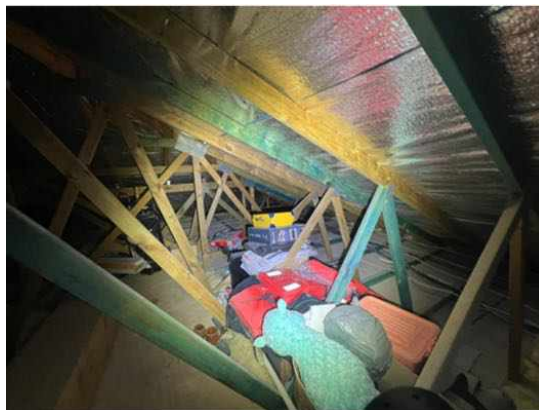
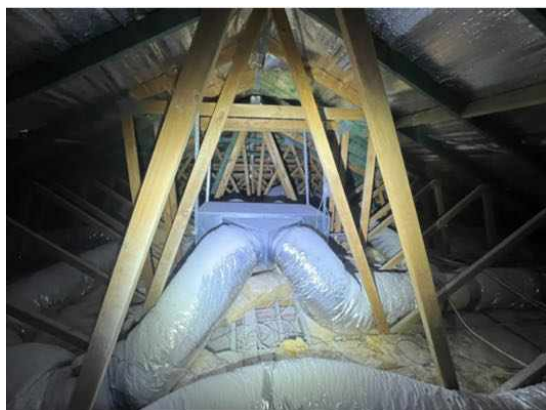
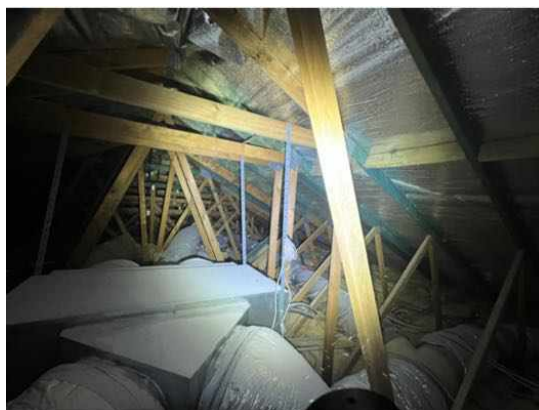
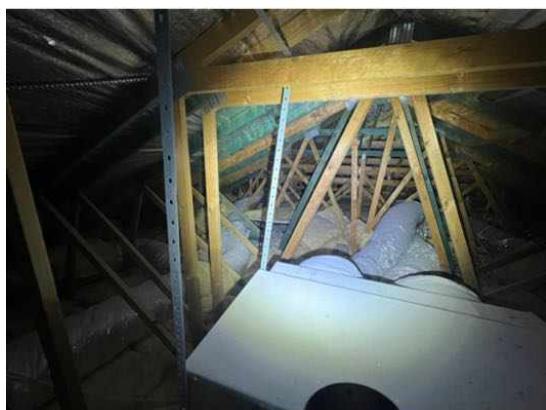
Building: Main Building
 Location: Roof Void

Finding: Additional Photos - Obstructions and Limitations
Information: These photographs are an indication of the obstructions and limitations which impeded full inspection of the property at the time of inspection. These obstructions can hide an array of defects and should be removed to allow full inspection to be carried out. A re-inspection is recommended once the areas are made accessible.

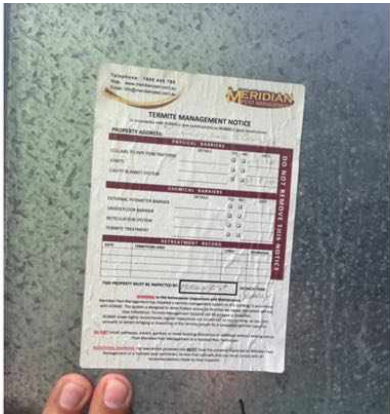
Where a Termite Management System has been identified you should refer to the type of barrier date of installation warranty conditions and any documentation provided by a builder or past owner. Consult the company who installed the barrier to confirm whether the system is still under warranty.

Most chemical termite management systems expire and require replenishment and all physical systems are primarily designed to prevent concealed entry.
