Building and Timber Pest Inspection Report

Inspection Date: Sat, 28 Feb 2026

Property Address: 12A Winifred St, Condell Park NSW 2200,
Australia

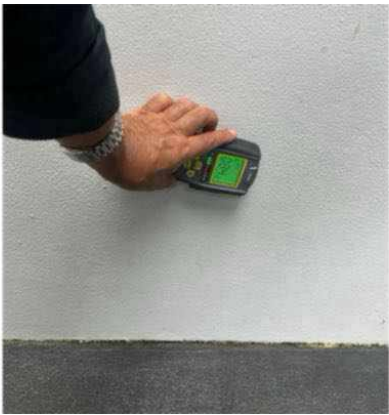
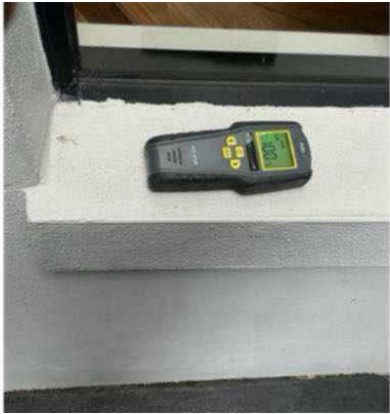
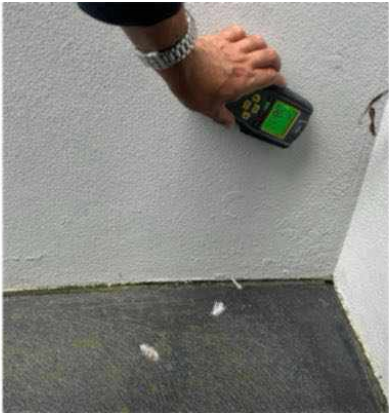
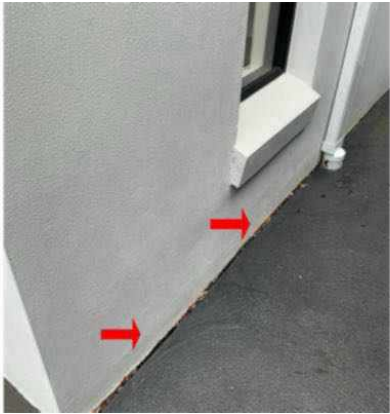
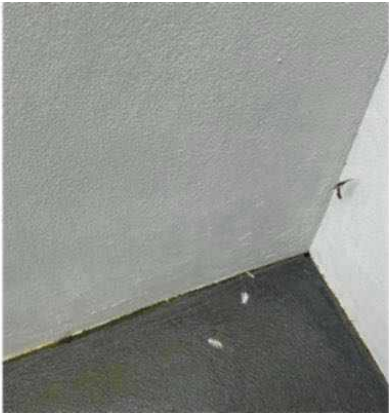
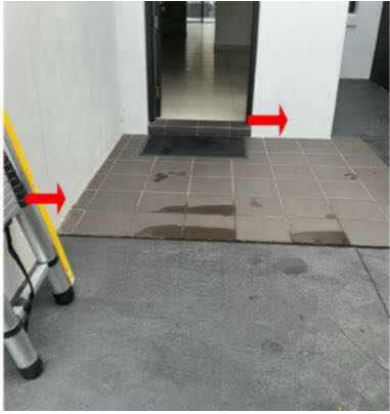
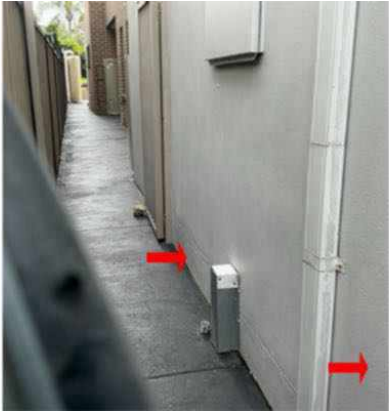
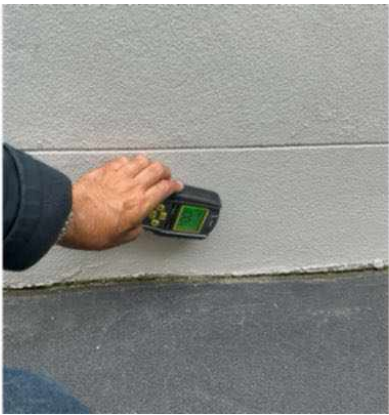
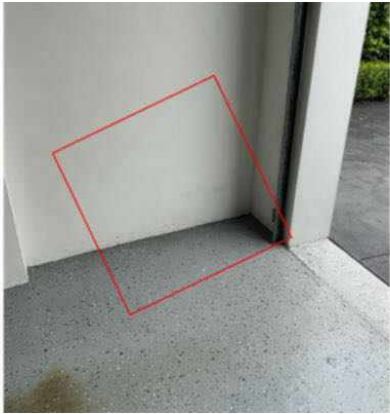
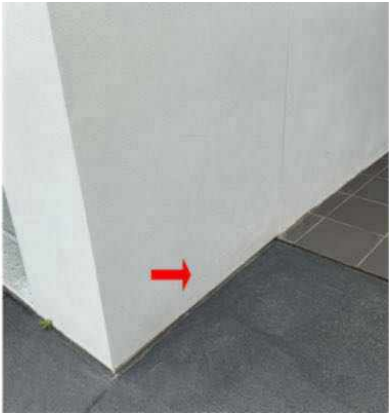
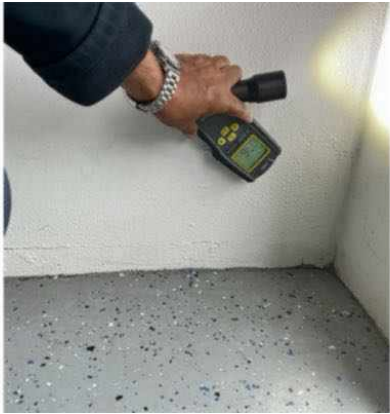
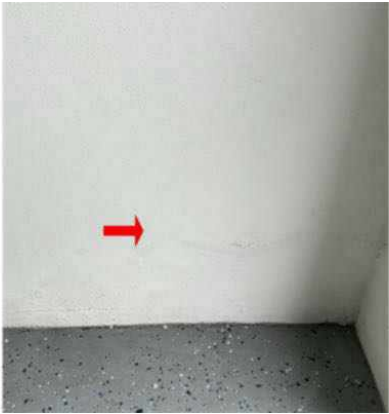
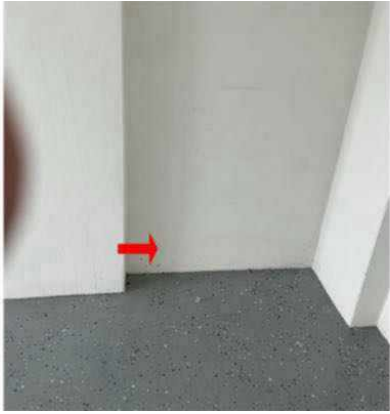
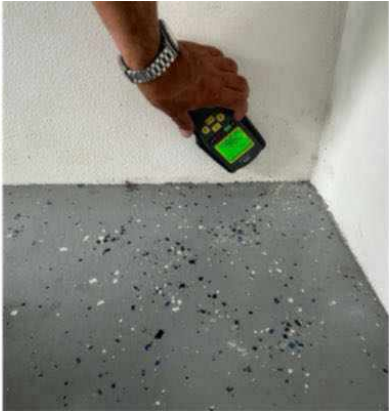
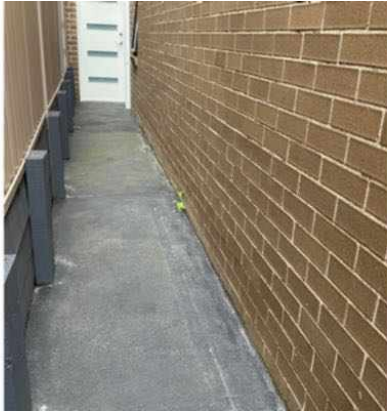
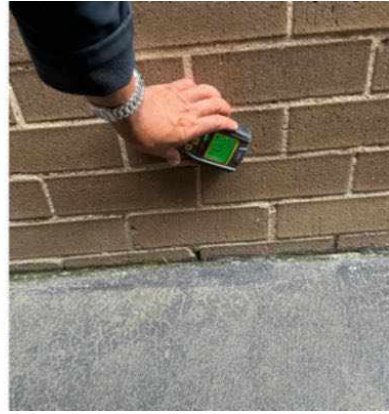
Building:	Main Building
Location:	All External Areas, Garage
Finding:	Damp (Also reference to 3.01 to 3.04)
Information:	Damp (or structural damp) refers to the presence of unwanted moisture in the structure of a building, either as the result of intrusion from outside, or condensation from within the structure. Generally, structural damp is caused by rain penetration, rising damp, and leaks from plumbing pipes.

Unmanaged damp facilitates the formation and development of mould, fungi growth and wood rot, decaying associated building materials and compromising their structural integrity. Damage to finishes is also likely to occur, including lifting, bubbling, peeling and staining of paint, plaster and wallpaper.

The first step in addressing damp is to diagnose the cause. The identified cause should be addressed first prior to repairing the appearance and other defects which have resulted from the rising damp. If the original cause is not resolved, further cases of damp are likely to ensue, resulting in secondary defects.

Consultation with a qualified plumber is advised immediately to identify the cause of damp and perform remedial works as required. Where excessive mould growth is present, further inspection by a specialist environmental health inspector should also be considered.

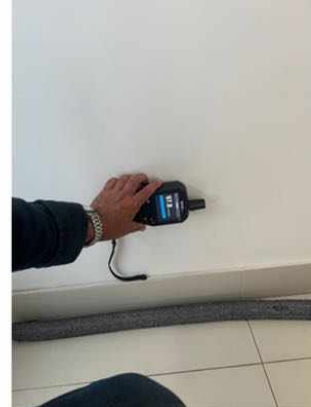
Finding 3.01

Building:	Main Building
Location:	All Internal Areas - Right external wall
Finding:	Elevated Moisture – Further Investigation Recommended
Information:	Elevated moisture readings were detected in several locations with no visible surface issues, although no significant structural damage was evident at the time of inspection, dampness can contribute to deterioration if left unaddressed. A further investigation by a licensed plumber or waterproofing specialist is recommended to confirm the source and ensure no concealed issues are developing.

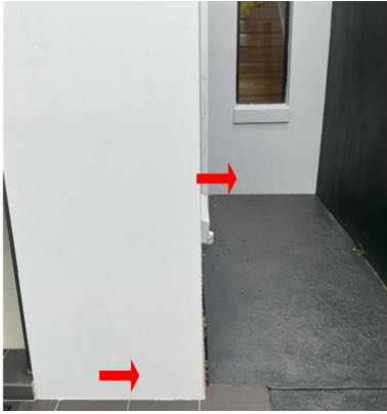
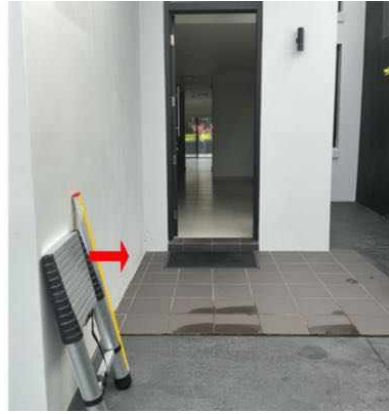
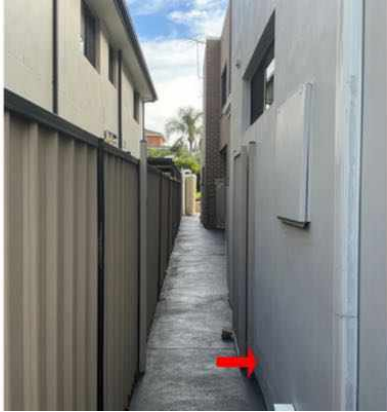
Finding 3.02

Building:	Main Building
Location:	All External Areas
Finding:	Render Finish Covering Damp Membrane
Information:	During the inspection, it was noted that the applied render finish is covering the damp-proof membrane. This is affecting the membrane's ability to prevent moisture movement above it, leading to moisture-related issues over time. It is recommended to consult a qualified builder to ensure the damp-proof membrane is properly exposed, maintaining its effectiveness in preventing moisture ingress.

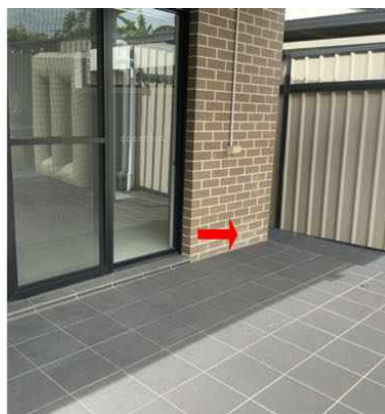
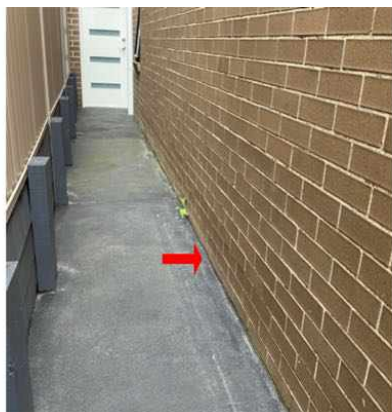
Finding 3.03

Building:	Main Building
Location:	All External Areas
Finding:	DPC & Weep Holes
Information:	The ground level is nearly flushed or level with no visible step-down or separation from the weep holes or the damp-proof course (DPC). This presents a moisture risk, as AS 2870 and NCC Volume 2 Part 3.1.2 require ground levels or hard surfaces to be at least 75 mm below the DPC or the lowest course of brickwork with weep holes to prevent rising damp or lateral moisture ingress. Monitoring is recommended along with creating a 75 mm clearance or isolation gap along the wall line as required by NCC Vol 2 Part 3.1.2.3 and AS 2870 Clause 5.3.3. Monitor for any signs of rising damp or efflorescence.

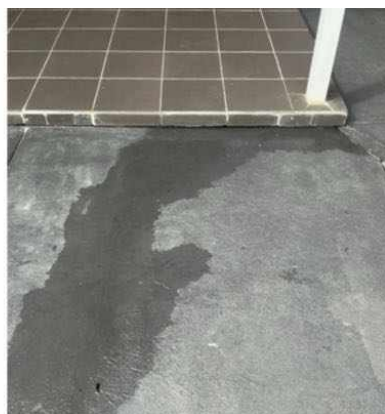
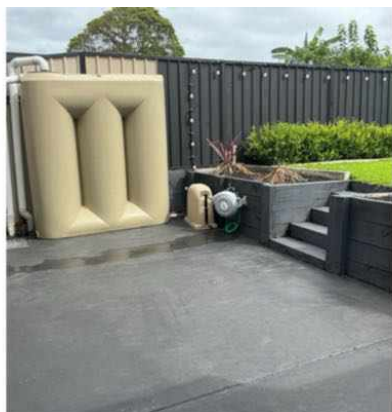
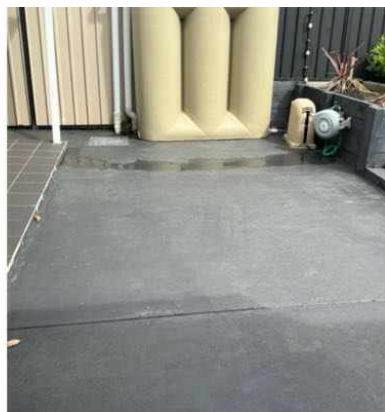
Finding 3.04

Building:	Main Building
Location:	All External Areas
Finding:	Site drainage - Inadequate
Information:	The site drainage in this area was found to be inadequate at the time of inspection, creating potential for subsequent water damage to associated building elements.

It is important that water does not lie against the base of walls; surrounding paths and ground levels should be sloped to drain water away from walls. Downpipes should not discharge stormwater onto lower walls or plinths. Stormwater should be carried away by large, regularly cleaned drains. Ground levels may need to be lowered to expose a buried DPC.

Where site drainage is inadequate, installation of an Agricultural (Aggie) Drain may be required. A qualified plumber should be appointed to further inspect the property and perform any remedial works as necessary. Water damage and secondary defects are likely to occur if left unmanaged.

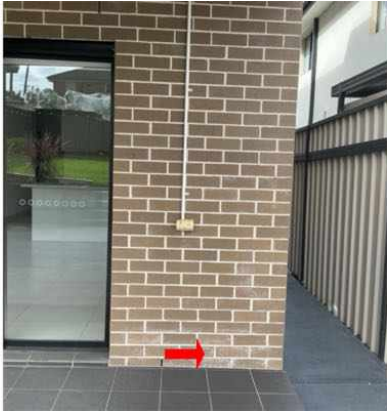
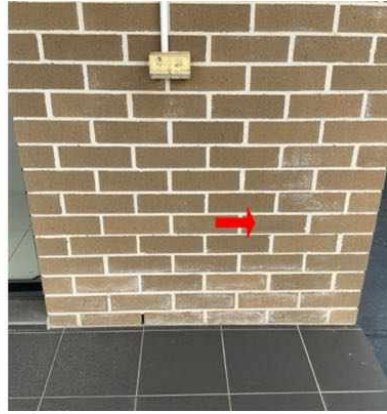
Finding 3.05

Building:	Main Building
Location:	Rear Elevation
Finding:	Brickwork - Efflorescence
Information:	Efflorescence appears to be affecting the brickwork, concrete or tiles in this area. Efflorescence typically occurs when excess salts within the concrete or cement mortar is leached to the surface due to water transfer.

It is typically seen as white salt deposits on the surfaces of concrete pavement or mortar between bricks or tiles. While detracting from the overall appearance of the affected area, efflorescence is not likely to develop into secondary damage if left unmanaged.

Generally, soluble salt deposits can be removed by dry brushing with a stiff-bristled brush. Repeated dry brushing is an ideal treatment for eliminating this forming of efflorescence. A cleaning contractor or general handyperson may be appointed to perform these works at the discretion of the client.

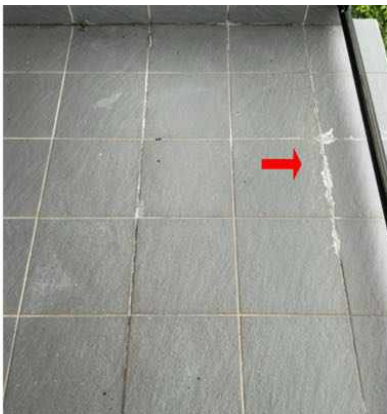
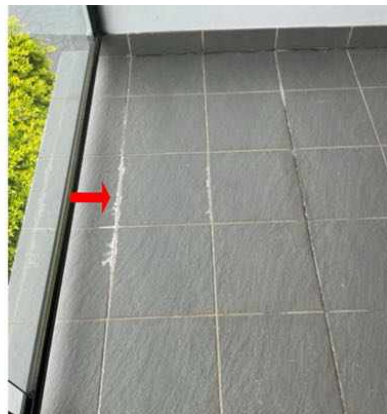
Finding 3.06

Finding: Balcony – Elevated Moisture to Tiled Floor Area

Information: Slightly elevated moisture readings were detected to the tiled balcony floor with visible efflorescence and discolouration to grout lines indicating prolonged or recurring moisture presence beneath the tile finish. This condition is commonly associated with failed grout or sealant joints, insufficient surface drainage and/or inadequate waterproofing allowing moisture to become trapped within the balcony substrate. While no internal water ingress was evident at the time of inspection, the readings exceed what would be expected under normal dry conditions and warrant further investigation. This issue is considered a minor defect at present, with the potential to escalate if moisture migration continues, and assessment by a suitably qualified waterproofing specialist is recommended.

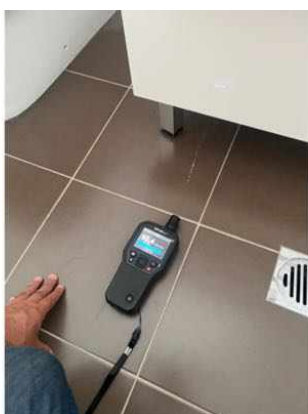
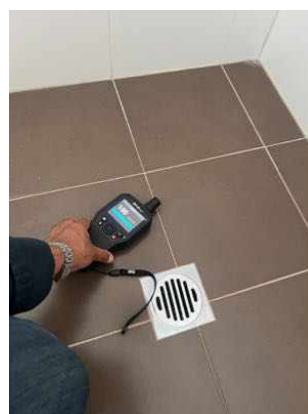
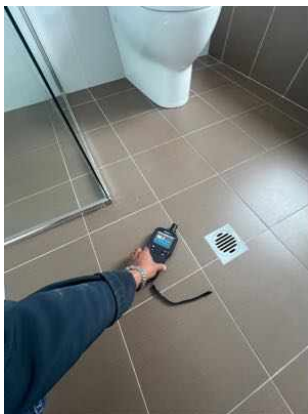
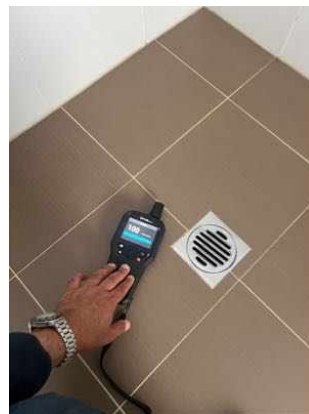
Finding 3.07

Building:	Main Building
Location:	Bathroom
Finding:	Elevated Moisture Bathroom (No visible deterioration noted)
Information:	Elevated moisture levels were detected to tiled surfaces in bathroom/shower areas. Persistent moisture ingress can lead to concealed damage, including timber rot and mould growth.

Elevated moisture readings in tiled wet areas can occur from normal shower use, age/deterioration of waterproofing membranes, plumbing leaks or moisture absorption through grout lines. While no damage was visible, elevated readings may indicate moisture retention behind tiles, which can be a conducive condition for future deterioration if not monitored.

No immediate action required. Monitor the area over time for signs of drumming, efflorescence, tile movement, or grout deterioration. If concerns arise, a licensed waterproofing specialist can perform further investigation (e.g., pressure testing, membrane assessment).

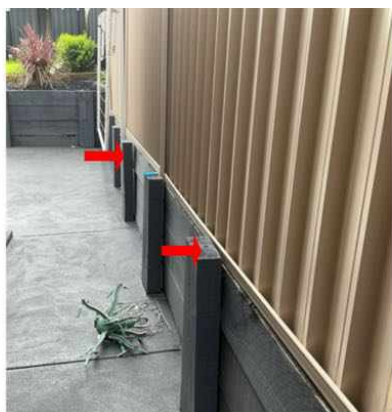
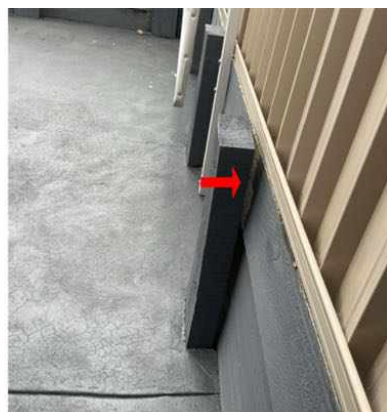
Finding 3.08

Building:	Main Building
Location:	All External Areas
Finding:	Retaining wall - Defective (posts misaligned, wood rot, drainage provision can't be confirmed)
Information:	The retaining wall in this area was found to be defective at the time of inspection. Generally, defective retaining walls are caused by poor original design or material use. However, deteriorated retaining walls may also be a result of substandard construction, poor site drainage or unmanaged stormwater flows.

If left unmanaged, the retaining wall may become a safety hazard if it continues to destabilise. Where retaining walls further rot and decay, an environment is created that is conducive to termite and pest infestation.

Significant repair and replacement should be expected. Where retaining walls are considered structural walls, a structural engineer / surveyor should be consulted regarding required remedial works. Otherwise, a landscaper or retaining wall installer may be appointed to repair or replace the wall, at the discretion of the client.

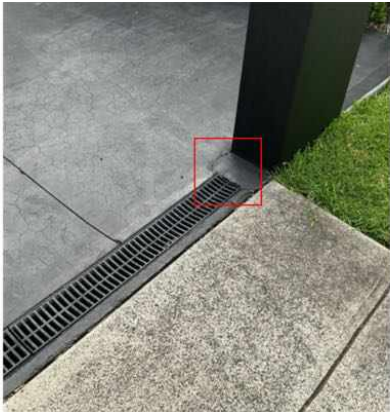
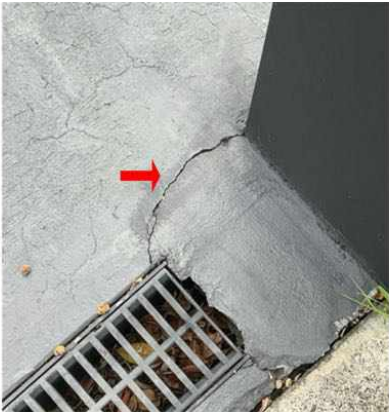
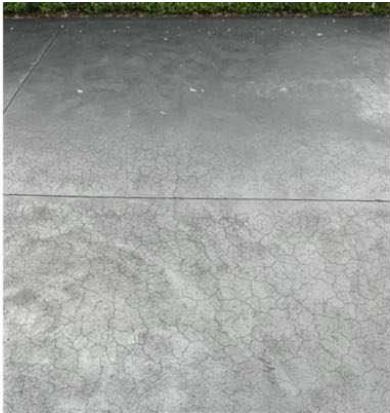
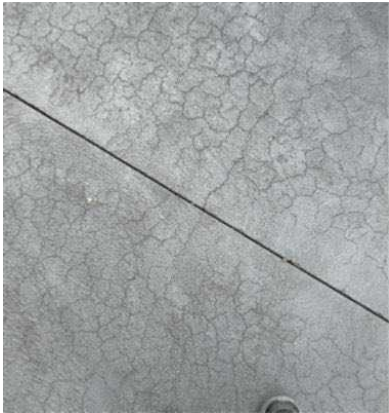
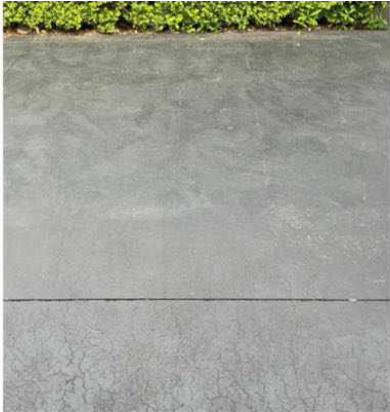
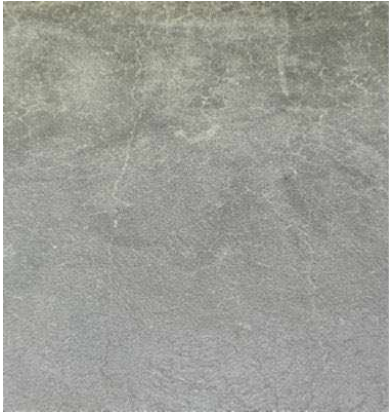
Finding 3.10

Building: Main Building
 Location: All External Areas
 Finding: Cracking - External Concrete Paving Damage Category 3 - Wide Cracks (2mm - 4mm)
 Information: Wide cracks were identified in external concrete paving Wide cracks are significant and are likely to lead to the development of safety hazards and secondary defects if left unmanaged.

General age and expected deterioration of the paved areas is a common cause of this type of cracking. However, expansion and contraction of the slab may also have occurred due to environmental factors. Such factors include variable moisture and weather conditions, the presence of trees and their roots having a settling or lifting

Cracking to this degree may also be due to poor original installation of the concrete. Factors such as poor compaction of the sub surface and/or inadequate reinforcing of the slab may create cracking and other secondary defects. Wide cracks may also have a more significant structural cause, such as subsidence of soils.

Where the crack is located adjacent to structural elements of the building, the advice of a Structural Engineer is advisable before undertaking repairs. Significant repair and likely replacement of the concrete paving is probable.

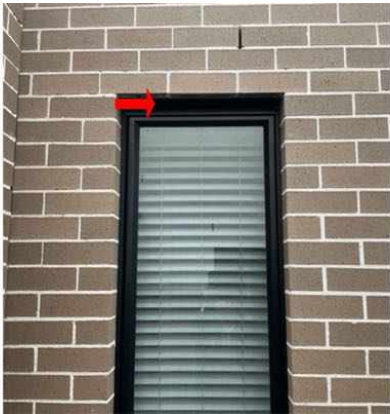
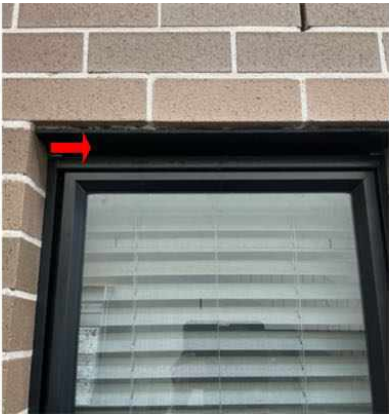
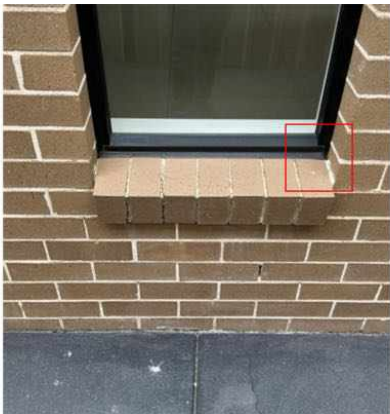
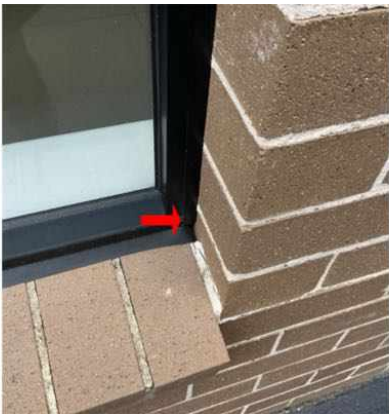
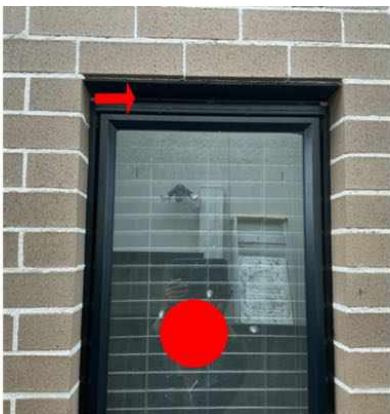
Finding 3.25

Building: Main Building
Location: All External Areas
Finding: Brickwork - Deteriorated mortar to some areas

Mortar, or 'bedding', is the material which fills joins and intersections between bricks in masonry walls and structures. Sections of mortar in this brickwork were identified as having deteriorated, which is generally expected for a property of this age and condition.

Mortar may deteriorate as a result of age of building materials, minor movement of bricks, or frequent exposure to weathering. Mortar should be replaced to ensure that bricks remain in their intended location and to prevent gaps, which would allow water or moisture ingress and secondary damage as a result.

Mortar deterioration can be addressed by a bricklayer where areas of deterioration are localised and easily accessible. Alternatively, appointment of a registered builder is advised, to repoint large areas of decaying mortar. Where secondary structural defects have become evident, consultation with a structural engineer may be required.

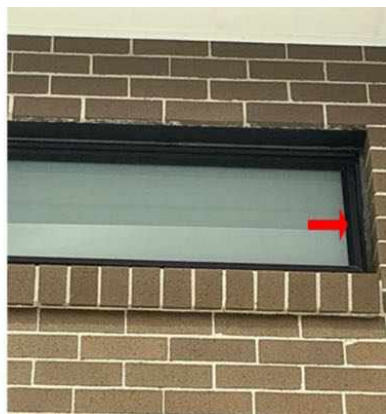
Finding 3.28

Building:	Main Building
Location:	All External Areas
Finding:	Sealant and grouting - Missing or degraded and poor tiling workmanship
Information:	It was noted on inspection that sealant or grout is degraded.

Different materials and floor areas move at different rates, generally causing cracking

Excessive mould to the sealant and grout may require scraping out and replacement.

Flexible and mould resistant materials should be applied to affected areas to prevent any subsequent water damage that is likely to occur. Regular maintenance and replacement of damage or missing or damaged sealant and grout is highly recommended to the wet areas, as this is a regular wear and tear defect. Sealant and grouting in areas that come into regular contact with water should be maintained for the long term care of your property.

A sealant specialist or tiling contractor should be appointed to complete these works as soon as possible

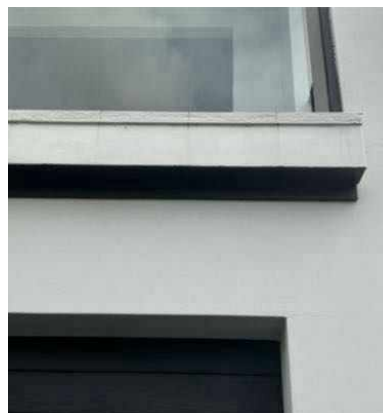
Finding 3.30

Building:	Main Building
Location:	All External Areas
Finding:	Cracking - Damage Category 1 - Fine (up to 1mm) - Eave front
Information:	Although fine cracks are quite noticeable, they are often only considered to be an appearance defect, and usually do not indicate any structural damage. Generally, the cause of a fine crack is indicative of a separation between building materials and finishes (e.g. paint, plaster, etc.) along joins.

Cracking of this nature can generally be repaired with minor sanding, filling and/or repainting. Such works should be performed by a qualified painter or a general handyman.

Monitoring of all cracking should be conducted frequently. Always contact a building inspector should cracks widen, lengthen, or become more numerous.

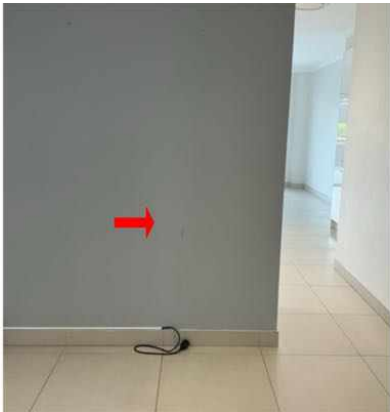
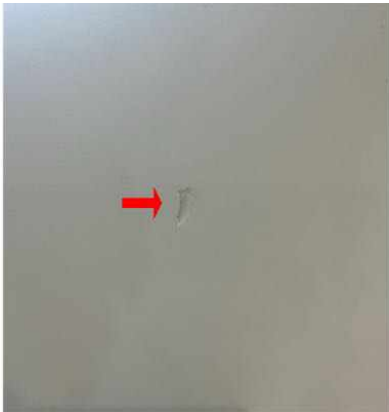
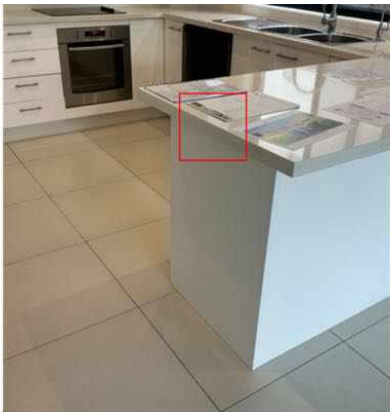
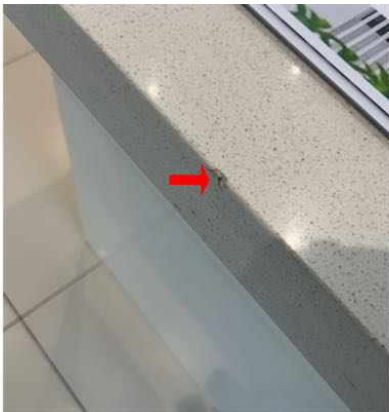
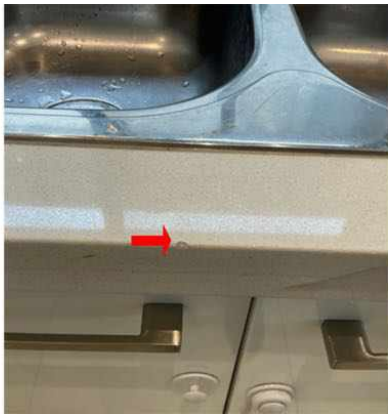
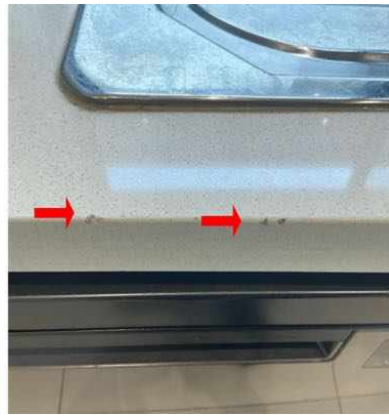
Finding 3.32

Building:	Main Building
Location:	All External Areas - Left side
Finding:	Paint finish - Incomplete if repairs not complete
Information:	The paint finish in this area was identified as being incomplete at the time of inspection.

Whilst incomplete or missing paint finish is generally an appearance defect, it can also lead to the development of secondary building defects over time. Incomplete areas of paint finish expose the area to moisture, potentially accelerating the deterioration of underlying building materials.

Incomplete paint finishes should be sanded back, filled, leveled and painted, as applicable. Where inadequate or missing paint protection has led to the deterioration of the associated building element, repair and/or replacement of this building element may be required.

A painting contractor should be appointed as soon as possible to perform necessary works to aid the appearance of the affected area and to ensure the area is protected against further deterioration. Alternatively, the homeowner following manufacturer instructions may perform these works.

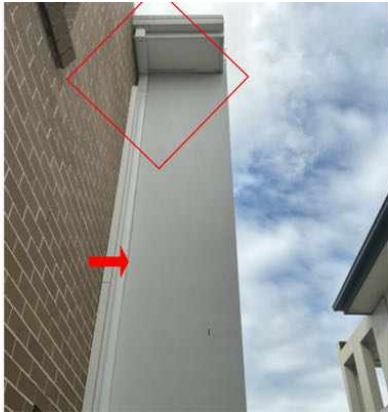
Finding 3.33

Building:	Main Building
Location:	All External Areas
Finding:	Box Gutters- Parapet wall
Information:	The dwelling appears to incorporate a concealed box gutter system discharging directly into a downpipe. A rain head or visible overflow provision was not evident from ground level. Concealed gutters require compliant overflow detailing to prevent surcharge and potential internal water ingress. Roof-level confirmation of overflow provisions is recommended by a licensed plumber.

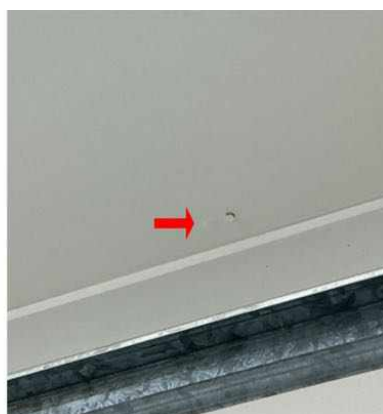
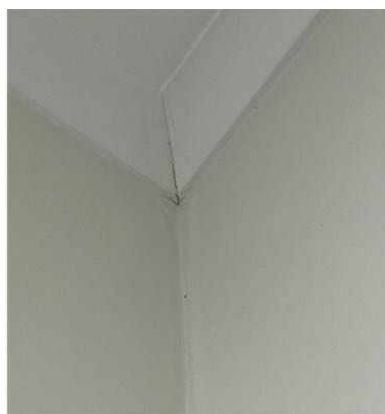
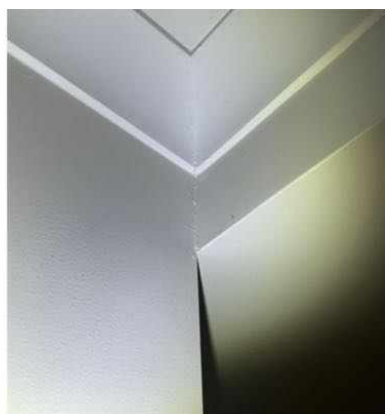
Finding 3.40

Building:	Main Building
Location:	All Internal Areas

Finding: Paint Finish & Hairline Cracking - To some areas
Information: The paint finish in this area was identified as being incomplete or substandard at the time of inspection including some hairline minor cracking/separation. Monitoring is recommended where cracking and separation is evident.

Whilst incomplete or missing paint finish is generally an appearance defect, it can also lead to the development of secondary building defects over time. Incomplete areas of paint finish expose the area to moisture, potentially accelerating the deterioration of underlying building materials.

Incomplete paint finishes should be sanded back, filled, leveled and painted, as applicable. Where inadequate or missing paint protection has led to the deterioration of the associated building element, repair and/or replacement of this building element may be required.

A painting contractor should be appointed as soon as possible to perform necessary works to aid the appearance of the affected area and to ensure the area is protected against further deterioration. Alternatively, the homeowner following manufacturer instructions may perform these works.

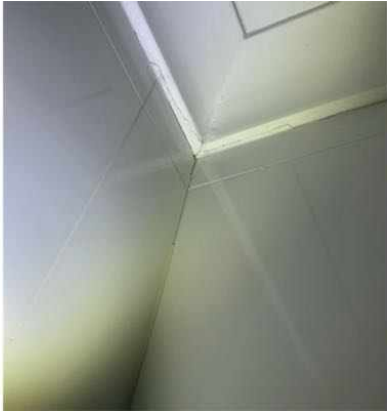
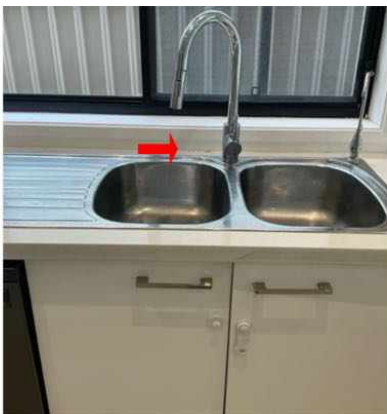
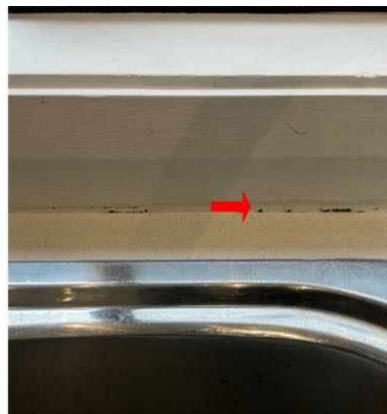
Finding 3.41

Building:	Main Building
Location:	All Internal Areas
Finding:	Sealant and grouting - Missing or degraded to some areas
Information:	It was noted on inspection that sealant or grout is degraded.

Different materials and floor areas move at different rates, generally causing cracking to grout or sealant at this point. A flexible sealant is required to allow for expected expansion and contraction, while keeping the joint water tight and protective of all associated building materials.

Excessive mould to the sealant and grout may require scraping out and replacement.

Flexible and mould resistant materials should be applied to affected areas to prevent any subsequent water damage that is likely to occur. Regular maintenance and replacement of damage or missing or damaged sealant and grout is highly recommended to the wet areas, as this is a regular wear and tear defect. Sealant and grouting in areas that come into regular contact with water should be maintained for the long term care of your property.

A sealant specialist or tiling contractor should be appointed to complete these works as soon as possible

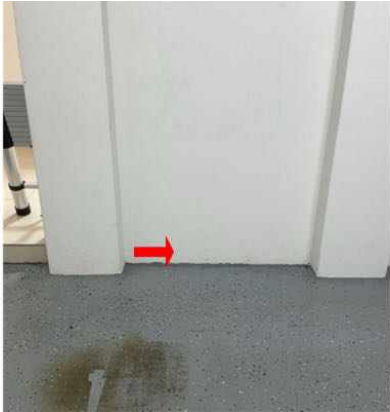
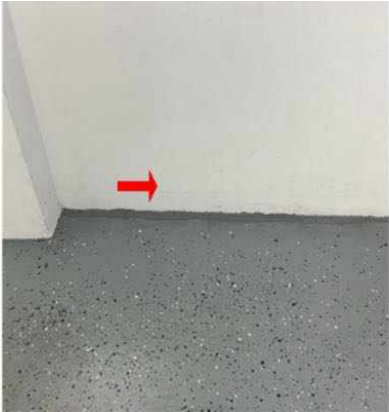
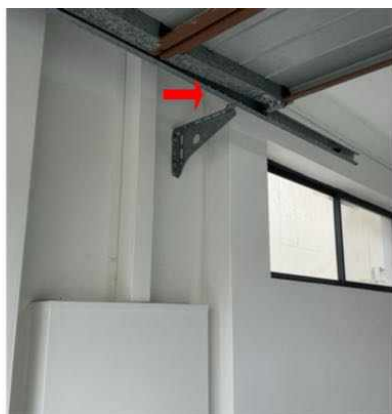
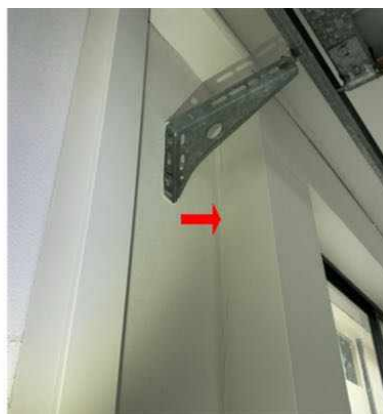
Finding 3.42

Building: Main Building
Location: All Internal Areas
Finding: Cracks to internal render - Category 1
Information: It has been observed that cracking to internal rendered surfaces has occurred. The degree of damage falls within Category 1, described as fine cracks that do not need repair and which are less than 1.0mm in width limit.

Damage of this category is not considered a defect for rectification. Always contact your building inspector should cracks widen, lengthen, or become more numerous.

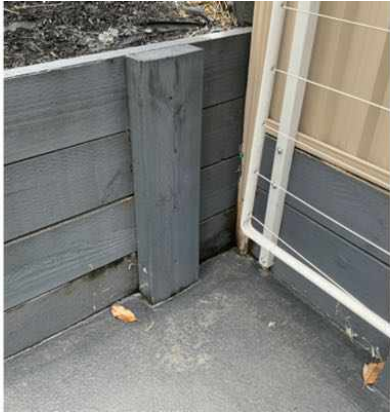
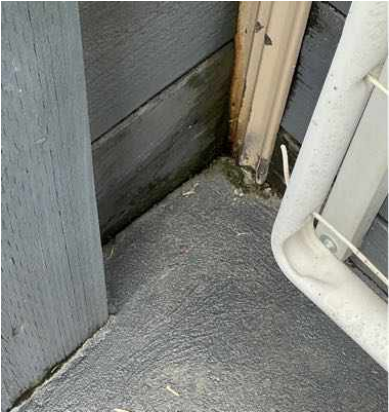
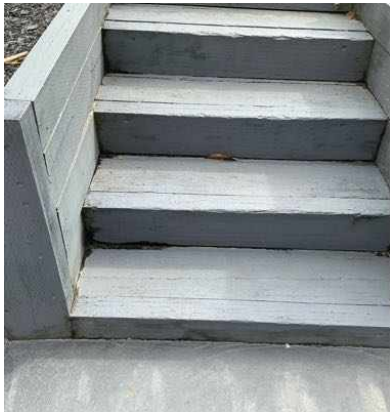
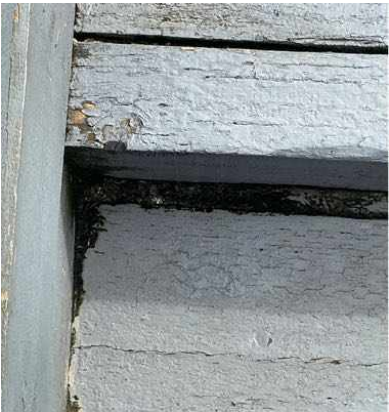
Finding 7.01

Building:	Main Building
Location:	All External Areas
Finding:	Fungal decay - present
Information:	Fungal decay also known as wood decay or wood rot generally refers to the deterioration of timber elements when in contact with excessive levels of moisture for a prolonged period of time.

The development of fungal decay is accelerated by temperatures in the range of 5degreeC to 40degreeC as well as the presence of oxygen. Generally fungal decay develops on timber elements that are in use in an external environment which are exposed to rain penetration.

In this case although the affected timber element is in a decaying state the extent of any visible damage appears to be localised to a specific area and is yet to spread to other parts of the building element or affect adjoining structures. The fungal decay is therefore likely to be of a relatively superficial nature with minimal impact on the

structural integrity or tensile strength of the timber element.

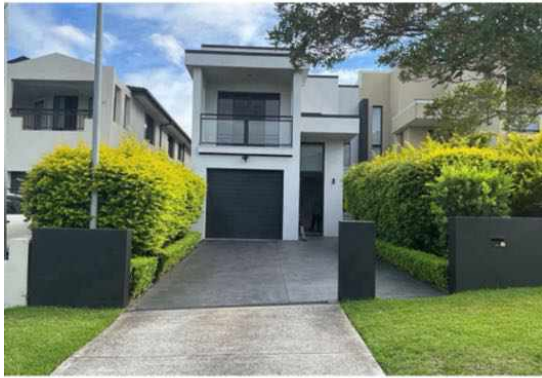
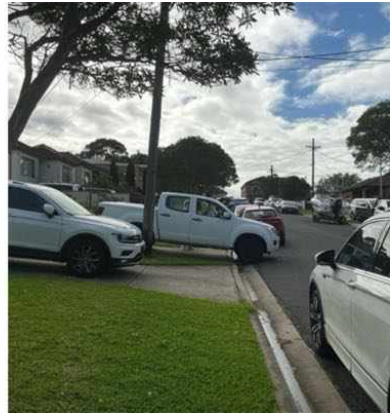
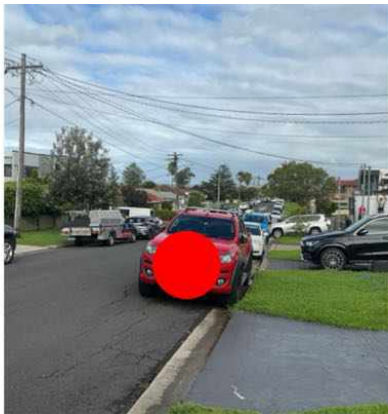
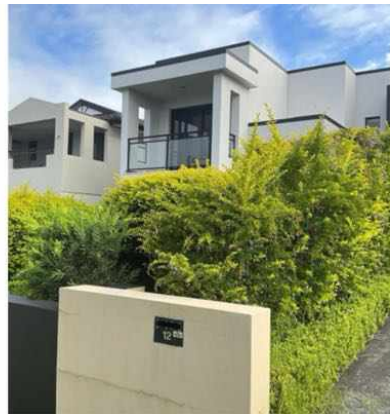
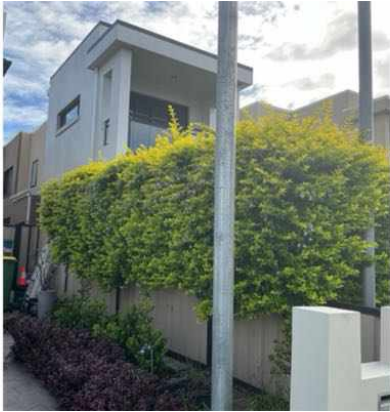
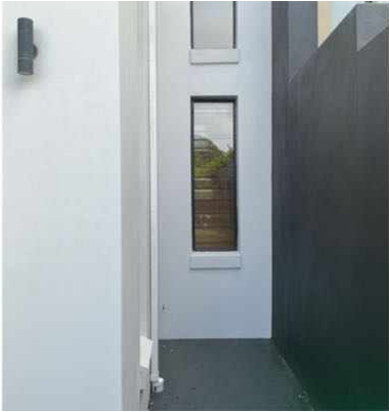
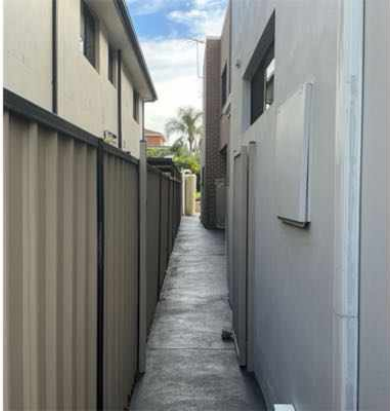
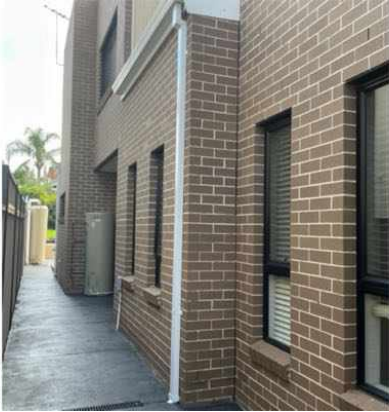
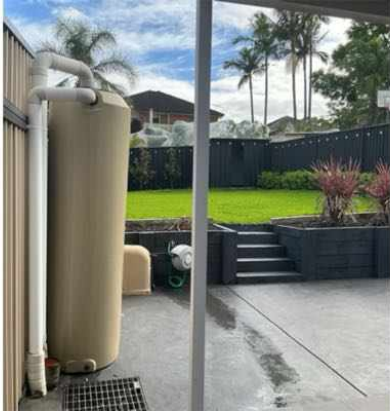
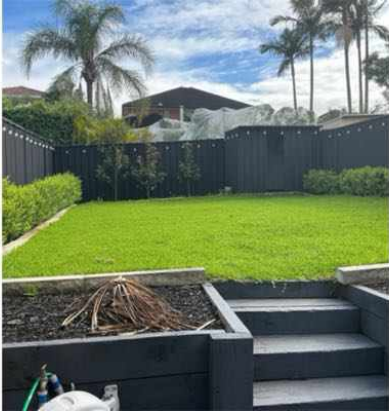
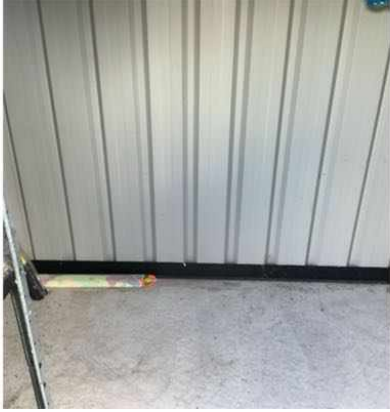
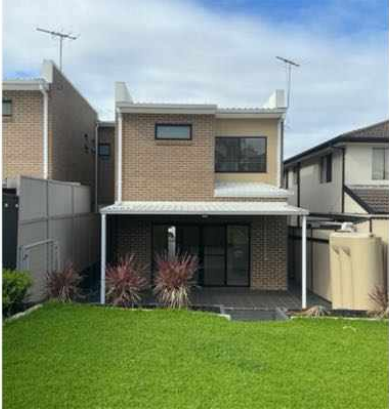
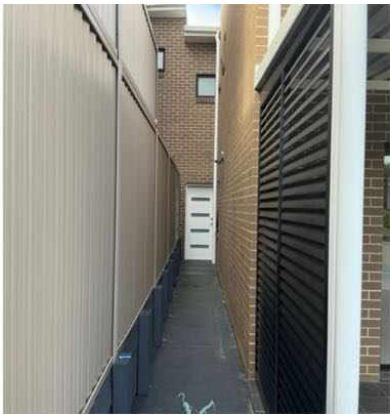
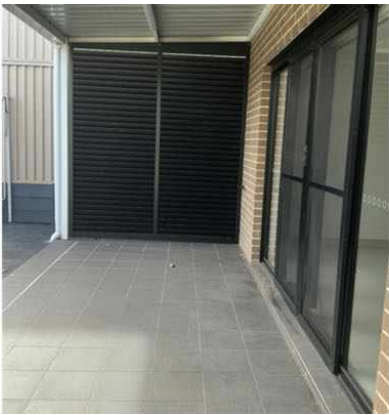
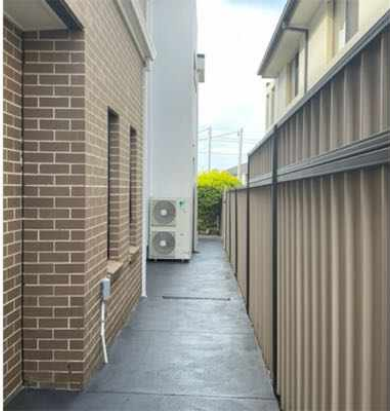
Building: Main Building
Location: All External Areas
Finding: Additional Photos - Obstructions and Limitations
Information: These photographs are an indication of the obstructions and limitations which impeded full inspection of the property at the time of inspection. These obstructions can hide an array of defects and should be removed to allow full inspection to be carried out. A re-inspection is recommended once the areas are made accessible.

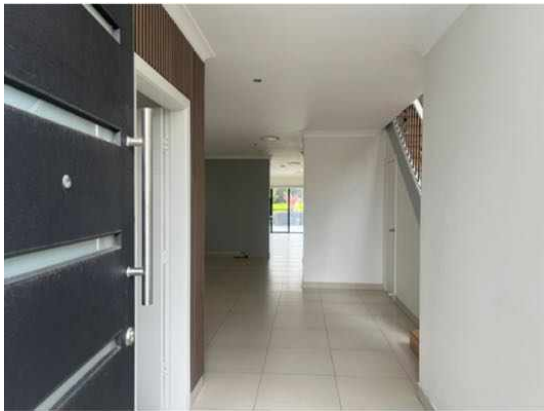
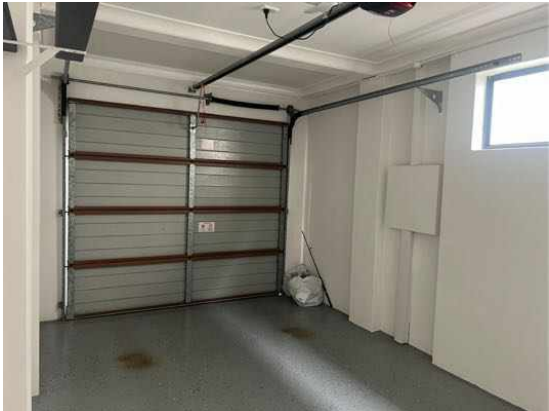
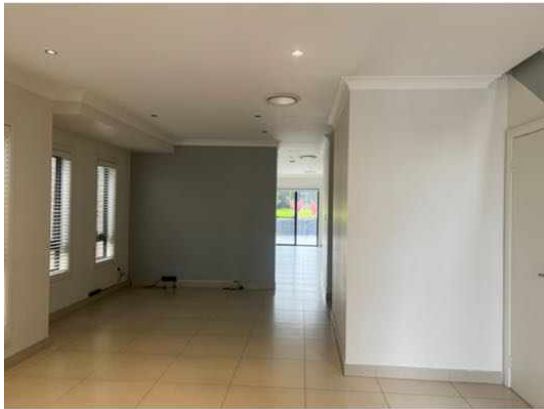
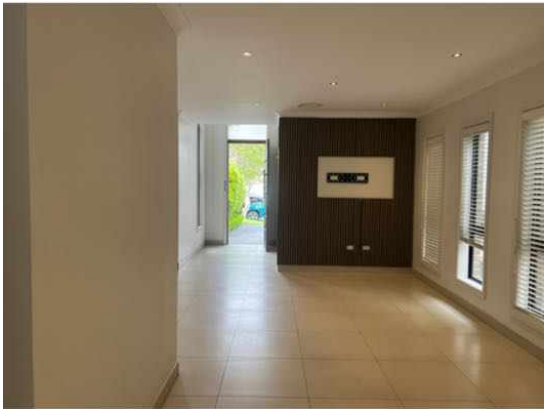
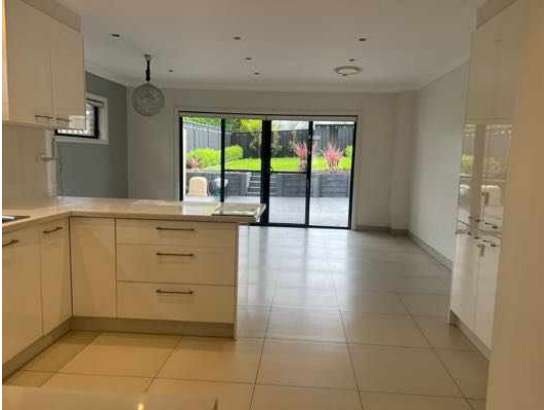
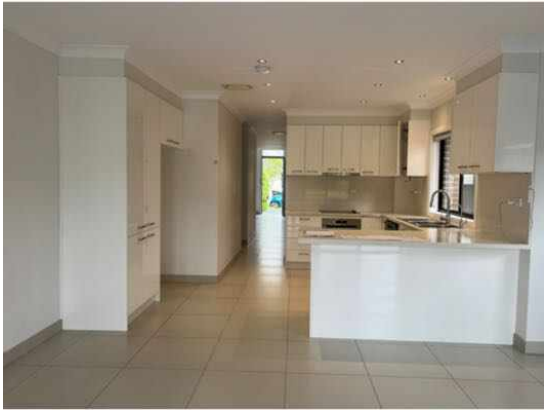
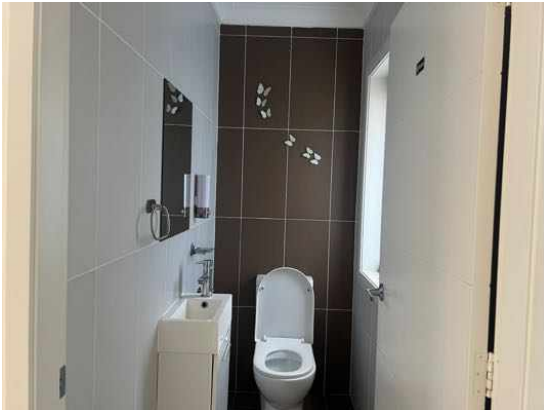
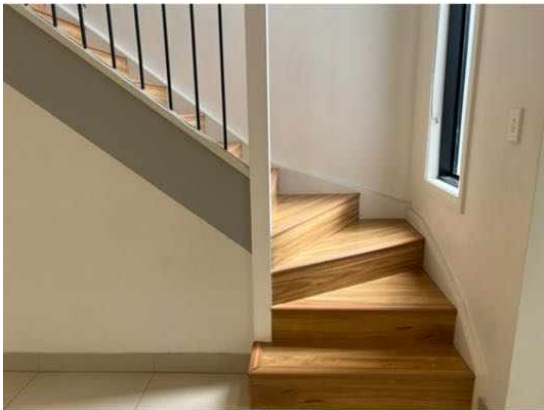
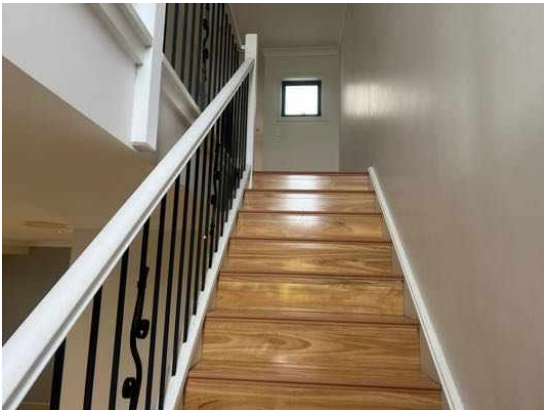
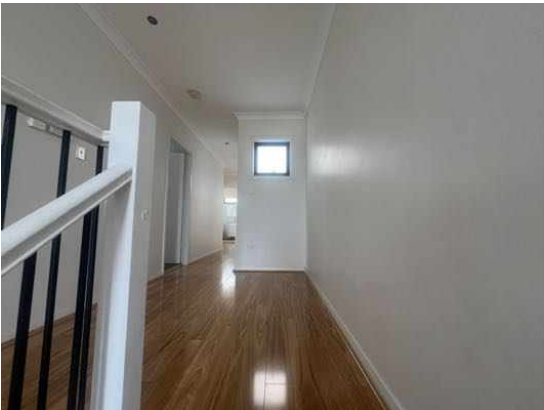
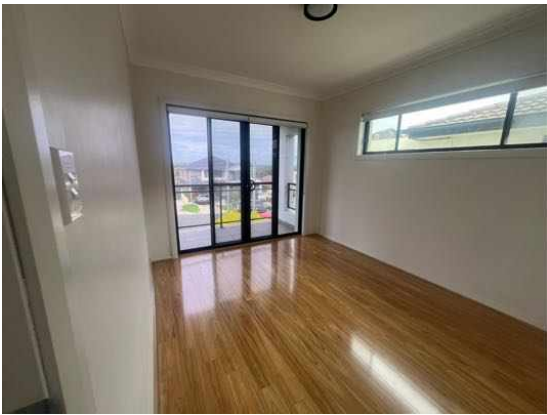
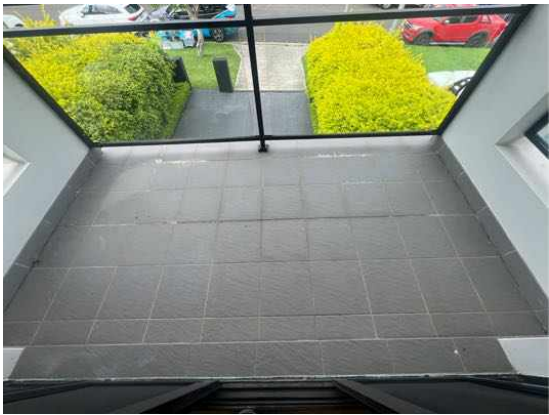
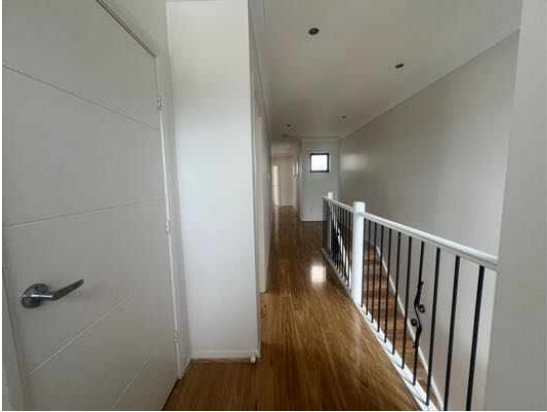
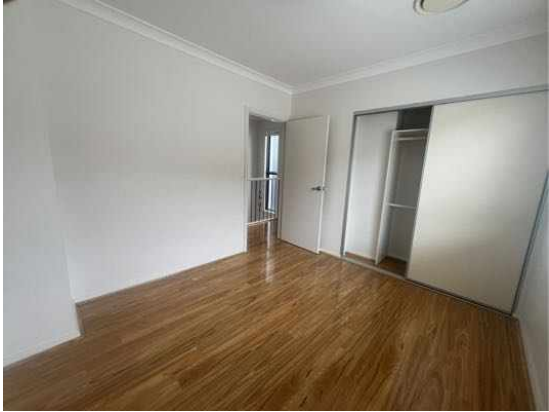
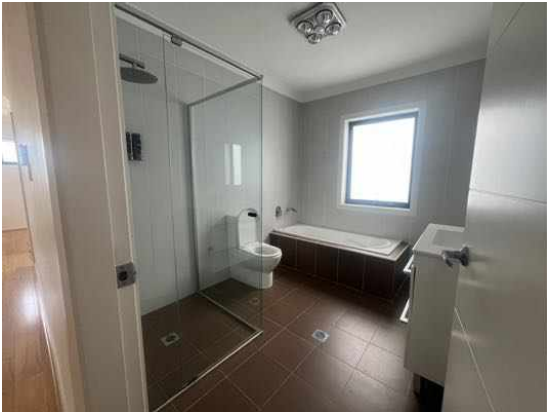
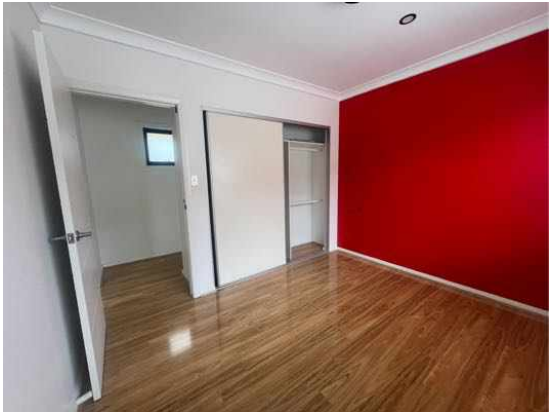
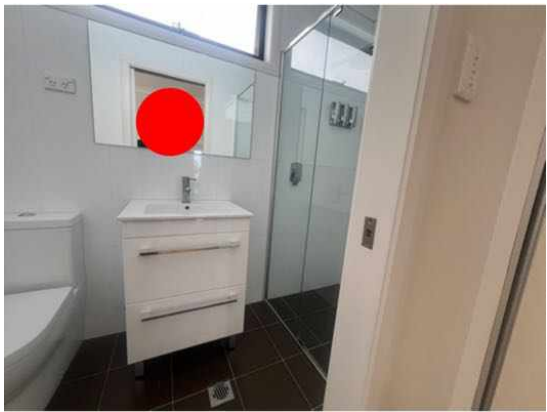
Building: Main Building
Location: All Internal Areas
Finding: Additional Photos - Obstructions and Limitations
Information: These photographs are an indication of the obstructions and limitations which impeded full inspection of the property at the time of inspection. These obstructions can hide an array of defects and should be removed to allow full inspection to be carried out. A re-inspection is recommended once the areas are made accessible.
