Building and Timber Pest Inspection Report

Inspection Date: Sat, 28 Feb 2026

Property Address: 12A Winifred St, Condell Park NSW 2200,
Australia

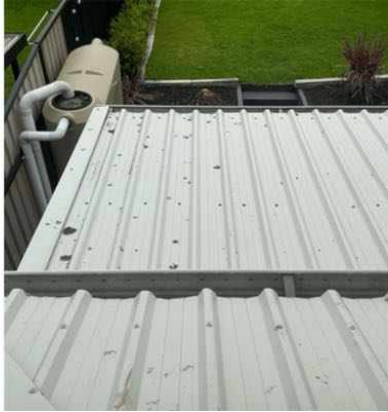
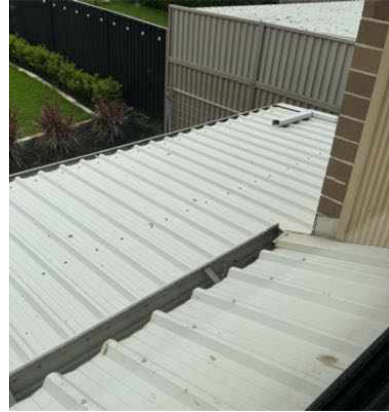
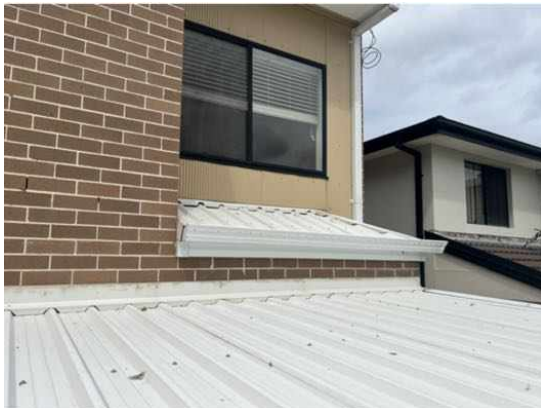
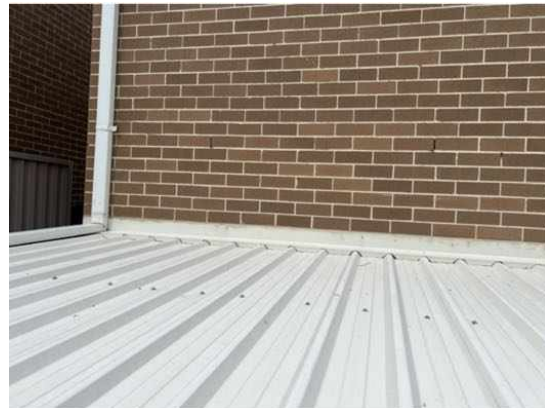
Building: Main Building
 Location: Roof Exterior
 Finding: Additional Photos - Obstructions and Limitations
 Information: These photographs are an indication of the obstructions and limitations which impeded full inspection of the property at the time of inspection. These obstructions can hide an array of defects and should be removed to allow full inspection to be carried out. A re-inspection is recommended once the areas are made accessible.

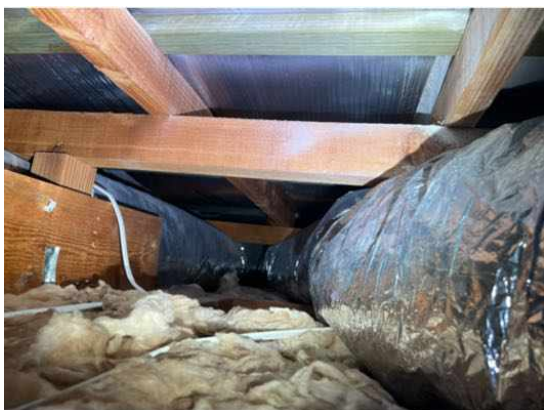
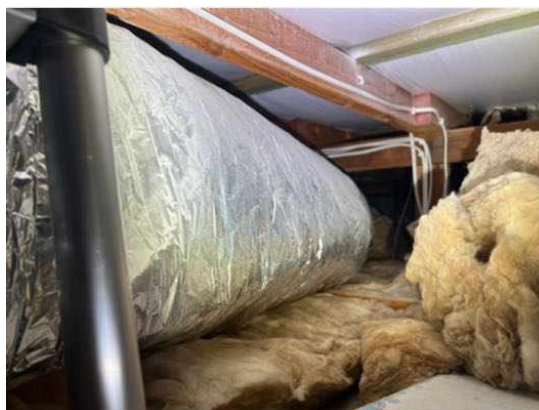
Building: Main Building
 Location: Roof Void
 Finding: Additional Photos - Obstructions and Limitations
 Information: These photographs are an indication of the obstructions and limitations which impeded full inspection of the property at the time of inspection. These obstructions can hide an array of defects and should be removed to allow full inspection to be carried out. A re-inspection is recommended once the areas are made accessible.

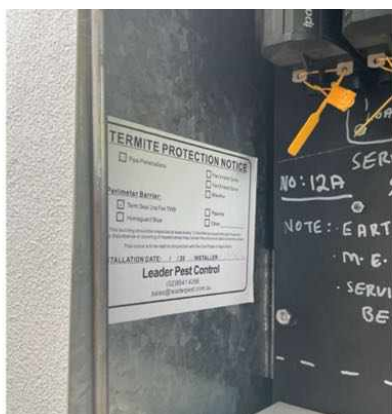
The following items were noted as - Evidence of a previous termite management program

Where a Termite Management System has been identified you should refer to the type of barrier date of installation warranty conditions and any documentation provided by a builder or past owner. Consult the company who installed the barrier to confirm whether the system is still under warranty.

Most chemical termite management systems expire and require replenishment and all physical systems are primarily designed to prevent concealed entry.
