Building and Timber Pest Inspection Report

Inspection Date: Thu, 22 Jan 2026

Property Address: 352 Alison Rd, Coogee NSW 2034,
Australia

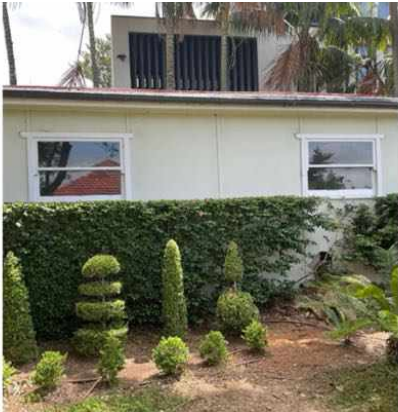
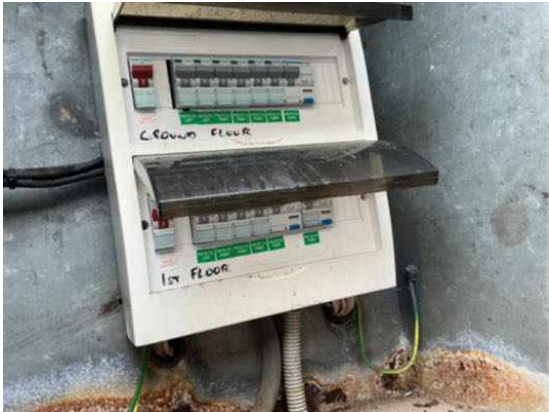
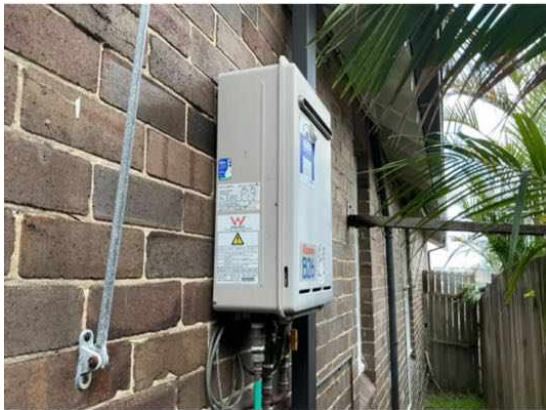
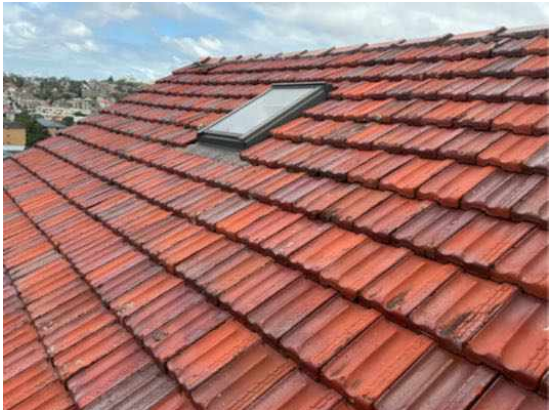
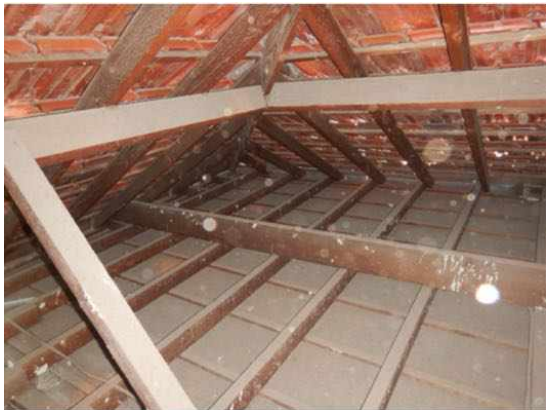
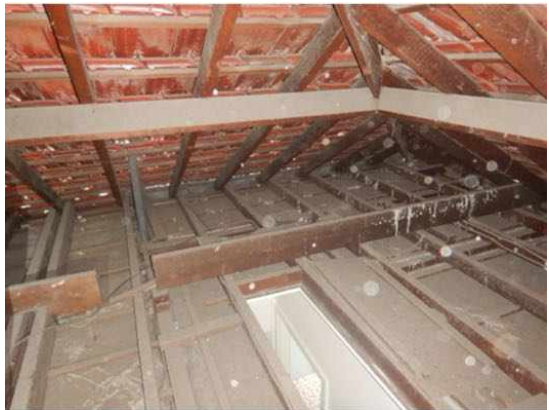
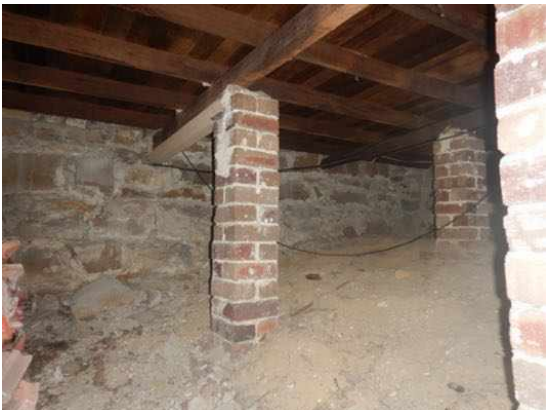
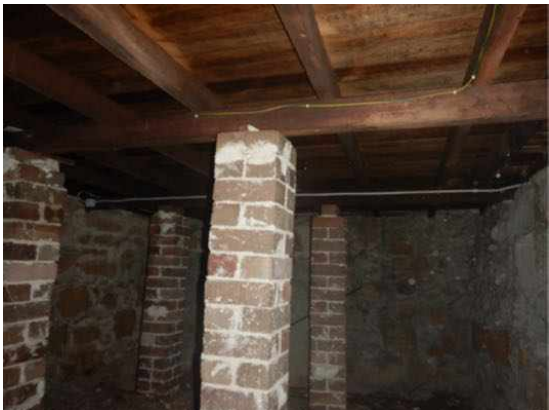
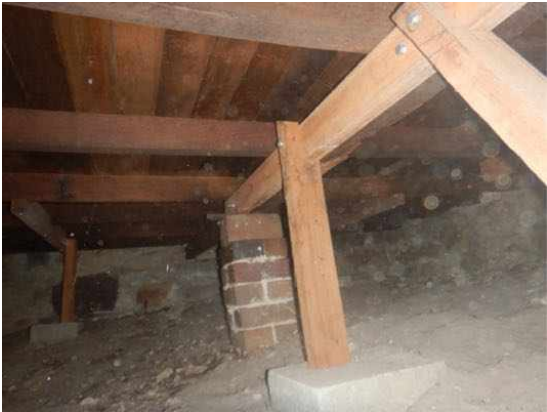
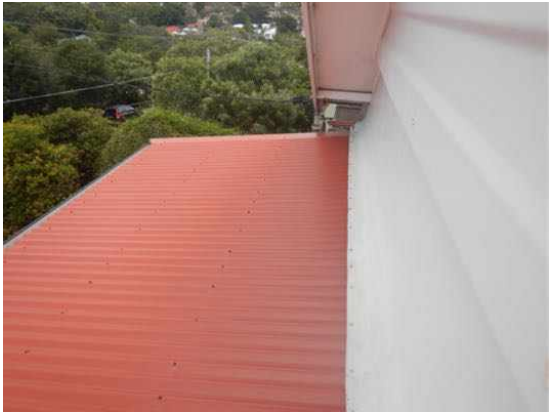
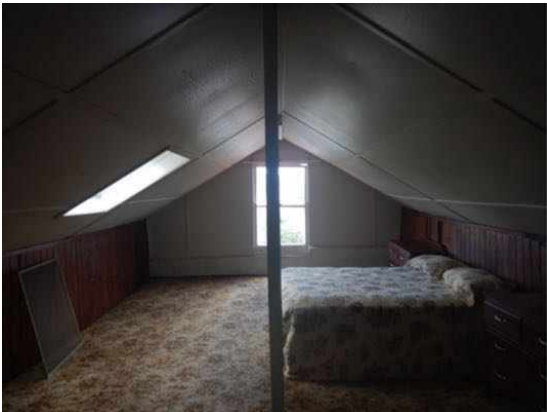
Some photos may also show obstructions and limitations which impeded full inspection of the property at the time of inspection. Additional photos also show other elements such as hot water systems and RCD switches (electrical safety switches) on power boxes.

This property has no insulation in the roof void as shown in the additional photos.
