Building Inspection Report

Inspection Date: Sat, 28 Feb 2026

Property Address: 1/37 Patty St Mentone VIC 3194

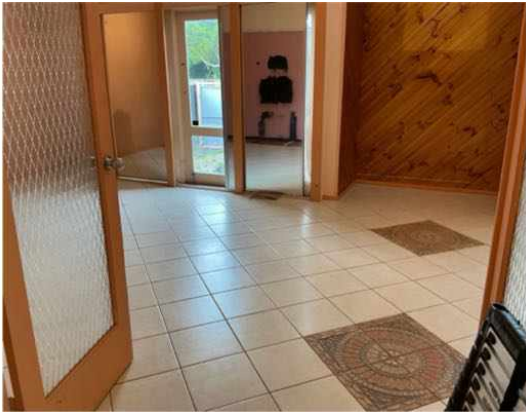
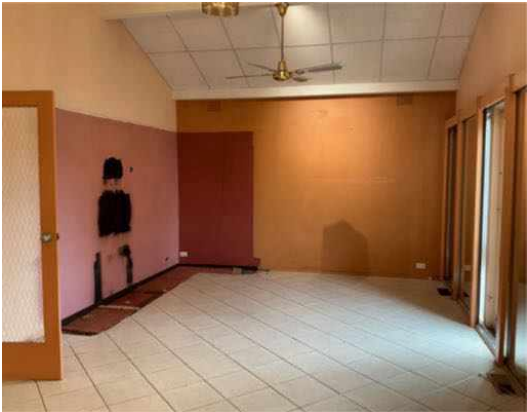
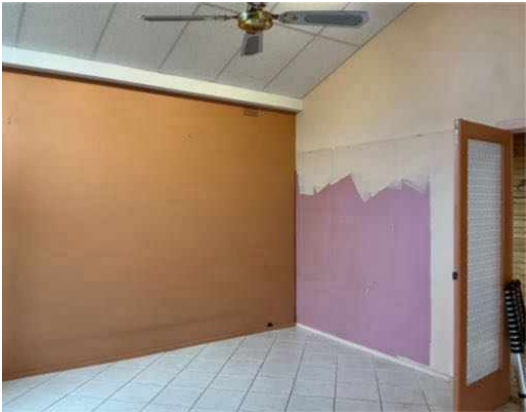
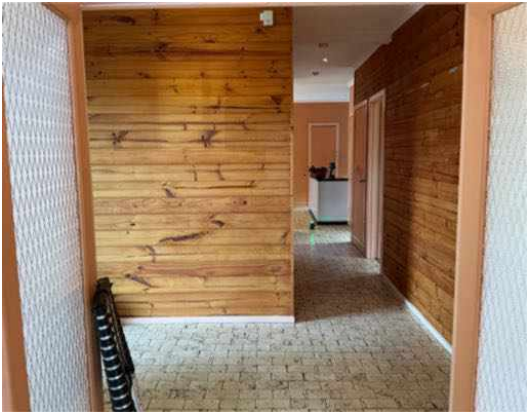
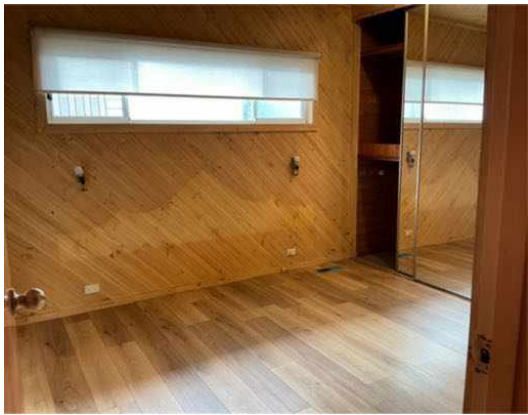
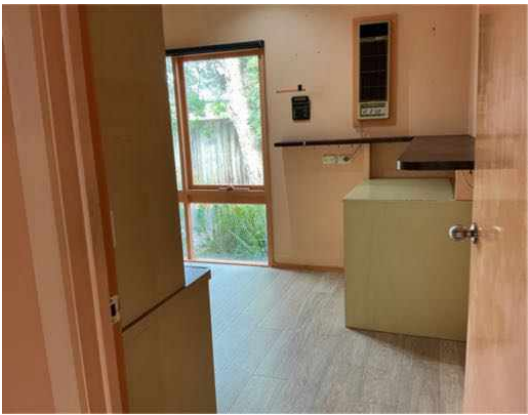
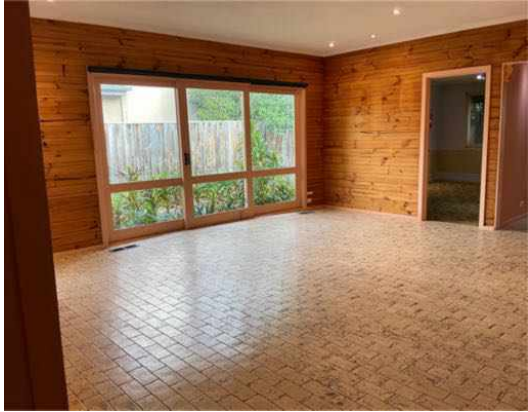
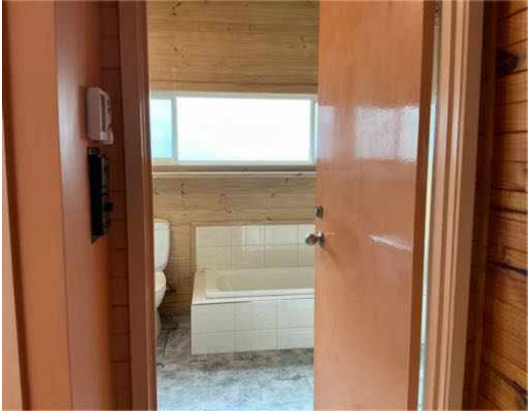
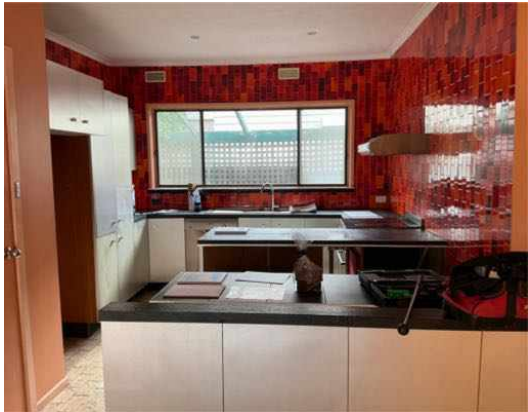
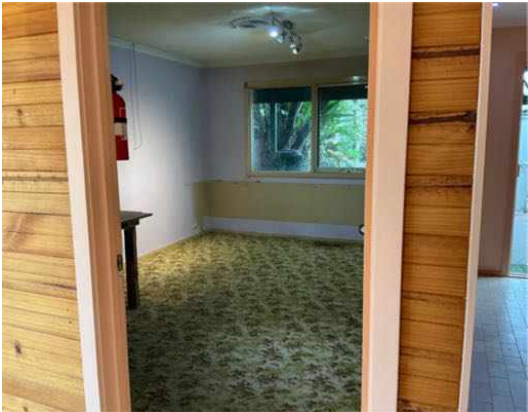
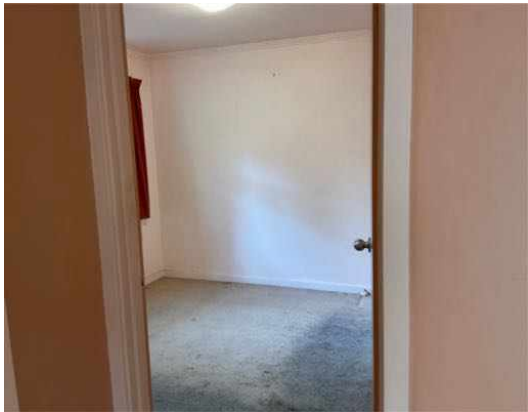
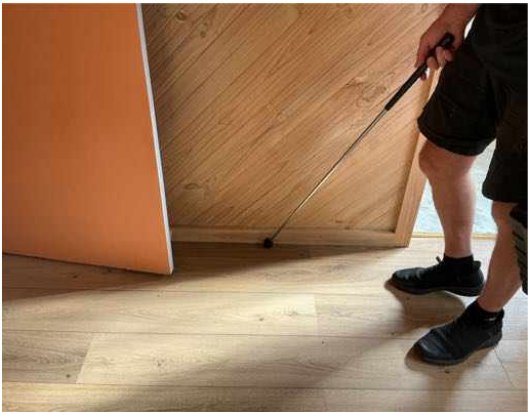
Building: Main Building
Location: All Areas
Finding: Additional Photos - Obstructions and Limitations
Information: These photographs are an indication of the obstructions and limitations which impeded full inspection of the property at the time of inspection. These obstructions can hide an array of defects and should be removed to allow full inspection to be carried out. A re-inspection is recommended once the areas are made accessible.

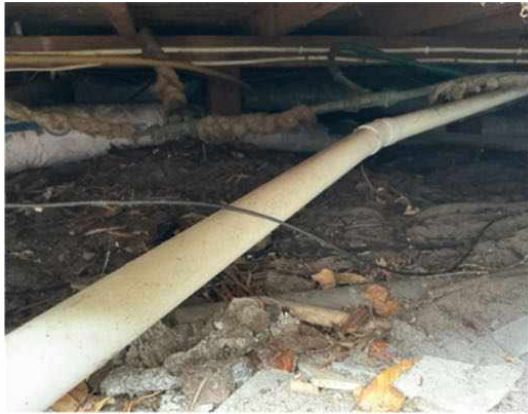
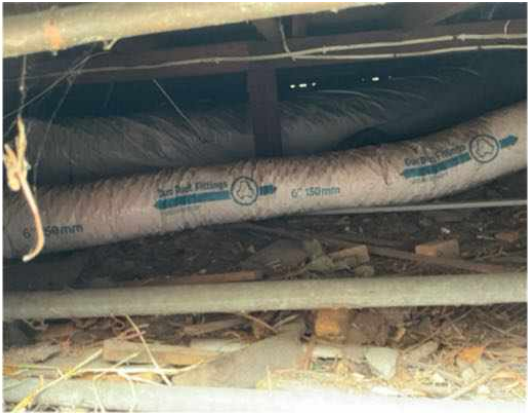
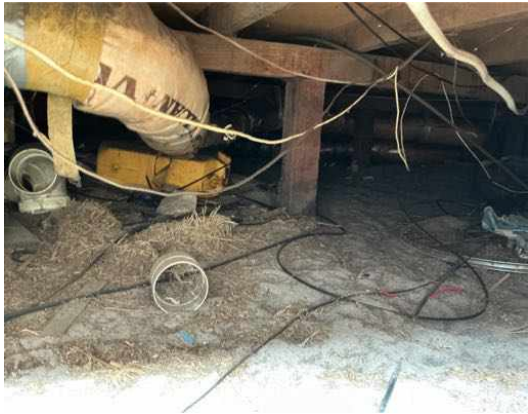
Building: Main Building
 Location: Subfloor
 Finding: Additional Photos
 Information: Additional photos are provided for your general reference

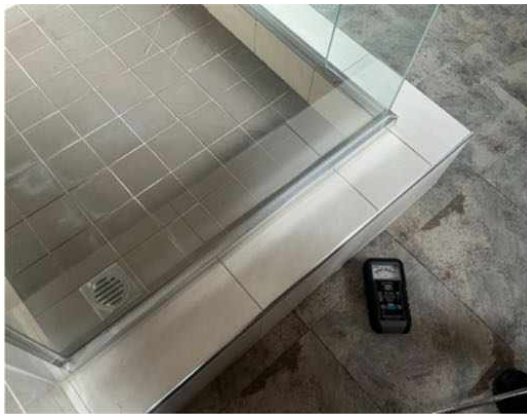
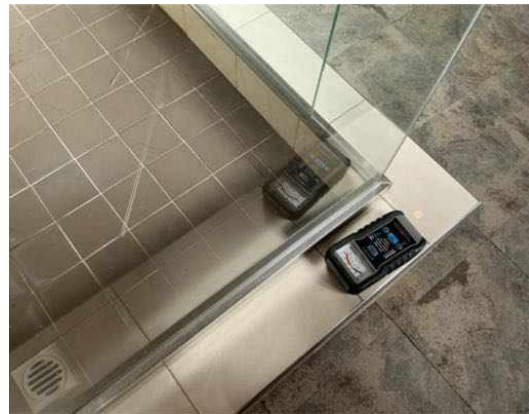
Building: Main Building
 Location: Bathrooms
 Finding: Additional Photos
 Information: Additional photos are provided for your general reference

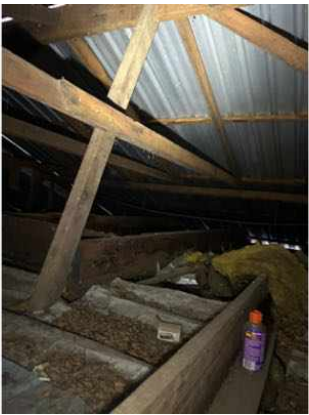
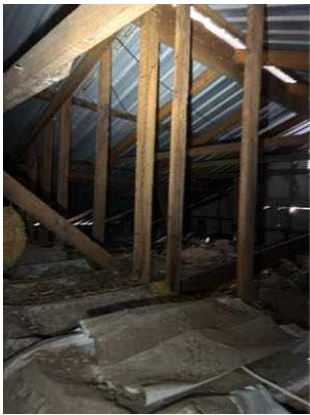
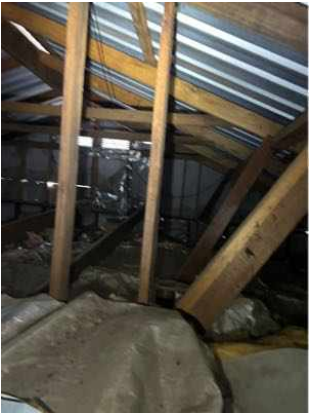
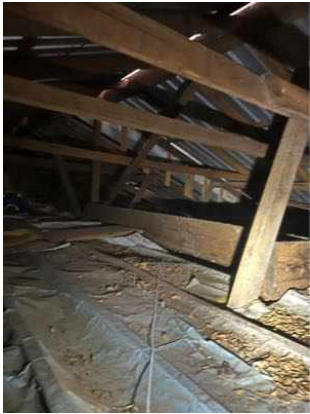
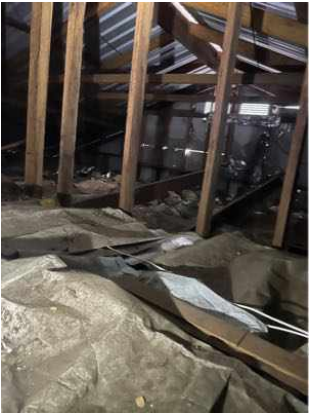
Building: Main Building
 Location: All Areas
 Finding: Additional Photos - Obstructions and Limitations
 Information: These photographs are an indication of the obstructions and limitations which impeded full inspection of the property at the time of inspection. These obstructions can hide an array of defects and should be removed to allow full inspection to be carried out. A re-inspection is recommended once the areas are made accessible.

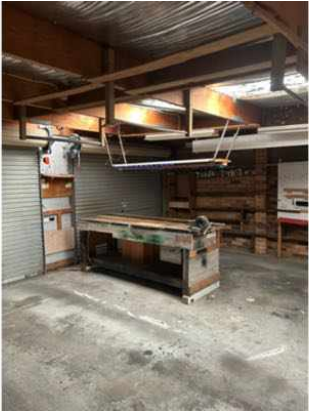
Building: Garage
Location: All Areas
Finding: Additional Photos
Information: Additional photos are provided for your general reference

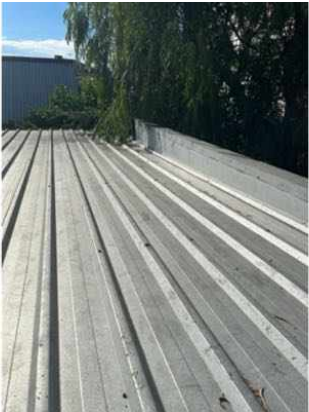
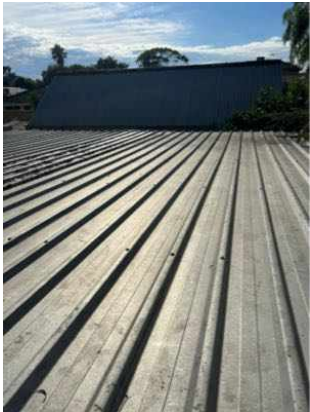
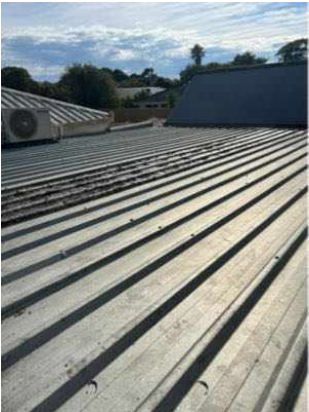
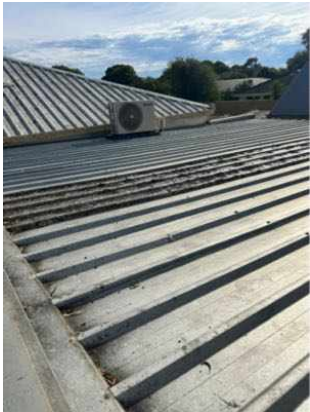
Building: Garage
Location: All Areas
Finding: Additional Photos
Information: Additional photos are provided for your general reference
