Building and Timber Pest Inspection Report

Inspection Date: Fri, 13 Mar 2026

Property Address: 524/1 Hutchinson Walk, Zetland NSW 2017,
Australia

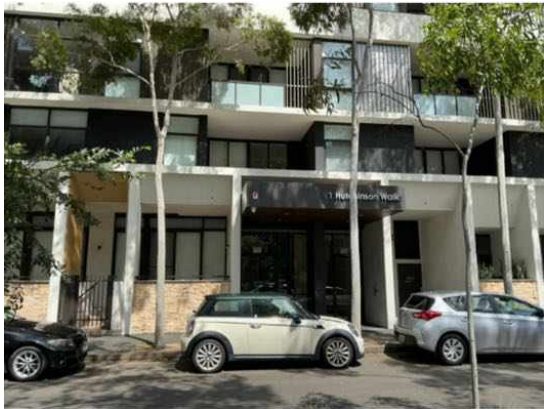
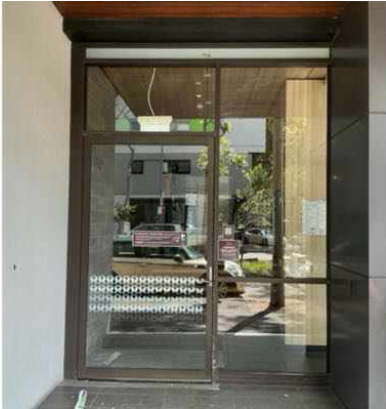
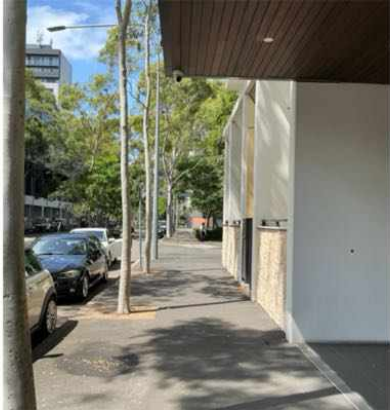
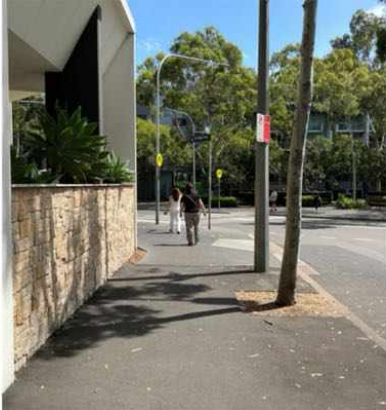
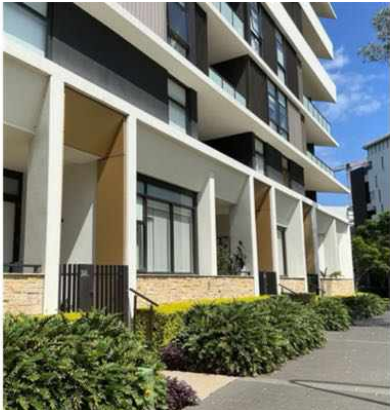
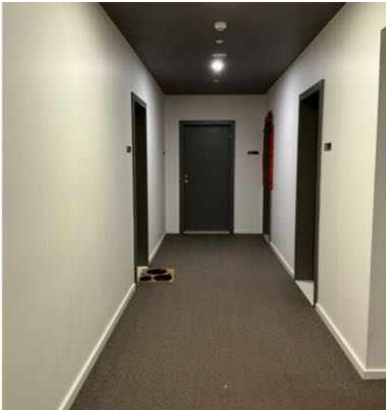
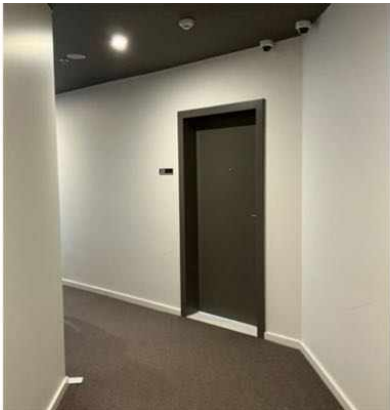
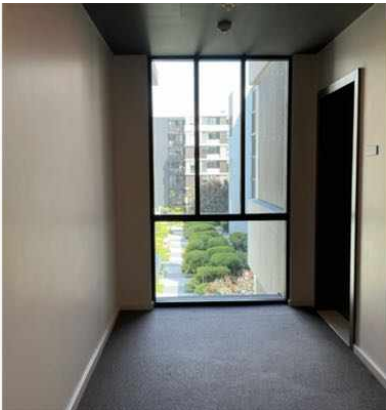
Building: Main Building
 Location: All External Areas
 Finding: Additional Photos - Obstructions and Limitations
 Information: These photographs are an indication of the obstructions and limitations which impeded full inspection of the property at the time of inspection. These obstructions can hide an array of defects and should be removed to allow full inspection to be carried out. A re-inspection is recommended once the areas are made accessible.

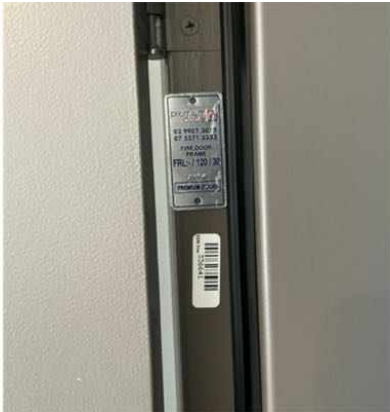
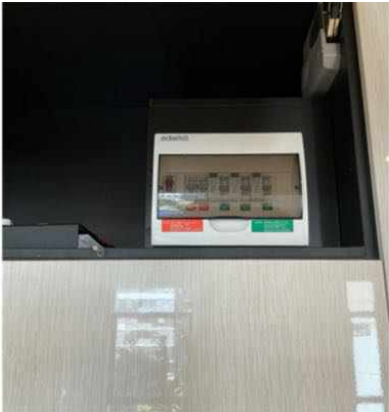
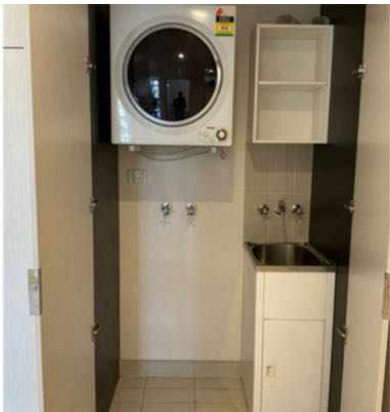
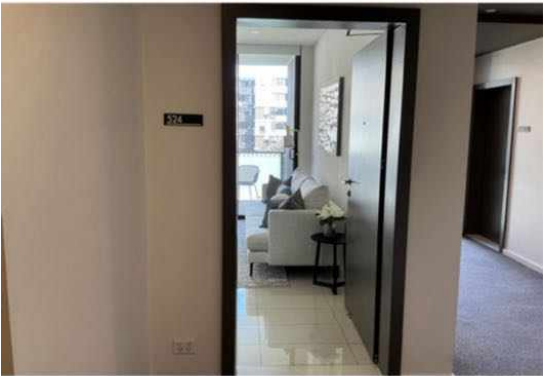
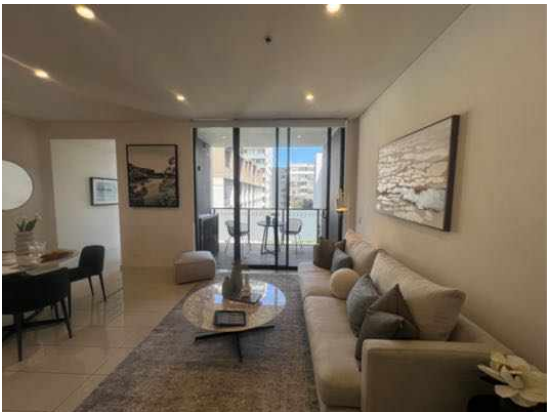
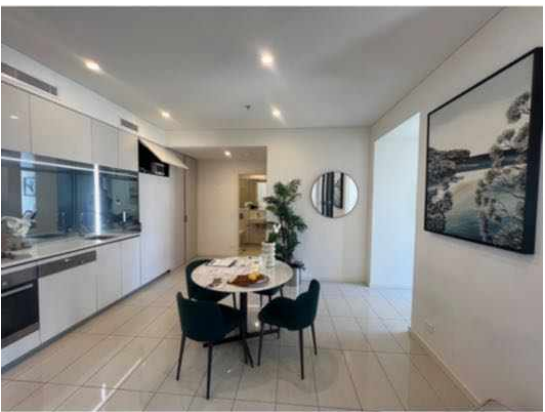
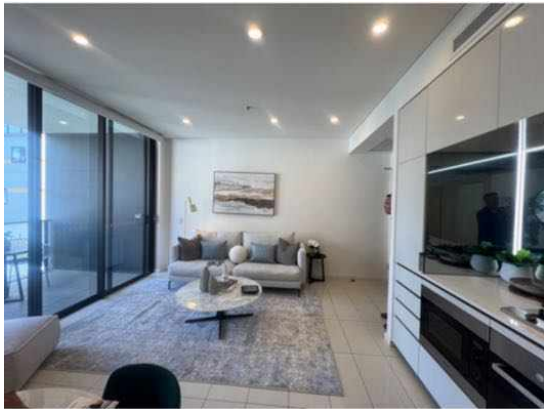
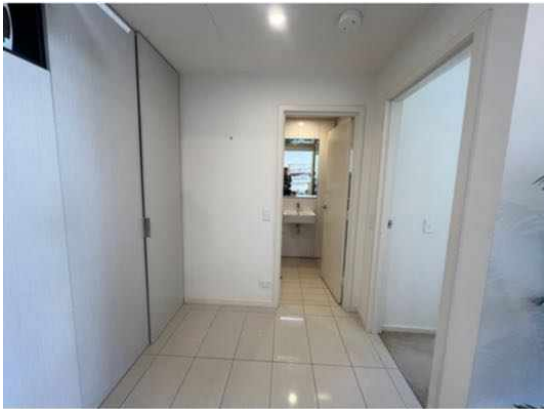
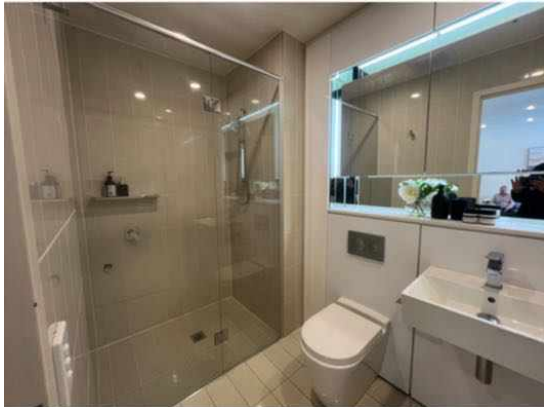
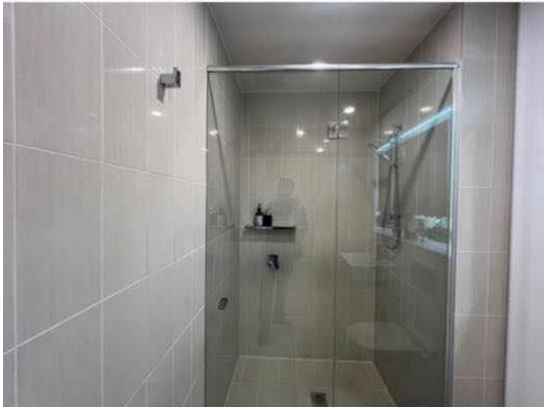
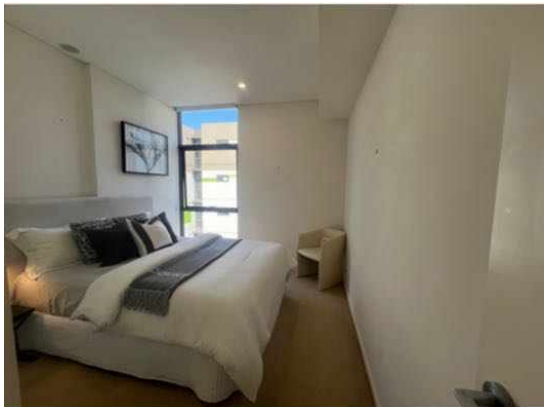
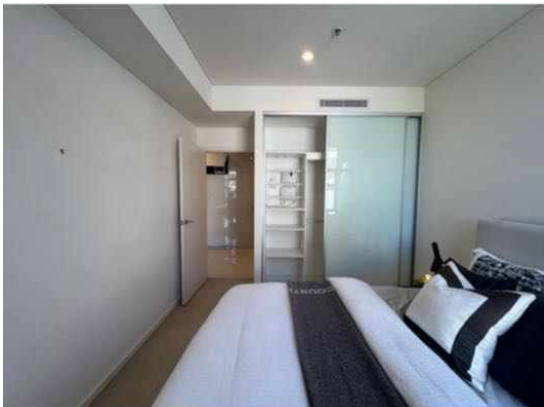
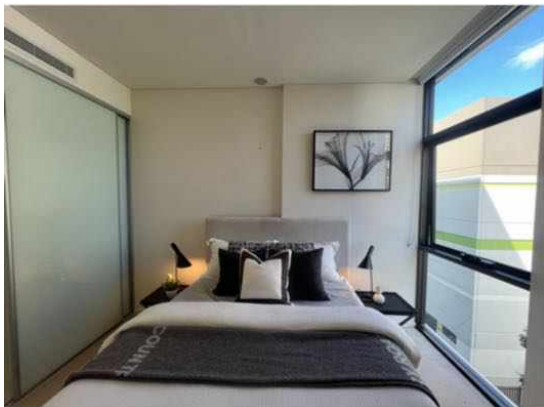
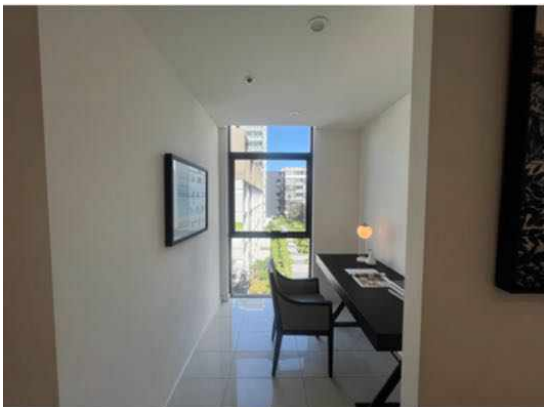
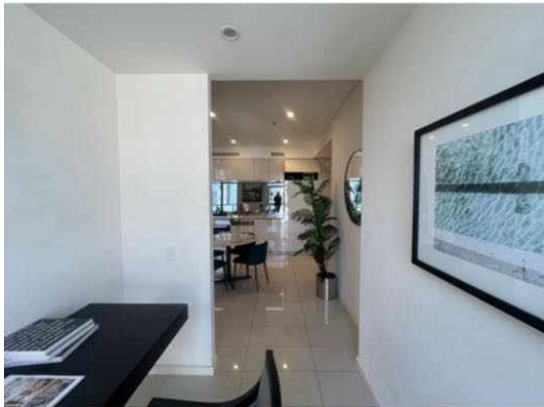
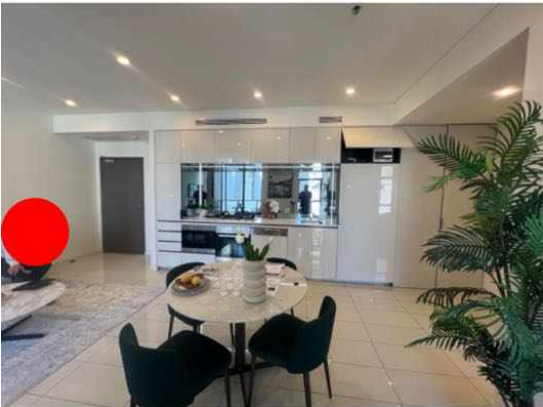
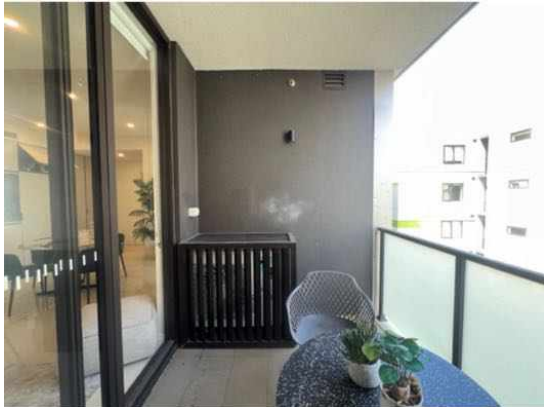
Building: Main Building
Location: All Internal Areas
Finding: Additional Photos - Obstructions and Limitations
Information: These photographs are an indication of the obstructions and limitations which impeded full inspection of the property at the time of inspection. These obstructions can hide an array of defects and should be removed to allow full inspection to be carried out. A re-inspection is recommended once the areas are made accessible.
