Building and Timber Pest Inspection Report

Inspection Date: Thu, 26 Feb 2026

Property Address: 19/346 PENNANT HILLS RD
CARLINGFORD NSW

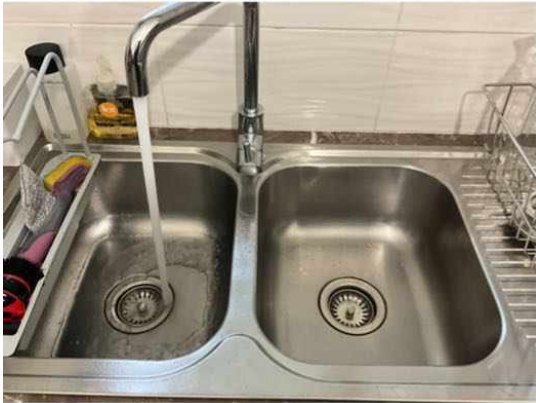
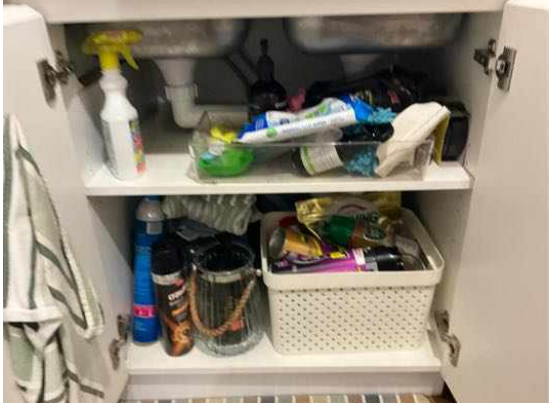
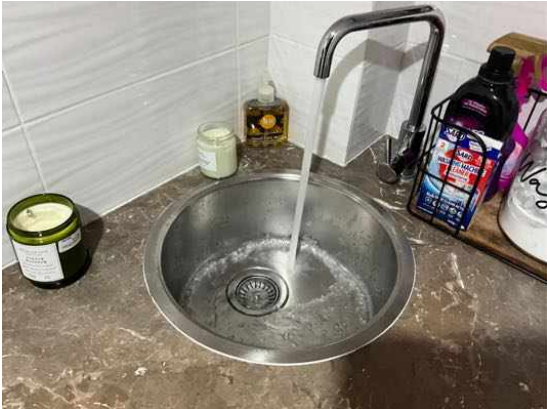
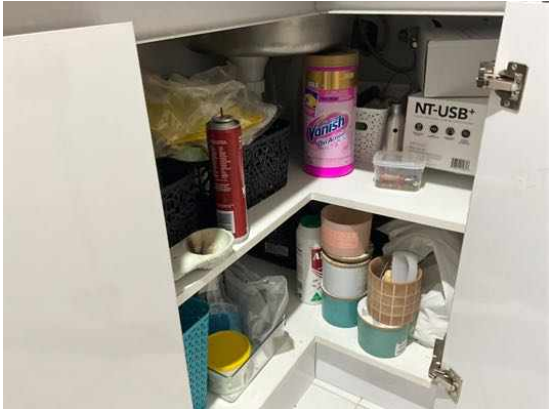
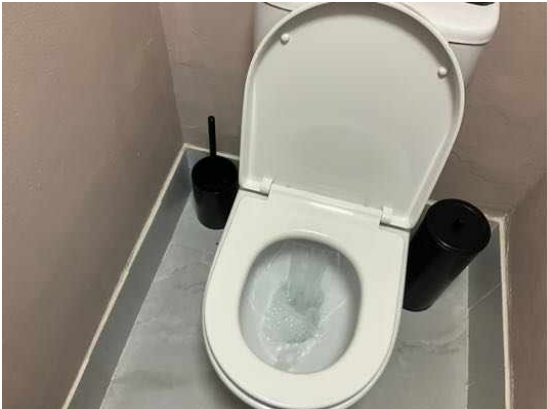
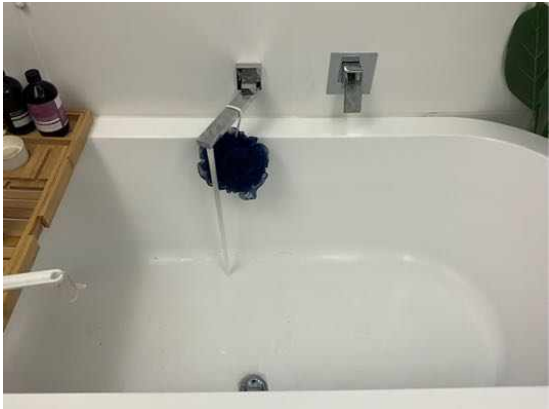
Building: Main Building
Location: All Wet Areas
Finding: Additional Photos
Information:

Additional photos are provided for your general reference.

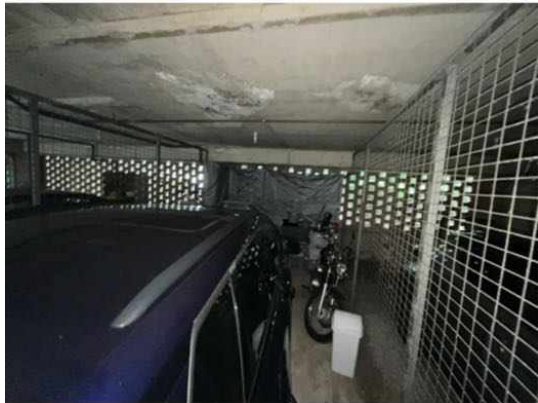
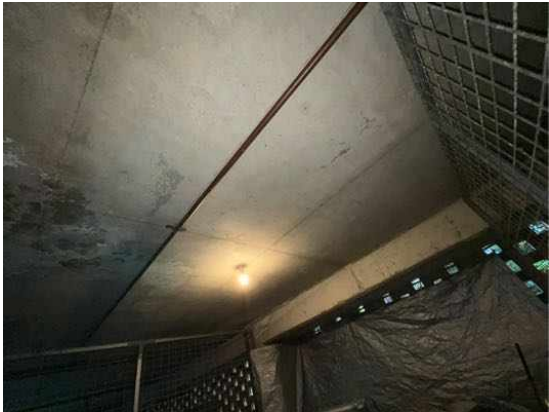
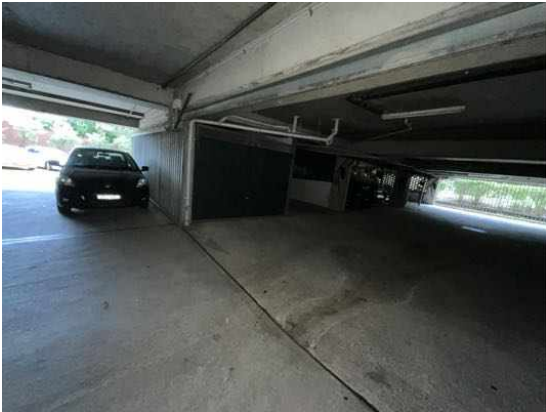
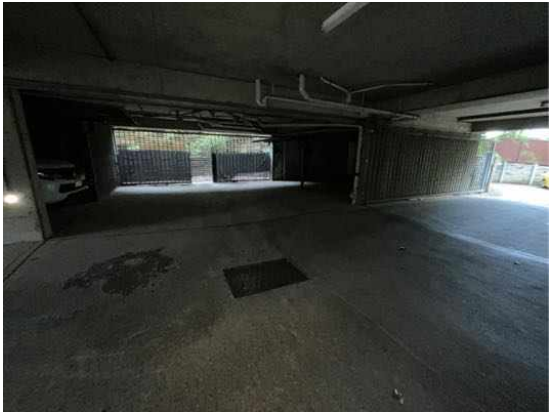
Building: Main Building
 Location: Garage
 Finding: Additional Photos- Garage
 Information: Additional photos are provided for your general reference. Arrows may have been included to highlight areas of importance. Please discuss these photos with your building consultant for clarification.

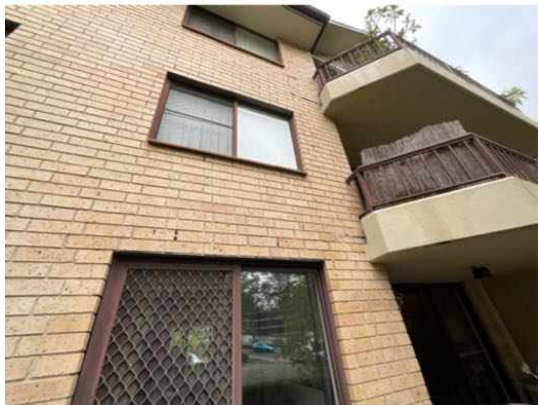
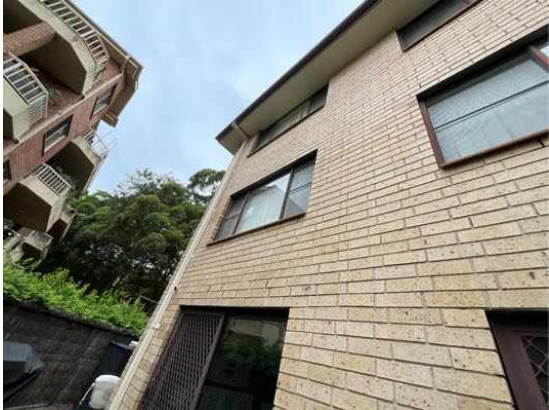
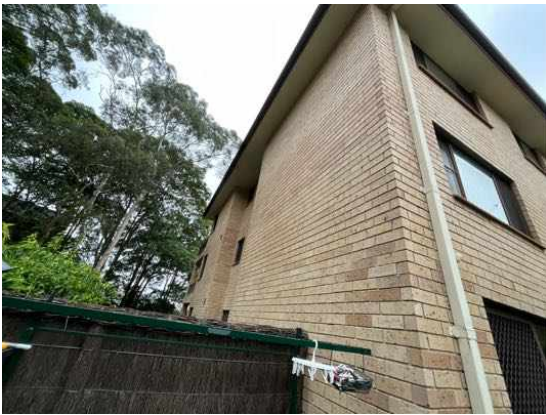
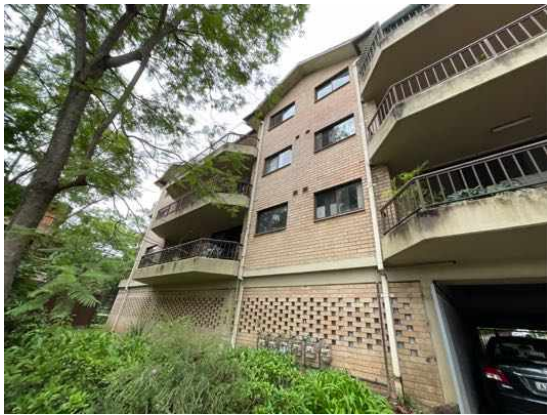
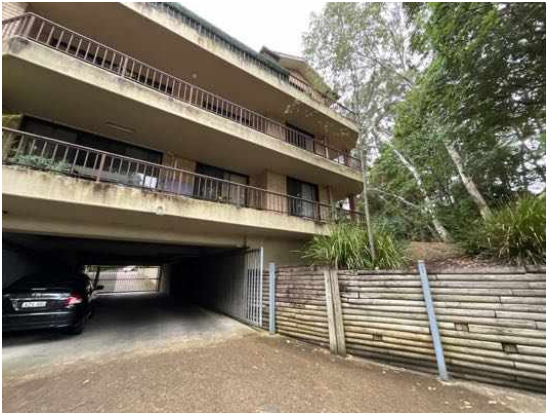
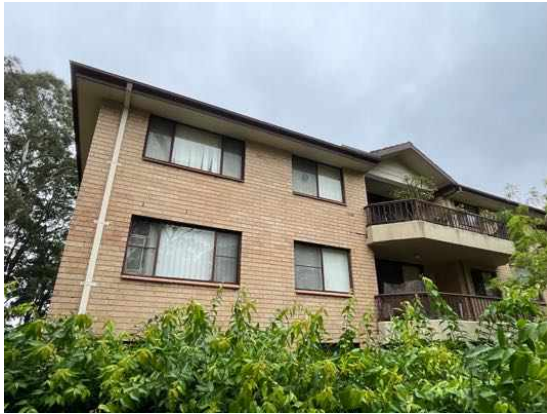
Building: Main Building
Location: Exterior
Finding: Additional Photos
Information:

Additional photos are provided for your general reference.

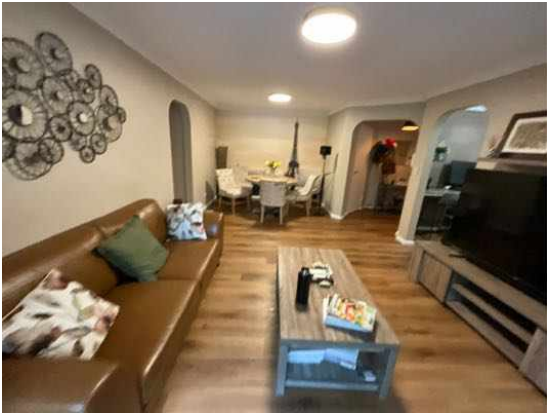
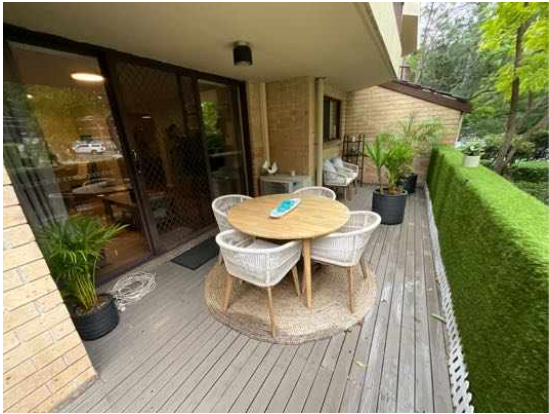
Building: Main Building
Location: All Areas
Finding: Additional Photos - Obstructions and Limitations
Information:

These photographs are an indication of the obstructions and limitations which impeded full inspection of the property at the time of inspection. These obstructions can hide an array of defects and should be removed to allow full inspection to be carried out. A re-inspection is recommended once the areas are made accessible.
