# Building and Timber Pest Inspection Report

Inspection Date: Wed, 25 Feb 2026

Property Address: 6 Gill Ave, Liverpool NSW 2170, Australia

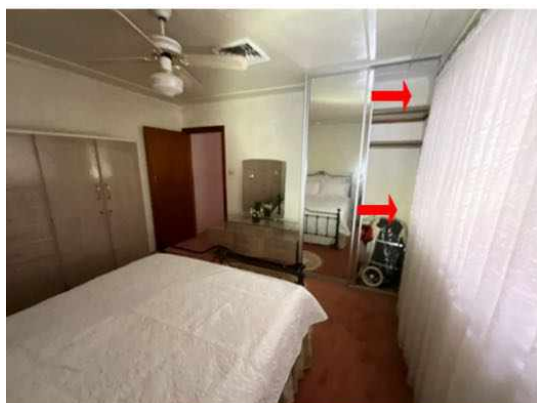
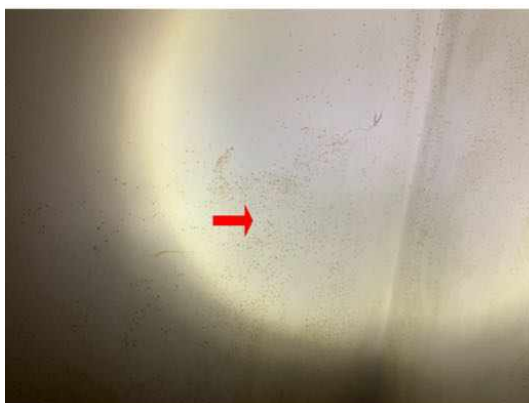
Building:	Main Building
Location:	Bedroom 2
Finding:	Mould present - Ventilation
Information:	Evidence of mould growth was noted, which is believed to have grown due to lack of ventilation to the area.

Generally, the client is advised to ensure that the general environment is free of moisture and humidity to aid in the prevention of mould formation and development. Any mould found during the inspection should be cleaned immediately by a cleaning contractor or the homeowner as applicable.

Although the exhaust fan was found to be working at the time of inspection, however a licensed electrician May be appointed to ensure the full exhaust fan operation.

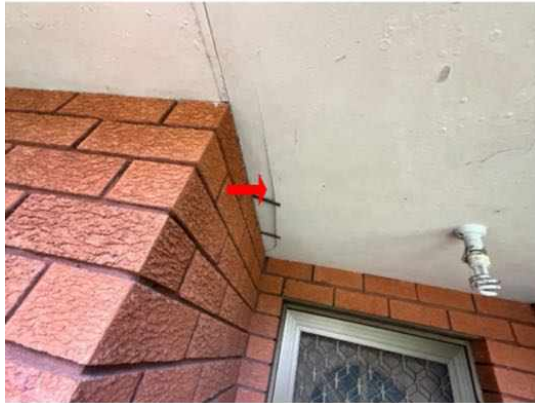
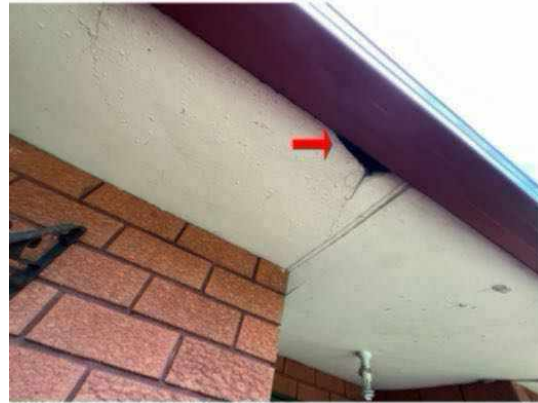
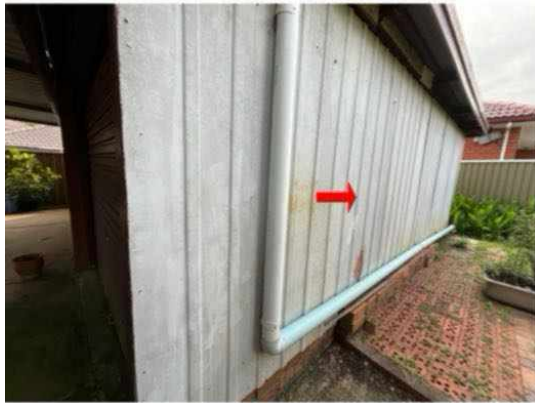
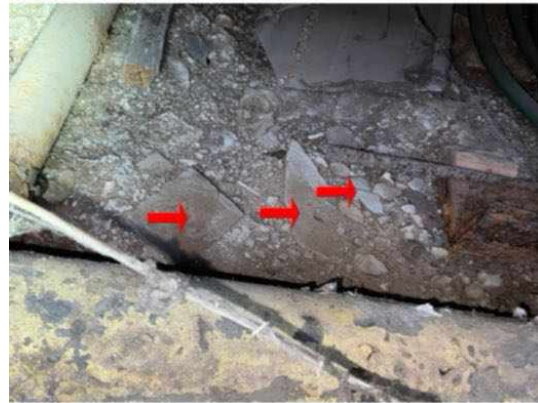
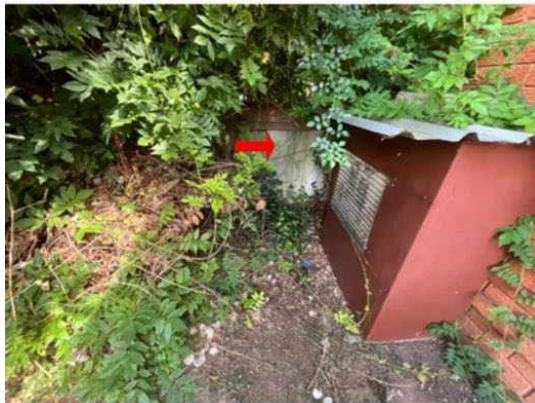
#### Finding 1.02

Building:	Main Building
Location:	Multiple areas
Finding:	Asbestos - Suspected ACM Identified on Site
Information:	Reporting on Asbestos is outside the Scope of this Report. This suspected defect is highlighted as a caution only. We suspect, based on our experience in the building industry, that there is a higher risk of the identified building element containing asbestos.

As Asbestos Reporting is outside the scope of this report, we advise that you consider a separate Asbestos Inspection and Condition Audit, which can include the taking of samples for definitive confirmation of the presence of Asbestos.

In the interim, the client is advised to act with caution, especially when considering any damage to building materials general wear and tear renovations extensions demolition and general maintenance activities due to the suspected presence of Asbestos.

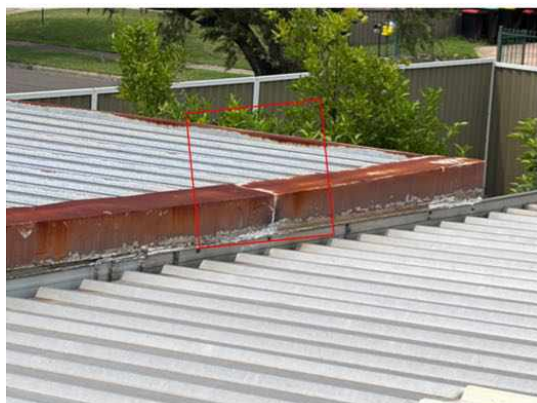
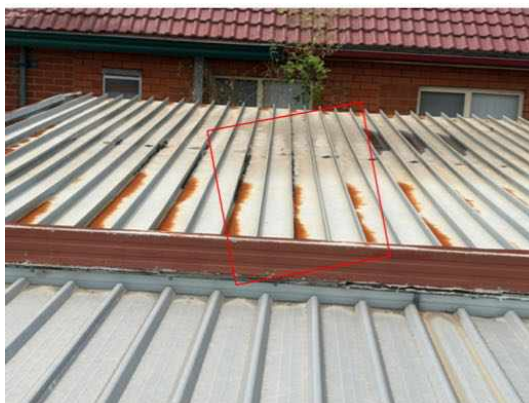
### Finding 2.01

Building: Main Building  
Location: Garage  
Finding: Roof sheets - Rusted

Information: Metal roofs generally comprise numerous individual sheets, which join and overlap. These intersections are particularly prone to lift at the edge and consequently rust at these points.

Upon inspection of the exterior roofing structure, evidence of rust to these sections was identified. If left unmanaged, these degrading joins can allow water ingress to the internal roofing structures, potentially leading to secondary damage of building elements. Accelerated deterioration of the roofing sheets and any associated building elements is also likely to occur.

A roofing contractor should be appointed immediately to assess the damage to the roofing sheets and to perform remedial works as necessary. Works may include replacement of severely affected roofing sheets or minor works such as the application of rust-retardant surface protectors.

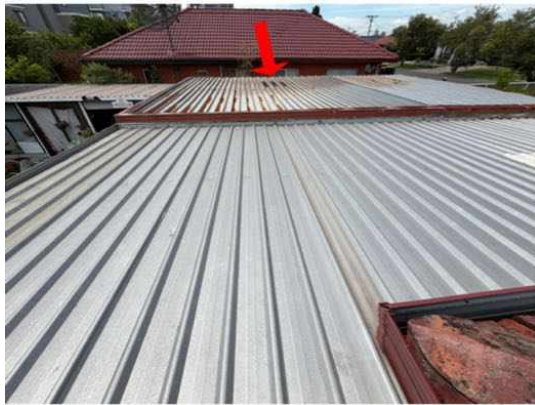
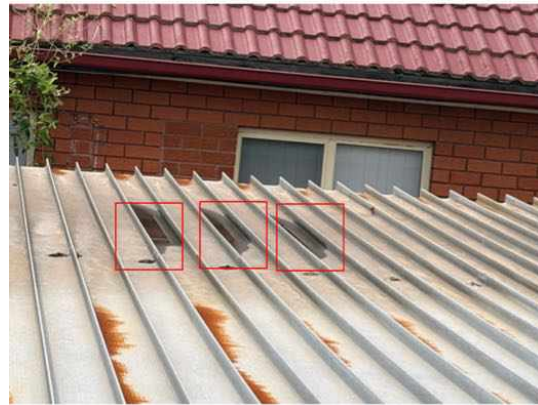
## Finding 2.02

Building: Main Building  
 Location: Garage  
 Finding: Roof sheets - Water pooling  
 Information: The roof drainage in sections of the exterior roof appears to be poor, evidenced by water pooling on the roof sheets. This is generally caused by either inadequate roof plumbing or roof structures not effectively draining due to the construction method.

Where water is pooling, rust and deterioration of the roof sheets is imminent if left unattended, which may necessitate major repair works.

Consultation with a roofing plumber is recommended as soon as possible to provide advice on rectification options. Additional works to rectify structural issues with the roof may also be required.

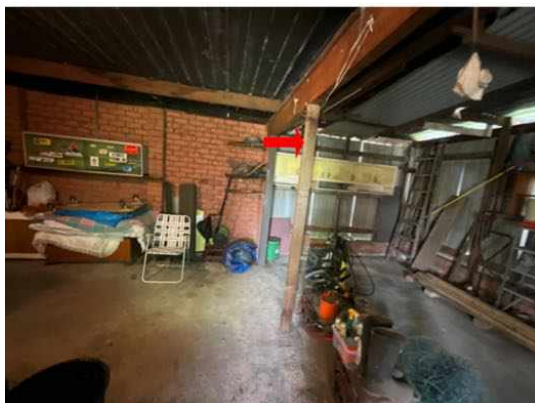
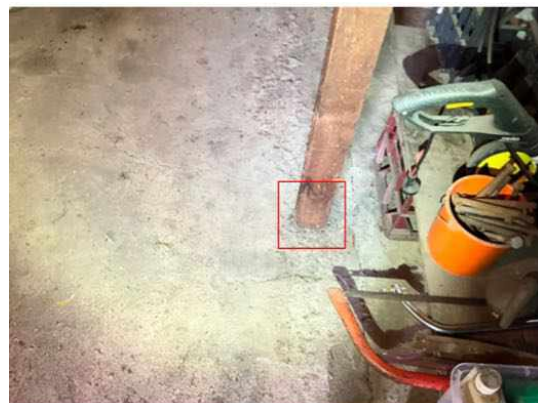
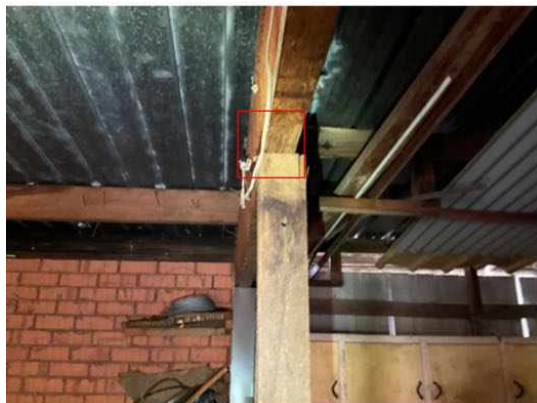
### Finding 2.03

Information: This handyman work appears to have been completed to a substandard level and does not comply with regular building practices. Where handyman work is not completed satisfactorily, accelerated deterioration of the associated building elements is likely to occur and secondary defects to surrounding structures may develop.

It is highly recommended that the substandard work be rectified by professional services. Works to improve this area are likely to increase the safety and the operation of the associated building elements.

The client should exercise care when coming into the immediate vicinity of the substandard works. Rectification works are advised as soon as possible by a licensed builder.

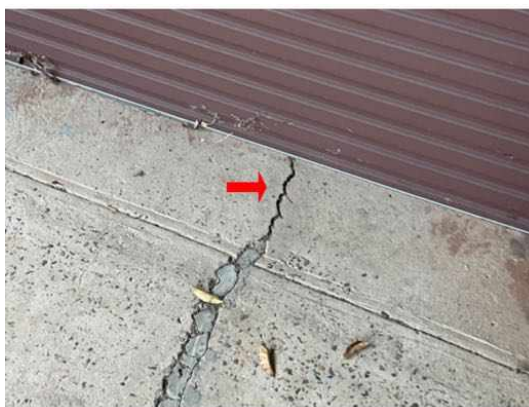
### Finding 2.04

Building:	Main Building
Location:	Garage
Finding:	Crack in concrete slab - Category 4
Information:	A crack coded as Category 4 was identified in the slab. A Category 4 crack is described as a crack that appears as a gap in the slab, with disturbing curvature or change in level affecting the slab.

The approximate width of the crack or gap is 4mm-10mm or a change in offset of greater than 25mm when a 3m straight edge is placed over the defect.

Category 4 cracking to slabs exceeds allowable Standards and Tolerances, and are therefore considered as major defects that require rectification.

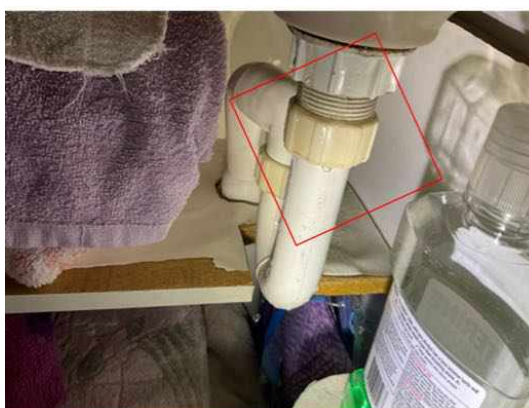
### Finding 3.01

Building:	Main Building
Location:	Bathroom
Finding:	Water leak - Active

Information: Generally, water leaks occur when a particular area of the property is not weather or water tight. As the surrounding area was found to be damp at the time of inspection, the leak is considered ongoing and hence requires urgent action.

Regardless of the location, even minor leaks that are left unmanaged can lead to serious damage of associated building elements and result in the need for replacement of building materials. Mould and other hazards such as electrical hazards may also arise if the leak is left to develop.

It is highly advised that the cause of the leak be identified and resolved immediately by a licensed plumber to prevent any further damage. Depending on the extent of the damage previously sustained, repair and/or replacement of any affected building materials may be required.

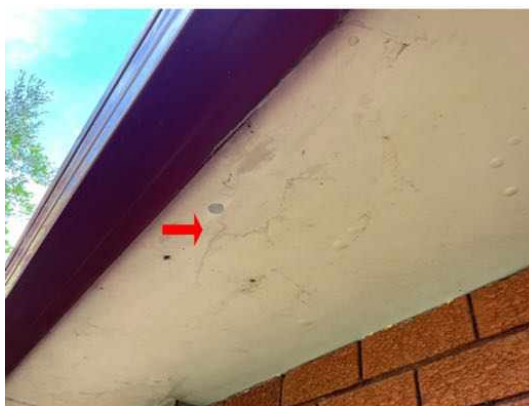
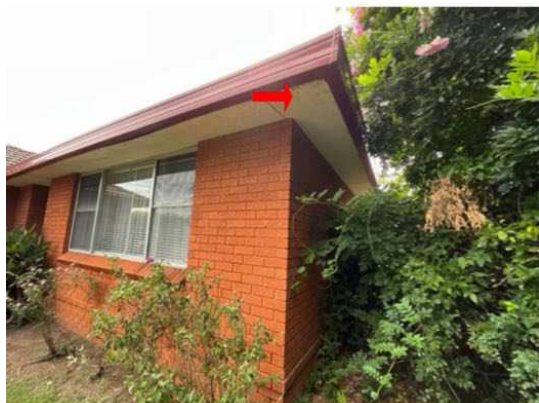
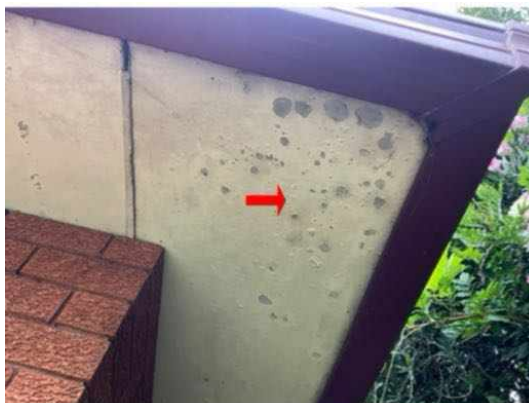
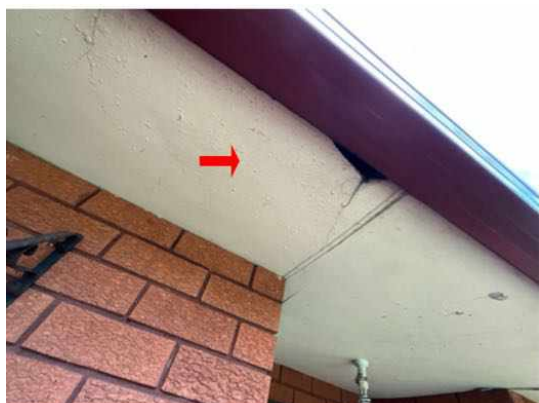
### Finding 3.02

Building: Main Building  
 Location: Multiple areas  
 Finding: Eaves/Roof plumbing -- water damages  
 Information: Water damage is generally an indication of excessive moisture being present, usually via a leak. It is suspected that gutter blockages causing stormwater to backflow into the eaves causing water damages. This is additionally conducive to termite activity due to the damp conditions.

Where water damage is evident, the primary requirement is to identify and rectify the source of the leak. Gutters must be kept clear of any blockages moving forward. A roofing plumber should be appointed for further assessment if the problem persists.

Once the leak is repaired, consultation with relevant tradespeople, including carpenters, plasterers and painters, is advised.

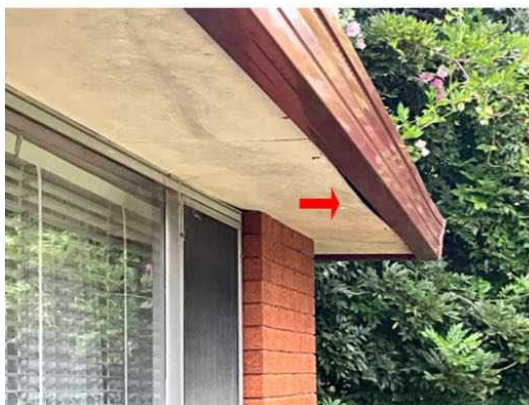
### Finding 3.03

Building: Main Building  
 Location: Front Elevation  
 Finding: Eaves - Sagging  
 Information: Sagging to the eaves was evident in this area at the time of inspection. This type of defect is generally consistent with older properties, where the eave sheeting has worn over time.

Sagging eaves are susceptible to the attraction of excessive moisture, and are therefore considered non-functional. This defect also detracts from the overall appearance and condition of the roofing structure and any associated structures.

A roofing plumber or general handyman is recommended to perform rectification works as soon as possible. Subsequent water damage is likely to result over time if left unattended.

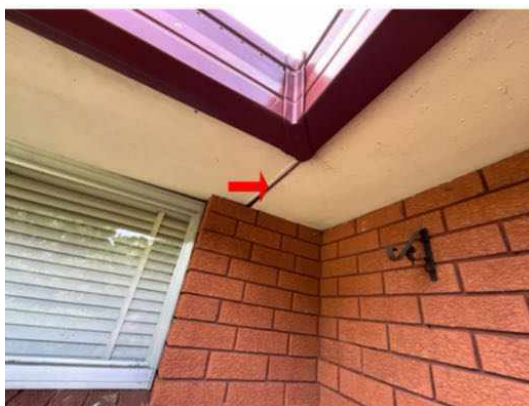
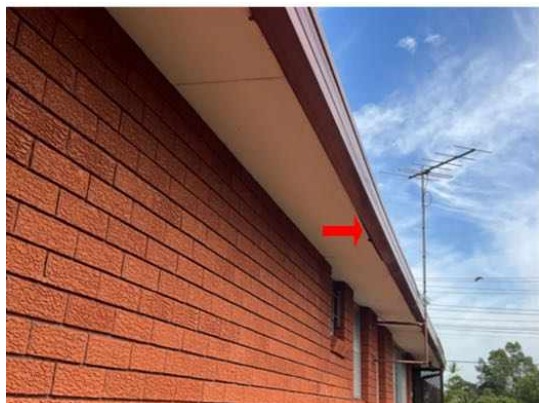
### Finding 3.04

Building:	Main Building
Location:	Multiple areas
Finding:	Beads - Damaged
Information:	Beading acts (like cornice or skirtings) to cover the intersection or joins of building materials. It was noted at the time of inspection that beading in this area has deteriorated. This deterioration is suspected to have been caused by general ageing and frequent exposure to weather, which is expected in a building of this age and condition.

Repair or replacement of the beading is advised to ensure the protection and longevity of any associated building elements. Such works may be performed by a general handyperson or qualified carpenter.

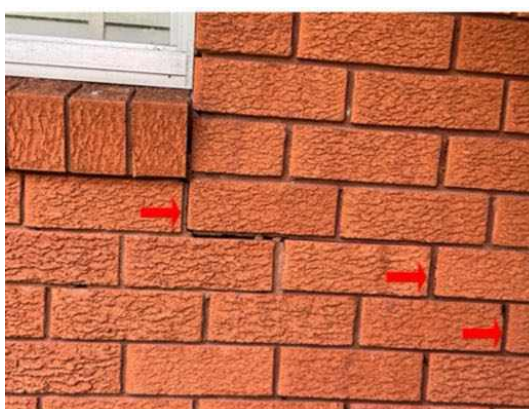
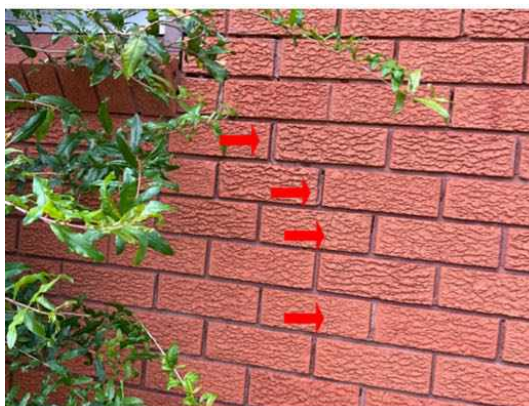
Building:	Main Building
Location:	Multiple areas
Finding:	Brickwork - Step cracking
Information:	Step cracking was identified to the brickwork in this area at the time of inspection. Step cracking, which is similar to other forms of cracking, has a variety of possible causes. However, the most common is the subsidence of adjacent footings.

Minor step cracking can be used as a warning sign to address factors causing stress to the wall, which can include the effect of surrounding trees, water leaks, soil erosion, or even the presence of reactive soils in the surrounding area. The degree of damage falls within Category 1, described as fine cracks, which are less than 1.0mm in width limit, and that do not need repair.

Damage of this category is not considered a defect for rectification. Always contact your building inspector should cracks widen, lengthen, or become more numerous.

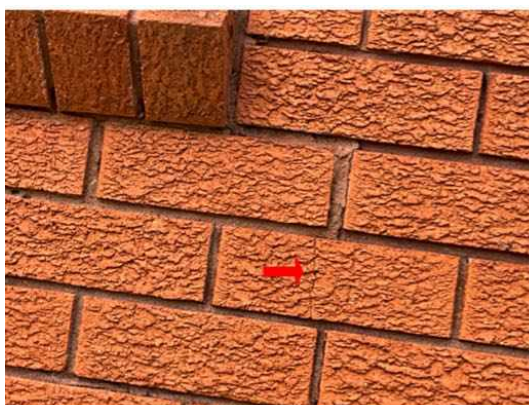
### Finding 3.07

Building:	Main Building
Location:	Multiple areas
Finding:	Brickwork - Cracking [Fine]
Information:	Although fine cracks are quite noticeable, they are often only considered to be an appearance defect and usually do not indicate any structural damage. Generally, the cause of a fine crack is indicative of a separation between brickwork and mortar throughout the structure, but single bricks may also show cracks of this nature.

Cracking of this nature can generally be repaired with minor filling and should be conducted by a qualified bricklayer.

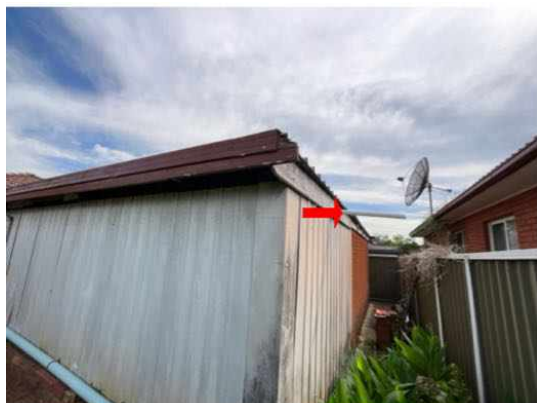
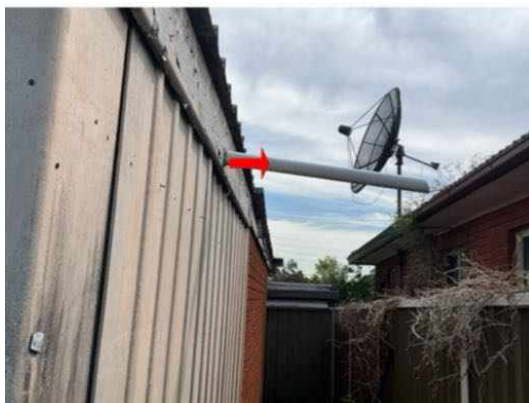
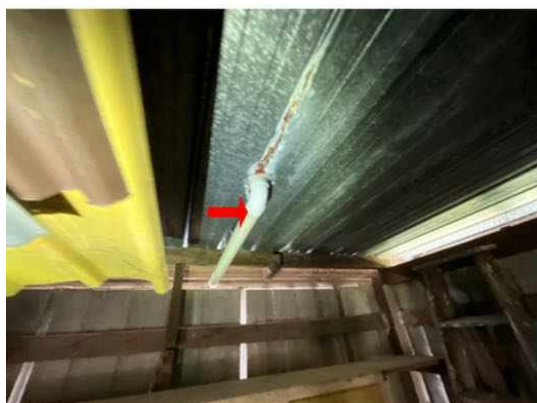
### Finding 3.08

Building:	Main Building
Location:	Garage
Finding:	Unconventional handyman work
Information:	This handyman work appears to have been completed to a substandard level and does not comply with regular building practices. Where handyman work is not

completed satisfactorily, accelerated deterioration of the associated building elements is likely to occur and secondary defects to surrounding structures may develop.

It is highly recommended that the substandard work be rectified by professional services. Works to improve this area are likely to increase the safety and the operation of the associated building elements.

The client should exercise care when coming into the immediate vicinity of the substandard works. Rectification works are advised as soon as possible by the appropriate trades.

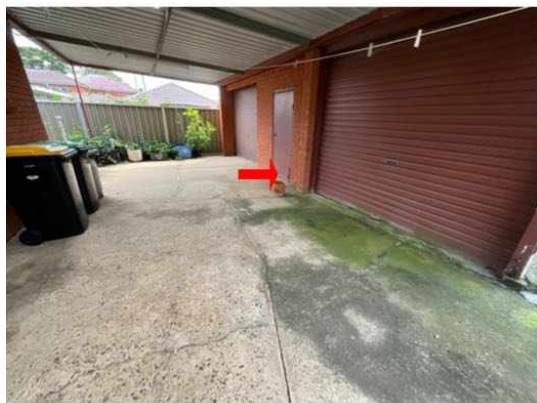
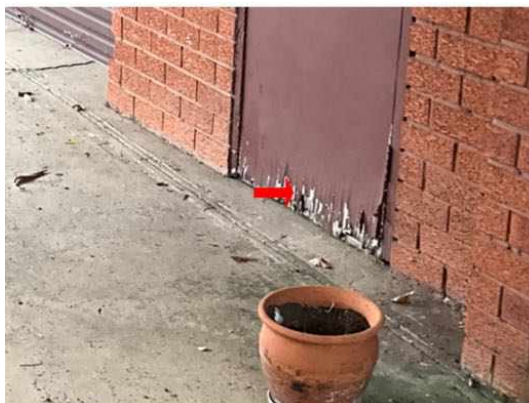
### Finding 3.09

Building:	Main Building
Location:	Garage
Finding:	Building element - Swollen
Information:	Swollen building elements generally indicate that the building materials have been affected by excessive moisture over a prolonged period of time, and have swollen as a result. The formation and development of mould/fungi or mildew is also a likely consequence of excessive moisture, which may pose major respiratory issues for occupants, particularly the elderly, the very young and those with existing illnesses and could be potential health safety hazards. In these cases an appropriately qualified inspector/tester should also be contacted for advice and/or technical assistance.

The structural integrity of swollen building elements can not be guaranteed, and further damage is likely to develop if left unmanaged. Excessive moisture is likely to lead to the development of secondary damage to any associated building elements, which may necessitate major reparation works if prolonged.

Repair and/or replacement of swollen building elements should be conducted by a licensed carpenter.

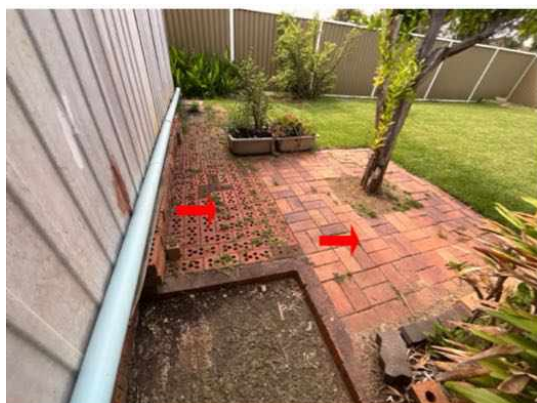
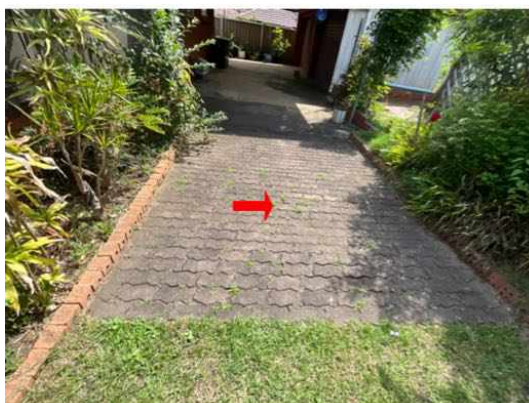
### Finding 3.10

Building: Main Building  
 Location: Multiple areas  
 Finding: Paving — Uneven  
 Information:

Sections of the external paved area are uneven, which may develop into a trip hazard. It appears as though the area has been subject to rough installation, or that paving sections have lifted due to movements in the foundation.

Left unmanaged, the May develop into a safety hazard due to trip and fall.

Re-paving of the area is required to remedy this situation. Further consultation with a specialist concreter is advised.

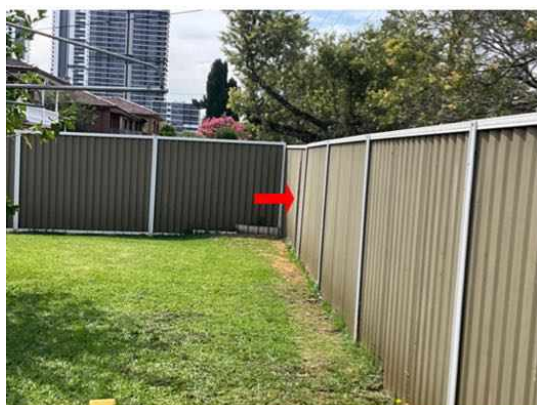
### Finding 3.11

Finding: Fencing - Deteriorated

Information: It was noted at the time of inspection that sections of the fencing in this area has deteriorated. Typically fencing deteriorates due to age and or wear, rot and or rust which is generally expected for a structure of this age, due to prolonged exposure to weather conditions. Sometimes inadequate installation or maintenance can be to blame.

If left unattended, it is likely that further damage will occur. It is suspected that repair of several elements of the fencing may be required however replacement may be a consideration of the client also.

A licensed fencing contractor should be appointed to provide further advice and perform rectification works as necessary.

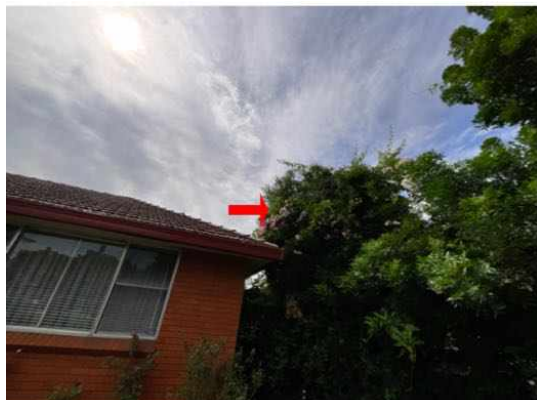
### Finding 3.12

Gutters are a critical part of the building's management of storm water and rain. It is therefore important that they be kept clear to prevent secondary damage to associated building elements, including exterior and interior walls, ceiling linings and any adjoining building elements. Where gutters are blocked, pooling of rainwater is likely to occur, fast-tracking rust and corrosion of the roof plumbing elements.

It is highly advised that all overhanging tree branches be removed as soon as possible to prevent any further damage. Repair and/or replacement of sections of damaged

guttering may also be required where the extent of the damage necessitates.

Such works should be performed by the homeowner; however, appointment of a landscape contractor or an arborist may be required. Consultation with a licensed roof plumber is required where guttering has been damaged.

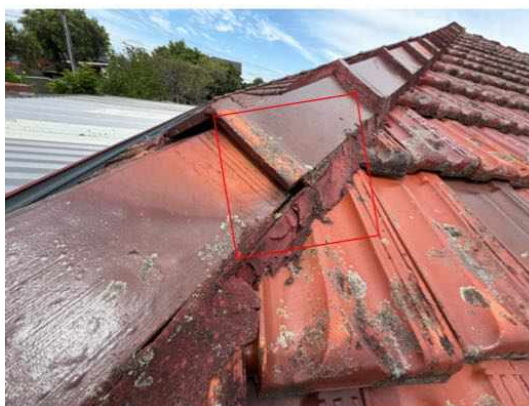
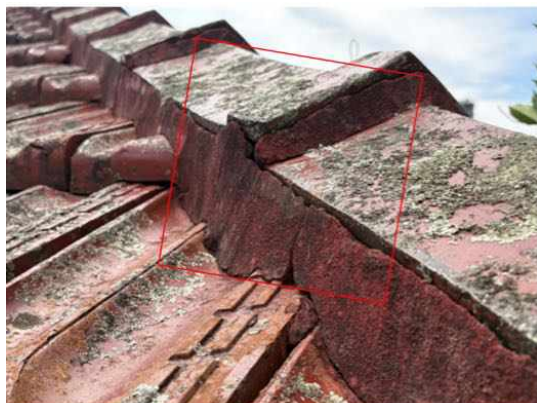
### Finding 3.13

Building: Main Building  
Location: Roof Exterior  
Finding: Roof tiles - Weathered  
Information:

Upon inspection of the exterior roofing, the majority of roof tiles were considered to be in a fair condition. While weathering of the tiles is consistent with the age of the property, maintenance works are required.

Isolated areas of mortar have come loose and minor cracking is also present. Re-pointing and re-sealing the may be considered as an interim solution by the client to help preserve and extend the life span of the tiles.

Where left unmanaged, deteriorating roof tiles are likely to lead to a number of secondary defects, including minor water leaks and weather exposure to internal roofing structures.

Consultation with a licensed roofing contractor is highly advised to gain advice on cost of remedial works that may be required in the short to medium term. Remedial works are likely to increase the longevity of the exterior roofing structure.

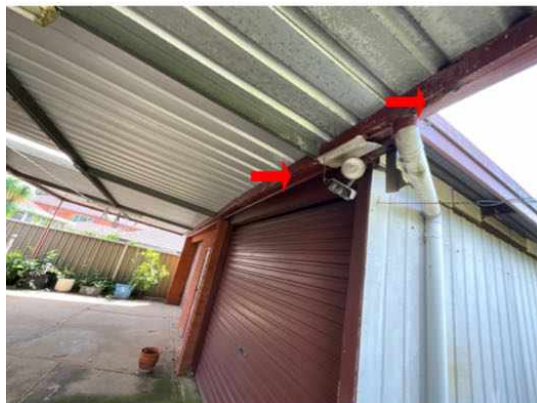
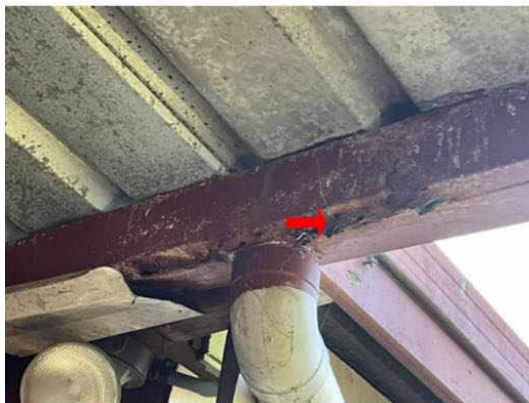
Building:	Main Building
Location:	Carport
Finding:	Roof plumbing - Rusted or corroded
Information:	The roof plumbing has areas of rust and corrosion. It is suspected that this has been caused by blockages, resulting in pooling or standing water, that have prematurely rusted elements of the roof plumbing.

Rusted roof plumbing will generally develop holes and leaks that can affect other building elements with poor drainage of storm water. Poorly drained roof areas will also lead to damp conditions surrounding the base perimeter of the building which, if left unmanaged, can lead to a range of secondary building defects.

Repair and/or replacement of rusted roof plumbing is highly required in order to reinstate the roof drainage system to a fully operational level. To further maintain these areas, gutters should be cleaned frequently, allowing the avoidance of any partial blockages.

A licensed plumber or specialist roof restoration company should be appointed to undertake these works. It is advised that such works be completed as soon as possible to prevent any further damage and deterioration.

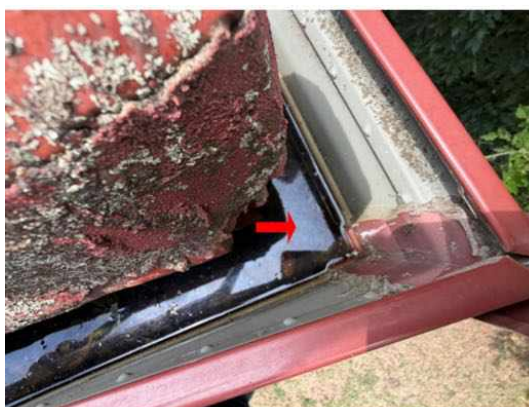
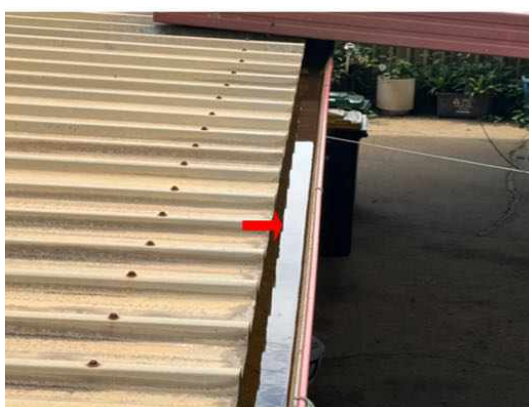
Finding: Gutters - Water pooling  
 Information: Water was found to be pooling in sections of the roof guttering. This is generally a secondary defect caused by blocked or partially blocked gutters. Furthermore inadequate fall to the adjacent downpipe could also be the underlying cause.

Water pooling is likely to lead to rust and water damage to associated structures if left unattended. This excess dampness is additionally conducive to termite activity.

Any areas of guttering that shows evidence of water pooling should be checked for partial or full blockages or otherwise appropriate fall to the downpipe must be applied accordingly. Any secondary damage that may have occurred as a result must be rectified. Depending on the extent of the damage, building elements may require repair and/or replacement to ensure adequate roof drainage and function of exterior plumbing system.

A roofing plumber must be appointed as soon as possible if inadequate fall to downpipe is deemed to be the cause. It is highly advised that all gutters be maintained on a frequent basis to ensure the condition of roof plumbing.

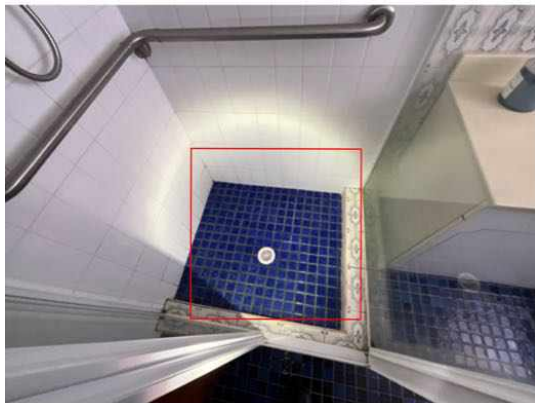
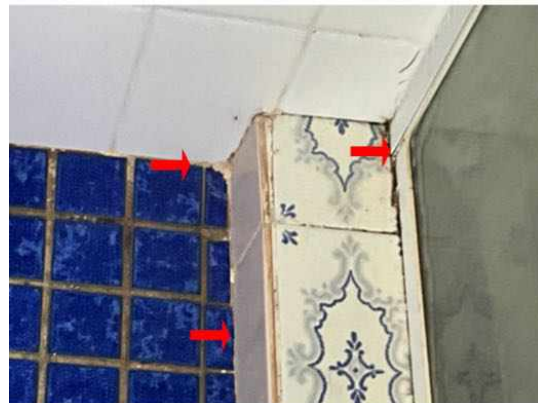
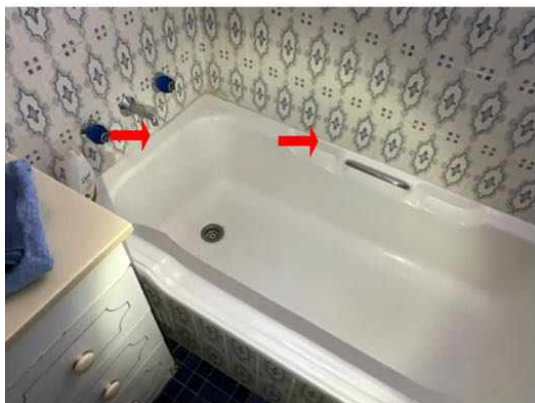
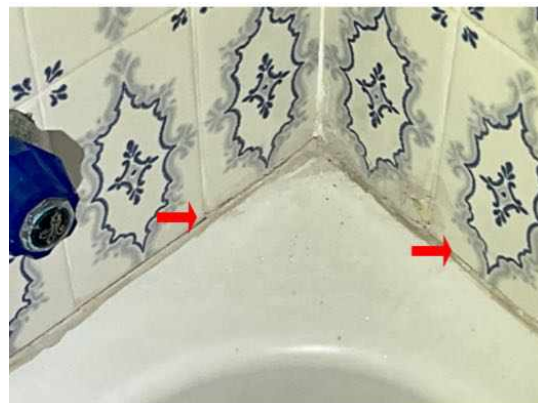
### Finding 3.17

Building: Main Building  
 Location: All Wet Areas  
 Finding: Sealant and grouting - Missing or damaged

It was noted on inspection that sealant or grout is degraded to this area.

Different materials and floor areas move at different rates, generally causing cracking to grout or sealant at this point. A flexible sealant is required to allow for expected expansion and contraction, while keeping the joint water tight and protective of all associated building materials.

Flexible and mould resistant materials should be applied to affected areas to prevent any subsequent water damage that is likely to occur. Regular maintenance and replacement of damage or missing or damaged sealant and grout is highly recommended to the wet areas, as this is a regular wear and tear defect. Sealant and grouting in areas that come into regular contact with water should be maintained for the long term care of your property.

A sealant specialist should be appointed to complete these works as soon as possible.

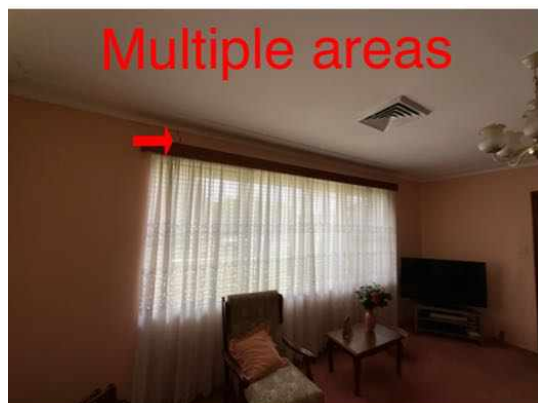
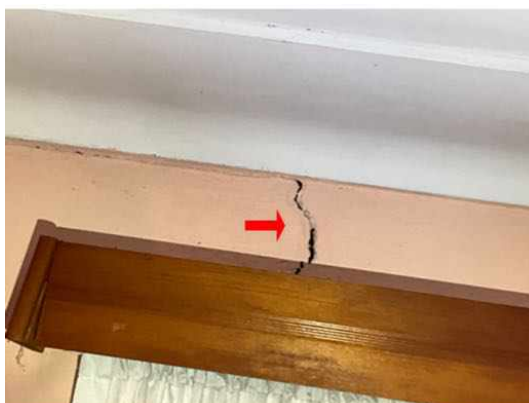
### Finding 3.18

Building: Main Building  
 Location: Front bedroom  
 Finding: Cracks to internal render - Category 2

Information: It has been observed that cracking to internal rendered surfaces has occurred. The degree of damage falls within Category 2, described as noticeable cracks which are easily filled. Cracking of this size are generally less than 5mm in width.

Category 2 damage is required to be monitored for a period of 12 months. After the monitoring period, a crack rated at Category 2 or above is considered a defect requiring rectification.

Always contact your building inspector should cracks widen, lengthen, or become more numerous.

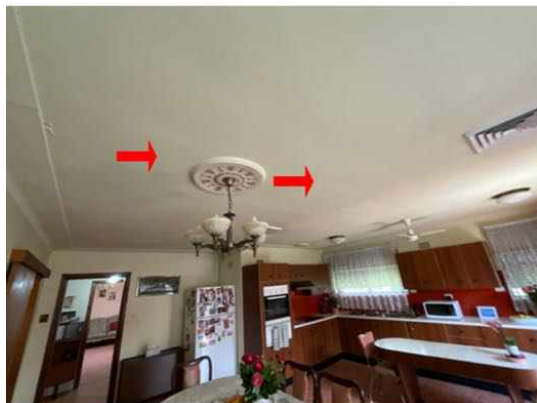
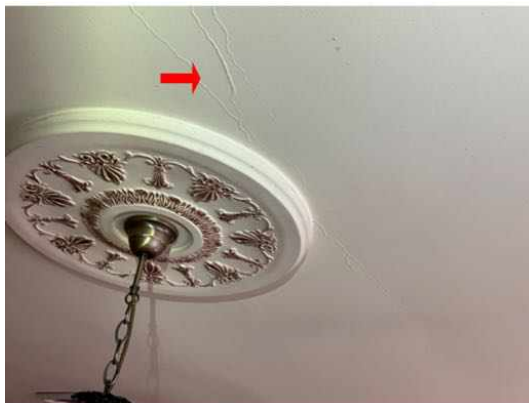
### Finding 3.19

Finding: Cracking - Damage Category 1 - Fine (up to 1mm)

Information: Although fine cracks are quite noticeable, they are often only considered to be an appearance defect, and usually do not indicate any structural damage. Generally, the cause of a fine crack is indicative of a separation between building materials and finishes (e.g. paint, plaster, etc.) along joins.

Cracking of this nature can generally be repaired with minor sanding, filling and/or repainting. Such works should be performed by a qualified painter or a general handyman.

Monitoring of all cracking should be conducted frequently. Always contact a building inspector should cracks widen, lengthen, or become more numerous.

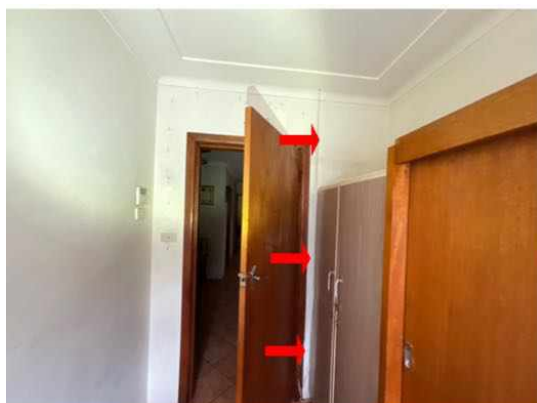
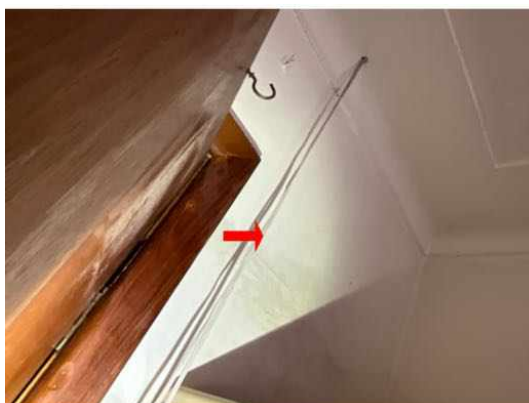
### Finding 3.20

Building:	Main Building
Location:	Study
Finding:	Unconventional handyman work
Information:	This handyman work appears to have been completed to a substandard level and does not comply with regular building practices. Where handyman work is not completed satisfactorily, accelerated deterioration of the associated building elements is likely to occur and secondary defects to surrounding structures may develop.

It is highly recommended that the substandard work be rectified by professional services. Works to improve this area are likely to increase the safety and the operation of the associated building elements.

The client should exercise care when coming into the immediate vicinity of the substandard works. Rectification works are advised as soon as possible by the appropriate trades.

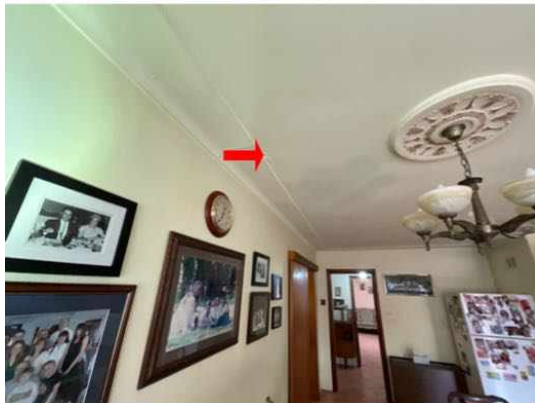
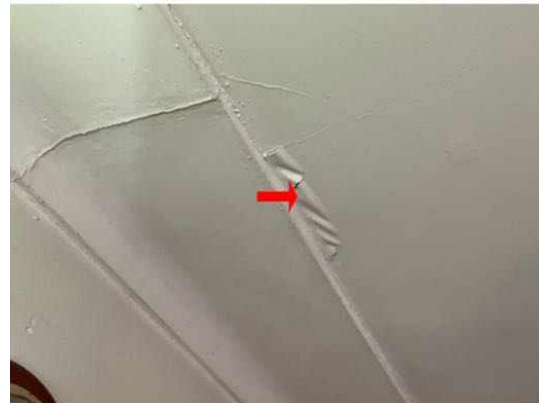
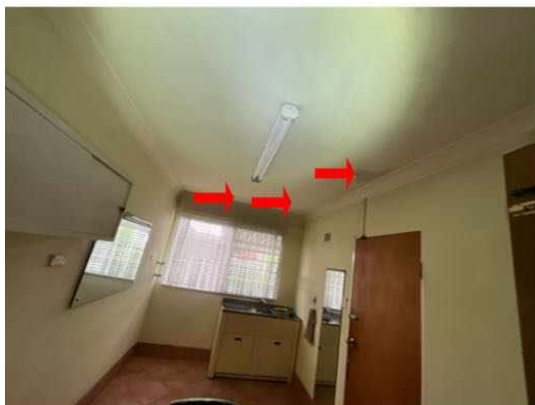
### Finding 3.21

Building:	Main Building
Location:	Multiple areas
Finding:	Paint cracking and peeling

Information: Cracking and ultimately flaking of paint can occur for a variety of reasons. Often these failures are due to the fact that the paint has inadequate adhesion and flexibility, both common problems with lower quality exterior flat paints.

When timber is involved, moisture intrusion results in swelling of the wood surface followed by contraction as the wood dries. The expansion and contraction cycles, can result in cracking and subsequent paint failure by flaking and peeling.

Cracking and flaking can also result when paint is applied too thinly due to overspreading (higher-than-recommended spread rate) or excessive thinning. These practices tend to diminish the paint's final film thickness, so that it is more vulnerable to cracking and flaking.

Inadequate surface preparation can also cause these failures, especially when paint is applied to bare wood or a very porous surface without first applying a primer.

A qualified painter should be appointed to rectify the problem.

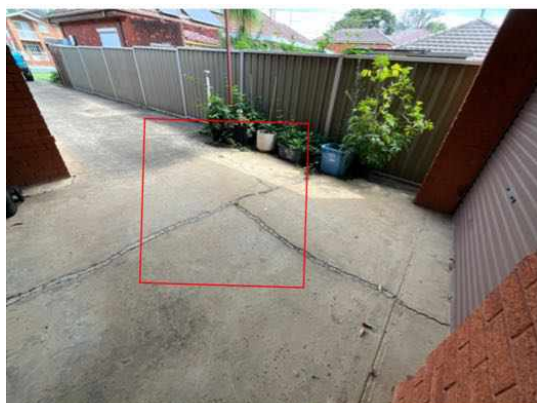
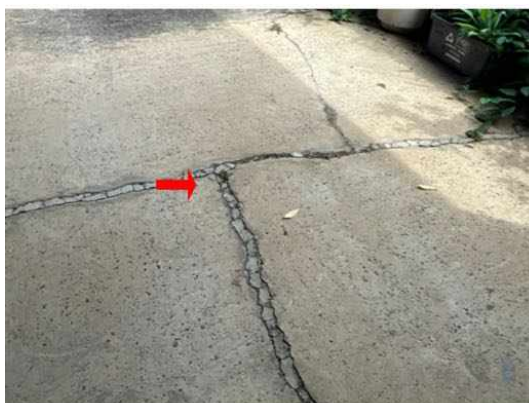
### Finding 3.22

Building: Main Building  
 Location: Driveway  
 Finding: Cracking - External Concrete Paving Damage Category 4 - Gaps in Slab (4mm - 10mm +)

Information: Gaps in the slab were identified in external concrete paving. Gaps in the slab are significant and are likely to lead to the development of safety hazards and secondary defects if left unmanaged, such as the creation of a trip hazard.

General age and expected deterioration of the paved areas is a common cause of this type of cracking. However, expansion and contraction of the slab may also have occurred due to environmental factors. Such factors include variable moisture and weather conditions, the presence of trees and their roots having a settling or lifting affect on the soil, or the effect of load bearing, e.g. heavy vehicles over a sustained period of time.

Cracking to this degree may also be due to poor original installation of the concrete. Factors such as poor compaction of the sub surface and/or inadequate reinforcing of the slab may create cracking and other secondary defects. Gaps in the concrete paving may also have a more significant structural cause, such as subsidence of soils.

Where gaps in the concrete paving are adjacent to structural elements of the building, the advice of a Structural Engineer is advisable before undertaking repairs. Significant repair and likely replacement of the concrete paving is probable.

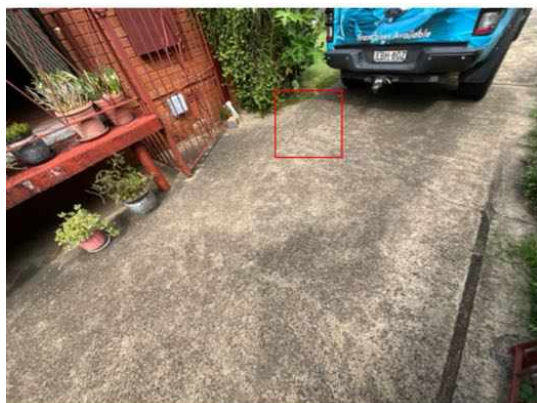
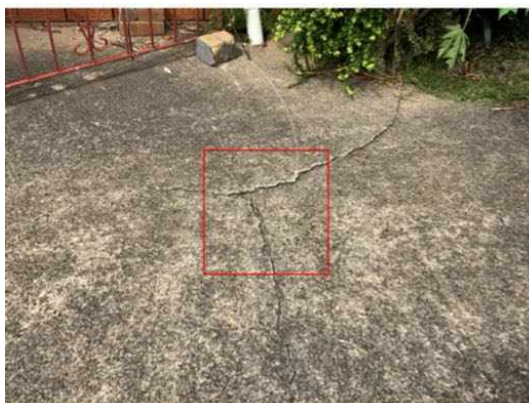
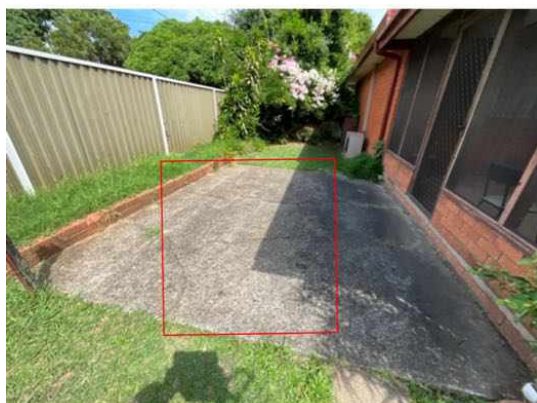
### Finding 3.23

Building: Main Building  
 Location: Multiple areas  
 Finding: Cracking - External Concrete Paving Damage Category 2 - Distinct (less than 3mm)  
 Information: Distinct cracks were identified in external concrete paving. Distinct cracks are generally found in older concrete paving, and may also present as a trip hazard as consequence of an uneven or curved surface.

General age and expected deterioration of the paved areas is a common cause of this type of cracking. However, expansion and contraction of the slab may also have occurred due to environmental factors. Such factors include variable moisture and weather conditions, the presence of trees and their roots having a settling or lifting affect on the soil, or the effect of load bearing, e.g. heavy vehicles over a sustained period of time.

Cracking to this degree may also be due to poor original installation of the concrete. Factors such as poor compaction of the sub surface and/or inadequate reinforcing of the slab may create cracking and other secondary defects.

Repairs are likely to be required to prevent further cracking and to reduce hazards associated with cracking, such as tripping. Monitoring of all cracking should be conducted frequently. Always contact a building inspector should cracks widen, lengthen, or become more numerous.

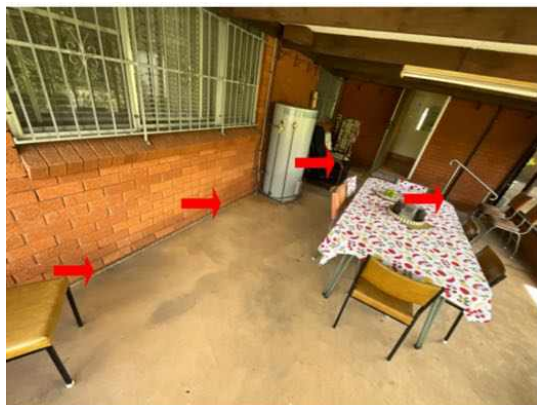
Location: Alfresco  
 Finding: Air vents - Blocked or inadequate  
 Information: It was noted at the time of inspection that the subfloor area lacks adequate ventilation. The cause of this inadequate ventilation is the state of the air vents to the subfloor area. Where air vents are insufficient in number or are blocked, either fully or partially, subfloor ventilation is decreased.

A well ventilated subfloor aids in maintaining dry conditions, preventing secondary damage such as wood rot and pest activity, as well as preventing the development of mould/fungi and mildew (which can lead to major respiratory issues or safety hazards for occupants, particularly the elderly, the very young and those with existing illnesses).

All air vents should be cleared of blockages to promote adequate air flow to the area. Where ventilation is still insufficient, retrospective installation of air vents may be required. Appointment of a registered builder may be required to perform these works as necessary.

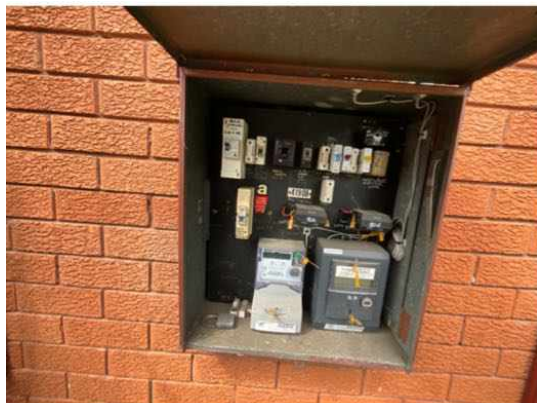
### Finding 6.02

Building: Main Building  
 Location: Meterbox  
 Finding: Termite Management System - no evidence of installation  
 Information: The application of a post-construction chemical termite barrier is highly recommended for all properties, particularly if live termite activity has been found on the site previously. Such barriers are highly effective in preventing termite attack on any timber building elements throughout the property.

A durable notice should be placed in the switchboard unit to indicate current termite barriers. At the time of inspection, it appeared as though no termite management system has been installed, with no evidence to suggest preventative works taking place.

The client may consider gaining further advice from a pest controller as to the costs and procedures involved with this application. It is recommended that obtaining such advice be a short-term priority.

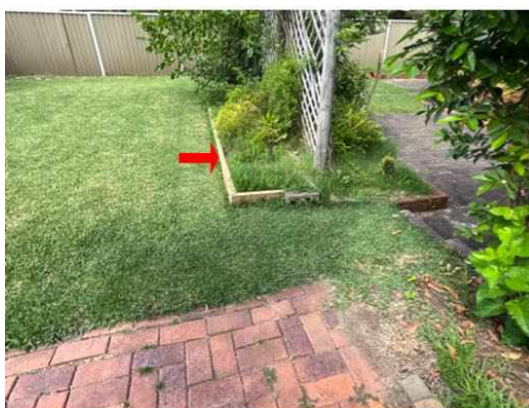
Information: Where timber elements are in direct contact with the ground and consequently moisture or dampness they become conducive to termite activity. Whether timber is used as a building element part of a fencing structure or stored as an unused item they can provide an environment that is attractive to termite infestation.

When met with excessive moisture timber begins to decay and develop wood rot. Any timbers that are in direct contact with external grounds especially if left untreated or non-durable also provide ingress for subterranean termites into that particular element.

The removal of any such materials that may be conducive to termite activity should be removed as soon as possible to minimise the risk of termite attack.

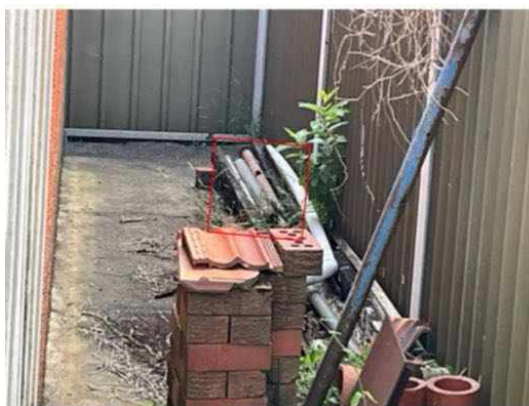
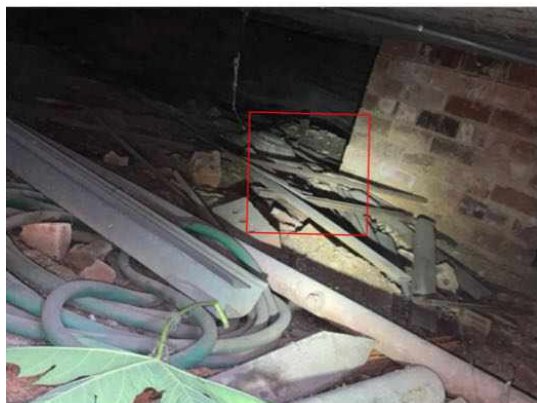
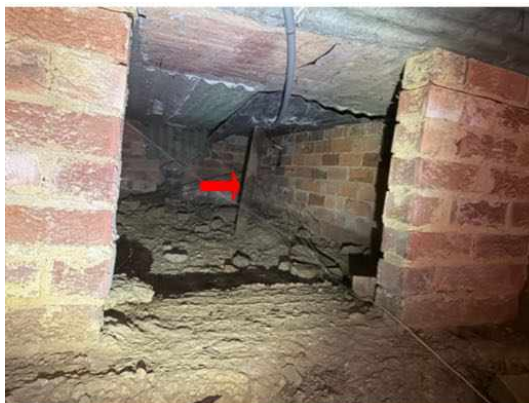
### Finding 6.05

Information: The storing of timbers in the subfloor space or around the external property increases the risk of termite activity being present. As they are likely to come into contact with weather conditions or excessive moisture wood rot is likely to develop on timbers that are not treated.

It is highly recommended that any stored timbers be immediately removed from areas in which they may attract any termite / timber pest attack. Minimisation of risk / prevention of termite attack is far more adequate than dealing with the presence of termite activity.

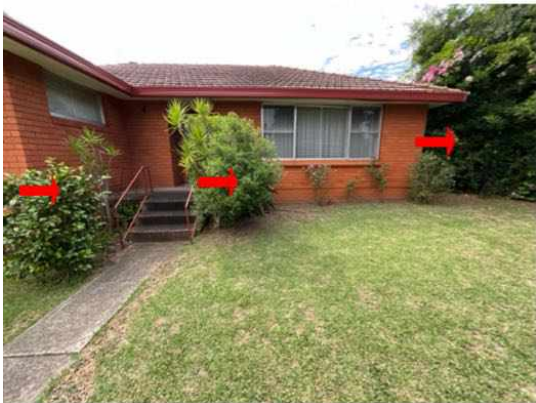
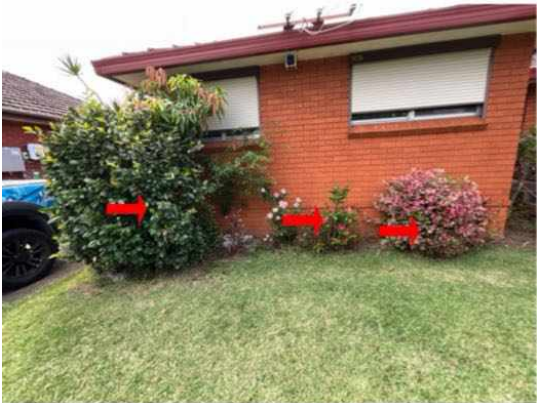
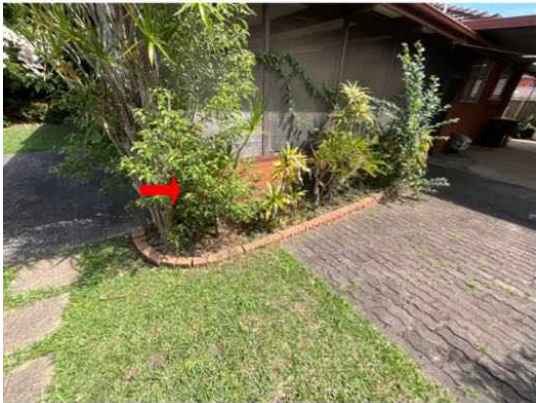
Building:	Main Building
Location:	Vegetation
Finding:	Vegetation - Abutting property
Information:	Vegetation against external wall may have an invasive root system. If there are weak points in the brick work or concrete slab, it is possible for the roots to gain entry into these areas. Once the roots have gained entry, it is possible for termites to gain concealed entry via these roots. It is recommended to remove the vegetation and root system where possible.
